SUBJECT: Historic Structures Survey Report, R-5836, Widening of US 601 from I-74 to SR 1104,
Surry County, ER 20-0821

HISTORIC STRUCTURES SURVEY REPORT

Widening of US 601 from I-74 to SR 1104 (Cody Trail), Surry County
TIP No. R-5836
WBS No. 47106.1.1
PA No. 18-05-0006

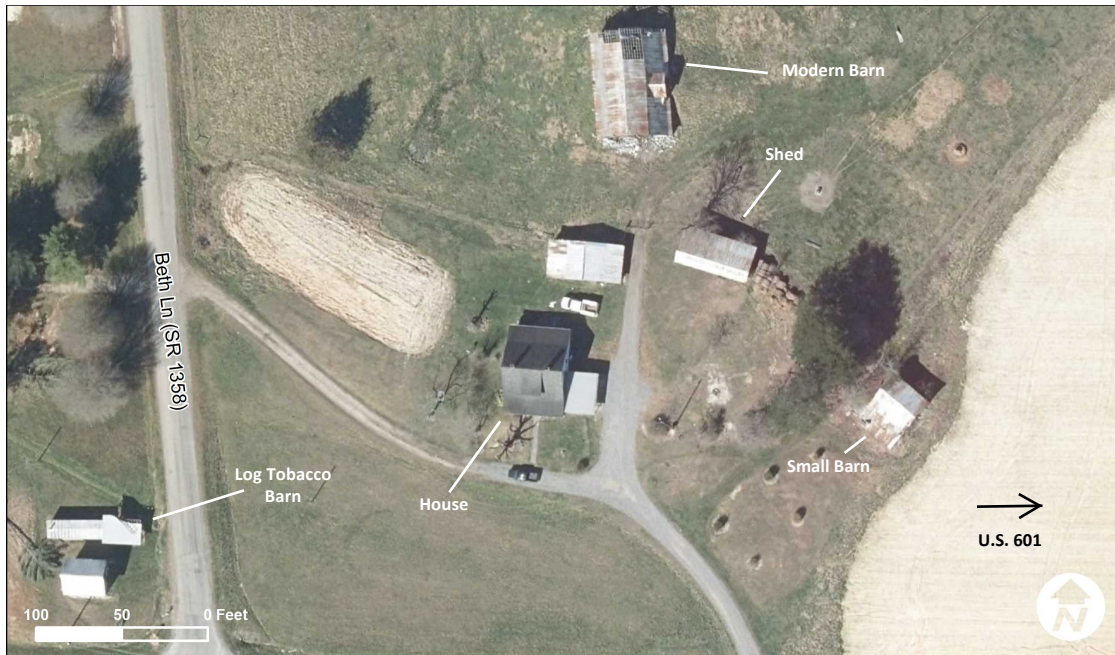
Figure 5: Site Map

Principal outbuildings consist of two early tobacco barns, and several twentieth-century structures including two cattle barns and two sheds. The tobacco barns are located west and south of the house. Both are of log construction, dating to the mid to late nineteenth century, and, like those on the Draughn-Barnes and Lambert Farms in this study, were moved from previous locations. The barns both have stacked stone foundations and v-notch corner joints. To the north and east of the house are a woodshed of frame construction with a shallow-gabled corrugated metal roof, and a general-purpose framed shed with a corrugated metal shallow-gable roof. A large feed barn with cinderblock walls and a

gambrel roof, open at each end and constructed of corrugated metal, stands north of the farmhouse. A smaller wooden barn with a corrugated metal gable roof is located due east.¹⁰

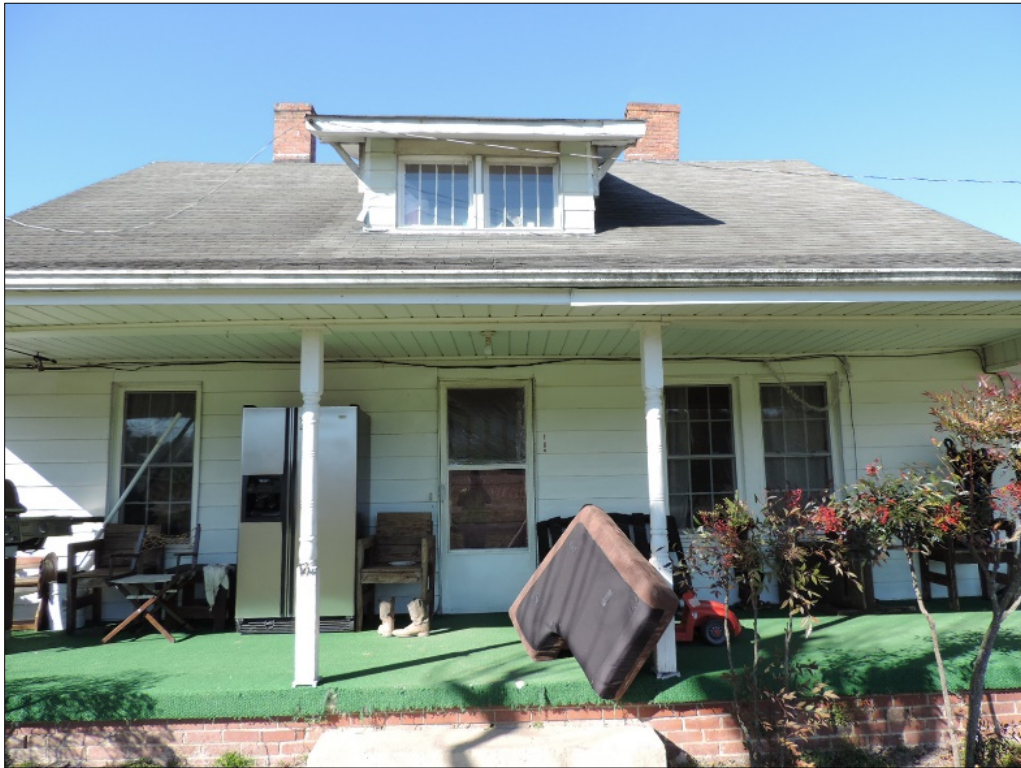
The southern, or front, elevation is entered by a single-leaf door, with four vertical panes of glass separated by wooden mullions on the top third, and what appears to be three horizontal inset wood panels on the lower two thirds (the door was partly obscured by an aluminum storm door and plastic sheeting). To the west of the door is a single double-hung six-over-six window, and to the east are a pair of identical windows. Four turned wooden posts, which are replacements, support the porch roof and rest on a poured concrete floor supported by a brick foundation. The house is occupied by renters, and the interior could not be accessed for evaluation.

Figure 6: South elevation detail

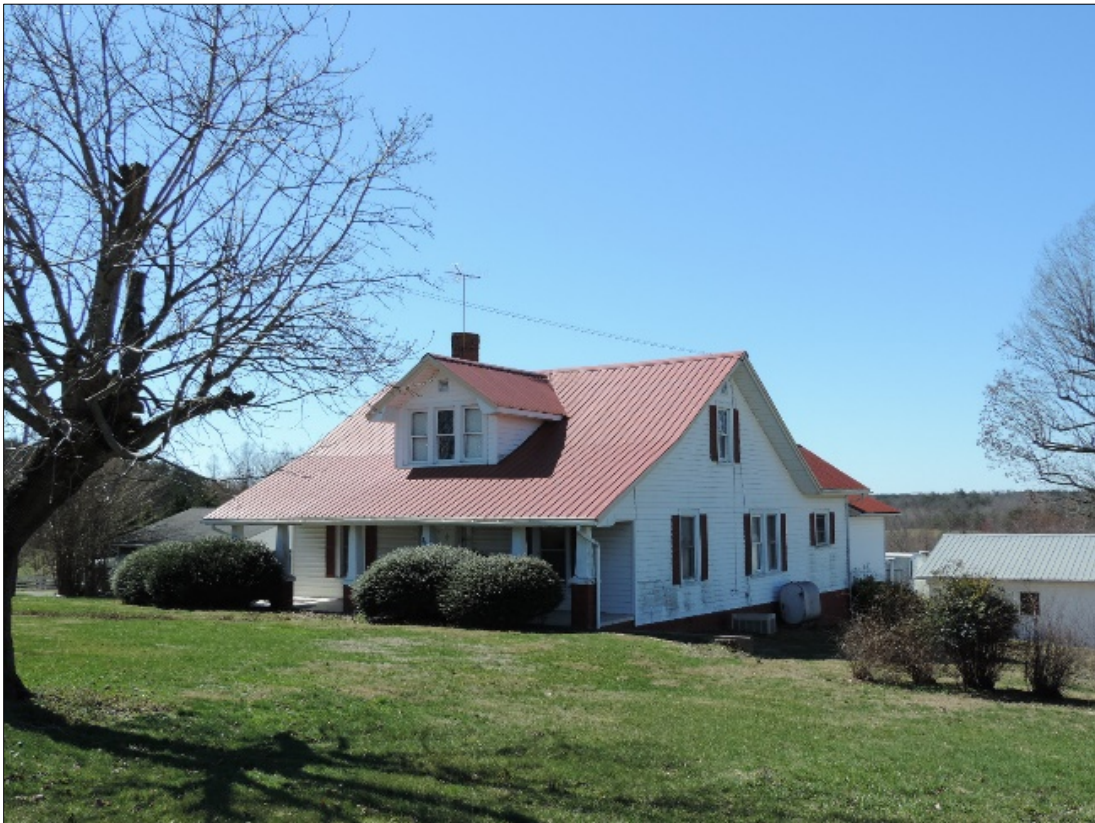
In terms of farmhouses, the nearby ca. 1925 example outside of Mt. Airy (2482 Siloam Road, Figure 17) is an excellent comparable to the Nichols House. Also anchoring a large farmstead, this rural example is less compromised architecturally than the Nichols House, retaining much of its original fabric as well as outbuildings. The house is well-proportioned but very simple, with no visible Craftsman architectural details such as knee braces, exposed rafter tails, or other trim.

Figure 17: Bungalow farmhouse, ca. 1925, 2482 Siloam Road, Mt. Airy

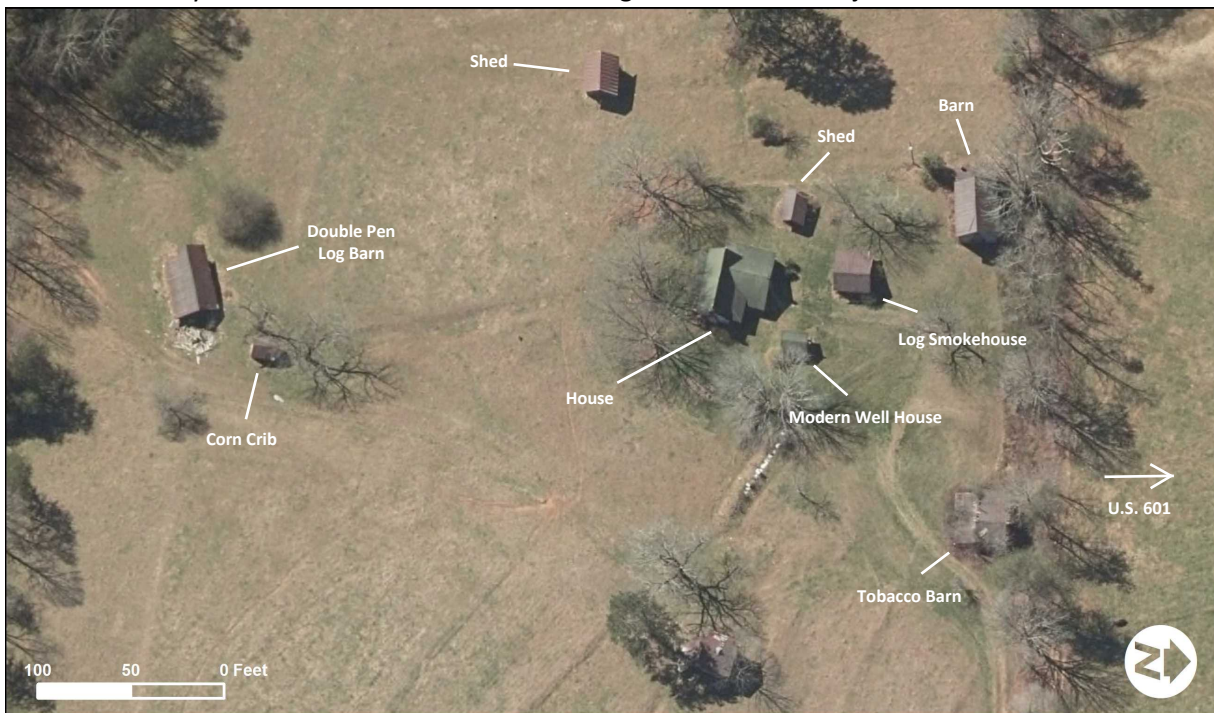
The farmstead consists of eight principal outbuildings. The earliest of these appears to be the large nineteenth-century, double-pen log barn with later standing seam metal roof, and the smaller log corncrib, also with a later standing seam metal roof. Both of these structures extend due south of the main house, down a fairly steep slope. An early log smokehouse is present north of the house, along with a later frame feed barn, tobacco barn, and two sheds (one of which is slightly southwest of the house). All of these structures are of frame construction with metal roofs of various ages. A late twentieth-century cinderblock well house with a shingled roof is located just northwest of the house.

Figure 34: Site Map

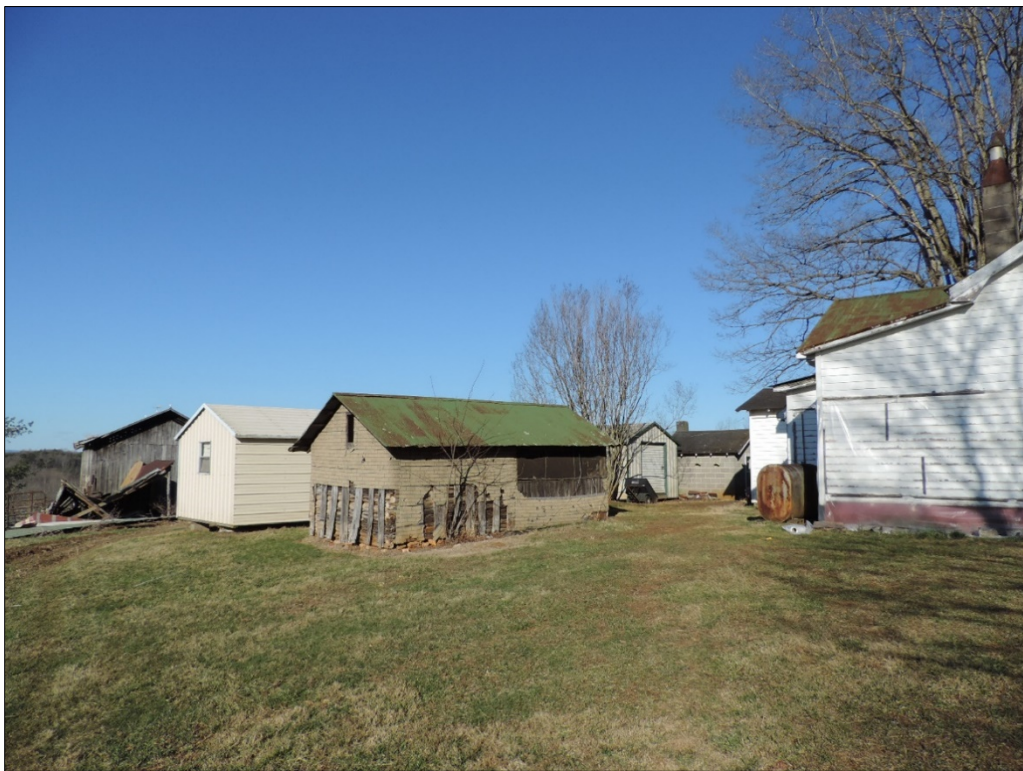
shingled roof (Figure 66). The remaining sheds and barns are twentieth century, and of frame or metal construction. Large pasture land stretches north and west of the house, and hayfields dot the landscape.²⁸

Figure 66: Looking northwest behind house; collection of twentieth century sheds and outbuildings

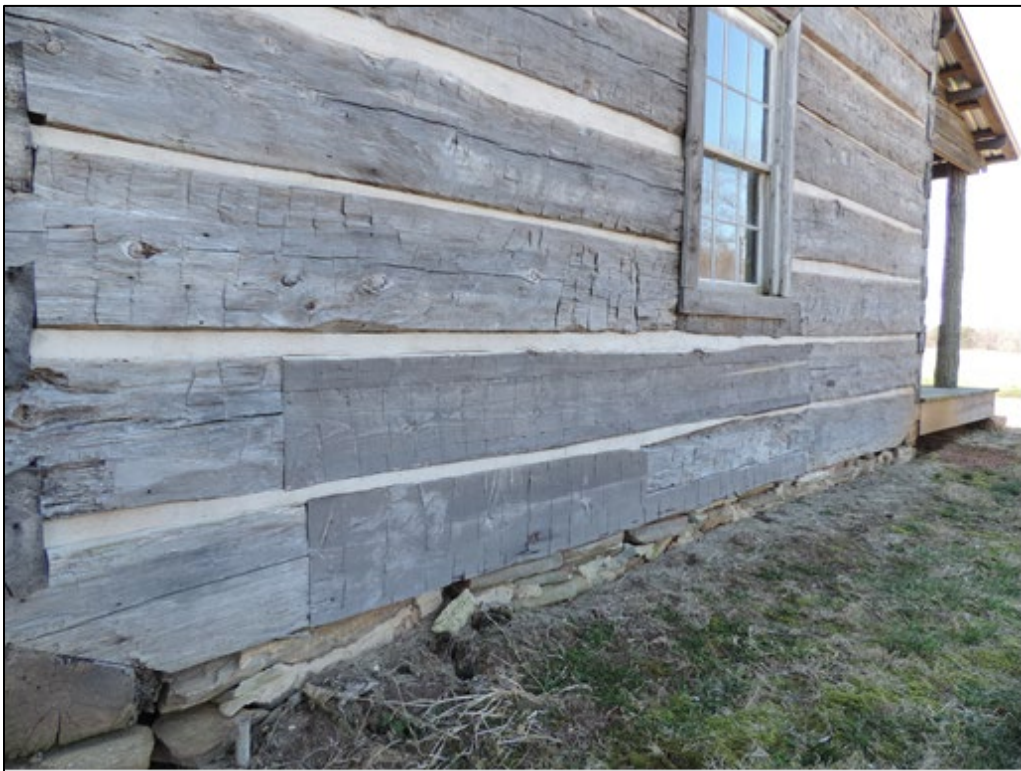
Figure 109: Detail of repaired original logs and new chinking on northwestern elevation

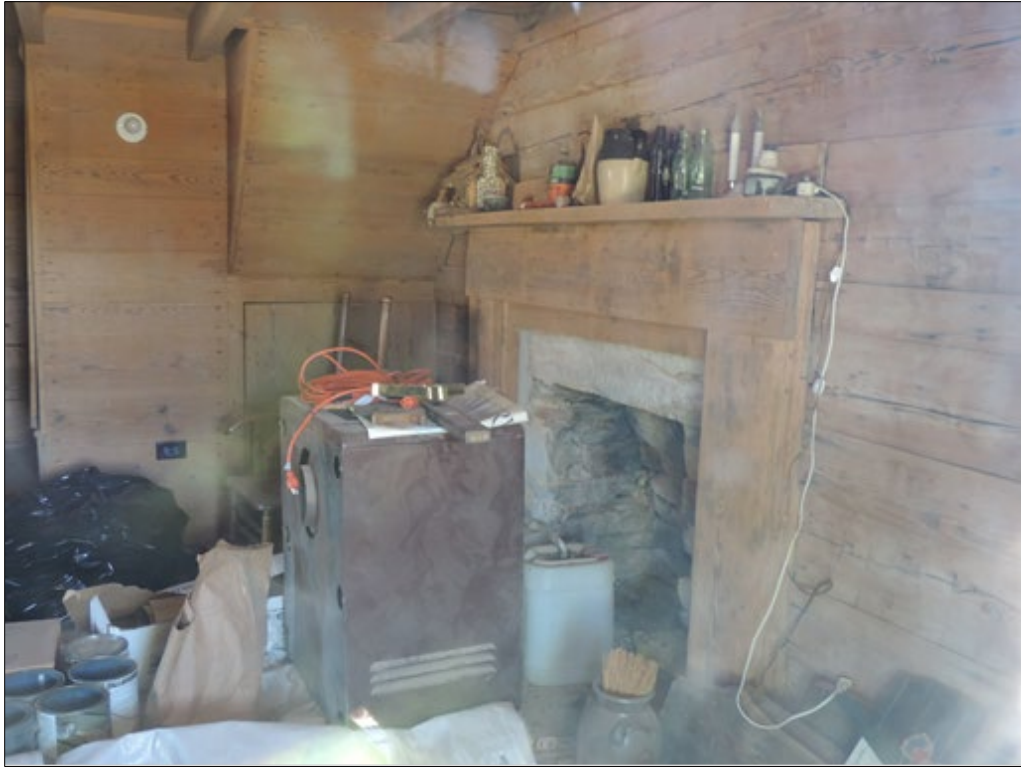
Figure 110: Interior view of the "hall," showing original plank walls, fireplace surround, and enclosed stairs to loft

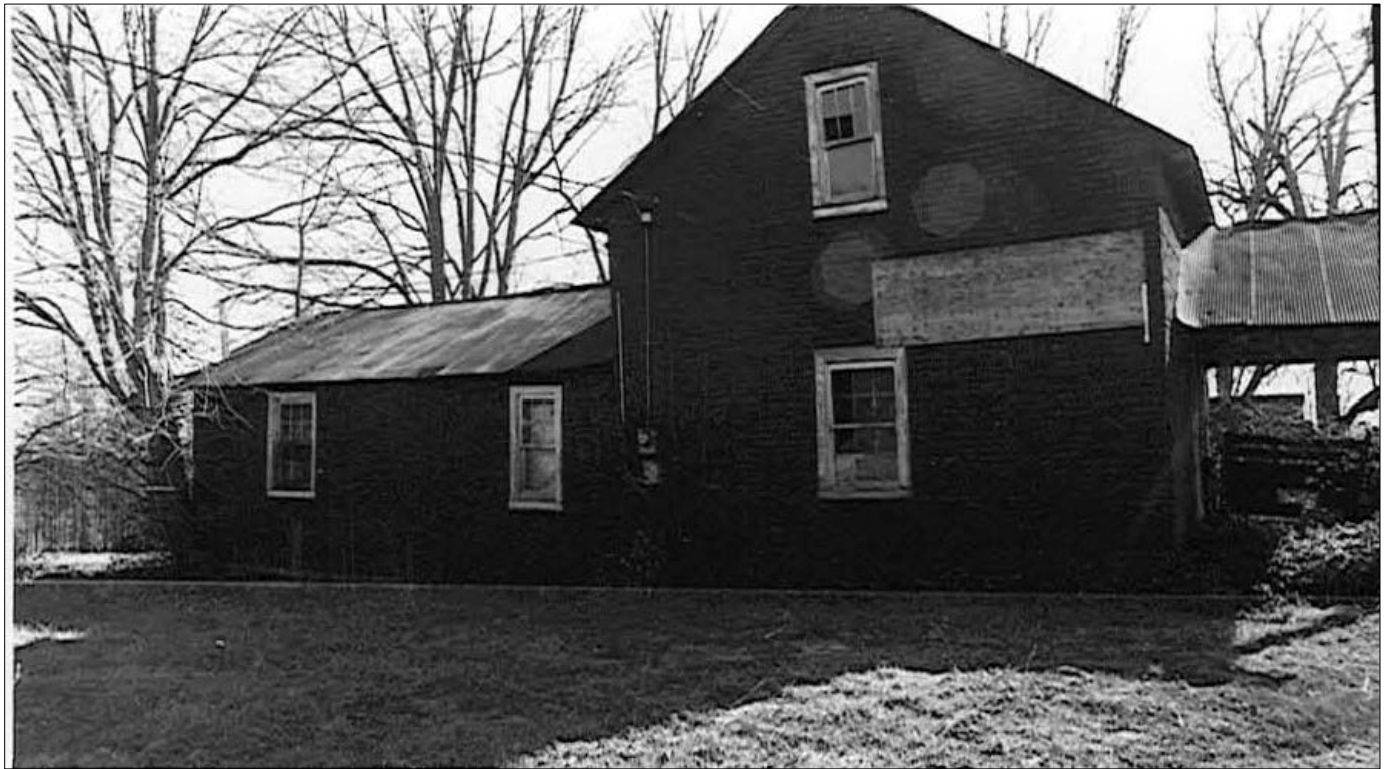
Figure 114: Northwestern elevation, 1981, showing later additions and siding (HPO Survey Files)
