Re: Construct residential development, Young property, 10209 Morrisville Parkway, Morrisville, Wake and Chatham Counties, ER 20-1107

**Historic Structures Survey Report: Bartley Yates Farm,
10209 Morrisville Road, Apex, North Carolina
Wake and Chatham Counties, North Carolina**

Historic Structures Survey Report Bartley Yates Farm, Wake and Chatham Counties, North Carolina

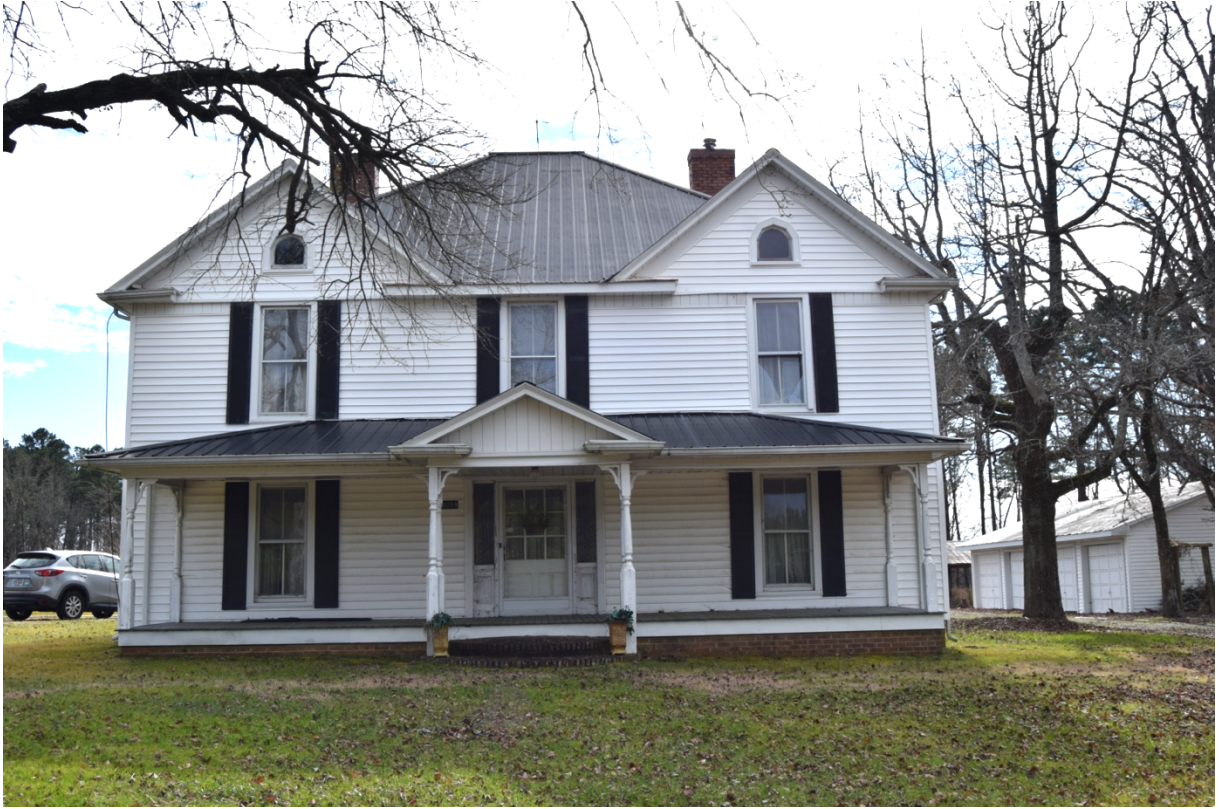
The Yates House is a two-story, double-pile, transitional Queen Anne-Colonial Revival dwelling with high hip roof, decorative attic gables with end returns, interior brick chimneys, and a hipped front porch with gabled entry bay. Windows are generally 2/2 sash, although some 4/4 sash are in evidence at the rear elevations and on a rear ell. The two-room, single-story ell has a hipped roof and an interior brick chimney. An open porch with the same turned posts and brackets edges the west side of the ell, and a screened porch is at its east elevation. Alterations in the last quarter of the twentieth century include installation of a continuous brick foundation and replacement steps at the front and side porches; vinyl siding that covers the walls and eave trim; metal roofing; faux shutters; and storm windows. Much of the interior trim in the double-pile part of the house, including the stair balustrade, has been sandblasted to remove the paint. The porch columns have likewise been sandblasted. A kitchen was installed in the north room of the rear ell around 1980, and much of the wall between that room and the rear west room of the double-pile house has been removed to open the two rooms to each other.

The façade is three bays wide, reflecting the dwelling's center-hall plan. The two end bays each have an attic gable lit with a round-arched sash. Side elevations, in contrast, have a single attic gable positioned between the windows that light the front and back rooms of the double-pile depth. Instead of a window, the side gables feature a round vent with carved covering. At the back of the house, original features of the earlier dwelling that now forms the rear ell are largely missing or obscured by later changes. The west side has a five-paneled single-leaf door paired with a four-over-four sash window in the rearmost room. A four-over-four sash window set sideways (to accommodate the twentieth-century kitchen remodel) pierces the west side of the ell's front room. The east side has four-over-four sash and a single-leaf, partially glazed paneled door. They overlook a screened porch that extends to the east toward the back of the rear ell to shelter a well. A passage and bathroom are tucked into two tiny additions appended to the east and south sides of the rear ell at its southeast corner.

Dwelling, Bartley Yates Farm, façade (N elevation), view to south.

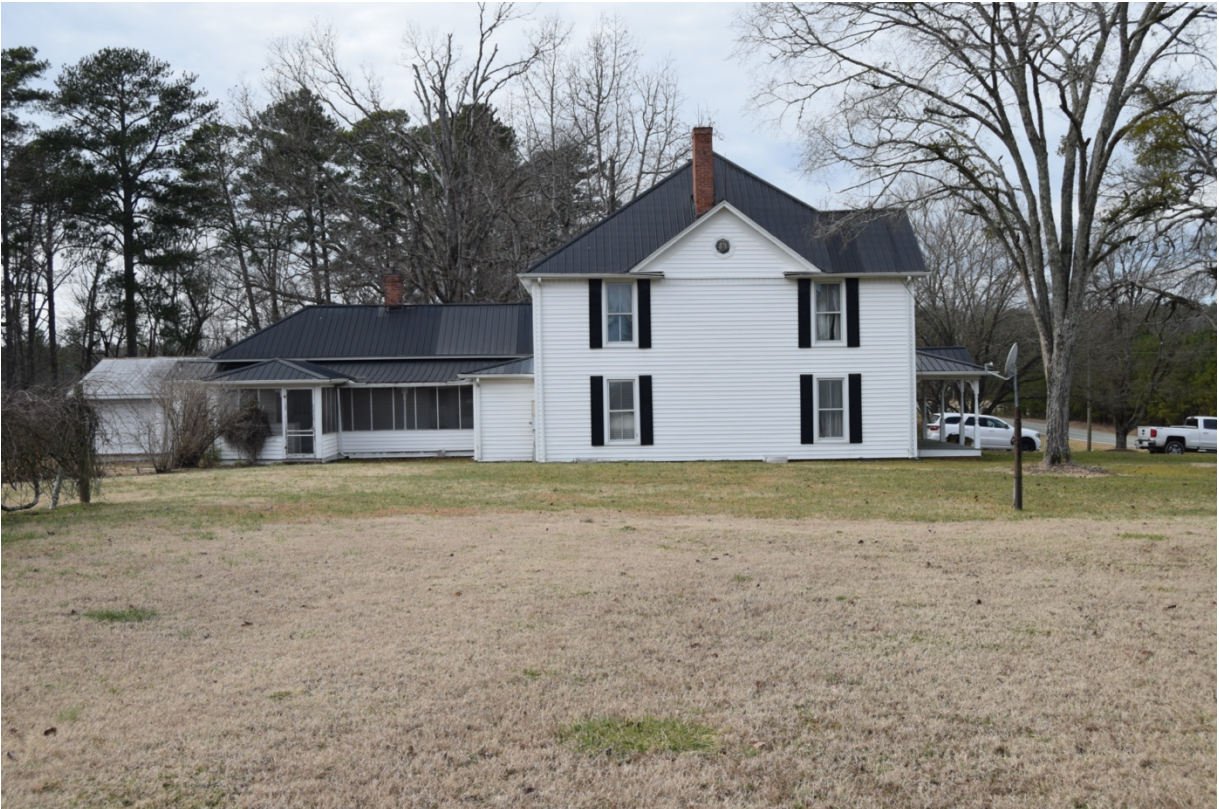
Dwelling, Bartley Yates Farm, E elevation, view to west.

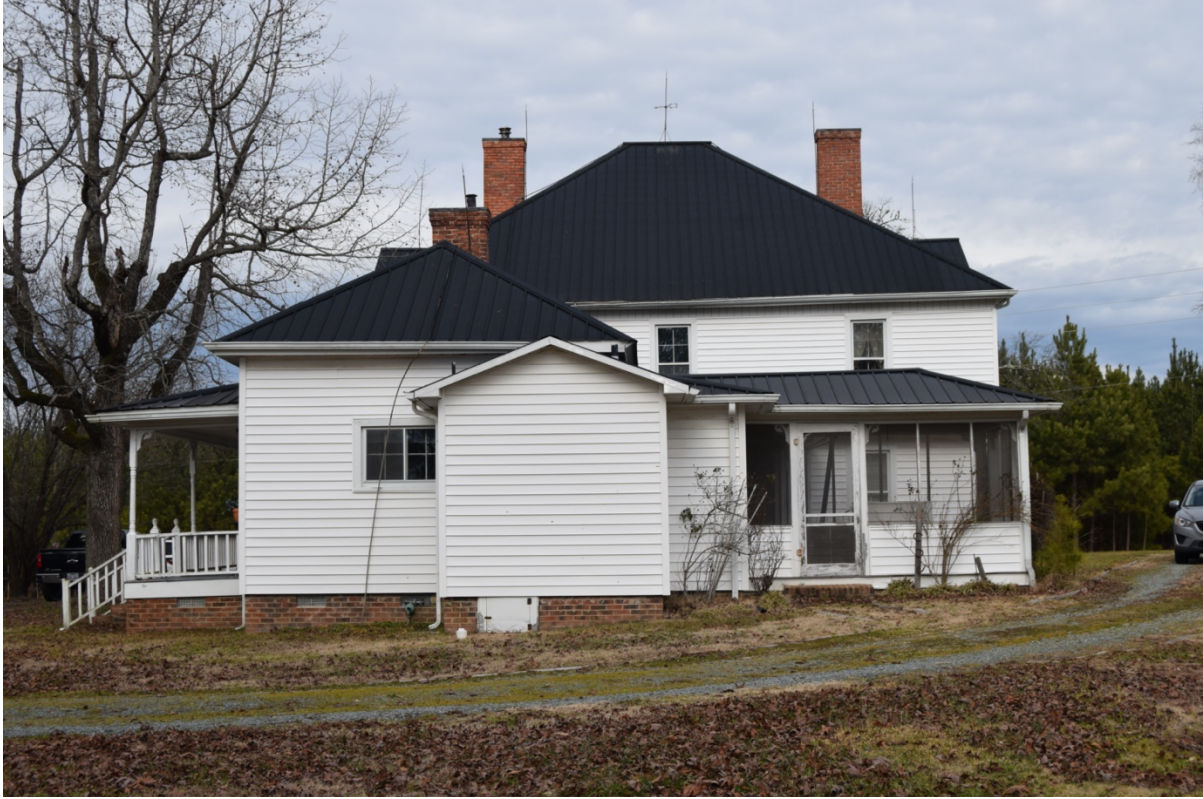
Dwelling, Bartley Yates Farm, S (rear) elevation, view to north.

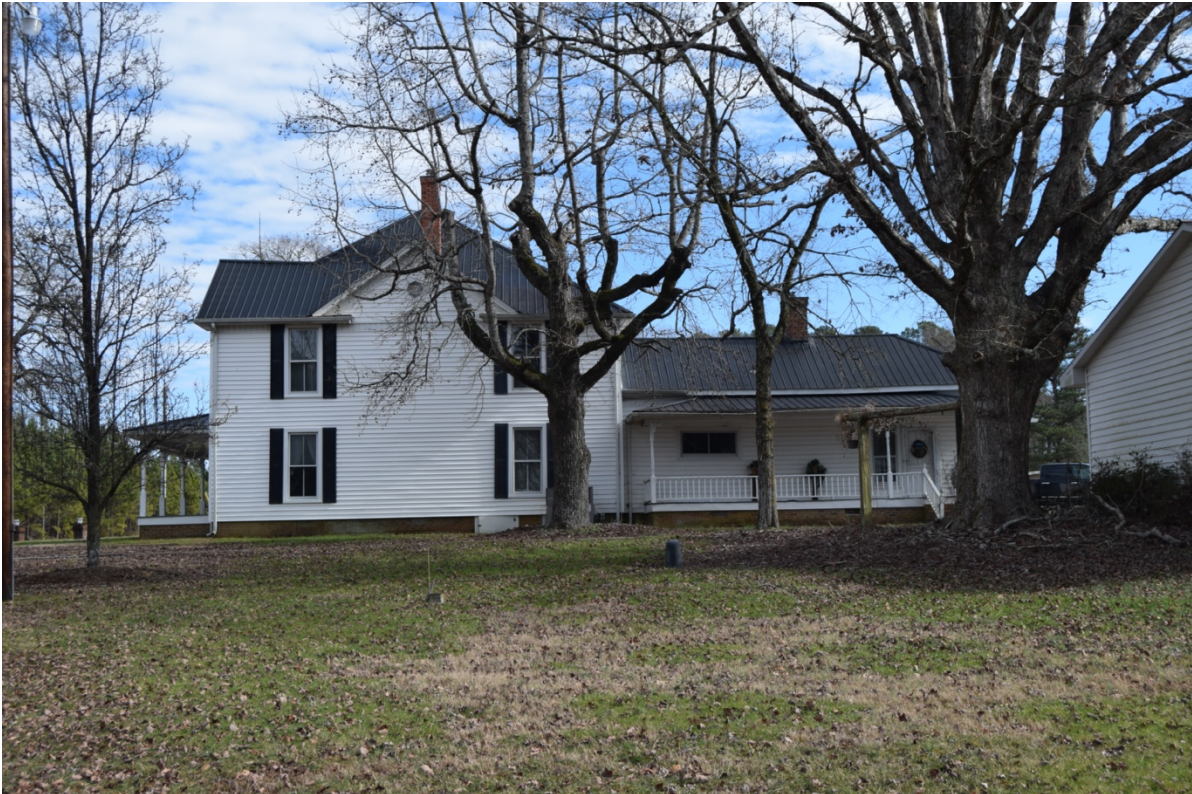
Dwelling, Bartley Yates Farm, W elevation, view to east.

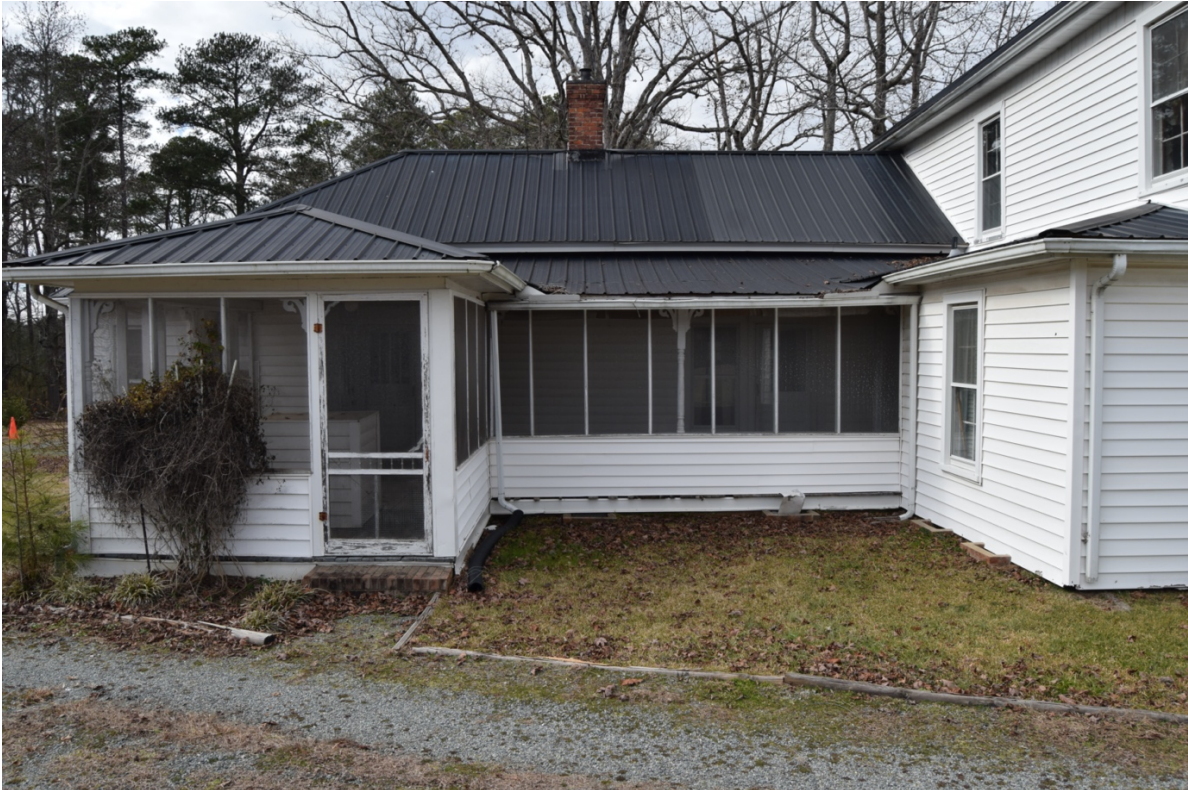
Dwelling, Bartley Yates Farm, enclosed well at S end of E screened porch, view to west.

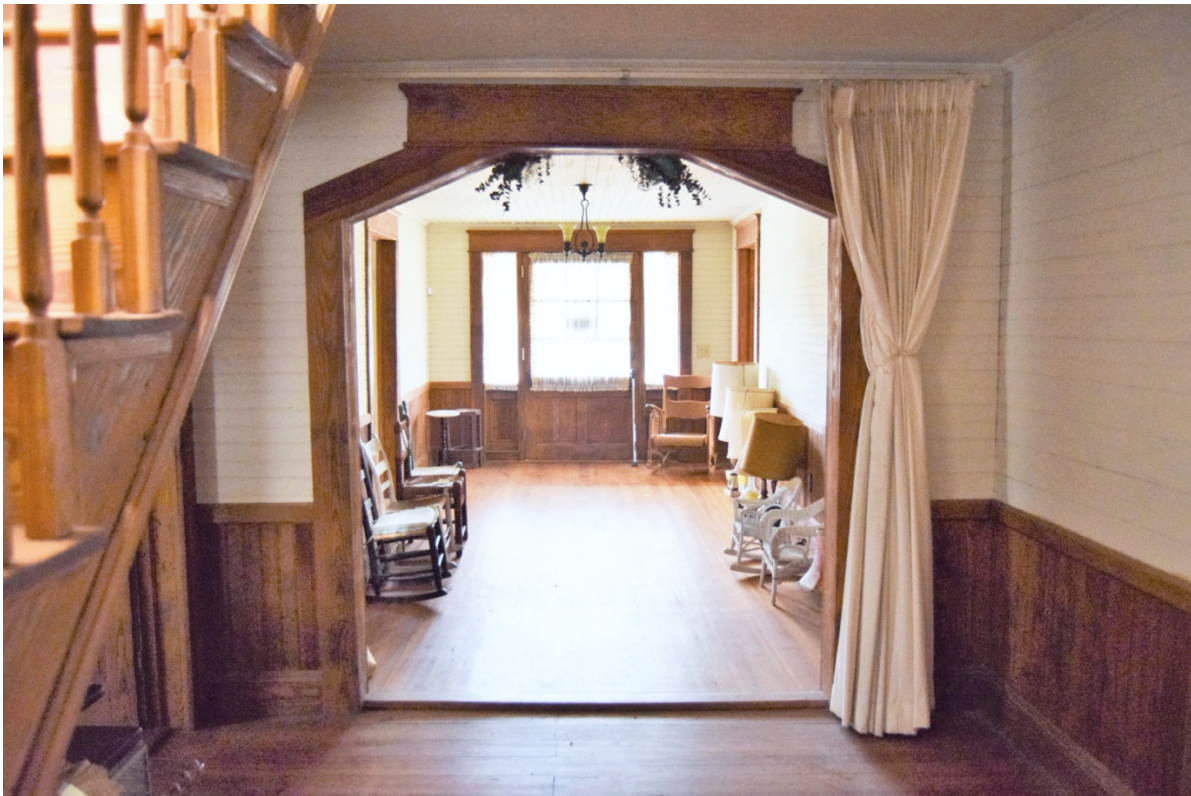
The dwelling's interior features four rooms at each story in addition to the center hall. A straight-run, open-stringer stair with turned balustrade rises from the back of the hall toward the front of the house. Exterior doors are at either end of the hall, and each room is accessed from this common space. An added set of French doors also provide connection between the two rooms on the west side at the first floor.

Dwelling, Bartley Yates Farm, center hall, view N to front door.

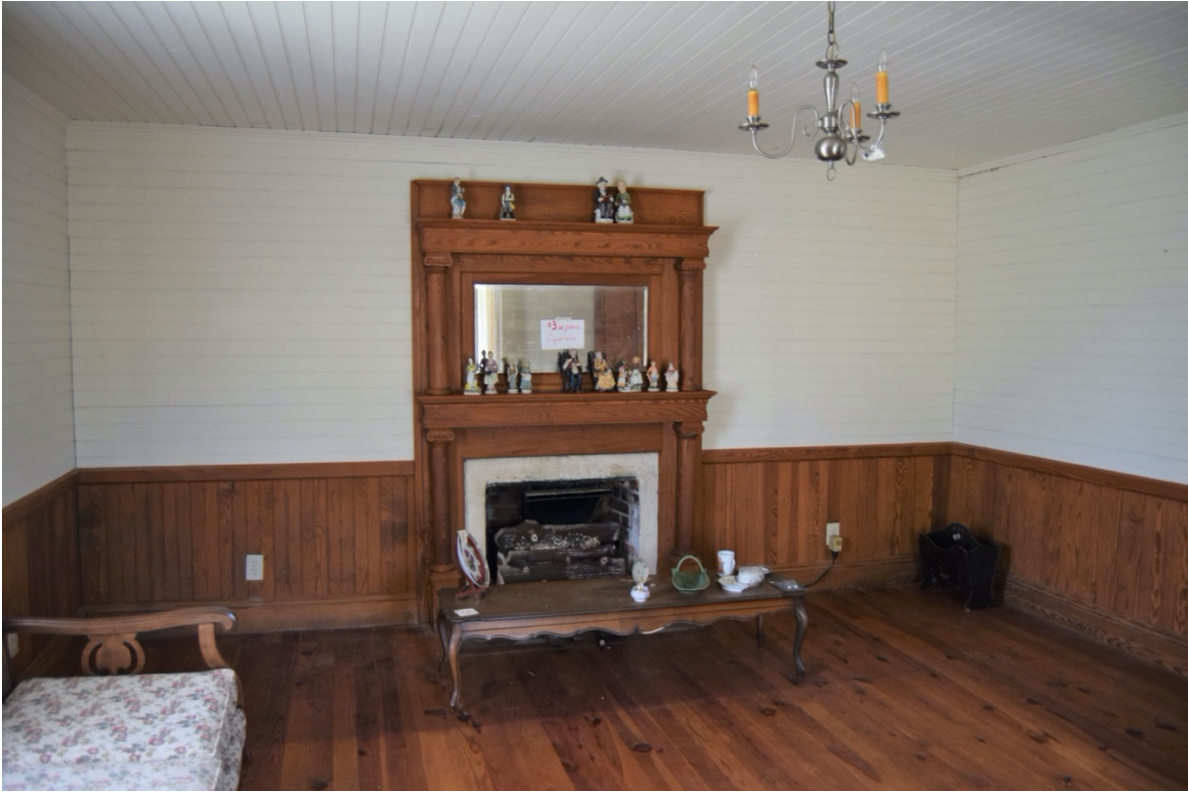
Fireplaces are in three of the four rooms at the first floor. Mantels are common Colonial Revival-style mail-order designs that include pilasters, plain lintels, and molded shelves. In one case, there is also a mirrored overmantel. Two mantels in the second story's front rooms are simpler post-and-lintel types with plain shelves. They do not appear frame a firebox and they do not have hearths; they seem to have been installed just to accent a wood or gas stove, although none are extant. They are positioned to allow a stove pipe to feed into the chimneys.

Dwelling, Bartley Yates Farm, front east room, view southwest.

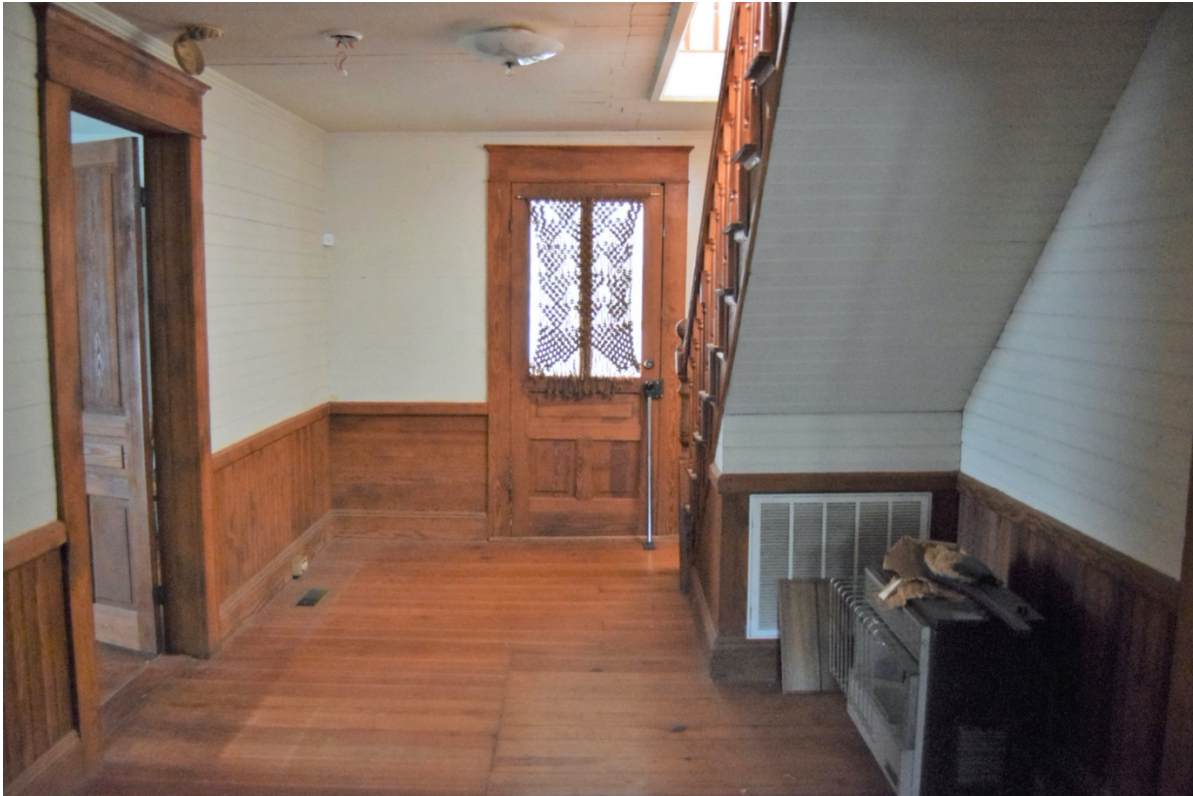
Dwelling, Bartley Yates Farm, center hall, view to south.

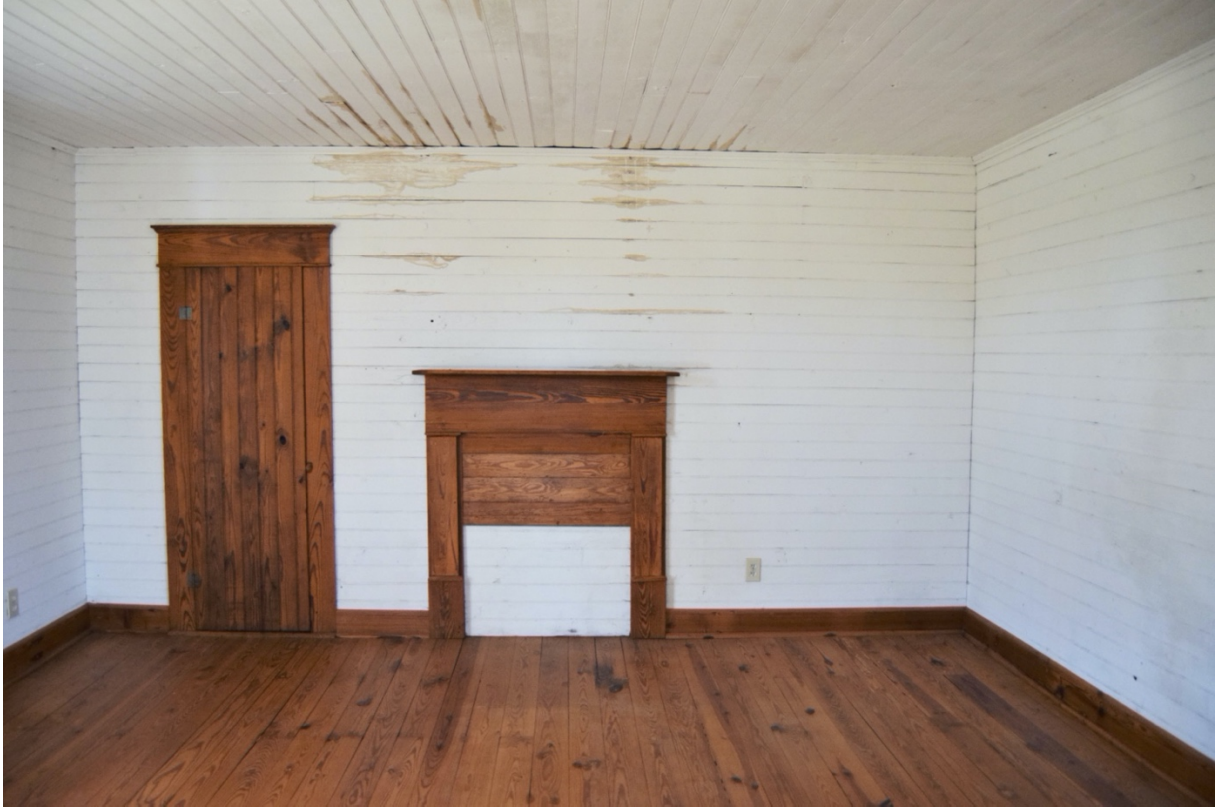
Dwelling, Bartley Yates Farm, front west room at second floor, view to south.

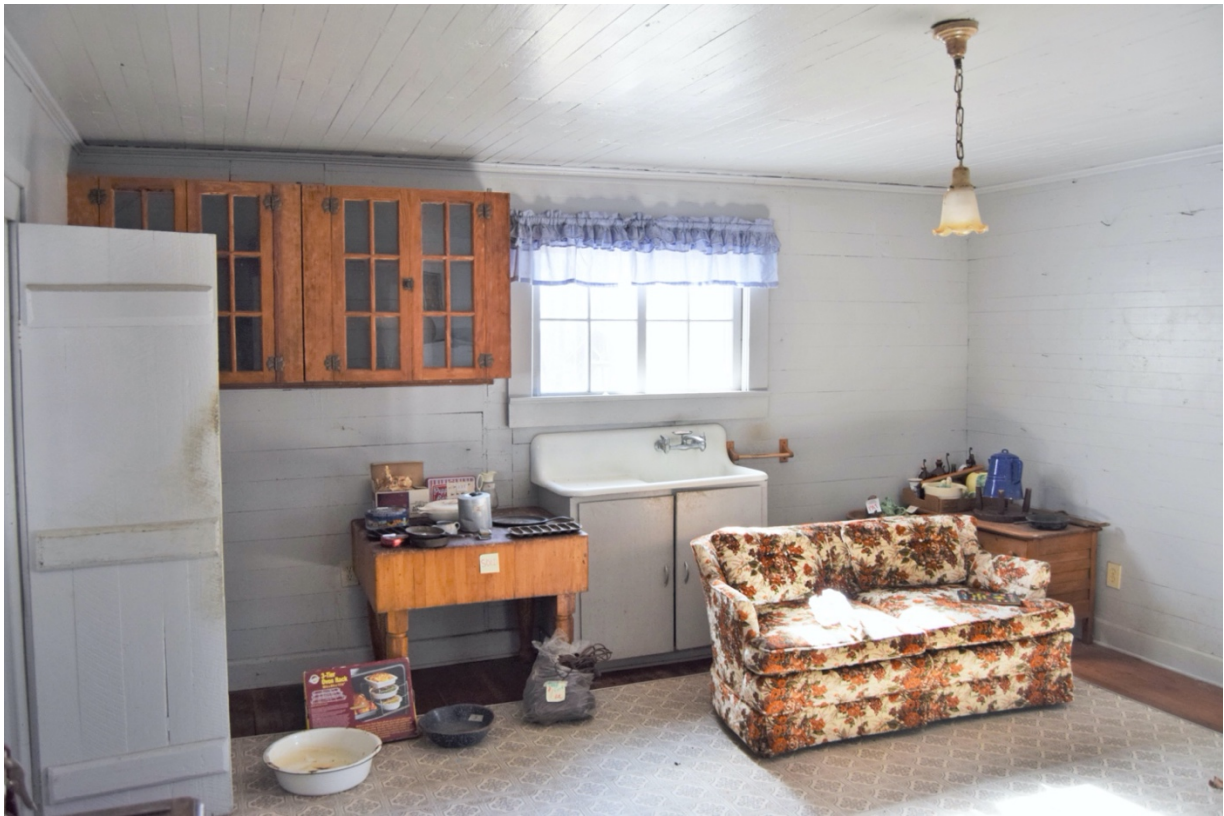
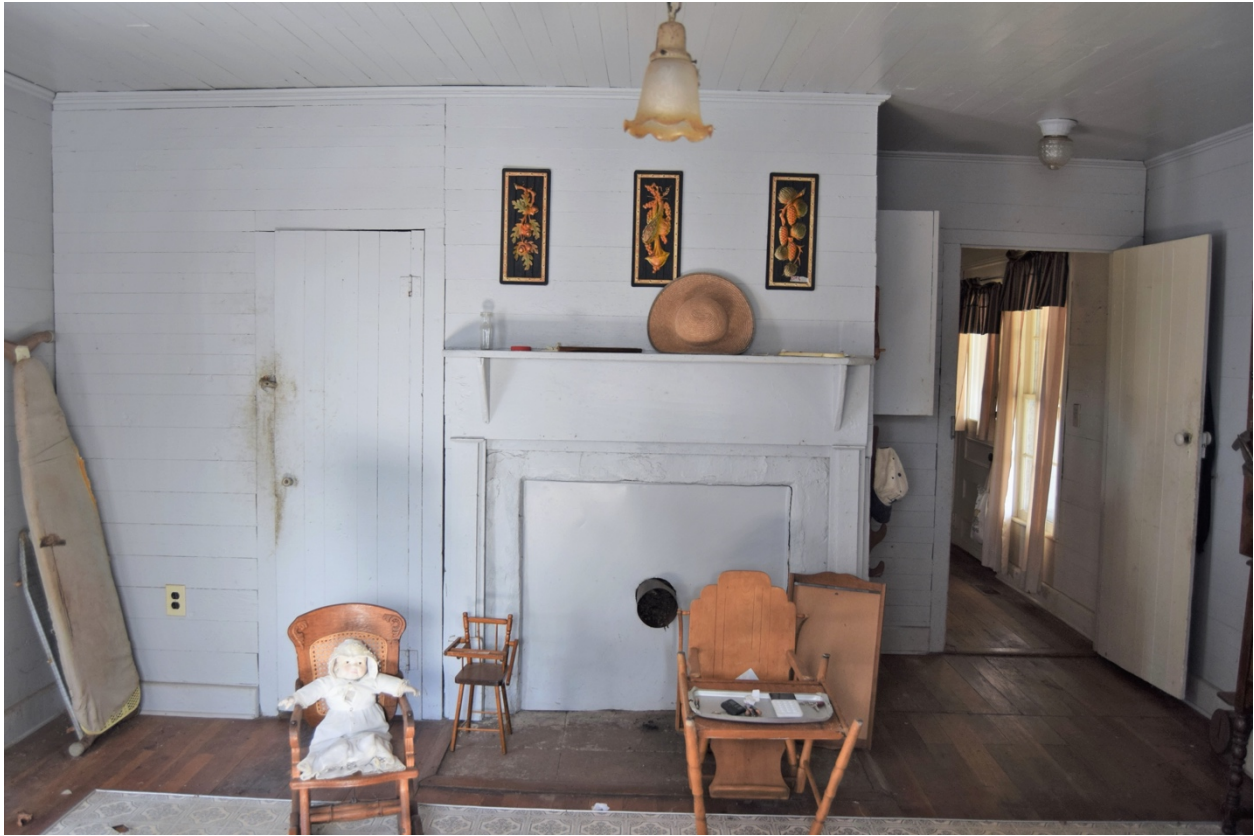
The interior of the rear ell features flush-board wall sheathing as well as wood floors and ceilings and crown and base molding in both rooms. The front room has been converted into a modern kitchen in the late twentieth-century, including a wide opening into the southwest room of the two-story section. The rear room has a vernacular mantel with plain shelf on triangular brackets. The firebox and chimney project into the room and the former is enclosed for use with a stove, now removed. To the left of the fireplace is a closet with vertical plank door. The ell has 4/4 sash partially-glazed paneled exterior doors that were added sometime in the twentieth century.

Dwelling, Bartley Yates Farm, back room of rear ell, view to southwest.

Dwelling, Bartley Yates Farm, back room of rear ell, view to northeast.

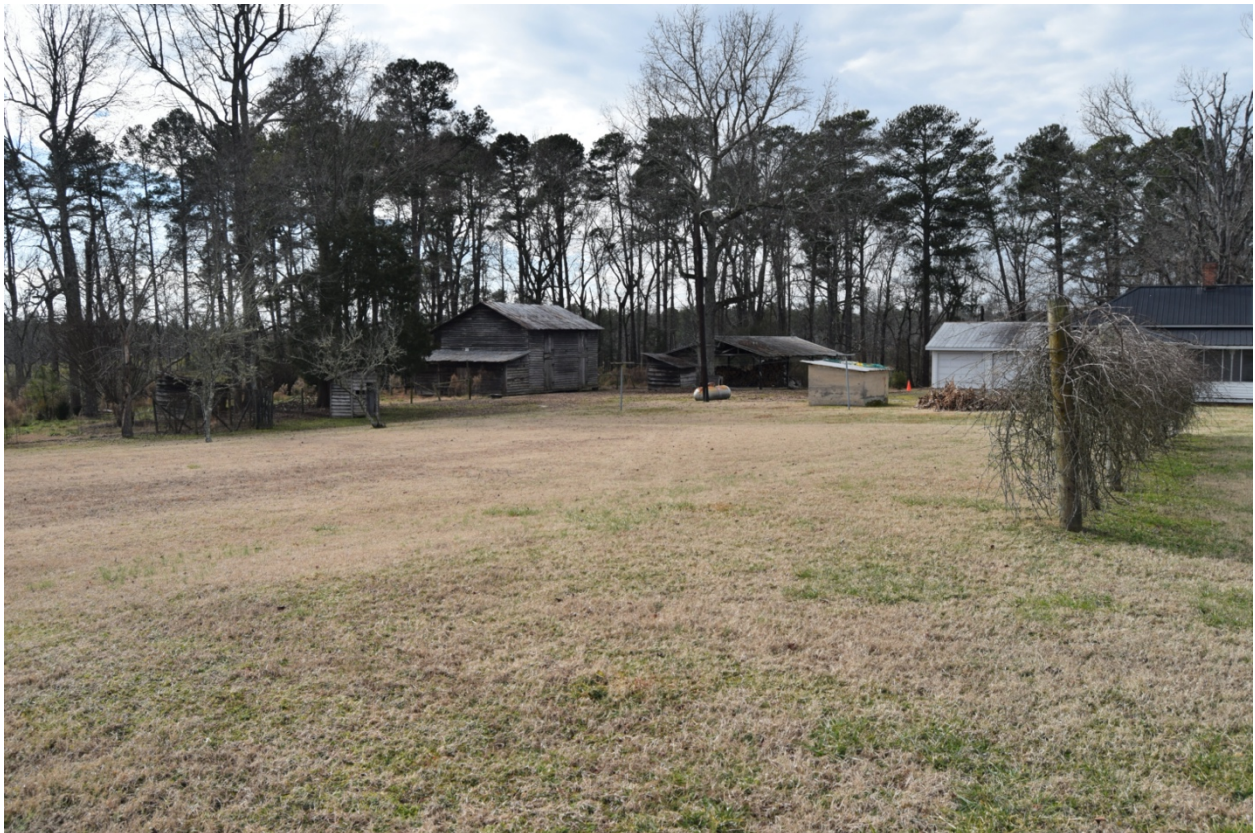
Grape arbor fashioned with wood posts and wire rungs stands directly east of the house in an open field. Although the grape arbor is not documented in earlier surveys, it was a common element in twentieth-century farmsteads across Wake County. It appears on the earliest aerial on the Wake County iMaps system, which is from 1981 and likely dates at least to mid-twentieth century.

Grape arbor (at right) and farmstead, Bartley Yates Farm, view to southwest.

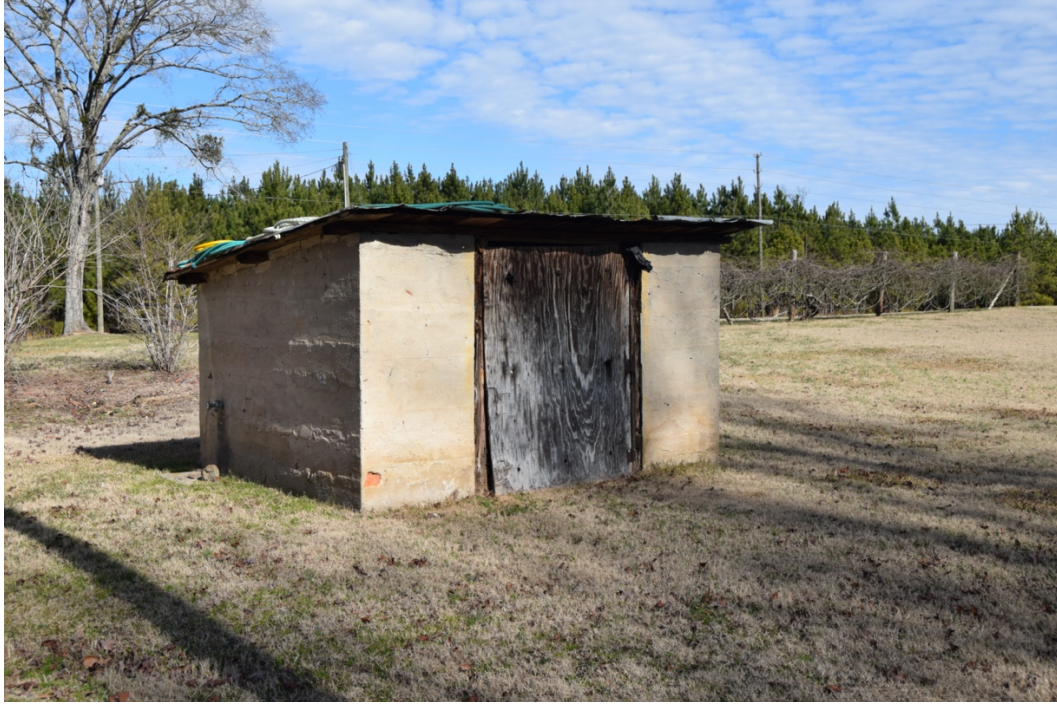
Shed-roofed, concrete-block structure stands immediately east of the house on the opposite side of the drive that circles around the back of the house.

New well, Bartley Yates Farm, view to northeast.

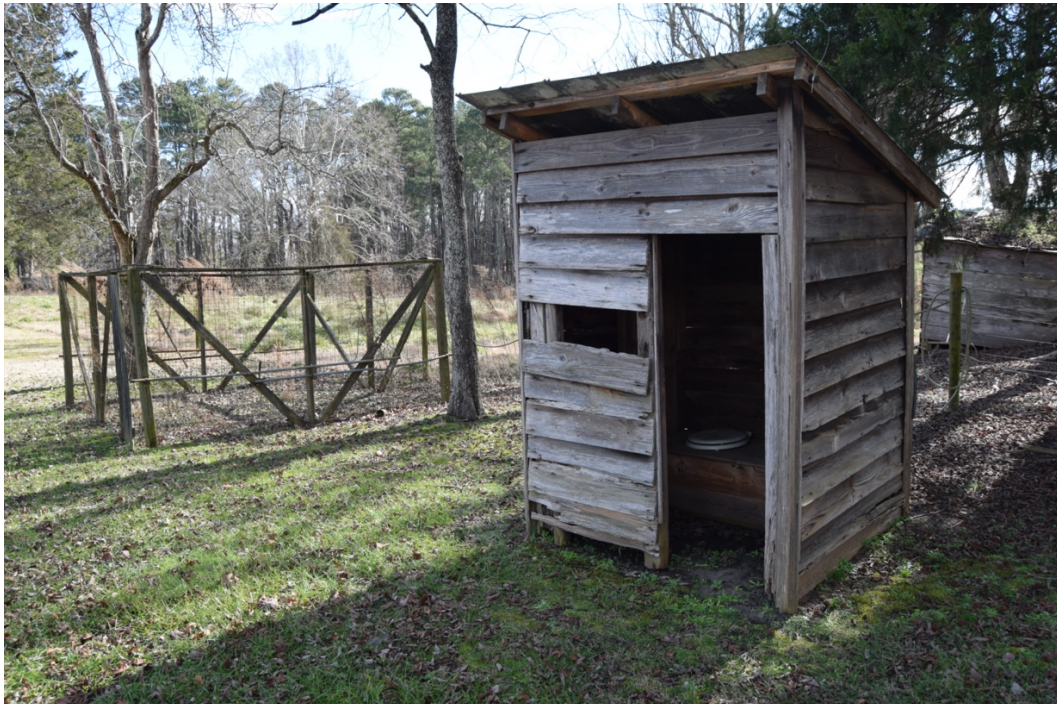
A shed-roofed, frame outhouse with weatherboard exterior stands southeast of the new well.

Outhouse, Bartley Yates Farm, view to southeast.

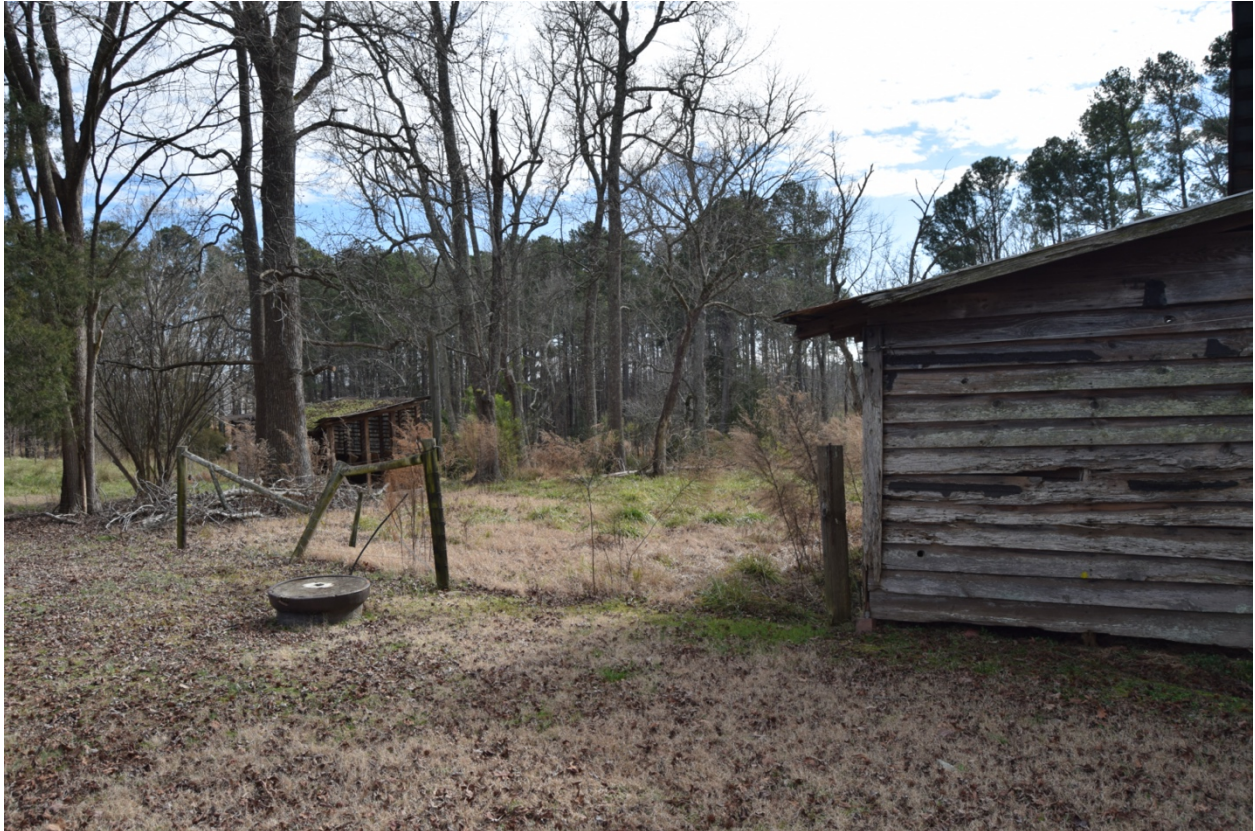
This well was previously documented with a pump still attached. The pump has been removed but the concrete cap remains. It is just north of the hay barn.

*Well (at foreground left), chicken house (background left) and hay barn (foreground right),
Bartley Yates Farm, view to southeast.*

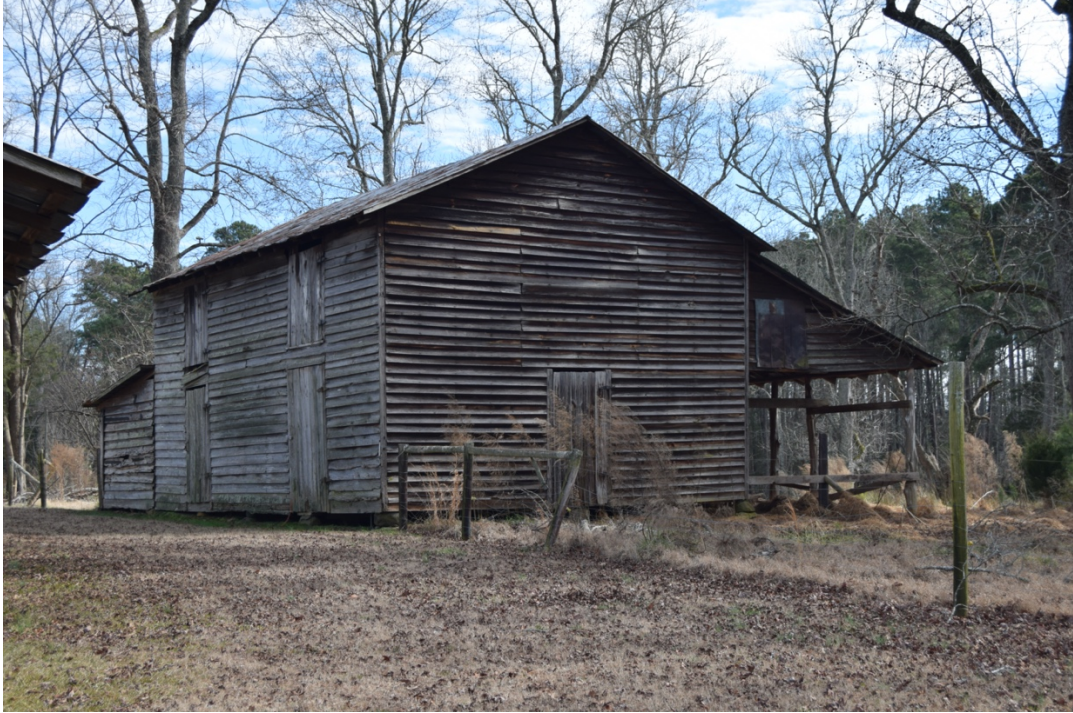
Frame, gabled barn of two stories stands south of the house. The weatherboarded barn has two doors at each level on its east side and a single-story shed-roofed room at the east side. A wide, open shed at the south side provides shelter and shade on the pasture side of the barn. Fencing encloses the pasture. The barn has a metal roof.

Hay barn, Bartley Yates Farm, view to southeast.

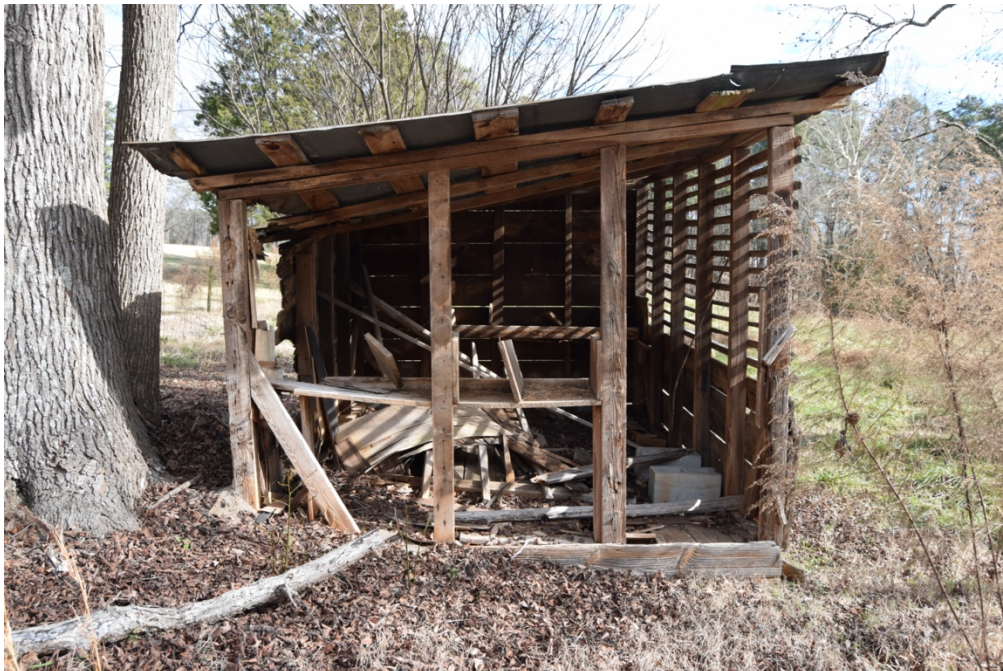
A shed-roofed chicken house with weatherboard siding and metal roofing stands in the pasture to the east of the barn. A section of the south side of the shed has open slats. The east wall is missing and a portion of the north wall is also gone.

Chicken house, Bartley Yates Farm, view to east.

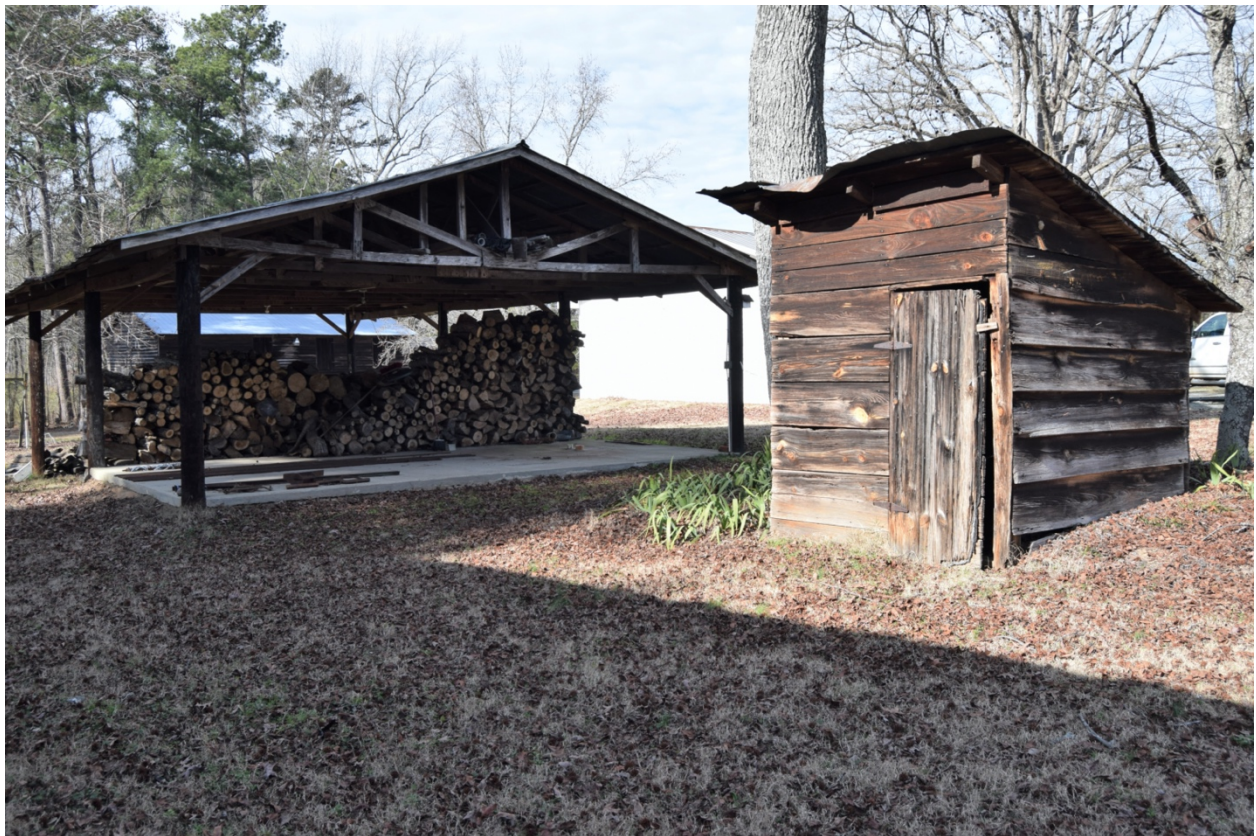
Frame, shed-roofed building with plank siding and metal roof. Interior walls are lined with hooks. The building stands north of and faces the hay barn.

Built of squared timber posts and kingpost roof trusses with metal roof and exposed rafter tails. Older survey refers to this structure as “rebuilt.”

Equipment shed (at left) and ice house, Bartley Yates Farm, view to northwest.

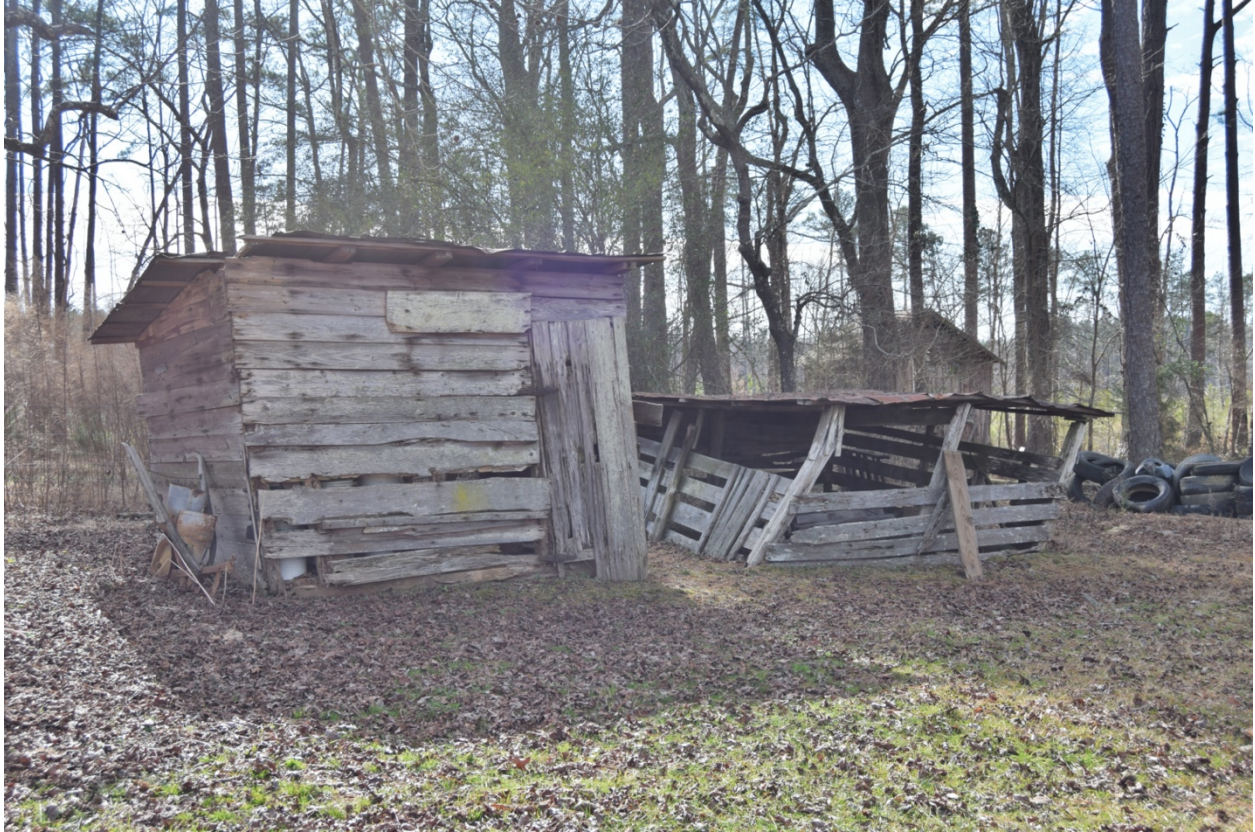
Shed-roofed frame building with horizontal plank siding, metal roof. The building stands west of the hay barn and immediately east of the pig pen.

Frame pen with metal roof and slatted sides; stands immediately west of the potato shed.

Pig feed house (at left) and pig pen (at right), Bartley Yates Farm, view to southwest.

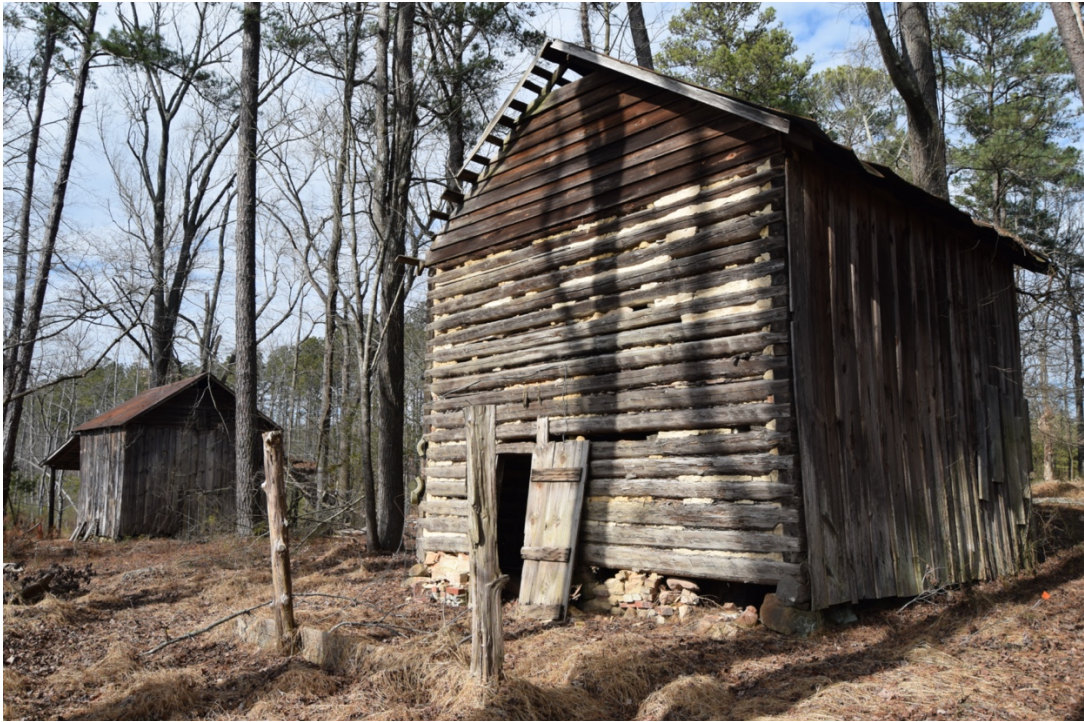
Log tobacco barn with some remaining vertical board sheathing and metal roofing, stands on brick and stone foundation southwest of the farmstead and south of the grading house. No sheds remain.

Log tobacco barn with some remaining vertical board sheathing and metal roofing, stands on brick and stone foundation west of tobacco barn #1. The barn has sheds on the west and north sides.

Tobacco barns, Bartley Yates Farm, view to northwest.

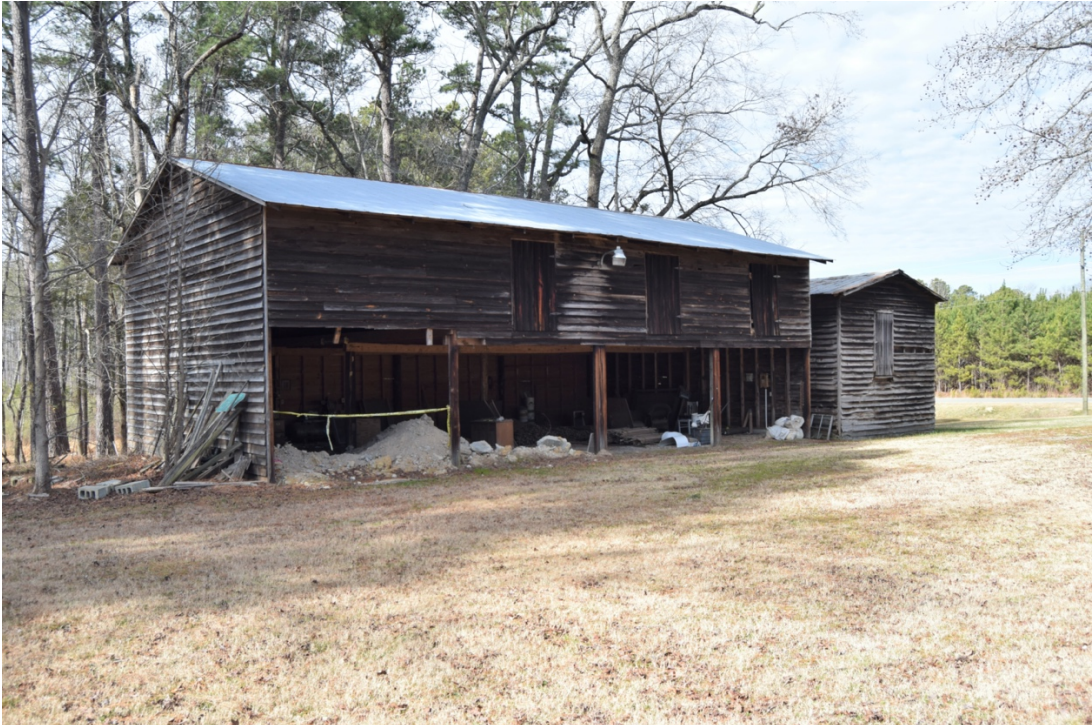
A broad, frame, side-gabled two-story building with four open bays at the first floor's east elevation and plank doors at the second story above. The building stands immediately south of the pack house, west of the dwelling.

Two-story gabled building with two windows on the north-facing eave end and a plank door at the east gable ends' the second-story. A door at the first story is at the south elevation. The building stands immediately north of the grading house, west of the dwelling.

Grading house (at left) and pack house (at right), Bartley Yates Farm, view to northwest.

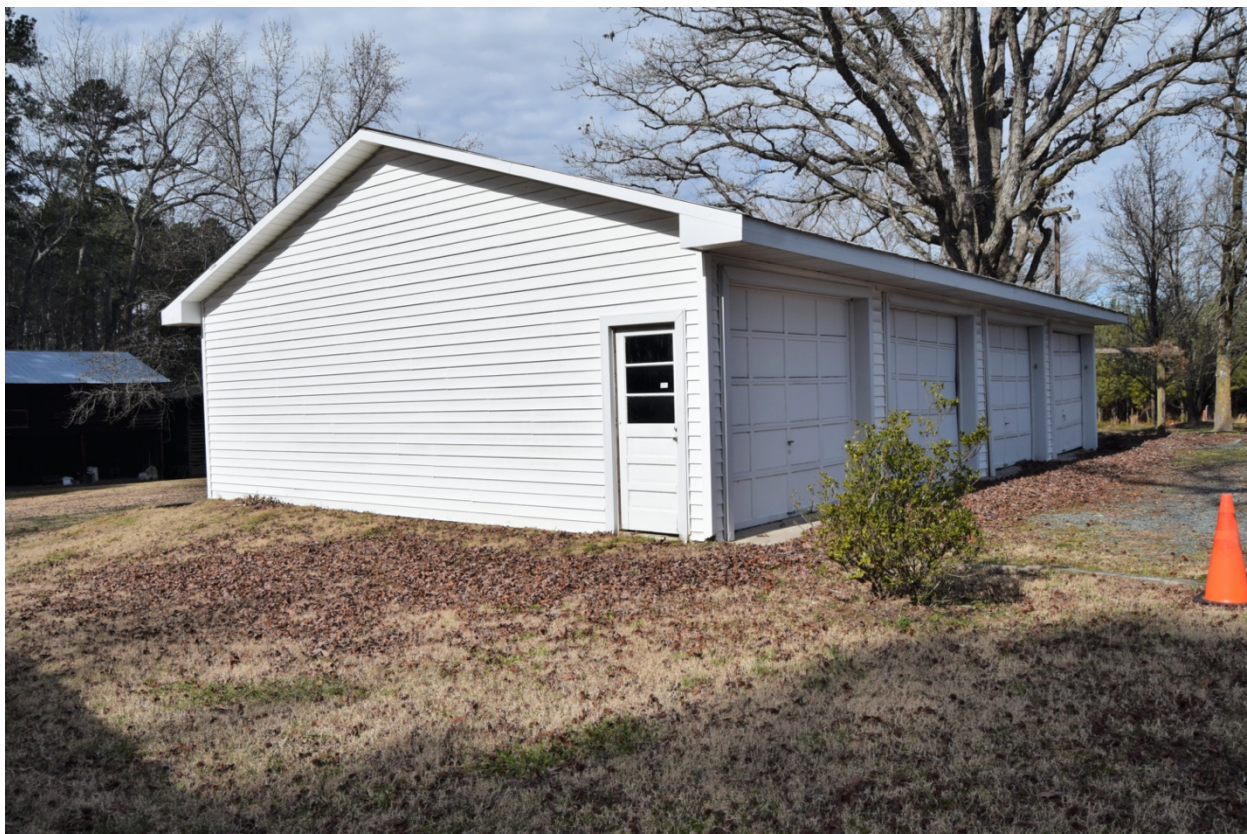
Side-gabled, four-bay frame garage with vinyl siding and metal roof. Bay openings face east to the house and a single-leaf door is on the south gable end. The garage stands west of the house on the opposite side of the driveway.

Garage, Bartley Yates Farm, view to northwest.
