Re: Construct residential development, Young property, 10209 Morrisville Parkway, Morrisville, Wake and Chatham Counties, ER 20-1107

**Historic Structures Survey Report: Bartley Yates Farm,
10209 Morrisville Road, Apex, North Carolina
Wake and Chatham Counties, North Carolina**

Historic Structures Survey Report Bartley Yates Farm, Wake and Chatham Counties, North Carolina

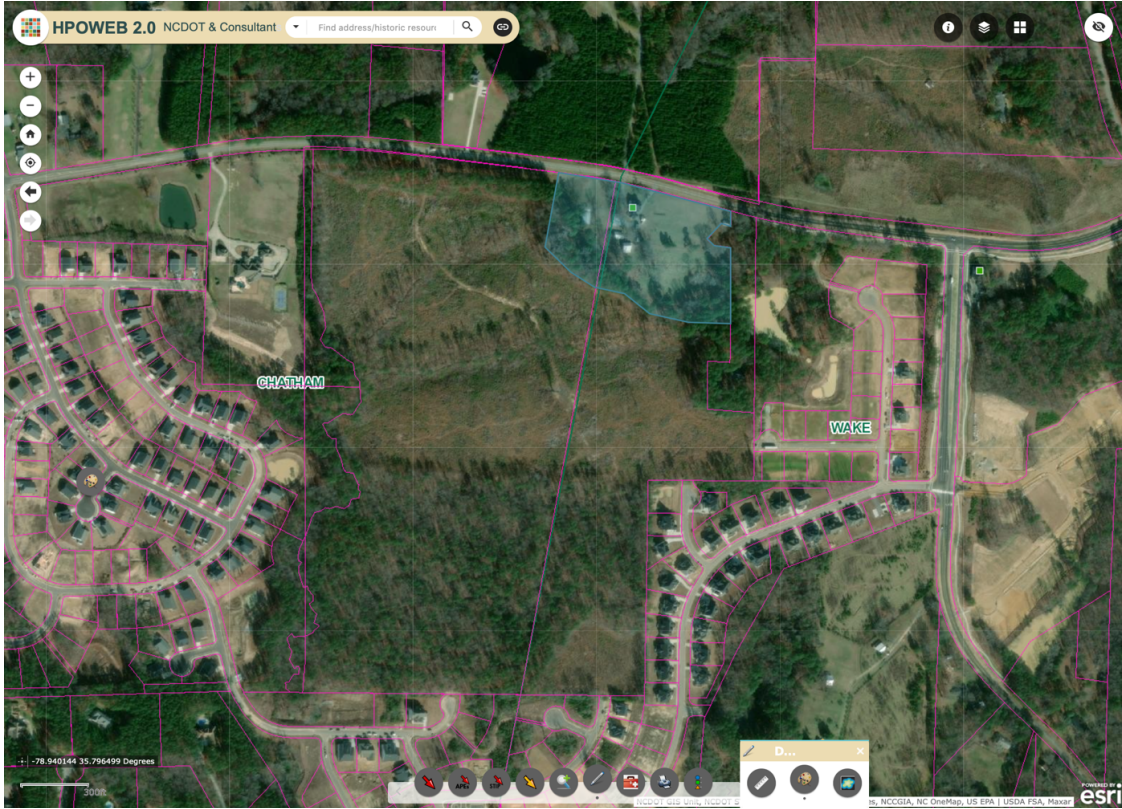
The recommended boundary for the Bartley Yates Farm is depicted in Figures 4 and 5, below. As described above, the majority of the farm was not tilled, and the location of the historically tilled acreage is not known. Comparing the 1969 aerial to a current aerial (see Historic Background) shows the farmstead is little changed from that period; it continues to be framed by wooded areas to the south and west and with open land east of the dwelling to the edge of the parcel. The proposed boundary, then can be described as follows: Beginning at the northeast corner of the parcel, follow the north parcel line west to a point 275 feet west of the county line. The boundary then turns southwest for 335 feet along a line parallel to the county line. The boundary then turns roughly east and follows along the south edge of the tree line until it meets the east parcel line. The boundary follows the east parcel line north to the start at the northeast corner of the parcel. This boundary encompasses all surviving buildings in the farmstead, the open land to the east that was likely used for a home garden, and the open land south of the hay barn that was likely used for pasture.

Figure 4. Proposed Boundary, Bartley Yates Farm, 10209 Morrisville Road, Wake & Chatham counties

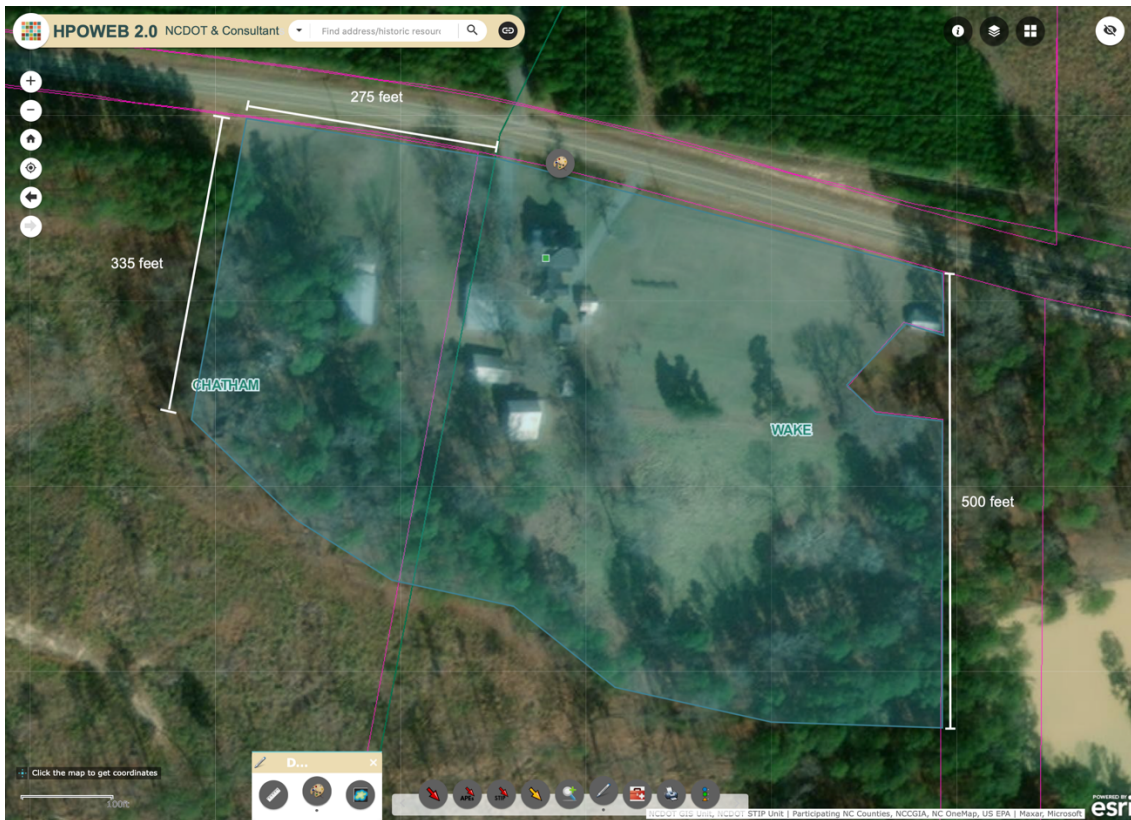
Figure 5. Proposed Boundary, Bartley Yates Farm, 10209 Morrisville Road, Wake & Chatham counties
