SUBJECT: Historic Structures Survey Report for R-5807, Proposed improvement to NC 343 from US 158 to SR 1119, PA 18-10-0034, Camden County, ER 21-0824

To: Renee Gledhill-Earley, NCHPO
From: Vanessa E. Patrick, NCDOT
Date: April 5, 2021
Subject: *Historic Structures Survey Report for TIP No. R-5807, Camden County, North Carolina. WBS No. 46969.1.1. PA Tracking No. 18-10-0034.*

**TIP PROJECT R-5807
WBS NO. 46969.1.1
PA TRACKING NO. 18-10-0034**

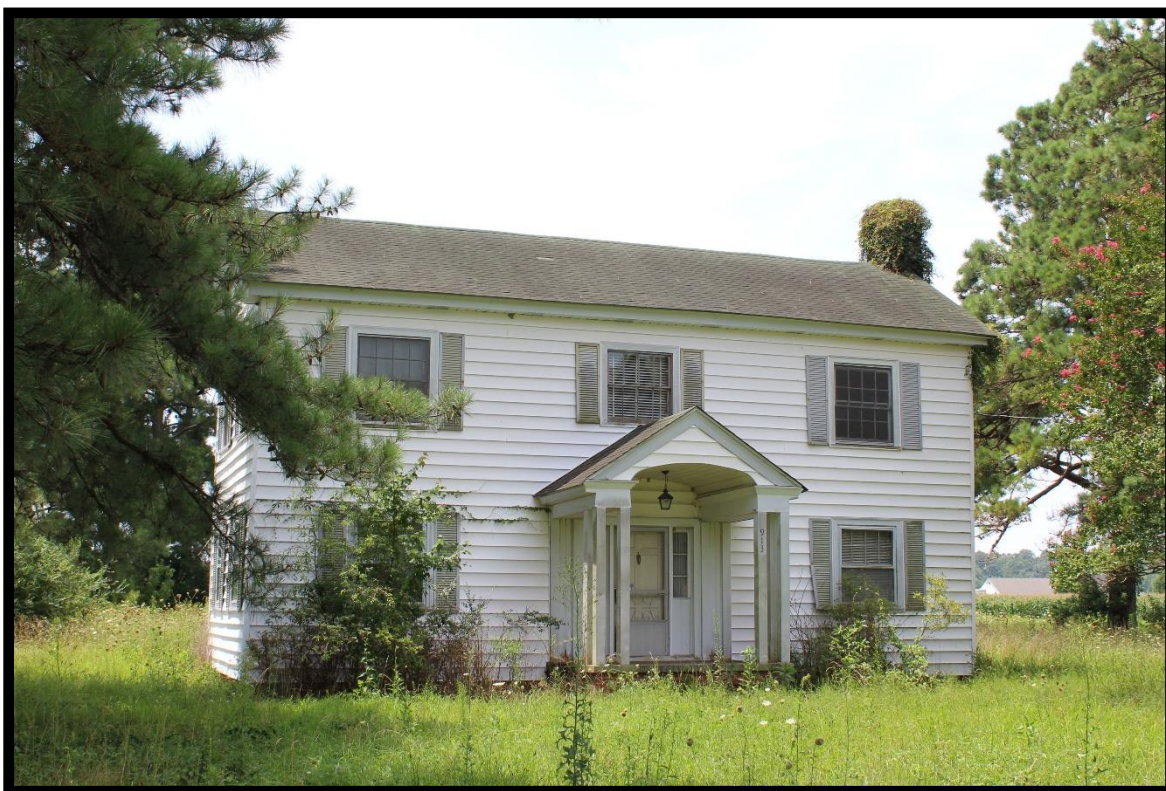
Figure 3: Gregory House, Looking Southwest.

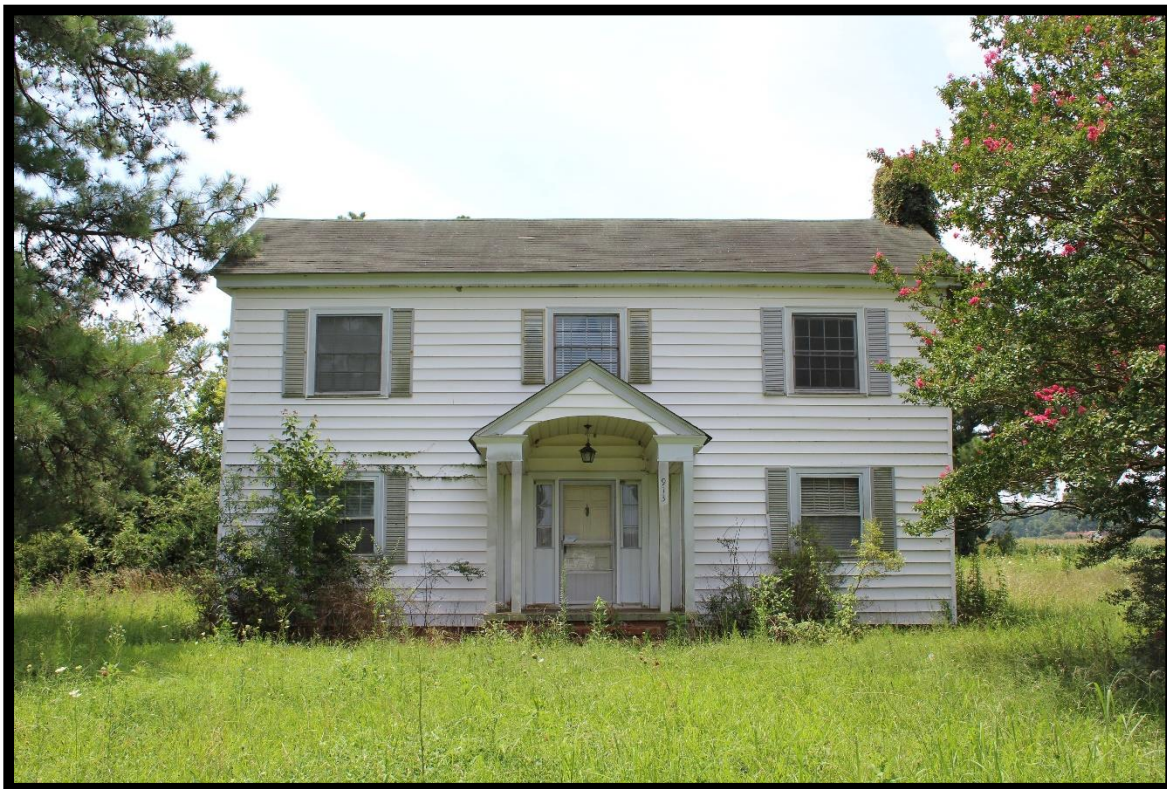
The dwelling is an I-house with a side-gabled asphalt shingle roof and two small rear additions. It rests on a continuous foundation of modern bricks at the front with brick piers at the rear and is clad with vinyl siding. Its three-bay façade features a centrally placed, front-gabled porch supported by tripled columns that rise from a modern brick stoop. The porch, which is encased with aluminum, shelters a six-panel entry door flanked by sidelights. The porch is flanked by eight-over-eight wooden sash windows, and three identical windows fill the upper story bays (Figure 5). Most of the dwelling's windows are covered by storm screens.

Figure 5: Gregory House, Looking South.

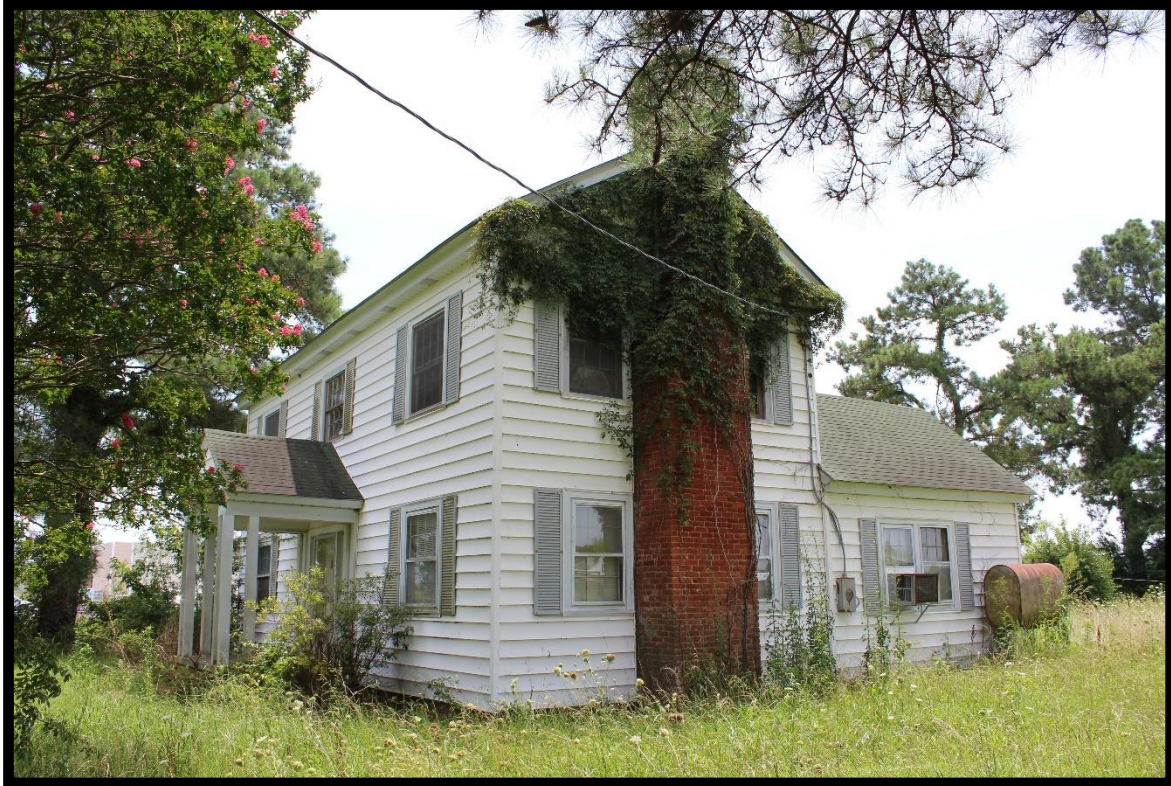
Figure 6: Gregory House, Looking Southeast.

The west (side) elevation features a brick exterior end chimney laid in common bond. It is flanked on both stories by six-over-six wooden sash windows. A one-and-one-half story, rear-gabled wing extends from the south side of the elevation. Its west (side) elevation contains an off-center pair of six-over-six wooden sash windows (Figure 6).

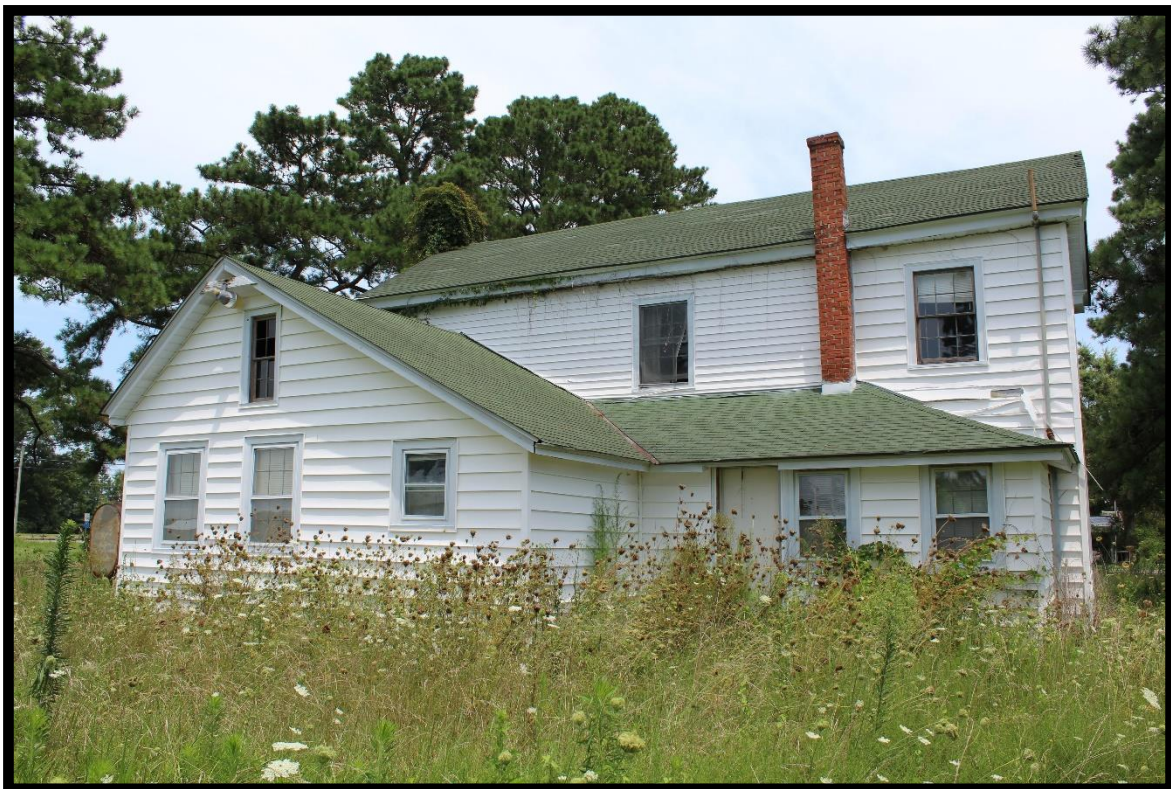
Figure 7: Gregory House, Looking Northwest.

wooden sash windows. A thin brick chimney rises from the hip-roofed addition along the rear elevation of the main block. It is flanked by two six-over-six wooden sash windows (Figure 7).

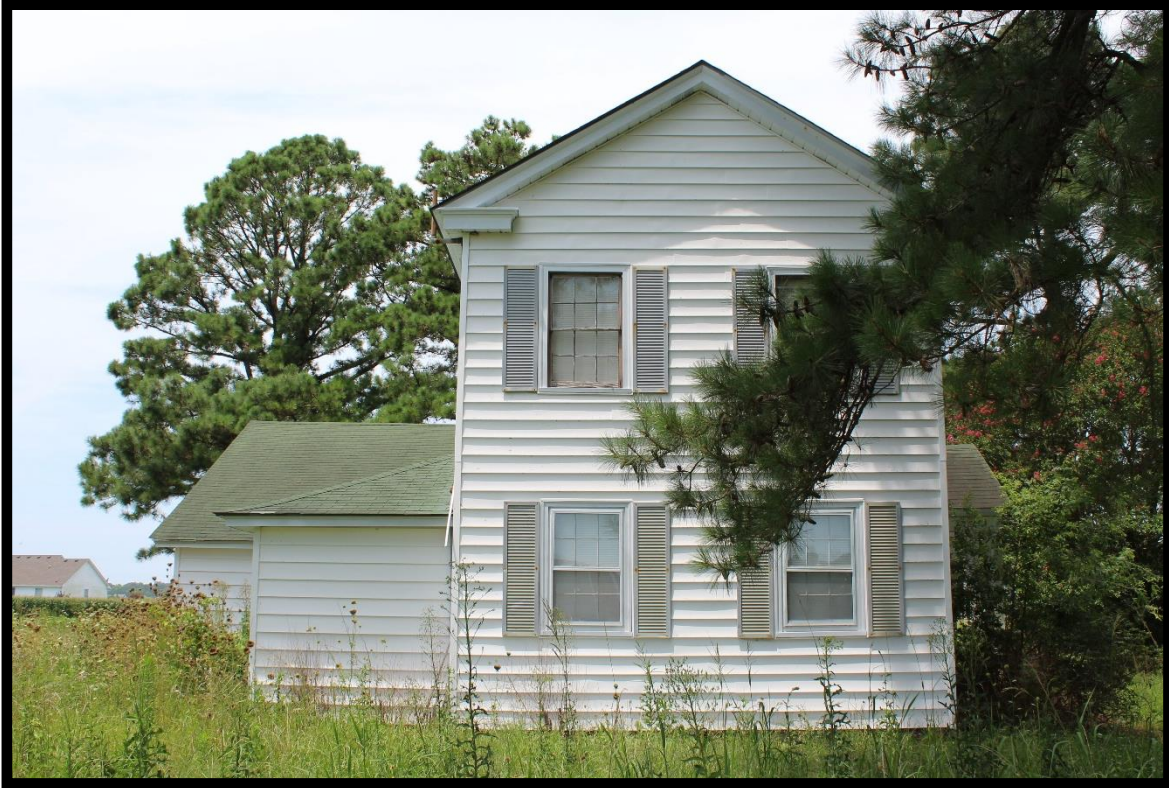
Figure 8: Gregory House, Looking West.

The east (side) elevations of the additions are blind while the main block is lit by two six-over-six wooden sash windows on each story and features cornice returns below the roof's eave (Figure 8).

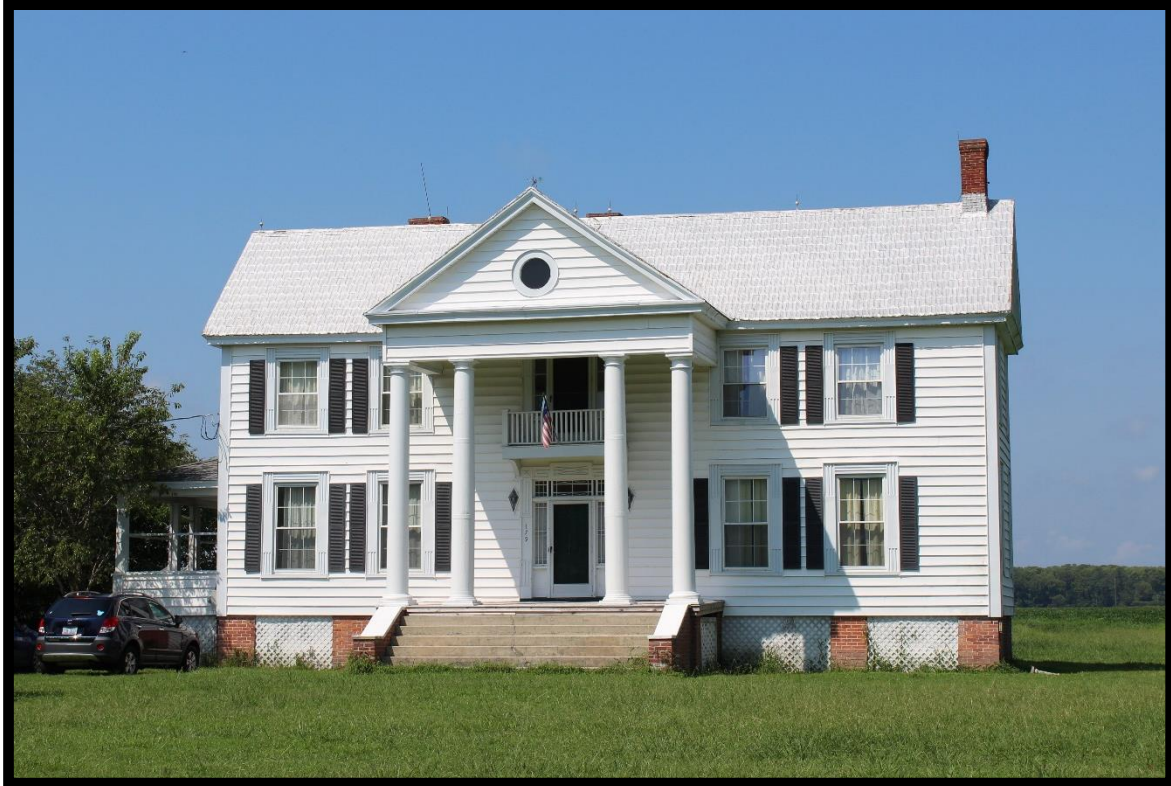
Figure 12: William Riley Abbott House (CM0003), Looking Southwest.

The William Riley Abbott House is the only nineteenth-century dwelling in Camden County that is listed on the NRHP (Figure 12).²⁴ More high style than the Gregory House, it is an additional two bays in width and has a wide, two-story, pedimented porch. The porch is supported by four Tuscan columns and shelters a balcony above a detailed entry door. Flanking windows display wide stylized surrounds as well. Though the house has been clad with vinyl siding and its roof has been replaced with a Queen Anne-era pressed metal, the dwelling still conveys the feeling of the mid-nineteenth century. Furthermore, it stands on a nearly 150-acre parcel of agricultural land surrounded primarily by additional agricultural land as opposed to the Gregory House's divided parcel located beside the Dollar General store.

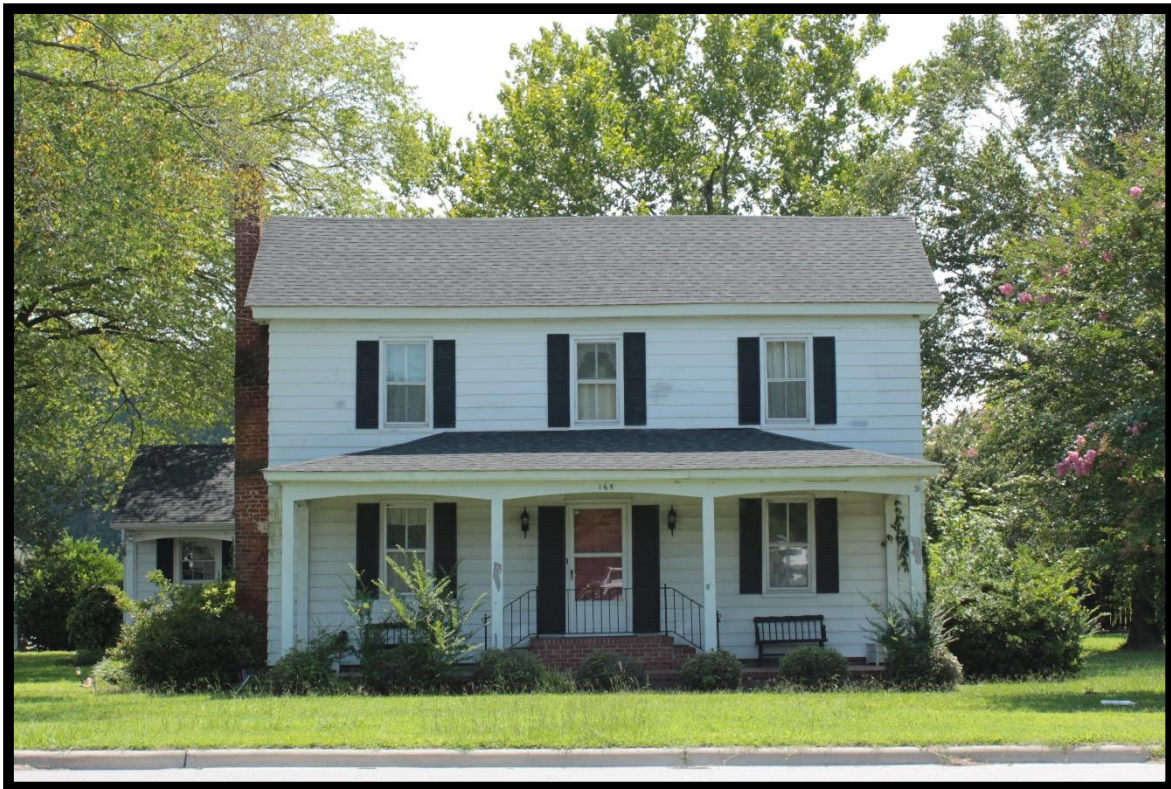
The Upton House is more comparable to the Gregory House in that it is three bays wide and lacks any ornate details. Also like the Gregory House, it has been clad with vinyl siding and an asphalt shingle roof, and similar to how the Gregory House's porch has been encased with vinyl, the decking of the Upton House's porch has been replaced with a brick stoop. One difference, however, is that the Upton House's wooden sash windows appear to relate to its late nineteenth-century construction date, while the Gregory House's windows appear later.²⁵ Due to the high

Figure 13: Upton House (CM0142), Looking East.

amount of alterations and replacement materials, the Upton House was determined ineligible for the NRHP.²⁶ It would follow that the Gregory House, which displays a similar level or less of material integrity, would also be found ineligible for the NRHP.

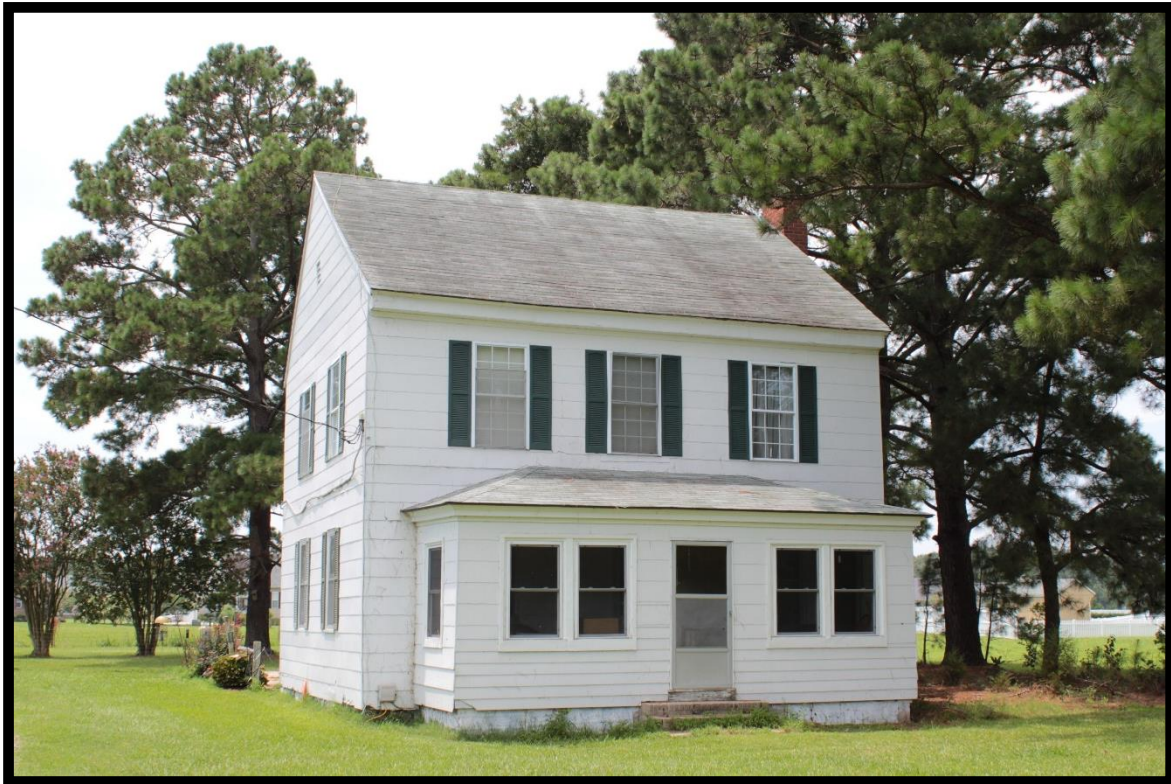
Figure 14: G. M. Bray House, Looking Southwest.

The two-story, side-gabled dwelling exhibits an almost symmetrical façade with a one-story, enclosed, hip-roofed porch and a gabled rear wing. It rests on a brick pier foundation infilled with sheets of pressed metal, is clad primarily with asbestos siding, and has an asphalt shingle roof. The enclosed porch is clad with wooden siding below asphalt shingles, suggesting that it may have had screens above the wooden siding before being completely enclosed. Its front elevation contains a metal screen door flanked by paired one-over-one vinyl sash windows and its side elevations each contain an individual one-over-one vinyl sash window. On the interior of the porch is a Craftsman-style entry door flanked by a wooden sash window with four vertical panes over a single large pane on the east and similar paired windows on the west. Vertical light windows, which are most often seen on Craftsman-style dwellings constructed in the early twentieth century, are present on a majority of the dwelling's elevations suggesting that the house was remodeled around this time. Above the porch are three unequally spaced windows – the center window tracks slightly east – with nine-over-nine vinyl sashes (Figure 14).

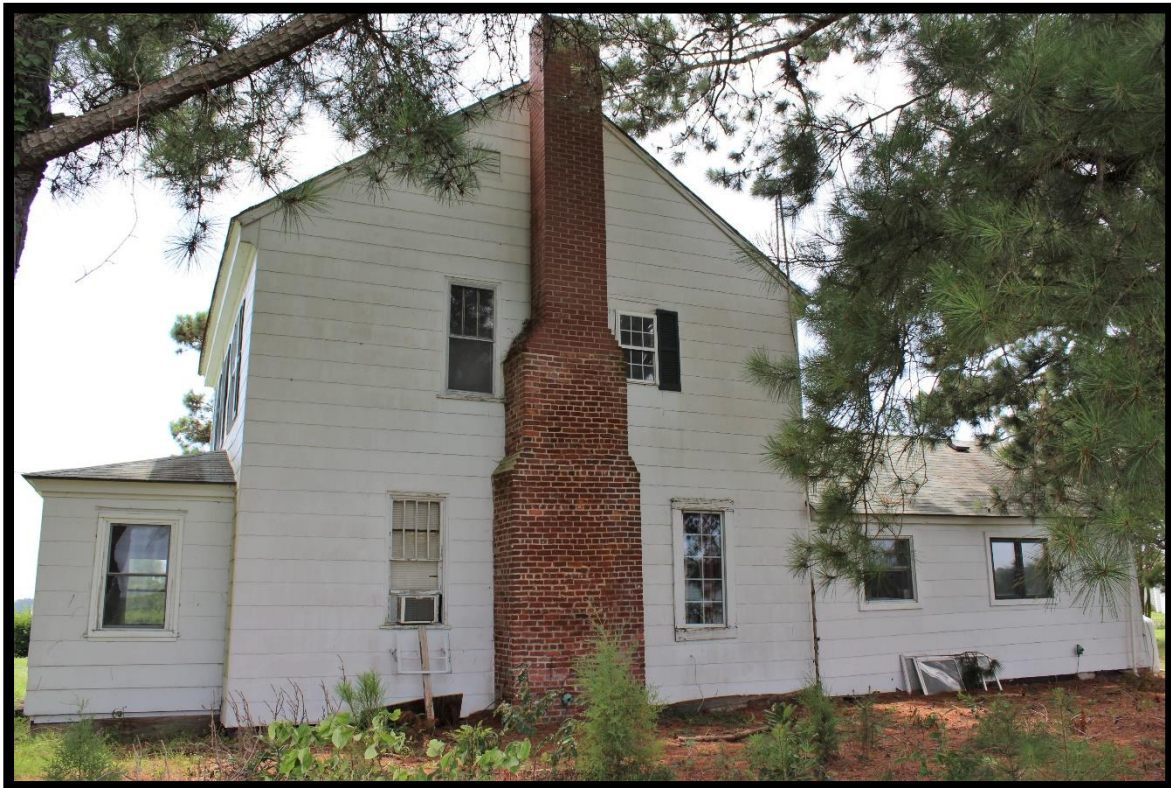
Figure 16: G. M. Bray House, Looking Southeast.

The west (side) elevation of the main block contains a double-shouldered brick chimney. The base of the chimney is laid in a common bond while the chimney stack, which has been replaced, is laid in stretcher bond. The chimney is flanked on both stories by two windows. On the first story, the south window has a wooden sash with four vertical panes over a single large pane while the north window has a vinyl sash with ten undivided panes. The windows also have

different surrounds, the first being a more typical surround and the second being wide boards. The upper windows differ as well with the north window containing a wooden sash with three vertical panes over a single large pane and the south window, which is also smaller, containing a six-over-six vinyl sash (Figure 16).

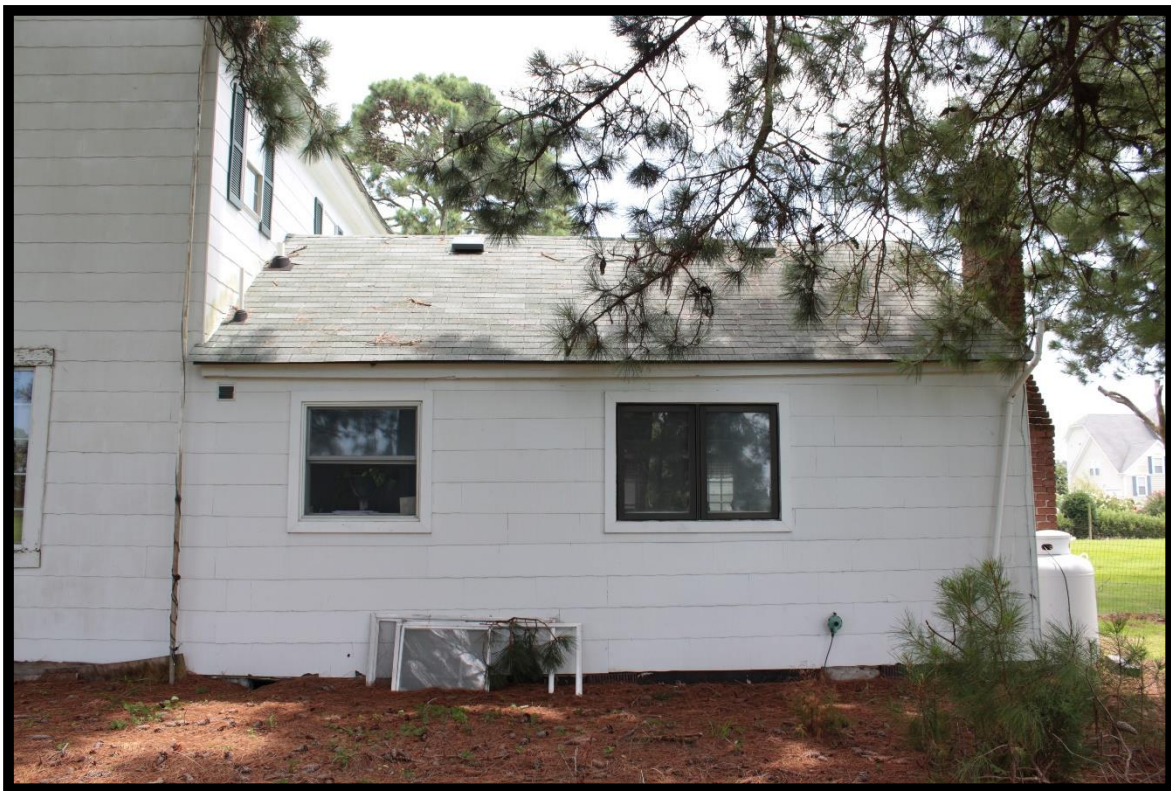
Figure 17: G. M. Bray House, Looking East.

The west (side) elevation of the rear wing contains a one-over-one, horizontal-pane, vinyl sash window and a paired, sliding-pane, vinyl or metal sash window, while its south (rear) elevation displays an asymmetrical gable and contains a single-shouldered brick chimney laid in common bond. The east (side) elevation of the wing contains a gabled entrance that is flanked on the south by a wooden sash window with three vertical panes over a single large pane and on the north by two paired wooden sash windows with three vertical panes over single large panes. An interesting element of this elevation is that the gabled entrance is flush with the exterior wall whereas most entrances might project. This seems to suggest that the elevation may have once sheltered a porch or was pushed forward encompassing the original entry (Figures 17 through 19).

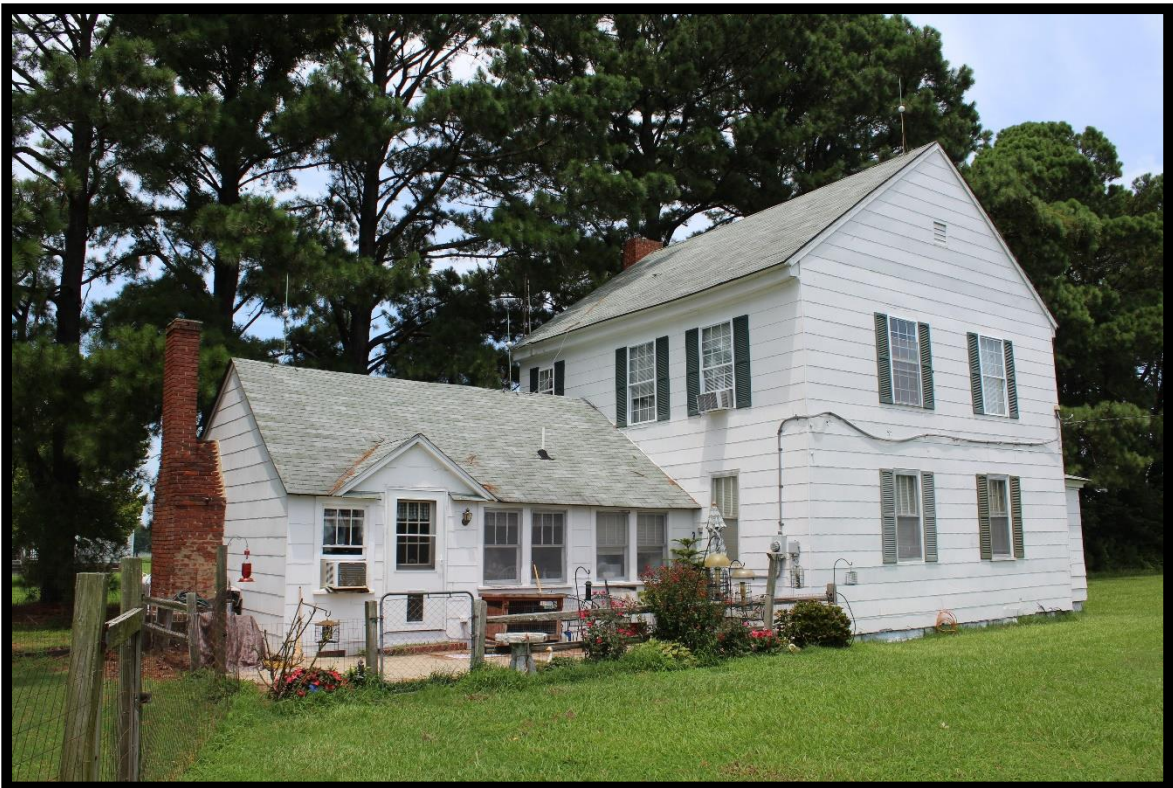
Though dominated by the rear wing, the south (rear) elevation of the main block contains a single window wooden sash window with three vertical panes over a single large pane on the first story (east of the wing) and three nine-over-nine vinyl sash windows across the second story. The upper windows are arranged as to avoid the peak of the wing. The east (side) elevation of the main block is lit by two windows on each elevation – wooden sash windows with three vertical panes over a single large pane on the first story and nine-over-nine vinyl sash windows on the second story (Figure 19).

Figure 19: G. M. Bray House, Looking Northwest.

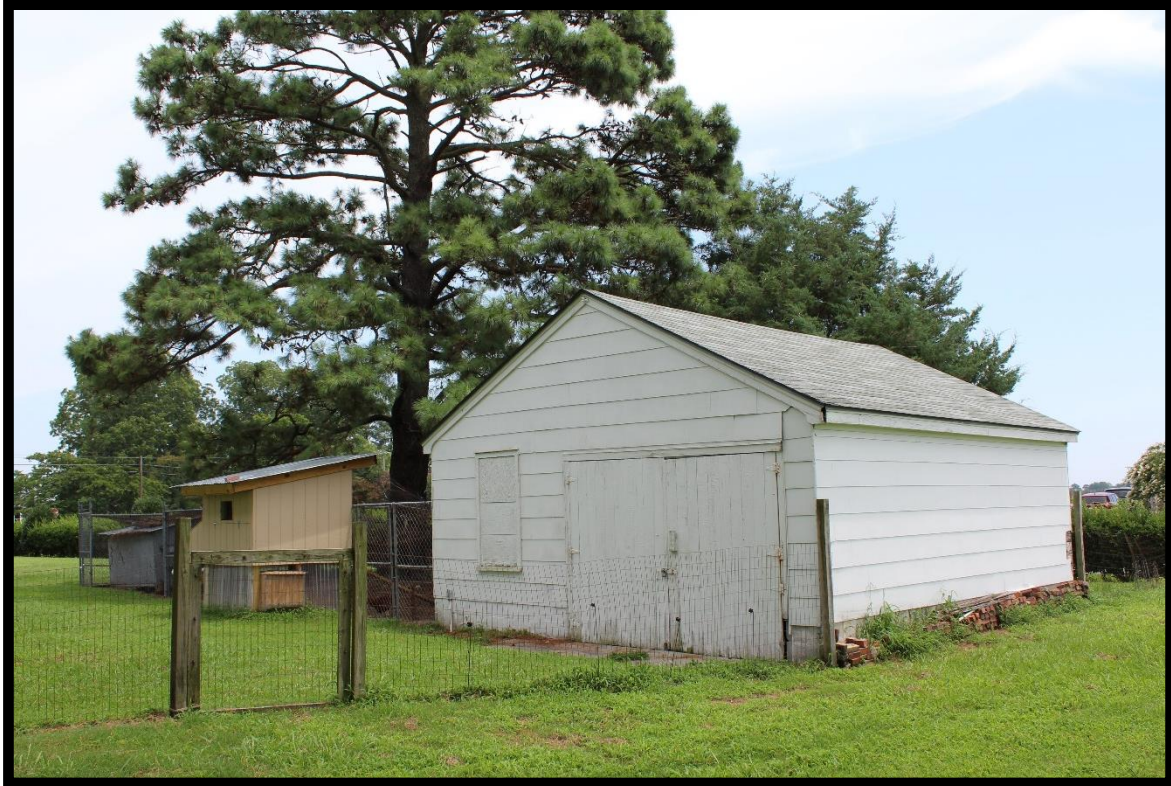
Ancillary structures associated with the dwelling include a small front-gabled barn that faces the dwelling and two modern chicken houses. The barn is clad with asbestos siding over flush boards and has a concrete block foundation and an asphalt shingle roof. It is entered through large board and batten doors on the front (west) elevation and was once lit by a window south of the doors that is now boarded over. A six-over-six window lights the north (side) elevation and faces an area that is fenced in and contains chickens (Figures 20 and 21).

Figure 20: G. M. Bray House, Barn, Looking Northeast.

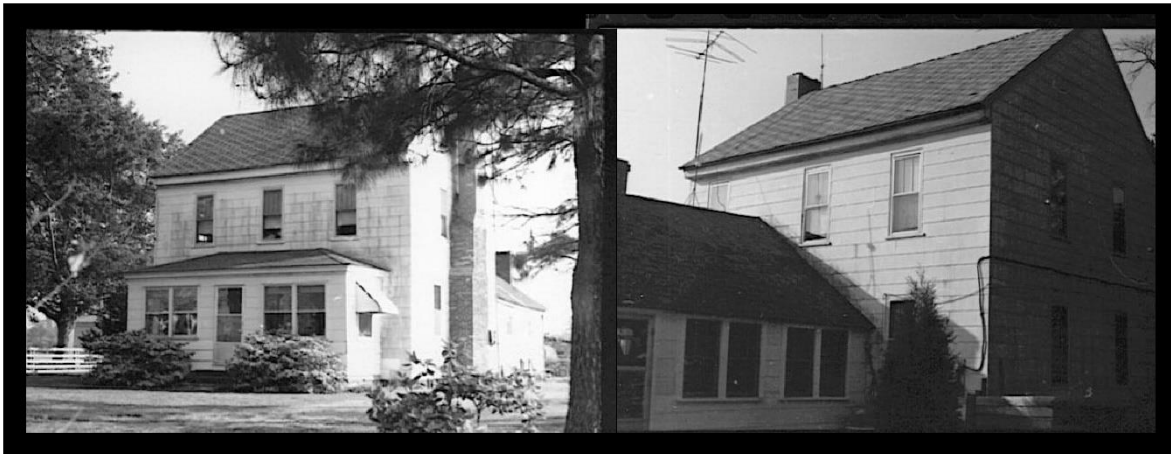
Figure 24: G. M. Bray House (HPO Survey File, CM0046).

ownership that the property was first surveyed by the HPO. Photos from this survey show the house with many of the same material changes exhibited today, though with vertical light windows on the second story where there are now vinyl windows (Figure 24).

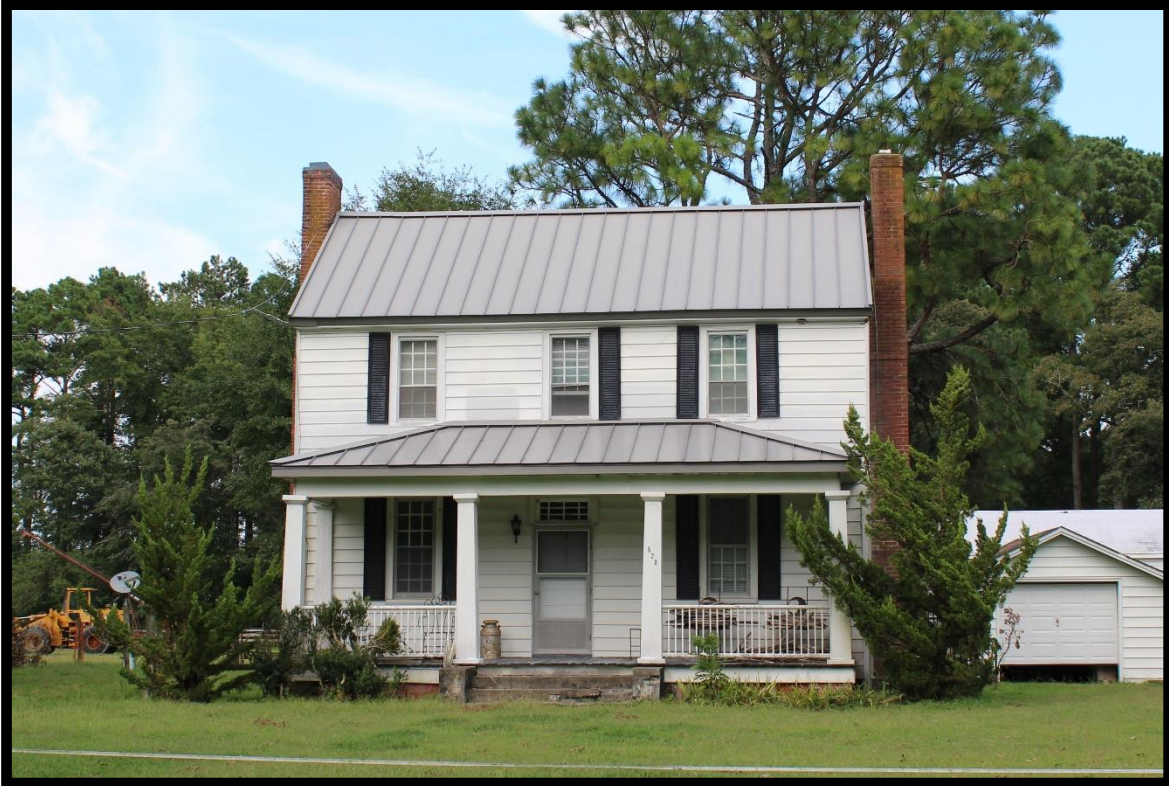
The Grandy House, while not quite as narrow as the G. M. Bray House, represents a smaller version of the I-house form (Figure 28). Like the G. M. Bray House, it is clad with replacement siding and has an altered porch, in this case a replacement with Craftsman-style details. The dwelling retains more integrity through the retention of nine-over-nine and nine-over-six wooden sash windows. Its original roof has also been replaced with metal sheets opposed to the G. M. Bray House's asphalt shingle roof. Furthermore, it is surrounded by agricultural outbuildings, some of which appear historic, and roughly 110 acres of plowed fields and wooded areas.

Figure 28: Grandy House, Looking East.

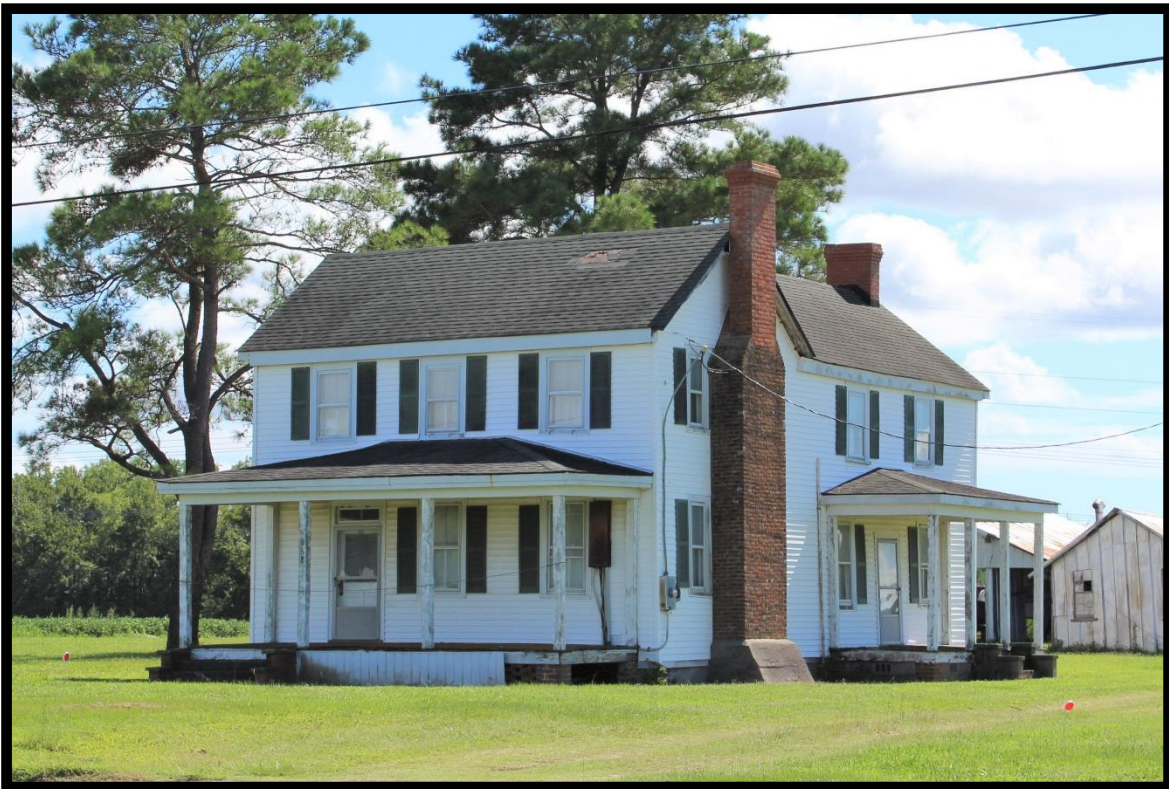
The ca. 1875-1910 Eldon Jones Farmstead displays a similarly narrow version of the I-house though it does not appear as deep as the G. M. Bray House (Figure 29).³⁷ It also shows how the form could be adapted on the interior with a side-hall plan. Found ineligible in 2013, the dwelling exhibits a higher level of design and workmanship through the retention of most, if not all, of its original wooden windows, its entry door, and simple hip-roofed front and side porches. However, alterations similar to those made to the G. M. Bray House, including the replacement of its wooden siding and metal roof, have decreased its architectural integrity to a level unacceptable for inclusion on the NRHP.

Figure 29: Eldon Jones Farmstead (CK0329), Looking South.

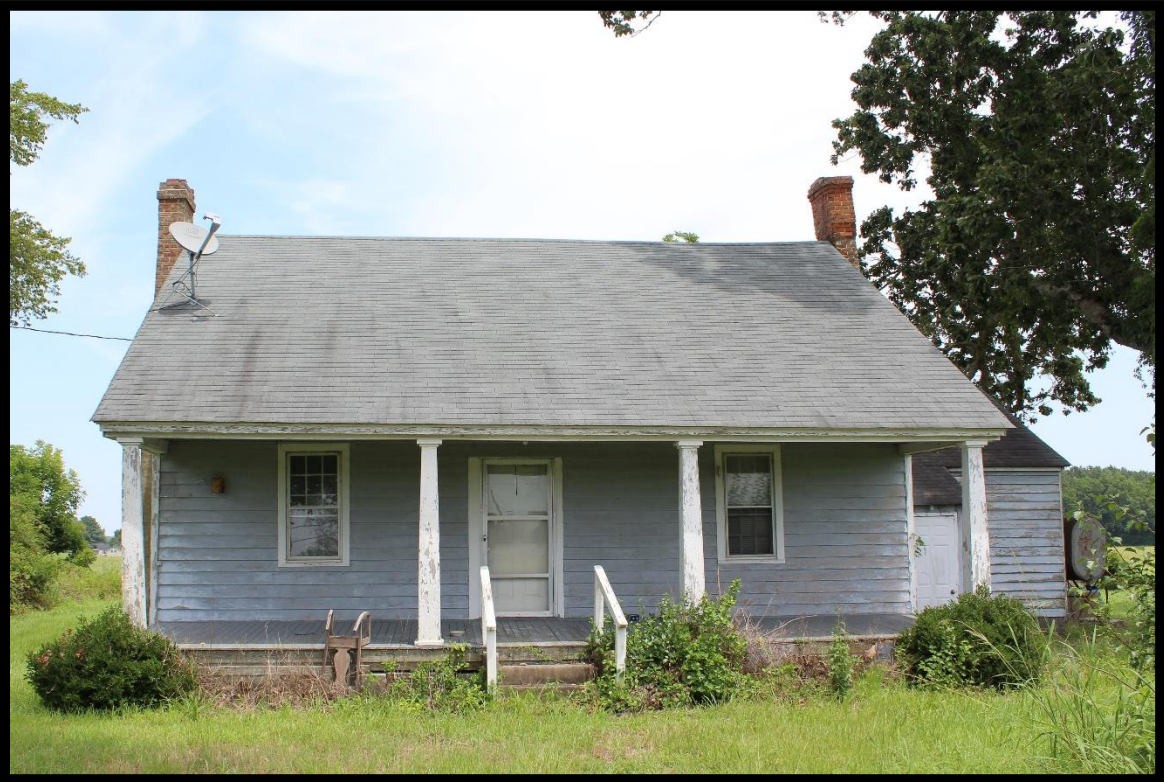
Figure 30: Stevens House, Looking Southwest.

The core of the dwelling is a one-and-one-half story, side-gabled structure with an integral porch and two brick gable-end chimneys. Small additions include a gabled side addition and a shed-roofed rear addition. The main section of the house appears to rest on brick piers infilled with concrete and is clad with wooden weatherboard siding and covered by an asphalt shingle roof. The integral porch is supported by tapered square columns and shelters a symmetrical façade with a modern entry door flanked by nine-over-six, wooden sash windows. The porch decking is simple boards and its ceiling is beadboard (Figure 30).

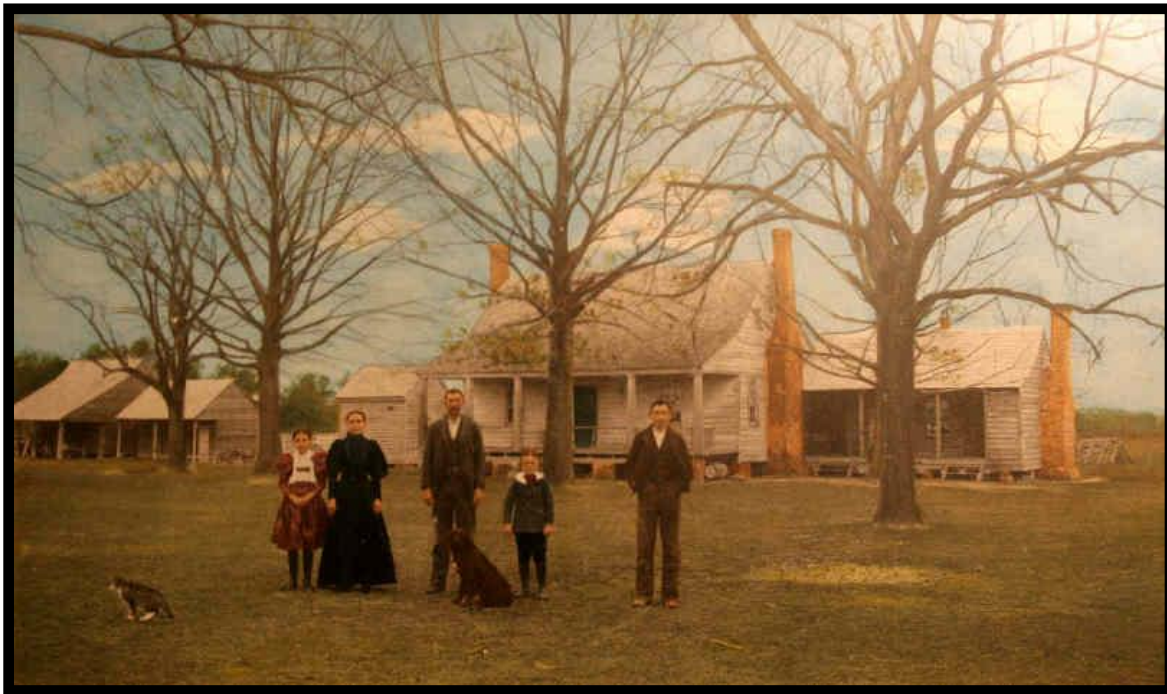
Figure 32: Late Nineteenth Century Photograph of Mary Matilda Stevens Godfrey with Her Husband, Thomas Burgess Godfrey, Daughter, Luna, Son, Will, and a Neighbor (to the Right) Standing in Front of the Stevens House (Photo Source: Bess Tillitt Godfrey Sawyer and William D. Godfrey).

Though seamless from the exterior, the property's survey file indicates that when it was surveyed in 1975 the attic and roof framing was new and that the homeowner stated the house had once been two stories. This is substantiated by a ca. 1900 photo of the dwelling that shows a split pitch roof (Figure 32). The height of the house, however, does not seem to vary significantly from its current form suggesting that it has always been one-and-one-half stories, but the upper story may no longer be livable space. The survey file also shares that the tapered porch columns and rear shed porch were present at the time.³⁹

The year after Noah's death, Sally married Enoch Sanderlin, who had previously lived with the family and helped on the farm, and they had five children in addition to those from Sally's first marriage.⁴⁴ However, per Noah's will, when Sally passed away in 1892 the homeplace was left only to his and her children.⁴⁵ It is unknown how the property was divided, except that the dwelling came into the ownership of Mary Matilda "Mamie" Stevens who had married Thomas Burgess Godfrey.⁴⁶ A ca. 1900 photo shows her family in front of the house. The photo shows that the side addition was once larger with an integral porch and a chimney. It also shows a small shed that may relate to the extant shed, and additional outbuildings (see Figure 32).

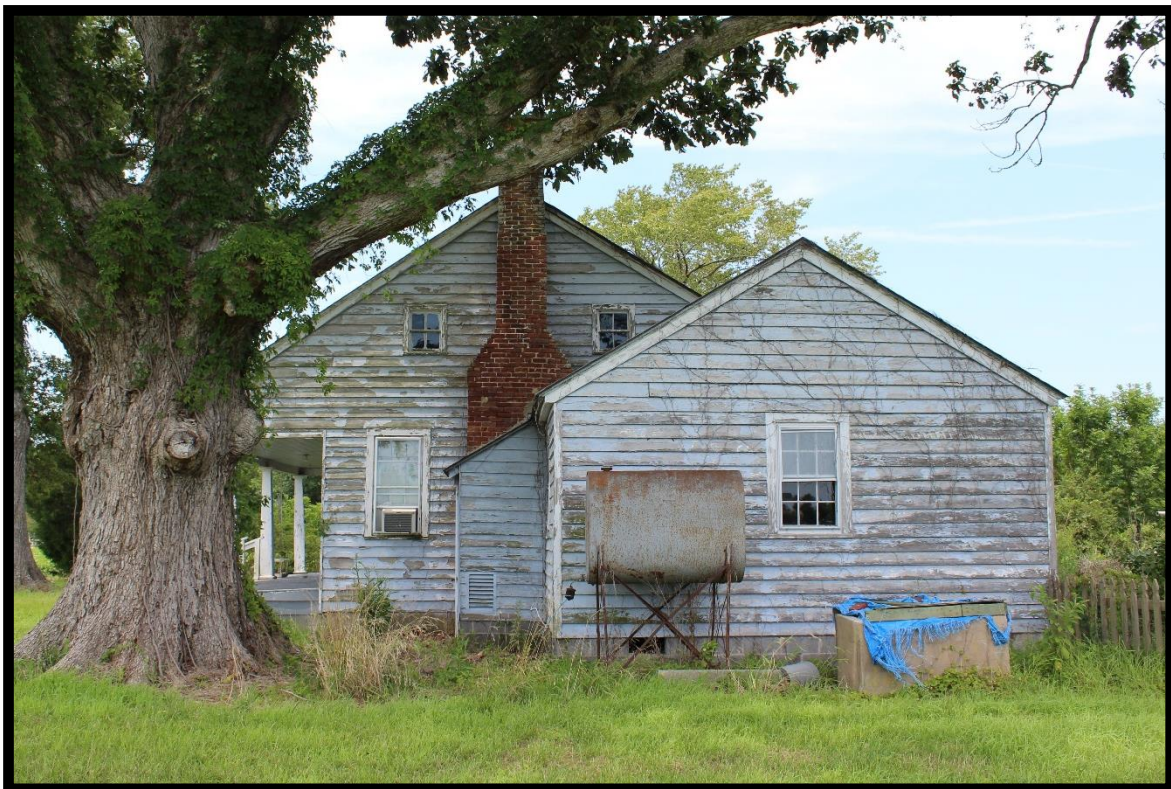
Figure 35: Stevens House, Looking Northwest.

A side-gabled addition extends from the rear corner of the southeast (side) elevation. The portion of the main dwelling's elevation that is not concealed by the addition contains a nine-over-six, wooden sash window on the first story and two small two-over-two wooden sash windows on the second story. The upper windows flank the chimney stack which has a corbelled top and shows some signs of repair/reconstruction (Figure 33). The southwest (front) elevation of the addition has a small shed-roofed room that projects forward, concealing the base of the chimney, and contains mechanical equipment. It rests on a modern brick and concrete block foundation and appears to significantly post-date the rest of the dwelling. To its east is a six-over-six, wooden sash window (Figure 34). The southeast (side) elevation of the addition contains a centered six-over-six, wooden sash window. The addition also rests on a concrete block foundation that may have been added for stabilization (Figure 35).

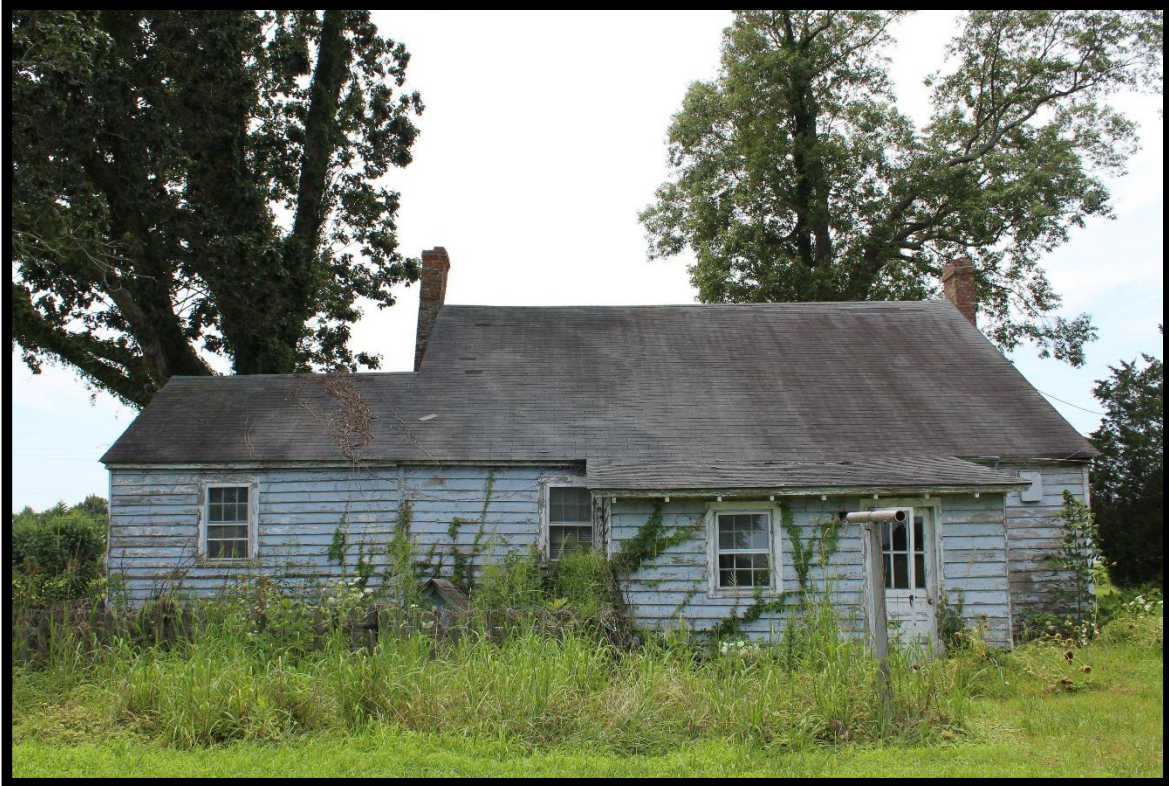
Figure 36: Stevens House, Looking Southwest.

The northeast (rear) elevation of the addition is seamless with the rear elevation of the dwelling. Both sections contain a six-over-six, wooden sash window to the east of a shed-roofed addition. The rear elevation of the addition contains an additional six-over-six, wooden sash window and a Craftsman-style door with six lights over panels, and one more six-over-six, wooden sash window lights the rear of the main block west of the addition (Figure 36). The side elevations of the addition are blind.

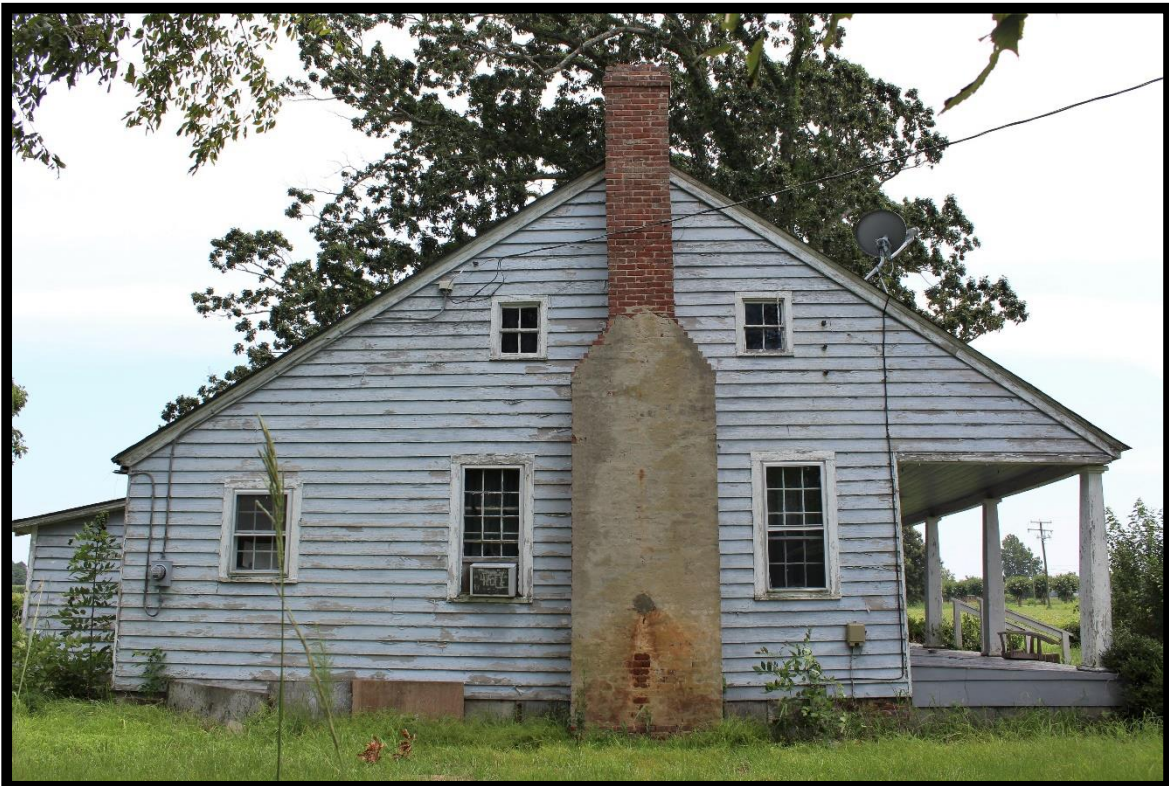
Figure 37: Stevens House, Looking Southwest.

The northwest (side) elevation is divided by a partially parged end chimney, which is flanked by nine-over-six, wooden sash windows on the first story and small two-over-two, wooden sash windows on the second story. An additional six-over-six, wooden sash window is located north of the other windows on the first story (Figure 37).
