SUBJECT: Historic Structures Survey Report for R-5807, Proposed improvement to NC 343 from US 158 to SR 1119, PA 18-10-0034, Camden County, ER 21-0824

To: Renee Gledhill-Earley, NCHPO
From: Vanessa E. Patrick, NCDOT
Date: April 5, 2021
Subject: *Historic Structures Survey Report for TIP No. R-5807, Camden County, North Carolina. WBS No. 46969.1.1. PA Tracking No. 18-10-0034.*

**TIP PROJECT R-5807
WBS NO. 46969.1.1
PA TRACKING NO. 18-10-0034**

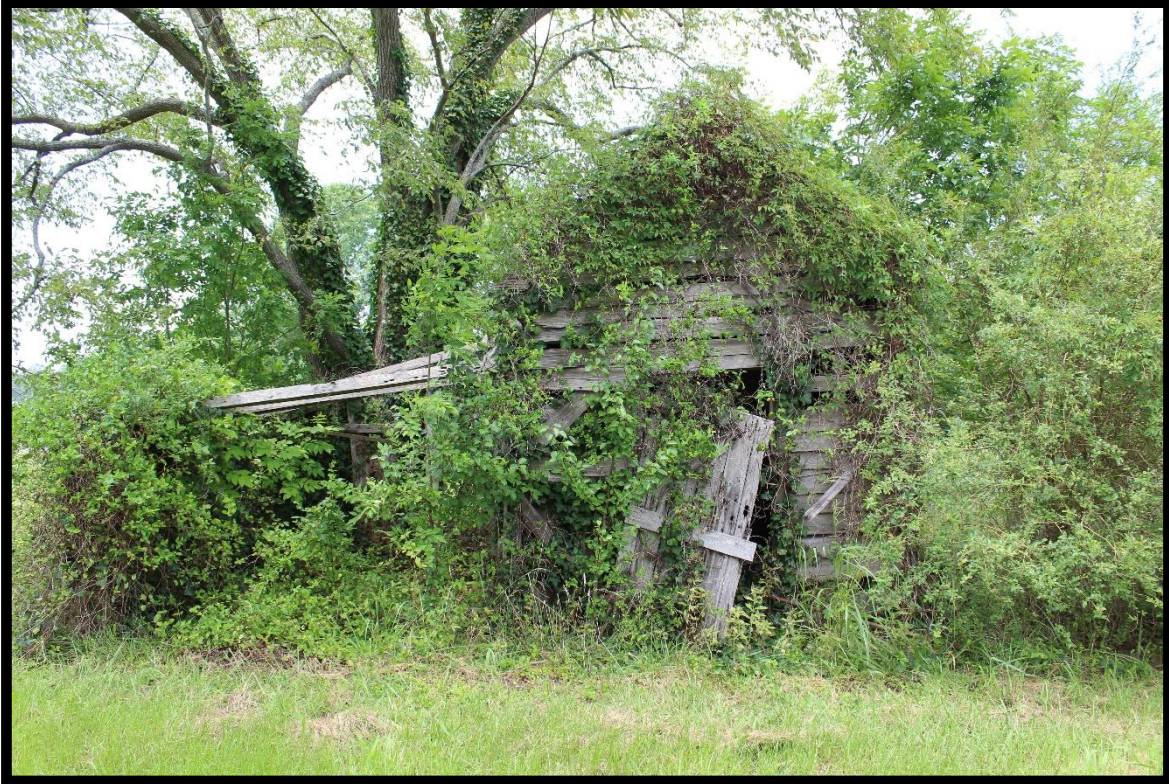
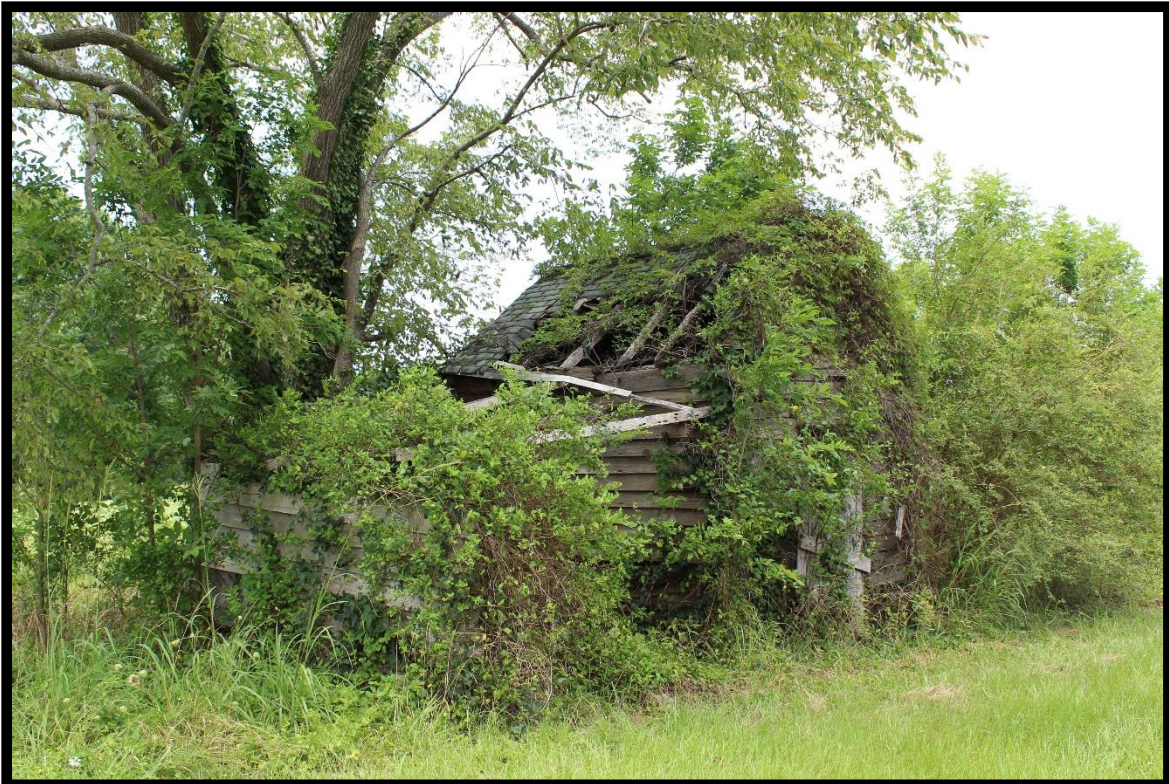
Figure 40: Stevens House, Shed, Looking Northwest.

A dilapidated shed stands east of the dwelling. It is frame with wooden weatherboard siding, a front-gabled asphalt shingle roof, a shed-roofed wing along the south elevation, and a board-and-batten door (Figures 40 and 41).

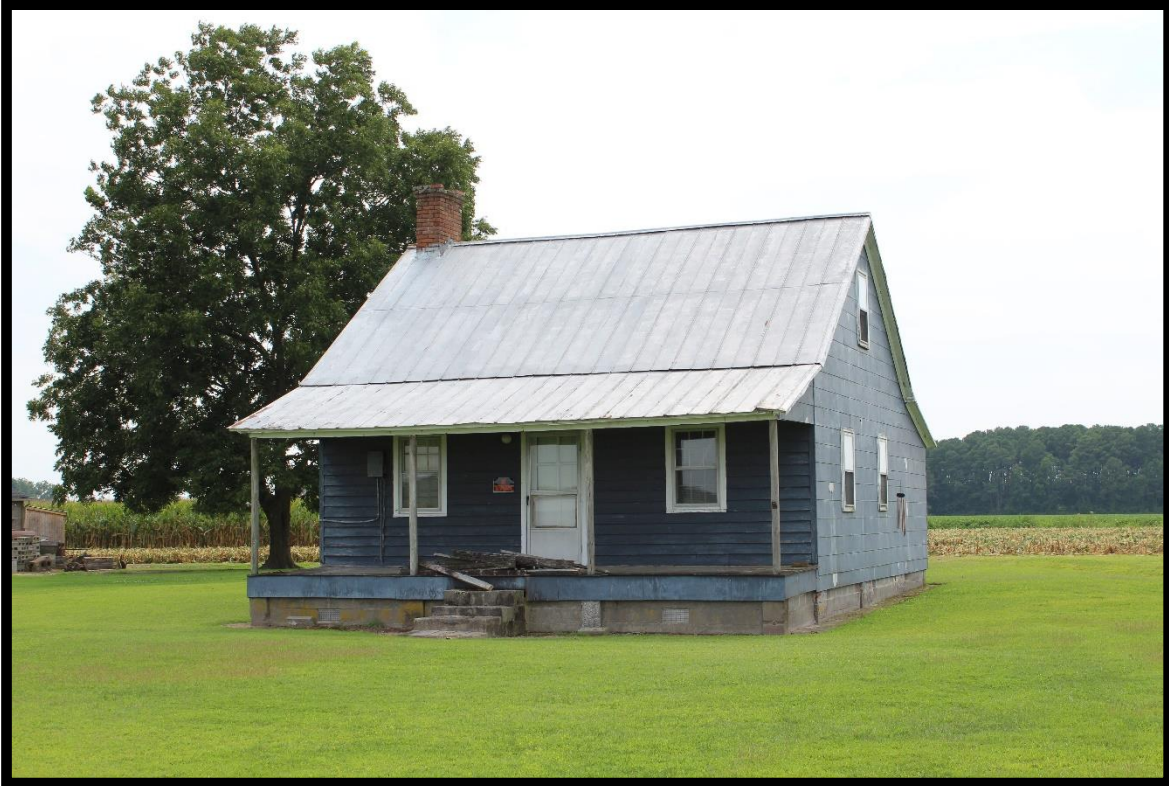
Figure 45: Charles Whitehurst House (CM0167), Looking Southwest.

Reportedly constructed the same year as the Stevens House, the Charles Whitehurst House is slightly smaller and has a single interior end chimney in comparison to the Stevens House's two exterior end chimneys (Figure 45). The house has been altered with asbestos siding added to its side (and likely rear) elevations, though it appears to retain its wooden sash windows, double-slope roof, and an early entry door. The house is located in the northern part of Camden County in a particularly agricultural area with only a handful of twentieth century dwellings in its vicinity. While both dwellings display alterations that were commonly made to nineteenth century dwellings during the twentieth century, they also stand out for being better preserved and more structurally sound than many of their observed contemporaries. The Stevens House also surpasses the integrity of the Charles Whitehurst House through the preservation of its wooden siding.

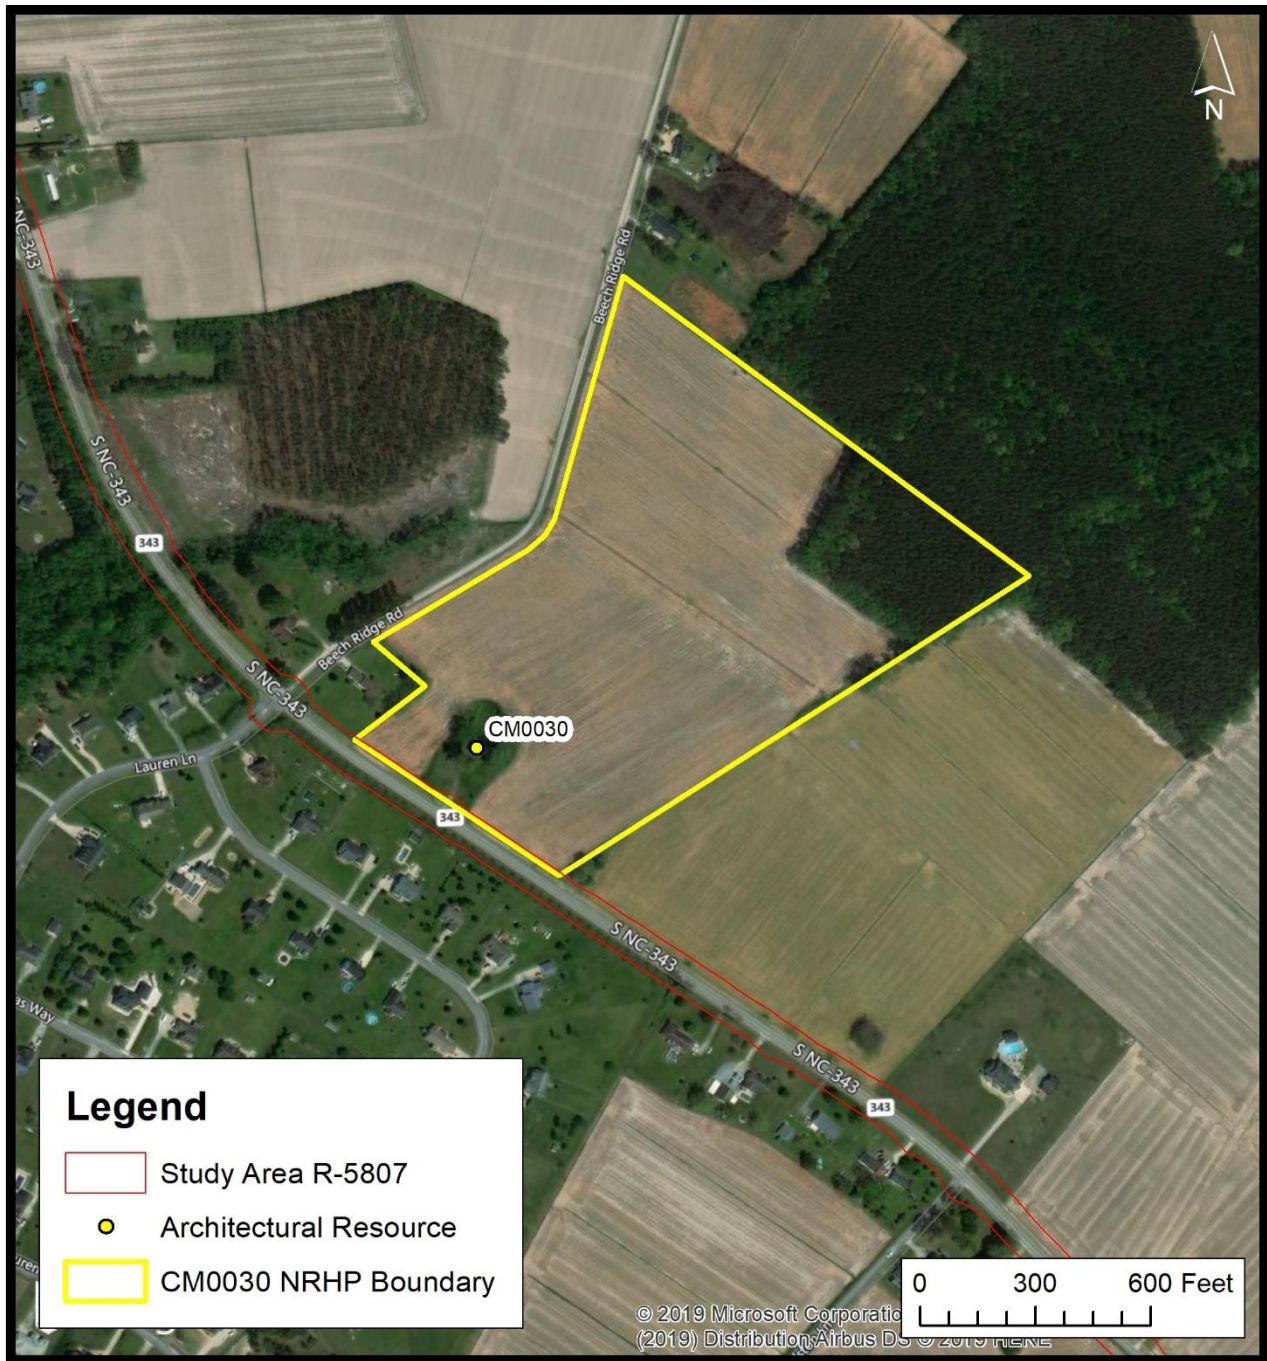
Figure 47: NRHP Boundary.

The National Register boundary for the Stevens House has been drawn according to the guidelines of National Register Bulletin 21, Defining Boundaries for National Register Properties. The boundary is drawn to include the dwelling, outbuilding and domestic yard, as well as the associated farmland (Figure 47). The boundary contains approximately 30.99 acres. The National Register boundary is identified as parcel 038953033381530000 (Camden County PIN).

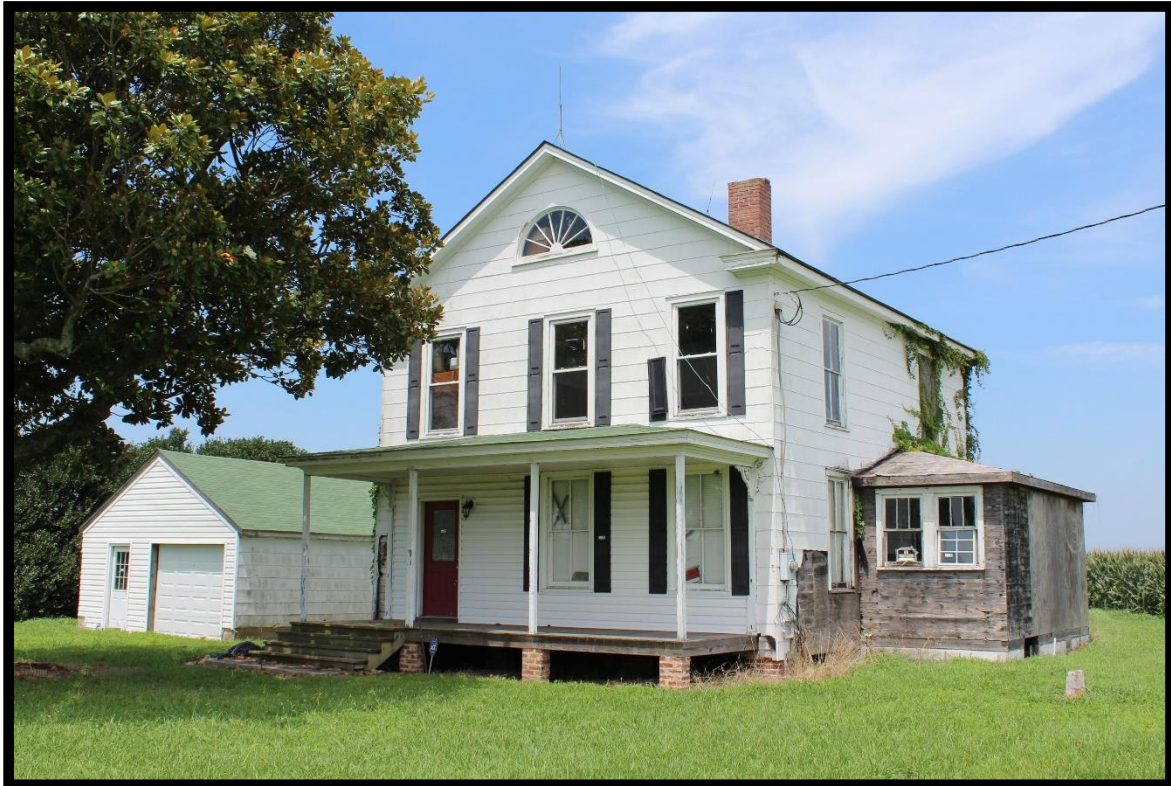
Figure 49: Berry House, Looking North.

The house is a two-story vernacular dwelling with a brick pier foundation, asbestos over wooden siding, and a front-gabled asphalt shingle roof. It has a one-story, full-width, hip-roofed porch supported by plain wooden posts. The deck of the porch and steps, which are located at the west corner of the porch, appear to be newly constructed. There are decorative sawn brackets on the columns where the porch meets the house but not on any other columns. It is uncertain if these are original elements of the porch or if they were added later. The porch shelters an asymmetrical façade with a modern entry door to the west of two two-over-two, wooden sash windows with modern shutters. The portion of the façade that is below the porch is also clad with vinyl siding, unlike the rest of the dwelling. The second story of the façade is lit by three one-over-one, replacement sash windows that align with the apertures below and have modern shutters. A circular fanlight is centered on the gable and lights the attic. Cornice returns also adorn the gable (Figure 49).

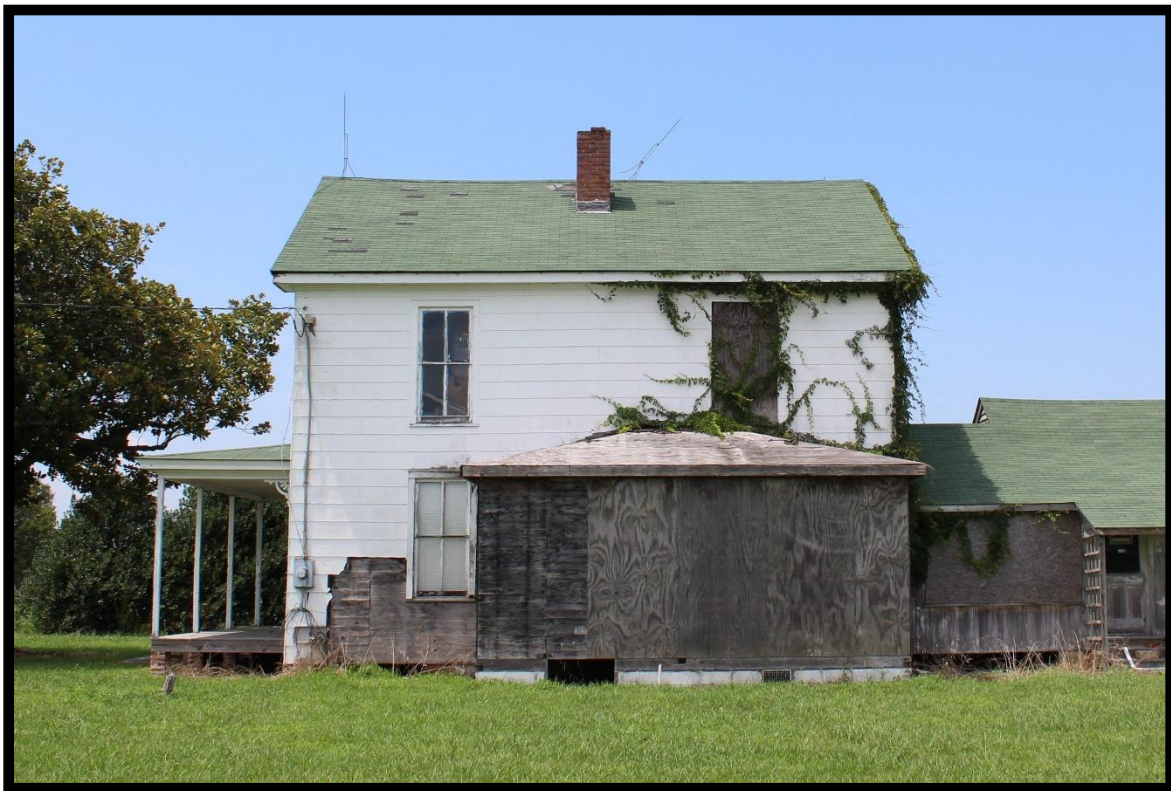
The southeast (side) elevation was likely symmetrically arranged with two two-over-two, wooden sash windows on each story when the dwelling was constructed. Today, the lower right window is obscured by a one-story, hip-roofed addition clad with flush board and plywood (roof and elevations). The left windows are still visible while the upper right window is covered with plywood. Though the small addition is not lit on its southeast elevation, it does contain paired three-over-one, vertical-light, wooden sash windows on its southwest elevation. A brick interior chimney rises from the center of the dwelling near the roof's peak (Figure 51).

Figure 51: Berry House, Looking Northwest.

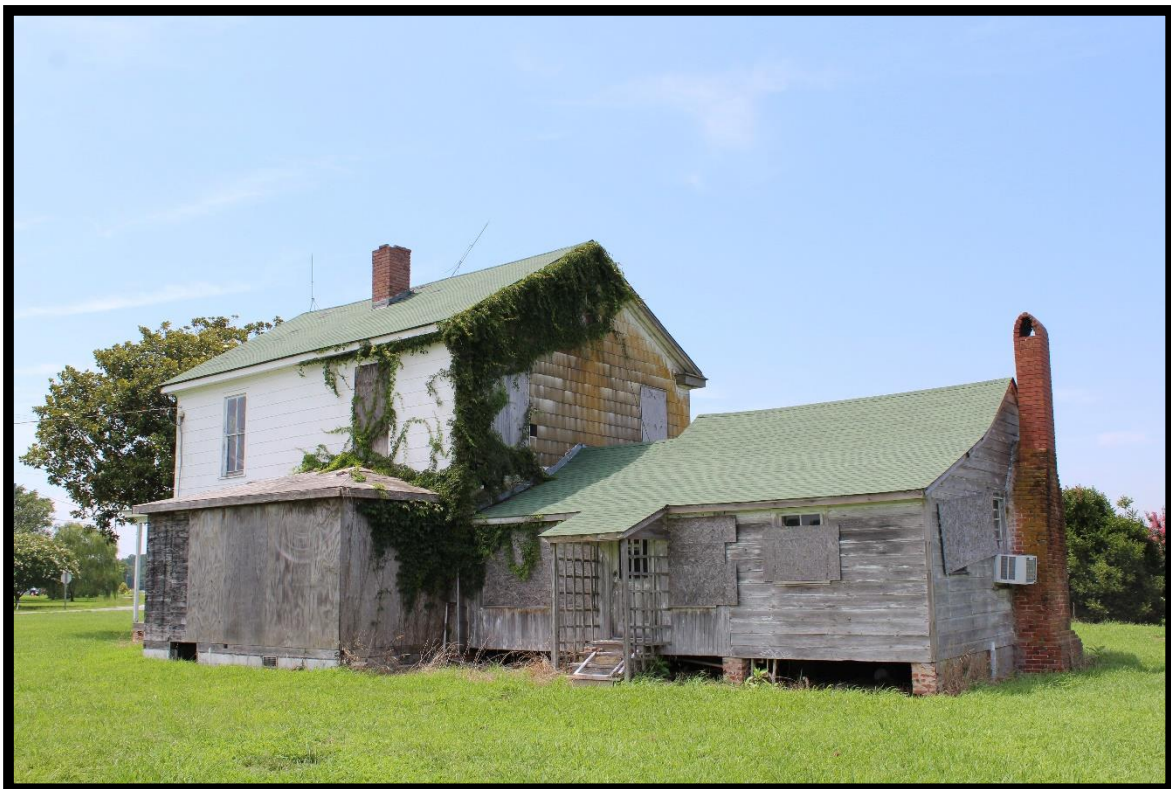
Figure 52: Berry House, Looking West.

A gabled, one-story structure is attached to the northeast (rear) elevation of the dwelling by a hyphen. The structure likely began as a kitchen house with an integral porch, that has now been enclosed, along its southeast elevation. Today, this elevation, which is flush with the hyphen, contains plywood covered windows that flank a wooden entry door. The entry door has a large light over panels and is sheltered by a shed roof. The northeast elevation of the structure contains two windows to the east of a single-shouldered brick chimney with a replacement stack. The east most window is covered with plywood while the second window contains a two-over-two, horizontal-light, wooden sash window and an air conditioning unit. The northwest elevation of the kitchen house contains two evenly spaced two-over-two, horizontal-light, wooden sash windows. The northwest elevation of the hyphen is recessed and blind. A raised platform with mechanical equipment is nestled in the recess. While the hyphen is clad with vertical beadboard on the southeast side, it is clad with asbestos sheets on the northwest side and the kitchen house is clad with German siding on the southeast, northeast, and northwest elevations and plain weatherboard on the southwest elevation. The kitchen house rests on a foundation of brick piers infilled with concrete blocks (Figures 52 and 53).

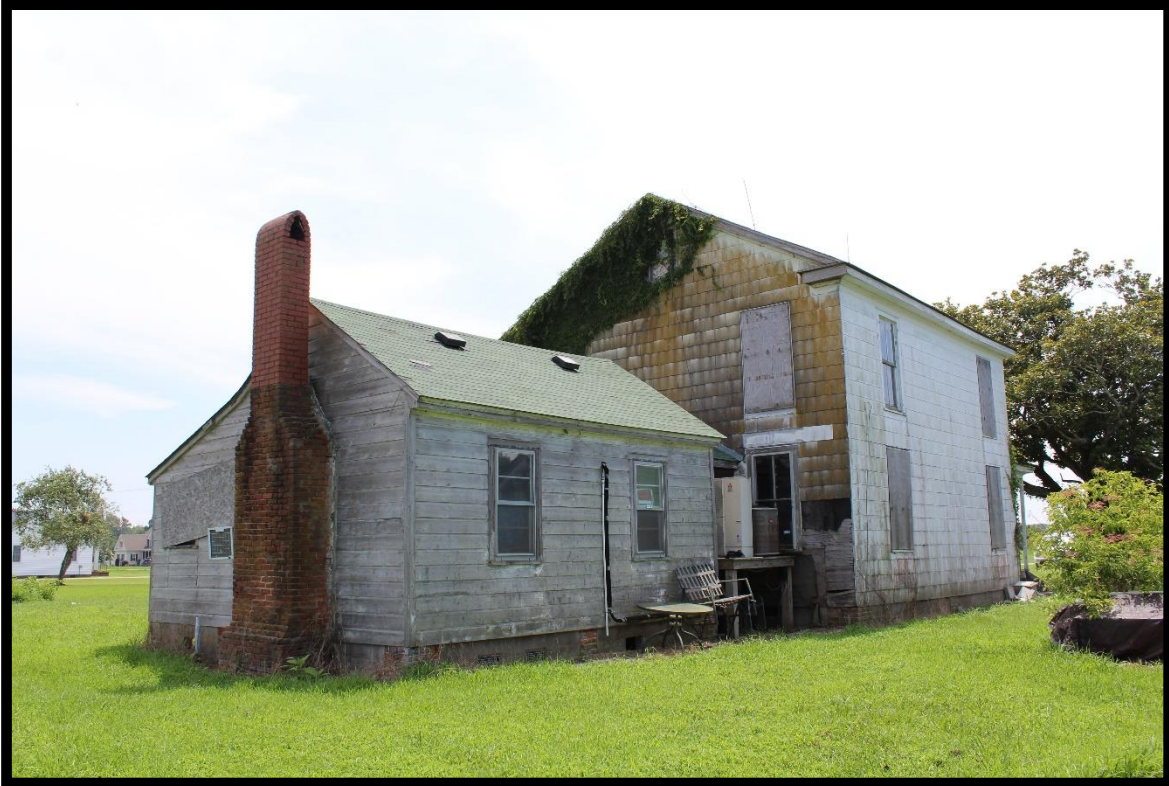
Figure 53: Berry House, Looking South.

The northeast (rear) elevation of the main block of the dwelling contains two boarded over windows along the second story and one two-over-two, wooden sash window in the lower right corner. It may have had an additional window or entry door in the lower left corner that was adapted as a connection point for the hyphen and kitchen house (Figure 53).

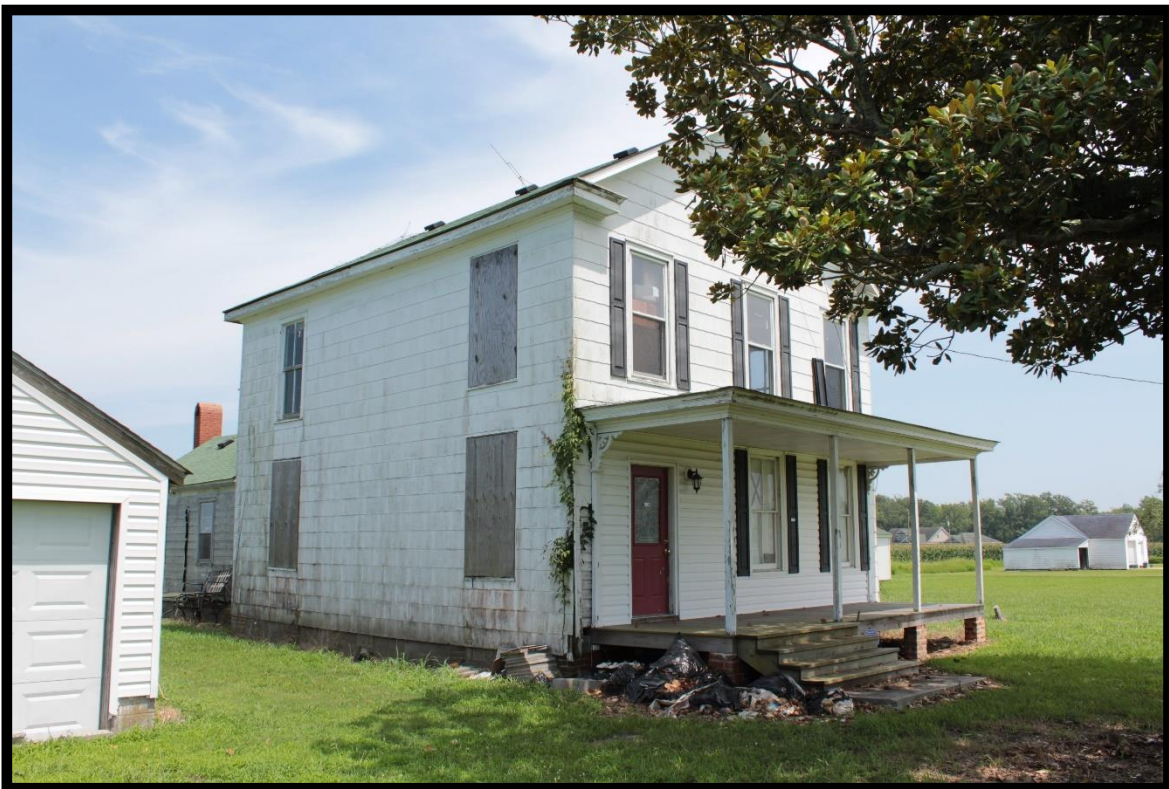
Figure 54: Berry House, Looking West.

The northwest (side) elevation of the main block contains four symmetrically placed windows. Three are covered with plywood while the upper left window is uncovered and contains a two-over-two, wooden sash (Figure 54).

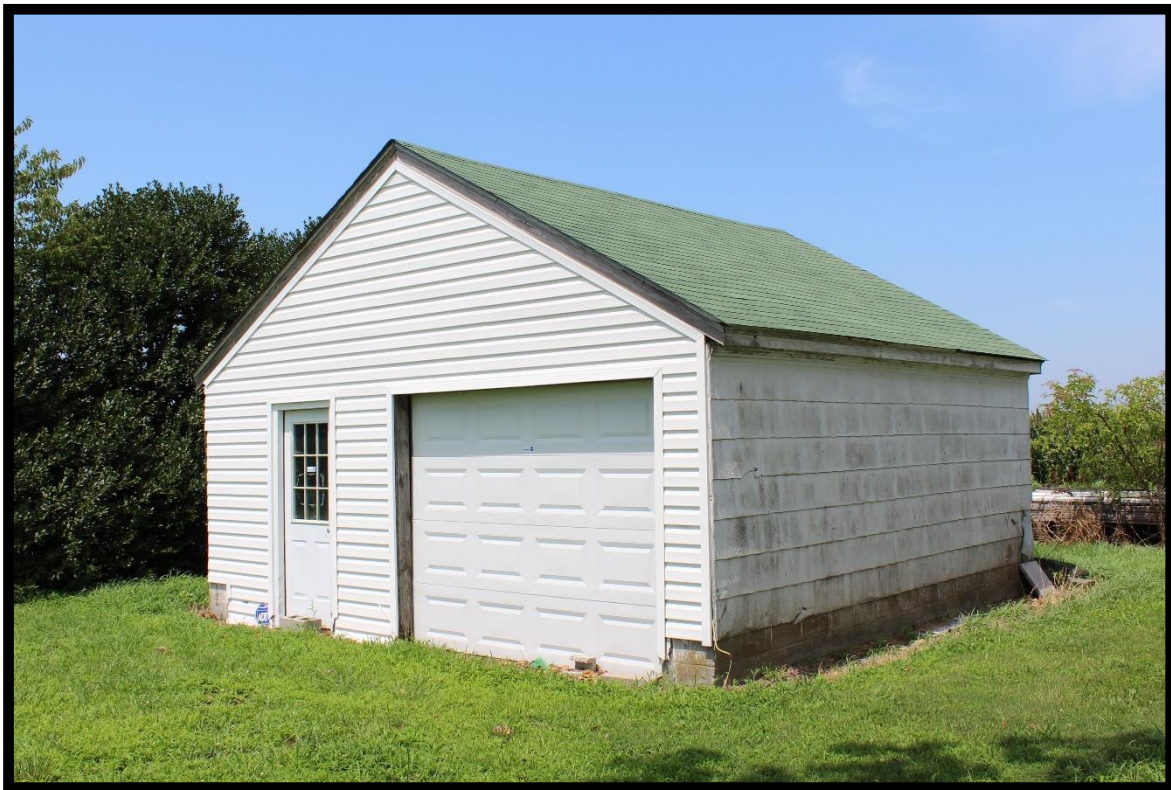
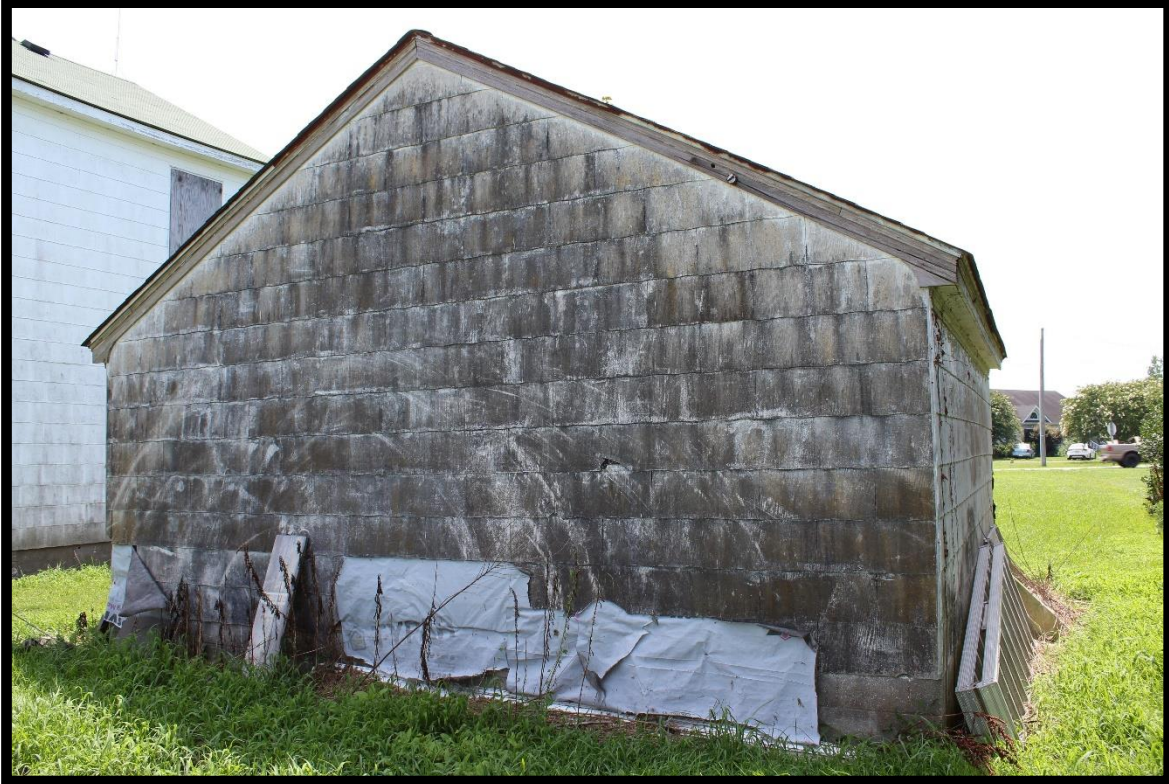
Figure 57: Berry House, Garage, Looking North.

Ancillary structures associated with the dwelling include a front-gabled garage that stands just west of the dwelling. The garage rests on a concrete block foundation, is clad with both vinyl and asbestos siding, and is covered by an asphalt shingle roof. Its front facade has a modern garage door flanked on the west by a modern entry door and its other elevations are blind (Figures 57 and 58).

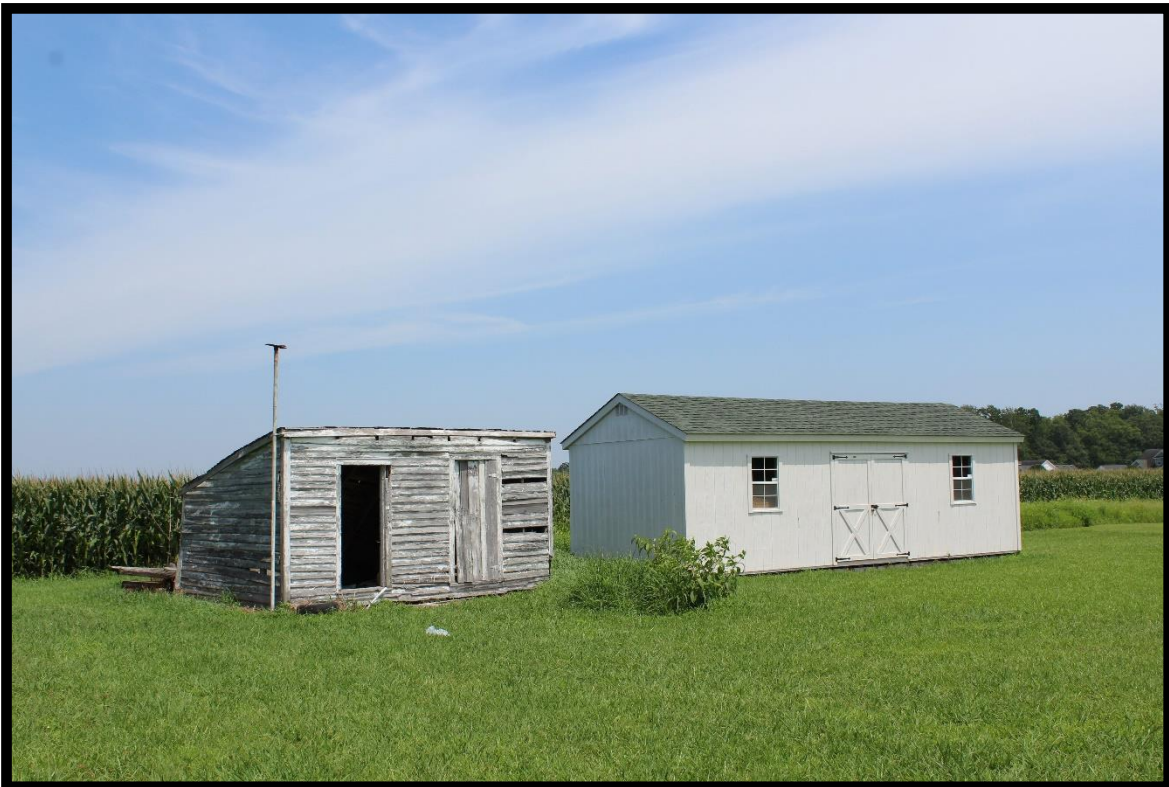
Figure 59: Berry House, Sheds, Looking East.

East of the dwelling, near the parcel line and the edge of a plowed field, are two additional ancillary structures. The first has a sunken-in, asphalt shingled, shed roof and is clad with plain weatherboard siding. It has two entry doors on its southwest (front) elevation and is blind on its other elevations. The second is more modern, in much better condition, has a side-gabled asphalt shingle roof, and is clad with sheets of paneling. It is a long structure, and its southwest (front) elevation contains a double-leaf board and batten door entrance flanked by four-over-four, vinyl sash windows (Figures 59 and 60).

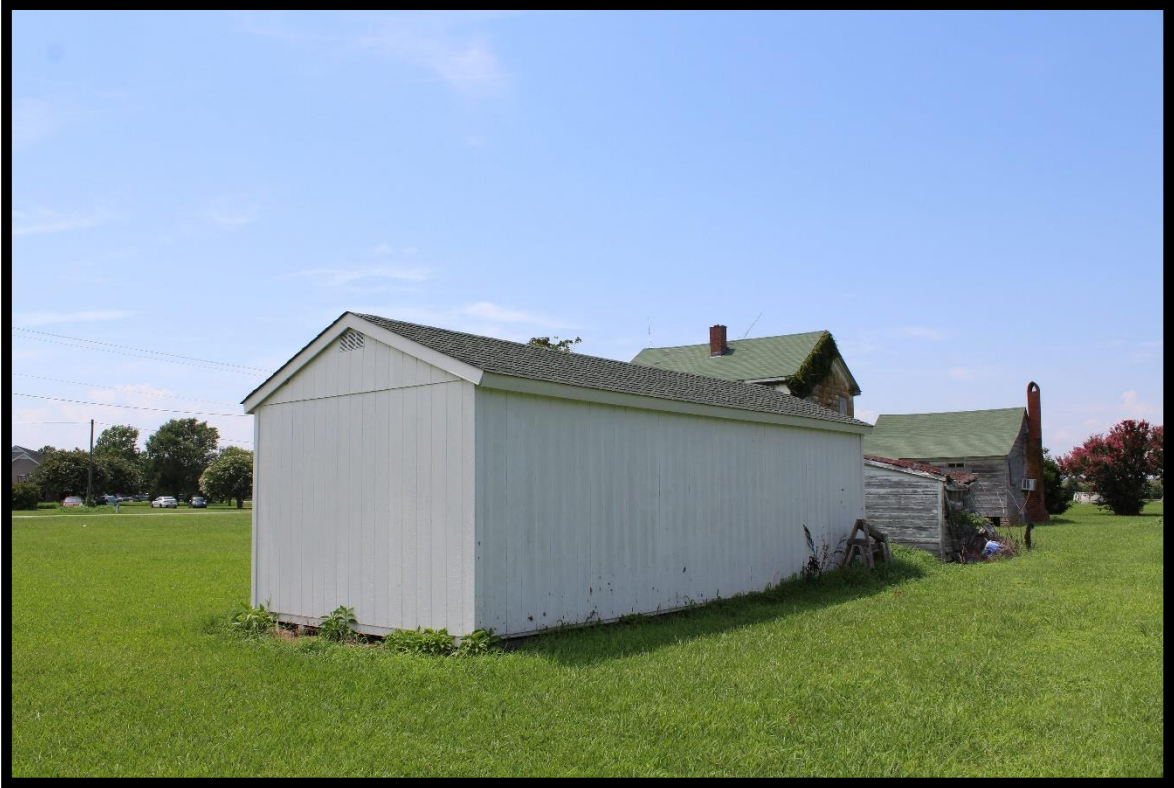
Figure 60: Berry House, Sheds, Looking West.

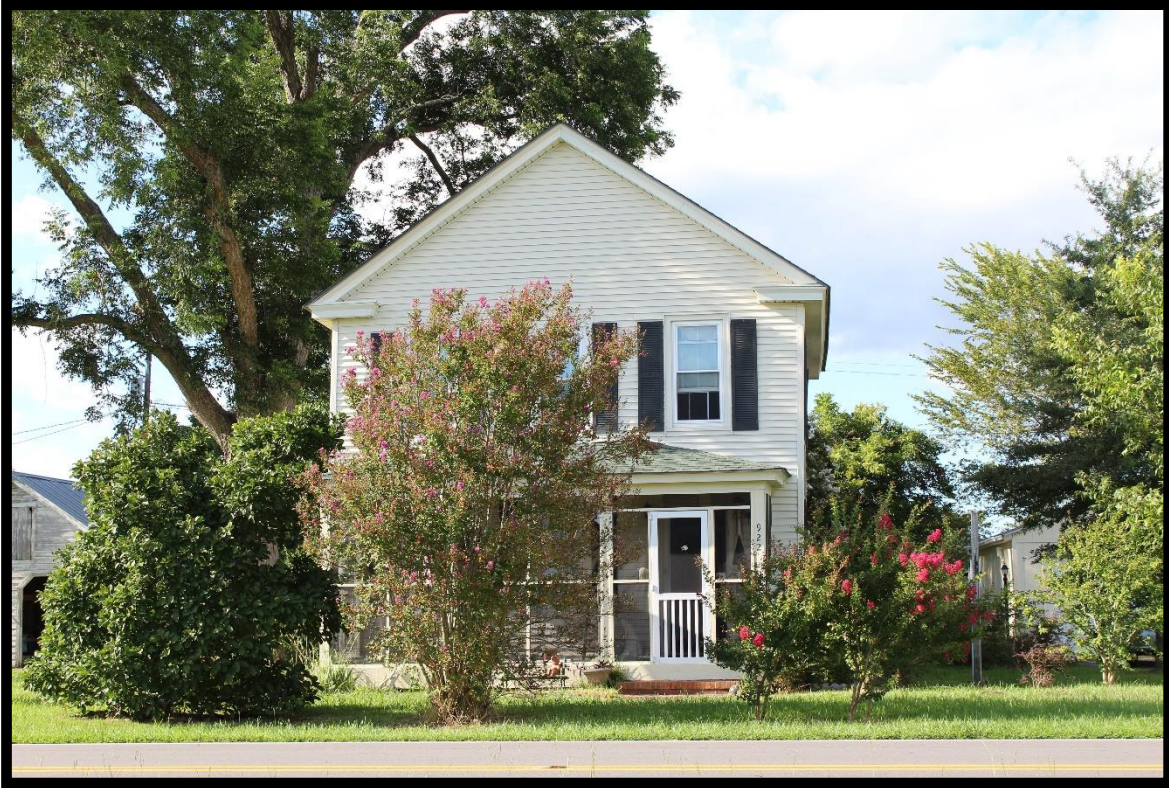
Figure 63: 922 NC Highway 343 (CM0208), Looking North.

The resource identified in HPOWeb is a ca. 1914 dwelling that is also located on NC Highway 343 and, though in better condition, exhibits an even lower level of architectural integrity than the Berry House with vinyl siding, replacement windows, and an enclosed porch (CM0208, Figure 63).⁵⁹ An additional front-gabled dwelling is located in the study area and included as a part of this report, the Nash Place (CM0238, Figure 64). This property also exhibits a low level of architectural integrity, though it does retain its wooden sash windows and a moderate to high level of interior elements.

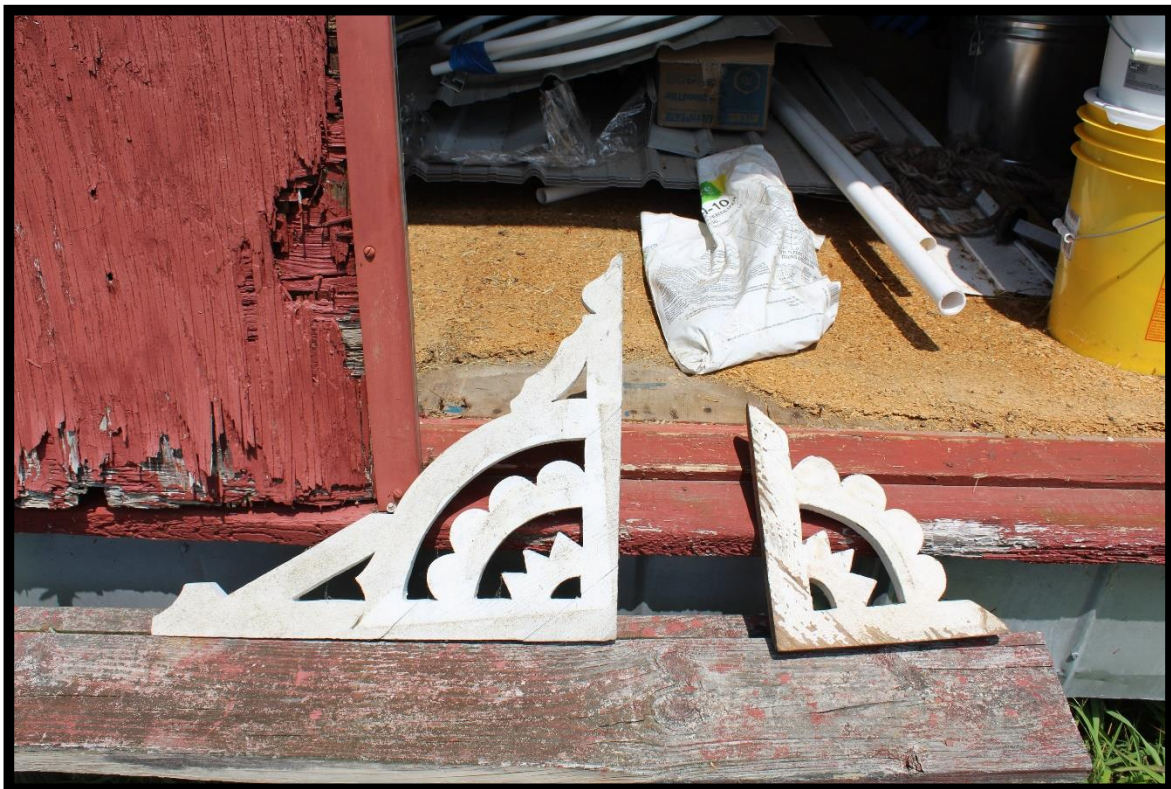
Figure 68: Nash Place, Detail of Removed Porch Brackets.

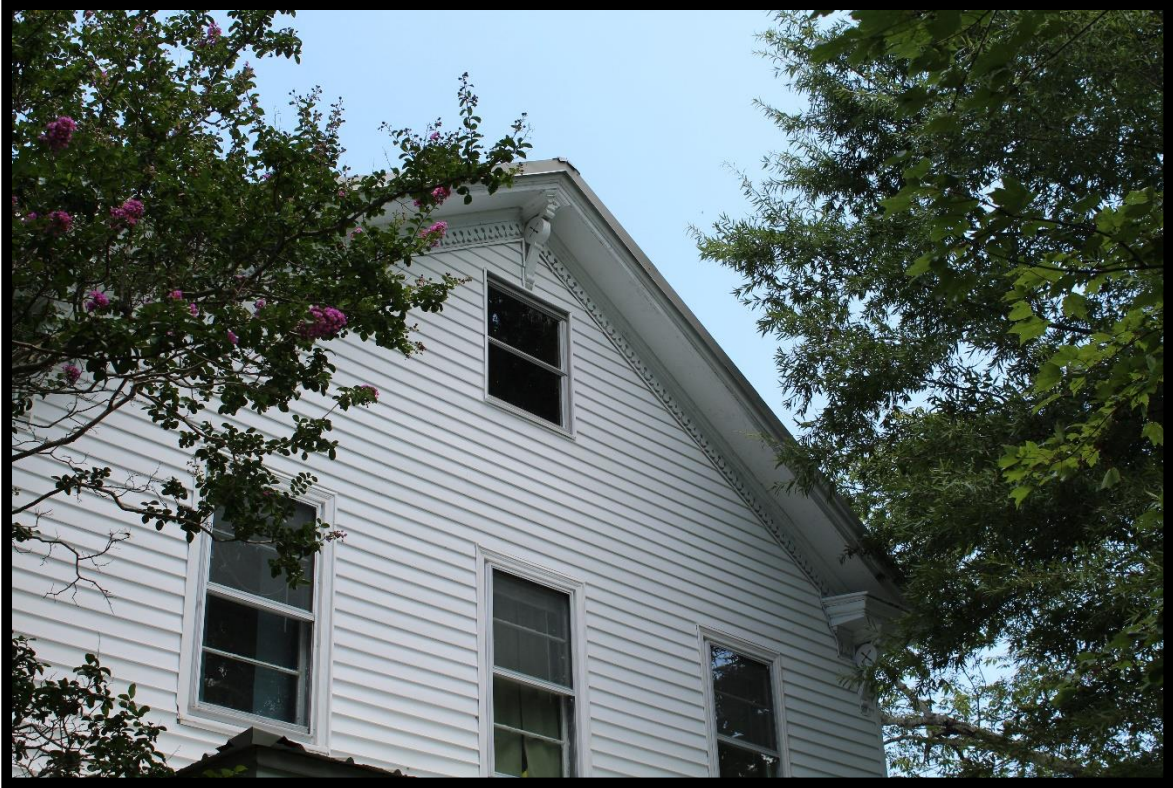
Figure 69: Nash Place, Façade, Detail of Eave.

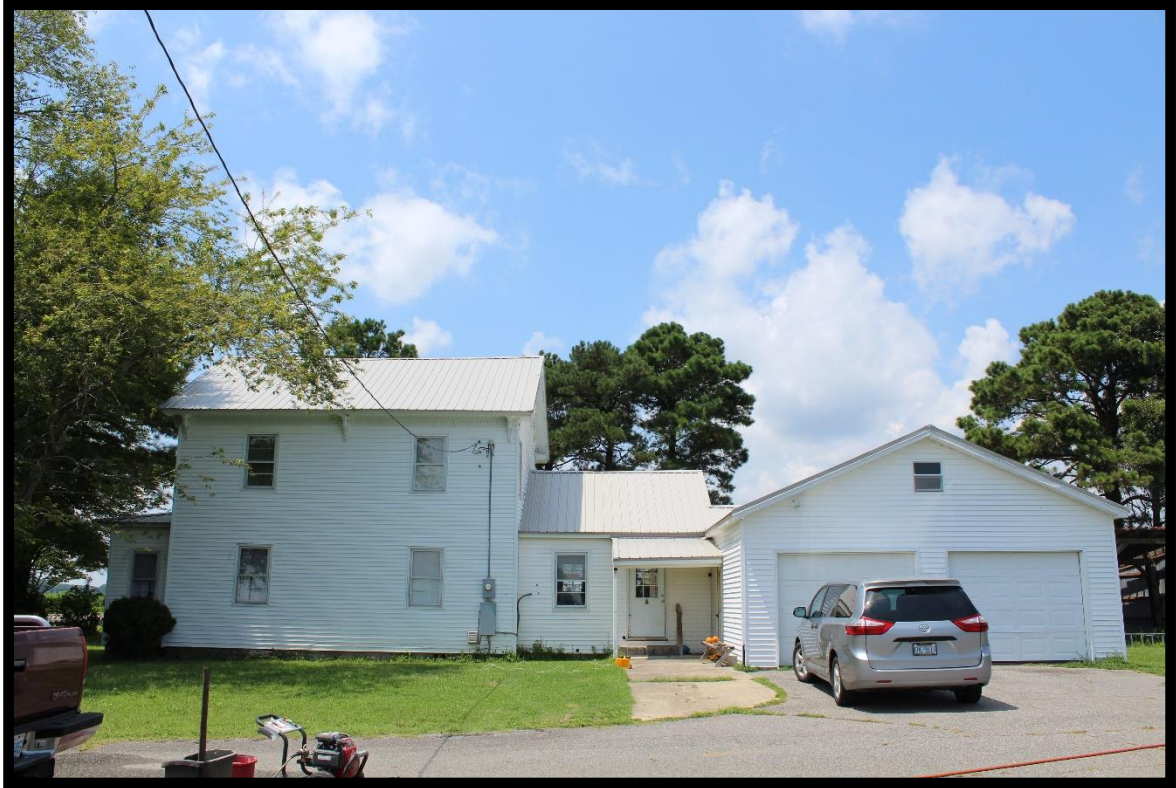
Figure 72: Nash Place, Looking West.

The garage projects east of the kitchen addition creating a space for a small shed-roofed stoop. The stoop shelters two modern entry doors – one that accesses the garage and one that accesses the kitchen. The kitchen door is flanked on the south by a window. The east (side) elevation of the main block of the dwelling contains two evenly spaced windows on each story (Figure 72).

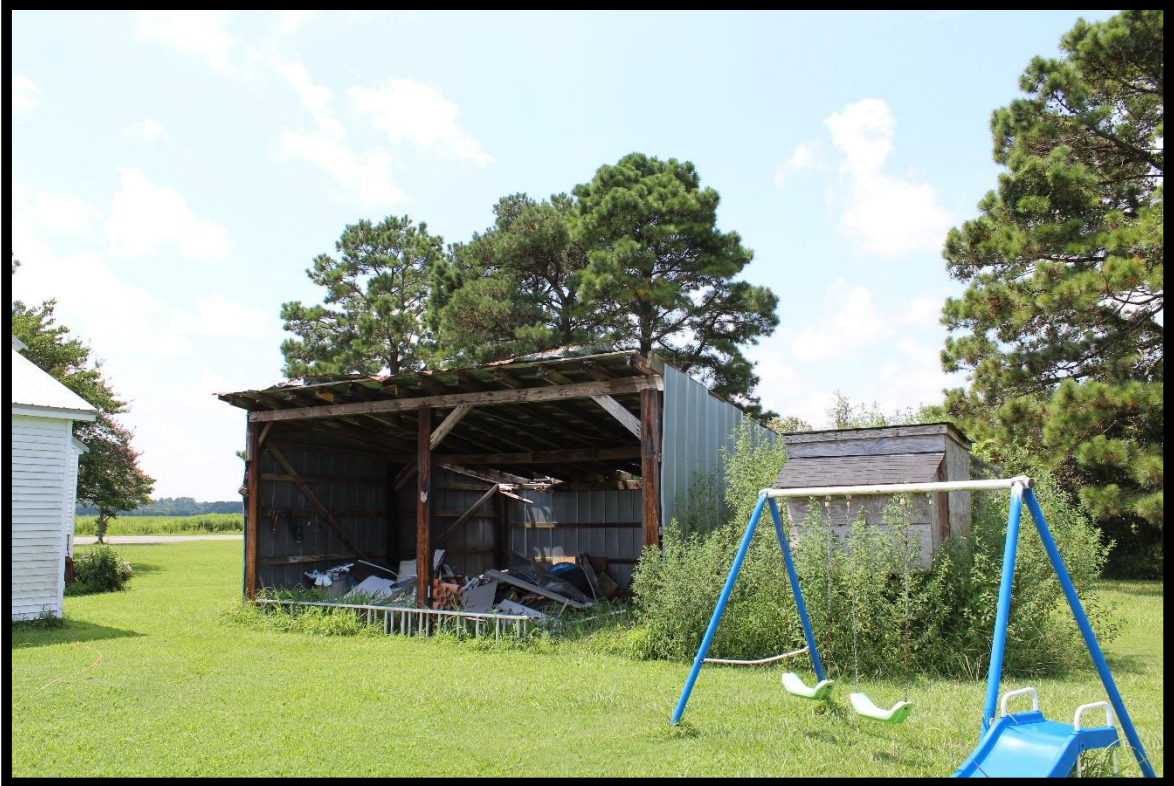
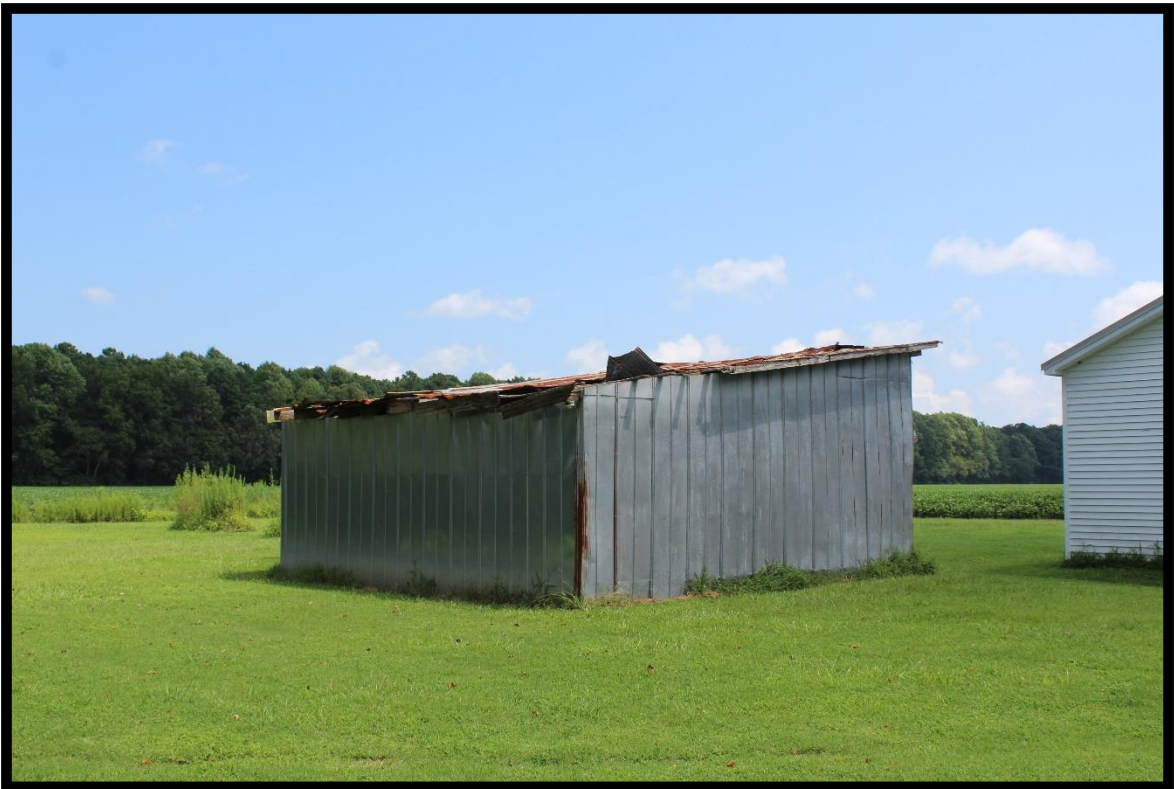
Figure 75: Nash Place, Shed, Looking Southwest.

Ancillary structures associated with the dwelling include a shed-roofed structure that is open on the east side and is clad with metal sheets. Its roof is collapsed at the rear and an overgrown chicken coop stands to its north (Figures 75 and 76). A front-gabled shed faces south toward the dwelling. It is also clad with metal sheets (siding and roof) and has a double-leaf particle board entry door with clipped corners. Next to the shed is a concrete pad that was occupied by a silo (Figures 77 and 78).

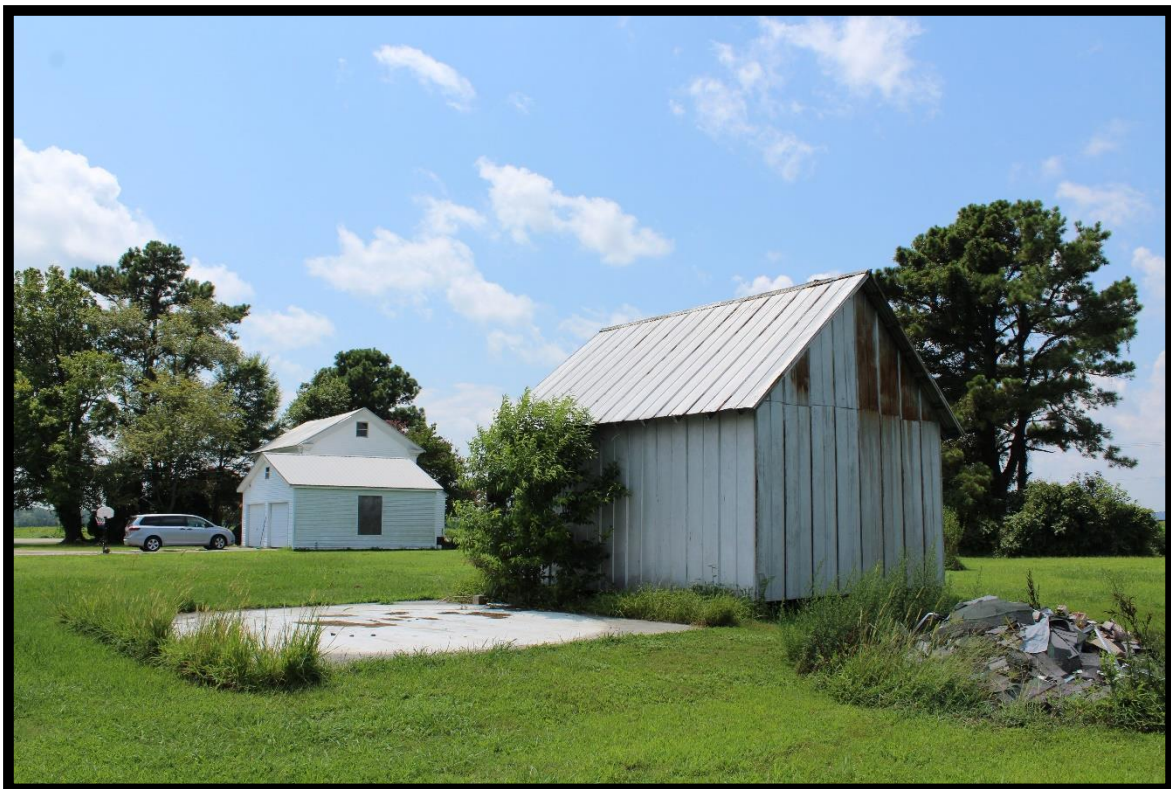
Figure 78: Nash Place, Shed and Concrete Slab, Looking Southwest.

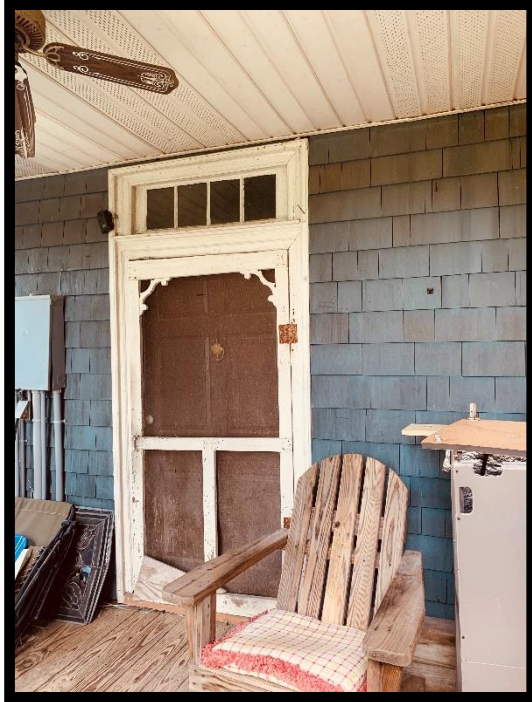
Figure 88: Morrisette House, Front Door.

The dwelling is an I-house clad with wooden shingles and sheltered by a standing seam metal roof. A one-story porch with an asphalt shingle hipped roof and Craftsman-style details, including tapered columns on brick pedestals, spans the elevation. The porch is screened with an entry door in the last bay to the west. According to the resource's survey file, the porch and shingles were likely added in the early twentieth century.⁷⁶ The application of shingles, however, became popular in the late nineteenth century around the same time as the Queen Anne style. The porch shelters an asymmetrical façade with a wooden entry door and transom flanked on the east by nine-over-six, wooden sash windows. Though the house is greatly unrestored, the ceiling and decking of the porch appear new. The shingles below the porch are also stained blue while those elsewhere show only faint signs of having been finished. Above the porch are three evenly spaced six-over-six, wooden sash windows (Figures 87 through 89).

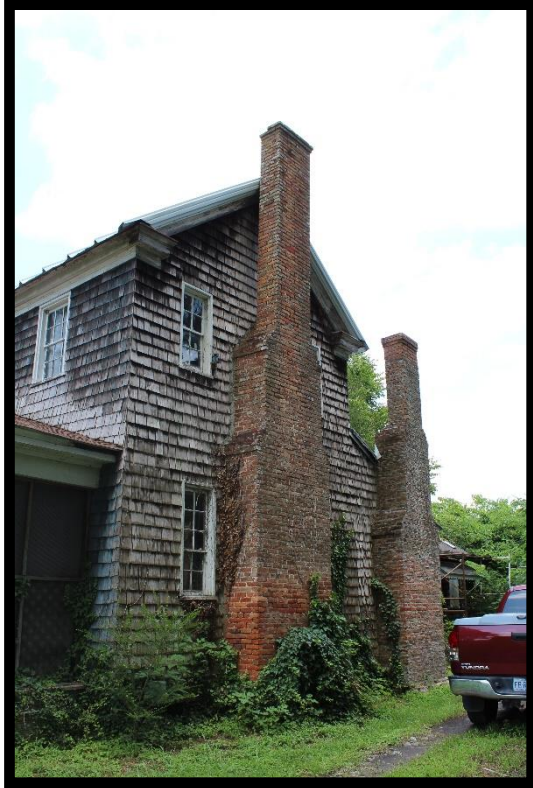
Figure 90: Morrisette House, Looking North.

The southeast (side) elevation is defined by two double-shouldered chimneys. The first heats the two-story, I-house portion of the dwelling, while the second, which is shorter, heats a shed-roofed rear section of the house. Both chimneys are laid with a common bond pattern, and according to the properties survey file, the rear chimney's stack was newly reconstructed when it was surveyed in 1969. The taller chimney is flanked on the first story by two slender six-over-

four, wooden sash windows and on the second story by two four-over-four, wooden sash windows (Figures 90 and 91). A one-story, gabled wing extends from the northeast (rear) elevation. Its southeast (side) elevation contains a bank of four six-over-six, wooden sash windows to the south of a screened entry door. A small gabled addition appears to extend from the wing, but overgrown vegetation prevented further evaluation (Figure 92).
