SUBJECT: Historic Structures Survey Report for R-5807, Proposed improvement to NC 343 from US 158 to SR 1119, PA 18-10-0034, Camden County, ER 21-0824

To: Renee Gledhill-Earley, NCHPO
From: Vanessa E. Patrick, NCDOT
Date: April 5, 2021
Subject: *Historic Structures Survey Report for TIP No. R-5807, Camden County, North Carolina. WBS No. 46969.1.1. PA Tracking No. 18-10-0034.*

**TIP PROJECT R-5807
WBS NO. 46969.1.1
PA TRACKING NO. 18-10-0034**

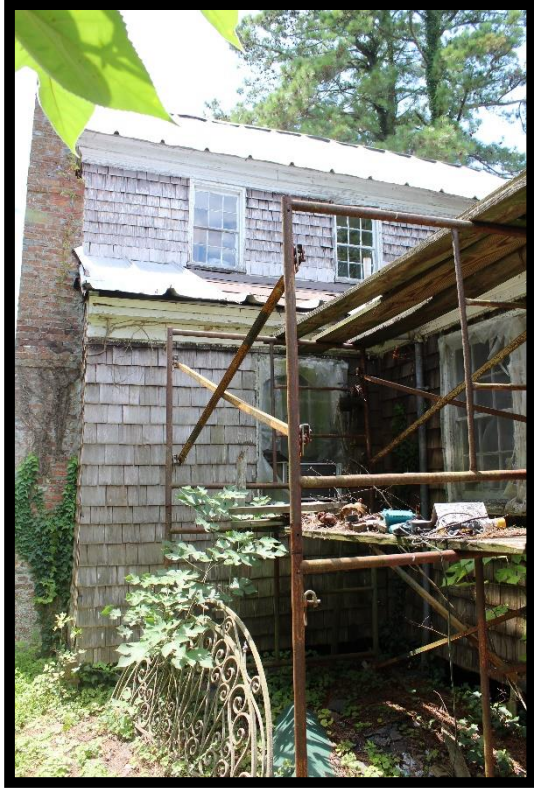
Figure 93: Morrisette House, Looking Southwest.

The northeast (rear) elevation of the main block contains a single six-over-six, wooden sash window on the rear of the shed-roofed section and three evenly spaced six-over-six, wooden sash windows on the second story (Figure 93).

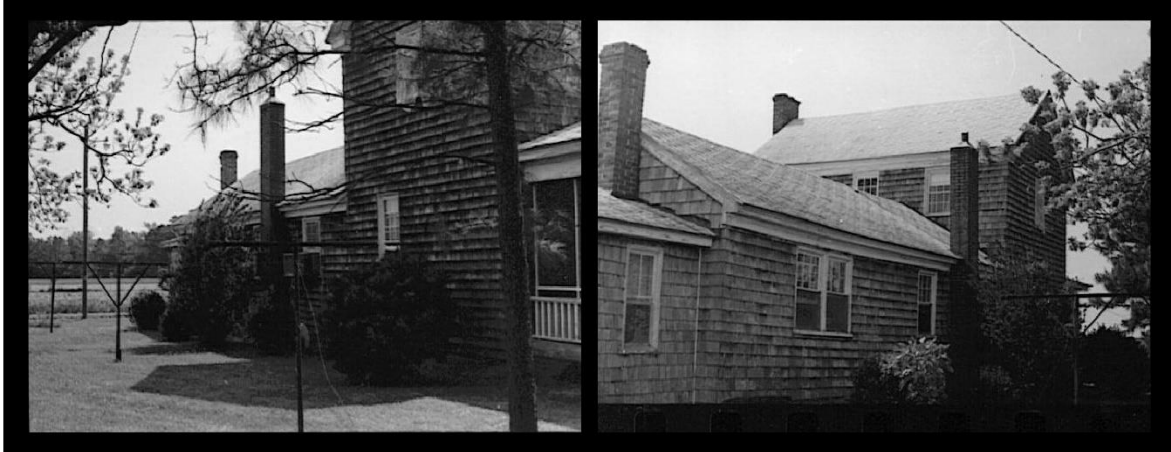
Figure 96: Morrisette House, Northwest Elevation, Looking East and South, Respectively (HPO Survey File, CM0021.)

The northwest (side) elevation of the I-house contains an off-center, nine-over-six, wooden sash window on the first story and a centered, six-over-six, wooden sash window on the second story (Figure 94). Only a portion of the wing, which is flush with the side of the I-house, was visible revealing a two-over-two, horizontal pane, wooden sash window (Figure 95). The rest is consumed with vegetation. Photos from 1969, however, show the elevation with individual and paired six-over-six, wooden sash windows and at least one two-over-two window (Figure 96).

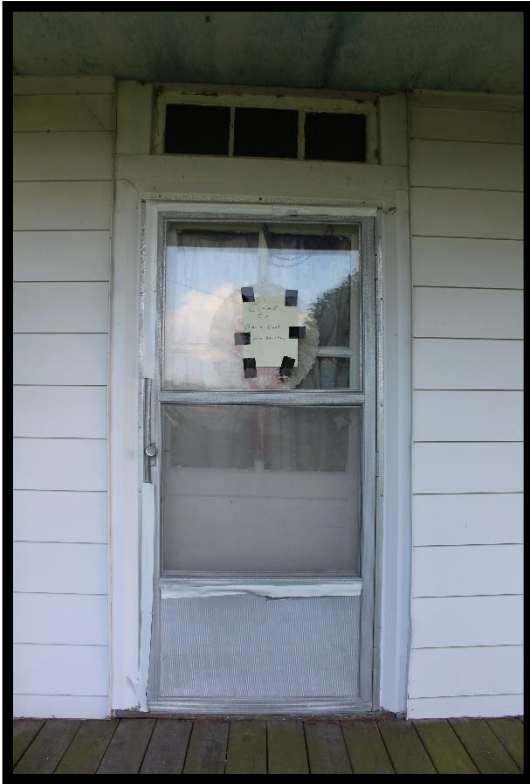
Figure 108: Hughes-Williams House, Front Door.

The dwelling is an I-house with a brick pier and concrete block infill foundation, vinyl siding, and an asphalt shingle roof. It has a three-bay façade with an off-center entry door. The entry door has four lights over panels and is topped by a linear three-light transom (Figure 108). It is flanked by nine-over-six wooden sash windows and sheltered by a hip-roofed porch supported by thin chamfered posts. Above the porch are three six-over-six wooden sash windows (Figures 107 and 109). Unless otherwise noted, all first story windows have nine-over-six wooden sashes and all second story windows have six-over-six wooden sashes.

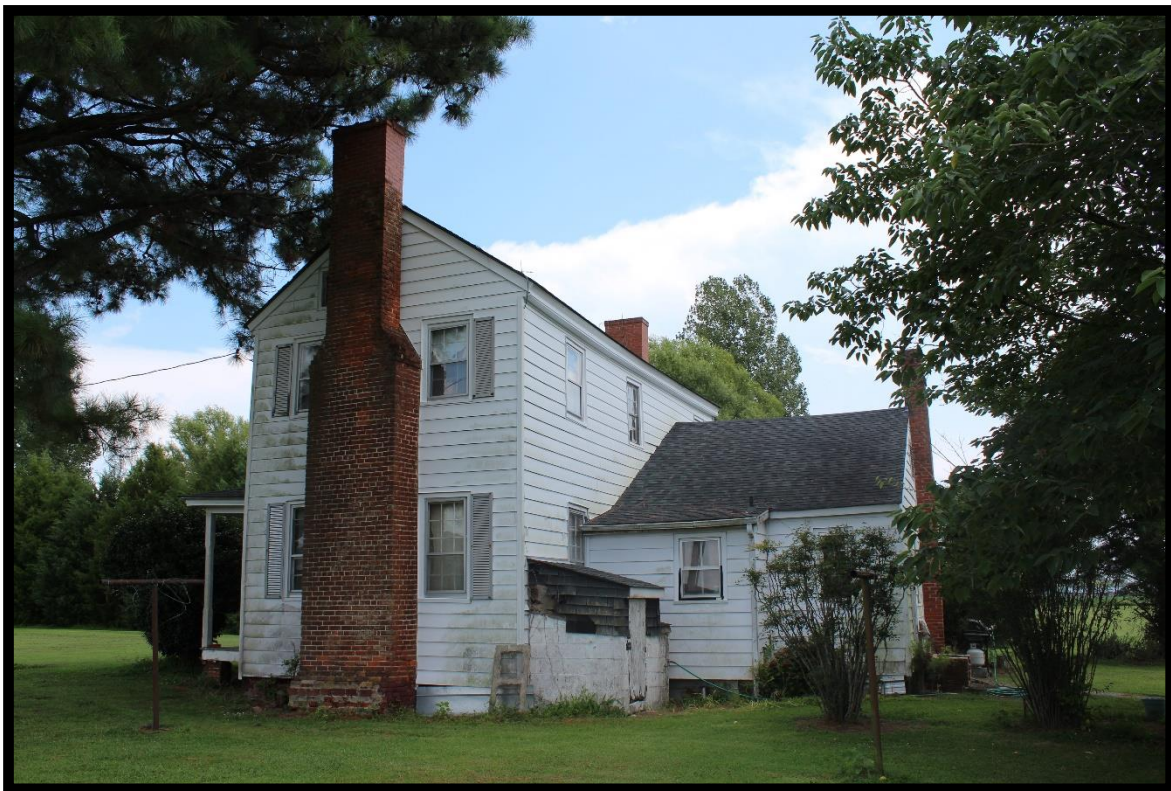
Figure 110: Hughes-Williams House, Looking South.

The northwest (side) elevation contains a single-shouldered brick chimney laid in common bond and flanked by two windows on the first story and two windows on the second story. A small four-light window, also with a wooden sash, exists to the north of the chimney and lights the attic. A gabled, one-story wing projects from the southwest (rear) elevation of the dwelling. Its northwest (side) elevation is divided into two bays, one of which projects forward and contains a two-over-two vinyl sash window, while the second bay contains a four-over-four vinyl sash window. A small shed-roofed section, that likely houses a pump or accesses a basement, is located in the corner created by the main block and wing. It is composed of concrete block and wooden shingles (Figure 110).

The southwest (rear) elevation of the main block has one window on the first story and two windows on the second story to the west of the rear wing and one second story window to the east of the wing (Figure 110). The southwest (rear) elevation of the wing is divided by a thin brick chimney. To the west of the chimney is an entry door, four-over-four vinyl sash window, and a louvered attic vent. The east side roughly mirrors the west side but is missing the attic vent and has a one-over-one metal sash window east of the door (Figure 111).

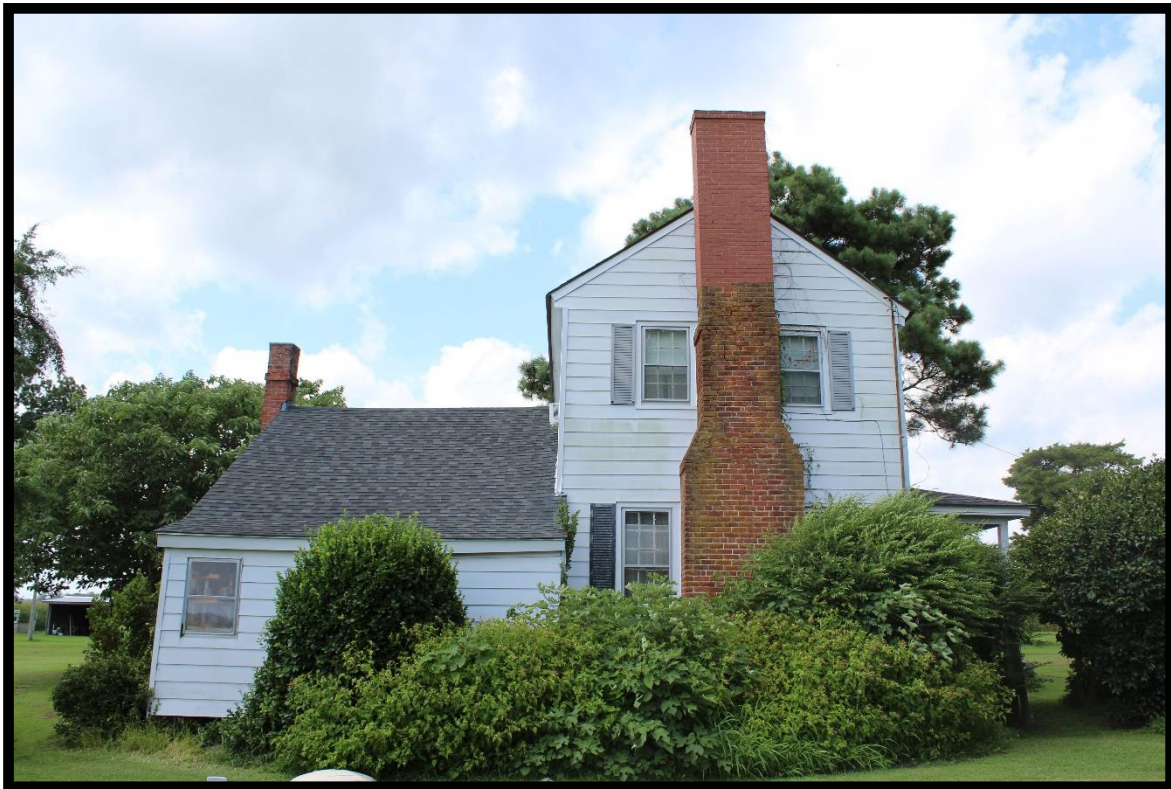
Figure 112: Hughes-Williams House, Looking Northwest.

The southeast (side) elevation of the wing is lit by a one-over-one metal sash window. The southeast (side) elevation of the main block of the dwelling is the same as the northwest (side) elevation except that its chimney is double shouldered, and it is missing the small attic window. The upper portion of the stack has been replaced as well (Figure 112).

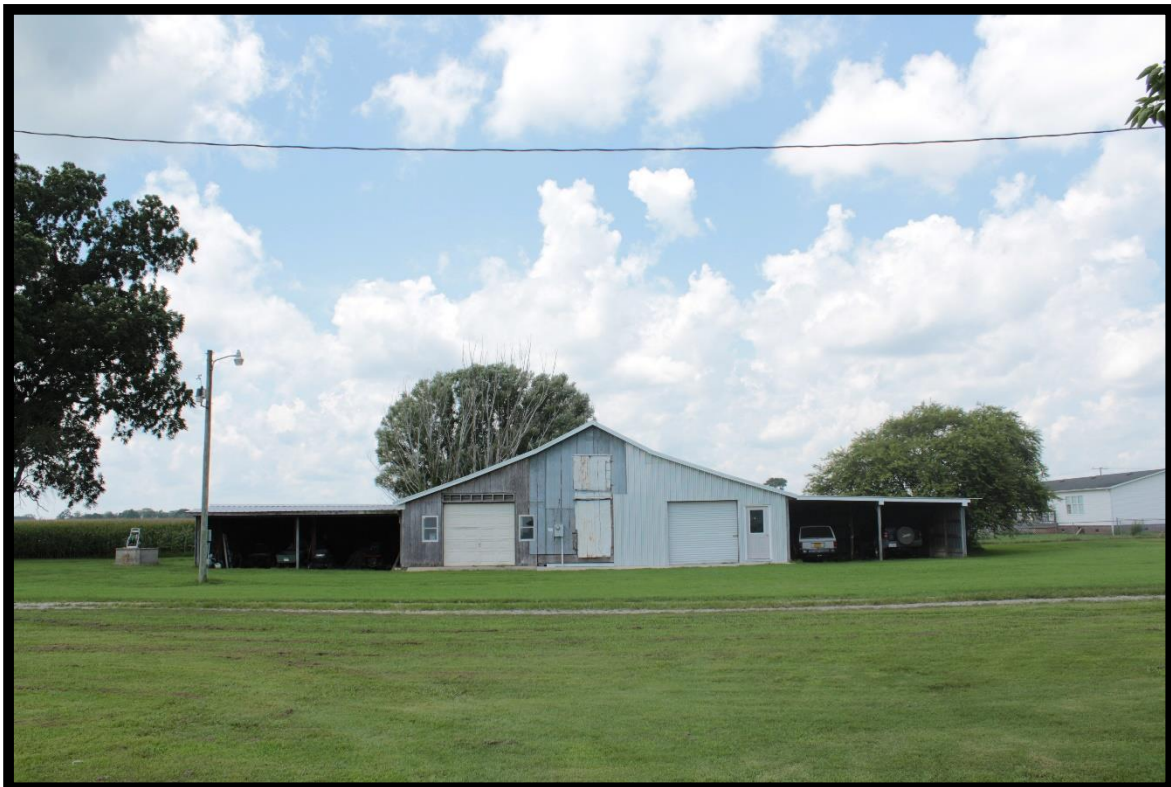
Figure 113: Hughes-Williams House, Barn, Looking Northwest.

Ancillary structures on the studied parcel include a front-gabled barn and a small shed. The barn stands west of the dwelling and faces southeast. It is clad with wooden and metal sheets and has a gabled, metal roof. Its façade features a centrally placed, sheet metal door below a similar loft door that is flanked by two modern garage doors. One-over-one vinyl or metal sash windows flank the south garage door and a modern entry door exists north of the north garage door. Two-bay, shed-roofed wings that are open on the front façade flank the gabled center section (Figure 113).

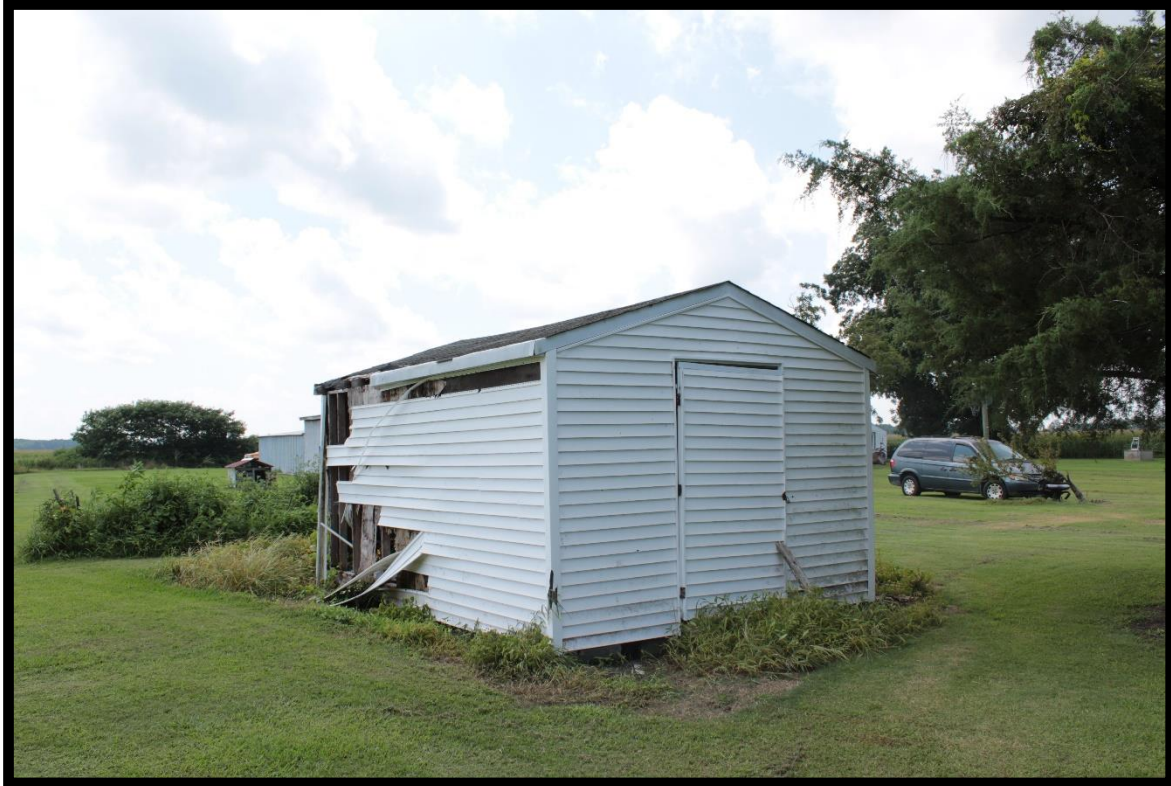
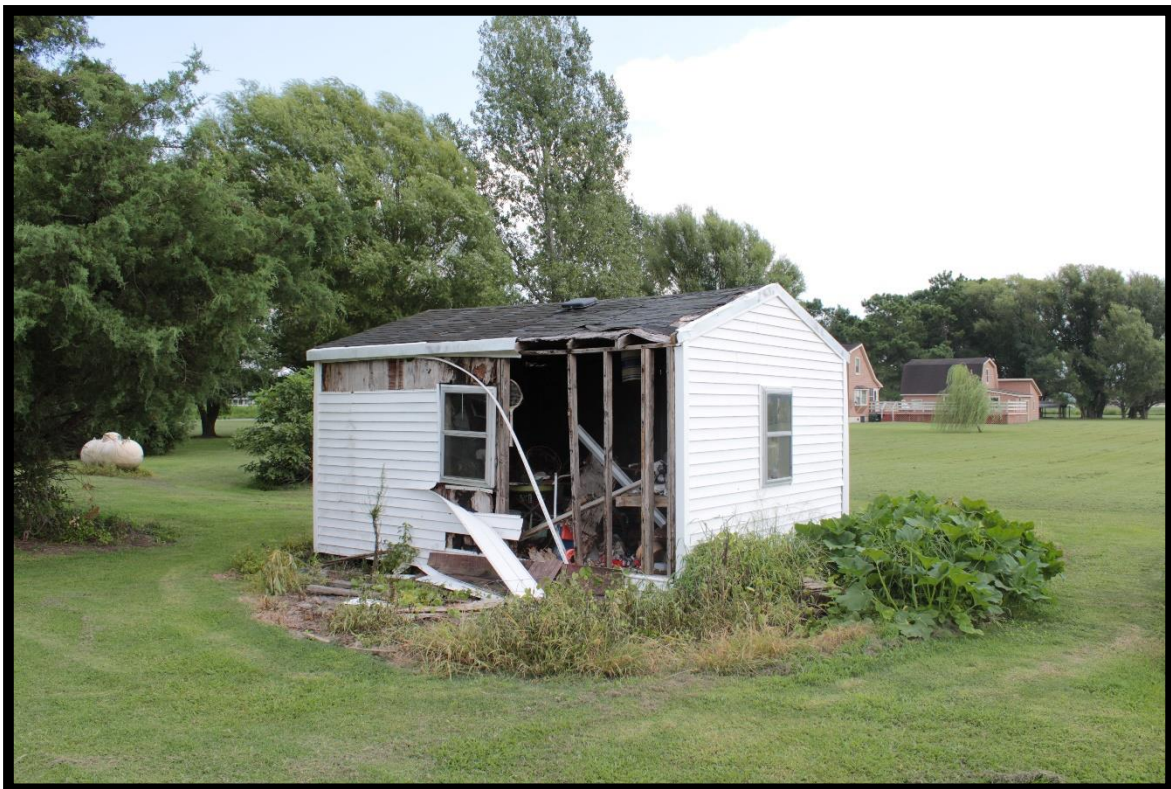
Figure 114: Hughes-Williams House, Shed, Looking West.

South of the dwelling is a front-gabled shed that faces northeast. The shed, which has sustained significant damage on its northwest and southeast (side) elevations and roof, is clad with vinyl siding and lit by one-over-one vinyl or metal sash windows. It has an asphalt shingle roof (Figures 114 and 115).

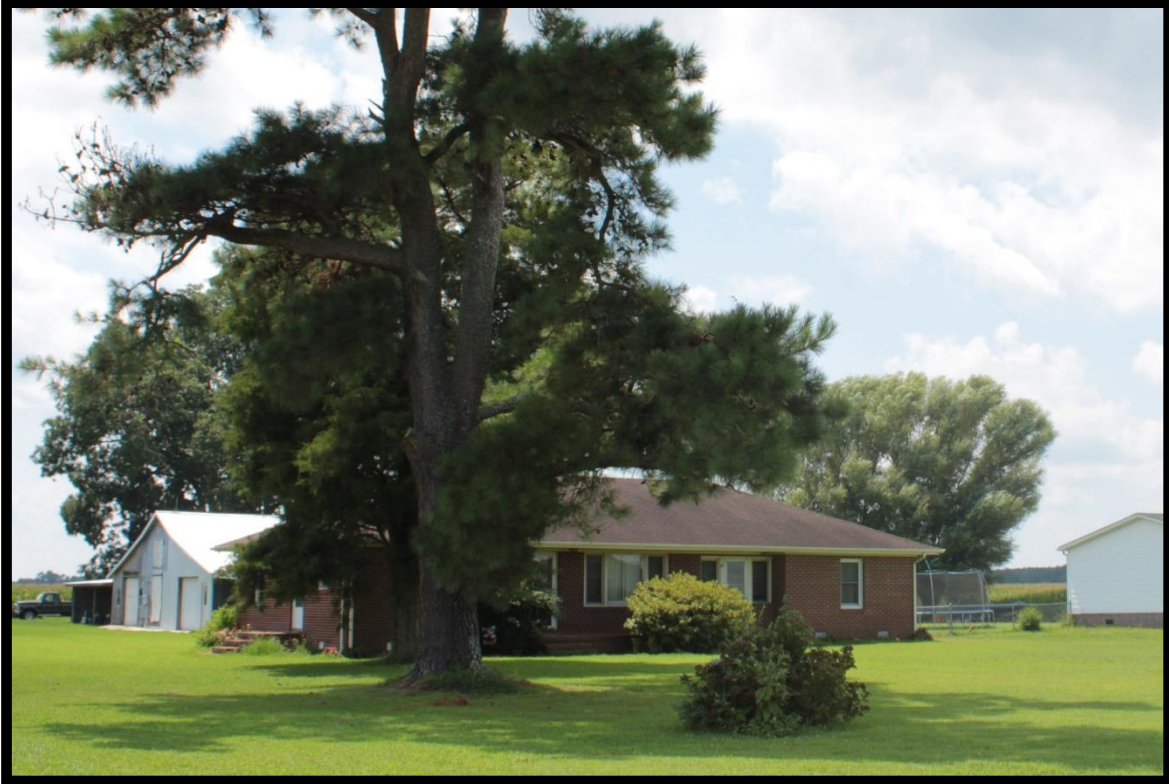
Figure 116: Hughes-Williams House, 1964 Dwelling, Looking East.

Northwest of the dwelling is a 1964 dwelling that is clad with brick veneer and sheltered by a hipped, asphalt shingle roof. Its façade, which faces northeast, is composed of two entry doors within an arrangement of paired, tripled, and individual windows (Figure 116).

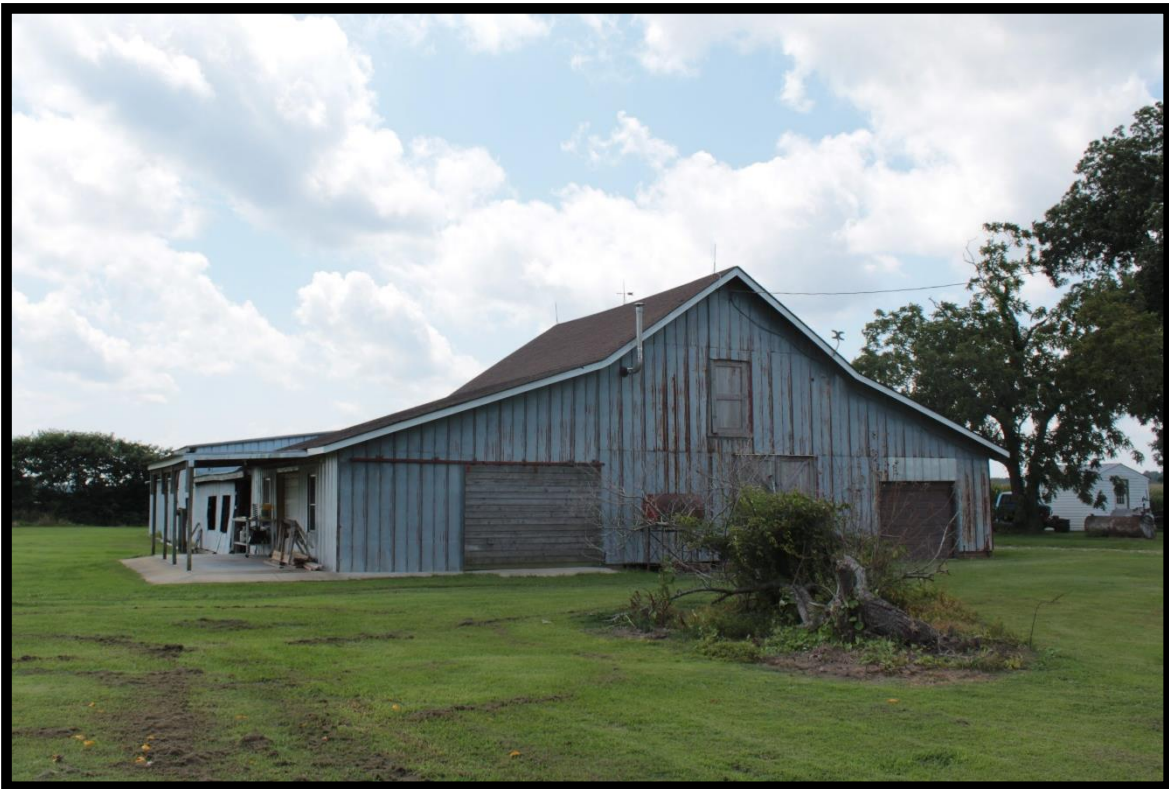
Figure 117: Hughes-Williams House, Barn, Looking West.

A second barn stands southwest of the dwelling on a separate parcel but faces northeast toward the dwelling. It is clad with vertical sheathing and has an asphalt shingled, double-pitch roof. It is front gabled and has an asymmetrical façade with, from east to west, a sliding garage door, a double board-and-batten door below a loft door, and a modern garage door. It has been expanded on its rear elevation with multiple sections that extend from one another (Figure 117).

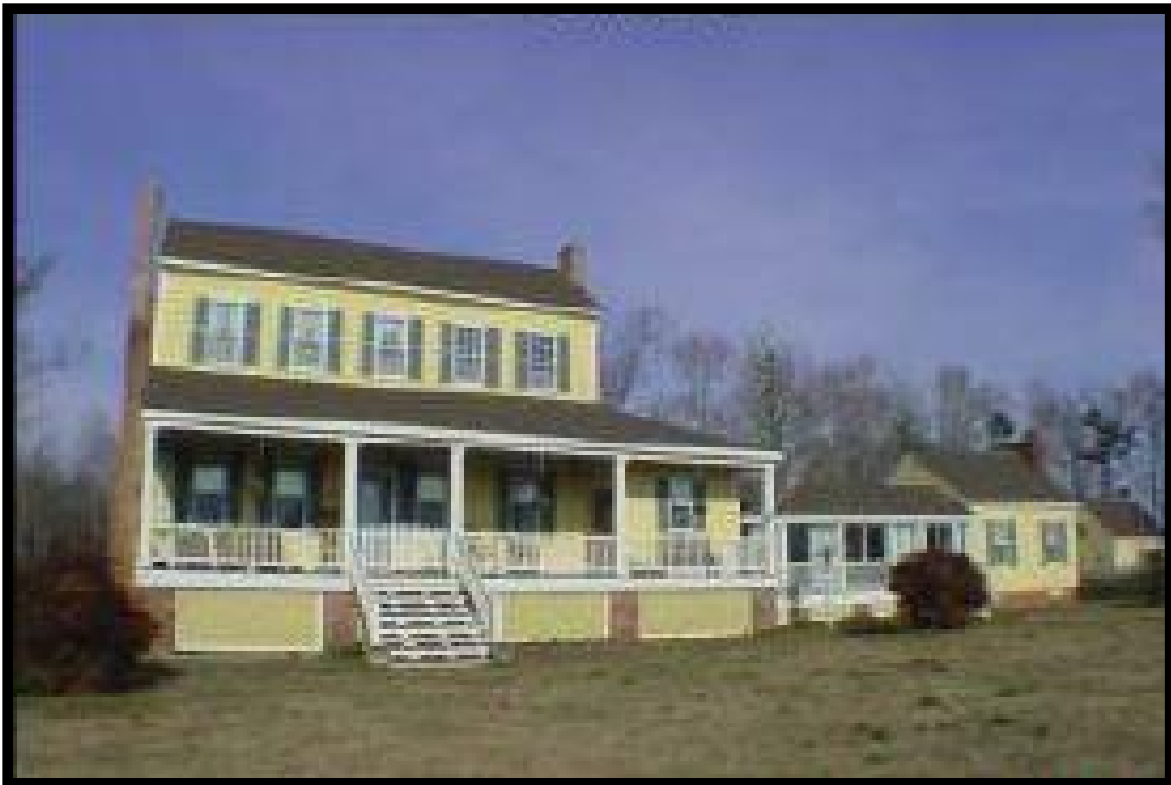
Figure 121: Joseph Sanderlin Sr. House (CM0059), Looking East (Camden County Property Record, PIN 028945003498260799).

The Joseph Sanderlin Sr. House, which was observed by the surveyor but could not be adequately photographed due to a substantial hedge along the forward edge of the property line,

presents an example of a well-preserved I-house with a centrally placed entrance. Larger than the Hughes-Williams House, it retains its wooden lap siding and appears to retain its original windows and porch. The house has also been expanded over time, appearing to incorporate a small kitchen house, and according to its property record retains an original frame outbuilding.⁹⁹ The house is somewhat detached from its agricultural environs due to landscaping and vegetative barriers, but remains in an area of Camden County that is dominated by agricultural land and through the retention of original architectural details better conveys the feeling of an nineteenth-century rural homestead.
