SUBJECT: Historic Structures Survey Report for Intersection Improvements at SR 2233 and
SR 1007, PA 21-01-0001, Wake County, ER 21-1371

**Historic Structures Survey Report
Intersection Improvements at SR 2233 (South Smithfield Road) and
SR 1007 (Poole Road)
Wake County, North Carolina**

T.I.P No. SM-5705AJ
WBS# 48996.1.1
PA No. 21-01-0001

May 12, 2021 – Final Report

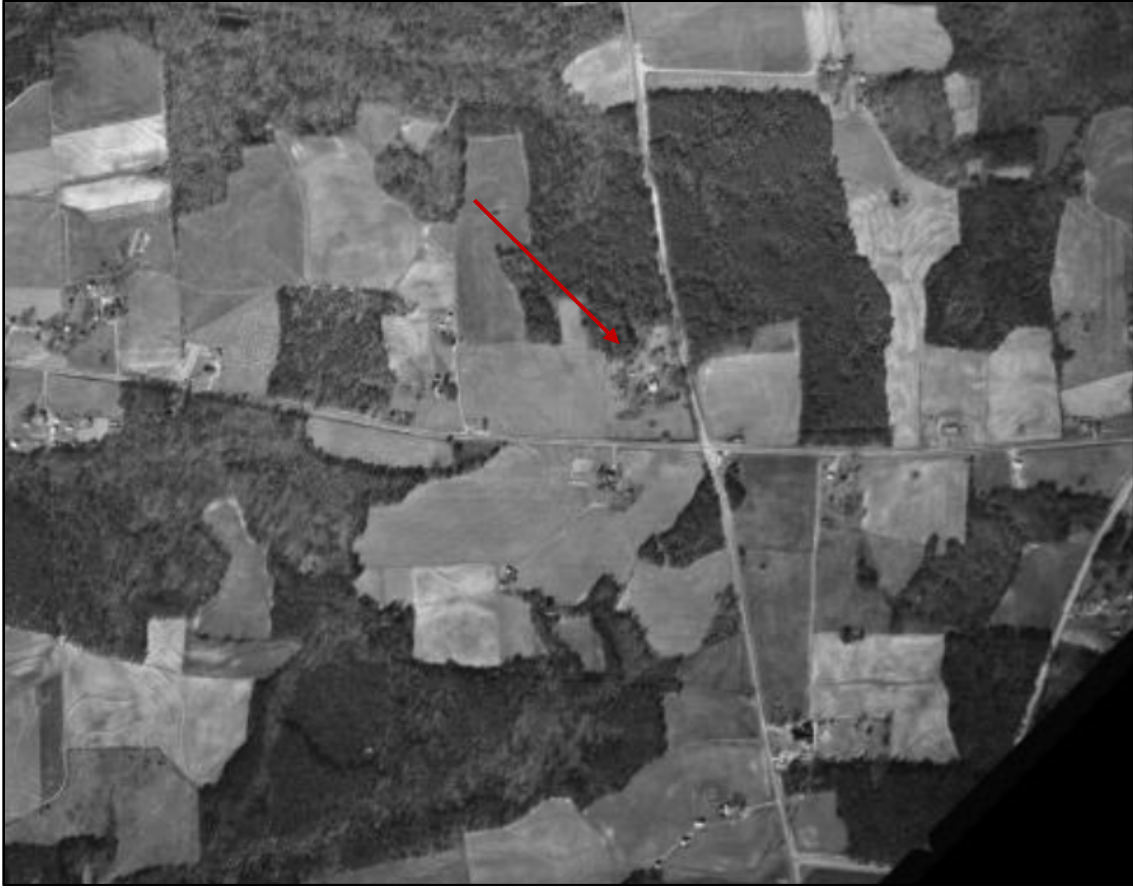
Figure 8. Aerial photograph dated February 18, 1969, showing Captain Bailey Williamson House in rural setting (NCDOT Photogrammetry Unit 1969).

The overall area has transformed from largely rural, agricultural uses with small farms to suburbanized residential construction over the past 30 years (Figure 8, Figure 9, and Figure 10). Historically, this house was part of a functioning farm located on the main roads between Knightdale, Shotwell, Raleigh, and Wendell. Numerous outbuildings would have supported the operation of the house and farm, but most have been lost as the land associated with this parcel was sold and various functions once necessary, became obsolete. Although the overall rural agricultural setting feels intact when on the property, the immediate surroundings of this residence have been altered by the loss of most of the associated outbuildings and fields.

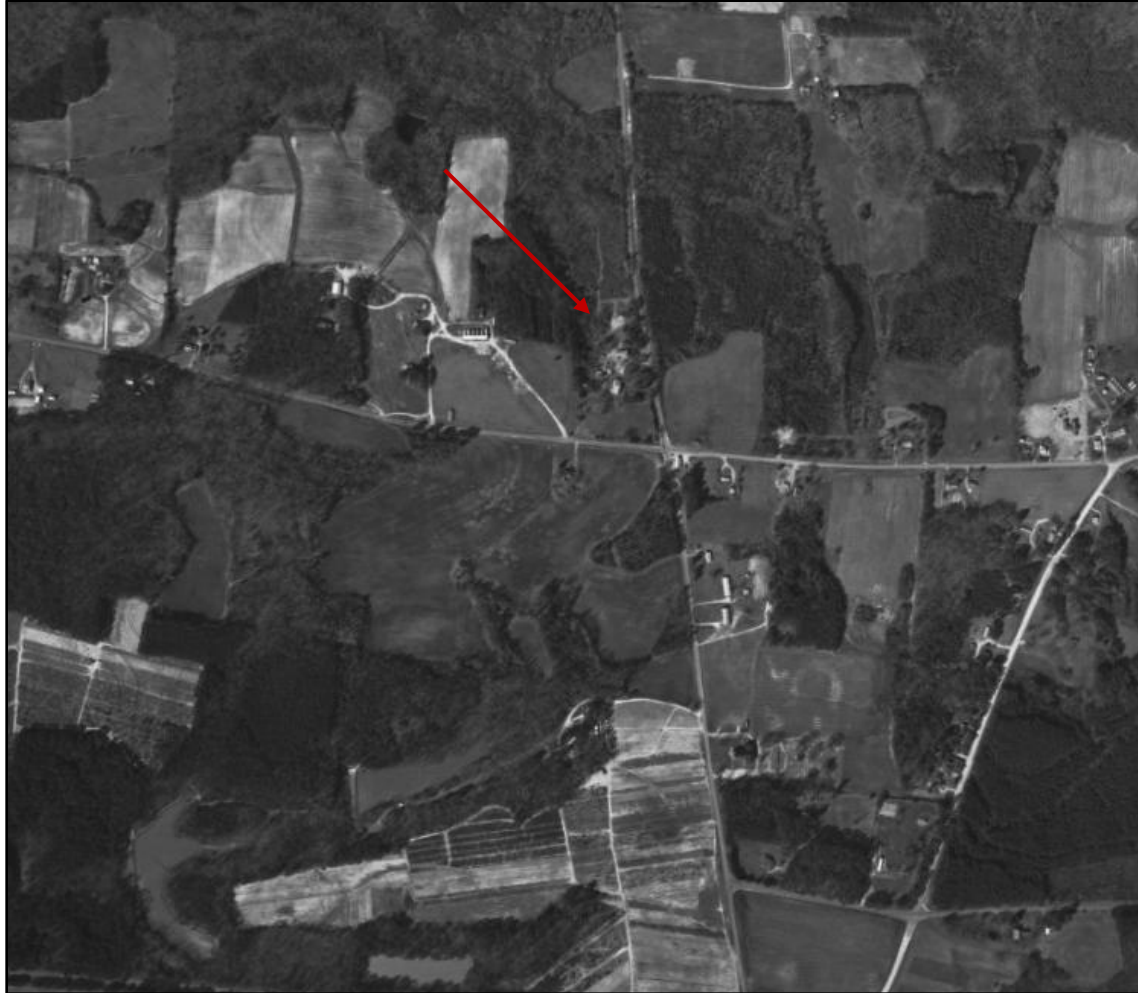
Figure 9. Aerial photograph dated March 9, 1991, showing Captain Bailey Williamson House in rural setting (NCDOT Photogrammetry Unit 1991).

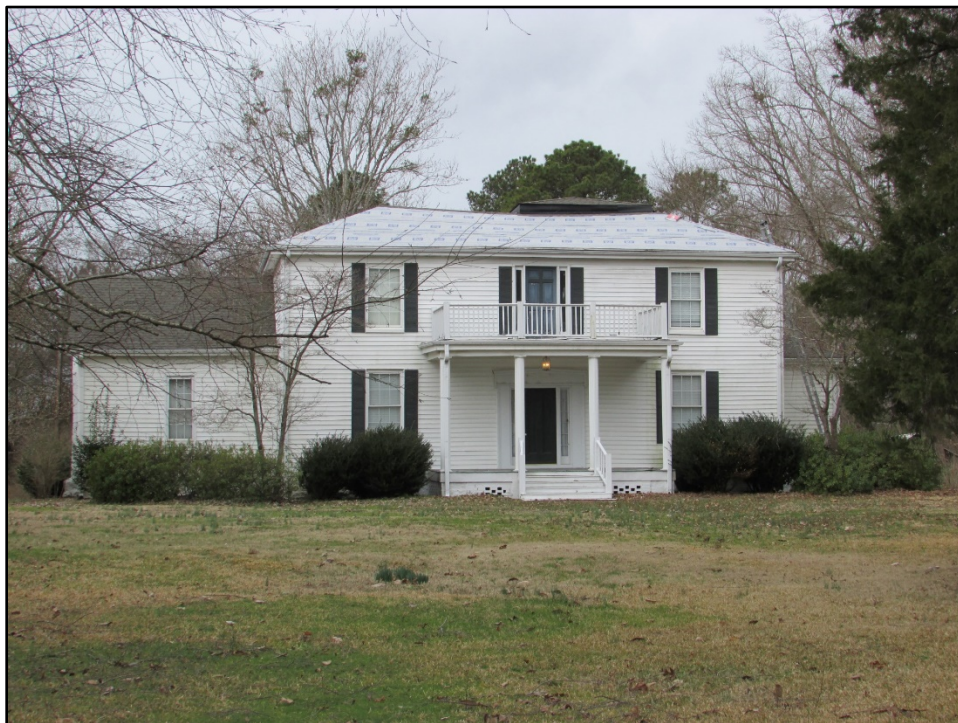
Figure 13. Captain Bailey Williamson House, east façade, looking west.

The original house, the front portion of the two-story section, was a three-bay wide by one-bay deep I-House with a one-story entrance portico centered on the east façade. Presently, this house exhibits an irregular, asymmetrical form with a central two-story mass flanked by one-story additions on the north and south and a second story addition to the rear (west) (Figure 13 and Figure 14). The two-story portion has a low hipped roof with widely overhanging boxed eaves; the hipped roof was undergoing resurfacing at the time of the site visit. The south addition has a composition shingle clad gable roof with a shed roof extending over the enclosed porch to the rear. The north addition has a composition shingle surfaced hipped roof with an inset porch at the northwest corner (Figure 15). Of the five chimneys evident in prior photographs, only an interior brick chimney on the west slope of the rear, two-story wing appears to be extant (Figure 16). The remnants of the exterior brick chimney on the south wall of the dining room (south) addition show that it has been capped just below the roofline (Figure 17).

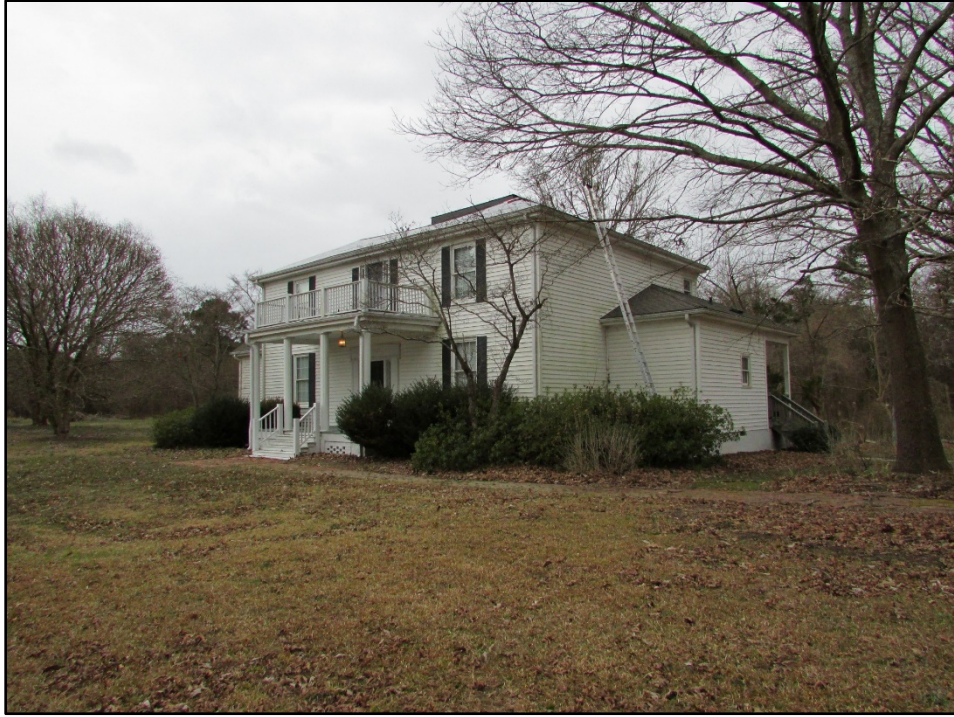
Figure 14. Captain Bailey Williamson House, east and north elevations, looking southwest.

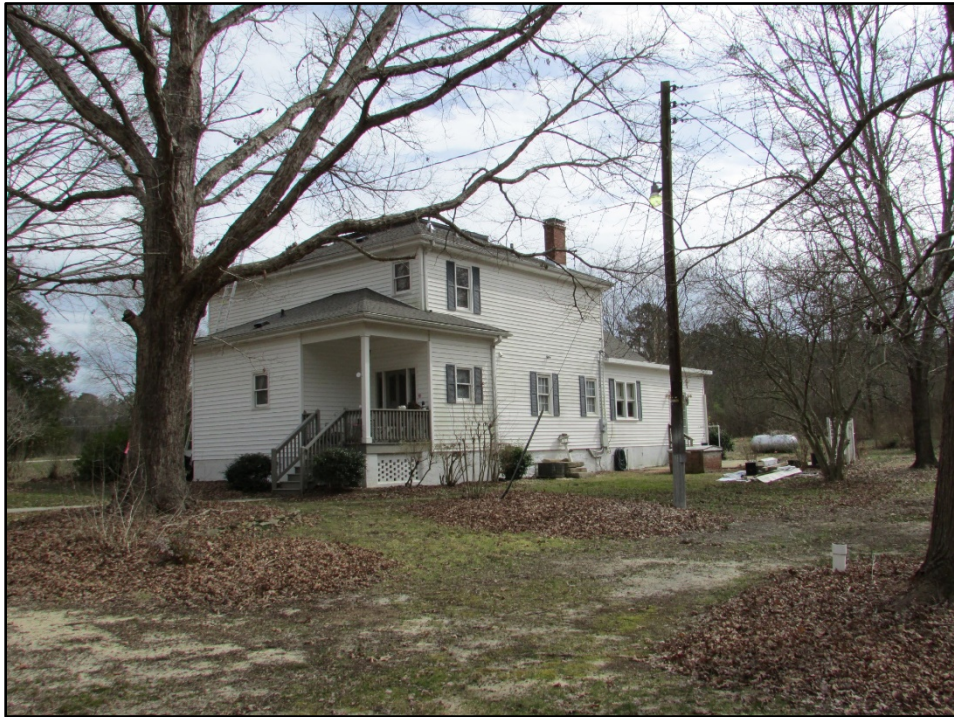
Figure 15. Captain Bailey Williamson House, north and west elevations, looking southeast.

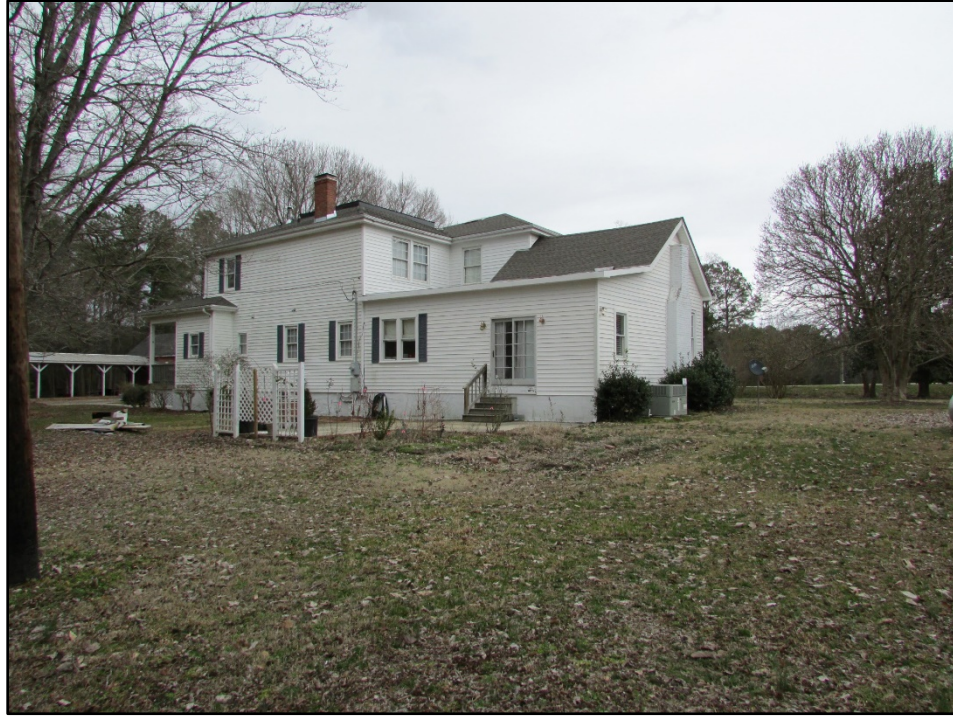
Figure 16. Captain Bailey Williamson House, west and south elevations, looking northeast.

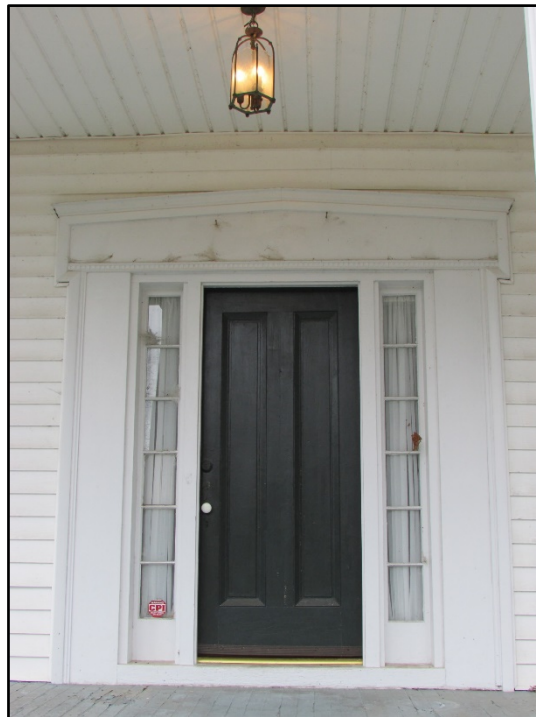
Figure 18. Captain Bailey Williamson House, detail of primary entrance, east façade.

Clad with vinyl siding, the original wood frame building rests on a stone foundation with brick infill, while the additions are set on a brick pier foundation with stuccoed masonry and concrete block infill. Windows are replacement single-hung sash units of vinyl with 6/6 false muntins

placed independently with fixed louvered shutters flanking those on the façade. Newer additions have paired and independently placed 1/1 single-hung sash vinyl windows. Centered on the façade of the original building, the one-story entrance portico features fluted aluminum columns and aluminum handrails added at the stairs and around the edge of the flat roof creating a walk-out balcony. The primary entrance, set within the portico, appears to be original with a two-paneled wood door with original hardware flanked by six-light sidelights set within a shouldered arch entrance surround (Figure 18). Directly above, the second floor balcony entrance has a six-panel door flanked by one-light sidelights and fixed louvered shutters. Secondary entrances are located within the inset porch at the northwest corner of the building and on the west elevation of the enclosed porch at the southwest corner of the house.

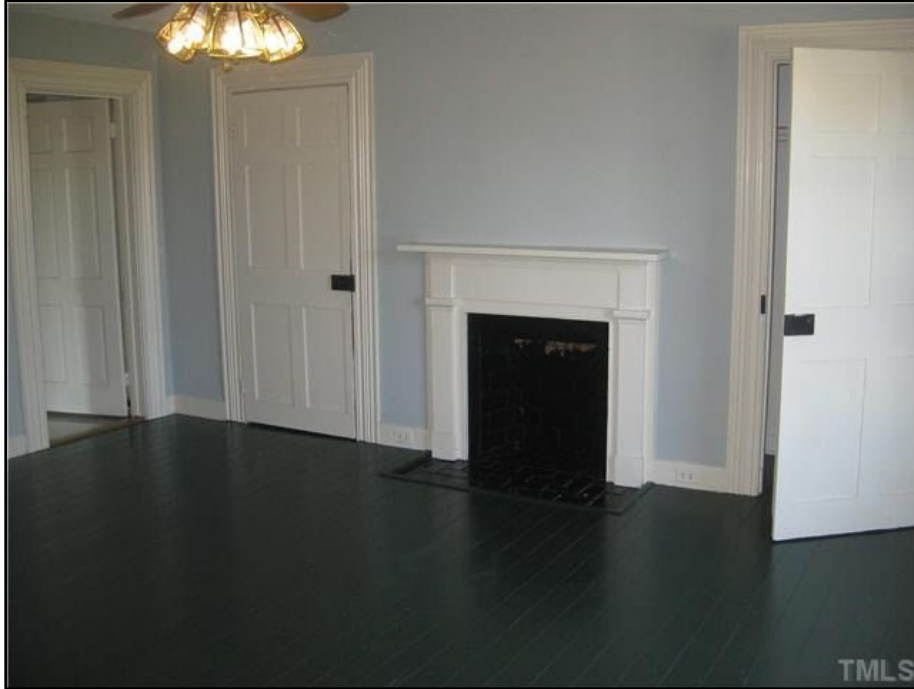
Figure 19. Interior photograph of fireplace and doors from 2011, when the property was listed for sale by Gilliam Kittrell with Hodge & Kittrell Sotheby’s International Realty (Kittrell 2011).

The 1988 survey form identified notable interior features including original Greek Revival inspired mantels, wide plank floors, a dogleg staircase, wide baseboards, and original doors. Photographs advertising the sale of the property in 2011 were found online and indicate that many of the interior finishes remained intact at that point (Figure 19 and Figure 20). However, neither the current owner nor the occupant responded to letters or site visits requesting historic information and access during this survey effort.

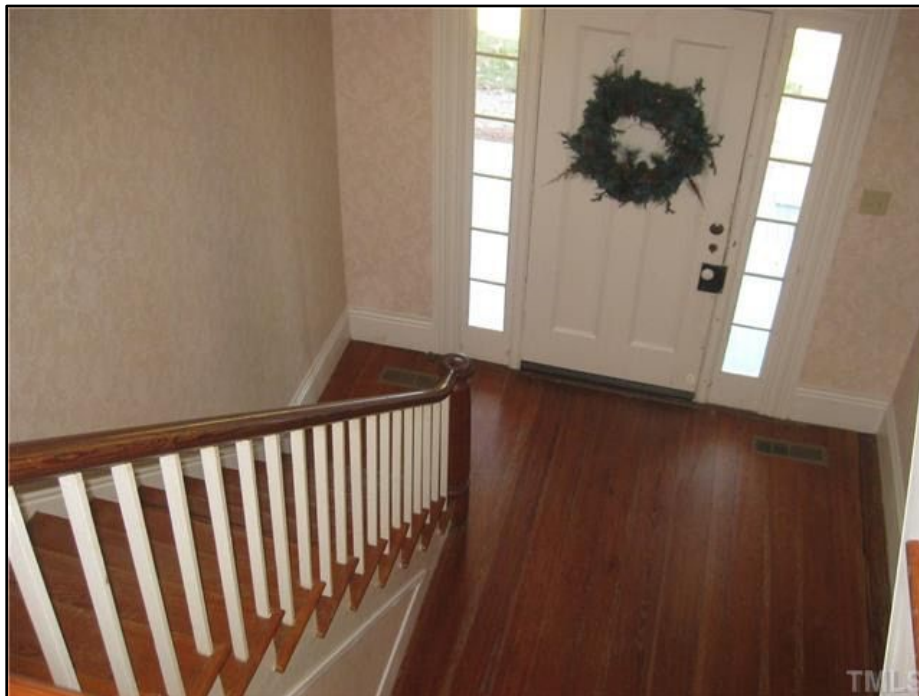
Figure 20. Interior photograph of entry and staircase from 2011, when the property was listed for sale by Gilliam Kittrell with Hodge & Kittrell Sotheby’s International Realty (Kittrell 2011).

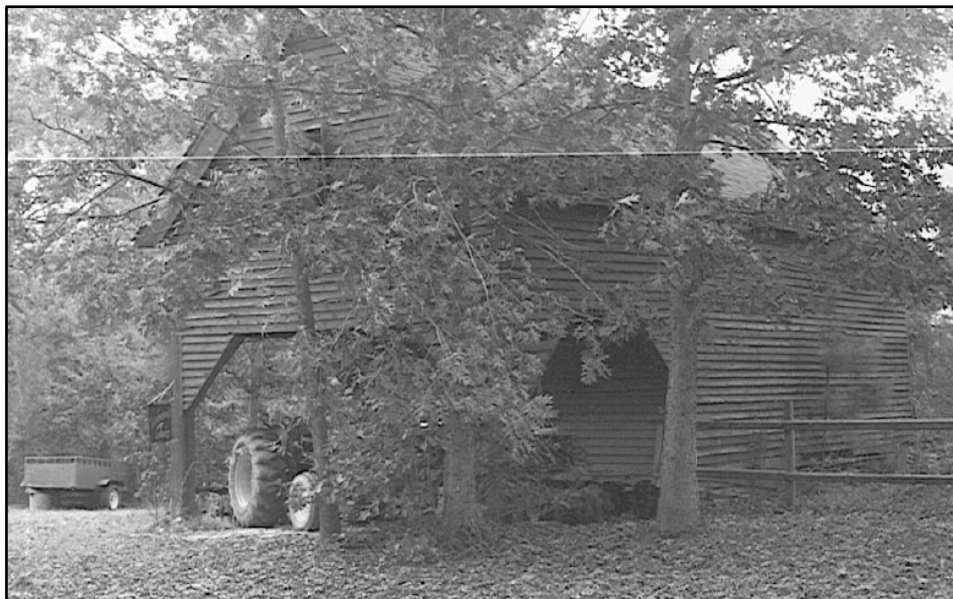
Figure 24. Captain Bailey Williamson House, Front-Drive Crib Barn, photograph from 1988 survey (Lally, 1988, WA0264).

Built ca. 1910, a Front-Drive Crib Barn is situated northeast of the house. The original building has a rectangular footprint, but an open equipment wing was added on the west elevation ca. 1990 (Figure 24 and Figure 25; Lally, 1988, WA0264; Google Earth 1993). The gable roof of the original structure is surfaced with composition shingles, while the gable roof on the addition is clad with 5V crimp sheet metal. At the same time as the addition, the front support posts were replaced, eliminating the almost arcaded appearance of the front-drive. The building also appears to have originally been surfaced with clapboard siding with a narrower profile in the 1988 photograph (Lally, 1988, WA0264), as compared to the drop siding evident on the building now. The barn has a stone pier foundation reinforced with bricks. A poured concrete pad and concrete piers are evident in the front-drive area. Notable elements include corner boards and rectangular loft openings with wooden shutters in the gable ends above pedestrian entrances with doors built of the same siding as the barn at the level of the first floor.

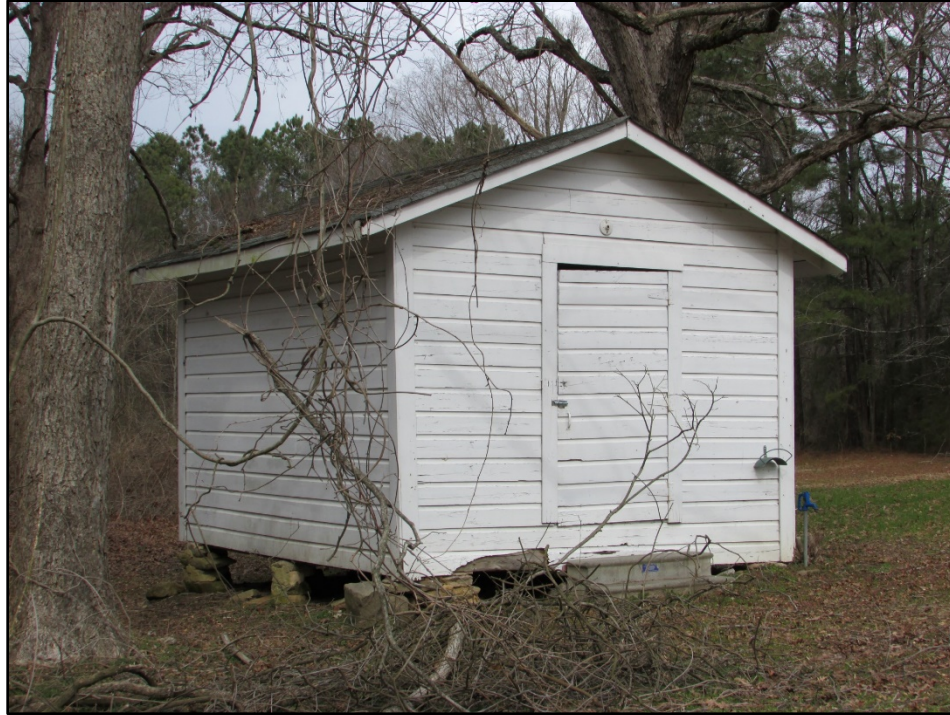
Figure 26. Captain Bailey Williamson House, Granary, west and south elevations, looking northeast.

A small, wood frame Granary is situated directly west of the barn (Figure 26). The construction date remains unknown, but the building was not depicted on the 1933 survey, and the design is indicative of outbuildings erected between 1935 and 1945 (Wake County Deed Book 678, Page 580). Aerials indicate that the structure was there prior to 1964 (NETR 1964). Set on a stone pier foundation, the wood frame building is topped by a composition shingle clad gable roof. Facing south, the primary entrance features a door with the same drop siding as the rest of the building. A one-over-one, double-hung sash wood window is present on the north (rear) elevation. A capped well appears to be located between the Granary and the Garage/Shed (Figure 27).

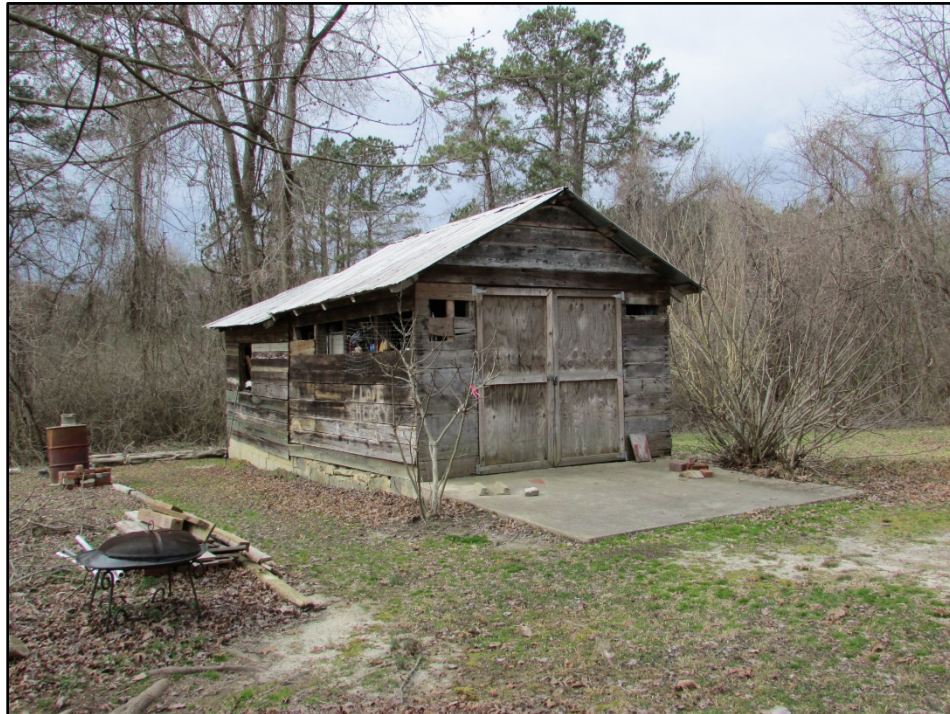
Figure 28. Captain Bailey Williamson House, Garage/Carriage House, east and south elevations, looking northwest.

Located northwest of the house, the small wood frame Garage or Carriage House appears to date from ca. 1910 (Figure 28). Evident on the 1964 aerials, the building features wide horizontal plank siding, laid flush, and set under a gable roof clad with 3V crimp accented with some exposed rafter ends. The easternmost portion of the structure appears older and is set on a largely continuous fieldstone foundation, while the rear addition rests on a continuous concrete block foundation. Some openings have been cut into the side elevations, but these are covered with wire mesh or plywood. A concrete pad has been poured in front of the east entrance which is accessed by paired plywood swing doors. Situated behind the house, the rectangular brick pump house has a gable roof surfaced with composition roll (Figure 29).

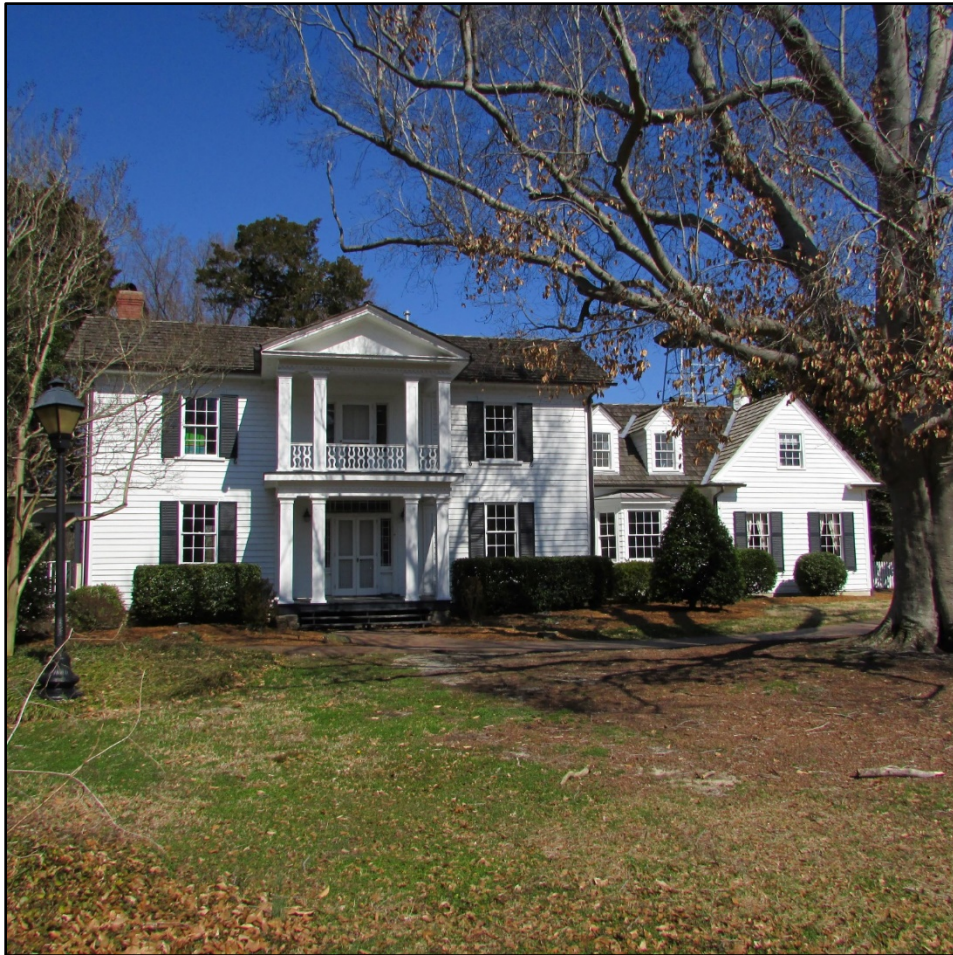
Figure 37. Oak View Plantation (WA1502), looking northeast.

The recorded examples shown below were all located in eastern Wake County and have good integrity. Oak View Plantation (Figure 37; WA1502), now part of Oak View County Park at 4028 Carya Drive, was listed in the NRHP in 1991 and is a designated local landmark. Built ca. 1855 by Benton S.D. Williams, this I-House with Greek Revival detailing has a 1940 Colonial Revival addition on the east (side) elevation. Wake County purchased the remaining 72-acre farm in 1983. The complex maintains its separate kitchen, water tower, cotton gin, carriage house, barns, a cemetery, and a portion of the historic pecan grove. The original portion of the house retains its two-story portico, entrances with transoms and sidelights, interior woodwork, and some historic windows with the remainder rebuilt to match. The addition, now historic, was sympathetic to the original design, yet still clearly of its own period of construction (WA1502; Lally and Johnson 1990; Raleigh Historic Development Commission 2021; Bishir and Southern 2003:136).

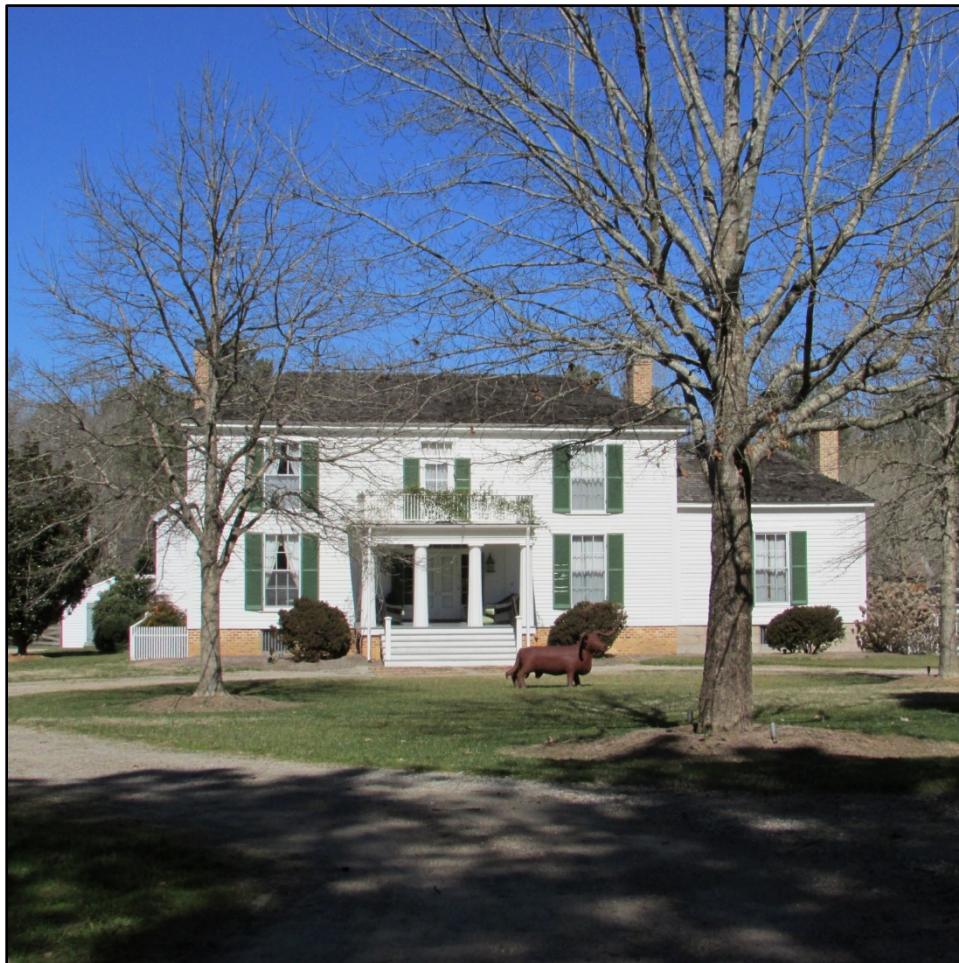
Figure 38. Midway Plantation (WA4818), looking north.

Midway Plantation (Figure 38; WA4818) was built along Tarboro Road (present-day US Highway 64) in 1848 as a wedding gift for David and Mary Hinton, but was relocated to 1900 Amethyst Ridge Road in 2005 when threatened with demolition due to development. Situated approximately two miles northeast of its original location, it was placed on land which was formerly part of the

plantation property. First listed in the NRHP in 1970, this building was listed again in the NRHP in 2007 following its relocation and is a designated local landmark. Most comparable to the original design of the Captain Bailey Williamson House, this house features a symmetrical, two-story façade clad with weatherboard dominated by a one-story front portico supported by Doric columns. Windows are 6/6 double-hung sash, while the entrance has a double-leaf paneled door surrounded by sidelights and a transom. Although some elements were reconstructed following the move based on physical and photographic evidence, the house retains its original design with a three-bay wide by one-bay deep mass topped by a low-pitched hip roof with a boxed cornice accented with interior brick end chimneys. The house also incorporated an original one-story rear extension and a ca. 1860 side wing, which remain. Several historic outbuildings including the kitchen, a smokehouse, a schoolhouse, and a dollhouse, were relocated along with the residence (De Miranda 2006; Lally 1994:40-42; Capital Area Preservation, Inc. 2021; Bishir and Southern 2003:136).

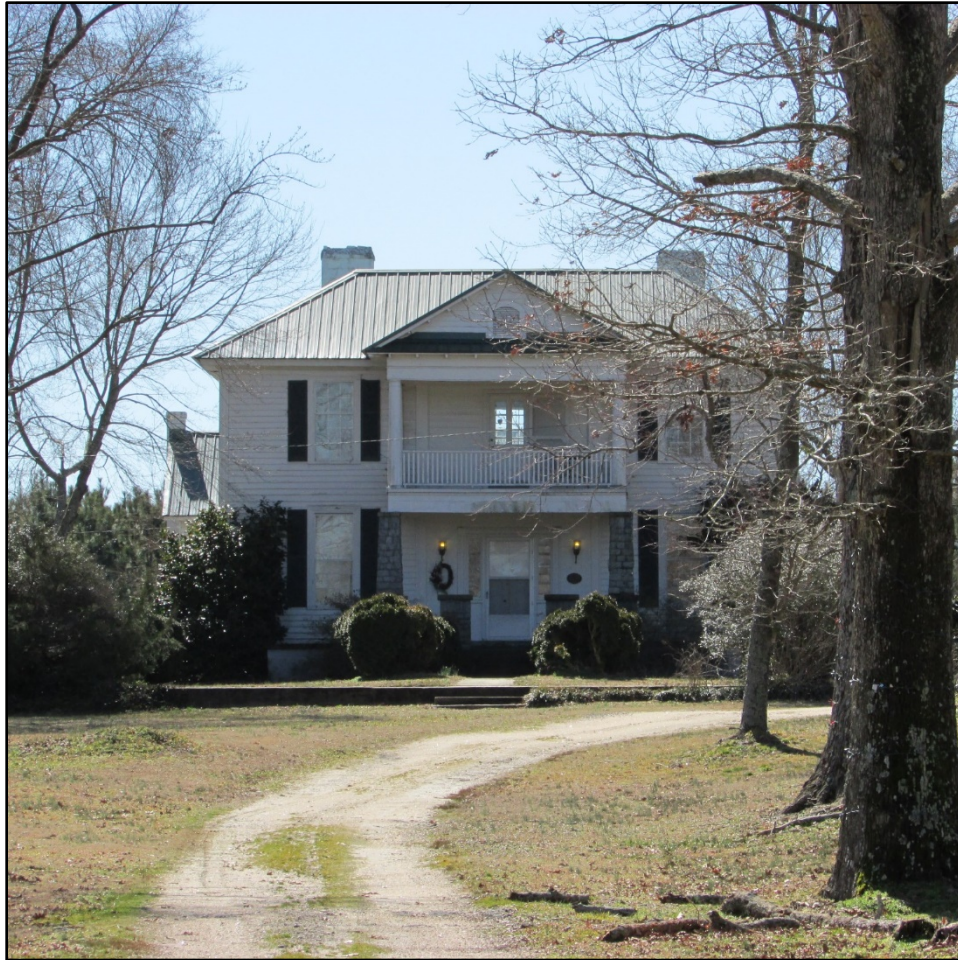
Figure 39. Harmony Plantation (WA1926), looking south.

A third example, Harmony Plantation (Figure 39; WA1926), also known as the Montague-Jones Farm, at 5104 Riley Hill Road, retains the most intact form. It was built ca. 1833 by Dr. Henry W. Montague. Clad with weatherboard, this two-story, single-pile Greek Revival style house is

three bays wide and has two stone chimneys at each end of the rear elevation. Symmetrical in design, a central, two-story portico with Doric columns anchors the north façade. Windows are a combination of 9/9 and 6/9, and the hip roof features a boxed cornice. This property was listed in the NRHP in 2008 and is a designated local landmark. Outbuildings include an office, smokehouse, wellhouse, chicken house, barn, a packhouse, and a garage (Martin 2007; Capital Area Preservation Inc. 2021).

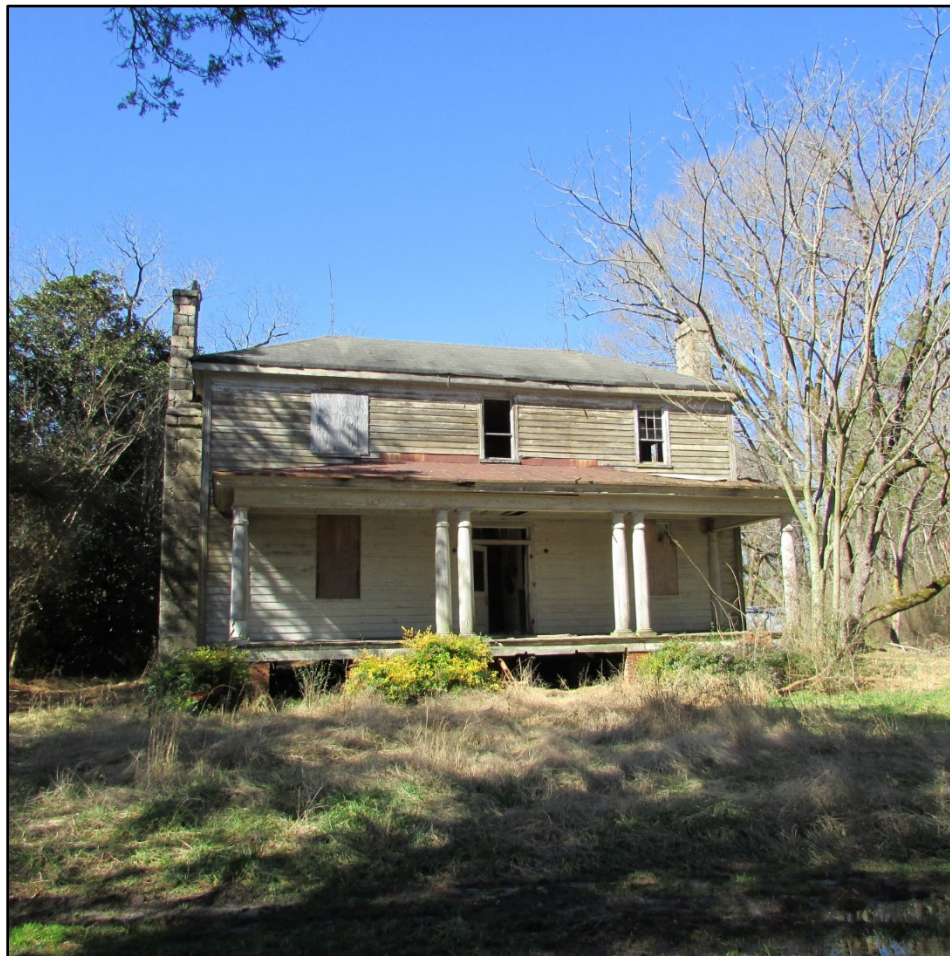
Figure 40. Hood-Anderson Farm (WA2021), looking west.

The Hood Anderson Farm (Figure 40; WA2021) at 2365 Old Battle Bridge Road is a modest example of a Greek Revival farmhouse with an exceptionally complete associated agricultural complex. Still incorporating 145 acres, the farm has a combined general store and post office, a tenant/slave house, tobacco barns, a smokehouse, a cemetery, a chicken house, a well house and the remains of a cotton gin, blacksmith shop, a privy, a dam, and agricultural fields. The main house was originally a two-story I-house with a low-pitched hip roof with a rear ell connected by a breezeway to a one-story kitchen. The one-story porch which extends the width of the façade dates from 1917, but the original entrance portico was a one-story structure which, based on photographic and structural evidence, was similar to the one at Midway Plantation. Clad with weatherboard, the house has exterior end chimneys, cornerboards, a transom above paired front

doors, and 9/9 and 9/6 double-hung sash windows. The farm was established in 1837 by William Henry Hood and was listed in the NRHP in 1999 (Anderson 1998)

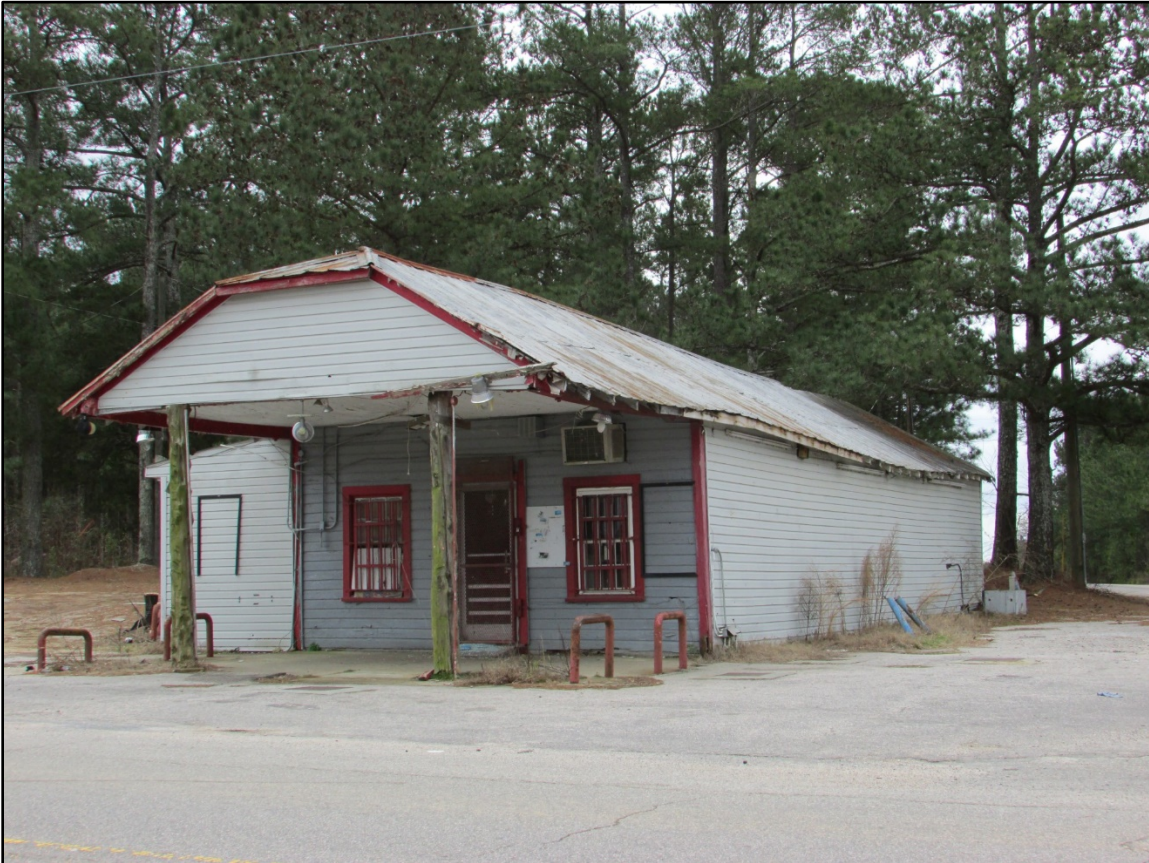
Figure 41. Martin's Store, front (north) and west elevations, looking southeast.

Built as a modest country mercantile ca. 1935, Martin's Store offered groceries and general merchandise inside, while a front canopy sheltered gas pumps providing fuel for automobiles (Figure 41). Set on a continuous brick foundation, the original wood frame building appears to have been originally surfaced with drop siding, which remains under the canopy and on the south (rear) elevation; the rest of the building has been clad with vinyl siding. The original rectangular structure has a clipped gable roof surfaced with 5V crimp sheet metal accented with exposed rafter ends in the eaves. The building may have been enlarged with a small addition to the rear during the historic period. The structure now has an irregular shape after two shed roof additions were attached to the east elevation between 1983 and 1993 (Figure 46; NETR 1964, 1983, 1993, 1999).

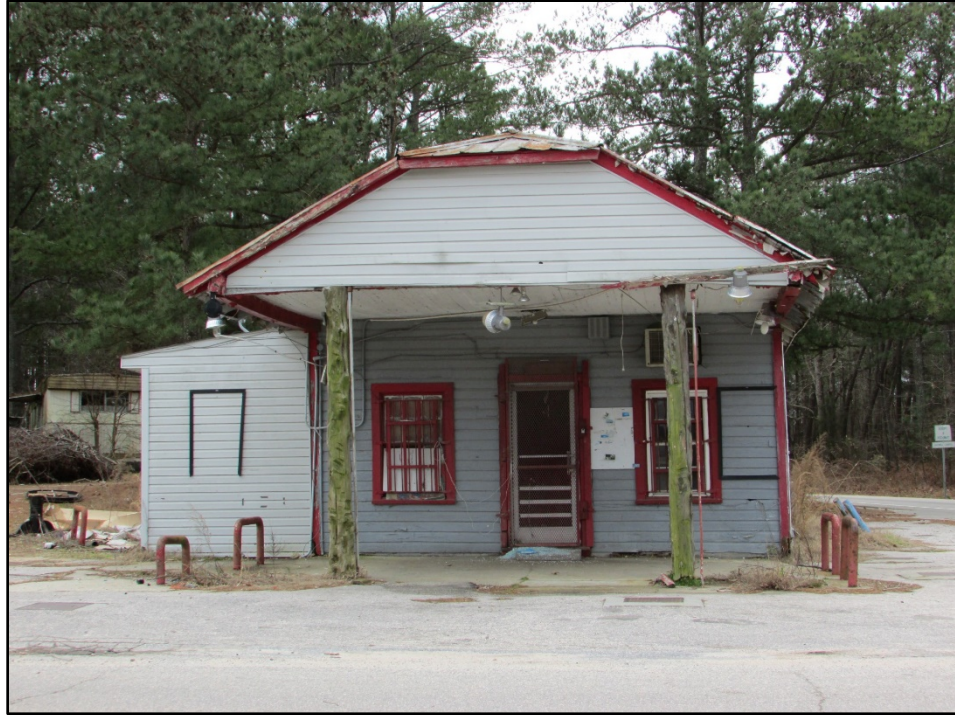
Figure 47. Martin's Store, façade, looking south.

The front canopy is supported by two replacement rough hewn log supports (Figure 47). The gas pumps have been removed, and vehicular access within the canopy is blocked by metal posts. The ceiling of the canopy is surfaced with novelty board siding. The three-bay wide façade set within the canopy features a central entrance flanked by individual windows. The main door, blocked by a metal security grate, is a replacement metal and glass door in which the glass has been broken. Only one historic window is extant; set within the canopy to the left of the door, it is a 6/6 wood, double-hung sash unit, now partially boarded and set behind metal security bars (Figure 48). The other window has been replaced with 6/6 vinyl, single-hung sash which is also set behind metal security bars.

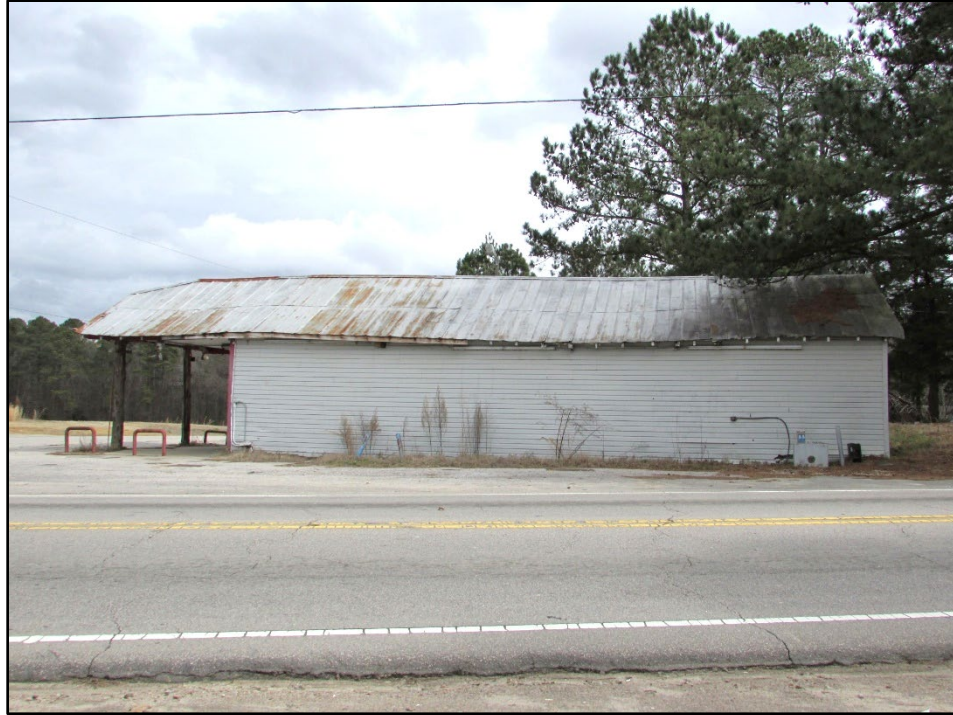
Figure 49. Martin's Store, west elevation, looking east.

No windows or doors exist on the west elevation, which is now covered with vinyl siding (Figure 49). A square window opening on the south (rear) elevation is covered by a metal grate, but the window appears to be broken (Figure 50). Of the two additions on the east elevation, the front or northernmost one appears to be earlier. Clad with vinyl siding, it has a shed roof surfaced with 5V crimp sheet metal, but no windows or doors. The rear or southernmost addition is constructed of plywood and has a shed roof of corrugated metal. It has no apparent openings either.

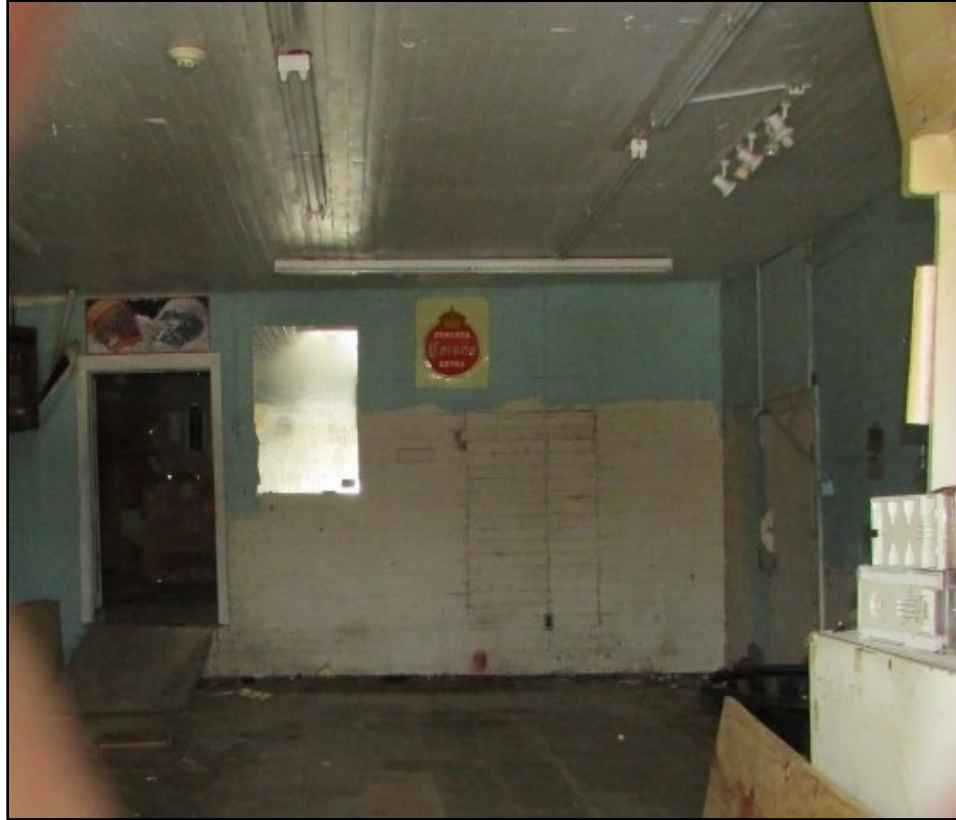
Figure 51. Martin's Store, interior.

The interior of the store is an open room with entryways into the additions (Figure 51). The front counter appears to be a replacement ca. 1980 version. The novelty board siding on the interior remains, but all of the shelving has been removed.

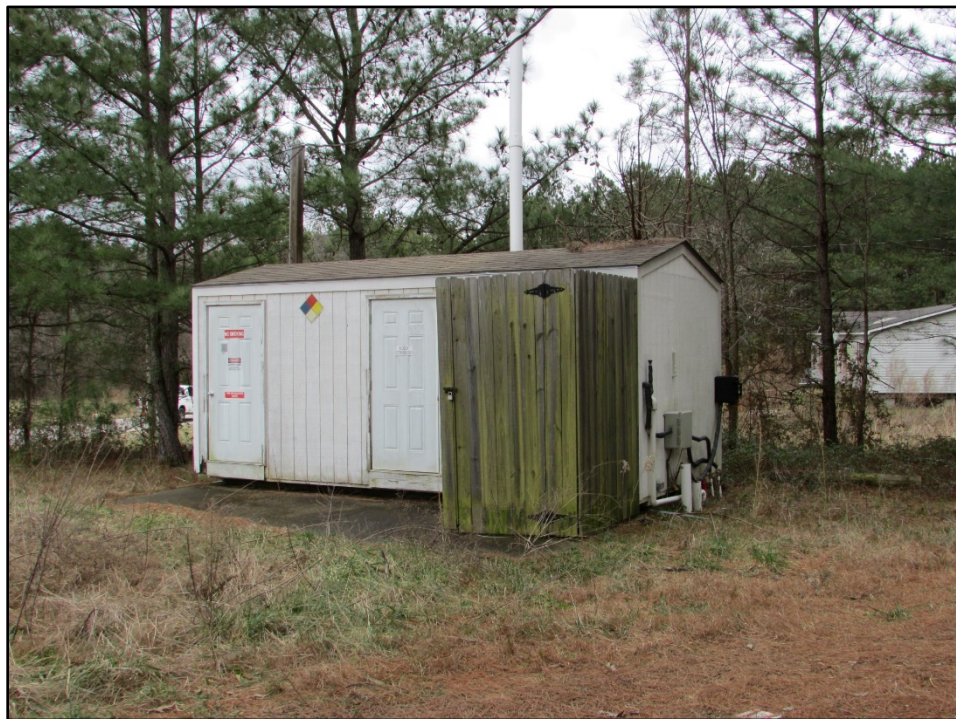
Figure 52. Martin's Store, storage shed, looking east.

A wood frame shed with a gable roof and T1-11 siding is situated along the eastern border of the property (Figure 52).

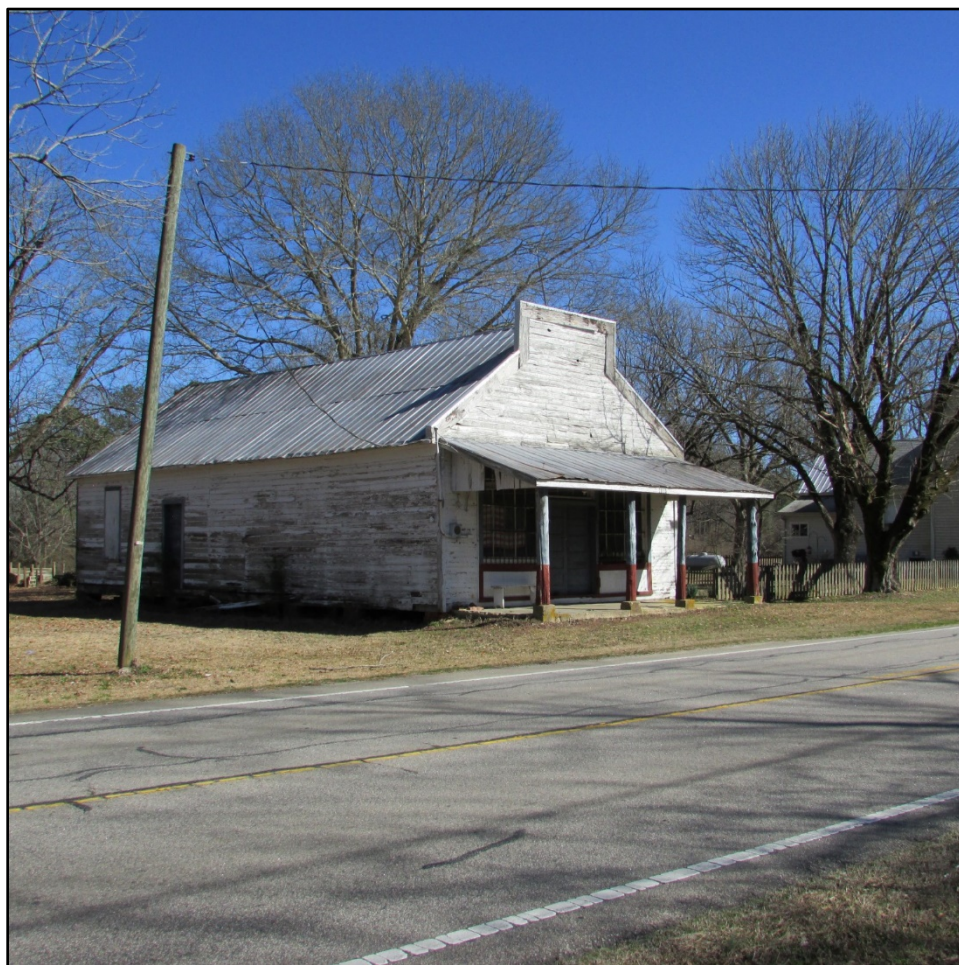
Figure 54. Davis Adcock Store (WA548), looking southeast.

The Davis Adcock Store (WA0548) is a one-story, wood frame store built at 2013 Piney Grove-Wilbon Road in Wilbon in 1906 (Figure 54). As the primary commercial establishment in the community for over 50 years, the independently operated store stocked a wide variety of general merchandise. Originally owned by William Davis, the store served as the local post office and as the center of community social life. Typical of small general stores, it has a rectangular footprint with a gable-front roof set behind a false front with a stepped parapet, German siding, and a brick pier foundation. The large 20-light display windows remain along with the historic entrance featuring five-panel, paired wood doors set beneath a nine-light transom. The two gas pumps originally located in front of the store are gone, although an associated historic house remains adjacent. A number of interior elements and finishes such as the wooden counter and wall of shelves, remain intact. The structure retains excellent integrity and was listed in the NRHP in 2006, but it is vacant (WA0548; Keane 2006; Lally 1994:356-57).

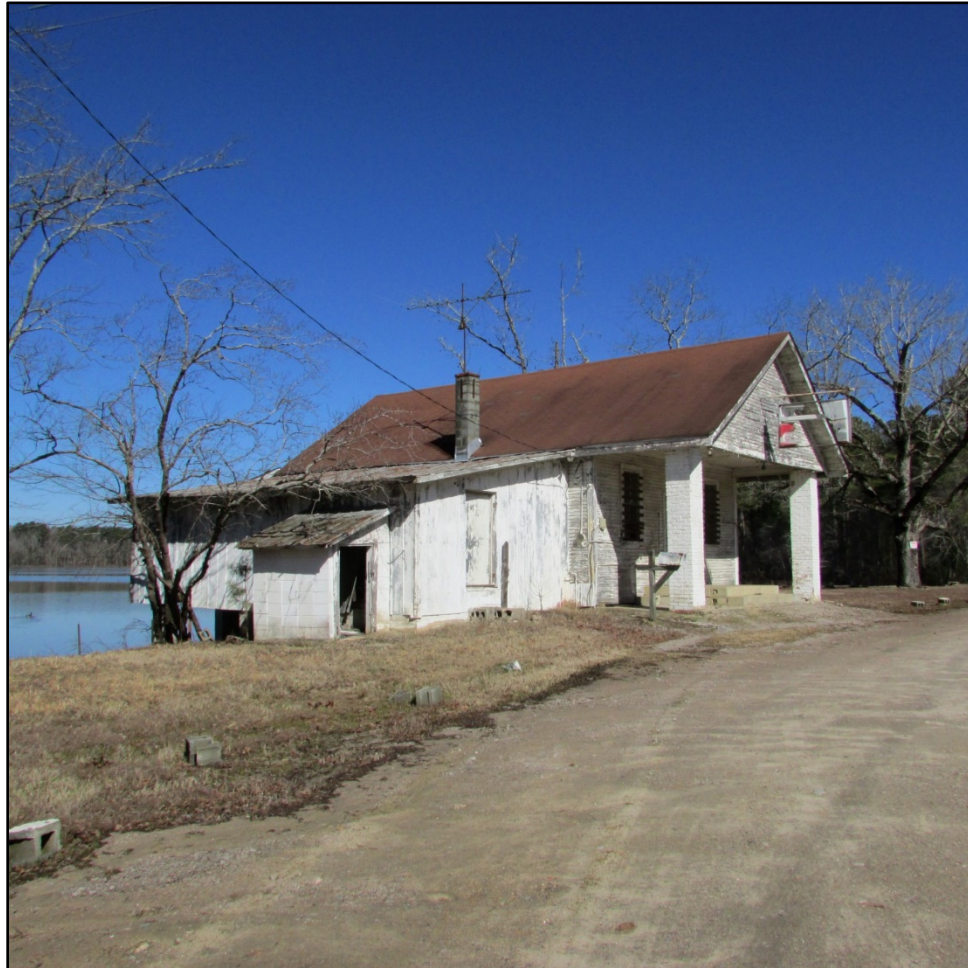
Figure 55. Lake Myra Store (WA1997), looking northeast.

Located just over a mile to the east of Martin's Store on Poole Road, the Lake Myra Complex (WA1997) includes a ca. 1935 country store situated on the south shore of Lake Myra. The property originally featured a mill (now in ruins) and dam, but evolved into a recreational facility with a dock, boat shed, and a two-story clubhouse in the 1930s. Clarence Martin acquired the property in 1939 and built the store; his son-in-law operated it until after 1991 (Figure 55). The mercantile is a one-story, rectangular building with a front-facing gable which extends into a

canopy that initially incorporated gas pumps. Shed roofed additions were subsequently built on the west elevation. The building retains portions of its original wood siding, brick support posts, and wood frame, 4/4 double-hung sash windows (WA1997; Lally 1994:225-26).
