SUBJECT: Historic Structures Survey Report for Intersection Improvements at SR 2233 and
SR 1007, PA 21-01-0001, Wake County, ER 21-1371

**Historic Structures Survey Report
Intersection Improvements at SR 2233 (South Smithfield Road) and
SR 1007 (Poole Road)
Wake County, North Carolina**

T.I.P No. SM-5705AJ
WBS# 48996.1.1
PA No. 21-01-0001

May 12, 2021 – Final Report

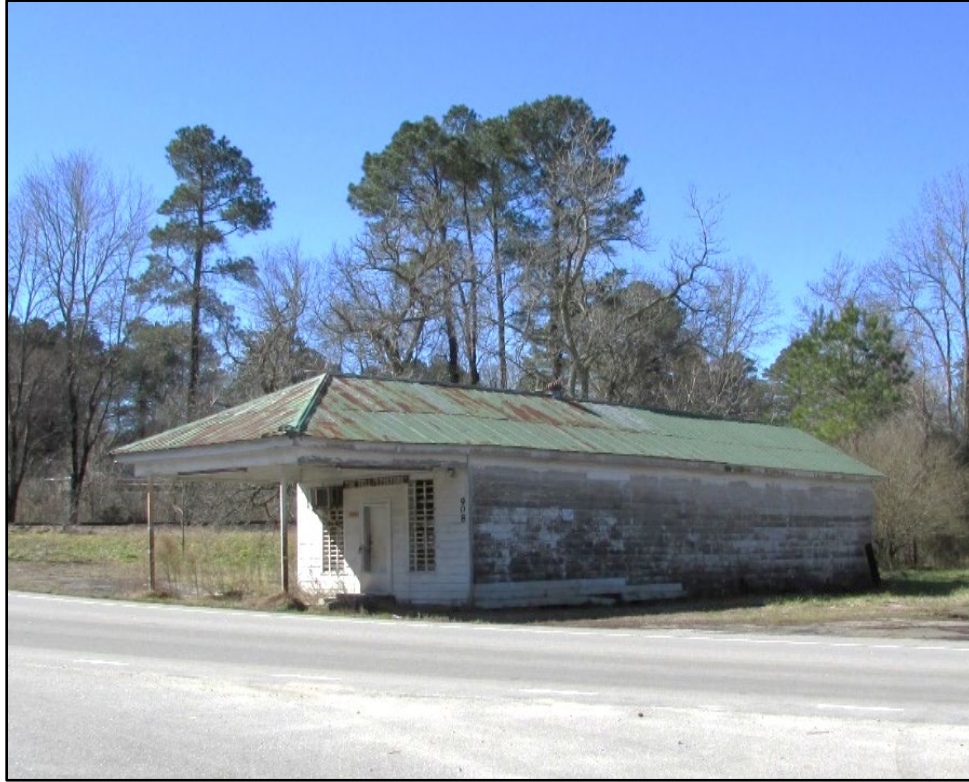
Located at 908 Eagle Rock Road, this Store (Figure 56; WA7707) is a ca. 1920 wood frame country store with a gable front. The building retains its large storefront windows, rectangular form, and large, hip roof incorporating a front canopy. Although clad with aluminum siding, the original wood siding is evident underneath. Situated at a crossroads in the Eagle Rock community, this building retains good integrity in form and design, although it is presently vacant (WA7707).

Figure 56. Eagle Rock Store (WA7707), looking southwest.
