**North Carolina Department of Natural and Cultural Resources
State Historic Preservation Office**

Re: Historic Structures Survey Report, Improve Intersection of NC 11 and SR 1169
(Woodrow School Rd), Tip # W-5701H, Hertford County, ER 21-2175

RALEIGH BLOWE SR. HOUSE

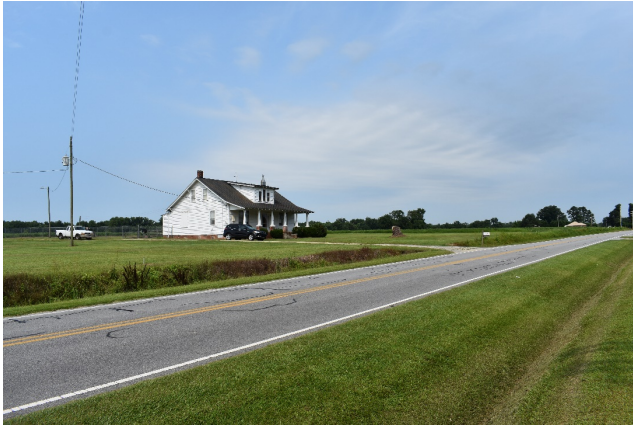
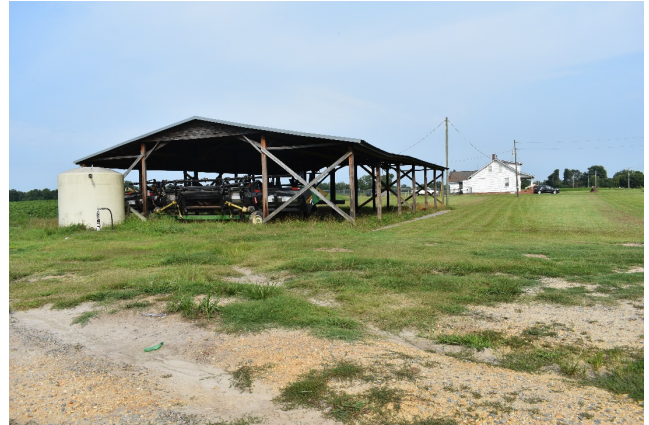
Figure 8: Left, view of Raleigh Blowe Sr. House from across East Woodrow School Road, facing northwest; right, view of house from neighboring parcel with equipment shed in the foreground, facing north. (Note: equipment shed lies on separate, unassociated parcel).

The early-twentieth-century Raleigh Blowe Sr. House is centrally placed on an approximately one-acre-square lot of land, roughly three miles south of the Murfreesboro town center. The house sits on the south side of West Woodrow School Road/SR 1169, and is just over 100 yards west of the state route’s intersection with NC 11. Once the seat of a modest tobacco farm, the bungalow now stands as the only building on its parcel, which has decreased significantly in size over recent decades. Its associated agricultural buildings, which at one time included an assortment of barns and packhouses, were largely demolished between 1998 and 2005 at the instruction of current property owner Lawrence Martin.¹ The house’s associated parcel is open and void of trees or notable vegetation. It is bordered to its west and south by actively cultivated fields, portions of which were historically part of the building’s associated land holdings.² To the east, the property is bordered by a large, open agricultural parcel which features a large equipment shed at its front (north) end. The house is bounded to the north by East Woodrow School Road (Figure 8 and Figure 9).

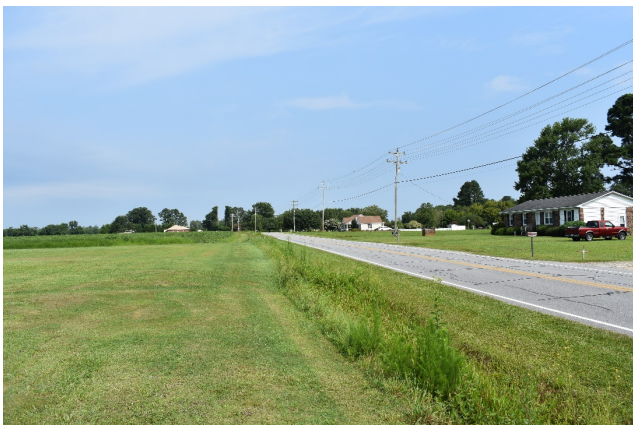
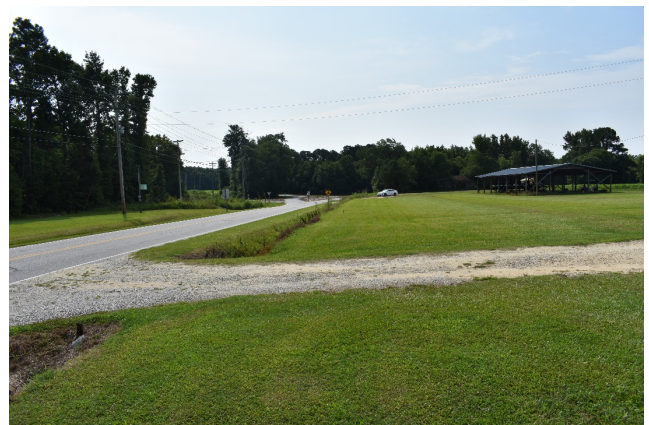
Figure 9: Left, context view facing north on West Woodrow School Road toward Raleigh Blowe Sr. House (out of image) from Roberta Parker Copeland House (HR1695); right, facing toward intersection of West Woodrow School Road and NC 11 from front yard of house.

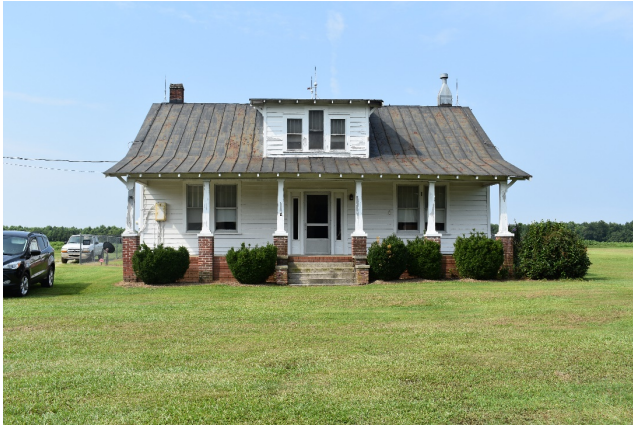
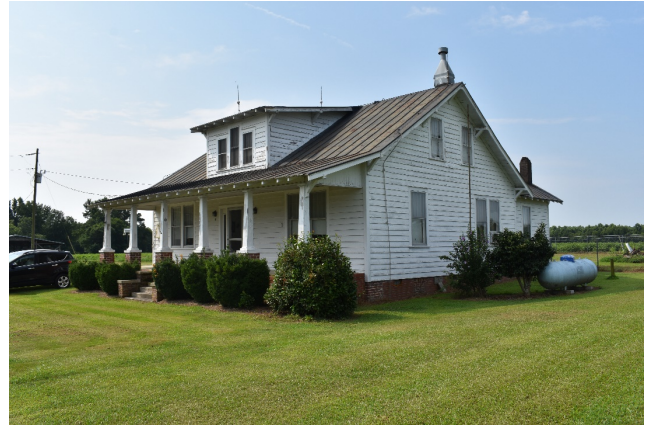
Figure 10: Left, northeast-facing facade of Raleigh Blowe Sr. House, facing southwest; right, oblique of northeast and southwest elevations of house, facing south.

The frame Craftsman-style bungalow stands one-and-a-half-stories tall and is L-shaped in plan. Information garnered through both historic research and a personal interview with the current property owner suggests the house was constructed sometime between 1920 and 1930. The residence is divisible into two distinct sections: an original square-shaped, double-pile, side-gabled, front block and a smaller, single-story, gabled, rear ell, which is original or an early addition. Both blocks are clad in original weatherboards and edged with cornerboards (Figure 10).

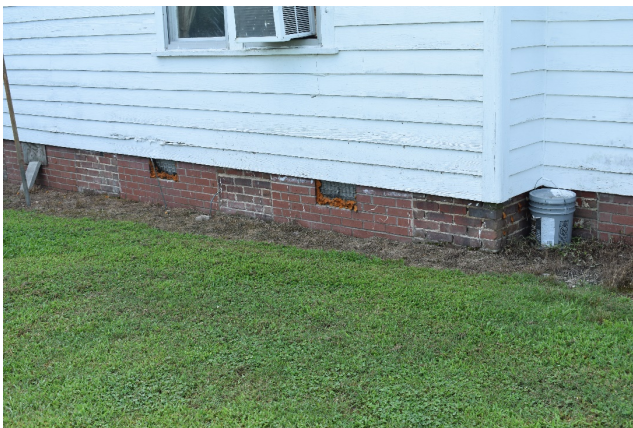
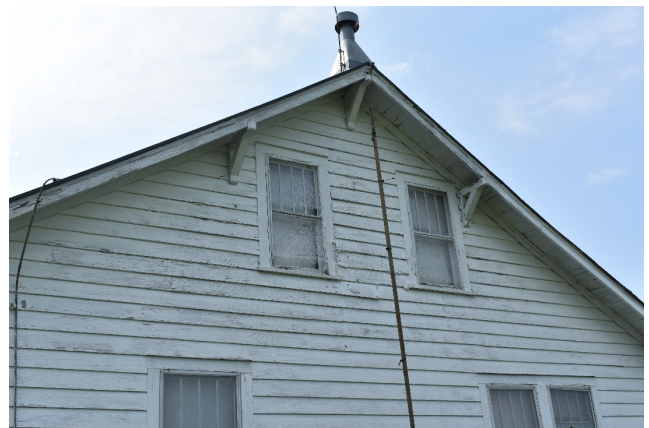
Figure 11: Left, view of Raleigh Blowe Sr. infilled foundation, facing southeast; right, detail of original windows, facing southeast.

Oriented northeast toward West Woodrow School Road, the original front block is three-bays wide and rests on brick piers which were later filled in to create a continuous brick foundation (Figure 11, left). The building’s roof is clad in standing-seam-metal and features exposed rafter tails at its ends and decorative kneebraces at its gables (Figure 11, right and Figure 12, right). Two chimneys project from the building’s roof ridge, the eastern chimney being exposed brick and the western clad with a metal chimney cap (Figure 10). A shed-roof dormer is centrally placed atop the front block’s roof. Like that block, the dormer is clad in original weatherboards and capped with a standing-seam-metal roof featuring exposed rafter tails and decorative kneebraces. A band of three double-hung, four-over-one, wood-sash windows is centrally placed on the dormer’s facade. The dormer windows, which appear to be original, retain their wooden surrounds (Figure 12).

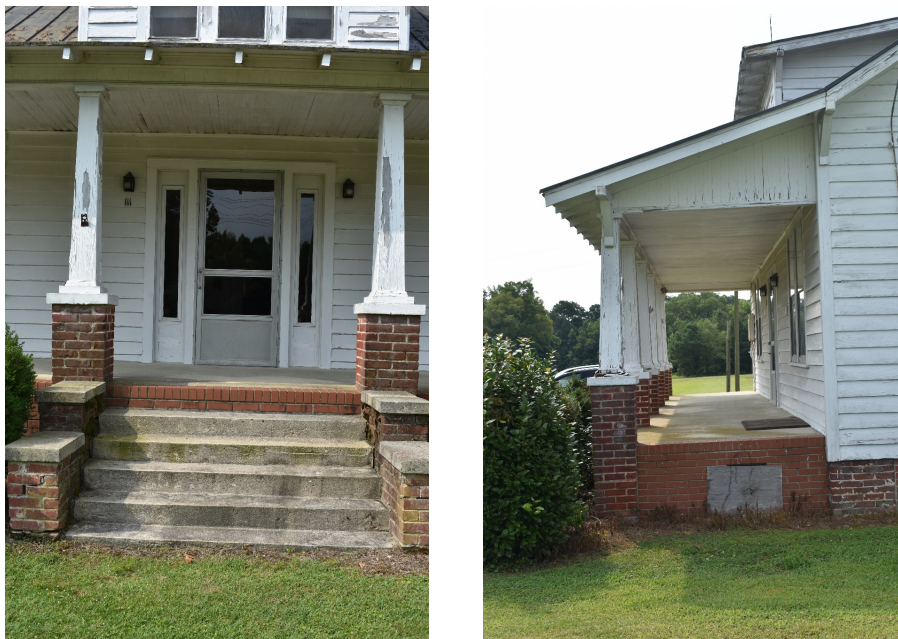
Figure 13: Left, detail of Raleigh Blowe Sr. original front entrance, facing southwest; right, detail of front porch, facing northwest.

A five-bay engaged front porch spans the entire width of the facade. Six battered wood columns atop six tall brick piers provide support for the porch. The piers and columns appear to be original, despite sitting on a replacement, poured-concrete, porch deck. The deck is clad on either end by brick veneer (Figure 13, right) and approached by a set of centrally placed concrete stairs. The stairs are framed on either side by short brick knee-walls topped with poured-concrete caps (Figure 13, left). Centered beneath the porch is the building’s primary entrance which is composed of an original wood-panel door flanked on either side by large, vertical, single-light sidelights. The door unit features original wood surrounds (Figure 13, left). A pair of four-over-one, double-hung, wood-sash windows with original wood surrounds flanks the doorway on either side (Figure 10).

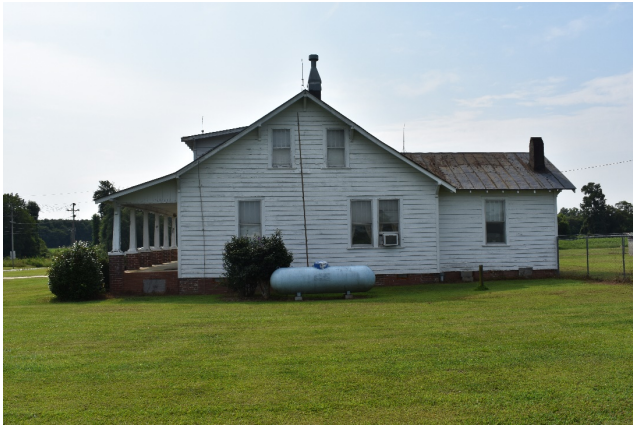
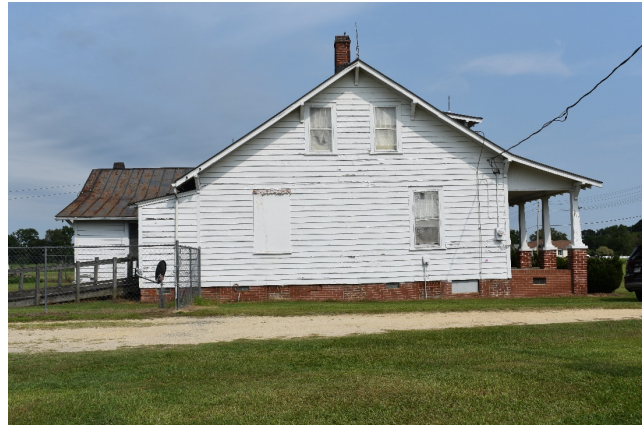
Figure 14: Left, northwest elevation of Raleigh Blowe Sr. House, facing southeast; right, southeast elevation, facing northwest.

The northwest and southeast side elevations of the original block are simple in their design, as seen at Figure 14. The northwest elevation features five windows, all of which are original and of the same style as those windows found at the facade. A set of paired windows is found at the elevation's southwestern corner and a single window found at its northwest. Two windows of the same style, although slightly smaller in scale, are found evenly spaced in the elevation's gable. The building's southeast elevation features this same fenestration pattern; however, its southeastermost window opening(s) has been covered over.

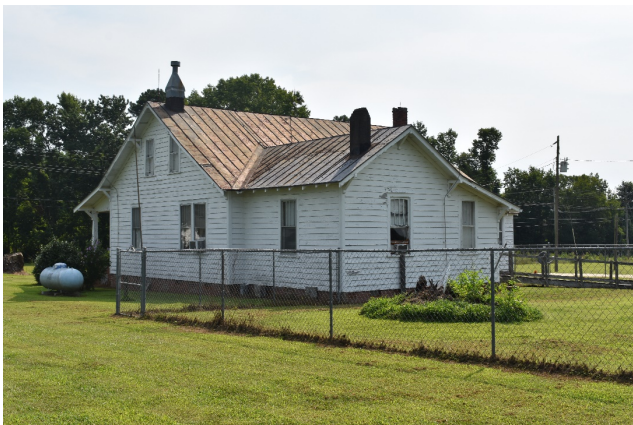
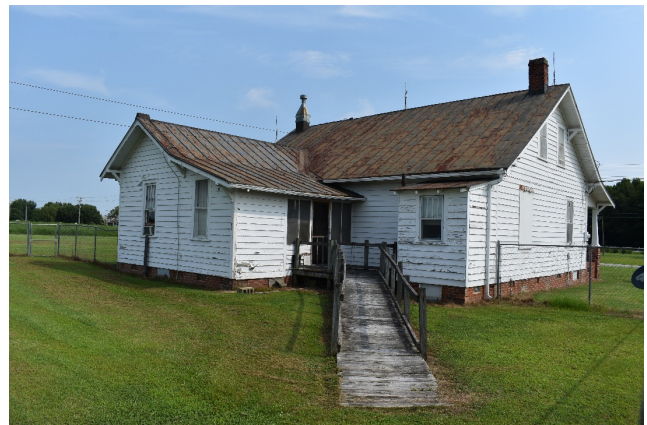
Figure 15: Left, oblique of northwest and southwest elevations, facing northeast; right, oblique of southwest and southeast elevations of Raleigh Blowe Sr. House, facing northwest.

Extending from the southwest corner of the original main block, the building's gabled rear ell features the same cladding materials as the original block. An interior brick chimney projects through the block's southwestern roof slope and a now partially enclosed porch, approached by a wooden wheelchair ramp, is attached to the southeastern elevation of the rear ell. Windows of the same style as the facade are also found on the ell's southwestern and southeastern elevations(Figure 15).

In addition to the rear ell, a small, single-bay, shed-roofed block extends from the southeastern corner of the main house and holds a four-over-one, double-hung, wood-sash window (Figure 15, right). Its size and placement suggest it may hold an early-added bathroom.

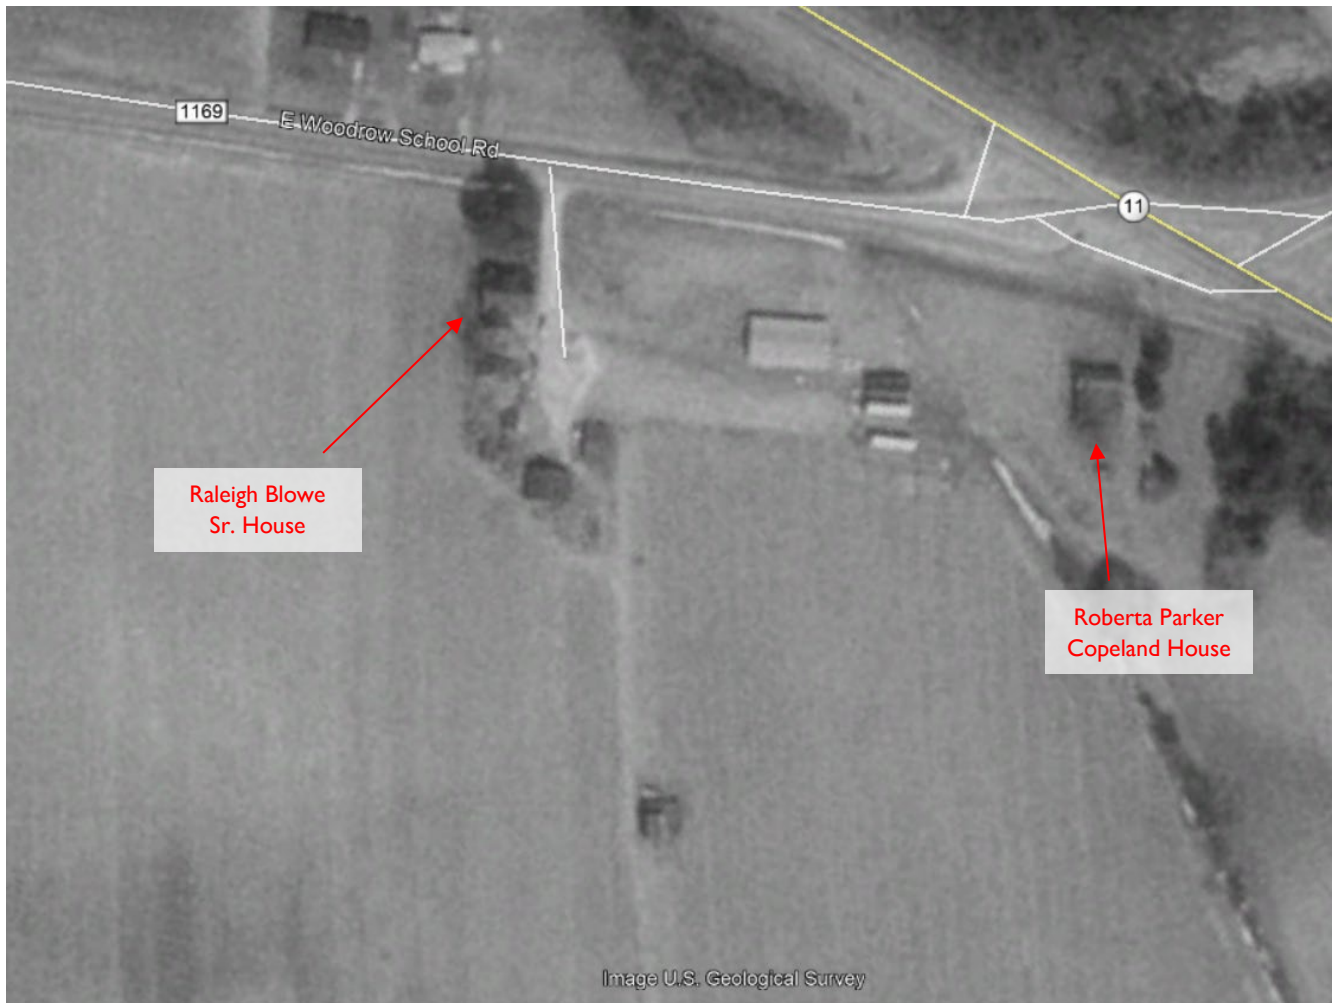
Figure 16: 1993 aerial image showing Raleigh Blowe Sr. House and associated outbuildings prior to their demolition.

Lawrence Martin.⁵ The 1940 census places Raleigh and his family on High Street within the city limits of Murfreesboro. Their home was valued at \$3,500. His occupation merely states “Proprietor” (U.S. 1940 Census). In 1950, Raleigh and Nannie’s youngest daughter, Ruth (1932-2003) married Lawrence Martin after a two-year courtship. During the July 2021 interview, Mr. Martin fondly recalled farming tobacco on the farmland originally, but no longer, associated with the Raleigh Blowe Sr. House. A 1993 Google Earth aerial photograph shows multiple agricultural buildings that once stood to the south of the house, providing visual context for these former land holdings (Figure 16).

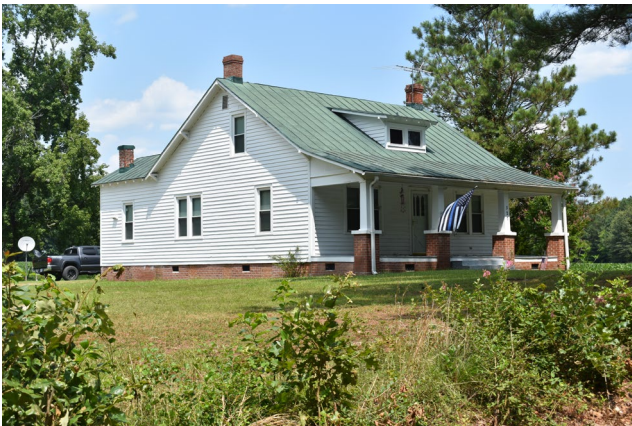
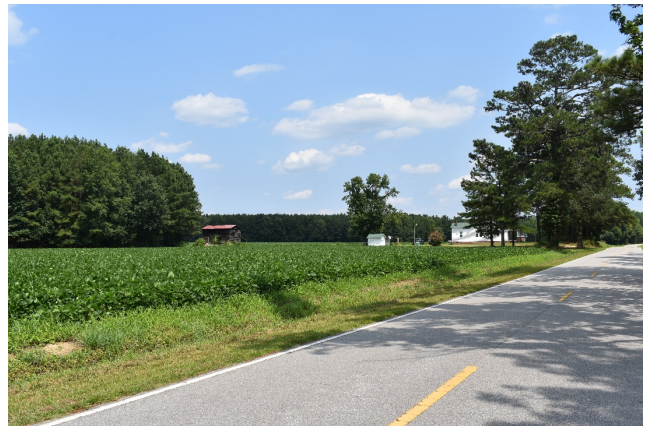
Figure 18: William G. Lawrence House (HF0784) at 327 Parkers Ferry Road, Como vicinity.

The William G. Lawrence House (HF0784), located in the Como vicinity at 327 Parkers Ferry Road, stands as an excellent example of the building type. The one-and-a-half-story Craftsman-style bungalow was built ca. 1926 according to NCHPOWeb and sits amidst a setting of actively cultivated fields. Built of frame, the house retains its original weatherboard siding and wooden cornerboards. A sweeping side-gabled roof tops the house and features exposed rafter tails and bracketed kneebraces. A shed-roof dormer tops the roof and is pierced by two replacement windows. An engaged porch with original tapered columns fronts the building and rests on a continuous brick foundation. At least three early/mid-twentieth century agricultural buildings are found to the rear (north) of the building (Figure 18).

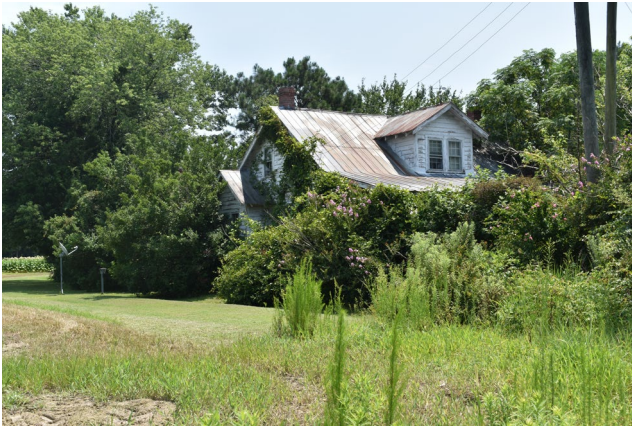
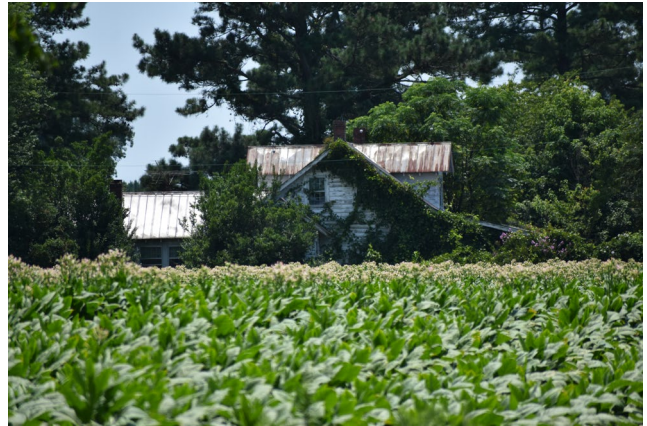
Figure 19: Simmons House (HF0967) at 451 Thomas Bridge Road, Cofield vicinity.

Located southeast of Cofield, the Simmons House (HF0967) stands at 451 Thomas Bridge Road. Data found at the NCHPOWeb online database lists a ca. 1948 construction date for the building; however, the residence appears to have been constructed slightly earlier. The one-and-a-half story Craftsman-style bungalow features the characteristic sweeping, side-gabled roof under which is housed a recessed porch (Figure 19). Two original interior brick chimneys stand atop its roof ridgeline and two large

front-gabled dormers are centered on the front and rear roof slopes. The residence displays a high degree of material integrity and retains original weatherboard siding, exposed rafter tails, and six-over-six, double-hung, wood-sash windows with original surrounds. A single-story ell extends to the rear. The bungalow retains its rural setting and is surrounded by actively cultivated fields. It is accompanied on its parcel by at least one supporting agricultural building.

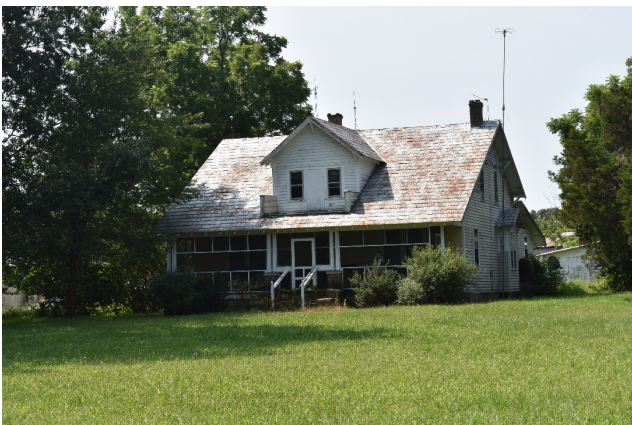
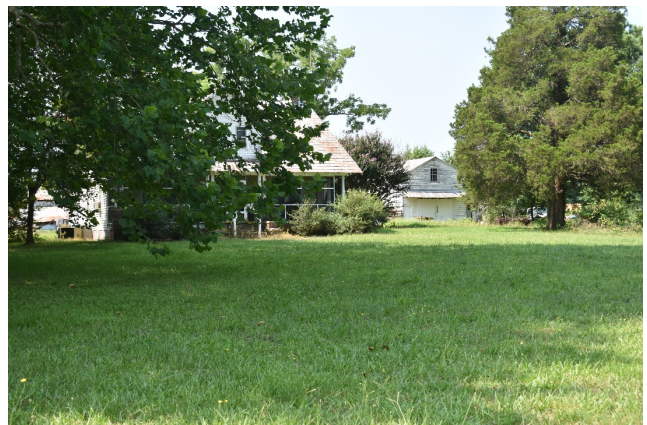
Figure 20: Grant Otwell House (HF0893) at 750 Menola St. John Road, Ahoskie vicinity.

The Grant Otwell House was built ca. 1928 and stands at 750 Menola St. John Road. It too is surrounded by cultivated fields. The Craftsman-style bungalow retains a high degree of material integrity including original weatherboard siding and cornerboards, exposed rafter tails and decorative kneebraces, a recessed front port, and two interior ridgeline chimneys. A large front-gabled dormer is centrally placed on the building's front roof. Between eight and ten supporting agricultural buildings accompany the house and stand to its rear. These buildings, which include various barns and sheds, retain a degree of material integrity similar to that of the house (Figure 20).

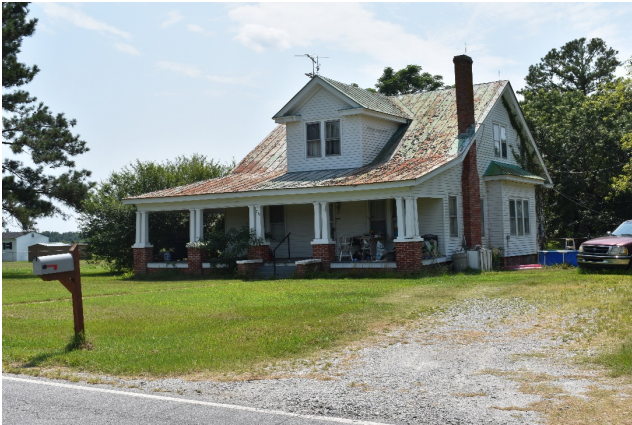
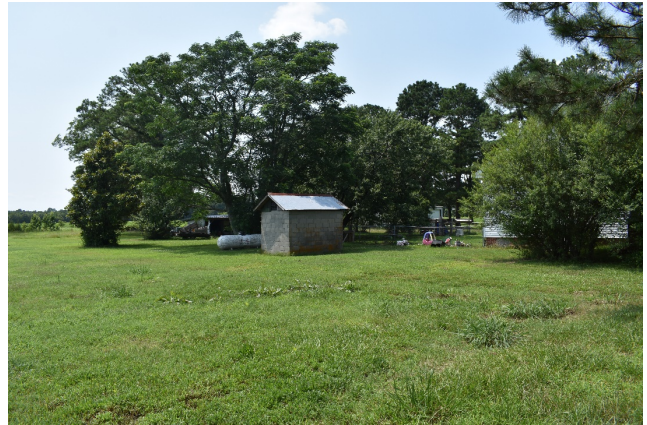
Figure 21: House (HF0805) at 210 Benthall Bridge Road, Murfreesboro vicinity.

Constructed ca. 1920, the house (HF0805) at 210 Benthall Bridge Road near Murfreesboro was recorded as part of the Hertford countywide survey (Figure 21). The rural residence displays many original Craftsman-style features such as a recessed porch supported by double-tapered columns; a

large front-gabled dormer centered on the building's facade roof; two brick chimneys; original three-over-one, double-hung, wood-sash windows arranged as both single and paired units; and an original door with Craftsman-style window design. A small number of supporting outbuildings, appearing to date largely to the mid-twentieth century, are found to the rear (west) of the residence.

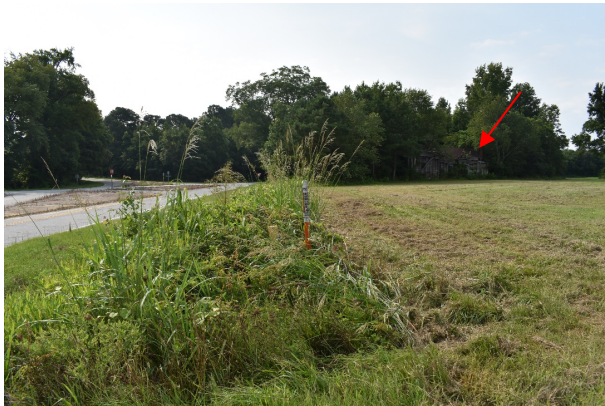
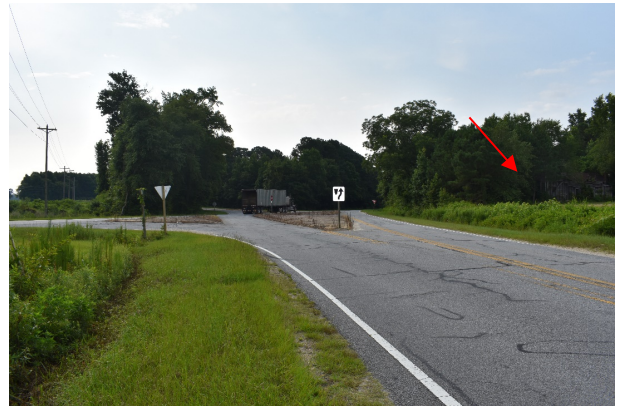
Figure 23: Left and right, views showing Roberta Parker Copeland House in relation to E Woodrow School Road/NC 11 intersection, facing southwest.

The Roberta Parker Copeland House sits at the northwest corner of a 43-acre parcel of land at the south side of the intersection of SR 1169/Woodrow School Road and NC 11. According to aerial imagery, the building historically featured a large setback from the road.⁶ However, following the construction of NC 11 in the early 1970s, the setback of the house was reduced significantly so that it now sits less than 30 yards from the intersection. The resource is bounded to the north by NC 11, to the west by the Raleigh Blowe Sr. House property and open fields, to the east by the Vera Parker Copeland House property, and to the south by dense woods (Figure 23 through Figure 25). The residence currently sits vacant and completely open to the elements, and as a result is significantly deteriorated.

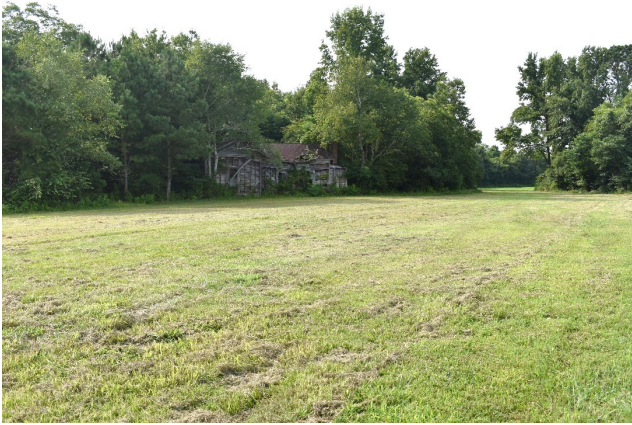
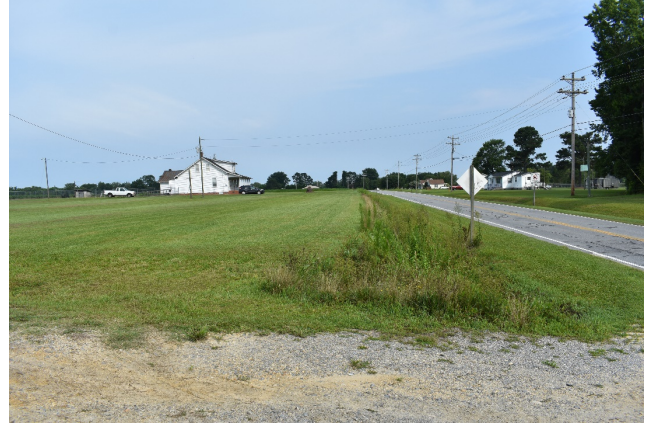
Figure 24: Left, view of Roberta Parker Copeland House, facing southeast; right, view of Raleigh Blowe Sr. House (HF1694) from Roberta Parker Copeland House, facing northwest.

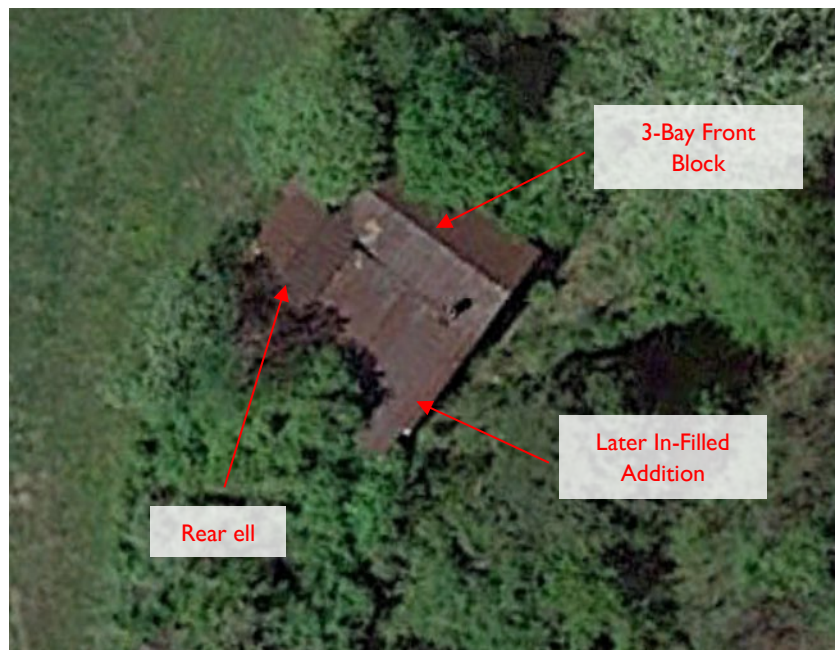
Figure 25: 2014 Google Earth aerial image of Roberta Parker Copeland House, providing clearer picture of building plan.

Oriented to the northeast and the road, the Roberta Parker Copeland House is built of frame and is one-story tall. Due to significant overgrowth and deterioration, many architectural and stylistic features of the late-nineteenth-century residence have been lost. Archival research, in conjunction with remaining architectural elements and a comparison of the house to similar residences found throughout Hertford County, suggests a ca. 1875-1900 date range of construction. Based on information garnered from aerial imagery, the house appears to feature an original L-shape plan, which includes a three-bay, single-pile, front block with rear-extending ell. The southeastern portion of the “L” was later infilled, resulting in the building’s present-day square footprint (Figure 25).

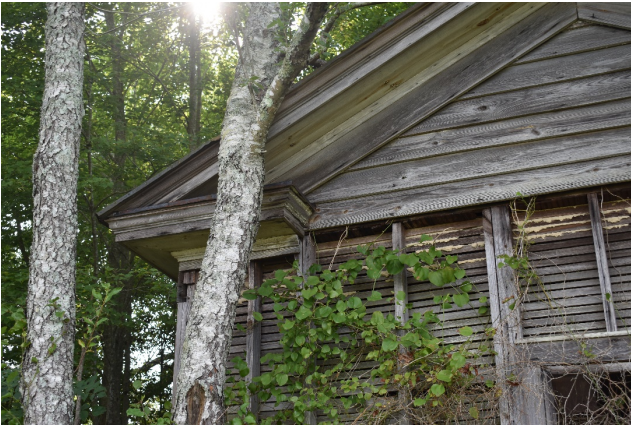
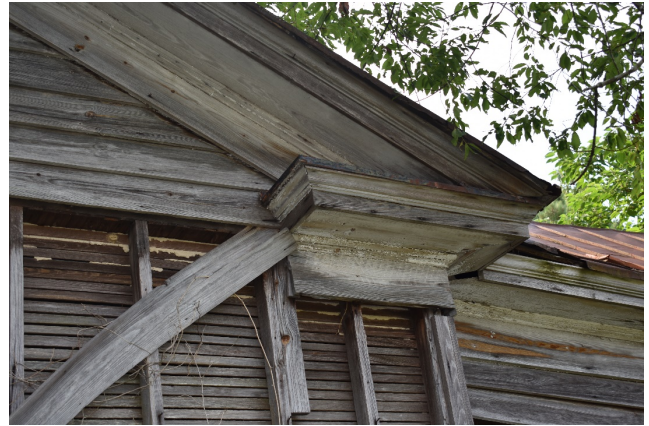
Figure 26: Detail of the house's northwest cornice and returns, facing southeast, at left, and northeast, at right.

The single-story, single-pile, front block of the Roberta Parker Copeland House is rectangular in plan and symmetrical. It rests on a foundation of stone piers. A low-sloped, side-gable roof tops the frame block. It is edged by a deep-set cornice and cornice returns underpinned by a large, unadorned frieze board. Although the building is modest in size, these architectural details suggest the house's builder, likely a member of the locally prominent Parker family, was of comfortable means. The block has been stripped of its original weatherboards, save for the top of its gabled ends, exposing original wood lath, plaster, and machine-sawn studs (Figure 26).

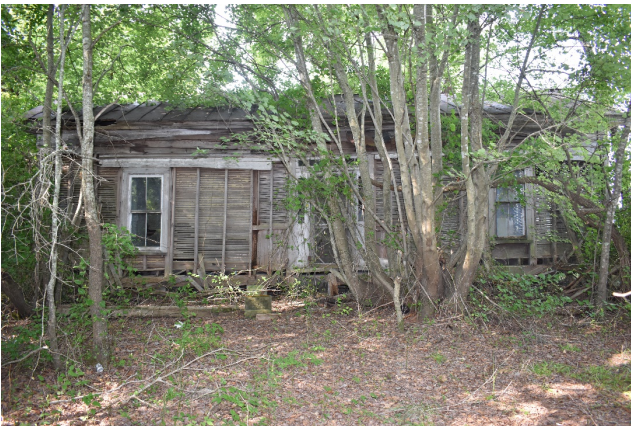
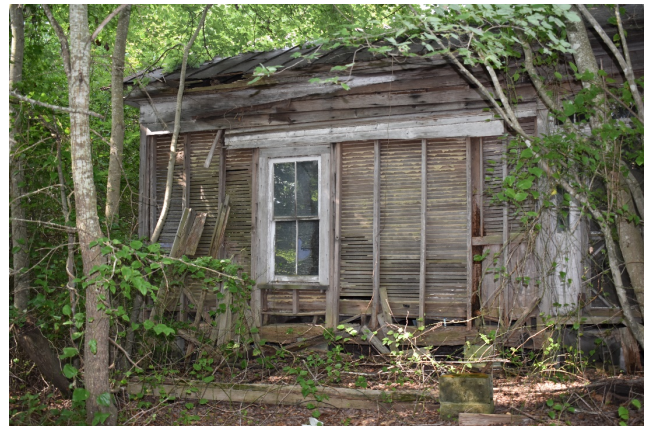
Figure 27: Left, view of facade, facing southwest; right, detail of southeastern end of facade, facing southwest.

The building's facade retains two early or original two-over-two, double-hung, wood-sash windows set in wood surrounds (Figure 27 and Figure 28). The windows are symmetrically placed on either side of the house's centrally located primary entrance. Over time, the building's original door has been lost or removed, but its surround remains. Sidelights are found to either side of the doorway and consist of a single, rectangular light resting above a single, recessed wooden panel. The unit is topped by a rectangular transom which appears to be divided into three rectangular lights (Figure 28). Ghost marks indicate a porch once embraced the facade.

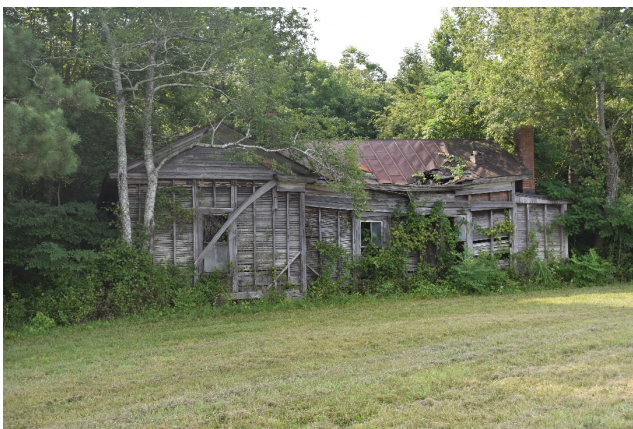
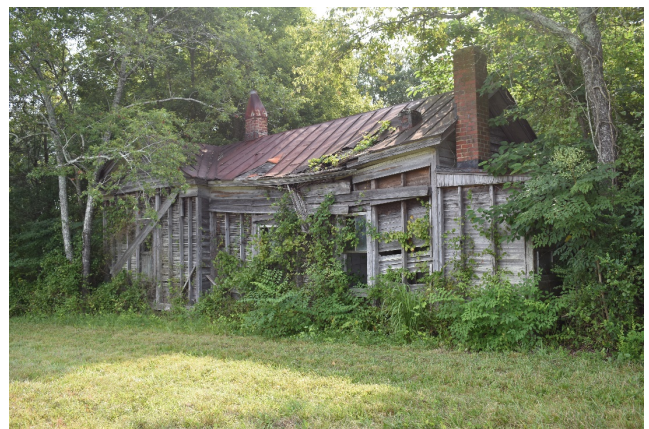
Figure 29: Left, view of northwest elevation, facing southeast; right, view of northwest elevation, facing northeast.

Windows of the same style as the facade are found centrally placed on the secondary (northwest and southeast) elevations of the main block (Figure 30, left and Figure 29, left) in addition to the northwest elevation of the rear ell (Figure 29). The rear ell likely displayed similar window openings on its northeastern elevation; however, this wall is now enclosed by a later frame addition (see below for further discussion). An interior brick chimney rises from the ridgeline of the rear ell near the wing’s juncture with the main building block. Remnants of a smaller, second interior chimney project through the northwest roof of the rear ell (Figure 29).

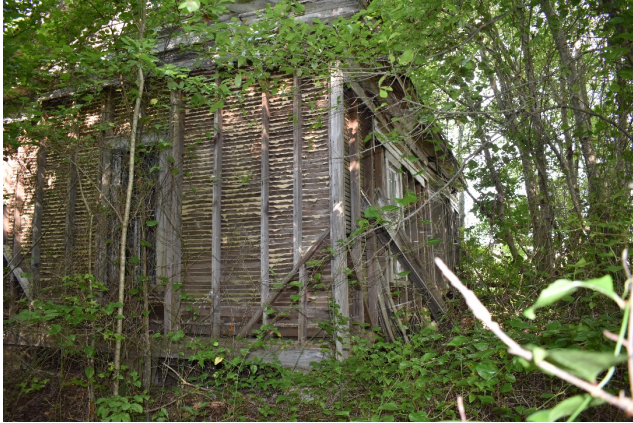
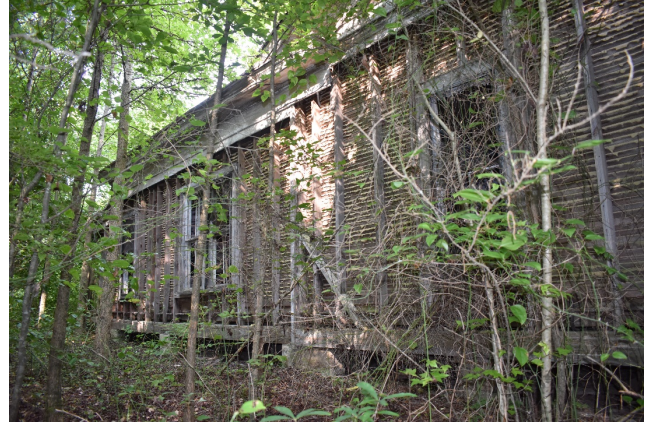
Figure 30: Left, northeast corner of main block of the Roberta Parker Copeland House, facing northwest; right, view of southeast elevation, with parapeted addition at left, facing southwest.

Likely during the early-twentieth century, a single-story frame addition was added to the house, connecting to the rear (southwest) elevation of the main block and the side (northeast) elevation of the rear ell. This effectively transformed the house’s original L-shaped footprint into a square. Like the main block of the house, the addition has lost all of its original weatherboard siding. It does, however, retain an unusual feature on its southeastern elevation: a large wooden parapet wall finished like an entablature. This decorative element spans the length of the addition’s southeast side, and suggests a flat roof lies behind. (Aerial imagery, partially obscured by trees, appears to confirm this.) The parapet

would have been visible to those traveling west on Woodrow School Road, suggesting that the addition may once have held a store. Beneath the parapet lies a single and a paired set of three-over-one, double-hung, wood-sash windows (Figure 30 and Figure 31).

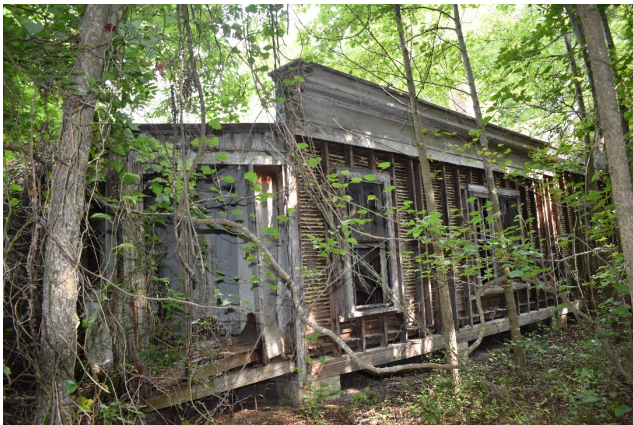
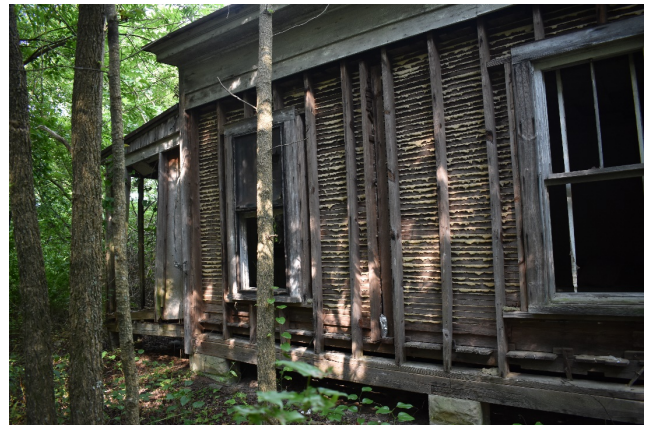
Figure 31: Left, view of southeast elevation of the Roberta Parker Copeland House's parapeted addition, facing northeast; right, view of southeast elevation and parapet, facing southwest.

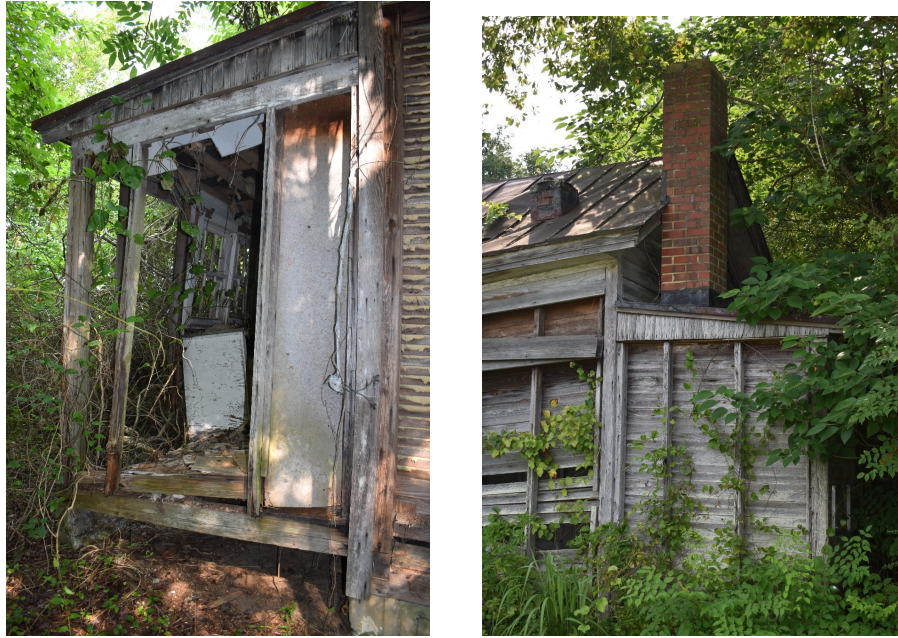
Figure 32: Left, looking northwest at secondary ell and southeast corner of the house; right, southwest corner of ell and secondary addition, facing southeast.

A secondary shed-roofed addition extends across the rear elevation of the house, attached to both the parapeted addition and the rear ell. Like the other sections of the house, it lacks its original siding, although its framing suggests that its southeastern end may have been open, creating a small, partially enclosed porch space. The secondary addition partially hides the house's third chimney. Affixed to the gabled end of the ell, the brick chimney rises through the addition's roof (Figure 32).

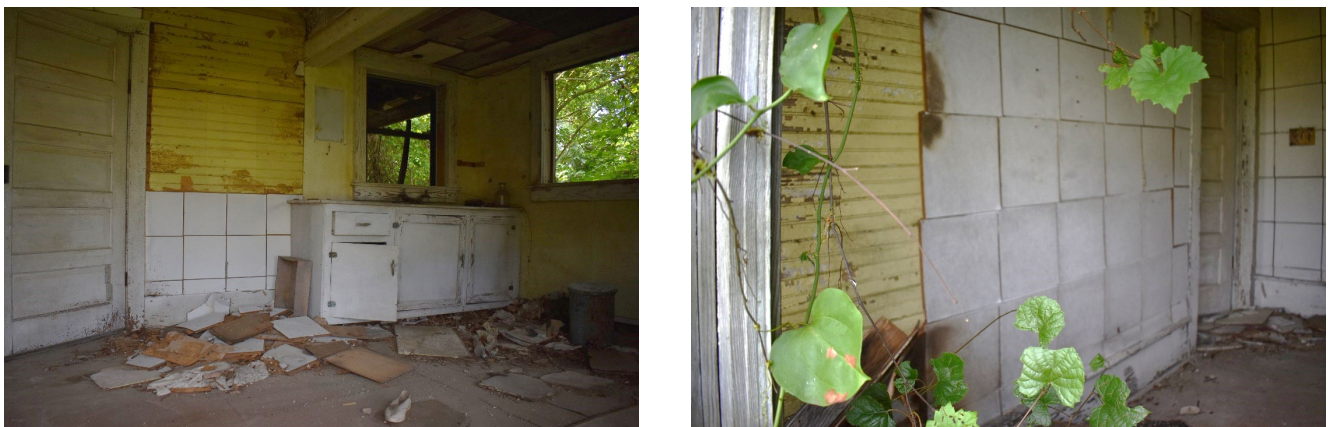
Figure 33: Left and right, interior views through rear ell windows of the house, facing southeast.

The house is vacant and deteriorated, restricting access. Views into the main front block were not possible due to a combination of window coverings, the presence of a beehive within the walls of the facade, and safety protocols. Images taken through open windows of the rear ell revealed original beadboard paneled walls partially covered by asbestos tile, as well as mid-twentieth-century kitchen fixtures. Original or early, four-paneled doors with original door surrounds were also observed (Figure 33). Views into the secondary addition revealed doors of the same style in addition to slightly later moldings and hardware, suggesting an early/mid-twentieth-century period of construction (Figure 33).

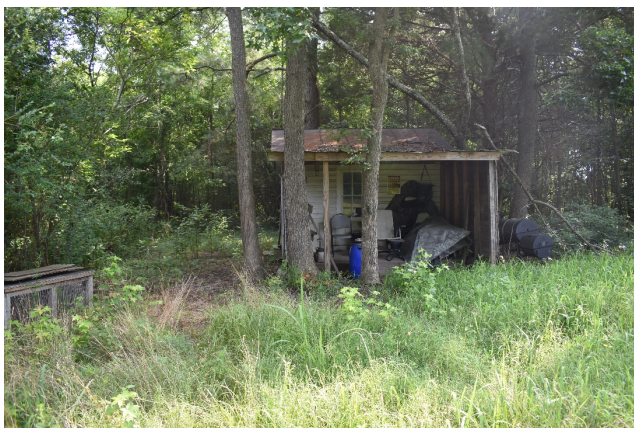
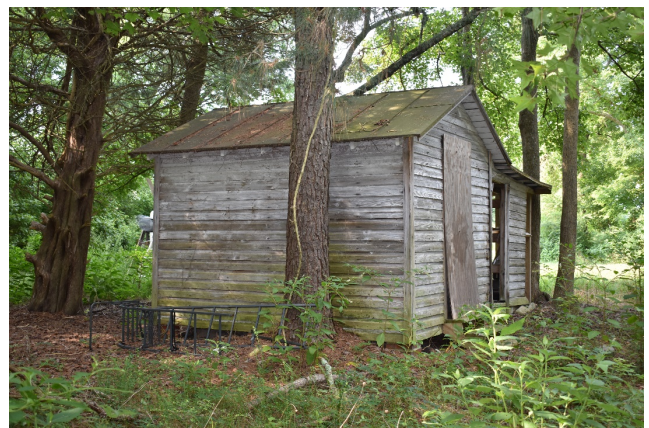
Figure 35: Left, view of converted shed, facing northeast; right, view of converted shed, facing southwest.

A small, single-story, frame shed sits a few yards to the southeast of the Roberta Parker Copeland House (Figure 35). The rectangular side-gabled building is clad in German siding and edged with cornerboards. It rests on a brick-pier foundation and its roof is clad in metal sheathing with exposed rafter tails. A modern shed-roof addition extends from the building's southern end. A centrally placed door opening on the shed's western elevation has been boarded-up. A four-over-four, double-hung, wood-sash window is off-centered on the shed's southern elevation. Originally utilized for agricultural purposes, today the building appears to operate as a hunting cabin.

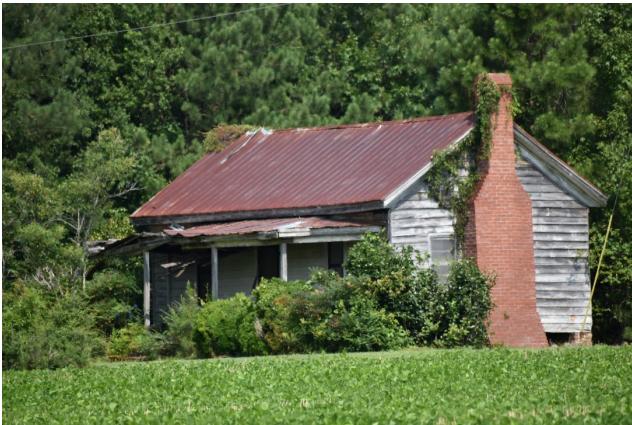
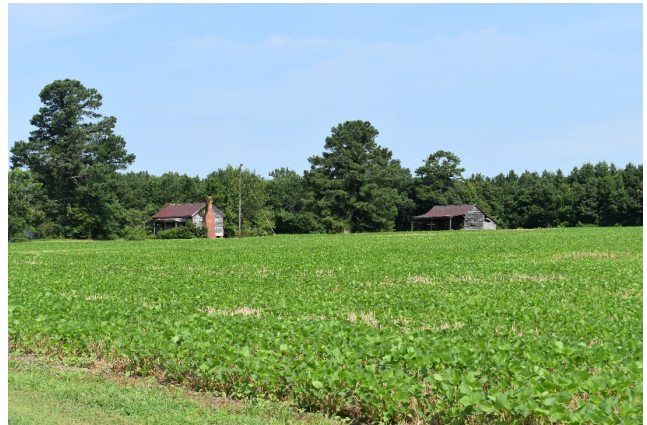
Figure 37: Johnson House (HF0846) at 802C Pine Tops Road, Murfreesboro vicinity.

The Johnson House (HF0846) stands at the center of a large agricultural parcel at 802C Pine Tops Road in the Murfreesboro vicinity. Constructed ca. 1900 according to NCHPOWeb, the resource stands one-story tall, is of frame, and retains a high degree of material integrity. A side-gabled roof tops the building and features a plain cornice with shallow eaves, while a shouldered brick chimney embraces the building's gable end. The modest residence retains its original weatherboard cladding and stands atop a brick pier foundation. A three-bay hipped-roof porch supported by wooden posts shades the facade. The resource retains at least one early/mid-twentieth-century outbuilding, which stands to its rear (Figure 37).

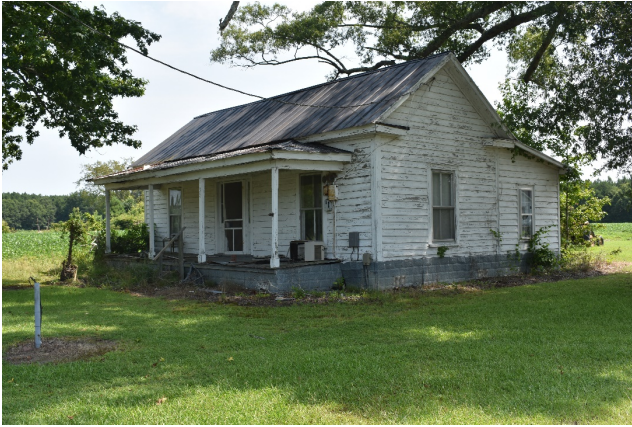
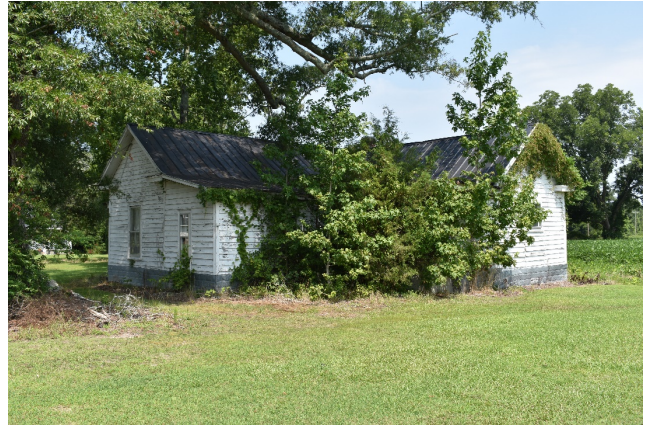
Figure 38: House (HF0895) at 351 S. Early Station Road, Ahoskie vicinity.

Constructed ca. 1900, the house (HF0895) at 351 S. Early Station Road near Ahoskie presents a similar form (Figure 38) to the Roberta Copeland House. The frame building stands one-story tall and is arranged in an L-shape plan, with a rectangular front block and rear ell. The front block is three bays wide and topped with a side-gabled roof featuring deep eaves and cornice returns. A hipped-roof porch supported by wood posts fronts the building, which retains its original weatherboard siding. Two-over-two, double-hung, wood-sash windows are found on all elevations of the main block. The residence also features a small shed-roof rear addition. No outbuildings accompany the resource.

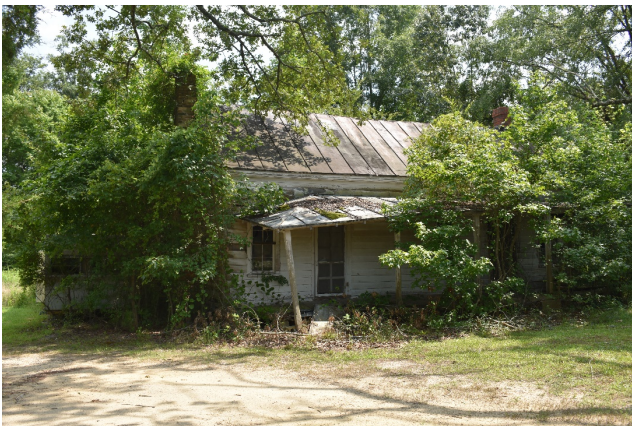
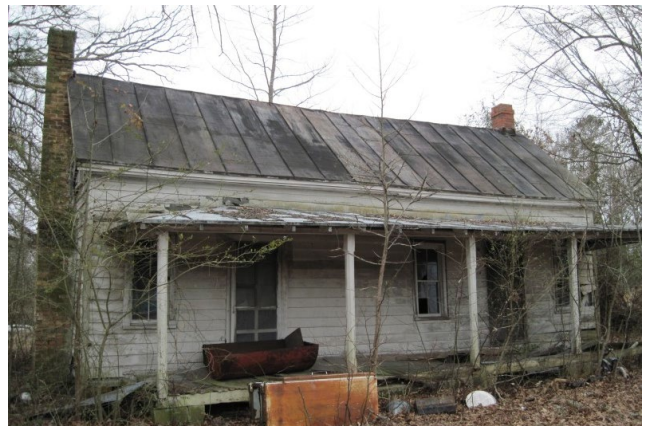
Figure 39: House (HF0831) at 143 Boones Bridge Road, Como vicinity. Left, present-day photo; right, undated image found at NCHPOWeb online collection.

The previously surveyed house (HF0831) that stands at 143 Boones Bridge Road in the Como vicinity is one-story tall and topped with a side-gabled roof (Figure 39). Original weatherboards clad the building and a four-bay hipped-roof porch embraces the facade. Small four-over-four, double-hung, wood-sash windows found at the building's facade, along with the cornice and returns, suggests the building may date earlier than the ca. 1900 date assigned to it in the NCHPOWeb database. The house retains a rural setting; however, due to overgrowth it is unclear if any secondary structures accompany it on its lot.

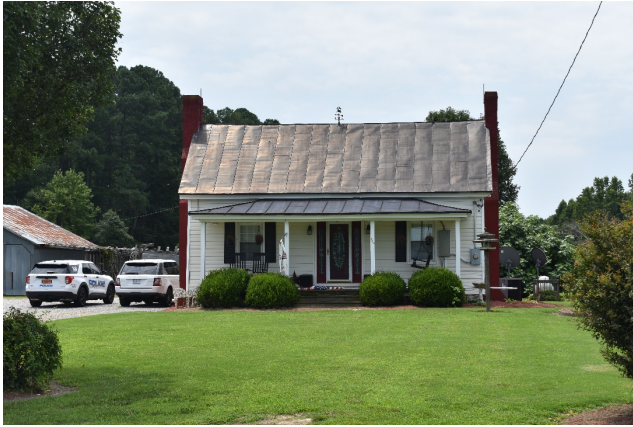
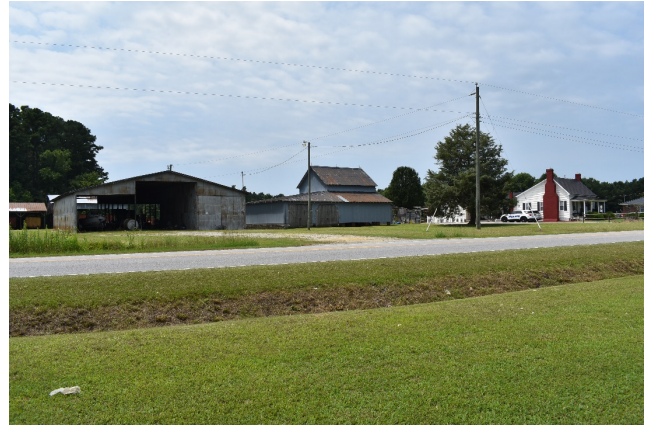
Figure 40: Minton House (HF0557) at 477 Godwin Town Road, Ahoskie vicinity.

The ca. 1880 Minton House (HF0557) is located at 477 Godwin Town Road in the Ahoskie vicinity (Figure 40). Standing one-story tall, the frame residence is three-bays wide at its facade and features a shed-roof addition at its rear. Shouldered exterior-end, brick chimneys bracket the house's gable ends. A hipped-roof porch embraces its facade. Replacement vinyl units occupy the window and door openings. The building is accompanied by a large collection of mid-twentieth-century outbuildings associated with tobacco farming, including a large packhouse and multiple barns.

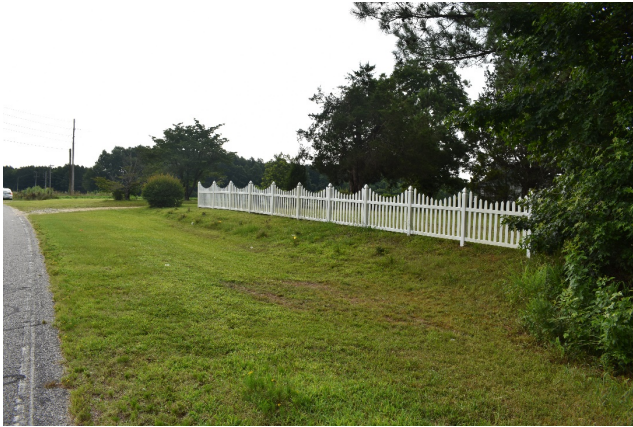
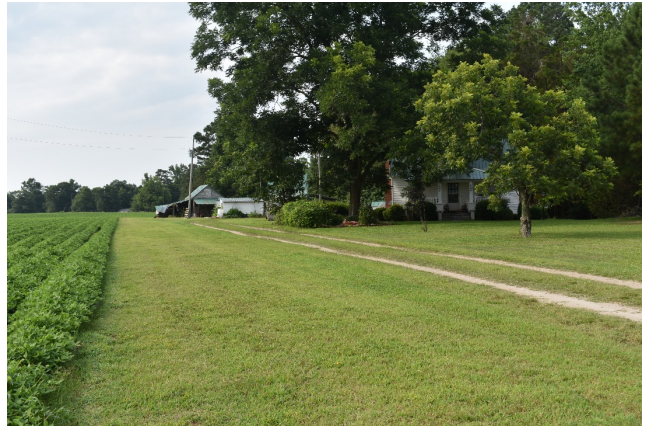
Figure 42: Left, view of Vera Parker Copeland House property in relation to E. Woodrow School Road, facing east; right, view of house from road, facing southwest.
