**North Carolina Department of Natural and Cultural Resources
State Historic Preservation Office**

Re: Historic Structures Survey Report, Improve Intersection of NC 11 and SR 1169
(Woodrow School Rd), Tip # W-5701H, Hertford County, ER 21-2175

RALEIGH BLOWE SR. HOUSE

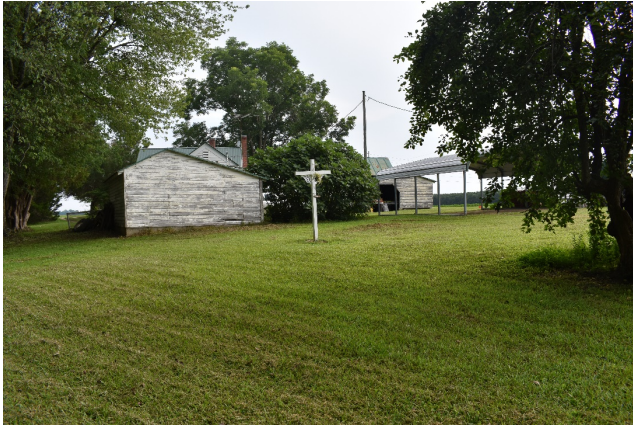
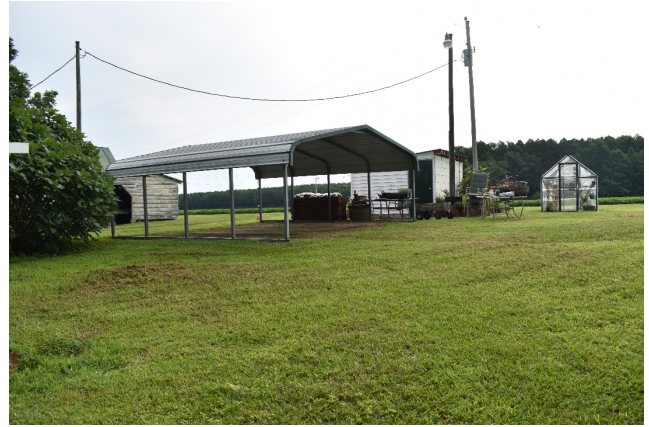
Figure 44: Left, view toward Vera Parker Copeland House and associated outbuildings, facing northeast; right, view toward outbuildings and fields, facing northeast.

The mid/late-nineteenth century Vera Parker Copeland House is situated on a 12-acre lot of land just east of the intersection of SR 1169 with NC 11. The resource is bounded to the north by SR 1169, to the west by NC 11, and to the east and south by actively cultivated agricultural fields. The house stands toward the front (north) end of its parcel and is separated from SR 1169 by a large, open, grassy yard, although a small cluster of mature hardwood trees screens the house from the road. It is accessed from SR 1169 via a long gravel drive. A twentieth-century white picket fence separates the front of the yard from the NCDOT right-of-way and the road (Figure 42 and Figure 43). A small farm complex sits to the rear (south) of the house. It contains a mid-nineteenth-century smokehouse, a mid-twentieth-century frame shed and barn, and two late-twentieth-century garden sheds and a carport (Figure 44 and Figure 45).

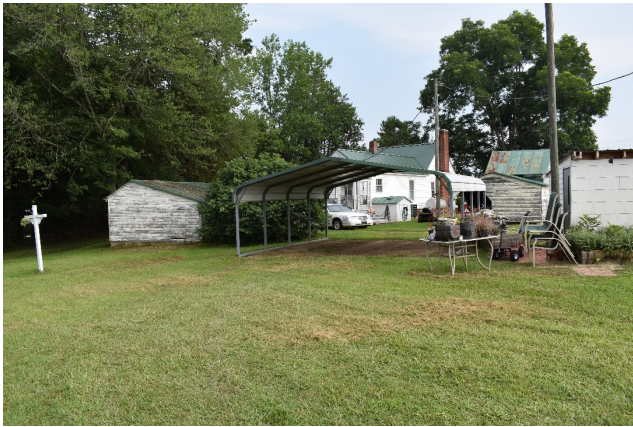
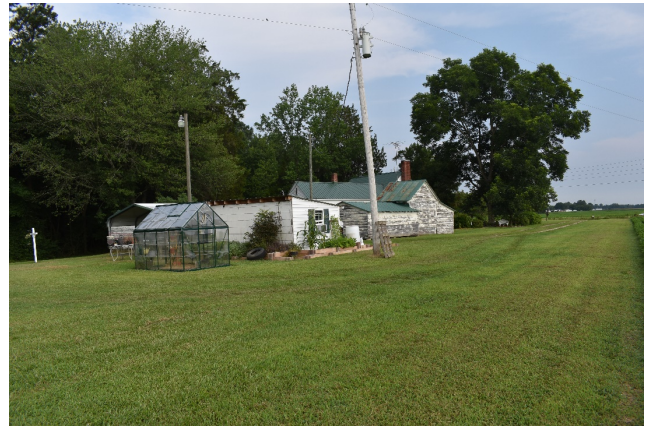
Figure 45: Left, view toward Vera Parker Copeland House and associated outbuildings, facing north; right, view toward house and associated outbuildings, facing northwest.

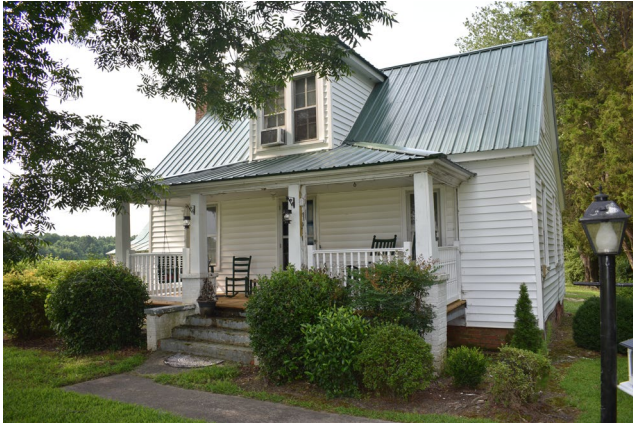
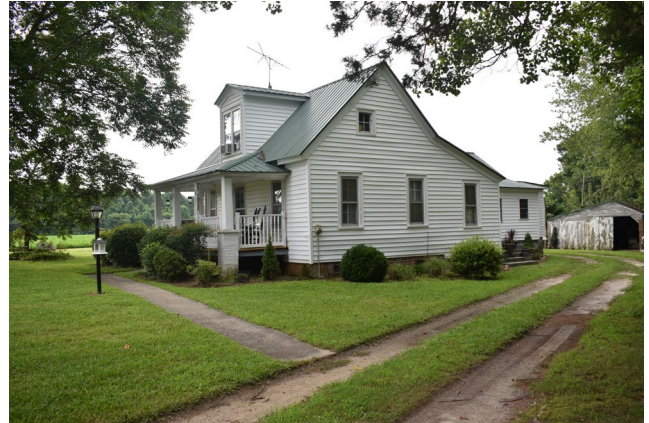
Figure 46: Left, facade of the house, facing southeast; right, oblique of northeast and southeast elevations, facing southwest.

The front block rests on a brick-pier foundation, which has been filled in with brick. Its roof is clad with standing-seam-metal (Figure 46). A large front-gabled dormer centered on the facade was likely added in the early/mid-twentieth century. The dormer features paired two-over-two, double-hung, wood-sash windows.

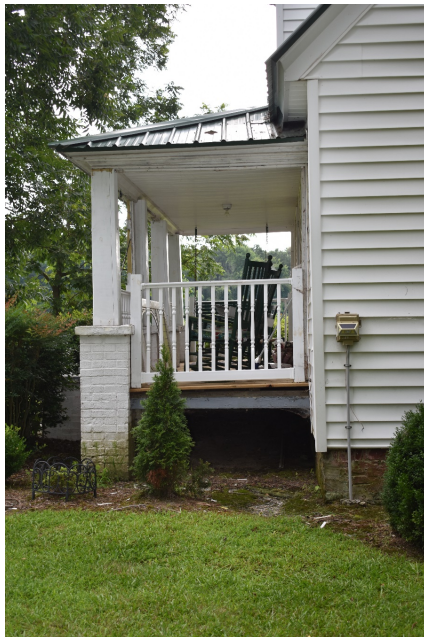
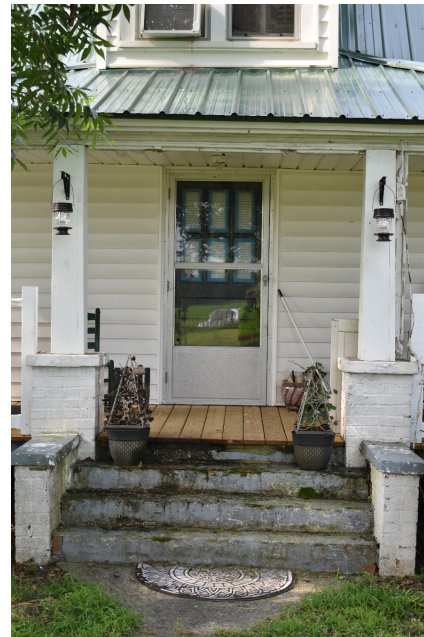
Figure 47: Left, detail view of replacement front porch, facing northwest; right detail view of front door and porch, facing southwest.

A three-bay hipped-roof porch that likely replaces an earlier one embraces the facade. Modern tapered box posts resting on mid-twentieth-century brick bases support its hipped roof. Premanufactured balustrades, also recent additions, connect the posts. Three mid-twentieth-century concrete steps,

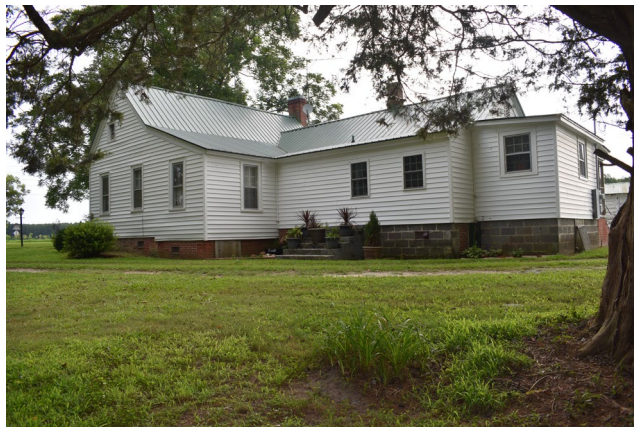
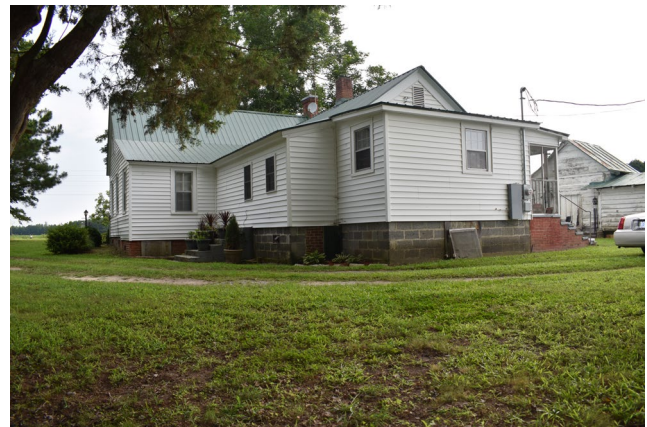
Figure 49: Left, oblique of the house northwest and southwest elevations, facing northeast; right, oblique of house's northwest and southwest elevations, facing north.

A single-story, gabled, rear ell extending to the front block's south gives the house an L-shaped footprint. It is likely a late-nineteenth/early-twentieth-century addition. A centrally placed brick chimney stack rises from the roof ridge of the ell. A continuous brick foundation is visible at the ell's eastern elevation, as are two asymmetrically placed windows: a two-over-two, double-hung, wood-sash unit at the north end of the elevation and a smaller six-over-six, double-hung wood sash unit toward the ell's southern end. The ell's western elevation, in contrast, rests on a concrete-block foundation. A set of concrete stairs abutting the foundation once led to a shed-roof porch, which was enclosed by 2010 (Figure 49 and Figure 50).

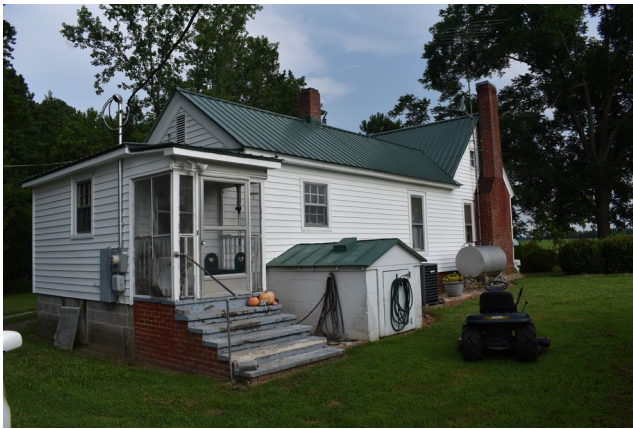
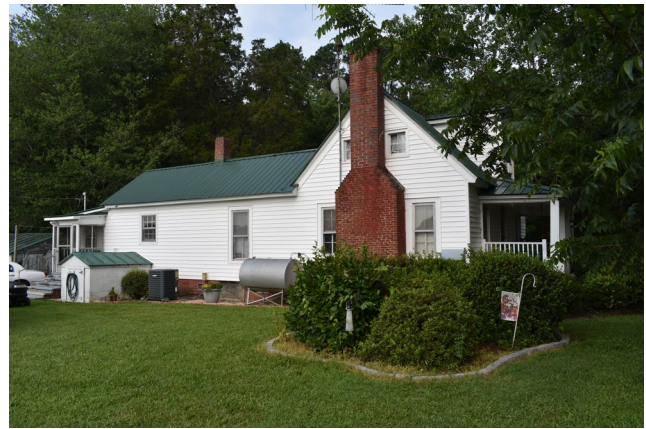
Figure 50: Left, oblique of Vera Parker Copeland House southeast and southwest elevations, facing north; right, view of southeast elevation, facing southwest.

A small flat-roofed addition was extended across the rear of the ell during the mid-twentieth century. Like the remainder of the house, the addition is built of frame and clad in vinyl. It features the same six-over-six, double-hung, wood-sash windows as found at the south end of the ell. A single-bay, enclosed porch topped with a metal-clad shed roof extends from the eastern corner of this addition. Its entry is approached by a set of brick stairs with a metal-pipe handrail. To the direct north of the enclosed porch is a small, front-gabled cinderblock building which may serve as a wellhouse or house other utilities. The small building abuts the eastern elevation of the rear ell and is accessed via a crude wooden door centered on its front (east) elevation (Figure 50).

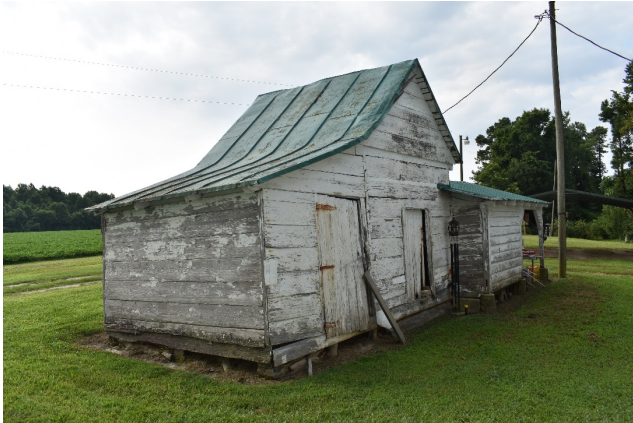
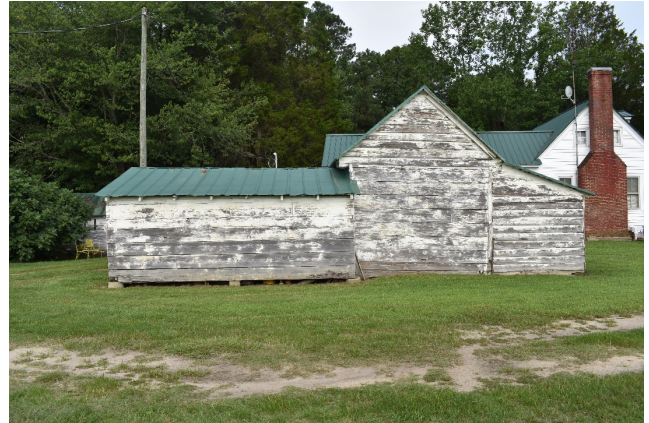
Figure 51: Left, oblique of smokehouse northeast and northwest elevations, facing southeast; right, southeast elevation, facing northwest.

A frame, shed-roofed, flushboard-sided addition is affixed to the smokehouse's north elevation (Figure 51 and Figure 52). A metal-sheathed roof at the north creates a continuous roofline for the smokehouse and this addition, but the boxed eaves of the plank construction are still distinguishable. Both the original block and the shed-roof addition rest on a stone-pier foundation. During the mid-twentieth century, a gable-roofed addition on a concrete-pier foundation was added to the smokehouse's south (Figure 53). Weatherboarded and topped by a standing-seam-metal roof with exposed rafter tails, it is open at the southwest corner for machine or vehicle storage.

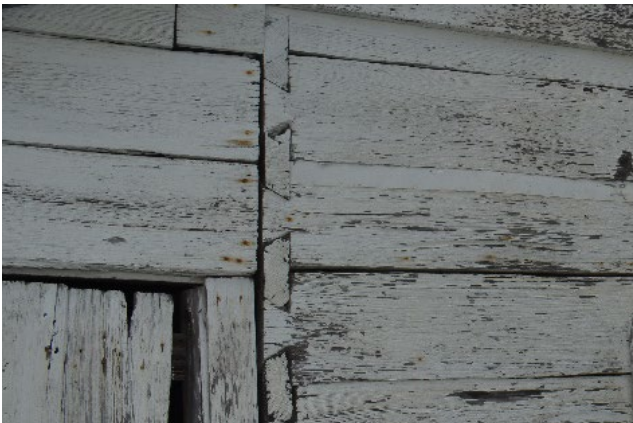
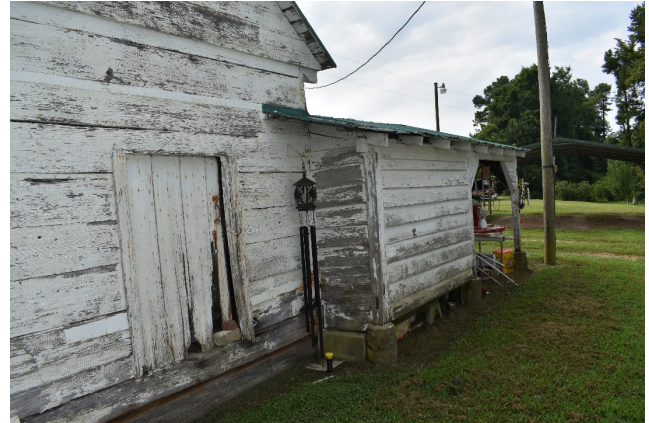
Figure 52: Left and right, smokehouse northwest elevation, facing southeast. Note the dovetail plank joinery in the image to the left.

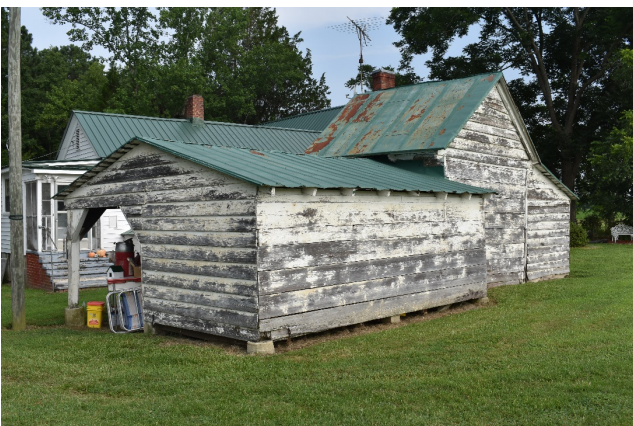
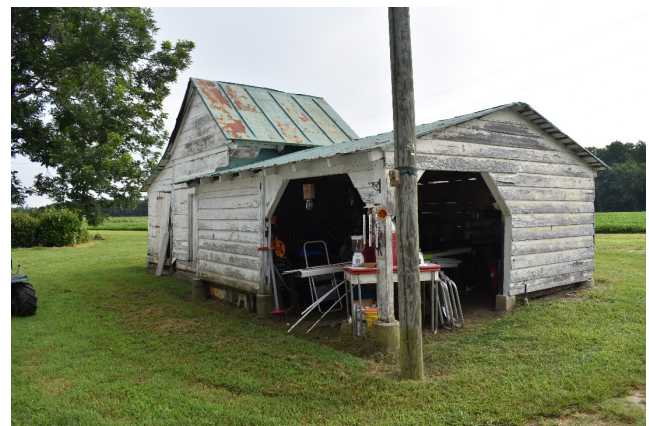
Figure 53: Left, oblique of smokehouse southeast and southwest elevations, facing northwest; right oblique of northwest and southwest elevations; facing northeast.

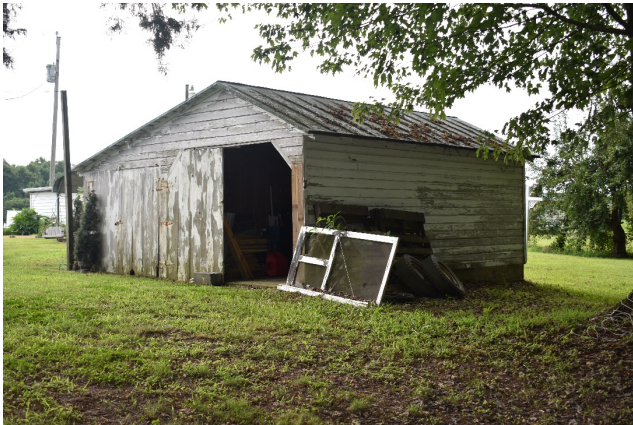
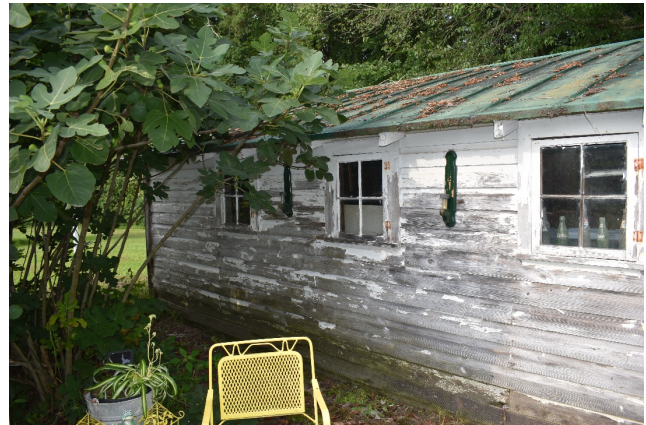
Figure 54: Left, view of shed, facing southeast; right, view facing southwest.

A small frame shed southwest of the house rests on a continuous concrete foundation and is oriented to the north. It is rectangular in plan and clad in German siding. The building's saltbox-style roof is topped with standing-seam-metal and features exposed rafter tails. A large arched doorway at its southeast elevation suggests the shed was built as a garage. One of the opening's two original, vertical, wood-paneled doors remains in place. A smaller door, also comprised of vertical wood boards, is found to the left (east) of the larger doorway. Three small, four-light, fixed casement wood-windows are found on the eastern elevation. The building likely dates to the mid-twentieth century.

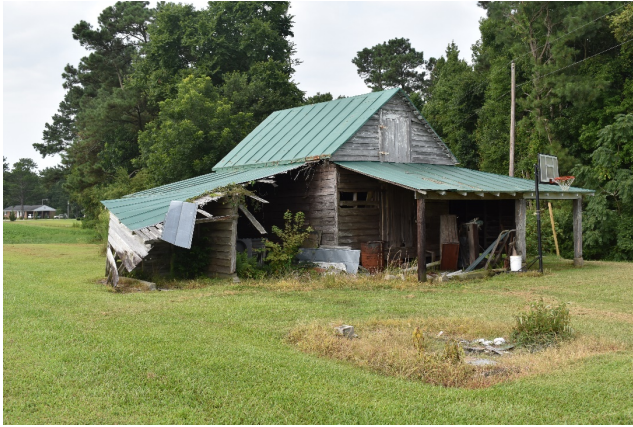
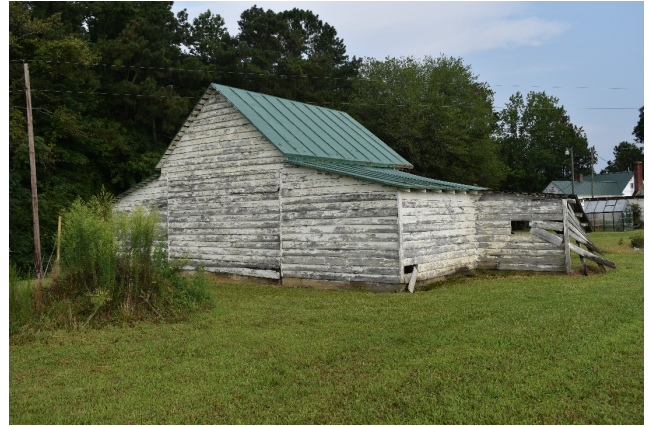
Figure 55: Left, oblique of barn northwest and northeast elevations, facing southwest; right oblique of northeast and southeast elevations, facing northwest.

A frame barn standing at the southwest corner of the outbuilding complex likely dates to the early-twentieth century. Clad in weatherboards, the barn's original central mass is one-and-a-half stories tall with a hayloft at its upper story.⁹ It rests on a brick-pier foundation that has been infilled with fieldstone. A small shed-roofed addition extending to the building's east was likely added in the mid-twentieth century. This addition is clad in weatherboards, rests on a continuous concrete foundation, and features exposed rafter tails. The addition was eventually expanded through the adding of a second shed-roof block at its northeast corner. Both additions are open at their northern ends. A large hip-roof lean-to extends from the facade of the barn and wraps around the building's western end. Topped with standing seam metal, the appendage is divisible into two bays at the barn's facade and is supported by three large, rough-cut posts that rest on concrete piers. The western side of this addition is enclosed and clad with weatherboards.

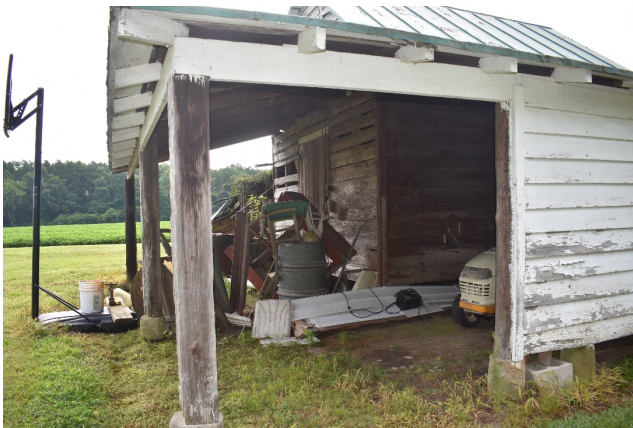
Figure 56: Left and right, interior details of barn, facing southeast.

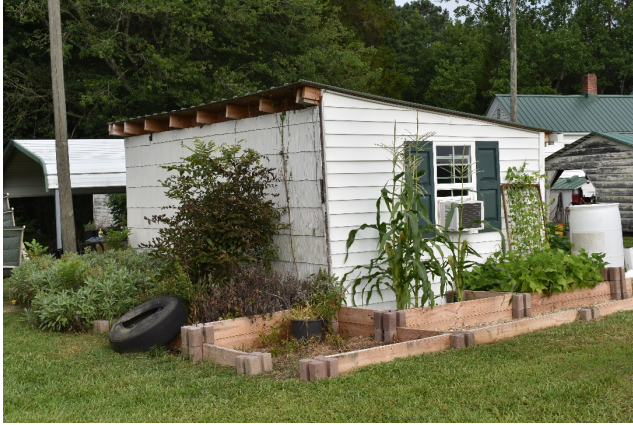
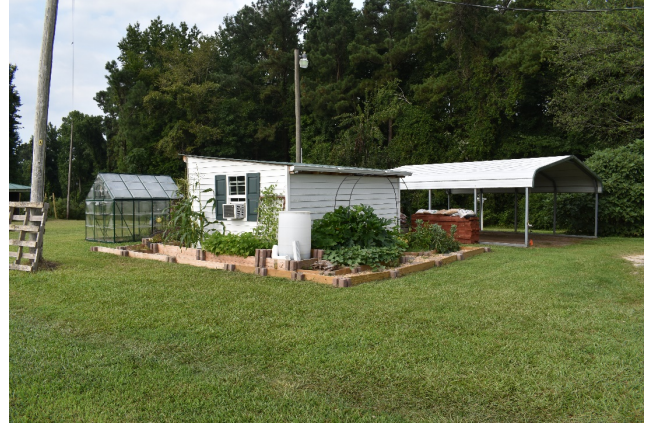
A late-twentieth-century frame garden shed, a prefabricated metal garden shed, and a metal carport are located to the southeast of the house. The frame shed is roughly rectangular in plan and topped with a shed roof edged by exposed rafter tails. It is clad in vinyl siding. The metal shed is situated to the direct south of the frame shed. The prefabricated carport stands to its direct west.

Figure 57: Left, view of frame garden shed, facing southwest; right, view of metal shed, frame shed, and modern carport, facing southwest.

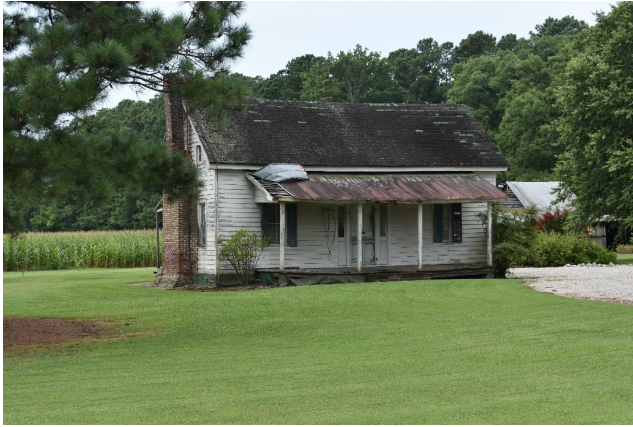
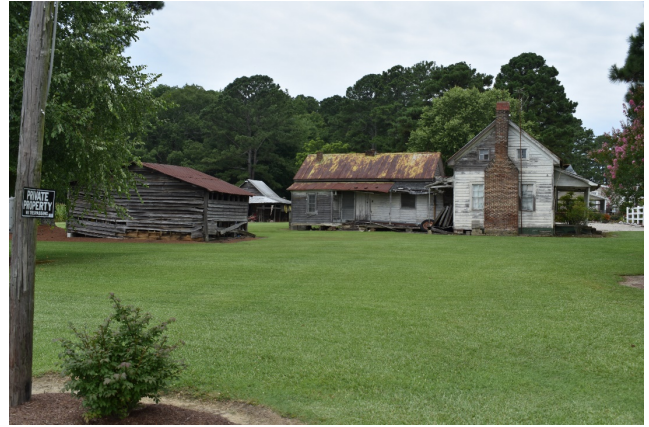
The story-and-a-jump house (HF0928) located at 2306 US 13 South near Ahoskie was constructed ca. 1890. It is clad in original weatherboards and features a brick shouldered chimney at its gable end. Its original entry with vertical sidelights is centrally placed beneath a shed-roof porch supported by wooden columns. The house is accompanied by several early/mid-twentieth century outbuildings in addition to a modern twentieth-century house. The resource retains a high degree of material integrity and stands as a good example of late-nineteenth/early-twentieth century farm complex (Figure 58).

Figure 58: House (HF0928) at 2306 US 13 South, Ahoskie vicinity.

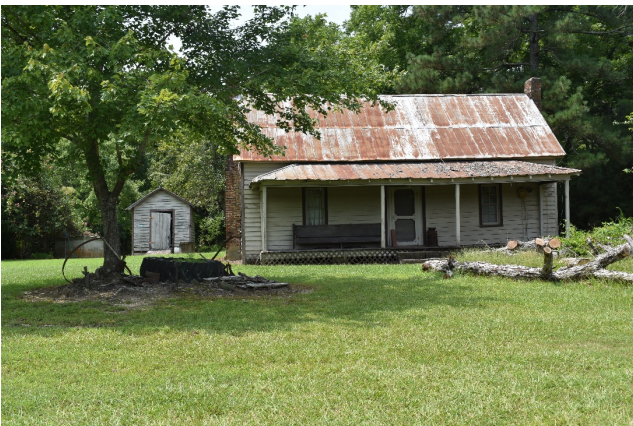
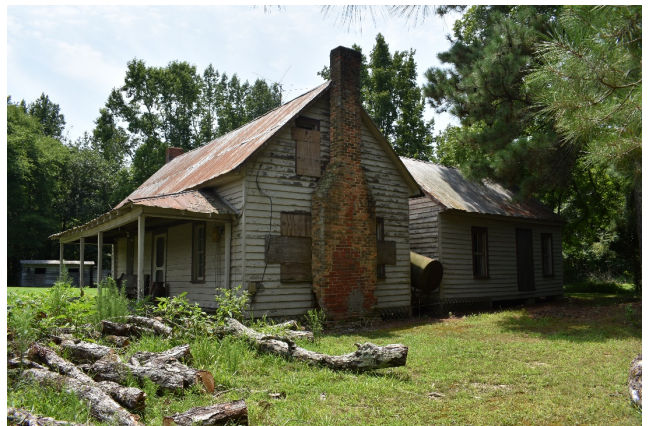
The Study-Listed Edward Brown (Figure 59) house at 237 Bethany Church Road near Cofield was constructed ca. 1880-1890. The entry for the residence in *West of the Chowan* states:

The house has a simple gabled form with brick end chimneys, a front porch on chamfered posts, and a one-story kitchen and dining room ell with a side porch. The center passage has narrow beaded matchboard sheathing and the mantels are of simple Greek Revival-influenced post-and-lintel form. The property also contains a mule barn, chicken house, meat house, and privy (Pezzoni, ed. 2016:135).

When visited during the fieldwork for this survey, only the house and privy were located. The house continues to retain a high degree of material integrity; however, some of its window openings have been covered over.

Figure 59: Edward Brown House (HF0927) at 237 Bethany Church Road, Cofield vicinity.

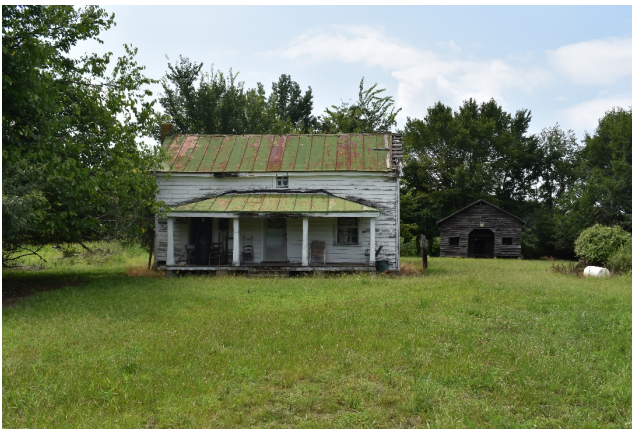
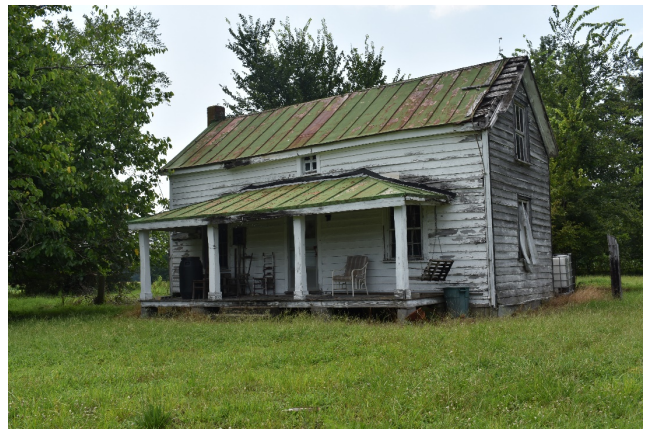
A house at 301 Statesville Road near Como (HF0785) was constructed ca. 1910 according to NCHPOWeb data. A story-and-a-half tall, the frame residence stands at the end of a long unpaved access path in the middle of a large clearing. Its facade features a tiny centrally placed window at its loft story. The house is clad in weatherboards and fronted by a hipped-roof porch. An exterior-end

chimney rises from one gable end. While it retains a high degree of material integrity, it appears to retain only one outbuilding: a mid-twentieth century garage, located to its rear (Figure 60).

Figure 60: House (HF0785) at 301 Statesville Road, Como vicinity.

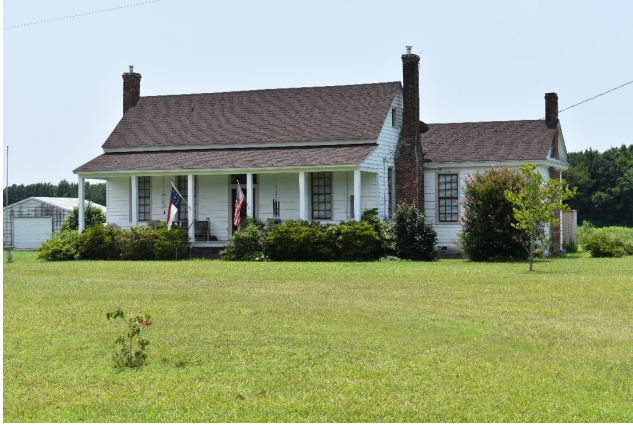
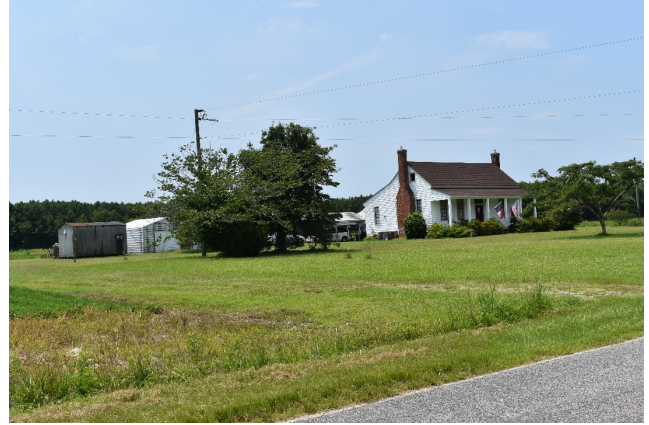
The Cullens House (HF0477) at 242 Cullen Road near Cofield was placed on the Study List in 2011 (Figure 61). Its entry in *West of the Chowan* makes the following observations (Pezzoni, ed. 2016:129-30):

The exterior has a Federal-Greek character that becomes more pronounced inside, as seen in the design of the mantels...

The house is accompanied by a small collection of outbuildings, some of which appear to date to the mid/late-twentieth century.

Figure 61: Cullens House (HF0477) at 242 Cullen Road, Cofield vicinity.
