Subject: Addendum to Historic Structures Survey Report for R-5826B, Upgrade Roadway NC 109  
from SR 1127 to SR 1174, Montgomery County, ER 21-2358

**ADDENDUM TO**  
**HISTORIC STRUCTURES SURVEY REPORT**  
**UPGRADE ROADWAY NC 109**  
**FROM SR 1127 (HEARNE FARM ROAD) TO SR 1174 (PEE DEE ROAD)**  
**MONTGOMERY COUNTY, NORTH CAROLINA**

**TIP PROJECT R-5826B**  
**WBS NO. 57098.1.3**  
**PA TRACKING NO. 19-06-0024**

**PREPARED BY:**  
***Commonwealth Heritage Group, Inc.***  
**P.O. Box 1198**  
**201 West Wilson Street**  
**Tarboro, North Carolina 27886**

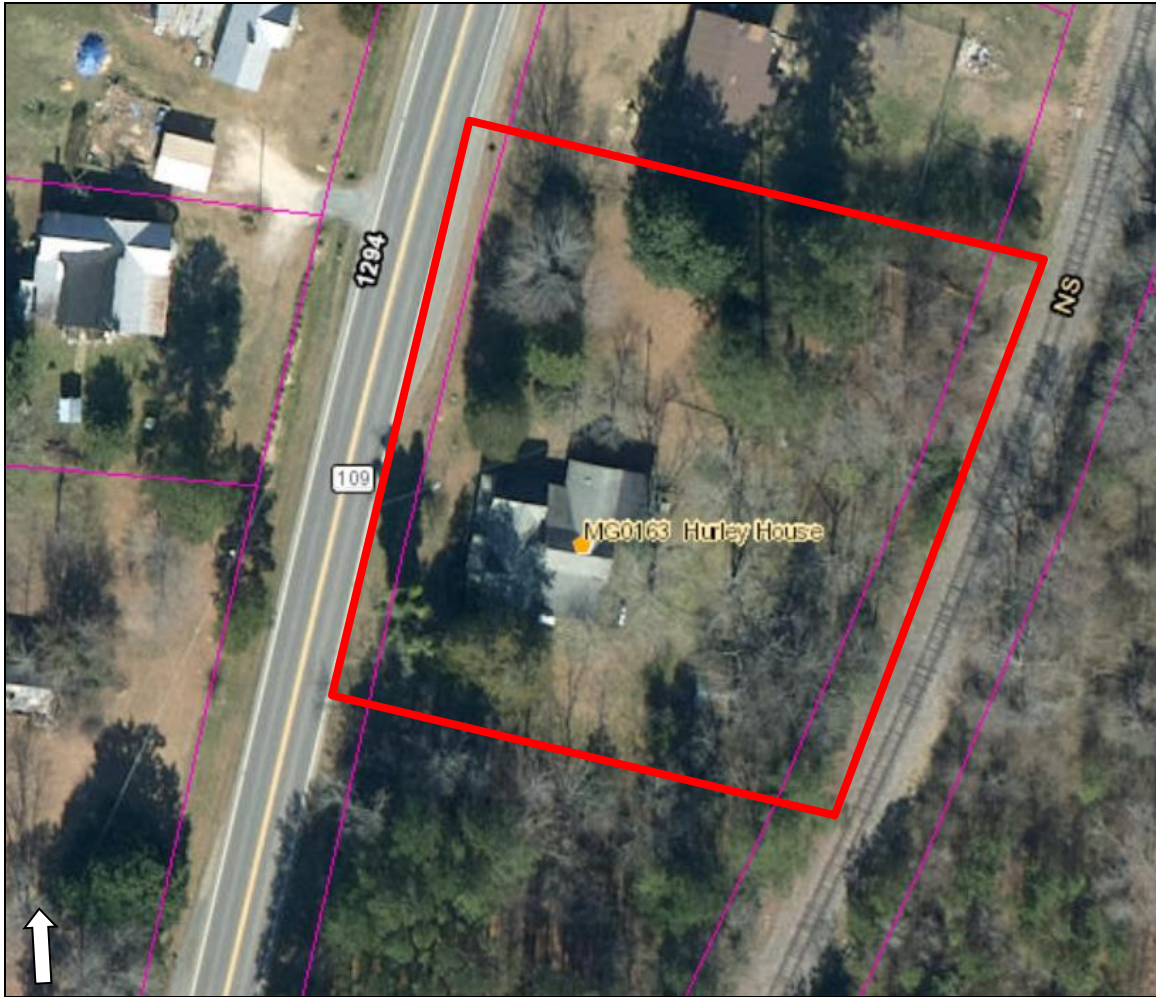
**Hurley House (MG0163) Proposed National Register Boundary.**

We concur that the Hurley House (MG0163) proposed boundary should follow the edge of pavement along the west, roughly follow the tree line to the south, turn to follow the railroad tracks to the east, and then the parcel line to the north, as illustrated below.

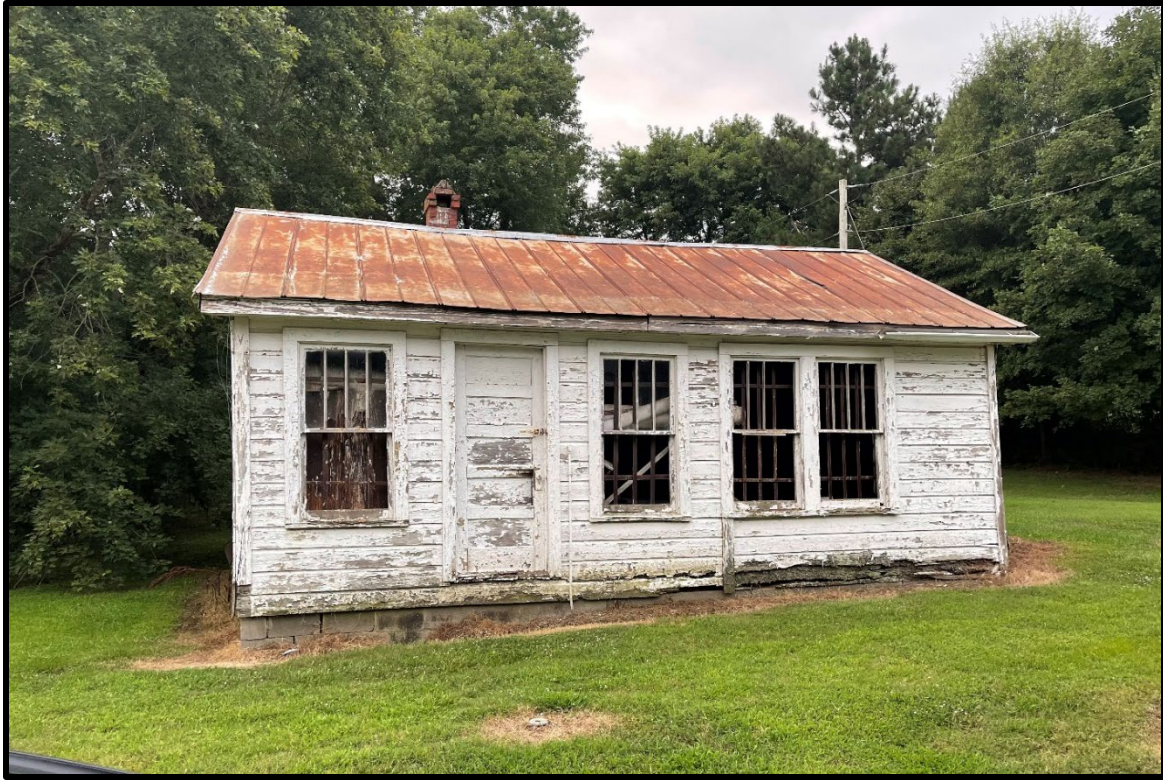
Figure 1. Ray Burleson Roadside Store (ST0381) located near Albemarle.

The Ray Burluson Store (ST0381) located at 28368 Canton Road outside of Albemarle is one such example (Figure 1). Although located in Stanly County, rather than Montgomery County, the Burluson Store is approximately 15 miles from the project area and located within a similarly rural area. No construction date is listed in HPO Web 2.0 or in local tax records, but it appears to date to the early twentieth century. Historic aerial imagery shows that the store was once associated with a dwelling approximately 300 feet to its southeast, currently located at address 28400 Canton Road. A barn located near the house indicates that the complex was run much like that of the Mortons.<sup>4</sup> The house and store are now visually separated by mature trees that exist around the store and along a driveway that passes between the store and house.<sup>5</sup> The buildings no longer have any visual linkage and no longer communicate their shared history to the degree seen at the Morton property (Figure 2). The Morton Store is distinguished from the Ray Burluson Store in its brick construction and its incorporation of a front porch. It is likely that the Burluson Store once had a porch, but it has been removed. Porches were commonly found on general stores of all types and are considered a character-defining element of this building type.<sup>6</sup>

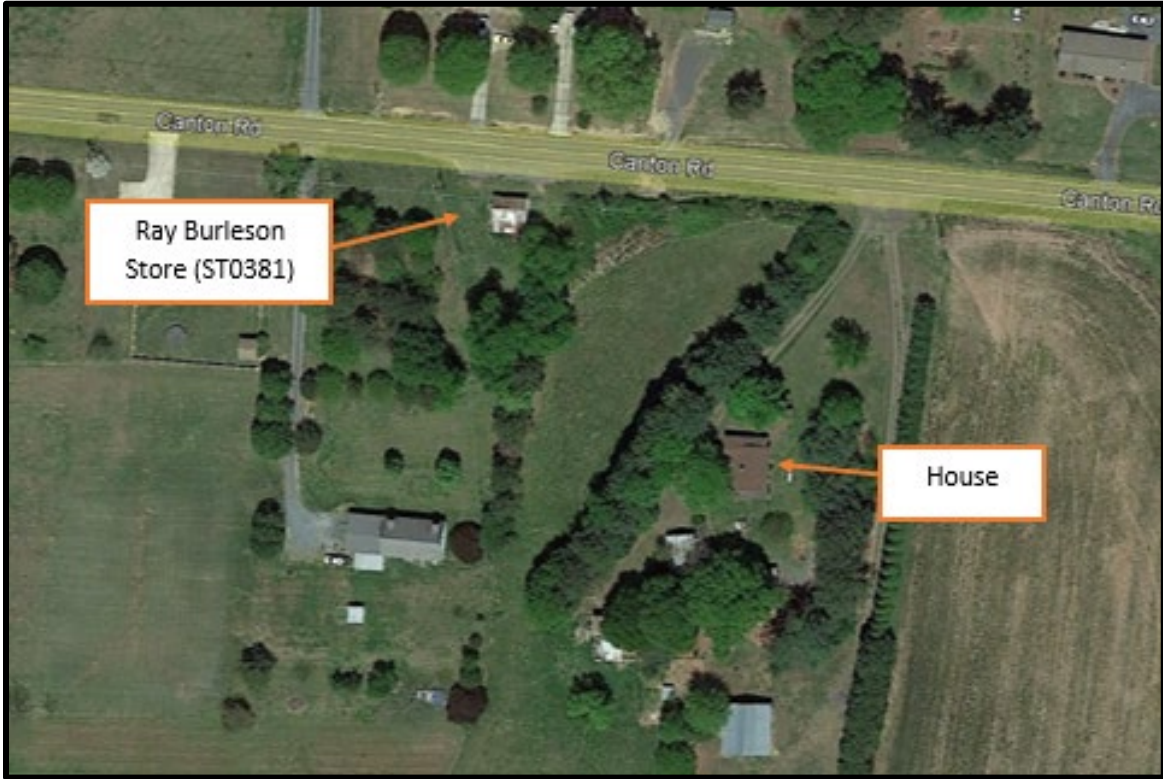
Figure 2. Location of the Ray Burleson Store (ST0381) in relation to its historically associated house (Google Earth). Note the presence of what appears to be a barn to the south of the residence.

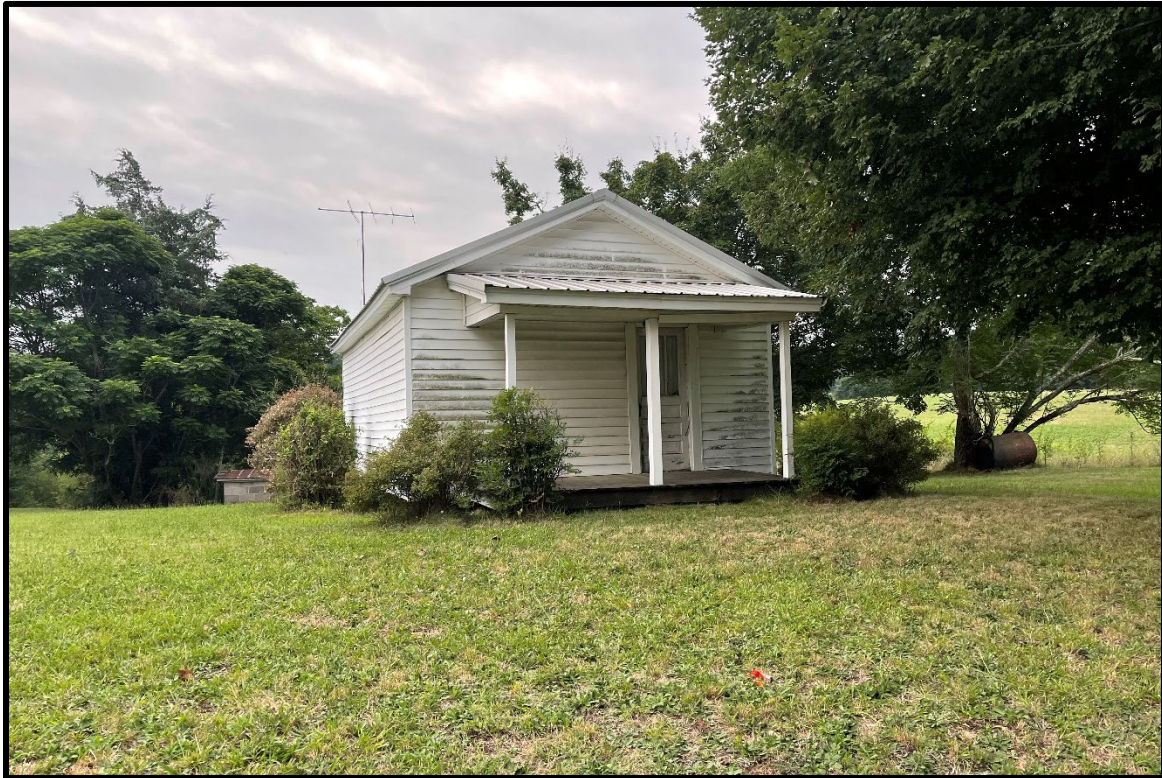
Another early to mid-twentieth century rural general store found in the HPO Web 2.0 database was originally part of a similar grouping of buildings. The Harward General Store (ST0335) is located near Aquadale, Stanly County, approximately 12 miles west of the project area in a rural area. Notably, it was one of a pair of related stores, the other being Harward-Floyd Seedgrader (ST0335), both of which are still standing (Figures 3 and 4). Aerial imagery shows that the stores were located in the midst of cultivated fields and stood very near two additional buildings. Given their spatial relationship it is very likely that one of the buildings (likely the small building directly across the road from the stores) was the residence of the store's owner/operator. The building to the south is large enough to have been a barn (Figure 5). Both of these buildings have been demolished, leaving only the stores standing. These two stores, although excellent examples of rural commercial buildings, form an incomplete picture of the more complex system in which they historically existed. It is notable that both the Ray Burleson Store and the Harward General Store are clad in weatherboard. Brick general stores like the Morton Store appear to have been constructed far less often.

**Figure 3. Harward General Store (ST0335) located near the intersection of Bethlehem Church Road and Chapel Road in Aquadale, Stanly County.**

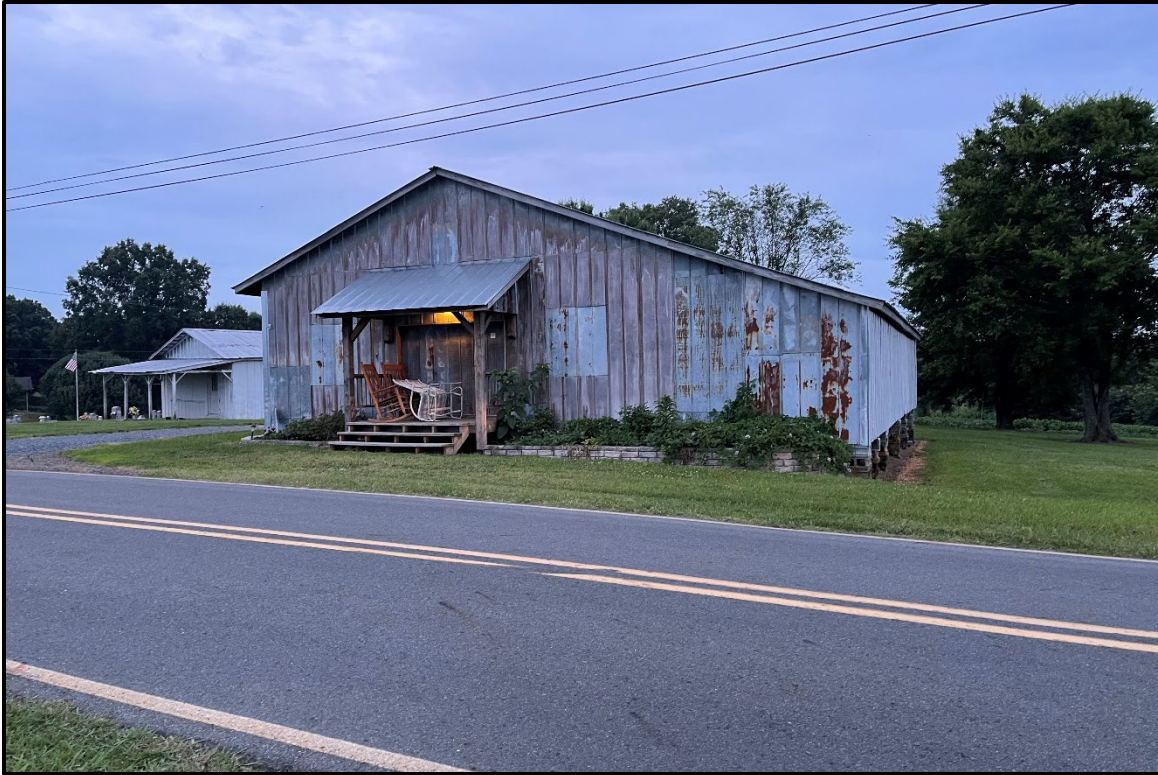
Figure 4. Harward-Floyd Seedgrader (ST0338). The Harward-Floyd General Store (ST0335) is visible in the background.

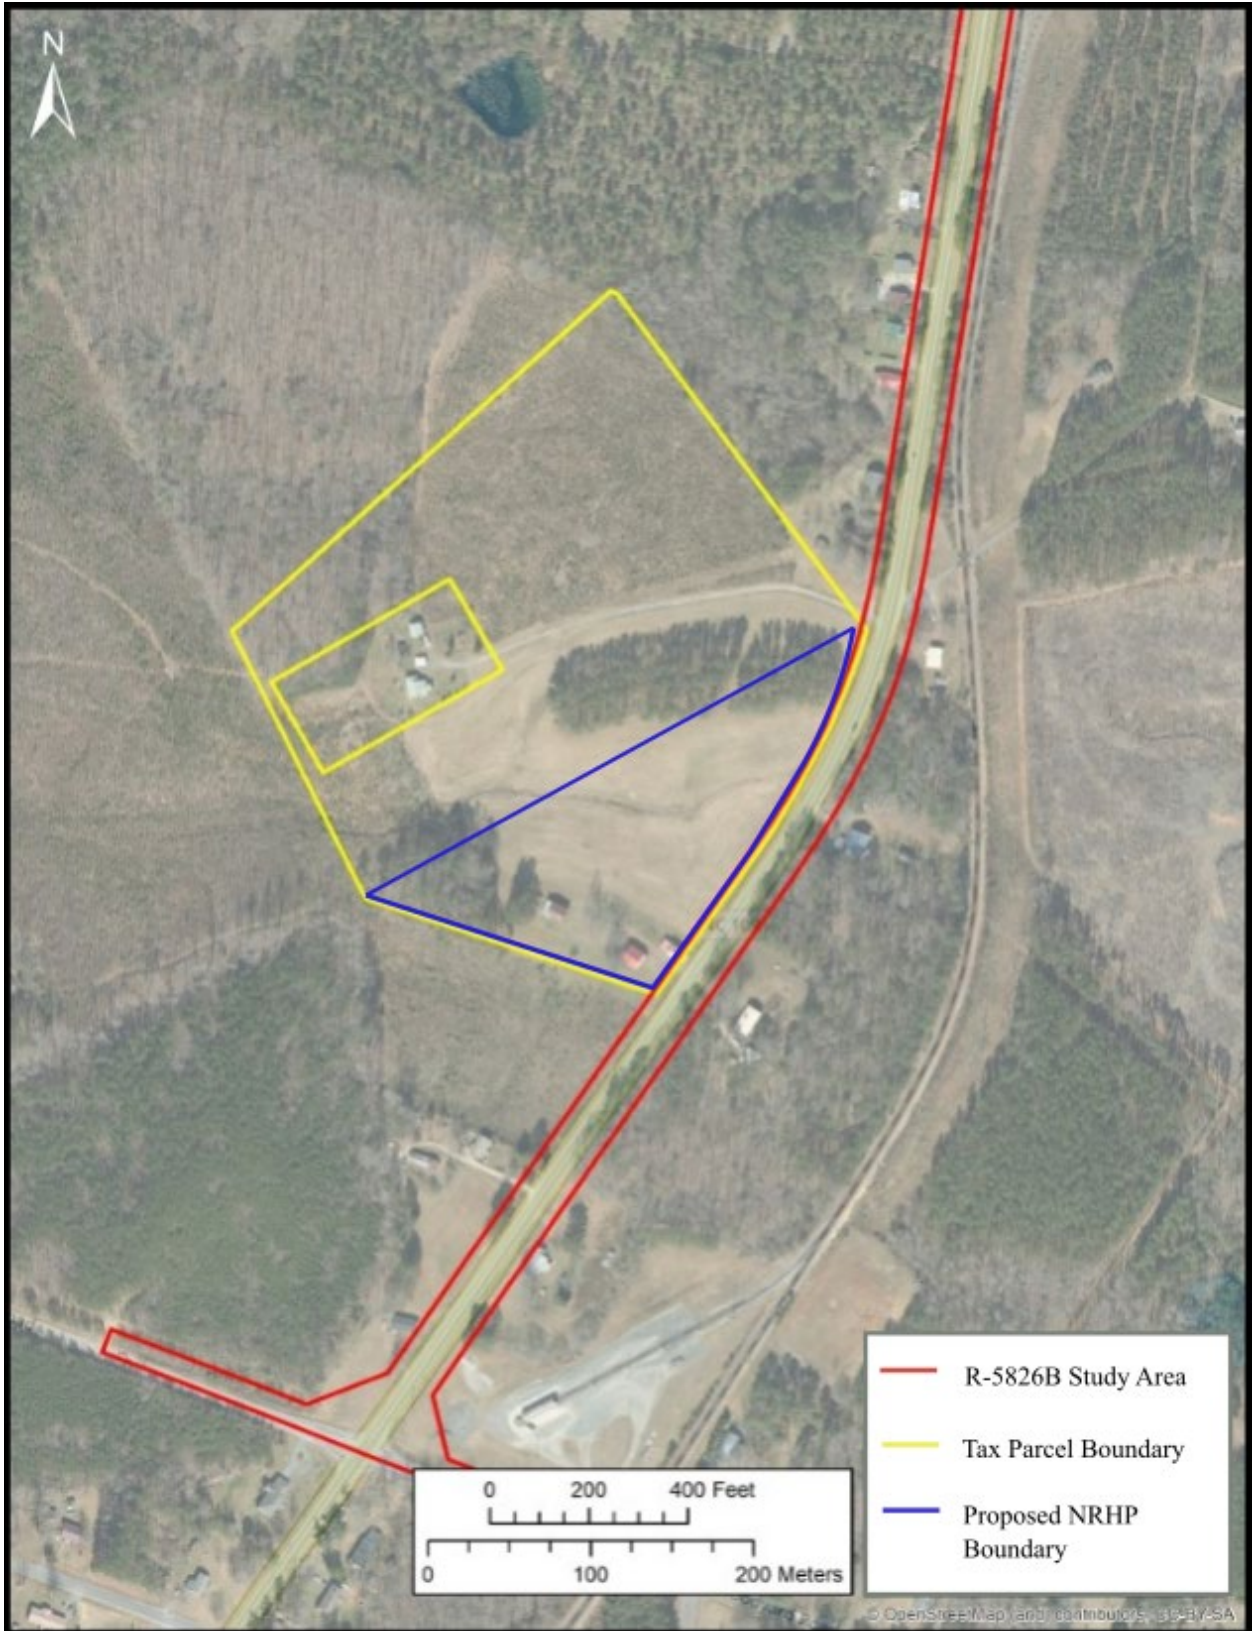
**Figure 6. Proposed NRHP boundary for the Morton House and Store**

The proposed NRHP boundary for the Morton House and Store has been drawn according to the guidelines of "National Register Bulletin 21, Defining Boundaries for National Register Properties." The boundary is comprised of the southern portion of its modern tax parcel (PIN 7504 00 65 3689) and includes the Morton House, Morton Store, and their historically associated barn and agricultural acreage which were a vital part of the system outlined in the context and contribute to their eligibility under Criterion A (Figure 6). The boundary does not include acreage within the modern 22.47-acre parcel acquired after the store had closed and does not include historically associated acreage on the south side of NC 109 which is no longer under cultivation and currently holds a ranch house.
