Re: Historic Architectural Resources Survey Report  
(Phase II, Abridged) for extension and widening of  
SR 1213 from proposed US 321/NC 127  
Interchange to SR 1184, Catawba County, U-  
2530B, 8.1792201, NHF-127(1), ER 95-7167

Historic Architectural Resources Survey Report  
Phase II (Abridged)

Extension and Widening of SR 1213 from the Proposed US  
321/NC 127 Interchange to SR 1184, Catawba County  
TIP No. U-2530B

North Carolina Department of Transportation  
Report Prepared by Clay Griffith

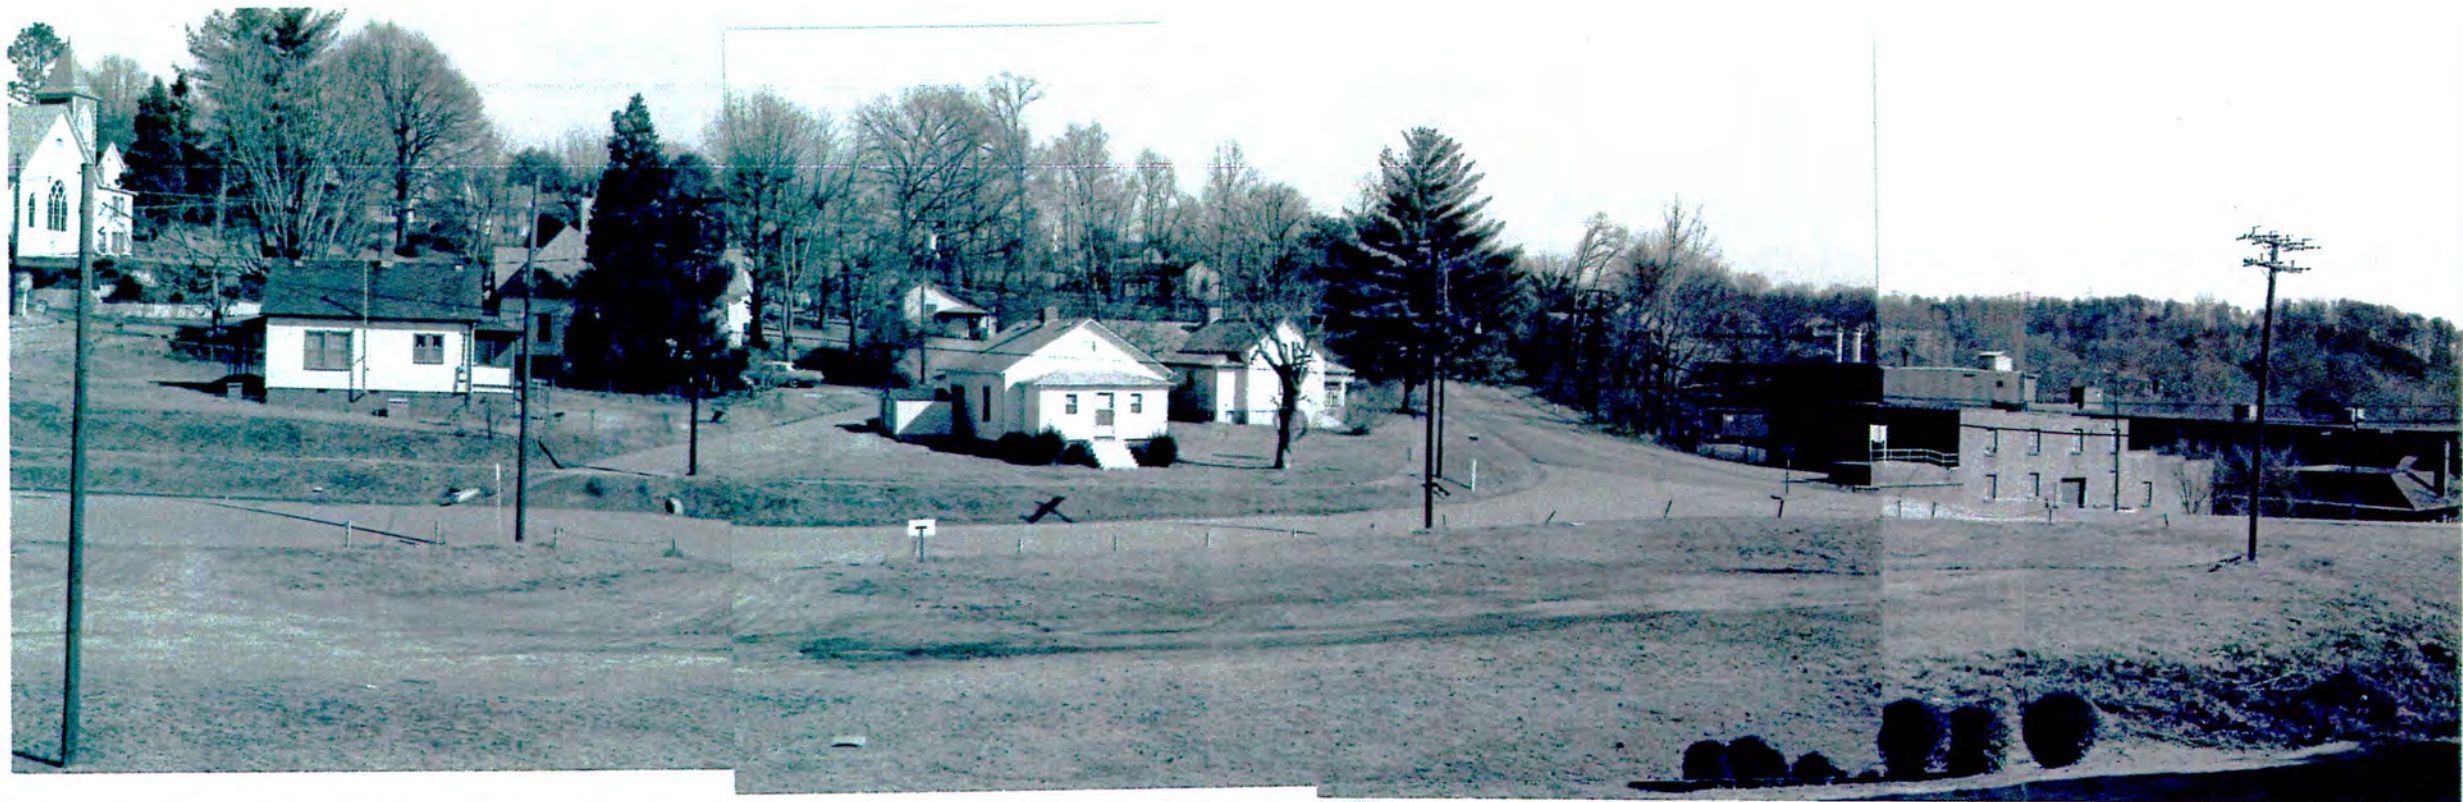
Illustration 6. View to east from Second Street SW. Brookford Baptist Church stands at far left. The entrance to the former Brookford Mills at South Center Street (NC 127) and First Street Drive SW is shown at far right.

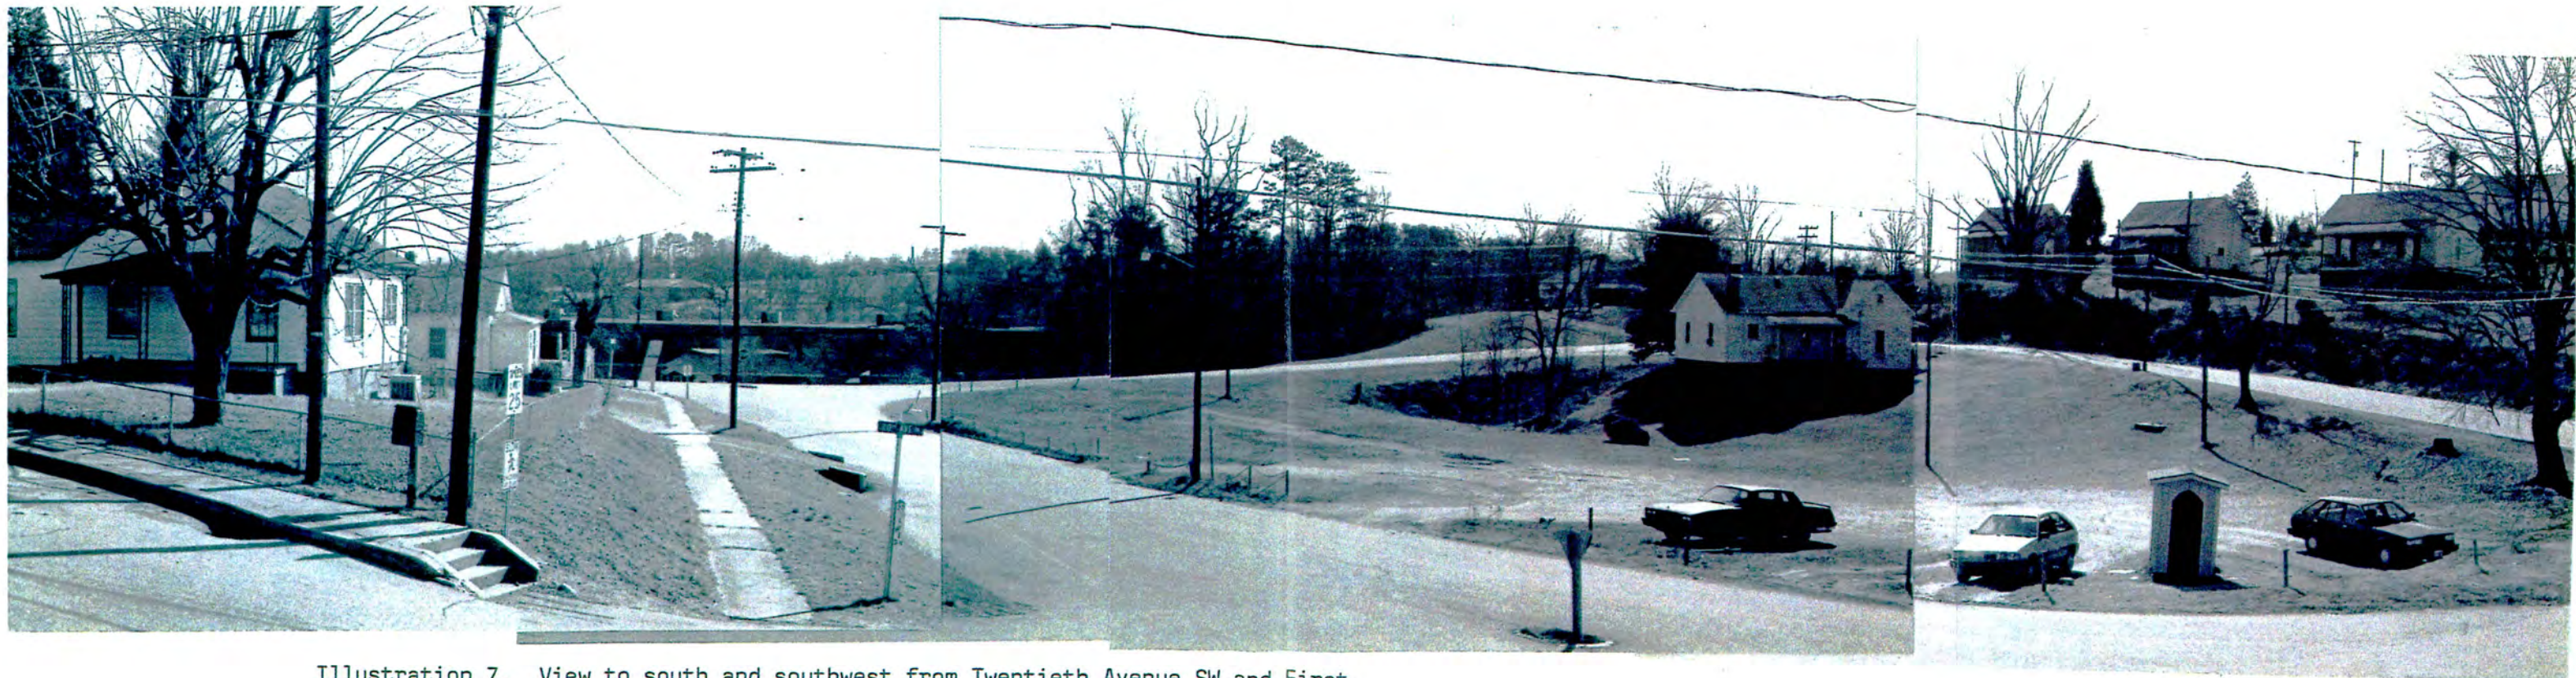
At the corner of First Street and Twentieth Avenue, opposite the store, stood the two-story Hotel Brookford, now demolished. A plain, one-and-one-half story, gable-front, frame house replaced the hotel on the site after 1925 (see Illustration 7).

Illustration 7. View to south and southwest from Twentieth Avenue SW and First Street Drive SW. House at far left stands on site of the Hotel Brookford. Photograph taken from in front of the former company store.

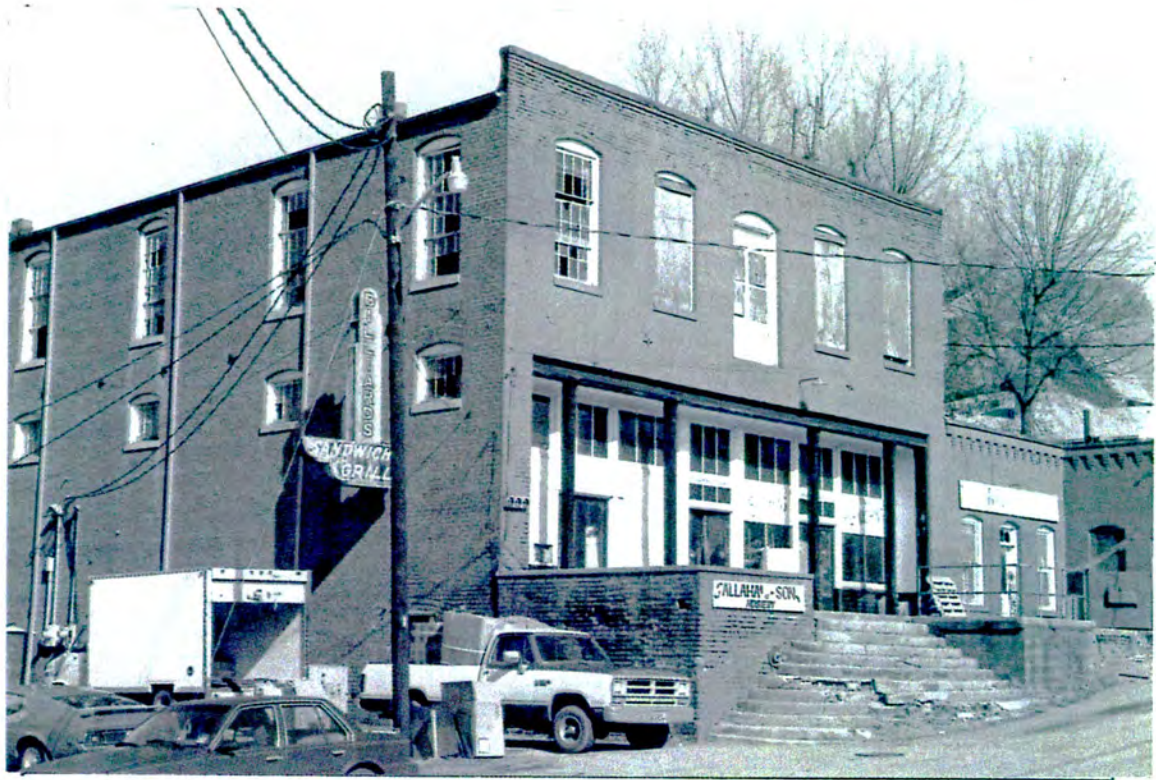
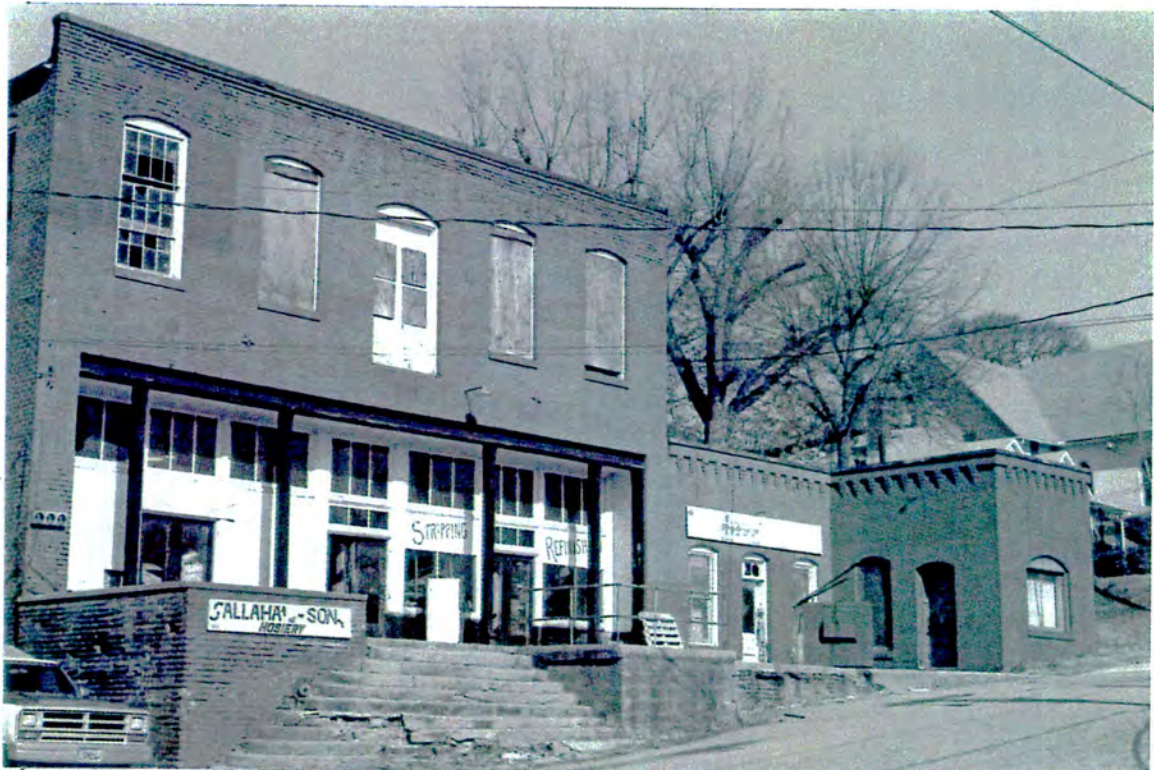
The company store building is a plain, two-story, three-bay, brick commercial building with a one-story, L-shaped addition extending to the east (see Illustrations 8-9). The largely intact store front is slightly recessed behind a screen of four cast-iron posts supporting a steel lintel. The store front features three double-leaf, glazed doors and expansive windows set on a black tile base. Seven sets of large three-light transoms cap the entire store front. Segmental arches frame the eight pane, triple-hung, second story windows and a central doorway on the second level suggests either a balcony or two-story porch long removed. The one-story addition housed two office or commercial spaces and displays a projecting cornice with brick corbels and segmentally arched door and window openings.

Illustration 8. Brookford Mills Company Store (former), Brookford village.

Illustration 9. Brookford Mills Comapny Store (former), Brookford village.

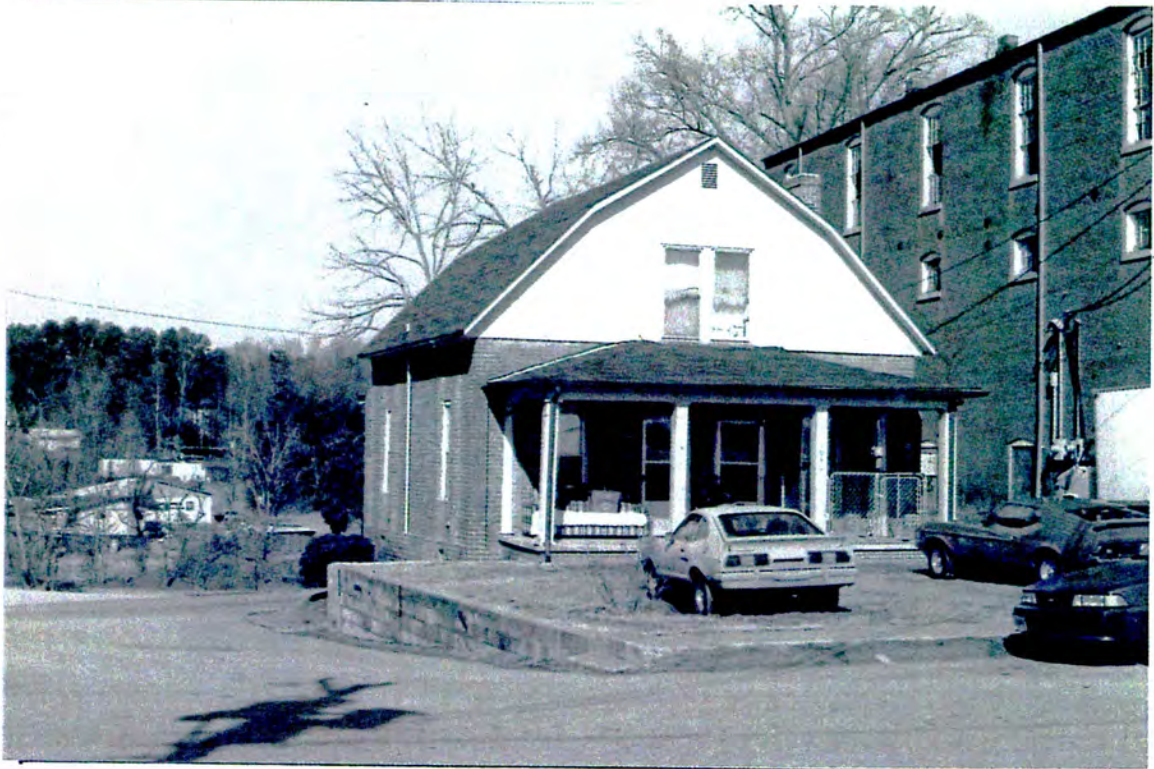
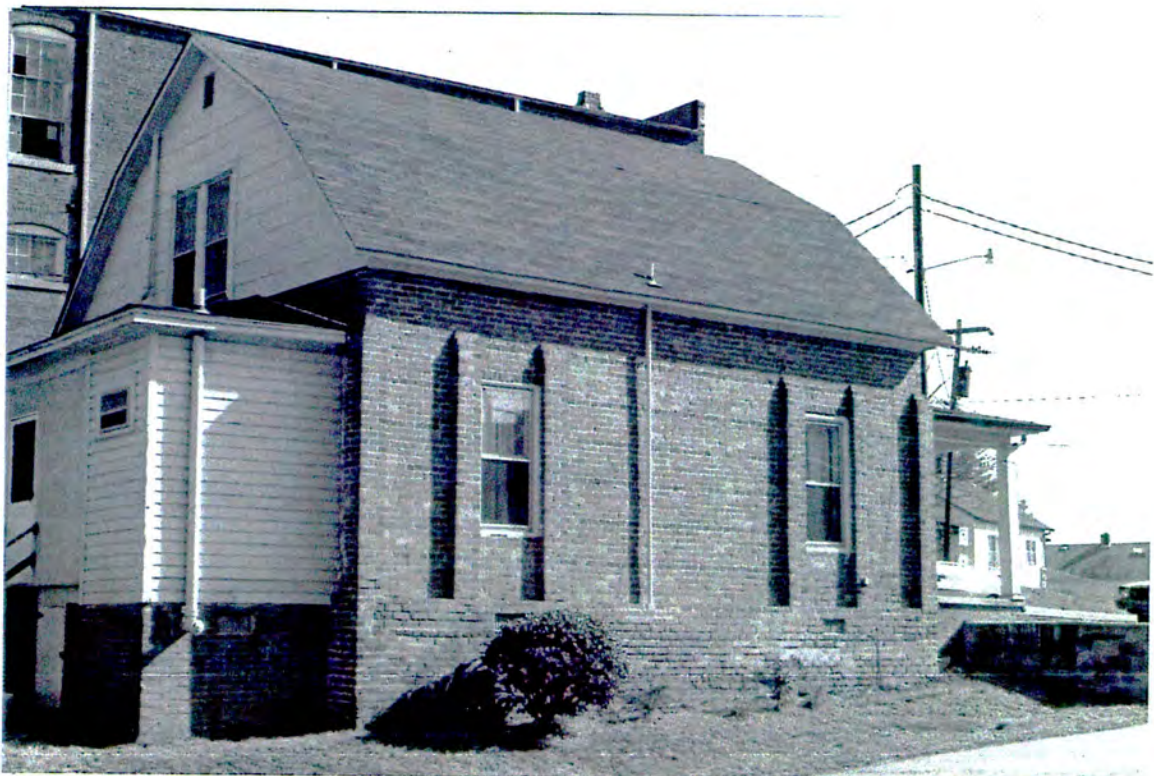
A one-and-one-half story, brick dwelling with a wide gambrel roof sits adjacent to the company store building at the corner of Second Street SW and Twentieth Avenue SW (see Illustrations 10-11). The brick is laid in American bond and features projecting "butresses" at the corners and flanking the window and door openings. The porch appears to retain its original hip roof and square wooden posts with two engaged columns set against the front of the building. The house most likely served as the store owner's residence.

Illustration 10. Store keeper's residence, Brookford village.

Illustration 11. Store keeper's residence, Brookford village.

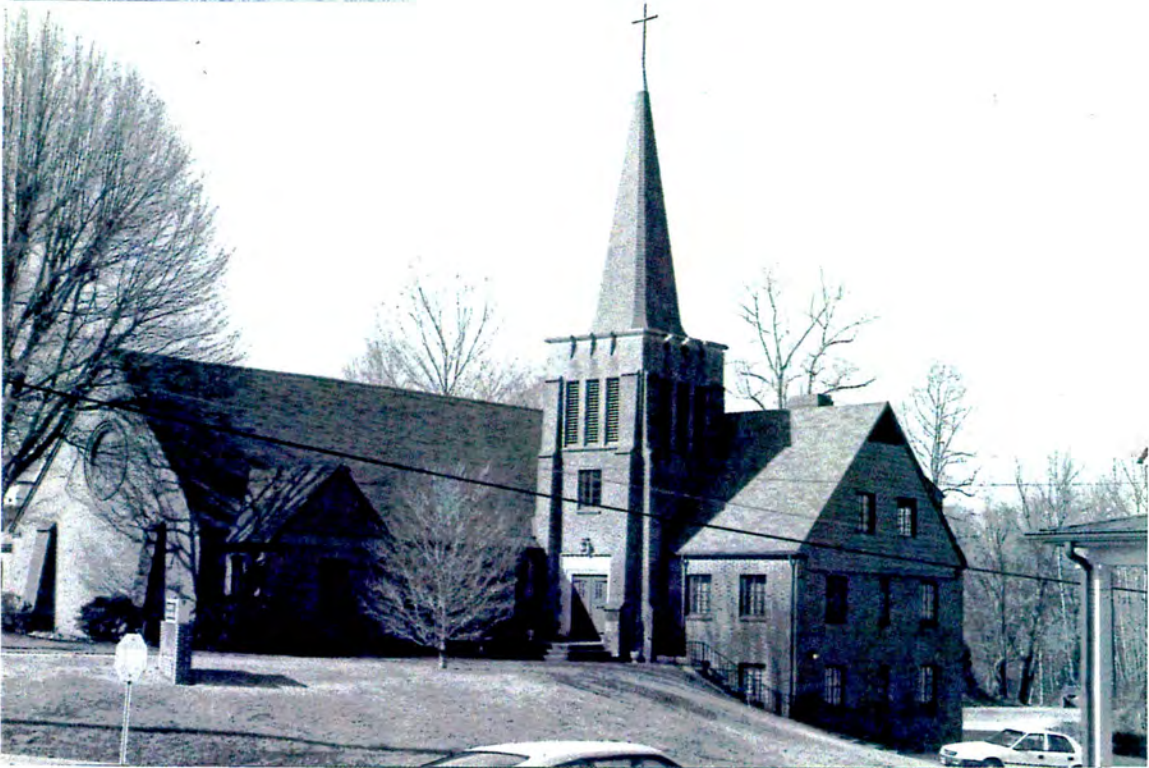
Two churches are located in Brookford village and grew up with the community. The Faith United Church of Christ, organized in 1901, is located on the west side of Second Street SW opposite the store owner's house and presently occupies a massive, L-shaped building dating from 1946, according to the cornerstone (see Illustration 12). The sanctuary is located in the long portion of the L-shaped plan and classrooms are grouped in a two-story block recessed into the sloping site. A squat, crenelated tower located in the interior angle of the plan serves as the principal entry to both areas of the church.

Illustration 12. Faith United Church of Christ, Brookford village.

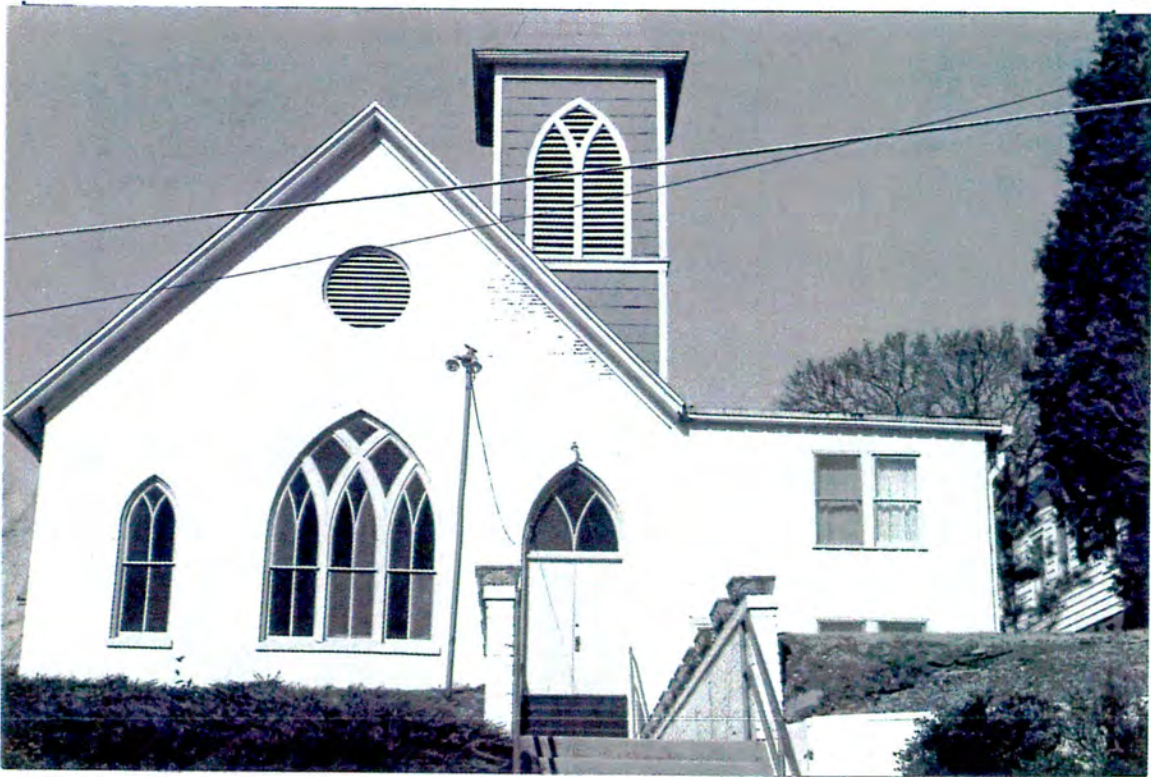
The Brookford Baptist Church fronts Twentieth Avenue SW to the east of the company store and dates from the formation of the congregation, c. 1901 (see Illustration 13). The church is a severely plain gable-front, brick building, rectangular in plan and suggestively Gothic in style. A board-and-batten addition on the east side of the church dates from after 1925. A large pointed-arch window flanked by pointed-arch window and door openings marks the facade. A simple, square tower rises from within the eastern wall of the church.

Illustration 13. Brookford Baptist Church, Brookford village.

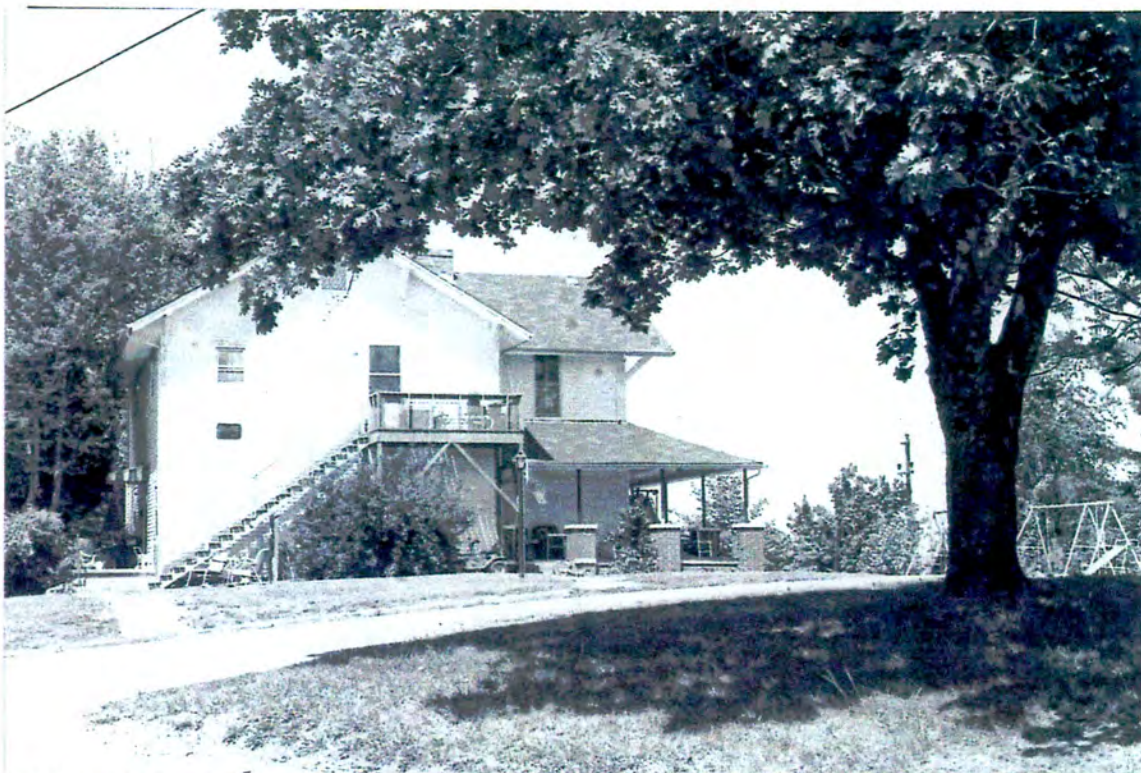
Further up the hill from the Baptist church on Twentieth Avenue but oriented north towards Hickory stands the former mill manager's residence (see Illustration 14). This two-story frame house has

been substantially altered since its completion in the first years of the twentieth century. The original four-square plan with a one-bay projection to the north and a larger, cross-gable projection to the east has been somewhat obscured through subsequent treatments of the exterior. The house is presently clad with vinyl siding and many of the window openings have been covered or altered. The wide wraparound porch still retains its hipped roof and brick piers but the porch supports have been reduced to simple four-by-four inch posts. An exterior wooden stair leads to a moderately-sized deck and second-story entrance. The house appears to have been subdivided into apartments. Henry Holbrook and his family occupied the house in the first decade of the twentieth century, and no evidence suggests that the house existed as part of one of the area farms prior to founding of the Brookford Mills. David L. Howard and his family occupied the house from 1927 to the 1940s while he was general manager of Brookford Mills.

Illustration 14. Mill manager's residence, Brookford village.

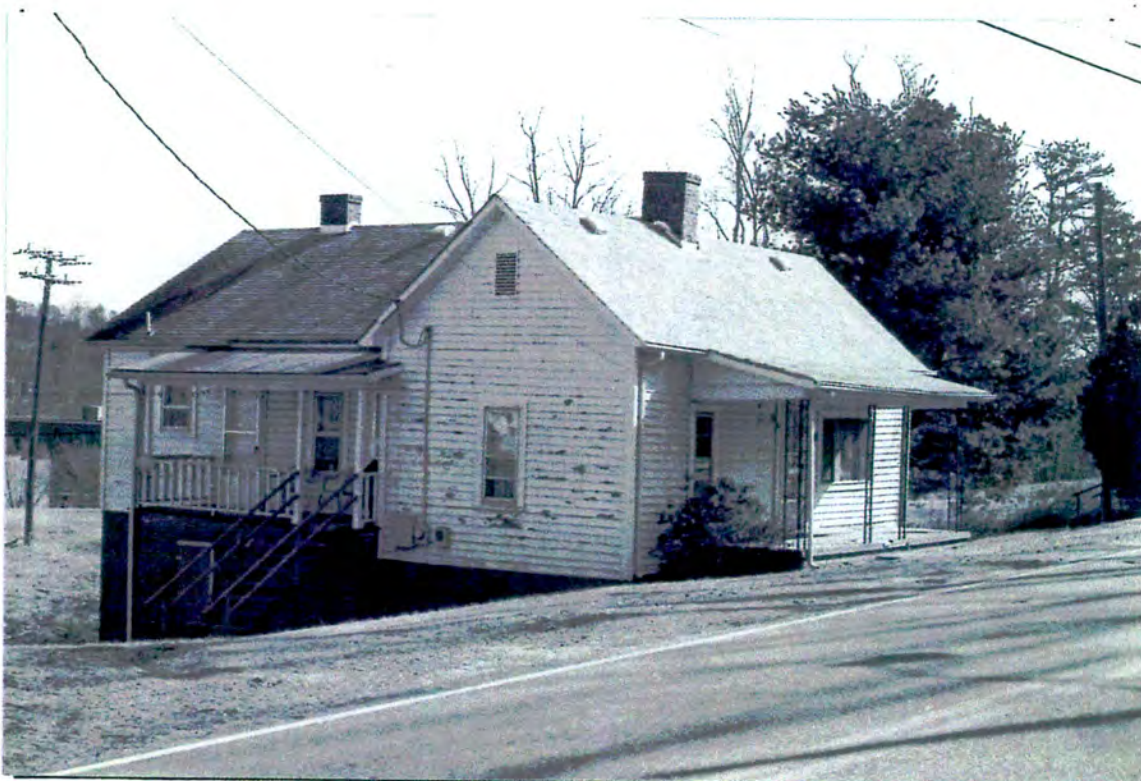
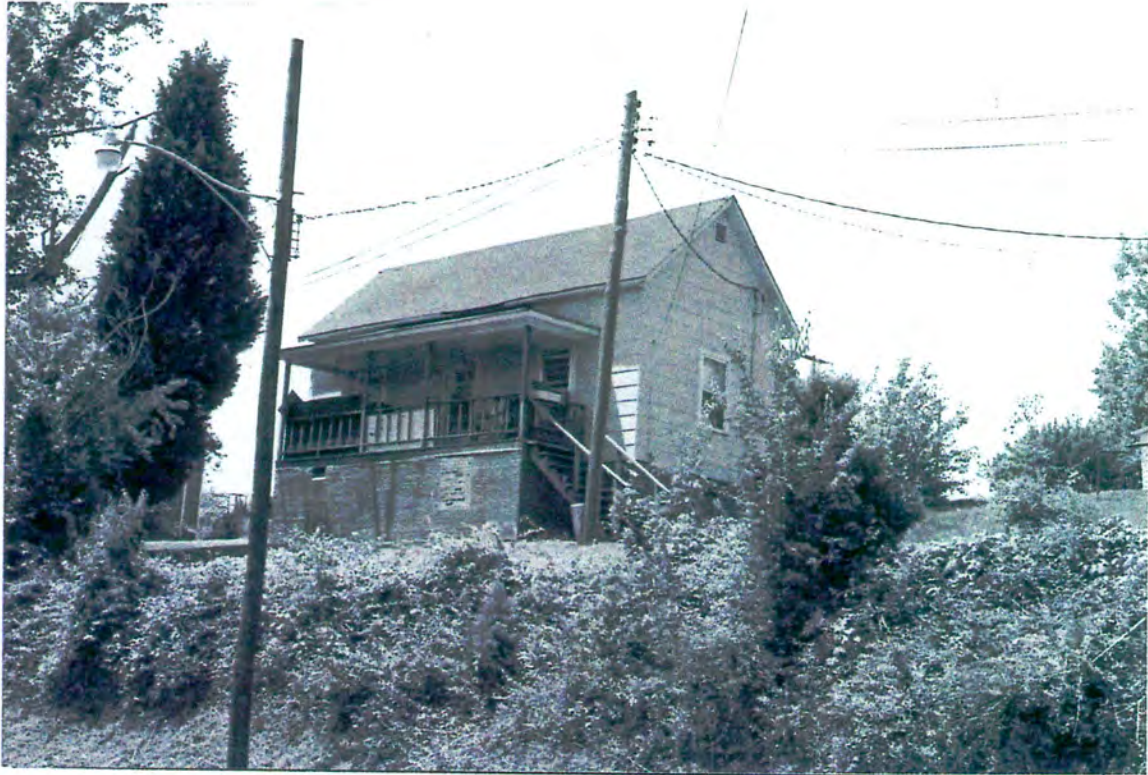
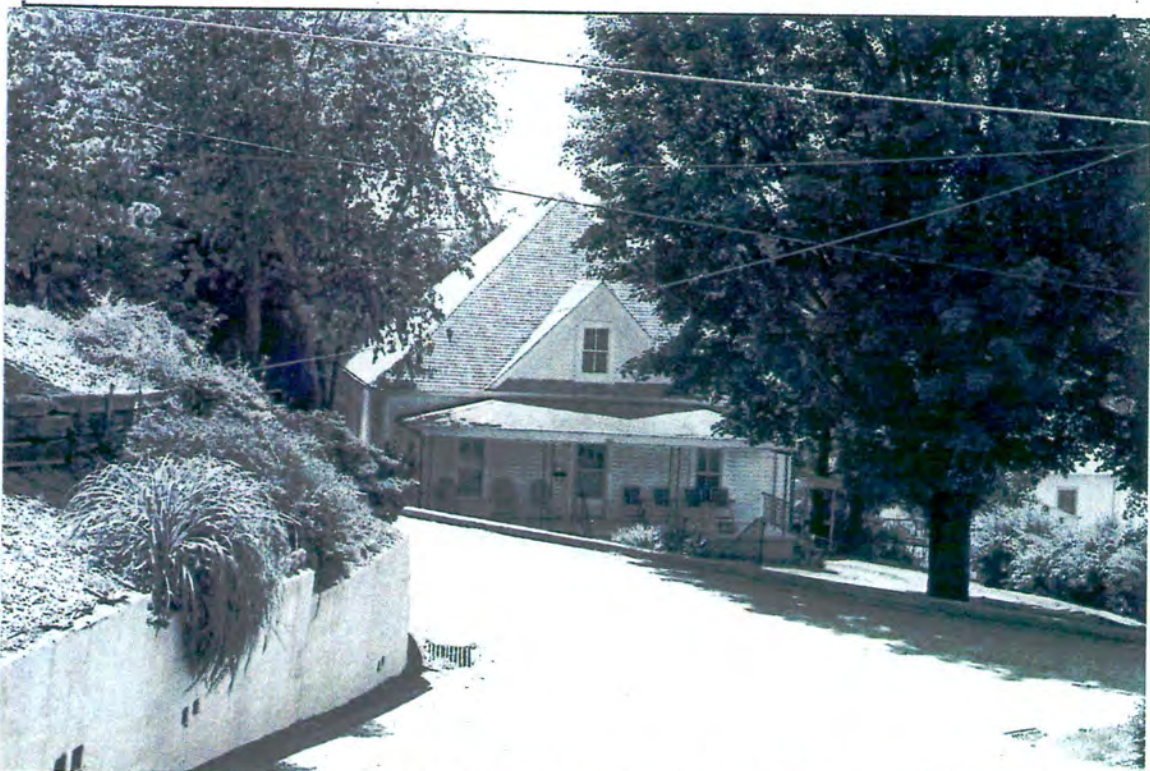
The majority of the mill houses are variations of a frame, one-story, side-gable form with an attached hipped-roof porch extending along the front facade and often a one-story, gable-roof ell (see Illustration 15-16). The houses are plainly detailed and fairly uniform in scale, arrangement, and setbacks. Aside from the typical house type, hipped-roof, double-pile, single-family houses and one-story, side-gable duplexes were also built in the village and a few examples remain (see Illustration 17). The repetitive character of the mill housing in Brookford is most apparent along present Third and Fourth Streets (see Illustration 18-19). The topography of the area creates variations in the layout and siting of the houses that relieves the monotonous progression buildings and provides more picturesque streetscapes (see Illustration 20-22).

Illustration 15. Brookford Mills employee housing (typical), Brookford village.

Illustration 16. Brookford Mills employee housing (typical), Brookford village.

Illustration 17. Brookford Mills employee housing, Brookford village.

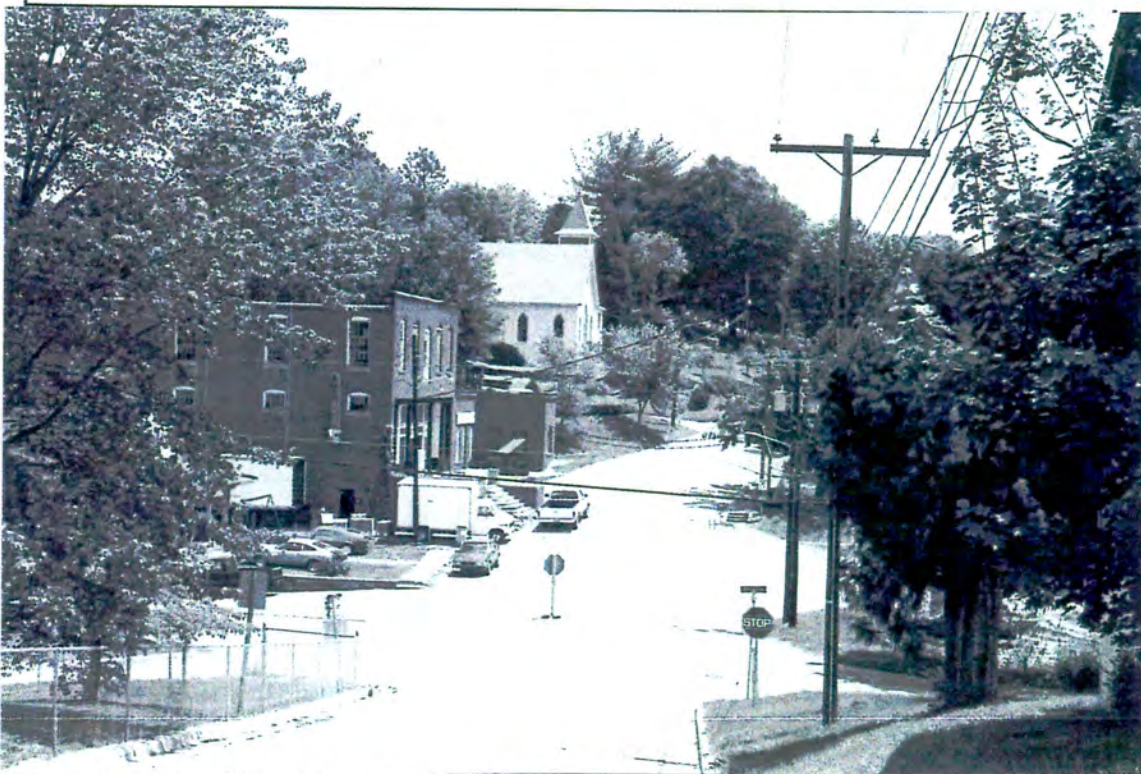
Very few, if any, of the employee houses in Brookford remain unaltered. Gaither Hefner, the present mayor of Brookford and formerly with Brookford Mills, stated that most of the houses were remodeled before they were sold by the mill in the 1950s. A 1985 community development block grant provided assistance for repairs to approximately half of the houses in the village. The extent of alterations varies from structure to structure. Most houses have replacement porch elements (most commonly supports, railings and steps) and vinyl or aluminum siding. Only a small number retain their weatherboard siding and a smaller number retain their original porch. Other common alterations include replacement windows and doors, enclosed porches, and various additions to the main block of the house. The houses east of the mill on Twenty-second Avenue SE and Twenty-second Avenue Court (formerly Valley and Hillside Streets) remain the least altered cluster of mill housing at Brookford. While the individual structures have been altered substantially, the basic forms and similarities of the houses and their disposition throughout the village remains readily apparent. The area as a whole retains much of the character of an early twentieth century textile mill village (see Illustration 23).

Illustration 23. View to east along Twentieth Avenue SW from Third Street SW.

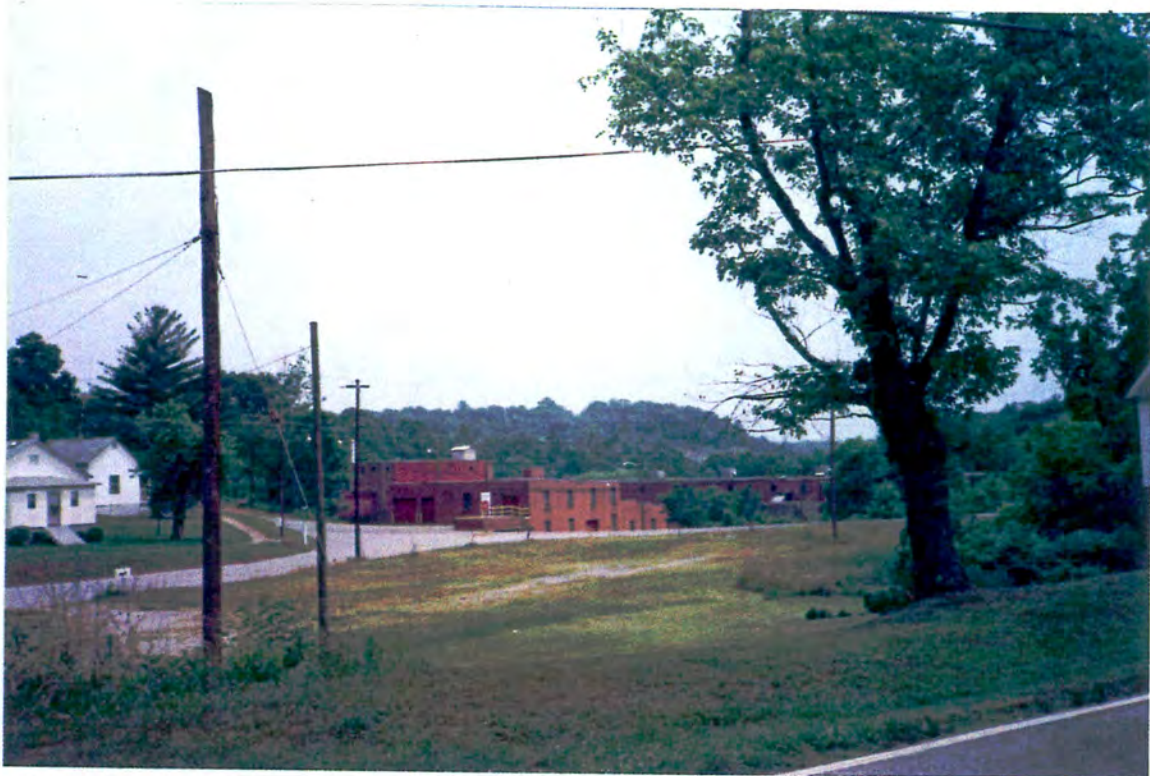
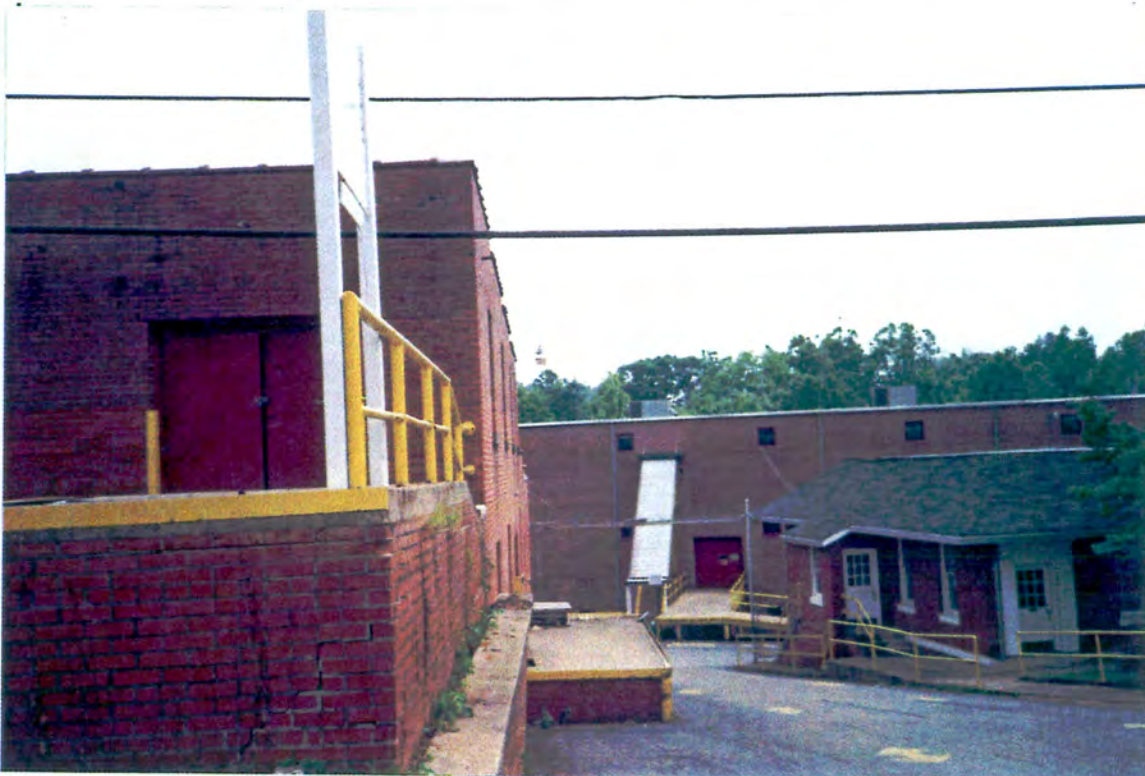
The former Brookford Mills manufacturing plant still stands along the north bank of the Henry Fork River in a much altered condition and is separated from the village by South Center Street (NC 127) (see Illustration 24-27). The mill plant has undergone numerous additions and alterations since completion of the first section, c. 1900. The mill buildings are presently owned by Shuford Mills and operated in conjunction with Century Furniture Company.

Due to a lack of integrity, the mill plant is located outside the proposed boundaries for the Brookford Mill Village. The historic character of the mill building has been significantly compromised by the replacement or blocking of all the original windows, a defining feature of late-nineteenth and early-twentieth century mill architecture. The construction of NC 127 (South Center Street) between the mill plant and village further compromises their relationship.

Illustration 24. Former Brookford Mills. View to southeast from Second Street SW at Twentieth Avenue SW.

Illustration 25. Entrance to Brookford Mills. Office is situated in the middle ground at right, and the warehouse occupies the left foreground.

Illustration 26. Former Brookford Mills, original mill building and entrance tower with later additions extending to the west.

Illustration 27. Former Brookford Mills. View  
from south of original mill building.

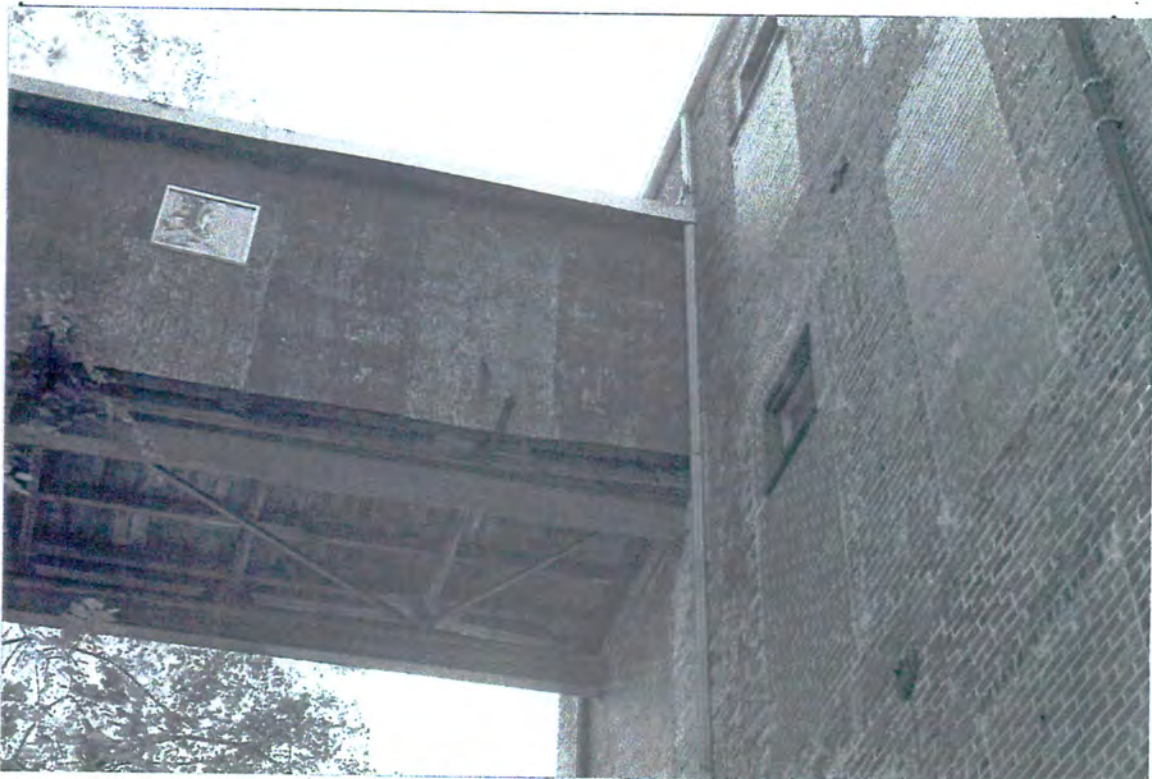
By 1913 a four-story addition to the mill building on its east end had increased the footprint of the structure by half its original size and provided another power plant. Another addition, completed some time before 1919, expanded the mill plant on its west end. A third level was added to the western portions of the building in the 1960s by Shuford Mills for manufacturing woolen products. The portions of the interior which were examined revealed that the original structural elements and wooden floors remained intact but other distinguishing features were absent.

Illustration 29. Former Brookford Mills, fifth level loading ramp.

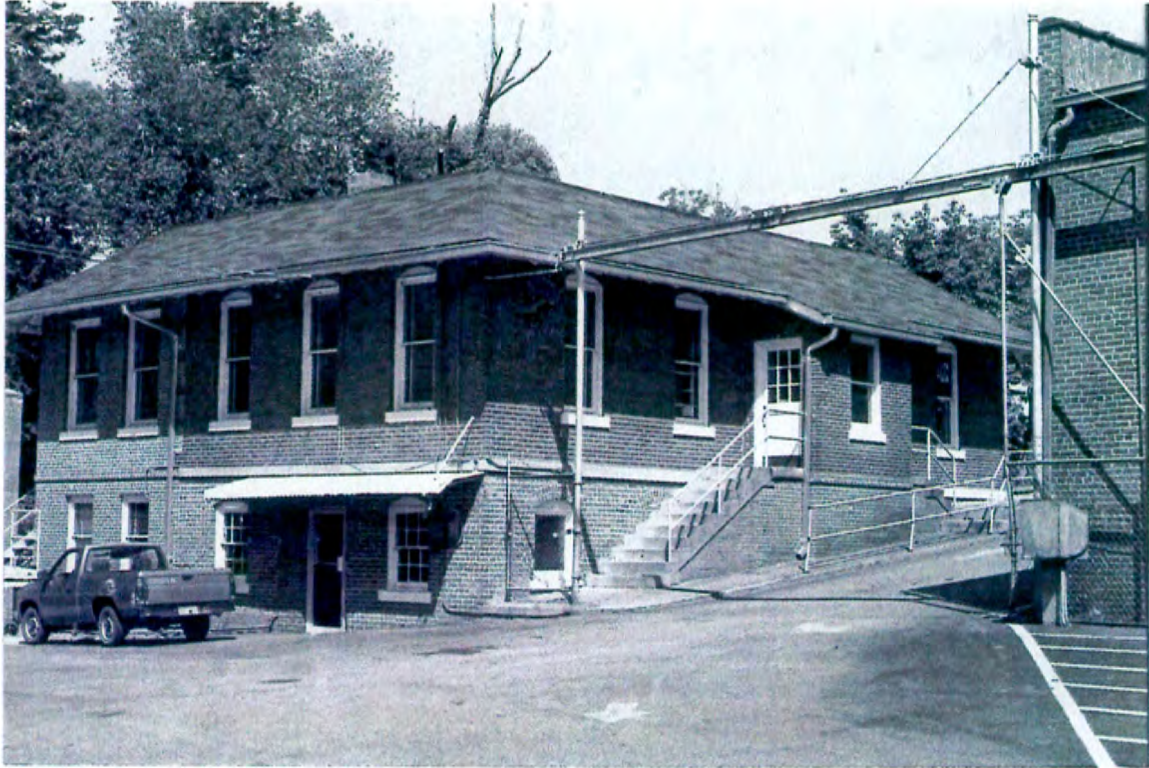
The dam for the mill, constructed in 1898, remains in place and continued to provide power for the mill until the late 1960s (see Illustration 28). The main mill building was a two-story block (three on the river side) which could be loosely described as industrial Italianate in style and symmetrically arranged around a square entrance tower. The building was constructed with slow-burn materials and the brick masonry walls were pierced by large windows. Trucks can be loaded from all five levels of the mill building by virtue of the steeply sloping site and elevated loading ramps (see Illustration 29). The detached warehouse which now fronts NC 127 was built during the first phase of construction and the adjacent office dates from the period between 1913 and 1919 (see Illustration 30).

Illustration 30. Office, former Brookford Mills.
