RE: Architectural Investigations at MCAS Cherry
Point, Craven County, ER 98-8724

VI.	SUMMARY AND RECOMMENDATIONS	112
	REFERENCES	113
	ACKNOWLEDGEMENTS	118
	APPENDIX I - REAL PROPERTY INVENTORY	
	APPENDIX II – NORTH CAROLINA SURVEY FORMS	
	APPENDIX III – INDEX TO MAPS	
	APPENDIX IV - RESUMES OF KEY PROJECT PERSONNEL	
	ATTACHMENT 1 – INSTALLATION MAPS

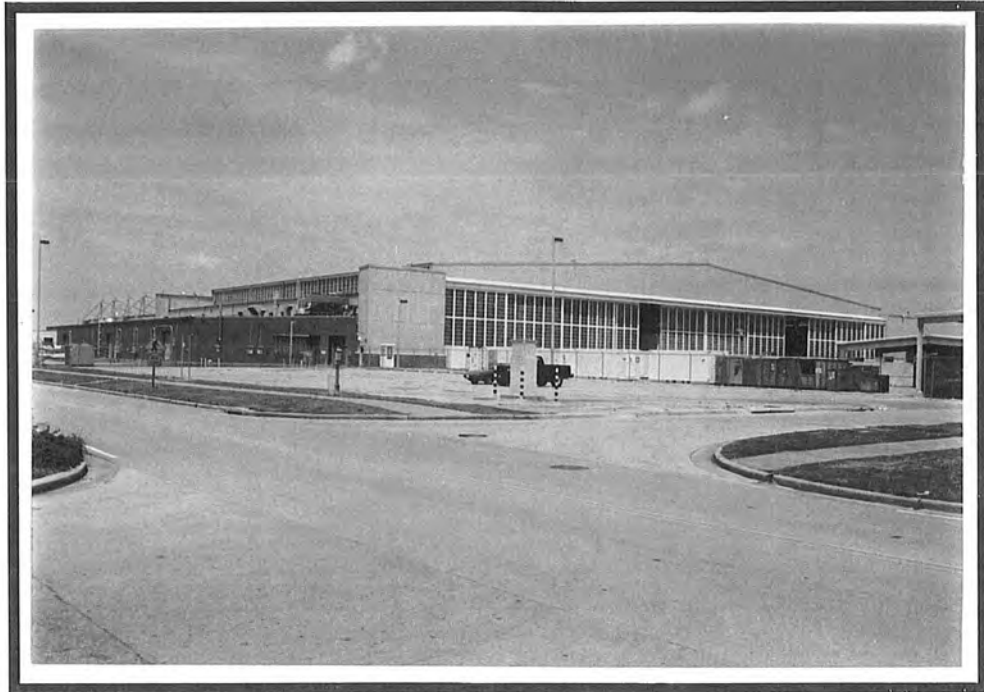
low-pitched gable roof. The hangars measure approximately 500 feet long, 275 feet wide, and 60 feet tall. Both gable ends are dominated by tall, multi-leaf, sliding metal hangar doors. The doors are punctuated by two rows of multi-light, metal-sash windows. A lower, two-story flat parapet roof wing occupies the sides of the buildings. These side wings contain additional space for offices and shops. The upper walls of these shop bays, and the main block of the hangar, are defined by bands of industrial metal-sash windows. A rectangular corner tower projects from Building 130 and distinguishes it from the other seaplane hangar (Figure 8). The tower contains an observation balcony and a rooftop observation deck. The interior plan of both hangars consists of an open maintenance area. Two-level shop and office bays occupy the side walls, and balconies overlook the central maintenance area. A two-story, freestanding, concrete shop bay is situated in the center of the maintenance area. Buildings 130 and 131 have been expanded and altered over the years in order to accommodate changing requirements. In 1945, interior partitions were installed in the shop

Figure 8. Above: Photograph of Hangar 130. Below: Photograph of Building 137, the former Assembly and Repair (A&R) Building

bays of Building 131. In 1957, a vehicle shed and a lean-to addition were appended along one side of Building 130. In 1962, an aircraft maintenance shop extension was added to both buildings. The freestanding, concrete shop bay was constructed in 1969 (McVarish 1994:14-16).

Building 137 was constructed in 1943 to serve as an assembly and repair (A&R) building (Figure 8). The shop at MCAS Cherry Point was the fourth of a series of A&R buildings designed by the Bureau of Yards and Docks during World War II that employed a similar design (Yards and Docks Drawing No. 301,331). Similar A&R structures were constructed at naval stations in Jacksonville, Florida; Quonset Point, Rhode Island; and Corpus Christi, Texas. The shops were designed to provide facilities for the assembly and major repair of aircraft (except major engine repairs) (Jacobs [n.d.]:74). The two-story, irregular plan, brick and steel-frame structure contains two separate hangar sections and numerous shop spaces. The buildings' original footprint covered an area 305,683 square feet; subsequent additions have resulted in significantly expanding the structure (Jacobs [n.d.]:77). Building 137, which stands as the largest structure at MCAS Cherry Point, currently houses the administrative offices and industrial shops for the Naval Aviation Depot (NADEP).

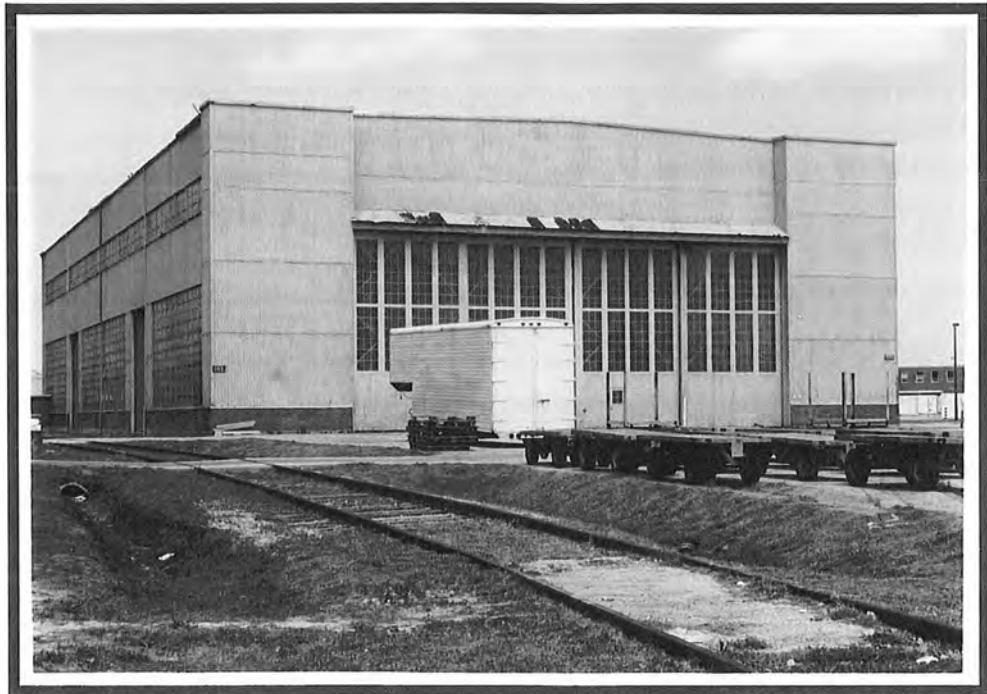
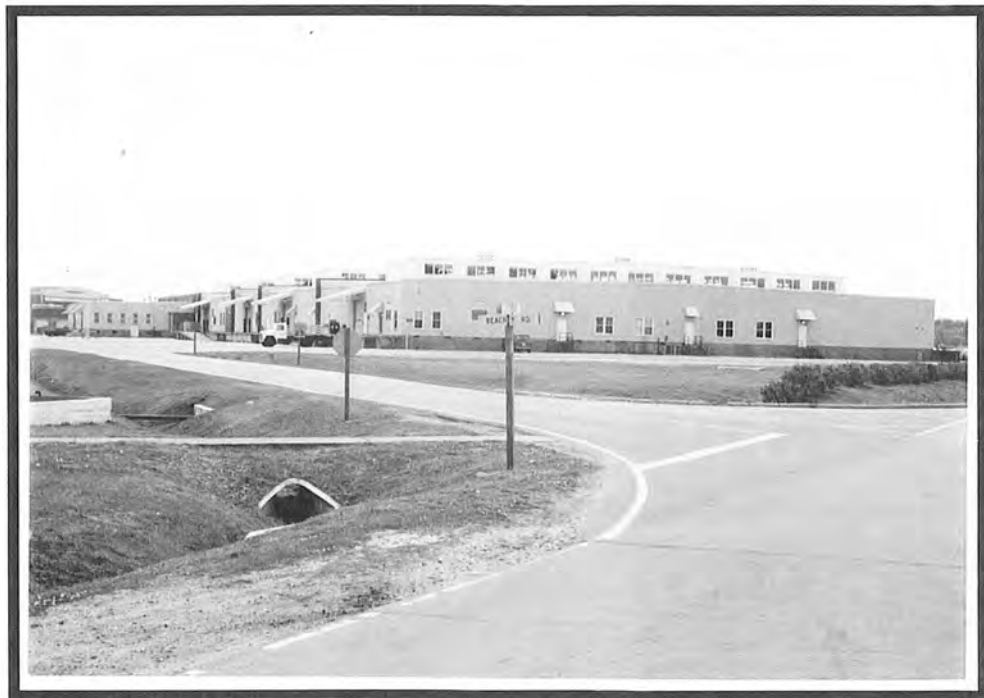
Buildings 144 and 145 were built in 1942 as Aircraft Storehouse No.1 and No.2 (Figure 9). Both buildings consist of a one-story, rectangular, steel-frame structure terminating in a side-gabled roof. The exterior walls and roof are sheathed in corrugated metal siding. The front and rear elevations contain rows of metal overhead track doors and a raised concrete loading dock. Building

Figure 9. Above: Photograph of aircraft storehouse (Building 145). Below: Photograph of general storage warehouse (Building 150).

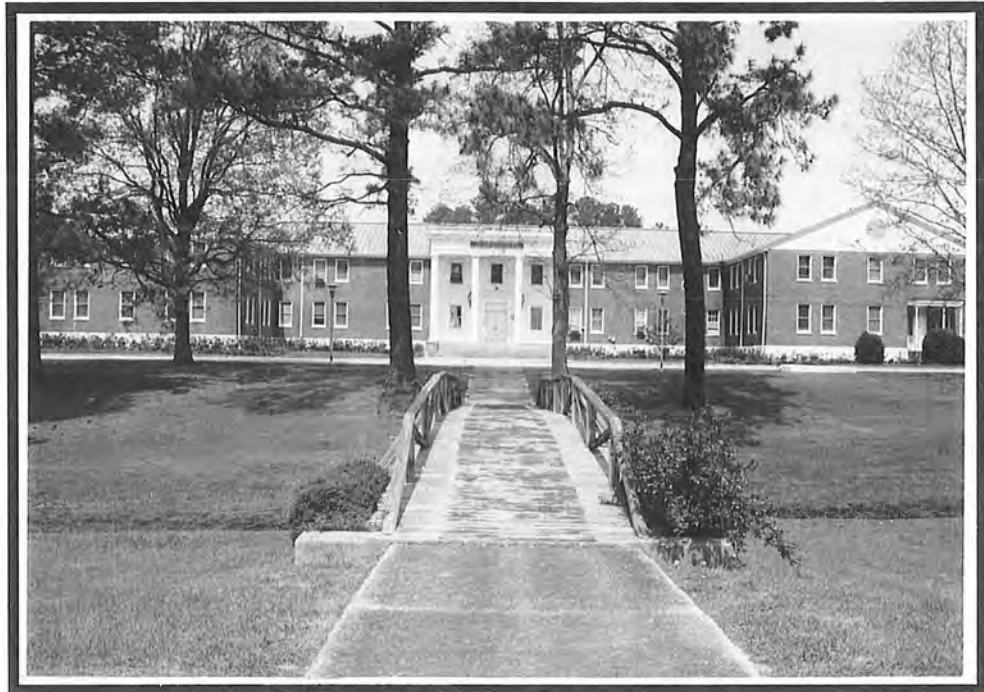
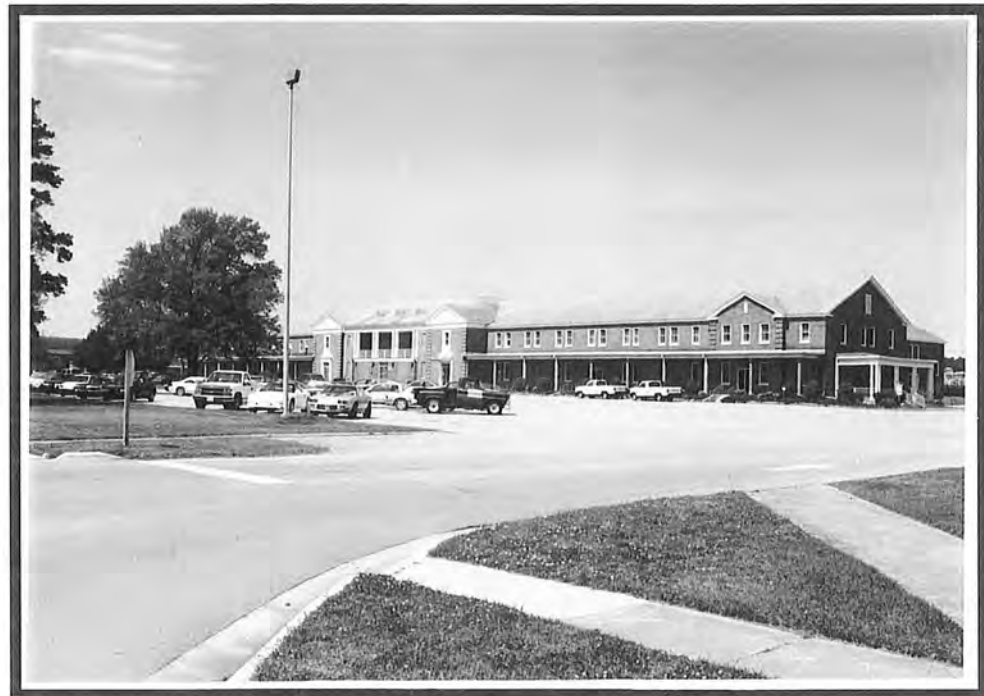
Building 298 was built in 1942 as the enlisted mens' recreational building (Figure 10). The building currently is used as the post exchange. The two-story, E-shaped brick building is formed by a main side-gabled block and three rear gable roof wings. The roof is sheathed in asphalt

Figure 10. Above: Photograph of Building 198, the MCAS and MAW Headquarters building. Below: Photograph of Building 298, Enlisted Mens' Recreational Building, originally the Post Exchange

We also concur with the report's determination that Building 298 is not eligible for the National Register due a lack of architectural integrity.

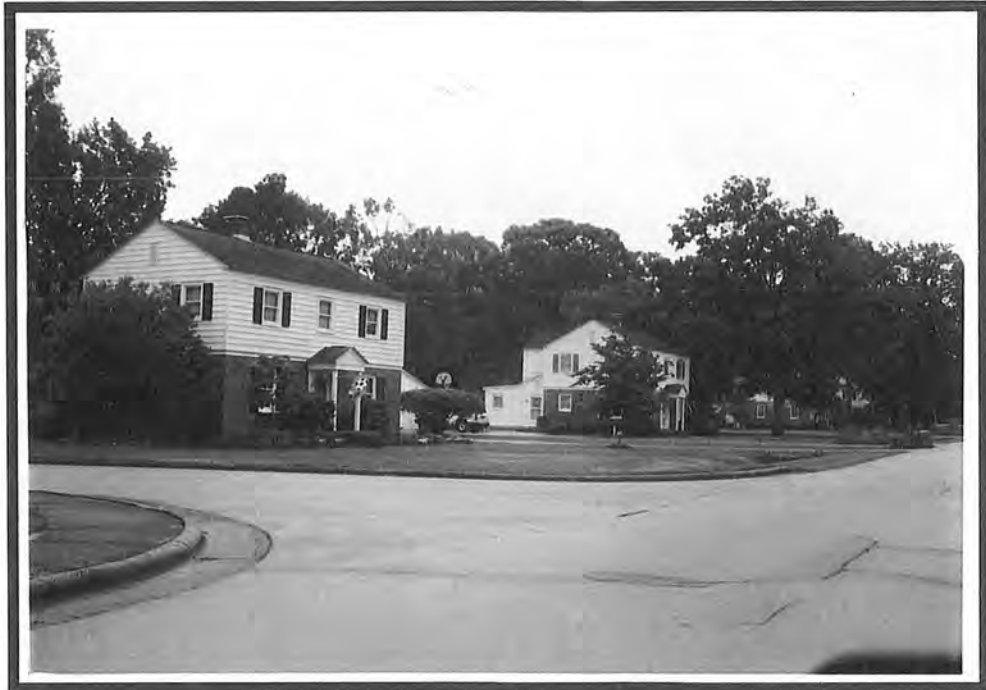
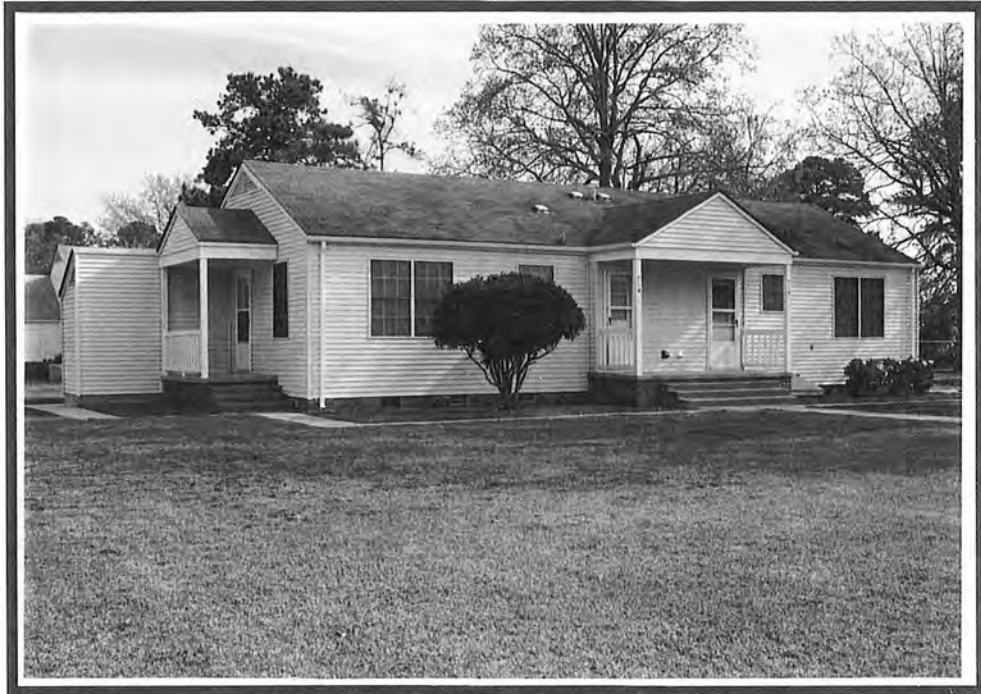
The single-family officers' housing was constructed in 1942 and consists of 49 units (Buildings 300-349) located on Jefferson Boulevard and Wilson Drive (Figure 11). The two-story, T-shaped plan, wood-frame structures terminate in intersecting side-gabled roofs. A central brick chimney punctuates the roofline. The first floor level is clad in brick veneer, while the second story level is clad in horizontal vinyl siding. A one-story kitchen wing extends from the rear side of the building. Detached wood-frame garages are located behind each of the residences. Doors and windows have been replaced throughout the residential units.

The married enlisted mens' quarters (MEQ) were constructed west of Roosevelt Boulevard adjacent to the main station in 1942 (Figure 11). Known as Lanham Housing, the area retains 74 of the original duplex units; several units have been demolished. The area is organized in a grid pattern. Two similar house types were constructed in the complex. Both types are one-story, rectangular wood frame buildings clad in vinyl siding that terminate in gable roofs, small one story gable roof porches extend from the gable ends of the building. A central, two-bay gable porch provides access to the units. The variation between the two house types is found in a pair of slightly projecting front gable wings that extend from the rear elevation of one of the types.

Figure 11. Above: Photograph of Building 312, Officers Single Family Residence. Below: Photograph of a typical Lanham Housing duplex unit (Building 597).

The married enlisted men's (Lanham Housing) is not eligible due to the recent reorientation of the front entries and resulting changes in the floor plans.

We do not concur with the report's finding that the Officers' Housing (Buildings 300-349) does not meet the National Register criteria for listing. Rather, we believe the Officers' Apartments (Building 486) and the Bachelor Officers' Quarters (Buildings 492, 493, 494, 495, 496 and 497), should have been evaluated with the Officers; Housing as part of a large residential district. Our site visit revealed that the exteriors of these buildings have not been substantially altered, and that the entire area retains distinctive layout and landscape features, such as curvilinear streets, sidewalks, and ornamental plantings, that give it a unity of place that is nearly unchanged since the period of construction. We believe the Officers' Housing, the Officers' Apartment Building and the Bachelor Officers' Quarters

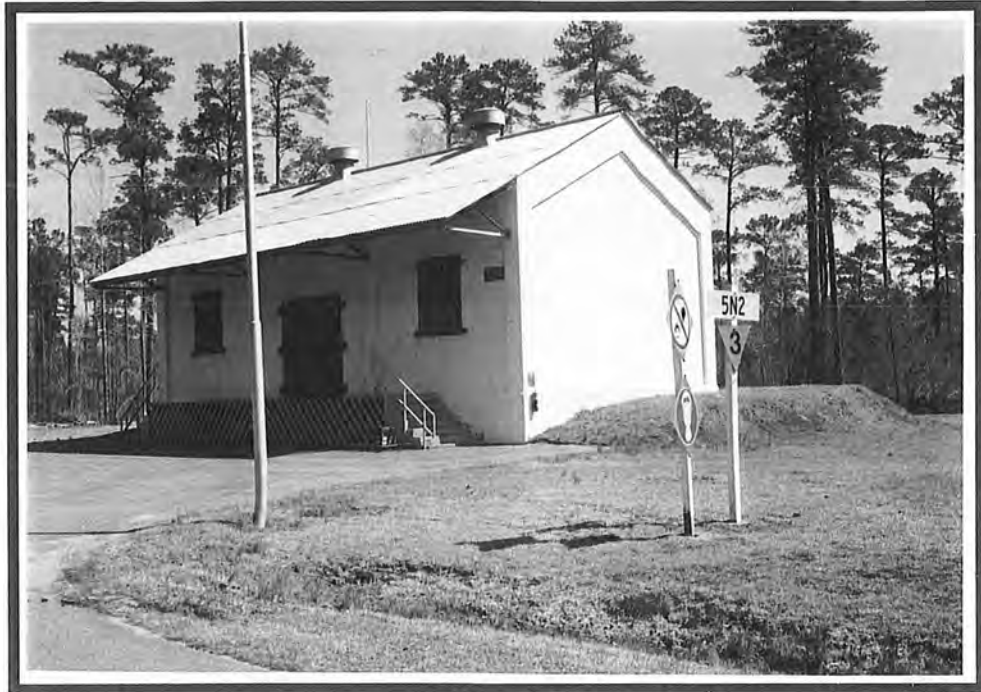
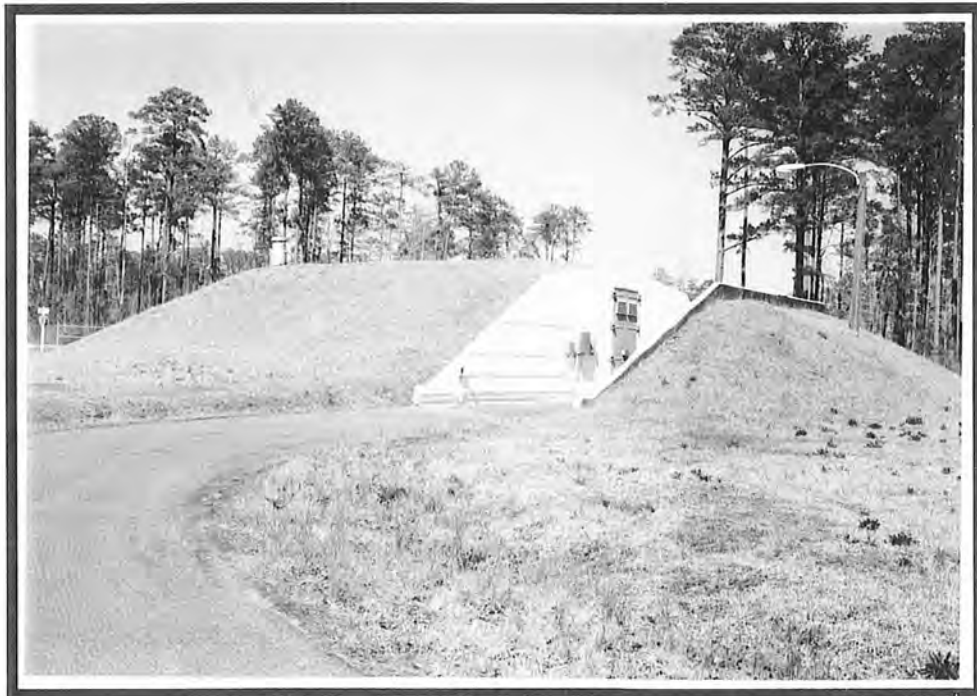
administrative buildings; and, one maintenance shop. The magazines at Cherry Point utilized standardized plans developed by the Bureau of Yards and Docks during the 1930s (Figure 12).

Above-ground magazines were used primarily to store smokeless powder, unfused projectiles, and small arms ammunition (Grandine et al 1995:90). The above-ground magazines were constructed as one-story, poured concrete structures raised on a concrete foundation and terminating in a gable roof. The magazines range in size from one to three bays. Concrete loading platforms are located along the longitudinal elevation of the magazines.

Figure 12. Above: Photograph of a typical above-ground magazine (Building 1231). Below: Photograph of a typical earth-covered magazine (Building 1203).

The 27 earth-covered magazines are arched-type, high-explosive (HE) magazines. Earth-covered storage was used to store the most hazardous materials, such as bulk high explosives, aircraft bombs, fuses, and detonators. Underground storage offered a greater measure of protection and a greater control over temperature than above-ground storage buildings (Grandine et al 1995:90). The one-story magazines feature a single metal door housed in a concrete retaining wall: an earthen berm covers the roof, rear and side elevation of each magazine. Earthen blast walls are located in front of the doors of each structure.

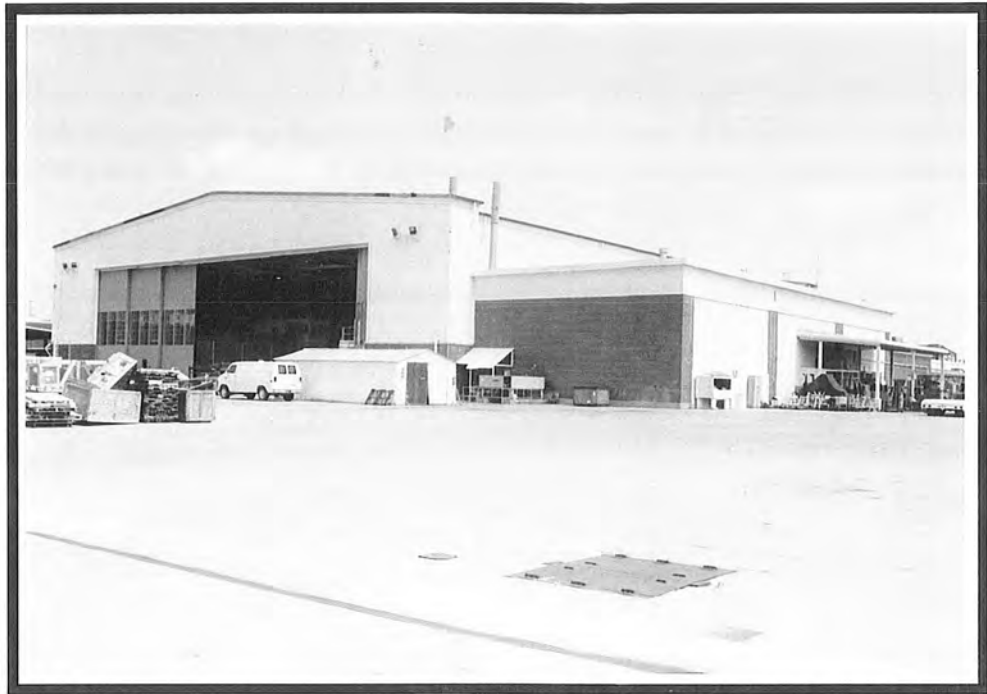
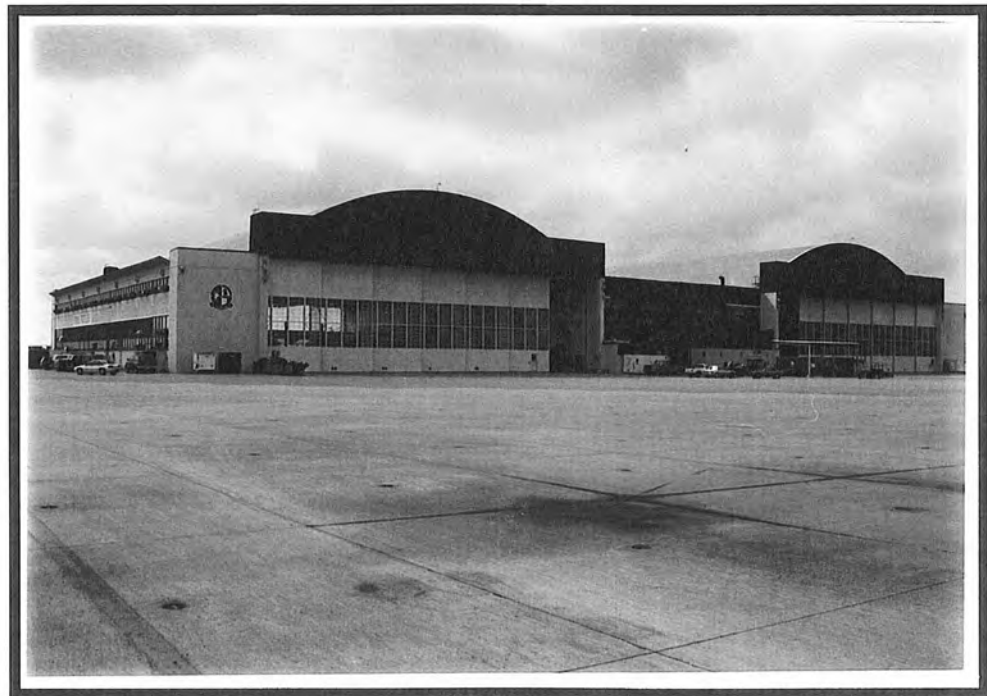
Hangar 188 was constructed in 1946 southeast of the Engine Overhaul Building (Building 133) on the former aircraft apron. The one-story, metal-frame hangar terminates in a front-gabled roof (Figure 14). The lower walls of the structure are clad in brick, and the upper walls are clad in corrugated metal. Bands of industrial metal-sash windows punctuate the upper wall surface of the side elevations. Sliding track, multi-leaf hangar doors with multi-light windows occupy the gable ends. Several additions have been constructed along the side of the building.

Building 250 was constructed in 1954 as a hangar to accommodate the station's larger planes. The hangar was constructed using standardized plans developed by the Bureau of Yards and Docks (Yards and Docks Drawing No. 562884); this hangar type was employed at Marine Corps and Naval installations on a nationwide level (Figure 14). The two-story building adopts a rectangular ground plan and consists of two one-story pull through hangar bays connected by a central office core. Arched, corrugated metal roofs cover the hangar bays. The gable ends are dominated by sliding, multi-leaf hangar doors with multi-light windows. The interior contains offices and shops along the side bays and central bay of the lower two-story block of the building. These two-story blocks terminate in flat parapet roofs.

Figure 14. Above: Photograph of Hangar 188. Below: Photograph of Hangar 250.

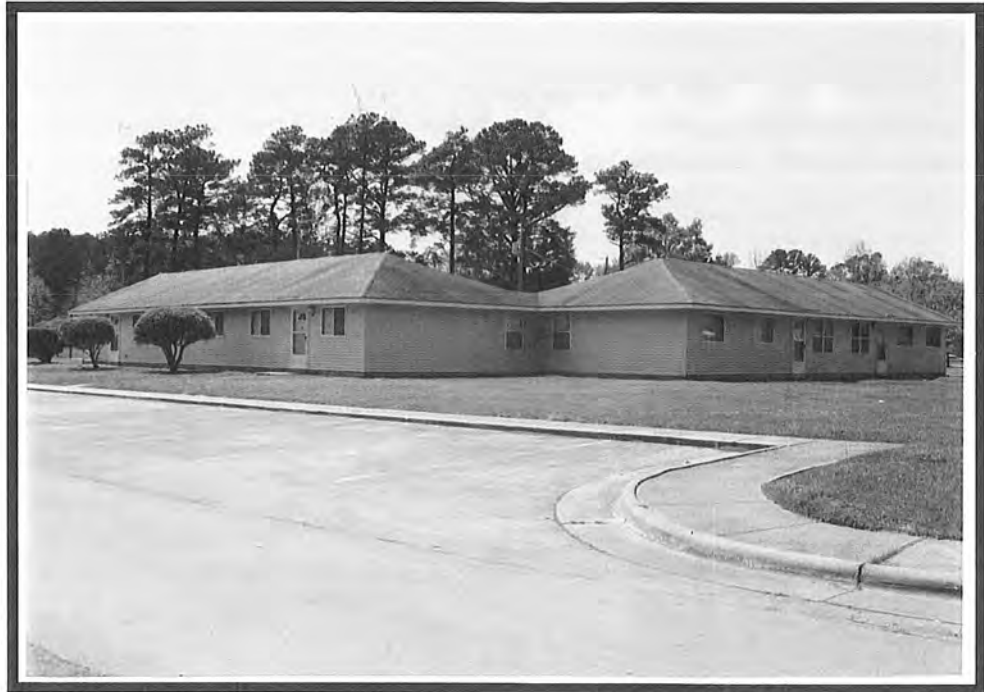
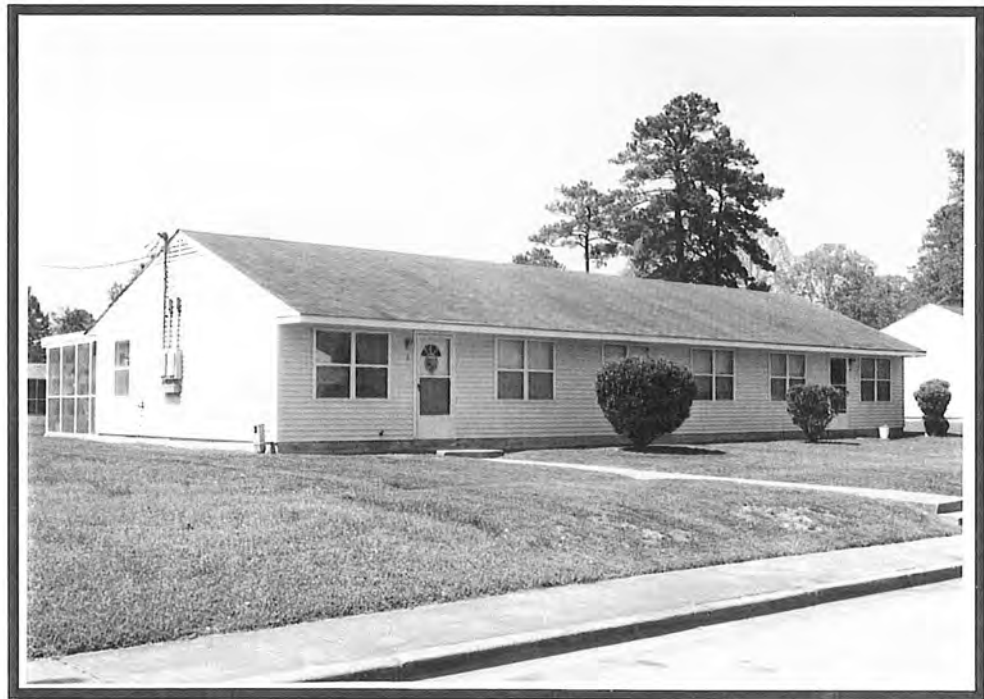
Figure 15. Above: Photograph of L-type, four family housing unit in Slocum Village. Below: Photograph of rectangular, two family housing unit Hancock Village.

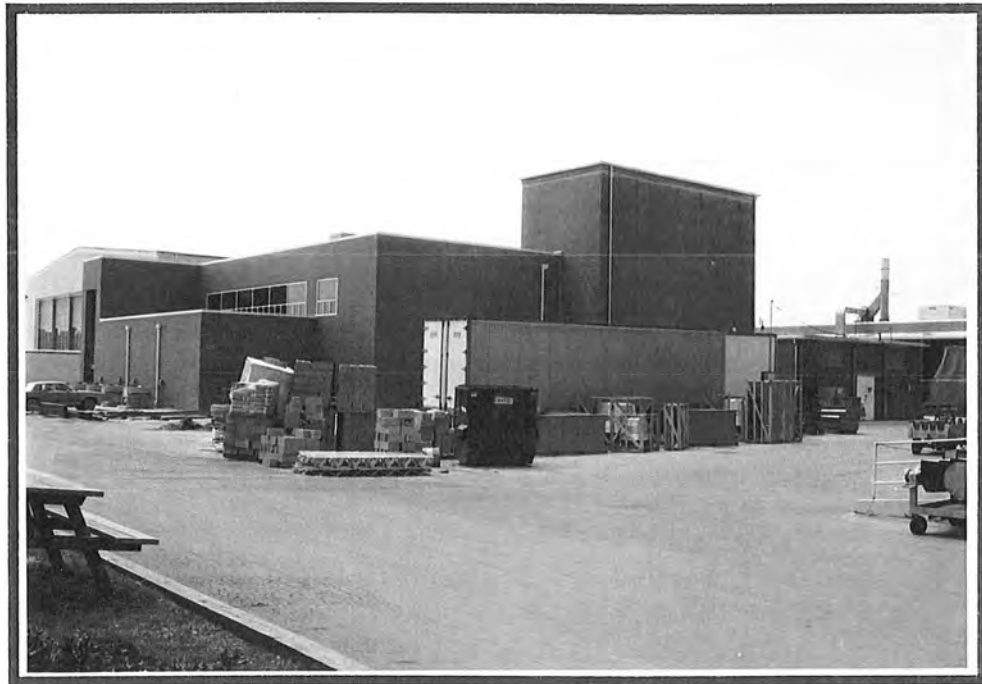
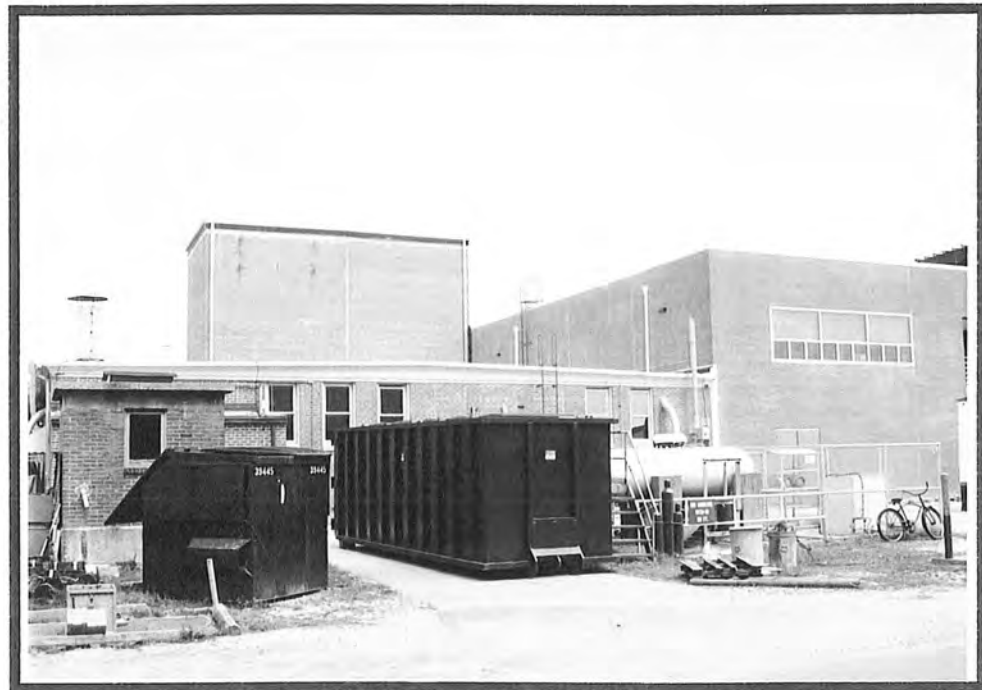
Figure 16. Above: Photograph of Building 129, view south Below: Photograph of Building 129, view north.

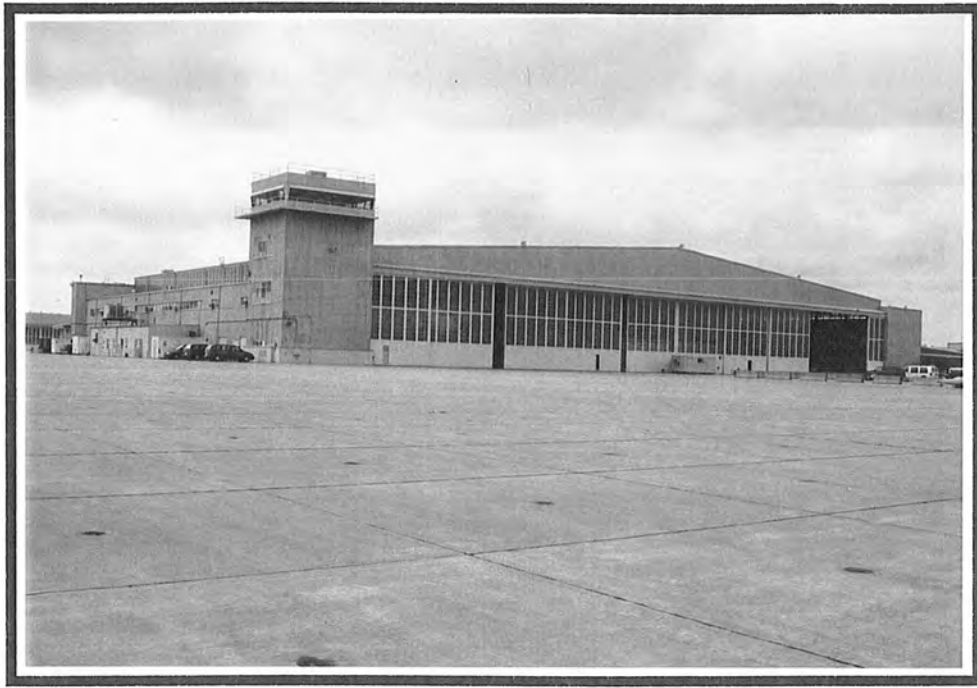
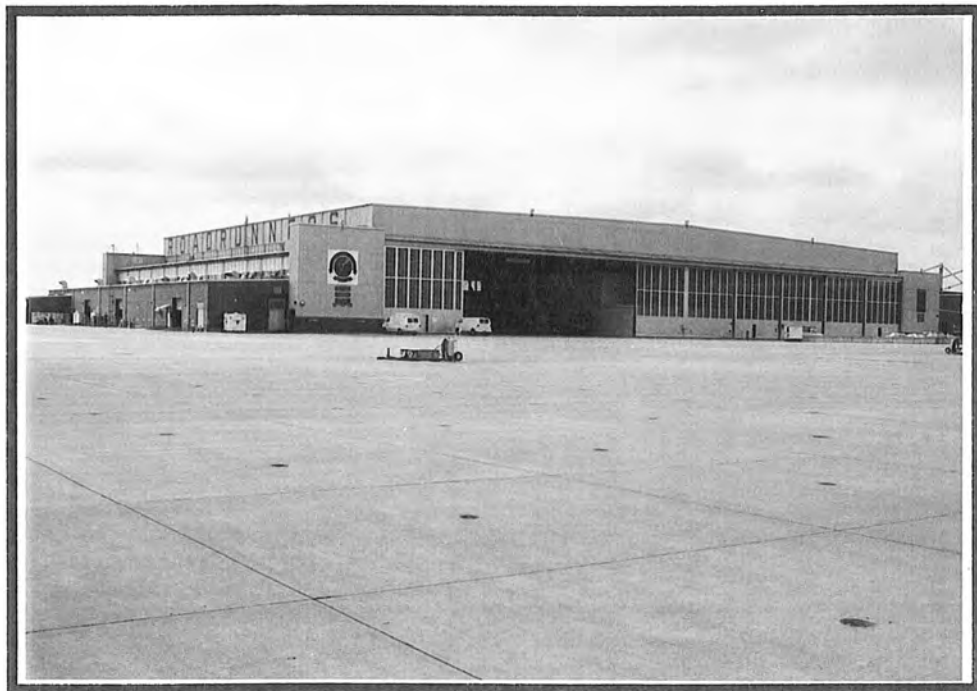
The two seaplane hangars, Buildings 130 and 131, were identified as potentially eligible for National Register listing in a previous architectural survey conducted by John Milner and Associates (McVarish 1994). Both hangars were built in 1942 using standardized plans developed by the Bureau of Yards and Docks (Yards and Docks Drawing No. 302,257). Buildings 130 and 131 were identified as significant under both Criteria A and C. The hangars were determined significant for their role as maintenance and repair sites for aircraft operated by the Third and, later, the Ninth Marine Air Wings (Criterion A). The hangars also were determined significant as examples of a standard hangar design erected at Naval and Marine air stations throughout the war (Criterion C).

The current investigation determined that, on an individual basis, both seaplane hangars have been expanded and altered substantially, and did not possess sufficient integrity to convey its period of significance (Figure 17). Interior partitions have been installed in the shop bays of Building 131. A vehicle shed and a lean-to addition have been added along one side of Building 130. An aircraft maintenance shop extension was added to both hangars in 1962. A freestanding, concrete shop bay was constructed in the interior of both structures (McVarish 1994:14-16). As a

Figure 17. Above: Photograph of Building 130, view south Below: Photograph of Building 131, view south

result of these modifications, the hangars at MCAS Cherry Point were not determined to represent the most intact examples of this type of standard design seaplane hangar. Comparative examples of this type were documented in a 1994 cultural resource survey conducted by the Onyx Group Survey of Naval Base Norfolk, Virginia. This survey identified three seaplane hangars (SP1, SP2 and SP31) that were identical to the two hangars surveyed at MCAS Cherry Point. The hangars at Naval Base Norfolk were determined to represent more intact examples, since they continue to house their original function and have undergone only minor modifications or alterations. The hangars at Naval Base Norfolk are currently under investigation by R. Christopher Goodwin & Associates, Inc. as contributing resources in a potential historic district (Cannan & Grandine 1996).

We concur that Hangars 130 and 131 are not eligible for the National Register of Historic Places due to major alterations to the roofs. Base records indicate that the original monitor roofs were removed within the last twenty years.

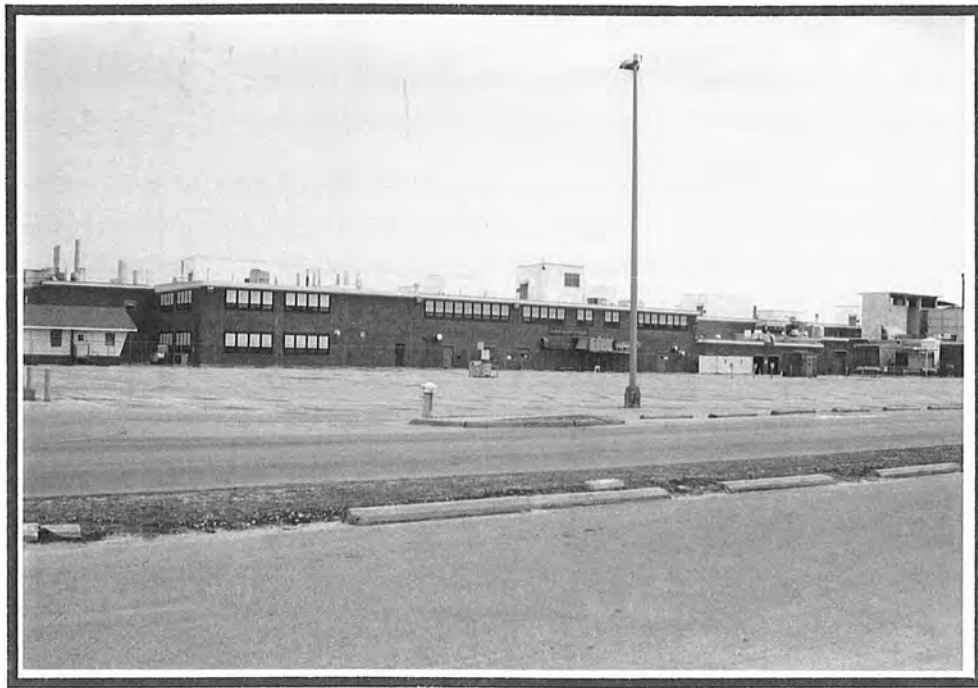
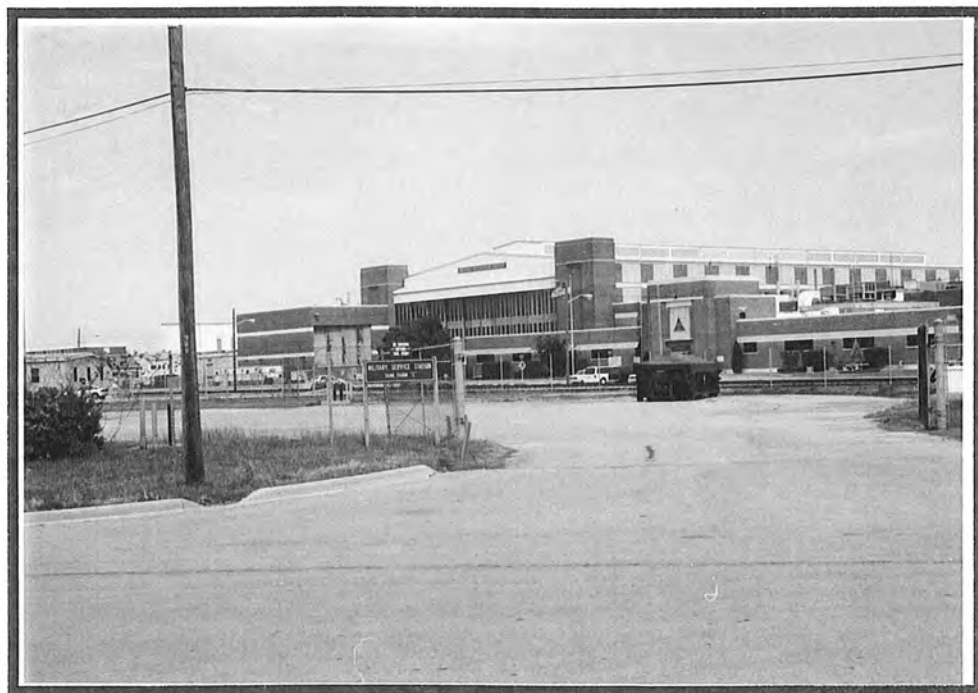
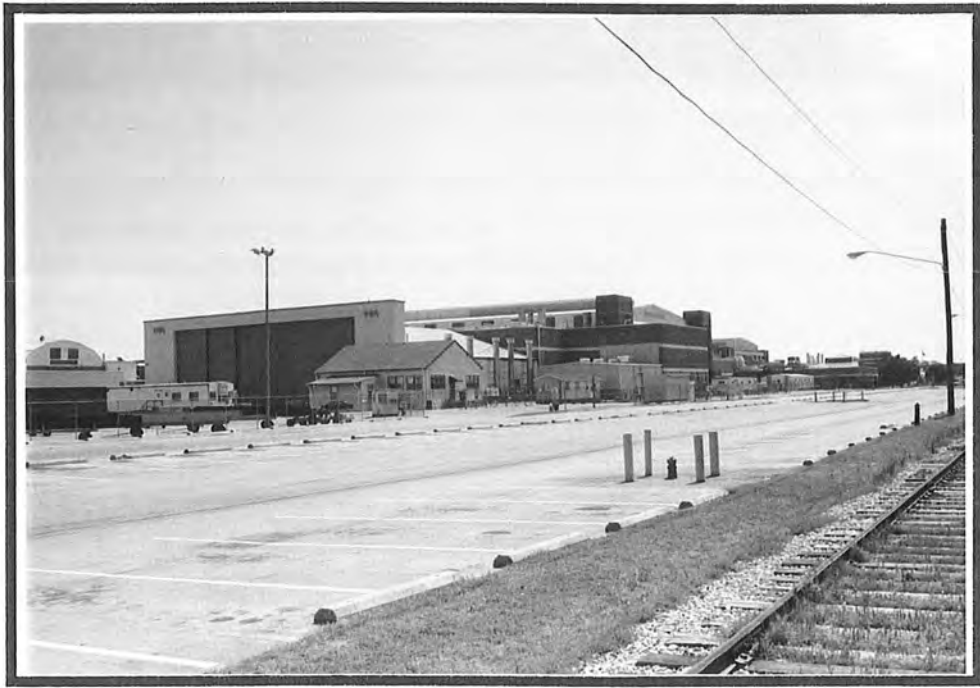
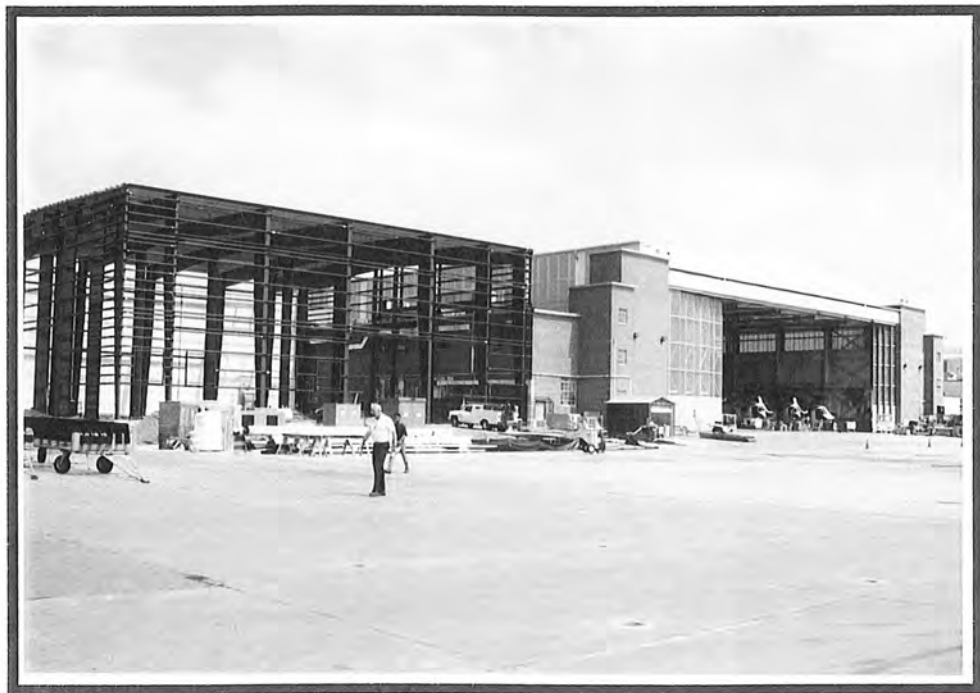
Building 137, originally known as the Assembly and Repair (A&R) Building, was constructed in 1943 using Bureau of Yards and Docks drawings (Figure 18). The A&R shop at MCAS Cherry Point was the fourth in a series of similar buildings constructed for the Navy and Marine Corps during the war (Criterion C). The enormous two-story, irregular plan, brick and steel-frame structure contains two original hangar sections and numerous shop areas. The original configuration of the building has been expanded by numerous additions, which have diminished its overall form and character-defining features. An aircraft hangar was added to the northeast end of Building 137 in 1951, and another aircraft hangar was added to the southwest end the following year. In 1968-69, a major addition was appended to the north end of the building. In 1970-80, a steel-frame gable roof addition was constructed at the southwest end of the building (Figure 19). These changes to the building's overall composition, building fabric, and interior layout have compromised the building's integrity and its ability to serve as an example of its type.

Figure 18. Above: Photograph of Building 133, view south Below: Photograph of Building 137, view southeast depicting original portion.

Figure 19. Above: Photograph of Building 137, view depicting north hangar addition. Below: Photograph of Building 137, view depicting southwest addition.

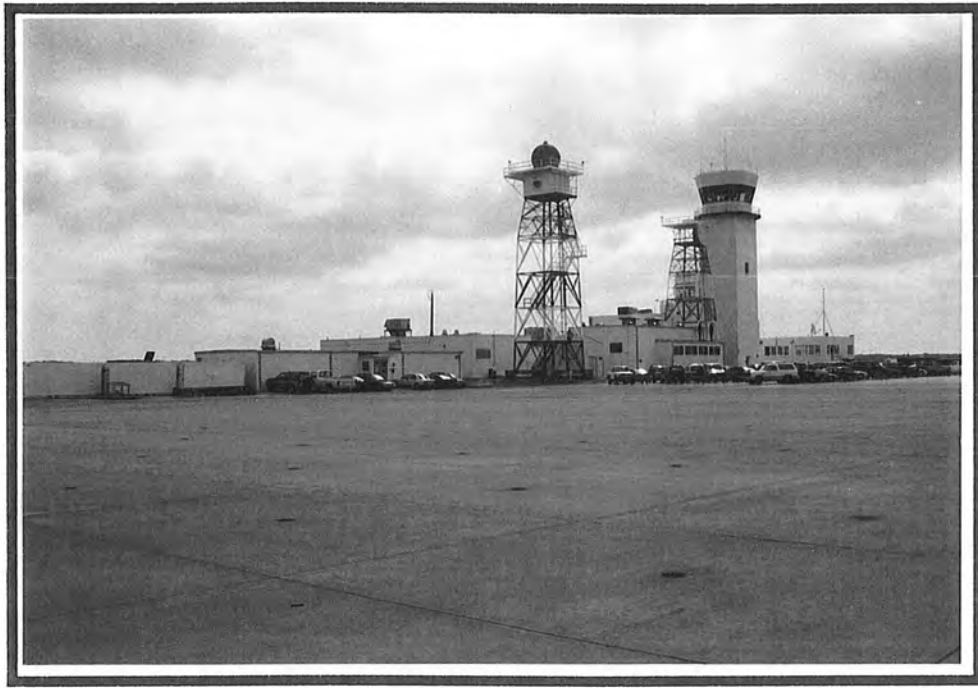
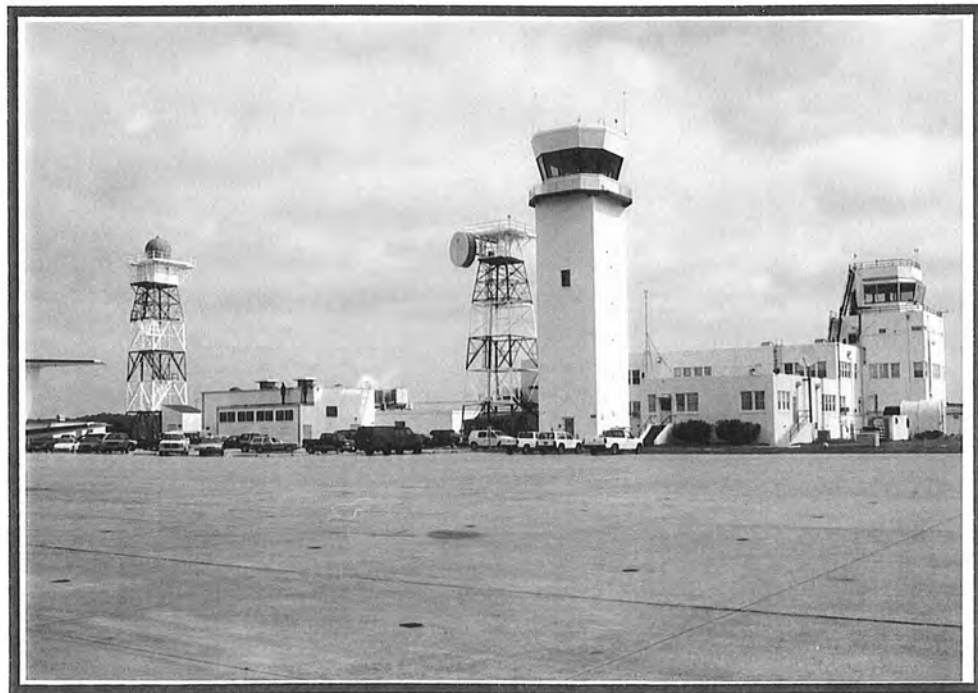
Building 199 was constructed in 1942 as the station's operations and aircraft control tower (Figure 20). The building is positioned at the intersection of the main runways, R-14 and R-5. The building was designed as a two-story, concrete structure terminating in a flat parapet roof. An octagonal metal-frame control tower projects from the building's east elevation. The majority of the doors and windows have been replaced, and a large, one-story garage area has been added along the southwest side of the building. The building is currently under renovation.

Figure 20. Above: Photograph of Control Tower (Building 199), view east, depicting modern tower. Below: Photograph of Control Tower (Building 199) view northwest depicting original portion and tower.
