Historic Architectural Resources Survey Report

Phase II (Abridged)

Oak Street Extension from Young Street to US 221A (Broadway Street) Forest City, Rutherford County, North Carolina

TIP No. U-2711B State Project No. 8.2890403 Federal Aid Project No. STP-1310(2)

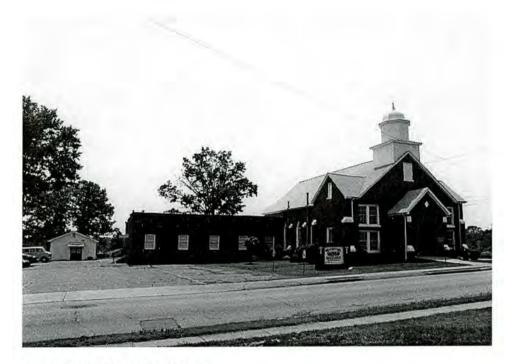
1. New Bethel Independent Church

- New Bethel Independent Church Early-twentieth-century, brick-veneered church. Tower covered in artificial siding. Modern wing, with same brick veneer, added before 1979. Interior has sheetrock walls and beaded board, tongue-and-groove ceiling. Church accompanied by brick-veneered parsonage and garage, and concrete block recreation building. Lacks integrity and architectural significance.
- 2. House

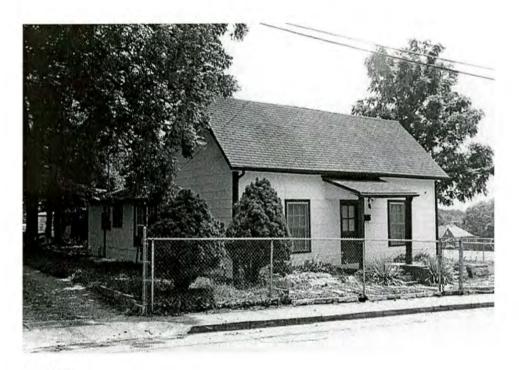
16. House

Side gable house. Lacks historical or architectural significance.

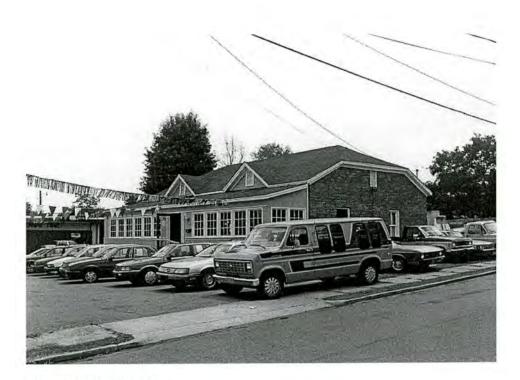
30. Swafford Auto Sales

Clipped gable, brick building with twin dormers overlooking frame addition in front. Lacks integrity, as well as historical or architectural significance.

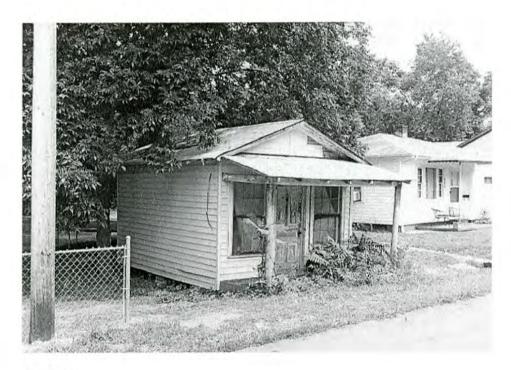
38. Store

One-room, gable front, frame building with attached porch. Lacks historical or architectural significance.

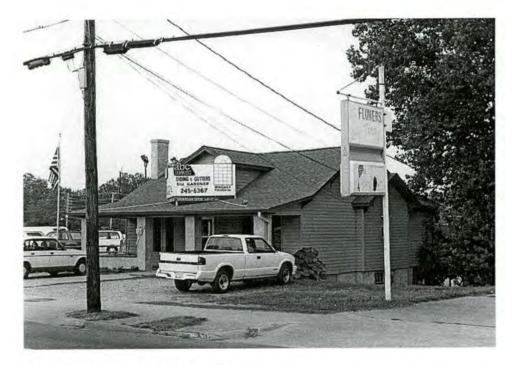
57. ABC Seamless Siding and Gutters

Side gable bungalow with knee brackets in eaves, an engaged porch, and stone veneer porch columns. Lacks historical or architectural significance.

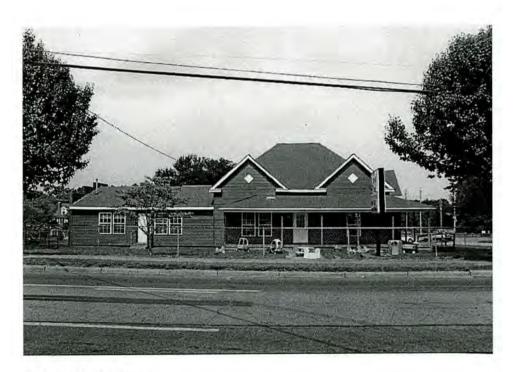
59. Little Red School

Hipped roof house with twin cross gables on front and attached porch. Projecting cross gable on one side, and large wing addition on the other. Lacks integrity, as well as historical or architectural significance.
