Historic Architectural Resources Survey Report

**Pave and Improve SR 1728, North Fork Road
Rutherford County, North Carolina
State Project No. 6.892511**

North Carolina Department of Transportation
Report Prepared by Nancy Van Dolsen

December 1999

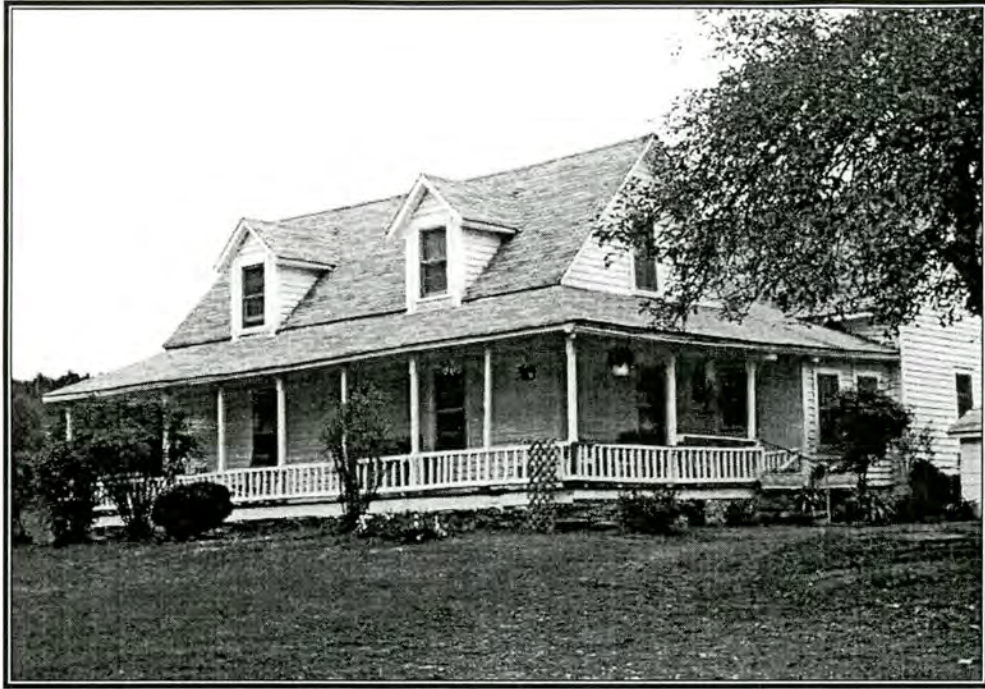
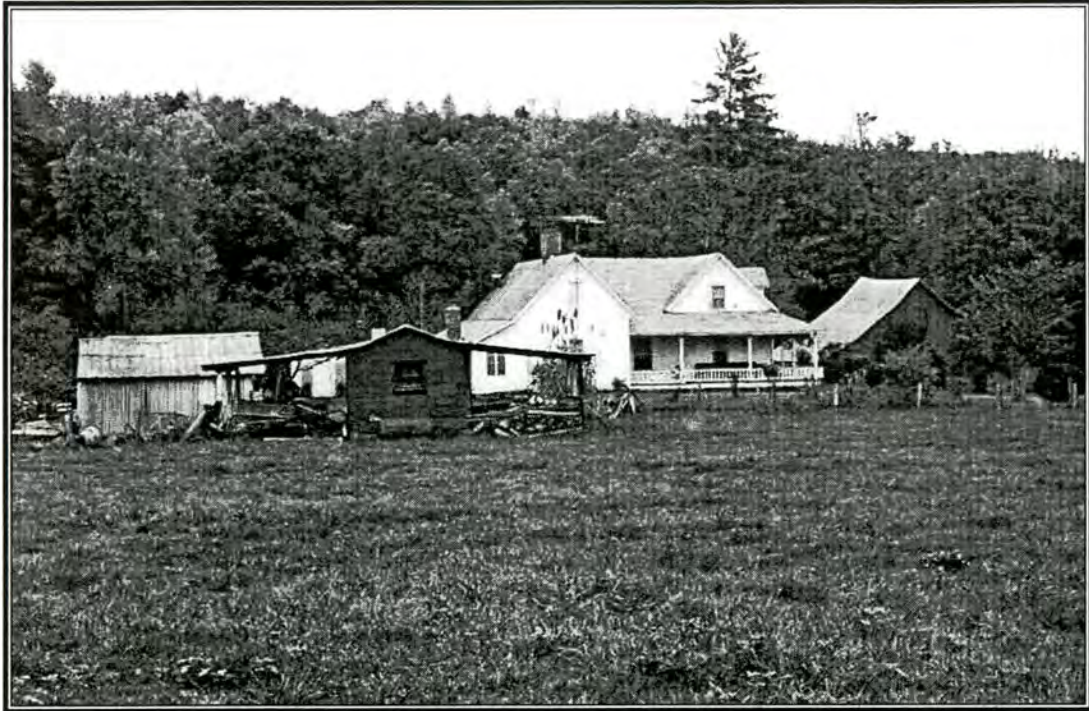
Frame Dwelling: Constructed in 1905, the primary residence is a one-and-a-half story three-bay residence with two side-gable sections, one placed behind the other, linked by a one-bay ell. The building stands on a stone foundation and retains its original wood siding. The rear side-gable section is longer than the front side-gable portion but the height of the two sections is identical. The gable ends of the two side-gable sections that face the drive feature elaborate sawtooth shingles. The back side-gable section also retains a louvred window (with sawn louvres) at the peak of the gable. A one-story porch supported by columns wraps around the front side-gable section; the columns had sawn spandrels that remain on the west elevation of the porch. Windows in the building are six-over-six sash, two-over-two sash, one-over-one sash, three-over-one sash, and four-light casement in rear shed addition.

The house retains much of its interior woodwork and finishes. The doors are five-panel. Inside a closet on the first floor are penciled notations pertaining to the construction of the house, the barn, and activities on the farm. A date of 1905 is given for the house and 1916 for the barn; construction and stylistic details concur with the dates written within the closet.

Photograph 1: Façade, Frame House, Sims-Melton Farm

**Photograph 2: Rear and West Elevation of Frame House,
Sims-Melton Farm**

**Photograph 3: Frame House, Barn to the right, Kitchen to the left,
Sims-Melton Farm**

Photograph 4: Frame House, looking southeast, Sims-Melton Farm

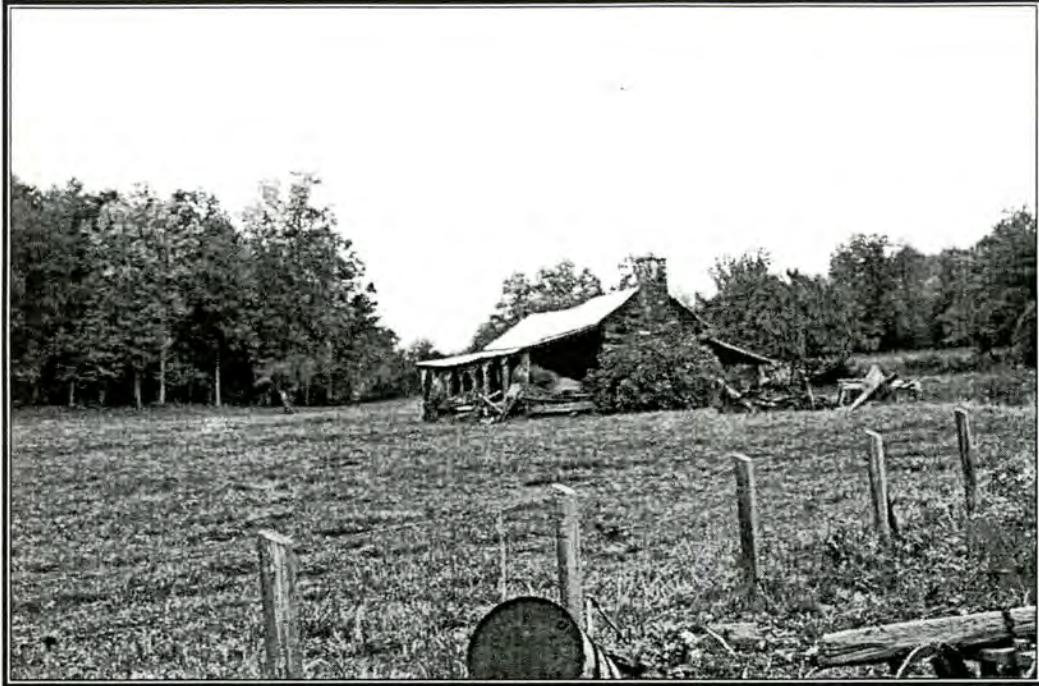
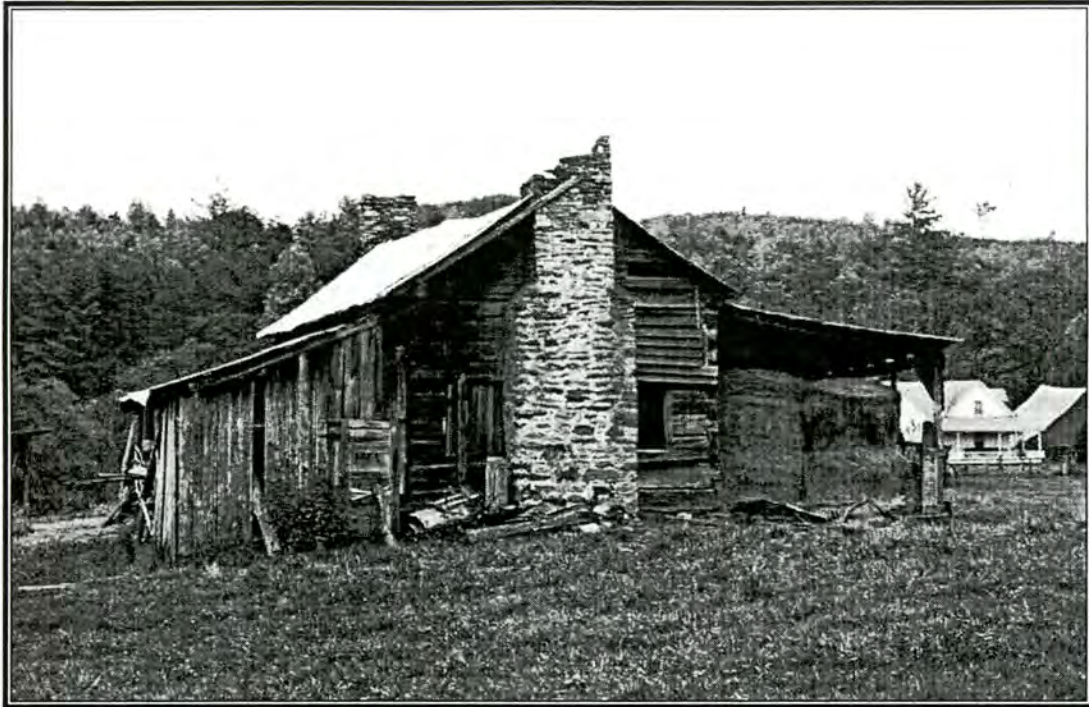
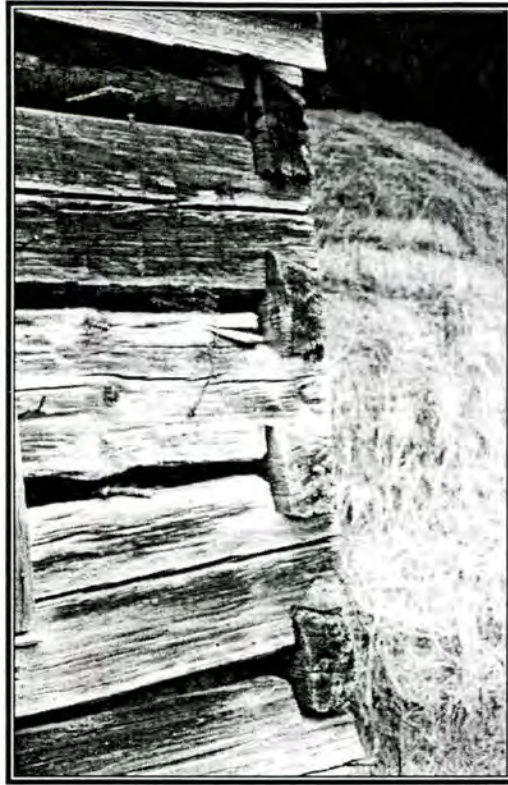
Log Dwelling: The earliest extant building on the property is a log house comprising two single-pen log cribs, each with an exterior stone chimney and linked by a central passageway. The building now shelters hay. The original section of the house is the eastern section, which has half dovetailed cornernotching, mortised, tenoned, and pinned rafters, and collar ties that are pinned to every third rafter. The logs are hewn on all four sides, and all framing members are also hewn. The second section of the dwelling features collar ties on all rafters. The floor for the passage between the two sections has been removed. The north wall of the original portion of the house partially collapsed and was rebuilt ca. 1990. A one-story porch runs the length of the façade, and a shed roof runs the length of the rear portion of the house. The rear shed roof was built to shelter hay, and replaced a kitchen and dining room addition that was built during the early twentieth century.

Photograph 5: Log House, Looking Northwest, Sims-Melton Farm

Photograph 6: Log House, Looking Northwest, Sims-Melton Farm

Photograph 7: Log House, Looking East, Sims-Melton Farm

Photograph 8: Log House, Looking East, Sims-Melton Farm

Photograph 9: Detail of Corner Notching, Log House, Sims-Melton Farm

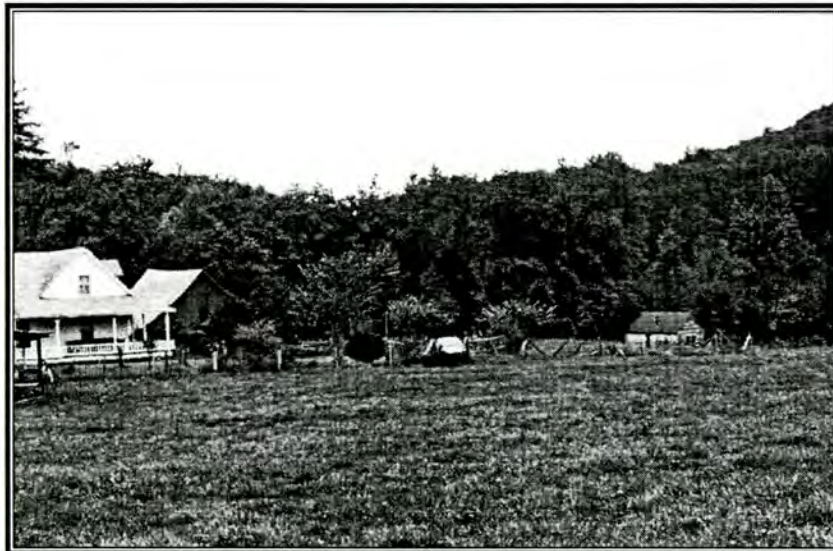
Tenant House: Built in 1957, the tenant house stands at the end of the farm lane, close to SR 1728. The one-story frame tenant house has an interior brick chimney, and is covered with horizontal board siding. The building is now used for hay storage.

Photograph 10: Tenant House to the Right, Sims-Melton Farm

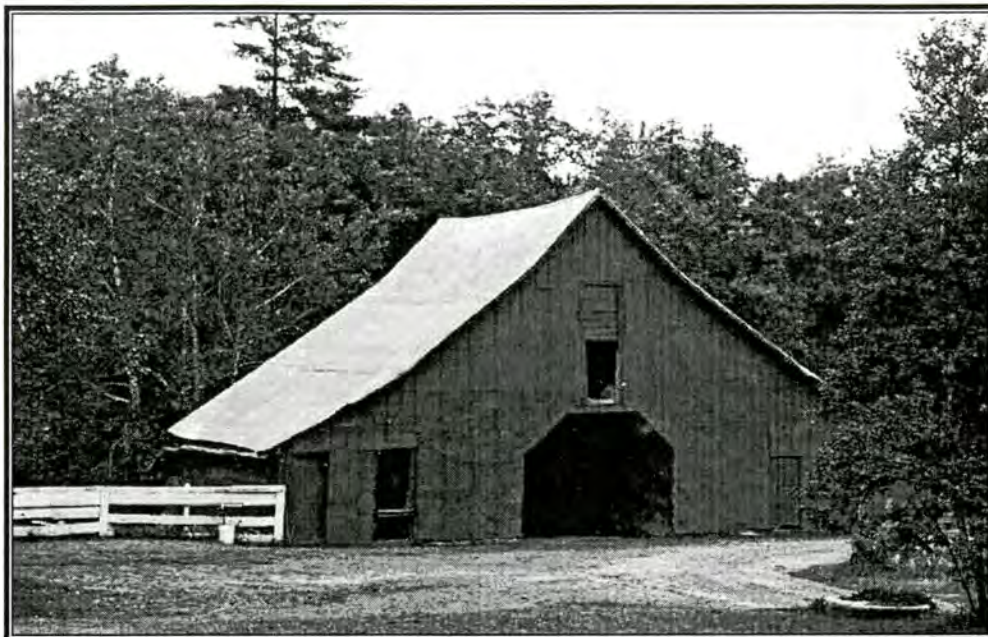
Barn: Dating to 1916, the frame barn stands southeast of the house. A three-bay, gable-front barn with a central drive-through flanked by two side-shed cribs, the barn features a steeply pitched roof. The barn has a loft above the central drive-through. The roof and walls of the barn are covered with sheet metal.

Photograph 11: Barn, Sims-Melton Farm

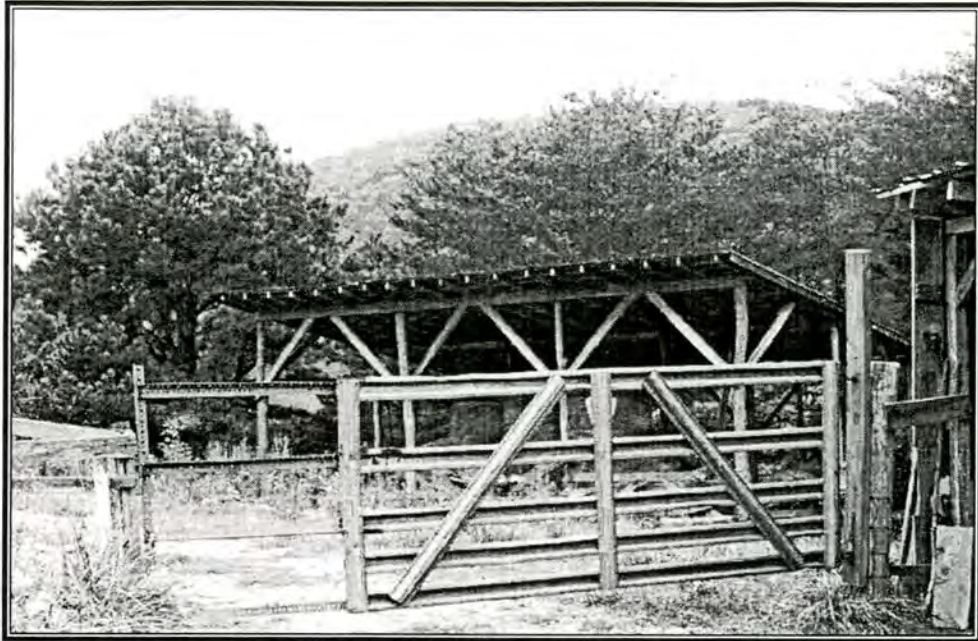
Pole Barn 2: A three-bay, shed-roof pole barn, open on all four sides stands at the north side of the gate leading to the back pasture. The building is used to store hay.

Photograph 13: Pole Barn 2, Sims-Melton Farm

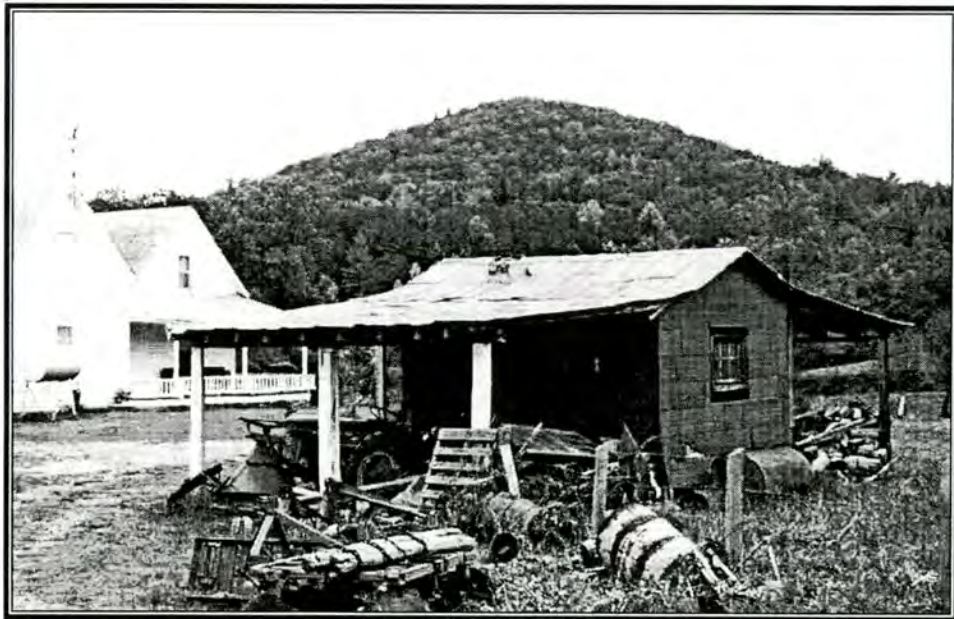
Kitchen: The one-story, gable-front, frame kitchen dating to the early twentieth century was moved to this farm ca. 1950. The building has a shallow gable roof and is sheathed in asphalt shingles and wood siding. The building is used for storage. Two large side sheds are located on the eave elevations and serve as protection for small tractors.

Photograph 14: Kitchen, Sims-Melton Farm

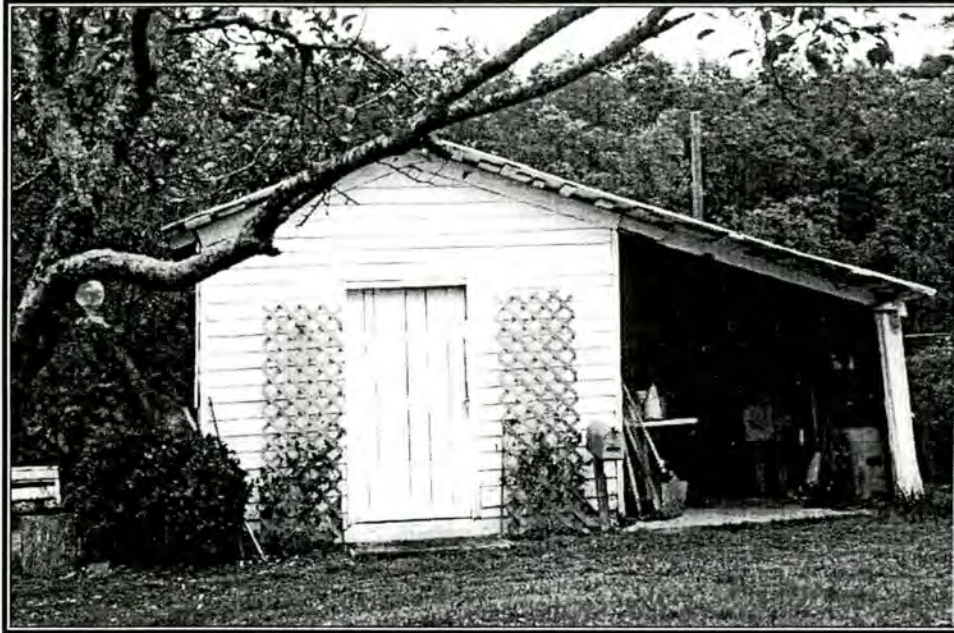
Smokehouse: The smokehouse (or meathouse, as the present owner refers to the building) stands east of the house. The shallow gable-roofed building features a board door on the west elevation. The building is sheathed in narrow board siding. The roof extends on the south elevation to form a small shed open on the west elevation.

Photograph 15: Smokehouse, Sims-Melton Farm

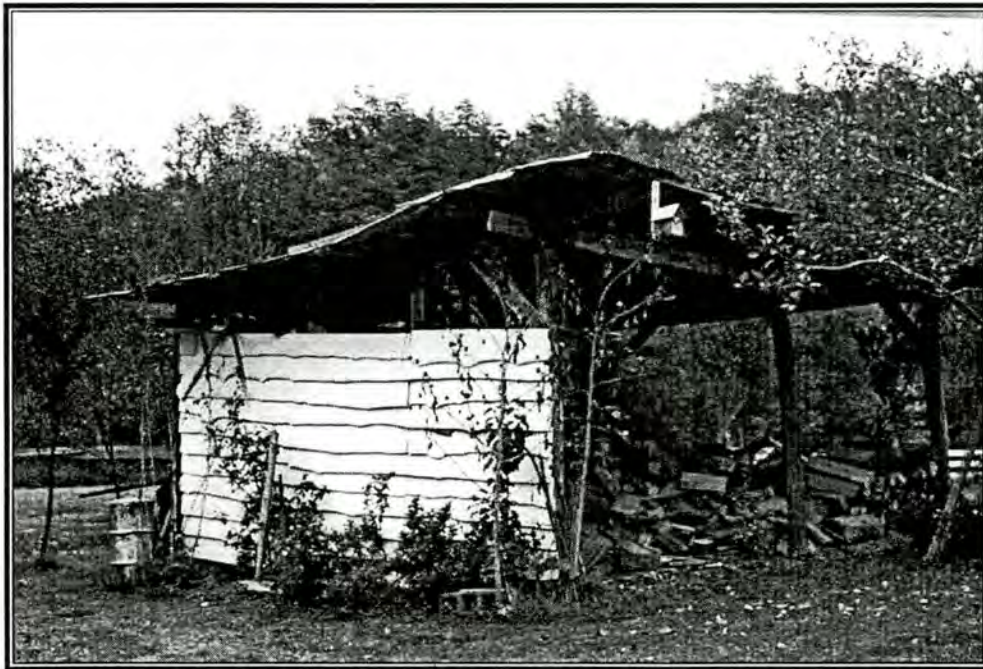
Wood Shed: An open shed constructed of groundset saplings and scavenged lumber, the wood shed stands behind the house. A metal shed roof covers the building.

Photograph 18: Woodshed, Sims-Melton Farm

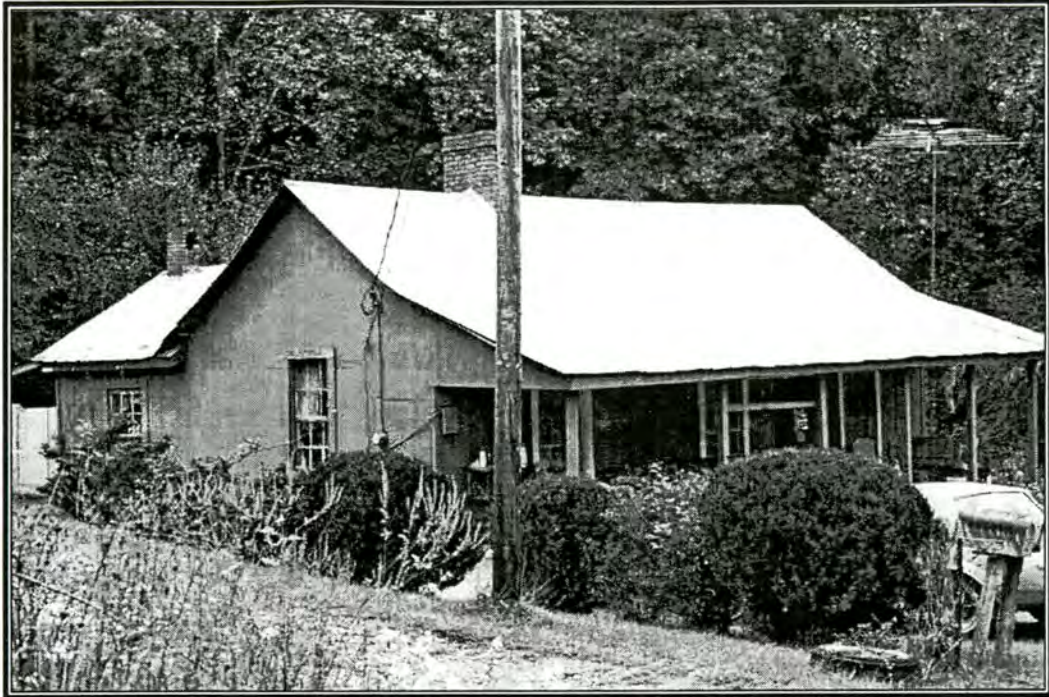
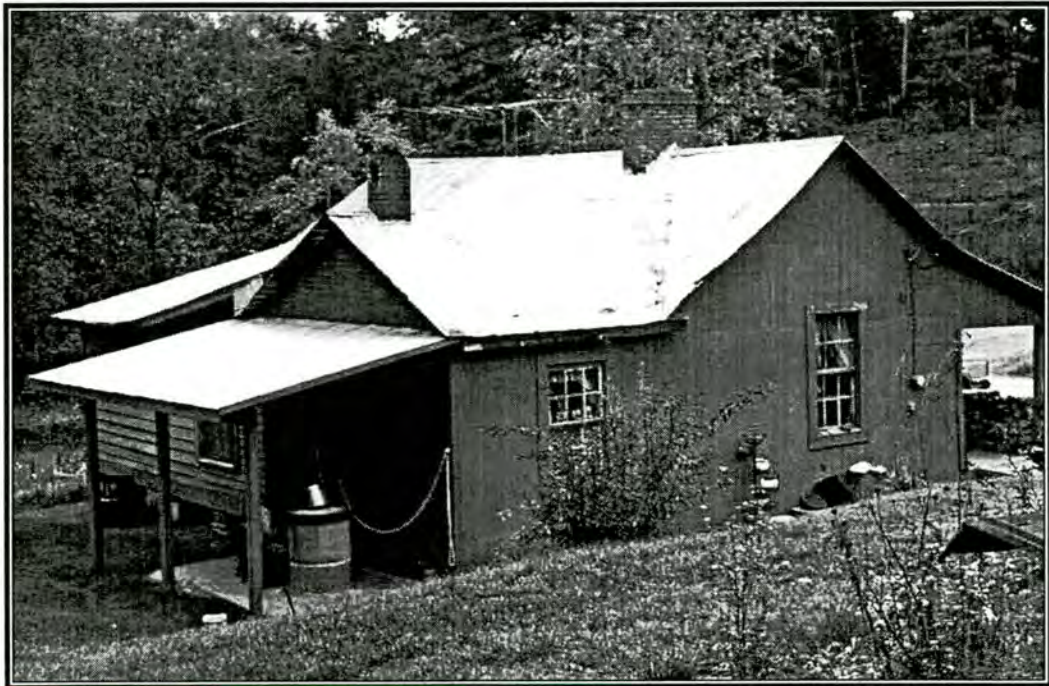
Dwelling: The one-story, single-pile, side-gable frame house, dating to the late nineteenth century, is composed of at least four sections. The original two-bay section of the building comprises the west end of the house, and it stands on stone piers, later supplemented with poured concrete piers. A one-bay addition was added to the original section. A one-bay ell was built onto the rear of the house. A shed-roof addition was then constructed in the space between the ell and the front portion of the house. A one-story shed roof porch runs the length of the house; the porch posts and floor are replacements. A one-story shed roof porch was also built onto the rear of the ell. The house is sided with composite wood panels. Windows in the house contain primarily six-over-six sash.

Evaluation: Property No. 1 is considered not eligible for the National Register of Historic Places under Criterion A, B, C, or D since it has lost the requisite integrity of design, association, setting, and feeling. The property is not representative of a significant trend in the history of the area. The property was once a small farmstead, but it has lost its agricultural context. The poultry houses have been altered by the insertion of sash and no longer resemble their original appearance. The hog pens have been moved to their present location and are no longer enclosed with a fence. The house has undergone some alterations, including the remodelling of the front porch and the residing of the

**Photograph 1: Façade and Northeast Elevation, Frame House,
Property No. 1**

**Photograph 2: Rear and Northeast Elevation, Frame House,
Property No. 1**

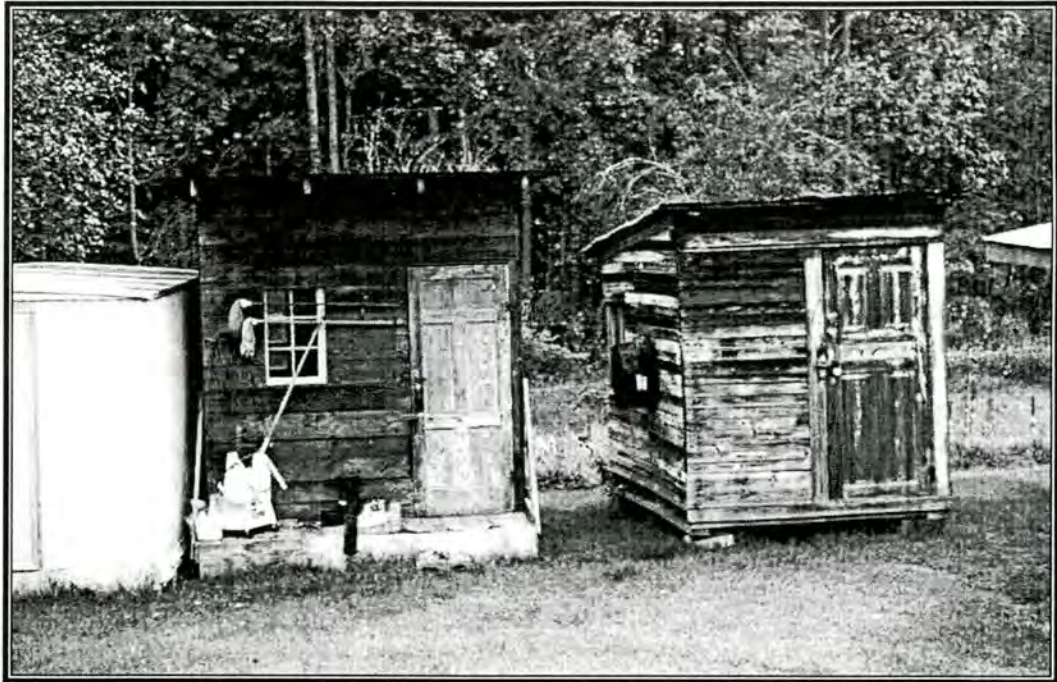
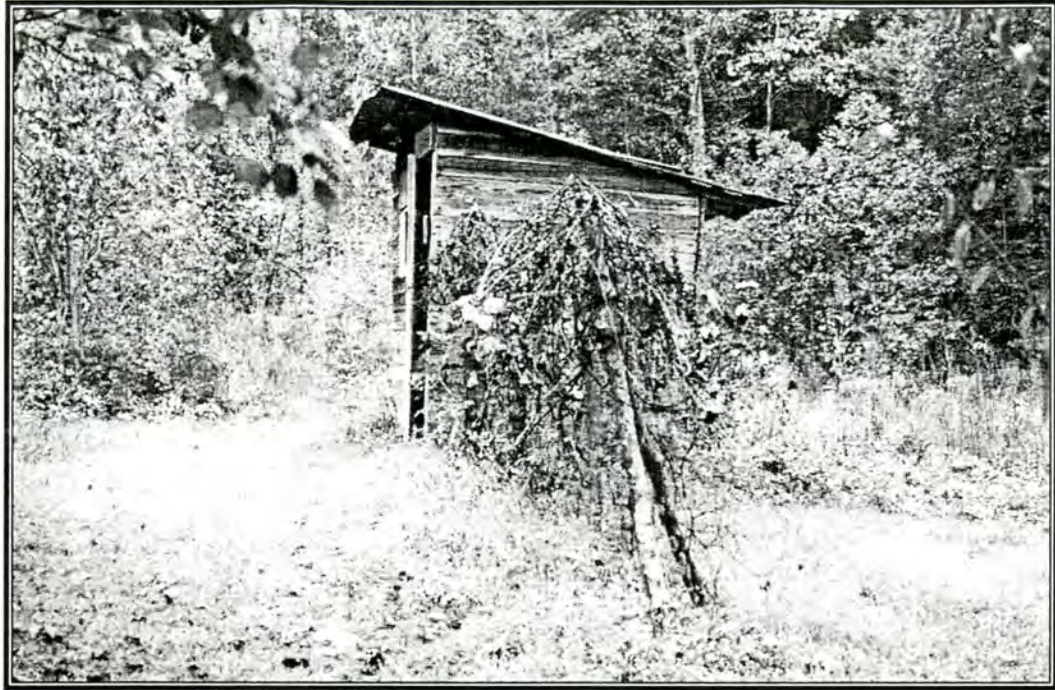
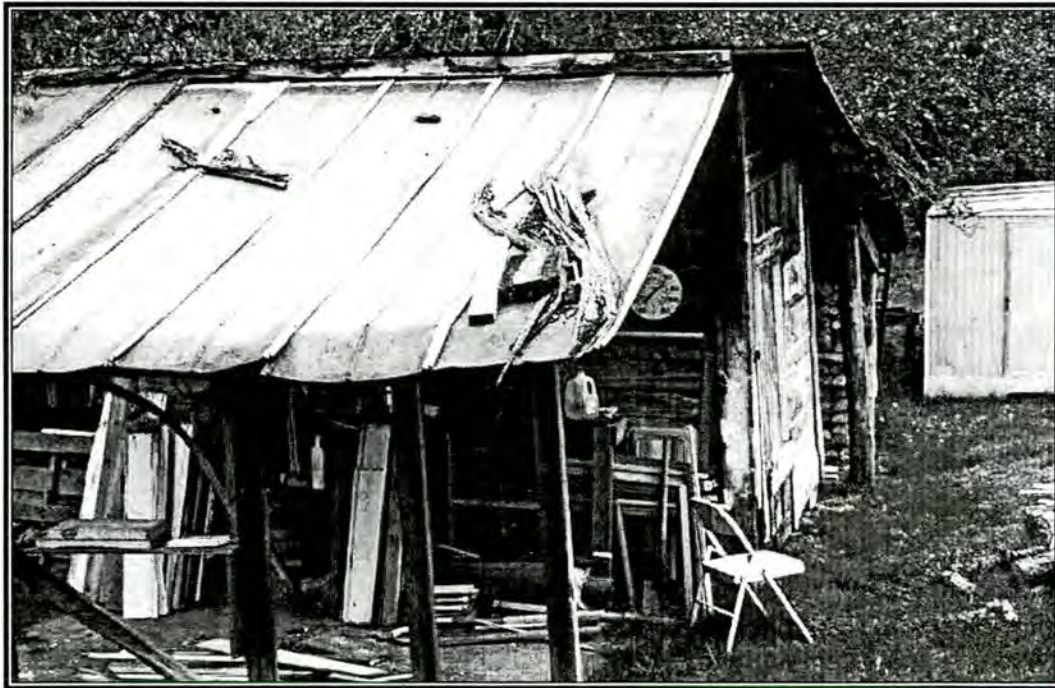
Outbuildings: Eight small frame, mid-twentieth century outbuildings stand on the property. Four small frame, shed-roof, mid-twentieth century outbuildings, sided with horizontal boards, are located near the house, and most likely were poultry houses. Two small frame shed-roof buildings have been moved to stand southeast of the house, and have slat siding approximately two-thirds of the height of the walls. These buildings have half-height doors and most likely served as hog pens. A shed-roof privy stands at the end of a grape arbor, to the south of the house. A gable front-shed with open side wings is located east of the house. A small late twentieth-century metal storage building occupies a location next to one of the poultry houses.

Photograph 3: Poultry Houses, Property No. 1

Photograph 4: Hog Pens, Property No. 1

Photograph 5: Privy, Property No. 1

Photograph 6: Shed, Property No. 1

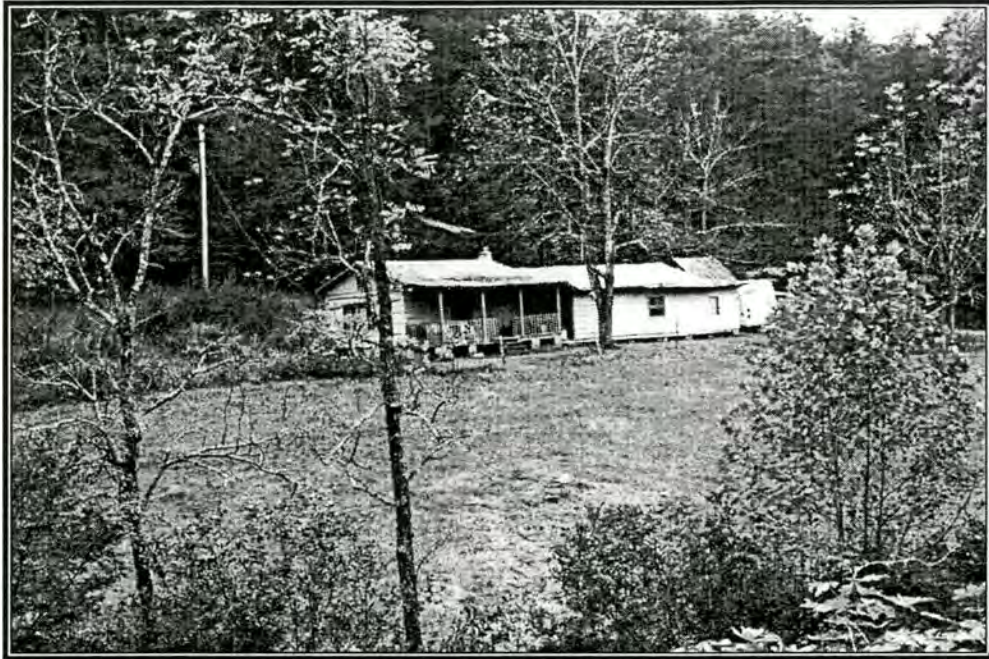
Dwelling: The reconstructed house was constructed from logs salvaged from two outbuildings that stood on the north side of SR 1728. The house was built ca. 1970.

Photograph 1: Reconstructed Log House, Property No. 2

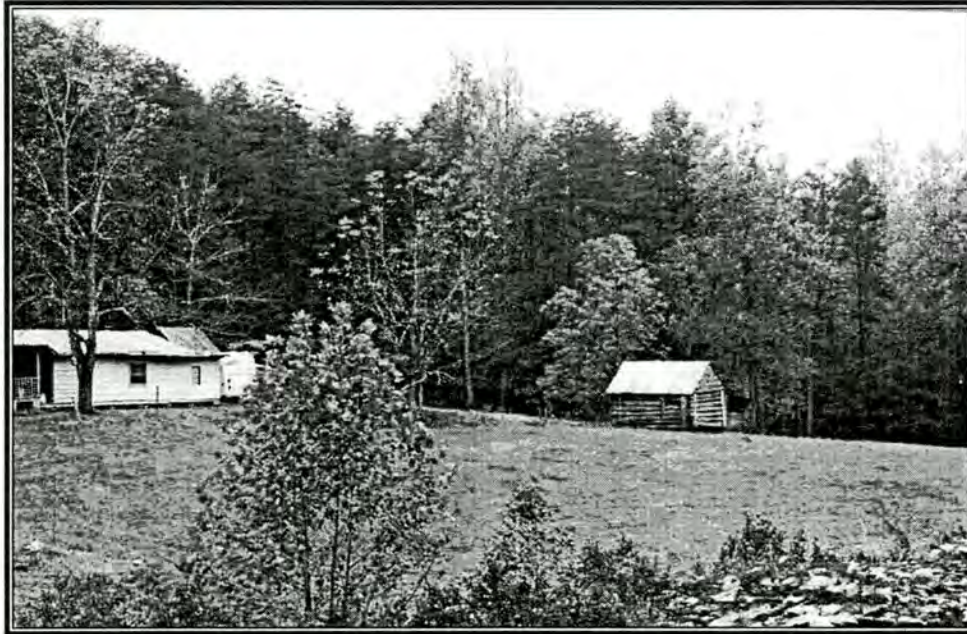
Barn: This log barn is a single crib building with corner saddle notching. The building has a side shed addition. Now used for hay storage, the barn was most likely constructed as a field barn during the late nineteenth or early twentieth century.

Photograph 2: Barn, Property No. 2

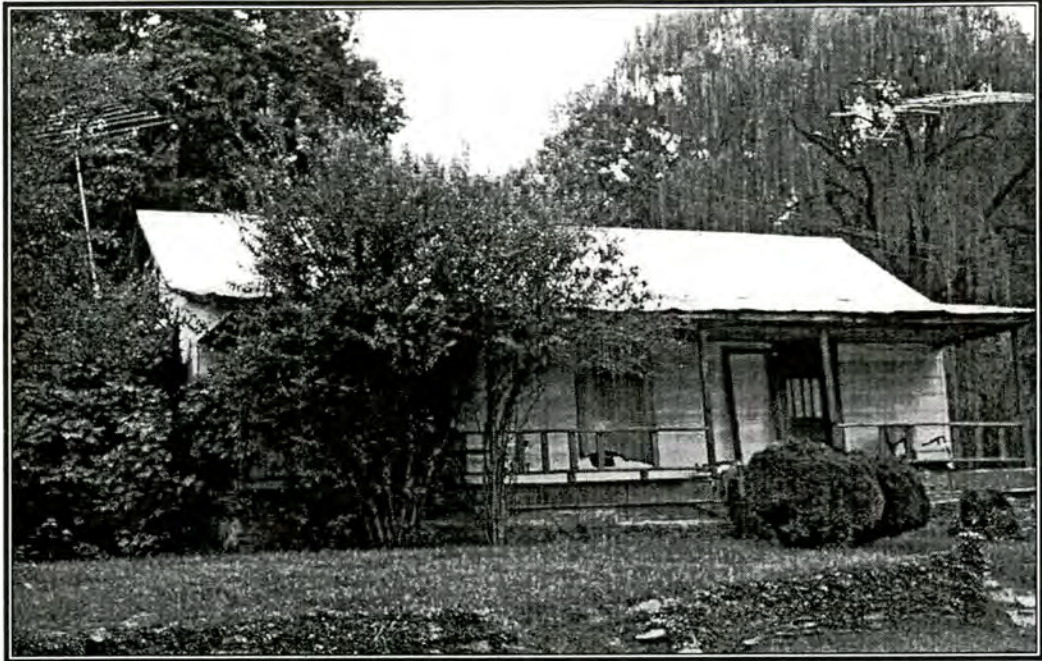
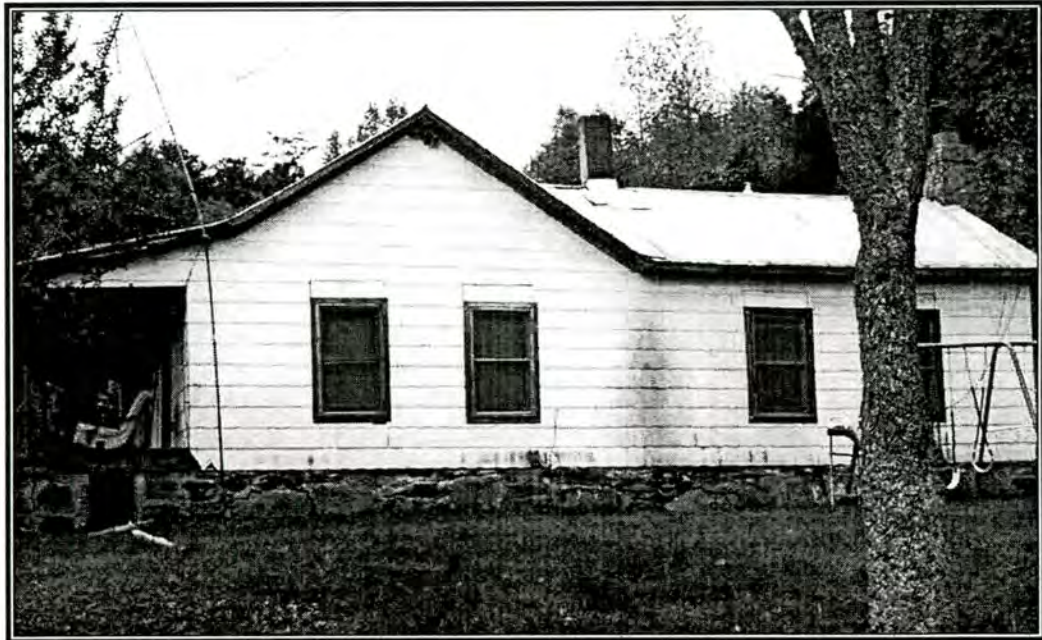
Dwelling: The frame house, dating to the late nineteenth or early twentieth century is a one-story, three-bay, single-pile dwelling with a one-story frame kitchen ell. The building stands on a stone foundation. The shed-roof porch across the façade of the building has been remodeled, and stands on a stone, concrete block, and brick foundation. The building has been sided with asphalt shingles. The size of the window openings have been changed (shortened and widened on the north elevation, and lengthened on the façade) and one-over-one sash windows inserted. The chimneys have been rebuilt in concrete block and brick.

Evaluation: Property No. 3 is considered not eligible for the National Register of Historic Places under Criterion A, B, C, or D since it does not retain the requisite integrity of setting, design, feeling, or association. The property was once a small farmstead, but it has lost its agricultural context. The land surrounding the house is now wooded, and does not convey an agricultural appearance. The house has undergone alterations, including the remodeling of the front porch, the residing of the building, the rebuilding of the chimneys, and the alteration of the fenestration and window sash.

Photograph 1: Façade, Frame House, Property No. 3

Photograph 2: North Elevation, Frame House, Property No. 3

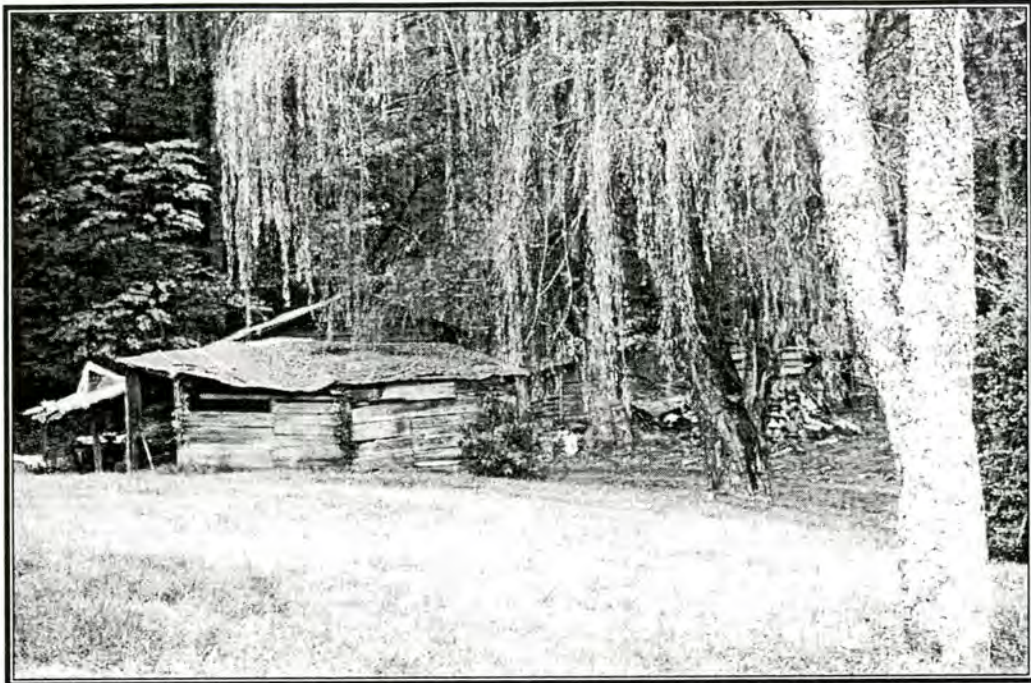
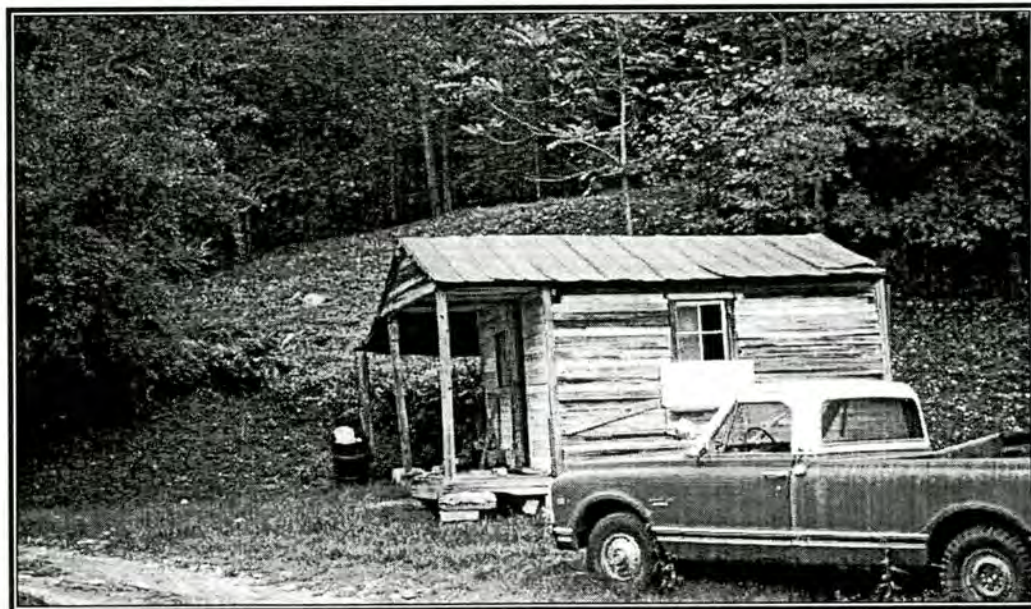
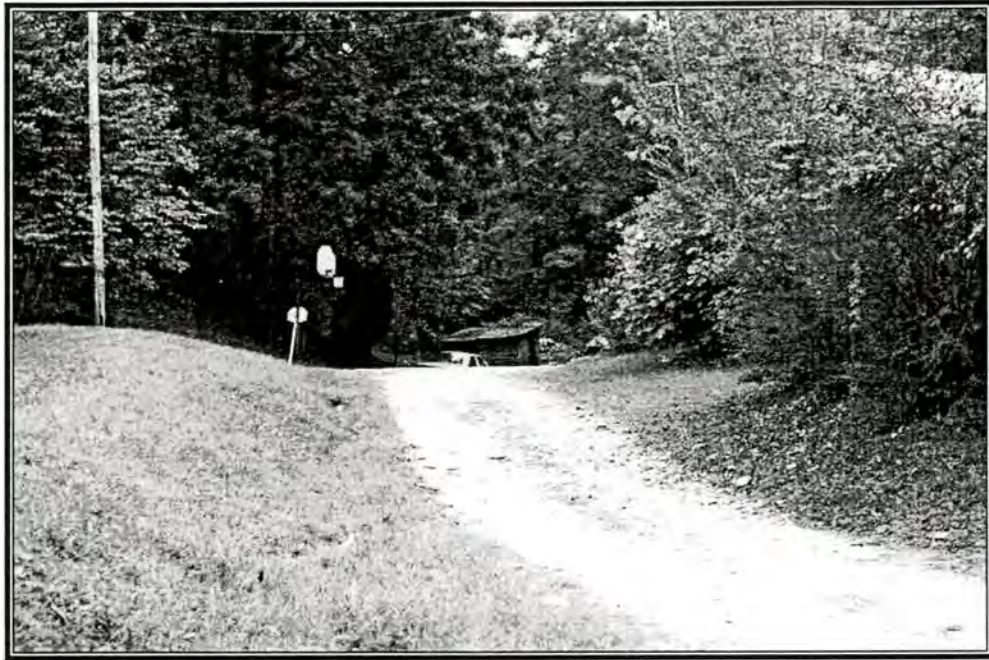
Outbuildings: Three frame outbuildings stand north and east of the house: a shallow gable-roofed barn with a side shed, a small shed-roof outbuilding, and a gable-front frame building with a porch extending over the door on the south elevation. The buildings are no longer used for agricultural purposes.

Photograph 3: Barn, Property No. 3

Photograph 4: Outbuilding, Property No. 3

Photograph 5: Shed, Property No. 3
