Re: Replace Bridge 140-1.5 at Courthouse Creek and Avery Creek Culvert on FSR 477, Pisgah Ranger District, Pisgah National Forest, Transylvania County, ER 16-0506

**Historic Documentation and National Register of Historic Places Evaluation of the  
Courthouse Creek Bridge and Avery Creek Culvert, Pisgah Ranger District,  
Pisgah National Forest, Transylvania County, North Carolina**

Final Report

August 18, 2015

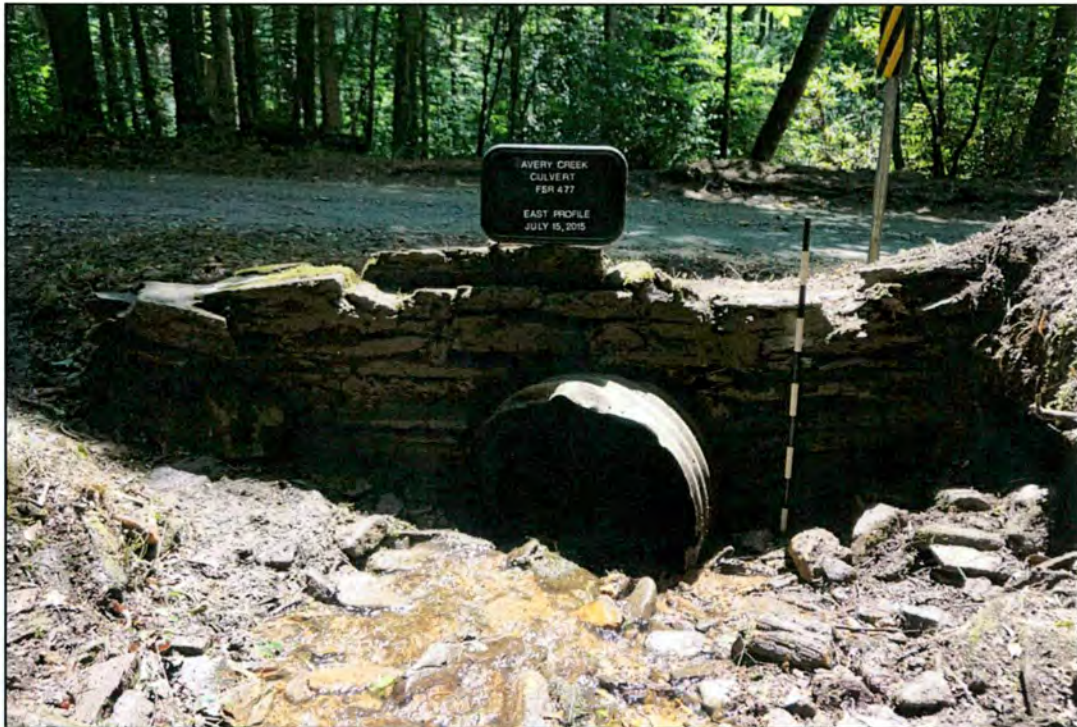
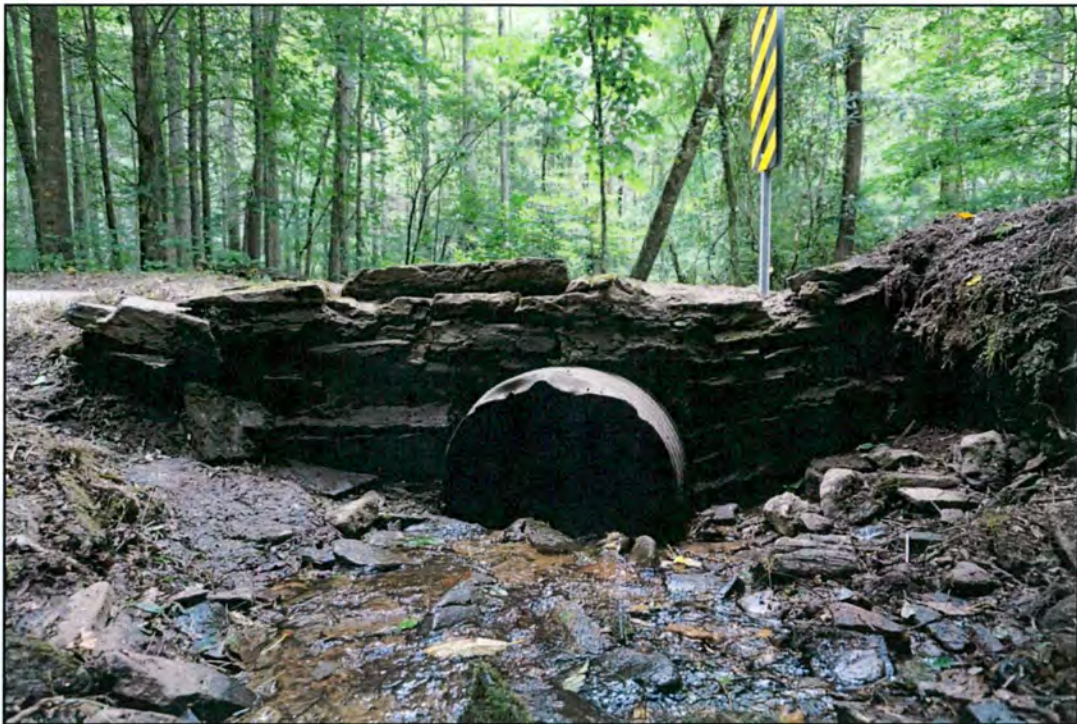
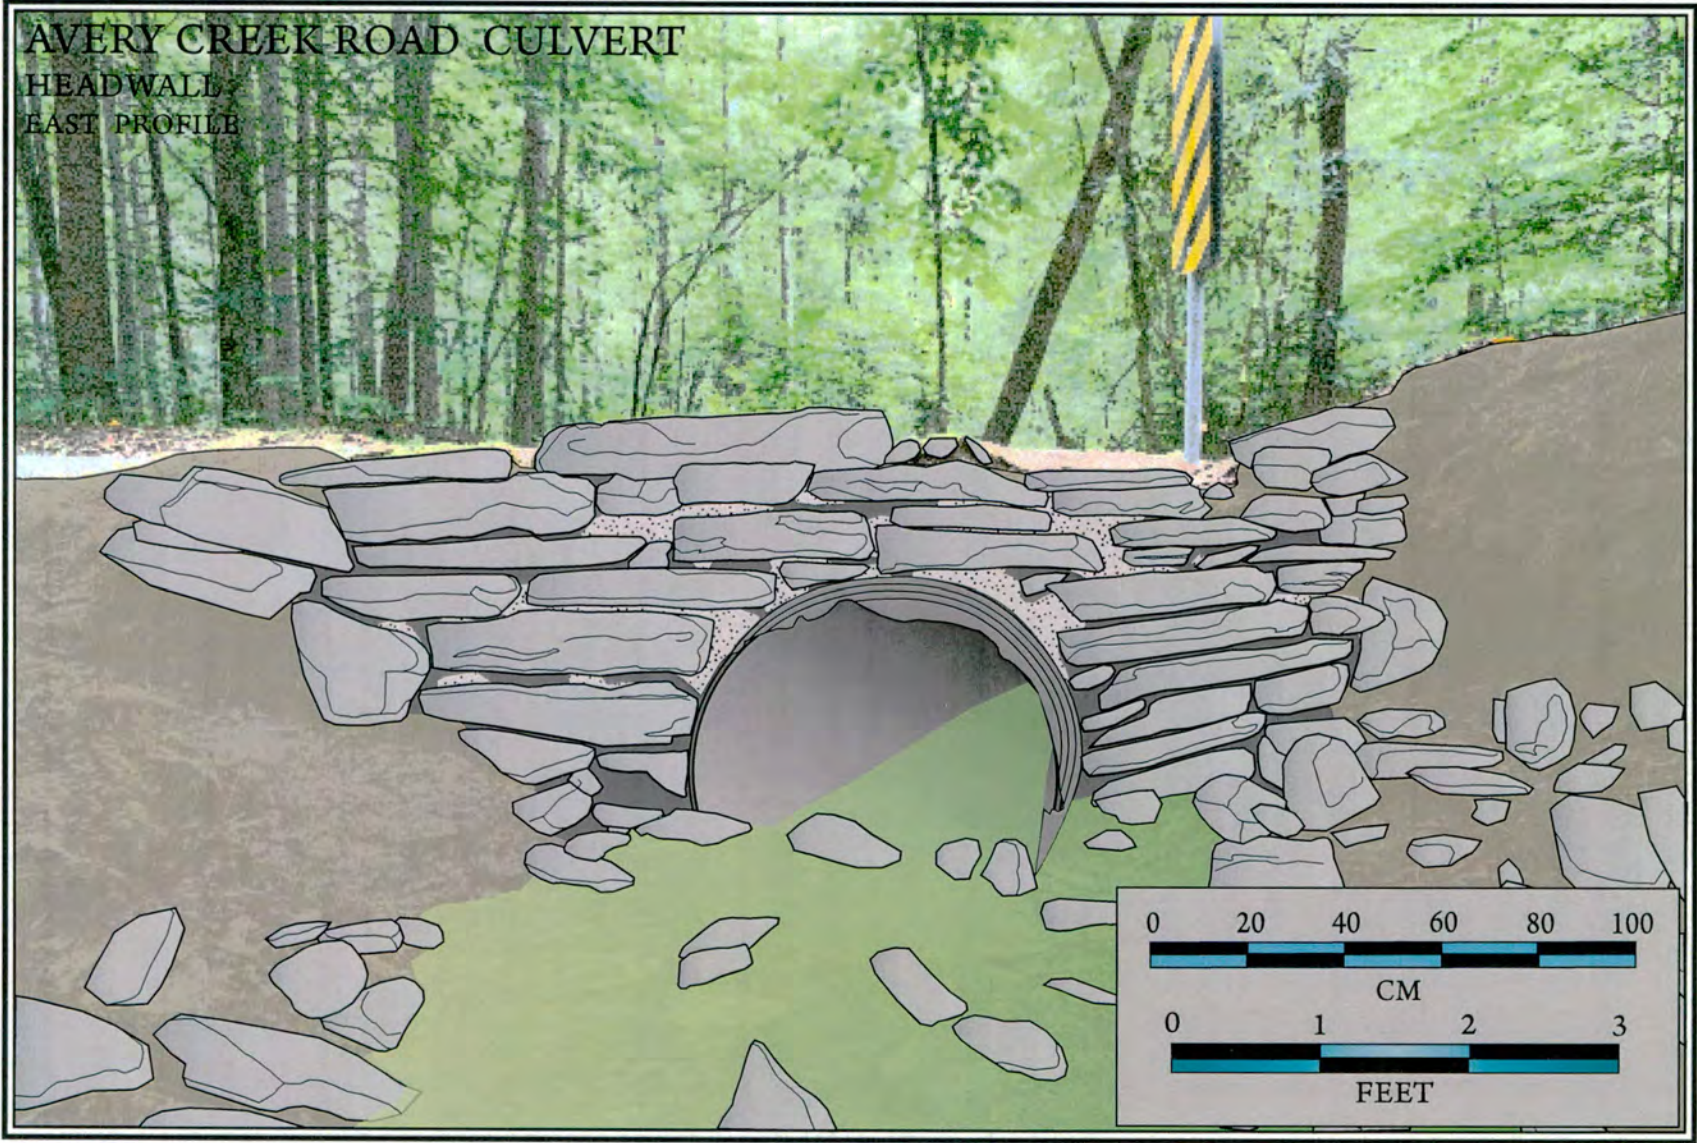
Figure 16. Profile view (with scale) of headwall at Avery Creek Road culvert. View to east.

As noted above, the mortar that binds the stones of both the headwall and the outflow wall is eroded in places, and this is especially the case near the base of both walls and in those areas immediately surrounding the steel culvert. The slap-dash and at times globular appearance of the mortar bond finish of the headwall contrasts with the smooth and more narrowly pointed bonds of the outflow wall. It is also clear that the mason of the outflow wall made a much more concerted effort to arrange stones in such a way that the end result was an exterior (east wall) surface that may be characterized as smooth and plumb, where the face of each stone was closely aligned with each of those beneath it and beside it. The same cannot be said of the western headwall. Despite the extra care and greater craftsmanship applied to the outflow wall, the stonework of this particular wall has suffered significant damage. The top four courses of stone in the north half of the wall are now pushed eastward by several inches and the northernmost and topmost several courses of stone have separated from the rest and settled downward by

several inches. The displacement of these stones is likely the result of impact with a heavy machinery or logging truck. Not surprisingly, the more poorly constructed west headwall has also suffered loss of integrity over time. Several of its uppermost stones are now displaced, while others appear to be missing. Stones at the north end of this wall may have been displaced by those who maintain the roadside ditches—one of which empties immediately adjacent to, if not onto the north end of the headwall. Most adversely impacted has been the corrugated steel pipe that passes beneath the Forest Road from headwall to outflow wall. Rust likely created a weak surface near its western end and the passage of some particularly heavy vehicle has recently created a breach in the top of the pipe and in the surface of the road (see Figures 14d and 15). The placement of a reflective caution sign on one side of this hole prevents others from driving over it, but its occurrence may indicate that the integrity of other portions of the steel pipe are also nearly as compromised.
