**SUBJECT:** Historic Structures Survey Report for the Replacement of Bridge 148 and I-95 Exit 19  
Improvements at SR 1528, PA 16-04-0028, Robeson County, ER 17-0881

**SUBJECT:** PA No. 16-04-0028, Replace Bridge No. 148 and I-95 Exit 19  
Improvements at SR 1528 (Carthage Road), Robeson County

**Replace Bridge No. 148 and I-95 Improvements to Exit 19  
on SR 1528 (Carthage Road),  
Robeson County, North Carolina**

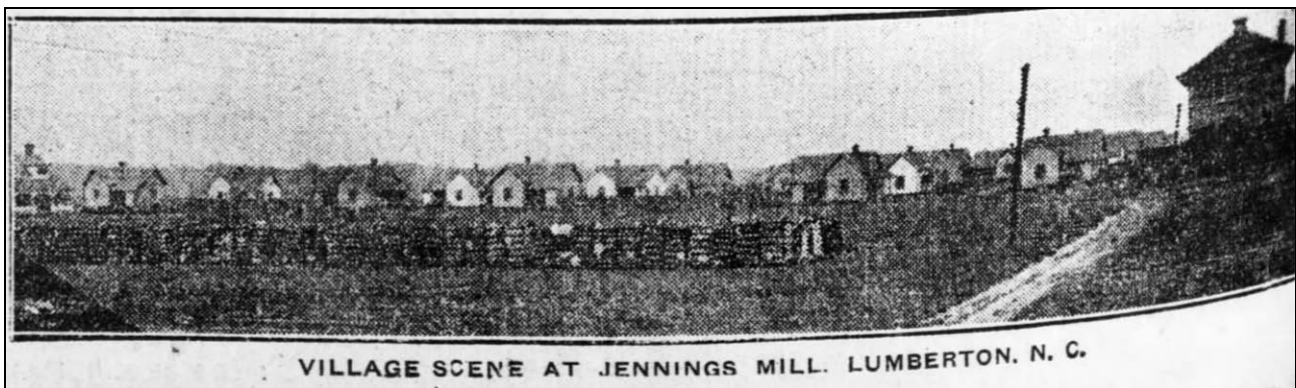
Alterations to Type A houses are many. Brick foundation piers have been infilled with brick or concrete block or totally displaced, generally by concrete. Windows are now often single-light with snap-in muntins. In some instances, a fourth bay has been added to the front elevation. Picture windows have also been inserted. Aluminum, vinyl, asbestos, and even some brick veneer cover or replace the weatherboards. At the façade gables these later materials may hide the ventilator. Porches often have lost their balusters and posts; some are enclosed. Chimney stacks have been removed from some houses, along with façade gables. Shed-roofed rooms with a recessed porch now fill the space between the legs of the ell and front block. These additions may date from 1923, when plumbing was brought to the houses. In many instances, ells have been further altered or extended. Depending on the number and severity of these changes, houses have been found to have lost their integrity. No formula for integrity was set, but the individual changes at each house are described in the following table.

**Figure 11. Looking north from mill at store/school at far right and Type A houses across Carthage Road; note interior stacks and off-center ells (*Charlotte News*, February 21, 1917)**

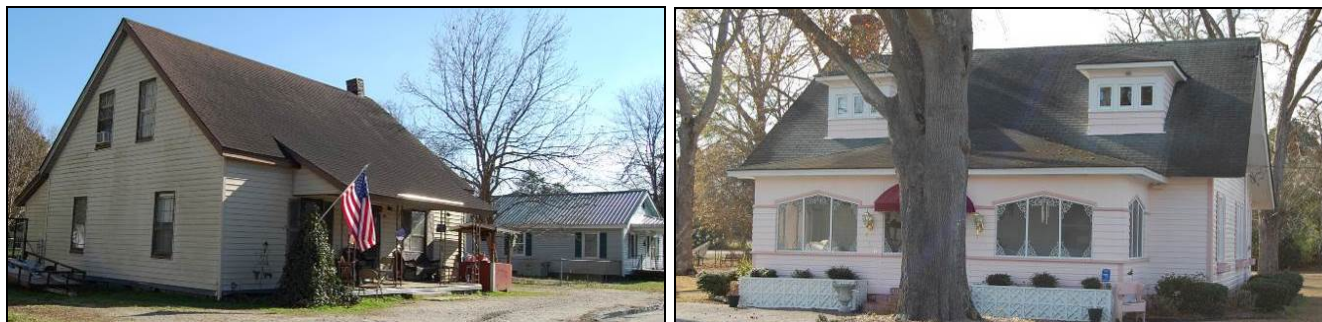
Type C is comprised of ten similar, but not matching, frame houses that are double-pile and topped by gable-end roofs (Figure 15). These dwellings are larger than Types A and B and likely housed either large families or higher-status mill workers. Their locations—either on the south side of Carthage Road close to the mill or at what was the northern edge of the village in 1924 as recorded by the Sanborn map—suggest the latter. In 1924 eight double-pile, gable-end houses stood at the village’s northern edge, five of which are extant. The survivors—22 Albion, 33 Bradford, 67 Crescent, and 76 and 77 Delmar—have or had chimneys located centrally or at their interior gable ends, and three-bay-wide, shed-roofed porches. The porches and interior chimney placement are like those of Type A; the double-pile footprint is not. Five of the ten double-pile, gable-end houses standing on Velcord near the mill in 1924 survive. The three at 4, 107, and 108 Velcord look similar to those in the village proper, but have deeper footprints. The two biggest Type C houses, at 3 and 106 Velcord, have even deeper footprints and usable half stories served by dormers. Type C houses likely had a similar finish to Type A houses, but the few survivors and numerous alterations foreclose determining their original features.

**Figure 15. Type C variants at 77 Delmar Street, at left, and 106 Velcord Drive, at right**  
**Inventory list**

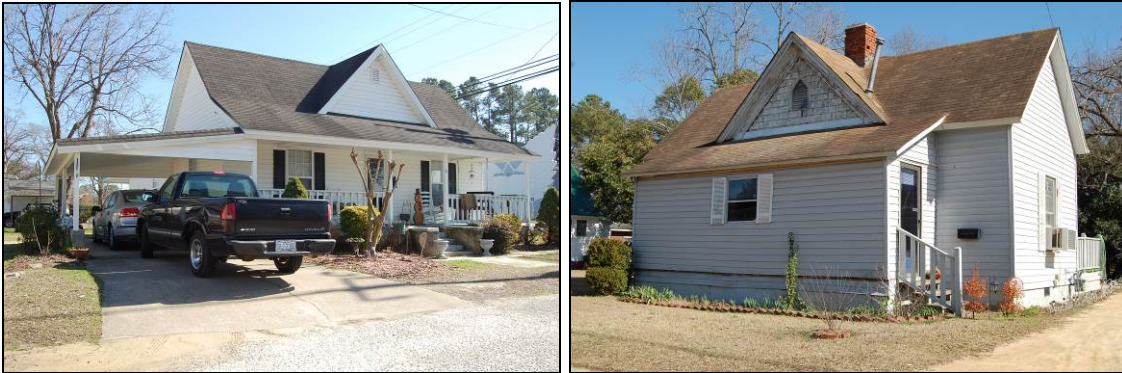
**Figure 17. 6 Albion St at left and 8 Albion St at right**

Address/ Mill Lot No.	Date	Type	Original/early features retained	Alterations	Contributing/C or Noncontributing/NC to potential HD – integrity losses
6 Albion/ Lot 6	c1910 -1923	A	Form, gables, bay placement intact	Artificial siding, windows replaced with snap-in sash, porch rebuilt and extended across entire façade, chimney stack removed, shed ell added at north side and carport at south side	NC – lost integrity of design, materials, workmanship, feeling
8 Albion/ Lot 8	c1910 -1923	A	Form, gables, bay placement, stack intact; façade gable retains ventilator, imbricated shingles	Artificial siding, windows replaced with snap-in sash, porch enclosed by siding	NC – lost integrity of design, materials, workmanship, feeling
10 Albion/ Lot 10	c1910 -1923	A	Form, gables intact; retains ventilator, imbricated shingles at façade gable	Artificial siding, replacement snap-in sash, bay window added as fourth façade bay, later porch balustrade and seam-metal roof added	C – retains integrity

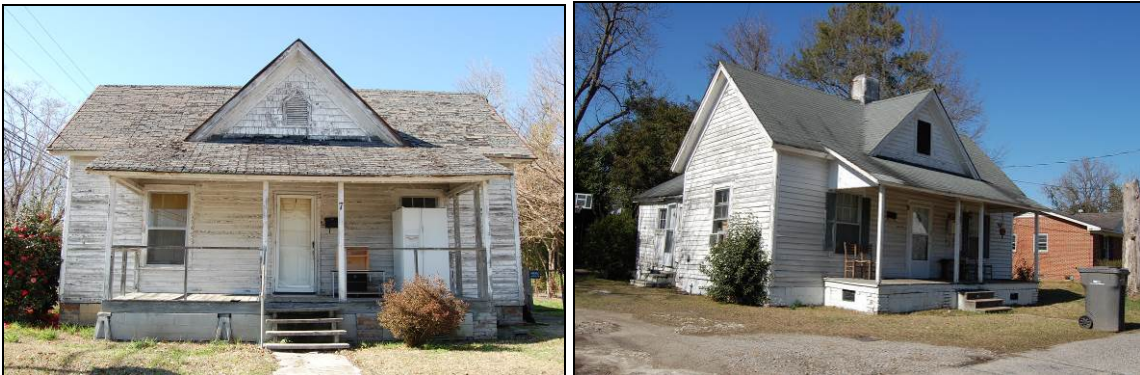
**Figure 22. 7 Albion St at left and 9 Albion St at right**

Address/ Mill Lot No.	Date	Type	Original/early features retained	Alterations	Contributing/C or Noncontributing/NC to potential HD – integrity losses
7 Albion/ Lot 7	c1910 -1923	A	Form, gables, bay placement, corbeled stack, sash, porch intact; façade gable retains imbricated shingles, ventilator	Brick foundation piers supplemented with concrete block, porch balustrade removed; shed added to rear ell	C – retains integrity
9 Albion/ Lot 9	c1910 -1923	A	Form, gables, bay placement, stack, sash, porch intact; façade gable retains imbricated shingles	Brick foundation piers supplemented with concrete block, porch balustrade and chimney corbeling removed	C – retains integrity
11 Albion/ Lot 11	c1970 -1979	Not a mill house	Lot vacant on 1924 and updated 1950 Sanborn maps	One-story, gable-end, brick-veneered, minimal traditional house erected 1972 according to tax records	NC – outside area and period of significance

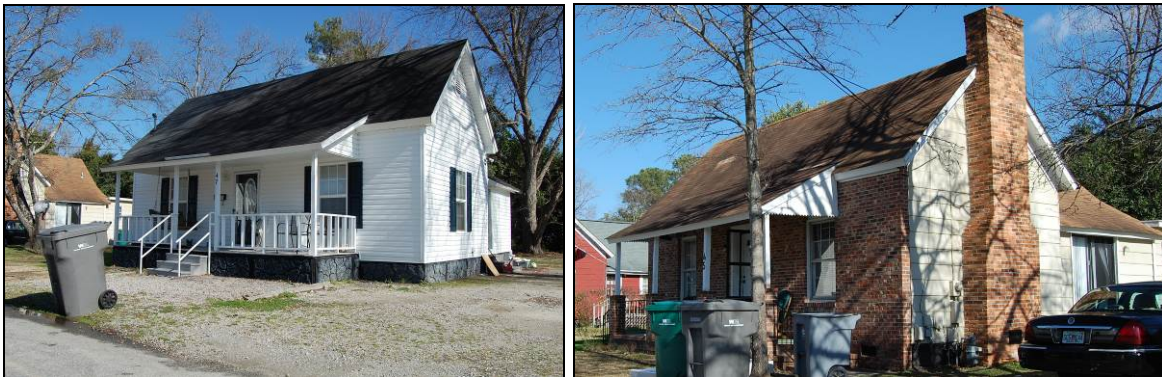
**Figure 27. 47 Bradford St at left and 45 Bradford St at right**

Address/ Mill Lot No.	Date	Type	Original/early features retained	Alterations	Contributing/C or Noncontributing/NC to potential HD – integrity losses
45 Bradford/ Lot 45	c1910 -1923	A	Form, bay placement, sash intact	Brick veneer added to front elevation and artificial siding at gables, central stack removed and replaced by exterior-end brick chimney, façade gable removed, porch replaced	NC – lost integrity of design, materials, workmanship, feeling
43 Bradford/ Lot 43	c1910 -1923	A	Form, gables, façade gable ventilator, some sash intact, chimney stack in place	Aluminum siding, metal porch supports, some 1/1 sash, long shed ell addition	C – retains integrity
41 Bradford/ Lot 41	c1910 -1923	A	Form, gables, bay placement intact	Vinyl siding, porch balusters and turned posts added, façade gable ventilator replaced, snap-in sash, windows added at end-gable peaks, chimney stack removed	NC – lost integrity of design, materials, workmanship, feeling

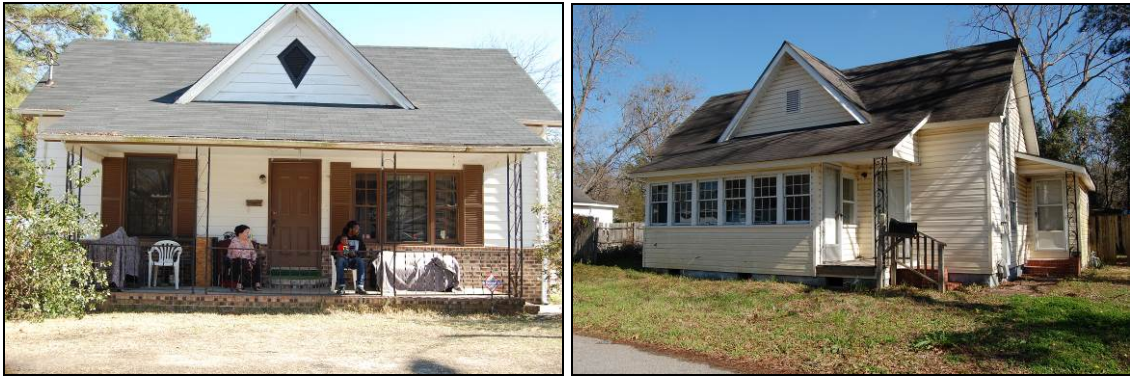
**Figure 29. 39 Bradford St at left and 37 Bradford St at right**

39 Bradford/ Lot 39	c1910 -1923	A	Form, gables, bay placement, façade gable ventilator intact	Artificial siding and brick veneer, triple window added at façade, porch supports replaced, central chimney stack removed, ell extended	NC – lost integrity of design, materials, workmanship, feeling
37 Bradford/ Lot 37	c1910 -1923	A	Form, gables intact	Artificial siding, snap-in sash, porch fully enclosed and fixed windows added, entry location shifted, chimney stack removed	NC – lost integrity of design, materials, workmanship, feeling
35 Bradford/ Lot 35	c1927	B	Form, bay placement, brick porch piers, most sash intact	Vinyl siding, porch posts altered	C – retains integrity
33 Bradford/ Lot 33	c1910 -1923	C	Form intact	Vinyl siding and brick veneer, porch posts, piers and double window bay added at façade, sash replaced, chimney stack removed and (base of) exterior end stone chimney added	NC – lost integrity of design, materials, workmanship, feeling

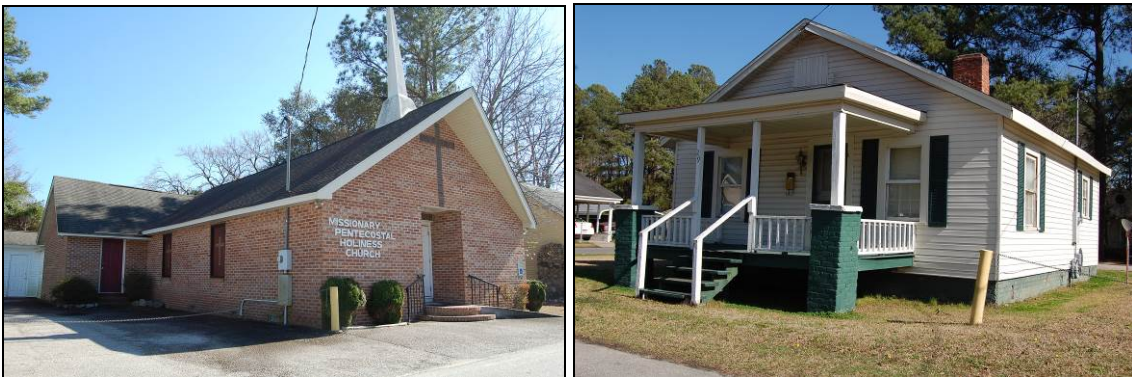
**Figure 31. 31 Bradford St at left and 29 Bradford St at right**

31 Bradford/ Lot 31	c1990 -1999	Not a mill house	Mill house that stood on lot by 1924 no longer extant	Missionary Pentecostal Holiness Church – modern, brick-veneered, front gabled church with T-shaped footprint	NC – outside area and period of significance; Freewill Church of God purchased property in 1956
29 Bradford/ Lot 29	c1927	B	Form, bay placement, some sash, and porch piers and posts intact	Artificial siding, boxed-in rafter tails, most sash replaced	C – retains integrity
48 Bradford/ Lot 48	c1910 -1923	A	Form, gables, bay placement intact and central chimney in place	Vinyl siding, snap-in sash, new turned porch supports and balusters, extended rear ell and attached open two-car garage	C – retains integrity
46 Bradford/ Lot 46	c1910 -1923	A	Form, gables, bay placement, façade gable ventilator intact	Aluminum siding, 2/2 sash, metal porch posts, removed central chimney stack	C – retains integrity

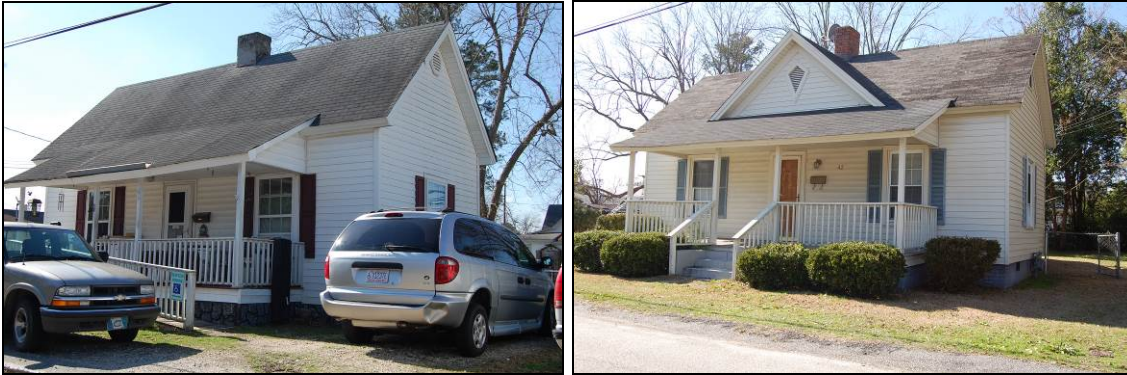
**Figure 33. 44 Bradford St at left and 42 Bradford St at right**

Address/ Mill Lot No.	Date	Type	Original/early features retained	Alterations	Contributing/C or Noncontributing/NC to potential HD – integrity losses
44 Bradford/ Lot 44	c1910 -1923	A	Form, end gables, porch posts, chimney stack in place	Artificial siding, snap-in-sash, altered porch steps and balusters, faux-rock foundation, removed façade gable	C – retains integrity
42 Bradford/ Lot 42	c1910 -1923	A	Form, gables, bay placement, porch posts, chimney stack, façade gable ventilator intact	Vinyl siding, snap-in sash, later porch balusters	C – retains integrity
40 Bradford/ Lot 40	c1910 -1923	A	Form, end gables, porch posts in place	Artificial siding, 2/2 sash, altered porch balusters, removed façade gable and central chimney stack	C – retains integrity
38 Bradford/ Lot 38	c1910 -1923	A	Form, end gables, chimney stack intact	Aluminum siding, porch piers added, one front window doubled, snap-in sash, removed façade gable	NC – lost integrity of design, materials, workmanship, feeling

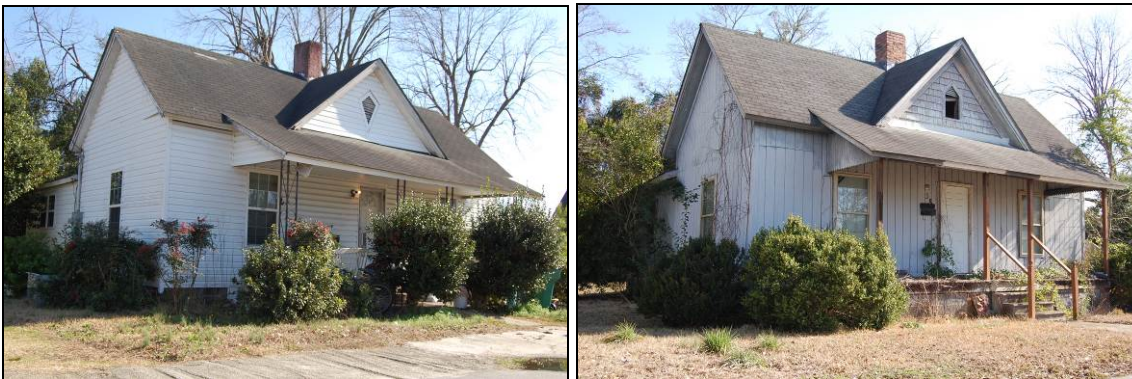
**Figure 39. 56 Crescent St at left and 58 Crescent St at right**

Address/ Mill Lot No.	Date	Type	Original/early features retained	Alterations	Contributing/C or Noncontributing/NC to potential HD – integrity losses
58 Crescent/ Lot 58	c1910 -1923	A	Form, gables, façade gable ventilator and imbricated shingles, bay placement, central chimney stack intact	T1-11-type siding, replaced porch posts, snap-in sash	C – retains integrity
60 Crescent/ Lot 60	c1910 -1923	A	Form, gables, façade gable ventilator, bay placement, central chimney stack intact	Vinyl siding, snap-in sash, metal porch supports, ell extended to rear and side	C – retains integrity
62 Crescent/ Lot 62	c1910 -1923	A	Form, gables, porch posts, central chimney stack intact	Vinyl siding, one façade window doubled, porch balustrade altered, ell extended to rear and side	C – retains integrity
64 Crescent/ Lot 64	c1927	B	Form, bay placement, exposed rafter ends intact	Aluminum siding, 1/1 sash, metal porch posts	C – retains integrity

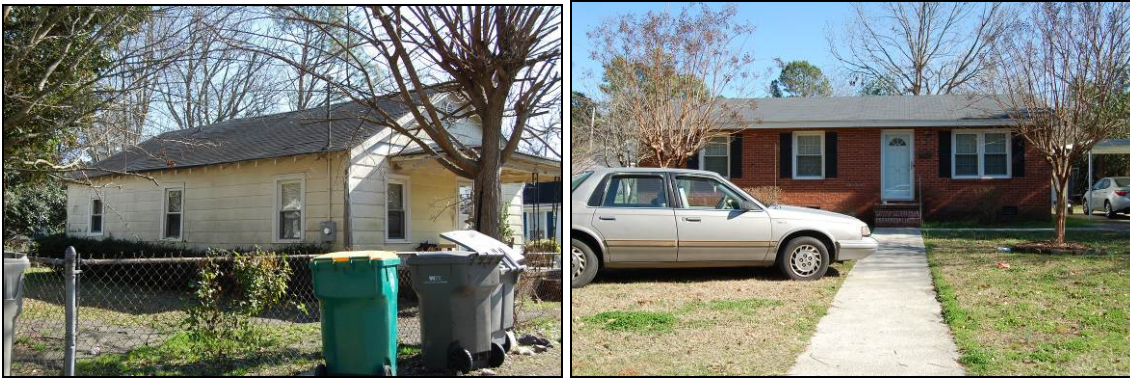
**Figure 41. 64 Crescent St at left and 66 Crescent St at right**

66 Crescent/ Lot 66	c1970 -1979	Not a mill house	Mill did not build a house on this lot	Single-pile, gable-end, vinyl-sided and brick-veneered house	NC – outside area and period of significance
68 Crescent/ Lot 68	c1927	B	Form, bay placement, 6/6 sash intact	Vinyl siding, porch posts and balustrade, boxed-in rafter tails	C – retains integrity
70 Crescent/ Lot 70	c1927	B	Form, bay placement, 6/6 sash at original block intact	Vinyl siding, replaced porch, doubled in size with extension to rear and entrance added along W. 24 <sup>th</sup> St.	NC – lost integrity of design, materials, workmanship, feeling
51 Crescent/ Lot 51	c1910 -1923	A	Form, gables, bay placement, sash, porch posts and perhaps even balustrade, chimney stack intact	Vinyl siding , side shed extension off of ell	C – retains integrity
53 Crescent/ Lot 53	c1910 -1923	A	Form, gables intact	Vinyl siding over weatherboards, fully enclosed with façade gable and windows, new different-sized sash at gable ends, chimney stack removed, ell extended to rear and side	NC – lost integrity of design, materials, workmanship, feeling

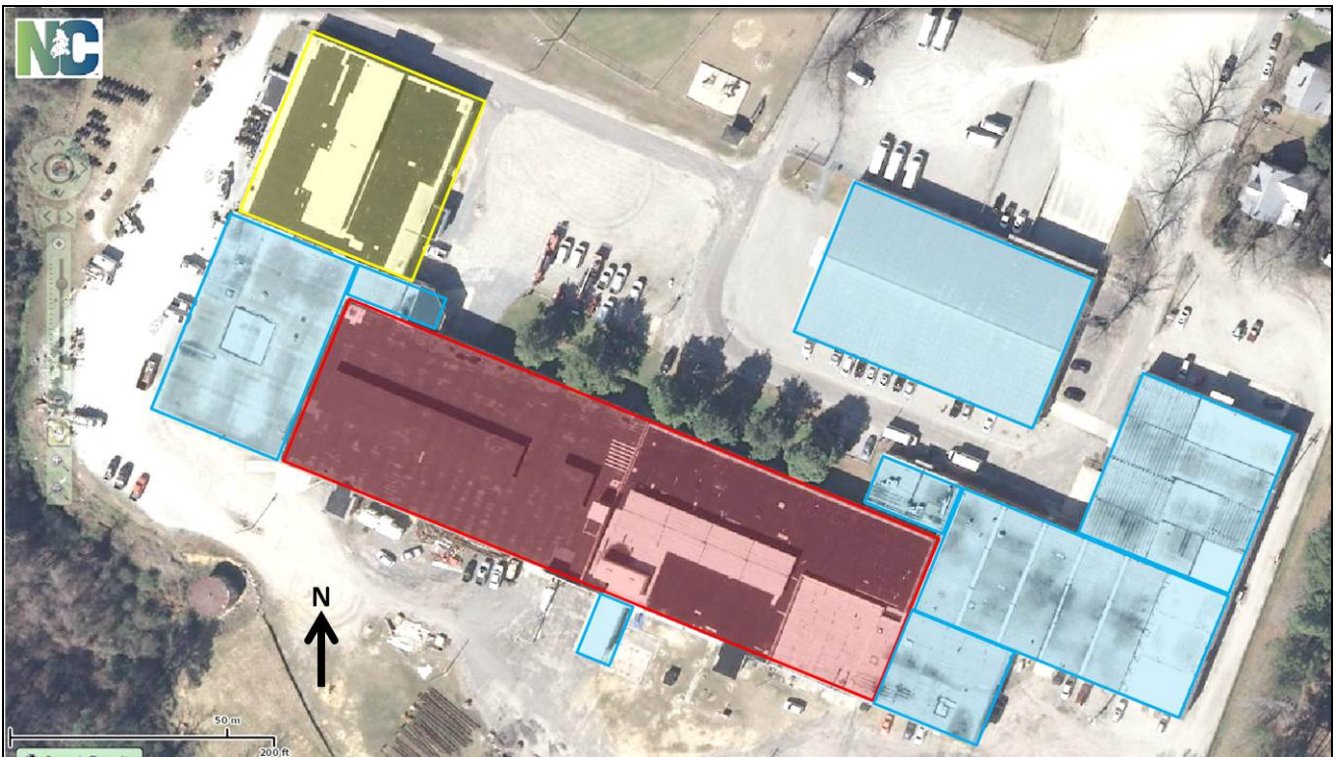
The Jennings Cotton Mill building was erected between 1910 and about 1965 on an almost 30-acre tract of former farmland that extended south from the edge of Carthage Road to the north bank of the Lumber River. It was built in three main phases, as shown in shaded colors on a modern aerial image of the complex (Figure 73): (1) the original brick building (shaded in red) was built in 1910-1911; (2) a nearly square brick building to the northwest, originally connected by a small hyphen, was added in 1927 (yellow); and (3) concrete-block and sheet-metal sided extensions and a freestanding warehouse were erected between about 1957 and 1965 (blue).

**Figure 73. Jennings Cotton Mill, periods of construction (source of base map: North Carolina HPO)**

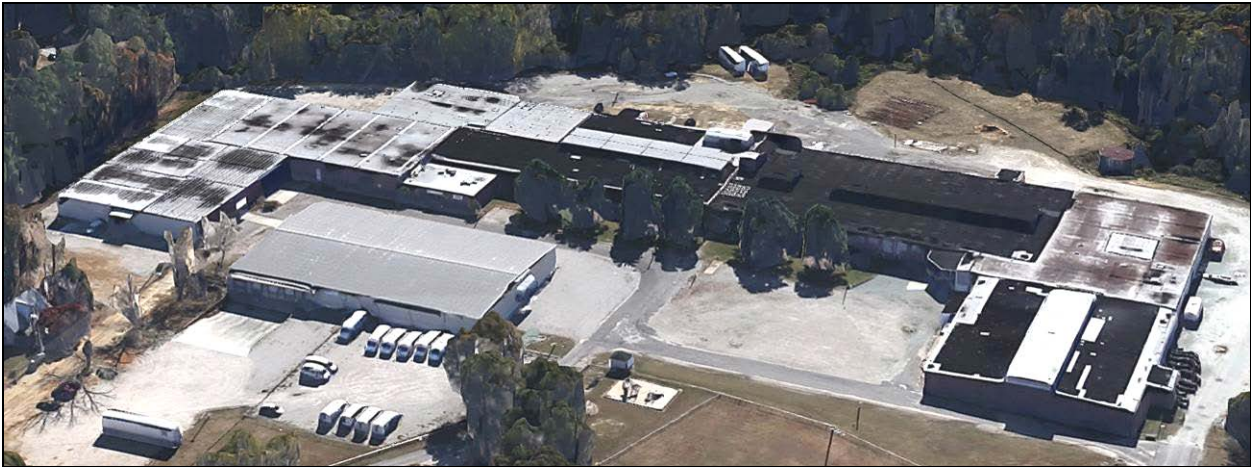
Modern photographs of the mill, from the air and the ground, show how dramatically it has changed since 1957 (Figure 81 through Figure 95). Between about 1957 and 1965, the mill’s then owners, Vel-Cord Southern, extended it with one-story additions in almost all directions. At the southwest, between the original mill and the 1927 addition, it added a sheet-metal-sided wing. At the east it supplanted the early frame wing with a large, roughly L-shaped, concrete block addition. The front of this addition, extending partially across the front of the original mill, is brick-veneered. Vel-Cord also added a freestanding, gable-roofed, sheet-metal-sided warehouse building to the north. Further, Vel-Cord or subsequent owners bricked-in, filled with concrete block, or covered with corrugated fiberglass sheeting all of the mill’s original windows and removed all of the remaining small subsidiary buildings. The only surviving freestanding resource, aside from the warehouse, is an on-ground, metal water tank.

**Figure 82. Modern Google Earth image of north front of mill**

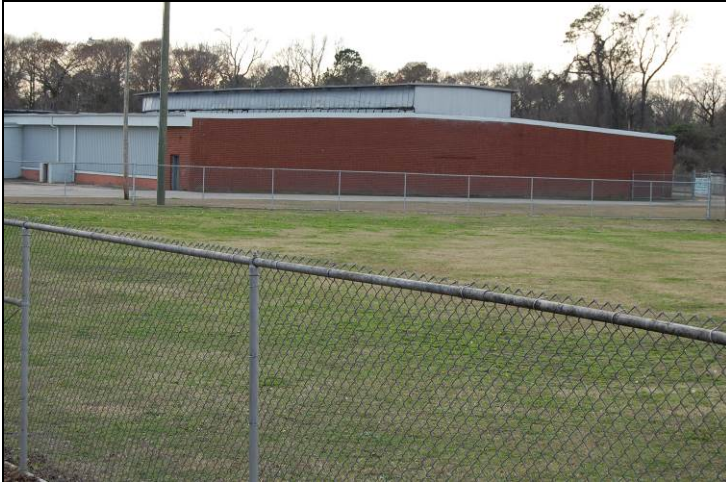
**Figure 85. East and north-facing elevations of 1927 knitting room; note post-1957 covering of window bays and clerestory with sheet metal and brick veneer**

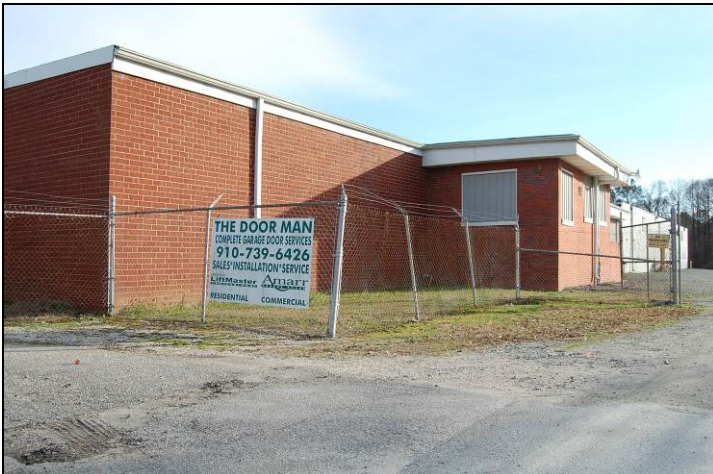
**Figure 86. West-facing elevation of 1927 knitting room with windows hidden by later brick veneer**

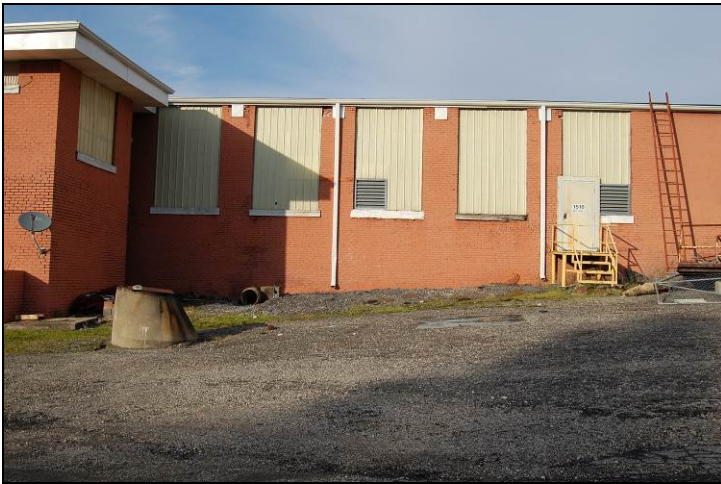
**Figure 88. South rear elevation of original mill building; windows enclosed by brick, concrete block, and fiberglass panels**

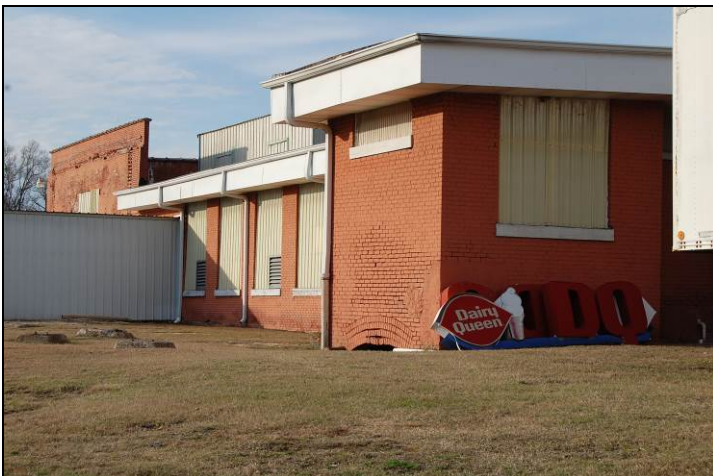
**Figure 89. Detail of western portion of south elevation with windows covered by fiberglass panels and, at right, red-painted concrete-block infill**

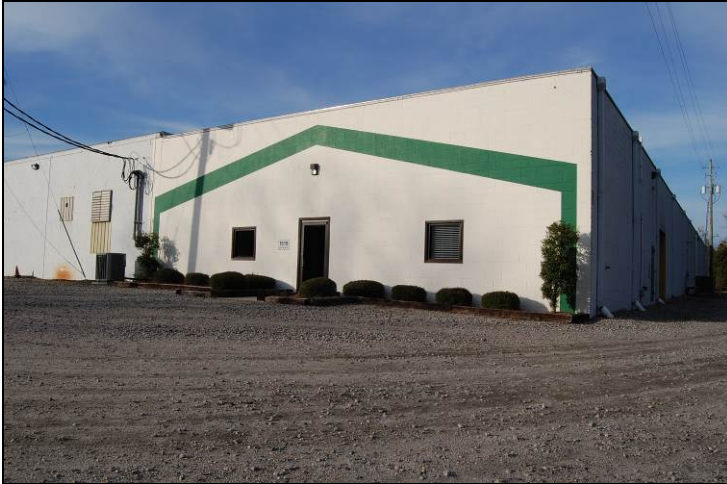
**Figure 90. Detail of eastern portion of south elevation; ghost marks of former powerhouse visible at parapet wall at left**

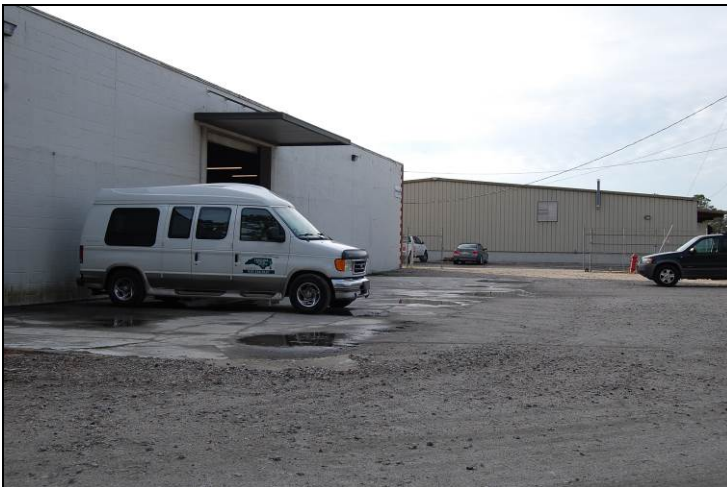
**Figure 91. South rear and east side elevations of c.1957-1965 concrete-block addition at mill's southeast corner**

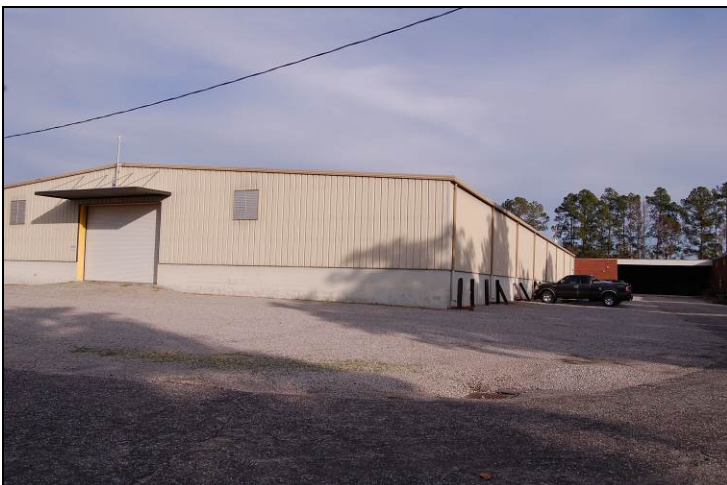
**Figure 92. North front elevation of southeast corner addition, at left, and east rear elevation of c.1957-1964 freestanding warehouse at right**

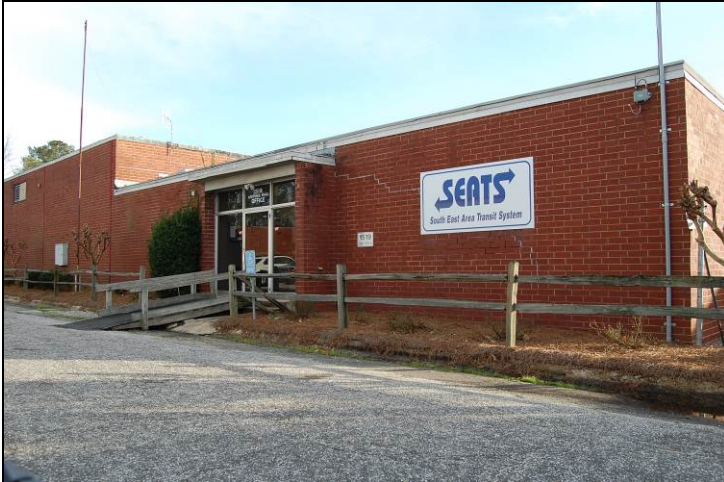
**Figure 93. West front and south side elevations of warehouse**

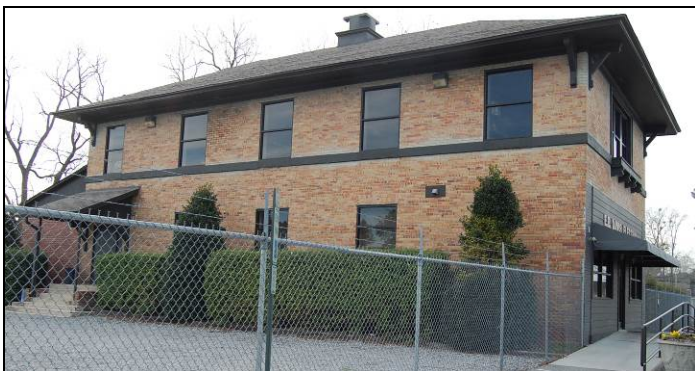
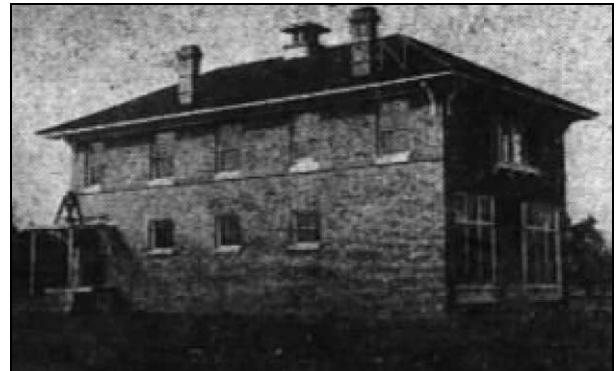
Brick walls, window bay placement, brackets, and roof form appear little altered when compared to a 1913 photograph. Many other exterior features have been altered, however. All of the building's multi-pane, double-hung sash have been replaced by modern 1/1 windows. The band that wraps the building is not original, but rather was set over the initial brick belt course when the building was renovated within the past few decades. This renovation also removed the tall paired storefront windows and original entry, which were supplanted by bands of brick, horizontal boards, and a modern door and windows. The central chimney stack was altered but left in place. Two corbeled brick stacks at the interior of the east elevation were removed, though. A shed-roofed, brick-veneered room that extends across half of the rear elevation, not standing in 1913, was left in place (Figure 97 through Figure 100).

**Figure 97. Store/school: long east side and street-facing north front elevations (source of image at right: *Robesonian*, July 24, 1913)**

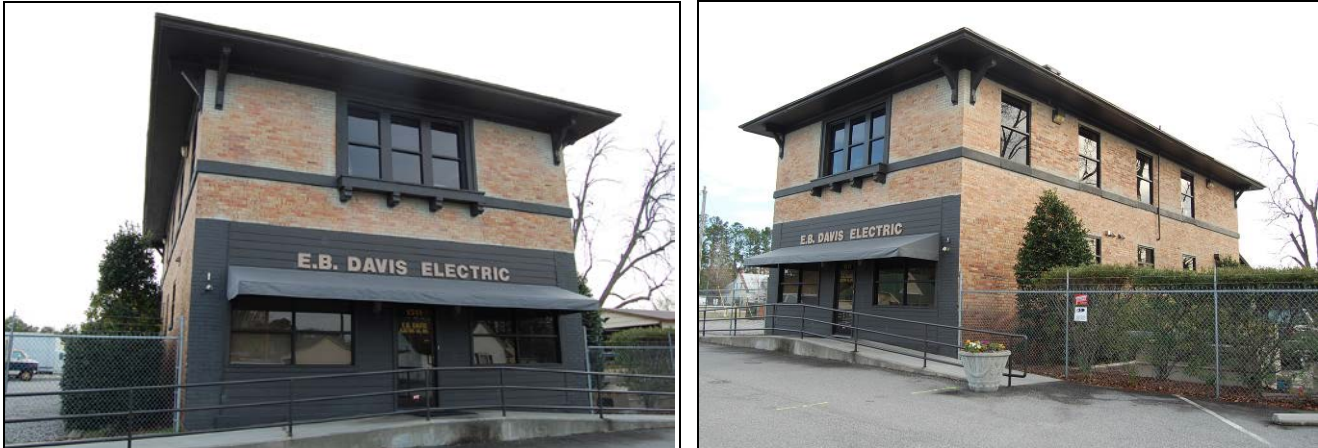
**Figure 98. Store/school: east side and north front elevations, at left; north front and west side elevations, at right**

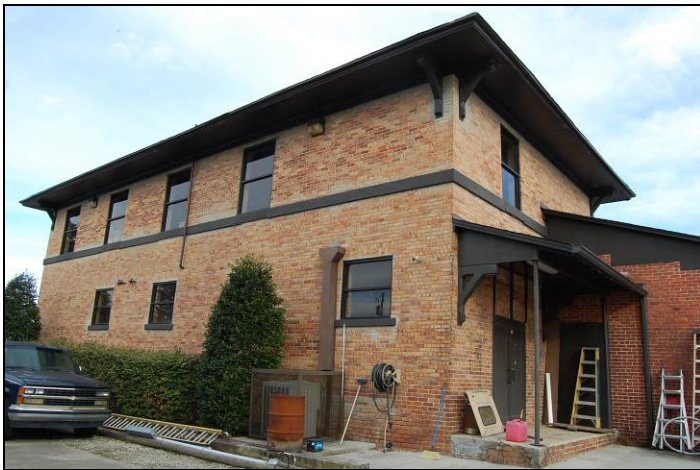
**Figure 99. Store/school: west side and south rear elevations; note rear porch with surviving kneebraces**

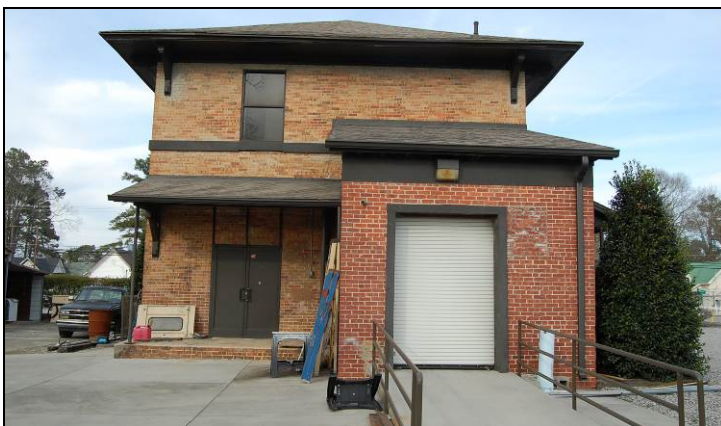
**Figure 100. Store/school: south rear elevation; porch but not shed room are in place at early photograph (source of historic image: *Charlotte Observer*, January 3, 1919)**

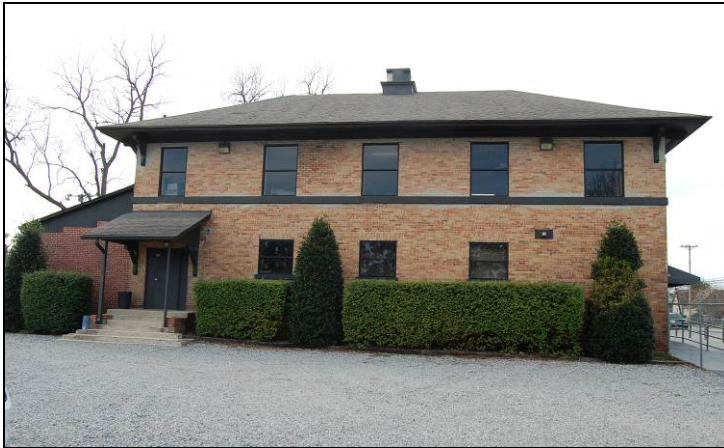
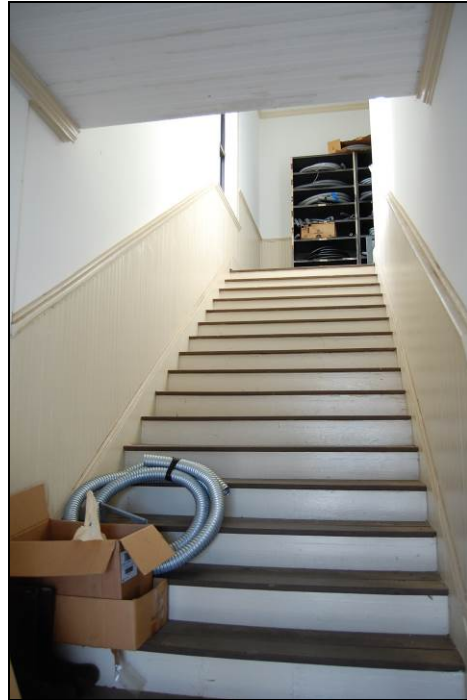
Inside, the first floor has been heavily altered, although it retains a bit of beaded-board wainscoting and ceiling board and some bull's-eye entry surrounds. It has been broken into multiple rooms by modern partitions and its mantels have been removed. The wainscot-flanked stair to the upstairs school room remains intact. The room is now filled with storage shelves and electrical supplies, but retains a slightly elevated stage, beaded ceiling boards, a wooden floor, and surrounds at the doorway leading out to the stairs marked by bull's-eye cornerblocks (Figure 101 and Figure 102).

**Figure 101. Store/school: east side elevation with shaded entry leading to school stairs at left; stairs leading up to second-story school room at right**

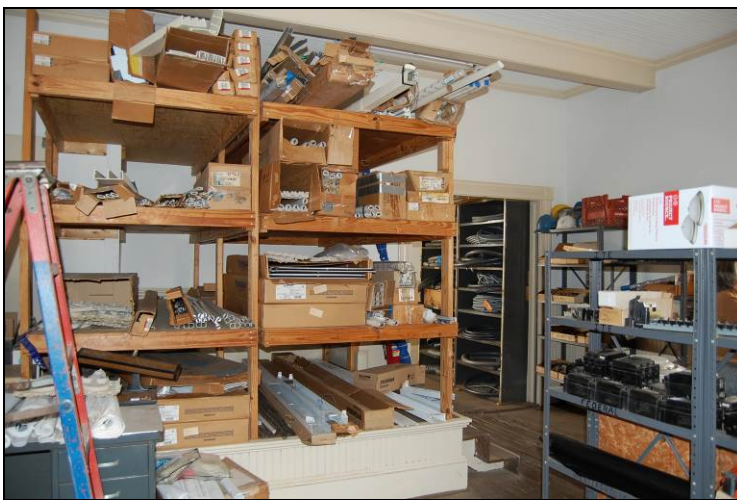
**Figure 102. School/store: second-story schoolroom with stage and two steps visible at bottom**
