SUBJECT: Historic Structures Survey Report for Roundabout at US 264 and NC 32, W-5702I,
PA 18-04-0006, Beaufort County, ER 18-3385

Historic Structures Report
TIP No. W-5702I, WBS No. 44848.1.1, PA No. 18-04-0006
Construct Roundabout at US 264 and NC 32
Beaufort County, North Carolina
S&ME Project No. 4213-18-199

**Historic Structures Report
TIP No. W-5702I
Construct Roundabout at US 264 and NC 32
Beaufort County, North Carolina**

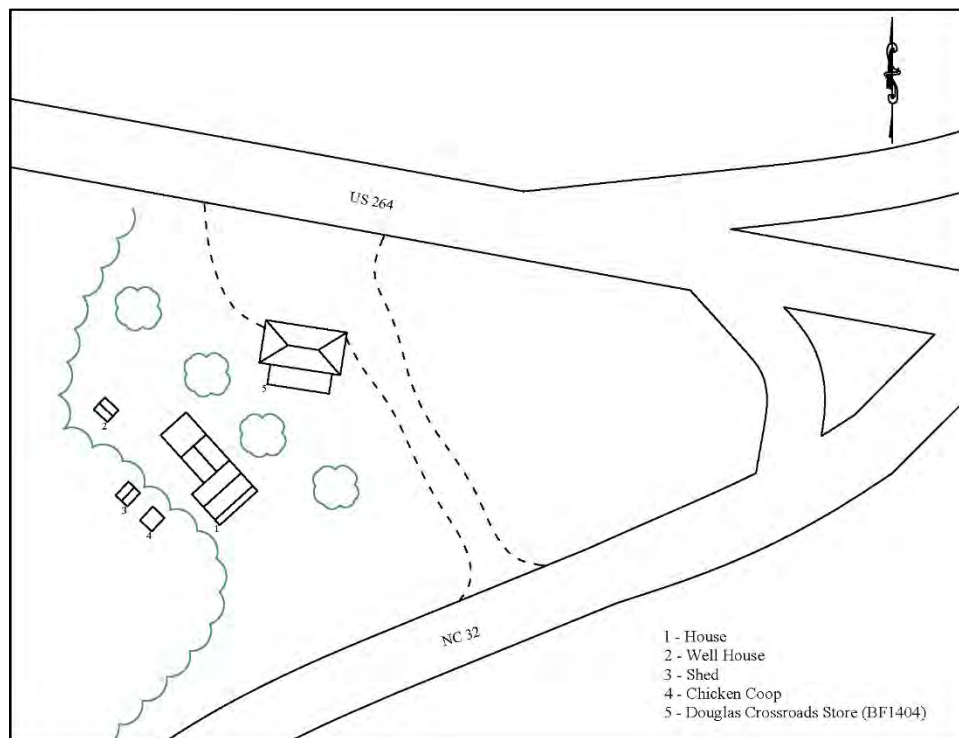
Figure 2.1.51. Site plan of the Jack Douglas House (BF1412).

The Jack Douglas House (BF1412) is located at 8275 Broad Creek Road, southwest of the intersection of US 264 and NC 32, approximately six miles east of the town center of Washington, in Beaufort County (Figures 1.1 and 1.2). The Jack Douglas House was originally surveyed as part of the historic architecture survey of rural Beaufort County in 2010 (Survey File 2010:BF1412). The house, which is located on the same approximately one-acre parcel as the Douglas Crossroads Store, is oriented toward Broad Creek Road and sits approximately 250 feet from the right-of-way. The form, materials, and details of the house suggest that it was built in the early-twentieth century. It is a one and one-half story residence with elements of Craftsman detailing (Figure 2.1.50). Associated with the Jack Douglas House are three outbuildings: an early-twentieth-century shed and chicken coop and a mid-twentieth-century well house (Figure 2.1.51).

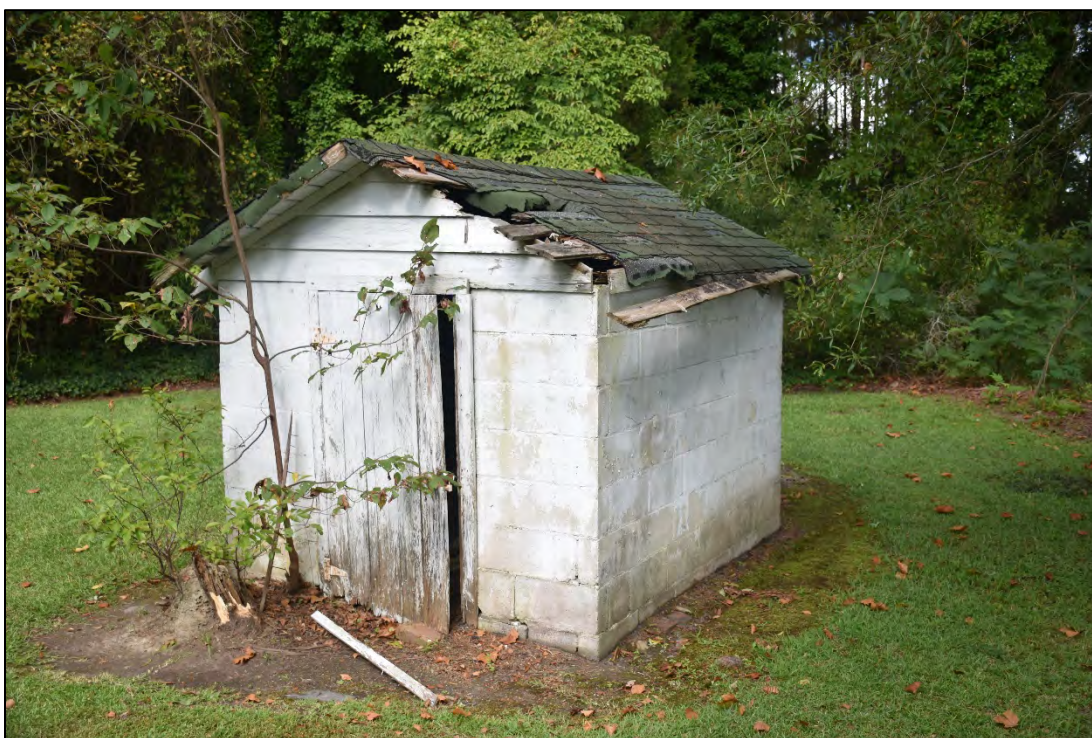
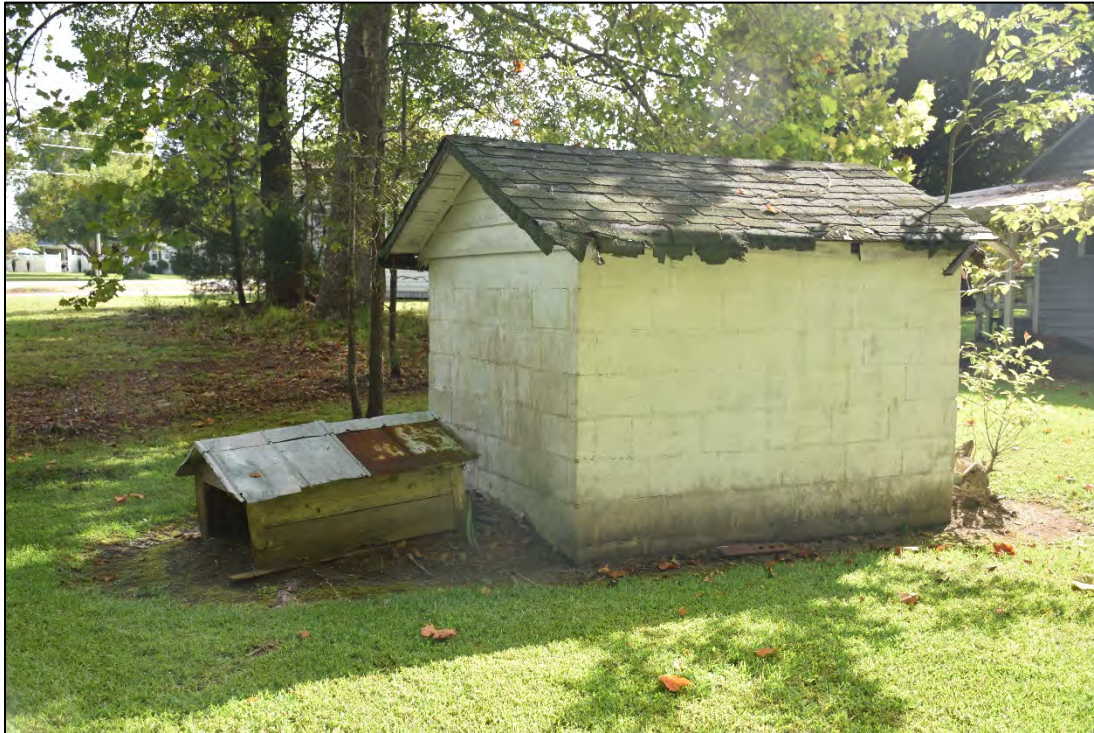
Surrounding the Jack Douglas House are three early-to-mid-twentieth century outbuildings. West of the house is a circa-1950s concrete block well house with a gabled roof, which is covered with asphalt shingles (Figures 2.1.58 and 2.1.59). South of the house are two early-twentieth-century structures that have not been in use in a number of years and have become overgrown with vegetation. A small, gable-roofed frame shed, with standing-seam metal roof, wooden siding, and visible rafter tails is slightly southwest of the house (Figure 2.1.60); east of the shed is a shed-roofed chicken coop, with wooden siding, standing-seam metal roof, and visible rafter tails (Figure 2.1.61). The Douglas Crossroads Store (BF1404) is also located on the tax parcel with the Jack Douglas House, but is surveyed under a unique survey number.

Figure 2.1.58. Jack Douglas House (BF1412), well house, facing southwest.

Figure 2.1.59. Jack Douglas House (BF1412), well house, facing northeast.

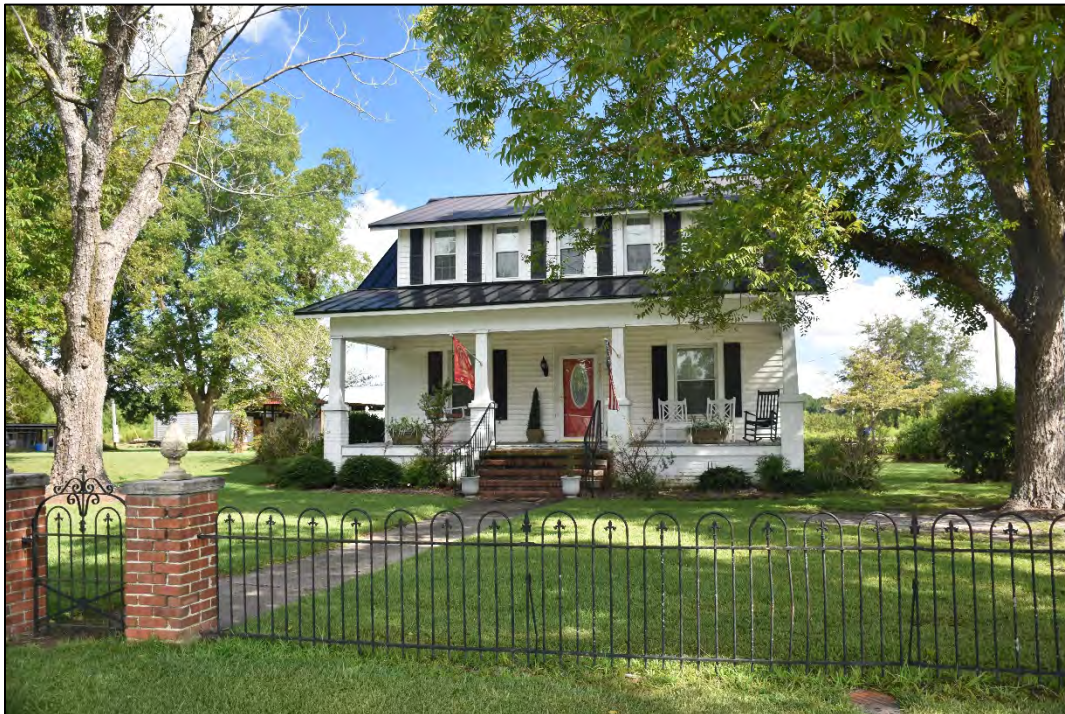
Figure 2.1.62. Douglas Farm house (BF1400), facing north.

In terms of comparative architecture for the Jack Douglas House, the closest comparable example is the house located on the Douglas Farm (BF1400), which is located at the northwest corner of US 264 and NC 32, at Douglas Crossroads (Figure 2.1.62). Both structures have a one-and-one-half-story main section with a rear ell; however, unlike the Douglas Farm house, the Jack Douglas House has not undergone significant modern alterations. Other examples of early-twentieth-century, side-gabled residences with at least nominal Craftsman detailing include the house at 23 Maple Street in Pantego (BF1052), that dates to around 1920, and a previously unsurveyed house at 25713 US 264 in Pantego (NSN – no survey number), which dates to around 1918. The house at 23 Maple Street has a similar side-gabled form and porch structure as the Jack Douglas House and it also retains much of its original Craftsman detailing along the eaves; however, it has a smaller, gabled dormer and more traditional tapered square columns resting on brick piers as porch supports (Figure 2.1.63). The house at 25713 US 264 also has a side-gabled form, with a shed-roofed dormer on the front elevation; however, its porch supports have been replaced with vinyl turned posts and the front porch has been enclosed (Figure 2.1.64).

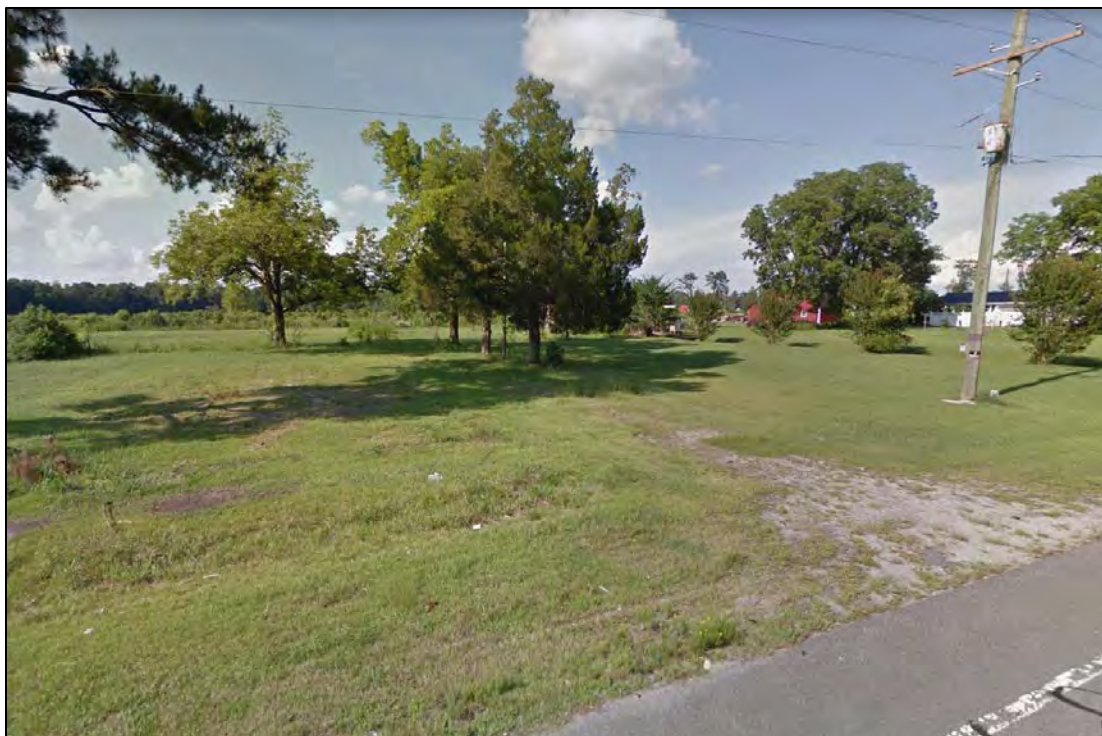
Figure 2.1.70. Location of Grady Douglas House (BF1437), facing northeast.

The Grady Douglas House (BF1437) was originally surveyed as part of the historic architecture survey of rural Beaufort County in 2010; it was identified as “House” with no historic association listed (Survey File 2010:BF1437). The house was located approximately 500 feet west of the intersection of US 264 and NC 32. The survey information indicates that it was a circa-1910 Foursquare house with a hipped roof and Colonial Revival details. Six outbuildings were associated with the house and located on the property. The Grady Douglas House was located on a portion of the James C. Douglas Farm that James Douglas sold to his son, Grady P. Douglas and his wife, Callie, in 1939 as he divided his property among his six children; Grady Douglas’s portion of the property contained approximately 60 acres but there was no mention of a structure in the deed. In 2012, the 60 acre parcel was sold to Douglas Crossroads, LLC. A field visit to the location of the Grady Douglas House indicates that the structure is no longer extant (Figure 2.1.70). Aerial photographs show that the house was demolished between 2014 and 2015 (Figures 2.1.71 and 2.1.72).
