**HISTORIC ARCHITECTURE  
ELIGIBILITY EVALUATION REPORT:  
WOODEN BRIDGES AND FOOTPATHS/ROADWAY  
WITHIN PEA ISLAND NATIONAL WILDLIFE REFUGE**

**Phase IIa for the Replacement of the Herbert C. Bonner Bridge  
(Bridge No. 11) on NC 12 over the Oregon Inlet  
and Improvements to NC 12, Dare County**

**TIP# B-2500  
WBS# 32635  
FA# BRS-2358(15)**

**November 2016**

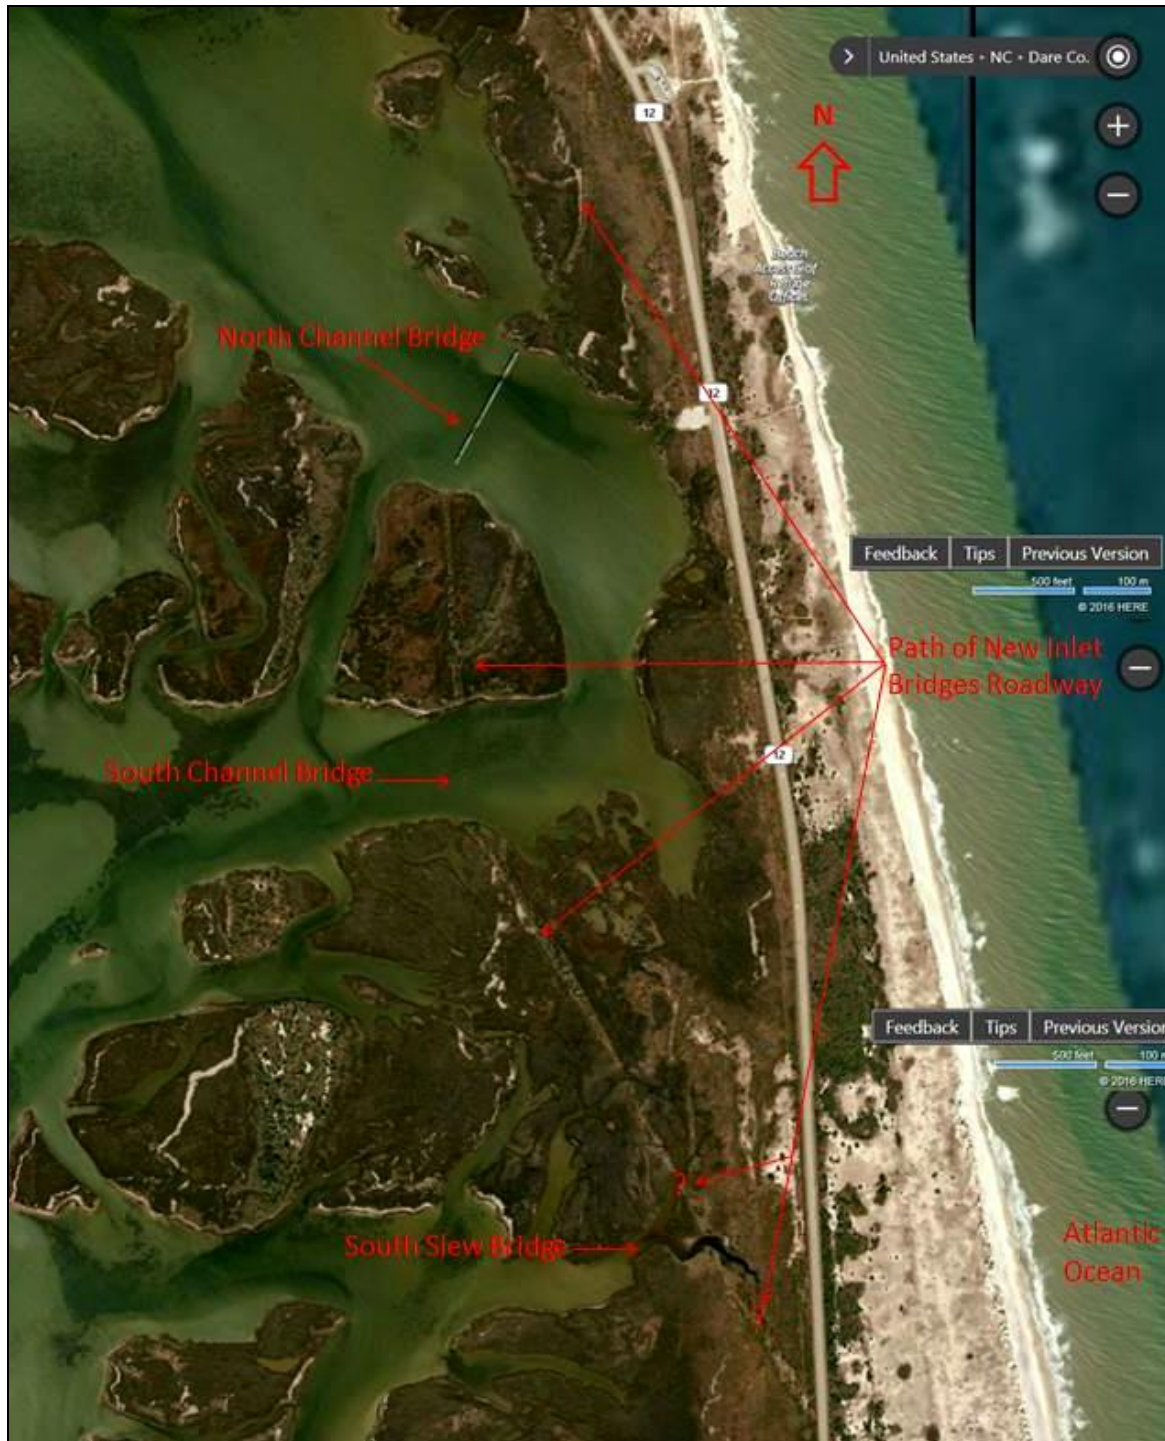
**Figure 24. Modern aerial photograph with resources labeled**

Although left unmaintained for at least 65 years, the three bridges continue to stand, in part, in Pamlico Sound (Figure 24). The north and south channel bridges can be viewed from NC 12 but, as some of the following photographs show, are best seen from a boat or kayak (Figure 26 through Figure 35). The South Slew Bridge, about five pile bents of which survive, is not apparent from the road and even difficult to identify in aerial photographs. It is depicted below through a series of bird's-eye aerial views (Figure 36 and Figure 37). Much of the path of the New Inlet Bridges Road is visible in aerial photographs. However, at ground level it is almost completely obscured by chest-high tangles of grasses. From the ground it is unrecognizable as a former roadway.

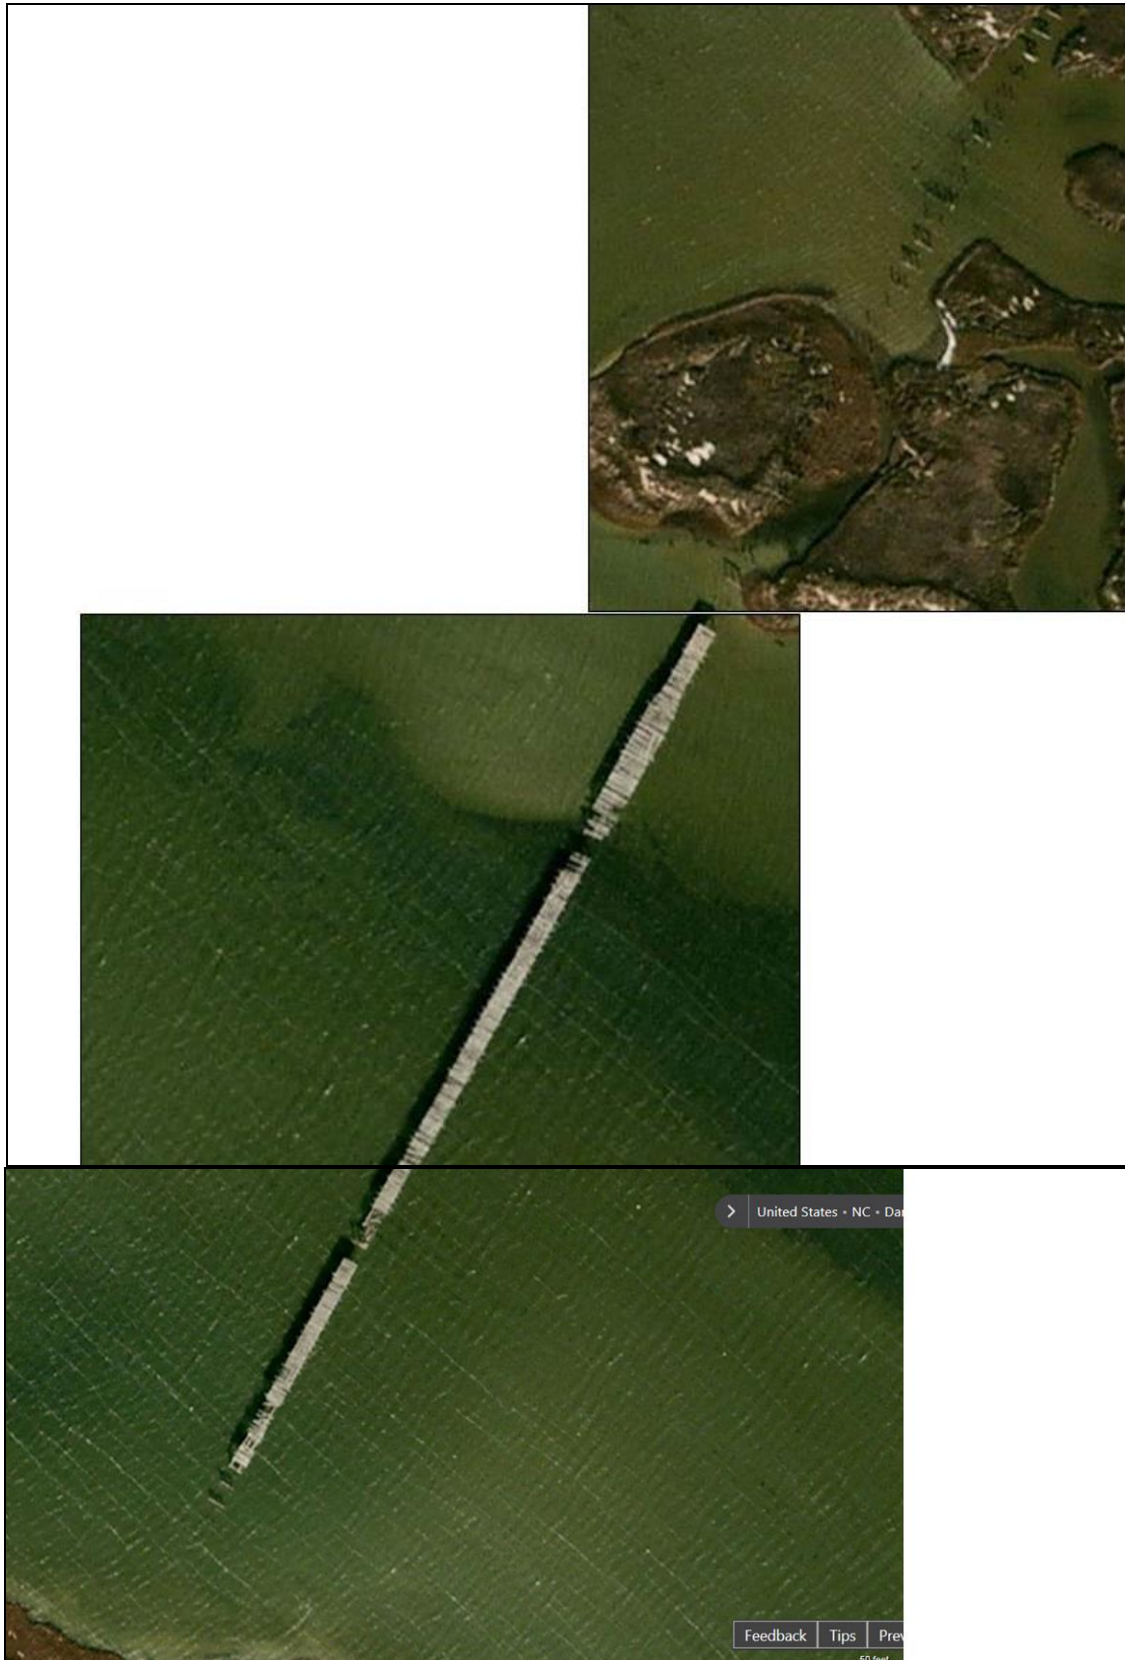
**Figure 25. Close up modern aerial view of North Channel Bridge**

The bridge, which has not been maintained for at least 65 years, has lost its integrity of design, materials, and workmanship. Its barrier rails are gone, as is almost all of its deck. Heavily deteriorated wooden caps and stringers survive in part atop and across most of the bents of its largest southern section. Its northern

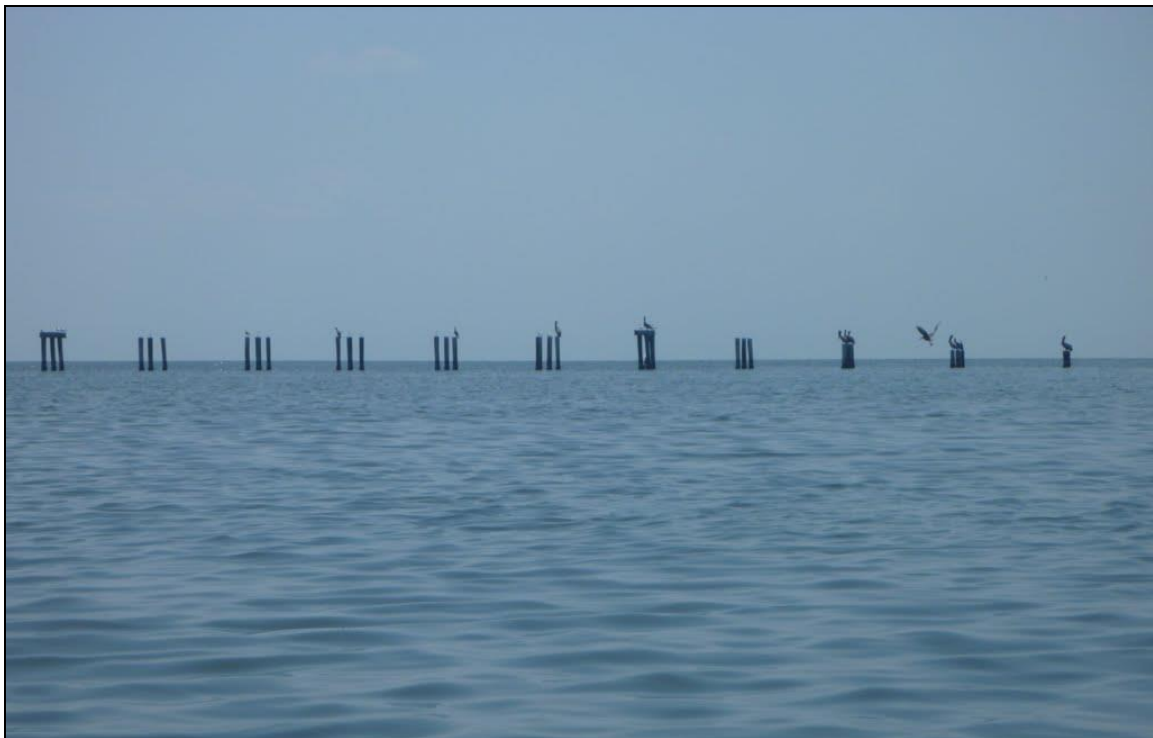
**Figure 33. South Channel Bridge from Pamlico Sound (photographer: Dan M. on Panoramio, 2010)**

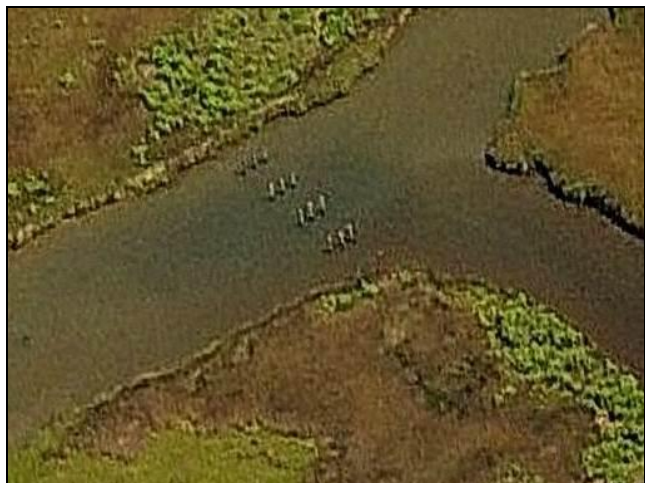
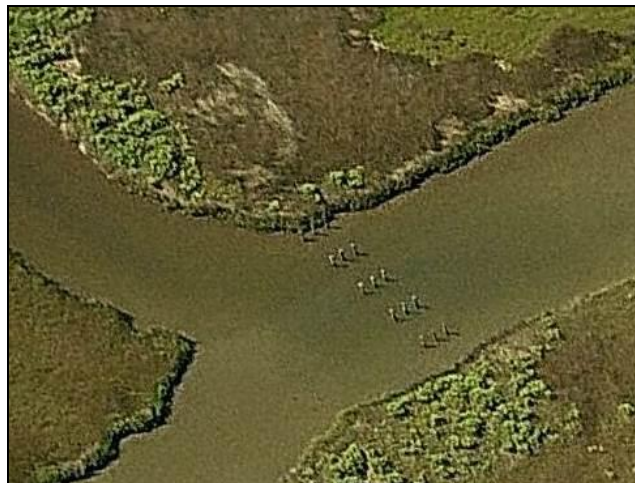
**Figure 36. Modern bird's-eye aerial photographs of South Slew Bridge with north at top at left image and south at top at right**

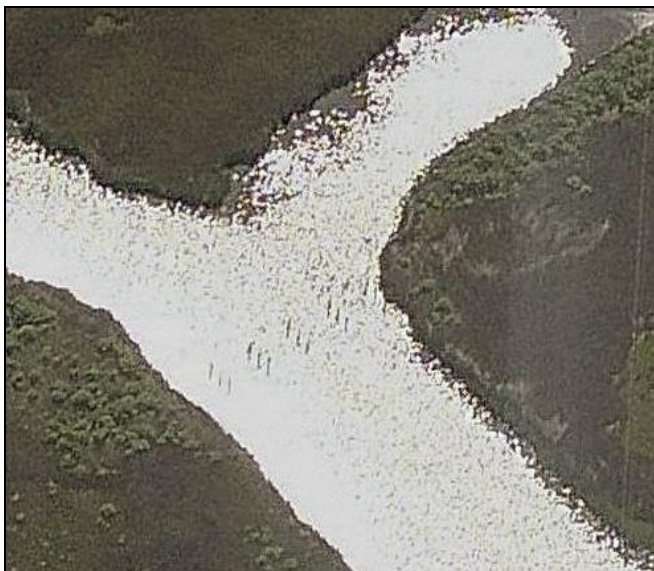
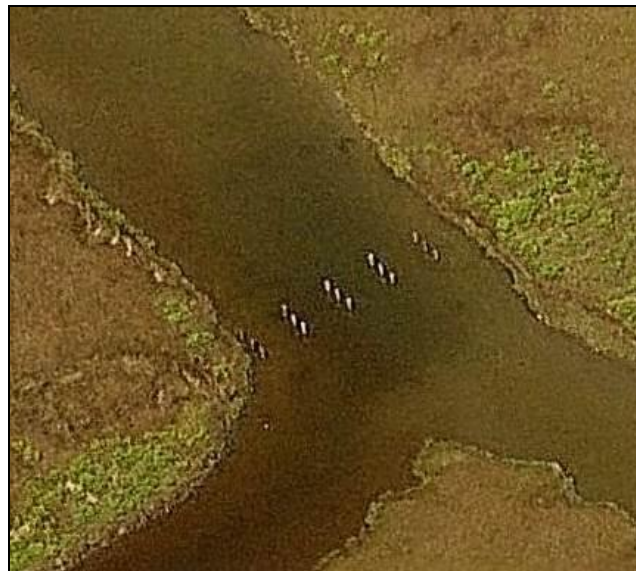
**Figure 37. Modern bird's-eye aerial photographs of South Slew Bridge with east at top at left image and west at top at right**
