**North Carolina Department of Natural and Cultural Resources**  
**State Historic Preservation Office**

July 22, 2019

Re: Draft Addendum Historic Structures Survey Report, MVP Southgate Pipeline Project,  
Multi County, ER 18-1041

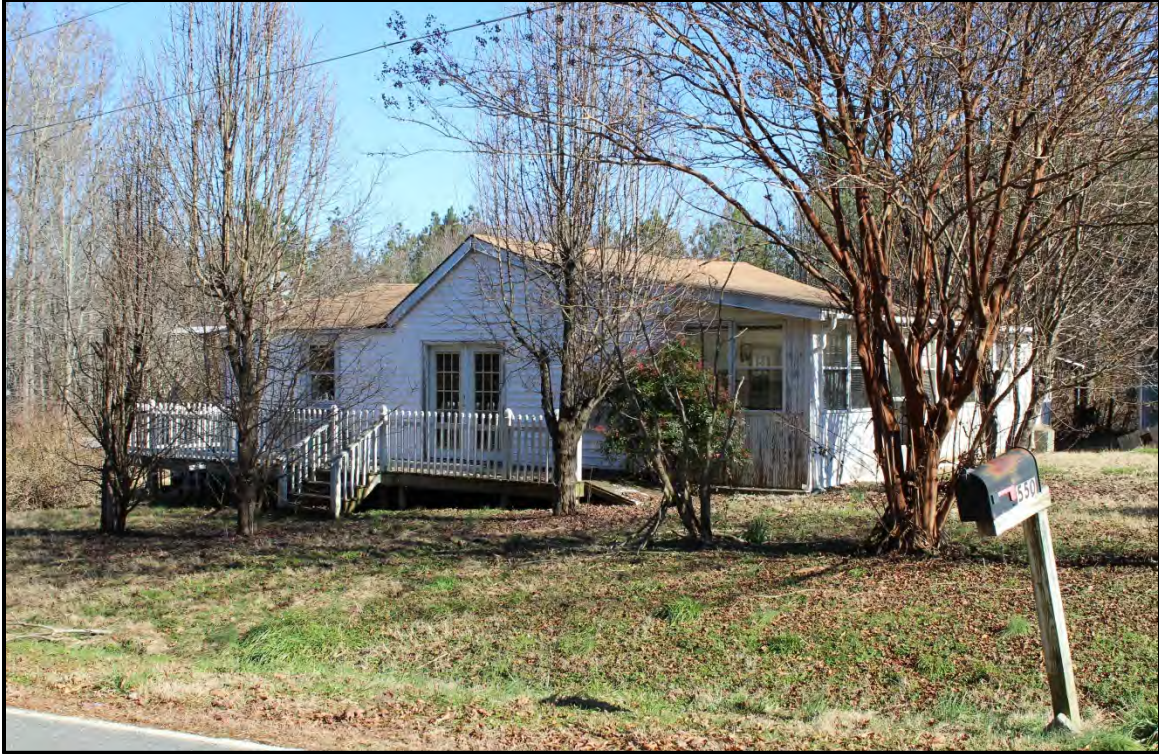
NRHP Assessment. Architectural resource RK1786 does not exhibit a distinctive architectural style or workmanship. In addition, the house has been altered through the installation of vinyl sashes, the application of vinyl siding, the construction of the south elevation shed extension, and the construction of the modern deck to the façade. Based on the lack of architectural merit, as well as the inability to associate the house and/or its original owner(s) with an important historical event or series of events, it is TRC’s opinion that architectural resource RK1786 is not eligible for the NRHP.

Figure 2.1. Architectural resource RK1786; view is northeast featuring the façade and the south elevation.

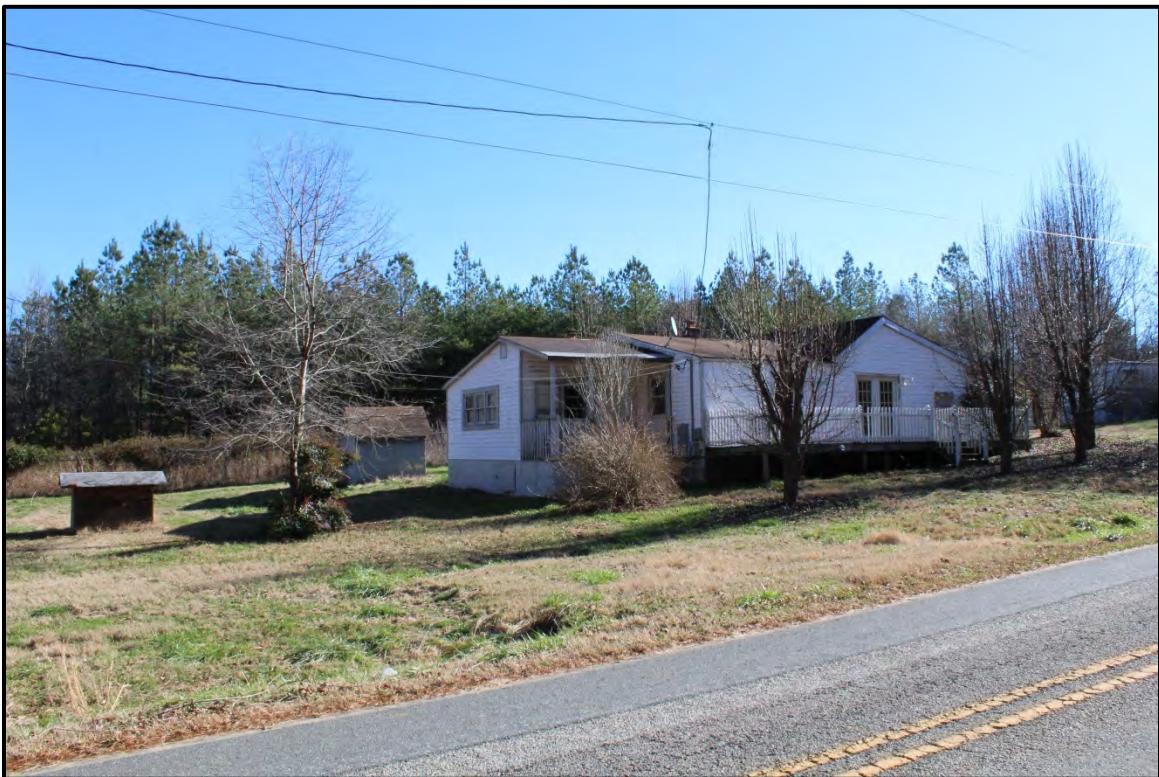
Figure 2.2. Architectural resource RK1786; view is southeast featuring the façade and the north elevation of the house with associated the pump shed and concrete storage shed.

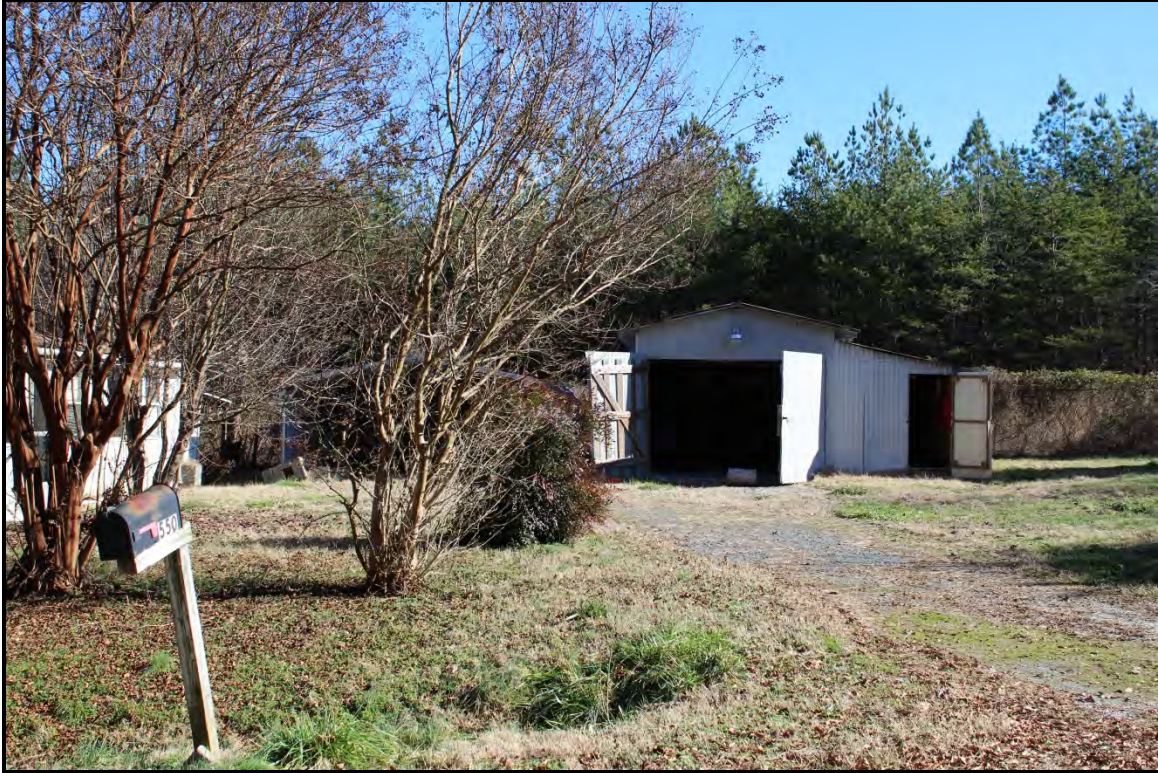
Figure 2.3. Architectural resource RK1786; view is west featuring the garage/storage building.

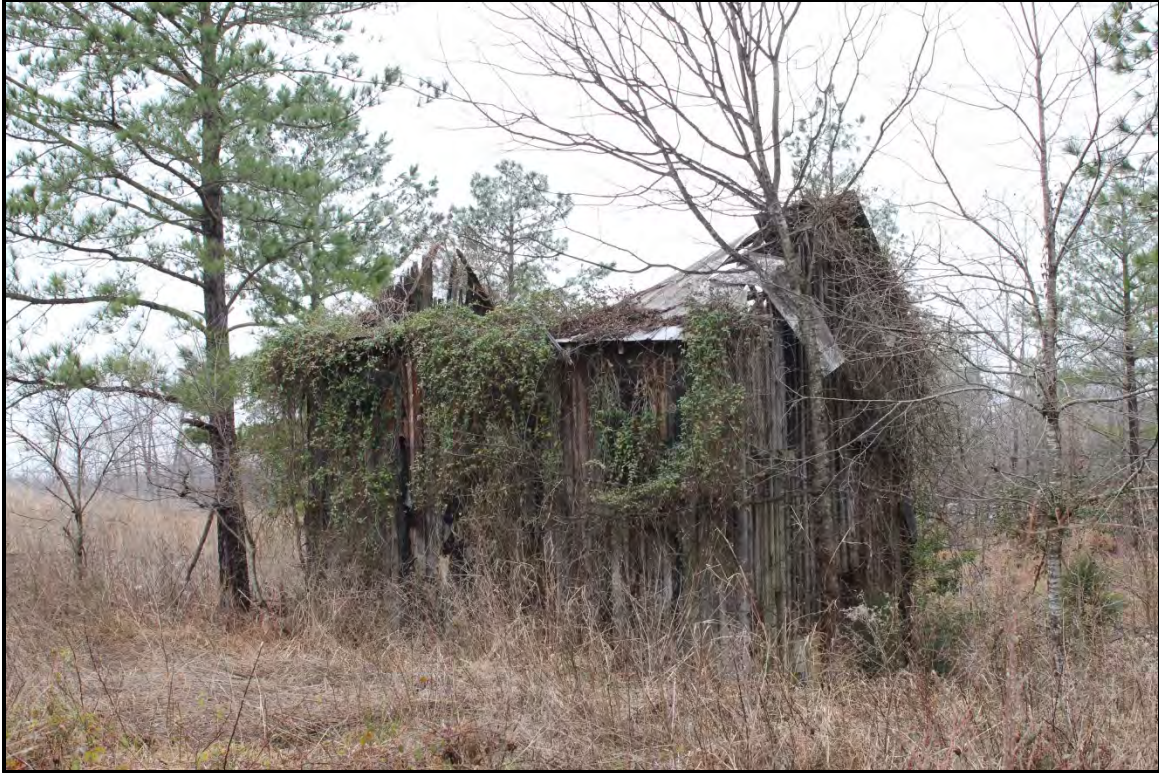
NRHP Assessment. Architectural resource RK1086 does not exhibit a distinctive architectural style or workmanship. Although the structure is likely associated with mid-twentieth century tobacco cultivation on Willow Oaks Farm, the resource is in poor condition due to neglect, which has resulted in the partial collapse of the roof and some exterior siding. Due to the poor integrity of the resource, it is the opinion of TRC that architectural resource RK1086 is not eligible for the NRHP.

Figure 2.5. Architectural resource RK1086; view is northwest featuring the south (rear) and east elevations.

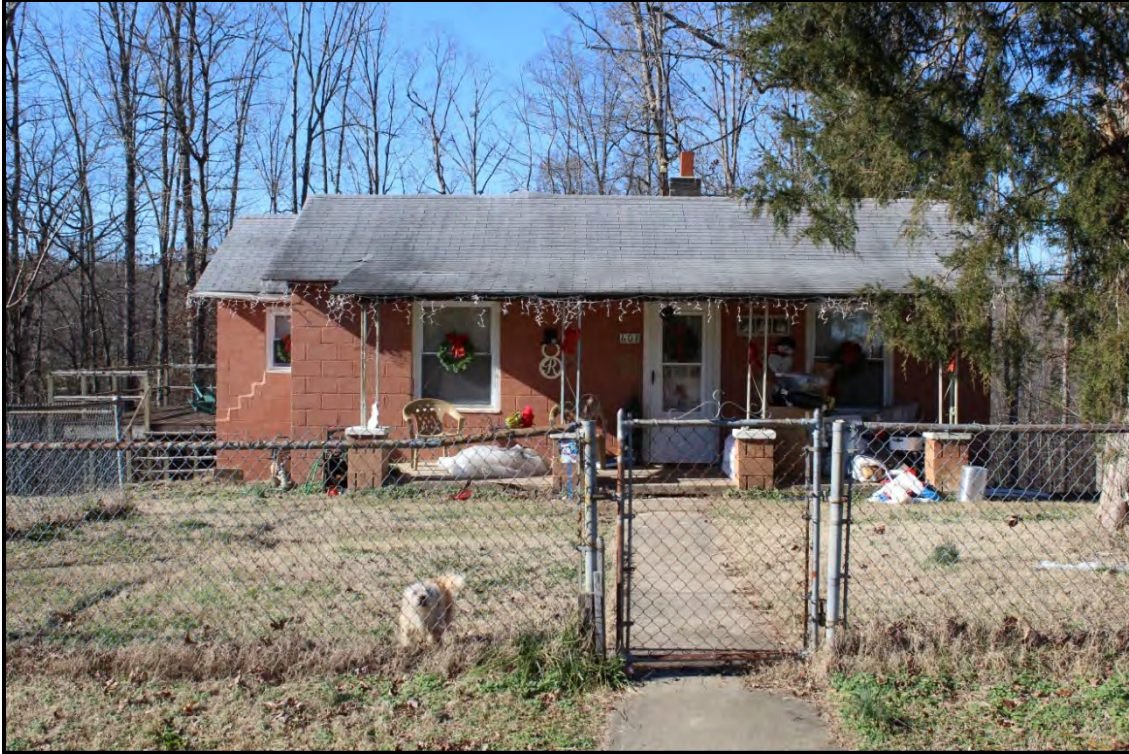
NRHP Assessment. Architectural resource RK1784 does not exhibit a distinctive architectural style or workmanship. In addition, the house has been altered through the installation of vinyl sashes. Based on the lack of architectural merit, as well as the inability to associate the house and/or its original owner(s) with an important historical event or series of events, it is TRC's opinion that architectural resource RK1784 is not eligible for the NRHP.

Figure 2.6. Architectural resource RK1784; view is west featuring the façade.

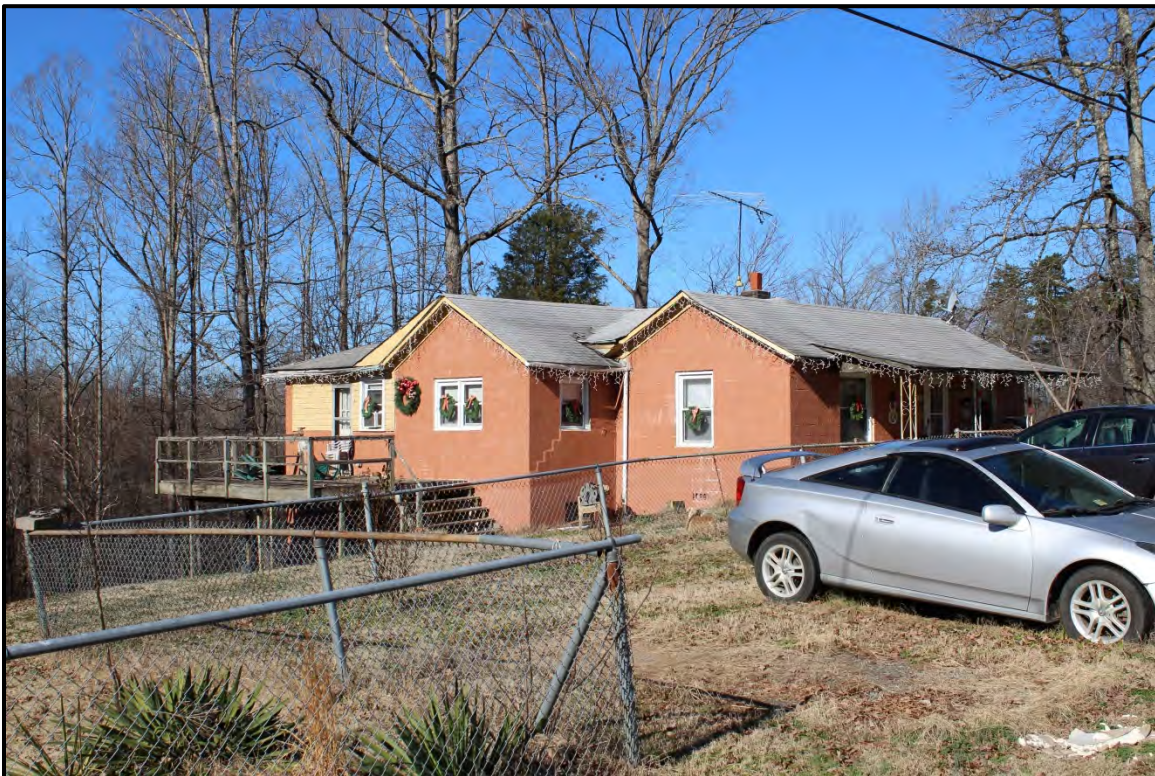
Figure 2.7. Architectural resource RK1784; view is northwest featuring the façade and the side-gabled extension to the west (rear) elevation.

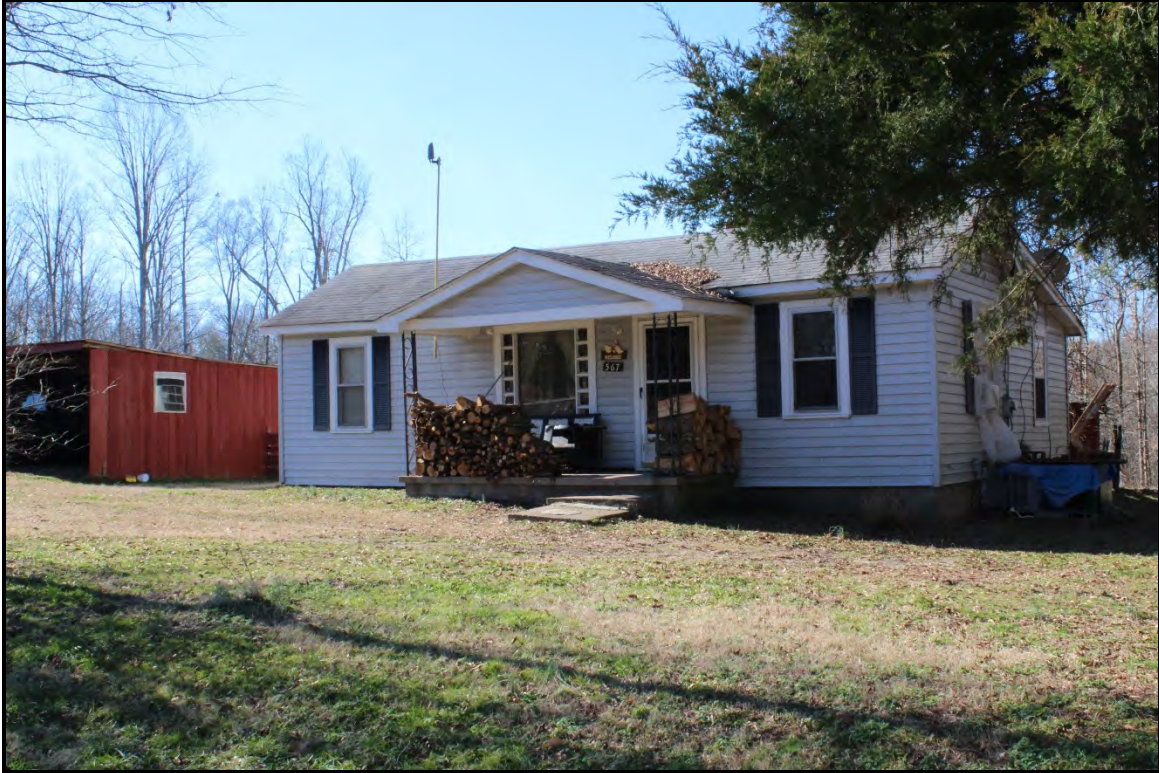
NRHP Assessment. Architectural resource RK1785 does not exhibit a distinctive architectural style or workmanship. In addition, the house has been altered through the installation of vinyl sashes and the application of vinyl siding. Based on the lack of architectural merit, as well as the inability to associate the house and/or its original owner(s) with an important historical event or series of events, it is TRC’s opinion that architectural resource RK1785 is not eligible for the NRHP.

Figure 2.8. Architectural resource RK1785; view is south featuring the façade and north elevation.

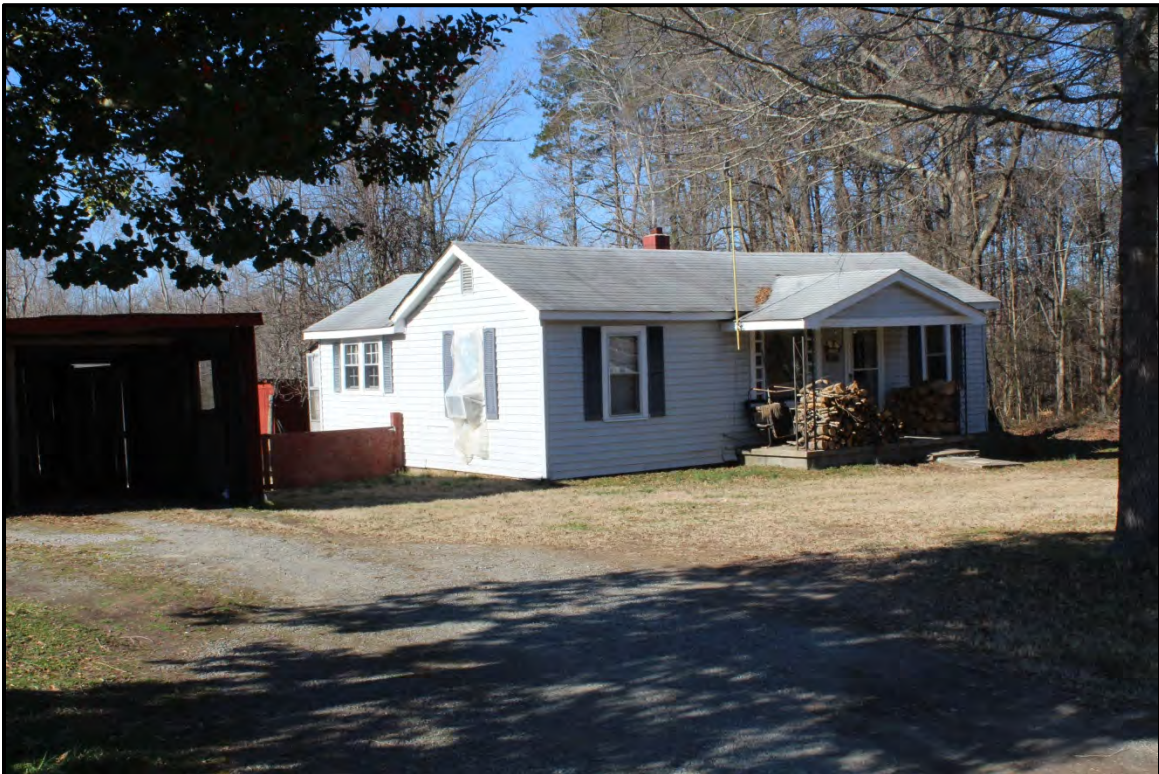
Figure 2.9. Architectural resource RK1785; view is northwest featuring the façade and the south elevation.

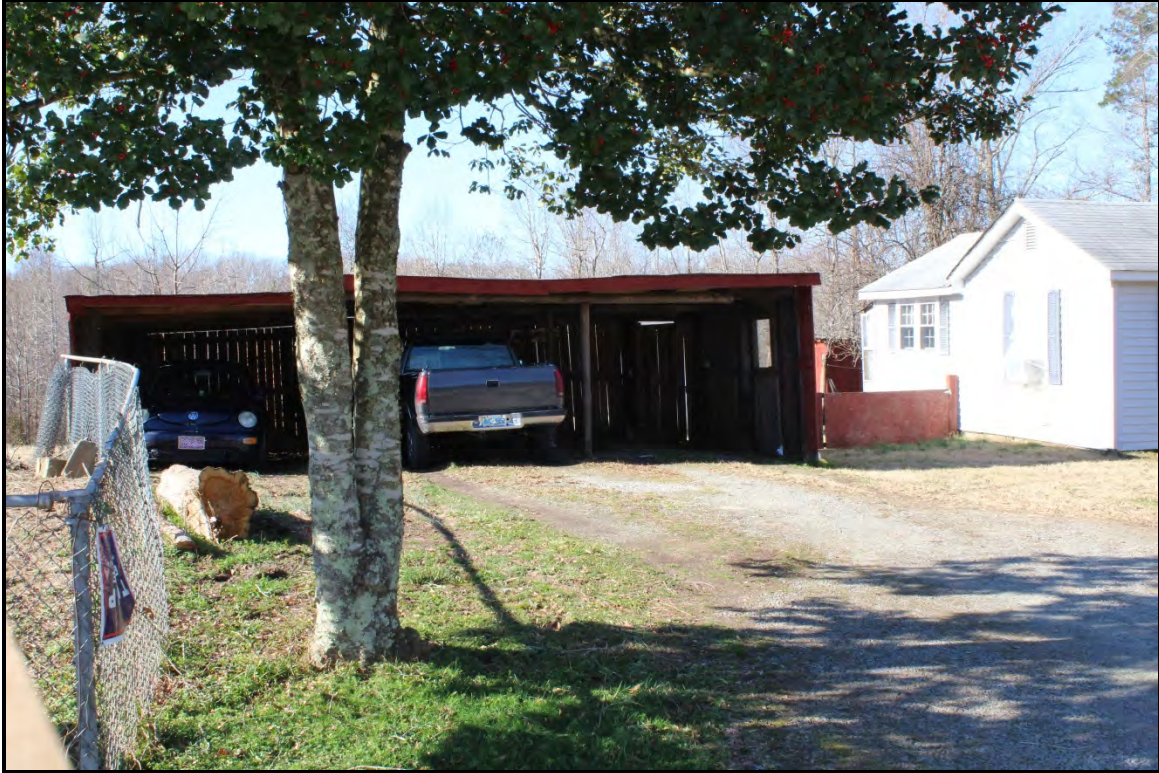
Located south of the house is a late twentieth century vehicle shed that contains three bays. The wood-frame structure features a shed roof and an exterior clad with vertical wood boards (Figure 2.10).

Figure 2.10. Architectural resource RK1785; view is west featuring the vehicle shed.

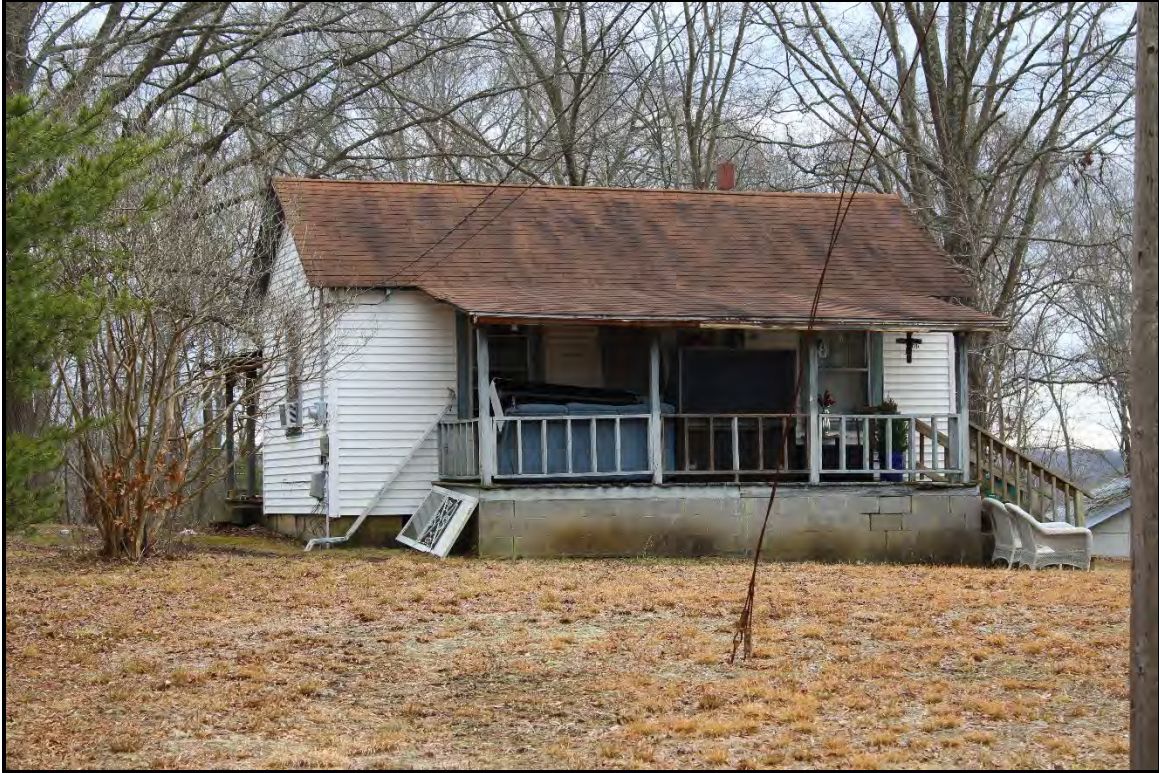
NRHP Assessment. Architectural resource RK1821 does not exhibit a distinctive architectural style or workmanship. In addition, the house has been altered through the reconstruction of the façade porch and the application of vinyl siding. Based on the lack of architectural merit, as well as the inability to associate the house and/or its original owner(s) with an important historical event or series of events, it is TRC's opinion that architectural resource RK1821 is not eligible for the NRHP.

Figure 2.11. Architectural resource RK1821; view is southeast and features the façade and the northeast elevation.

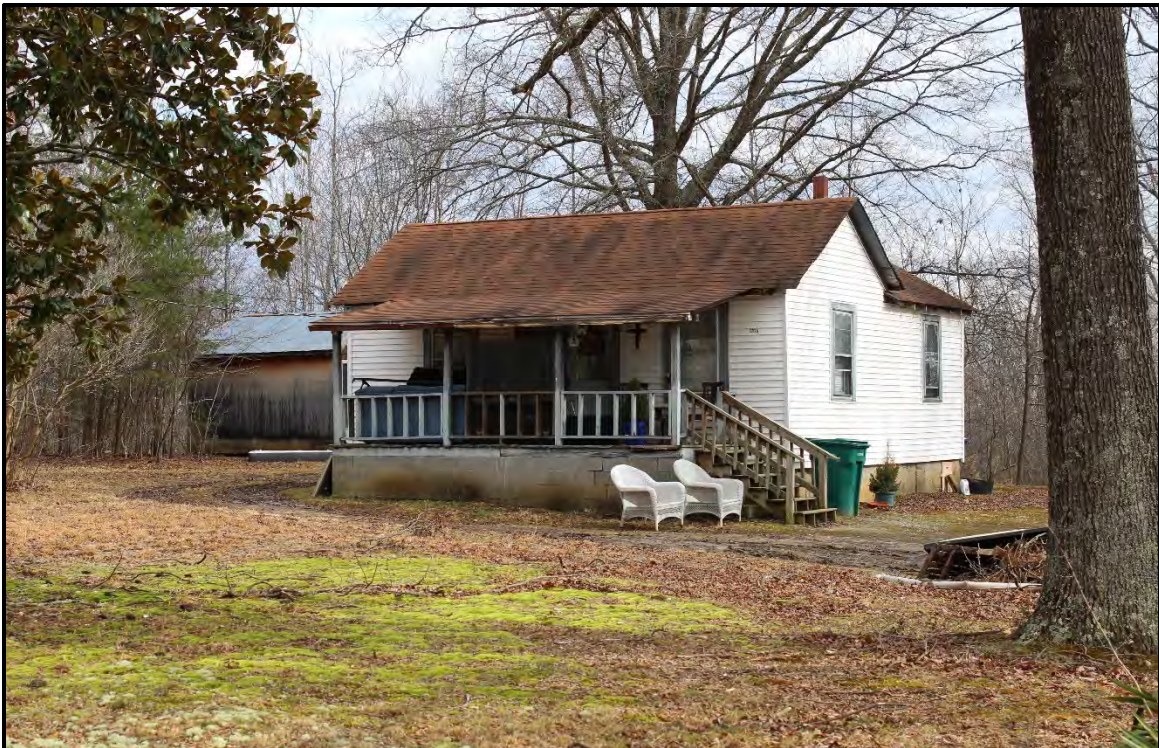
Figure 2.12. Architectural resource RK1821; view is north and features the façade and southeast elevation.

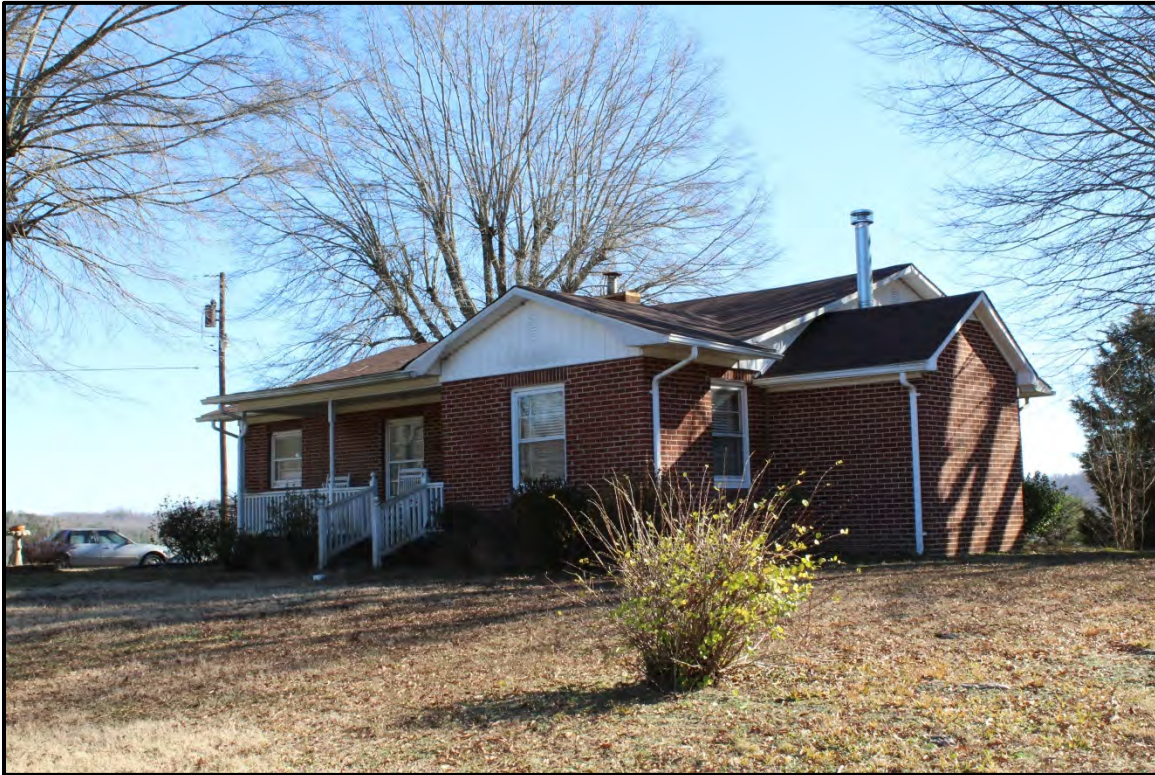
NRHP Assessment. Architectural resource RK1787 is an active farmstead anchored by a Ranch-style house that does not exhibit distinctive characteristics of architectural style or workmanship. In addition, the building has been altered through the reconstruction of the façade and east elevation porches. The historic setting of the property has been compromised with the construction of modern agricultural buildings on the property. For these reasons, the farm no longer conveys its mid-twentieth century appearance, thereby rendering the property ineligible for its agricultural associations. For these reasons it is the opinion of TRC that architectural resource RK1787 is not eligible for the NRHP.

Figure 2.13. Architectural resource RK1787; view is southeast featuring the façade and west elevation.

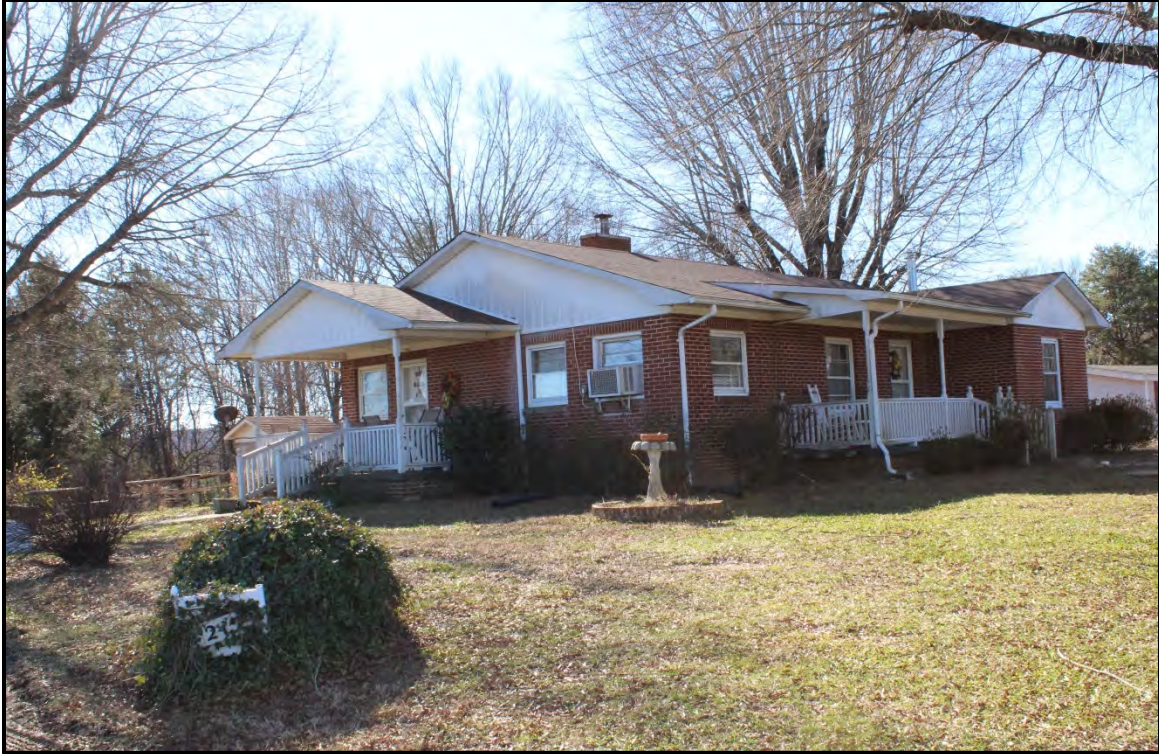
Figure 2.14. Architectural resource RK1787; view is southwest featuring the façade and east elevation.

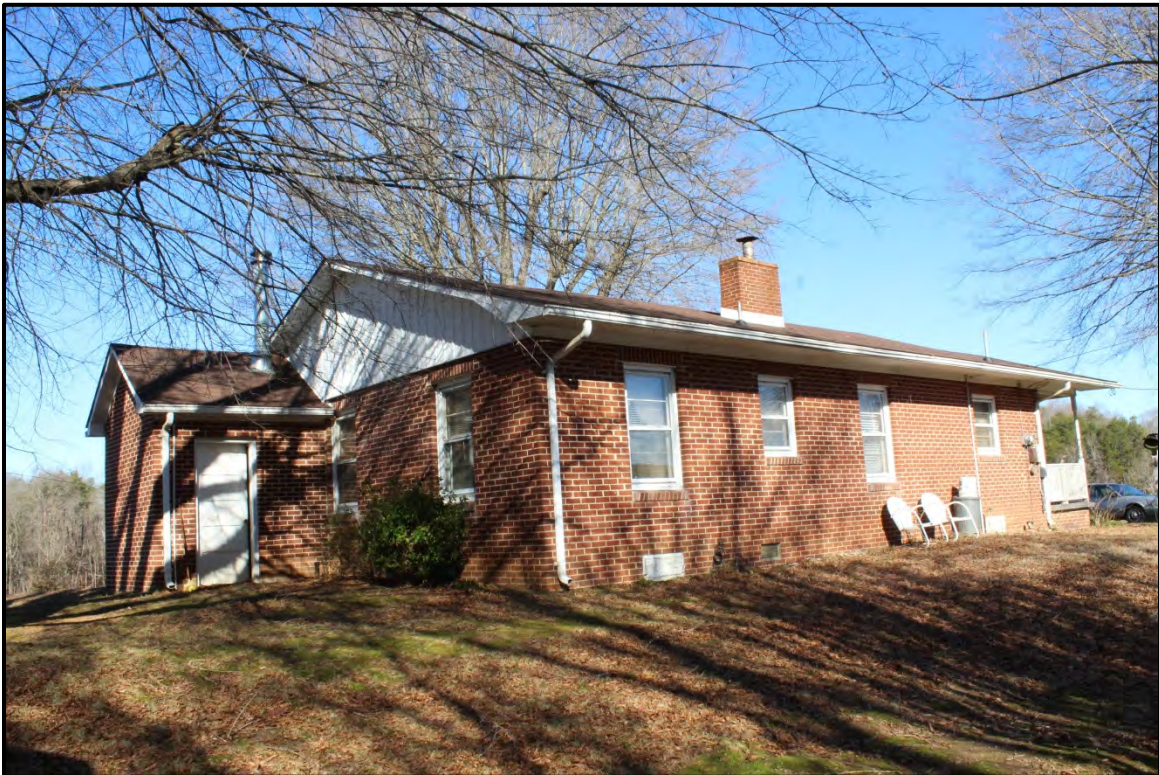
Figure 2.15. Architectural resource RK1787; view is northeast featuring the façade and west elevation.

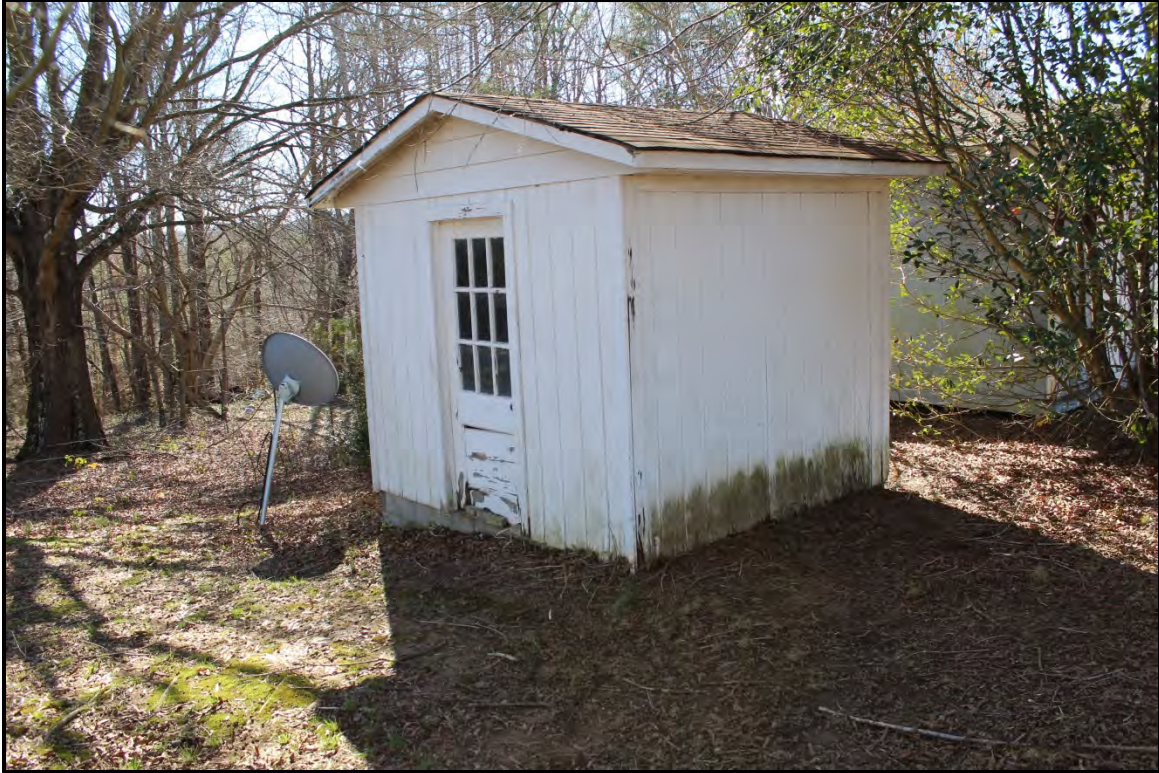
- A ca. 1980 storage shed. The wood-frame structure is capped with a front-gabled roof and features an exterior clad with wood panel siding. The shed is supported by a concrete block foundation. A wood door with 9-lights is located on the east elevation (Rockingham County, NC WebGIS 2019) (Figure 2.16);

Figure 2.16. Architectural resource RK1787; view is southwest featuring ca. 1980 storage shed.

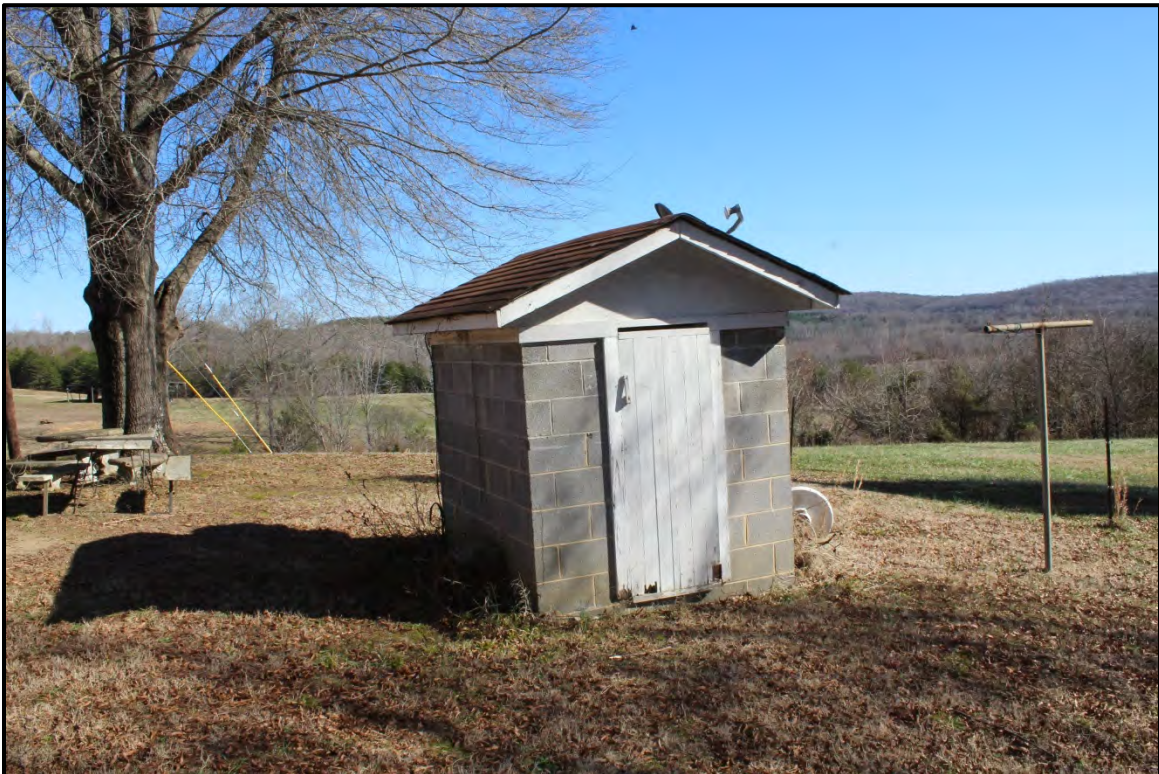
- A ca. 1997 storage shed. The concrete block structure is capped with a front-gabled roof and features a wood-board door on the west elevation (Rockingham County, NC WebGIS 2019) (Figure 2.17);

Figure 2.17. Architectural resource RK1787; view is east featuring the ca. 1997 storage shed.

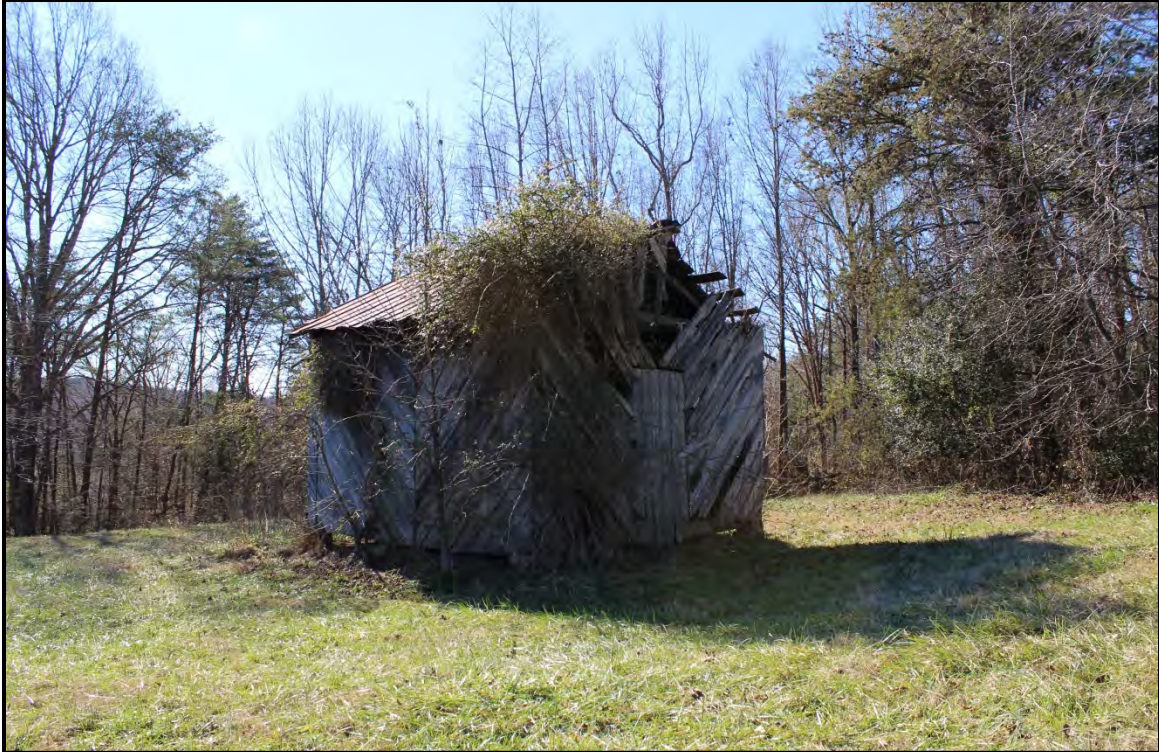
- A mid-twentieth century agricultural storage building. The wood-frame structure features a front-gabled roof covered with standing seam metal and an exterior clad with wood boards. A door is positioned on the structure’s north elevation (Figure 2.18);

Figure 2.18. Architectural resource RK1787; view is south featuring the mid-twentieth century agricultural storage building.
