SUBJECT: Historic Structures Survey Report, Left Turn Lane Construction, SR 1650 and SR 1538,
W-5710AC, Stanly County, ER 19-2324

**Historic Structures Survey Report
Left Turn Lane Construction at SR 1650 (NE Connector) and
SR 1538 (Moss Springs Road)
Stanly County, North Carolina**

TIP No. W-5710AC
WBS No. 44856.1.29
PA No. 18-10-0054

July 17, 2019– Final Report

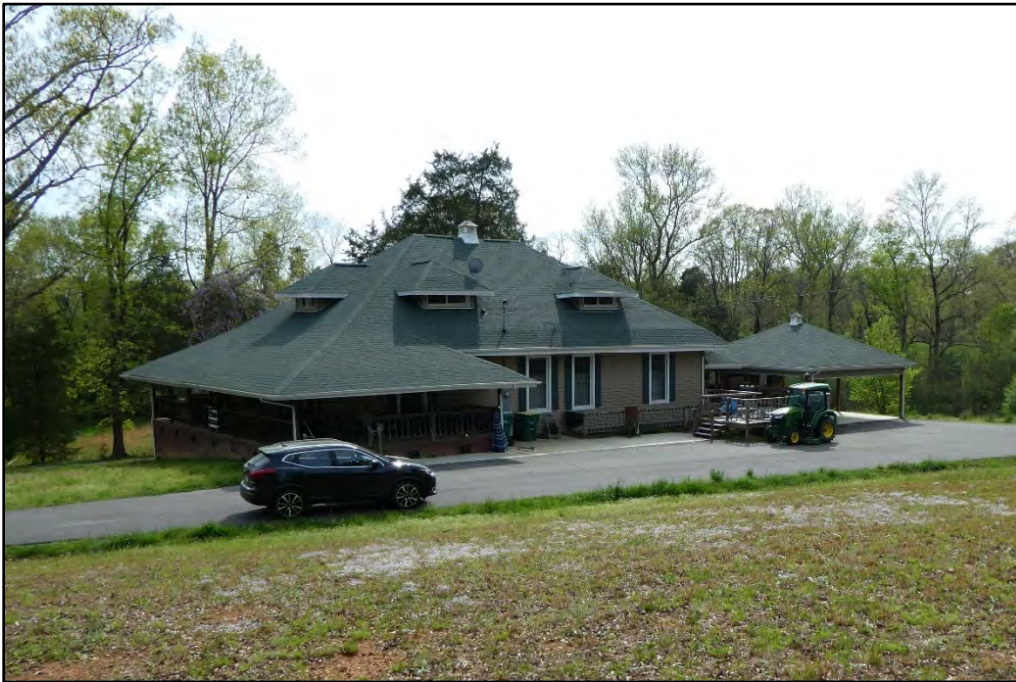
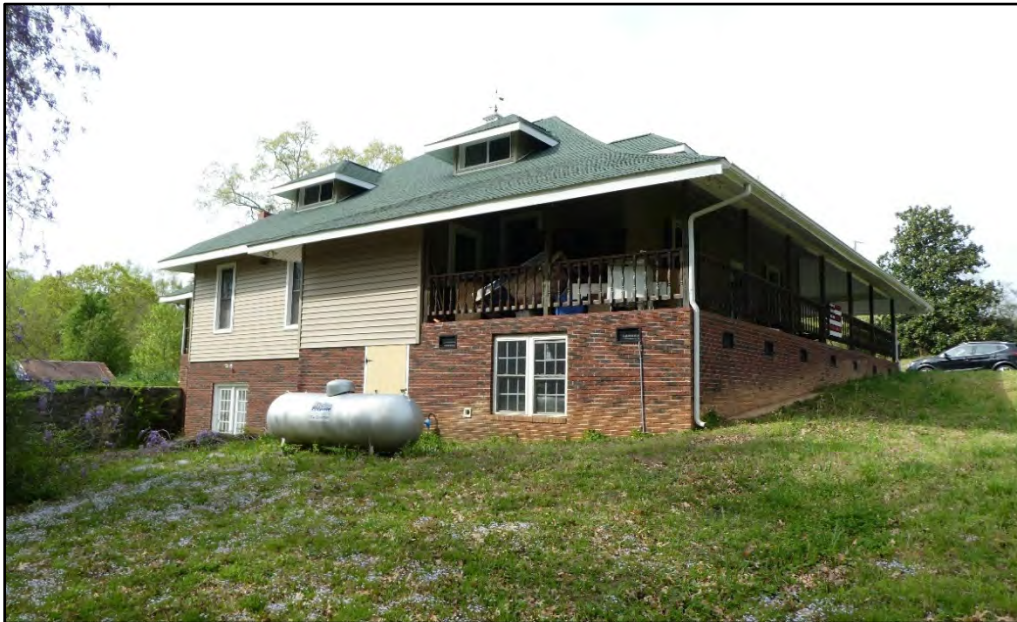
Significant recent alterations have masked some of the building’s original elements (Figure 12 through Figure 15). These changes include:

- Loss of chimneys, rear screen porch, original windows and shutters;
- New porch supports, classically ornamented balusters, composite decking, and vinyl ceiling treatment which masks exposed framework;
- Gutters and fascia boards that box character-defining rafter tails throughout;
- Installation of vinyl siding, windows, and mock shutters;

- Installation of modern brickwork and alteration of window and door openings at the foundation level;
- Construction of a new partially wrap-around deck in place of the screen porch, using composite decking and classically ornamented balusters;
- Addition of a carport with shallow-pitch, hip roof;
- Installation of mock ventilators with weather vanes on ridge of house and carport; and
- Significant alteration to the immediate landscape around the house, including the removal of trees and installation of an extensive, hardscaped driveway.

Figure 12. Current view of north elevation of the Moss-Coble Farm dwelling, taken facing southwest.

Figure 14. Current view of south elevation of the dwelling, taken facing north.

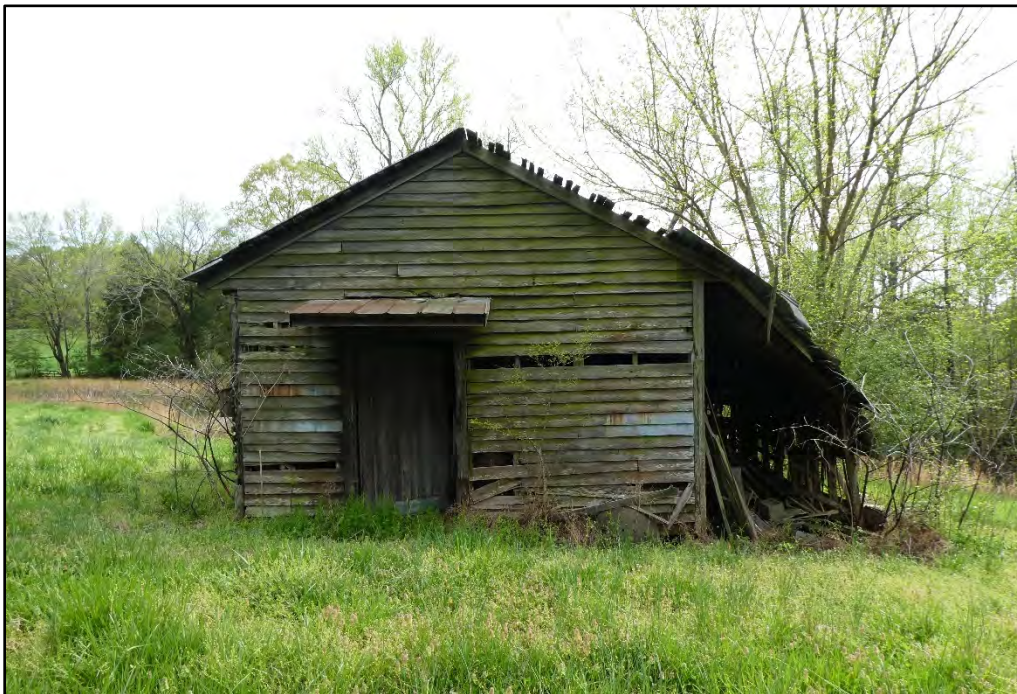
2. **Corn Crib A** (Figure 16 and Figure 17): This single-story, wood frame structure with unpainted, vented wood planks and clapboard siding was built ca. 1912. There is a lean-to, open-storage area at the west side. The gable roof is clad in rusted, 5V-crimp metal sheeting, which is lost in some areas. The pedestrian entrance is located on the north elevation and has a shed-roof awning, also treated in 5V-crimp metal cladding. The door itself is unpainted vertical planks.

Figure 17. North elevation of Corn Crib A (Site Plan # 2), taken facing south.

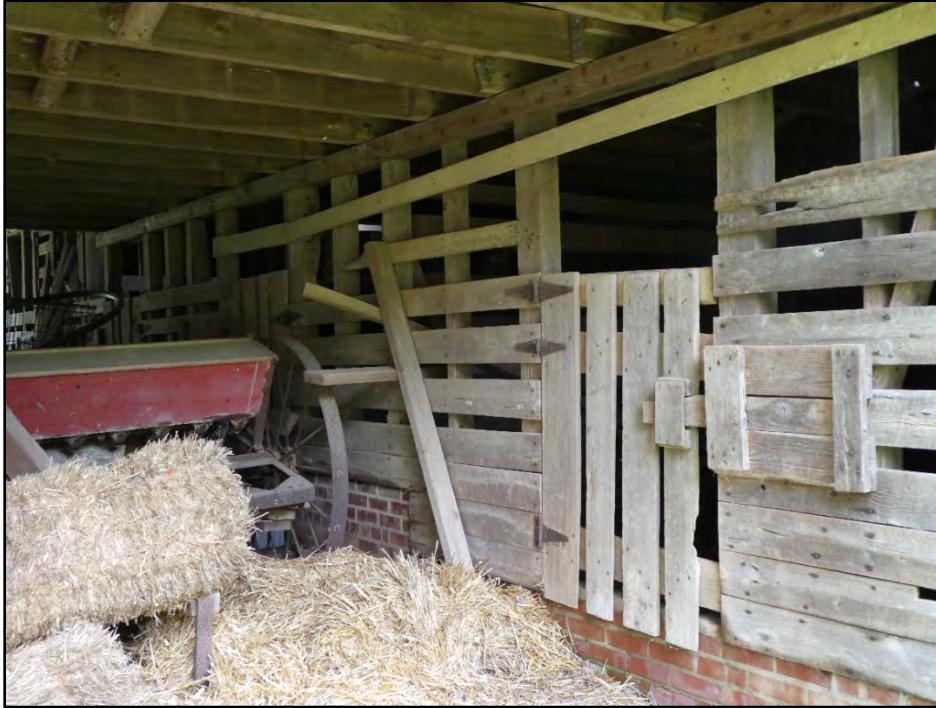
The interior was partly accessible during survey (Figure 20). Along the inner passageway, there are a number of pens with vented wood planks and plank half-doors set on the brick stem wall. Crossing through the passageway is hindered by its current use as a storage area for building materials and farm equipment. A light fixture indicates that electricity was brought to the barn at some point in the past.

Figure 20. Interior of Transverse-Crib Barn (Site Plan # 3), viewed from western entrance facing southeast.

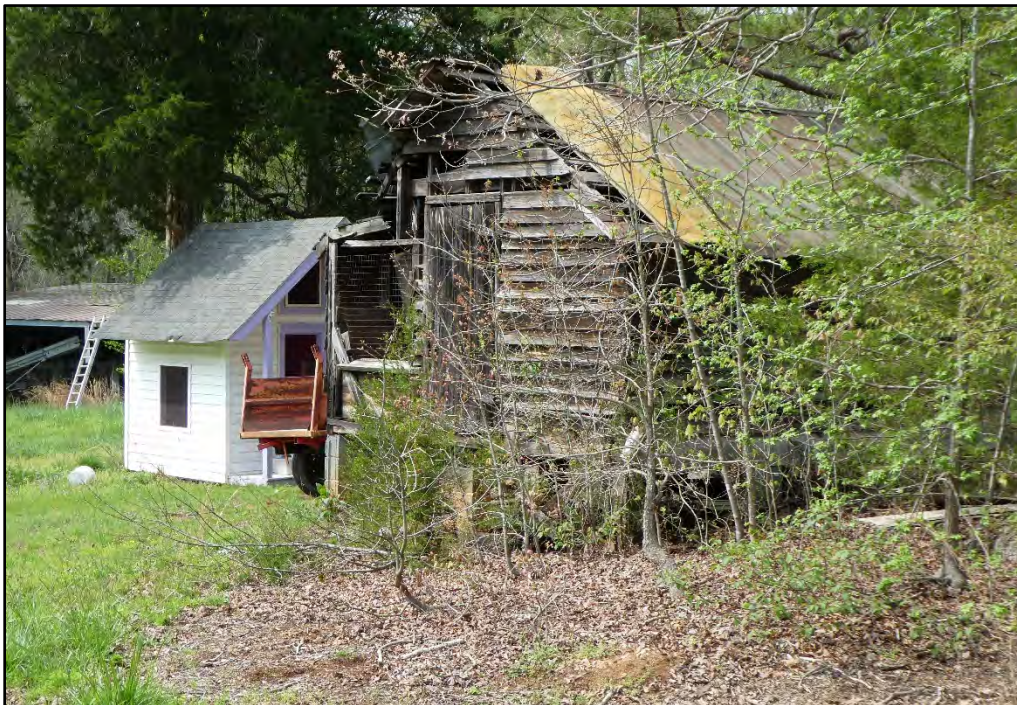
5. **Coop A** (Figure 21, Figure 22, and Figure 23): This partially collapsed, wood-frame structure with a gable roof was built ca. 1912. Exterior walls are clad in unpainted clapboard, which is missing in places. The roof is partially covered in rusted, 5V-crimp metal sheets. The only openings are on the south end of the building: a pedestrian door of vertical planks and an unglazed, square, ventilation window treated with chicken wire. The building is set on concrete-block piers.

Figure 22. Playhouse and Coop A (Site Plan # 12 and 5), taken facing northwest from edge of paved driveway.

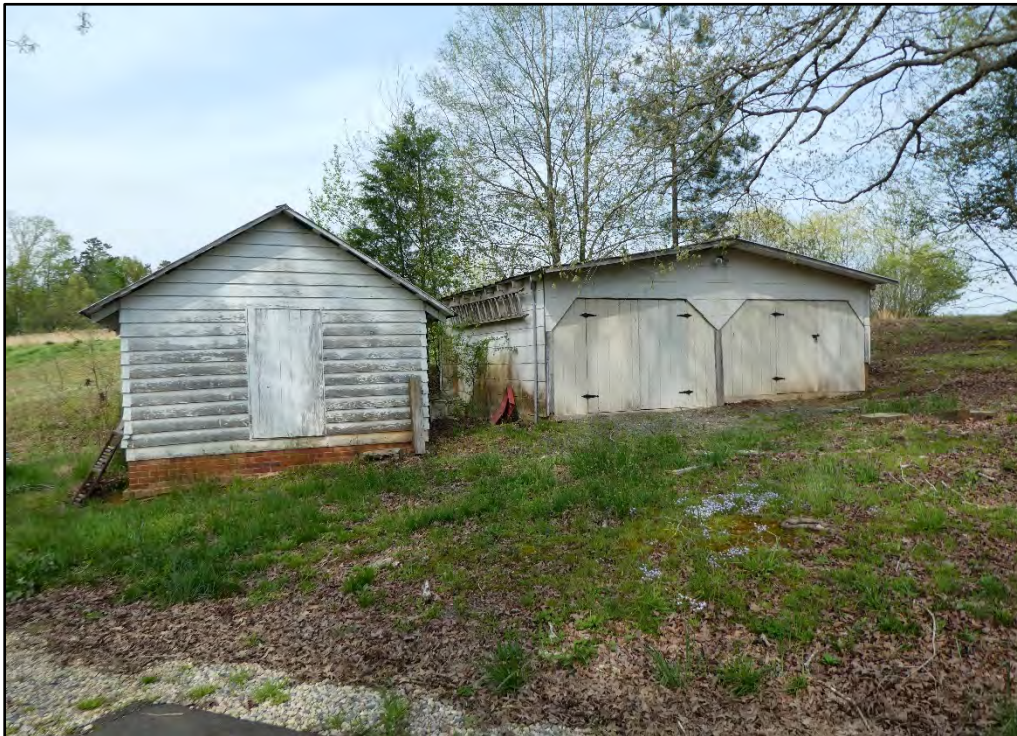
6. **Smokehouse or Sweet Potato Curing Barn** (Figure 21, Figure 24, and Figure 25): This one-story building appears to have served as either a smokehouse or a sweet potato curing barn as indicated by the venting evident in the eaves of the gable ends and the brick chimney on the northeast corner of the structure. Built ca. 1912, this weatherboard-clad building is set on a brick stem wall partially built into the slope of the ground. The visible portion appears to be set in a running bond pattern. Elevated entrances on the north and south elevations have pedestrian doors of vertical planks. A wood frame, four-light casement window is centrally located on both the east and west elevations. The gable roof

7. **Two-Bay Garage** (Figure 21, Figure 24, and Figure 26): Facing south, the ca. 1940 two-bay garage is wood-frame clad with asbestos shingles. The gable roof clad with 5V-crimp sheet metal has a shallow pitch and exposed rafter ends. Each vehicular opening has vertical plank siding infill; the eastern opening has a vertical plank pedestrian door, and the western opening paired vertical plank pedestrian doors. The structure appears to rest on a concrete slab foundation, but a brick stem wall can be seen under asbestos shingles at the southeast corner. The interior was not accessible.

Figure 24. Smokehouse or Sweet Potato Curing Barn and Two-Bay Garage (Site Plan # 6 and 7), south elevations as viewed from end of paved section of driveway, taken facing north.

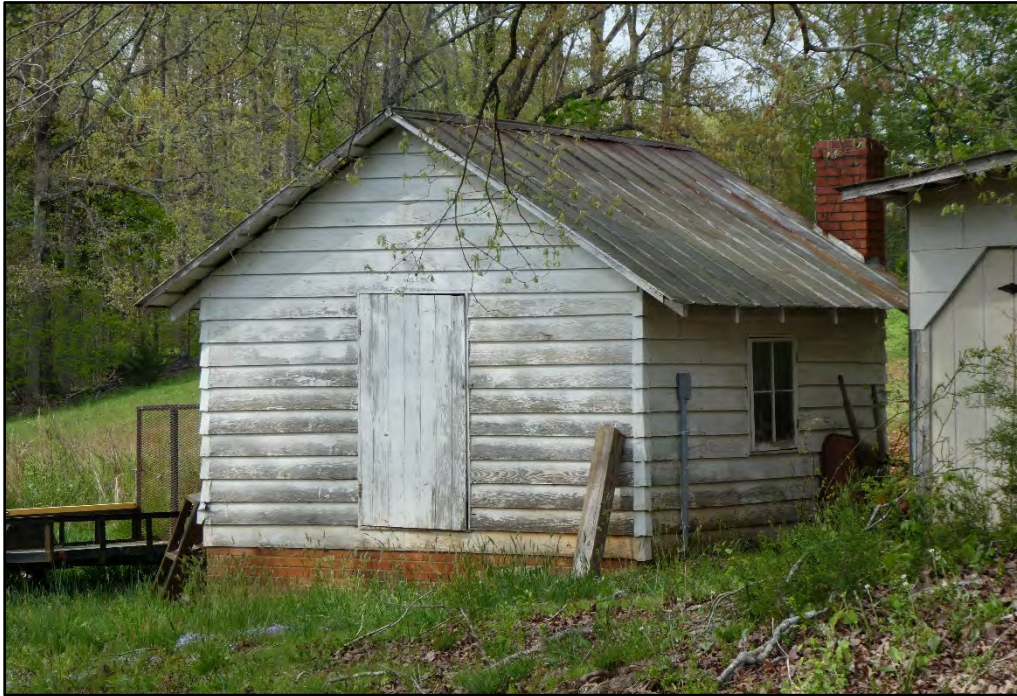
Figure 25. South and east elevations of the Smokehouse/Sweet Potato Curing Barn (Site Plan #6) taken facing northwest from the paved driveway northwest of the dwelling.

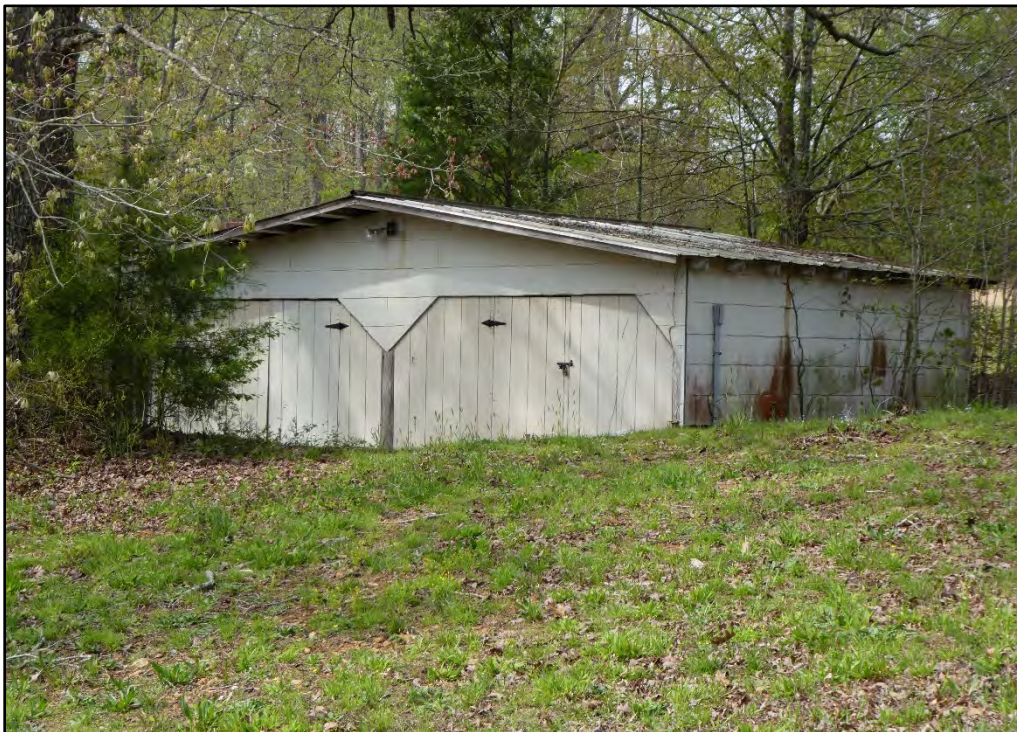
Figure 26. South and east elevations of the Two-Bay Garage (Site Plan #7) taken facing northwest from the paved driveway northwest of the dwelling.

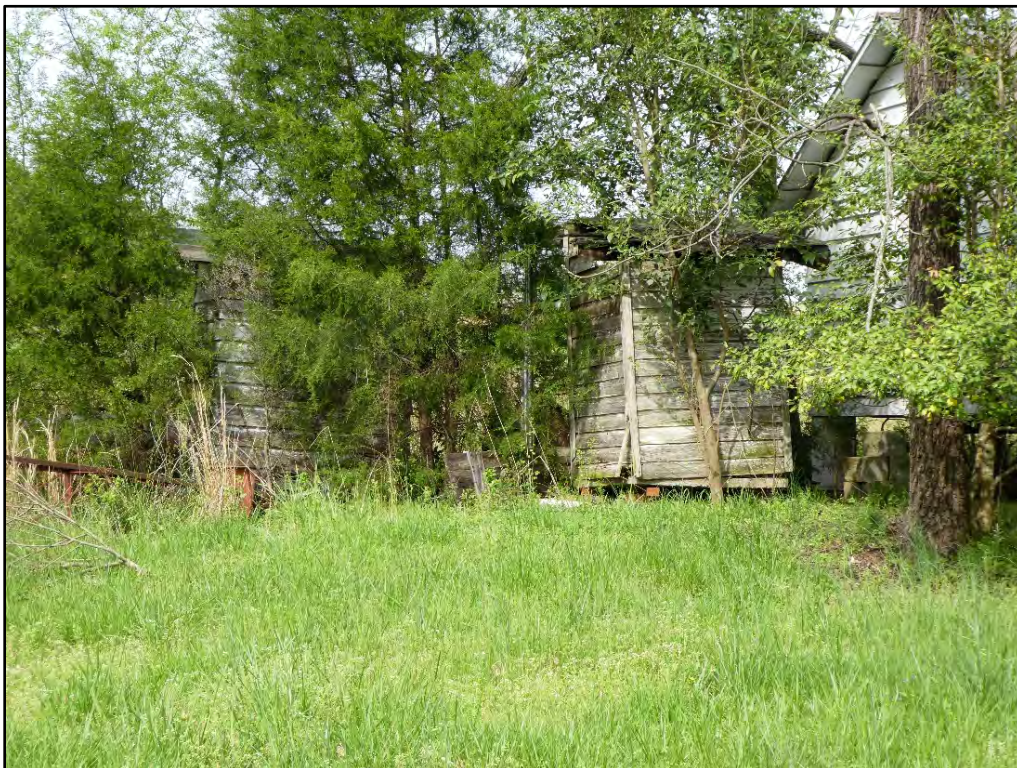
13. **Privy A** (Figure 30 and Figure 32): Privy A is situated immediately west of Granary A. Both Privy A and Privy B are overgrown with vegetation. Estimated to have been built ca. 1912, it may be somewhat younger than Privy B due to its different design. It is clad with weatherboard with corner boards. Its opening is on the north elevation, but the door is missing and a portion of the sheet metal covering the shed roof has fallen. The building appears to rest on loose bricks so is likely to have been moved to this location.

14. **Privy B** (Figure 30 and Figure 32): Privy B is located immediately northwest of Granary A and has paired vertical plank doors facing north. Built ca. 1912, the outbuilding is clad with weatherboard and vertical plank siding topped by a shed roof surfaced with sheet metal. Exposed rafter ends are evident in the eaves on the north and south elevations. Based on photographic evidence, the structure appears to have been moved since the 1990 survey; a foundation was not visible during the current survey.

Figure 32. From left to right, Privies B and A with Granary A (Site Plan # 14, 13, and 9), south elevations as viewed from field near Transverse-Crib Barn, taken facing northeast.

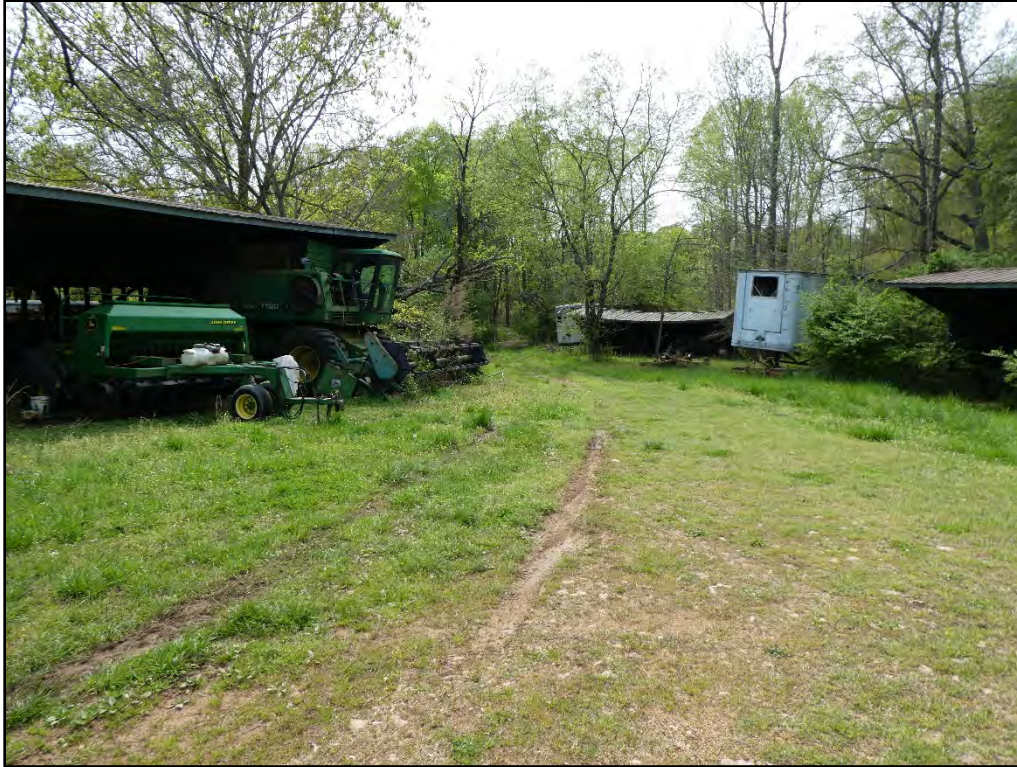
16. **Machine Shed C** (Figure 33 and Figure 36): Built ca. 1940, Machine Shed C is the smallest of the machine sheds, incorporating only two bays. The wood-frame structure is clad with 5V-crimp and standing seam sheet metal. The shed roof features a pent roof along the open, northeast elevation and is surfaced with 5V-crimp sheet metal. In poor condition, the roof has bowed and the structure appears in danger of collapse.

Figure 33. General setting of Group C, showing (left to right) Machine Sheds B, C, and A (Site Plan # 15, 16, and 10), taken facing west-southwest.

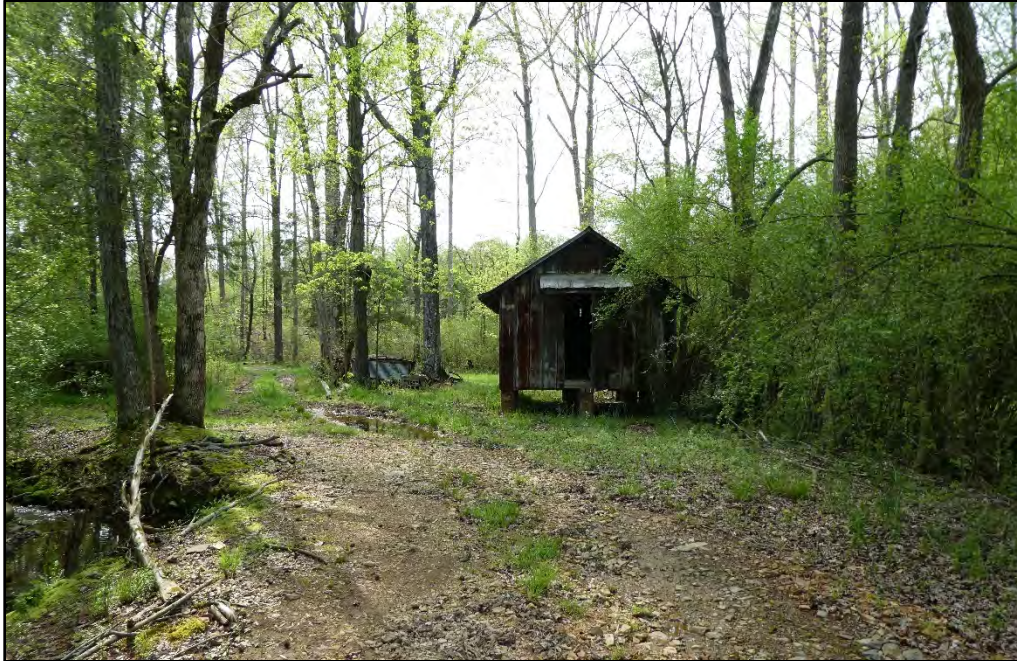
17. **Granary B** (Figure 37 and Figure 38): Facing northeast, the ca. 1912 Granary B is a one-story, wood-frame rectangular structure clad with rusting standing seam sheet metal. The gable roof is surfaced with 5V-crimp sheet metal and features exposed rafter ends. Open areas at the top of the wall under the eaves provided the ventilation necessary for the granary. Both entrances, located in the gable ends, are shaded by a shed roof, or pentice, surfaced with 5V-crimp. The openings have vertical plank wood doors. A brick pier foundation supports the structure, but most of the piers are partially encased in sheet metal at the top of the pier.

Figure 37. Animal Shelter and Granary B (Site Plan # 18 and 17), taken facing west-southwest.

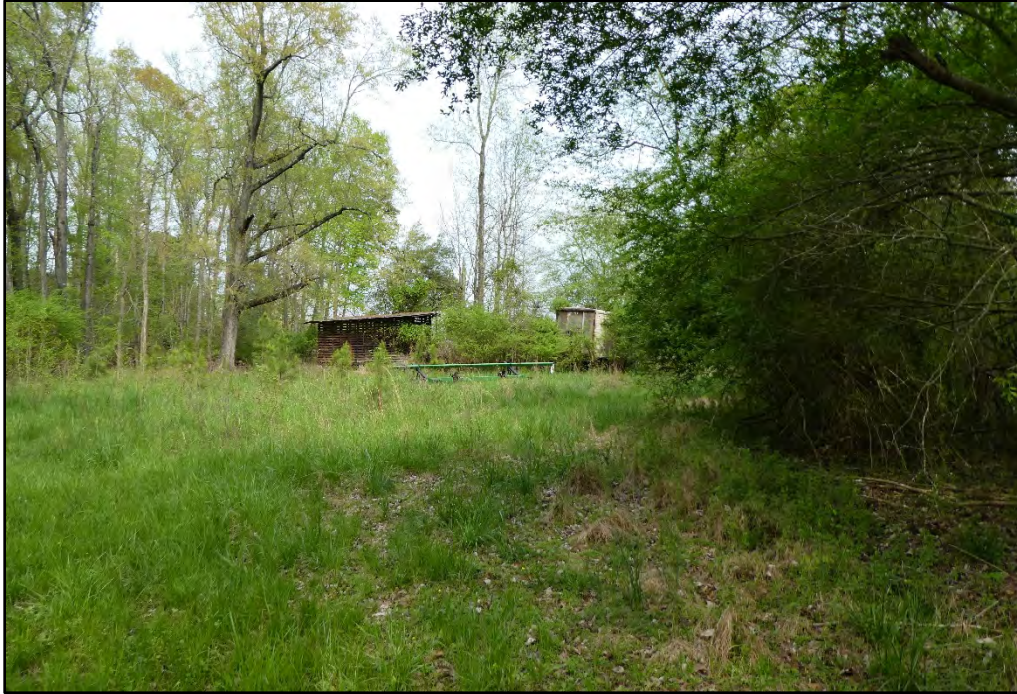
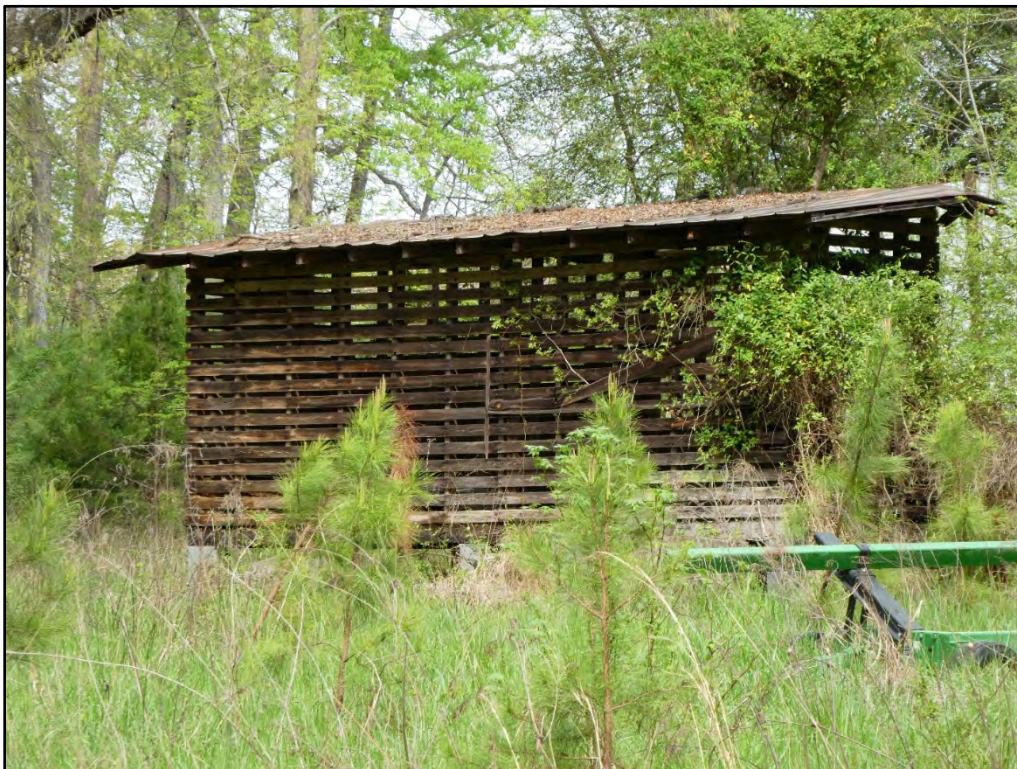
20. **Corn Crib B** (Figure 41 and Figure 42): Built ca. 1912, Corn Crib B is a wood-frame structure set on a replacement concrete block pier foundation, with an entrance facing east. Walls are composed of horizontal wood slats with the open venting necessary for a corn crib. The shed roof is clad with 5V-crimp sheet metal and features exposed rafter ends in the eaves. Given the presence of a concrete-block pier foundation, this structure may have been moved to this site during the Coble family's use of the farm starting in 1940.

Figure 41. Corn Crib B (Site Plan # 20), taken facing northeast from fenceline at Granary B.

Figure 42. Corn Crib B (Site Plan # 20), west elevation, taken facing northeast.

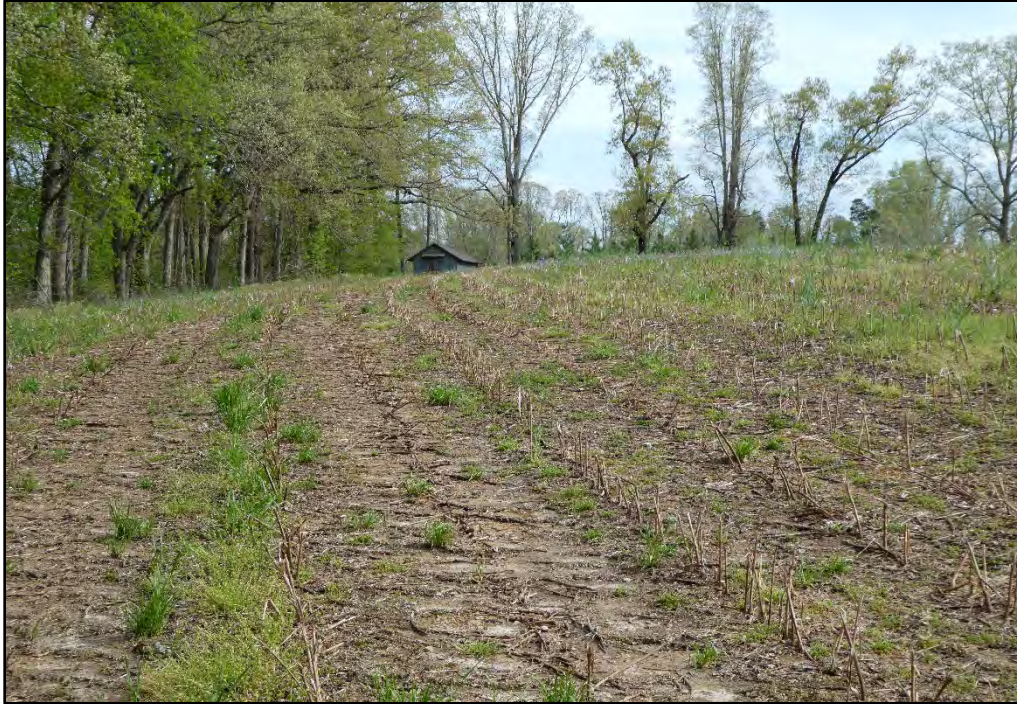
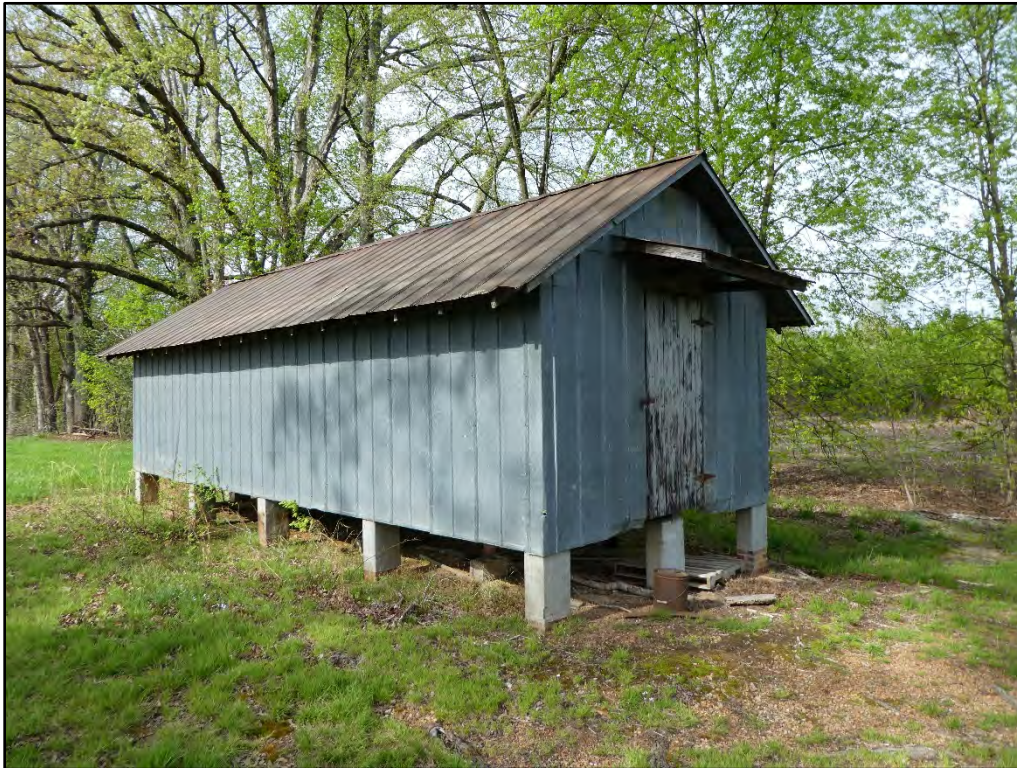
21. **Granary C** (Figure 43 and Figure 44): Oriented to face north-south, the ca. 1912 Granary C is a wood-frame structure set on a brick pier foundation with the top portion of the piers clad with sheet metal. The outbuilding and the gable roof are surfaced with 5V-crimp sheet metal, of which the wall cladding appears newer than the roof and entrances. The ventilation characteristic of a granary has been covered by the replacement siding. Exposed rafter ends decorate the eaves on the side elevations. The gable ends feature vertical plank wood doors set beneath shed, or pentice, roofs covered with 5V-crimp sheet metal. Northeast Connector is visible from Granary C (Figure 45).

Figure 43. Approach to Granary C (Site Plan # 21) from Northeast Connector, taken facing south-southeast with cotton fields in the foreground.

Figure 44. Granary C (Site Plan # 21), taken facing northeast.

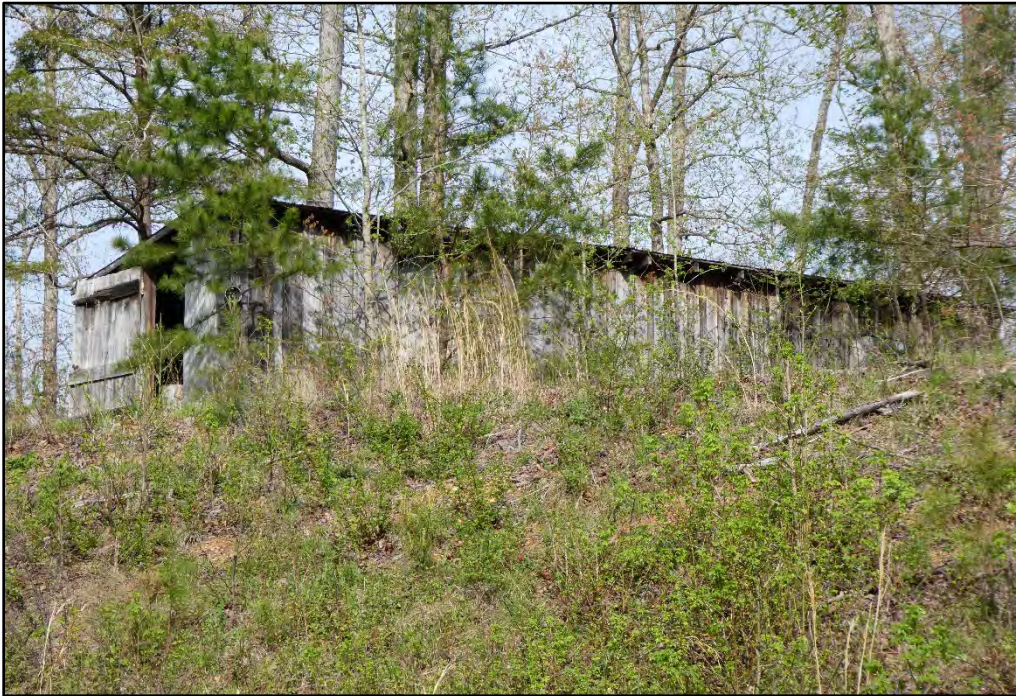
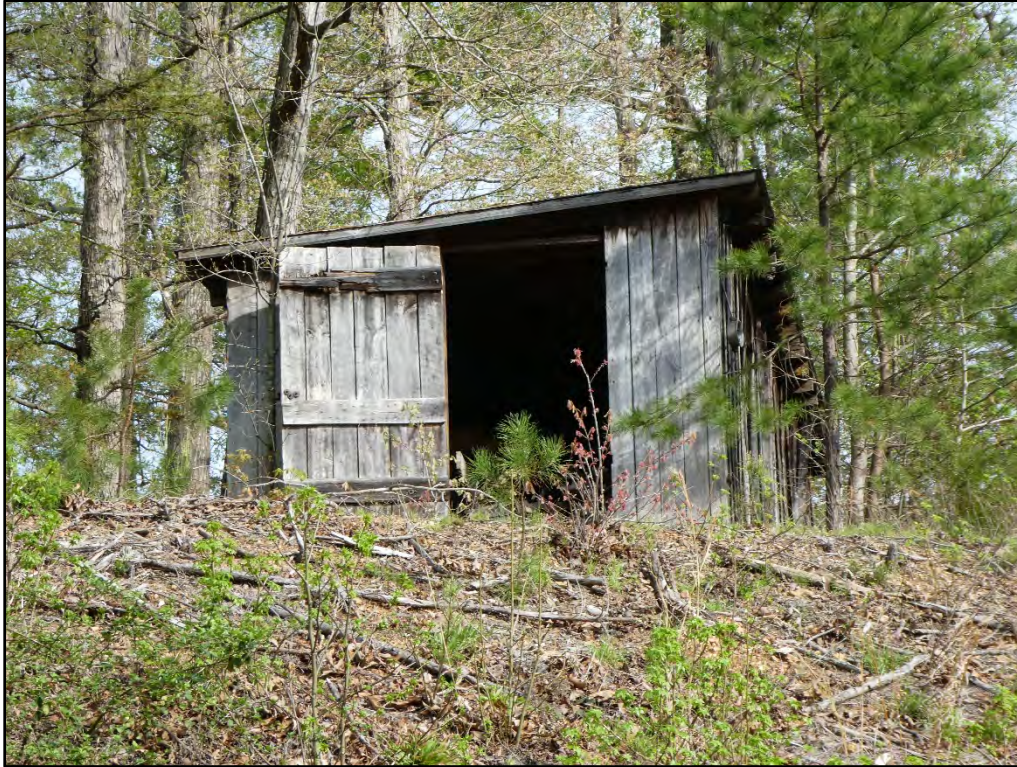
22. **Shed** (Figure 46 and Figure 47): Situated immediately adjacent to the Northeast Connector, this ca. 1912 shed is a rectangular, wood-frame building surfaced with vertical plank siding. The shed roof is covered with 5V-crimp sheet metal, and the structure is accessed by a vertical plank wood door on the west end. Exposed rafter ends are evident in the eaves. A broken meter on the south elevation indicates that this building was once connected to electricity. Although this structure does not appear on the 1990 survey site plan (Appendix A), its design and construction are consistent with the Moss-era of use.

Figure 46. Shed (Site Plan # 22) viewed from Northeast Connector, taken facing northeast.

Figure 47. Shed (Site Plan # 22) viewed from Northeast Connector, taken facing east.

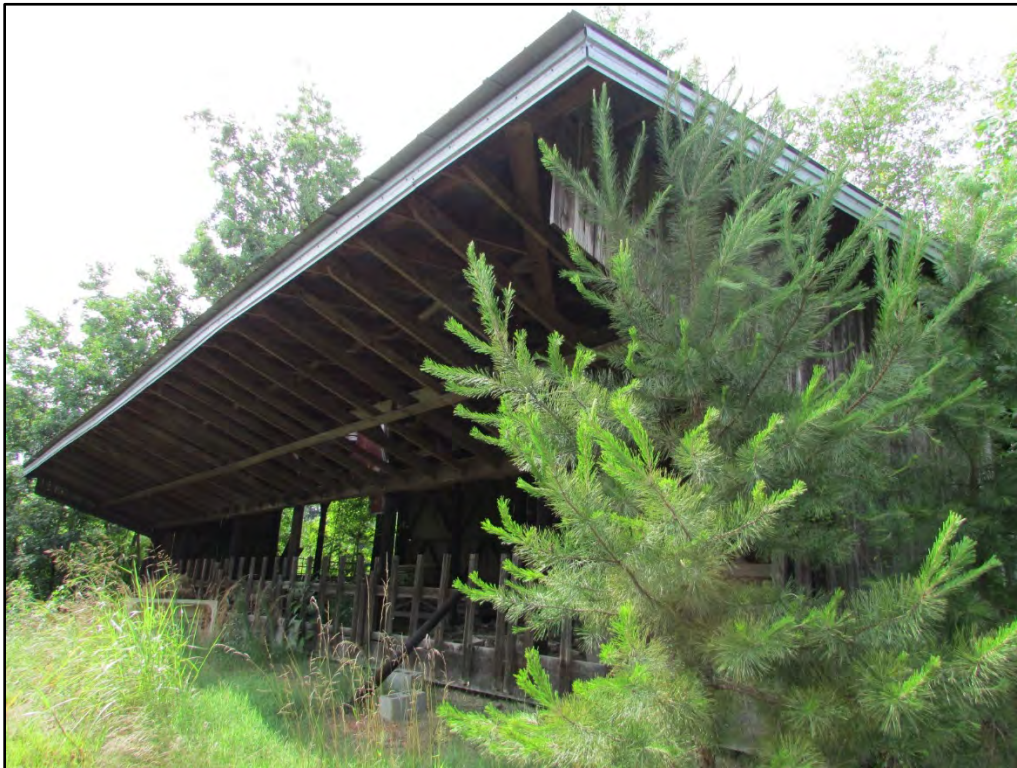
23. **Livestock Shelter** (Figure 48): The ca. 1940 livestock shelter is set in a largely overgrown portion of the property with no visibility from the Northeast Connector. The wood-frame structure has a shed roof surfaced with metal sheets in poor condition with large holes. The south elevation is completely open, while the west and east elevations are have vertical board siding along the roof and at the north end. The north wall has widely spaced vertical boards allowing for ventilation. Cut openings at the east and west ends allow vehicular access but are blocked by metal pipe gates. Based on historical Google Earth imagery, this area was surrounded by more mature trees in 2013 but by 2014, they had been felled. The trees planted since then have grown sufficiently to limit access to the site.

Figure 48. Livestock Shelter (Site Plan # 22), taken facing northwest.
