North Carolina Department of Natural and Cultural Resources
State Historic Preservation Office

MEMORANDUM

SUBJECT: Historic Structures Survey Report, Upgrade US 276 (Jonathan Creek Road) from US 19 to I-40 R-5921, Haywood County, ER 21-1422

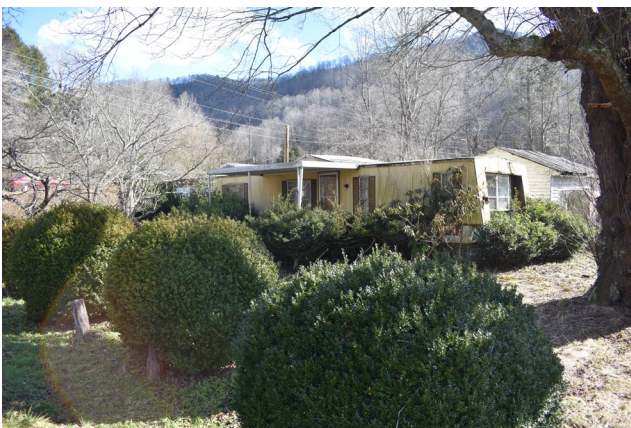
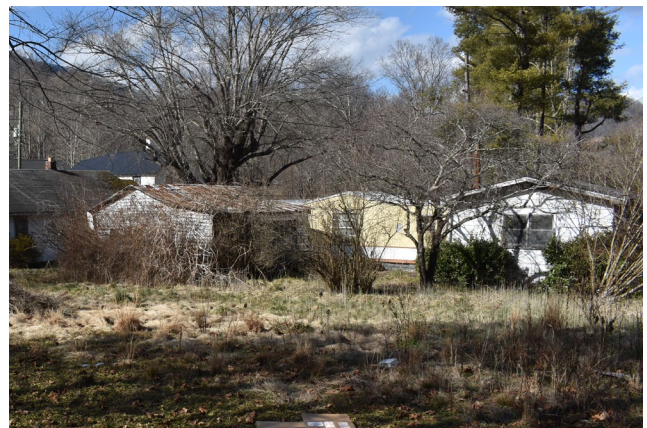
Figure 13: Left, oblique view of 146 Teague Loop, north and west elevations looking southeast; right, view of 146 Teague Loop south (rear) elevation and accompanying sheds, looking north.

Likely dating to the mid-twentieth century, the rectangular-plan mobile home (Resource A) stands at the eastern boundary of the community, near the intersection of Teague Loop and Jonathan Creek Road/US 276. The building is oriented to the north, clad in vertical metal sheathing and is topped by a flat roof. Two raised front-facing gables rest on top of the roof and are centered in their placement. A metal, flat-roof portico supported by metal posts projects from the building's façade. Beneath the portico rests a centrally placed doorway which holds an original metal screen door. Fixed windows featuring four stacked lights are unevenly spaced on the façade, and a recessed bay window is found at the building's western end. A small front-gabled frame shed clad in weatherboards and topped with standing-seam metal likely predates the mobile home and stands to its southwest. A second front-gabled shed clad in asbestos shingle siding stands to the southeast of the mobile home.

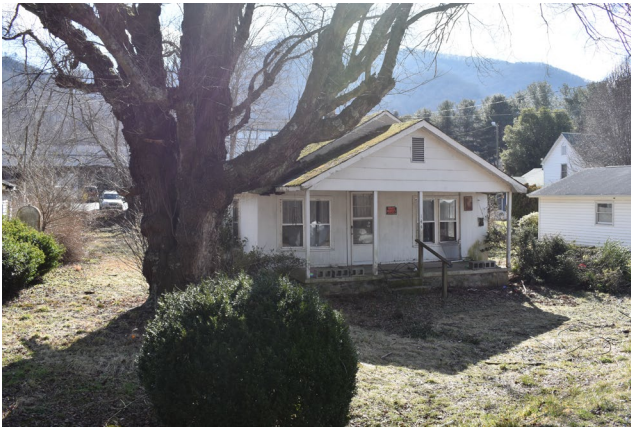
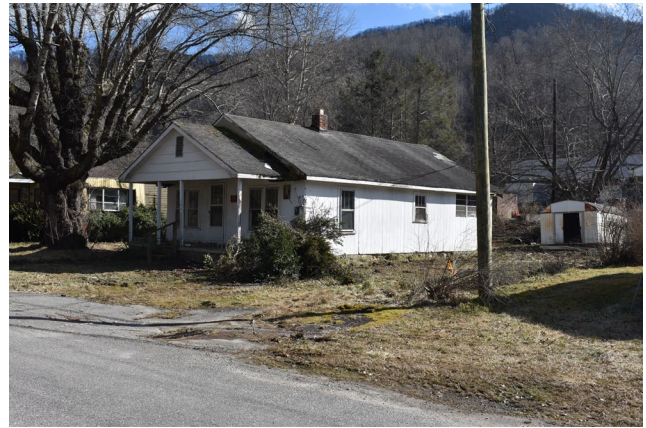
Figure 14: Left, view of 144 Teague Loop north (front) elevation, looking southwest; right, oblique view of 144 Teague Loop north and west elevations, looking southeast.

According to Haywood County tax records, the single-story frame residence at 144 Teague Loop was constructed ca. 1944. The building is oriented to the north and stands at the northern end of its 1.25-acre lot, which fronts the road. It appears to retain its original rectangular plan and features an unornamented design. The single-family residence is clad in T1-11 siding, which likely replaces or covers earlier weatherboards. A front-gabled roof with asphalt shingles tops the building and features a centrally placed interior brick chimney along its ridgeline. Standing three-bays wide, a front-gabled porch projects from the façade and is supported by replacement posts. Like the main building mass, it rests on a continuous stone foundation. The porch shelters the building's main entrance, which is slightly off-center and holds an original three-light-over-three-panel wood door with a replacement surround. Original three-over-one, double-hung, wood-sash windows flank the door on either side and are set in replacement surrounds. Windows of the same style are found asymmetrically placed on the building's secondary elevations.

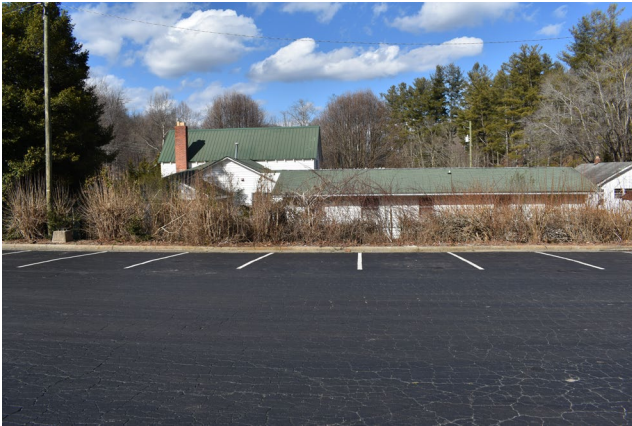
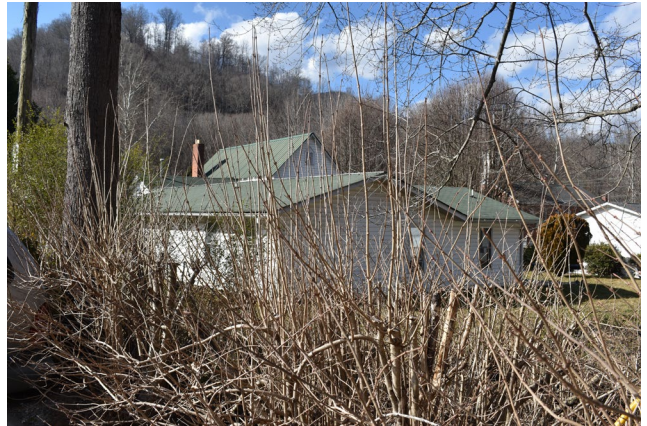
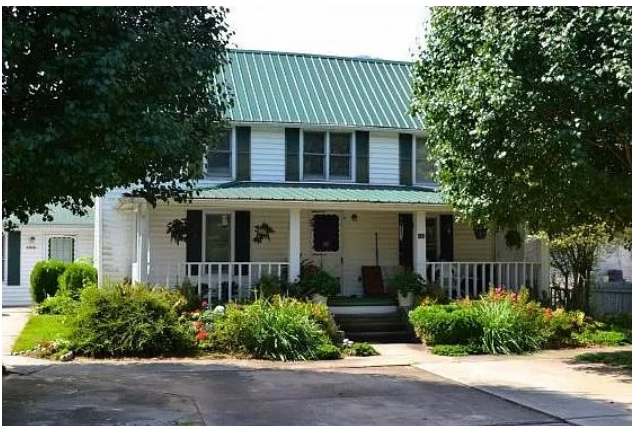
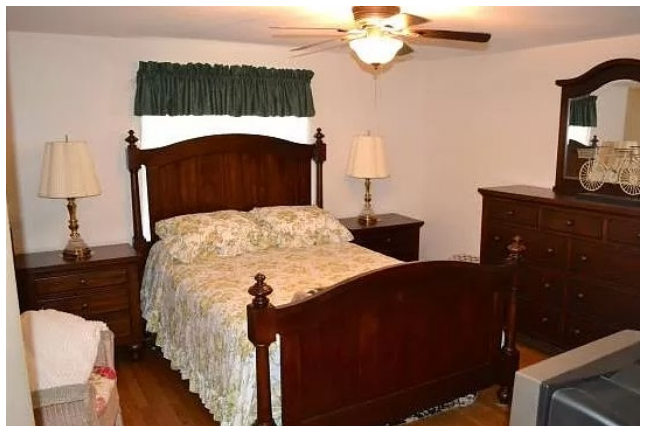
Figure 19: Left, south elevation of Resource D at 132 Teague Loop, looking north; right, oblique of Resource D at 132 Teague Loop, south and east elevations, looking northwest.

In the almost four decades since Cotton's survey, the building has been significantly altered and lost an extensive amount of original material. The biggest alteration to the residence is the increase in its building footprint through the addition of a large single-story, frame L-wing which extends from its western elevation (Figure 16). According to historic aerial images, this addition was added sometime between 1982 and 1998. Material changes to the original I-house block include the removal or covering of original weatherboards with vinyl; the replacement of the original two-over-two sash windows with one-over-one vinyl units; the replacement of the hipped-roof porch in its entirety; and the application of a new roof and removal of exposed rafter tails. Limited views of the building's interior as seen at Zillow.com suggest the interior retains very little, if any, of the original material observed by Cotton in 1982 (Figure 18-Figure 20).

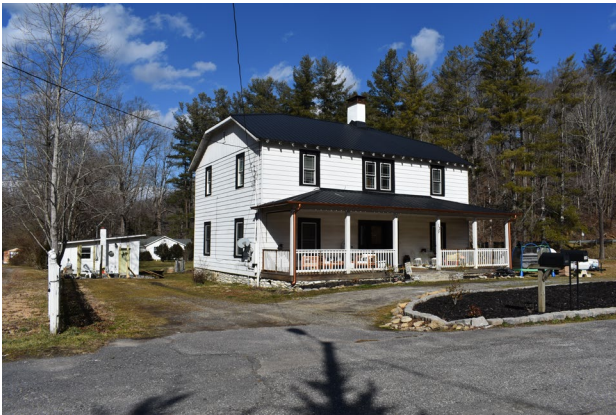
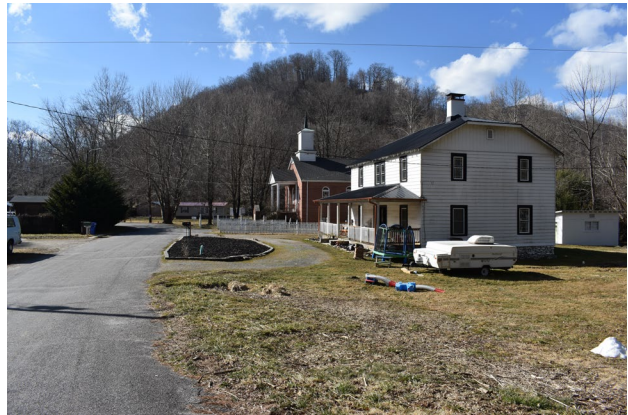
Figure 21: Left, oblique of Resource E at 129 Teague Loop, south and west elevations, looking northeast; right, oblique of Resource E at 129 Teague Loop, south and east elevations, looking northwest.

The house at 129 Teague Loop stands on the north side of Teague Loop and faces south. The building is situated at the eastern edge of the Dellwood Community and is bounded to the east by the NCDOT right-of-way buffer for Jonathan Creek Road/US 276. Haywood County tax records list a 1930 construction date for the house. However, its form and finish, and the inclusion of a building in its general location on a 1912 USGS map (Figure 29), suggests a late-nineteenth/early-twentieth century construction date. The residence is likely the second-oldest building in the community and has recently undergone significant material alterations. The frame building stands two-stories tall and three-bays wide and is clad in replacement aluminum or vinyl. It is topped with a jerkinhead roof that has recently been re-clad with standing-seam metal. Projecting through the newly clad roof is an original interior brick chimney. A recently replaced hipped-roof porch supported by replacement wood posts extends from the building's façade. The porch is spanned by a replacement wood rail and crowned at its roofline with new copper gutters. All of its window openings hold replacement vinyl sash. Recent photographs of the house taken prior to its 2020 sale reveal the retention of significant original material on the building's interior. These original details include original flooring, thick cased moldings, original paneled doors (including the front door) and an original newel post and stair (Figure 22).

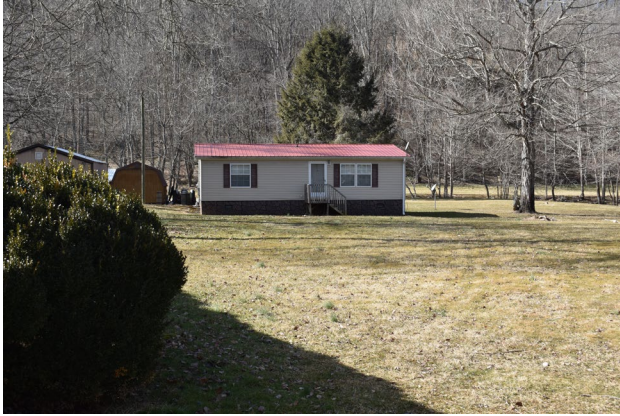
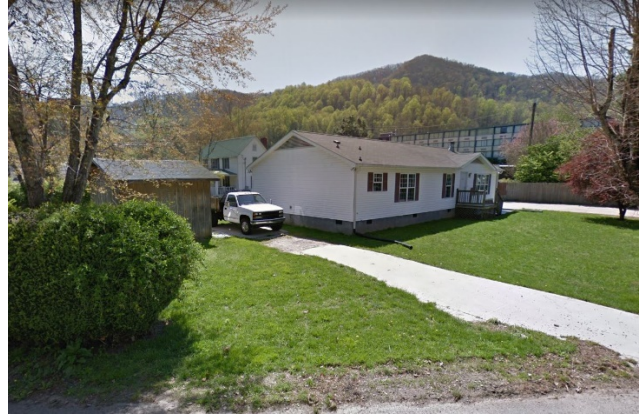
Figure 25: Left, east elevation of Resource G at 99 Teague Loop looking west; right, oblique of Resource H at 86 Teague Loop, north and west elevations, looking southeast.

The single-story residence sits at the center of two lots at the western end of the Dellwood Community. According to Haywood County tax data, the residence, which appears to be prefabricated in construction, was placed on its lot between 1971 and 2005. The non-historic building is rectangular in plan, clad in vinyl siding, and topped with a side-gabled roof. The building rests on a raised foundation clad in faux-stone and its four simple elevations feature vinyl windows and doors. The building is accompanied on its lot by a small assortment of non-historic frame sheds.

Oriented to the west, the single-family prefabricated residence was placed on its lot ca. 1995 according to Haywood County tax records. The side-gabled building stands one-story tall and its façade is divisible into five bays. The building rests on a raised concrete foundation. The

building's roof is clad in asphalt shingles and its elevations in vinyl. All of the building's openings hold vinyl windows and doors.

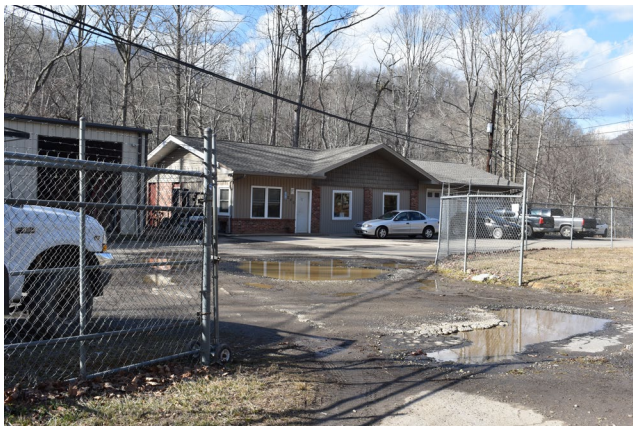
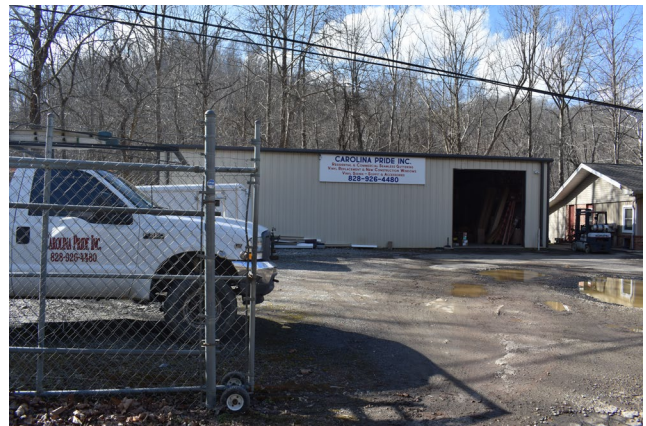
Figure 26: Left, south and east elevations of main building of Resource I at 245 Jonathan Creek, looking northwest; right, view of east elevation of garage building at Resource I at 245 Jonathan Creek, looking west.

The commercial building at 245 Jonathan Creek Road stands on an oblong 0.6-acre parcel which fronts Jonathan Creek Road/US 276. The parcel is located north of Teague Loop, and thus outside of Dellwood proper. The parcel's primary resource is a ca. 1970 single-story, side-gabled commercial building centered along the parcel's eastern end. The building features a variety of cladding materials including vertical vinyl siding, wood-shake shingles, and brick veneer. All of its openings hold replacement vinyl units. The building is accompanied by a large, rectangular, metal-clad workshop building and a variety of smaller non-historic sheds.

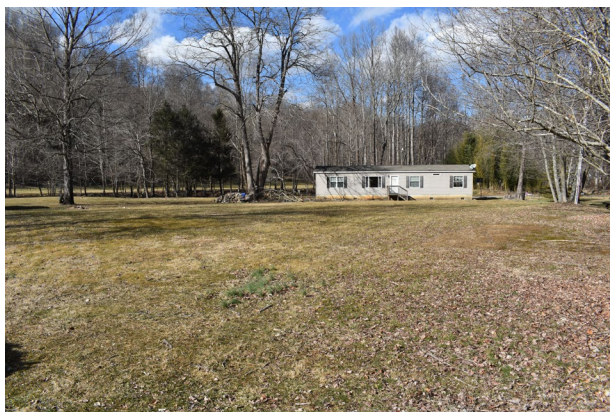
Figure 27: Above, south elevation of Resource J at 181 Jonathan Creek Road, looking north.

The side-gabled prefabricated house was placed on its lot ca. 2012 according to Haywood County tax records. The non-historic house sits to the northeast of the former Dellwood Baptist Church on a 1.25-acre partially wooded parcel. The building is rectangular in plan, stands on a poured concrete foundation and features vinyl siding, vinyl windows, and vinyl doors. It is accessed via a gravel drive that runs behind (north) of the church.
