SUBJECT: Historic Structures Survey Report for Widening US 441 from US 64 to Blanton Road, R-5734,
Macon County, ER 17-0883

The North Carolina Department of Transportation (NCDOT) proposes to widen US 441 from US 64 to Blanton Rd. The initial screening of the Area of Potential Effects (APE) was conducted in November 2016. The presence of a circa 1940 house was noted in the APE was noted. NCDOT contracted with Environmental Corporation of America to conduct a field survey and complete an intensive evaluation of the property. The attached report concluded that the Stockton House is not eligible for the National Register of Historic Places.

The Stockton House (MA0802)
 563 Belden Circle, Macon County, North Carolina
 NCDOT Project: Widening of US441 from US 64 to Blanton Road; TIP No.R-5734 WBS
 No. 50192.1.1
 Figure 2: USGS Topographic Map Showing Site Location

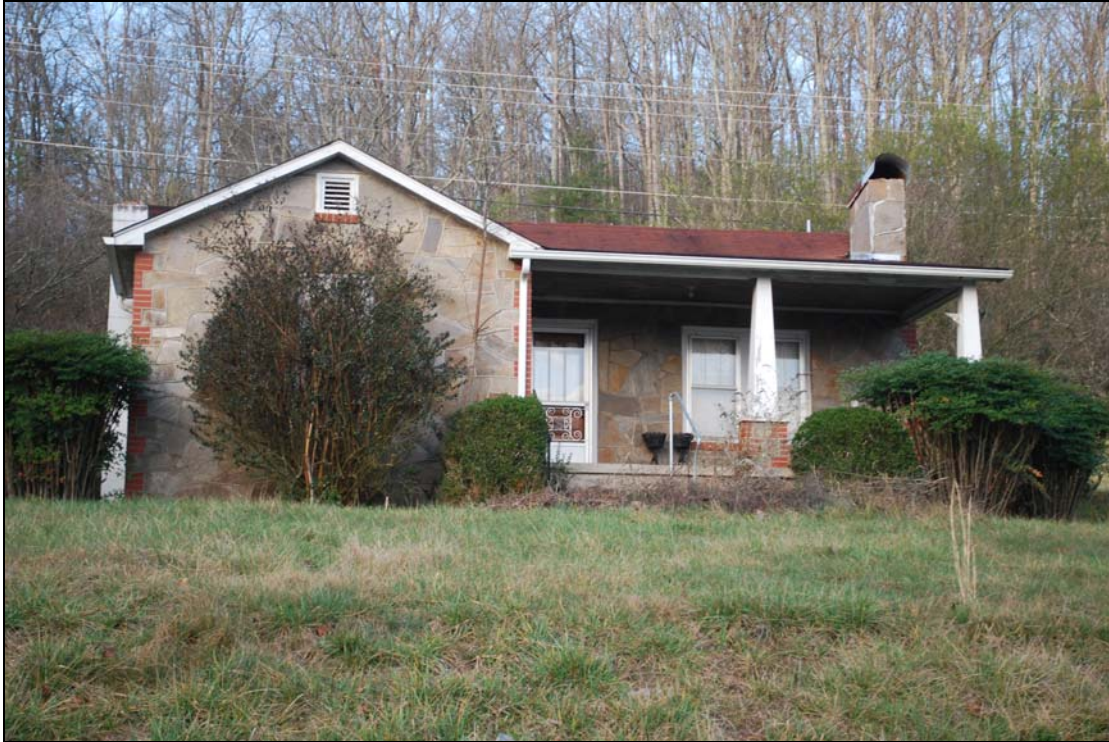
Photograph 5. The Stockton House façade (northeast elevation), looking southwest

Constructed in 1946, the Stockton House is comprised of a rectangular massing with a projecting front-gabled bay on the façade (northeast elevation). The side-gabled roof is low-pitched and covered with asphalt shingles. The house features slightly overhanging boxed eaves. Wood-louvered gable vents with brick sills are located within the peak of the gable ends. The exterior features a veneer of random-coursed stone slabs of varying shapes and sizes. Each corner of the house is enhanced by red-brick quoins. A partial-width shed porch is inset in the front ell and features tapered square wood columns on brick piers. The foundation is concealed behind the stone veneer. Primary windows throughout the house are three vertical-over-one, double-hung wood sash with brick sills. Most of the windows include exterior metal storm windows.

The façade of the house is asymmetrical and three bays wide. A single window is centered on the projecting bay. The entry door is indicative of the Craftsman-style with three vertical lights and horizontal wood panels. The third bay on the façade is a set of paired windows. Concrete steps with a simple metal railing extend from the entry porch.

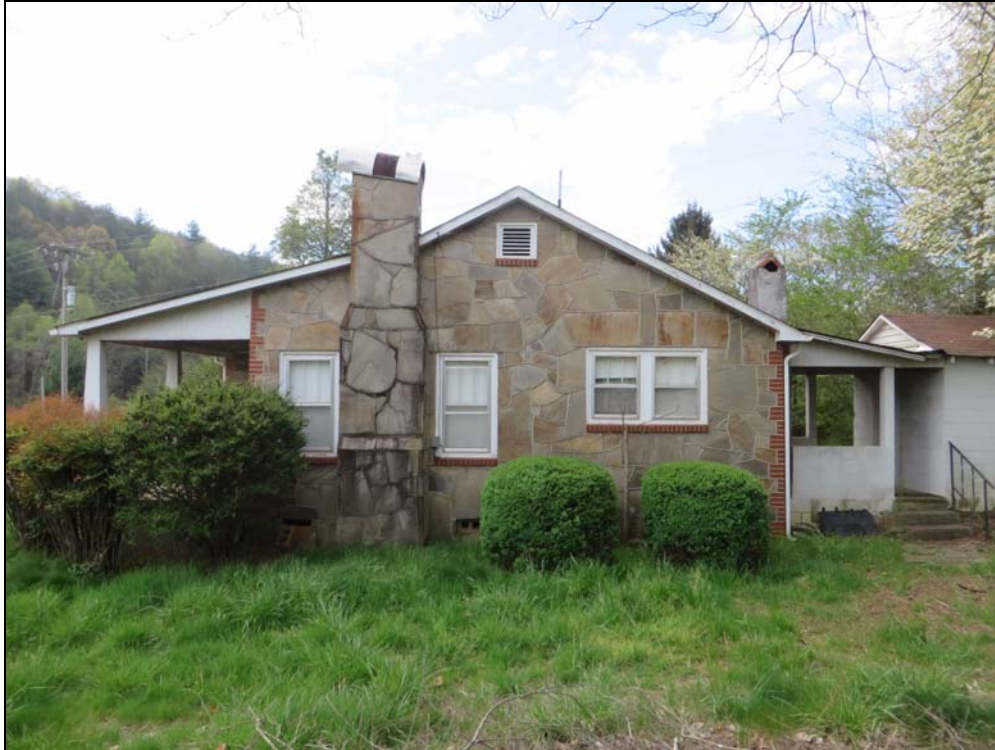
Photograph 8. North Elevation

The north elevation is three bays with a prominent exterior stone veneer chimney situated between the first two bays (from left to right). The chimney is topped with a metal cap. A change in roof pitch occurs left of the chimney, and is consistent with the roof of the entry porch. The third bay on the north elevation is a set of smaller, paired windows.

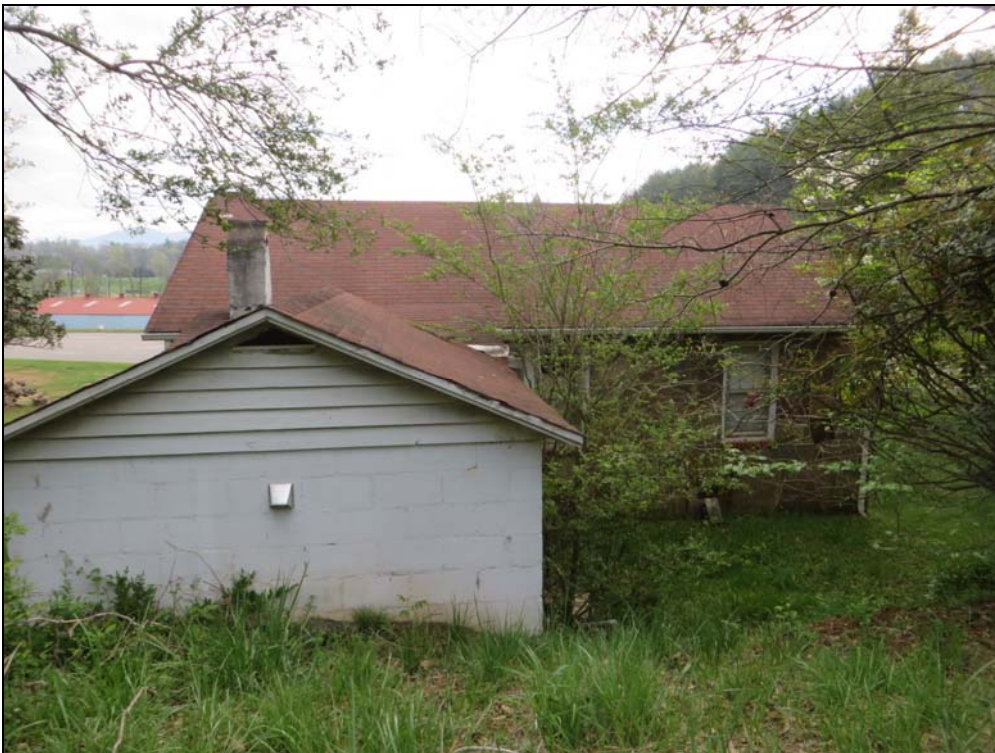
Photograph 9. Rear (West) Elevation

The rear (west elevation) of the house features an interior concrete chimney. A shed roof breezeway constructed of concrete block extends to a small, gabled utility room. The room is constructed of concrete block and features exposed rafter ends. A door is centered on its northeast elevation. The enclosed breezeway and utility room were constructed later than the 1946 dwelling; however, both likely date to the mid-20th century.

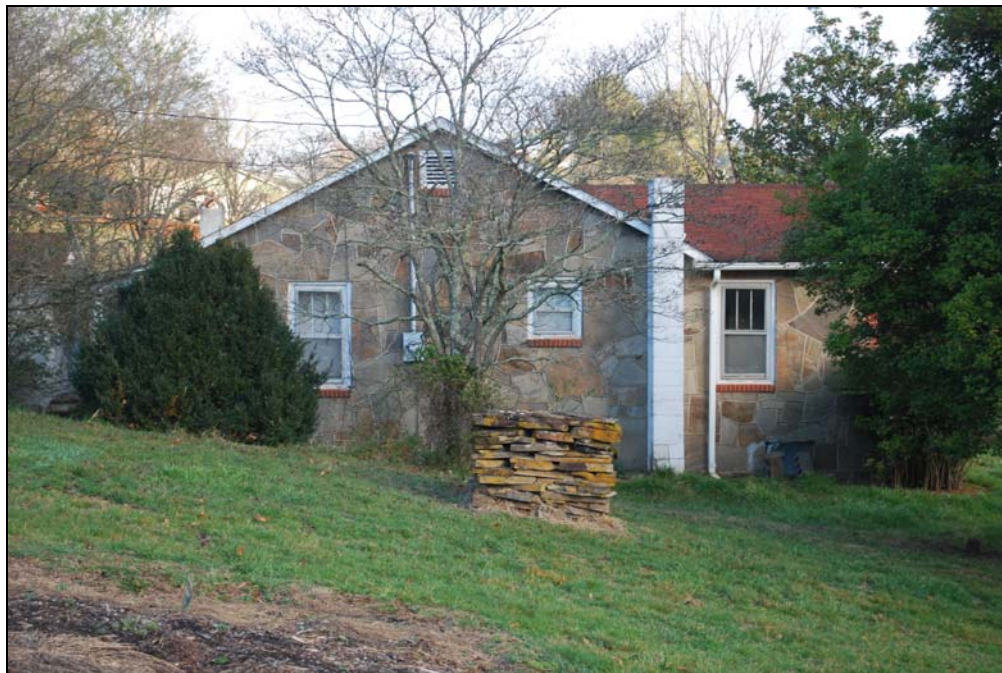
Photograph 11. South Elevation

The south elevation of The Stockton House is two bays, with both bays occupied by a single window. The second window (right) is smaller than the first. A narrow, exterior concrete block chimney is at the east end of the elevation. A single window is located on the south elevation of the projecting front bay.

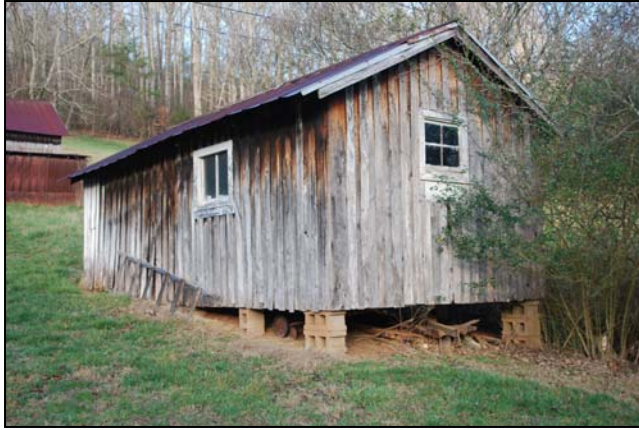
Photograph 12. Frame Utility Building
CENTURY

A frame, gabled utility building with board-and-batten siding is located near the southwest corner of the Stockton House. It is oriented perpendicular to Boyd Lane, and its entry door is on its southwest elevation. The building features a metal roof and cinder block pier foundation, which likely replaced an earlier pier foundation. A single window is on the north, south, and east elevations. Windows include a two-light and a four-light, fixed wood sash.

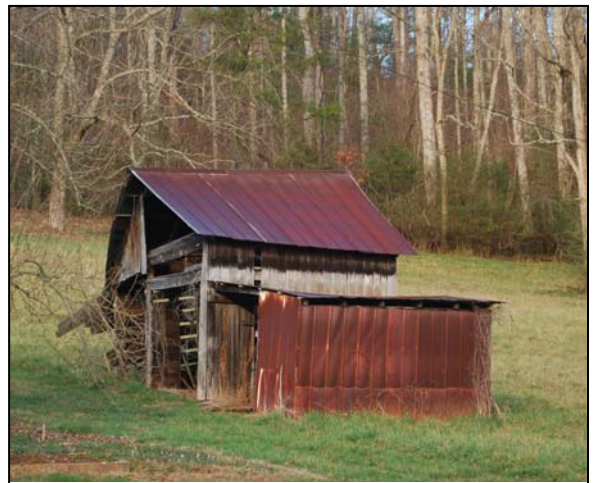
Photograph 13. Frame Equipment Garage

The one-story, frame equipment garage is located southwest of the utility building. It features a front gable, metal roof and vertical board exterior siding. The southwest elevation appears to be sided with horizontal boards. The front of the garage faces southeast toward Boyd Lane. Its front façade is open. A metal lean-to extends along the east elevation.

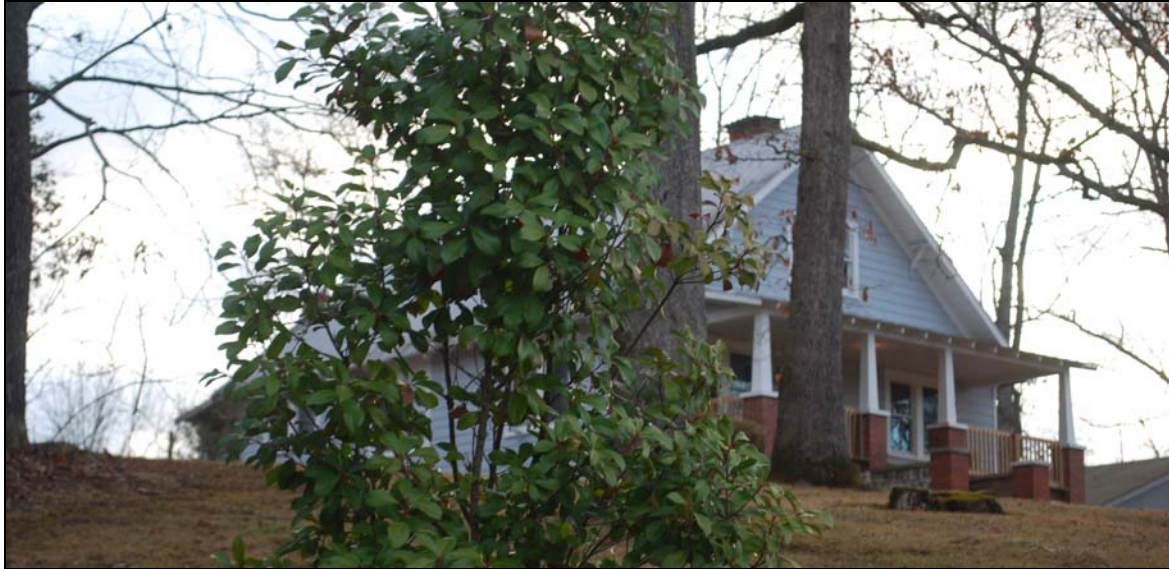
Photograph 14. 7 Baldwin Lane, looking southeast

The residence located at 7 Baldwin Lane is an illustration of a rural, front-gabled bungalow exhibiting restrained Craftsman-style influences. Constructed during the 1930s, the house is earlier than the Stockton House and features a prominent entry porch enhanced by Craftsman-style tapered wood posts on brick piers. Exposed rafter ends and gable end brackets further reflect Craftsman influences. Compared to the Stockton House, this residence better reflects both the bungalow form and restrained Craftsman-style enhancements.

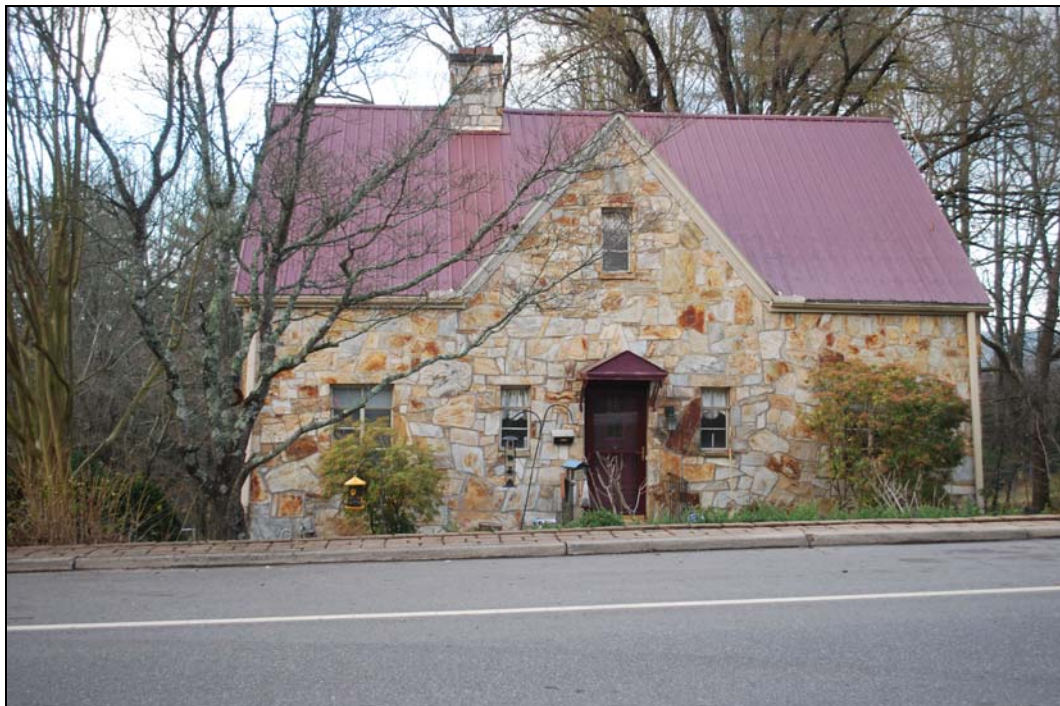
Photograph 15. Belle Johnson House (MA0615)

The Belle Johnson House (MA0615, study list denied 2013) was constructed in 1939 along a residential street in the town of Franklin. The Johnson House is an illustration of an intact English Cottage featuring a stone veneer exterior. The one-and-one-half-story dwelling features a relatively high-pitched, side-gable roof, and a projecting gabled bay centered on the façade. Similar to the Stockton House, the veneer is comprised of random course stone of varying shapes and sizes. The stone applied to the Johnson House is generally smaller than that occurring on the Stockton House.

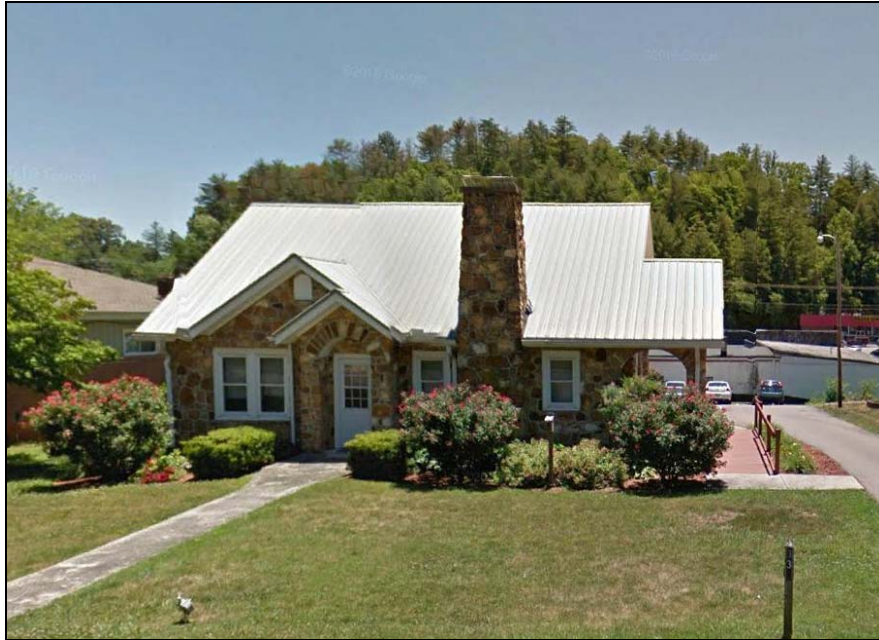
Photograph 16. 330 W. Main Street

The resource located at 330 W. Main Street in Franklin is another example of a 1930's dwelling enhanced by a stone veneer. This particular illustration is distinguished by its Tudor Revival influences including arched entry door and prominent exterior stone chimney on the façade. Not only does this house retain its historic stone veneer, it is distinguished by its well-defined residential form.

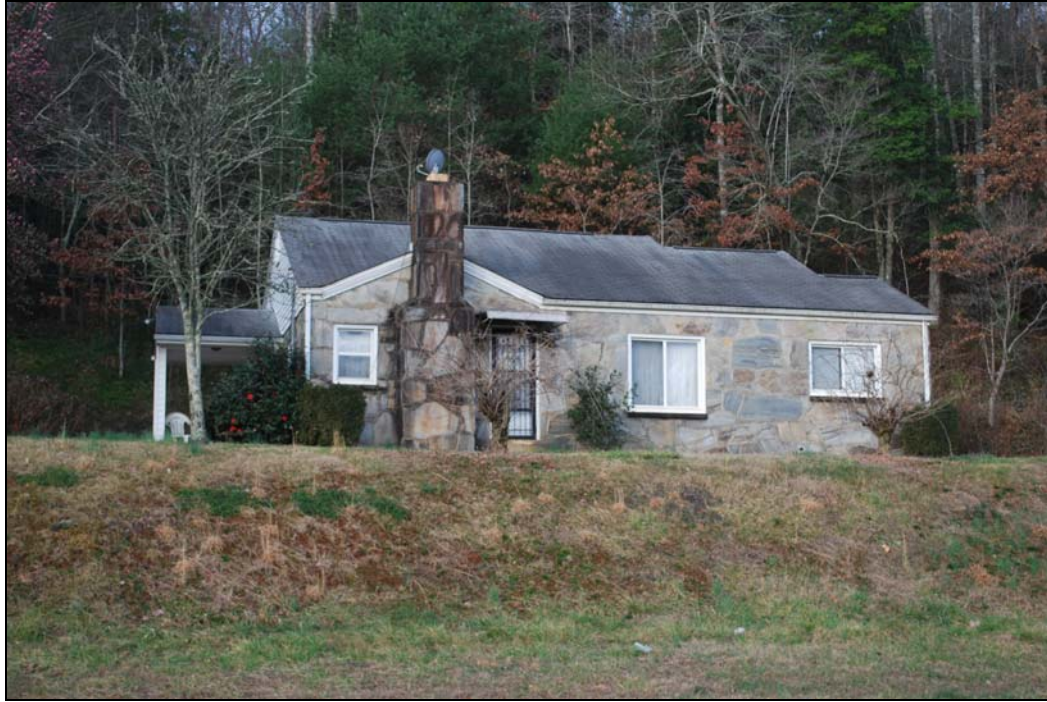
Photograph 17. 1170 Riverview Street

Built in the 1940s, the resource located at 1170 Riverview Street is an example of stone veneer applied to a mid-century residence that exhibits a transitional house form. Like The Stockton House, this example was built in a relatively rural setting along a now busy thoroughfare. Unlike The Stockton House, which reflected a combination of bungalow and Minimal Traditional forms, the resource on Riverview Street appears to be a transition from Minimal Tradition to early Ranch house.
