SUBJECT: Historic Structures Survey Report, , Improvements to US 23 Business (South Main Street) from SR 1164 (Hyatt Creek Road) to US 276 (Pigeon Street), Waynesville, PA 17-12-0027, U-4712, Haywood County, ER 18-4249

MANAGEMENT SUMMARY	i
I. INTRODUCTION.....	1
II. METHODOLOGY.....	1
III. DESCRIPTION, HISTORIC CONTEXT, AND EVALUATION	7
CLYDE’S RESTAURANT (HW0735)	7
COMMERCIAL BUILDING (HW0736).....	18
COMMERCIAL BUILDING AND FORMER GROCERY (HW0737).....	28
REPAIR SHOP (HW0738)	41
MAPLE GROVE MOTEL (HW0739)	50
HYATT HOUSE AND CARRIAGE HOUSE.....	68
(HW0015 / HW0740).....	68
SILER HOUSE (HW0741)	88
ETHEL ROSS BRADLEY HOUSE (HW0742)	97
PEARL HYATT AND MARGARET HYATT PILARSKI HOUSE (HW0743)	110
HOUSE, 1262–1270 S. MAIN STREET (HW0744).....	119
GEORGE HOUSE (HW0745)	133
HOUSE, 1157 S. MAIN STREET (HW0746).....	143
HOUSE, 1153 S. MAIN STREET (HW0747).....	155
THE GABLES APARTMENTS (HW0096).....	163
DR. ALBERT HEYWARD SMITH, JR. HOUSE (HW0748).....	173
THE ATKINS HOUSE (HW0109)	187
THE HILLTOP TOURIST LODGE (HW0056).....	202
FORMER HOUSE, 809 S. MAIN STREET (HW0749).....	212
HOUSE, 761 SOUTH MAIN STREET (HW0750)	222
THE CHARLES RAY HOUSE (HW0055) AND CARRIAGE HOUSE (HW0751)	233

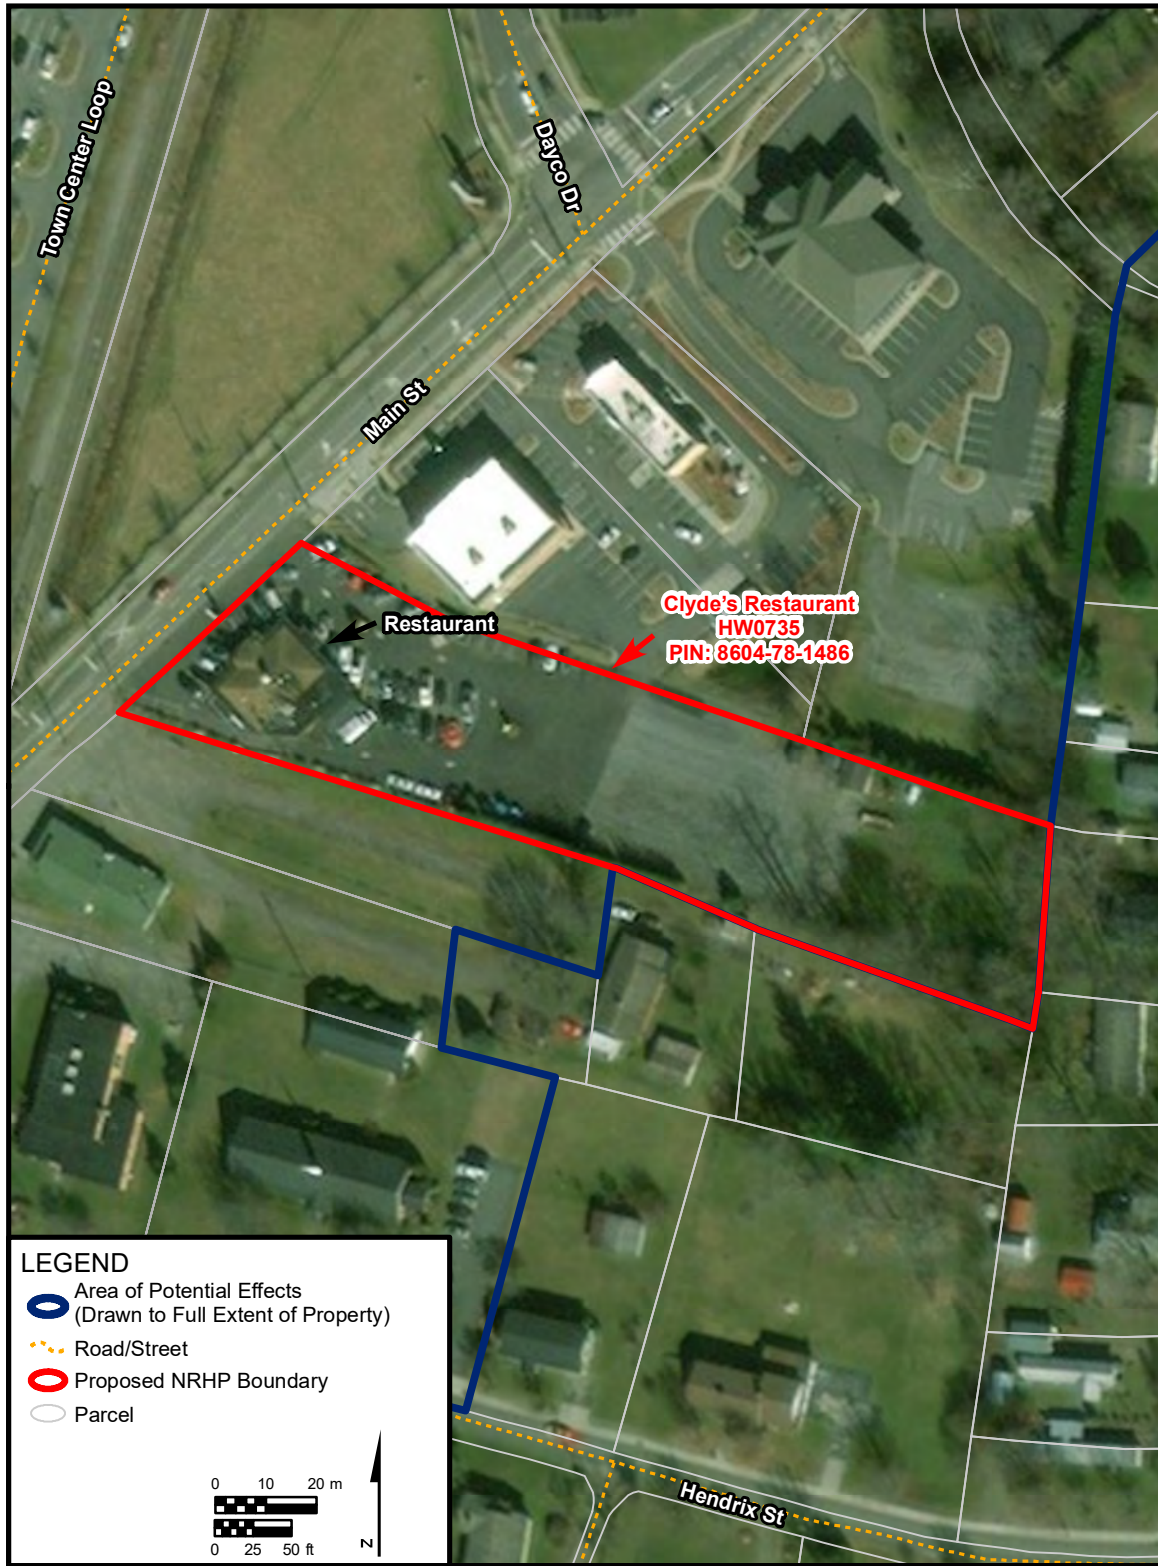
Figure 2: Map showing Clyde's Restaurant and the proposed NRHP-eligible boundary.

Setting: Located in the community of Hazelwood on the southwest side of the Waynesville town limits, Clyde's Restaurant is situated on the southeast side of South Main Street (US 23 Business), approximately 485 ft north-northeast of its intersection with Hendrix Street (Figure 2). The area is defined by commercial and industrial development. A modern shopping center is located northwest of the subject property. The restaurant occupies a flat, 1.68-acre parcel adjacent to South Main Street. A paved parking lot surrounds the building and extends toward the rear of the lot. A poured concrete walkway accessible from the parking lot extends along the façade and side elevations of the building. The east section of the parcel is unpaved. A segment of a stone retaining wall extends along the northeast side of the parking lot. The historic neon sign, elevated on stacked stone base, is located in the parking lot in front of the restaurant (Figure 3).

The proposed NRHP-eligible boundary for the Clyde's Restaurant (HW0735) approximately follows the paved parking surrounding the business and abuts a line of trees to the east. The boundary runs immediately along South Main Street to include the historic sign immediately adjacent to the road and divides the parking area along South Main street from the adjacent travel lanes. See Figure 2 for the map depicting property boundaries and the proposed NRHP boundary.

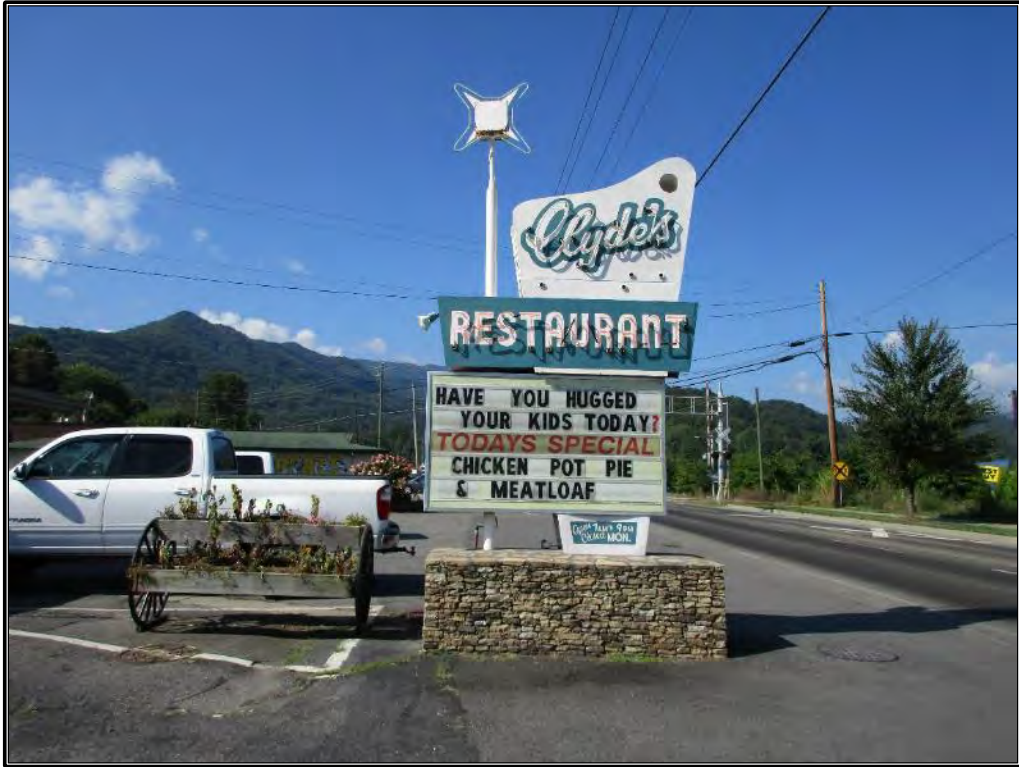
Figure 3. Overview of sign, looking west-southwest.

Sign: A circa 1956–1967 Googie-style sign is located immediately west of the restaurant’s main façade. The neon sign sits on a stacked stone base over a moveable-type panel and is supported by a metal post. The metal post terminates in a burst pattern typical of star- and atom-derived forms that are hallmarks of the style (see Figure 3).

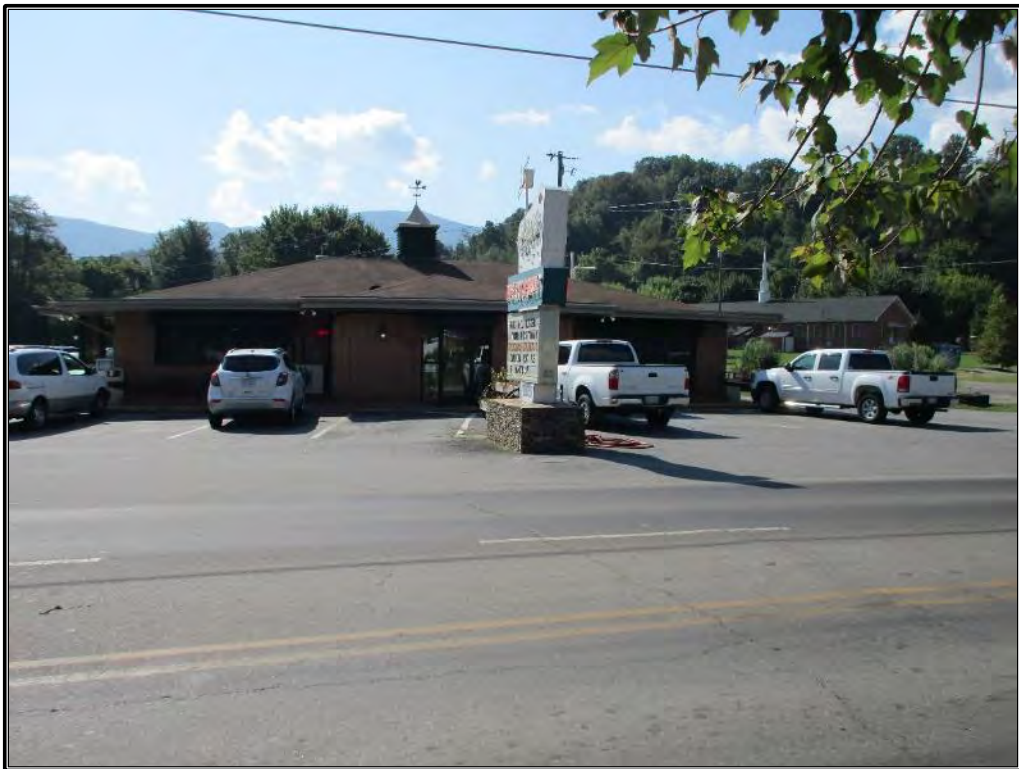
Figure 4. Façade of restaurant, looking south-southeast.

Restaurant, exterior: The circa 1959 restaurant features a one-story, three-bay (www/wdw/www), hip-roof form (Figure 4). The exterior of the building is clad in a brick veneer laid in stacked bond on the façade projection and stretcher bond on the primary façade, side, and rear elevations. The building rests beneath a hip-roof sheathed in asphalt shingles with overhanging eaves. The central ridgeline of the roof is pierced by a pyramidal cupola. The foundation is not visible. The windows throughout the building present one-over-one, double-hung vinyl sashes and horizontal two-light vinyl sashes.

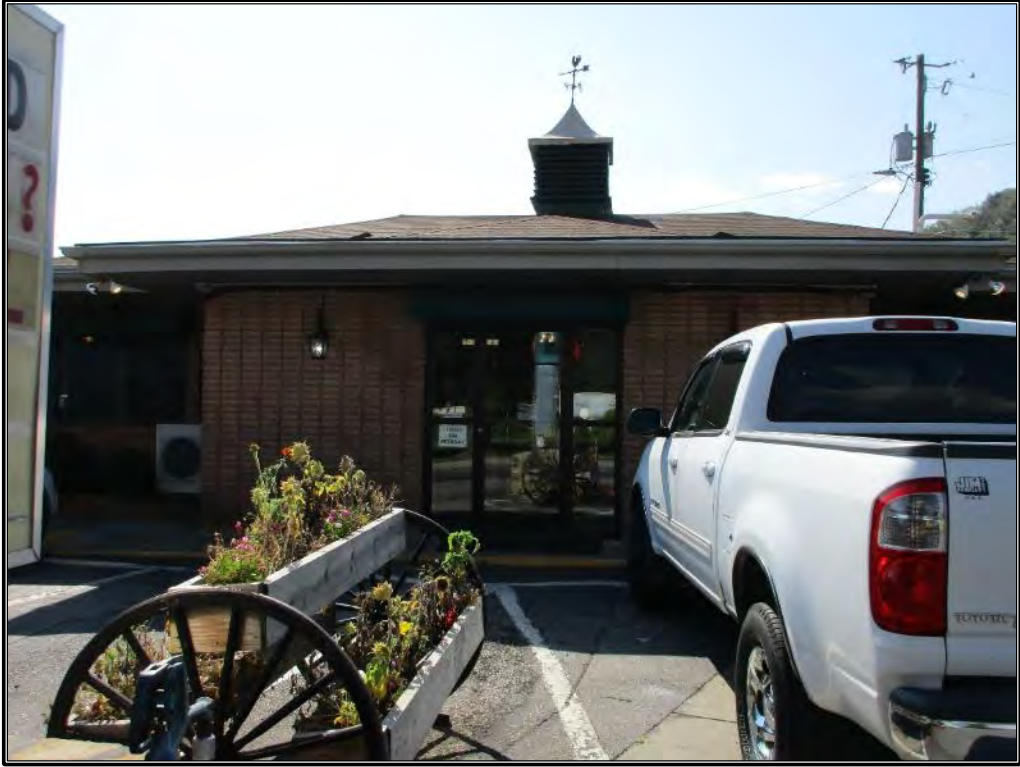
Figure 5. Detail of entry vestibule, looking south-southeast.

The façade features a central hip-roof entry vestibule (Figure 5). The façade elevation of the projection contains the primary single-leaf entry filled by a full-light commercial door flanked by two-light sidelights. The entry is sheltered by the roof overhang. A single window pierces the northeast and southwest elevations of the projection. Ribbons of windows flank the façade projection.

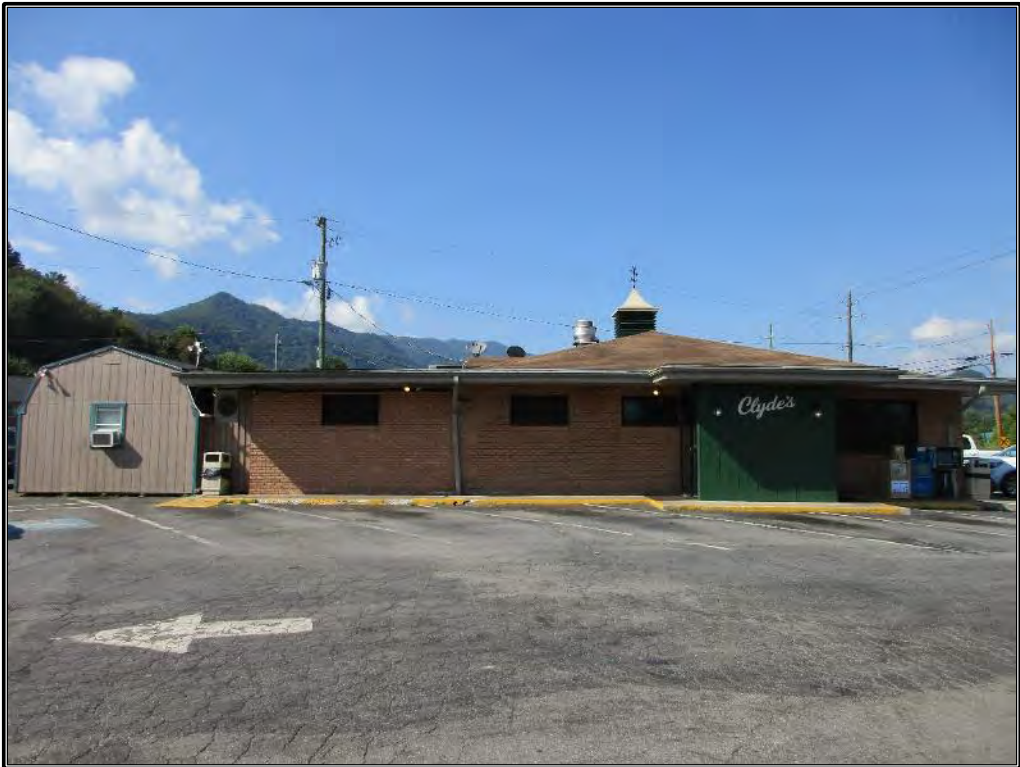
Figure 6. Northeast elevation of restaurant, looking southwest.

The northeast elevation of the restaurant features a central shed-roof vestibule (Figure 6). The northeast elevation of the vestibule is clad in T1-11 siding and features a wooden sign reading "Clyde's" in cursive text. The southeast and northwest elevations consist of a full-light metal commercial door with a fixed transom and two-light sidelight. A large opening filled by an industrial cooler occupies the southeast (right) side of the southwest elevation of the restaurant (Figure 7). The rear elevation of the restaurant features a one-story, flat-roof, concrete block addition (Figure 8). The northeast elevation of the addition is clad in a brick veneer. The rear elevation of the addition contains two single-leaf entries. The southwest (left) entry is filled by a two-light metal door. The northeast (right) entry features a full-light metal commercial door.

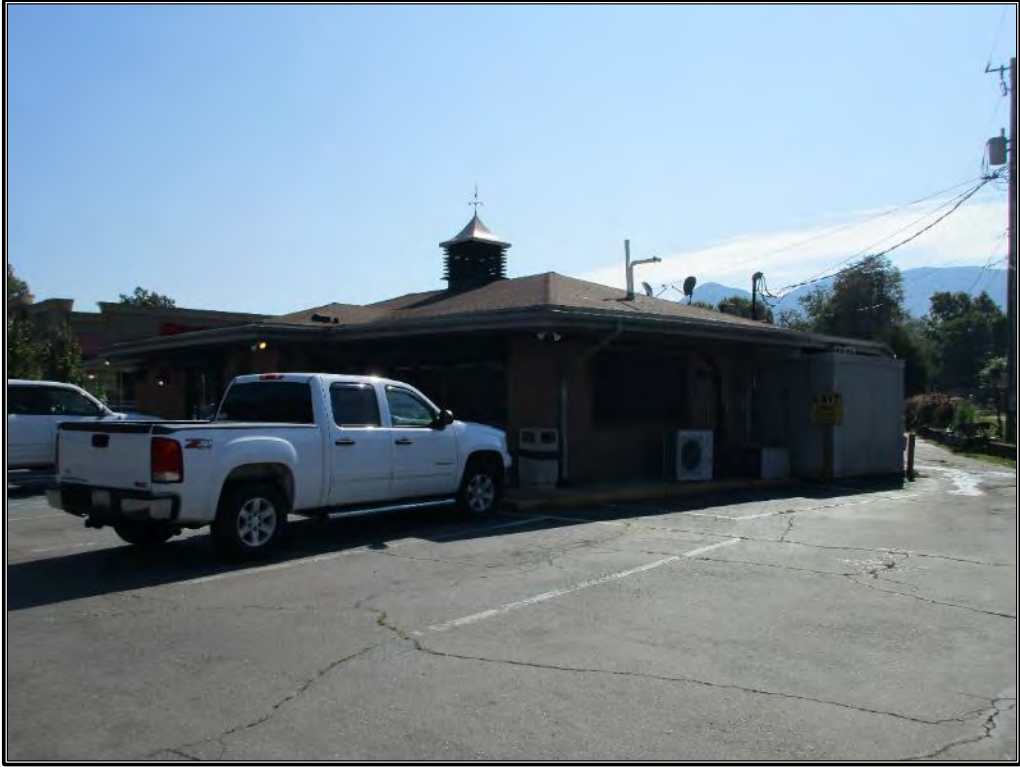
Figure 7. Façade and southwest elevation restaurant, looking east.

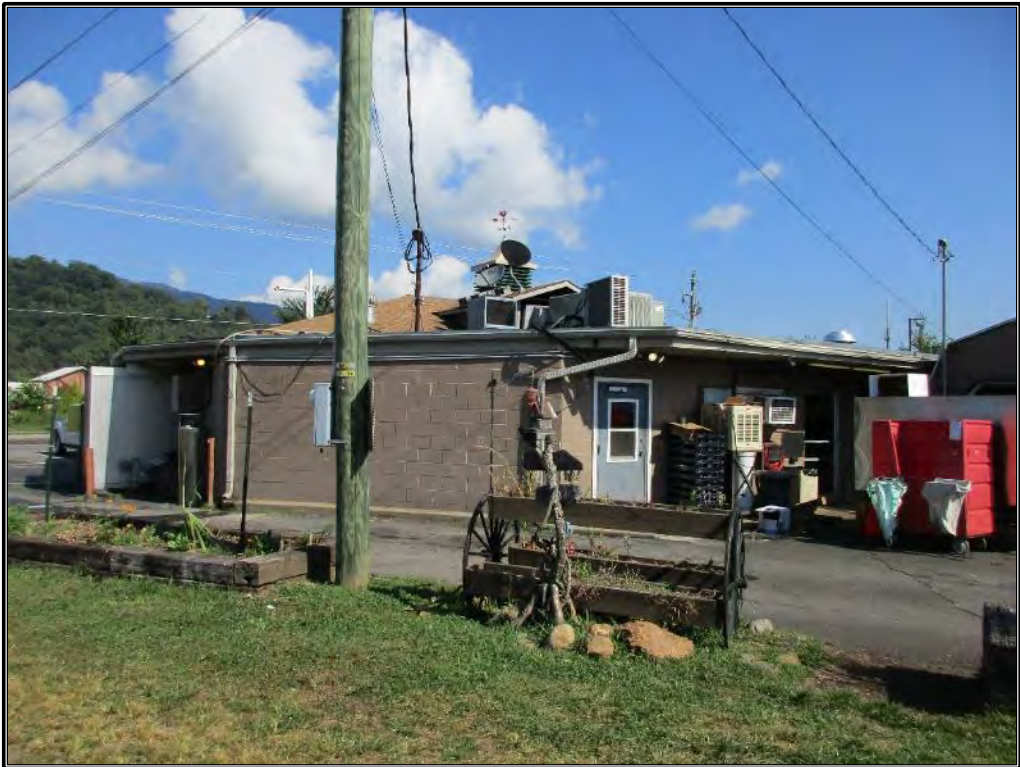
Figure 8. Rear elevation of restaurant, looking north-northwest.

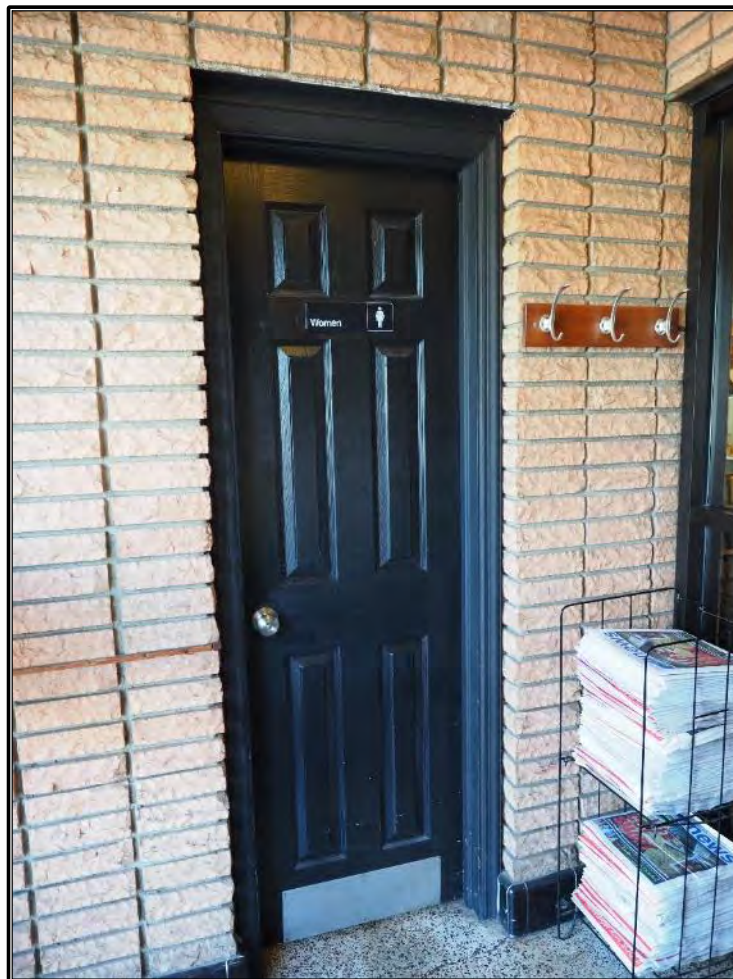
Figure 9. View of restroom door in entry vestibule.

Restaurant, interior: The front entry along the façade projection opens into a vestibule clad in stacked brick. The bathrooms are located on either side of the vestibule (Figure 9). Wood doors set in simple wood frames lead into the bathrooms. The bathroom walls are wrapped in turquoise, high-gloss tile. The building’s concrete block construction is visible along the interior of the restrooms. From the vestibule, a full-light commercial door opens into the main interior of the restaurant (Figures 10–12). The interior features a linoleum floor and a drop tile ceiling. A counter lined by stools wraps around back wall of the dining area and frames an entrance to the kitchen, which features tiled walls and floors. Booths flank the primary entrance along the front wall and extend beneath banks of windows along the northeast and southwest walls. The secondary dining area, located on the northeast side of the building next to the kitchen, features wood floors and chair rail and wainscoting along the northeast and southwest walls (Figure 13). The rear wall features exposed stacked brick.

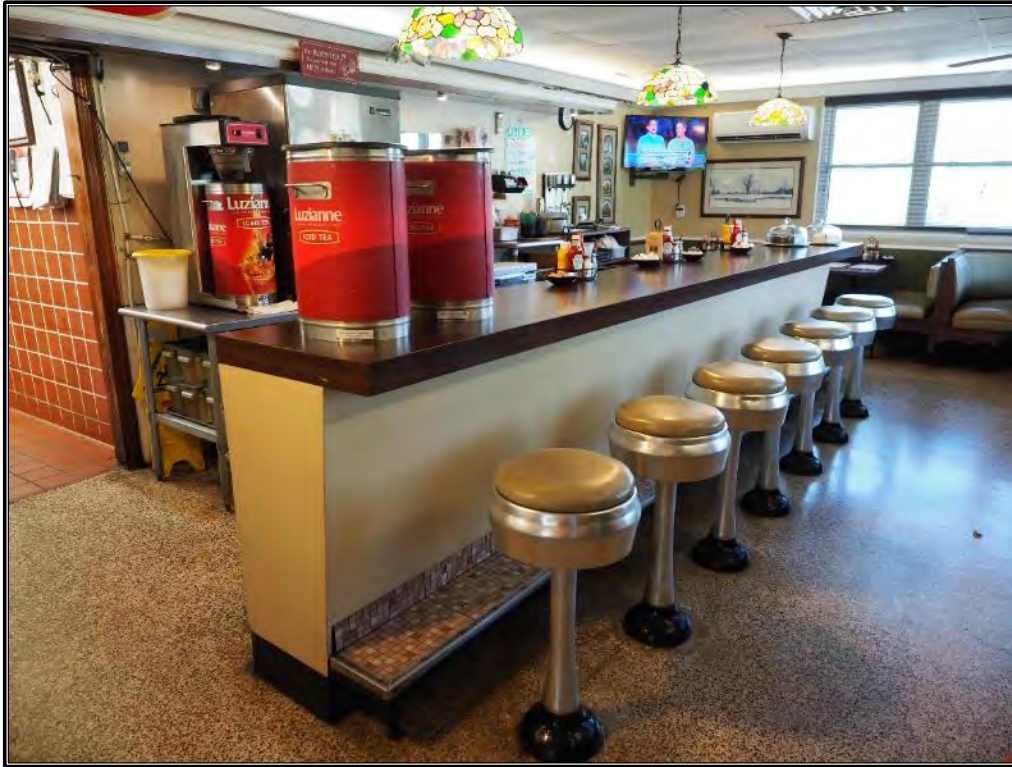
Figure 10. View of restaurant interior from façade entrance with original stools.

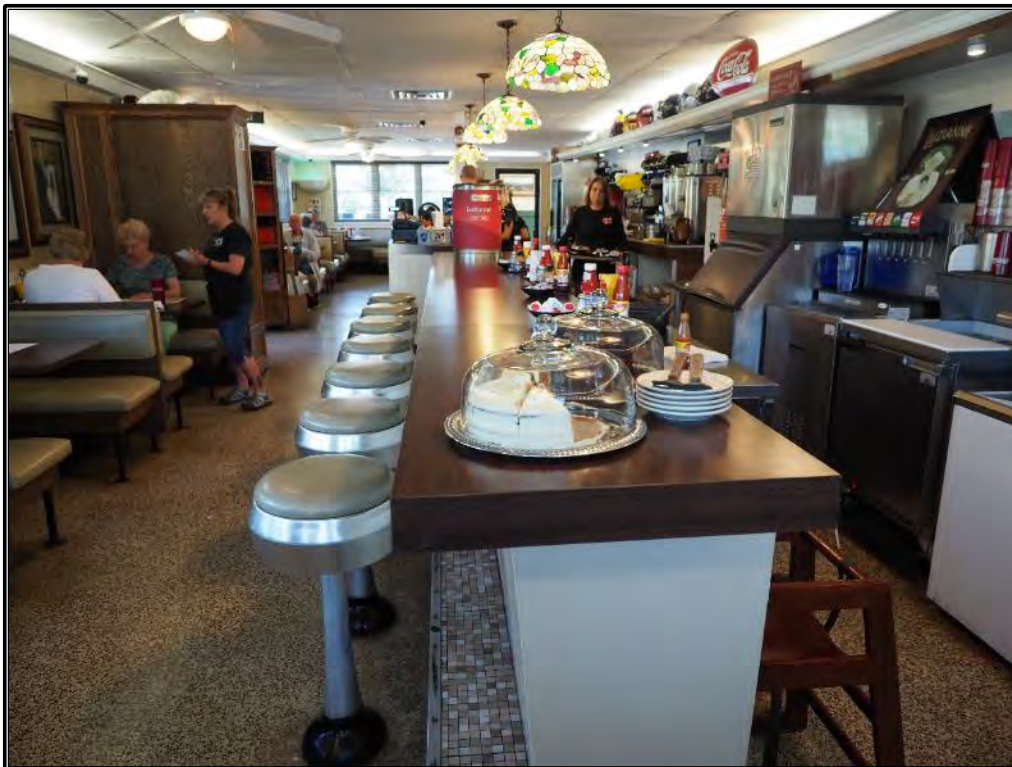
Figure 11. Overview of restaurant interior. Entrance vestibule is located to the left.

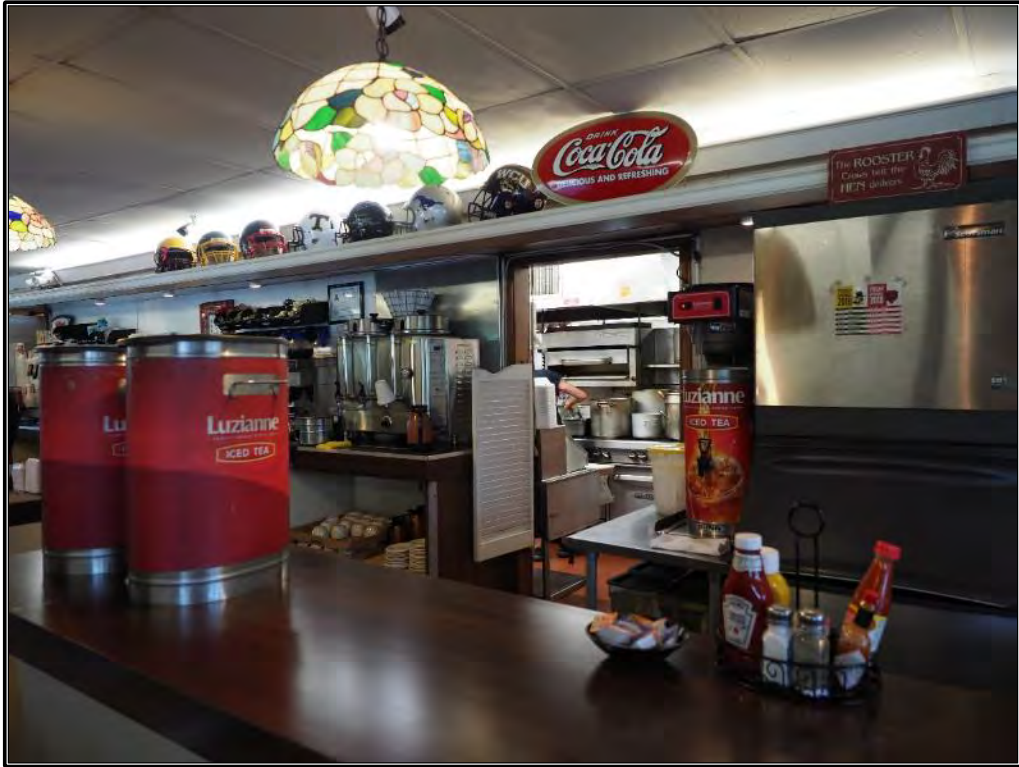
Figure 12. View of kitchen and back counter.

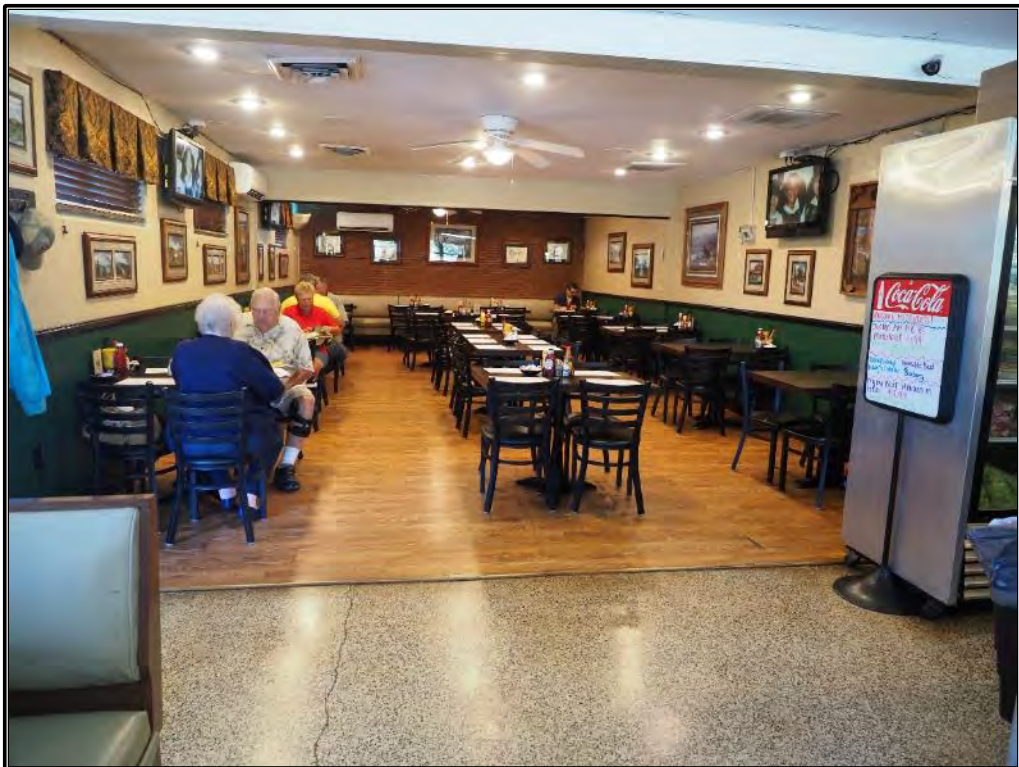
Figure 13. Overview of secondary dining room.

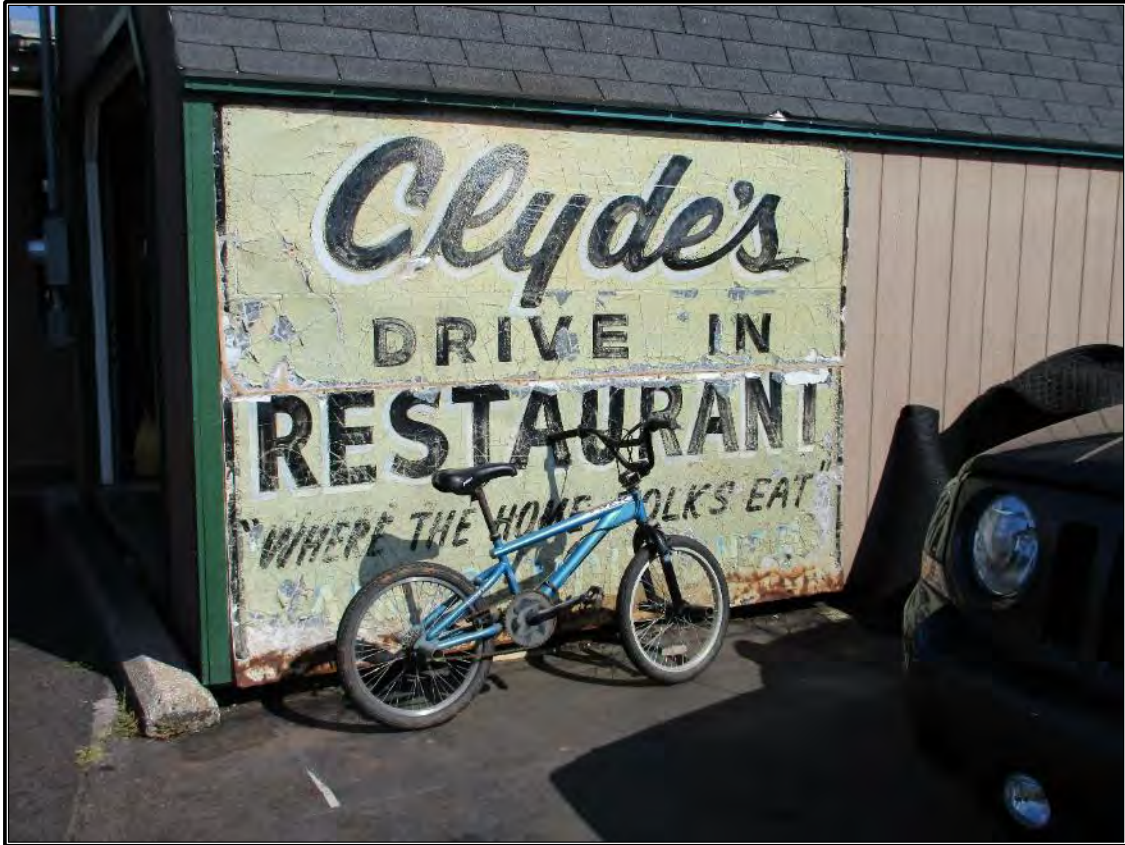
Figure 14. Façade and southeast elevation of shed, looking north.

Shed: A circa 2008–2009 one-story, gambrel-roof shed is located immediately southeast of the restaurant (Figure 14). The shed features frame construction and is clad in T1-11 siding. The roof is sheathed in asphalt shingles. A single large bay pierces the façade.

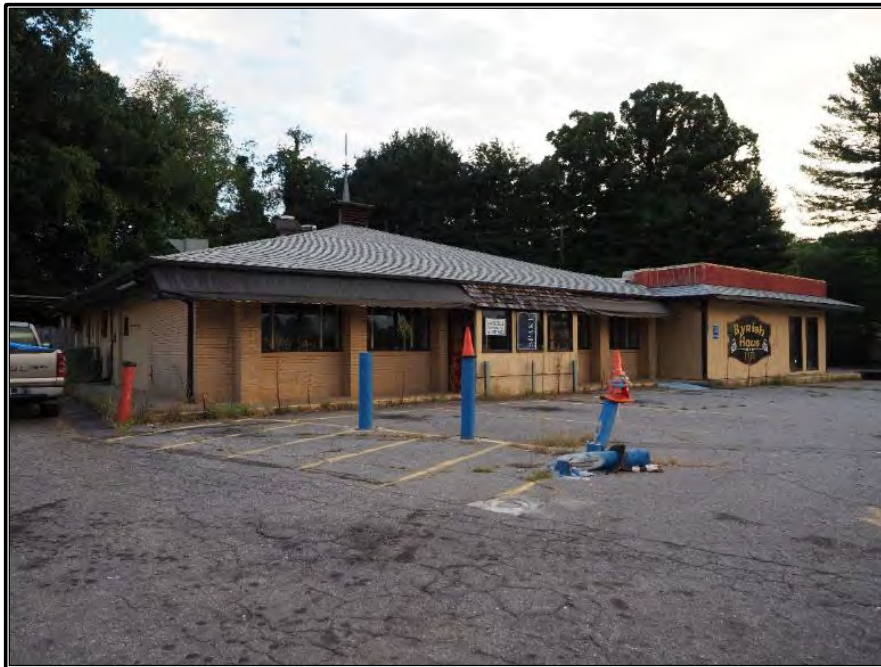
Figure 15. Comparable mid-century example of a restaurant in West Asheville, North Carolina, along US 23 (Patton Avenue) near the intersection with Haywood Road.

Research and windshield survey did not reveal additional mid-century restaurants with both intact signage and architectural form comparable to Clyde's Restaurant (HW0735) within Haywood County. One former restaurant, now abandoned, was located in West Asheville, Buncombe County along US 23 (Patton Avenue) near its intersection with Haywood Road (Figure 15).

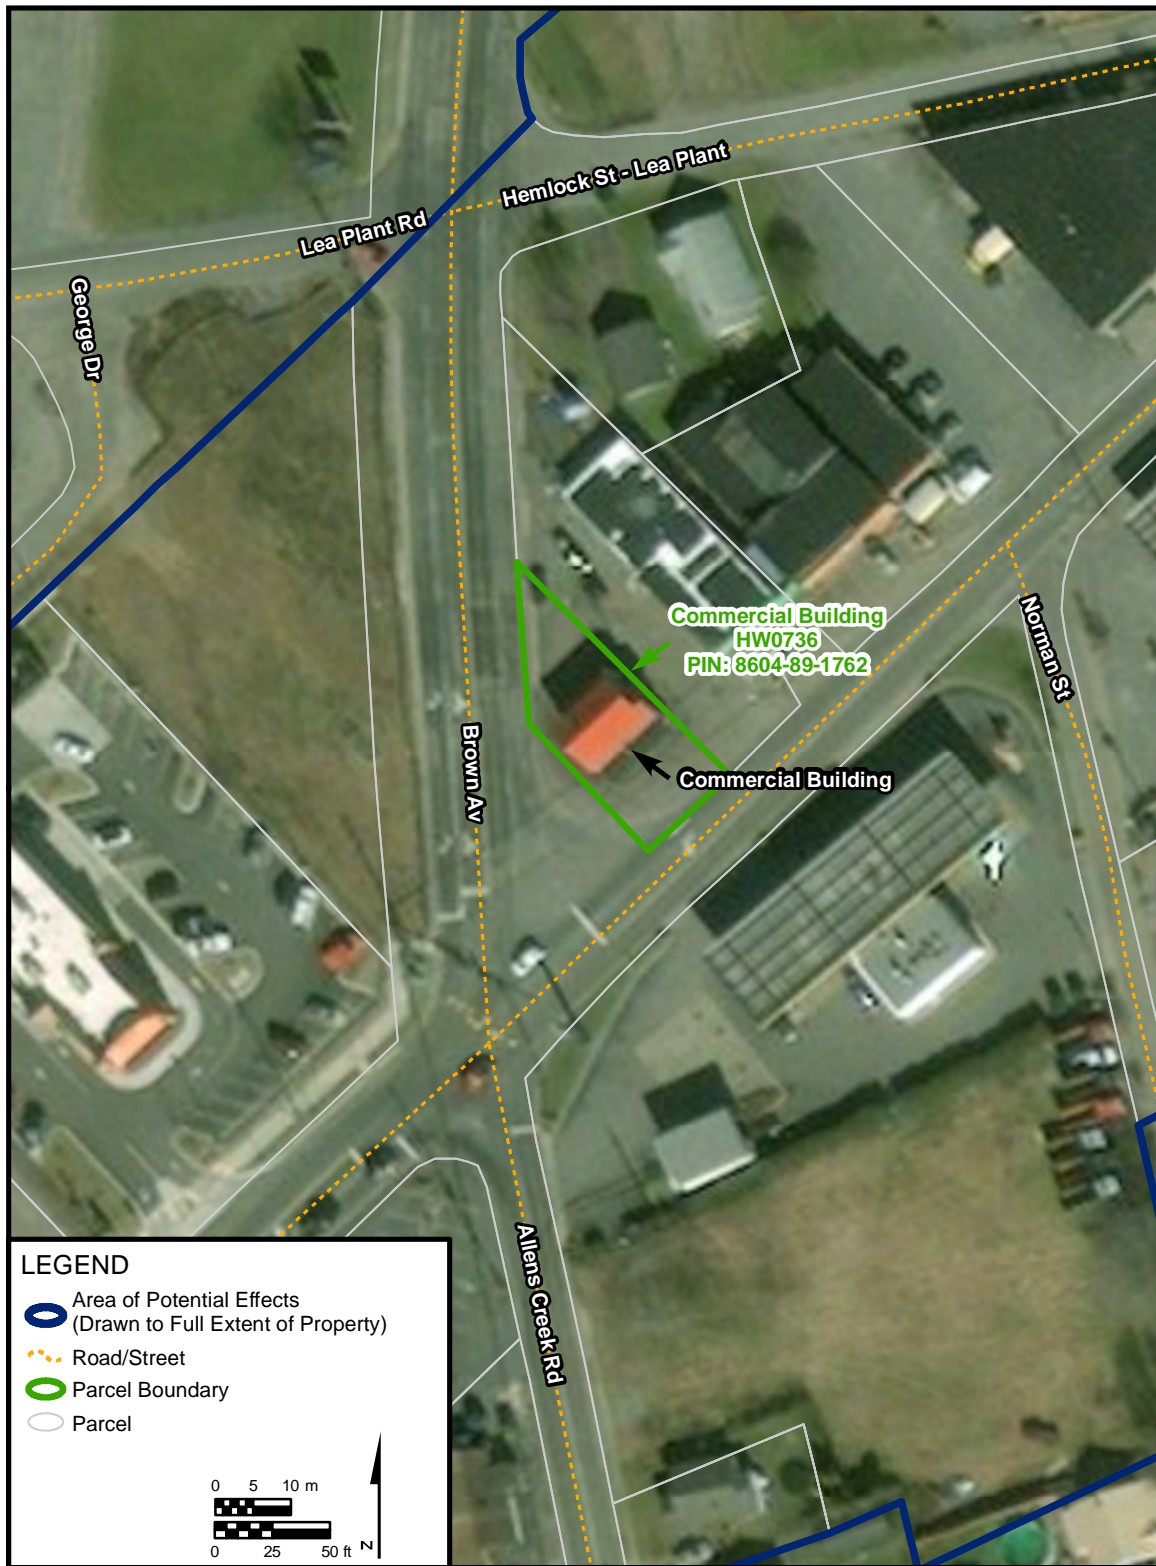
Figure 16. Map showing the commercial building (HW0736) at 1794 S. Main Street.

Setting: Located in the community of Hazelwood on the southwest side of the Waynesville city limits, the commercial building is situated on the northwest side of South Main Street (US 23 Business) on the northwest corner of South Main Street and Brown Avenue. Surrounding parcels contain a mixture of modern and historic commercial development. The commercial building occupies a .12-acre parcel adjacent to South Main Street. A paved parking lot extends along the façade, northeast, and rear elevations of the building (Figure 16).

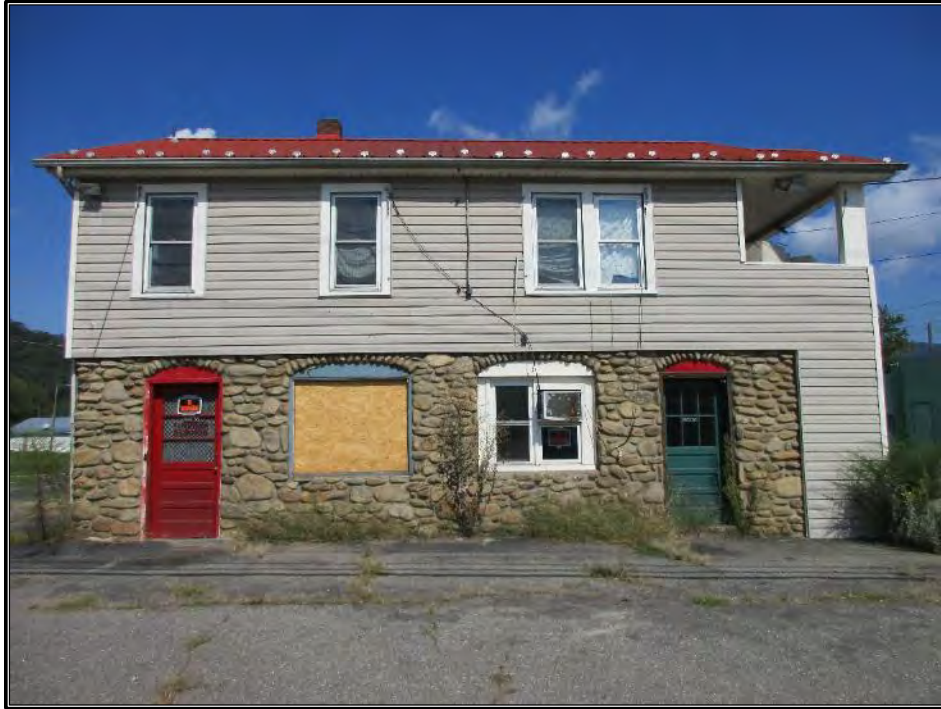
Figure 17. Façade of commercial building, looking northwest.

Commercial building, exterior: The circa 1940–1955 commercial building presents a two-story, four-bay (d/ww/ww/d), side-gable form (Figure 17). The building rests upon a continuous concrete block foundation. The exterior is primarily clad in vinyl siding. The first story of the façade, southwest (side), and southwest (rear) elevations are clad in a river rock veneer. The roof is sheathed in a replacement metal paneled roof. The windows throughout contain four-over-one or one-over-one, double-hung wood sashes and one-over-one, double-hung vinyl replacement sashes (Figure 18). The façade windows feature arched stone lintels (Figure 19). An interior brick chimney pierces the rear roof slope.

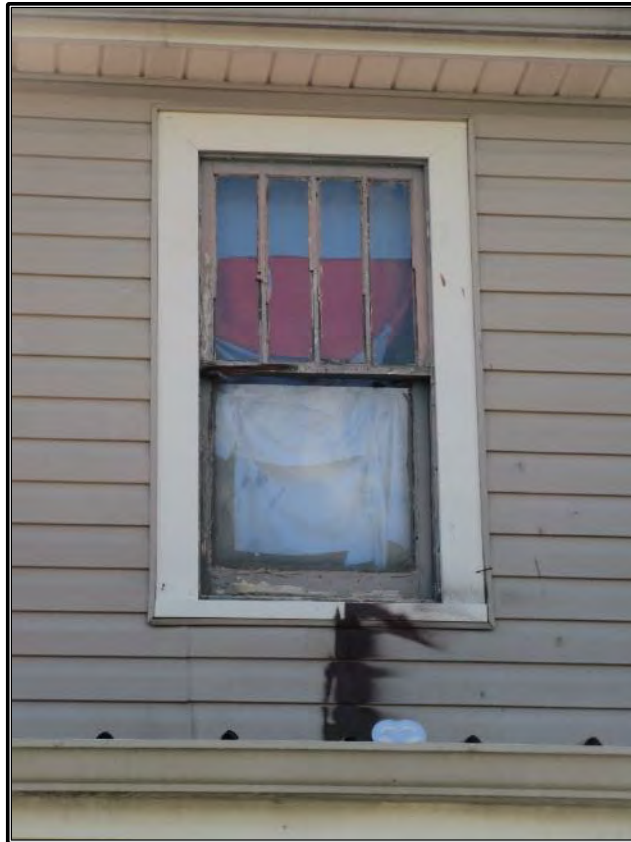
Figure 18. Detail of historic window sash.

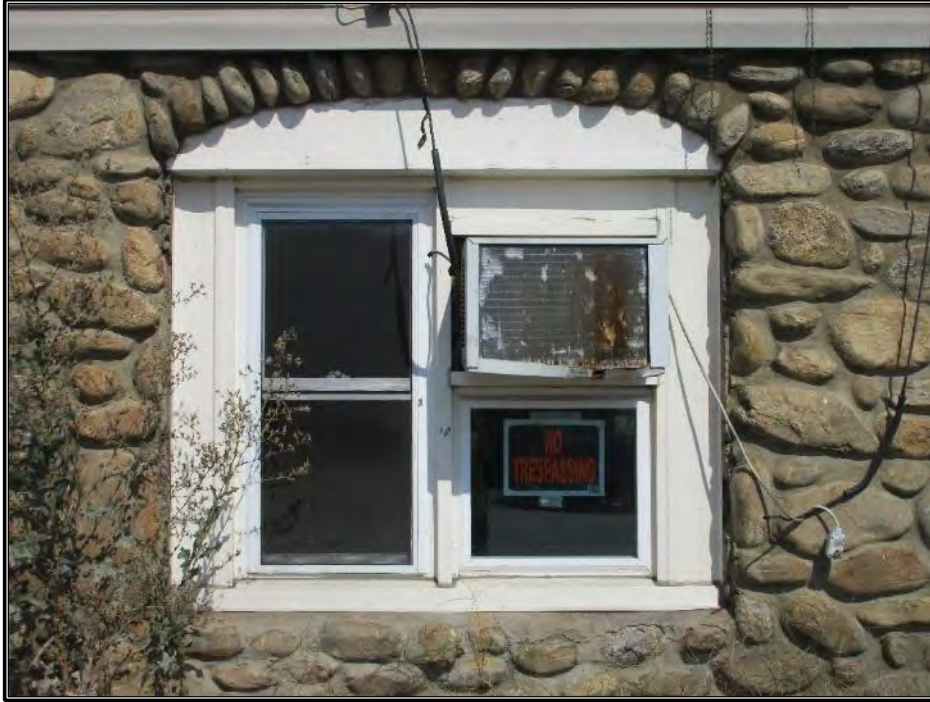
Figure 19. Detail of façade window.

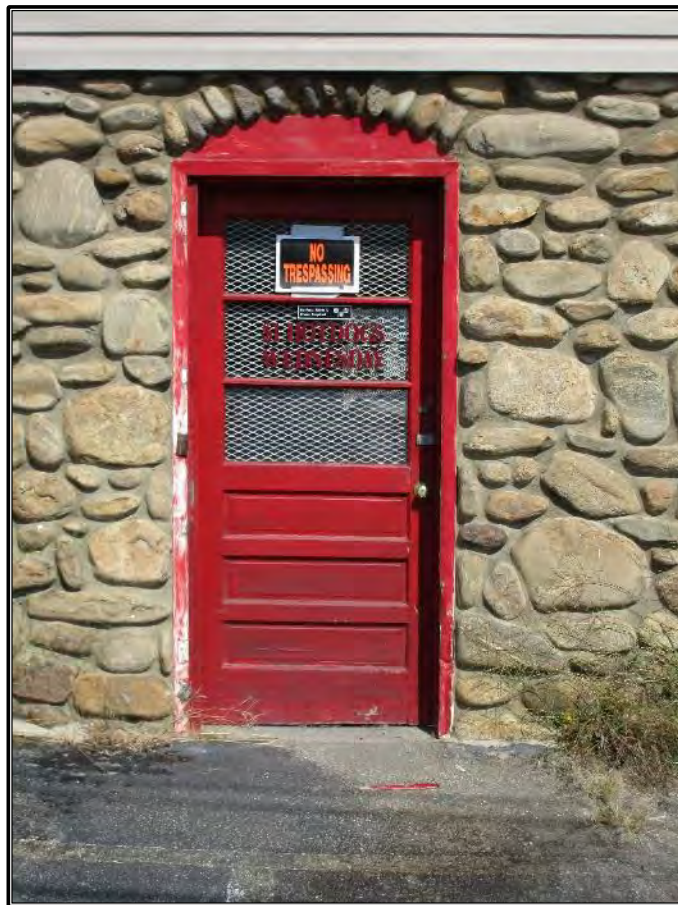
Figure 20. Detail of façade entry.

The façade features two single-leaf, arched entries with river rock lintels. The southwest (left) entry contains a three-light wood paneled door (Figure 20). The northeast (right) entry features a six-light wood paneled door. A window enclosed with plywood and a paired window bay are located between the two façade entries. Two single windows and one paired window pierce the second story of the façade. The southwest elevation contains two vents along the first story enclosed with wood siding (Figure 21). The northeast elevation features a single-leaf entry along the second story sheltered by an elevated single-bay porch with a front-gable roof supported by wood columns (Figure 22). The porch is accessed by a set of wood stairs. The lower portion of the porch has been enclosed and clad in vinyl siding. A single-leaf entry filled by a metal door pierces the northeast elevation of the enclosed section. A large vent is located southeast (left) of the first story entry. The rear elevation features an arched, single-leaf entry filled by a three-light wood paneled door. A window enclosed with vinyl siding pierces the elevation southwest (left) of the rear entry. A one-story, shed-roof addition clad in vinyl siding is attached to the northeast (left) side of the elevation. The rear elevation of the addition contains a single-leaf entry filled by a three-light wood paneled door.

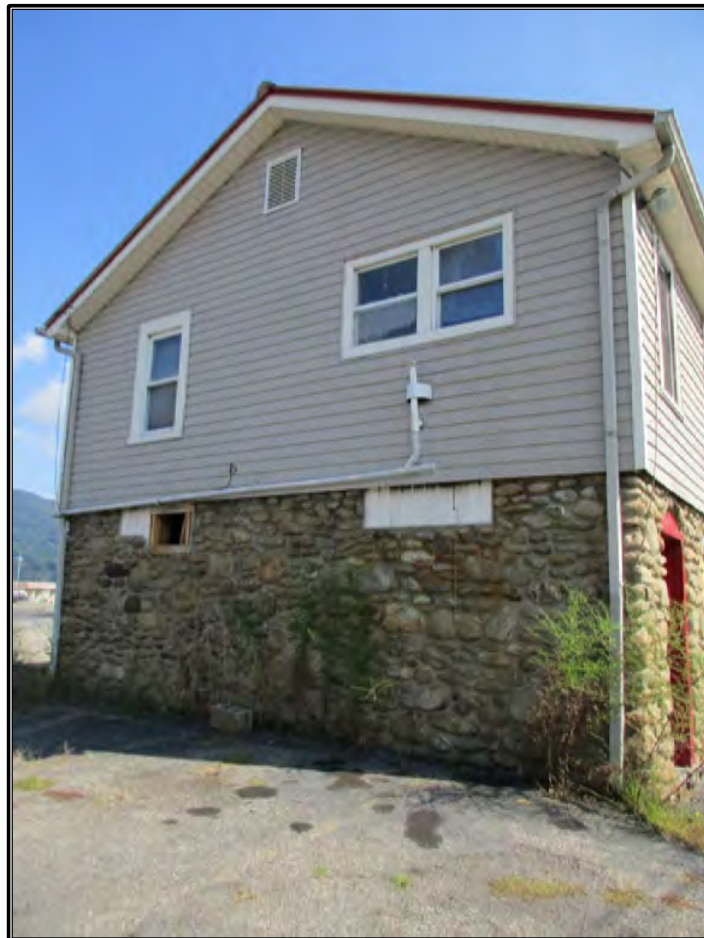
Figure 21. Southwest elevation of commercial building, looking north.

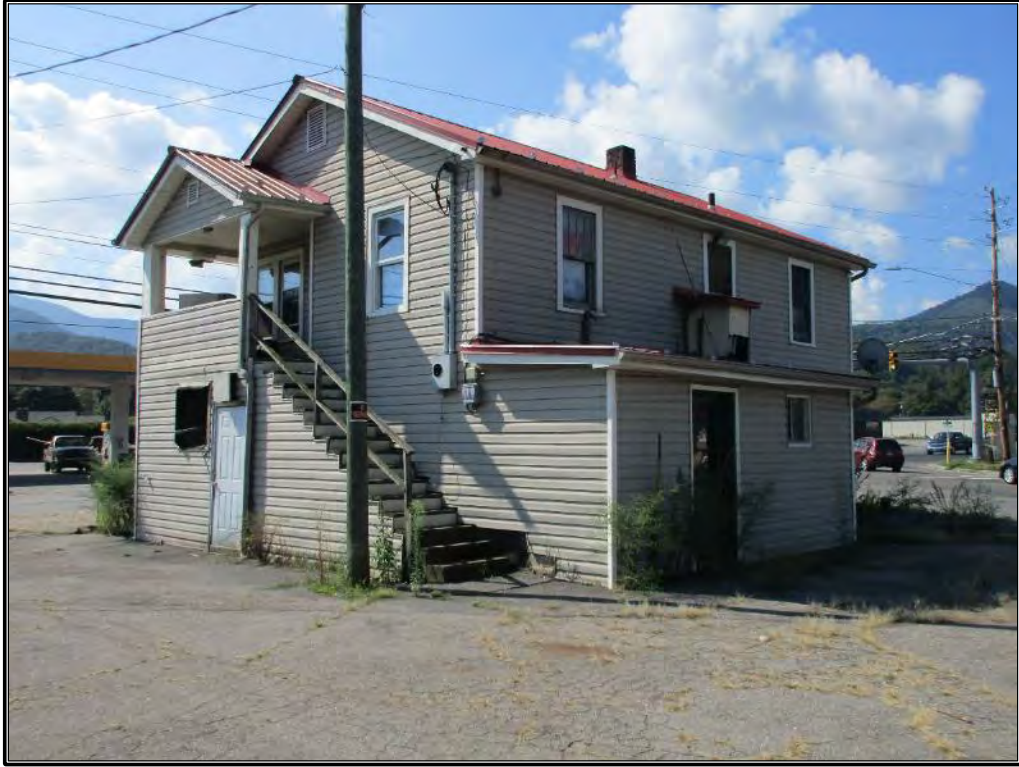
Figure 22. Northeast and rear elevation of commercial building, looking south.

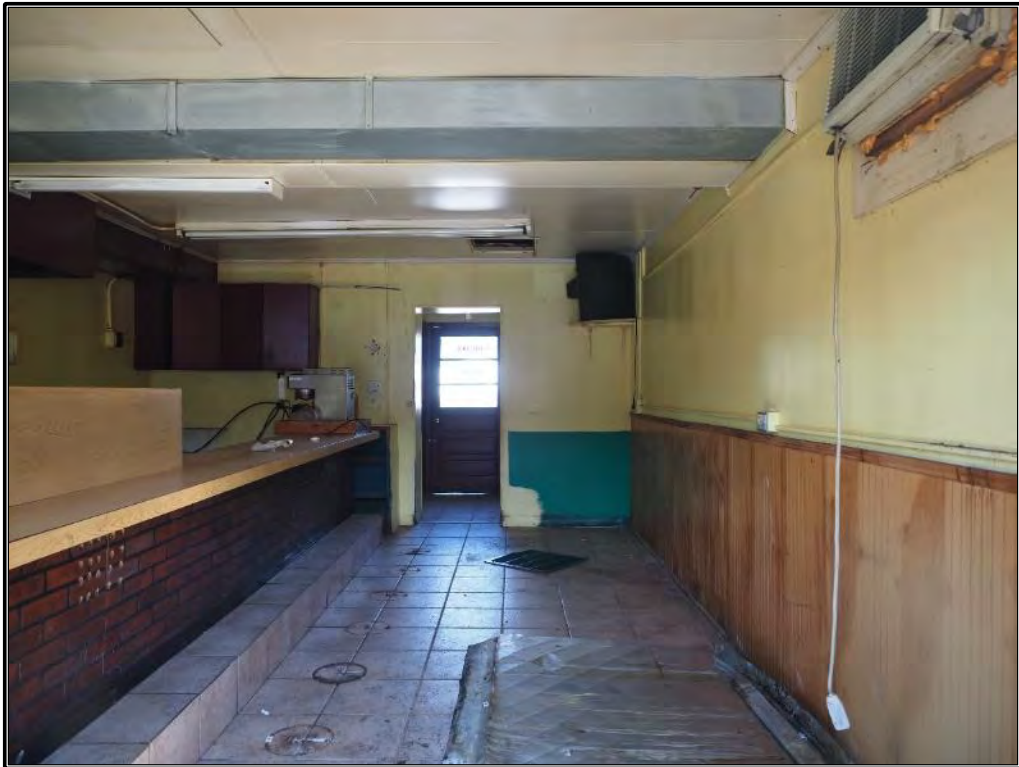
Figure 23. View of interior of commercial building from the front entry.

Commercial Building, interior: Access to the interior of the commercial building could not be secured in the field. Based on a limited view from the exterior, the front entry opens into a large interior room with tile floors and exposed ductwork along the ceiling (Figure 23). The northeast wall is lined with wainscoting. A counter with a faux brick veneer extends southwest (left) of the front entry. Wood cabinets are attached to the rear wall. An entry foyer along the rear wall leads to the rear entry.

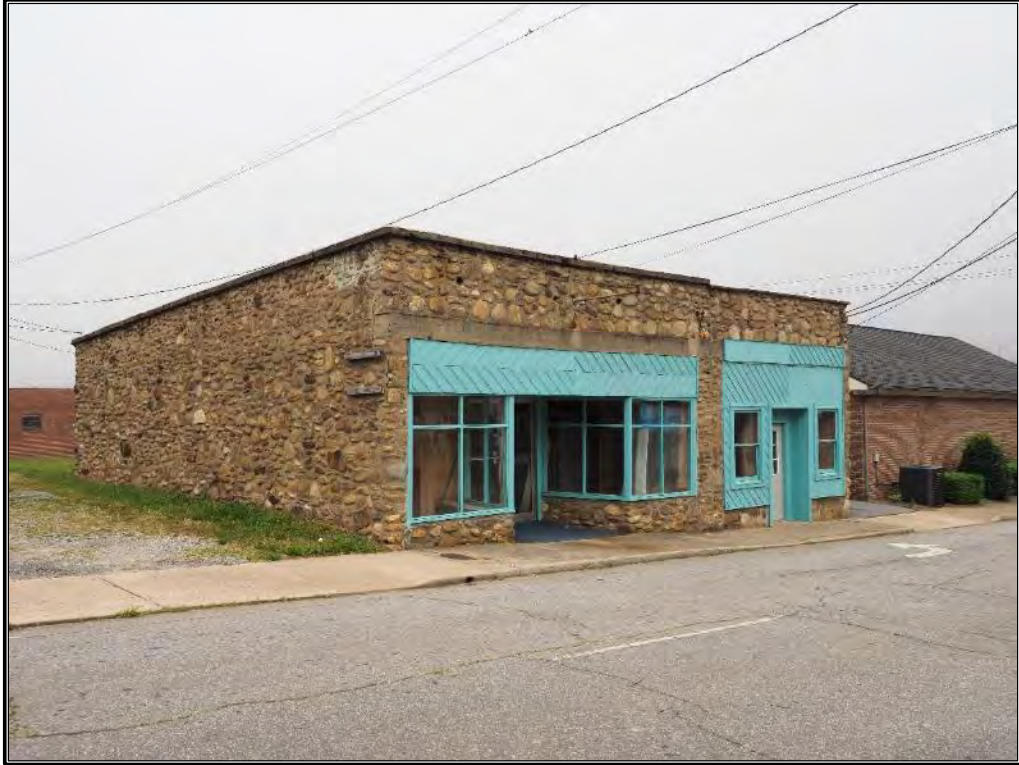
Figure 24. Rubble-rock masonry, circa 1945–1950 commercial building on Adams Street in Canton.

Criterion C: For a property to be eligible for significance under Criterion C, it must retain integrity and embody distinctive characteristics of a type, period, or method of construction, or represent the work of a master, possess high artistic values, or represent a distinguishable entity whose components may lack individual distinction. While the building does represent a method of masonry construction (rubble-rock) that is regionally distinctive, it is not the best example of its type and also has been significantly modified over time, removing character-defining features that are retained by other buildings in Haywood County. Moreover, the Commercial Building (HW0736) does not exhibit unique features of other representatives of its type (see Figures 24–26). As a result, the Commercial Building (HW0736) is recommended not eligible under Criterion C.
