SUBJECT: Historic Structures Survey Report, , Improvements to US 23 Business (South Main Street) from SR 1164 (Hyatt Creek Road) to US 276 (Pigeon Street), Waynesville, PA 17-12-0027, U-4712, Haywood County, ER 18-4249

MANAGEMENT SUMMARY	i
I. INTRODUCTION.....	1
II. METHODOLOGY.....	1
III. DESCRIPTION, HISTORIC CONTEXT, AND EVALUATION	7
CLYDE’S RESTAURANT (HW0735)	7
COMMERCIAL BUILDING (HW0736).....	18
COMMERCIAL BUILDING AND FORMER GROCERY (HW0737).....	28
REPAIR SHOP (HW0738)	41
MAPLE GROVE MOTEL (HW0739)	50
HYATT HOUSE AND CARRIAGE HOUSE.....	68
(HW0015 / HW0740).....	68
SILER HOUSE (HW0741)	88
ETHEL ROSS BRADLEY HOUSE (HW0742)	97
PEARL HYATT AND MARGARET HYATT PILARSKI HOUSE (HW0743)	110
HOUSE, 1262–1270 S. MAIN STREET (HW0744).....	119
GEORGE HOUSE (HW0745)	133
HOUSE, 1157 S. MAIN STREET (HW0746).....	143
HOUSE, 1153 S. MAIN STREET (HW0747).....	155
THE GABLES APARTMENTS (HW0096).....	163
DR. ALBERT HEYWARD SMITH, JR. HOUSE (HW0748).....	173
THE ATKINS HOUSE (HW0109)	187
THE HILLTOP TOURIST LODGE (HW0056).....	202
FORMER HOUSE, 809 S. MAIN STREET (HW0749).....	212
HOUSE, 761 SOUTH MAIN STREET (HW0750)	222
THE CHARLES RAY HOUSE (HW0055) AND CARRIAGE HOUSE (HW0751)	233

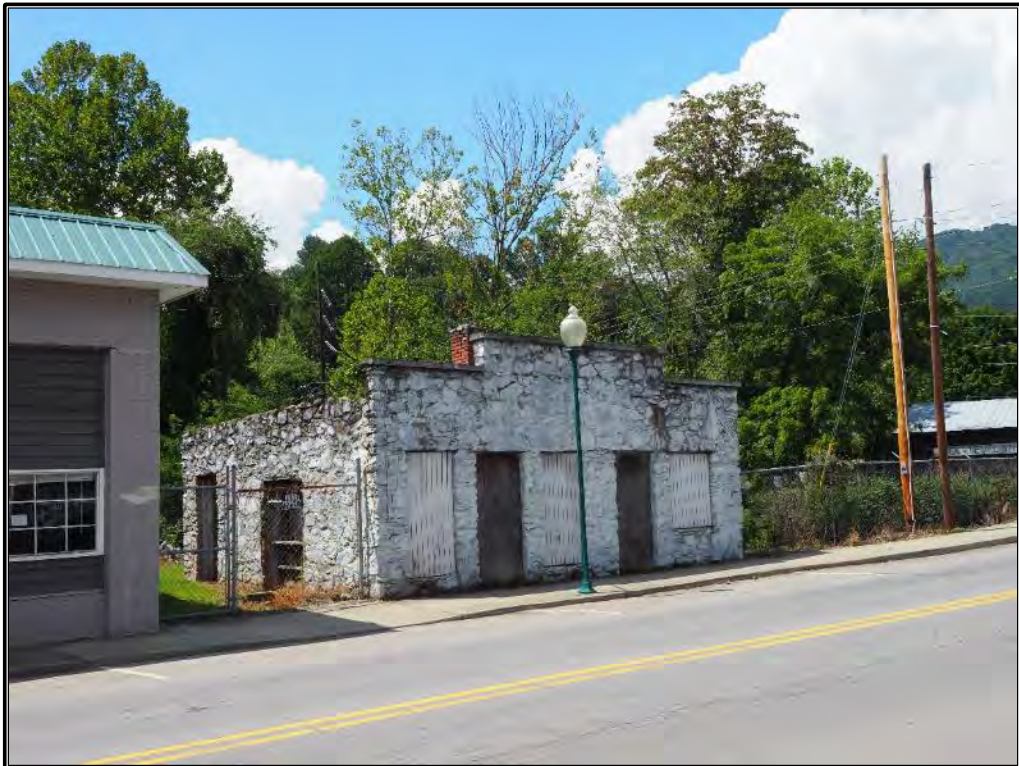
Figure 25. Rubble-rock masonry, circa 1940 commercial building in Frog Level, just west of the Waynesville Main Street Historic District (HW0161) on Depot Street adjacent to Richland Creek.

Commercial and residential buildings featuring rubble-rock construction or veneer are a relatively common form in Haywood County, but still significantly less popular than brick or frame construction. Comparable resources were located in Canton, Frog Level, Waynesville, and east of Canton along Asheville Highway. However, these resources were typically one-story structures dating from 1920 to 1960. The two-bay store in Canton on Adams Street (Figure 24) featured large storefront windows and lacked the decorative arched window openings of Commercial Building (HW0736). The form of the commercial building in Frog Level (Figure 25) is of a similar, if somewhat smaller, scale.

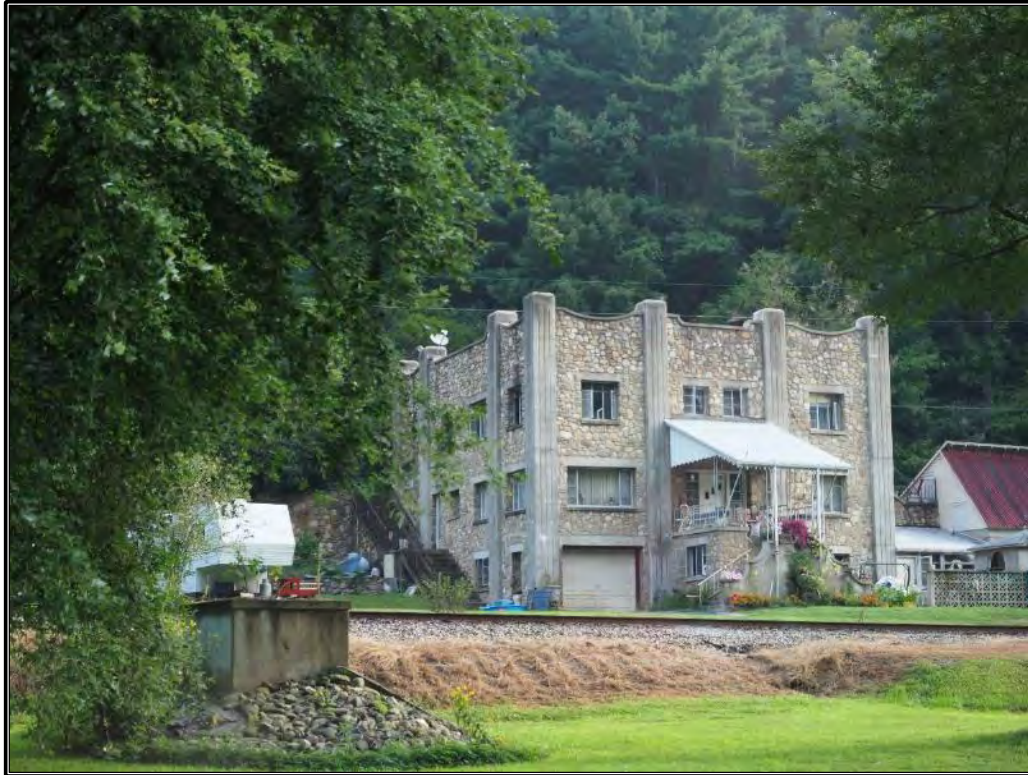
Figure 26. Rubble-rock masonry and cast-concrete commercial building along Asheville Highway east of Canton. This circa 1930–1950 building is among the largest and most intact examples encountered during the survey.

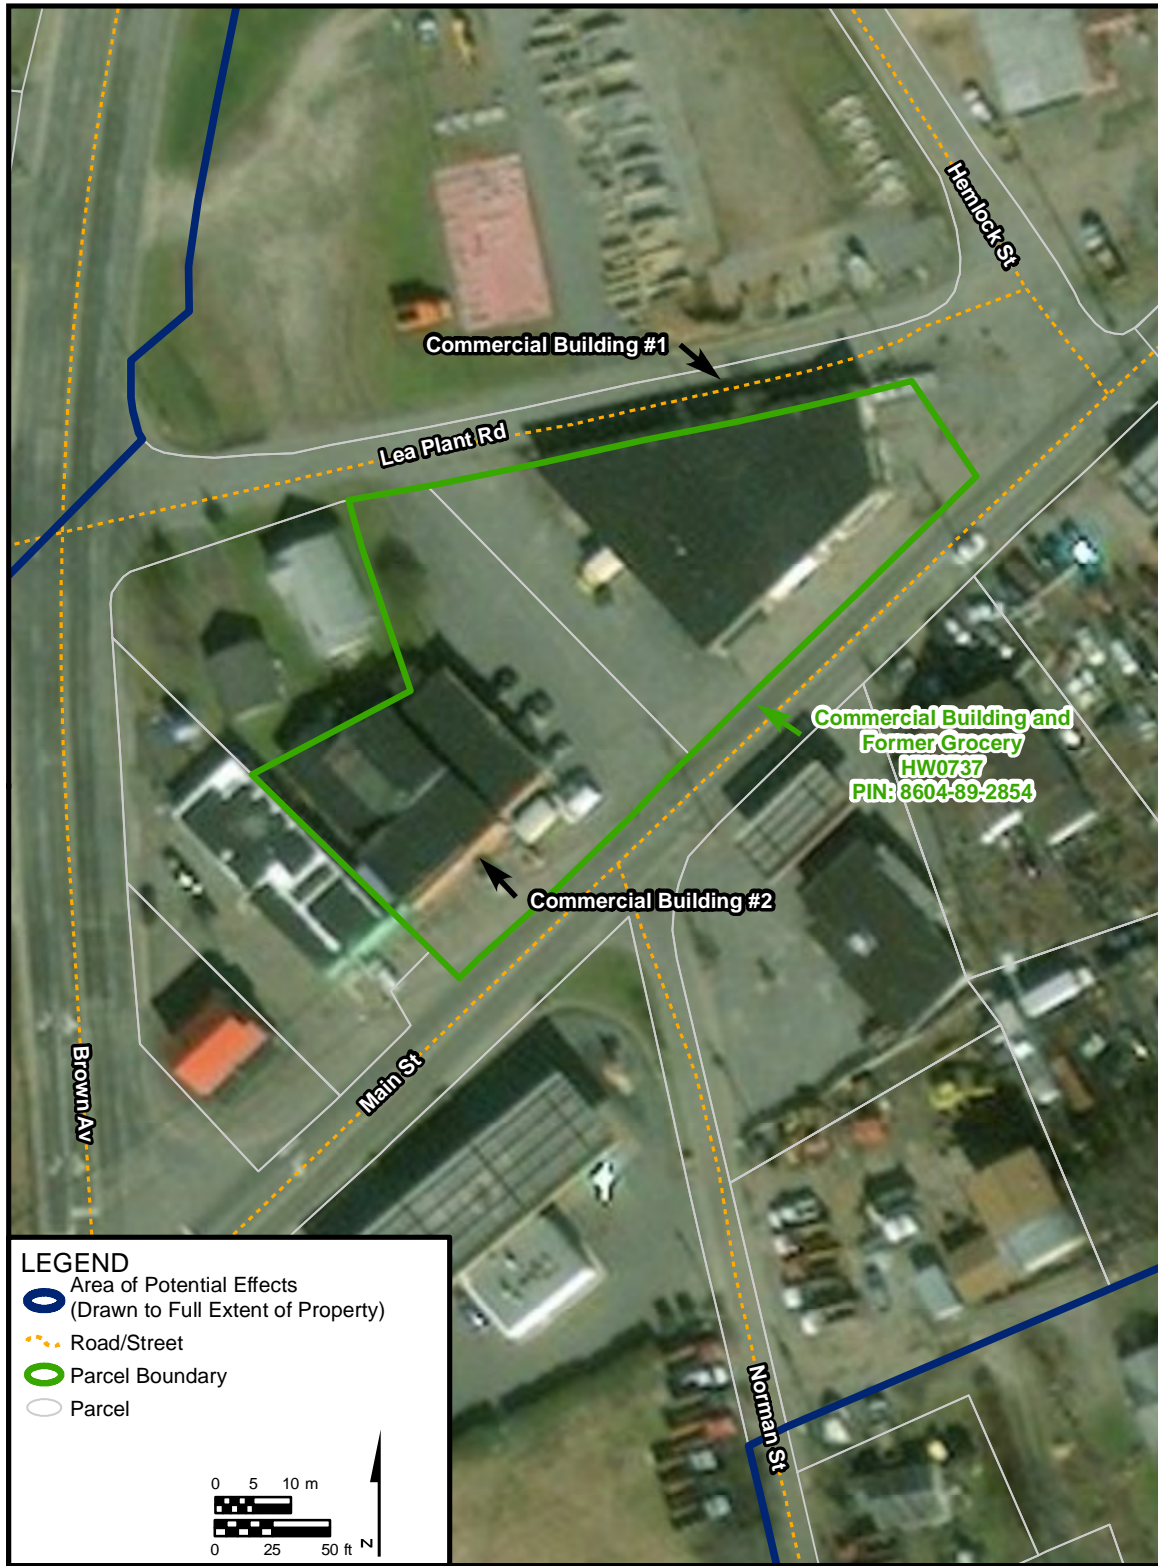
Figure 27. Map showing the Commercial Building and Former Grocery (HW0737) at 1720-1738 S. Main Street and 1756-1766 S. Main Street.

Setting: Located in the community of Hazelwood on the southwest side of the Waynesville city limits, the primary commercial building is situated on the northwest side of South Main Street (US 23 Business) on the southwest corner of South Main Street and Hemlock Street. The area is characterized by a mixture of historic and recent commercial and industrial development. A paved parking lot is adjacent to the façade, southwest, and northeast elevations of the building. The secondary commercial building associated with the property is located southwest of the primary resource. The commercial buildings occupy a .92-acre parcel adjacent to South Main Street. The secondary commercial building attaches to an adjacent commercial building, Smoky Mountain Billiards, via a flat-roof hyphen, although the adjacent building is located on a separate parcel. A paved parking lot extends along the façade and northeast elevation of the secondary commercial building. A service road extends to the rear of the buildings (Figure 27).

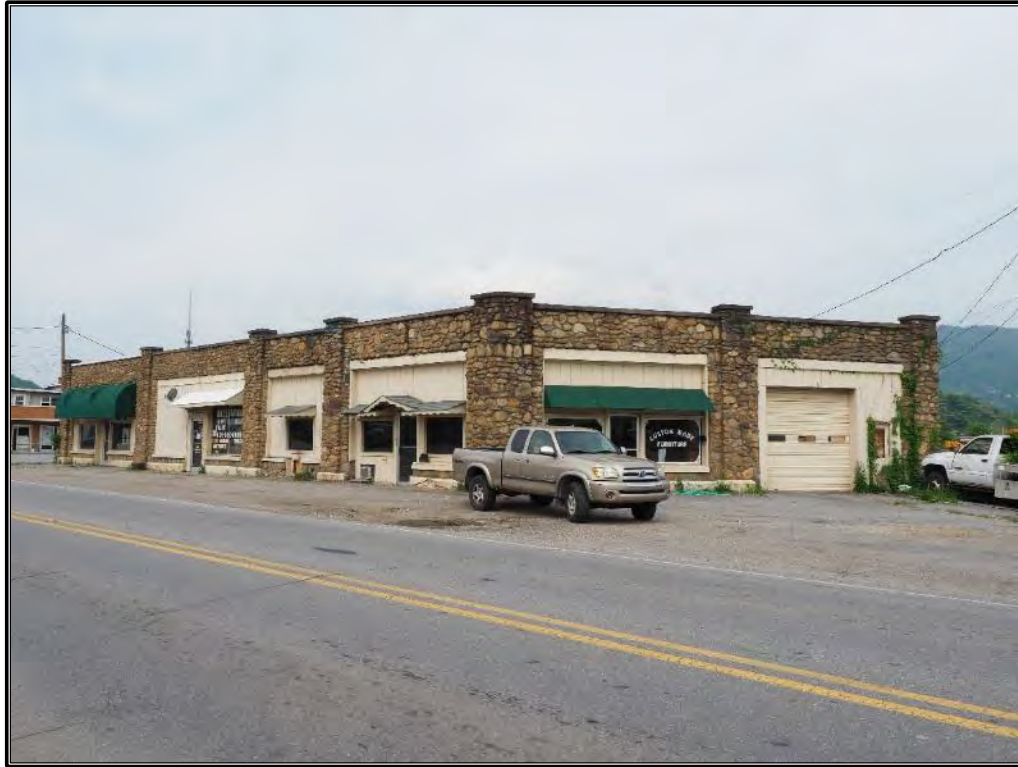
Figure 28. Façade and northeast elevation of commercial building, looking west.

Commercial building, exterior: The primary structure associated with the property consists of a circa 1935–1941 one-story, nine-bay (w/d/w/d/w/w/w/d/w), flat-roof, asymmetrical commercial building (Figure 28). The exterior of the building is clad in a river rock veneer. The roof is sheathed in rolled asphalt. A parapet clad in a river rock veneer extends along the edge of the façade and northeast roof line. The foundation is not visible. The storefront windows contain single-light wood commercial sashes with wood sills. The windows throughout the remainder of the building are enclosed with T1-11 siding. An interior brick chimney with a metal stove pipe pierces the roof. Exposed rafter tails are visible under the eaves along the side elevations.

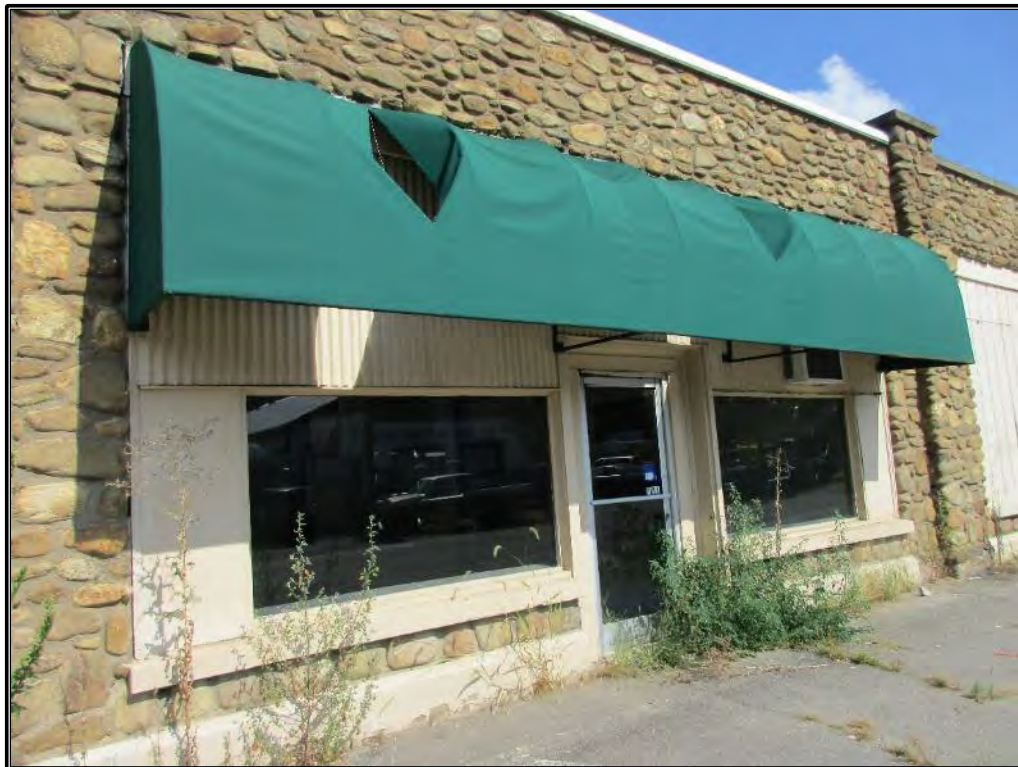
Figure 29. Detail of southwest façade storefront.

The façade features three commercial storefronts defined by full-height pilasters clad in a river rock veneer. The southwest storefront consists of a central single-leaf entry filled by a full-light metal commercial door flanked by commercial windows (Figure 29). The transoms above the door and windows are enclosed with metal siding. The storefront is sheltered by a canvas awning. The central storefront contains a single-leaf entry filled by a full-light metal commercial door (Figure 30). A commercial window is located northeast (right) of the entry. The entry and window are sheltered by a shed-roof awning sheathed in metal panels. The southwest (left) storefront window is enclosed with T1-11 siding. The transoms above the entry and northeast window are enclosed with T1-11 siding. The northeast (right) storefront consists of two parts: a single-leaf entry filled by a full-light metal commercial door between two commercial windows and a commercial window located between the central and northeast storefronts (Figure 31). The portion of the storefront above the entry and adjacent windows is enclosed with T1-11 siding. The individual commercial window has been partially enclosed with T1-11 siding to accommodate a smaller sash. The sections of the storefront are sheltered by a shed-roof hood featuring scalloped trim and an asphalt shingle roof.

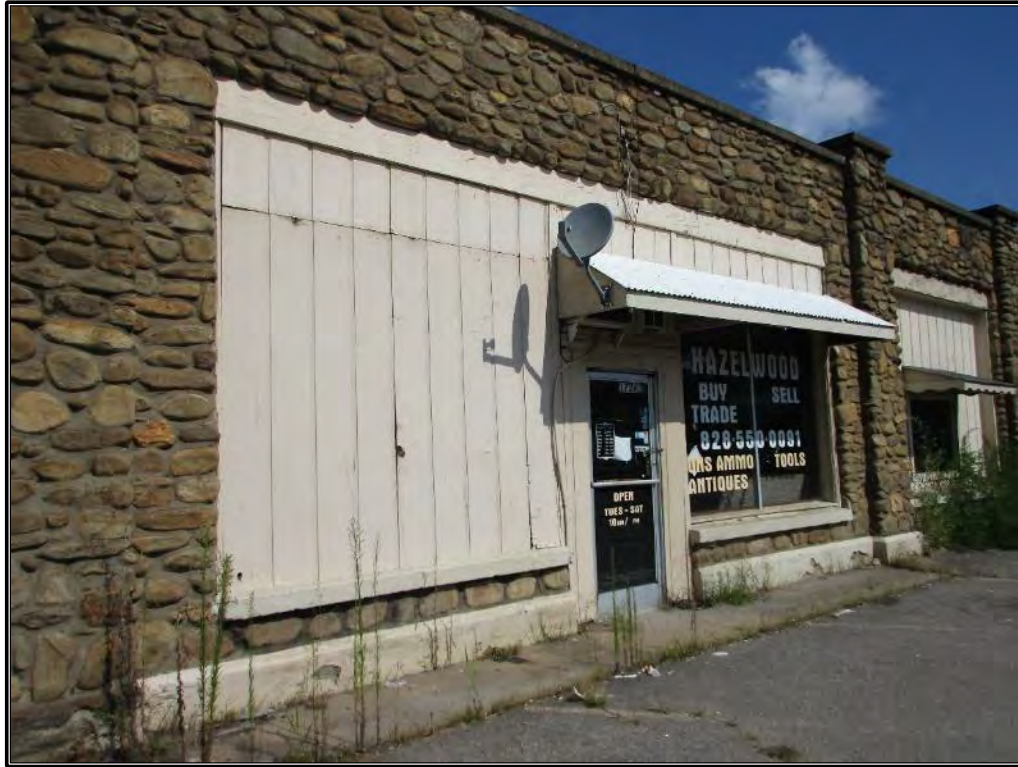
Figure 30. Detail of center façade storefront.

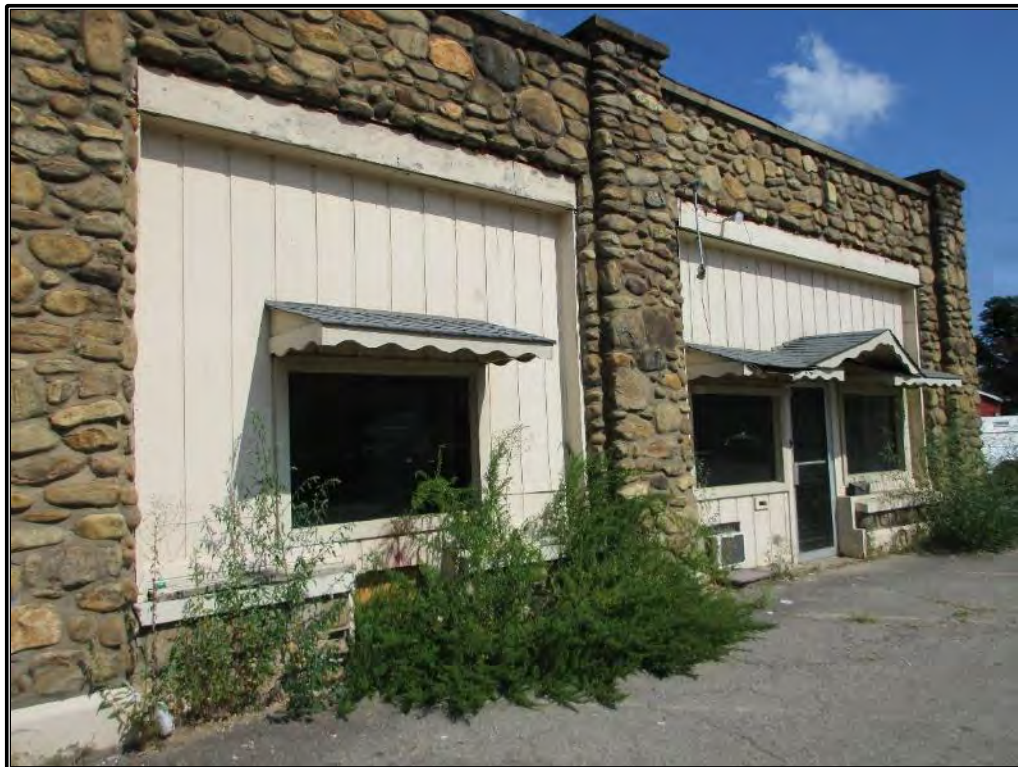
Figure 31. Detail of northeast façade storefront.

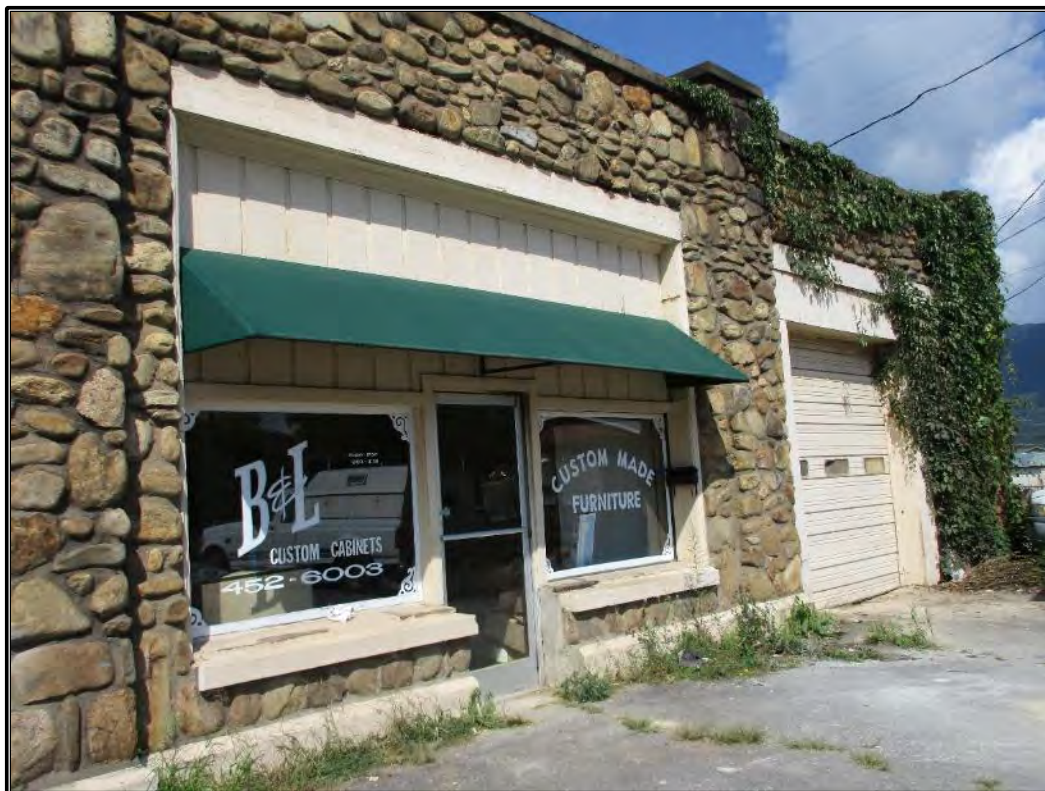
Figure 32. Detail of storefront along the northeast elevation.

The northeast elevation contains a fourth storefront and a vehicular bay (Figure 32). The sections of the elevation are delineated by full-height pilasters clad in a river rock veneer. The storefront features a central single-leaf entry filled by a full-light metal commercial door flanked by commercial windows. The storefront is sheltered by a shed-roof awning. The transom above the door and windows and a portion of the storefront above the awning is infilled with T1-11 siding. The vehicular bay, located northwest (right) of the storefront contains a three-light, metal sectional overhead door. The southwest elevation of the commercial building features two vehicular bays and three single-leaf entries (Figure 33). The vehicular bays contain sectional overhead doors. The northwest (left) and central entries contain replacement metal doors. The southeast (right) entry features a replacement nine-light door. The windows along the southwest elevation are enclosed with wood siding. The fenestration along the rear elevation is enclosed with plywood panels (Figure 34). The rear elevation is partially covered by vegetation.

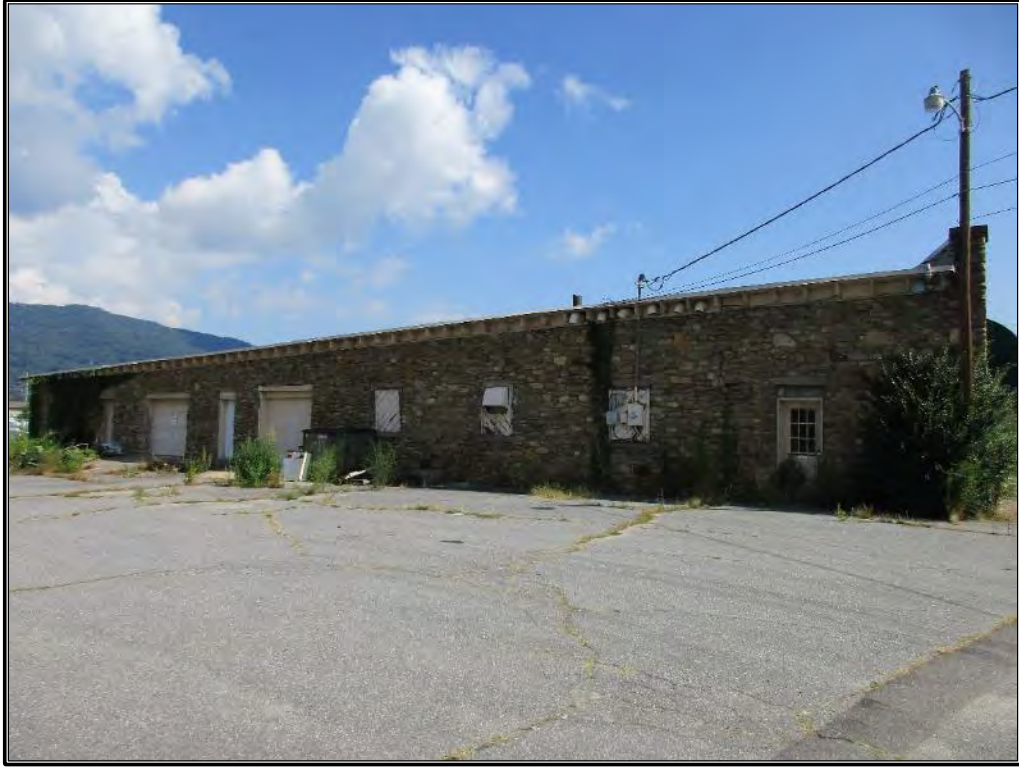
Figure 33. Southwest elevation of commercial building, looking north-northeast.

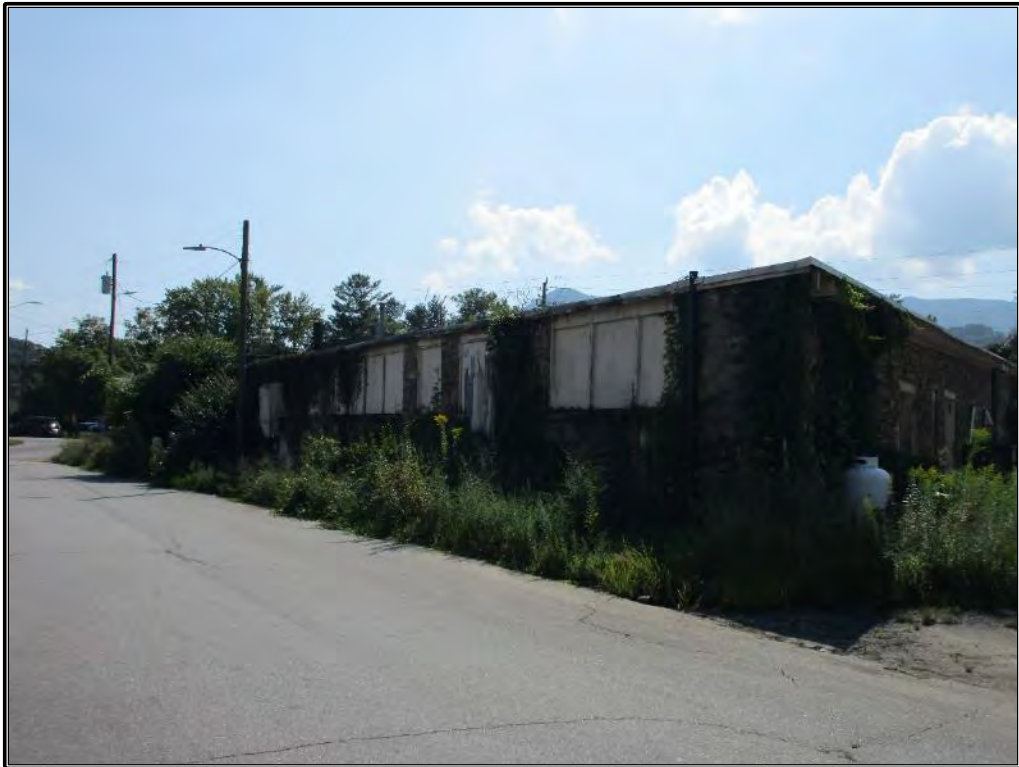
Figure 34. Rear elevation of commercial building, looking east-southeast.

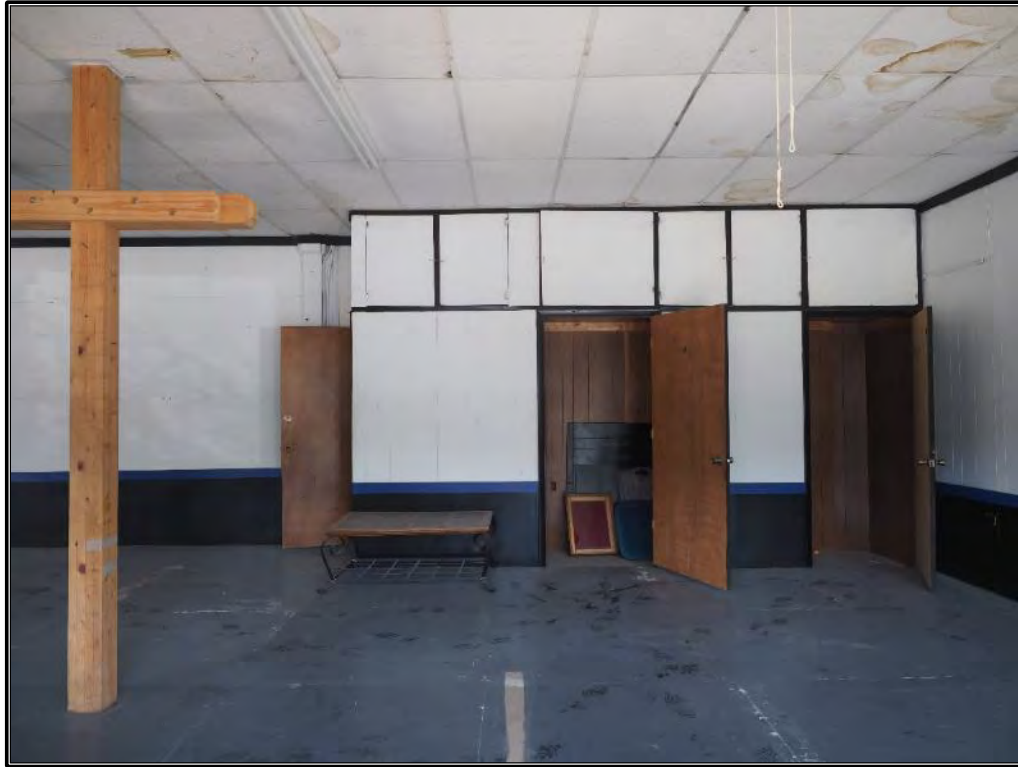
Figure 35. Interior view of southwest façade storefront.

Commercial Building, interior: Access to the interior of the commercial building could not be secured in the field. Based on a limited view from the exterior, the southwest (left) commercial space features concrete floors and a drop tile ceiling (Figure 35). The walls are covered in painted wood paneling. A large, T-shaped wood beam supports the ceiling. Opposite the entry, partition walls enclose a storage area. Cabinets are integrated into the top portion of the storage room along the ceiling. Three wood doors, two along the southeast (front) wall and one along the southwest (left) wall access the individual interior rooms. Two entries filled by wood doors pierce the rear wall southwest (left) of the storage space and lead to additional rooms.

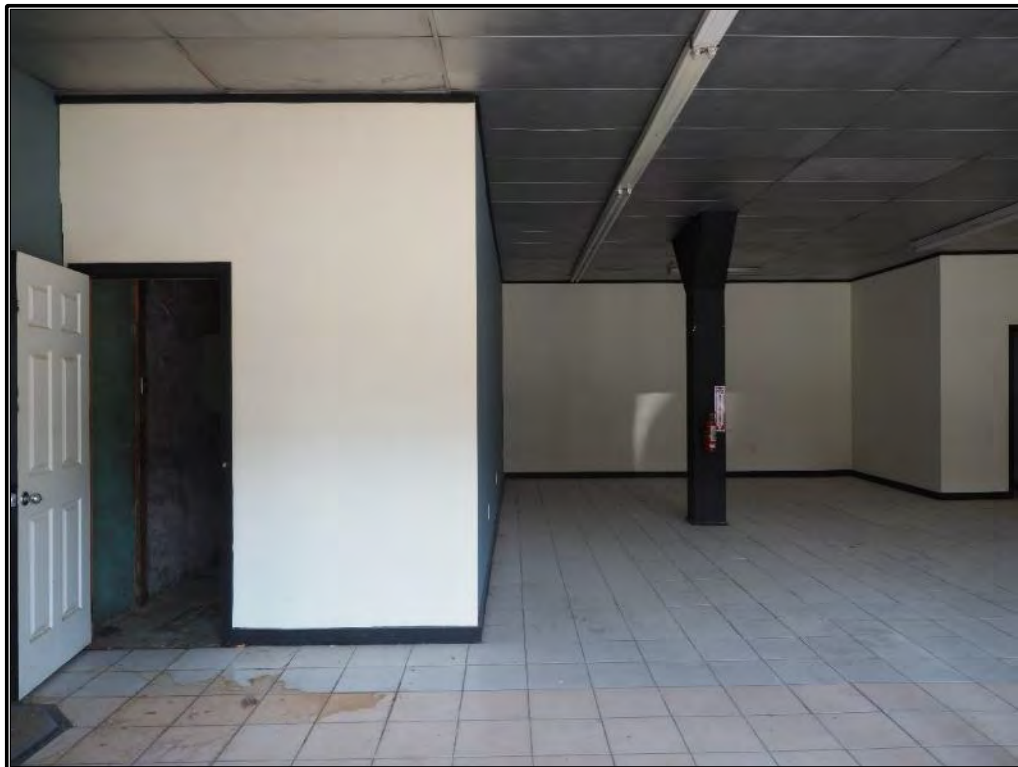
Figure 36. Interior view of center façade storefront.

The center storefront features a tiled floor and a metal paneled drop ceiling (Figure 36). A large, vertical beam pierces the ceiling. The front entry opens into a large central room. Partition walls enclose a room along the southwest (left) and northwest (rear) wall. Two interior rooms are accessed by metal doors along their southeast (front) partition walls.

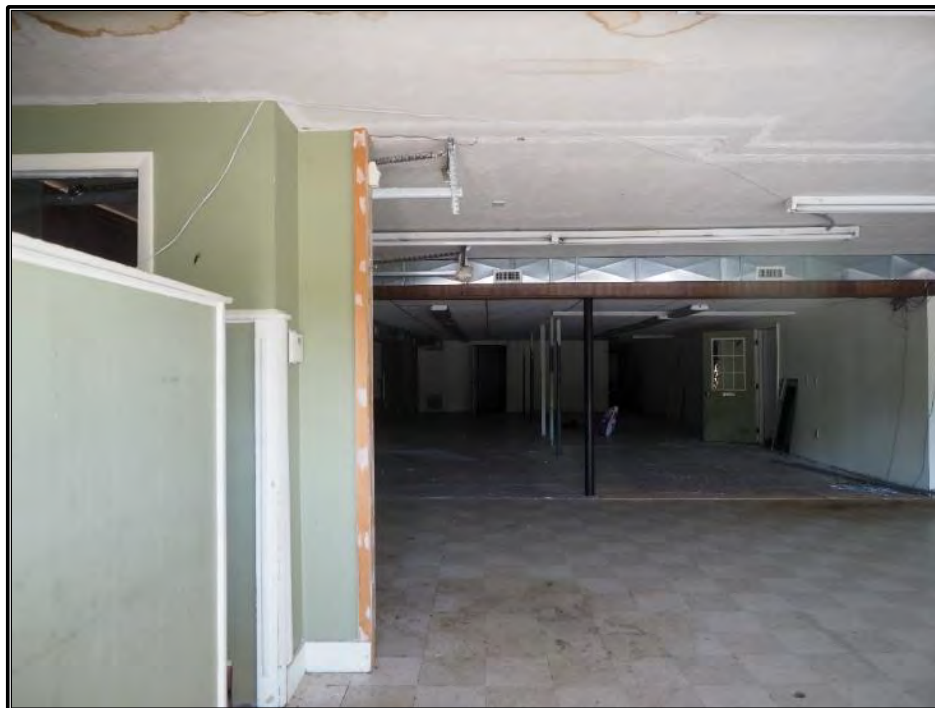
Figure 37. Interior view of northeast façade storefront.

The northeast (right) storefront features a tiled floor and exposed ductwork along the ceiling (Figure 37). The commercial space consists of two open rooms. The rear section of the commercial space contains a drop tile ceiling and is bisected by a line of metal poles supporting the ceiling. An enclosed area southwest (left) of the entry is partitioned off from the front room by a three-quarter-height wall. An entry along the southeast (front) elevation of the enclosed section leads to an interior roof. An entry filled by a nine-light door pierces the northeast (right) wall of the rear section. An entry along the rear wall leads to an interior room. The northeast (right) side of the rear wall is recessed.

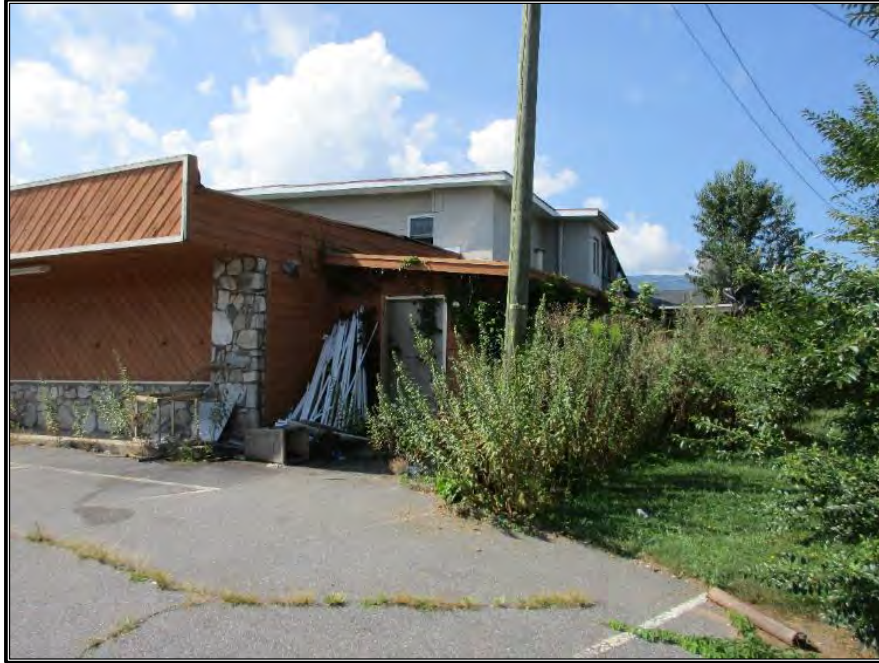
Figure 39. Façade and northeast elevation of secondary commercial building, looking west.

Figure 40. Northeast and rear elevation of secondary commercial building, looking south.

Secondary Commercial Building, Former Grocery: A circa 1940–1967 secondary commercial building is located approximately 90 ft southwest of the primary commercial building. The building displays a two-story, flat-roof form with façade, side, and rear additions and a rear projection (Figure 39). The core of the building is clad in aluminum siding. The façade and side additions feature diagonal wood siding and a stone veneer. The core of the building, the façade and side additions, and the rear projection are sheltered by a rolled asphalt roof. The rear additions feature metal paneled roofs. The windows throughout present a mixture of three-over-one, double-hung wood sashes, two-light wood sashes, and single-light vinyl replacement sashes. An interior brick chimney pierces the roof of the main block of the building and the roof of the rear projection. The façade addition spans the full-width of the front elevation. The primary entry is relocated along the northeast elevation of the one-story, flat-roof side (northeast) addition. The primary entry is sheltered by a flat-roof overhang. A vehicular bay filled by a sectional overhead door pierces the façade elevation of the side addition. A one-story, shed-roof addition is attached to the rear elevation of the side addition (Figure 40). A two-story, flat-roof, concrete block projection with one-story, shed-roof, concrete block side and rear additions extends from the rear elevation of the commercial building. A one-story, gable-oriented, concrete block addition also extends from the rear elevation of the building.

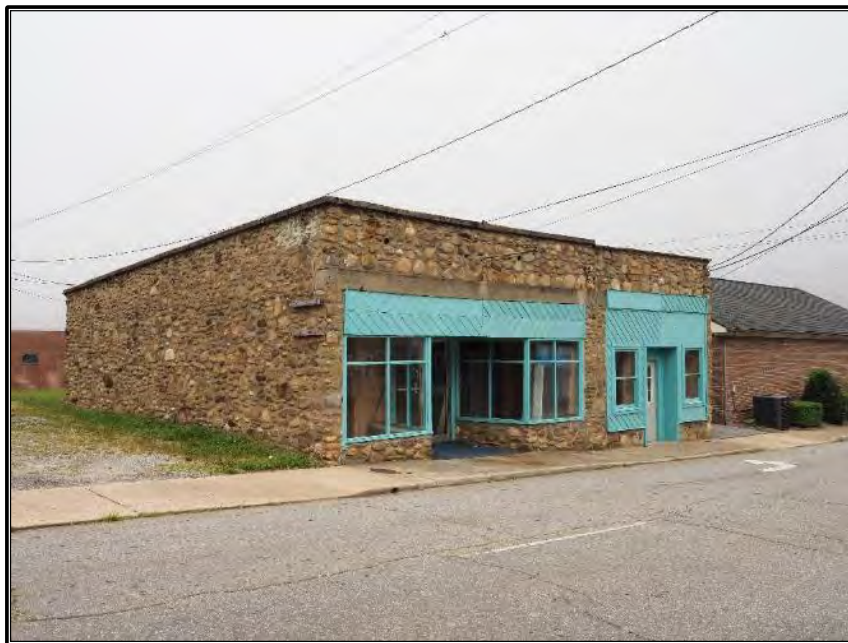
Figure 41. Rubble-rock masonry, circa 1945–1950 commercial building on Adams Street in Canton.

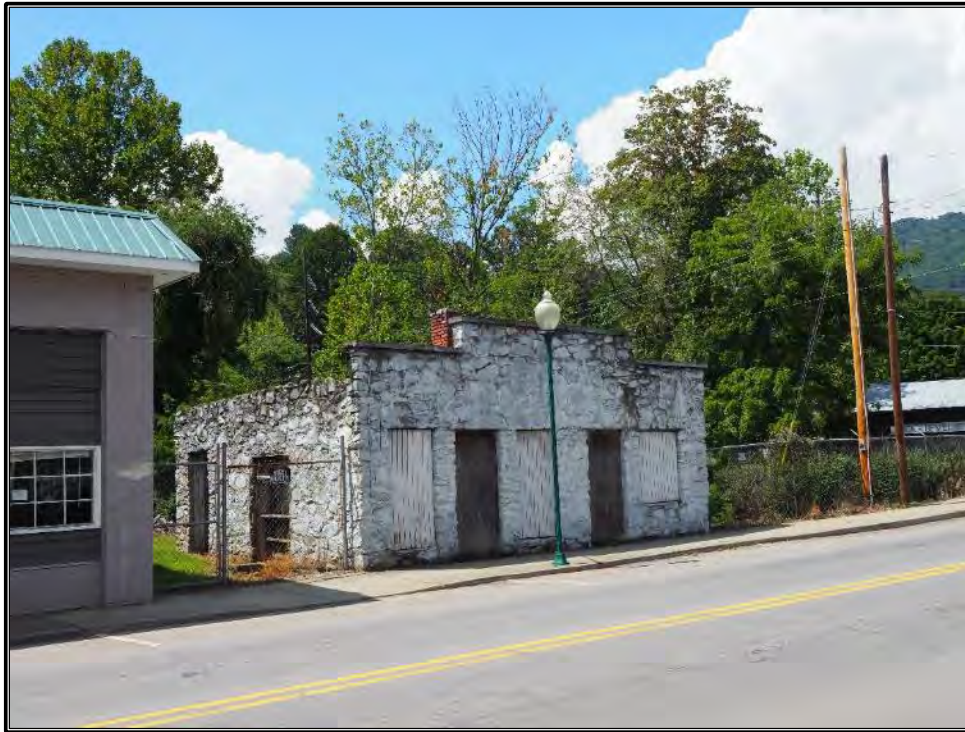
Figure 42. Rubble-rock masonry, circa 1940 commercial building in Frog Level, just west of the Waynesville Main Street Historic District (HW0161) on Depot Street adjacent to Richland Creek.

Commercial and residential buildings featuring rubble-rock construction or veneer are a relatively common form in Haywood County, but still significantly less popular than brick or frame construction. Comparable resources were located in Canton, Frog Level, Waynesville, and east of Canton along Asheville Highway. However, these resources were typically one-story structures dating from 1920 to 1960. The two-bay store in Canton on Adams Street (Figure 41) featured large storefront windows similar to the primary commercial building at the southwest corner of Hemlock and South Main Streets within the Commercial Building and Former Grocery (HW0737). The form of the commercial building in Frog Level (Figure 42) is of a similar, if significantly smaller, scale.

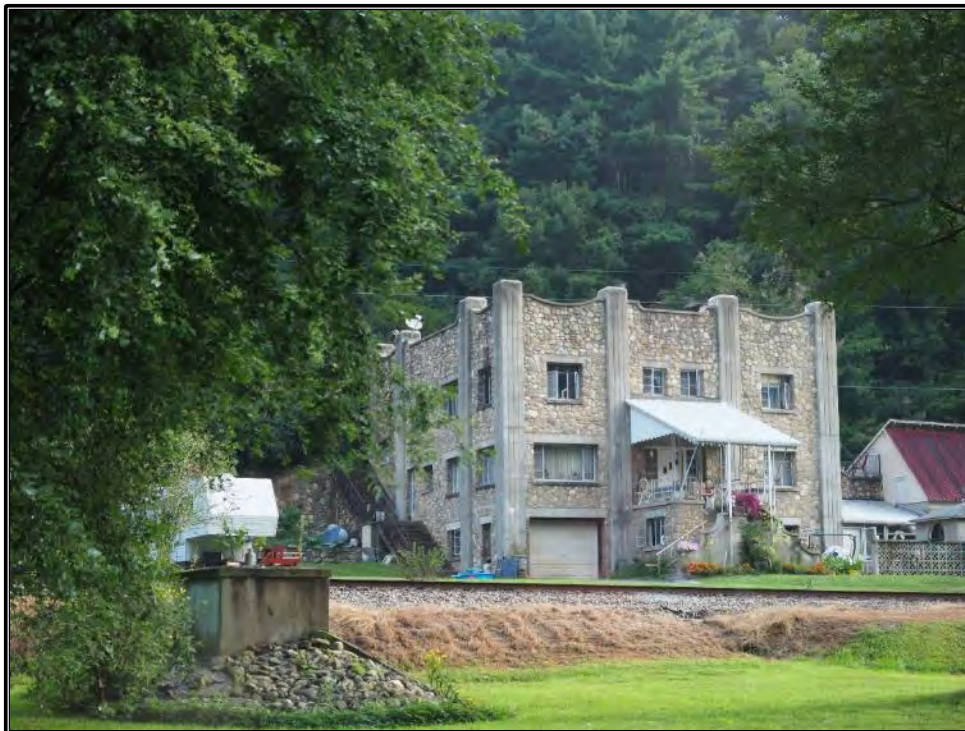
Figure 43. Rubble-rock masonry and cast-concrete commercial building along Asheville Highway east of Canton. This circa 1930–1950 building is among the largest and most intact examples encountered during the survey.

The comparative examples that are one-story in form feature fewer bays than the present example, while the three-story, rubble-rock building east of Canton on Asheville Highway is perhaps the largest and most sophisticated for this class of building observed during the survey (Figure 43). The building features metal casement windows, two basement garage entries with stucco and cast-concrete details. The building is wedged between Asheville Highway and the railroad to the south and Groundhog Road to the north, a significant location to take advantage of both rail and automobile travel as the region grew. As a result, the Commercial Building and Former Grocery (HW0737), while a large building featuring rubble-rock construction throughout, is a relatively common type locally.

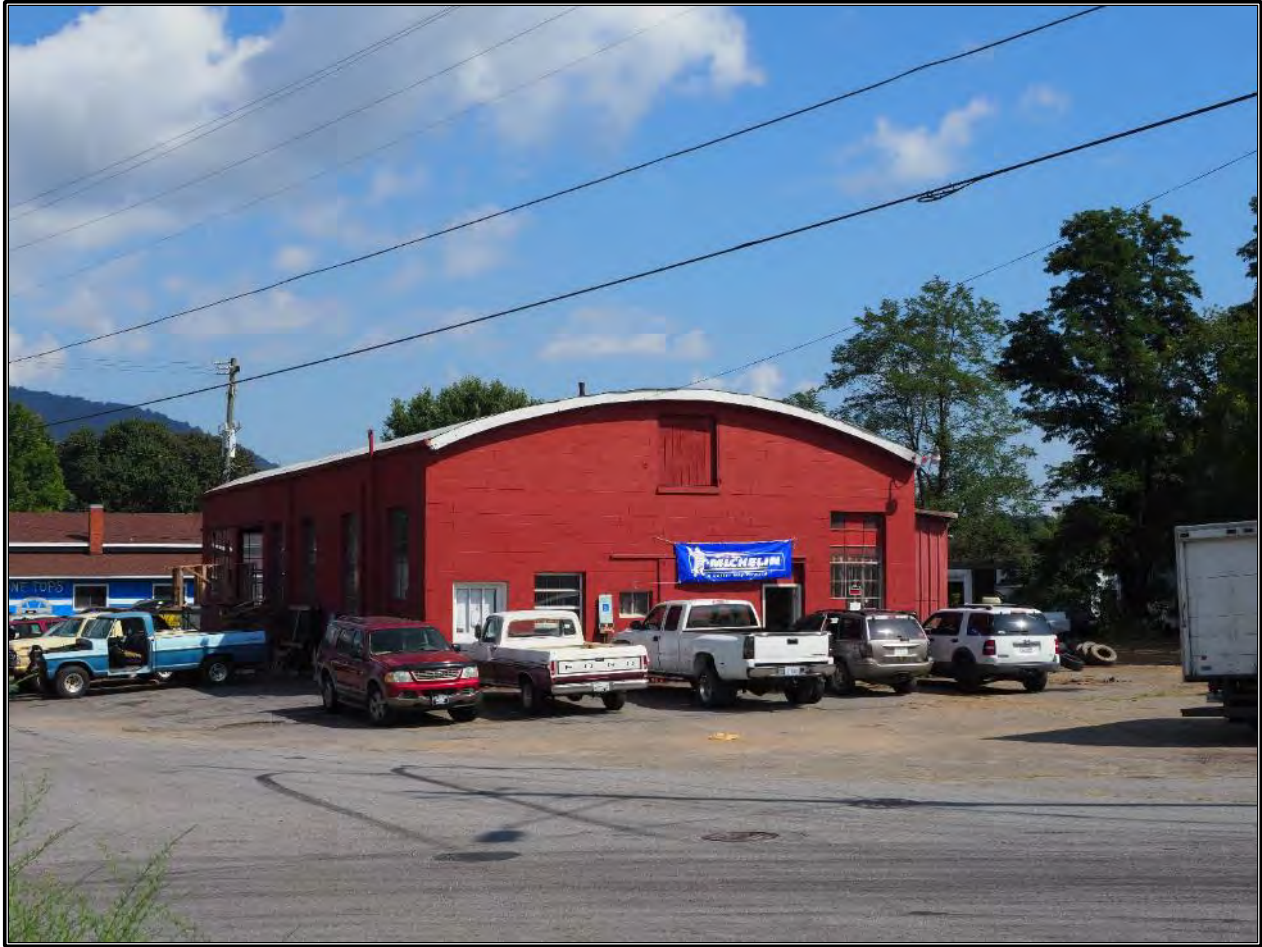
Figure 45. Façade and west elevation of repair shop, looking north-northeast.

Repair Shop, exterior: The circa 1940–1956 concrete block and brick repair shop, potentially a former warehouse, displays a one-story, six-bay (d/w/w/d/d/w) form with a barrel roof (Figure 45). Set on a continuous concrete block foundation, the repair shop features exposed concrete block exterior walls. The arched roof is sheathed in metal panels. The windows contain multi-light metal sashes.

The façade contains a large central bay filled by a sliding metal door on a metal track. A single-leaf entry filled by a three-light wood door pierces the west (left) side of the façade. Two windows east (right) of the entry are filled by four-light awning and a two-light metal sash. A single-leaf entry filled by a metal door pierces the façade immediately east (right) of the large central bay. An opening covered by a wood shutter is centered above the sliding door.

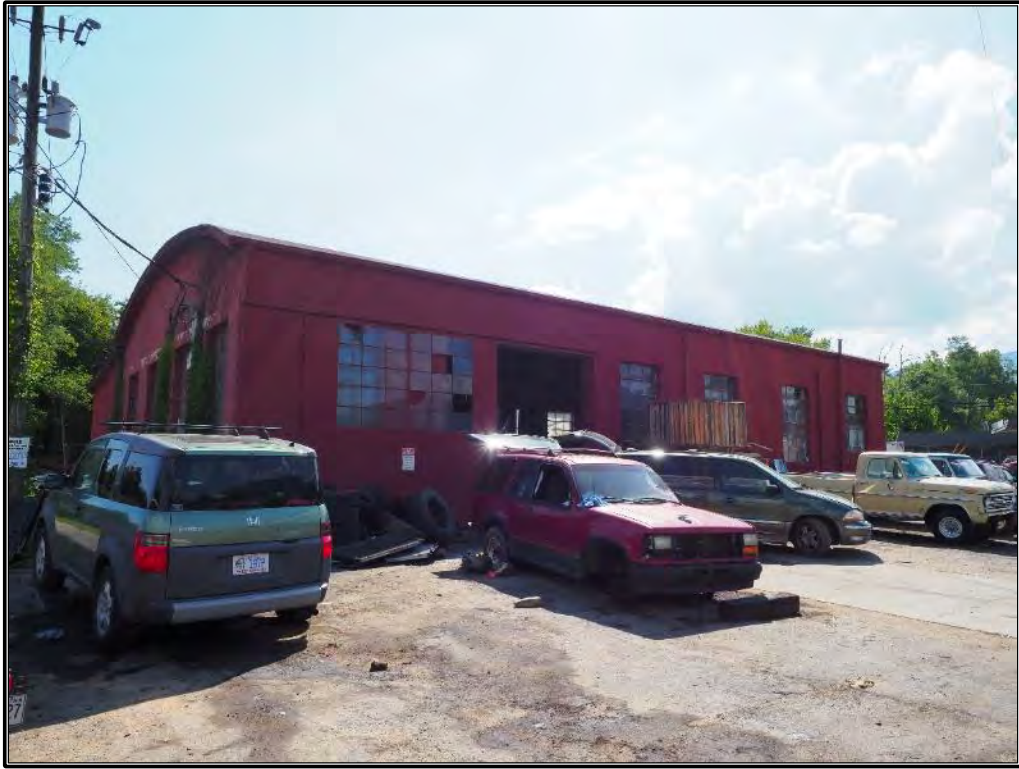
Figure 46. West and rear elevation of repair shop, looking east-southeast.

The west elevation contains a large bay filled by a sliding metal door on a metal track (Figure 46). The door is pierced by a single-leaf entry filled by a wood door. A large window filled by a multi-light metal sash is located along the sliding door above the single-leaf entry. A one-story, shed-roof addition clad in metal siding extends from the east elevation of the warehouse (Figure 47).

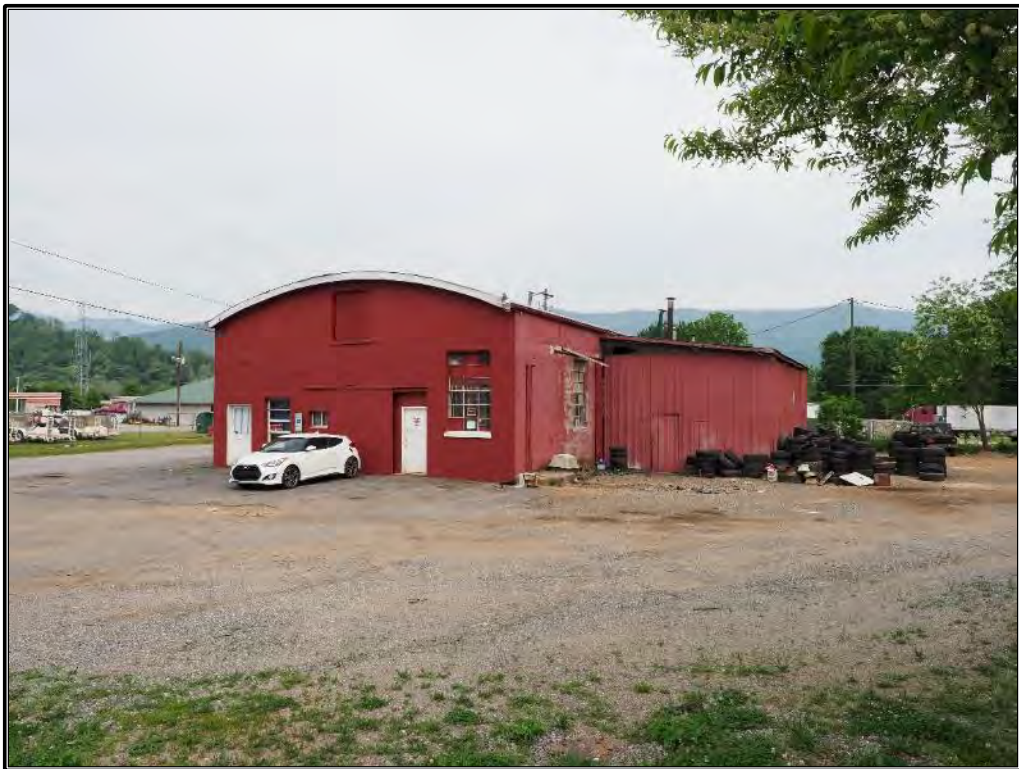
Figure 47. Façade and east elevation of repair shop, looking northwest.

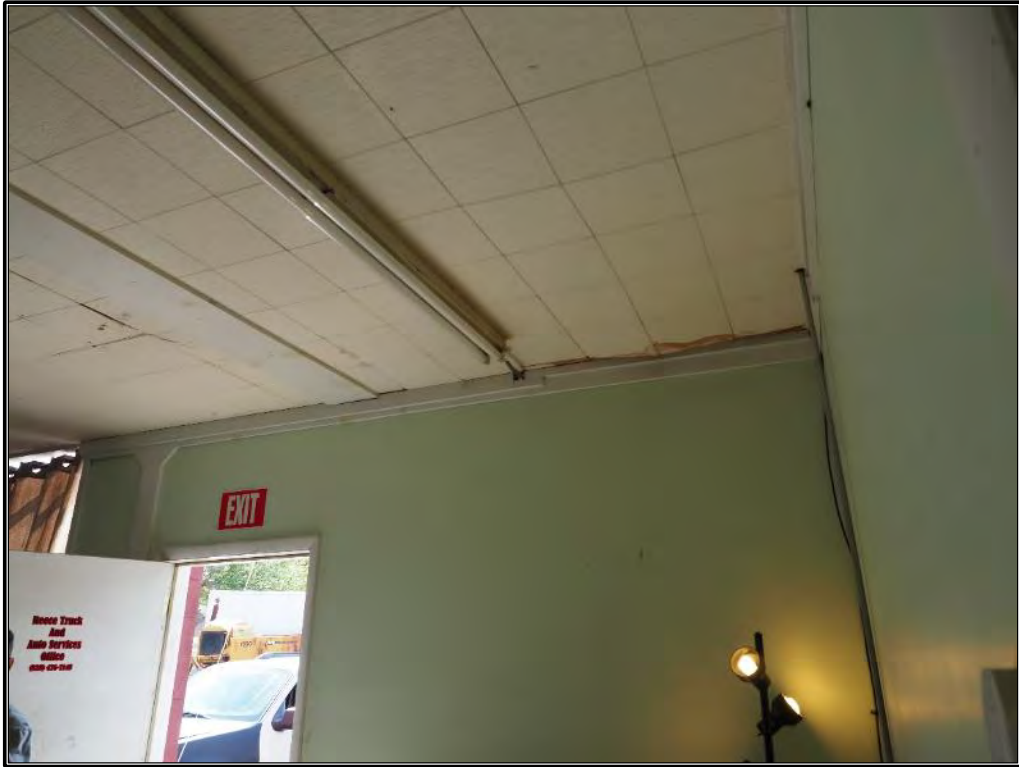
Figure 48. View of office interior, looking towards the front entry.

Repair Shop, interior: The northeast (right) façade entry opens into an office with finished interior walls and a drop tile ceiling (Figure 48). A bathroom accessed by an interior metal door is located southwest (left) of the office. The restroom features painted concrete block walls and a tile floor. The interior of the warehouse primarily consists of a large central room (Figure 49 and Figure 50). The walls feature painted brick and concrete block. Metal trusses and support beams span the width of the building along the ceiling. A large bay filled by a metal sliding door pierces the east (right) wall. The sliding door is enclosed by the shed-roof addition along the east elevation. Like the exposed sliding door along the west (left) wall, the sliding door is pierced by a single-leaf entry and a large window filled by a multi-light metal sash. The entry along the sliding door provides access to the east addition. Several windows along the east (right) wall are enclosed with concrete block and drywall.

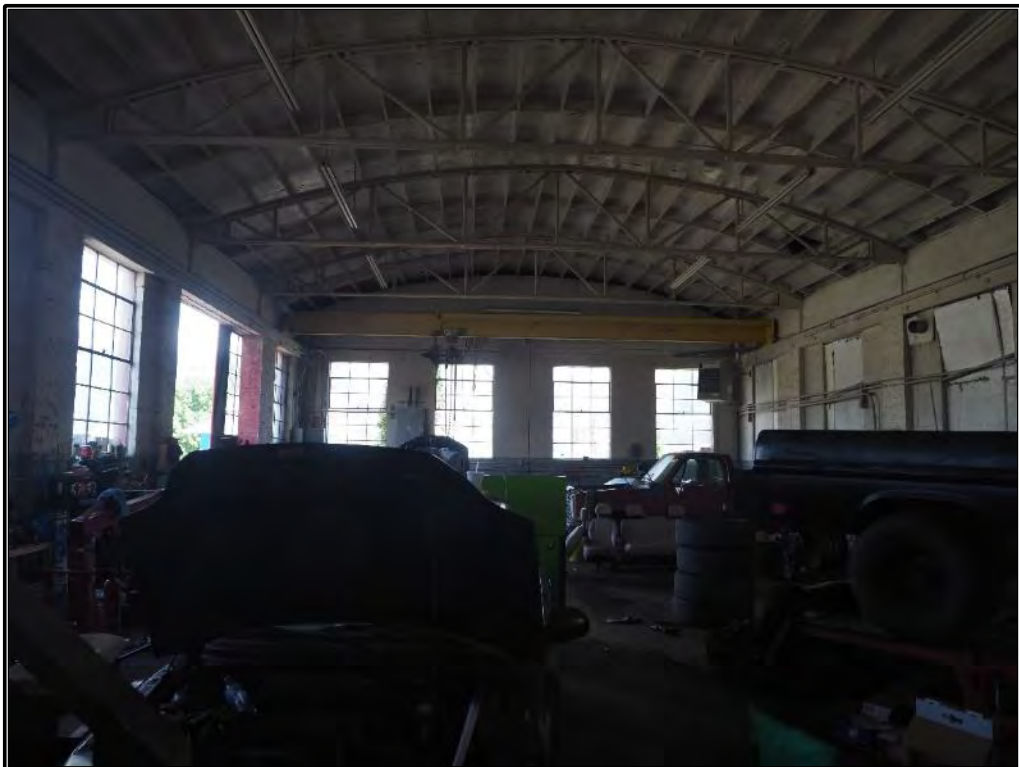
Figure 49. Interior view of repair shop from the front office.
