SUBJECT: Historic Structures Survey Report, , Improvements to US 23 Business (South Main Street) from SR 1164 (Hyatt Creek Road) to US 276 (Pigeon Street), Waynesville, PA 17-12-0027, U-4712, Haywood County, ER 18-4249

MANAGEMENT SUMMARY	i
I. INTRODUCTION.....	1
II. METHODOLOGY.....	1
III. DESCRIPTION, HISTORIC CONTEXT, AND EVALUATION	7
CLYDE’S RESTAURANT (HW0735)	7
COMMERCIAL BUILDING (HW0736).....	18
COMMERCIAL BUILDING AND FORMER GROCERY (HW0737).....	28
REPAIR SHOP (HW0738)	41
MAPLE GROVE MOTEL (HW0739)	50
HYATT HOUSE AND CARRIAGE HOUSE.....	68
(HW0015 / HW0740).....	68
SILER HOUSE (HW0741)	88
ETHEL ROSS BRADLEY HOUSE (HW0742)	97
PEARL HYATT AND MARGARET HYATT PILARSKI HOUSE (HW0743)	110
HOUSE, 1262–1270 S. MAIN STREET (HW0744).....	119
GEORGE HOUSE (HW0745)	133
HOUSE, 1157 S. MAIN STREET (HW0746).....	143
HOUSE, 1153 S. MAIN STREET (HW0747).....	155
THE GABLES APARTMENTS (HW0096).....	163
DR. ALBERT HEYWARD SMITH, JR. HOUSE (HW0748).....	173
THE ATKINS HOUSE (HW0109)	187
THE HILLTOP TOURIST LODGE (HW0056).....	202
FORMER HOUSE, 809 S. MAIN STREET (HW0749).....	212
HOUSE, 761 SOUTH MAIN STREET (HW0750)	222
THE CHARLES RAY HOUSE (HW0055) AND CARRIAGE HOUSE (HW0751)	233

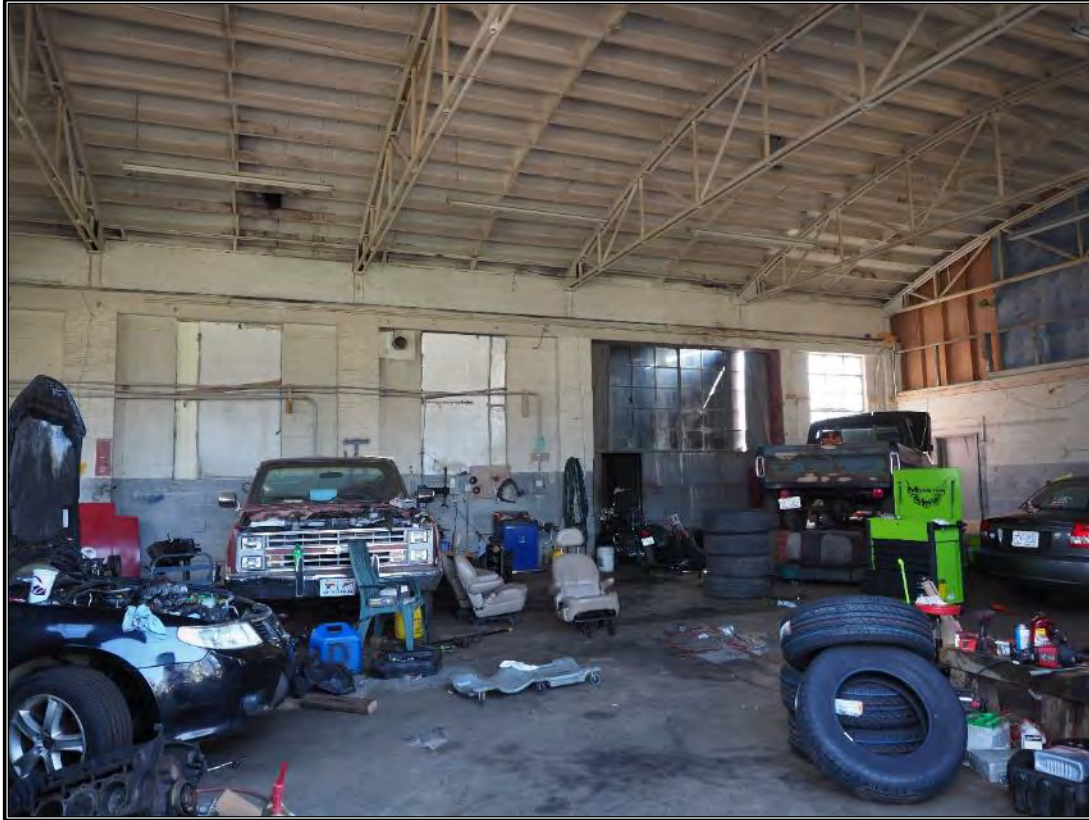
Figure 50. Interior view of repair shop looking toward the front office.

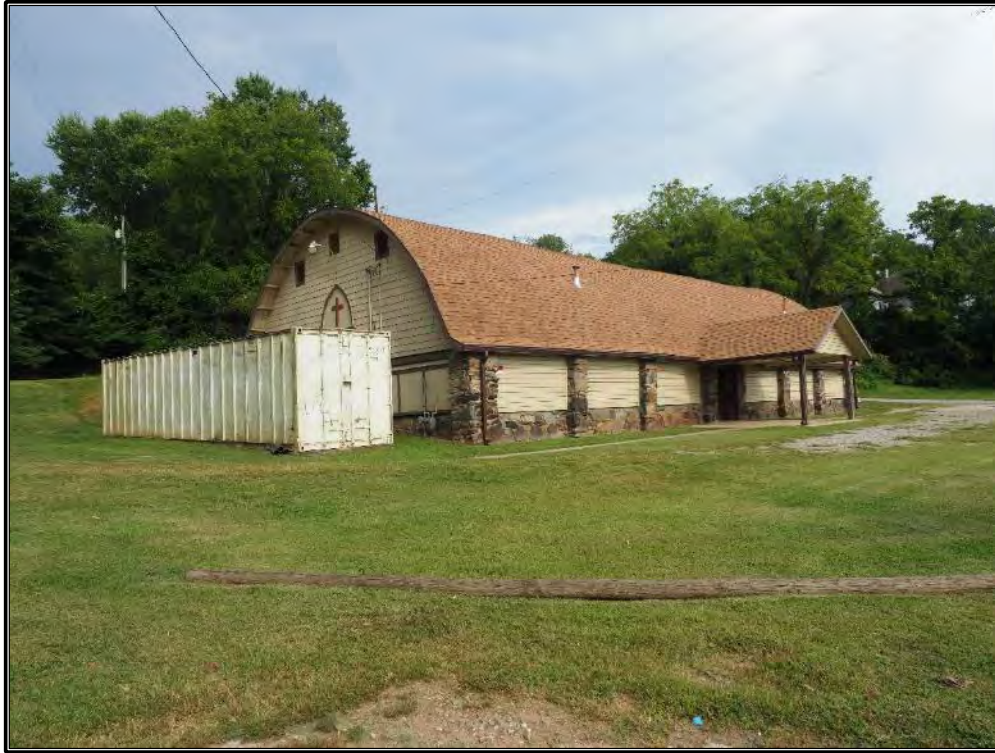
Figure 51. View of church with a barrel roof located in Asheville at the intersection of Roberts Street and Craven Street.

During the course of survey work, former industrial or warehouse buildings are a common feature of the landscape. However, those with arched or barrel rooves were exceedingly rare. The only building with a similar roof configuration located during the course of the survey was in the Asheville industrial district along the French Broad River at the intersection of Roberts Street and Craven Street. Currently a church, the building featured rubble-rock masonry and large window openings that have been infilled (Figure 51). The roof form is one of the few commonalities between these otherwise stylistically disparate buildings. Industrial buildings throughout the region are typically large, rectangular forms with flat or gable rooves, parapet walls, and of brick, concrete block or steel construction. While the majority of the industrial fabric relation to the Repair Shop’s (HW0378) period of construction has been demolished in Waynesville and Hazelwood, limiting the opportunities for local comparisons, the formal industrial district in Asheville provides sufficient comparison to regionally-typical types (Figure 52).

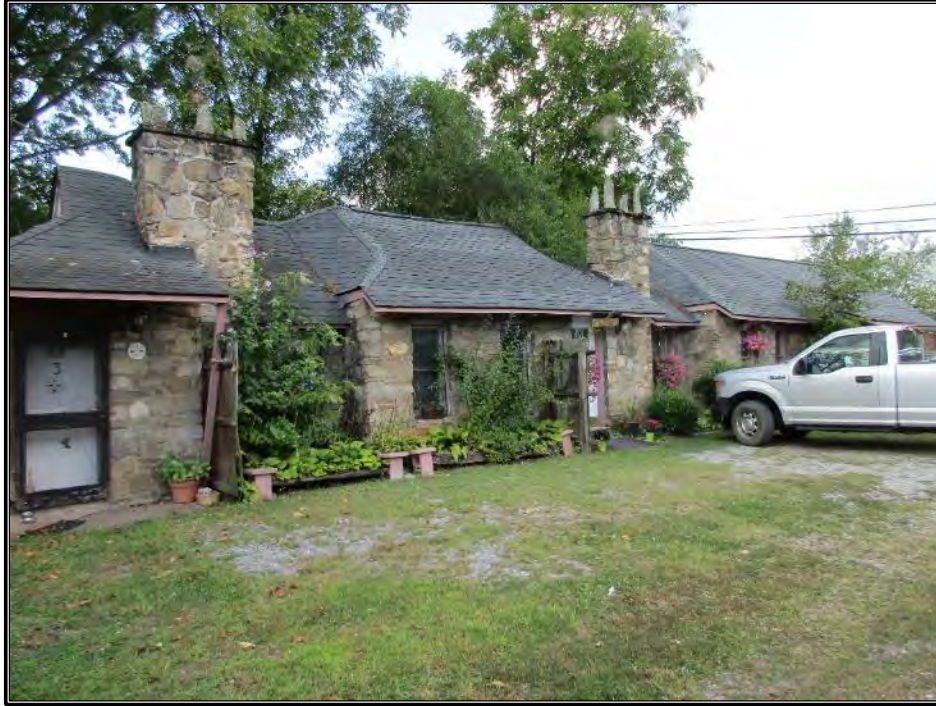
Figure 54. Façade of linear building, looking west.

Motel, exterior: The motor court consists of a linear main building and ten detached cottages. The circa 1930-1935 one-story, twelve-bay (d/w/w/w/d/w/w/w/w/d/w/w) linear building is divided into three attached units. The first (northwest) unit features a side-gable form. The second (center) unit presents a hip-roof form (Figure 54). The third (southwest) unit features a gable-on-hip roof. The gable-oriented, recessed hyphen connects the first (northeast) and second (center) units. The third (southwest) unit is also recessed from the front plane of the building. The building rests on a continuous stone-clad foundation and the exterior is clad in a stone veneer. The northwest gable is clad in drop wood siding. The roof is sheathed in asphalt shingles and features wide, overhanging eaves. The windows contain one-over-one, double-hung wood sashes with simple wood surrounds (Figure 55). Some windows are sheltered by arched wood hoods. Two exterior stone-clad chimneys extend from the façade of unit two and three (Figure 56). Upright stones adorn the top of each chimney. An exterior concrete block chimney extends from the rear elevation of the first unit.

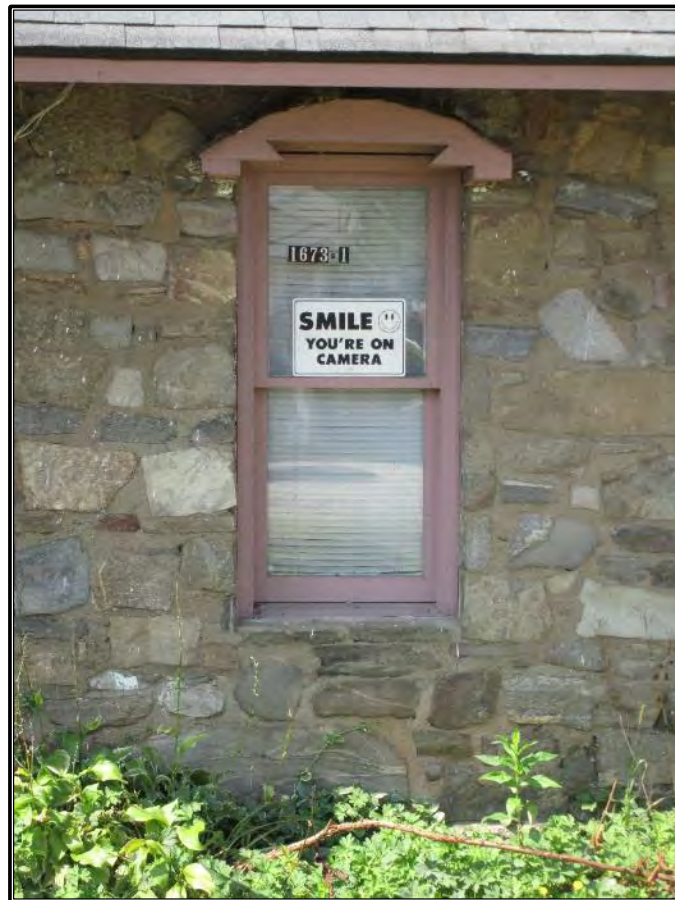
Figure 55. Façade window detail.

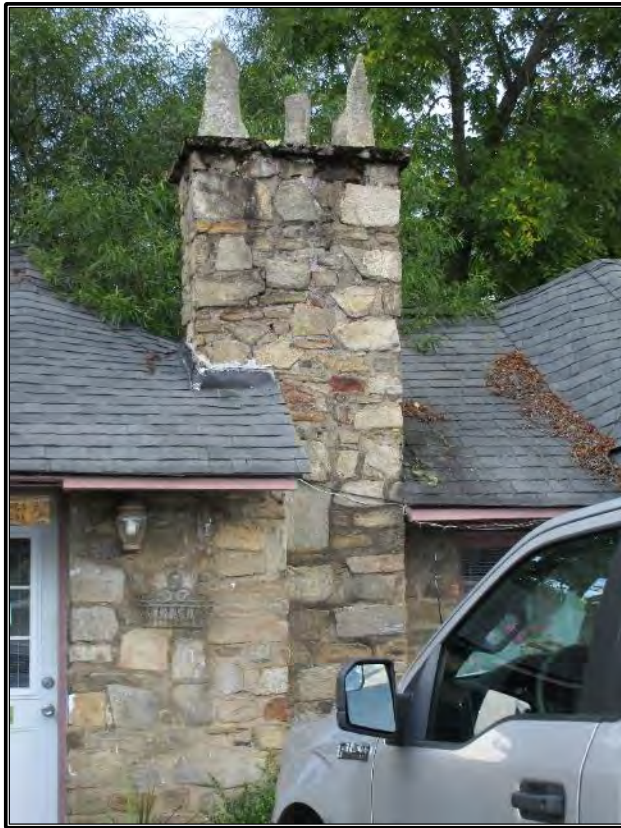
Figure 56. Detail of façade chimney.

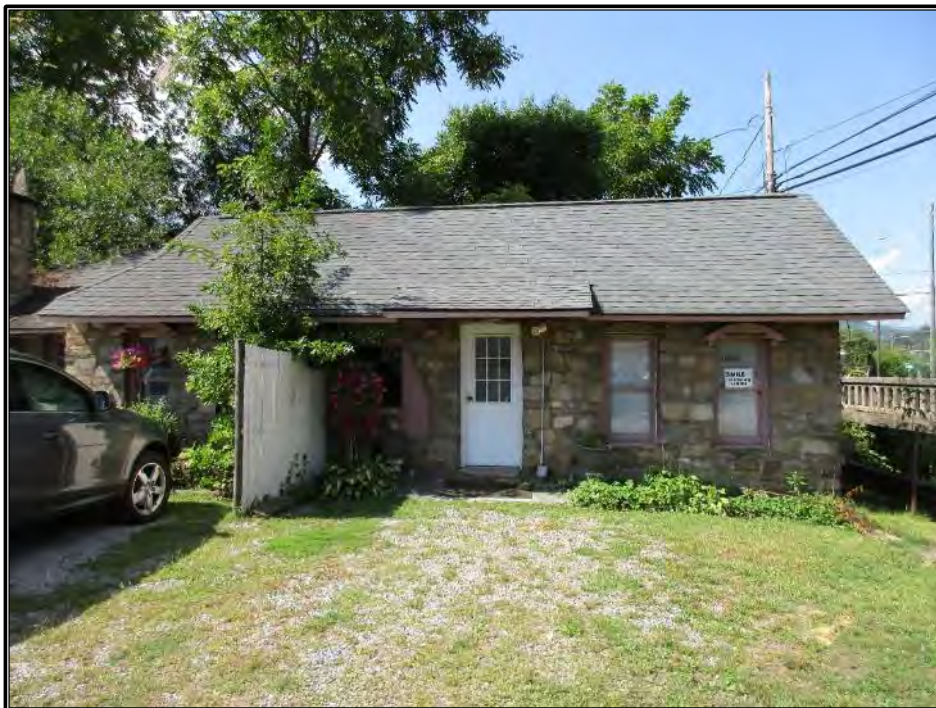
Figure 57. View of the first unit, looking southwest.

The façade of the first (northeast) unit features a single-leaf entry and three single windows. The entry contains a nine-light replacement door and is sheltered by a shed-roof hood (Figure 57). The southwest (left) window is filled by a single-light wood sash. The second (center) unit is defined by an off-center single-leaf entry and two single windows (Figure 58). The entry is filled by a nine-light replacement door. The façade of the third unit features a single-leaf entry and a single window. The entry contains a single-light slab door and is sheltered by a shed-roof hood.

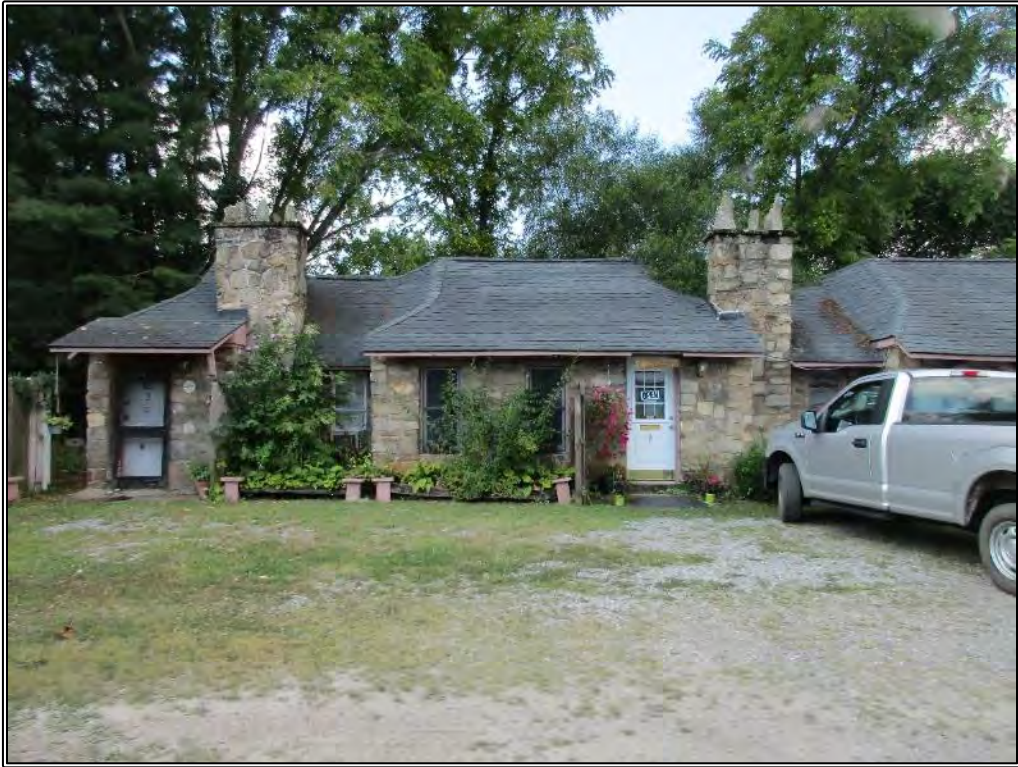
Figure 58. View of the second and third units, looking southwest.

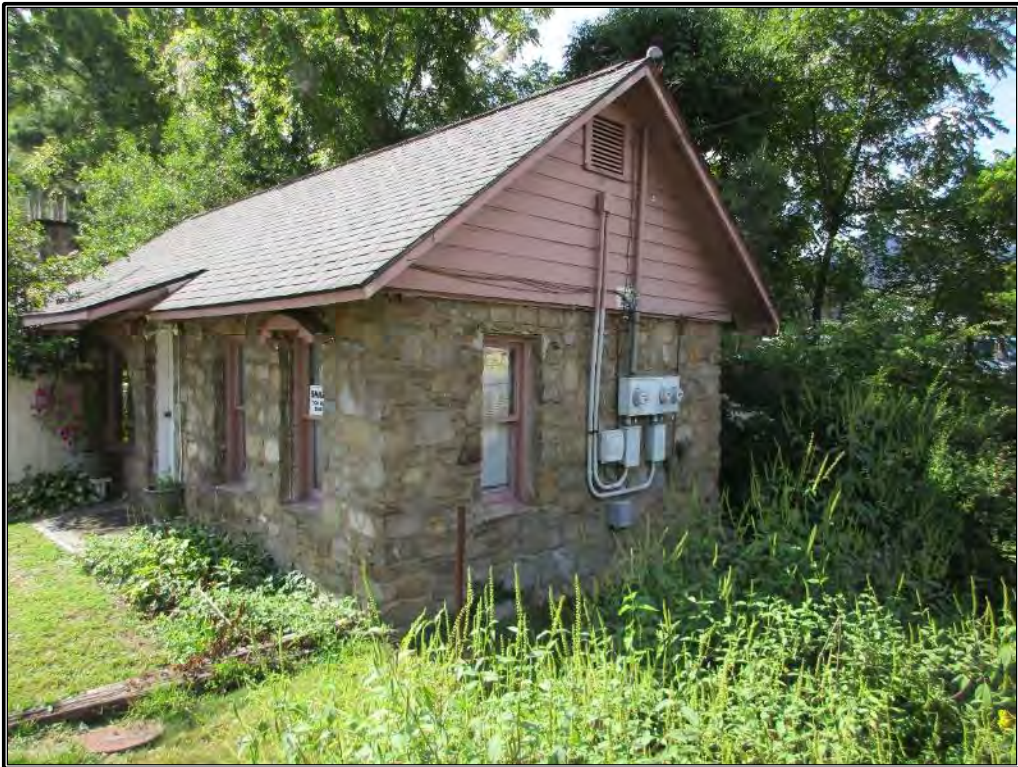
Figure 59. Northeast elevation of linear building, looking south.

The northwest and southeast elevations of the linear building are pierced by a single window bay (Figures 59 and 60). A single-leaf entry along the rear elevation of the second (center) unit is enclosed (Figure 61). A shed-roof hood shelters the enclosed entry. A portion of the rear elevation of the third (southwest) unit is covered in poured concrete, perhaps an enclosed large bay.

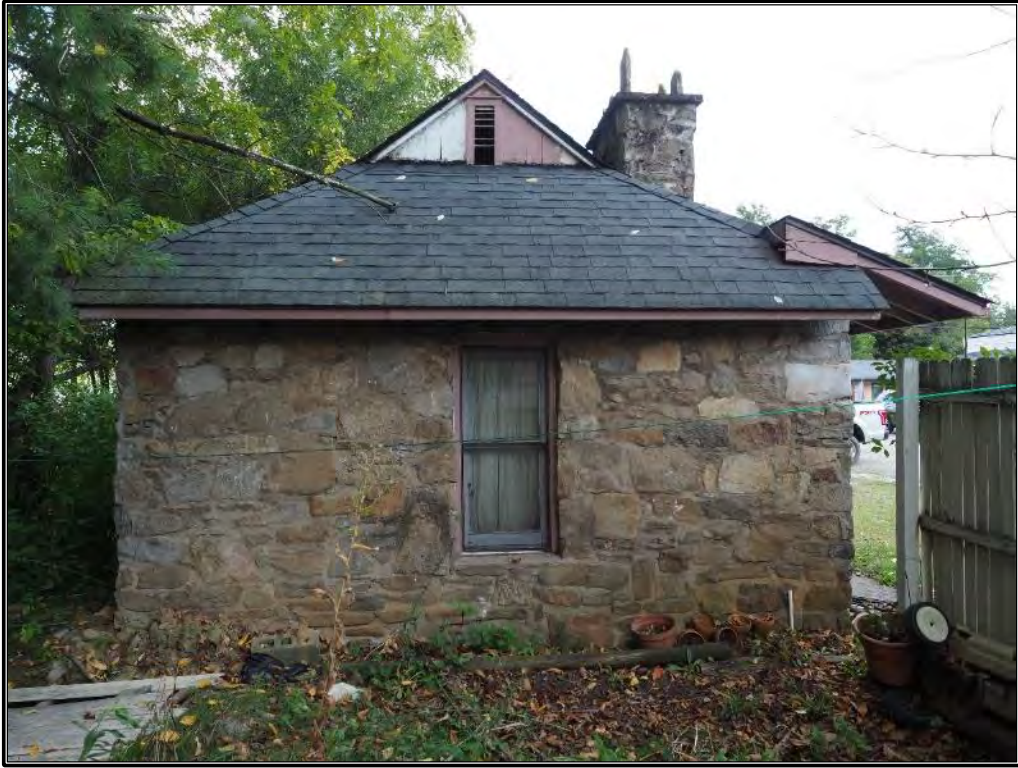
Figure 60. Southwest elevation of linear building, looking northwest.

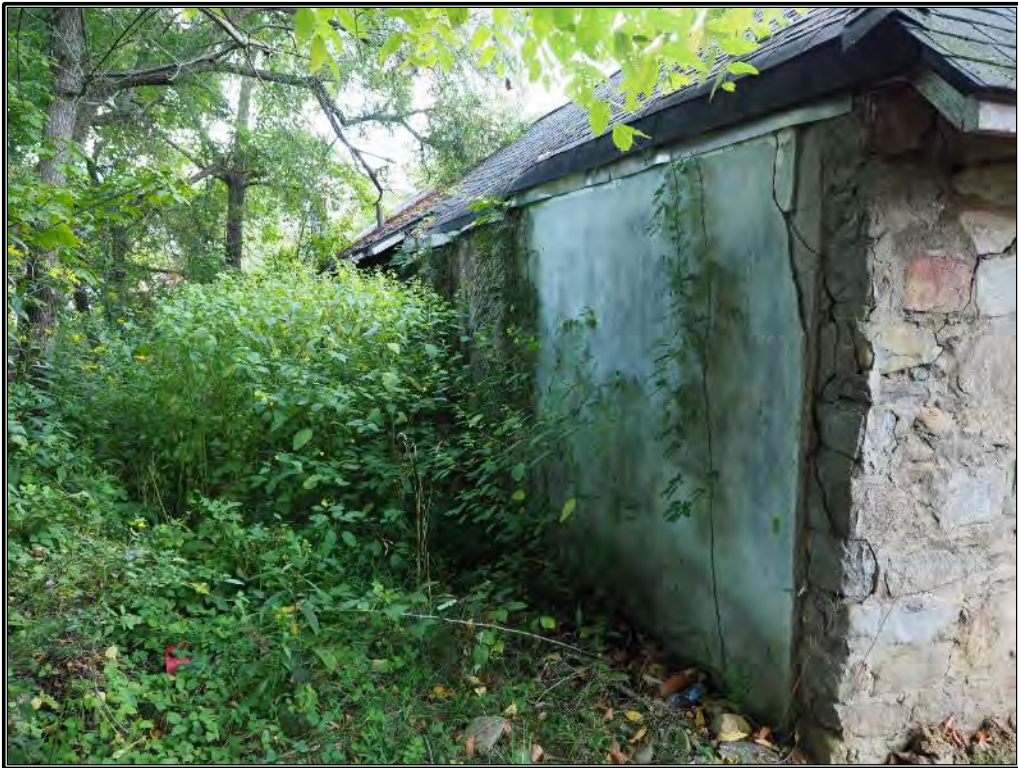
Figure 61. Rear elevation of linear building, looking north-northwest.

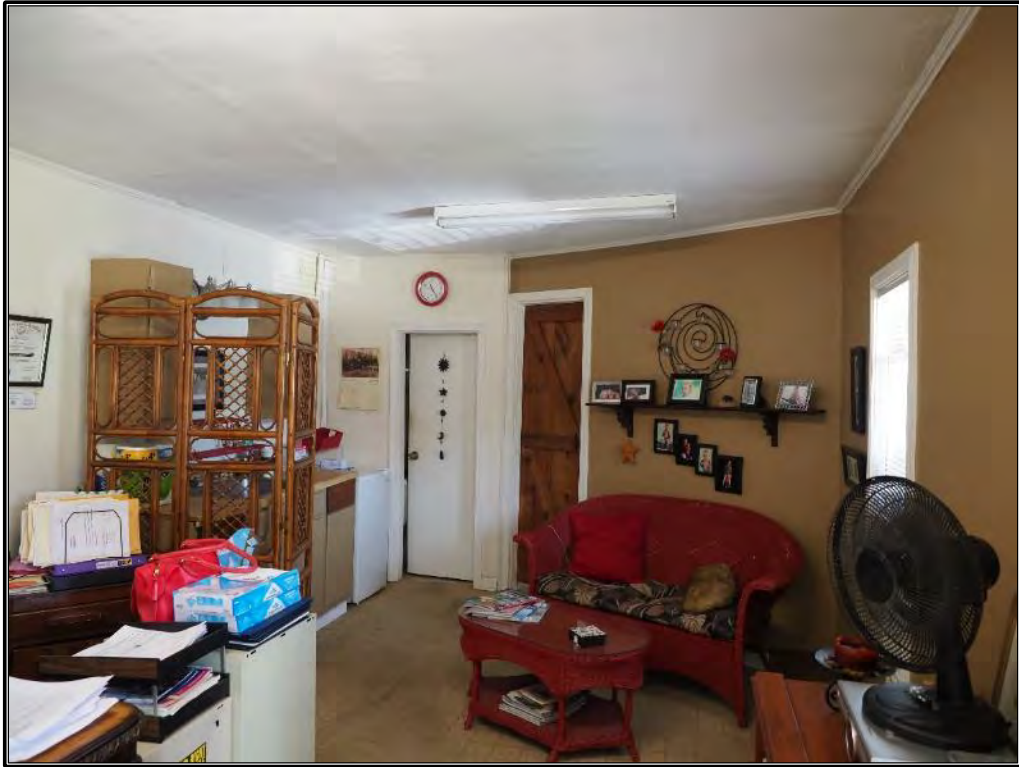
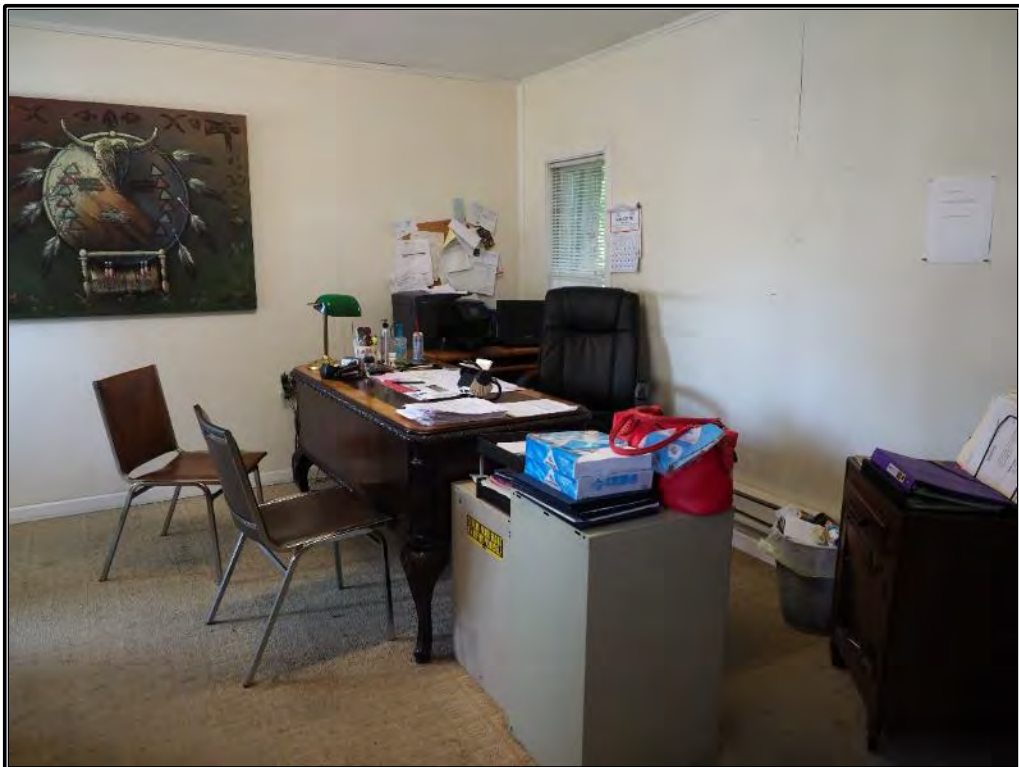
Figure 62. Interior view of second unit from the front entry.

Figure 63. Interior view of second unit from the front entry.

Motel, interior: Access to the interior of one unit of the motel was secured in the field. The second (center) unit operates as a real estate office and the current owners indicated that the other two units have similar interiors ((Figures 62 and 63). The front entry of the unit opens into the asymmetrical main room feature floors covered in low-pile carpet. The walls are covered in drywall and painted with simple crown molding. The windows and doors feature simple wood surrounds. An entry filled by a metal door pierces the northwest (right) wall and leads to the bathroom.

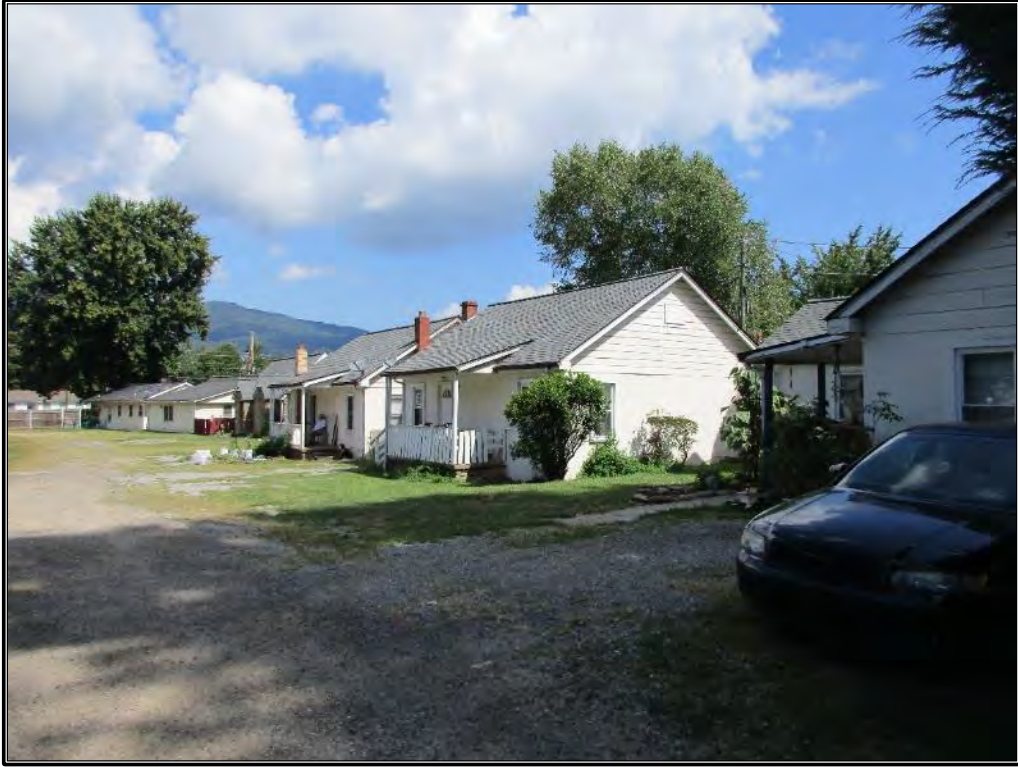
Figure 64. Overview of the northeast row of cottages (Cottages A-F), looking north.

Cottages, exterior: Eight detached cottages and two modern dwellings are situated along Neon Place (Figures 64–66). The eight historic cottages currently associated with the property date to the early to mid-twentieth century. A circa 1975–1995 residence is located on the southwest side of Neon Place and adjacent to Chelsea Road (Figure 67). A neighboring residence on the southwest side of Neon Place was added to the property circa 2013 (Figure 68). Six of the historic cottages are arranged in a row on the northeast side of the property and back onto Swan Street. These cottages date to circa 1935–1941. A circa 1935–1941 cottage is located on the southwest side of Neon Place, just southeast of the linear building. Another cottage, historically a bus stop according to the current owners, dates to circa 1942–1967 and is located in the inner loop of Neon Place.

The fourth cottage (Cottage D) presents a one-story, five-bay (w/d/w/d/w), side-gable form with a side-gable projection. The exterior is clad in stucco and the roof is sheathed in asphalt shingles. The gable ends are clad in wood drop siding. The foundation is not visible. Windows contain one-over-one, double-hung vinyl sashes. An exterior brick chimney extends from the façade of the cottage. An exterior concrete block chimney is located on the rear elevation of the side projection. The façade entry is filled by a replacement nine-light door and opens onto a partial-width, single-bay porch with a shed-roof supported by wood posts set on a poured concrete deck. A one-story, side-gable projection extends from the northeast elevation.

The fifth cottage (Cottage E) in the northeast row features a one-story, three-bay (w/d/w), side-gable form. The exterior is covered in stucco and sheltered by an asphalt shingle roof. The gable ends are clad in wood drop siding. The foundation is not visible. The windows exhibit one-over-one, double-hung vinyl sashes. An exterior brick chimney extends from the northeast elevation. The façade entry opens onto a partial-width, single-bay porch with a shed-roof supported by wood posts set on a poured concrete deck.

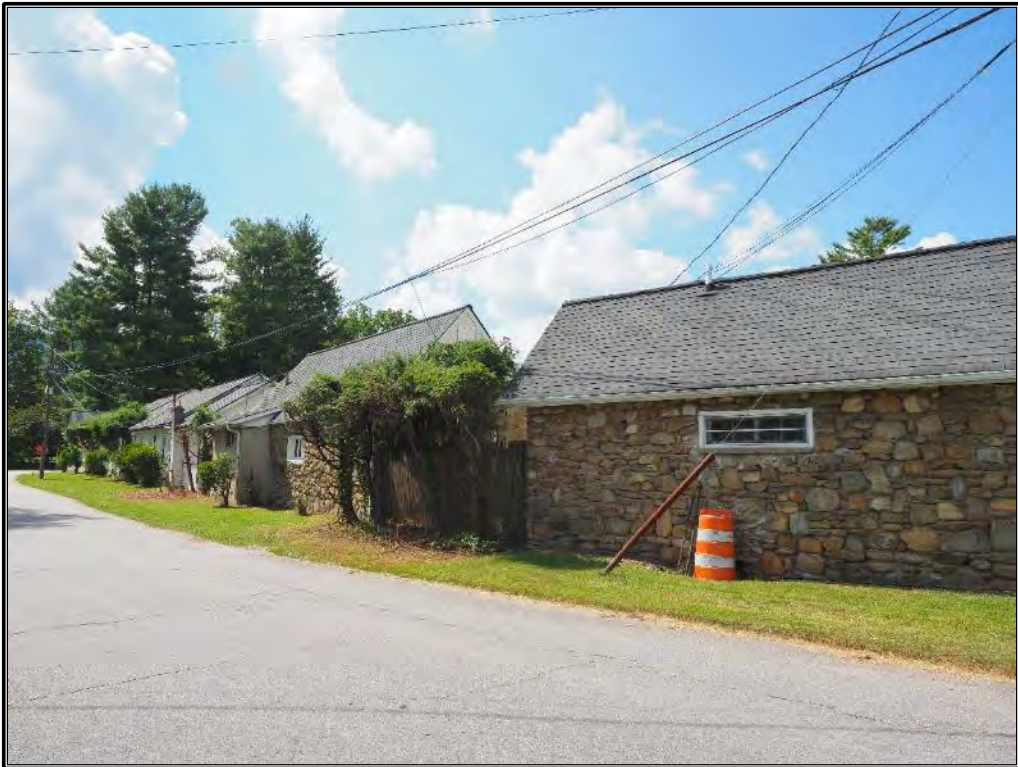
Figure 65. Rear view of northeast row of cottages (Cottages A-F), looking south-southeast.

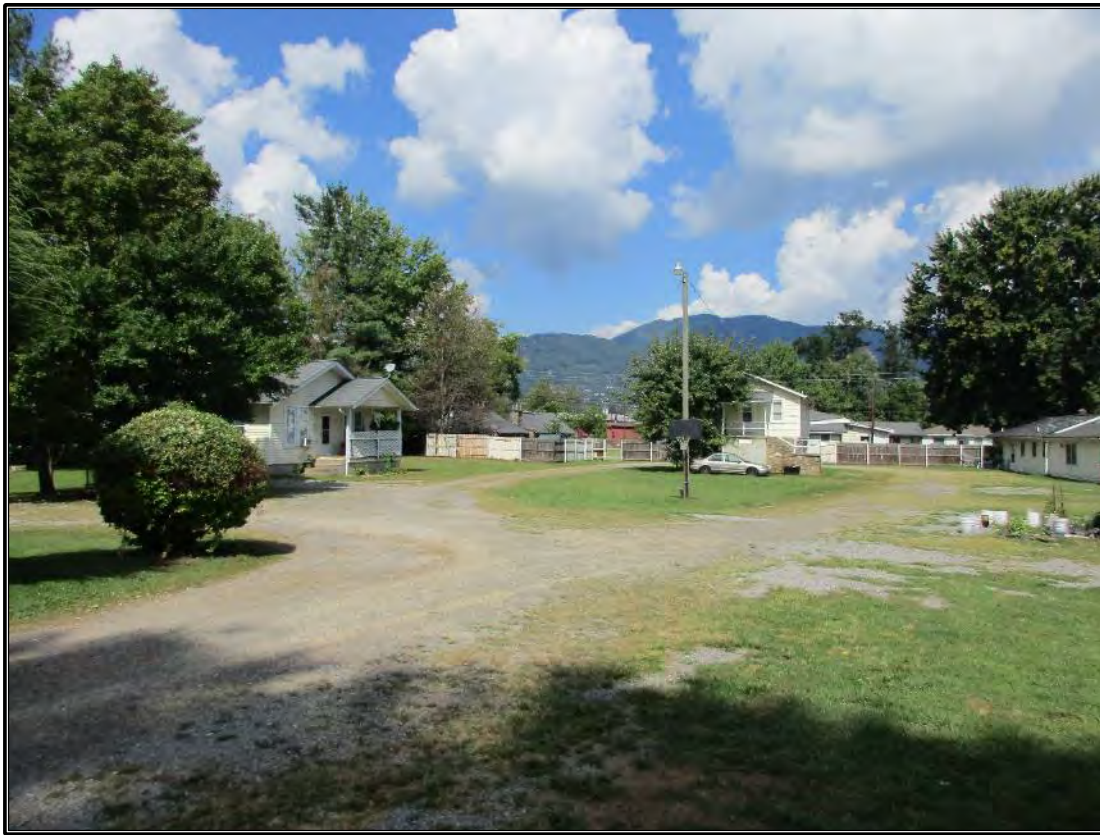
Figure 66. Overview of Neon Place, including a cottage and the former bus stop (Cottages I–J), looking northwest.

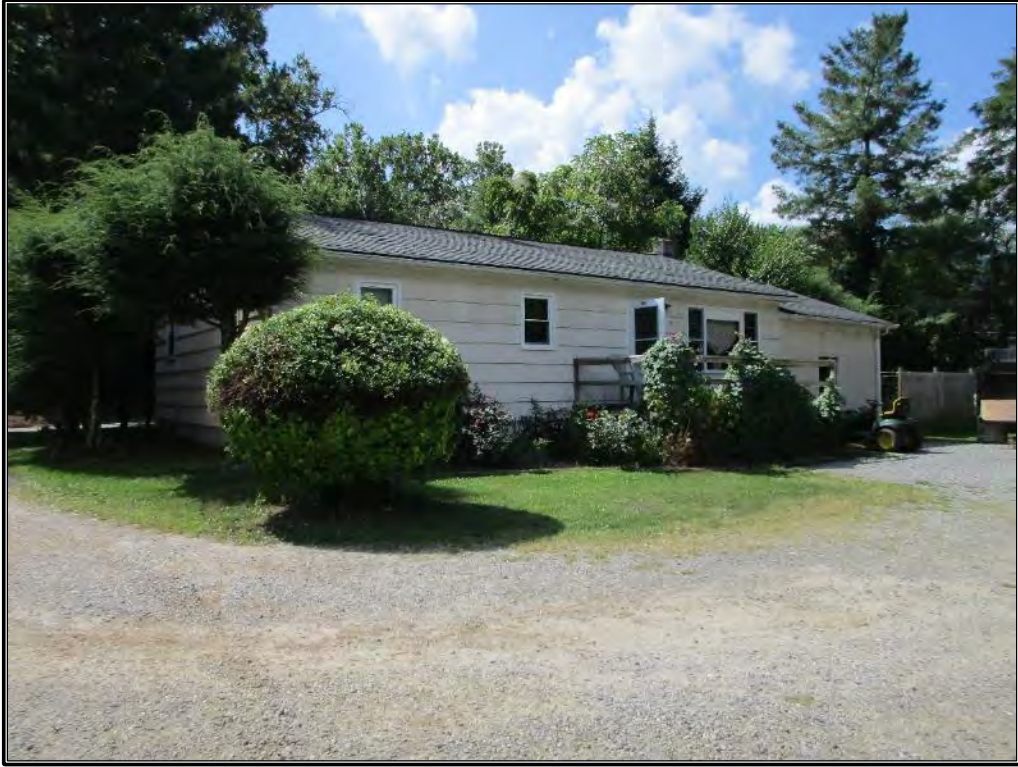
Figure 67. View of modern cottage (Cottage G), looking south.

The circa 1975–1995 cottage adjacent to Chelsea Road (Cottage G) exhibits a one-story, four-bay (w/w/d/www), side-gable form. The dwelling rests on a continuous concrete block foundation and is clad in composite siding. The roof is sheathed in asphalt shingles. The windows contain one-over-one, double-hung wood and vinyl sashes. An exterior concrete block chimney extends from the southwest elevation. The front entry opens onto a wood deck lined by a wood railing. A tripartite window bay consisting of a central picture window between two narrow sashes filled by two-over-two, double-hung wood sashes pierces the façade southwest (right) of the entry. A one-story, side-gable addition clad in wood panels extends from the southwest elevation.

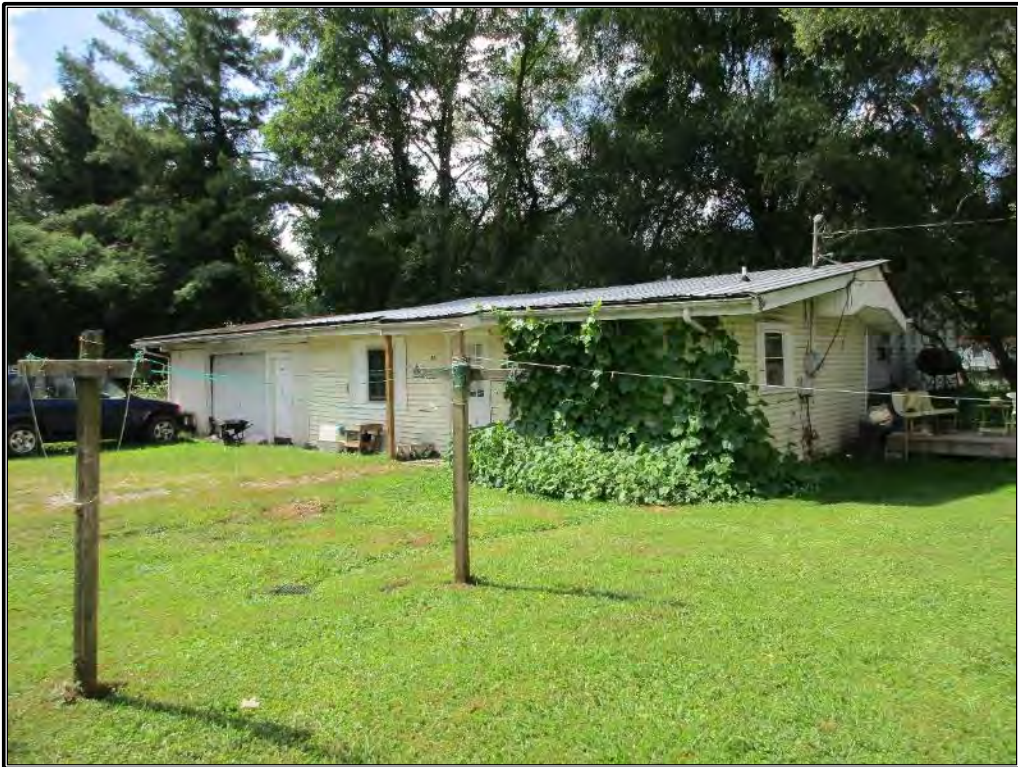
Figure 68. View of modern cottage (Cottage H), looking south.

The circa 2013 cottage (Cottage H) features a one-story, three-bay (w/d/w), side-gable form. The exterior is clad in vinyl siding and the roof is sheathed in metal panels. The foundation is not visible. The windows contain one-over-one, double-hung vinyl sashes. The front entry is filled by a nine-light replacement door and opens onto a poured concrete landing sheltered by a shed-roof hood supported by wood posts. A one-story, side-gable addition containing a single-car garage extends from the southeast elevation. The addition is clad in T1-11 siding. A one-story, shed-roof addition extends from the rear elevation.

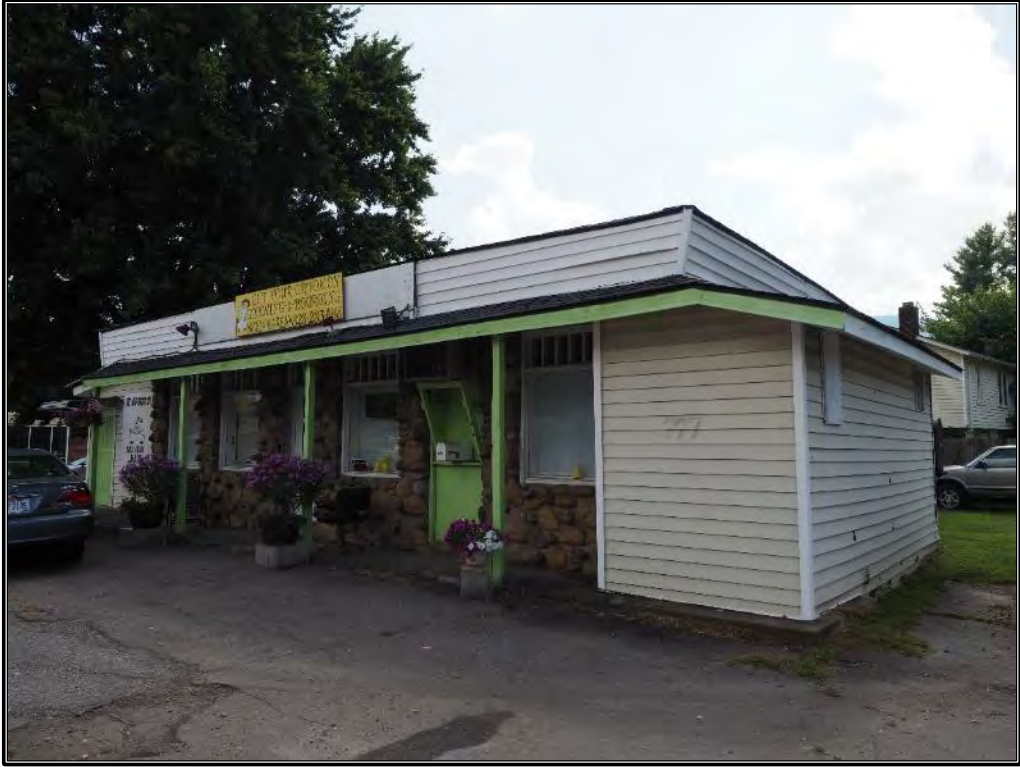
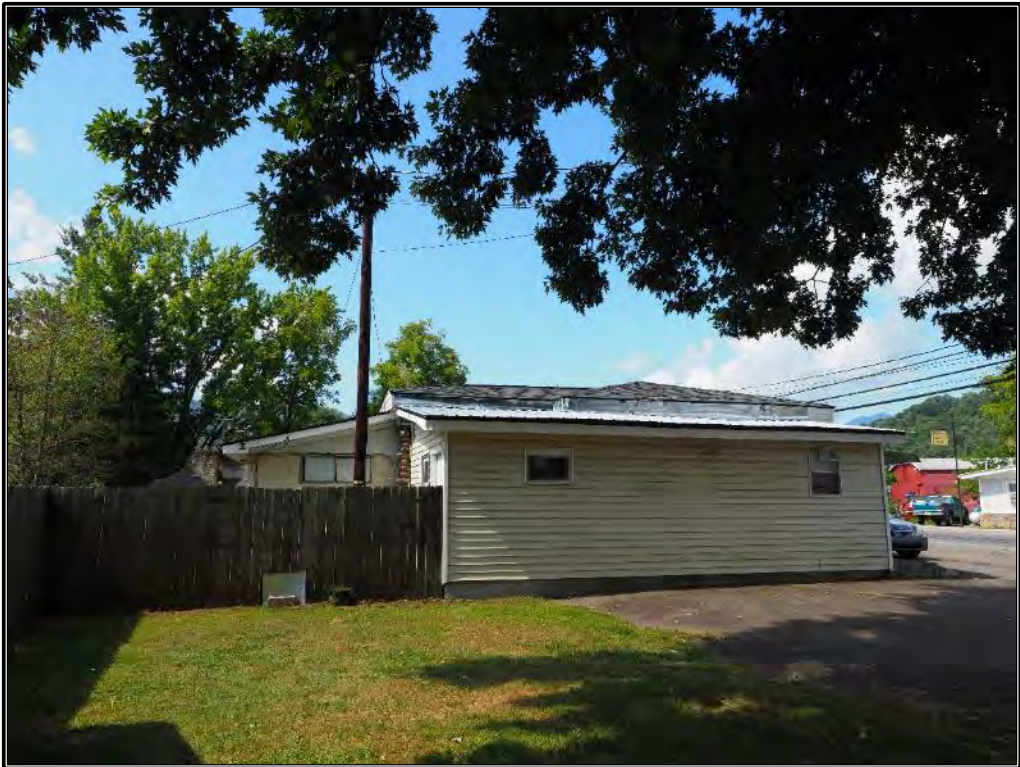
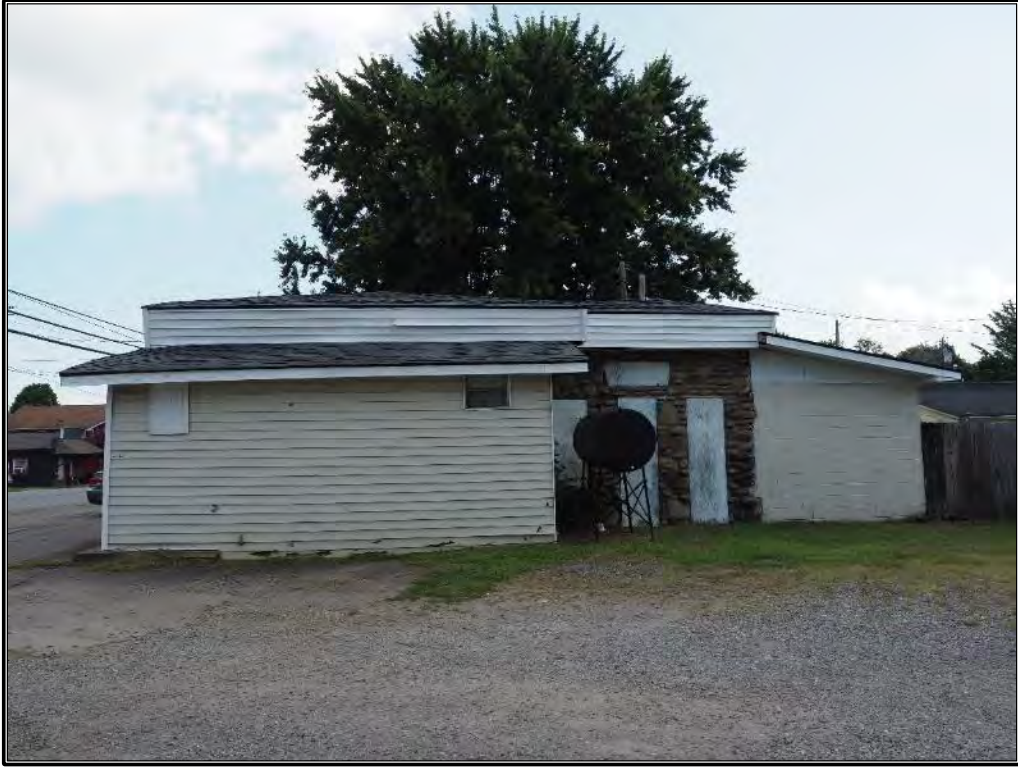
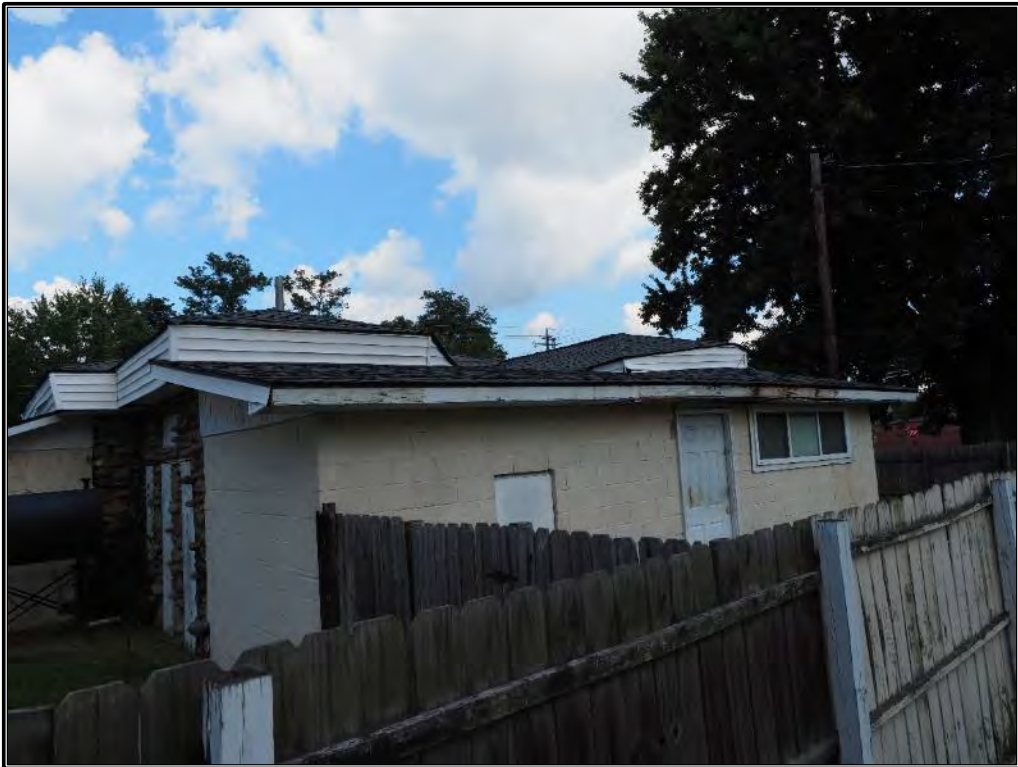
Figure 69. Façade and southwest elevation of commercial building, looking east.

Figure 70. Northeast elevation of commercial building, looking west-southwest.

Figure 71. Southwest elevation of commercial building, looking north-northeast.

Figure 72. Rear elevation of commercial building, looking north-northwest.

Commercial Building: A one-story, six-bay (w/w/d/w/d/w), hip-roof commercial building is located approximately 50 ft north-northeast of the linear building. The commercial building rests on a continuous concrete block foundation (Figures 69–72). The exterior is clad in river rock and the roof is sheathed in asphalt shingles. The façade windows consist of wood picture windows with five-light transoms. Windows throughout the remainder of the building contain a mixture of two-over-two, double-hung metal sashes, single-light sliding metal sashes, and one-over-one, double-hung vinyl replacement sashes. A parapet clad in vinyl siding extends along the edge of the roof line. The façade features two single-leaf entries. The northeast (left) entry contains a three-quarter-light replacement door. The southwest (right) entry is enclosed with wood paneling. The entries feature a five-light wood transom and open onto a full-width, three-bay porch with a shed-roof supported by wood posts set on a poured concrete landing. Vinyl-clad, shed-roof additions extend from the northeast and southwest elevations. The northeast addition is sheltered by a metal paneled roof. A concrete block, shed-roof addition spans the rear elevation.

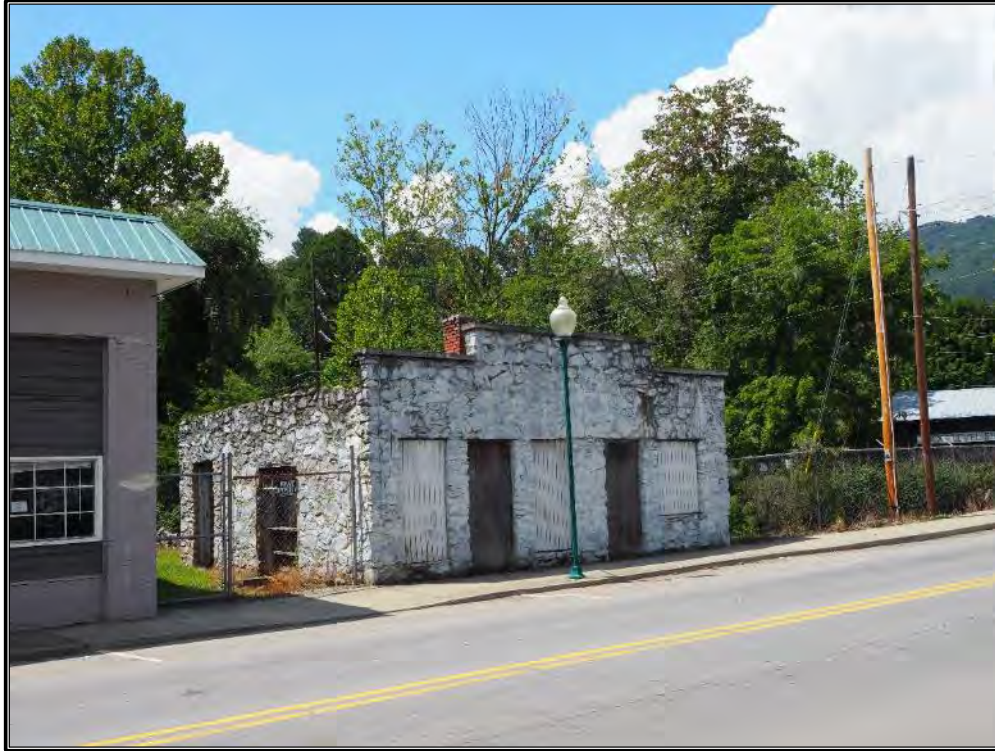
Figure 73. Rubble-rock masonry, circa 1940 commercial building in Frog Level, just west of the Waynesville Main Street Historic District (HW0161) on Depot Street adjacent to Richland Creek.

Stone veneer commercial buildings, including both retail and industrial spaces, were typically one-story structures dating from 1920 to 1960. The form of the commercial building in Frog Level (Figure 73) was among the smallest buildings clad in stone veneer located during the survey to compare with the Maple Grove Motel’s (HW0739) linear building. However, no motels of a similar size and construction could be located in Maggie Valley, Waynesville, or Asheville. One motel, the Rock Haven Motel in West Asheville along Patton Avenue, included stone veneer of a similar type with multiple rooms located in linear buildings (Figure 74). However, the Rock Haven Motel does not feature any comparable decorative details including chimneys with vertical-stone embellishments, individual cottages, or overhanging eaves emphasizing an articulated façade. Maggie Valley has several examples of motor courts organized around a central picnic area (or activities building) with cottages forming a u-shape, such as the Leatherwood Cottages on Soco Road, but these examples did not feature the decorative stonework or other features of Maple Grove Motel (HW0739) (Figure 75). The only rock veneer building featuring vertical stone masonry crowning the chimney was a residence at 641 East Street in Waynesville (Figure 76).

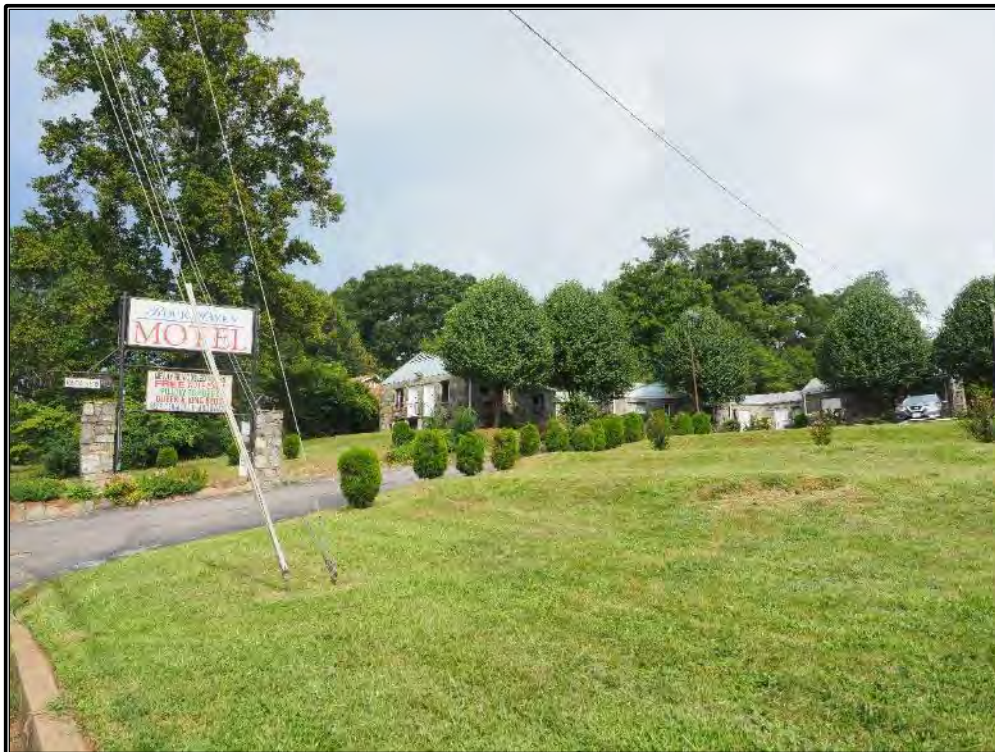
Figure 74. The Rock Haven Motel located in West Asheville on Patton Road featuring stone veneer and linear buildings with multiple guest rooms.

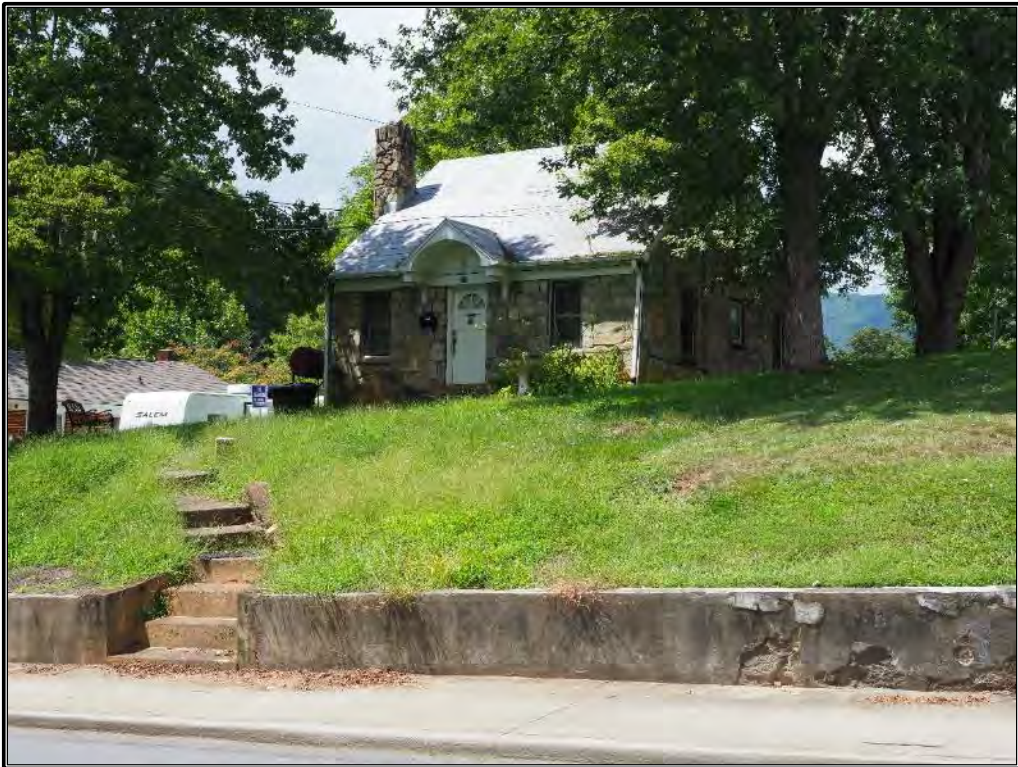
Figure 76. Residence at 641 East Street in Waynesville with vertical stone chimney detail.
