SUBJECT: Historic Structures Survey Report, , Improvements to US 23 Business (South Main Street) from SR 1164 (Hyatt Creek Road) to US 276 (Pigeon Street), Waynesville, PA 17-12-0027, U-4712, Haywood County, ER 18-4249

MANAGEMENT SUMMARY	i
I. INTRODUCTION.....	1
II. METHODOLOGY.....	1
III. DESCRIPTION, HISTORIC CONTEXT, AND EVALUATION	7
CLYDE’S RESTAURANT (HW0735)	7
COMMERCIAL BUILDING (HW0736).....	18
COMMERCIAL BUILDING AND FORMER GROCERY (HW0737).....	28
REPAIR SHOP (HW0738)	41
MAPLE GROVE MOTEL (HW0739)	50
HYATT HOUSE AND CARRIAGE HOUSE.....	68
(HW0015 / HW0740).....	68
SILER HOUSE (HW0741)	88
ETHEL ROSS BRADLEY HOUSE (HW0742)	97
PEARL HYATT AND MARGARET HYATT PILARSKI HOUSE (HW0743)	110
HOUSE, 1262–1270 S. MAIN STREET (HW0744).....	119
GEORGE HOUSE (HW0745)	133
HOUSE, 1157 S. MAIN STREET (HW0746).....	143
HOUSE, 1153 S. MAIN STREET (HW0747).....	155
THE GABLES APARTMENTS (HW0096).....	163
DR. ALBERT HEYWARD SMITH, JR. HOUSE (HW0748).....	173
THE ATKINS HOUSE (HW0109)	187
THE HILLTOP TOURIST LODGE (HW0056).....	202
FORMER HOUSE, 809 S. MAIN STREET (HW0749).....	212
HOUSE, 761 SOUTH MAIN STREET (HW0750)	222
THE CHARLES RAY HOUSE (HW0055) AND CARRIAGE HOUSE (HW0751)	233

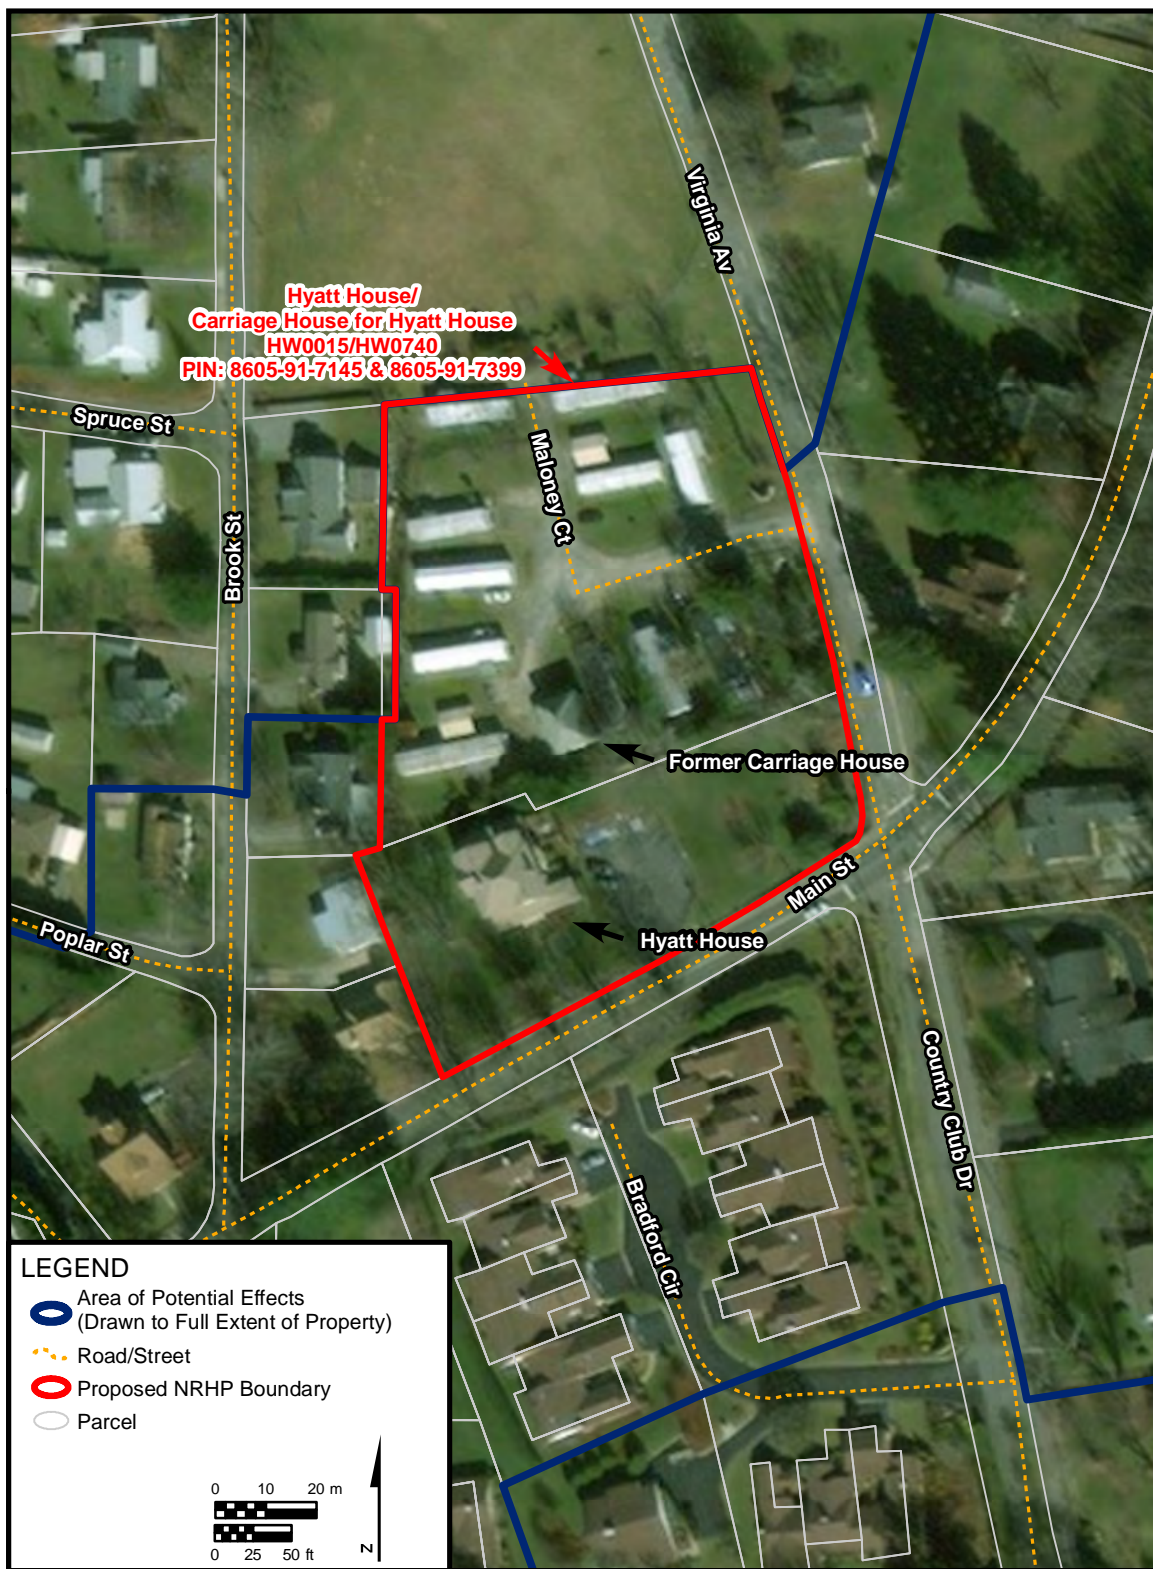
Figure 77. Map of Hyatt House and Carriage House (HW0015 / HW0740).

Hyatt House, Setting: The Hyatt House is situated on the northwest side of South Main Street (US 23 Business), approximately 180 ft west-southwest of its intersection with Virginia Avenue. The residence occupies a flat, grassy .9111-acre parcel dotted with mature trees (Figure 77). The surrounding parcels contain both modern and historic residential development. A paved driveway northeast of the residence provides access to the property. A low river rock wall extends along the southeast and northeast side of the property (Figure 78 and 79). A set of stone gateposts frame the entrance to the driveway (Figure 80). A set of stone steps framed by a pair of stone gateposts provides access from the public sidewalk to poured concrete walkway leading to the front porch. A wood fence extends along the rear property line. Farmers Branch creek extends northwest of the property.

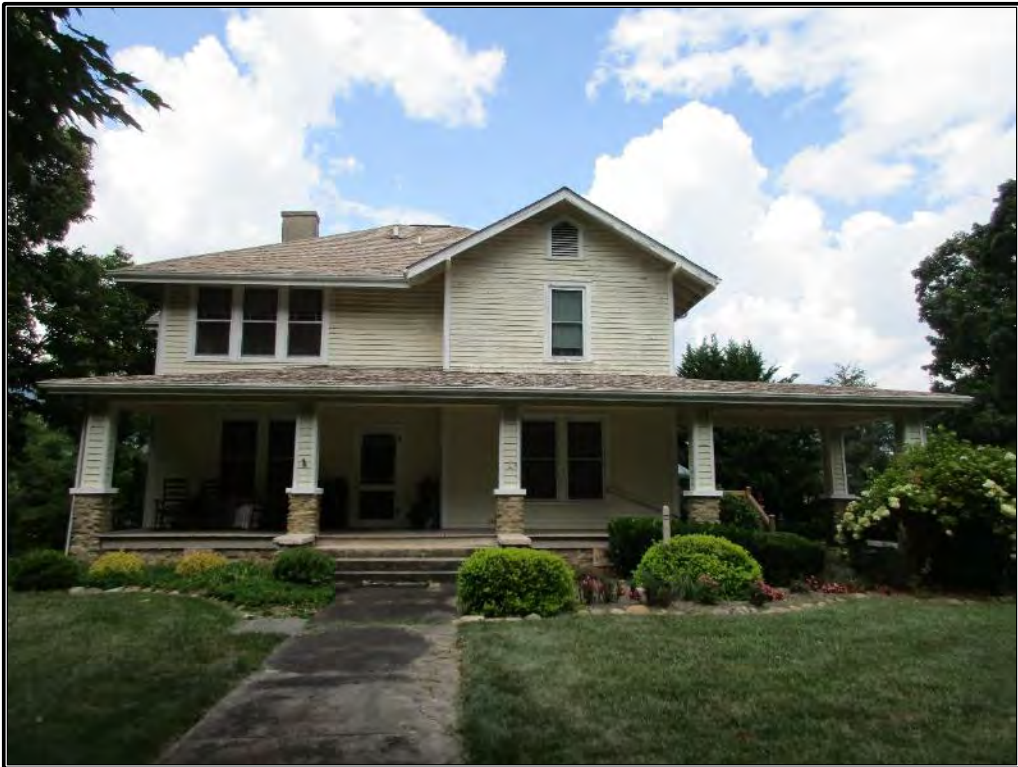
Figure 81. Façade of residence, looking north-northwest.

Hyatt House, exterior: The circa 1918 residence is a hybrid of vernacular Victorian and Craftsman styles. The building presents a two-story, three-bay (ww/d/ww), hip-roof form (Figure 81). Of frame construction, the dwelling is set on a raised basement foundation construct of mortared river rock. The exterior is clad in weatherboard siding and the roof is sheathed in asphalt shingles. The roof features wide overhanging eaves. The windows throughout contain six-over-one, double-hung Craftsman-style wood sashes (Figure 82). An exterior brick chimney extends from the northeast elevation. An interior brick chimney pierces the southwest roof slope.

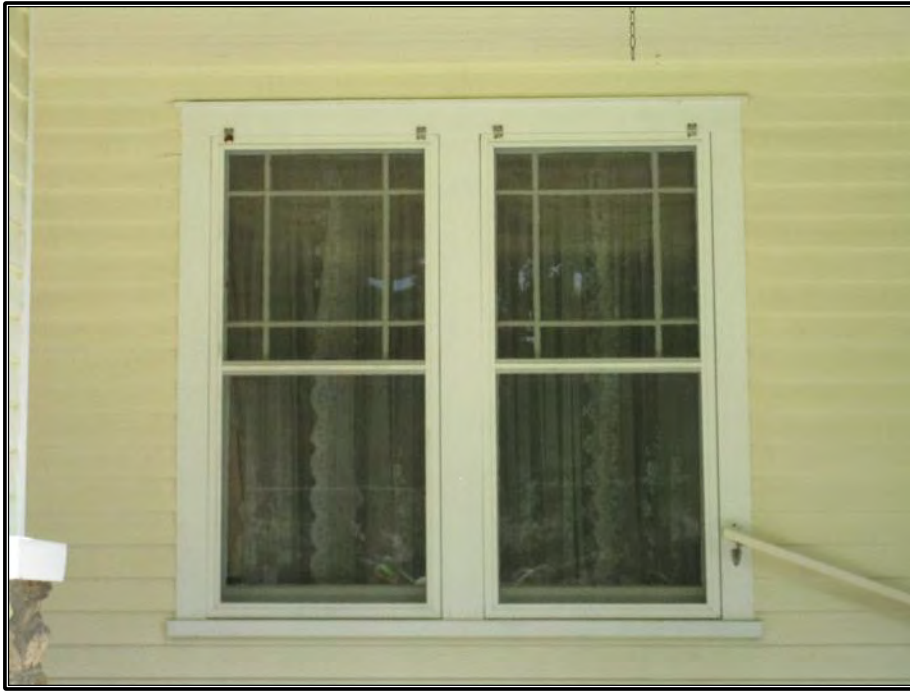
Figure 82. Detail of historic windows.

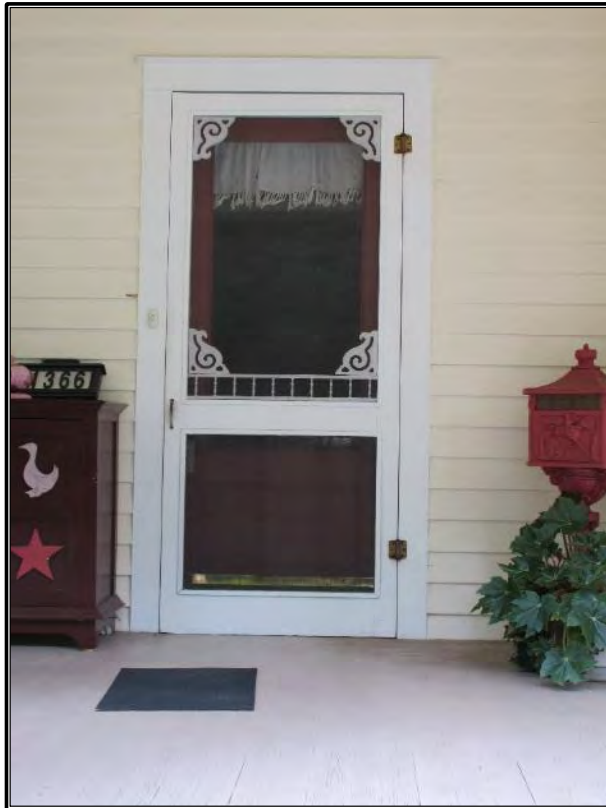
Figure 83. Detail of front entry.

The façade features a central single-leaf entry filled by a three-quarter-light wood door (Figure 83). The entry opens onto a wraparound porch with a hip-roof supported by porch posts clad in weatherboard siding and set on river rock piers. The porch features a wood deck and is accessed by a set of poured concrete steps. A porte cochère extends from the northeast (right) side of the porch. A paired window bay pierces the façade southwest (left) of the entry. A ribbon of three windows pierces the second story of the façade. A two-story, front-gable projection extends from the northeast (right) side of the façade. The first story façade elevation of the projection contains a paired window bay. A single window pierces the second story (Figure 84).

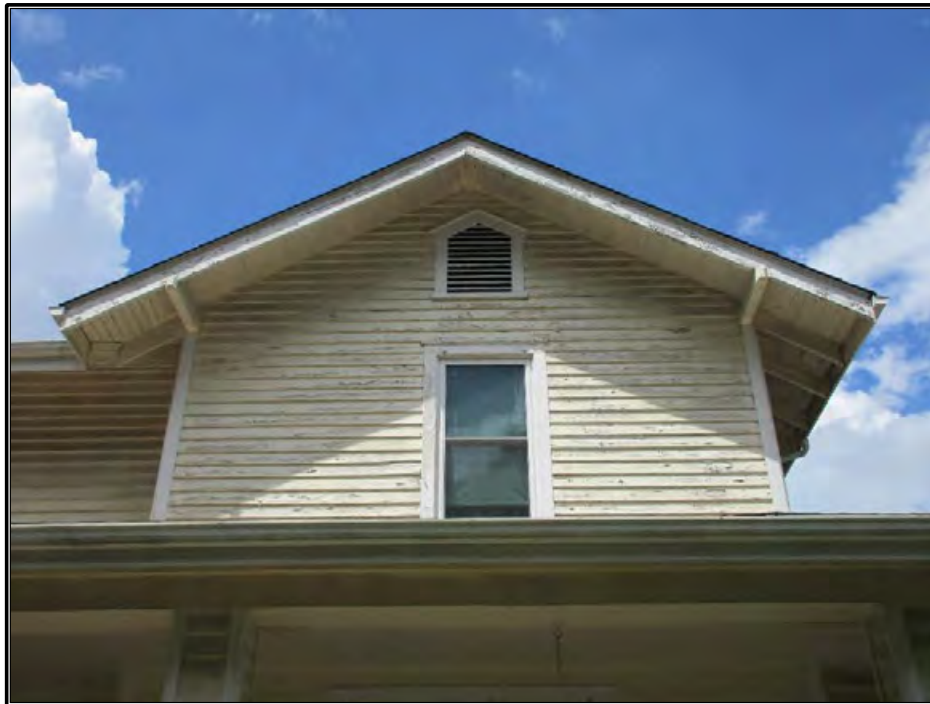
Figure 84. Detail of façade projection.

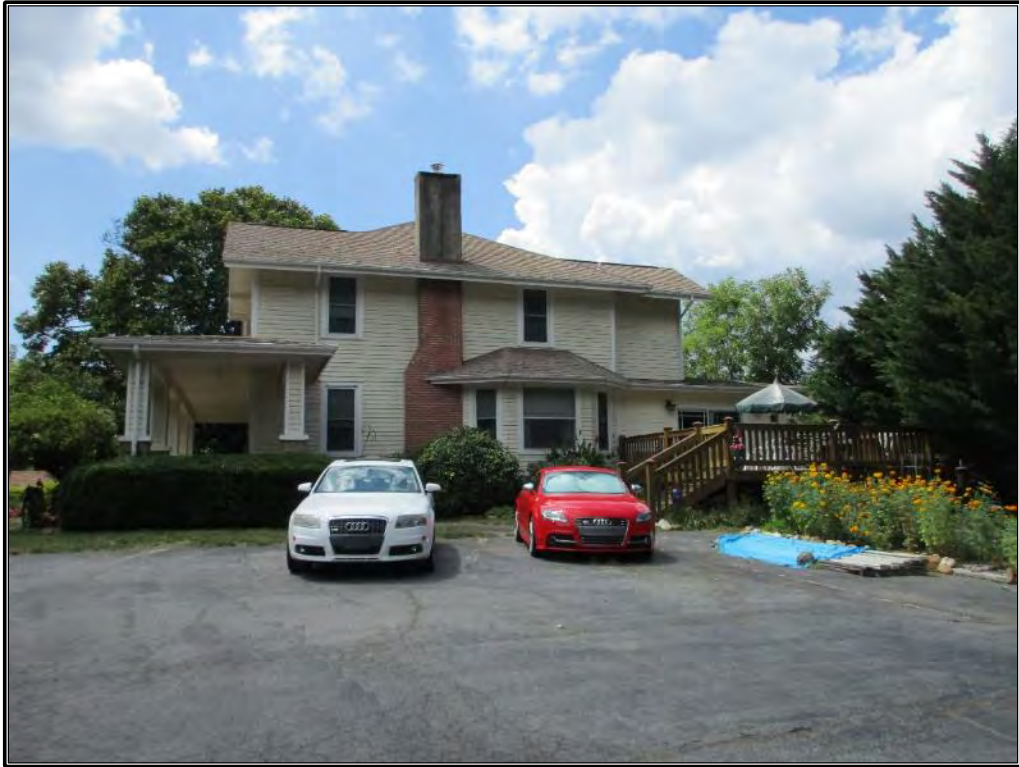
Figure 85. Northeast elevation of residence, looking west-southwest.

The northeast elevation features a single window and a bay window pierced by three single windows along the first story (Figure 85). The second story contains two single windows. The southwest elevation features a paired window bay along the first story (Figure 86). A ribbon of three windows pierces the second story of the elevation. A two-story, gable-oriented projection extends from the northeast (left) side of the southwest elevation. A paired window pierces the southwest elevation of the projection. A single window pierces the second story. A single-leaf entry filled by a wood paneled door and accessed by a set of poured concrete steps pierces the southwest elevation of the projection along the basement level. A single window filled by a one-over-one, double-hung wood sash and enclosed with plywood is located along the basement story southwest (right) of the basement entry.

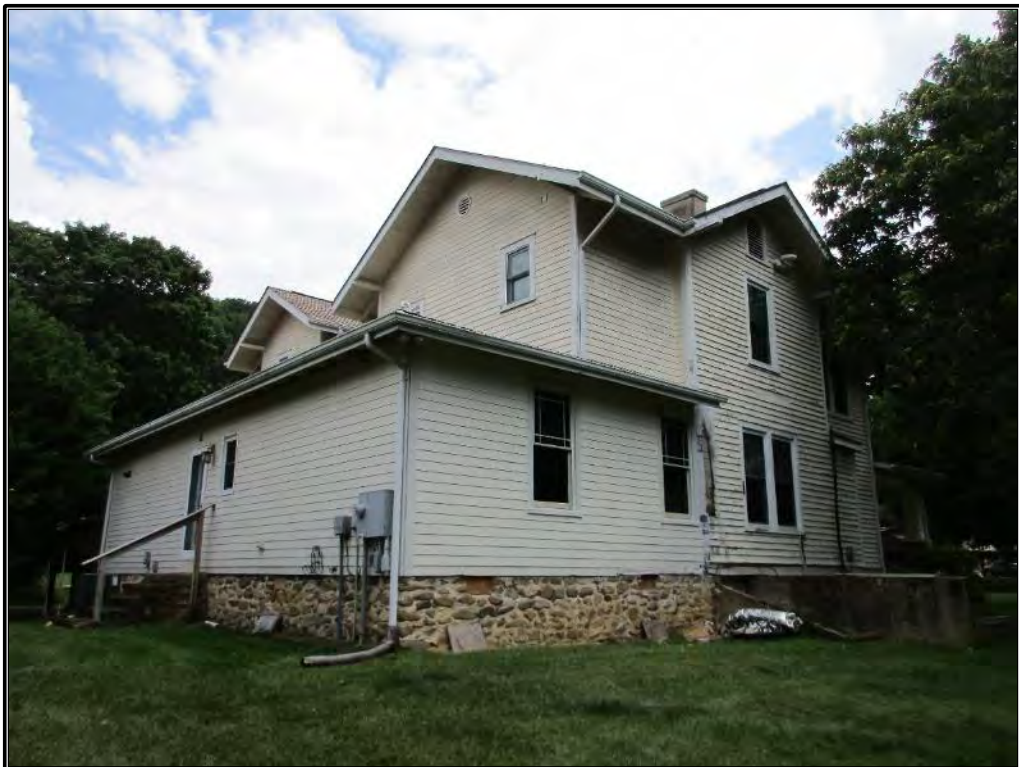
Figure 86. Southwest and rear elevation of residence, looking east-southeast.

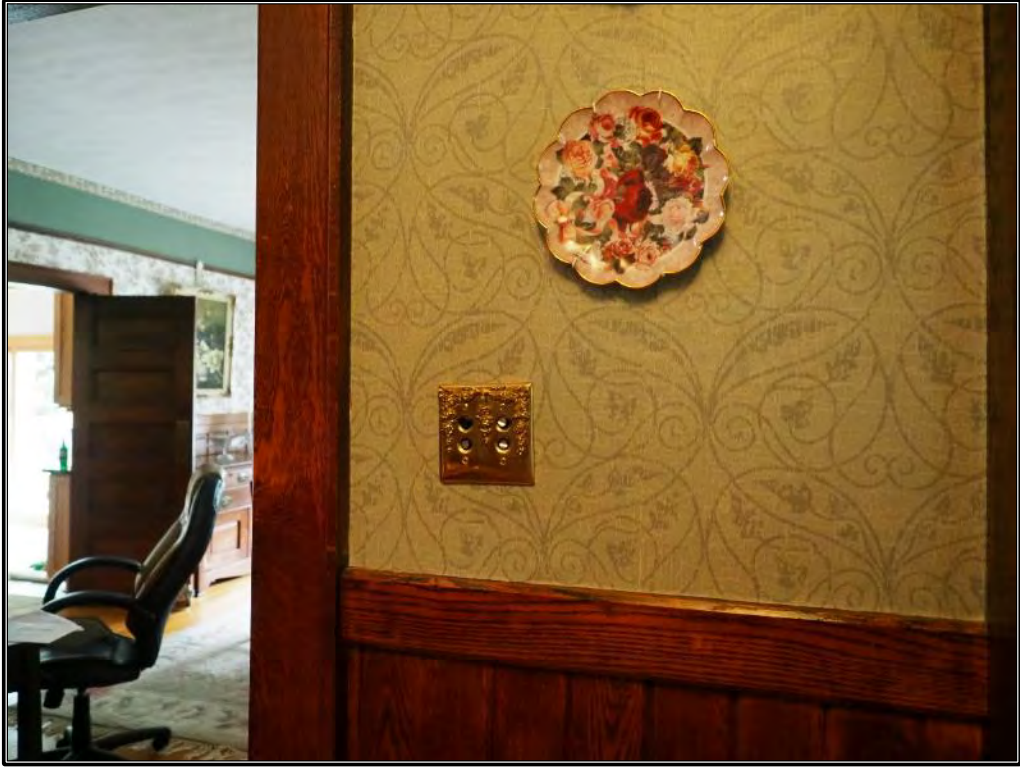
Figure 88. Detail of light switch plate.

Hyatt House, interior: The interior of the residence features extensive wood work throughout the first and second story (Figure 87). Rooms feature hardwood floors and plaster walls. Chair railing and paneled wainscoting line the walls along the first floor and many interior walls are covered with wallpaper. Wood picture railing is found throughout the first and second story. Windows and doors feature simple, unpainted wood surrounds and interior doors are generally wood paneled with original hardware. The push button light switches are set in pressed metal wall plates adorned with floral designs (Figure 88).

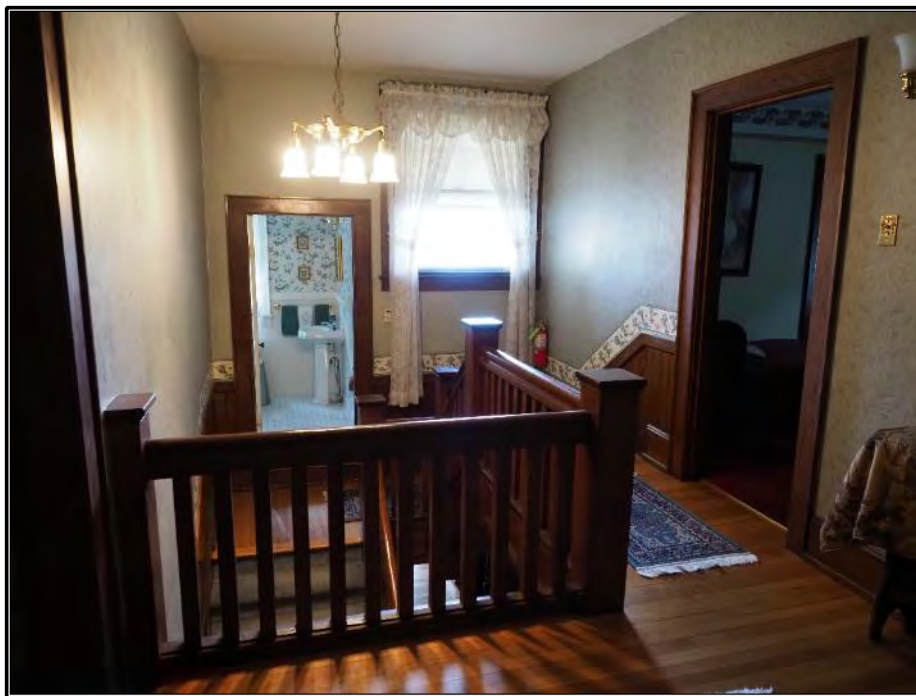
Figure 91. Overview of staircase from the second-story landing.

A carpet-lined, U-shaped staircase joins the first and second stories. The staircase is lined by a wood railing with simple balusters and square newel posts with simple caps (Figure 91). Wainscoting lines the walls along the staircase. A bathroom is located on a landing at the top of the first run of stairs (Figure 92). The bathroom features a tile floor and porcelain fixtures. The second story contains four bedrooms organized around a central landing located at the top of the stairs (Figure 93). Each room features plaster walls with a wallpaper header and simple wood baseboards (Figure 94 and 95).

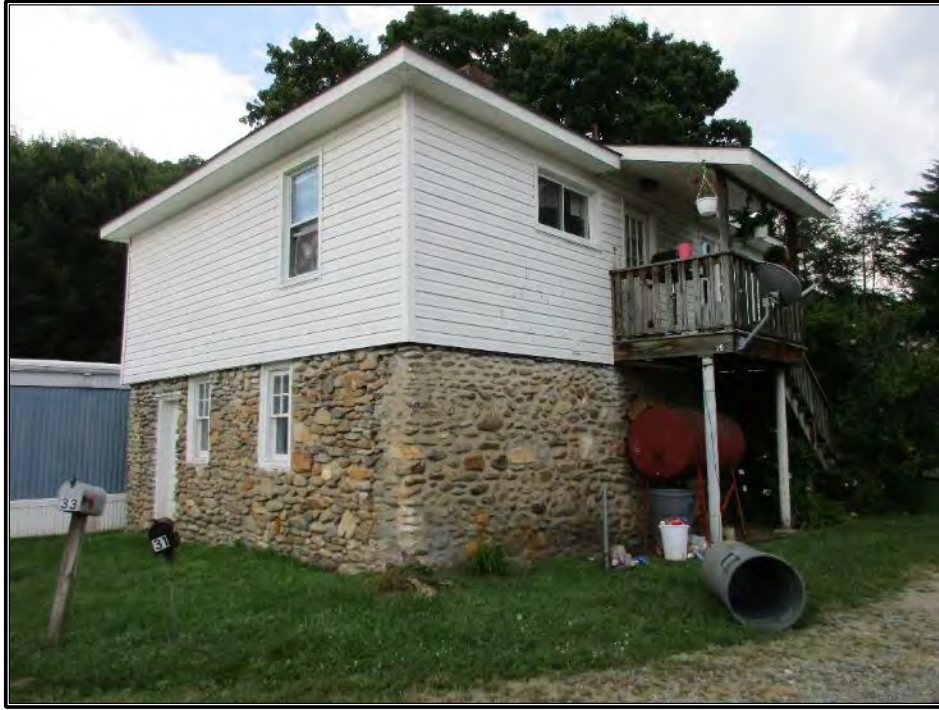
Figure 97. Façade and northwest elevation of converted carriage house, looking east-southeast.

Carriage house, exterior: The circa 1918 carriage house displays a two-story, three-bay (w/d/www), single-pile, hip-roof form (Figure 97). The carriage house rests on an infilled river rock pier foundation (Figure 98). The first story features an exposed river rock exterior and the second story is clad in wood drop siding. The roof is sheathed in asphalt shingles. The windows contain a mixture of four-over-one, double-hung wood sashes, one-over-one, double-hung vinyl replacement sashes, and single-light sliding vinyl replacement sashes (Figure 99). An interior brick chimney pierces the ridgeline.

The façade of the carriage house features a single-leaf entry filled by a replacement nine-light door along the first story (see Figure 97). The entry opens onto an elevated single-bay porch sheltered by an asphalt shingle roof supported by wood posts. The porch is lined by a wood railing and accessed by a set of wood stairs. The entry is situated between a single window and a ribbon of three single windows. The basement story of the façade contains no fenestration.

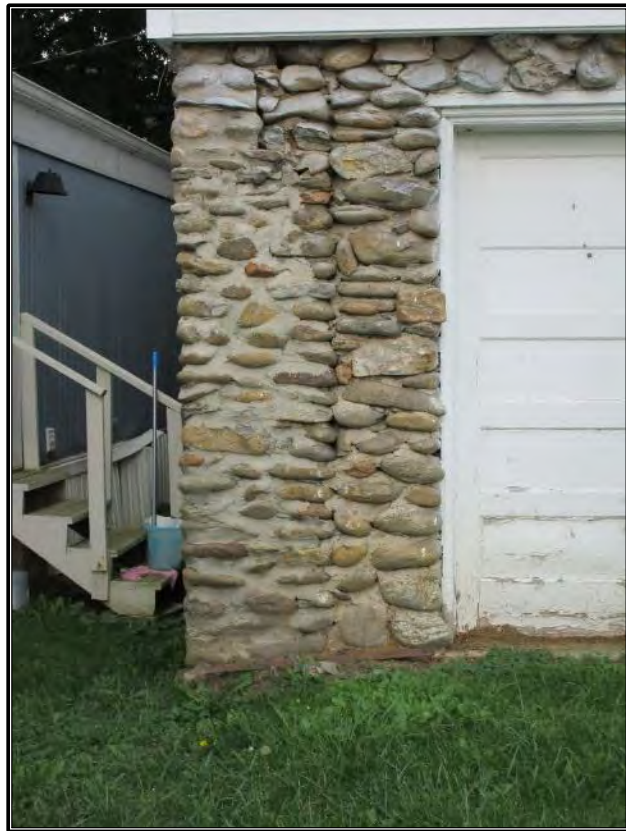
Figure 98. Detail of infilled pier foundation.

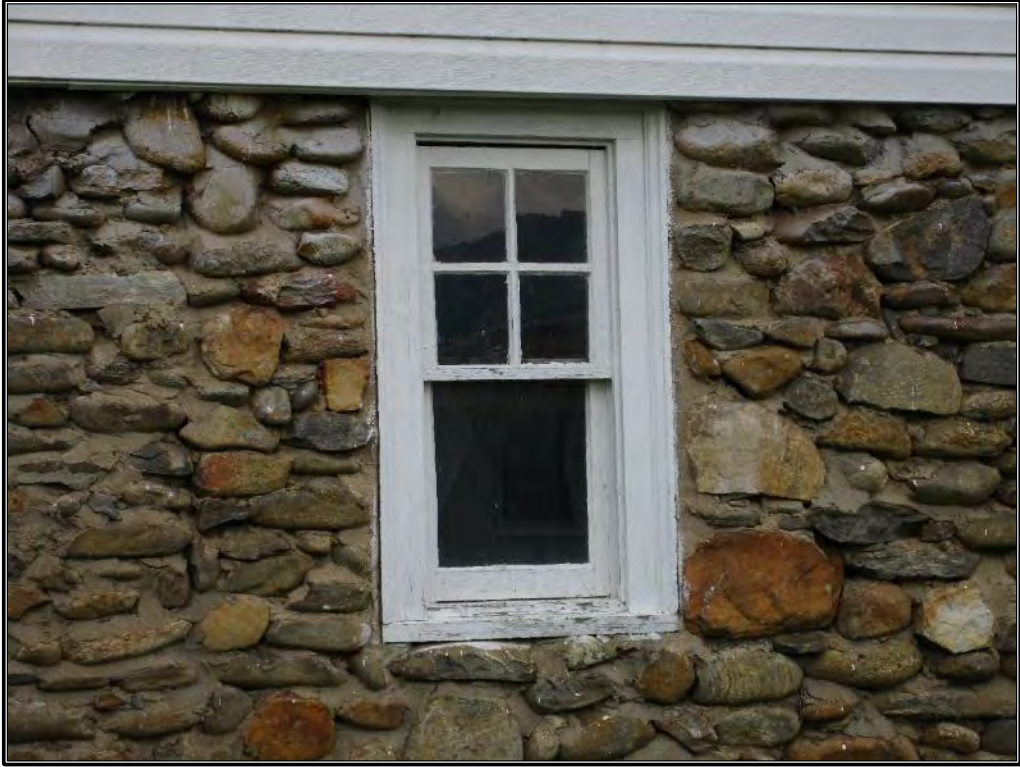
Figure 99. Detail of historic window.

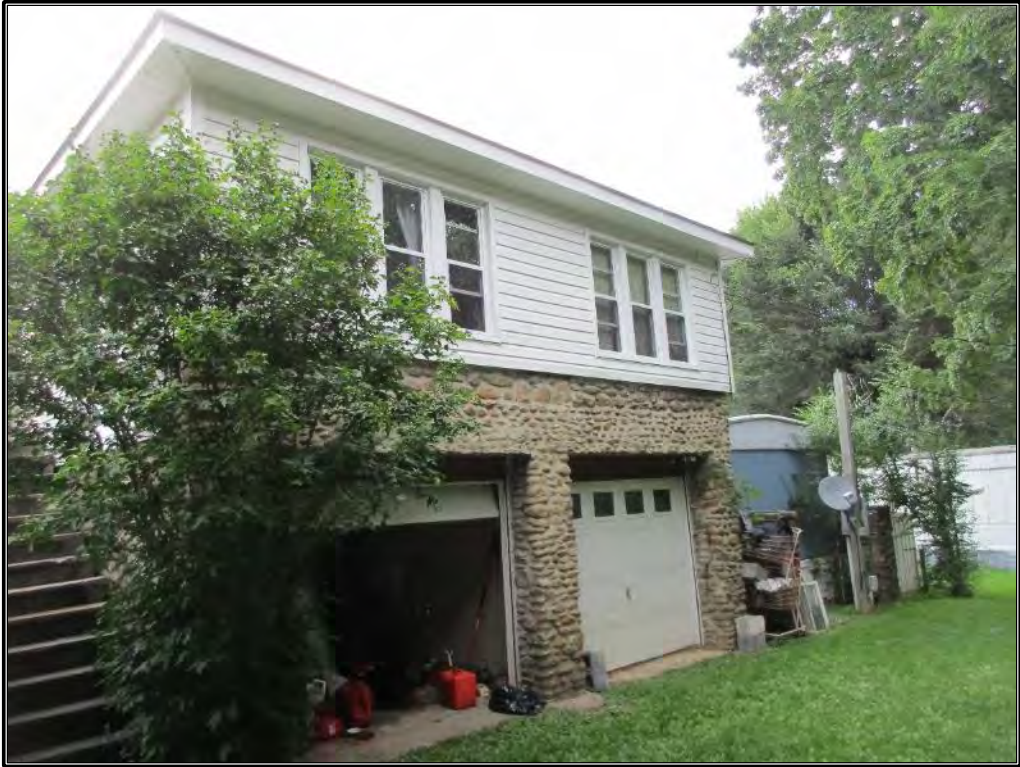
Figure 100. Southeast elevation of converted carriage house, looking east.

The northwest elevation features a single-leaf entry filled by a wood paneled door along the basement story. Two single window bays pierce the elevation southwest (right) of the entry. A single window bay pierces the elevation along the first story. The southeast elevation features two vehicular bays filled by four-light replacement sectional overhead doors along the basement story (Figure 100). Two ribbons of three windows pierce the first story. The rear elevation features three single windows along the first story (Figure 101). The basement story of the elevation is devoid of fenestration.

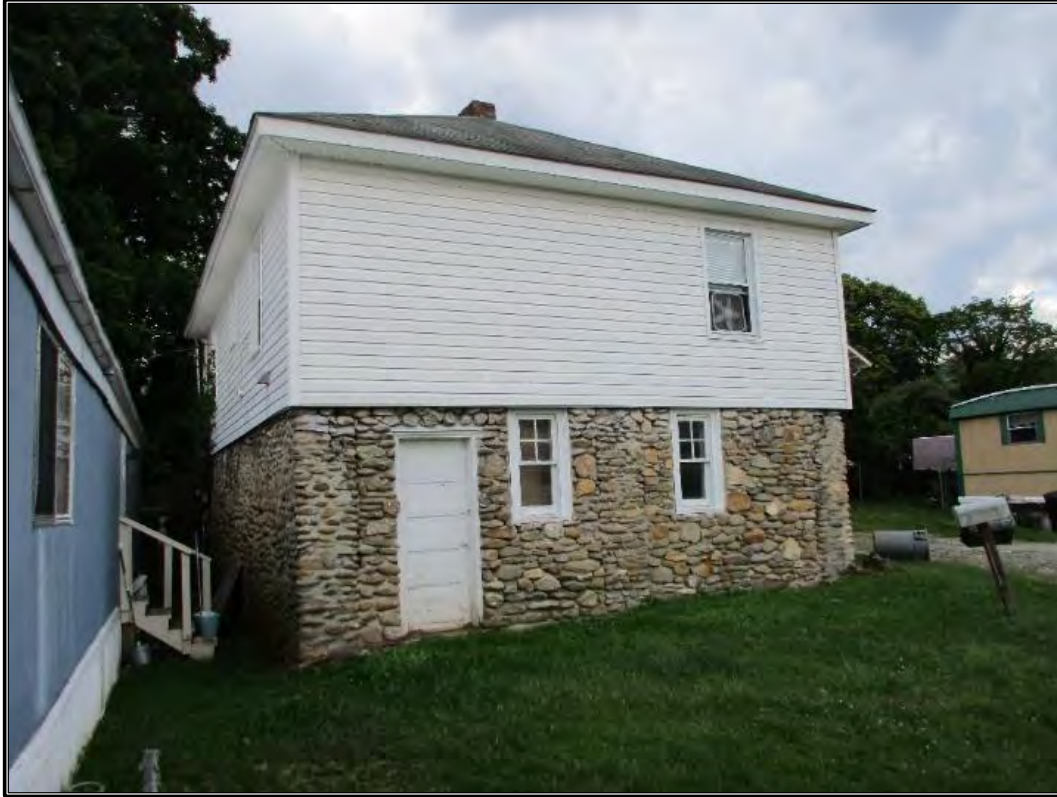
Figure 101. Northwest and rear elevation of converted carriage house, looking south.

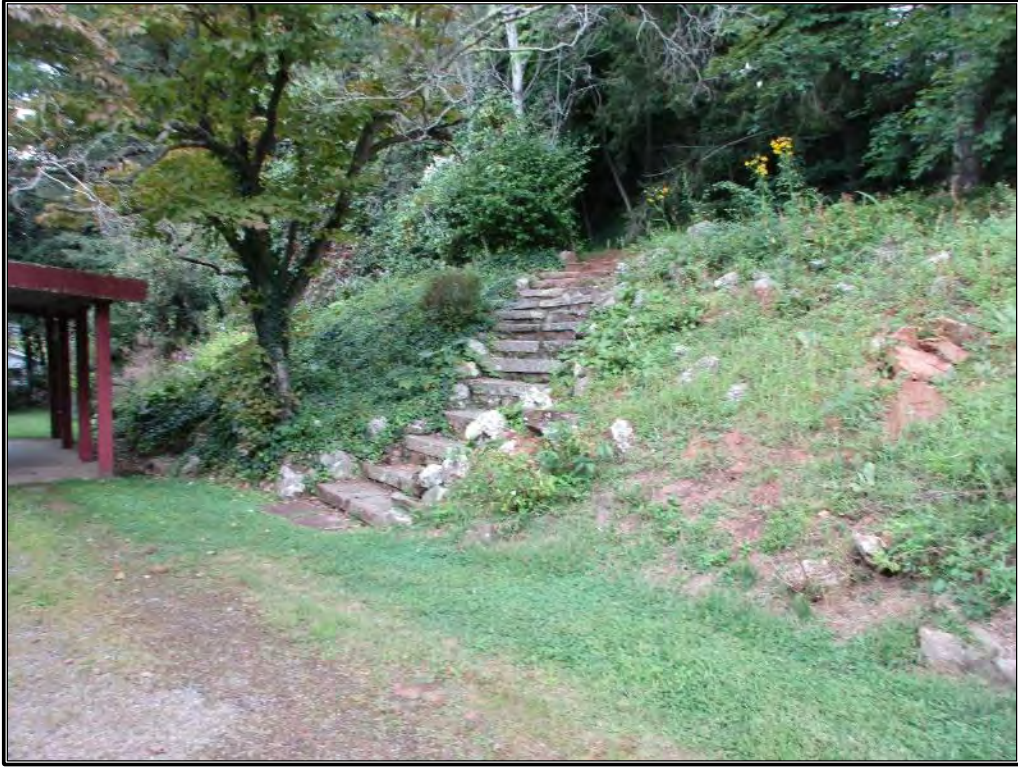
Figure 108. View of stone steps along rear yard, looking east-northeast.

Setting: The residence is situated on the east side of Country Club Drive, approximately 280 ft south-southeast of its intersection with South Main Street (US 23 Business) (Figure 105). The surrounding area contains both modern and historic residential development. Perched atop a slight rise, the residence occupies a grassy .64-acre parcel dotted with mature trees. A gravel driveway south of the residence leads to the associated detached carport and the attached carport. A stone retaining wall extends along the south (right) side of the driveway (Figure 106). Hedges line the west side of the property. A poured concrete wall encloses a portion of the north side yard (Figure 107). A set of stone steps are built into a hill in the rear yard (Figure 108).

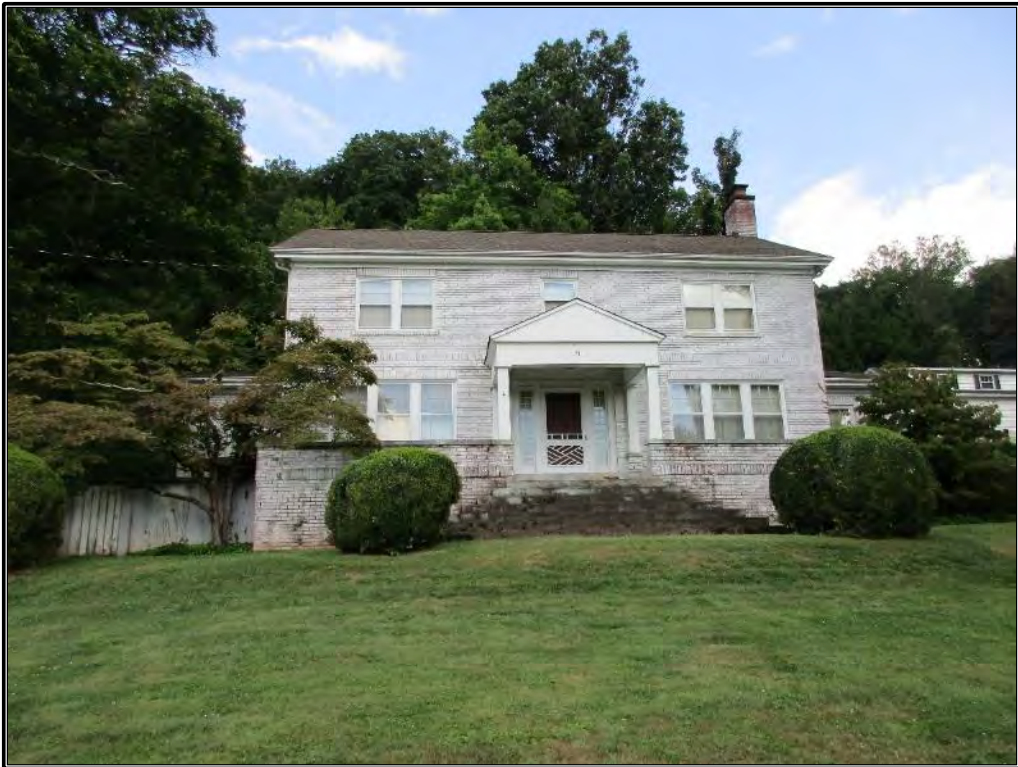
Figure 109. Façade of residence, looking north-northeast.

House, exterior: The circa 1922 Colonial Revival-style residence presents a two-story, three-bay (www/d/www), double-pile, side-gable form with hip-roof side wings (Figure 109). The exterior is clad in a brick veneer laid in stretcher bond with stacked brick accents forming a faux belt course. The roof is sheathed in asphalt shingles and features wide eaves with heavy gable returns. The foundation is not visible. The windows contain six-over-one, double-hung wood sashes set in stacked brick lintels and brick sills (Figure 110). An exterior brick chimney extends from the south elevation and rear elevations.

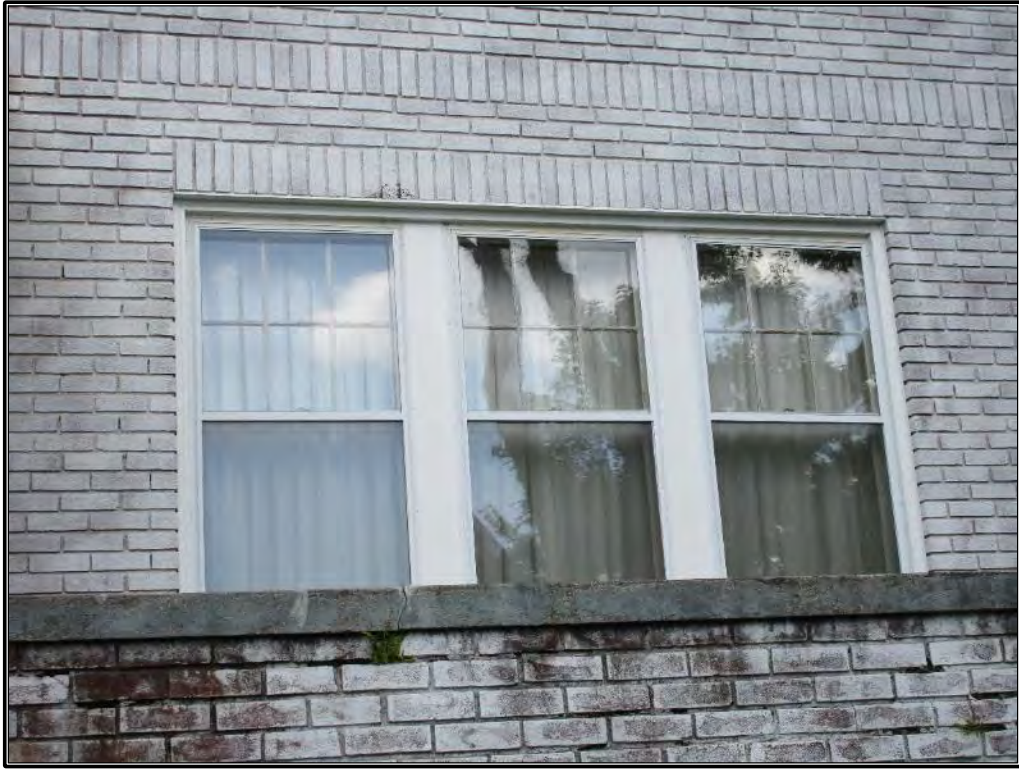
Figure 110. Detail of historic windows.

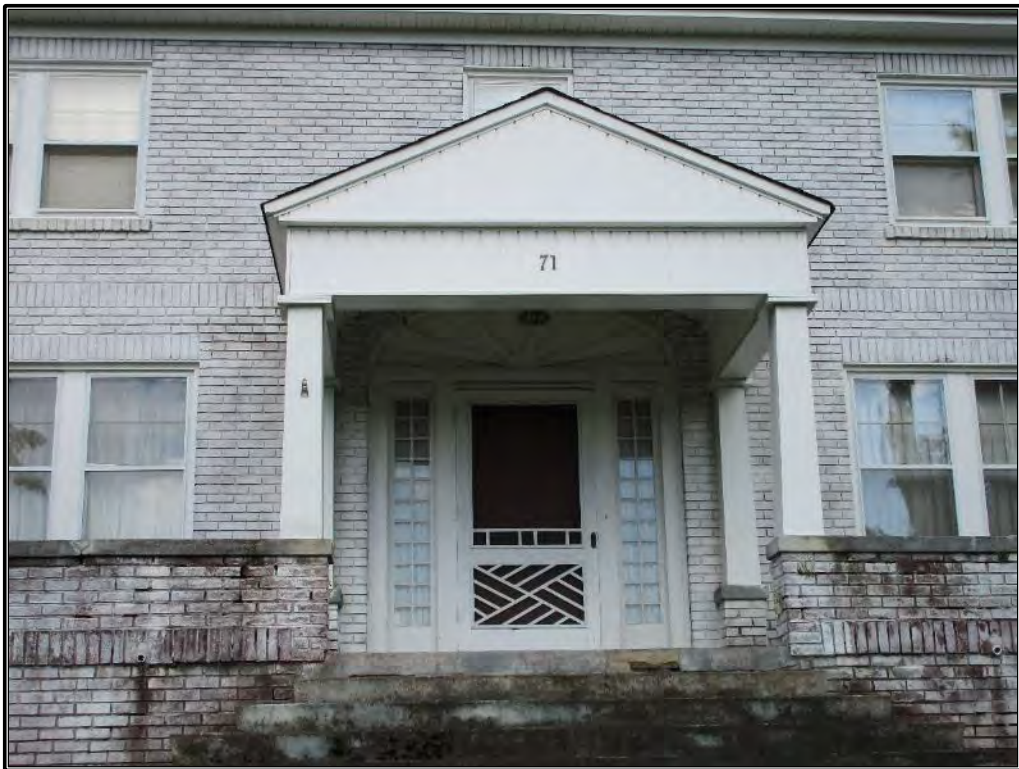
Figure 111. Detail of façade entry.

The façade of the residence features a central single-leaf entry filled by a wood paneled door (Figure 111). The entry is flanked by multi-light sidelights with a large, central fanlight over the entry. A single-bay entry porch with a front-gable-roof supported by wood posts shelters the entry. The porch posts are set on brick piers and a low brick wall surrounds the full-width poured concrete deck. The porch is accessed by a set of wide poured concrete steps. The entry is flanked by ribbons of three single windows. A single window situated between paired windows pierces the second story of the façade.

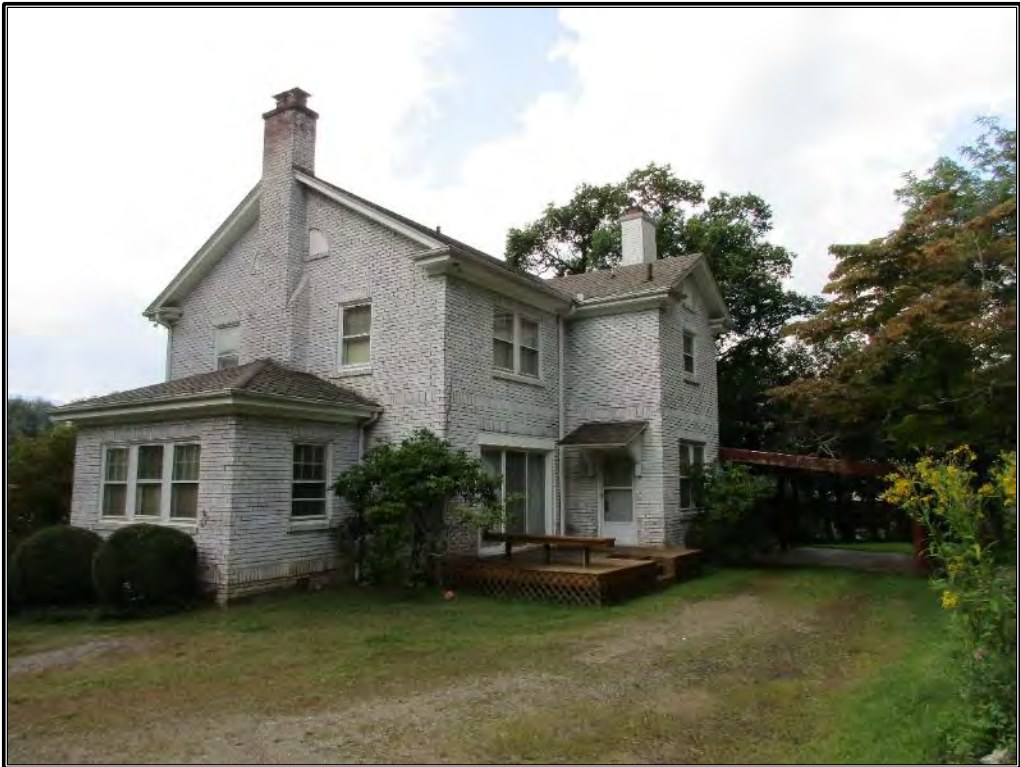
Figure 112. North and rear elevation of residence, looking south-southwest.

A one-story, hip-roof wing extends from the north and south elevations (Figures 112 and 113). A pair of quarter-round windows are centered underneath the north and south gables. The rear elevation features a double-leaf entry filled by a replacement three-light sliding patio door along the first story, which opens onto a wood deck. A two-story, gable-oriented projection extends from the center of the rear elevation. A single-leaf entry filled by a three-light wood door pierces the south elevation of the projection and opens onto the rear deck. A single window pierces the rear chimney. A shed-roof frame carport sheltered by a metal paneled roof is attached to the north (right) side of the rear elevation.

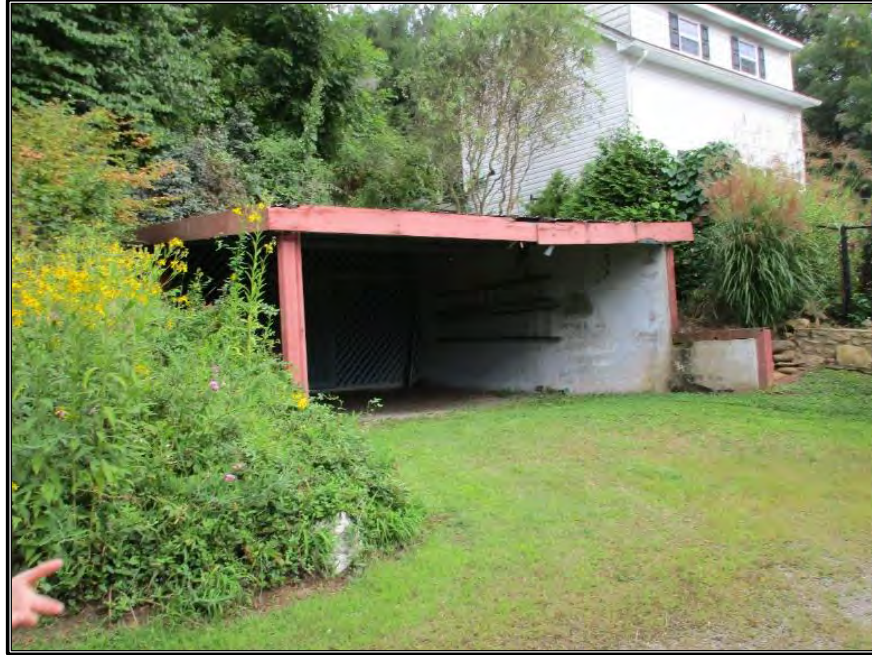
Figure 113. South and rear elevation of residence, looking west-northwest.

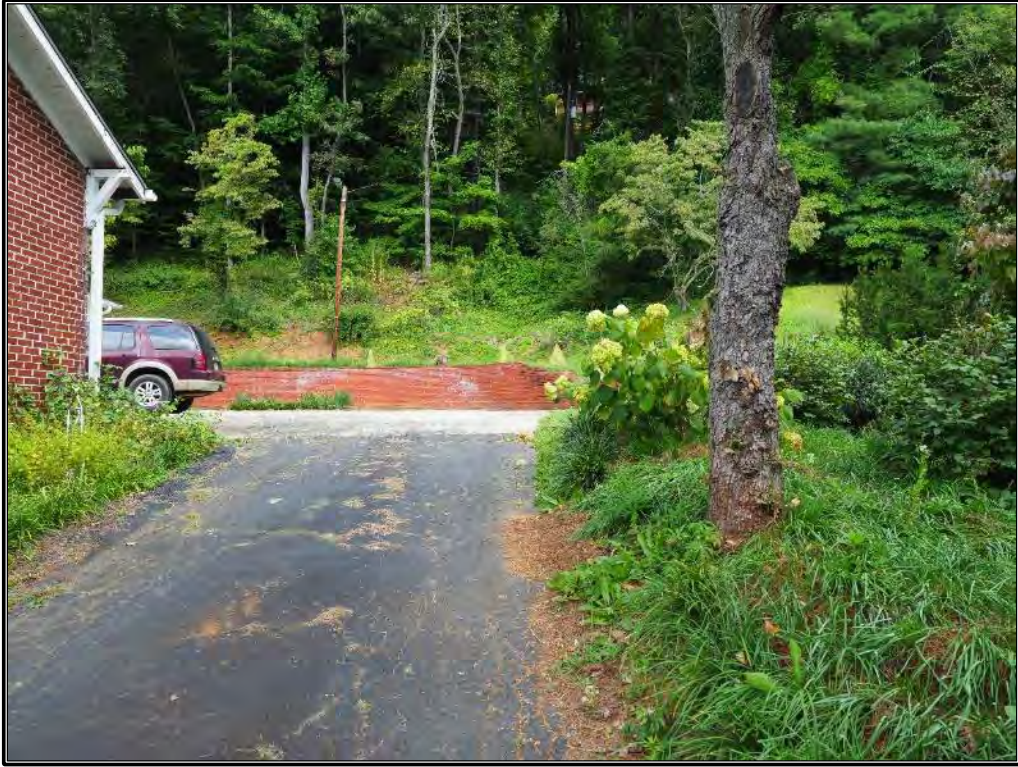
Figure 117. View of driveway and brick retaining wall, looking east.

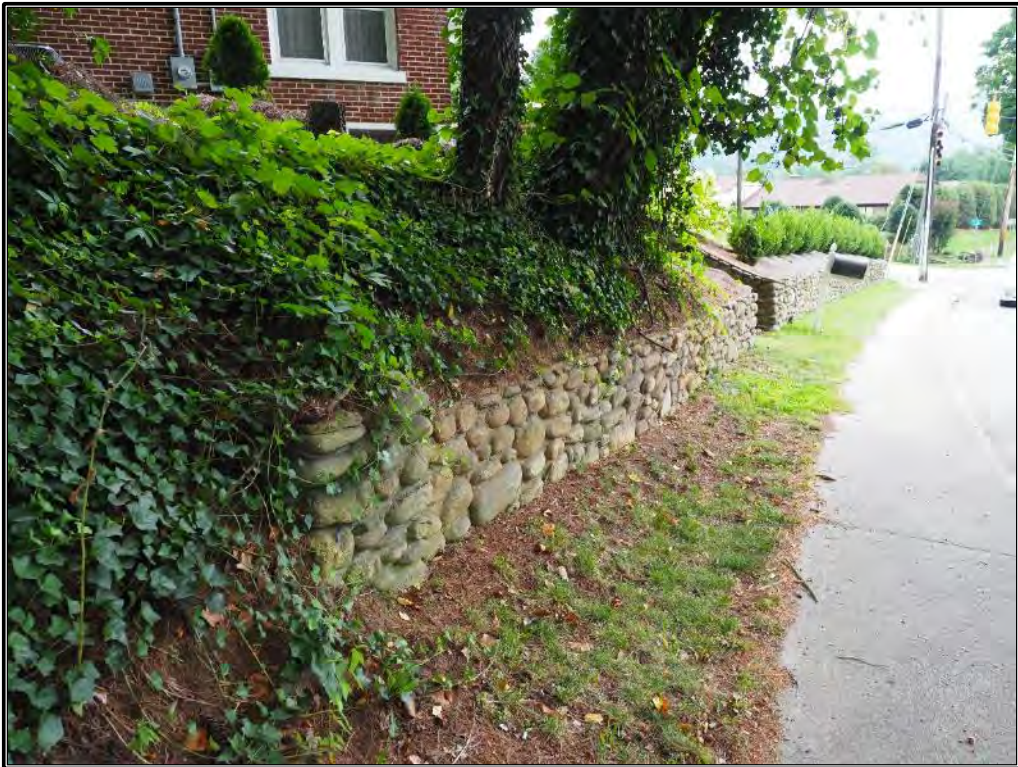
Figure 118. View of river rock retaining wall and steps, looking south-southwest.

Location – The Ethel Ross Bradley House (HW0742) has remained at the same location since its construction and Country Club Road has not encroached on the property since its original development. The surrounding river rock walls and stairs, while exhibiting signs of deterioration, have not been impacted by the road or later development.

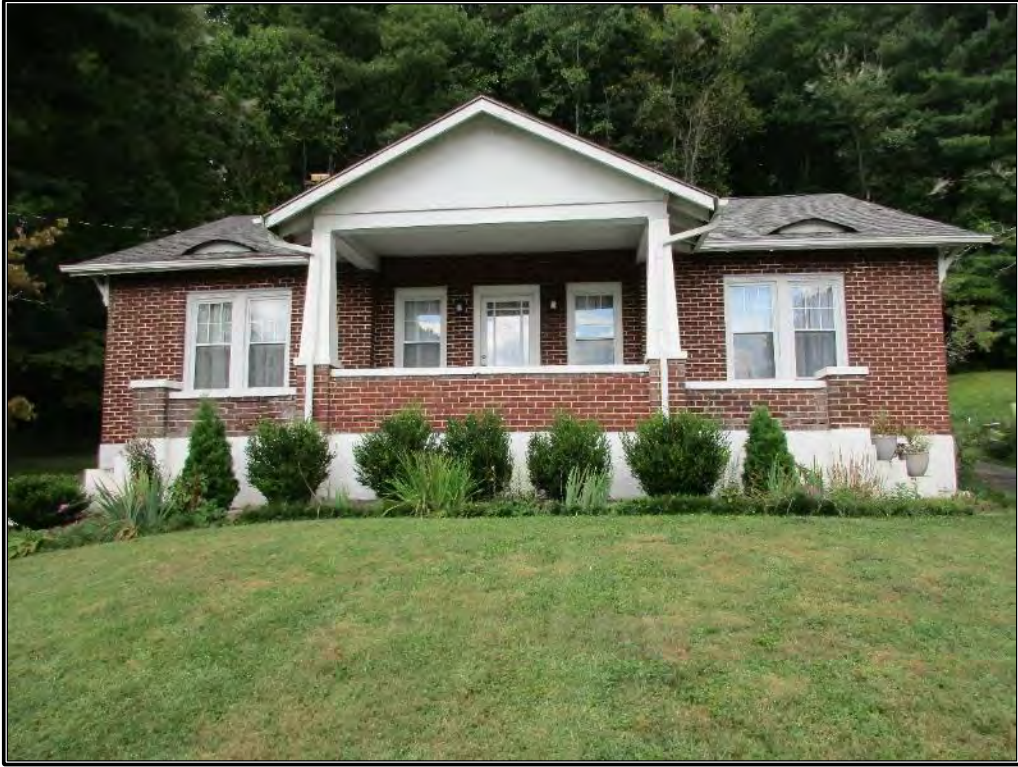
Figure 119. Façade of residence, looking east-northeast.

House, exterior: The circa 1928–1935 Craftsman-style residence presents a one-story, five-bay (ww/w/d/w/ww), double-pile, side-gable form (Figure 119). The dwelling rests on a raised basement foundation of poured or parged concrete. The exterior is clad in a brick veneer laid in stretcher bond. The roof is sheathed in asphalt shingles. The windows contain one-over-one, double-hung wood sashes with poured concrete sills and storm windows (Figure 120). Basement windows contain two-light wood sashes. An interior brick chimney pierces the ridgeline and the rear roof slope. Decorative brackets are located underneath the wide eaves (Figure 121).

The façade features two brick-clad pilasters which divide the elevation into three visual bays (see Figure 119). The central bay contains a single-leaf entry filled by a multi-light Craftsman-style wood door. The entry opens onto a partial-width, single-bay porch with a front-gable roof supported by battered wood posts over brick piers. The porch deck extends almost the width of the façade and is accessed by poured concrete steps along the north (left) and south (right) sides. A low brick wall serves as railings along the porch and porch stairs. The front entry is flanked by single windows. A paired window pierces the north (left) and south (right) sides of the façade. Two eyebrow dormers project from the façade roof slope (Figure 122).

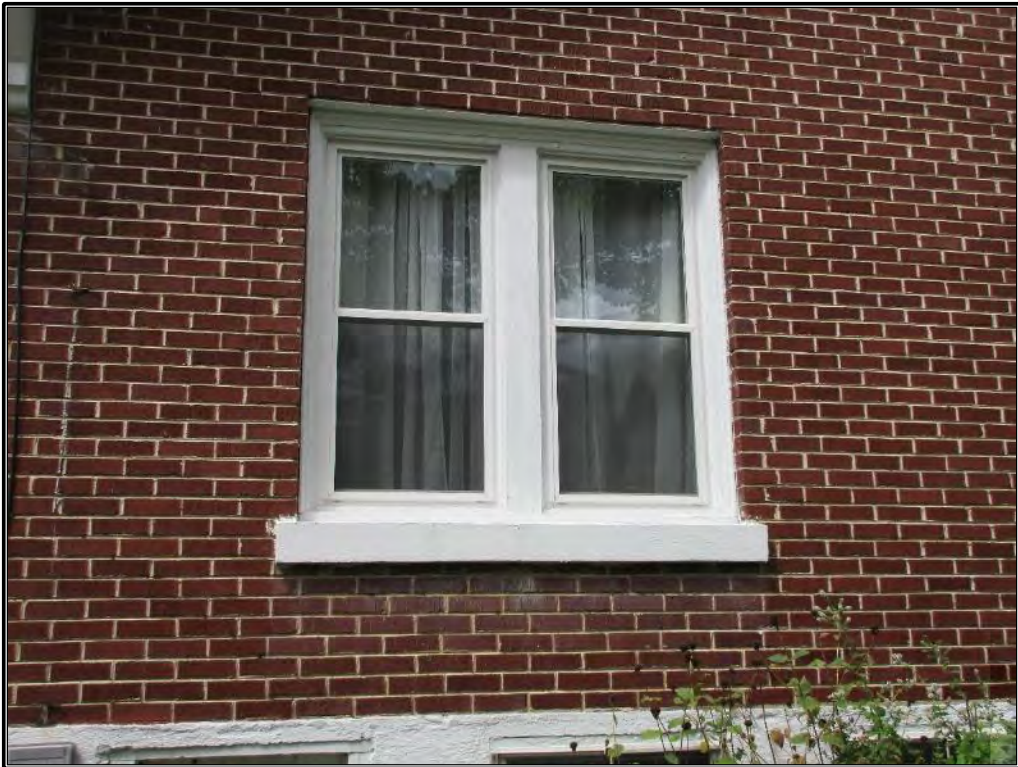
Figure 120. Detail of windows.

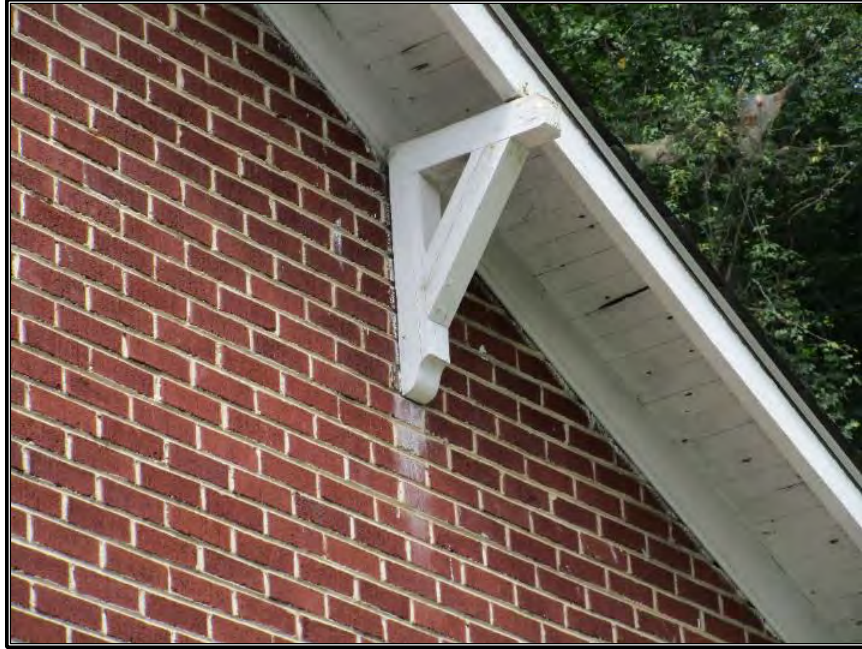
Figure 121. Detail of brackets and rafters.
