SUBJECT: Historic Structures Survey Report, , Improvements to US 23 Business (South Main Street) from SR 1164 (Hyatt Creek Road) to US 276 (Pigeon Street), Waynesville, PA 17-12-0027, U-4712, Haywood County, ER 18-4249

MANAGEMENT SUMMARY	i
I. INTRODUCTION.....	1
II. METHODOLOGY.....	1
III. DESCRIPTION, HISTORIC CONTEXT, AND EVALUATION	7
CLYDE’S RESTAURANT (HW0735)	7
COMMERCIAL BUILDING (HW0736).....	18
COMMERCIAL BUILDING AND FORMER GROCERY (HW0737).....	28
REPAIR SHOP (HW0738)	41
MAPLE GROVE MOTEL (HW0739)	50
HYATT HOUSE AND CARRIAGE HOUSE.....	68
(HW0015 / HW0740).....	68
SILER HOUSE (HW0741)	88
ETHEL ROSS BRADLEY HOUSE (HW0742)	97
PEARL HYATT AND MARGARET HYATT PILARSKI HOUSE (HW0743)	110
HOUSE, 1262–1270 S. MAIN STREET (HW0744).....	119
GEORGE HOUSE (HW0745)	133
HOUSE, 1157 S. MAIN STREET (HW0746).....	143
HOUSE, 1153 S. MAIN STREET (HW0747).....	155
THE GABLES APARTMENTS (HW0096).....	163
DR. ALBERT HEYWARD SMITH, JR. HOUSE (HW0748).....	173
THE ATKINS HOUSE (HW0109)	187
THE HILLTOP TOURIST LODGE (HW0056).....	202
FORMER HOUSE, 809 S. MAIN STREET (HW0749).....	212
HOUSE, 761 SOUTH MAIN STREET (HW0750)	222
THE CHARLES RAY HOUSE (HW0055) AND CARRIAGE HOUSE (HW0751)	233

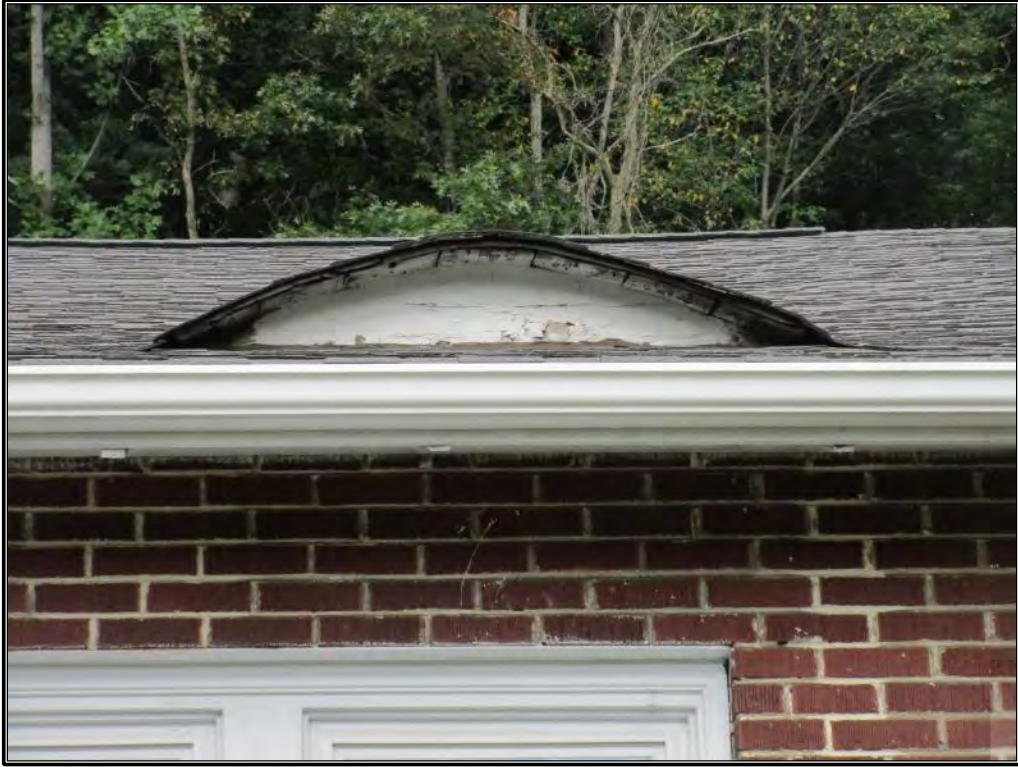
Figure 122. Detail of eyebrow dormers.

The façade features two brick-clad pilasters which divide the elevation into three visual bays (see Figure 119). The central bay contains a single-leaf entry filled by a multi-light Craftsman-style wood door. The entry opens onto a partial-width, single-bay porch with a front-gable roof supported by battered wood posts over brick piers. The porch deck extends almost the width of the façade and is accessed by poured concrete steps along the north (left) and south (right) sides. A low brick wall serves as railings along the porch and porch stairs. The front entry is flanked by single windows. A paired window pierces the north (left) and south (right) sides of the façade. Two eyebrow dormers project from the façade roof slope (Figure 122).

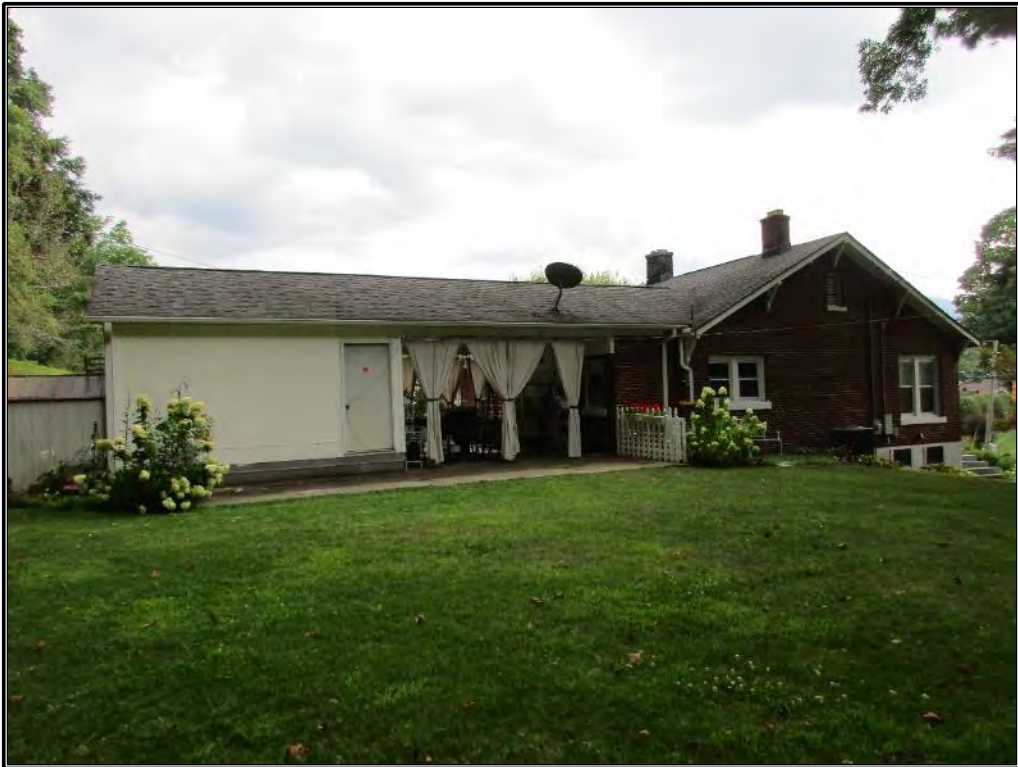
Figure 123. North and rear elevation of residence, looking south-southwest.

The basement story is exposed along the north and south elevations (Figures 123 and 124). A metal coal chute inscribed “Angert” and “1928” is located along the basement level of the south elevation (Figure 125). A gable-oriented carport extends from the north (right) side of the rear elevation (see Figures 123 and 126). The carport, constructed between 1975 and 1995, envelops a rear projection and enclosed porch along the north (right) side of the elevation. The enclosed porch is clad in aluminum siding. A gable-oriented addition, most likely constructed between 1998 and 2005, is attached to the rear elevation of the carport. A single-leaf entry filled by a metal door pierces the east elevation of the addition.

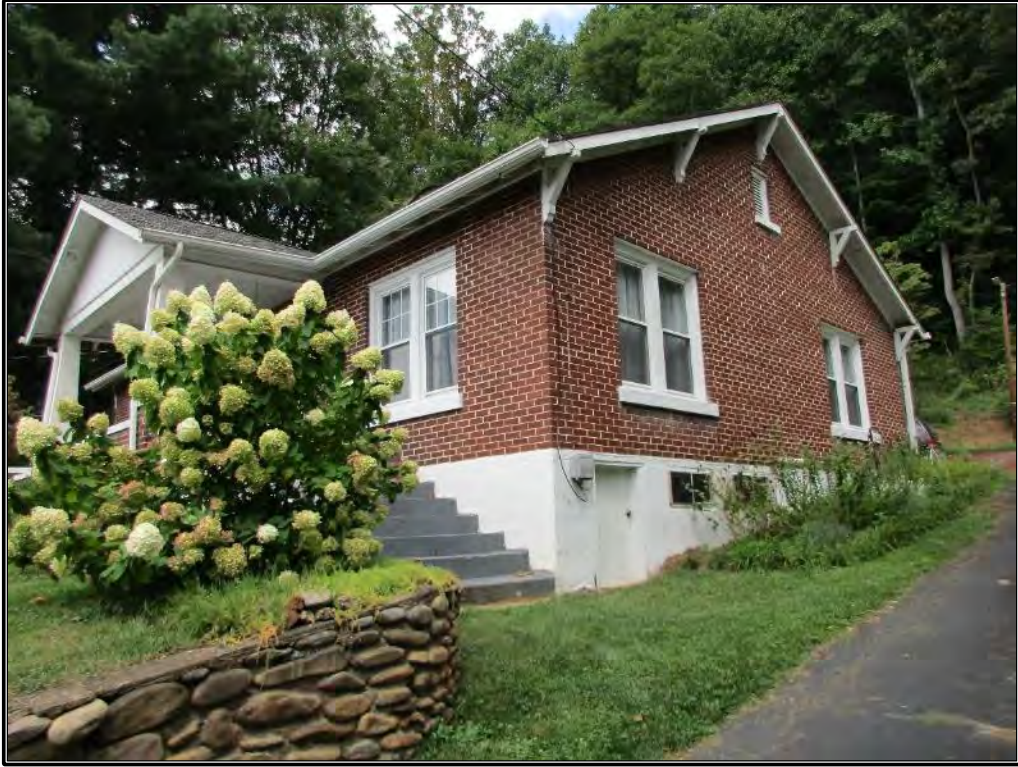
Figure 124. Façade and south elevation of residence, looking north-northeast.

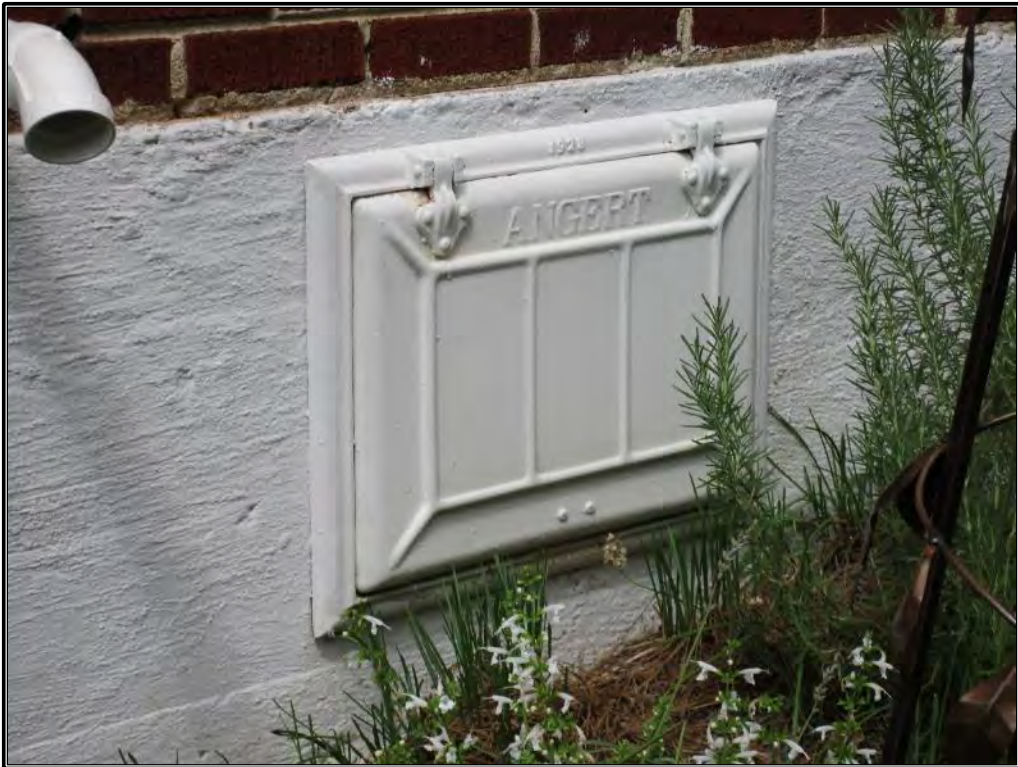
Figure 125. Detail of coal chute.

Materials – The Ethel Ross Bradley House (HW0742) retains its original materials, including brick veneer and wood-sash windows. Only the rear addition features the substantial addition of modern materials, but is physically separated from the house by the carport/outdoor living area. Details, including the 1928 coal chute, remain intact.

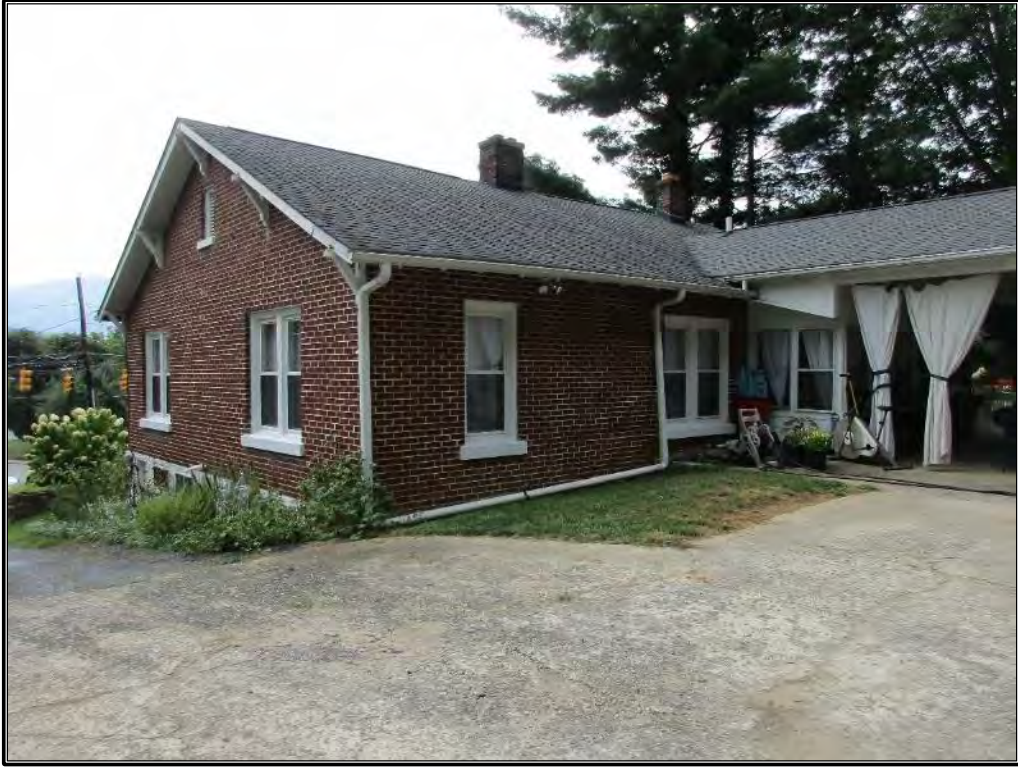
Figure 126. South and rear elevation of residence, looking west-northwest.

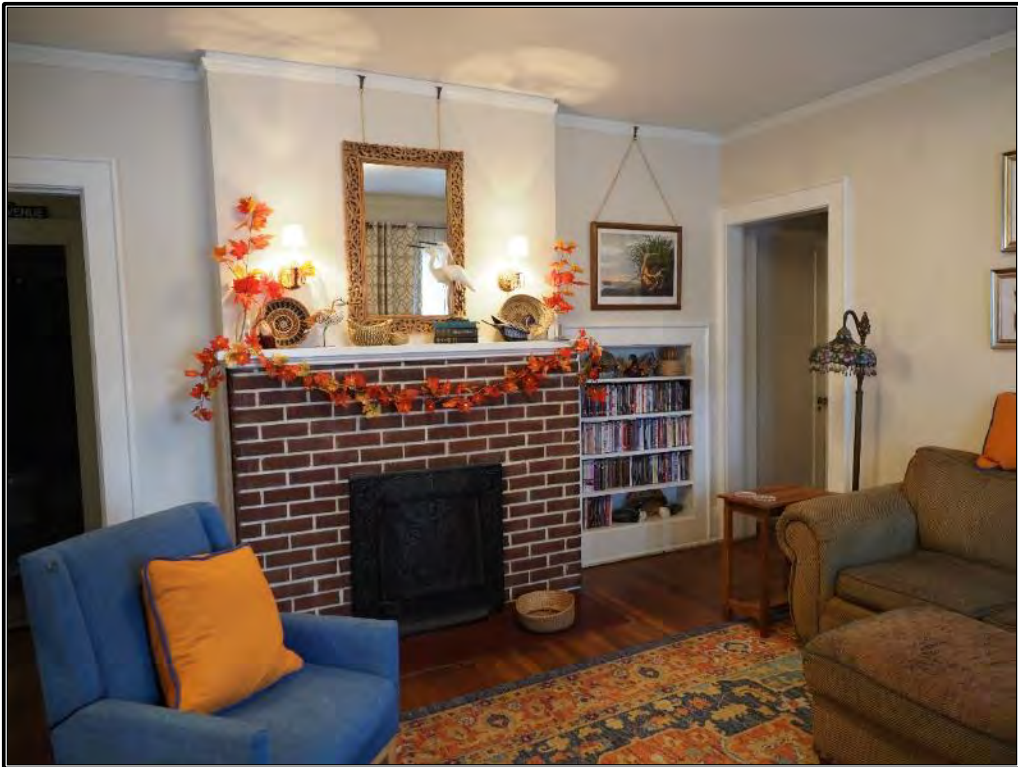
Figure 127. View of living room, looking towards the rear of the house.

House, interior: The interior of the residence features plaster walls with wood picture rail and baseboards (Figures 127 and 128). Doors and windows are cased with simple beaded molding. Interior entries contain simple wood doors with original hardware. The coal burning living room fireplace contains a metal insert with scrollwork detailing, a tiled hearth, a brick surround, and a simple wood mantel. Built-in shelves are set along the east (rear) living room wall, south (right) of the fireplace. A chandelier with a plaster medallion hangs from the living room ceiling. The kitchen occupies the northwest corner of the house and is accessible from the rear entry. A bathroom with a tile floor, tiled walls, and modern fixtures is located south (right) of the kitchen (Figure 129). A bedroom, which was not accessible during the survey, occupies the southeast corner of the house.

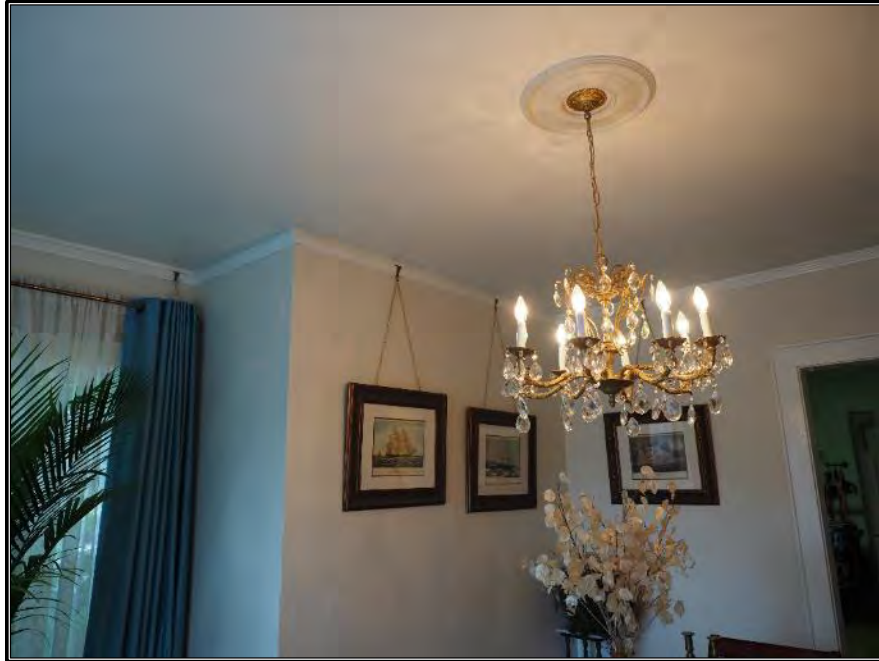
Figure 128. Detail of picture rail and chandelier in living room, looking towards the front entry.

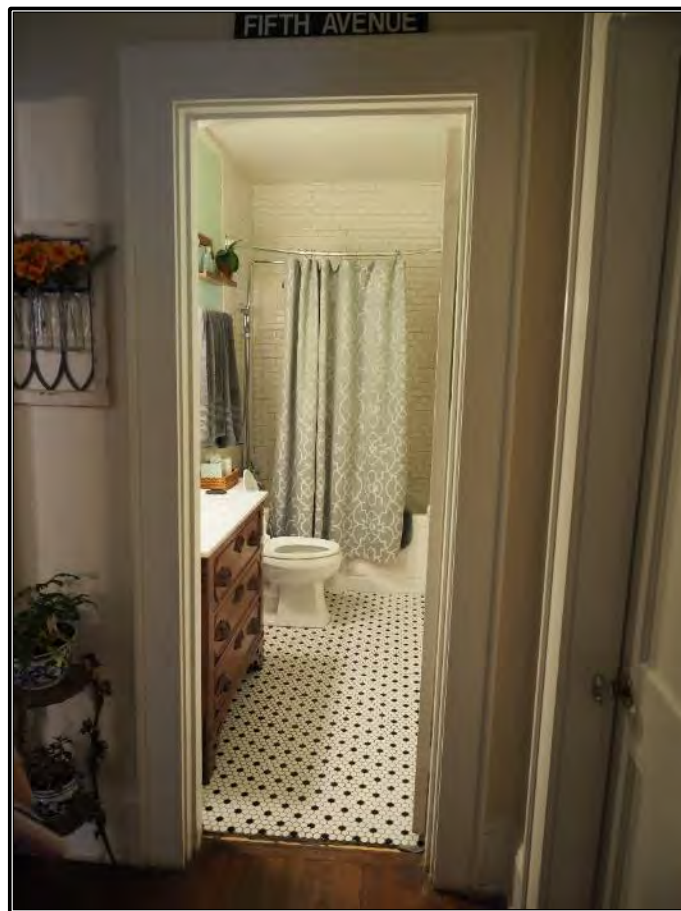
Figure 129. Interior view of bathroom.

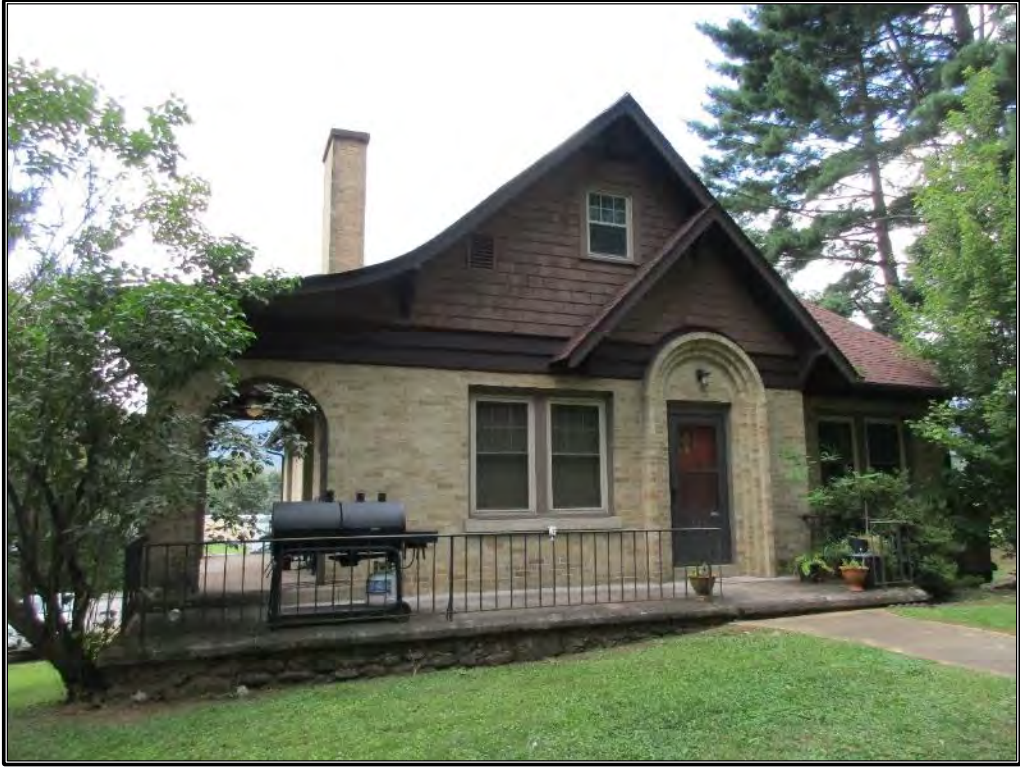
Figure 133. Façade of residence, looking west-northwest.

House, exterior: The circa 1935–1940 residence displays a one-and-one-half-story, three-bay (ww/d/ww), double-pile, front-gable form (Figure 133). The dwelling rests on an exposed basement foundation clad in a stone veneer. The exterior is clad in a brick veneer laid in stretcher bond. The roof is sheathed in asphalt shingles. The windows contain one-over-one, double-hung vinyl sashes with poured concrete sills and false grids. An exterior brick chimney along the southwest elevation pierces the roof of the side porch. An interior brick chimney pierces the northeast roof slope. Wood brackets are located under the wide eaves on gable ends (Figure 134).

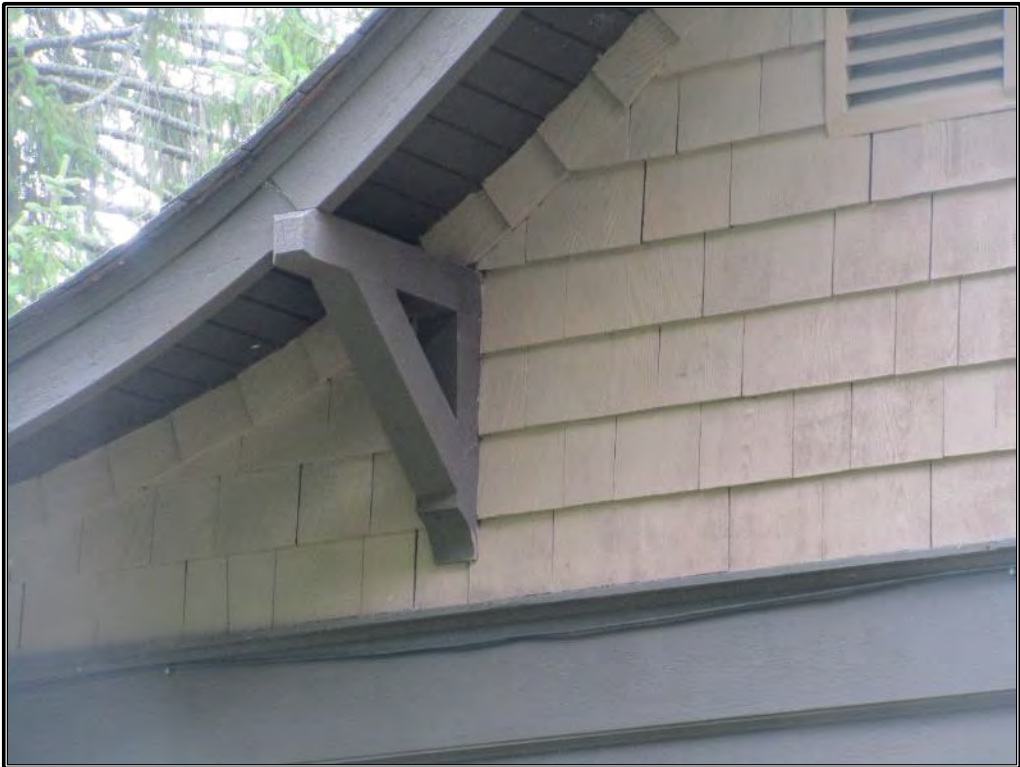
Figure 134. Detail of brackets and eaves.

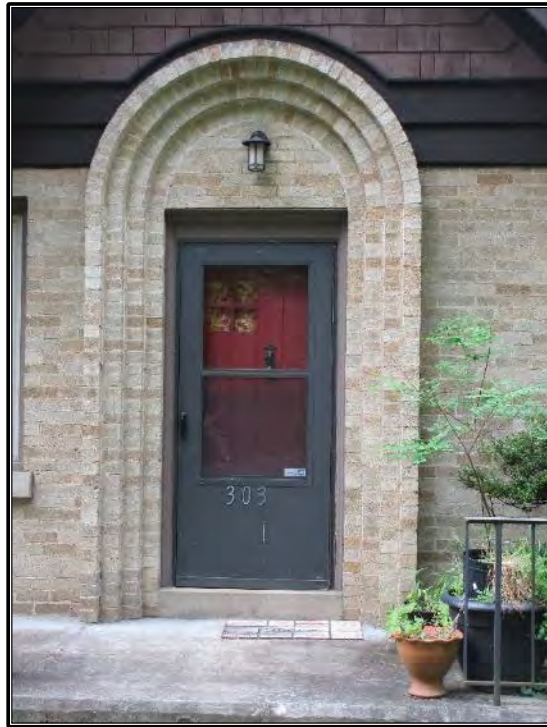
Figure 135. Detail of front entry.

The façade of the residence features an off-center single-leaf entry filled by a four-light wood door set within an arched brick surround (Figure 135). The entry opens onto a poured concrete deck, faced in river rock, that spans the width of the façade. A large gable-roof hood shelters the front entry. A paired window bay pierces the façade southwest (left) of the entry. An archway along the southwest (left) side of the façade leads to the side porch.

Workmanship – The integrity of workmanship remains visible through the stepped-arch brick surround framing the entry, as well as the combination of brick veneer and stone masonry which remains intact and well-maintained. While the replacement windows have slightly diminished the integrity of workmanship, the

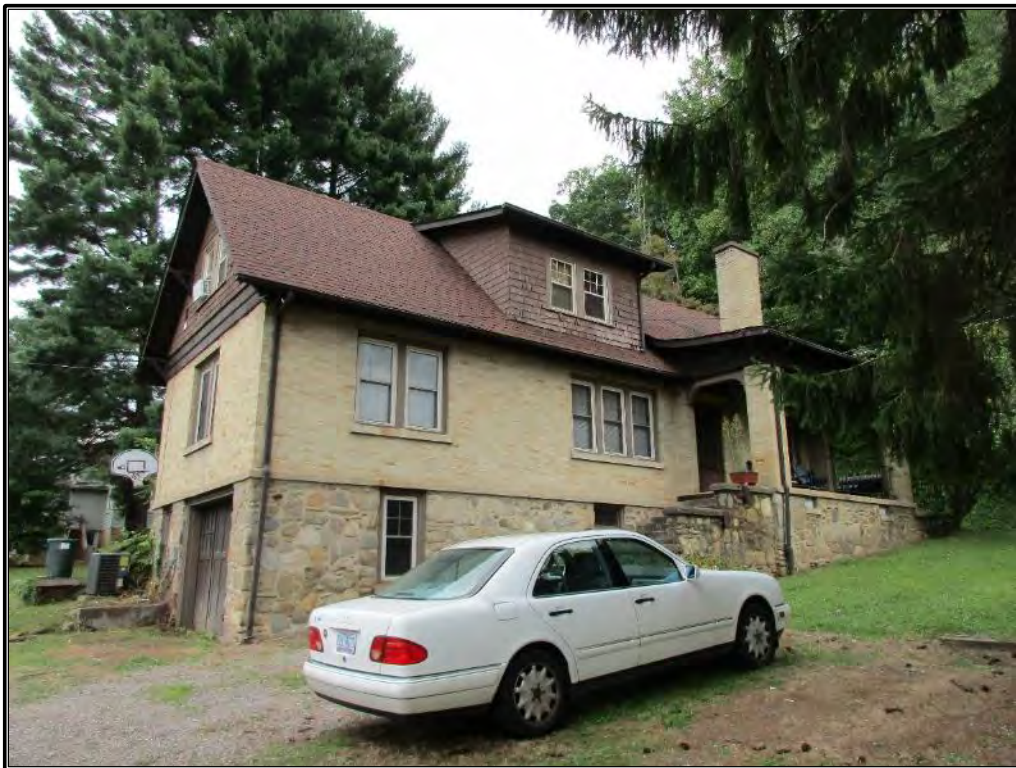
Figure 136. Southwest and rear elevation of residence, looking east-northeast.

The southwest elevation of the residence features a single-leaf side entry filled by a multi-light wood door (Figure 136). The entry opens onto a partial-width, single-bay porch with a sloping shed-roof supported by brick columns set on a poured concrete deck. The porch is lined by a metal railing and accessed by a set of poured concrete and stone steps. A shed-roof dormer clad in wood shingles and pierced by a paired window bay projects from the southwest roof slope (Figure 137).

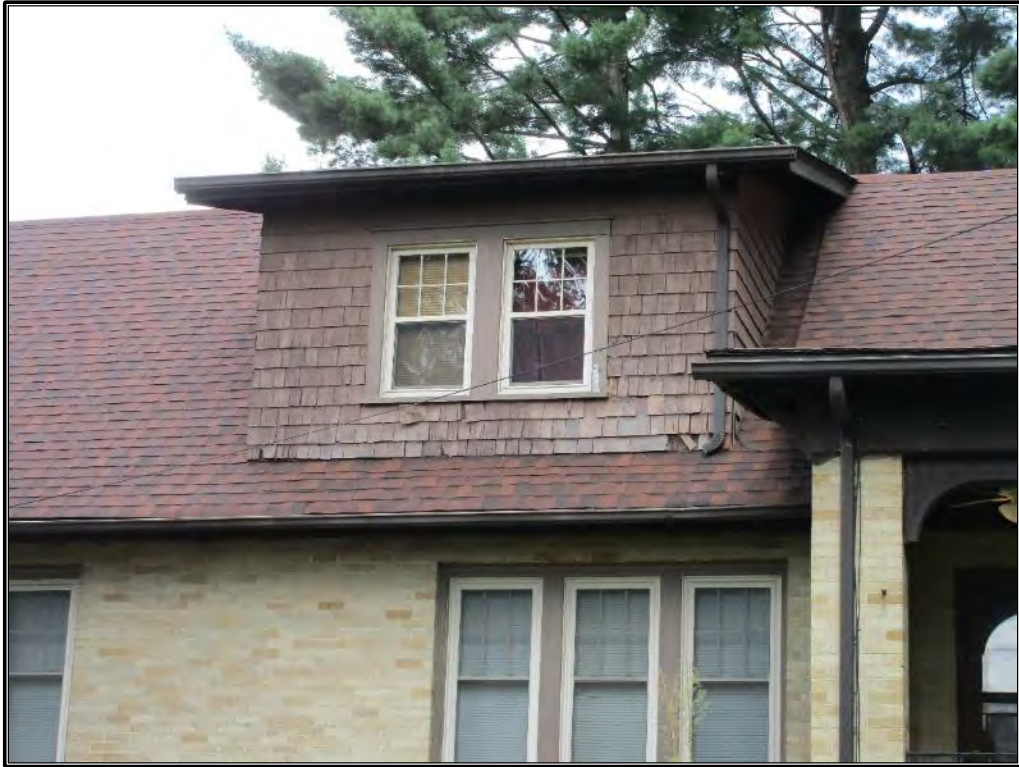
Figure 137. Detail of shed-roof dormer.

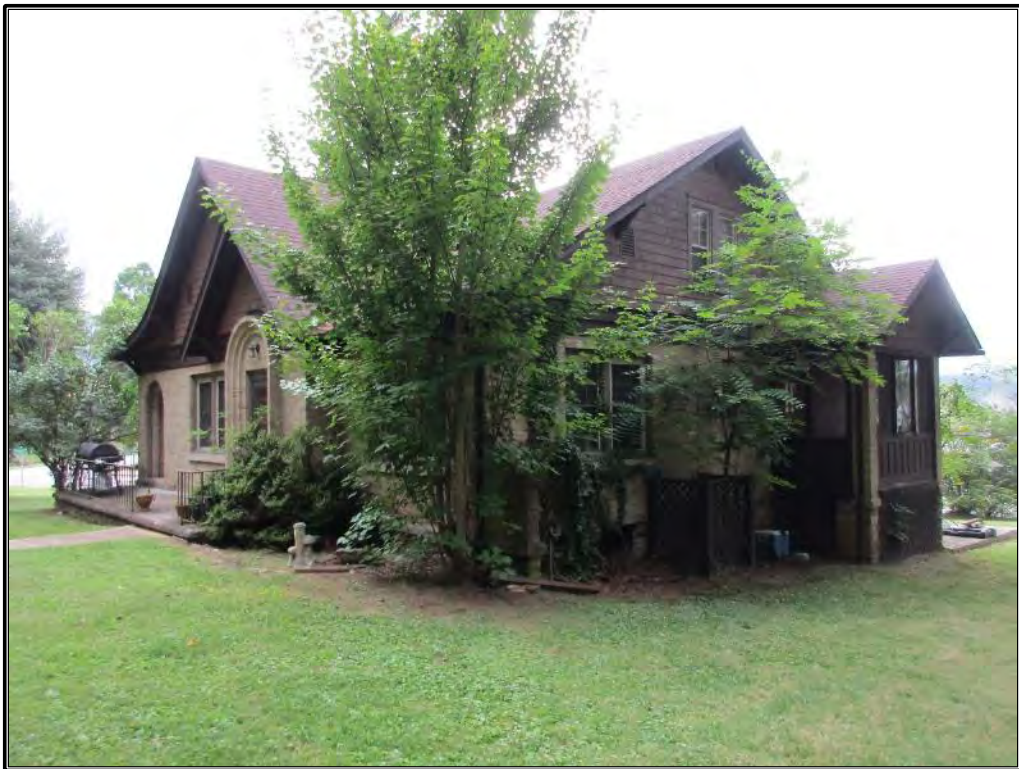
Figure 138. Façade and northeast elevation of residence, looking west-southwest.

The northeast elevation is one-and-a-half stories with a one-story side porch sheltering a side entry (Figure 138). The porch roof is supported by brick columns. The basement story is exposed along the northwest elevation. The rear elevation of the building features a rear, gable-roof ell with a shed-roof dormer clad in wood shingles at the intersection of the roofline. A wood deck abuts the building's northwestern corner. The rear elevation of the residence features a basement story, single-car garage (Figure 139). The garage features a large bay filled by a wood overhead door and a single-leaf entry filled by a six-light wood door (Figure 140).

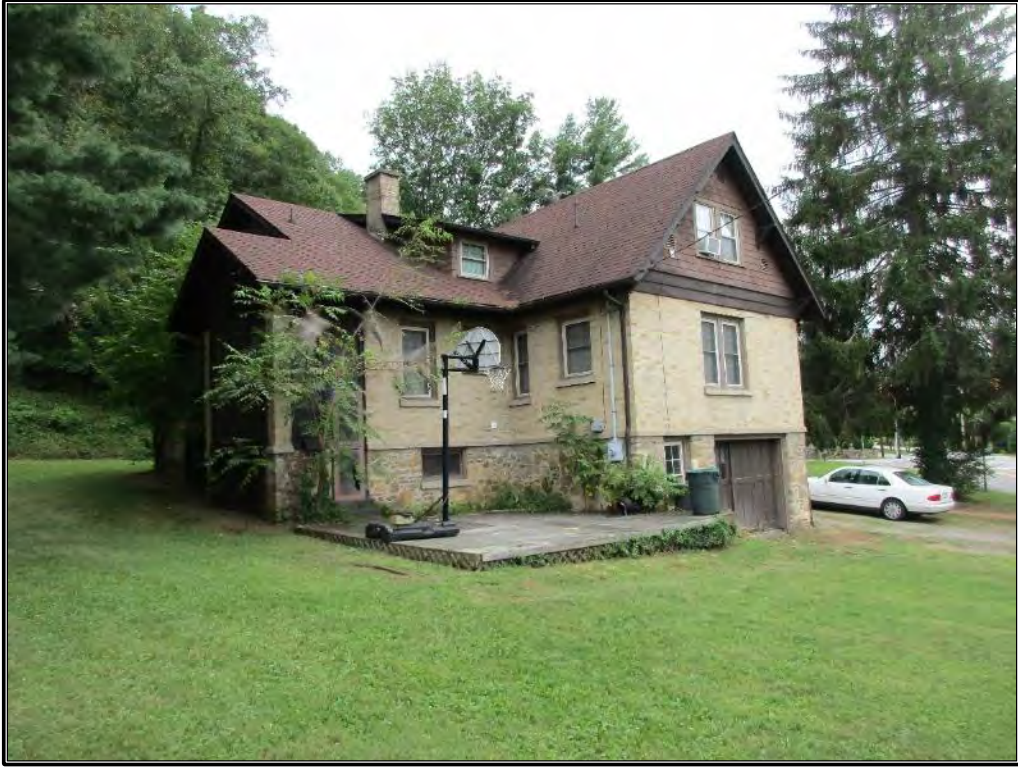
Figure 139. Northeast and rear elevation of residence, looking south-southwest.

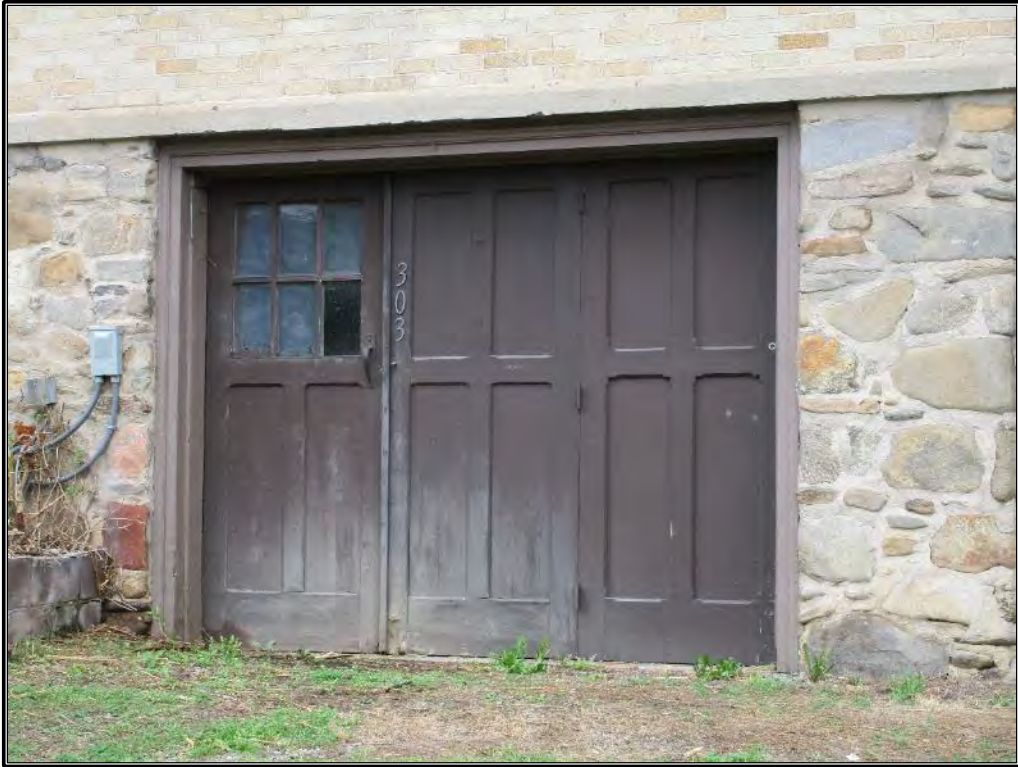
Figure 140. Detail of basement level garage.

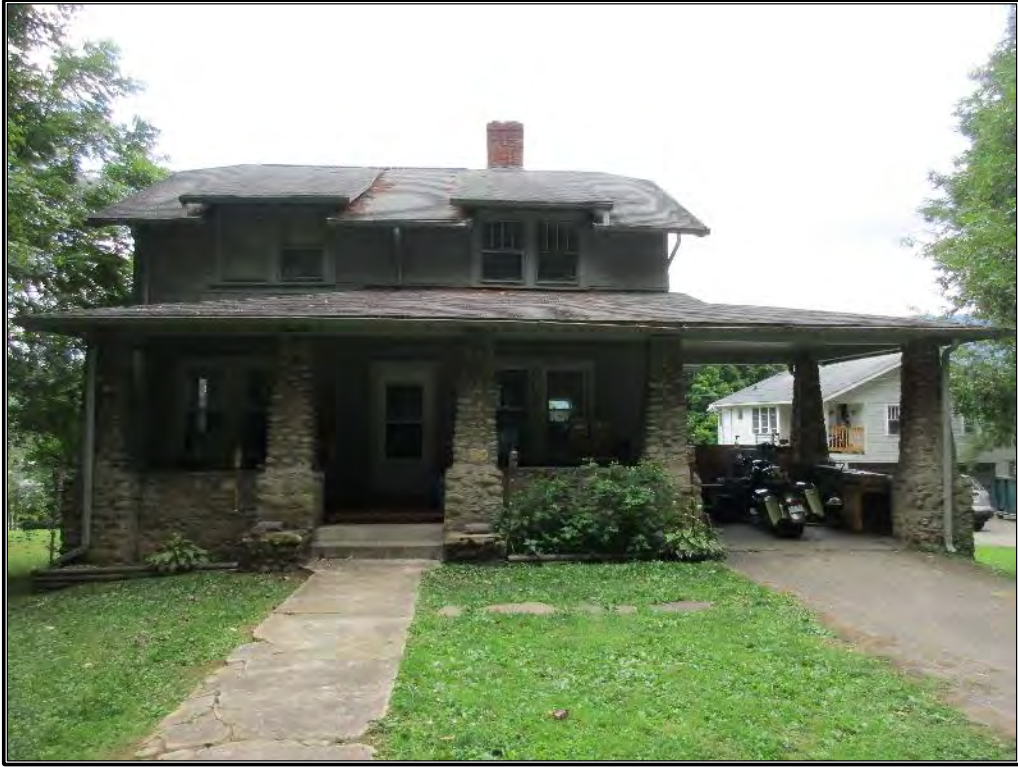
Figure 144. Façade of residence, looking west-northwest.

House, exterior: The circa 1930 Craftsman-style residence exhibits a two-story, three-bay (ww/d/ww), double-pile, clipped-gable form (Figure 144). The dwelling rests on an exposed river rock basement foundation. The first story of the exterior is clad in wood drop siding. The second story is clad in wood shingles. The roof is sheathed in asphalt shingles. Unless otherwise indicated, the windows present four-over-one, double-hung wood sashes and one-over-one, double-hung vinyl sashes (Figure 145). An interior brick chimney pierces the rear roof slope. An interior brick chimney pierces the northeast roof slope of the rear projection. Exposed rafter tails are located under the wide eaves (Figure 146).

The façade features a central single-leaf entry filled by a four-light wood door (Figure 147). A full-width, three-bay front porch with a hip-roof supported by battered river rock posts resting on river rock piers (see Figure 144). The piers are incorporated into a low river rock wall that lines the perimeter of the porch, and a hip-roof carport extends from the northeast side of the porch. The carport is supported by battered river rock columns. The front entry is flanked by paired windows. There are two shed-roof wall dormers with paired windows on the façade.

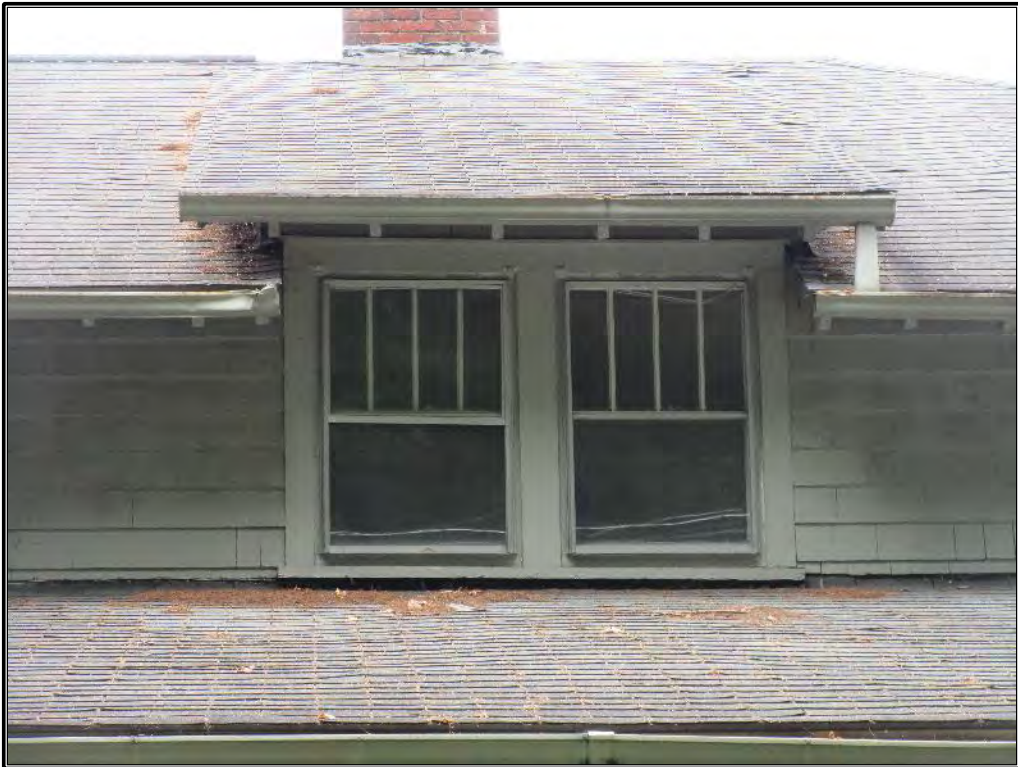
Figure 145. Detail of historic windows and wall dormer.

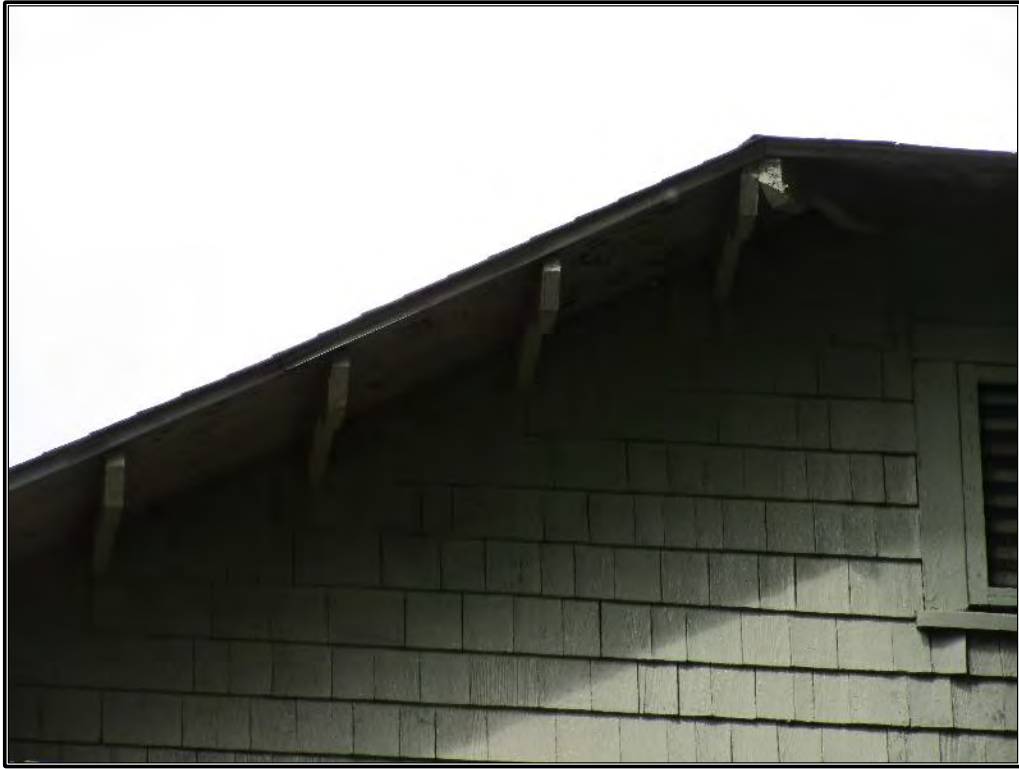
Figure 146. Detail of eaves and exposed rafter tails.

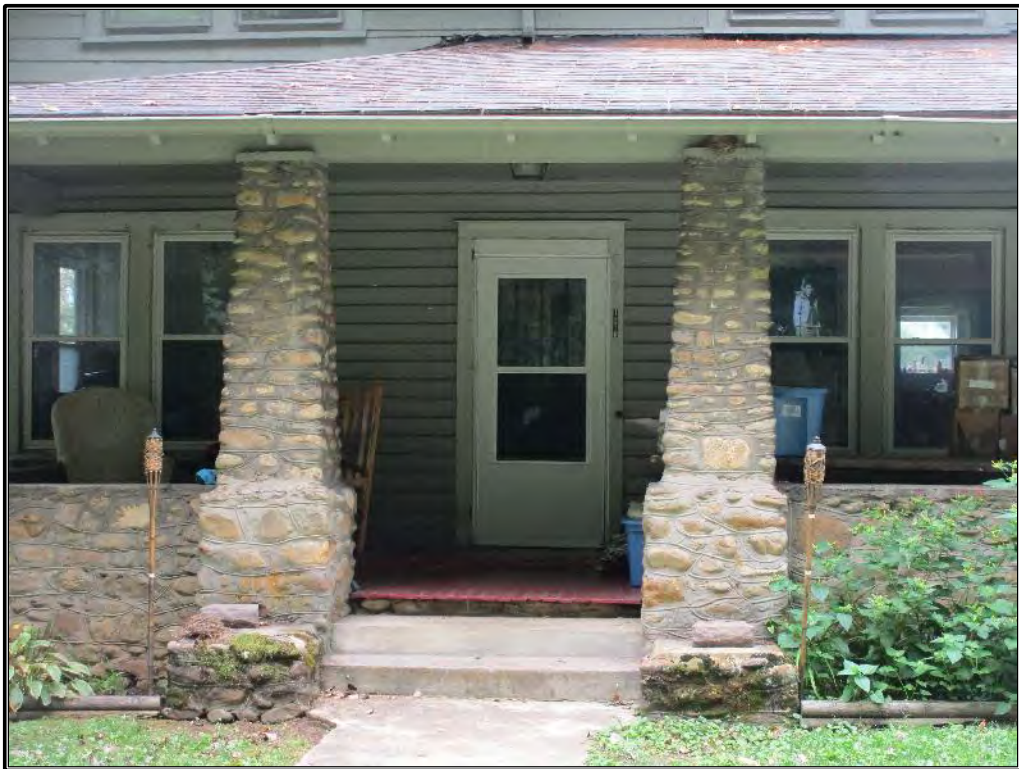
Figure 147. Detail of front entry and porch posts.

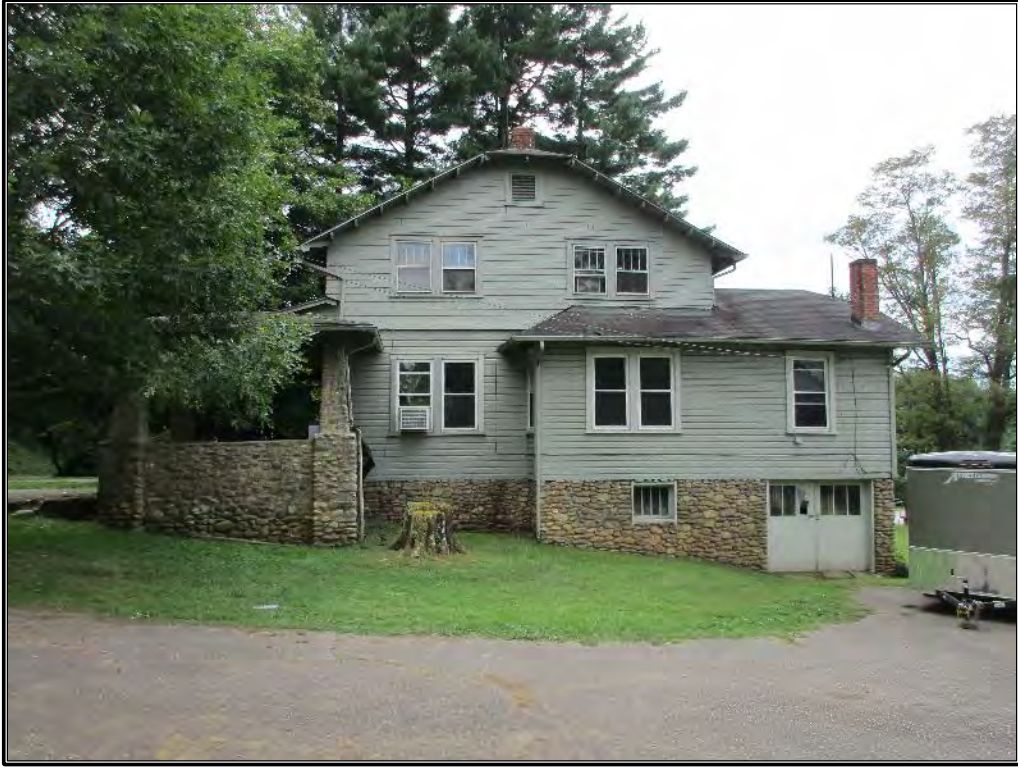
Figure 148. Northeast elevation of residence, looking south-southwest.

The northeast elevation features paired windows in both the first and second floors (Figure 148). A rear addition wraps around to the southeast side of the northeast elevation. The southwest elevation features a ribbon of three windows and a paired window along the first story and paired windows on the second story (Figure 149). The northwest (left) windows contain single-light sliding vinyl sashes sheltered by shed-roof hood supported by wood brackets. A single window bay filled by a single-light vinyl sash pierces the elevation along the basement story.

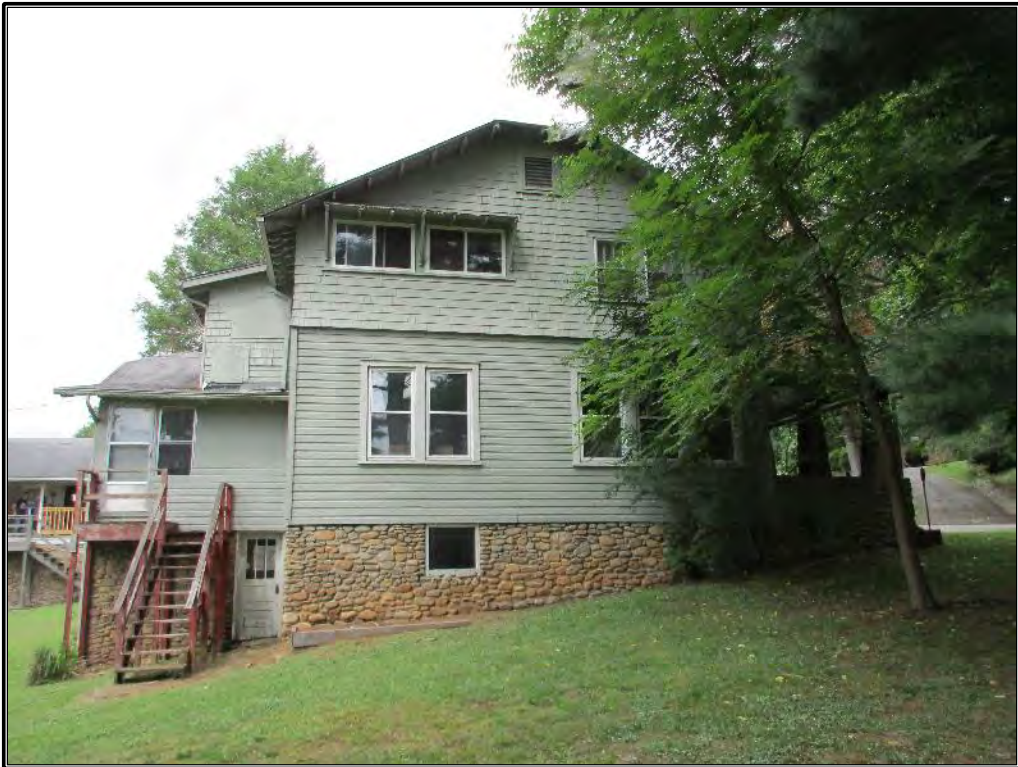
Figure 149. Southwest elevation of residence, looking north-northwest.

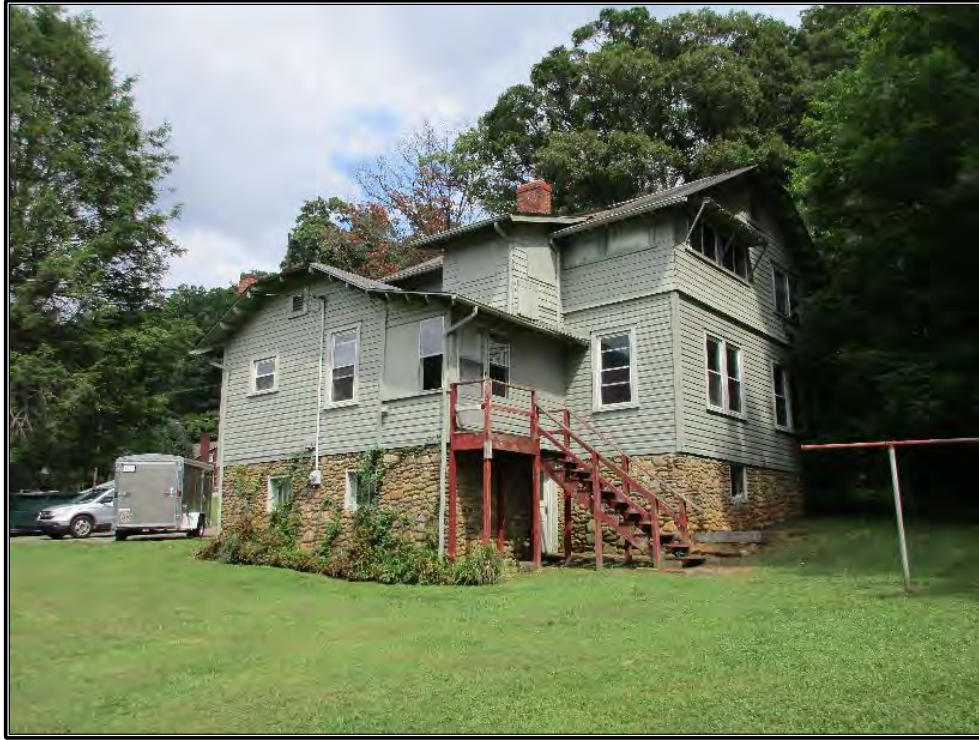
Figure 150. Southwest and rear elevation of residence, looking east-northeast.

The rear elevation features a one-story, clipped-gable ell (Figure 150). The ell wraps around the northeast elevation of the residence. A vehicular bay filled by a pair of three-light wood doors pierces the elevation along the basement story. A single window bay is located southeast (left) of the vehicular bay. The southwest elevation of the ell features an enclosed shed-roof porch. A single-leaf entry filled by a wood paneled door pierces the southwest of the porch. The entry opens onto a wood landing accessed by a set of wood stairs. A single window is located northwest (right) of the entry. A single window pierces the rear elevation of the porch. A second-story, shed-roof addition extends from the roof of the porch that is now enclosed with wood shutters, and likely functioned as a sleeping porch or bathroom. Two single windows filled by four-light wood sashes pierces the rear elevation along the basement story. A single-leaf entry filled by a half-light wood paneled door pierces the elevation along the basement story.

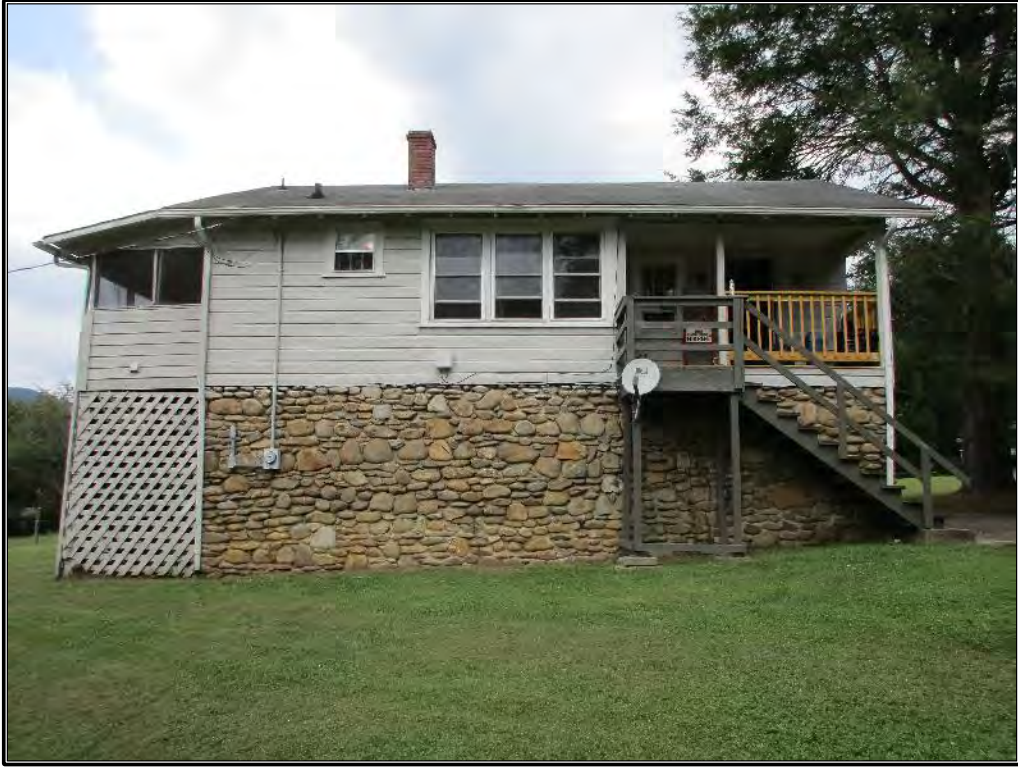
Figure 151. Façade of carriage house, looking north-northeast.

Carriage House, exterior: A circa 1930 carriage house is located approximately 30 ft north of the residence (Figure 151). The carriage house presents a single-story, four-bay (w/www/d/w), double-pile, side-gable form. The basement story is a two bay garage, and the first story contains living space. Set on a river rock foundation, the carriage house features exposed river rock masonry in the basement story, and the first story is clad in wood drop siding. The roof is sheathed in asphalt shingles. The windows present three-over-one, double-hung wood sashes and one-over-one, double-hung vinyl replacement sashes (Figure 152). An interior brick chimney pierces the façade roof slope. Exposed rafter tails are located under the wide eaves.

The façade features a recessed single-leaf entry along the first story filled by a three-quarter-light, wood-paneled door (see Figure 151). The entry is sheltered by an integral porch supported by wood posts set on a wood deck. The porch is lined by a wood railing and accessed by a set of wood stairs. A single window bay pierces the façade east (right) of the entry. A single window filled by a three-light wood sash and a ribbon of three single windows pierce the west side of the façade along the first story. The east elevation features two vehicular bays along the basement story (Figure 153). The south (left) bay contains a four-light overhead wood door. The north (right) bay features a two-light overhead wood door and a single-leaf entry filled by a three-light wood door. Two paired windows pierce the elevation along the first story. The west elevation features an elevated shed-roof screened porch (Figure 154). The porch supports are enclosed with a wood lattice. The porch is accessed by a set of wood steps. A single window bay pierces the basement story of the elevation north (left) of the porch. A single window bay is located north (left) of the porch along the first story. A small window filled by a single-light wood sash is centered under the gable. The rear elevation features a paired window bay flanked by single windows along the first story. The basement story is devoid of fenestration.

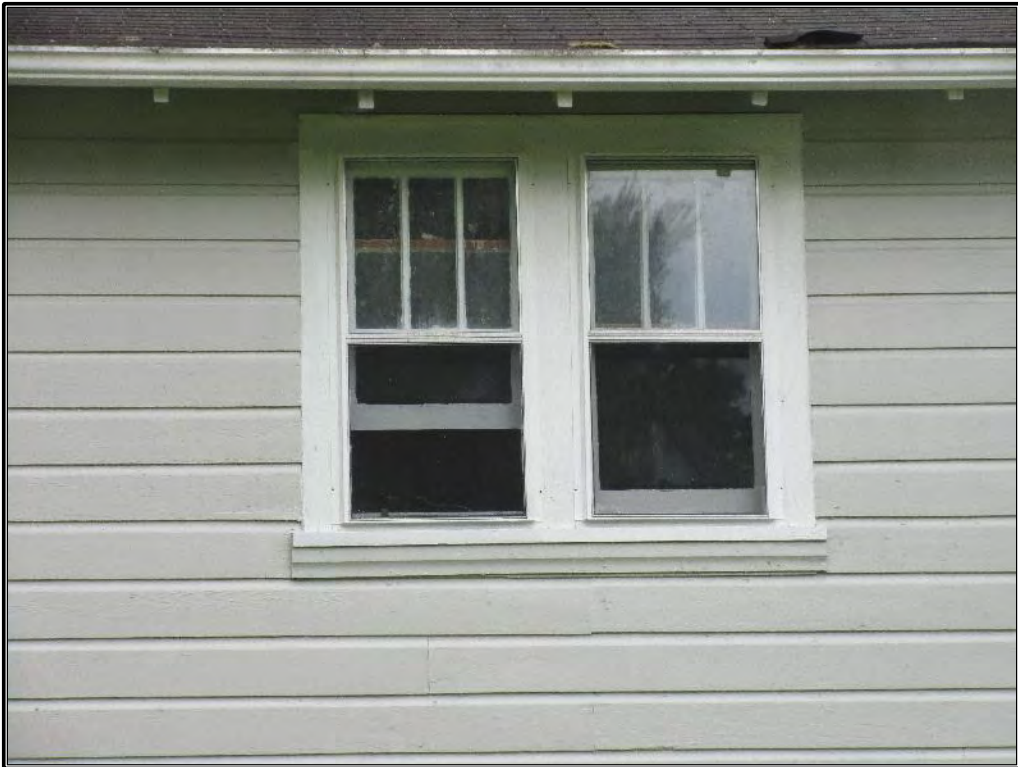
Figure 152. Detail of historic windows.
