SUBJECT: Historic Structures Survey Report, , Improvements to US 23 Business (South Main Street) from SR 1164 (Hyatt Creek Road) to US 276 (Pigeon Street), Waynesville, PA 17-12-0027, U-4712, Haywood County, ER 18-4249

MANAGEMENT SUMMARY	i
I. INTRODUCTION.....	1
II. METHODOLOGY.....	1
III. DESCRIPTION, HISTORIC CONTEXT, AND EVALUATION	7
CLYDE’S RESTAURANT (HW0735)	7
COMMERCIAL BUILDING (HW0736).....	18
COMMERCIAL BUILDING AND FORMER GROCERY (HW0737).....	28
REPAIR SHOP (HW0738)	41
MAPLE GROVE MOTEL (HW0739)	50
HYATT HOUSE AND CARRIAGE HOUSE.....	68
(HW0015 / HW0740).....	68
SILER HOUSE (HW0741)	88
ETHEL ROSS BRADLEY HOUSE (HW0742)	97
PEARL HYATT AND MARGARET HYATT PILARSKI HOUSE (HW0743)	110
HOUSE, 1262–1270 S. MAIN STREET (HW0744).....	119
GEORGE HOUSE (HW0745)	133
HOUSE, 1157 S. MAIN STREET (HW0746).....	143
HOUSE, 1153 S. MAIN STREET (HW0747).....	155
THE GABLES APARTMENTS (HW0096).....	163
DR. ALBERT HEYWARD SMITH, JR. HOUSE (HW0748).....	173
THE ATKINS HOUSE (HW0109)	187
THE HILLTOP TOURIST LODGE (HW0056).....	202
FORMER HOUSE, 809 S. MAIN STREET (HW0749).....	212
HOUSE, 761 SOUTH MAIN STREET (HW0750)	222
THE CHARLES RAY HOUSE (HW0055) AND CARRIAGE HOUSE (HW0751)	233

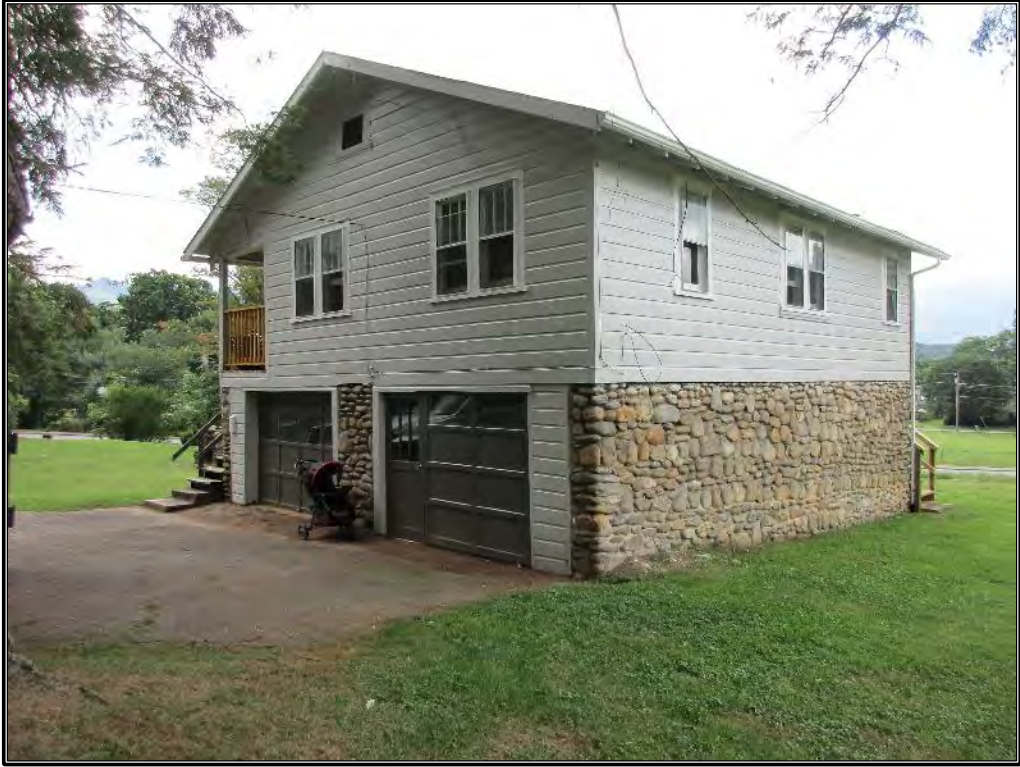
Figure 153. East and rear elevation of carriage house, looking west-southwest.

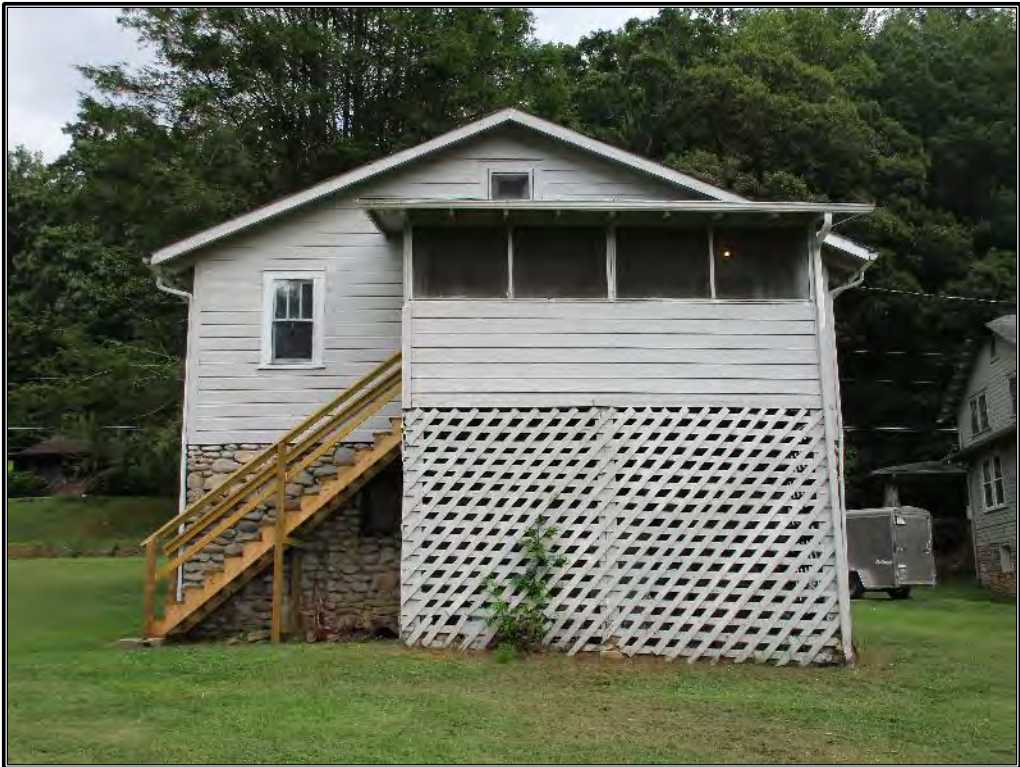
Figure 154. West elevation of carriage house, looking east-southeast.

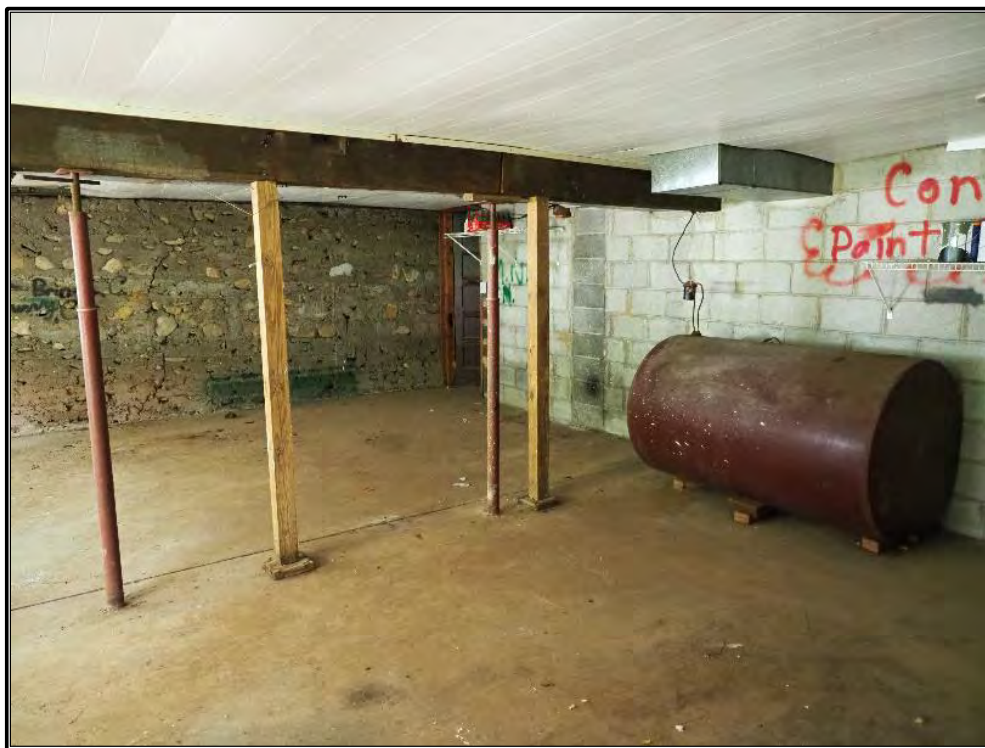
Figure 155. Interior of basement story of carriage house.

Carriage house, interior: The basement story of the carriage house consists of a two-bay garage with a poured concrete floor (Figure 155). The side walls feature exposed river rock. The ceiling is clad in wood panels and features exposed wood beams. Wood and metal posts support the exposed beams. A concrete block partition wall separates the main portion of the garage from a rear storage area. An entry along the partition wall filled by a wood paneled door leads to the storage area. The first-story living space features hardwood floors throughout and plastered walls with simple molding and baseboards (Figures 156 and 157). The windows are cased with simple wood surrounds with wood sills. Interior doors contain wood paneled doors and wood surrounds with triangular along the top of the casing. The front entry opens into the main living room. Two bedrooms are accessed by doors along the north wall of the living room. The kitchen occupies the west side of the carriage house and features a tiled floor with modern cabinetry and appliances.

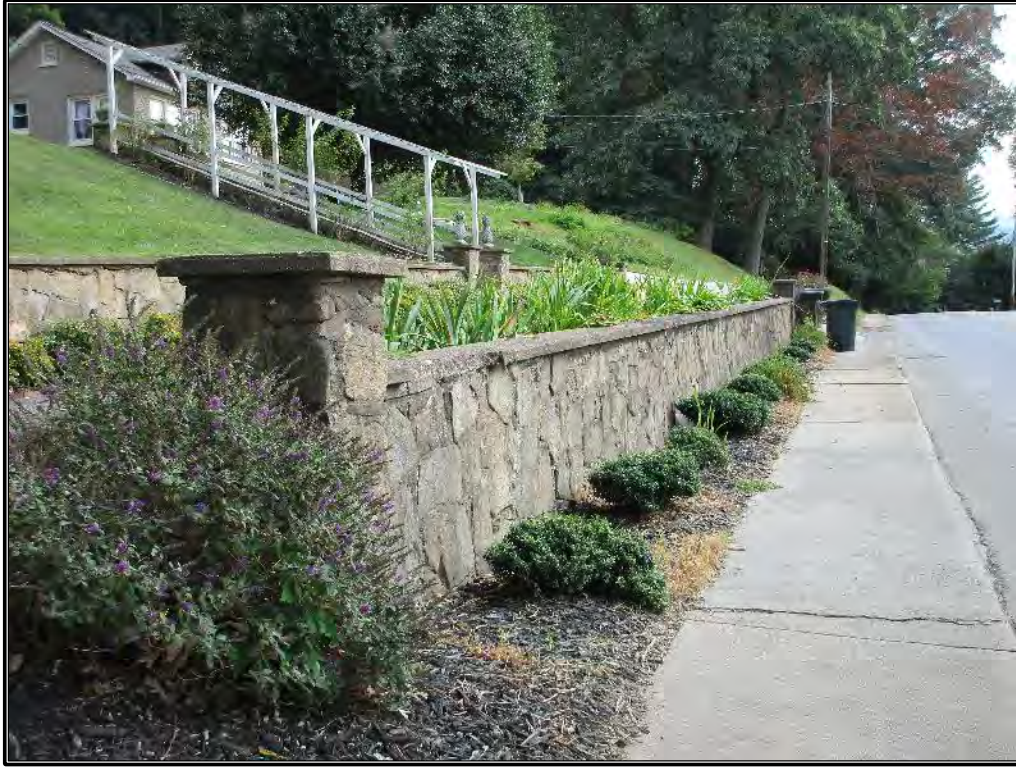
Figure 161. Stone walls along service drive.

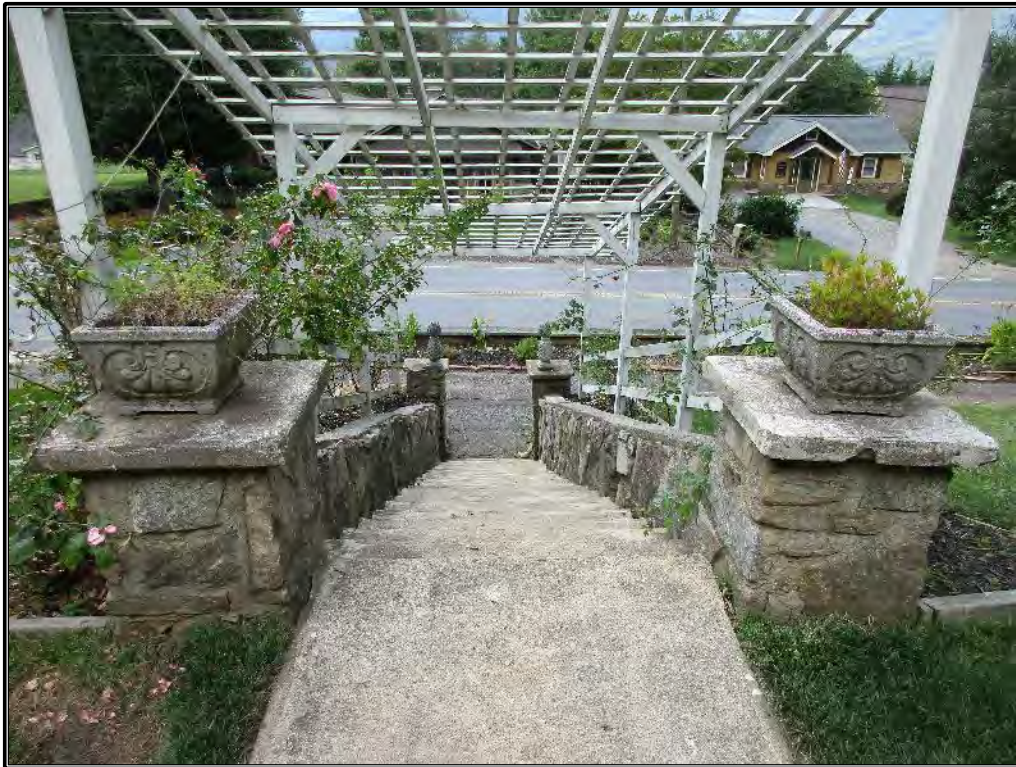
Figure 162. View of concrete steps, stone walls, and pergola.

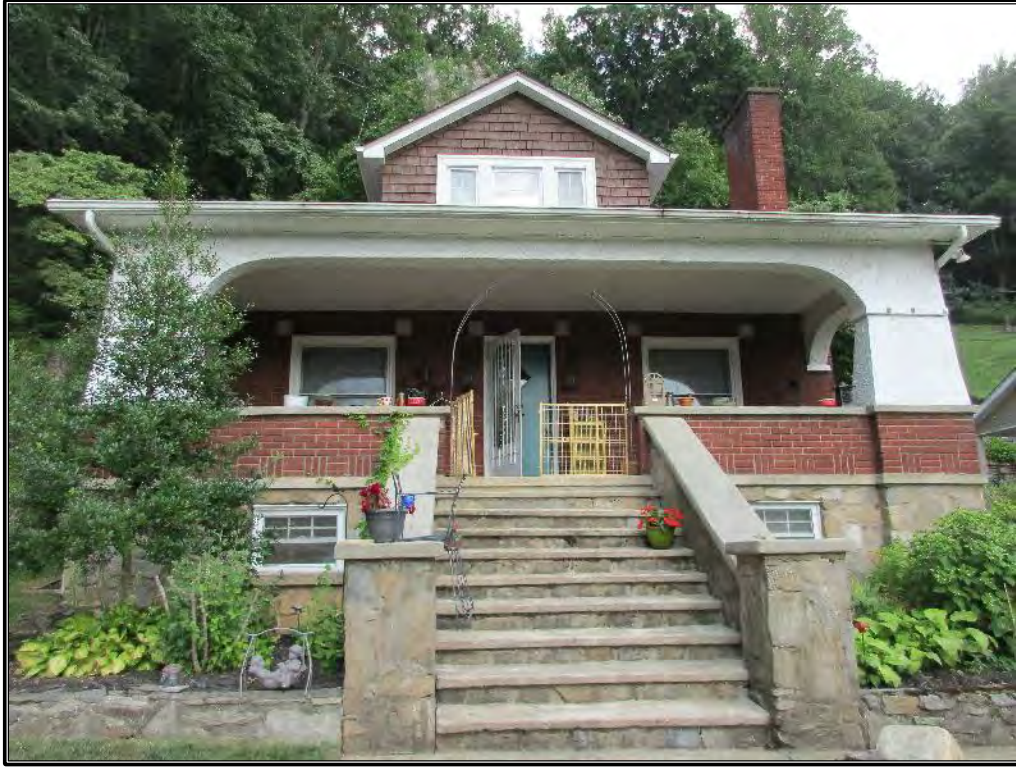
Figure 163. Façade view of the George House (HW0745).

House, exterior: The circa 1940 Craftsman-style Bungalow displays a one-and-one-half-story, three-bay (w/d/w), double-pile, side-gable form (Figure 163). Of brick construction, the residence rests on a stone-clad, raised basement foundation and features brick laid in stretcher bond with stacked brick accents. The roof is sheathed in asphalt shingles. The roof features wide overhanging eaves. The windows contain one-over-one, double-hung vinyl replacement sashes with false grids. The windows feature poured concrete sills and stacked brick and poured concrete accents. An exterior brick chimney extends from the south elevation (Figure 164).

The façade features a central single-leaf entry filled by a single-light slab door. The entry opens onto a full-width, single-bay front porch with a shed-roof supported by battered porch posts covered in stucco resting on brick piers. The piers are set within a brick railing with decorative brick accents extending along the perimeter of the porch. Arched spandrels covered in stucco spring from the porch posts to support the roof. The porch is accessed by a set of poured concrete and stone steps with a stone railing. The front entry is flanked by single windows. Two single windows pierce the basement level of the porch. A metal coal chute inscribed “Majestic” and “1926” is located along the basement level on the south side of the porch (Figure 165). A front-gable dormer clad in wood shingles and pierced by a tripartite window projects from the façade roof slope.

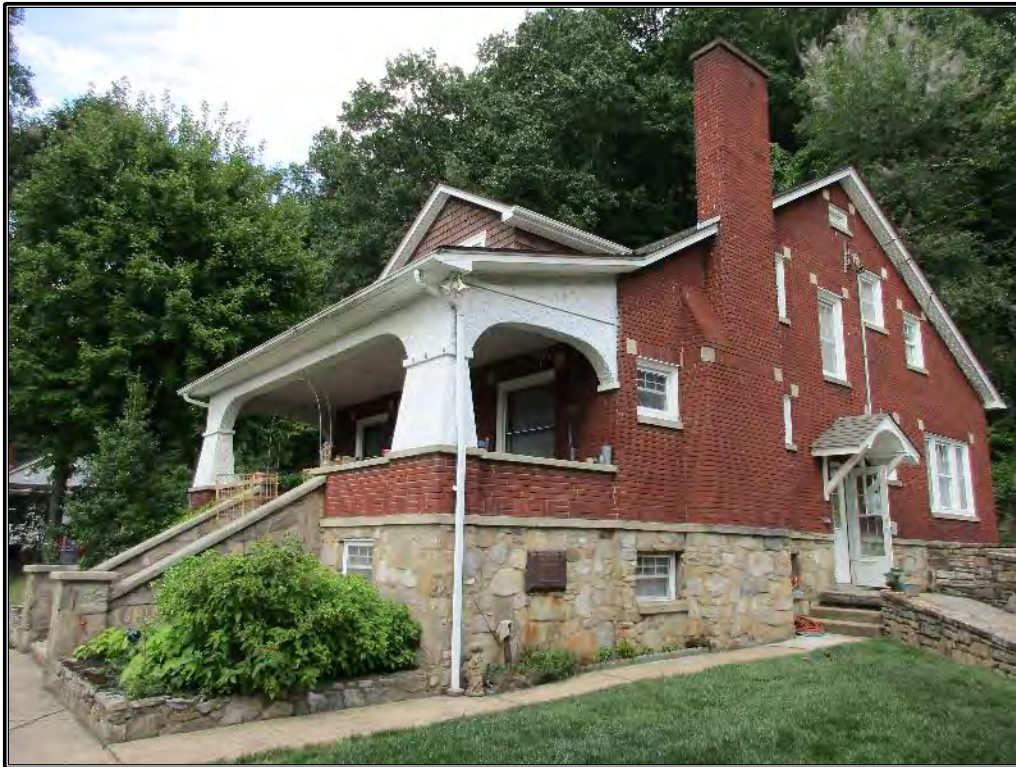
Figure 164. View of south elevation.

The south elevation features a single-leaf entry filled by a replacement nine-light door (see Figure 164). The entry opens onto a poured concrete landing accessed by a set of poured concrete steps and sheltered by a front-gable hood supported by wood brackets. A tripartite window is located along the east side of the elevation. The basement is partially exposed along the south elevation. The north elevation of the residence features a central box window along the first story pierced by a tripartite window (Figure 166). A tripartite window pierces the half-story. The rear elevation features an enclosed shed-roof porch (Figure 167). A single-leaf entry filled by a storm door pierces the south elevation of the porch. The porch encloses a single-leaf rear entry filled by a multi-light wood door. A gable-roof dormer clad in wood shingles and pierced by a tripartite window projects from the rear roof slope.

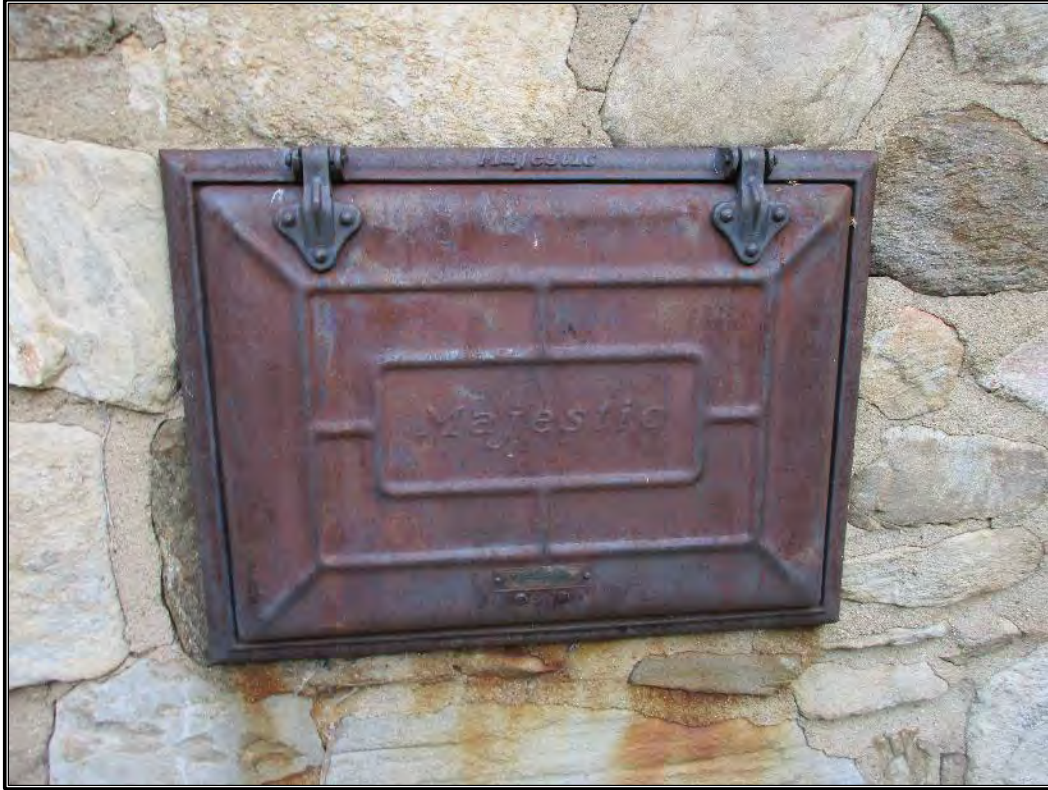
Figure 165. Coal chute on south elevation.

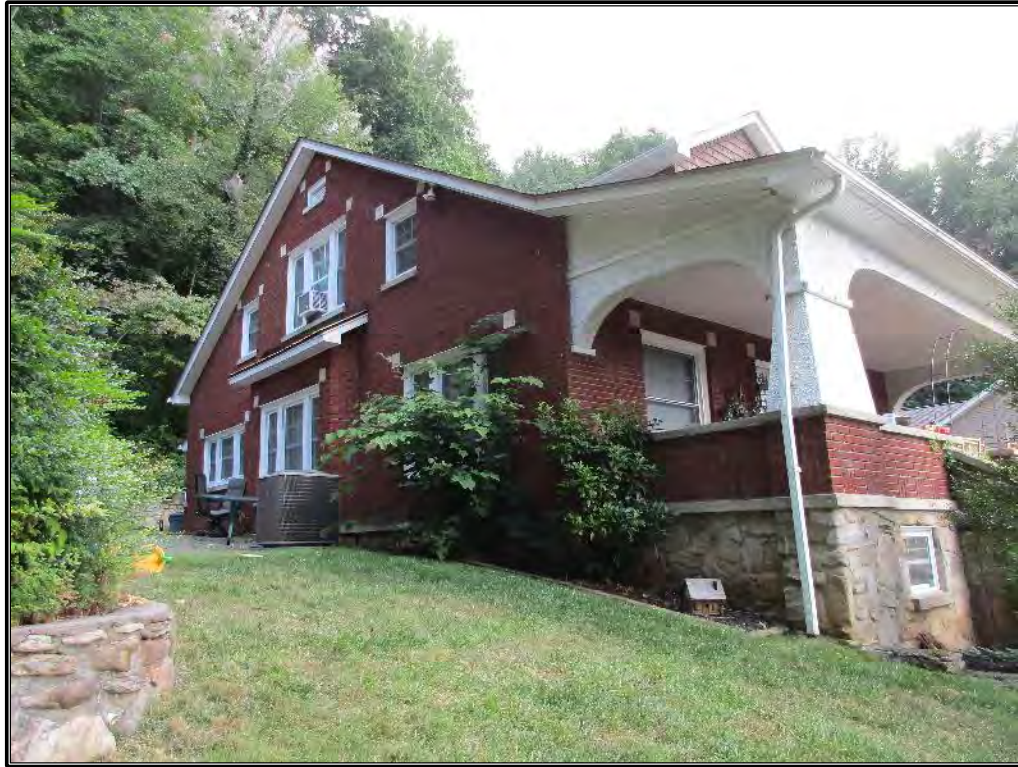
Figure 166. North elevation with tripartite window.

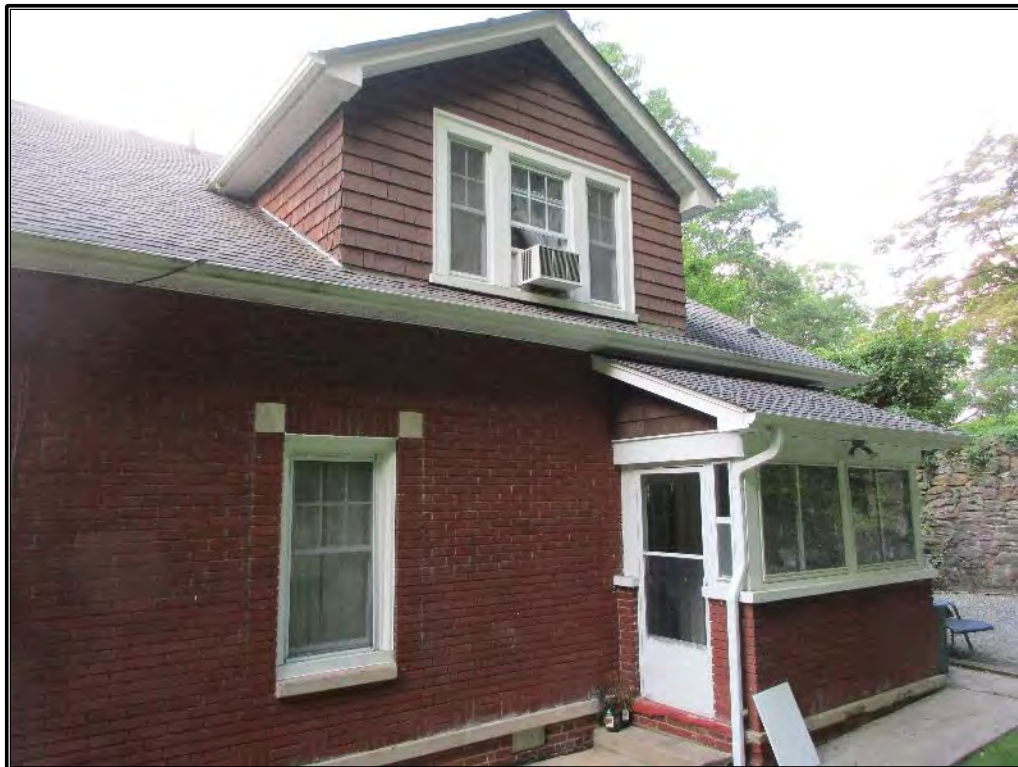
Figure 167. Rear elevation with dormer and porch.

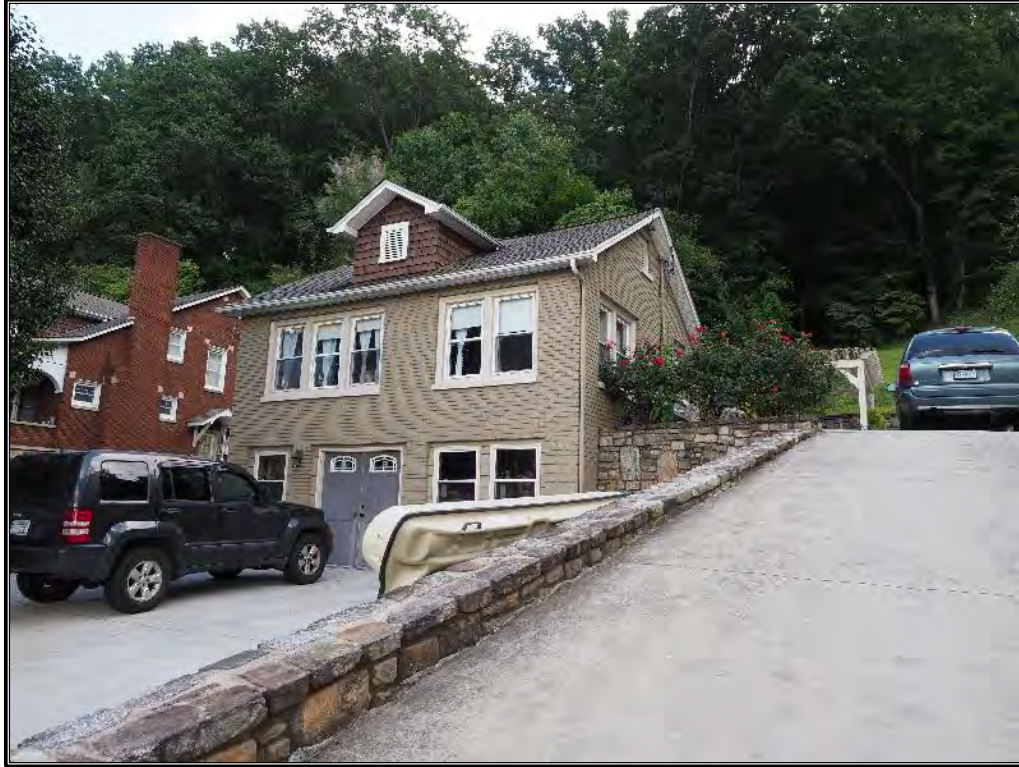
Figure 168. Garage with second-story living space.

Garage: A circa 1940 garage is located approximately 30 ft south of the residence (Figure 168). The garage presents a two-story, side-gable form with a rear addition. The first story consists of a two-car garage and the second story contains living space. The exterior of the garage is clad in a brick veneer laid in stretcher bond. The roof is sheathed in asphalt shingles. The foundation is not visible. The windows present one-over-one, double-hung vinyl sashes. The façade of the garage contains a central vehicular bay along the first floor filled by a pair of replacement doors. The bay has been partially infilled with vinyl siding to accommodate a smaller entryway. A vehicular bay south (right) of the central bay is enclosed with vinyl siding and pierced by two single window bays. A single-leaf entry north (left) of the central bay is infilled with vinyl siding and pierced by a single window bay. A front-gable dormer projects from the façade roof slope. A one-story, gable-oriented addition extends from the rear elevation. A flat-roof pergola extends from the east side of the south elevation.

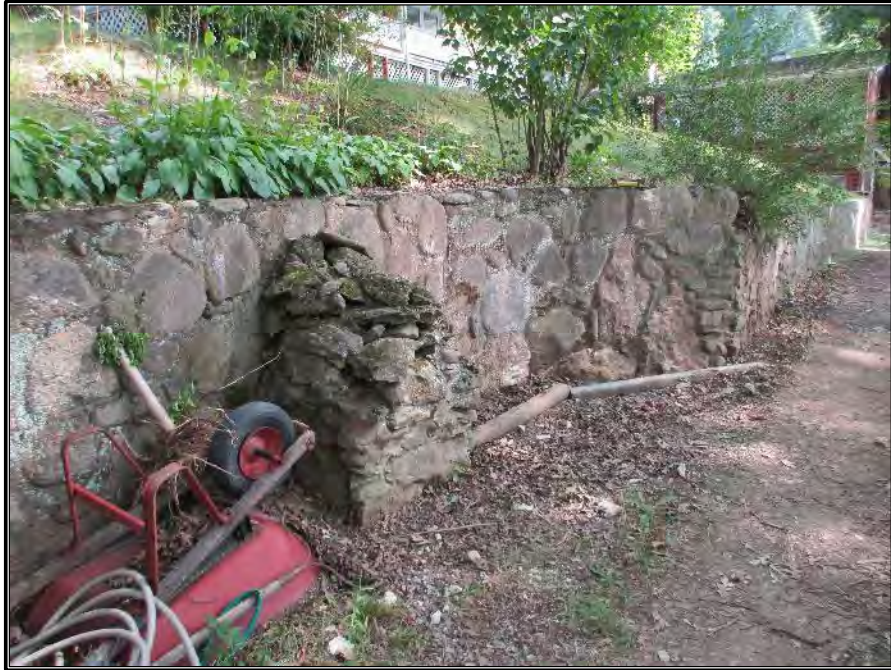
Figure 173. View of rock retaining walls along service road and stairs.

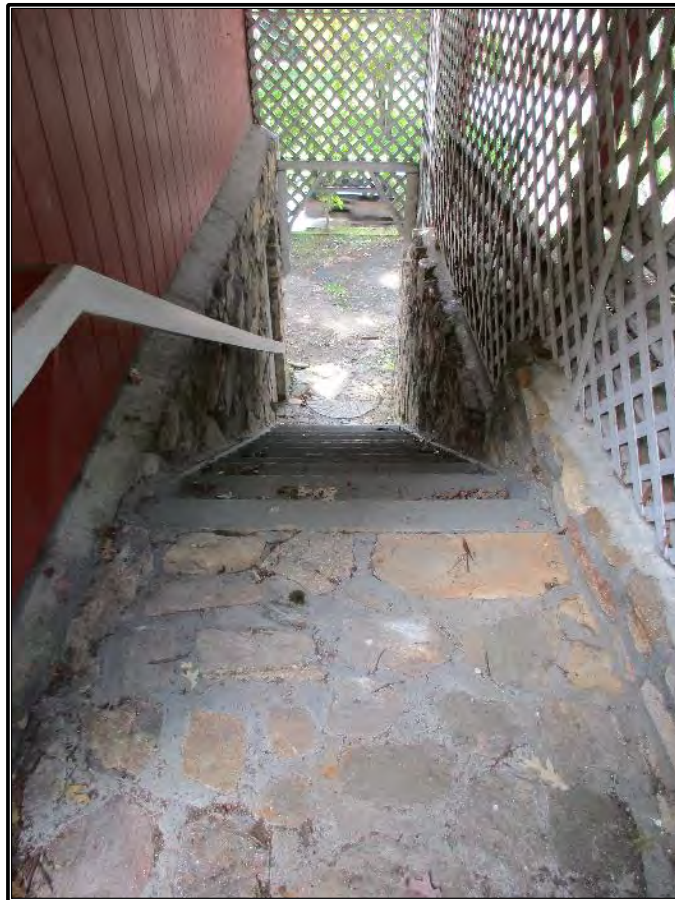
Figure 174. Concrete and stone stairs immediately next to the secondary residence.

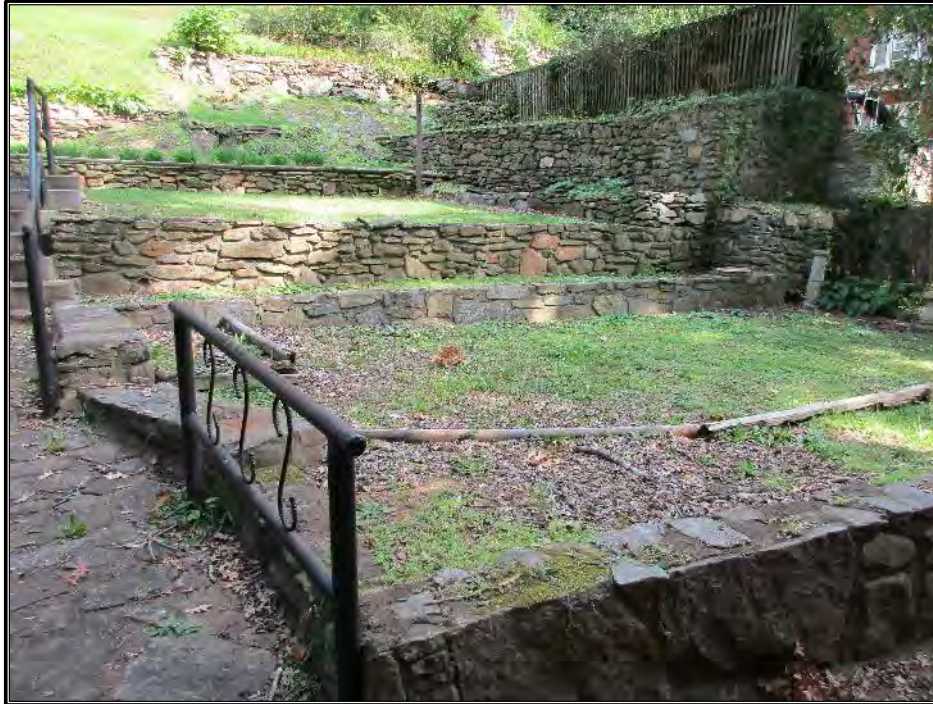
Figure 175. Terraces on the southern side yard.

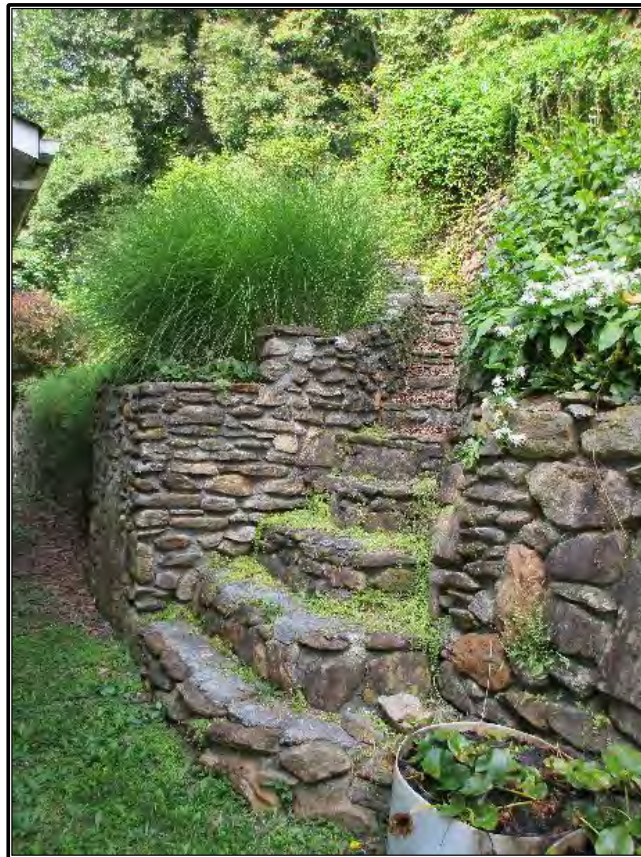
Figure 176. Stone stairs in the rear yard leading to a secondary terrace.

Setting: The residence is situated on a .5114-acre parcel on the east side of South Main Street (US 23 Business), approximately 170 ft south of its intersection with Mississippi Avenue (Figure 172). One of several properties elevated on a hill with a steep grade, the residence is surrounded by historic residential development and backs onto a wooded area. A paved service drive accessible from South Main Street extends along the west side of the residence and provides access to two other adjacent parcels. A stone retaining wall lines the east and west side of the service drive (Figure 173). A set of poured concrete steps covered by a shed-roof overhang attached to the north elevation of the associated secondary residence lead from the service driveway to a stone walkway lined by a metal railing along the south side of the house (Figure 174). A set of poured concrete steps leads from the stone walkway to the wraparound porch. The south yard is terraced with mortared stone retaining walls (Figure 175). A stone retaining wall extends along the east side of the rear yard. A set of stone steps is integrated in the retaining wall and leads to a flat, elevated portion of the yard (Figure 176).

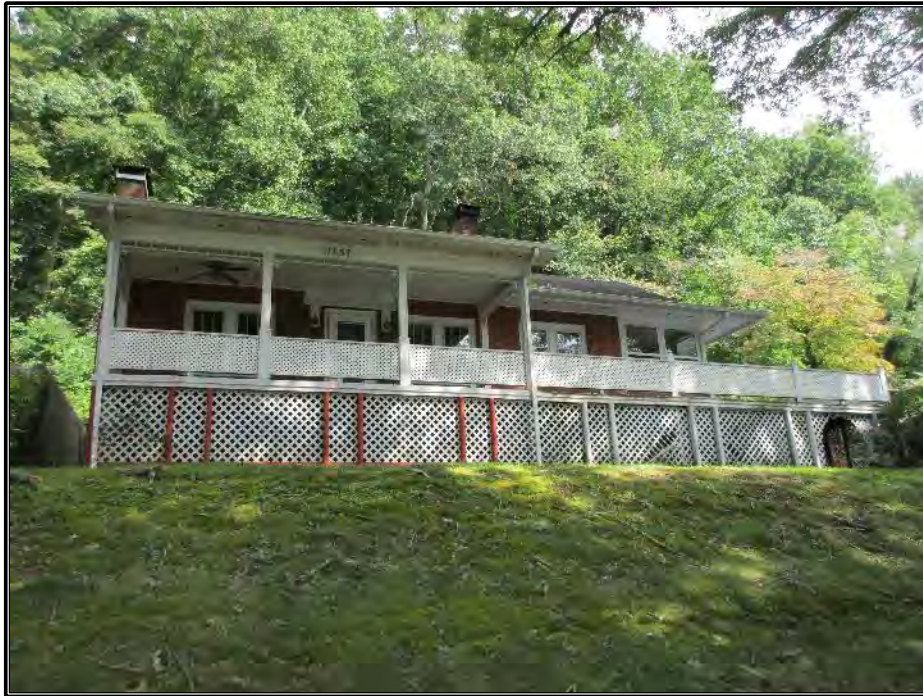
Figure 177. Façade with porch and raised basement enclosed with lattice.

House, exterior: The circa 1936 residence presents a one-and one-half-story, four-bay (ww/d/ww/ww), double-pile, side-gable form with a rear projection and additions (Figure 177). The dwelling rests on a continuous poured concrete foundation. The exterior is clad in brick veneer laid in stretcher bond. The south elevation and north gable is clad in T1-11 siding. The roof is sheathed in asphalt shingles. The windows present three-over-one, double-hung wood sashes. An exterior brick chimney extends from the north elevation. An interior brick chimney pierces the façade roof slope. Spindlework extends underneath eaves along the façade, north (side), and south elevations.

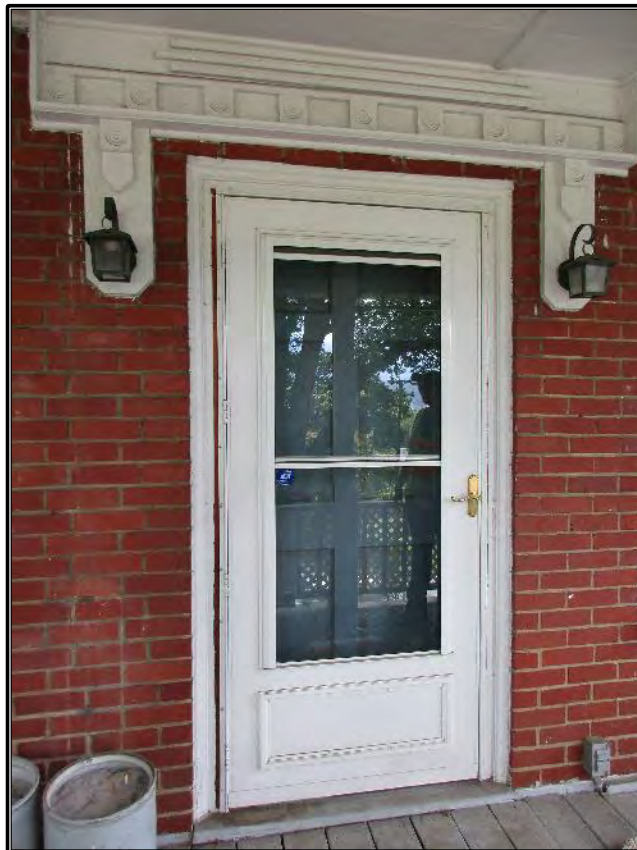
Figure 178. Detail of door with decorative surround.

The façade of the residence features a single-leaf entry filled by a wood paneled door. An ornamental hood with dentil molding and bullseye detailing frames the entry (Figure 178). A partial-width, three-bay front porch with a shed-roof supported by wood posts set on a wood deck spans the façade. The porch is adorned with spindlework and decorative brackets and lined by a wood lattice railing. A paired window pierces the façade north (left) of the entry. Two paired windows are located south (right) of the entry.

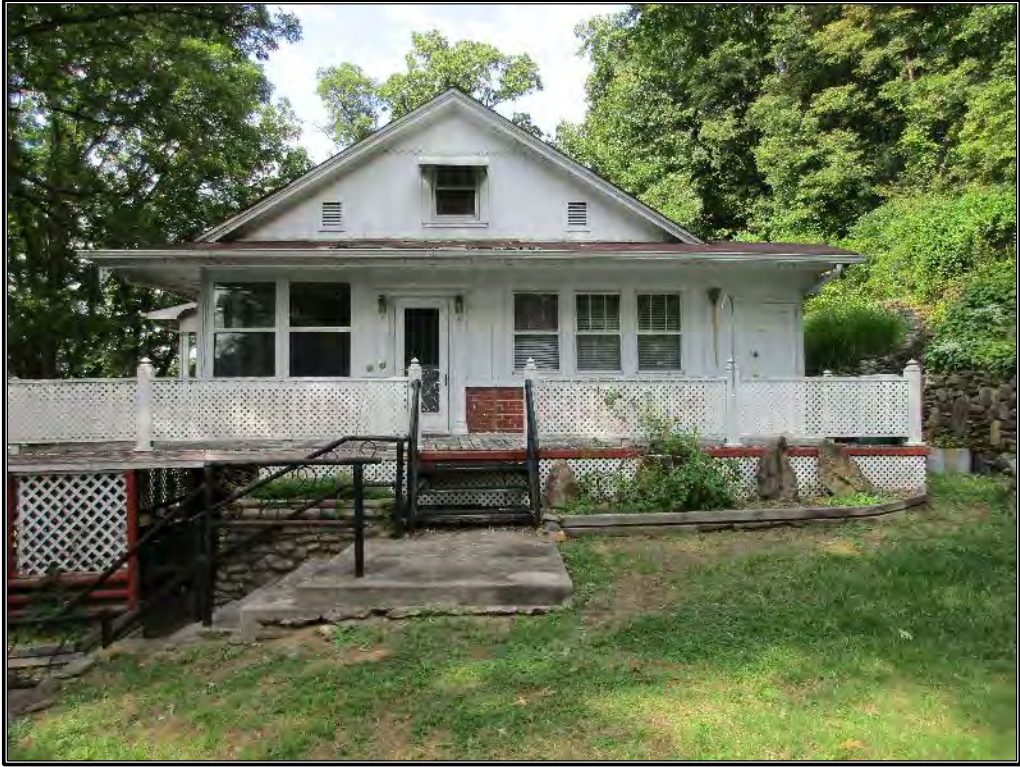
Figure 179. Southern elevation with concrete steps.

The south elevation features a single-leaf side entry filled by a four-light wood door (Figure 179). The west (left) side of the elevation consists of an integral enclosed porch. A window along the north elevation of the residence is enclosed with brick (Figure 180). The rear elevation features a one-story, shed-roof projection clad in T1-11 siding. A one-story, shed-roof addition clad in T1-11 siding extends from the rear elevation of the residence and along the north and south elevations of the rear projection.

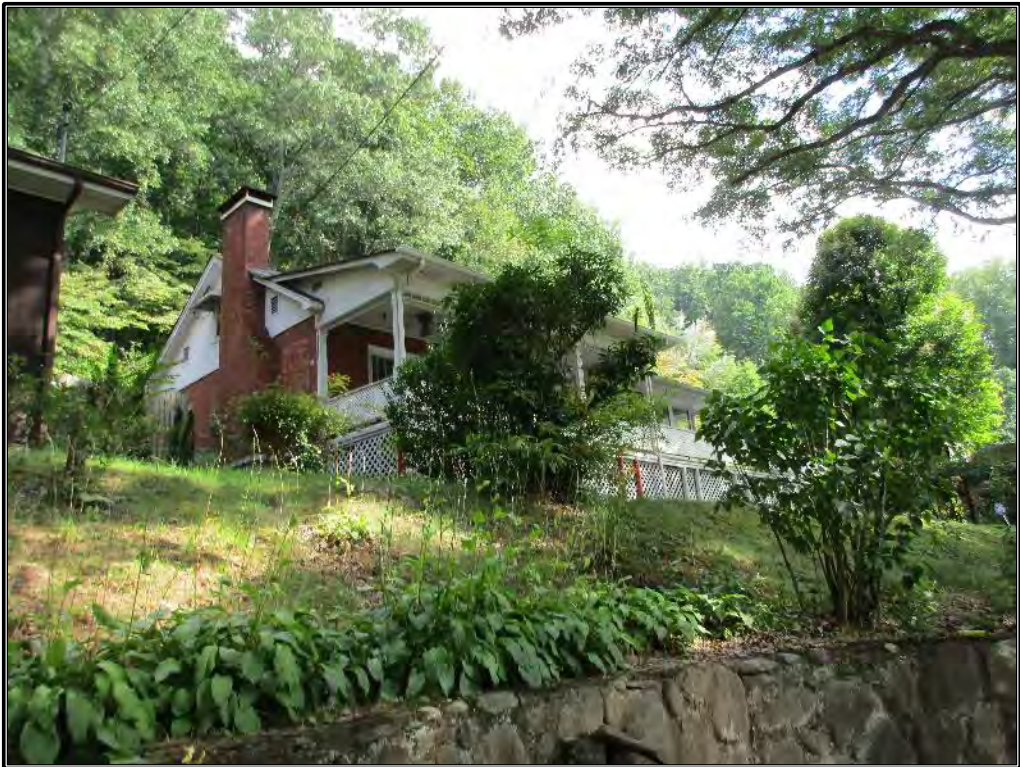
Figure 180. Northern elevation showing steeply sloping lot.

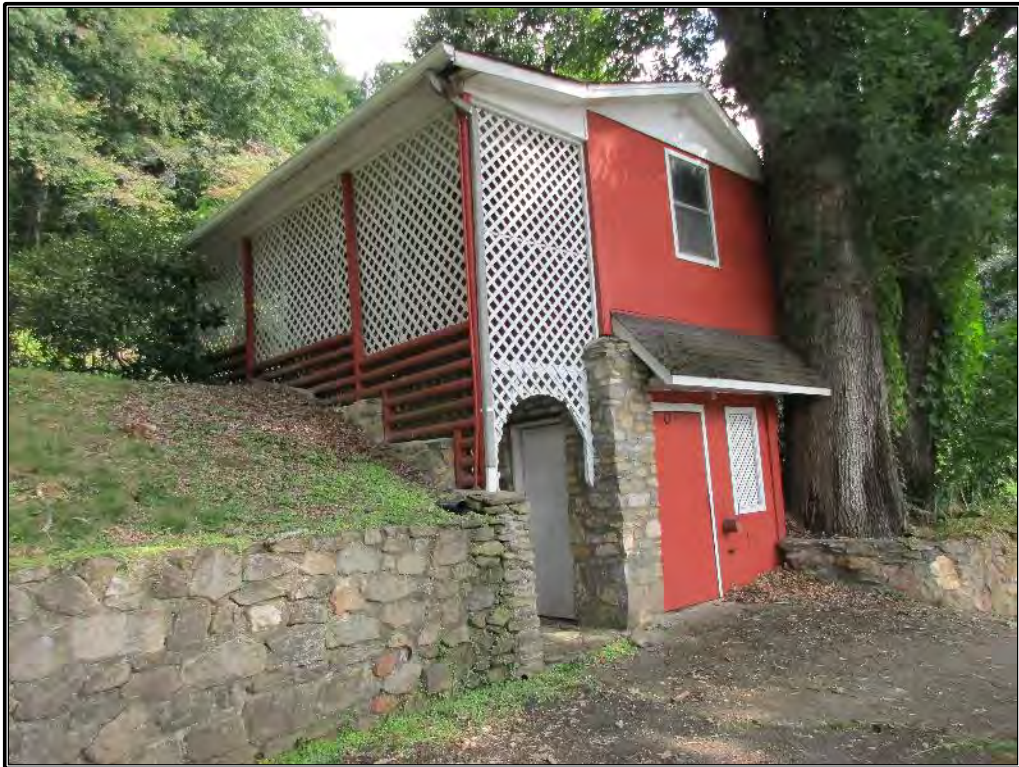
Figure 182. Northwest corner of secondary dwelling with covered steps.

Secondary residence, exterior: A circa 1975–1995 secondary residence is located approximately 20 ft west-southwest of the primary residence (Figure 182). The secondary residence displays a two-story, two-bay (w/d), front-gable form. The building is constructed on a slope. The secondary residence rests on a continuous foundation clad in a stone veneer. The exterior of the building is clad in T1-11 siding. The north elevation features a stone veneer. The roof is sheathed in asphalt shingles. The windows contain one-over-one, double-hung wood sashes. The façade of the secondary residence features a single-leaf entry filled by a wood door. A shed-roof porch with wood posts, a wood deck, and a wood railing spans the south elevation (Figure 183). A shed-roof overhang partially enclosed by a wood lattice extends from the north elevation and shelters a set of poured concrete steps. A single-leaf entry filled by a wood door pierces the elevation along the basement story. The rear elevation contains a single-leaf entry filled by a wood door along the basement level. A window covered by a wood lattice is located south (right) of the entry. A shed-roof overhang shelters the basement level of the elevation.

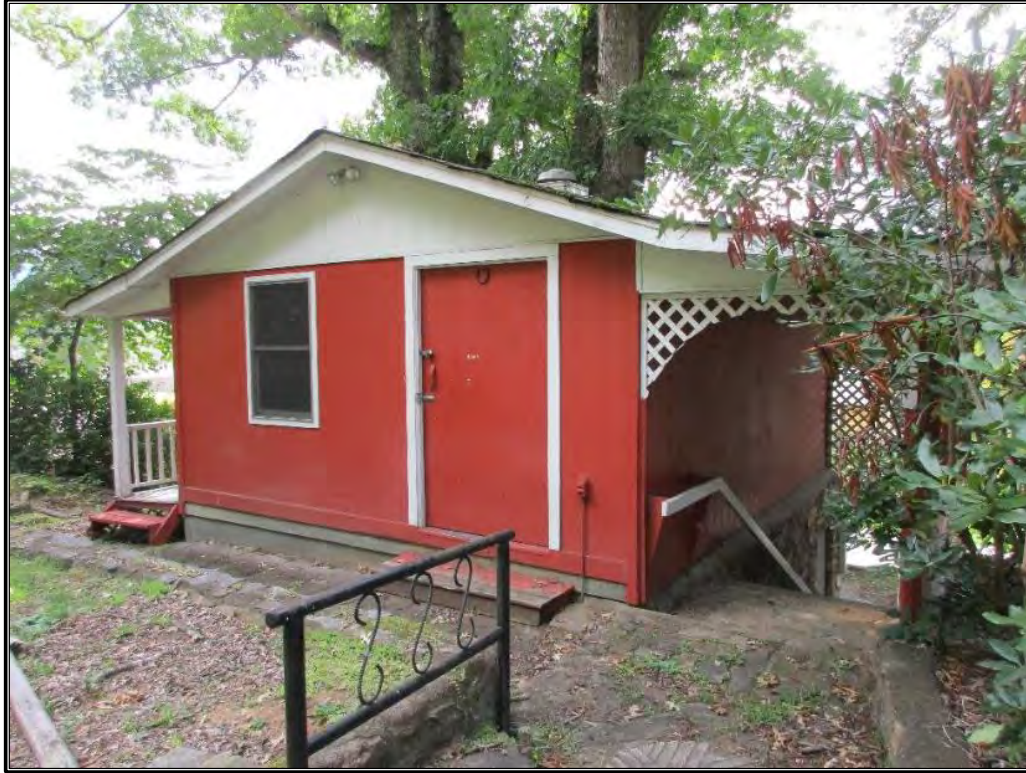
Figure 183. Rear (eastern) elevation of secondary dwelling showing southern porch and covered steps.

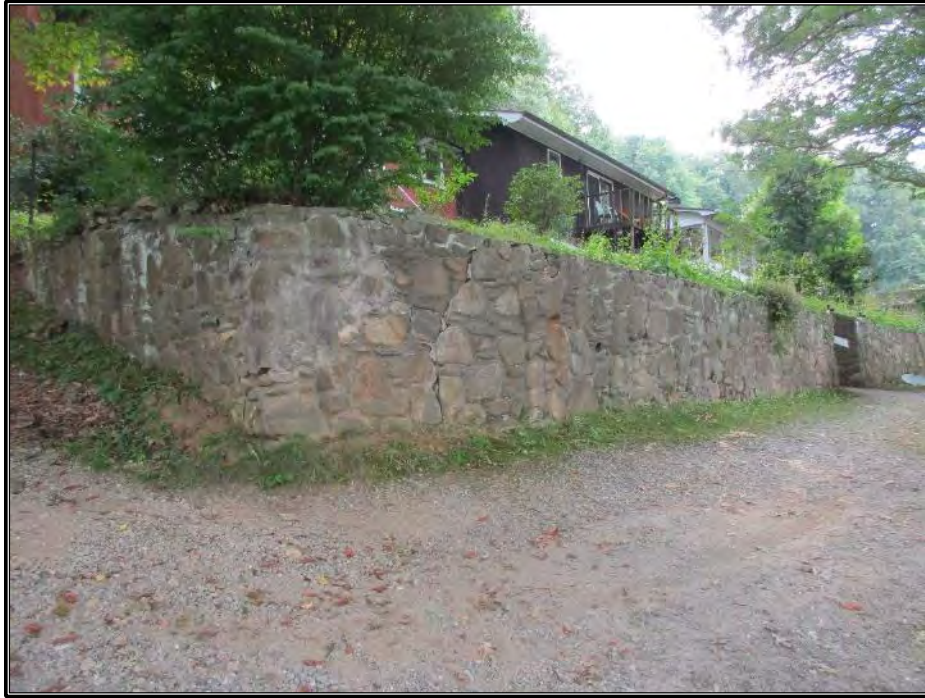
Figure 187. Stone retaining wall along service road and gravel drive with stair entry.

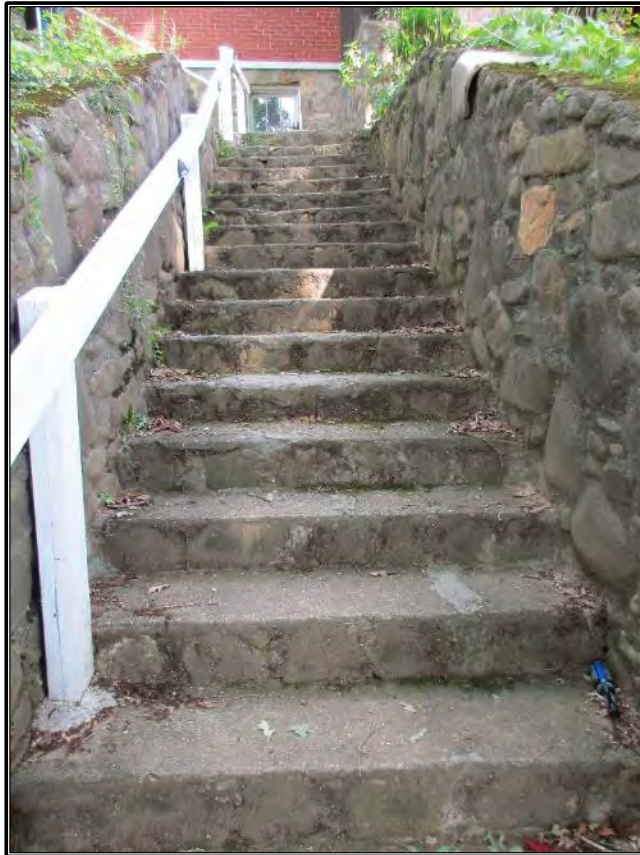
Figure 188. Stone and concrete stairs leading up the steeply sloping lot to the residence.

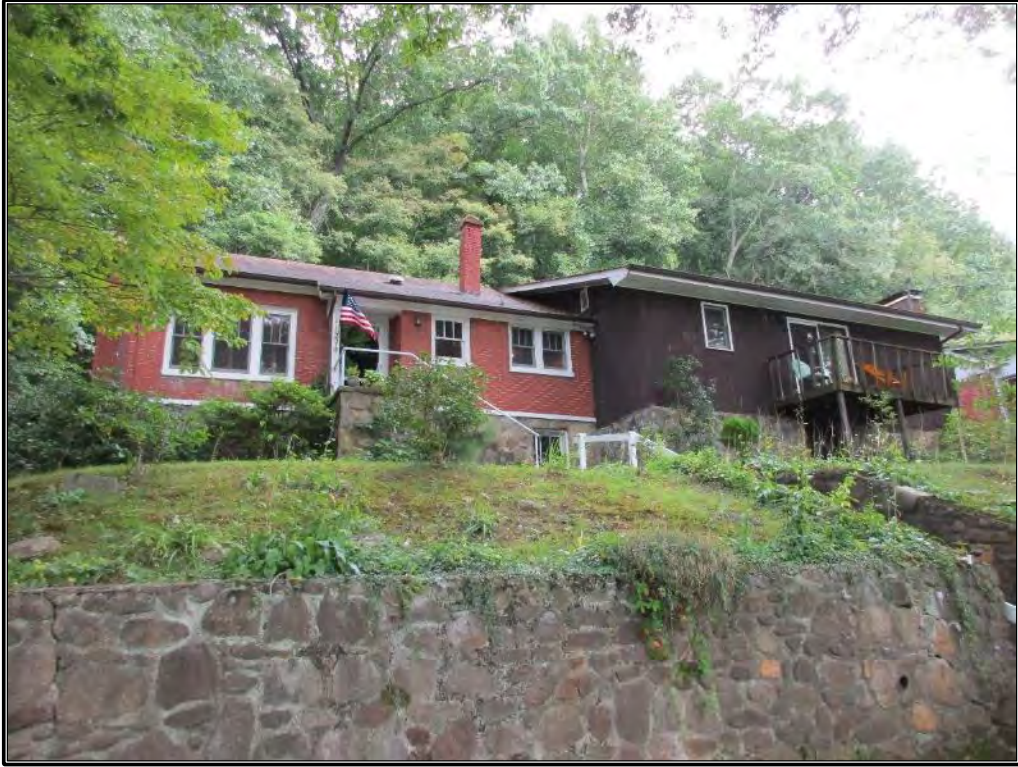
Figure 189. Façade of the residence with side addition to the south.

Design – While the three bays of the original brick-veneer structure are clearly visible from the façade, the side addition has substantially altered the design of this residence. The addition doubles the size of the House at 1153 South Main Street (HW0747) and features T1-11 and other exterior claddings that are inconsistent with the brick veneer and wood windows of the main block.

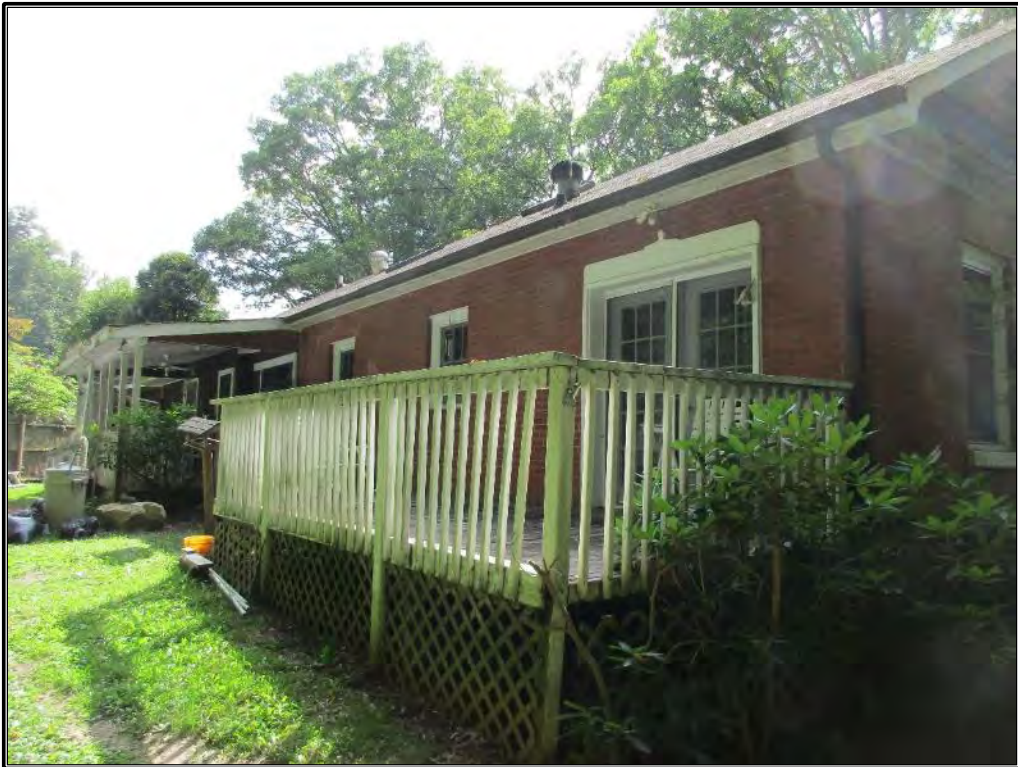
Figure 190. Rear elevation with porch.

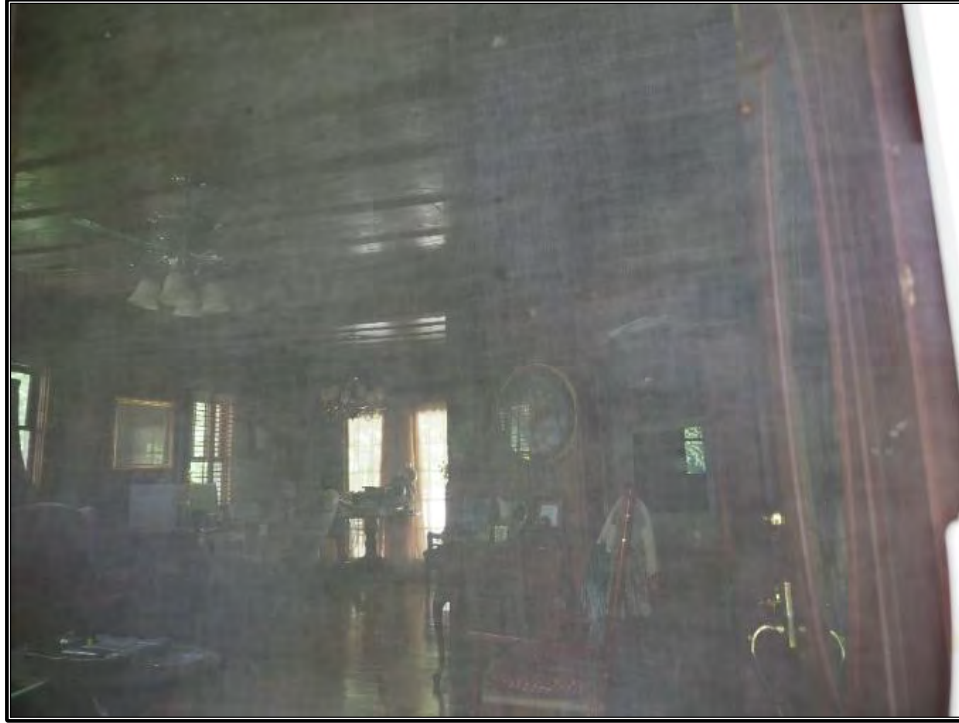
Figure 191. Limited view of living room interior from front door.

House, interior: Access to the interior of the residence could not be secured in the field. Based on a limited view from the exterior, the front entry opens into the main living room, which features hardwood floors, wood paneled walls, and a wood paneled ceiling (Figure 191). Built-in shelving lines the east wall opposite the front door. Due to limited access, further details about the interior are not available.
