SUBJECT: Historic Structures Survey Report, , Improvements to US 23 Business (South Main Street) from SR 1164 (Hyatt Creek Road) to US 276 (Pigeon Street), Waynesville, PA 17-12-0027, U-4712, Haywood County, ER 18-4249

MANAGEMENT SUMMARY	i
I. INTRODUCTION.....	1
II. METHODOLOGY.....	1
III. DESCRIPTION, HISTORIC CONTEXT, AND EVALUATION	7
CLYDE’S RESTAURANT (HW0735)	7
COMMERCIAL BUILDING (HW0736).....	18
COMMERCIAL BUILDING AND FORMER GROCERY (HW0737).....	28
REPAIR SHOP (HW0738)	41
MAPLE GROVE MOTEL (HW0739)	50
HYATT HOUSE AND CARRIAGE HOUSE.....	68
(HW0015 / HW0740).....	68
SILER HOUSE (HW0741)	88
ETHEL ROSS BRADLEY HOUSE (HW0742)	97
PEARL HYATT AND MARGARET HYATT PILARSKI HOUSE (HW0743)	110
HOUSE, 1262–1270 S. MAIN STREET (HW0744).....	119
GEORGE HOUSE (HW0745)	133
HOUSE, 1157 S. MAIN STREET (HW0746).....	143
HOUSE, 1153 S. MAIN STREET (HW0747).....	155
THE GABLES APARTMENTS (HW0096).....	163
DR. ALBERT HEYWARD SMITH, JR. HOUSE (HW0748).....	173
THE ATKINS HOUSE (HW0109)	187
THE HILLTOP TOURIST LODGE (HW0056).....	202
FORMER HOUSE, 809 S. MAIN STREET (HW0749).....	212
HOUSE, 761 SOUTH MAIN STREET (HW0750)	222
THE CHARLES RAY HOUSE (HW0055) AND CARRIAGE HOUSE (HW0751)	233

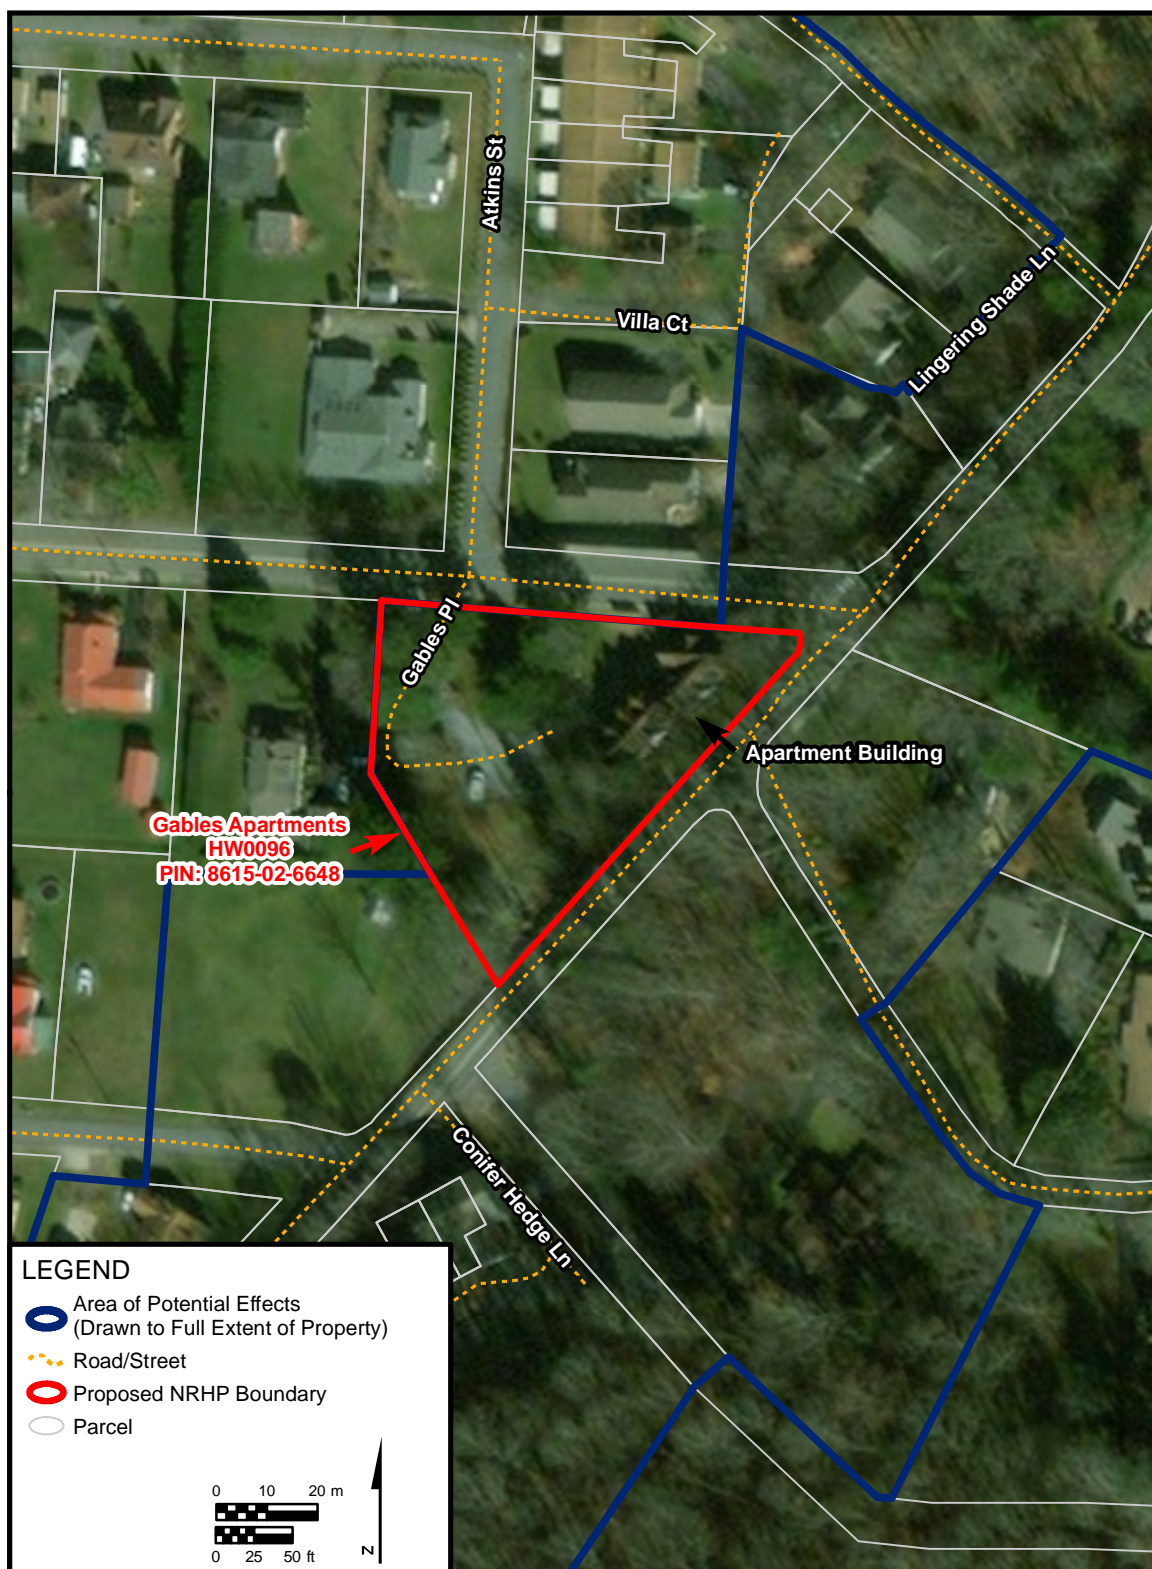
Figure 194. Map of the Gables Apartments (HW0096).

Setting: The Gables Apartments (HW0096) are situated a .92-acre parcel on the northwest side of South Main Street (US 23 Business), immediately south of its intersection of Hazelwood Avenue (Figure 194). Built into a slope with a steep grade, the apartments are the only building located on Gables Place, which is accessible from Hazelwood Avenue. The surrounding neighborhood contains historic residential development with some modern infill. A gravel parking area to the rear of the building is accessible from Gables Place. Gravel walkways lead from the parking lot to the rear entrances to the building. A brick walkway extends along the front of the apartment building and leads to a set of brick stairs lined by a metal railing that provides access to the rear parking lot (Figure 195).

The proposed NRHP-eligible boundary for the Gables Apartments (HW0096) bound by both the pavement edge of South Main Street and Hazelwood Avenue to include sidewalks and the historically steep terrain that creates the impression of a single story building from South Main Street. The boundary along Hazelwood Avenue ends just west of the driveway along a row of established cedar, pine and other specimen trees. The western boundary follows this treeline to include a small outdoor seating area and grill pit, and then turns southeast to meet South Main Street. See Figure 194 for the map depicting property boundaries and the proposed NRHP boundary.

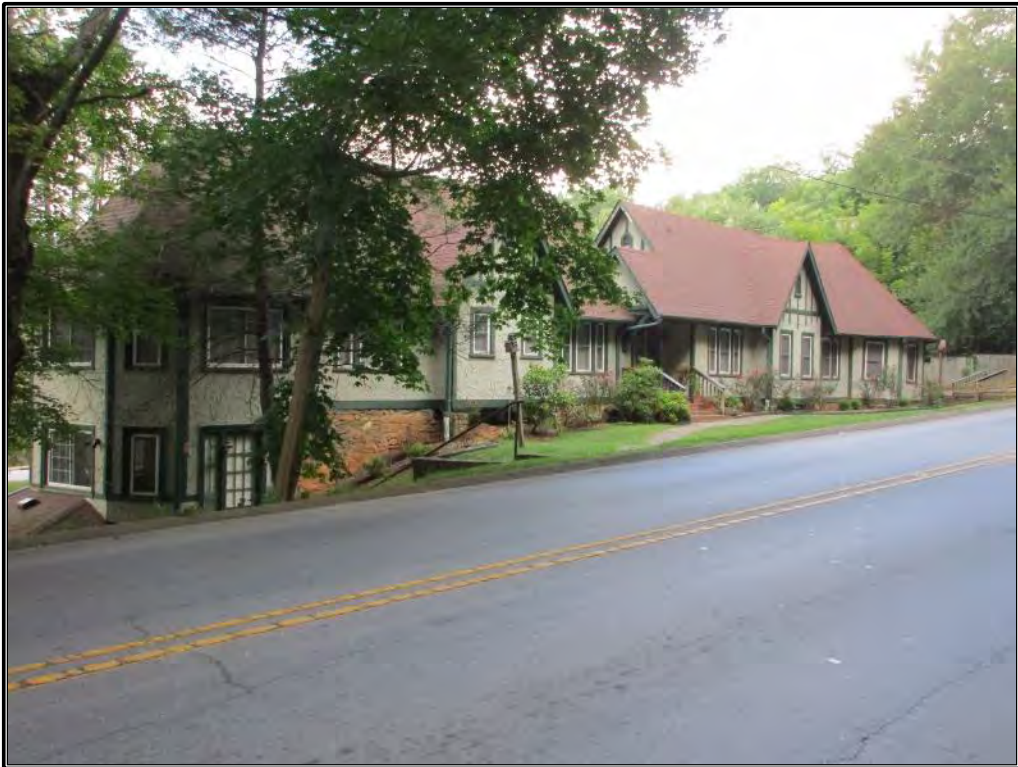
Figure 196. Southeast elevation with hyphen and entrances from sidewalk along South Main Street.

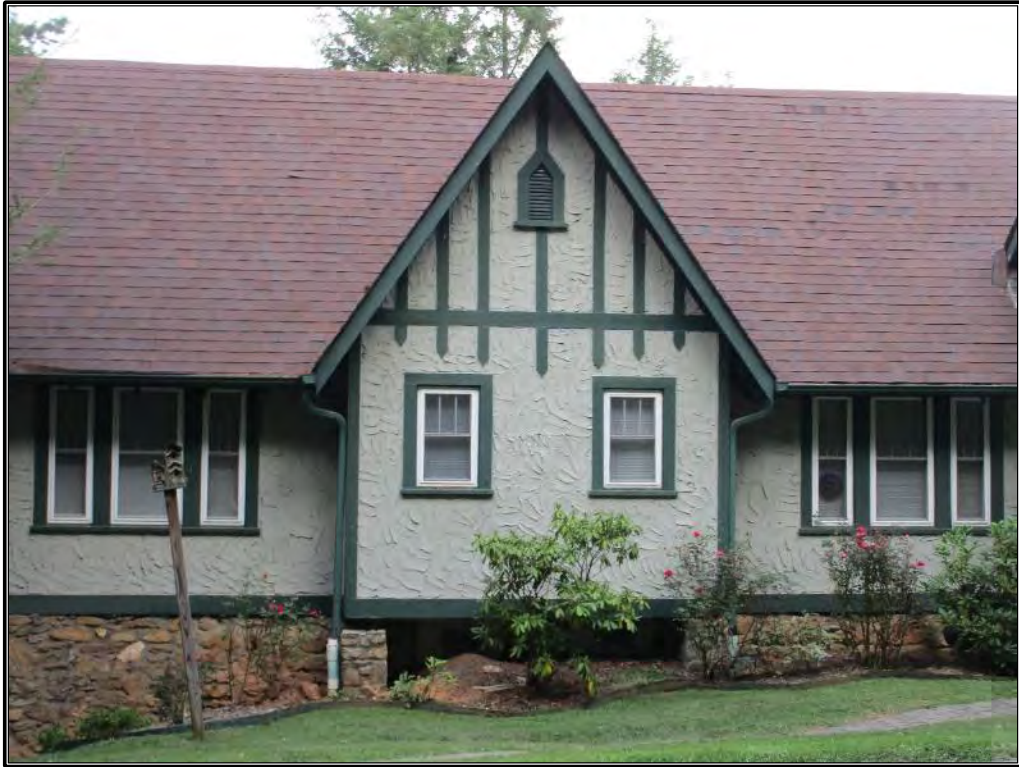
Figure 197. Detail of gable with faux half timbering.

The façade of the two sections of the building contain a central front-gable projection pierced by two single windows (see Figure 197). The projection is framed by tripartite window bays. The central hyphen, which extends from the southwest elevation of the northeast (right) section, contains the double-leaf front entry (Figure 198). The entry is arched and filled by a pair of wood doors. The entry opens onto a brick stoop accessed by a set of brick steps and sheltered by an extension of the roof overhang supported by wood brackets.

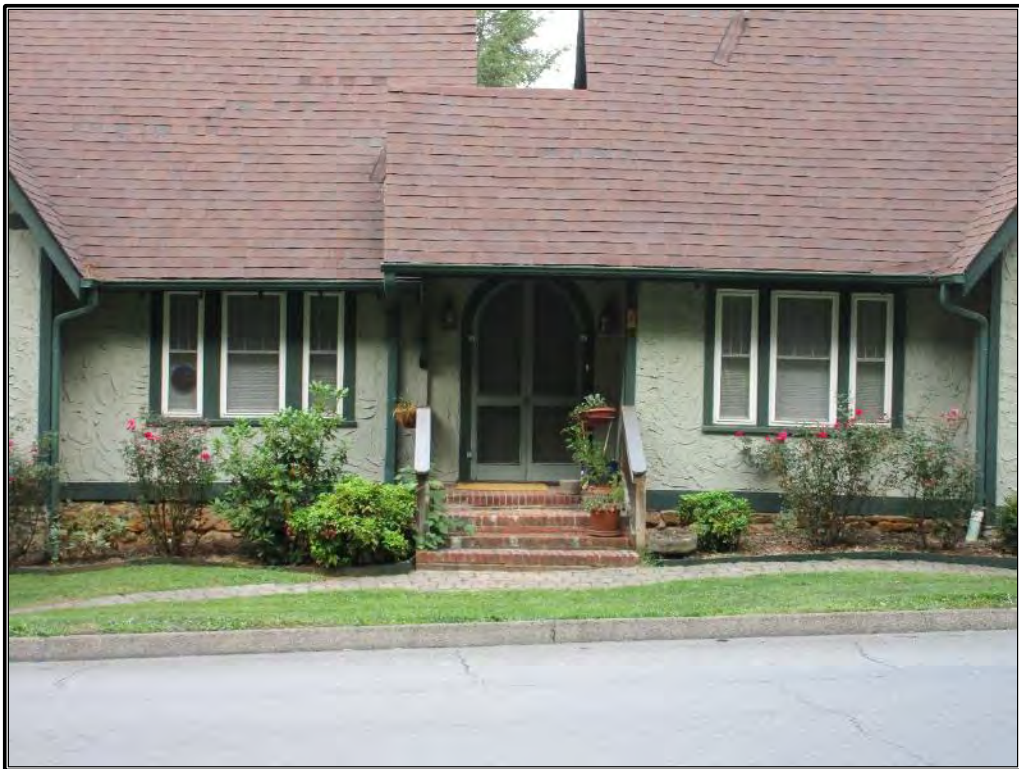
Figure 198. Detail of entry.

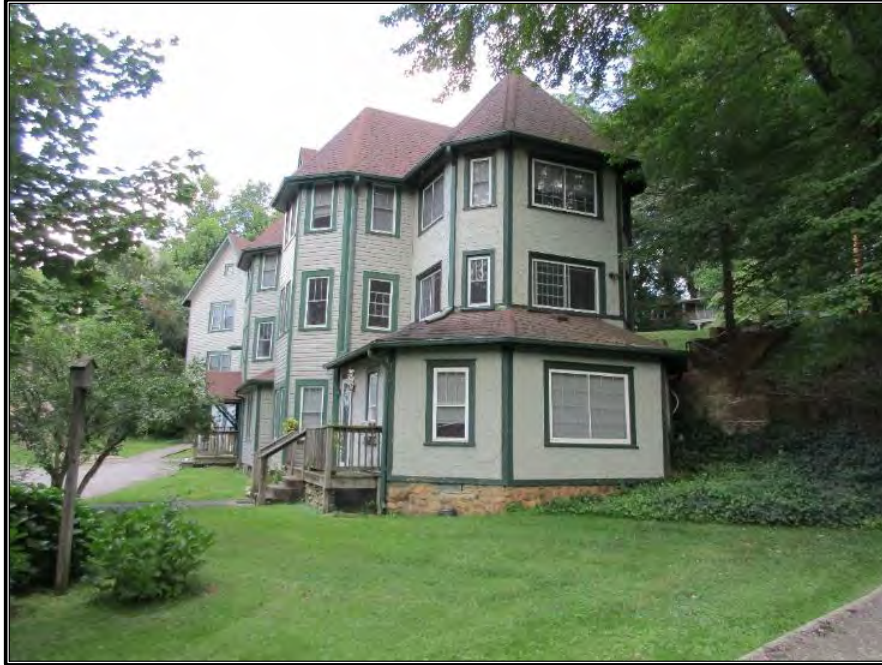
Figure 199. Southwest elevation showing the sloping lot.

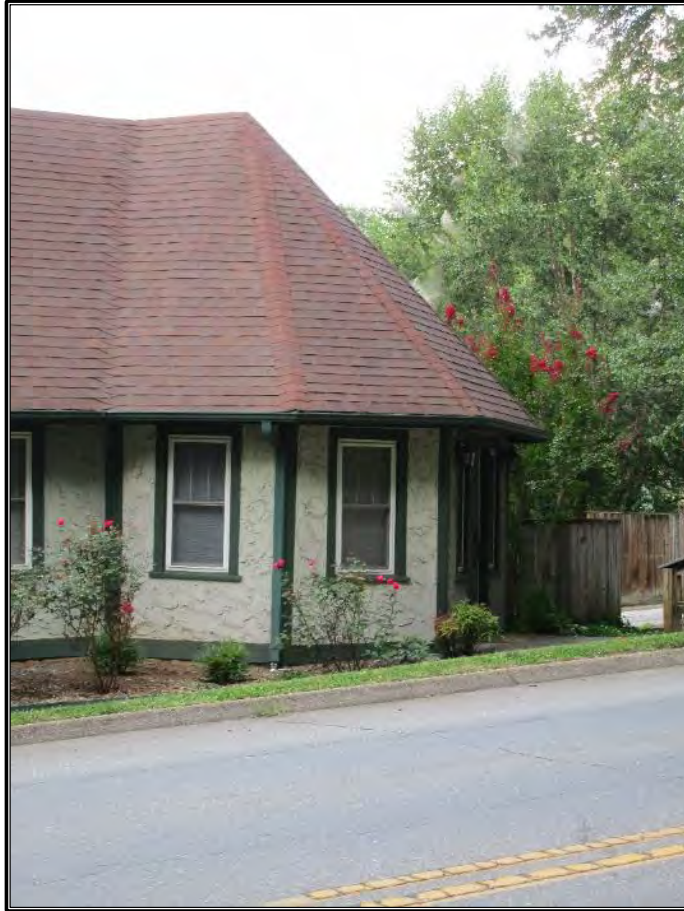
Figure 200. Northeast projection and apartment entrance.

The northeast elevation of the northeast (right) section features a one-story, five-sided projection (Figure 200). The south (side), southeast (side), northeast (side), and north elevations of the projection contain a single window. The east (façade) elevation of the projection is pierced by a single-leaf entry filled by a three-light wood door. The entry opens onto a brick landing. Narrow three-light windows flank the entry. A two-story, gable-oriented projection extends from the rear elevation of the five-sided projection. The north elevation of the gable-oriented projection features a central two-story, front-gable projection containing a single-leaf entry filled by a three-light wood door. The entry is sheltered by a front-gable hood supported by wood brackets. The entry opens onto a wood deck.

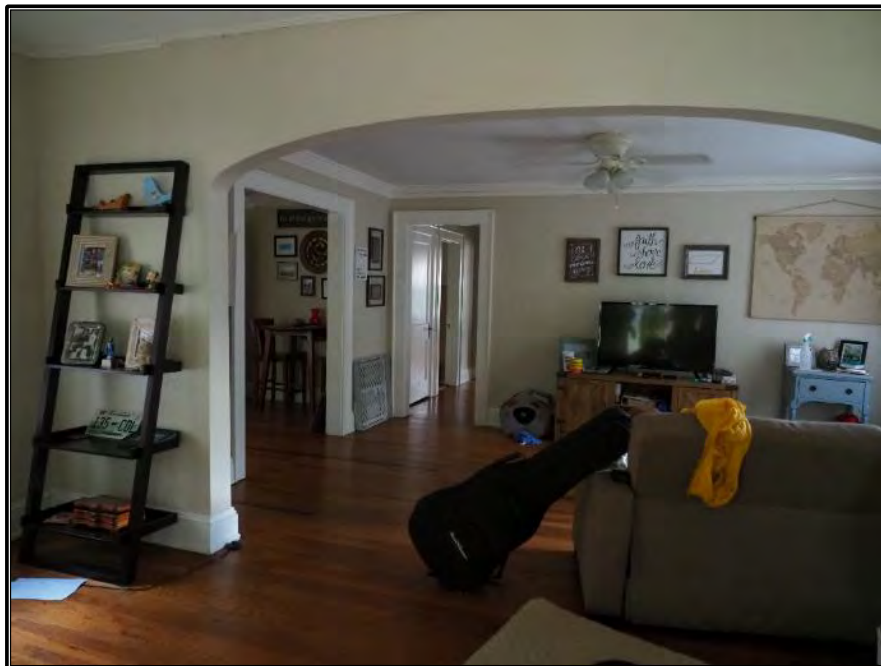
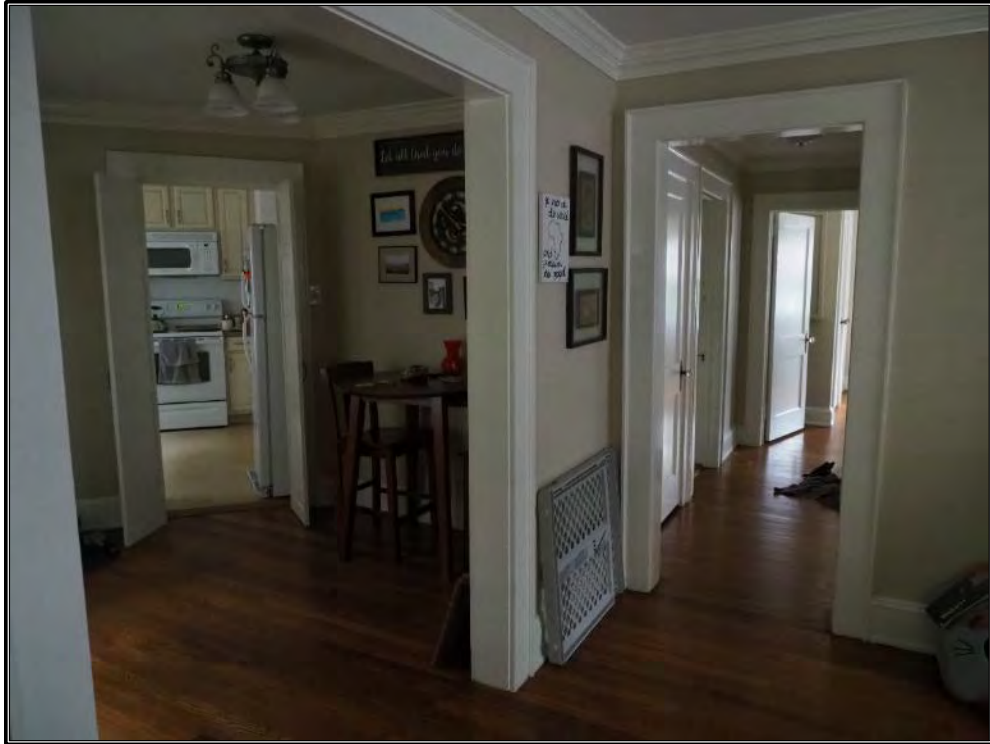
Figure 201. View of arch dividing entrance and living area in the apartment.

Figure 202. Interior of apartment showing rooms and hallways with wood flooring.

Apartment, interior: Access to the interior of one apartment was secured during the survey. Located within the five-sided projection along the northwest side of the apartment building, the apartment features hardwood floors throughout and plaster walls with simple crown molding and baseboards (Figures 201 and 202). The interior entryways and doors feature simple wood casings. The front entry opens into a foyer. An uncased archway leads from the foyer to the main living room. The kitchen occupies the south side of the apartment. A hallway off the living room leads to the west side of the apartment containing additional interior rooms that were not accessible during the survey. While the interior of other apartments in the building were not accessed during the survey, they most likely contain similar finishes and features.

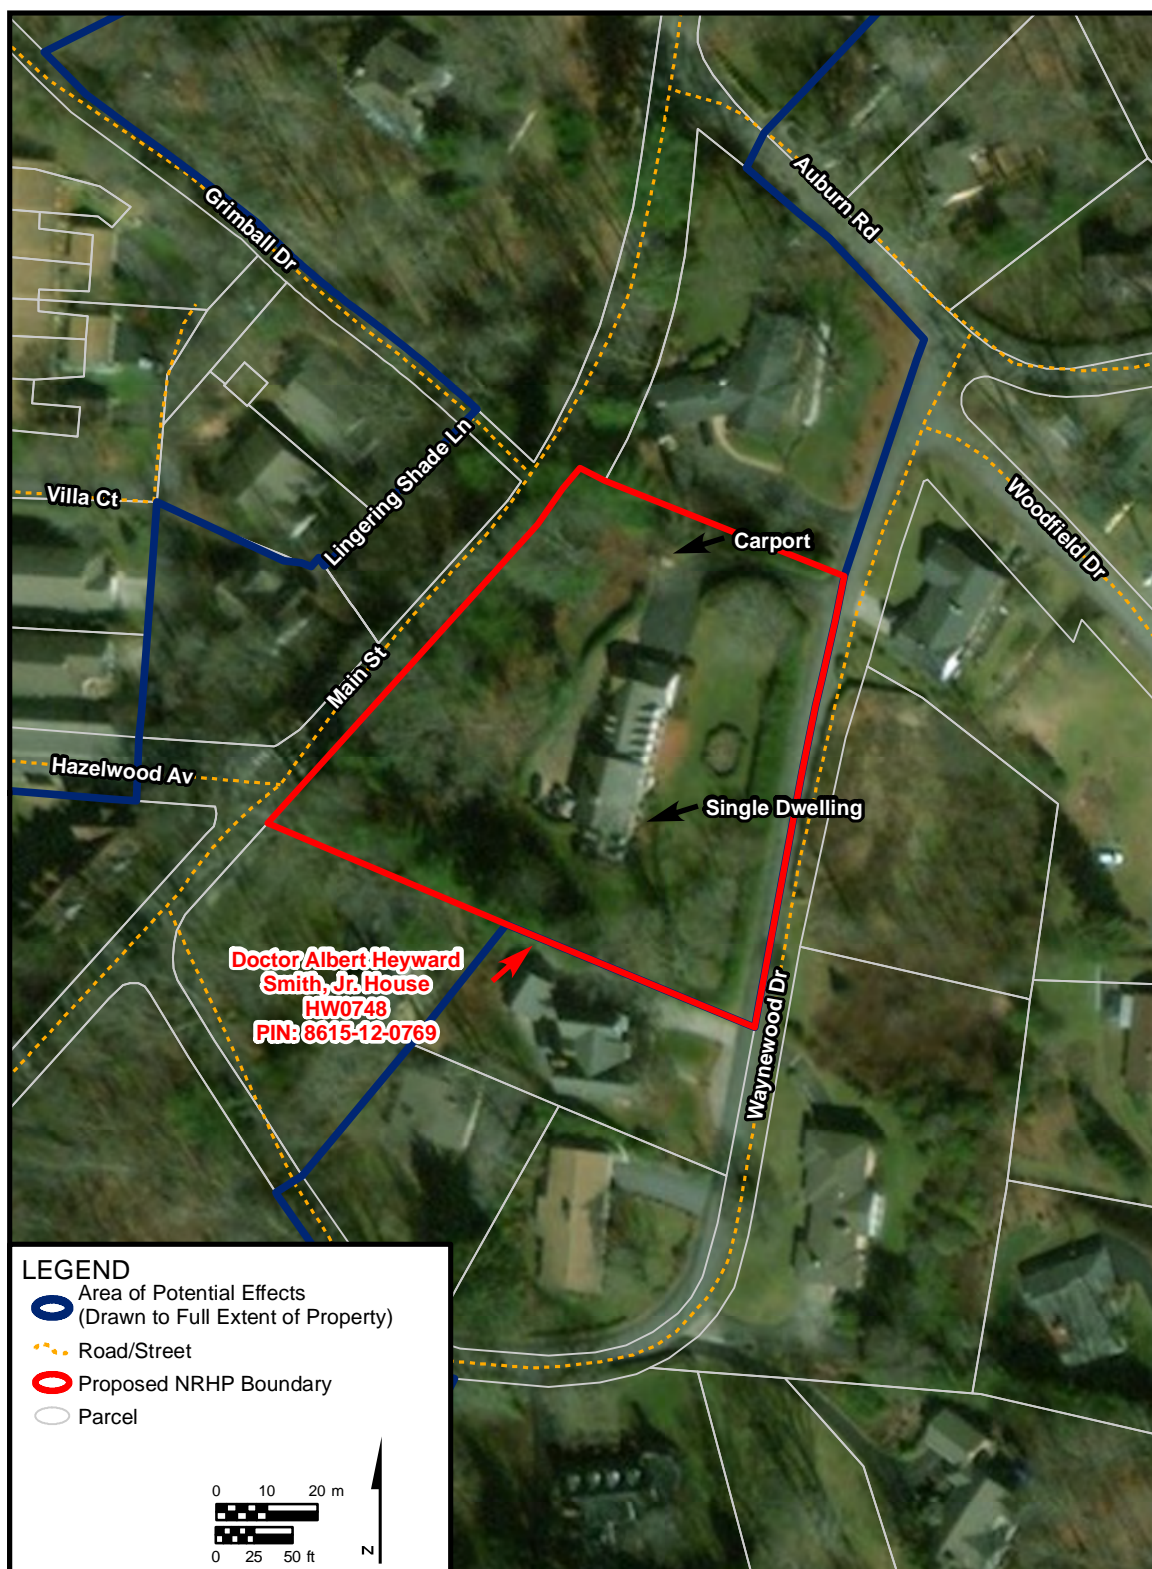
Figure 205. Map of the Dr. Albert Heyward Smith, Jr. House (HW0748).

Setting: The residence is situated on a flat, grassy 1.72-acre parcel on the west side of Waynewood Drive, approximately 245 ft south-southwest of its intersection with Auburn Road (Figure 205). Oriented toward South Main Street, the residence occupies a tree-lined property. The foundation is surrounded by hedges, shrubbery, and other plantings. A decorative hedge arch ornaments the rear lawn (Figure 206). A paved driveway north of the residence leads to a paved parking area in front of the attached garage. A brick walkway leads from the driveway to the front entry. The front yard immediately west of the residence is paved with brick. Hedges line the driveway and the front brick patio.

The proposed NRHP-eligible boundary for the Dr. Albert Heyward Smith, Jr. House (HW0748) approximates land divisions created with the Waynewood Forest subdivision. The northern boundary is defined by a thick hedge which transitions into steeply downward sloping terrain meeting South Main Street. The western border follows the pavement edge before turning east directly across from the southern edge of Hazelwood Avenue. Forested and lined with bushes, the boundary intersects with the pavement edge of Waynewood Drive to include the large privacy hedge to the east that nearly obscures the house from the road. See Figure 205 for the map depicting property boundaries and the proposed NRHP boundary.

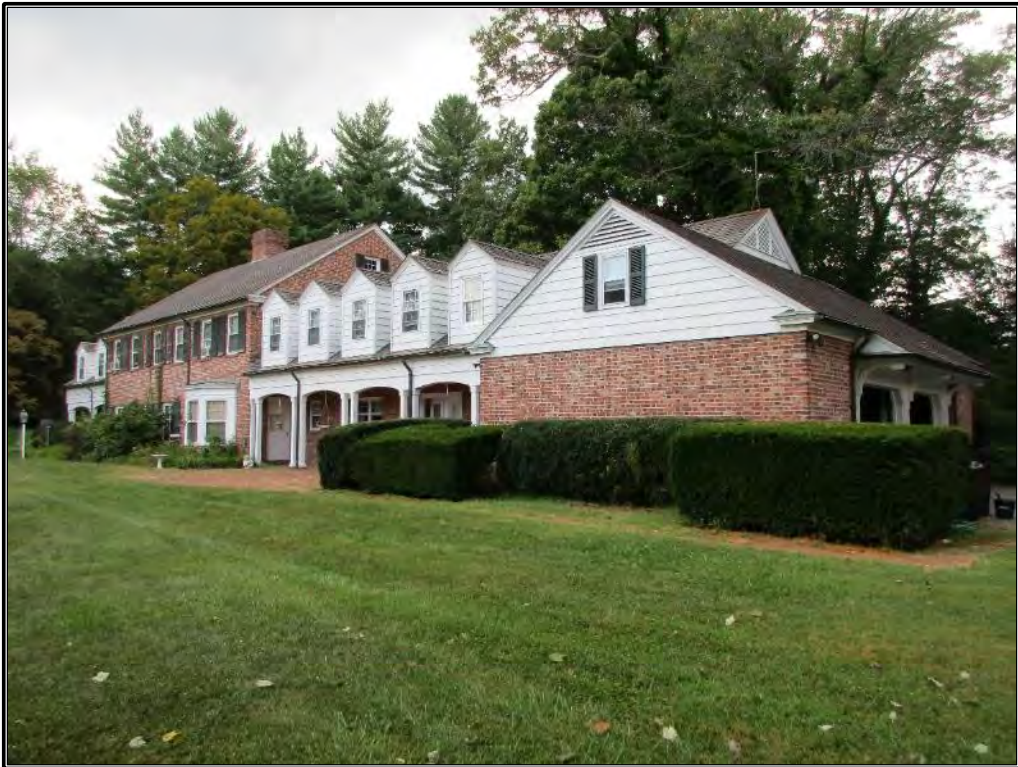
Figure 207. East elevation of the residence showing wings and dormers, as well as the central block.

House, exterior: The circa 1965 Colonial Revival-style residence presents a two-story, ten-bay (w/w/d/w/w/d/w/w/w/w/w), double-pile, side-gable form with side wings and an attached garage. The exterior is clad in a brick veneer laid in Flemish bond (Figure 207). The north wing and the rear of the south wing are clad in vinyl siding. The gable ends of the attached garage also feature vinyl siding. The roof is sheathed in asphalt shingles. The foundation is not visible. Unless otherwise indicated, the windows throughout contain eight-over-eight or six-over-six, double-hung wood sashes. The windows throughout the core of the residence and the south wing are framed by louvered wood shutters. An exterior brick chimney extends from the south elevation of the south wing. An interior brick chimney with corbelling pierces the ridgeline. The boxed eaves with gable returns feature simple molding.

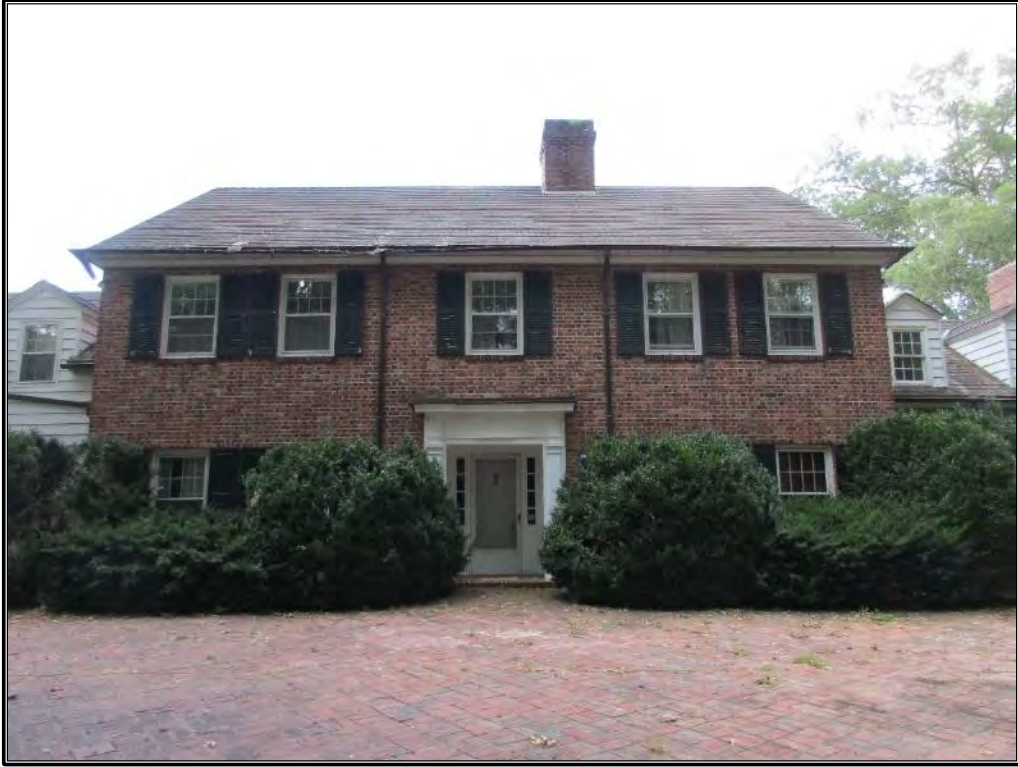
Figure 208. Façade of the residence, west elevation.

The façade of the core of the residence is defined by a central, recessed single-leaf entry filled by a wood paneled door (Figure 208). Flanked by six-light sidelights, the entry features a wood surround with engaged pilasters and a simple cornice and entablature (Figure 209). A shed-roof hood shelters the opening. The entry is framed by single windows. Five single windows pierce the façade along the second story.

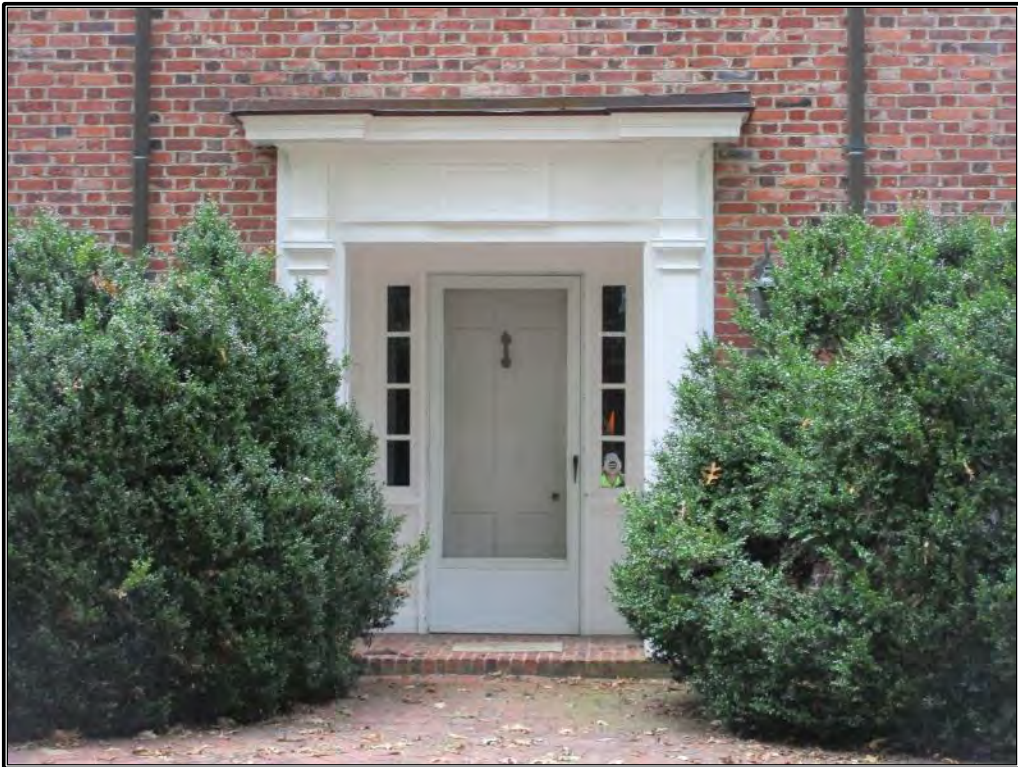
Figure 209. Detail of entry with door and sidelights.

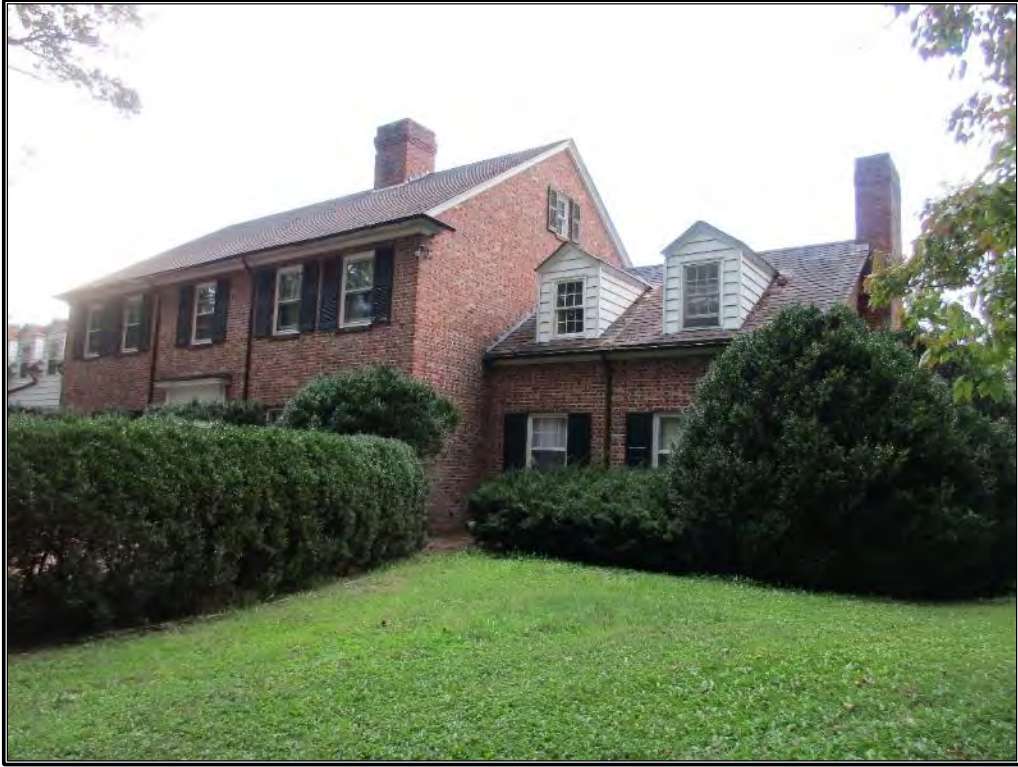
Figure 210. View of the west elevation of the southern wing.

The south elevation contains a one-and-one-half-story, side-gable wing (Figure 210). The façade elevation of the wing contains two single windows. A pair of front-gable dormers project from the front roof slope. The dormers are clad in vinyl siding and pierced by a single window. The rear elevation of the wing features an integral arcade (Figure 211). The archways are supported by wood posts with simple capitals. The arcade shelters a single-leaf entry filled by a nine-light wood door. A single window pierces the elevation south (left) of the entry. Gable-roof dormers clad in vinyl siding project from the wing's rear roof slope. The dormers are pierced by a single window. A single window bay is centered under the gable along the south elevation of the core of the residence.

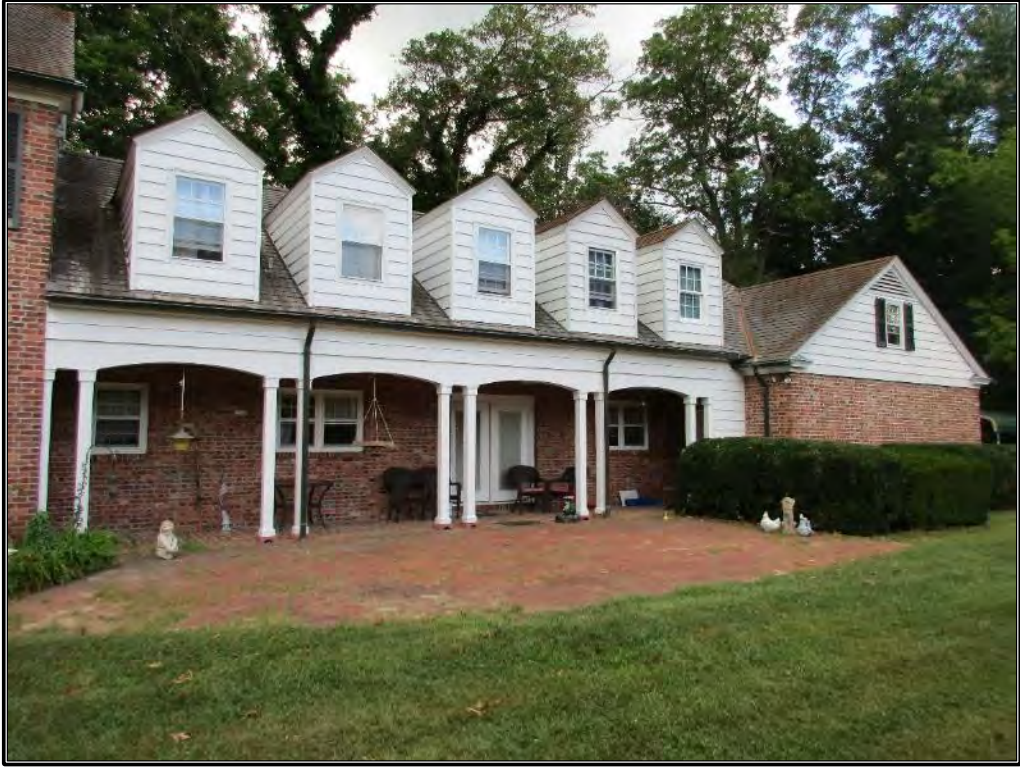
Figure 212. View of the east elevation of the northern wing.

The north elevation of the house features a one-and-one-half-story, side-gable wing. Like the south wing, the façade and rear elevations of the wing feature integral arcades (Figure 212). The façade arcade shelters a single-leaf entry filled by a wood paneled door. The entry opens onto a brick deck. A single window pierces the façade elevation south of the entry. A secondary entry pierces the north elevation of the core of the residence, which is also sheltered by the integral arcade. Three front-gable wall dormers

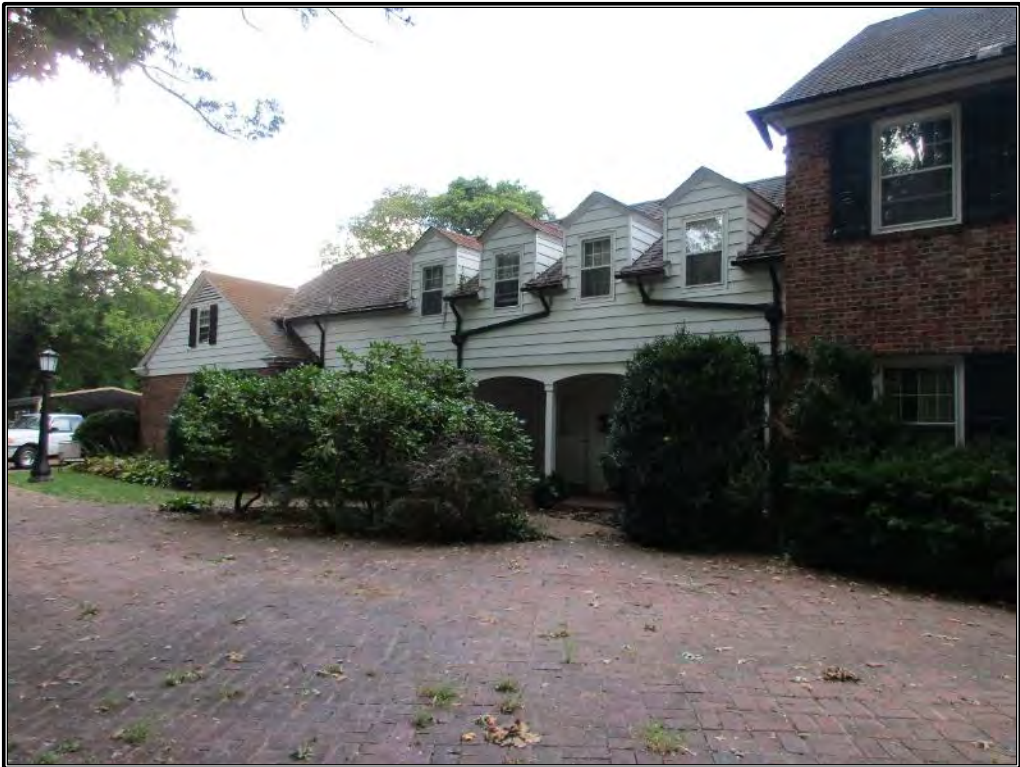
Figure 213. View of the west elevation of the northern wing.

project from the wing's façade roof slope (Figure 213). The dormers contain a single window. The one-story, side-gable, two-car garage is attached to the north elevation of the north wing. The façade of the garage contains two vehicular bays sheltered by an integral shed-roof hood supported by wood brackets (Figure 214). A single window pierces the garage's east gable. A single window is located along the west elevation of the garage. The wing's rear arcade shelters a double-leaf rear entry filled by a pair of full-light doors. A single and a paired window bay pierce the elevation south (left) of the entry. A paired window is located north (right) of the entry. Five gable-roof dormers clad in vinyl siding project from the wing's rear roof slope. The dormers are pierced by single windows. A single-leaf entry filled by a wood paneled door along the north elevation of the core of the residences is also sheltered by the arcade. A single window is centered under the gable along the south elevation of the core of the residence.

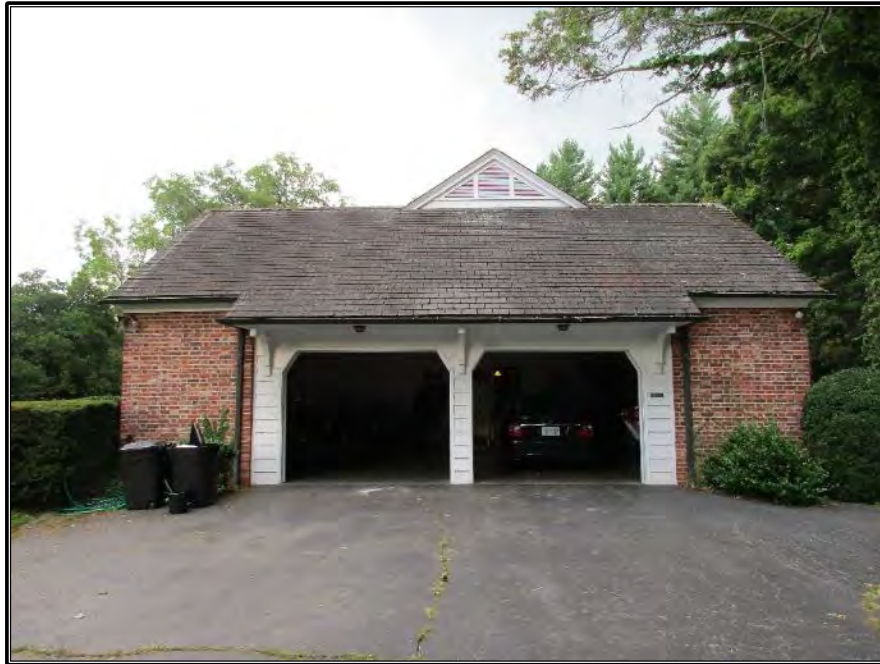
Figure 214. View of the north elevation showing the two-bay attached garage.

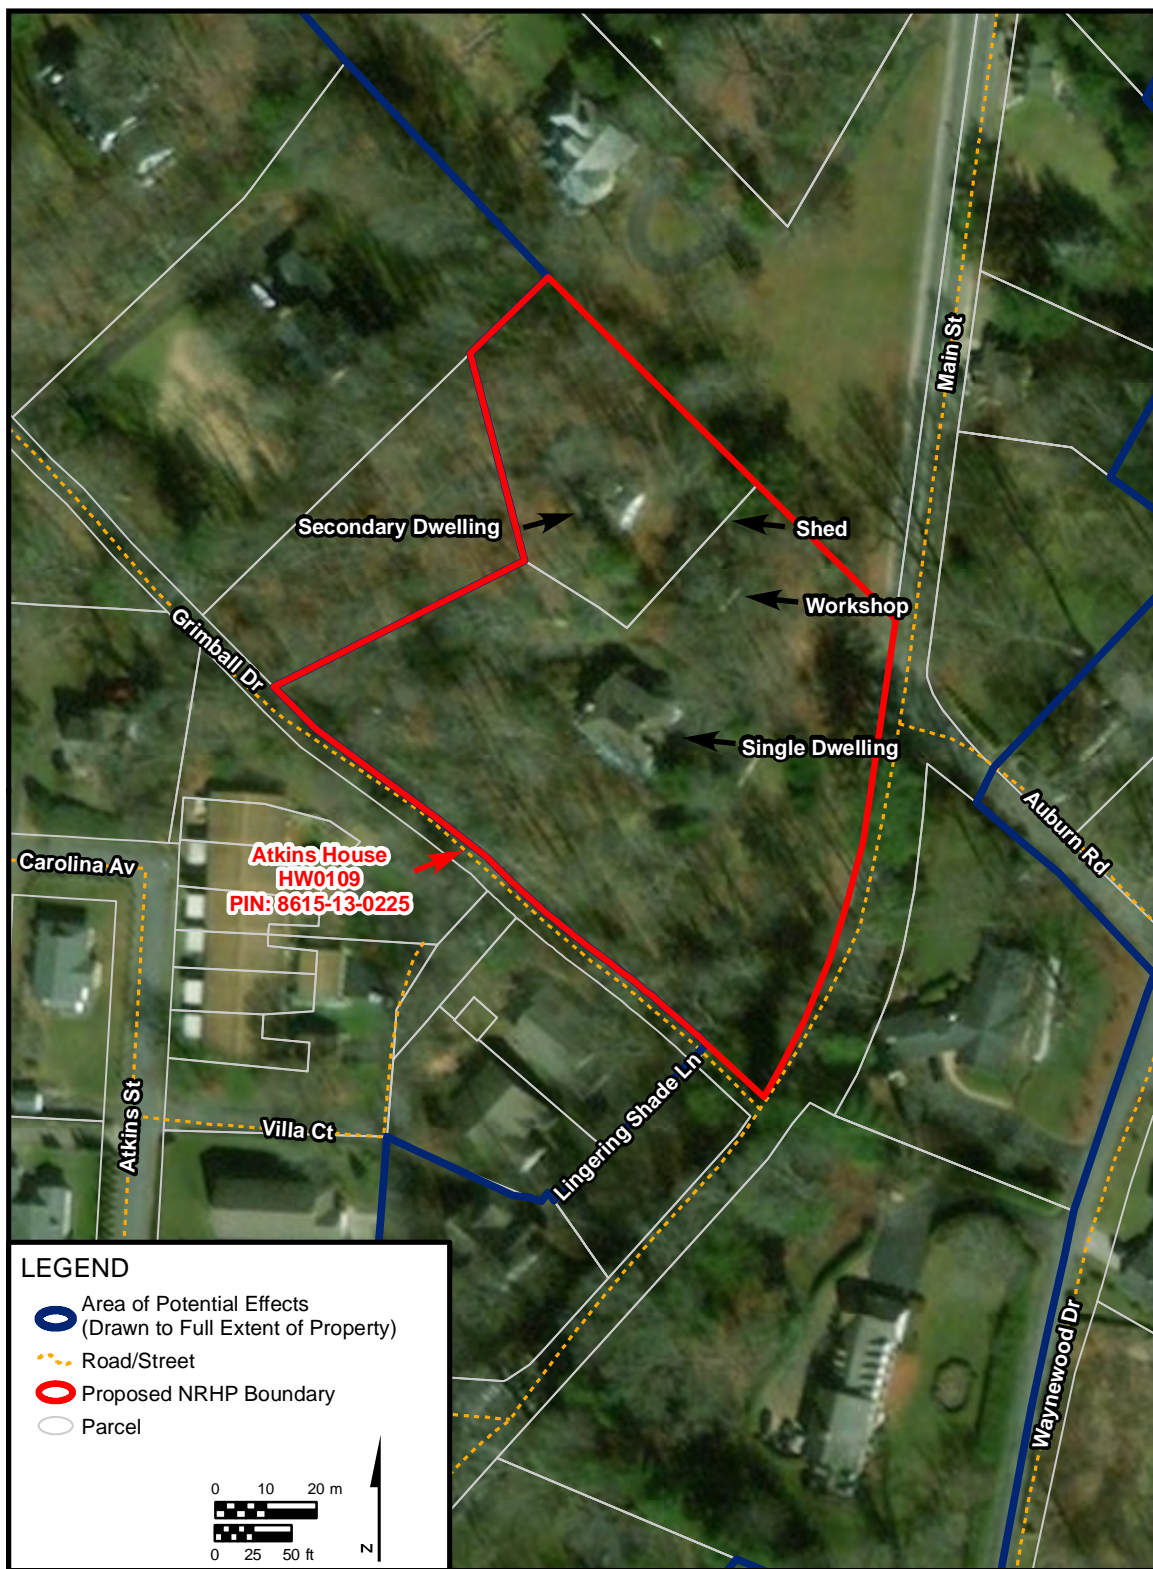
Figure 222. Map of the Atkins House (HW0109).

Setting: The Atkins House is situated northeast side of Grimball Drive, approximately 200 ft west-northwest of its intersection with South Main Street (US 23 Business). The property is divided into two parcels. The primary residence and associated workshop occupy a 1.82-acre parcel (Figure 222). An adjoining .52-acre parcel contains the associated secondary residence. The primary residence is situated on a hill and surrounded by trees. The foundation is lined with bushes and other plantings. A paved looping driveway northwest of the residence branches from the loop toward the rear of the residence along a stone retaining wall (Figure 223). A branch along the northwest side of the driveway extends toward the secondary residence and workshop. A stuccoed wall extends along the southwest side of the property, creating a buffer along Grimball Drive (Figure 224). A metal gate within a set of gateposts frames the entrance to the driveway (Figure 225). A set of brick stairs lined by a brick retaining wall and a metal railing extend from the driveway to the front porch. A metal lamp post is located at the base of the stairs. A pathway leads from the rear of the house to the associated workshop and secondary residence.

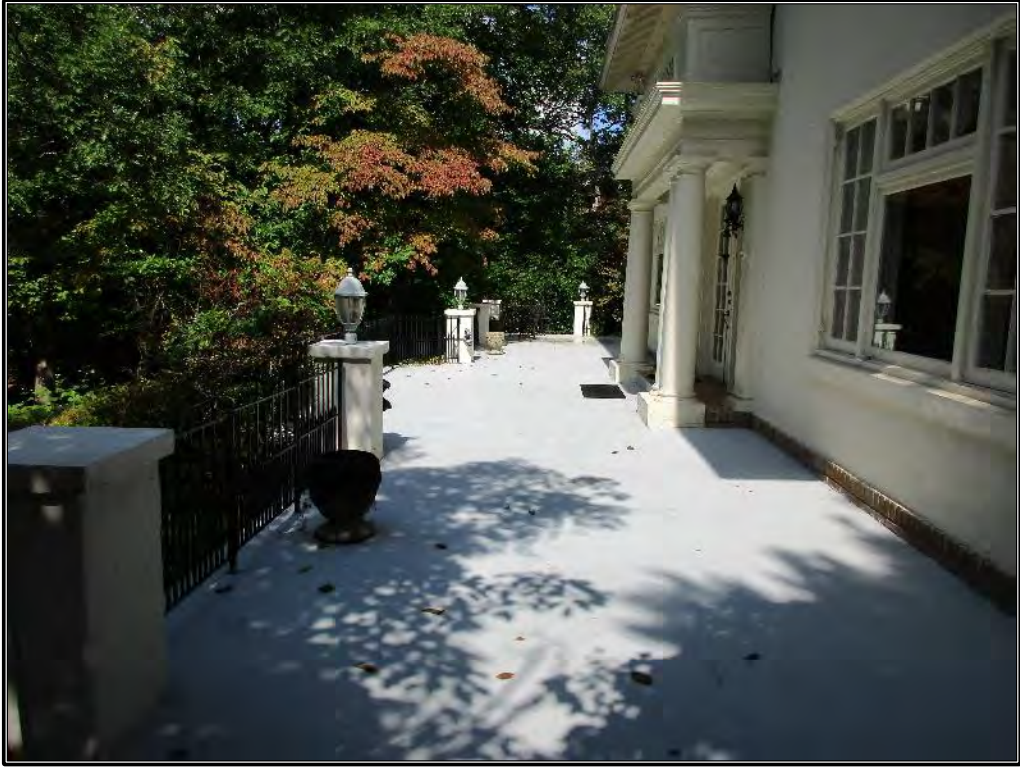
Figure 226. Façade of the Atkins House (HW0109).

House, exterior: The circa 1924 Colonial Revival-style residence with some Craftsman detailing presents a two-story, three-bay (www/d/www), double-pile, hip-roof form with a side porch and a sun room (Figure 226). The dwelling rests on a continuous basement foundation clad in stucco. The exterior is covered in stucco and the roof is sheathed in asphalt shingles. Unless otherwise indicated, the first-story windows contain twelve-light wood casement sashes and the second-story windows present six-over-one, double-hung wood sashes. The windows throughout feature simple wood surrounds and wood sills. The upper-story windows are framed by louvered wood shutters with crescent moon cutouts. An exterior brick chimney with a metal cap extends from the southeast and northwest elevation. An interior brick chimney pierces the southeast roof slope. Exposed rafter tails are visible under the wide eaves.

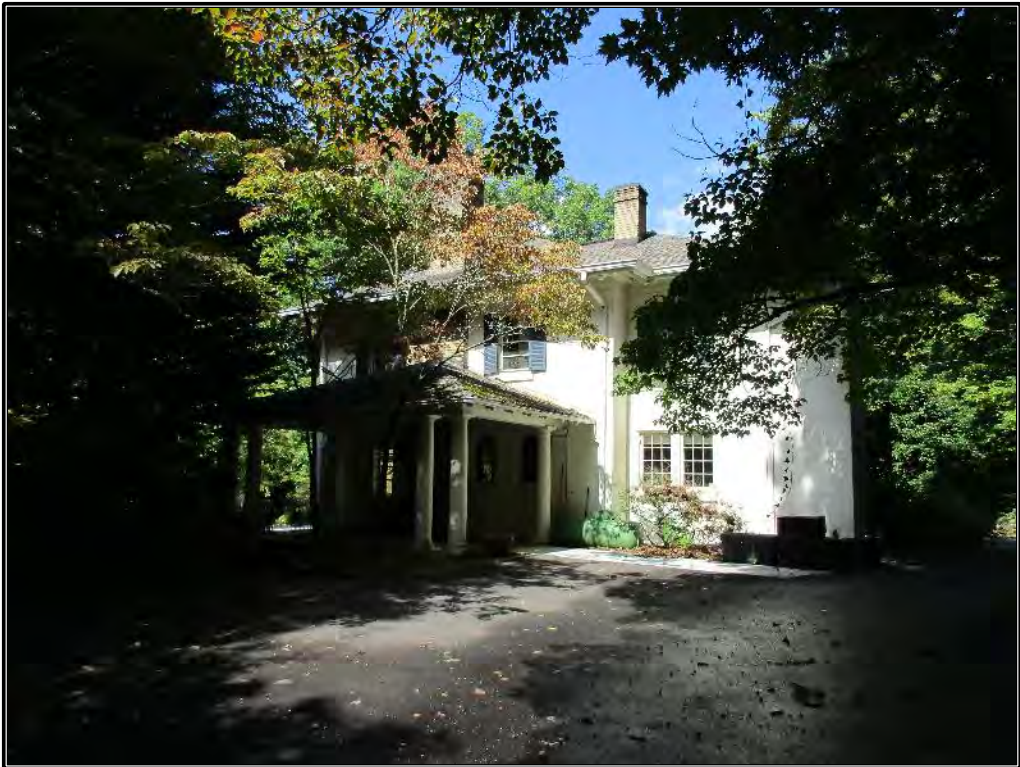
Figure 227. Detail of front porch and entrance.

The façade of the Atkins House features a central double-leaf entry filled by a pair of multi-light wood doors (Figure 227). The entry is flanked by multi-light sidelights and is framed by pilasters. It opens onto a brick landing. A flat-roof portico, sheltering a poured concrete deck and the house's primary entry, is supported by paired Tuscan columns set on poured concrete piers. A wood balustrade extends along the roof of the portico. The poured concrete deck spans the width of the façade. The deck is lined by a metal railing punctuated by poured concrete gateposts topped with light fixtures. The front entry is flanked by four-part windows consisting of a central picture window flanked by eight-light wood casement windows and topped with a four-light transom. A paired window and two ribbons of three windows pierce the second story of the façade.

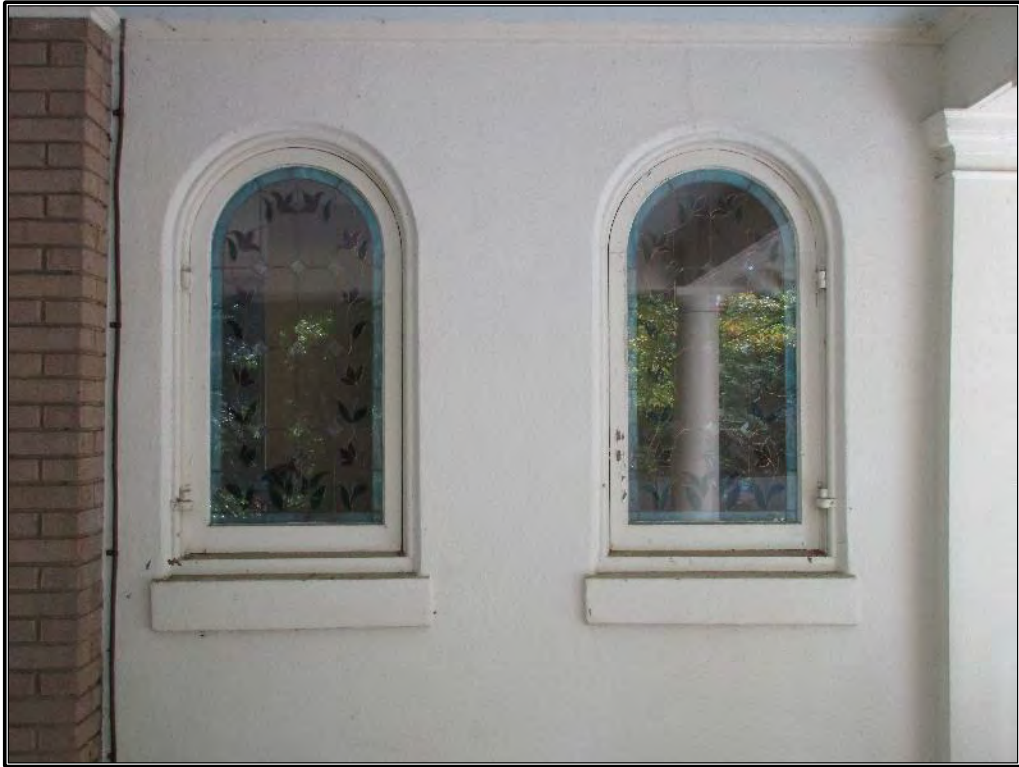
Figure 228. Northeast side elevation with hip-roof porch.

The southeast elevation features a two-story, hip-roof wing with a single-leaf side entry filled by a multi-light wood door (Figure 228). The entry opens onto a partial-width, single-bay porch with a hipped roof supported by paired Tuscan columns set on a brick deck. Two arched windows northeast (right) of the side entry contain wood casement sashes with stained glass (Figure 229). A two-story, hip-roof wing
