SUBJECT: Historic Structures Survey Report, , Improvements to US 23 Business (South Main Street) from SR 1164 (Hyatt Creek Road) to US 276 (Pigeon Street), Waynesville, PA 17-12-0027, U-4712, Haywood County, ER 18-4249

MANAGEMENT SUMMARY	i
I. INTRODUCTION.....	1
II. METHODOLOGY.....	1
III. DESCRIPTION, HISTORIC CONTEXT, AND EVALUATION	7
CLYDE’S RESTAURANT (HW0735)	7
COMMERCIAL BUILDING (HW0736).....	18
COMMERCIAL BUILDING AND FORMER GROCERY (HW0737).....	28
REPAIR SHOP (HW0738)	41
MAPLE GROVE MOTEL (HW0739)	50
HYATT HOUSE AND CARRIAGE HOUSE.....	68
(HW0015 / HW0740).....	68
SILER HOUSE (HW0741)	88
ETHEL ROSS BRADLEY HOUSE (HW0742)	97
PEARL HYATT AND MARGARET HYATT PILARSKI HOUSE (HW0743)	110
HOUSE, 1262–1270 S. MAIN STREET (HW0744).....	119
GEORGE HOUSE (HW0745)	133
HOUSE, 1157 S. MAIN STREET (HW0746).....	143
HOUSE, 1153 S. MAIN STREET (HW0747).....	155
THE GABLES APARTMENTS (HW0096).....	163
DR. ALBERT HEYWARD SMITH, JR. HOUSE (HW0748).....	173
THE ATKINS HOUSE (HW0109)	187
THE HILLTOP TOURIST LODGE (HW0056).....	202
FORMER HOUSE, 809 S. MAIN STREET (HW0749).....	212
HOUSE, 761 SOUTH MAIN STREET (HW0750)	222
THE CHARLES RAY HOUSE (HW0055) AND CARRIAGE HOUSE (HW0751)	233

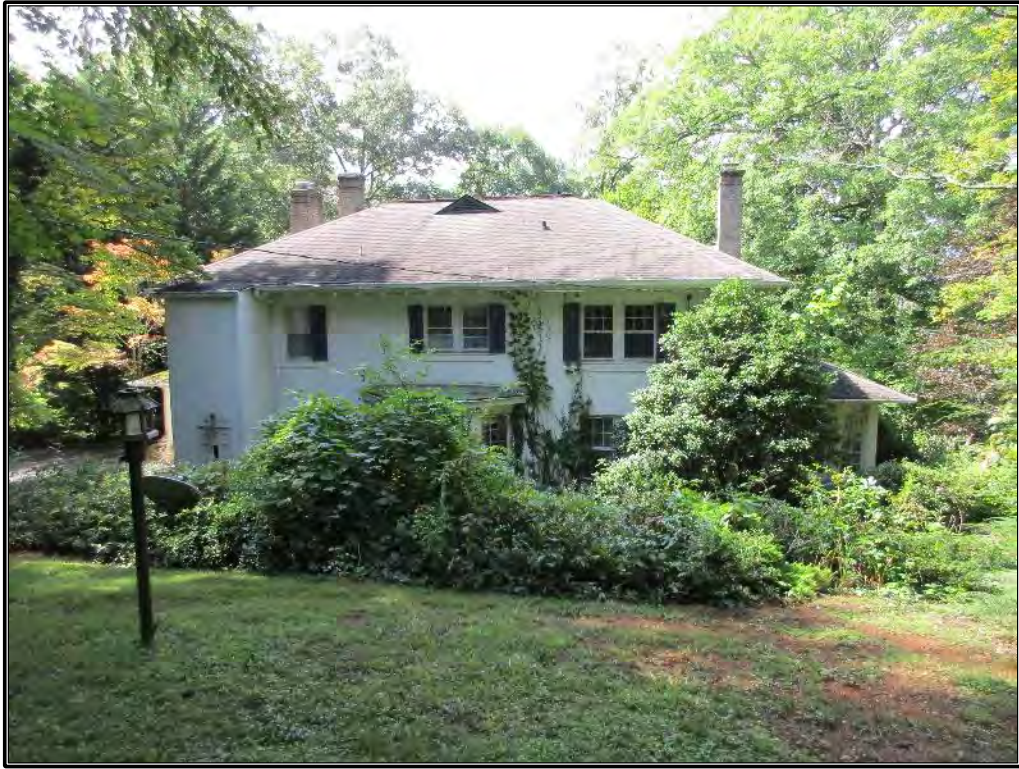
Figure 230. View of western elevation with sunroom.

extends from the northwest elevation containing a one-story, hip-roof sun room (Figure 230). The sun room features full-height windows along the southwest, northwest, and rear elevations. The windows contain elongated twelve-light fixed wood sashes and twelve-light paired wood casement sashes. The rear elevation features a central canted bay window along the first story (Figure 231). A two-story, shed-roof projection extends from the southeast side of the elevation. A single-leaf entry filled by a single-light wood paneled door pierces the rear elevation of the projection. The basement is partially exposed along the rear elevation. A single window filled by a single-light wood sash pierces the rear elevation along the basement story. A gable-roof eyebrow projects from the roof slope.

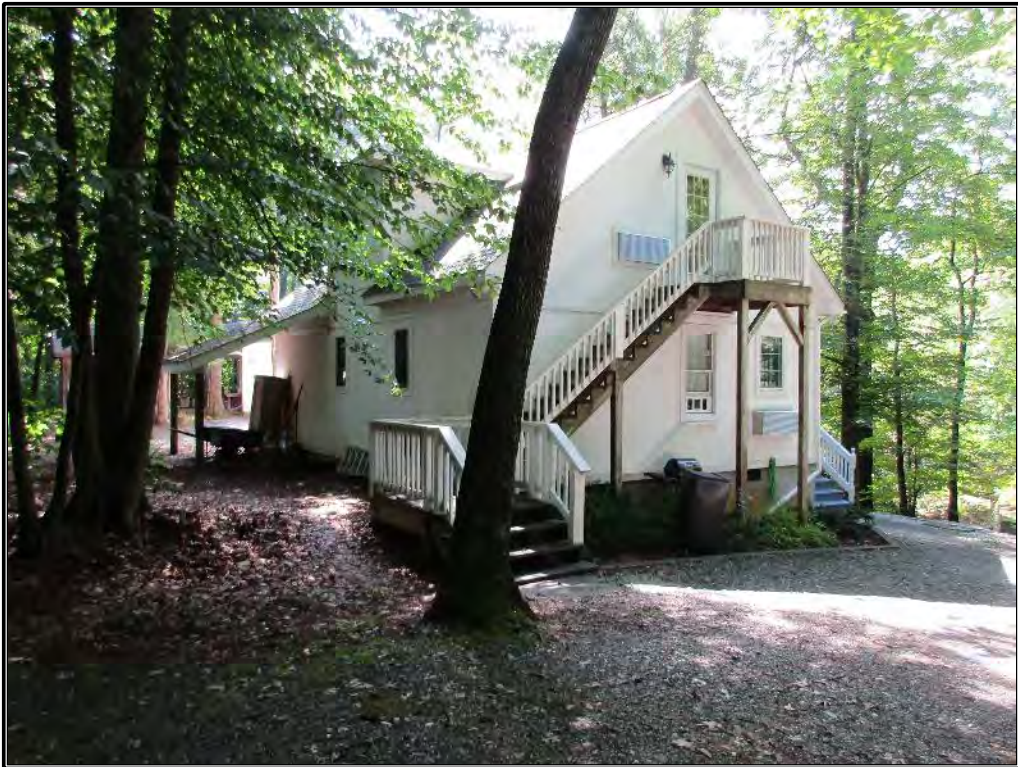
Figure 233. Secondary dwelling façade looking north.

Secondary Residence: The circa 1995–1998 secondary residence is located approximately 95 ft north of the primary residence (Figure 233). The secondary residence presents a one-and-one-half-story, three-bay (w/d/w), double-pile, side-gable form. The dwelling rests on a poured concrete foundation and the exterior is covered with stucco. The roof is sheathed in asphalt shingles. The windows throughout display either one-over-one, double-hung vinyl sashes or single-light vinyl sashes with false grids. The façade features two single-leaf entries filled by multi-light wood doors. The entries open onto a partial-width, three-bay front porch with a front-gable roof supported by wood columns set on a wood deck. The porch is lined by a wood railing and accessed by a set of wood steps along its northwest (left) and southeast (right) sides. The northwest elevation contains a single-leaf entry along the second story filled by a multi-light door. The entry opens onto an elevated wood landing accessed by a set of wood stairs. A shed-roof overhang supported by wood posts extends from the rear elevation (Figure 234). A hip-roof dormer projects from the rear roof slope.

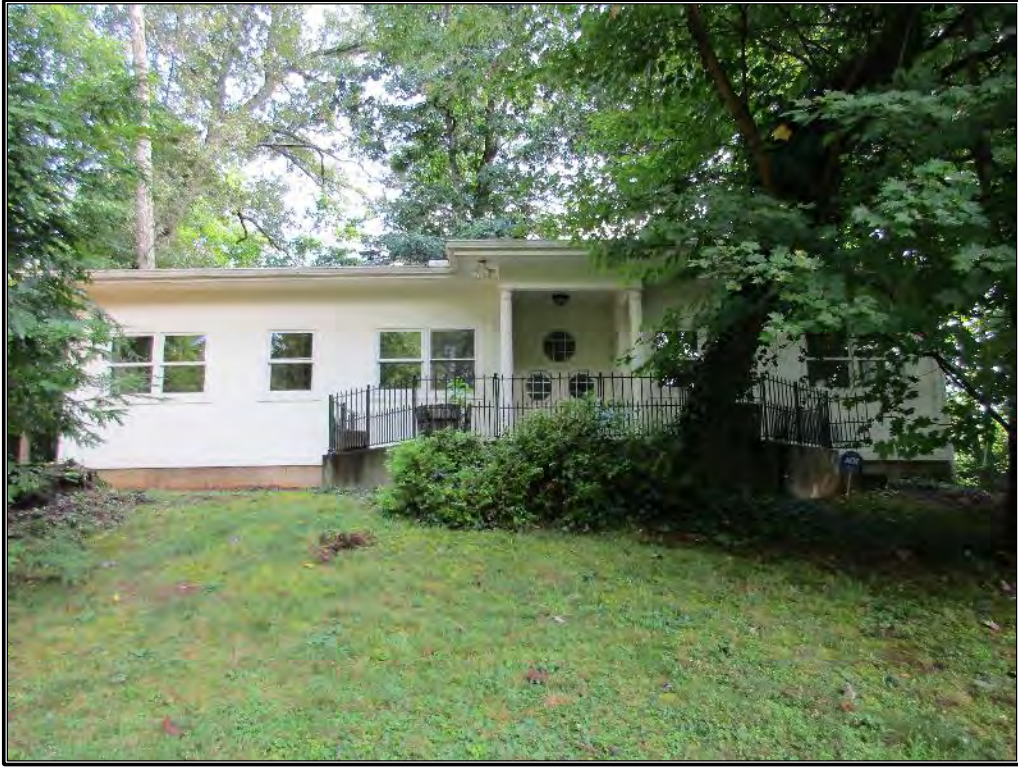
Figure 234. Secondary dwelling, view of northwest corner.

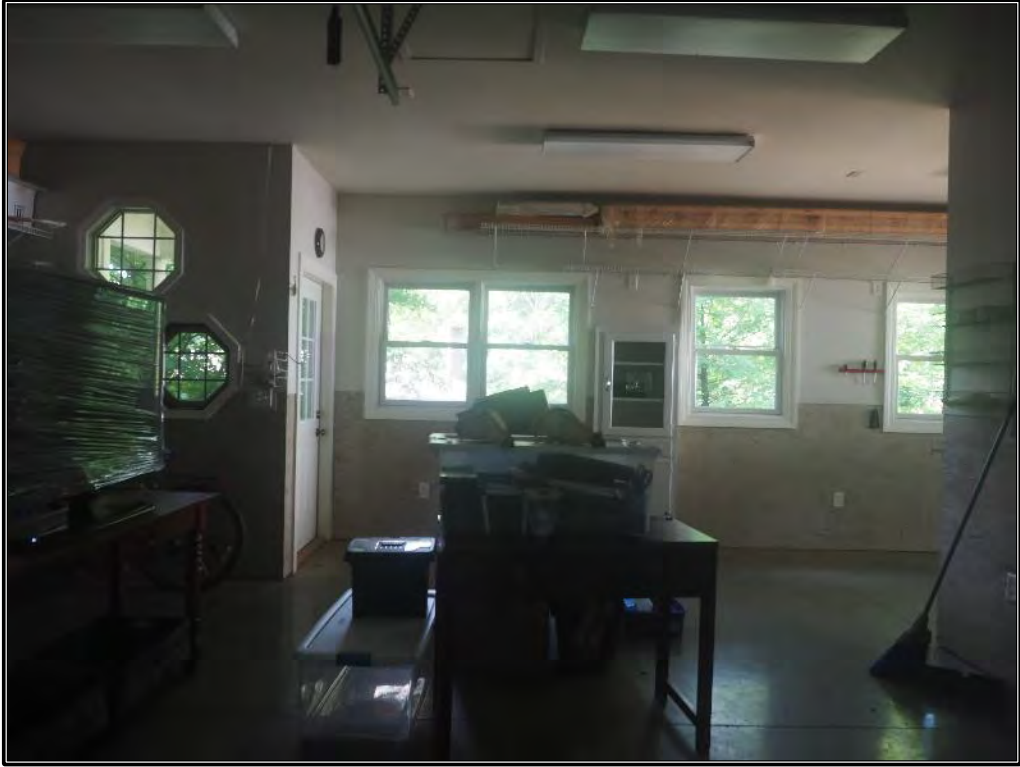
Figure 237. Large interior room of the workshop.

Workshop, interior: The interior of the workshop contains a large central room with poured concrete floors and accessed from the northwest façade entry (Figure 237). The bottom portion of the interior walls are clad in tile. The windows and doors are cased with simple wood surrounds. A partition wall lined with shelves extends across the southeast side of the central room, separating it from the main part of the workshop. A mudroom occupies the northwest portion of the workshop. Separated from the main room by a partition wall, the mudroom is accessible from the northwest exterior entry and contains the same interior finishes as the main room. A nine-light door leads from the mudroom to the main room of the workshop. The garage door along the rear elevation of the building opens into the main portion of the workshop.

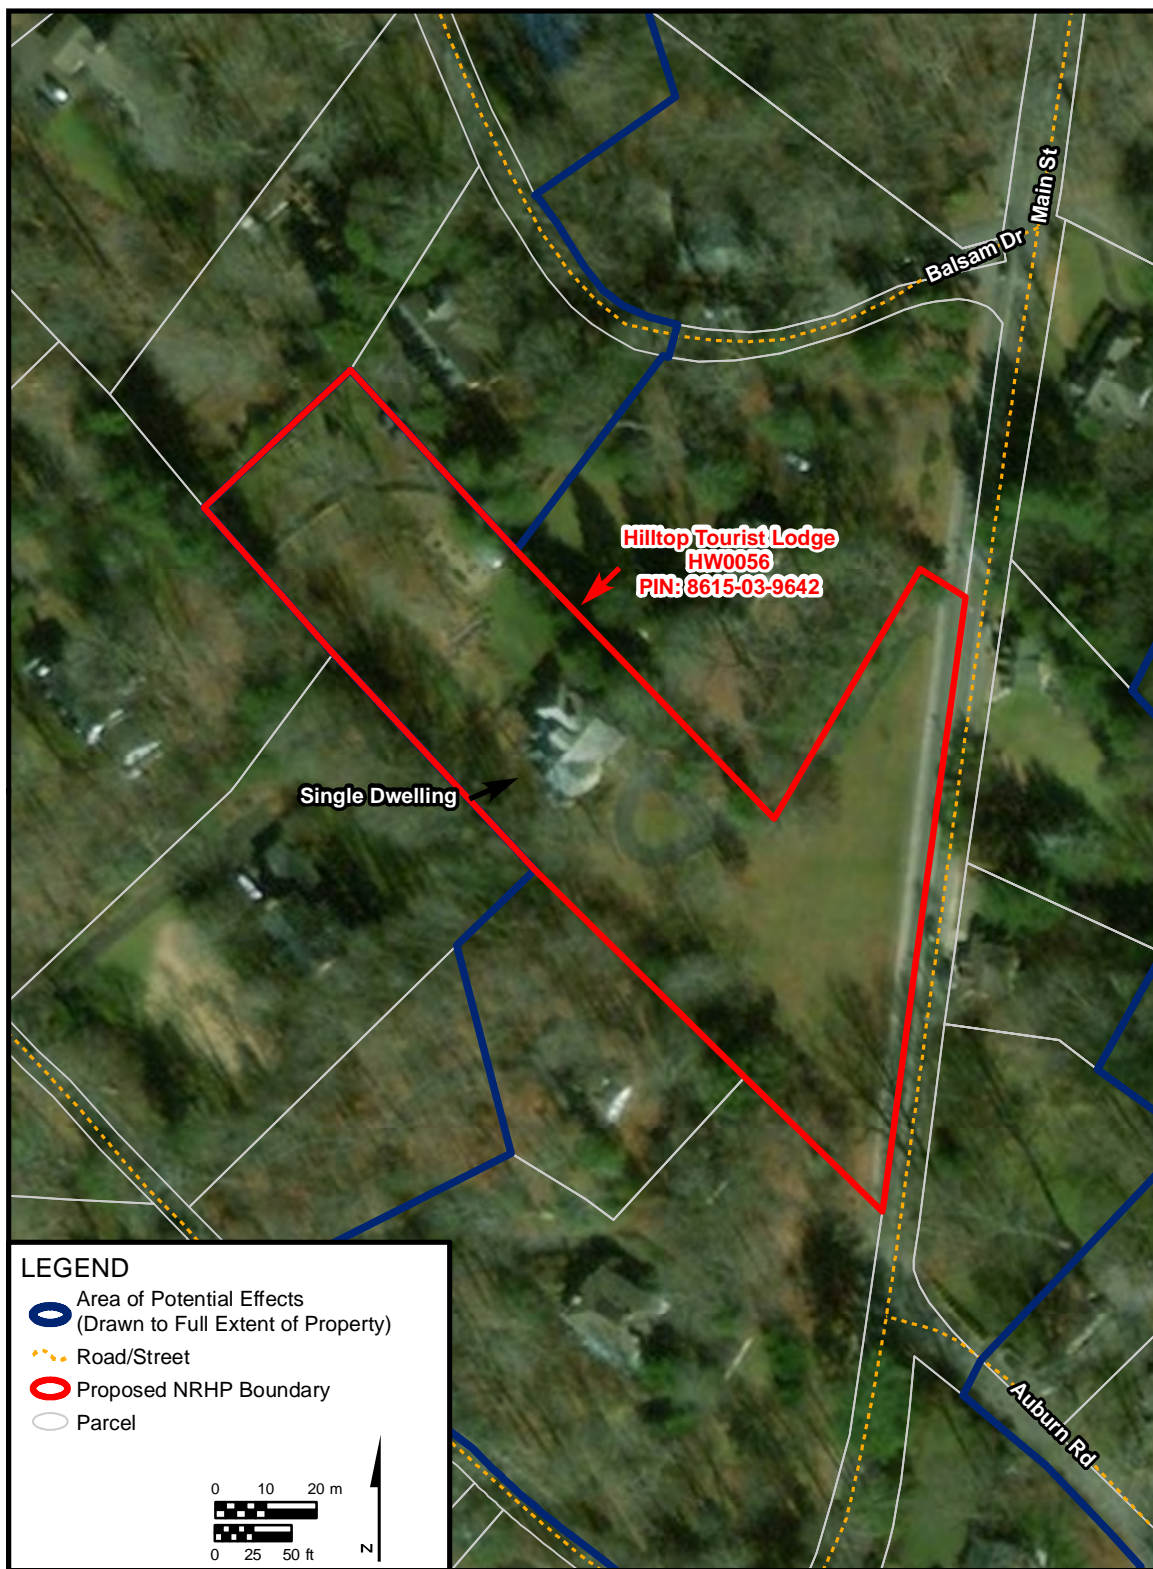
Figure 241. Map of the Hilltop Tourist Lodge (HW0056).

Setting: The Hilltop Tourist Lodge occupies a 2.32-acre parcel on the west side of South Main Street (US 23 Business), approximately 340 ft south of its intersection with Balsam Drive (Figure 241). Situated in a historically residential area, the residence is situated on a hill on a grassy, tree-lined property. Bushes and other plantings surround the house's foundation. A paved circular driveway loops southeast of the residence and extends along the northeast side of the house (Figure 242). The driveway is lined by trees, and a line of trees extends along the northeast property boundary. A wood picket fence encloses the rear yard.

The proposed NRHP-eligible boundary for the Hilltop Tourist Lodge (HW0056) follows the majority of the historic road frontage along South Main Street as the steep terrain preserves the isolated approach to the house and begins directly across from Auburn Road, and turns southwest to follow the driveway's northern edge. The western boundary then makes a sharp, northward corner as the driveway forms a teardrop roundabout to follow the line of trees northwest to encompass the narrow rear yard the preserves some of the open space once present along the hilltop. The western and southern boundaries similarly follow lines of trees along the currently maintained yards. See Figure 241 for the map depicting property boundaries and the proposed NRHP boundary.

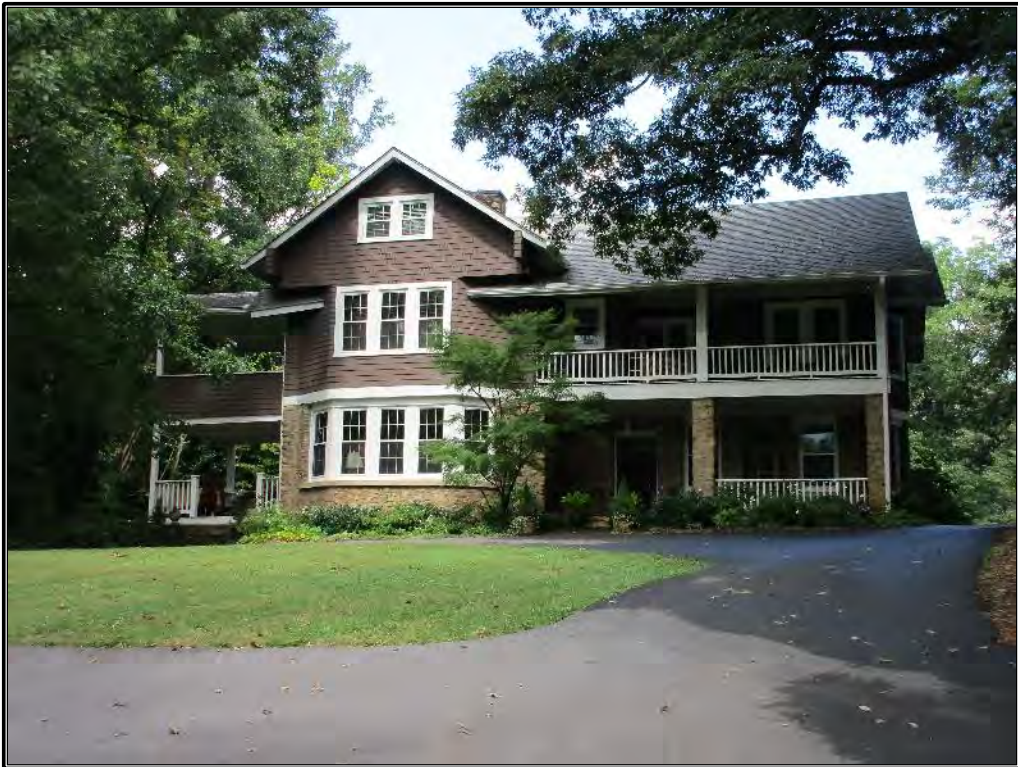
Figure 243. Façade looking northwest.

House, exterior: The circa 1908 Craftsman-style residence presents a two-and-one-half-story, five-bay (wwwwww/d/w/ww/w), double-pile, side-gable form with multiple projections (Figure 243). The first story of the residence is clad in river rock, while the upper stories feature wood shingle siding. The roof is sheathed in asphalt shingles. The foundation is not visible. The original diamond-paned windows have been replaced with one-over-one, double-hung vinyl sashes with false grids. The windows are accompanied by simple wood surrounds (Figure 244). The windows along the first story of the façade and the northeast projection feature stone stills. An interior stone chimney pierces the ridgeline of the façade projection. An interior stone chimney pierces the ridgeline of the northeast rear projection. An exterior stone chimney extends from the northeast elevation of the northeast rear projection (Figure 245). Exposed rafter tails extend underneath the wide eaves.

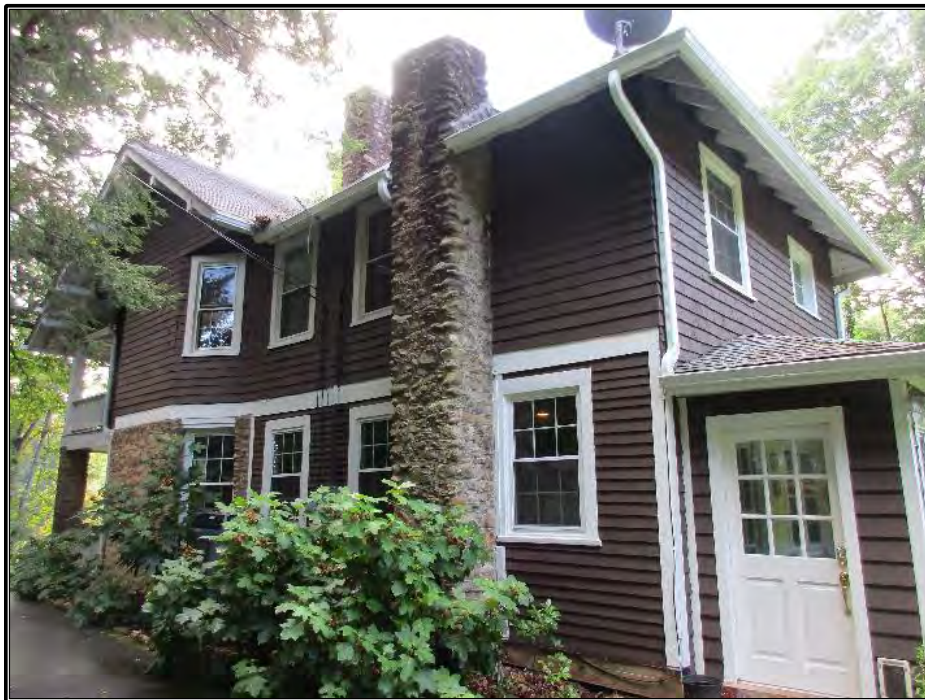
Figure 245. View of northeast (side) elevation.

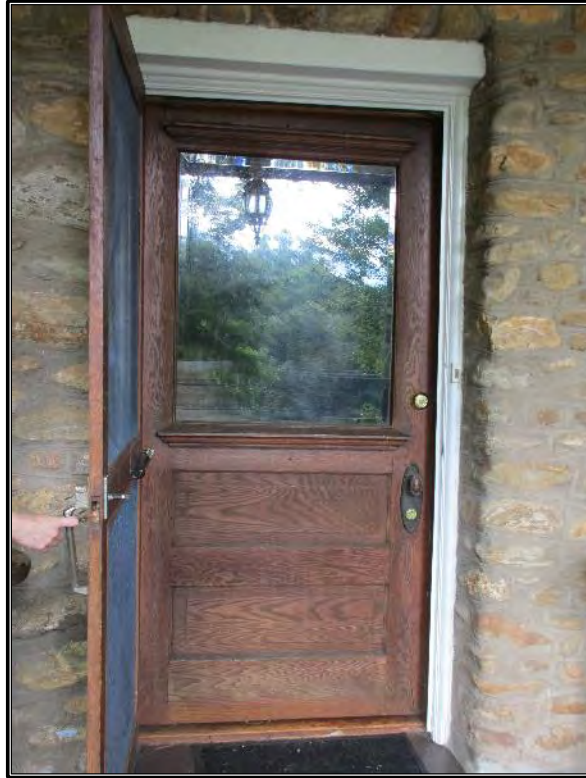
Figure 246. Detail of historic door and screen door.

The façade of the residence features a half-light wood paneled door covered by a historic wood screen door (Figure 246). The entry opens onto the first-story of an integral two-story, two-bay porch along the northeast (right) side of the façade. Stone columns support the porch along the first story, while the second story of the porch features wood posts. Both stories feature a wood deck and a simple wood railing.

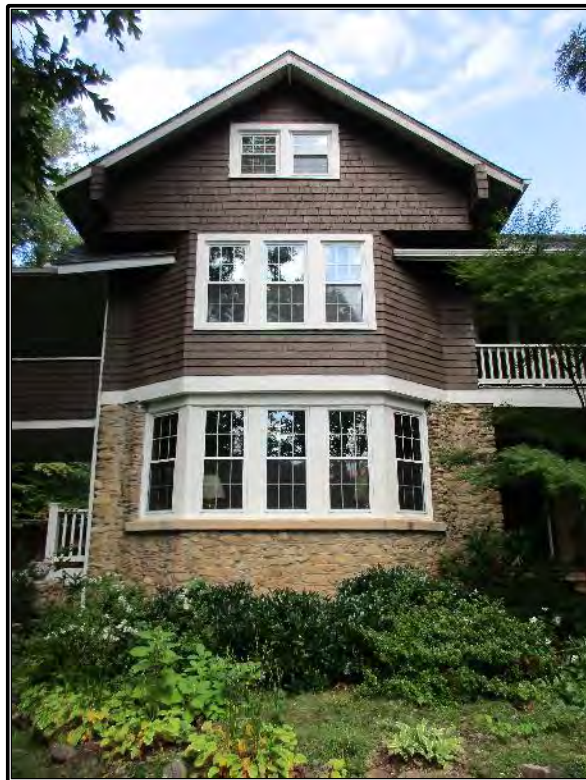
Figure 247. Detail of façade projection.

A two- and-one-half-story, front-gable projection extends from the southwest (left) side of the façade (Figure 247). The first and second story façades of the projection are canted. A ribbon of five window bays pierces the first story of the façade of the projection.

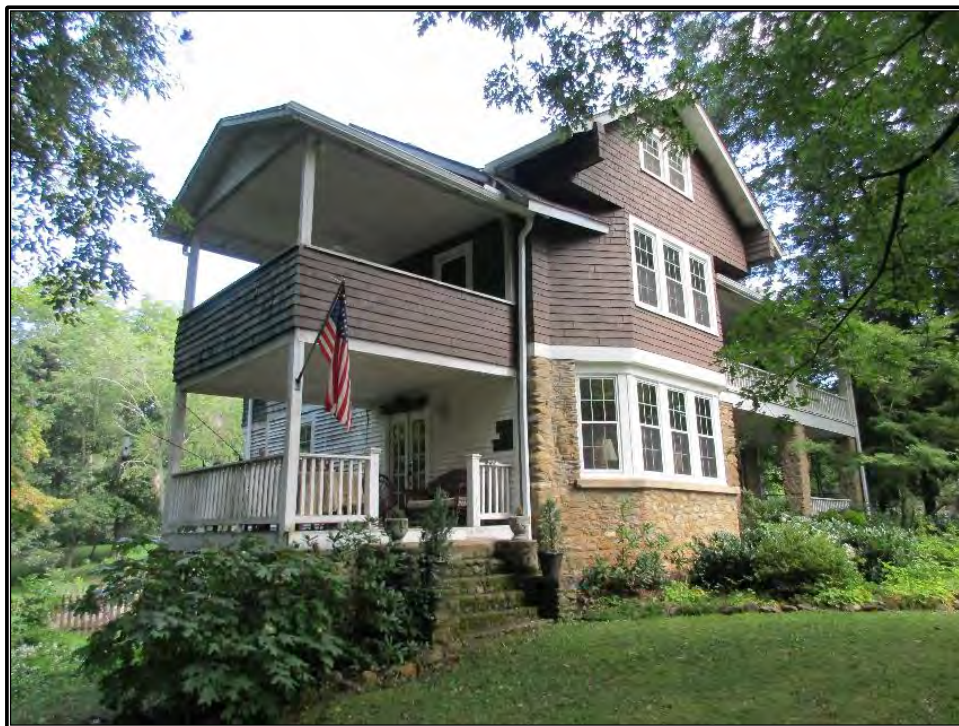
Figure 248. View of south corner with two-story porch.

The northeast elevation features a two-story, side-gable, canted projection centered under the northeast gable. The southwest elevation of the residence contains a two-story, single-bay porch with a side-gable roof supported by wood posts (Figure 248). The first story features a wood deck lined by a wood railing and is accessed by a set of stone steps. The second story of the porch is clad in wood shingles. A double-leaf side entry filled by a pair of multi-light wood doors pierces the southwest elevation of the façade projection and opens onto the first story of the porch. The southwest elevation of the residence and the façade projection are clad in weatherboard siding along the first floor. The rear elevation features a two-story, hip-roof projection along the northeast (left) side. The first story of the projection is clad in weatherboard siding. A one-story, hip-roof addition is attached to the rear elevation of the projection. The rear elevation was only partially accessible in the field. An aerial view indicates that a gable-roof dormer projects from the rear roof slope. Two hip-roof projections extend from the southwest (right) side of the rear elevation, but were not visible in the field.

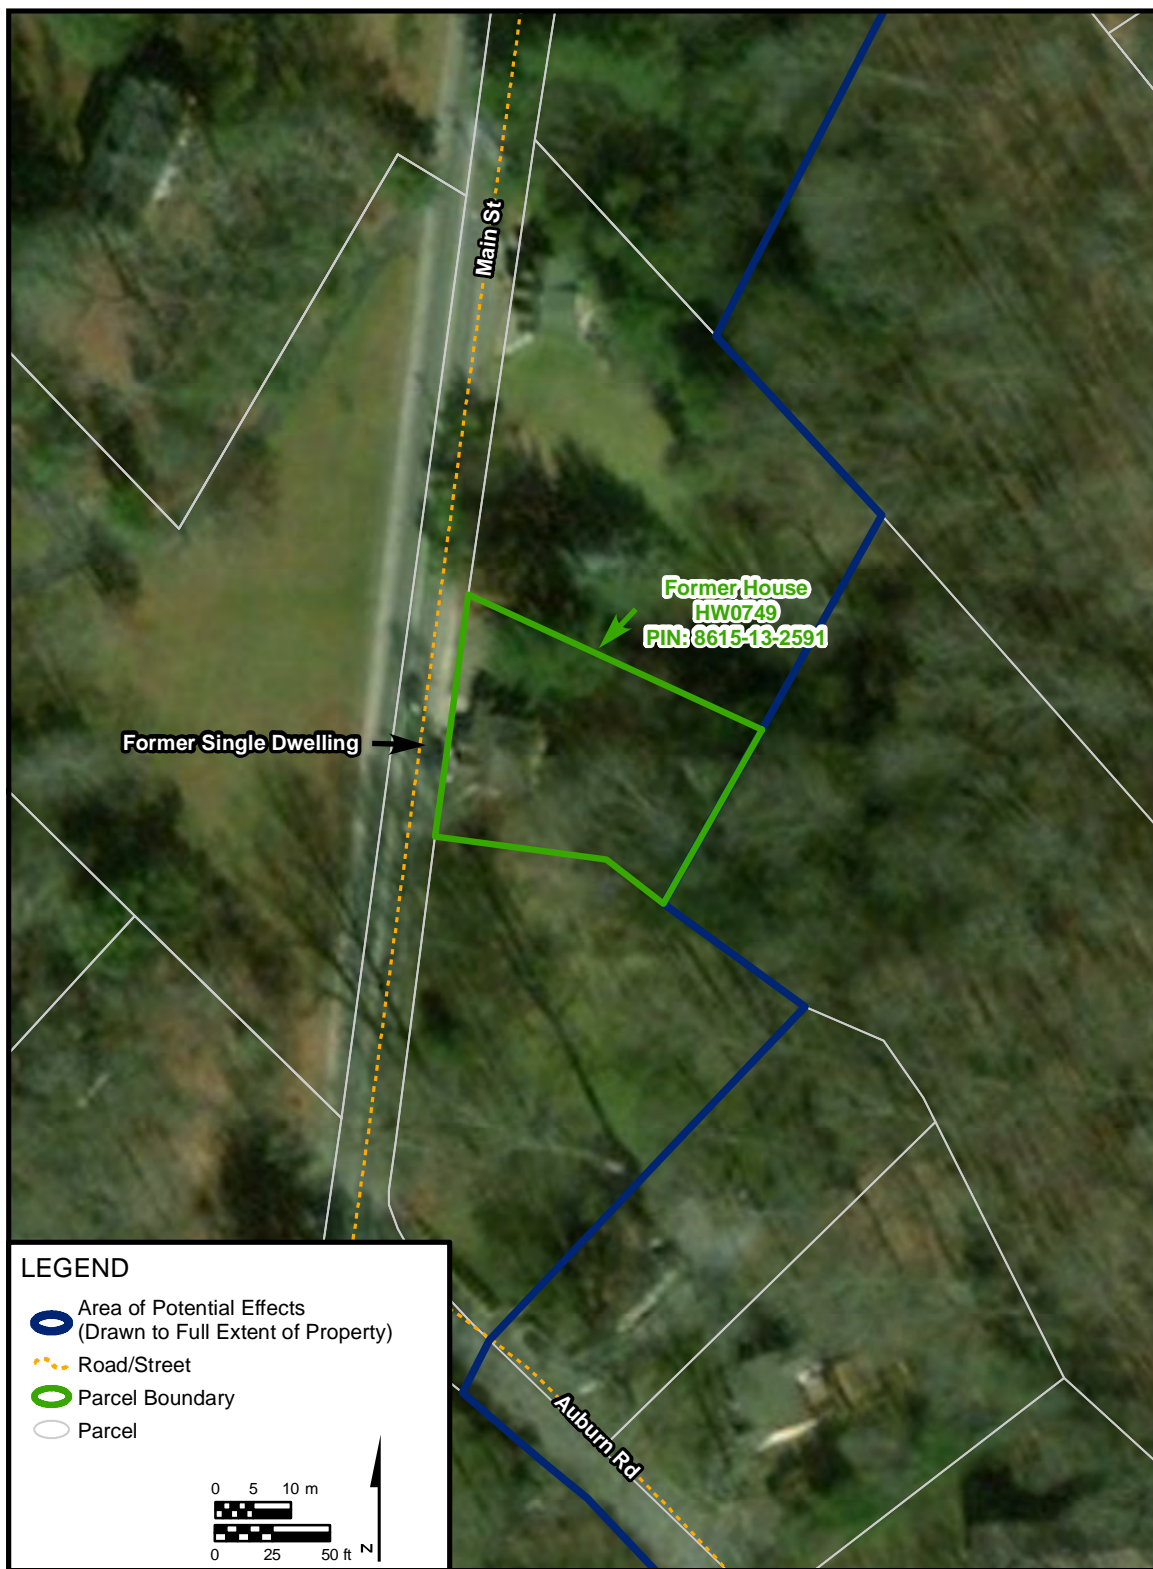
Figure 252. Map of the Former House, 809 S. Main Street (HW0749).

Setting: The converted residence is situated on a .25-acre parcel on the east side of South Main Street (US 23 Business), approximately 175 ft north of its intersection with Auburn Road (Figure 252). Constructed into a slope with a steep grade on a partially wooded property, the residence has been converted to an art studio. A poured concrete and a gravel parking area extends along a flat section of the property along the west and north side of the studio. A post and rail fence lines the east side of the gravel parking lot, a portion of which is supported by cantilevered posts and fill. The east side of the property slopes steeply towards a wooded area behind the converted residence.

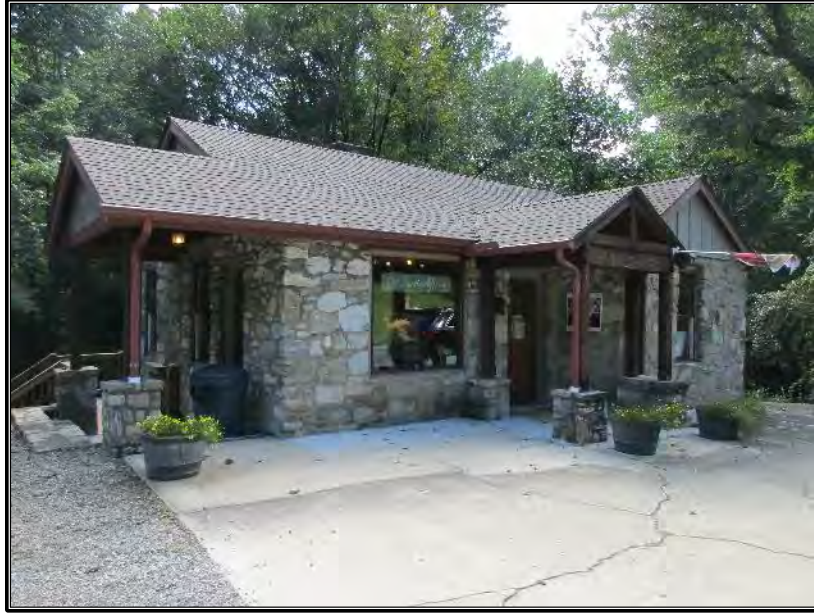
Figure 253. Façade of the Former House, 809 S. Main Street, now an artist studio.

House, exterior: The circa 1938 converted residence exhibits a one-story, three-bay (w/d/w), double-pile, side-gable form (Figure 253). The studio rests on an exposed basement foundation. The exterior is clad in a stone veneer. The first story of the rear elevation and the gable ends are clad in board and batten siding (Figure 254). The roof is sheathed in asphalt shingles. Unless otherwise indicated, the windows contain one-over-one, double-hung wood sashes or single-light wood sashes. The windows feature simple wood surrounds with wood lintels. An interior, stone-clad chimney pierces the rear roof slope.

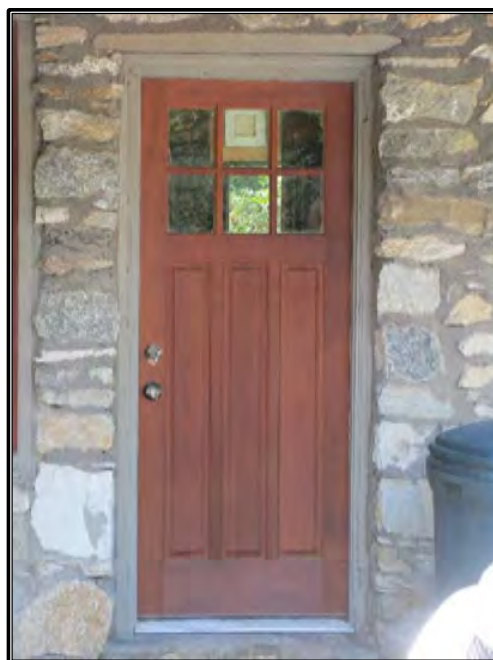
Figure 255. Detail of front entry door.

The façade features an off-center single-leaf entry filled by a six-light wood door (Figure 255). A simple wood surround with a wood lintel frames the entry. The entry opens onto a single-bay entry porch with a front-gable roof supported by wood post set on stone piers. A picture window pierces the façade north of the entry. A front-gable projection extends from the south side of the façade.

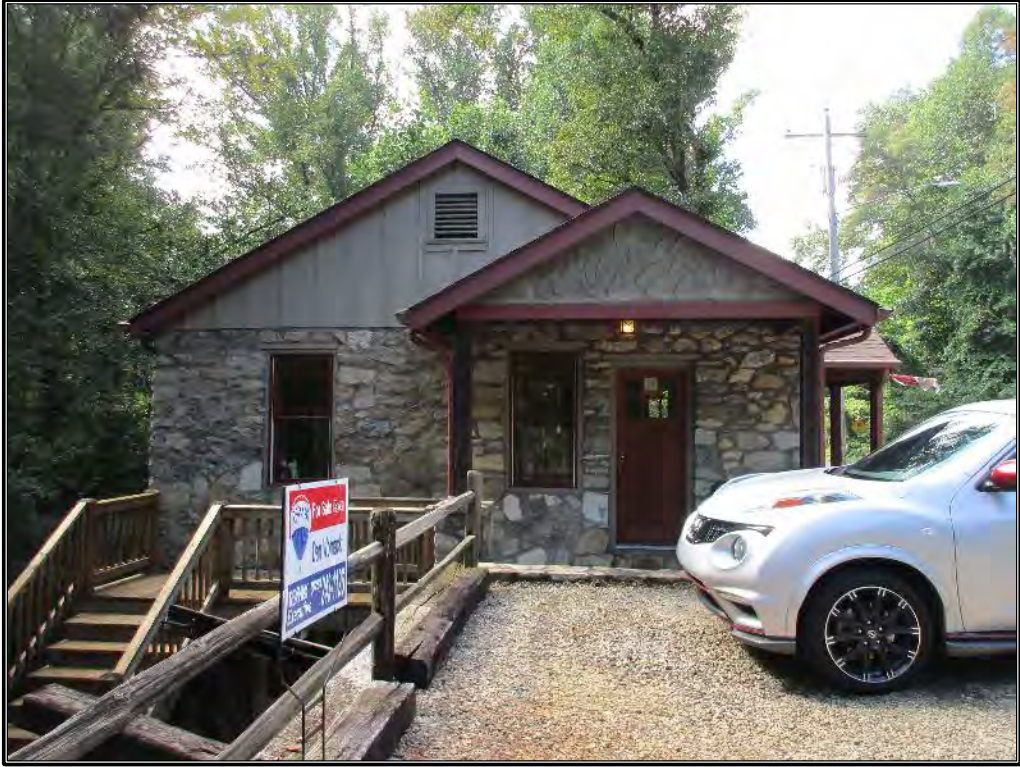
Figure 256. View of north elevation.

The north elevation contains a single-leaf entry filled by a six-light wood door with a simple surround and wood lintel (Figure 256). The entry opens onto a partial-width, single-bay porch with a side-gable roof supported by wood posts set on stone posts. The porch gable is clad in stucco. A set of stone steps lead from the gravel driveway to the porch. An elevated wood deck lined by a wood railing extends along the east (left) side of the elevation. A set of wood stairs leads from the first story deck to a wood deck along the basement level. The basement story is exposed along the south and rear elevation of the converted residence (Figure 257). A single-leaf entry along the south (left) side of the rear elevation opens onto an elevated wood deck lined by a wood railing.

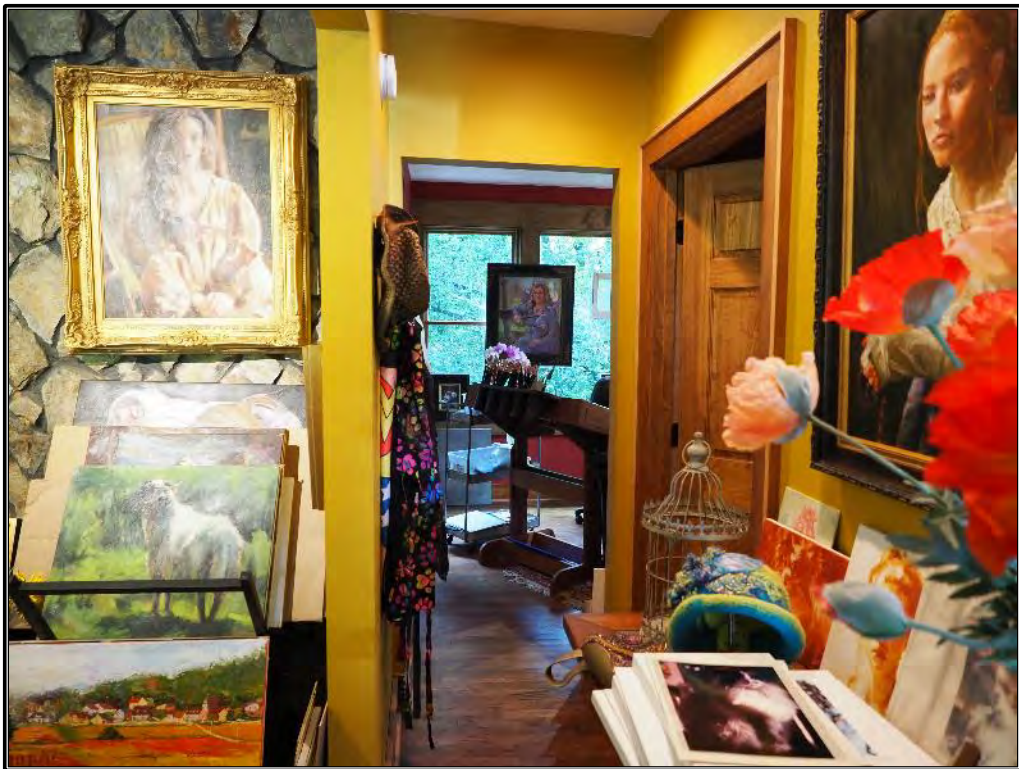
Figure 259. Interior view of hallway and rear studio space looking from the entry.

House, interior: The interior of the converted residence features hardwood floors throughout and plastered walls with simple wood baseboards. Windows and doors are cased with simple wood surrounds. The front entry opens into the main living room, which connects to an additional living space to the rear of the house (Figure 258). The living room fireplace features a poured concrete hearth. The fireplace wall is clad in a stone veneer. Partition walls enclose a room, most likely the former kitchen, behind the fireplace wall. An entryway along the south (right) wall of the living room opens into a hallway along the south side of house. The hallway provides access to a bathroom and a studio, most likely the former bedroom, to the rear of the residence. A wood door along the south (right) wall of the hallway leads to the bathroom. An entry at the end of the hallway provides access to the rear studio (Figure 259).

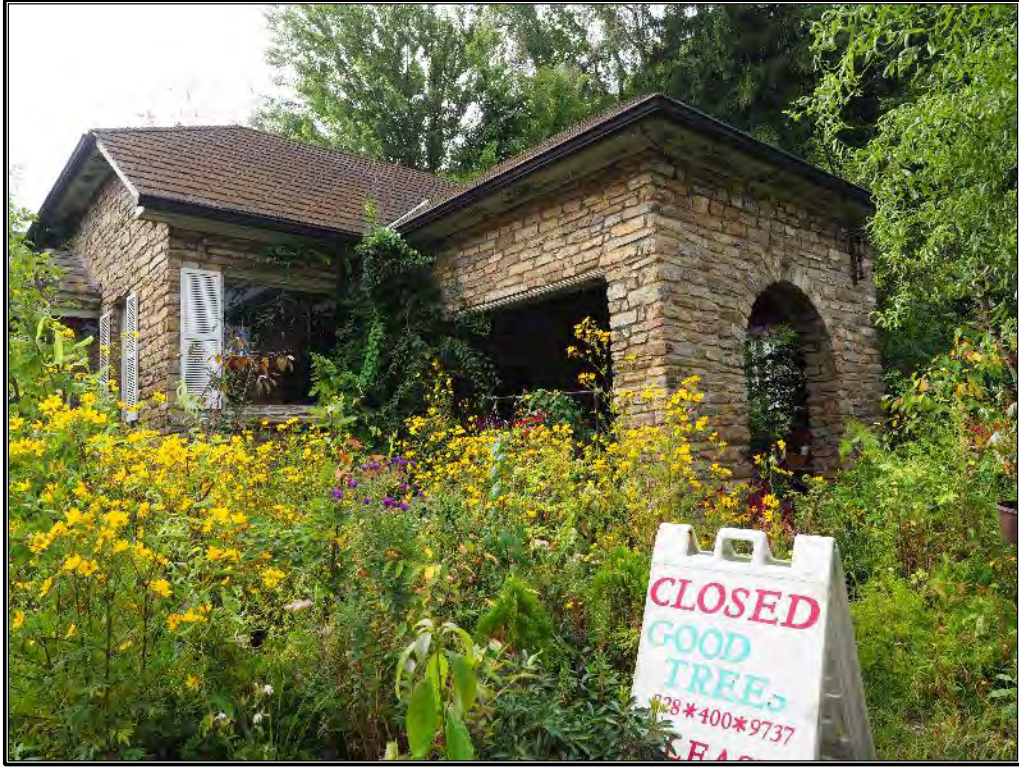
Figure 260. Residence converted to a retail space, Good Trees Garden Center at 44 Academy Street, Canton.

Surveyors located examples similar to the Former House at 809 South Main Street (HW0749) in both Canton and Waynesville. The Good Trees Garden Center at 44 Academy Street in Canton is an example of cut-stone masonry with a hipped roof porch entry (Figure 260). The Former House at 809 South Main Street (HW0749) has been converted to an artist’s studio and retail shop, and 44 Academy Street in Canton has similarly transitioned from residential to commercial use. The façade windows of both structures have been replaced with plate glass to facilitate views into the retail space. In Waynesville, stone residential buildings include 641 East Street and 335 East Street (Figure 261 and 262). The residence at 641 East Street is an example of a Minimal Traditional residence that is entirely clad in stone. Meanwhile, 335 East Street shows the common use of stone for porch piers, low walls, and partial exterior cladding. The Former House at 809 South Main Street (HW0749) presents as a one-story dwelling from South Main Street, but takes advantage of the steeply rear-sloping lot to create an exposed basement story. Similarly, all three comparable buildings are one-story residences.

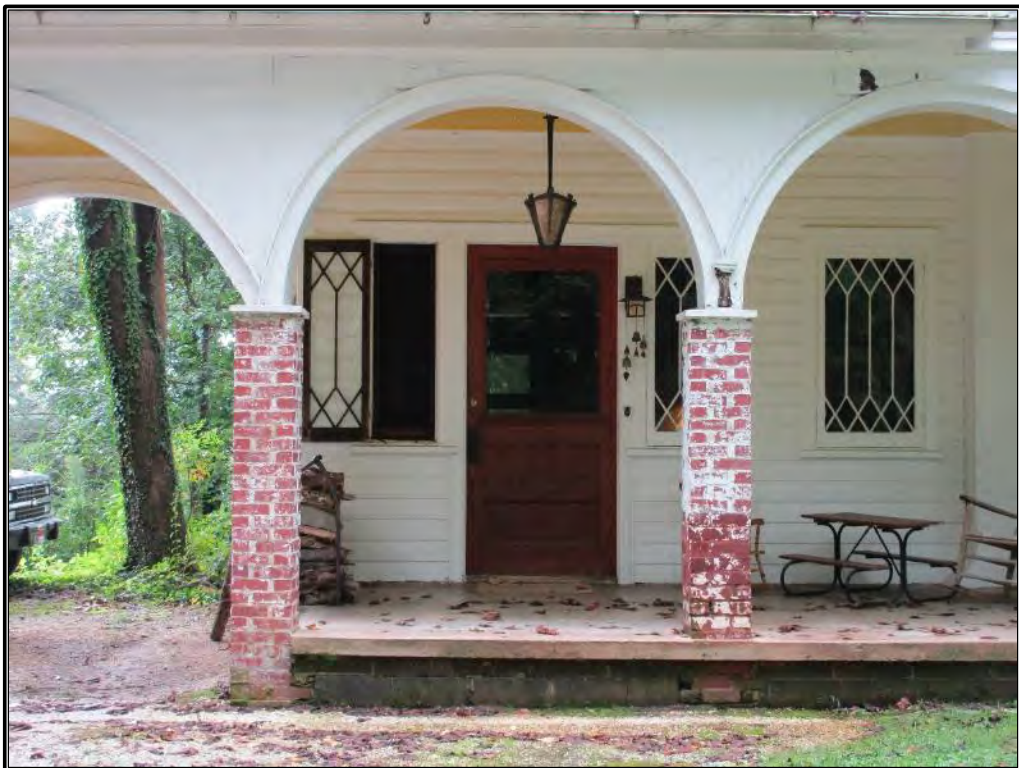
Figure 280. Detail of the arcade with the porte cochère to the left and the concrete porch with foyer entry to the center and right.

The façade of the residence features a full-width arcade along the first story. The arcade wraps around to the southwest elevation (see Figure 278). The arcade consists of a series of archways with impostes set on brick piers resting on a replacement poured concrete deck (Figure 280). The arcade shelters two single-leaf façade entries. The entries are filled by half-light wood paneled doors and flanked by narrow single windows. Two single window bays pierce the façade between the two entries. A gambrel-roof projection extends from the upper story of the arcade. Two ribbons of three windows pierce the façade elevation of the projection. A hip-roof porte cochère, added circa 1910, with an upper-story sleeping porch extends from the northeast side of the porch (Figure 281). The porte cochère features large archways with impostes set on brick piers. The second-story sleeping porch contains a paired window and a ribbon of three windows along the façade elevation. A ribbon of three windows pierce the northeast and rear elevation of the sleeping porch. The lower portion of the porch is flared.

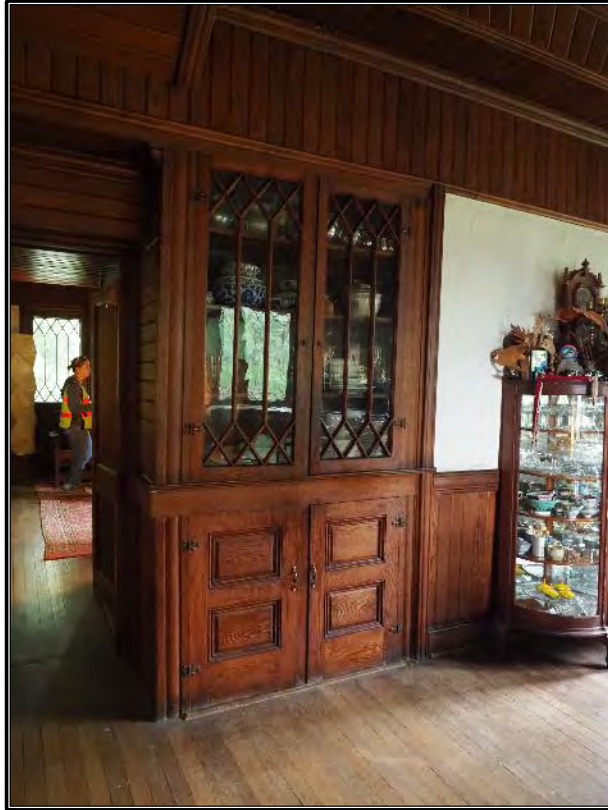
Figure 287. Interior paneling and built-in cabinetry in the dining room.

House, interior: The interior of the Charles Ray House features hardwood floors throughout and plaster walls with extensive woodwork (Figure 287). Wood baseboards, sometimes with finial details, and picture rail are found throughout the house. Wainscoting lines the base and top of the walls in the front foyer, living room, dining room, hallway, and stairway on the first floor. The first-floor ceiling features elaborate paneling and trim (Figure 288). Doors and windows throughout the house are framed with fluted surrounds with bullseye detailing. The front entry opens into the foyer (Figure 289). A large fireplace with elaborately carved ornamentation, a brick hearth and firebox, and a wood mantel is located next to the front entry along the northeast (left) wall of the foyer. Opposite the entry, a curved Y-shaped wood staircase extends to the second story (Figure 290). The staircase features a carpeted runner, a wood banister, decoratively turned balusters, and extensively carved newel posts with heavy caps. Integral window seats line the first landing of the stairs.

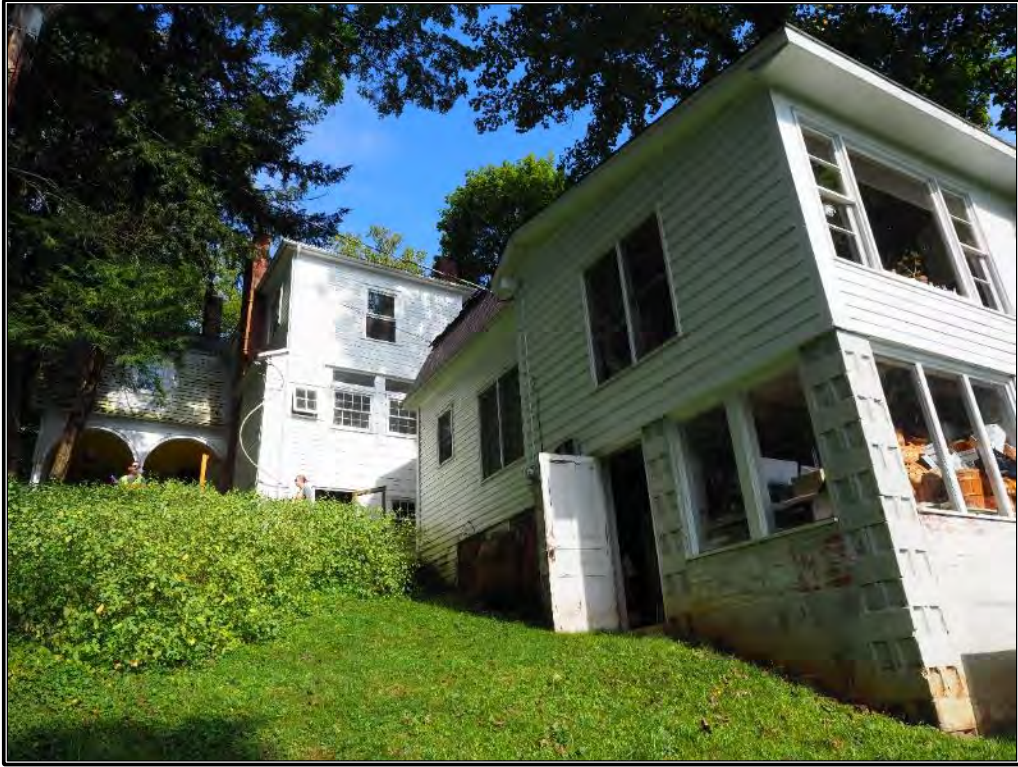
Figure 299. View of southeastern corner of the laundry building.

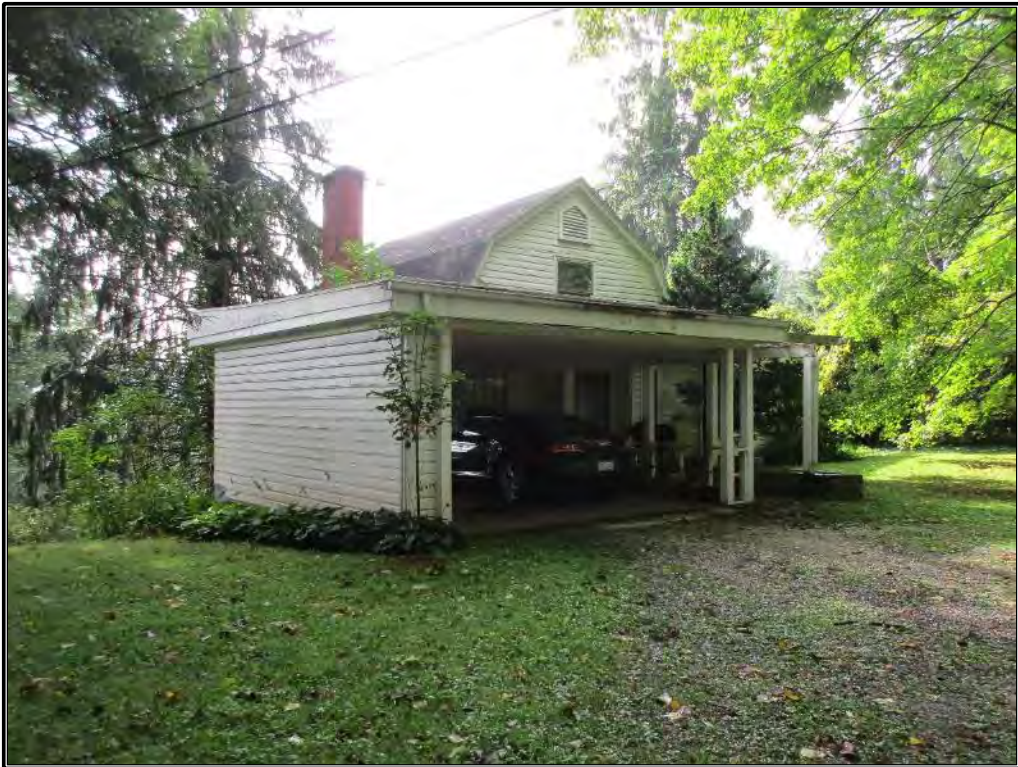
Figure 300. Façade view of carriage house (HW0751) with large carport.

Carriage House (HW0751), exterior: The circa 1895–1898 one-and-one-half-story, three-bay (w/d/w), double-pile converted carriage house with a front-facing gambrel-roof is located approximately 65 ft south-southwest of the residence (Figure 300). The carriage house rests on an exposed brick basement foundation and the exterior is clad in wood drop siding. The roof is sheathed in asphalt shingles. The windows contain eight-over-eight, double-hung wood sashes. An exterior brick chimney extends from the northeast elevation. The façade of the carriage house has been modified to contain a single-leaf entry filled by a full-light wood door. Entry is located on a slanted bump-out and is sheltered by a wood pergola. A single window pierces the façade northeast (left) of the entry. A full-height narrow window filled by a multi-light wood sash is located southwest (right) of the entry. A flat-roof carport supported by wood posts set on a poured concrete pad is attached to the northeast (left) side of the façade. The northeast elevation of the carport is enclosed. A single window is centered under the front gable. The southwest elevation of the converted carriage house contains a one-story, shed-roof addition. The façade elevation of the addition contains a single window. The southwest elevation of the addition is obscured by vegetation. The northeast elevation of the carriage house features two single windows (Figure 301). A two-story, shed-roof porch is attached to the rear elevation (Figure 302). The lower level of the porch is supported by scrollwork metal posts set on a poured concrete deck. The upper story features wood posts set on a wood deck lined by a wood railing. The rear elevation was only partially visible.

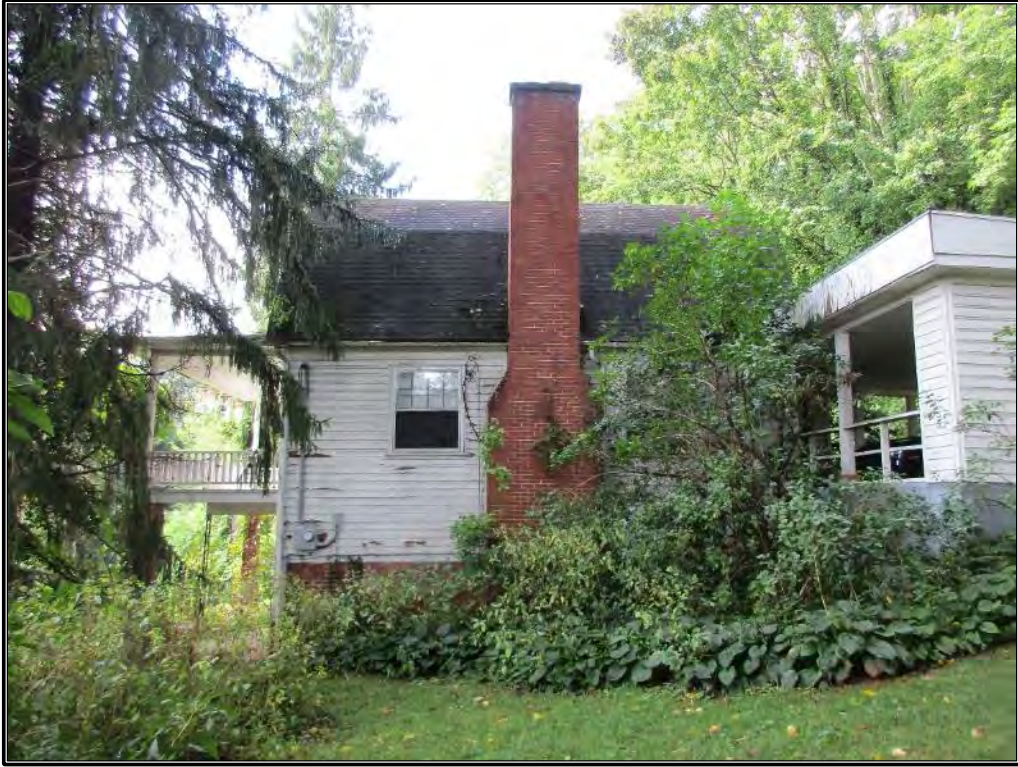
Figure 301. View of the northeast (side) elevation of the carriage house (HW0751).

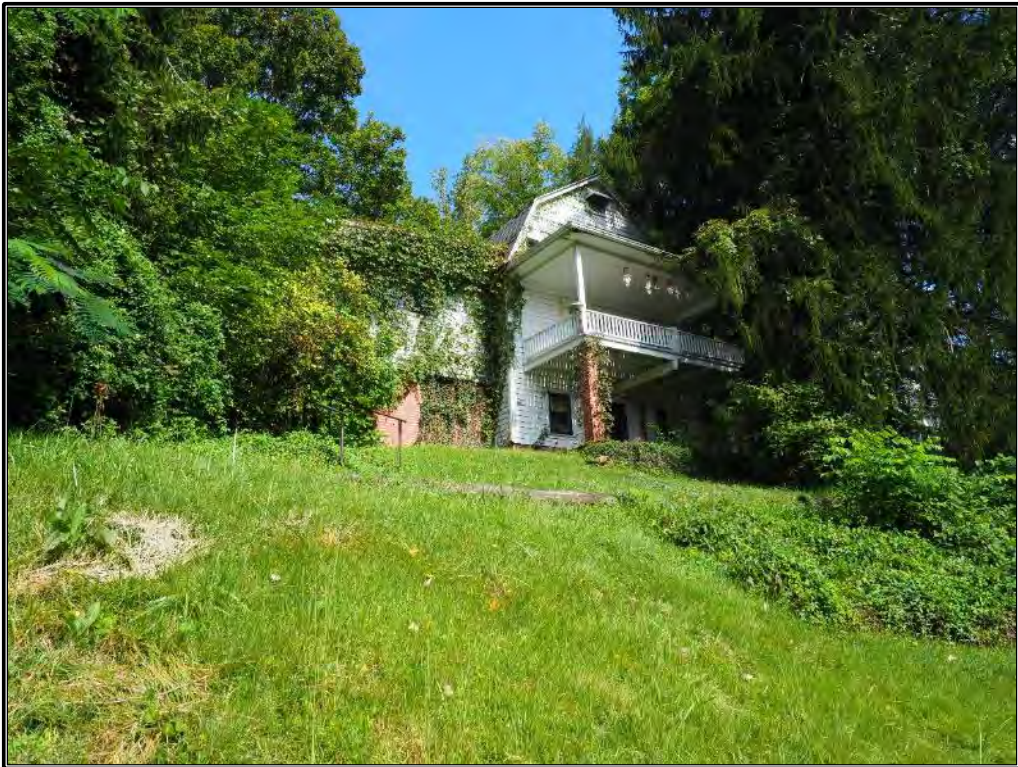
Figure 302. Rear view of carriage house (HW0751).
