SUBJECT: Historic Structures Survey Report, , Improvements to US 23 Business (South Main Street) from SR 1164 (Hyatt Creek Road) to US 276 (Pigeon Street), Waynesville, PA 17-12-0027, U-4712, Haywood County, ER 18-4249

MANAGEMENT SUMMARY	i
I. INTRODUCTION.....	1
II. METHODOLOGY.....	1
III. DESCRIPTION, HISTORIC CONTEXT, AND EVALUATION	7
CLYDE’S RESTAURANT (HW0735)	7
COMMERCIAL BUILDING (HW0736).....	18
COMMERCIAL BUILDING AND FORMER GROCERY (HW0737).....	28
REPAIR SHOP (HW0738)	41
MAPLE GROVE MOTEL (HW0739)	50
HYATT HOUSE AND CARRIAGE HOUSE.....	68
(HW0015 / HW0740).....	68
SILER HOUSE (HW0741)	88
ETHEL ROSS BRADLEY HOUSE (HW0742)	97
PEARL HYATT AND MARGARET HYATT PILARSKI HOUSE (HW0743)	110
HOUSE, 1262–1270 S. MAIN STREET (HW0744).....	119
GEORGE HOUSE (HW0745)	133
HOUSE, 1157 S. MAIN STREET (HW0746).....	143
HOUSE, 1153 S. MAIN STREET (HW0747).....	155
THE GABLES APARTMENTS (HW0096).....	163
DR. ALBERT HEYWARD SMITH, JR. HOUSE (HW0748).....	173
THE ATKINS HOUSE (HW0109)	187
THE HILLTOP TOURIST LODGE (HW0056).....	202
FORMER HOUSE, 809 S. MAIN STREET (HW0749).....	212
HOUSE, 761 SOUTH MAIN STREET (HW0750)	222
THE CHARLES RAY HOUSE (HW0055) AND CARRIAGE HOUSE (HW0751)	233

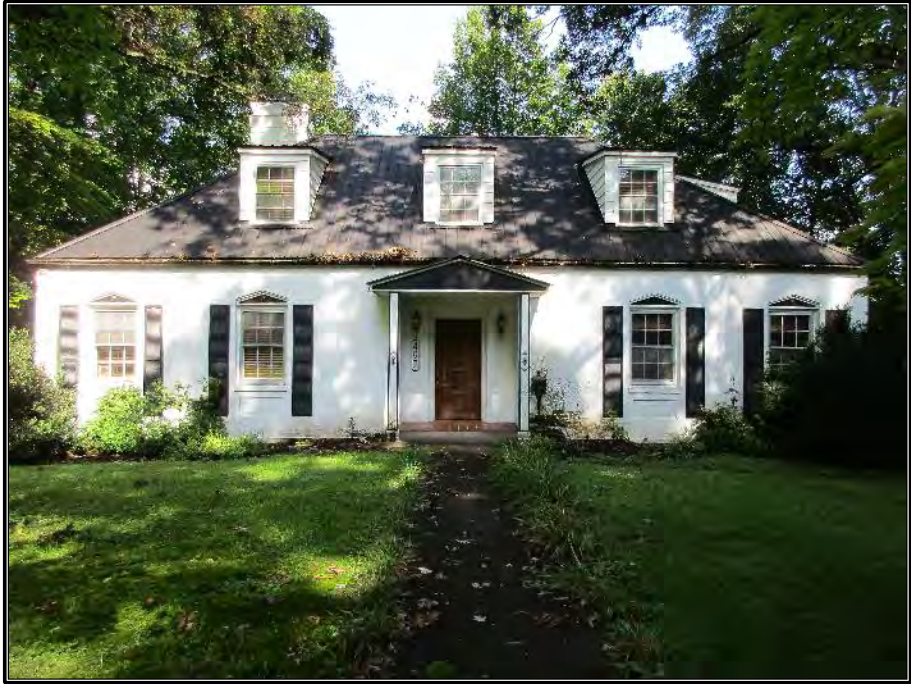
Figure 306. View of façade looking west.

House, exterior: The circa 1941 converted residence displays a one-story, five-bay (w/w/d/w/w), double-pile, hip-roof form (Figure 306). The residence rests on an exposed basement foundation covered in a stone veneer. The exterior is clad in a stretcher bond brick veneer. The roof is sheathed in replacement metal panels. Unless otherwise indicated, the windows contain six-over-six, double-hung wood sashes with brick sills. The windows along the façade and side elevations are pedimented and feature an incised

The façade of the converted residence features a central, recessed single-leaf entry filled by a wood paneled door (see Figures 306 and 308). The entry opens onto a single-bay entry porch with a front-gable roof supported by ornamented wood posts set on a tiled, poured concrete deck. Two single windows pierce the façade northeast (right) and southwest (left) of the entry. Three shed-roof dormers clad in vinyl siding and pierced by a single window project from the façade roof slope.

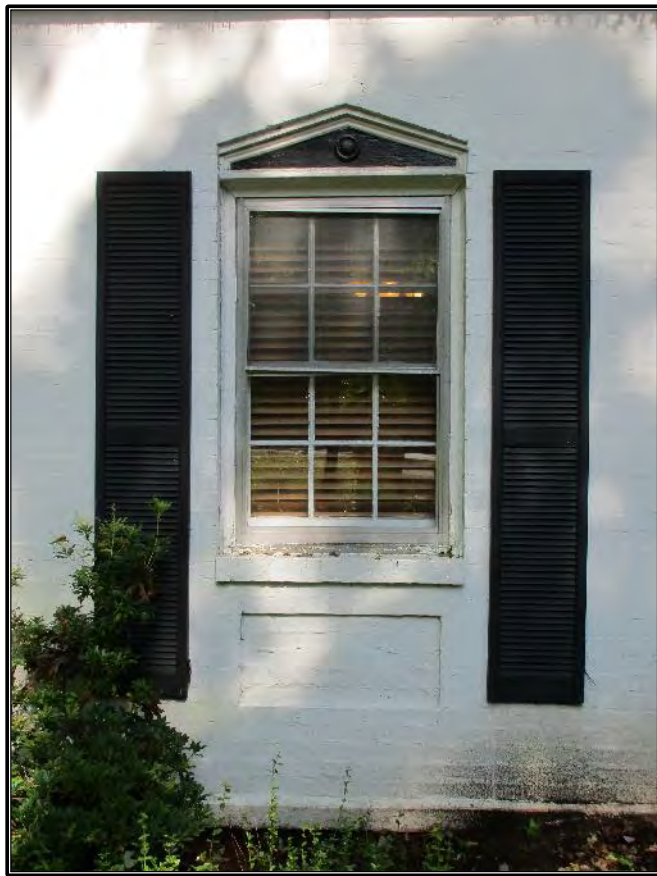
Figure 307. Detail of window with pediment on the façade.

rectangular panel underneath the sill (Figure 307). The façade and some of the windows along the side elevations are framed by louvered wood shutters. An interior brick chimney pierces the southwest roof slope.

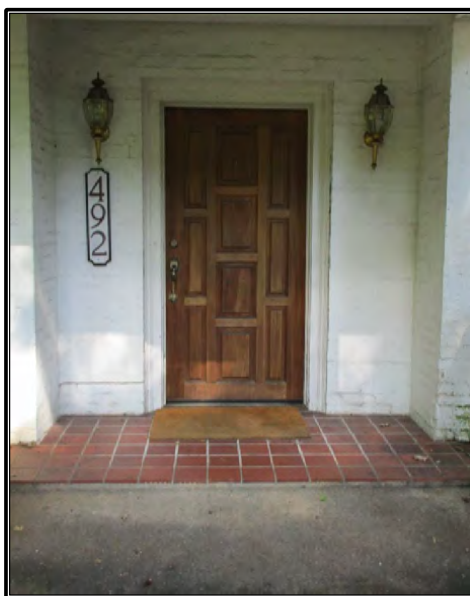
Figure 308. Detail of entry door.

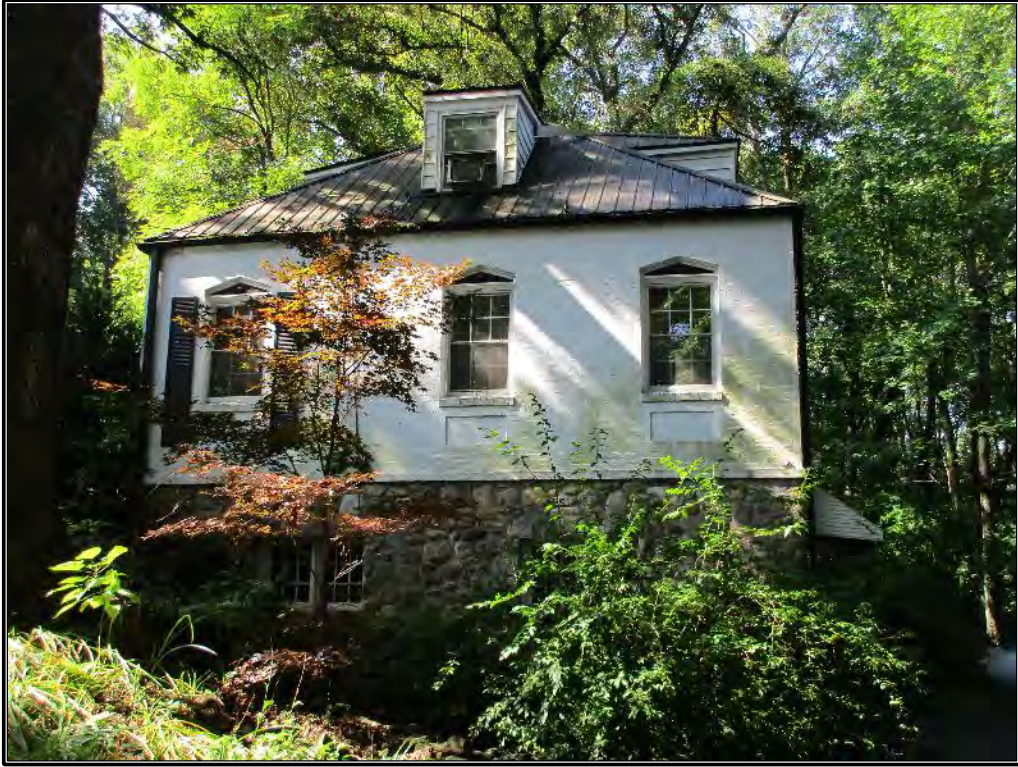
Figure 309. View of northeast (side) elevation.

The northeast and southwest elevations contain three single windows along the first story (Figures 309 and 310). A shed-roof dormer clad in vinyl siding and pierced by a single window projects from the northeast roof slope. A window along the rear elevation is partially enclosed with a faux stone veneer to accommodate a smaller replacement sash. A vehicular bay pierces the basement story of the rear elevation (Figure 311). The bay is infilled with aluminum siding. The enclosed bay contains a single-leaf entry filled by a multi-light wood door. A paired window filled by one-over-one, double-hung wood sashes is pierced the enclosed bay northeast (left) of the basement entry. A five-light wood transom extends along the top of the bay. The enclosed bay is sheltered by a shed-roof metal awning. A shed-roof dormer clad in vinyl siding and pierced by five single windows projects from the rear roof slope.

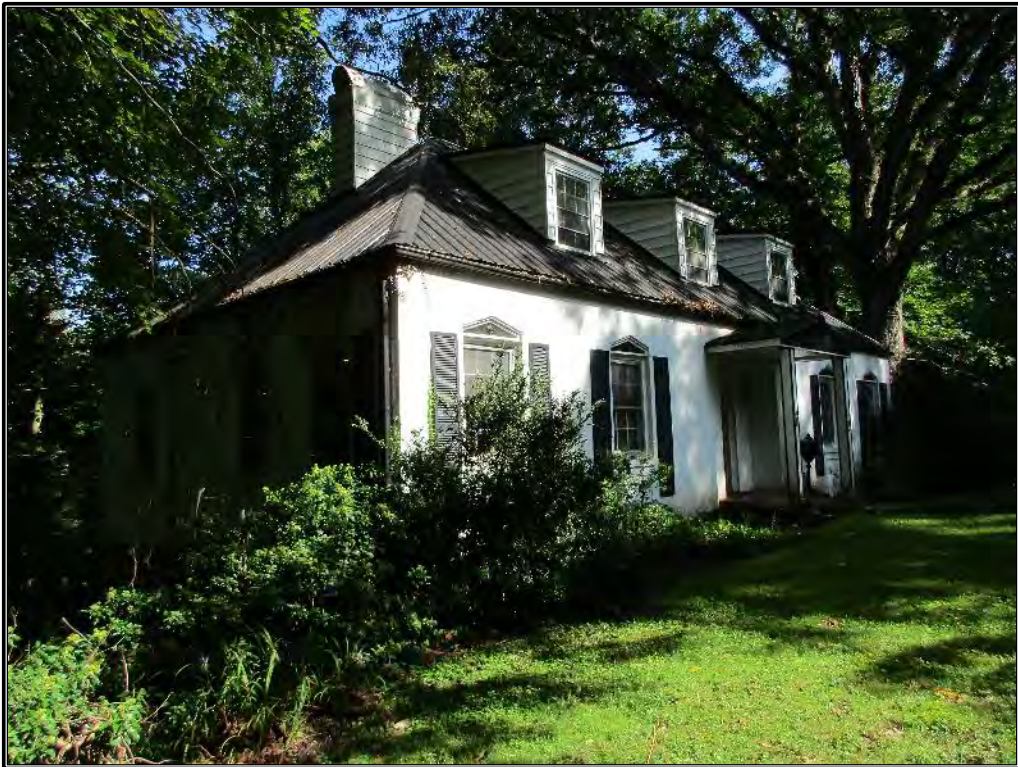
Figure 310. View of the building's southern corner.

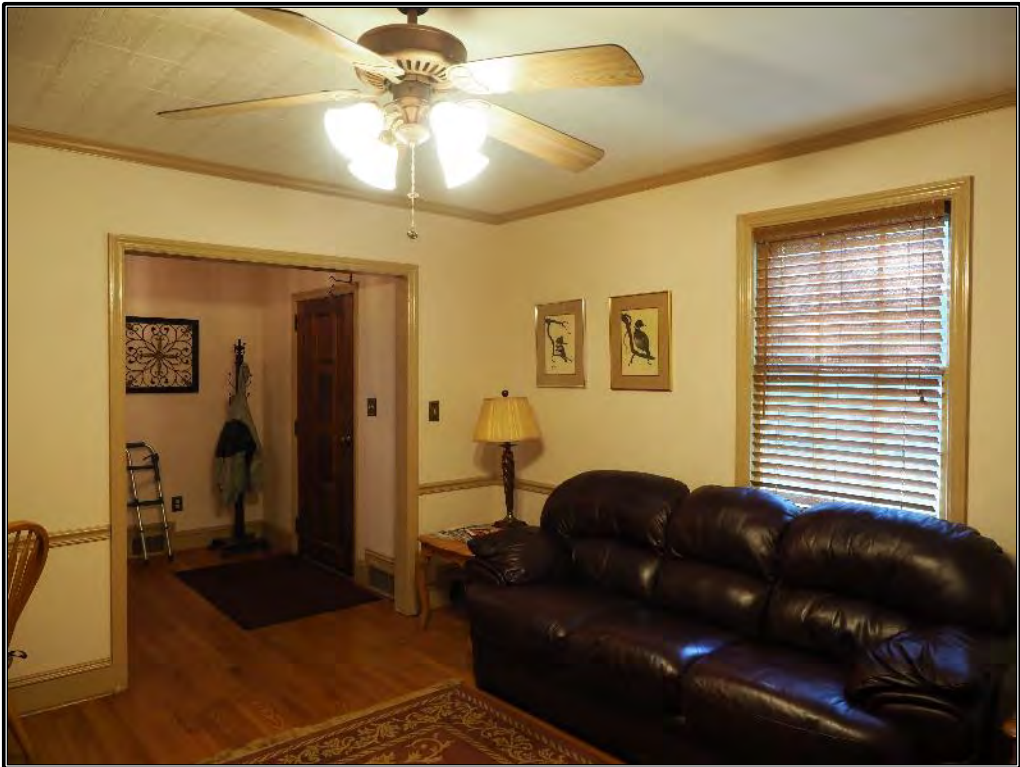
Figure 312. Interior view of living room looking towards front entry.

House, interior: The interior of the converted residence features hardwood floors throughout and painted plaster walls with simple wood baseboards and crown molding (Figure 312). The entryways and windows are cased with simple wood surrounds. The interior entries contain wood paneled doors with original hardware. The front entry opens into the foyer. The wood staircase is located immediately opposite the front entry (Figure 313). The staircase is lined by a wood banister and a wood railing with turned balusters and a simple newel posts. A doorway pierces the northwest (rear) wall of the foyer northeast (right) of the stairs. A cased entryway along the southwest (left) wall of the foyer leads to the living room. The living room features simple wood chair rail and a fireplace. A room, most likely the former kitchen or dining room, along the southwest side of the house is enclosed as an office and counter area. On the second floor, two rooms, most likely converted bedrooms, are situated off the second-story landing. The rooms serve as an office and conference room. A closet is located along the southwest (front) wall of the second-story landing.

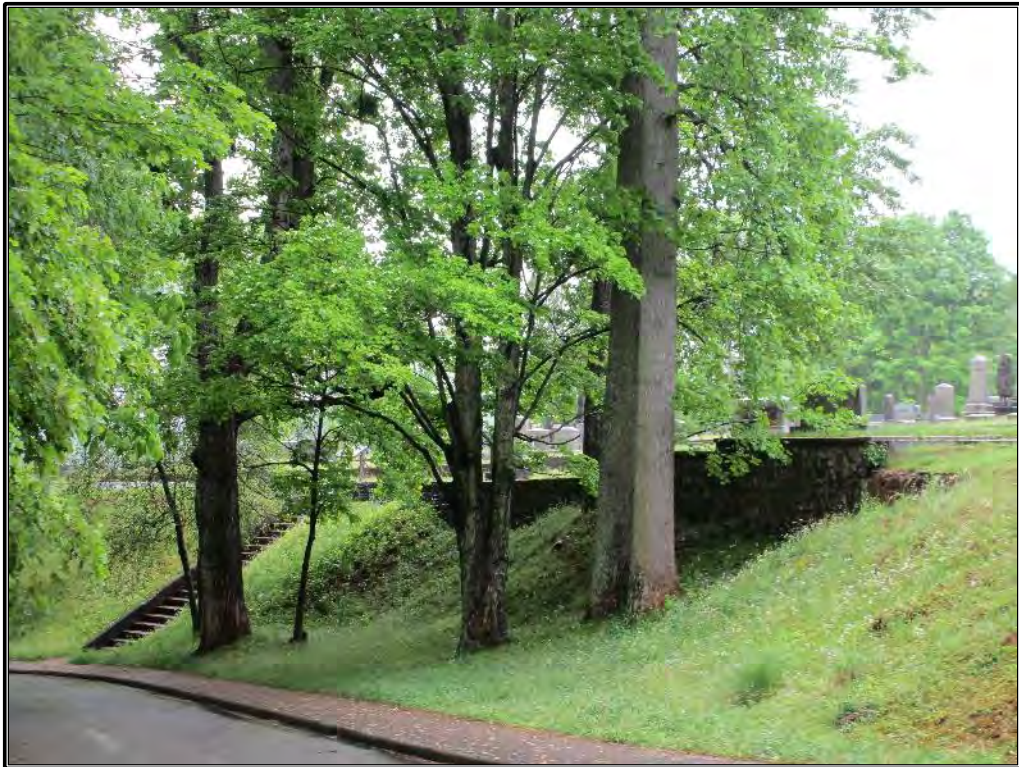
Figure 319. View of Hillview Circle looking northeast along the cemetery's stone wall and stairs.

of the northwest perimeter of the cemetery and frames the Hillview Circle entrance and Veterans Circle. A set of stone stairs incorporated into the retaining wall provides access to the cemetery from the public sidewalk along Hillview Circle. A metal archway inscribed “Green Hill” supported by stone piers frames the cemetery driveway. Within the northwest section of the cemetery, family plots and sections of burials are framed by low, poured concrete borders inscribed with family names. Stone benches are scattered throughout the cemetery. The southeast side of the cemetery along Shelton Street is vacant.

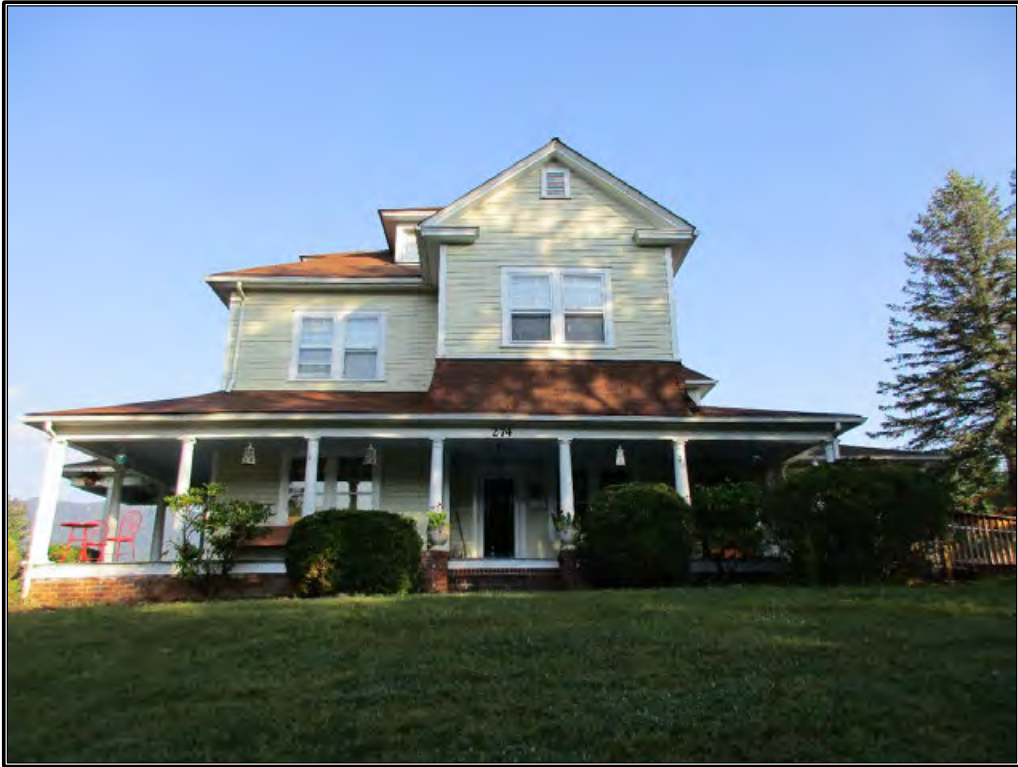
Figure 329. View of the façade looking northwest.

House, exterior: The circa 1902 Queen Anne and Colonial Revival-style residence presents a two-and-one-half-story, three-bay (ww/d/ww), double-pile, hip-roof form with multiple projections and additions (Figure 329). The dwelling rests on a partially exposed brick basement foundation. The exterior is clad in wood drop siding. The roof is sheathed in asphalt shingles. Unless otherwise indicated, the windows present nine-over-nine, double-hung wood sashes. An exterior brick chimney extends from the northeast elevation of the northeast addition (Figure 330). An interior brick chimney pierces the ridgeline of the southwest rear projection.

The façade features a central, single-leaf entry door and a storm door. A wraparound porch with a hip-roof supported by Tuscan columns set on a wood deck spans the façade along with portions of the northeast and southwest elevations (see Figure 329). A set of brick steps along the façade and a wood ramp along the northeast elevation provides access to the porch. The porch supports a second-story, front-gable projection. The projection features a flared base and deep gable returns. A paired window pierces the façade elevation of the projection. The northeast elevation of the projection contains a single window. A hip-roof dormer pierced by a paired window projects from the façade roof slope. A set of brick stairs along the southwest elevation of the porch are sheltered by a hipped roof projection supported by Tuscan columns over brick piers. The façade entry is flanked by paired windows.

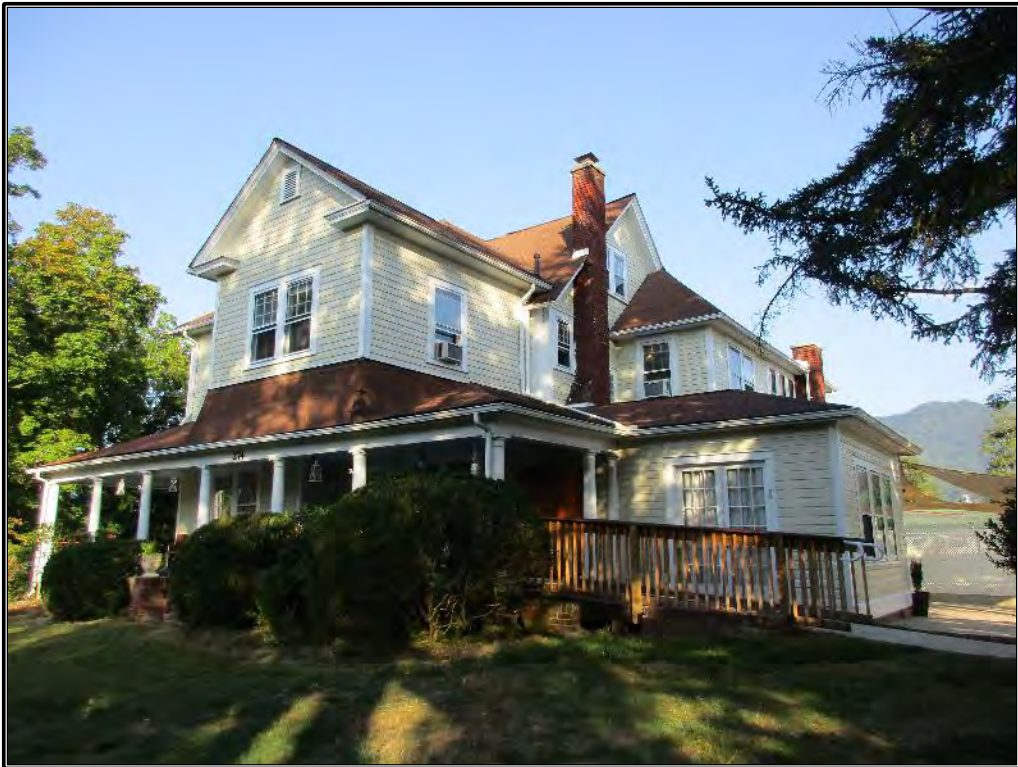
Figure 330. View of the northeastern (side) elevation with chimney.

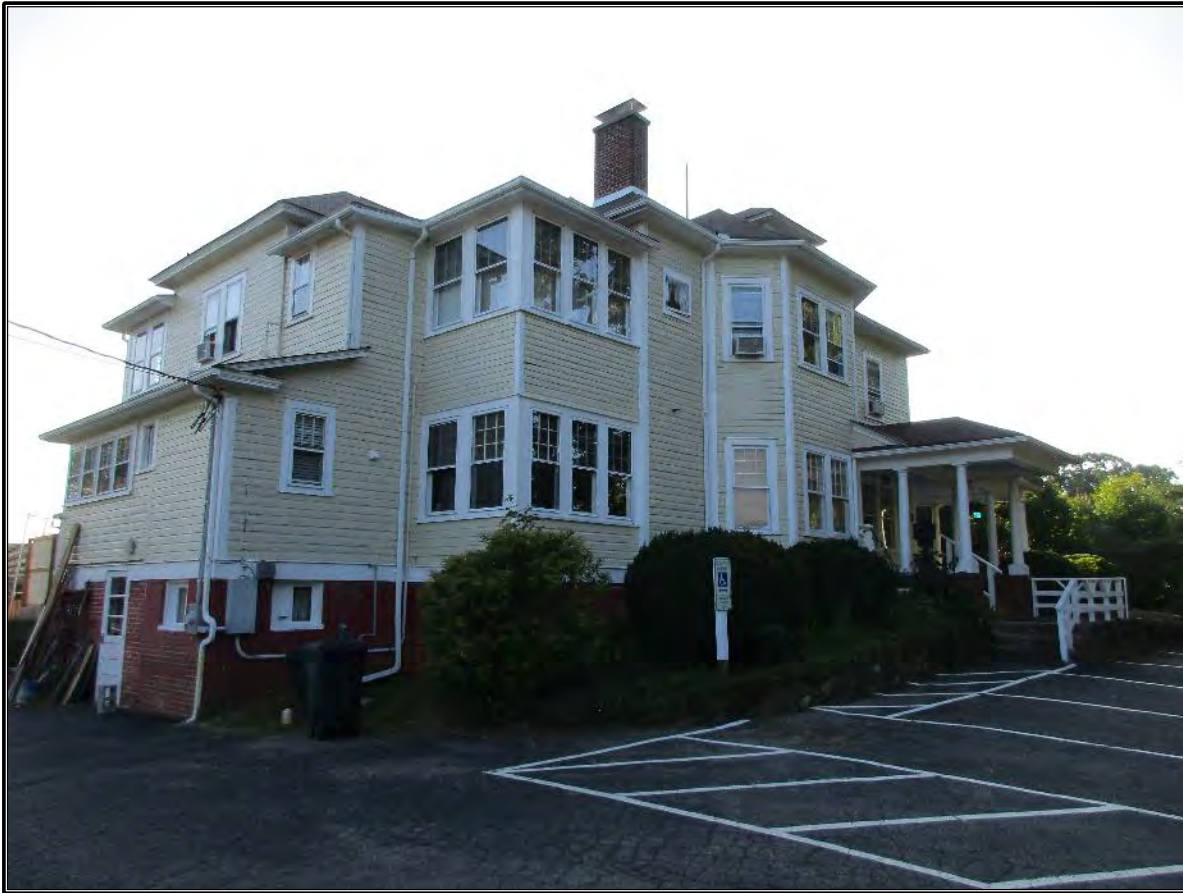
Figure 331. View of the southeastern (side) elevation.

The southwest elevation features a two-story, canted projection (Figure 331). The angled elevations (west and south) contain a single window along the first and second stories. The southwest elevation of the projection is pierced by a paired window along the first and second story. A paired window bay pierces the southwest elevation of the residence along the first story, southeast (right) of the canted projection. A single window is located along the second story of the elevation southeast (right) of the projection. A hip-roof dormer pierced by a paired window filled by a nine-light wood casement sash projects from the southwest roof slope. The northeast elevation of the residence features a two-story, side-gable projection (see Figure 330). A one-story, hip-roof addition is attached to the southeast (left) side of the projection. A two-story, hip-roof enclosed porch extends from the northwest (right) side of the side-gable projection and spans the northeast elevation of the rear ell. The northeast elevation

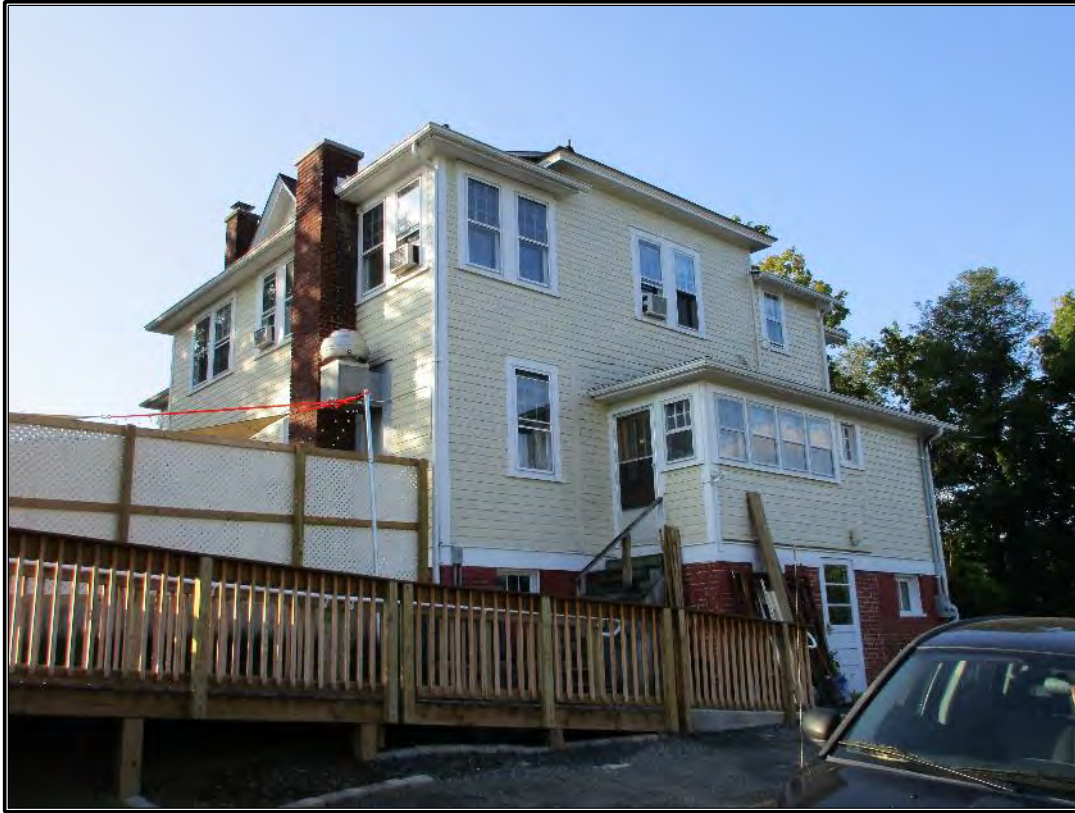
Figure 332. View of the rear elevation.

A two-story, hip-roof ell extends from the center of the rear elevation of the residence (Figure 332). A two-story, hip-roof enclosed porch extends along the southwest elevation of the ell. The rear elevation of the porch contains a paired window along the first and second story. A small single-leaf entry filled by a wood door along the rear basement story of the porch provides access to the crawl space. The rear elevation of the ell features a paired window along the second story. A one-story, shed-roof addition extends from the first story of the ell's rear elevation. A single-leaf entry filled by a multi-light wood door pierces the northeast elevation of the addition and opens onto a set of poured concrete steps. A single window is located northwest (right) of the entry. A single window is located along the southwest elevation of the addition. A single window filled by a two-light wood sash is located along the basement story. The rear elevation contains a ribbon of four windows and a single window filled by a six-light wood sash. A single-leaf entry filled by a three-light wood door pierces the rear elevation of the addition along the basement story. The entry is framed by single windows filled by two-light wood sashes.

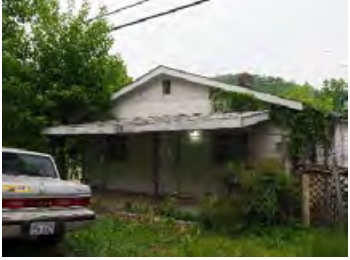
<p>115 Old Balsam Road c. 1955 NRHP Recommendation: Not Eligible</p> <p>This one-story, three-bay (w/d/w), front-gable, frame vernacular residence rests on a fully exposed river rock basement foundation. The house is clad in aluminum siding with wood panels underneath the front gable and is set beneath an asphalt shingle roof pierced by a parged interior slope chimney. Windows throughout the house contain one-over-one, double-hung wood sashes. The windows along the façade present multi-light wood sashes. A three-bay, shed-roof front porch with metal posts shelters the façade. A single-story, shed-roof addition extends from the rear elevation. The residence is attached to a neighboring structure to the south via a metal beam. The secondary building is clad in vinyl siding and sheltered by a gable-oriented roof sheathed in asphalt shingles. Multiple additions extend from the main block of the structure. The secondary building was largely obstructed by vegetation. A gable-oriented, concrete block outbuilding sheltered by an asphalt shingle roof is associated with the property.</p>

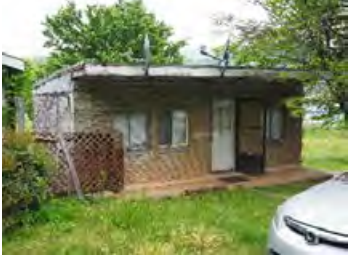
<p>114 Old Balsam Road c. 1955 NRHP Recommendation: Not Eligible</p> <p>This single-story, four-bay (w/w/d/w), shed-roof, concrete block residence is set on an exposed concrete block basement foundation. The façade is clad in a stacked brick veneer and the dwelling is sheltered by a metal paneled roof. Windows throughout the house present single-light sliding metal or vinyl sashes. An integral shed-roof overhang shelters the façade. The front entry contains a two-light wood door. A shed-roof projection extends from the west side of the north elevation. A side entry filled by a wood paneled door pierces the basement story of the north elevation.</p>
3

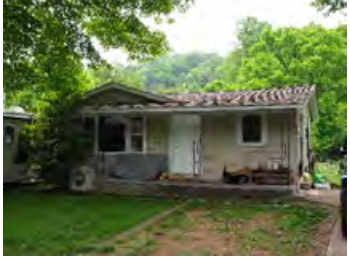
<p>141 Brendle Street c. 1959 NRHP Recommendation: Not Eligible</p> <p>The one-story, three-bay (www/d/w), side-gable, frame dwelling features a front-gable façade projection pierced by a tripartite window bay consisting of a central picture window between two narrow one-over-one, double-hung vinyl sashes. The house is set on a continuous foundation clad in aluminum siding and rests beneath an asphalt shingle roof. Windows throughout the residence contain one-over-one, double-hung vinyl sashes. A two-bay, shed-roof porch with scrollwork metal posts shelters the front entry.</p>

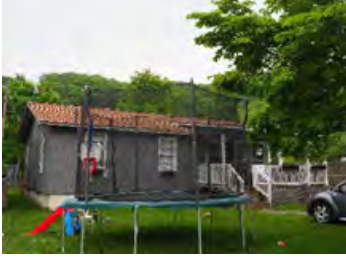
<p>93 Brendle Street c. 1966 NRHP Recommendation: Not Eligible</p> <p>The one-story, five-bay (w/w/d/w/w), side-gable, frame dwelling exhibits a continuous parged concrete foundation and T-111 siding. The roof is sheathed in asphalt shingles. The windows throughout present one-over-one, double-hung vinyl sashes with false snap-in-grids mimicking six-over-six configurations. A two-bay, shed-roof porch with wood posts and a wood railing shelters the front entry. A single-story, shed-roof addition with a shed-roof porch extends from the rear elevation.</p>
