Re: Close/cul-de-sac SR 1103 (Galatia Church Road), W-5205Z, PA 14-02-0032,
Cumberland County, ER 14-1735

This project proposes to close SR 1103 (Galatia Church Road) at SR 1102 (Gillis Hill Road) and to create a cul-de-sac. The property examined during this investigation is situated on the north side of SR 1103 (Galatia Church Road), between SR 1102 (Gillis Hill Road) to the northeast and Stoney Point Road (SR 1112) to the southwest (Figure 1–Figure 4, pp. 6–8). This resource has not been previously surveyed or evaluated for the NRHP.

Galatia Presbyterian Church

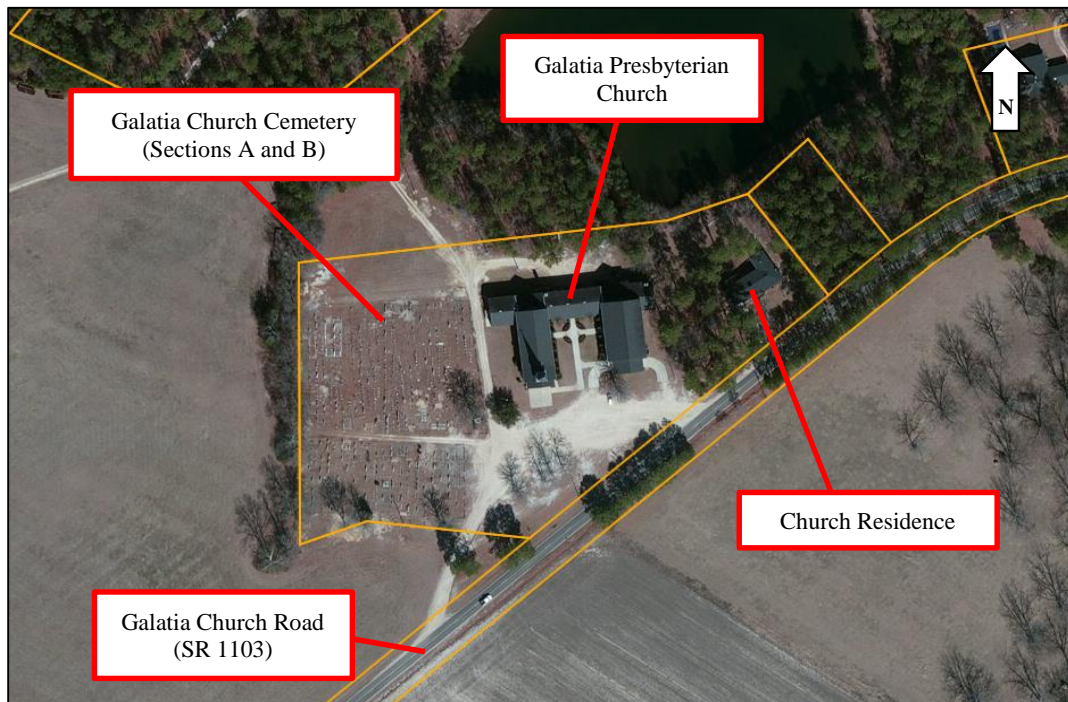
Figure 3: Site Plan of Galatia Presbyterian Church property, including Church, Cemetery, and Residence (Cumberland County GIS Data and Map Viewer 2014). Not drawn to scale.

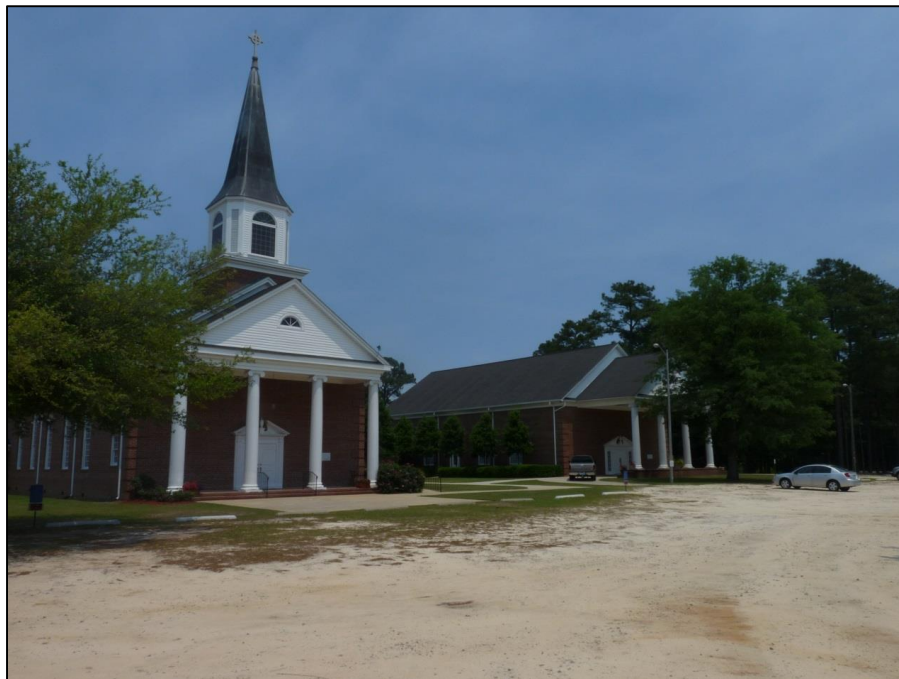
Photo 1: View of the Galatia Presbyterian Church Property, Looking Northeast from Galatia Church Road (SR 1103). Original (1960) section on left, 1991 addition on right.

This resource is located at the western edge of Cumberland County, approximately 0.5 miles east of the Hoke County line. Situated on the north side of Galatia Church Road (SR 1103), the 5.96-acre property consists of a church, a cemetery, and a residence (Photo 1). The property is oriented with the cemetery on the western side of the parcel, the church in the center of the parcel, and the dwelling on the eastern side of the parcel (Figure 3, p. 6). The land in front of the church is flat and sandy and partially used as a parking lot. The land immediately surrounding the church, as well as the entry courtyard, is manicured grass, shrubs, trees, and flowers. There is a driveway along the west side of the church, accessed from Galatia Church Road, leading to a parking lot behind (north of) the church.

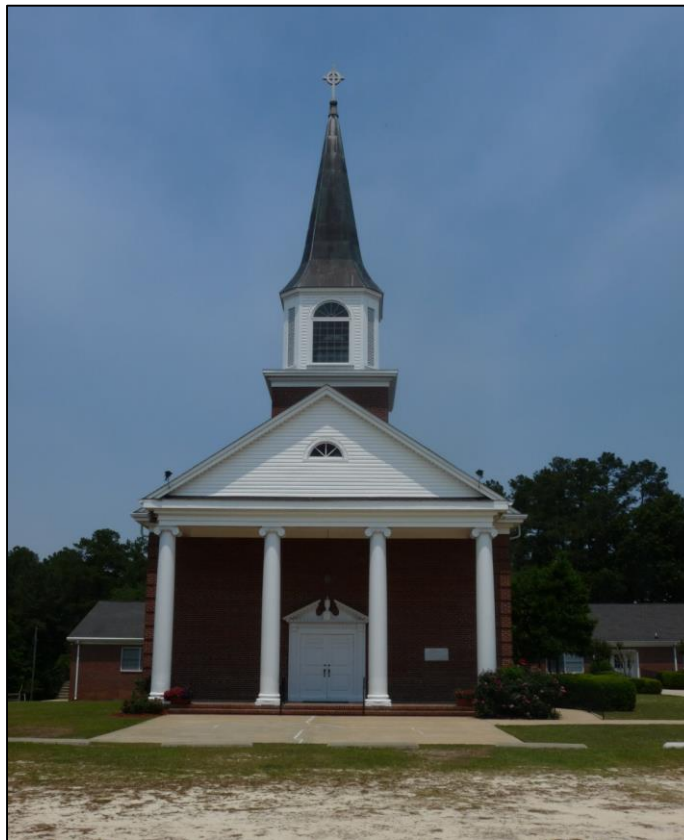
Photo 2: View of South Elevation of Original Church Section (1960), Looking North.

The southern façade includes a front-gable portico rising to the ridge of the main roof. The portico is supported by four wooden Ionic columns. The columns rest on a brick floor beneath the portico. A small lunette window is centered in the gable above the columns. There is a single centered entrance on this façade, leading into the sanctuary. This entry consists of a paneled paired wooden door set within a Colonial Revival surround and broken pediment. A datestone is set to the east of the central door which presents the dates of the current and earlier churches on this site (Photo 3). Brick quoins are set into the corners of this façade.

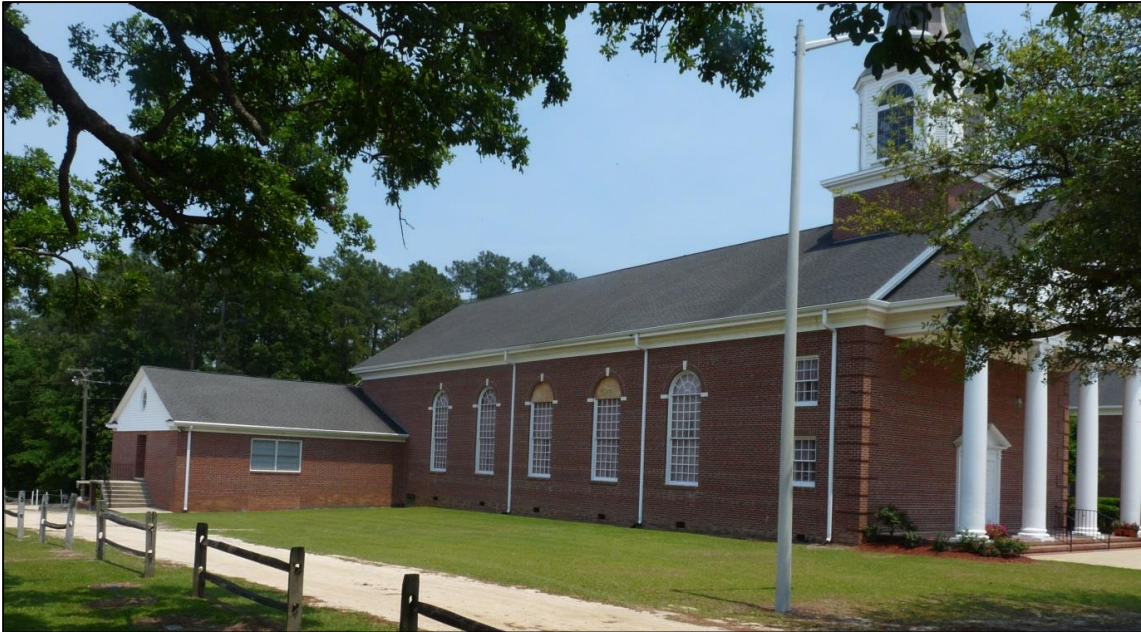
Photo 4: View of West Elevation, Looking Northeast from the Adjacent Cemetery. The sanctuary is on the right, while classrooms occupy the rear projecting wing. Both sections were built in 1960.

The western elevation is six bays long. The southernmost bay is composed of two eight-over-eight double-hung wood frame windows. The other five bays along this façade are all identical windows, each consisting of 25 over 25 double hung sash, set beneath a fixed fanlight (Photo 4, p. 12). Two of the windows on this elevation have wooden panels replacing the fanlights. The east elevation mirrors the west elevation.

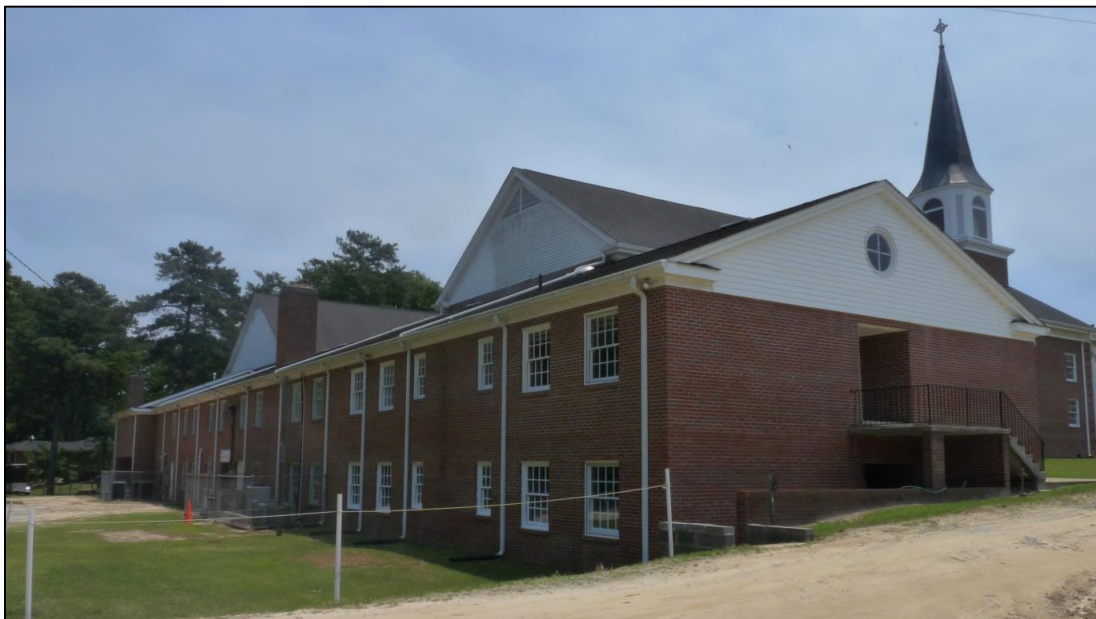
Photo 5: View of the Rear (North) Section of the Church, Looking Southeast.

The rear (northern) section of the church is more utilitarian in nature (Photo 5, p. 12). This section consists of a brick structure with an asphalt-covered gable roof running east to west, and perpendicular to the roof line of the main section of the church, creating the T-plan. The rear section is set into sloped topography, so it consists of two full stories. The upper story is visible when looking northward from the front of the property, so it appears to be only a one story building. When looking from the south (rear), the full two stories can be seen. This section includes a variety of eight-over-eight double hung windows as well as six-over-six double hung windows, all set in wooden sashes. The main entrance to the church offices and classrooms is through this section, located on the south elevation (east of the main church block). This entrance is through a tri-partite wood and glass panel door. A second entrance into this rear section is present on the west elevation, accessed from concrete steps to a paneled wooden door.

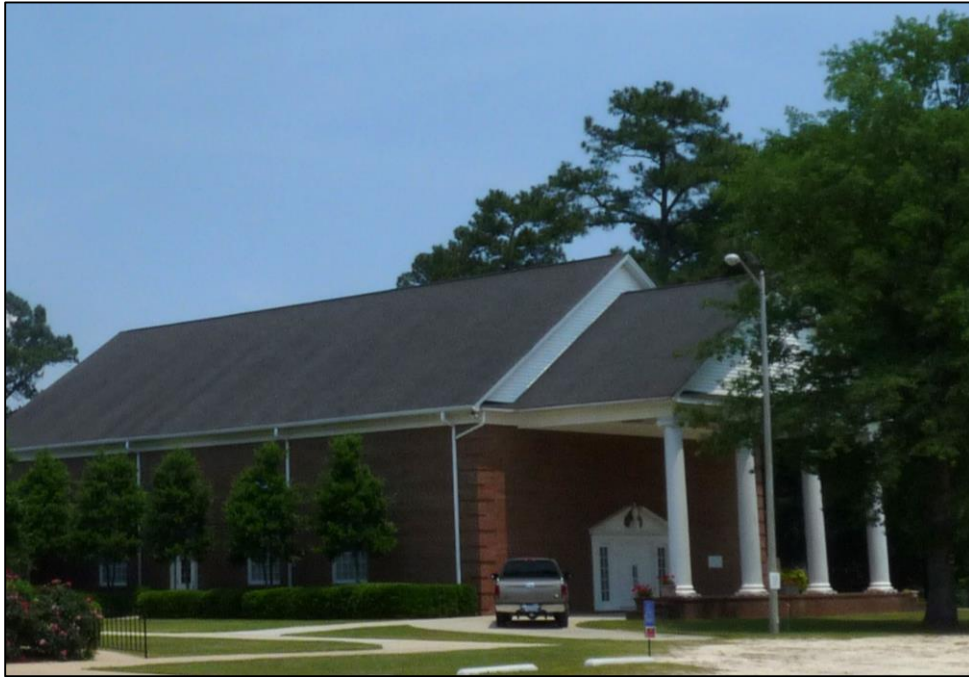
Photo 6: View of 1991 Addition, Looking Northeast.

match the pattern on the original (1960) section of the church. The main portion of the addition is a two-story rectangular gable-front structure used as a Fellowship Hall. The south elevation of this addition is dominated by gable-roofed portico supported by four Ionic columns (Photo 6). The wooden columns are set on a raised brick wall, creating a partially enclosed “portecochere” where vehicles can drive right up to the entrance. There is a tri-partite centered entrance on this façade, composed of a central paneled paired doorway flanked by fixed sidelights. The doorway is set beneath a Colonial Revival broken pediment with urn detailing. A datestone is present on the south façade of this addition (Photo 7).

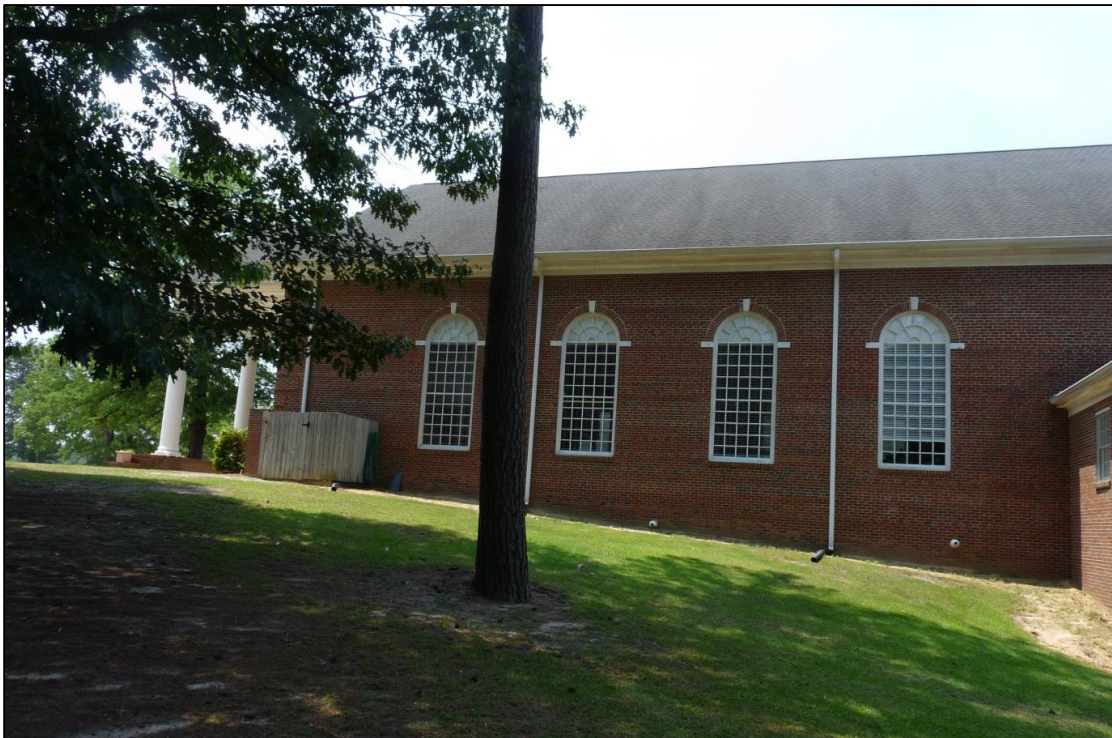
Photo 8: View of Eastern Elevation of 1991 Addition, Looking West.

The west elevation of this addition is four bays long, with a door located in the third bay from the south. The three windows on this elevation are wood, multi-pane, and appear to be fixed, with a fanlight above (Photo 8). The door is paneled but has multi-pane glass panels to allow light into the building. The east elevation of this addition has four symmetrically placed windows, each identical to the windows found on the west elevation. As is found on the original section of the church, there is a two story side-gable roofed section at the northern end of the addition, extending east and west of the addition, creating the T-plan. This section is also clad in brick, and is sloped so it includes two full stories. Multiple eight-over-eight double hung windows are located across both stories of this rear section. There is a separate entrance to this section on the north elevation, from the parking lot behind the church.

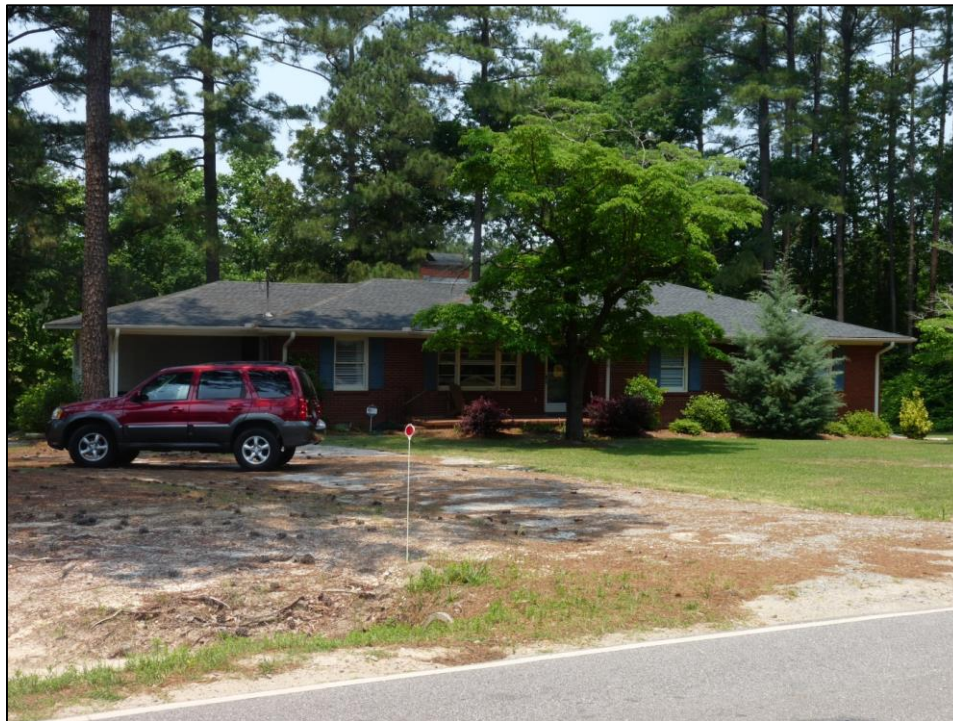
Photo 18: View of Residence on the Galatia Presbyterian Church Property, Looking North.

There is a one-story, five-bay residence also located on the Galatia Presbyterian Church property, east of the church itself (Photo 18). It should be noted that although the building is on the same parcel as the church (9486-20-0838), it has a separate street address (8750 Galatia Church Road). The brick Ranch style house is set low to the ground, with overhanging eaves, a long narrow plan, and minimal decoration. The foundation is composed of concrete block, and the structural system is formed of wood frame. The side-gable roof is clad in asphalt shingles. There is a central brick chimney rising through the ridge of the roof. The residence was constructed between 1957 and 1958 (Parker 2000).

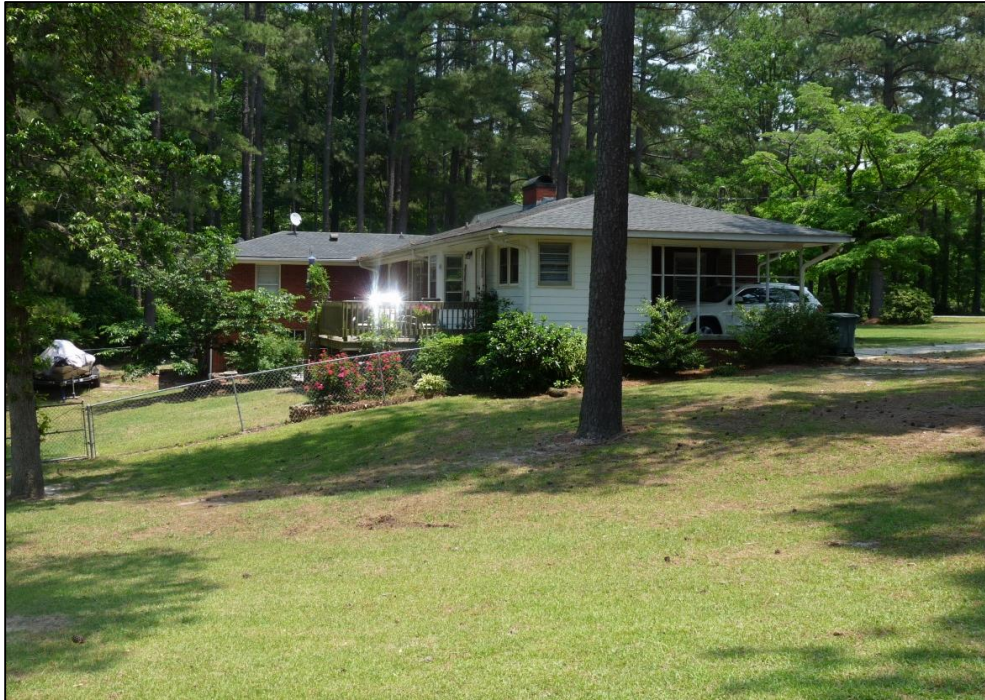
Photo 19: Northeast Oblique View of Residence. Note wooden deck and partially enclosed carport.

The house rests on a sloping terrain, which dips toward the rear (north side) of the building (Photo 19, p. 23). Because of this, there is a two story section to the Ranch house, with what appears to be a basement set beneath the eastern side of the dwelling. A wooden porch constructed of pressure treated lumber has been constructed on the rear (northern) elevation, likely within the past 20 years.

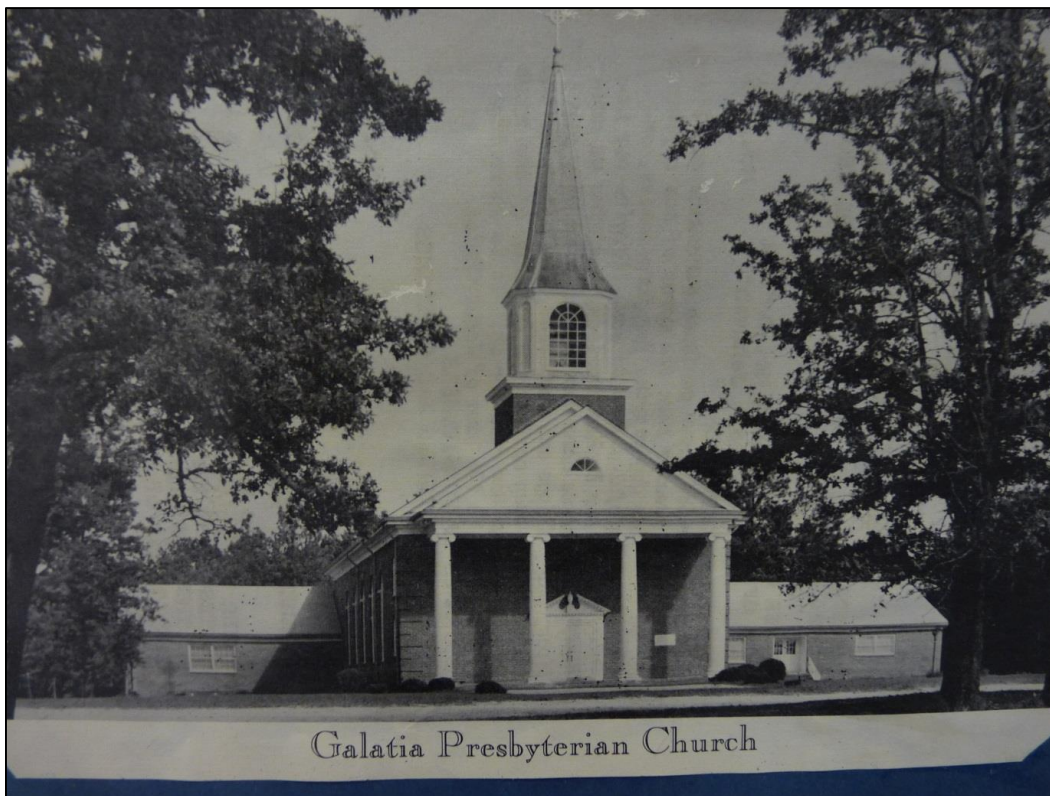
Figure 9: View of 1960 Galatia Presbyterian Church, Prior to Large Addition Constructed on the East.

On December 13, 1959, the Galatia Presbyterian Church burned to the ground in a massive fire, and planning for the current church was quickly undertaken. A planning committee was established, and various types of new churches were visited. In addition, materials recommended by the Department of Church Architecture of the Board of Church Extension of the Presbyterian Church of the United States were reviewed by the committee. Finally, the committee discussed ideas and plans with architect James R. Pittman, from Fayetteville, North Carolina (No additional information could be found on this architect). The building was completed in 1960 and included the sanctuary, 16 classrooms, pastor’s study, choir room, a kitchen, restrooms, storage and utility rooms, as well as central air conditioning and heat (Figure 9).

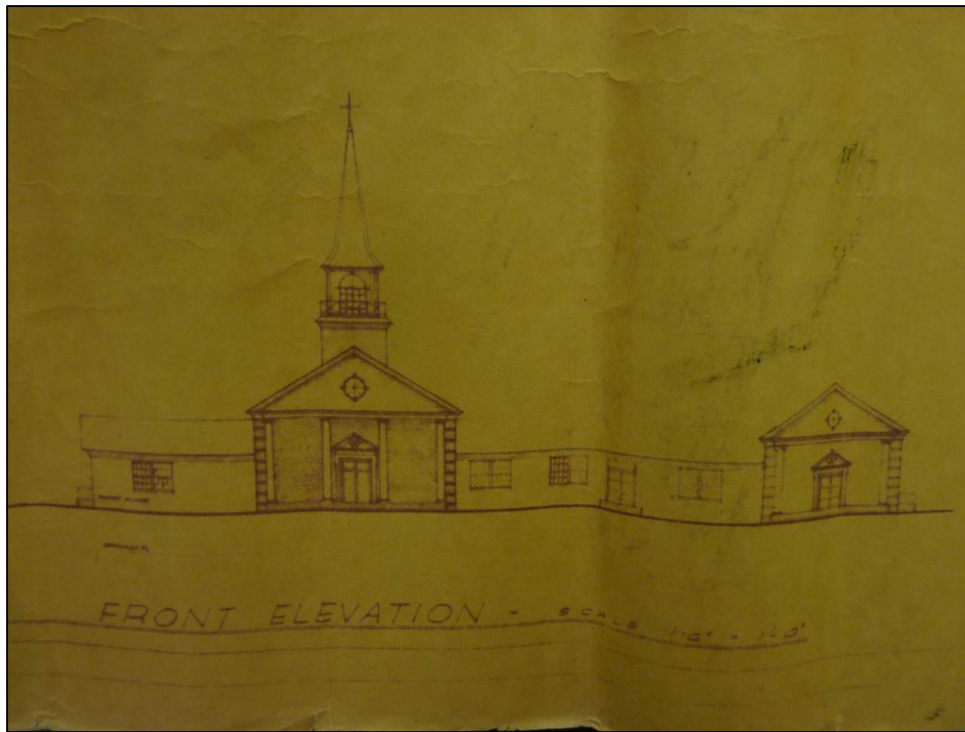
Figure 10: Front Elevation of Plan for Galatia Presbyterian Church, 1960. On file at Galatia Presbyterian Church.

An examination of the plans prepared for the 1960 church did reveal that an eastern wing containing a social hall was anticipated, however that element of the building was not implemented for more than three decades (Figure 10–Figure 11, p. 27).

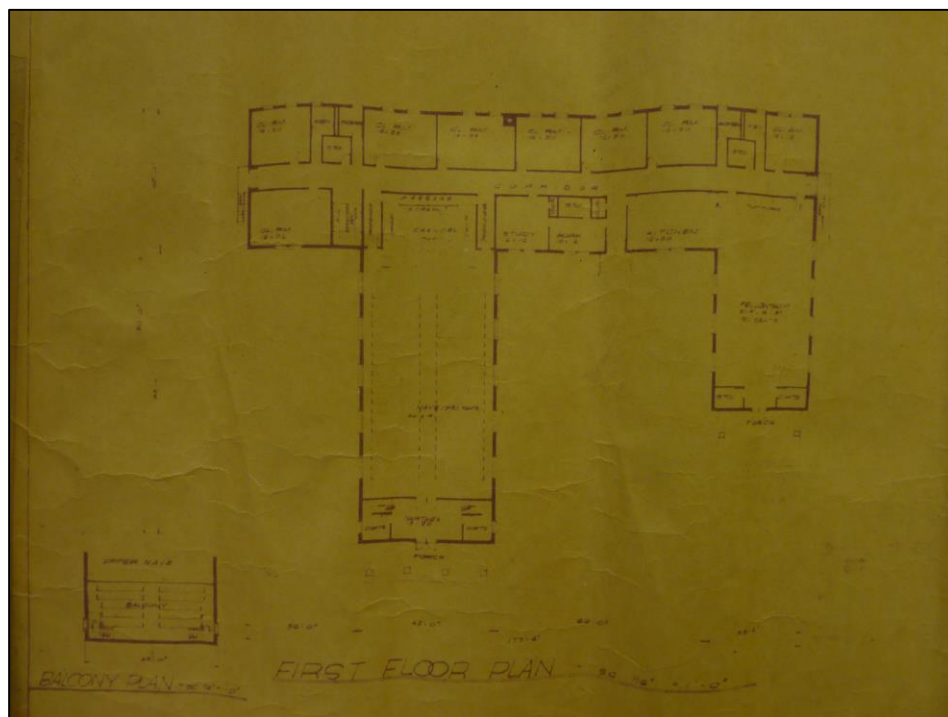
Figure 11: First Floor Plan for Galatia Presbyterian Church, 1960. On file at Galatia Presbyterian Church.

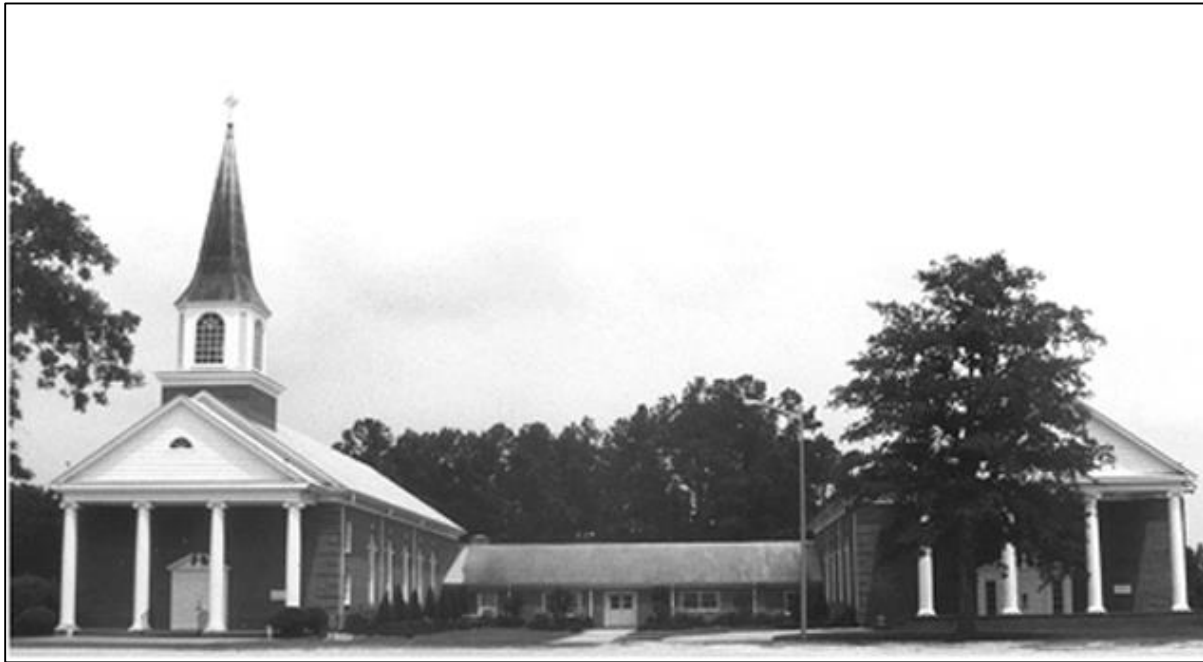
Figure 12: Undated photograph (post-1991) Showing the New Eastern Addition to the Galatia Presbyterian Church. Half of the central wing, as well as the entire eastern Fellowship Hall, were added to the original (1960) building to the left of the photograph.

In 1991 the church expanded with a large addition on the east, doubling the overall size of the facility, but still following the intent of the 1960 plans. This section of the building includes the large fellowship hall, as well as additional classrooms and an expanded kitchen area (Figure 12). A comparison between the plans developed in 1960 and those executed in 1991 reveal that the addition constructed was much larger than that planned for in 1960.

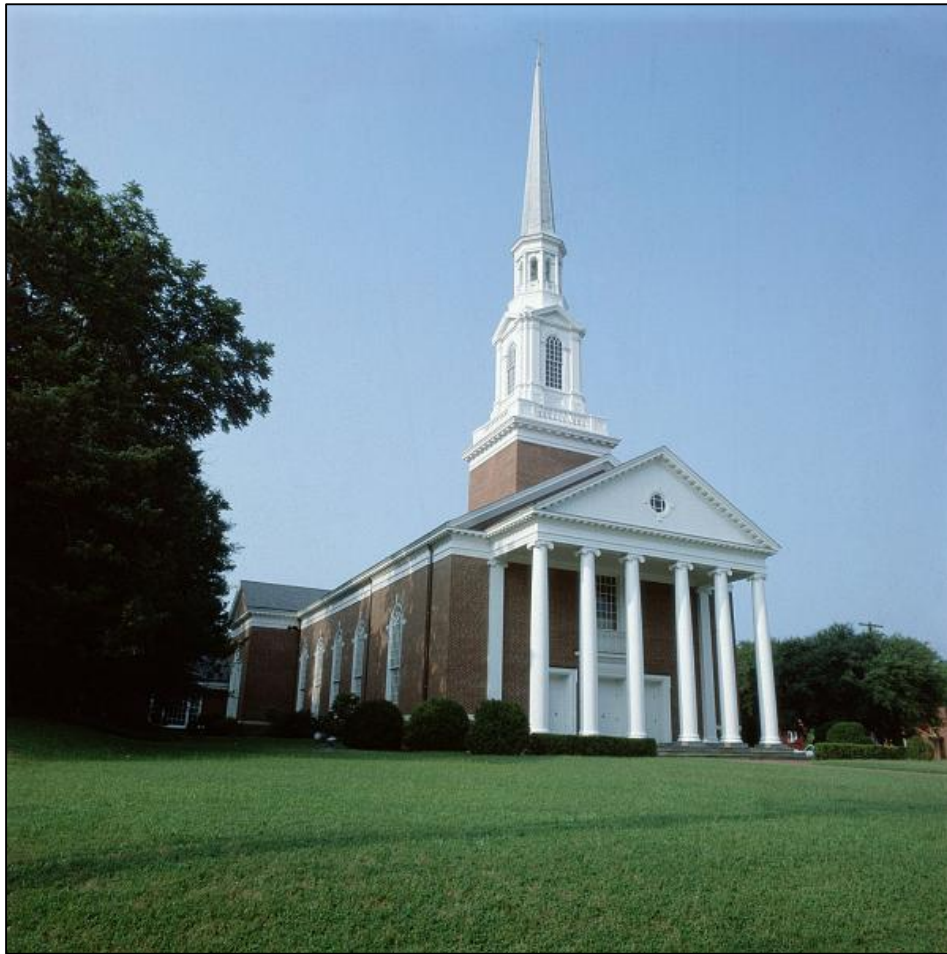
Photo 20: View of Highland Presbyterian Church, Fayetteville.

Additional research was undertaken to try to find other examples of similar Colonial Revival churches dating to the 1960s in the Fayetteville area, to provide additional context. The Highland Presbyterian Church (111 Highland Avenue) is a good example of the form, and was built in 1961. This building is a similar “Wren-Gibbs” design with a porticoed front and columns, large rectangular sanctuary, balcony, and a towering dramatic tiered steeple. This is a more “high-style” design than that found at Galatia, but does provide comparative context and is an excellent example of the form in Fayetteville (Photo 20).

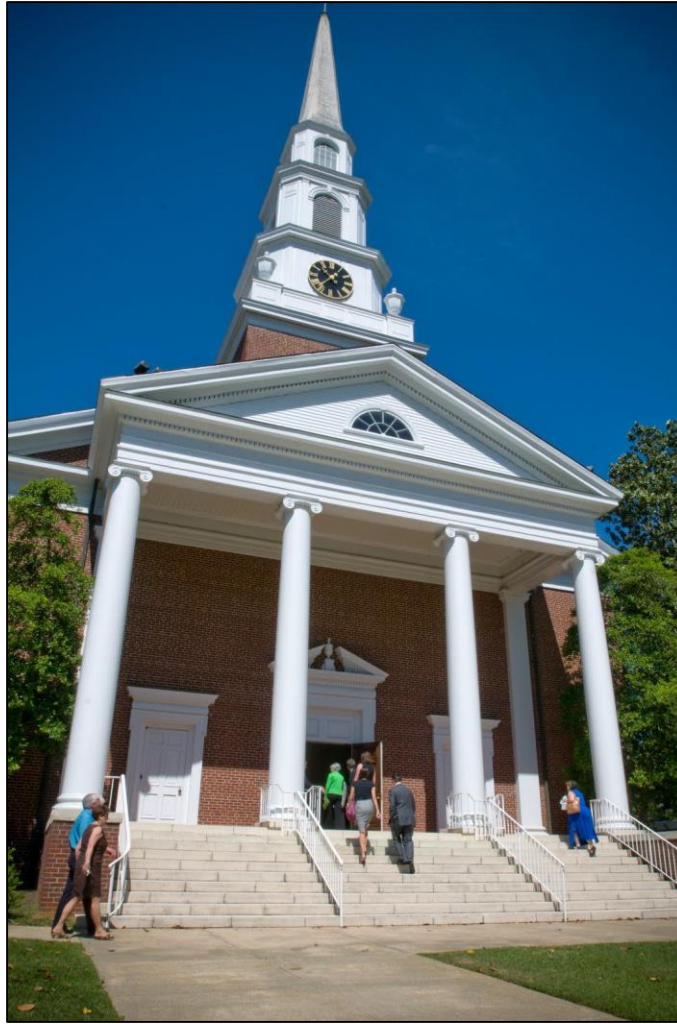
Photo 21: View of the main elevation of the Snyder Memorial Baptist Church in Fayetteville.

Another example is the Snyder Memorial Baptist Church, located at 701 Westmont Drive in Fayetteville (Photo 21, p. 32). This brick church was constructed in 1958, and is illustrative of the style with a dominant Ionic columned portico, stepped tower, and a series of tall narrow multi-paned windows allowing light to flood the sanctuary. This building is an excellent example of the Wren-Gibbs style executed in the mid-twentieth century.

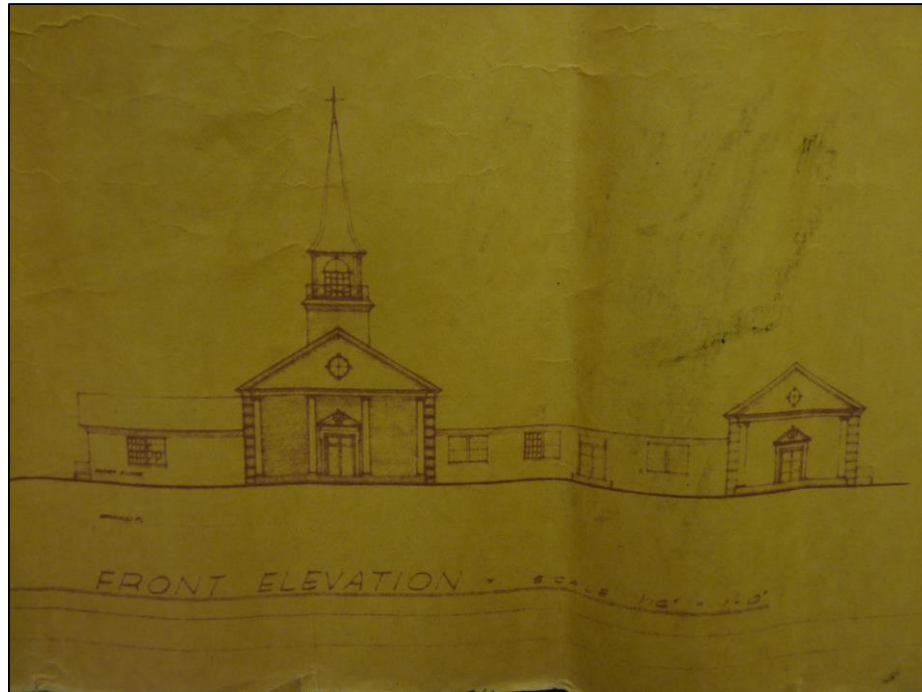
Figure 13: 1960 Front Elevation Drawing of Galatia Presbyterian Church, as planned by architect James R. Pittman.

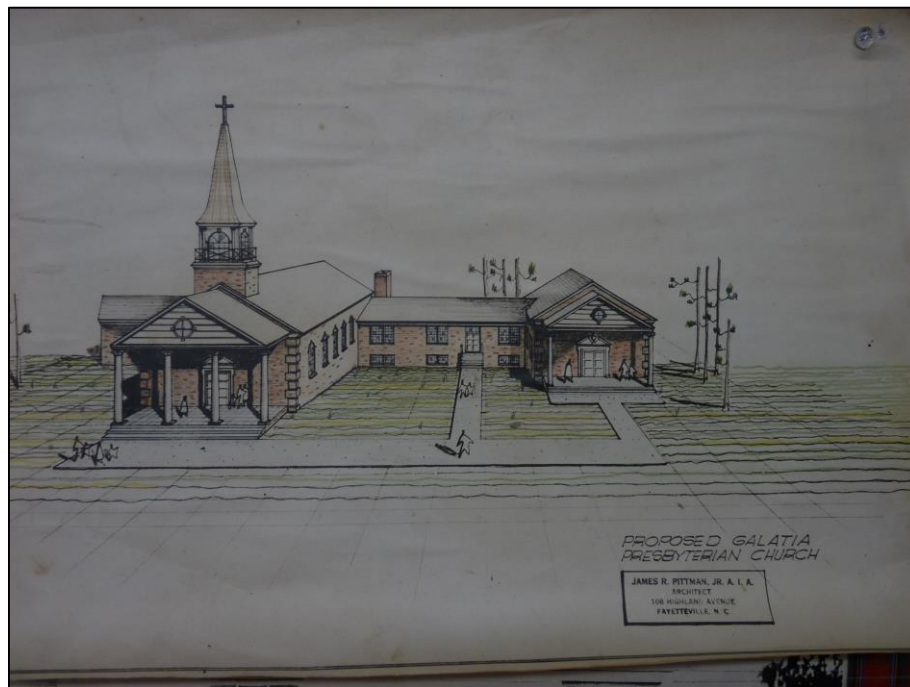
Figure 14: Galatia Presbyterian Church 1960 rendering by James R. Pittman. Note diminished size of eastern section and prominence of main sanctuary.

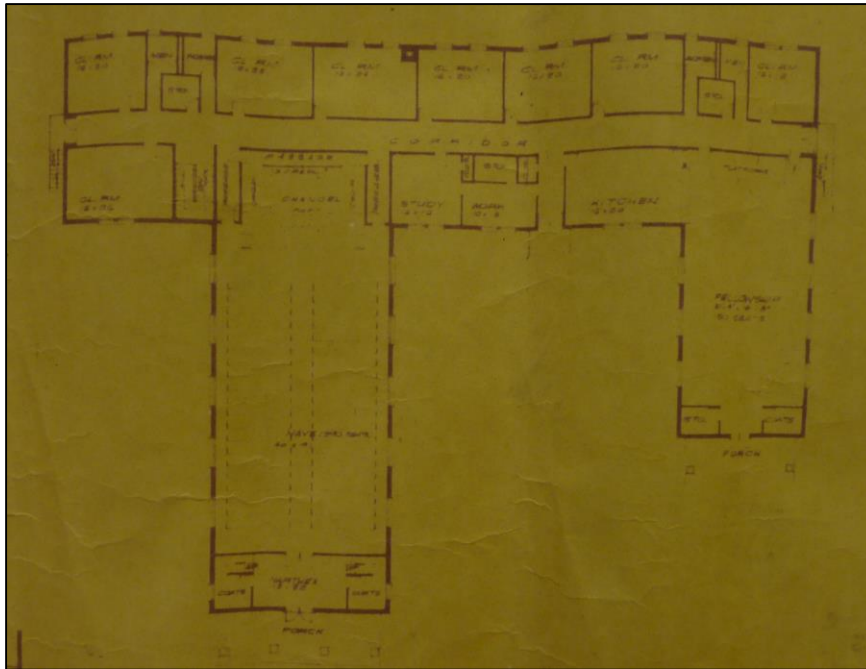
Figure 15: 1960 Plan of Galatia Presbyterian Church Enlarged. Note that the eastern addition is much smaller in scale than the main block of the church, and was to be set back significantly from the primary block.

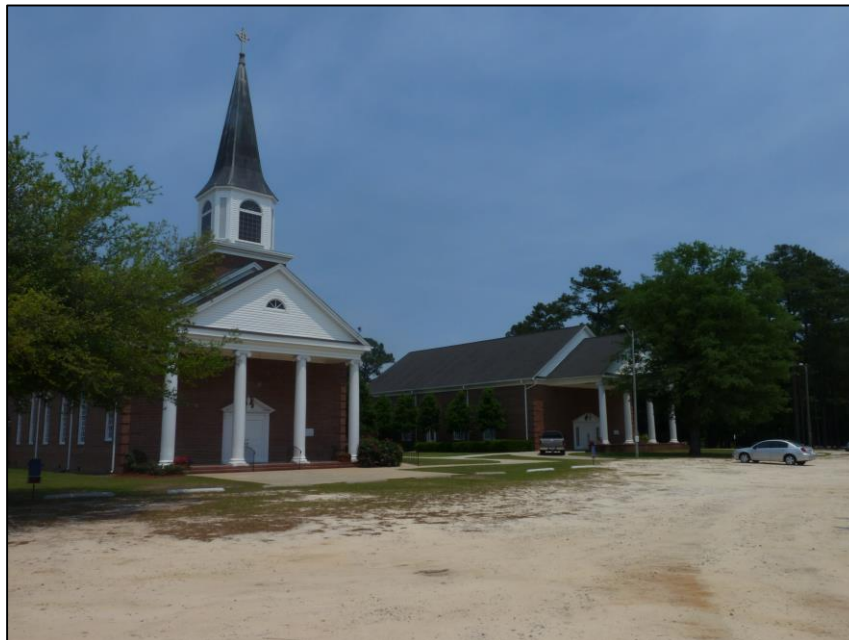
Photo 22: Current view of Galatia Presbyterian Church, including 1991 addition on right. Note prominence of the addition in comparison to the main sanctuary.

As can be seen from the previous analysis, as constructed, the 1991 addition parallels the original 1960 church in terms of size and scale, and substantially changes the visual quality of the resource. Although the addition was constructed of brick and the appearance and fenestration is complementary to the original section, the scale and prominence detract from the primary section and change the intended relationship between the primary sanctuary and the secondary Fellowship Hall. Due to the impact of the construction of the 1991 addition to the Galatia Presbyterian Church property, as well as a number of interior alterations over the past 54 years (renovation of chancel, construction of new kitchen, upgrades to classrooms, renovation of ground floor of rear wing), the resource has lost integrity of Design, Materials, and Feeling (Table 2).
