NATIONAL REGISTER OF HISTORIC PLACES

Burdett Woody House

Siler City vicinity, Chatham County, CH0815, Listed 8/16/2008

Nomination by Beth Keane

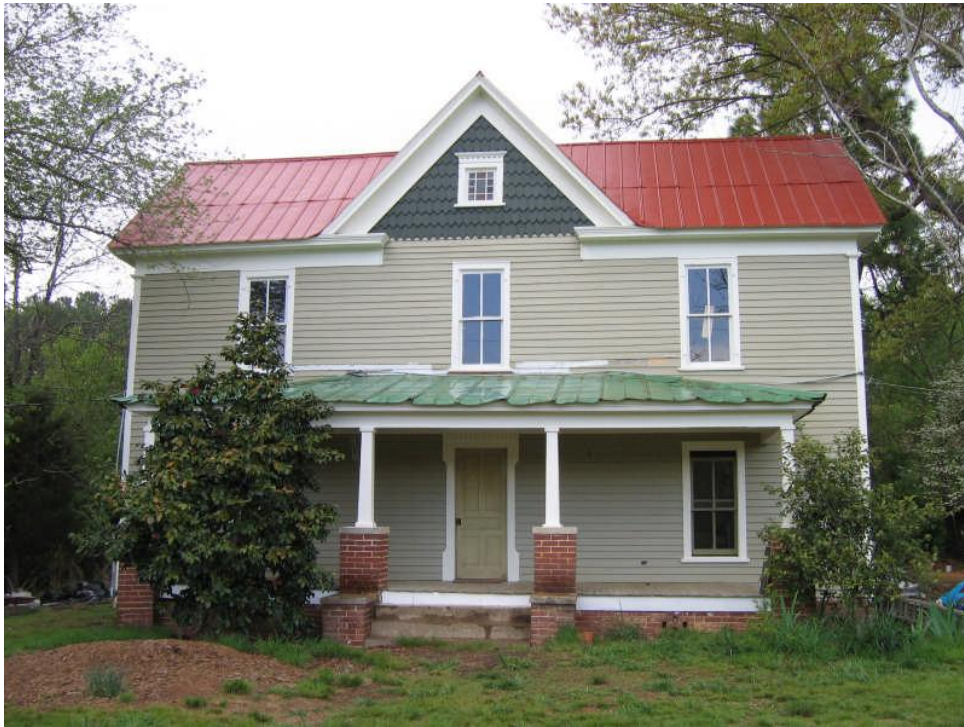
Façade view

The Woody House sits on brick piers infilled with a brick foundation. The three-bay frame house, clad with weatherboard siding, is enhanced with corner boards featuring elaborate capitals, a flat frieze with cornice moldings, dentil molding over the crosetted central front door, and square multi-paned, stained-glass windows with denticulated cap molding centered in each saw-toothed shingled gable. The boxed eaves feature applied diamond-shaped wooden medallions in the cornice returns. Prior to World War II, the original posts of the three-bay, one-story, hipped-roof, partial-façade front porch were replaced with slender battered posts resting on brick piers. The roof of the porch is covered with 5-V tin of undetermined age.

The central five-panel front door is flanked on either side by two-over-two, double-hung, sash windows. The three windows at the second level of the façade are symmetrically placed over the first level openings. The newly installed windows throughout the house replicate the original two-over-two sash windows.

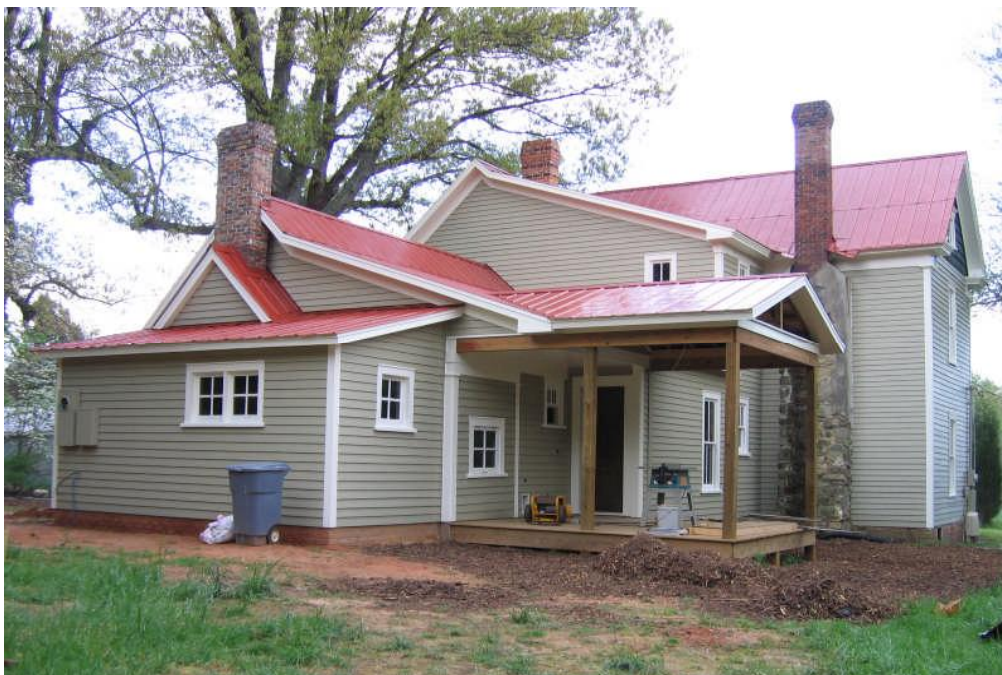
Rear view

The east and west elevations of the main block of the house are identical and include a single window centered at both the first and second levels. The north (rear) elevation of the main block has two single-shoulder stone chimneys with brick stacks. The chimney to the east is placed between the house and the gabled rear ell, while the western chimney is fully exterior.

The original one-story rear ell has recently been reconfigured. A second-floor addition, measuring approximately eight-feet long by twenty-five-feet wide, abuts the north elevation of the main block of the house. In addition, the west wall of the original dining room/enclosed porch has been bumped out approximately two feet to accommodate the second-floor addition. The east-side fenestration of the ell consists of two small two-over-two, double-hung, sash windows, symmetrically arranged at the first and second levels, an original two-over-two, double-hung, sash window, providing light for the dining room, and a five-panel, door opening into the dining room. Paired four-pane casement windows are located north of the door. An attached gabled portico shelters the entrance. The ell's north elevation features an exterior, single-shoulder, stone chimney with a brick stack. The bottom portion of the chimney has recently been enclosed by a newly constructed rear utility room with a shed roof. A small gable on the roof of the utility room abuts the chimney. Fenestration of the utility room features an east-elevation entry door, paired four-pane awning windows on the north elevation, and a single four-pane awning window on the west elevation.
