SUBJECT: Historic Architectural Resources Survey Report/Winston-Salem Northern Beltway,
Western Section, US 158 to US 52, R-2247, Forsyth County, CH91-0603

Clayton House

April 2003

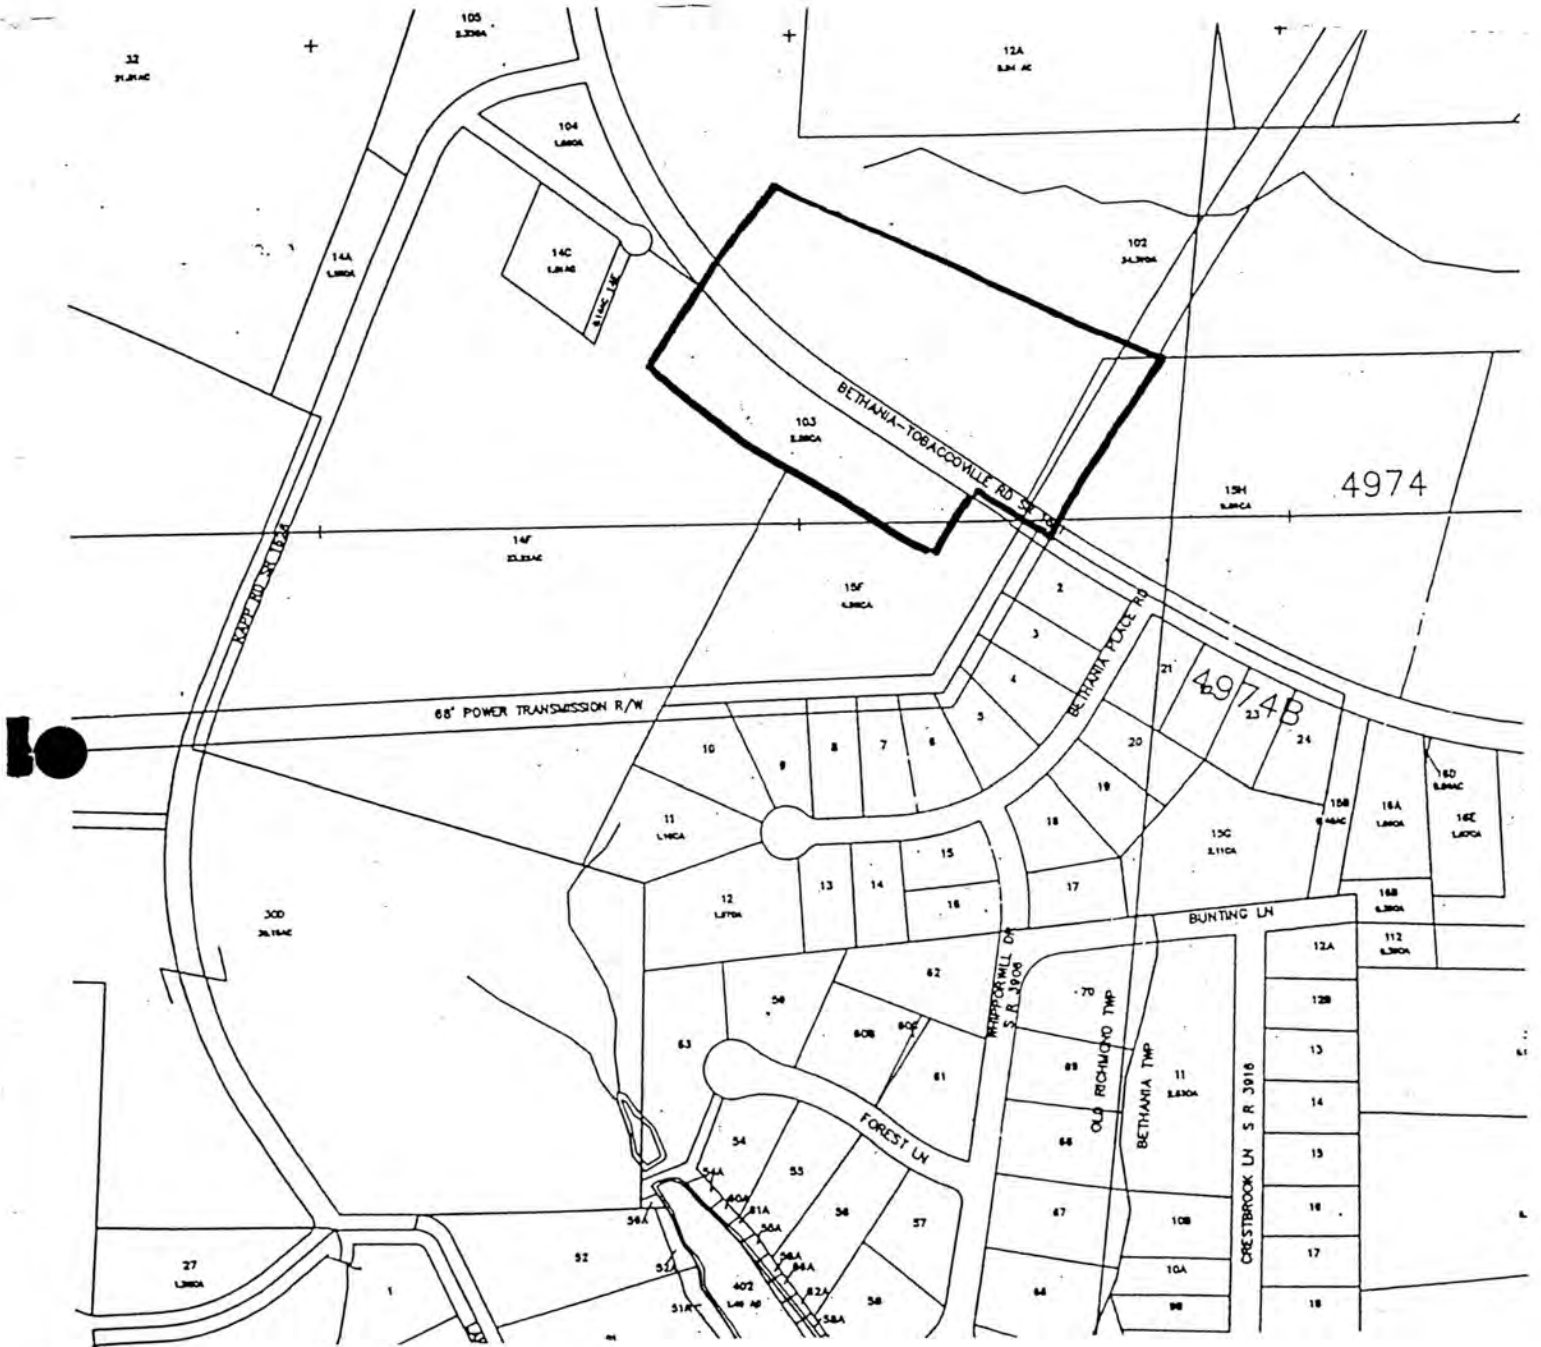
Samuel B. Stauber House and Barn Tax Map Showing Eligible Boundaries

Boundary Description and Justification: *from the 1987 National Register Nomination by Gwynne Taylor* The complex of buildings is surrounded by a 6.9 acre tract. The boundary contains the land immediately surrounding the house and outbuildings, which visually maintains the integrity of setting, feeling and association of the period of significance, 1852-1884, of the Samuel Stauber farm. The tree lines, fence lines, and power lines, which delineate this parcel visually from the surrounding countryside, have been used as boundaries, in addition to the boundaries of the tract left to Mary Jane Stauber after Samuel's death. The setting and surroundings have not changed since the 1987 nomination or the 1991 study by Ms. Opperman. Thus, no boundary changes are recommended.

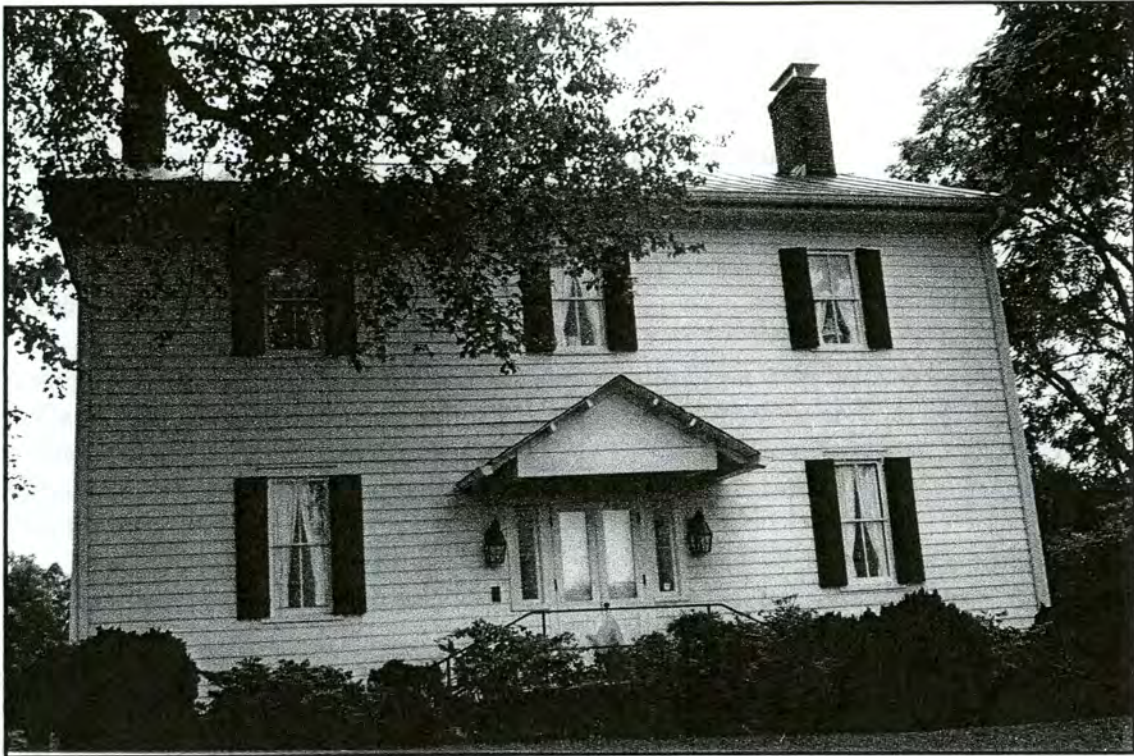
Samuel Stauber House

Description: The 1852 Samuel B. Stauber House is a two-story, weatherboarded, gable-roofed dwelling, 3 bays wide and 2 deep with a ca. 1947 rear ell on the southeast corner. The house is of heavy-timber frame filled with brick noggin, a fieldstone foundation and interior end brick chimneys. It is one of only two mid-nineteenth century frame houses in the county with interior chimneys and pedimented flush gable ends. An exterior end brick chimney stands on the east end of the rear ell. The front façade features a ca. 1947 fieldstone stoop, a late nineteenth century double-leaf front door surrounded by sidelights and a straight transom glazed with red glass, and a ca. 1947 pedimented porch roof. The 1947 changes replaced a façade-length, one-story porch that probably dated from the late nineteenth century.

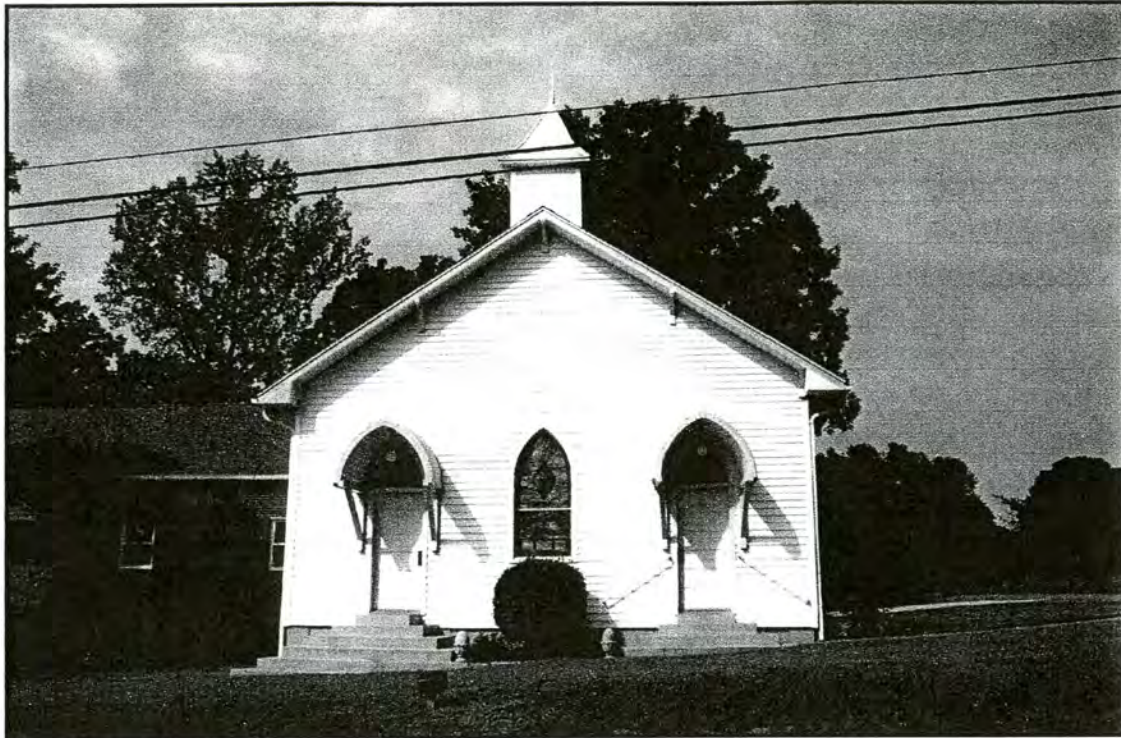
Description: Community United Church of Christ is a one-story, gable-front frame church building. A stained glass Gothic arch window pierces the center of the front elevation. Double-leaf Gothic arch doors sheltered by Gothic arch bonnets flank this window. Gothic arch, stained glass windows also pierce the side elevations. A small, square steeple with a pyramidal roof caps the building. Kneebraces are located in the front gable end. Vinyl siding covers the exterior. A brick addition is attached to the south elevation. A frame addition is attached to the brick addition's south elevation. A large cemetery with a historic gazebo is located across the road.

Community United Church of Christ, east elevation

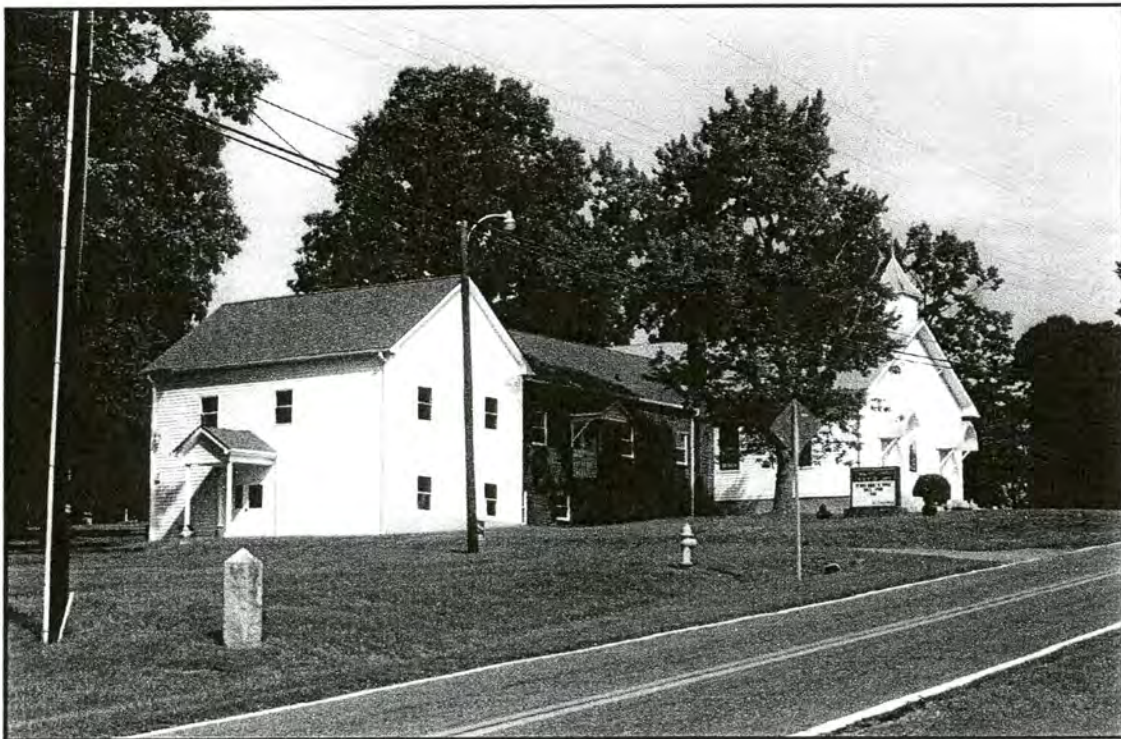
Community United Church of Christ, south and east elevations

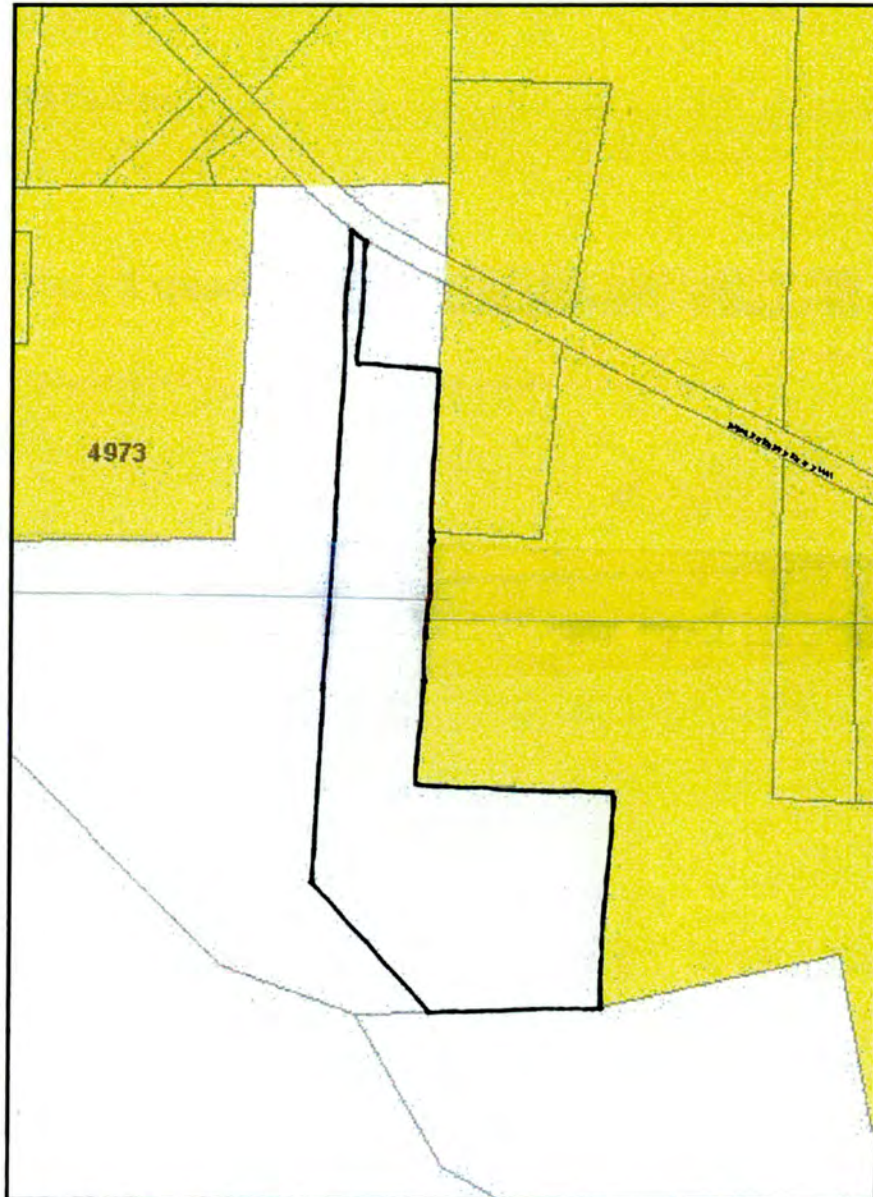
Wolff-Moser House Tax Map Showing Eligible Boundaries
(PIN Number 6900-30-7461)

Boundary Description and Justification: The boundary follows the lot line of the parcel on which the house stands.

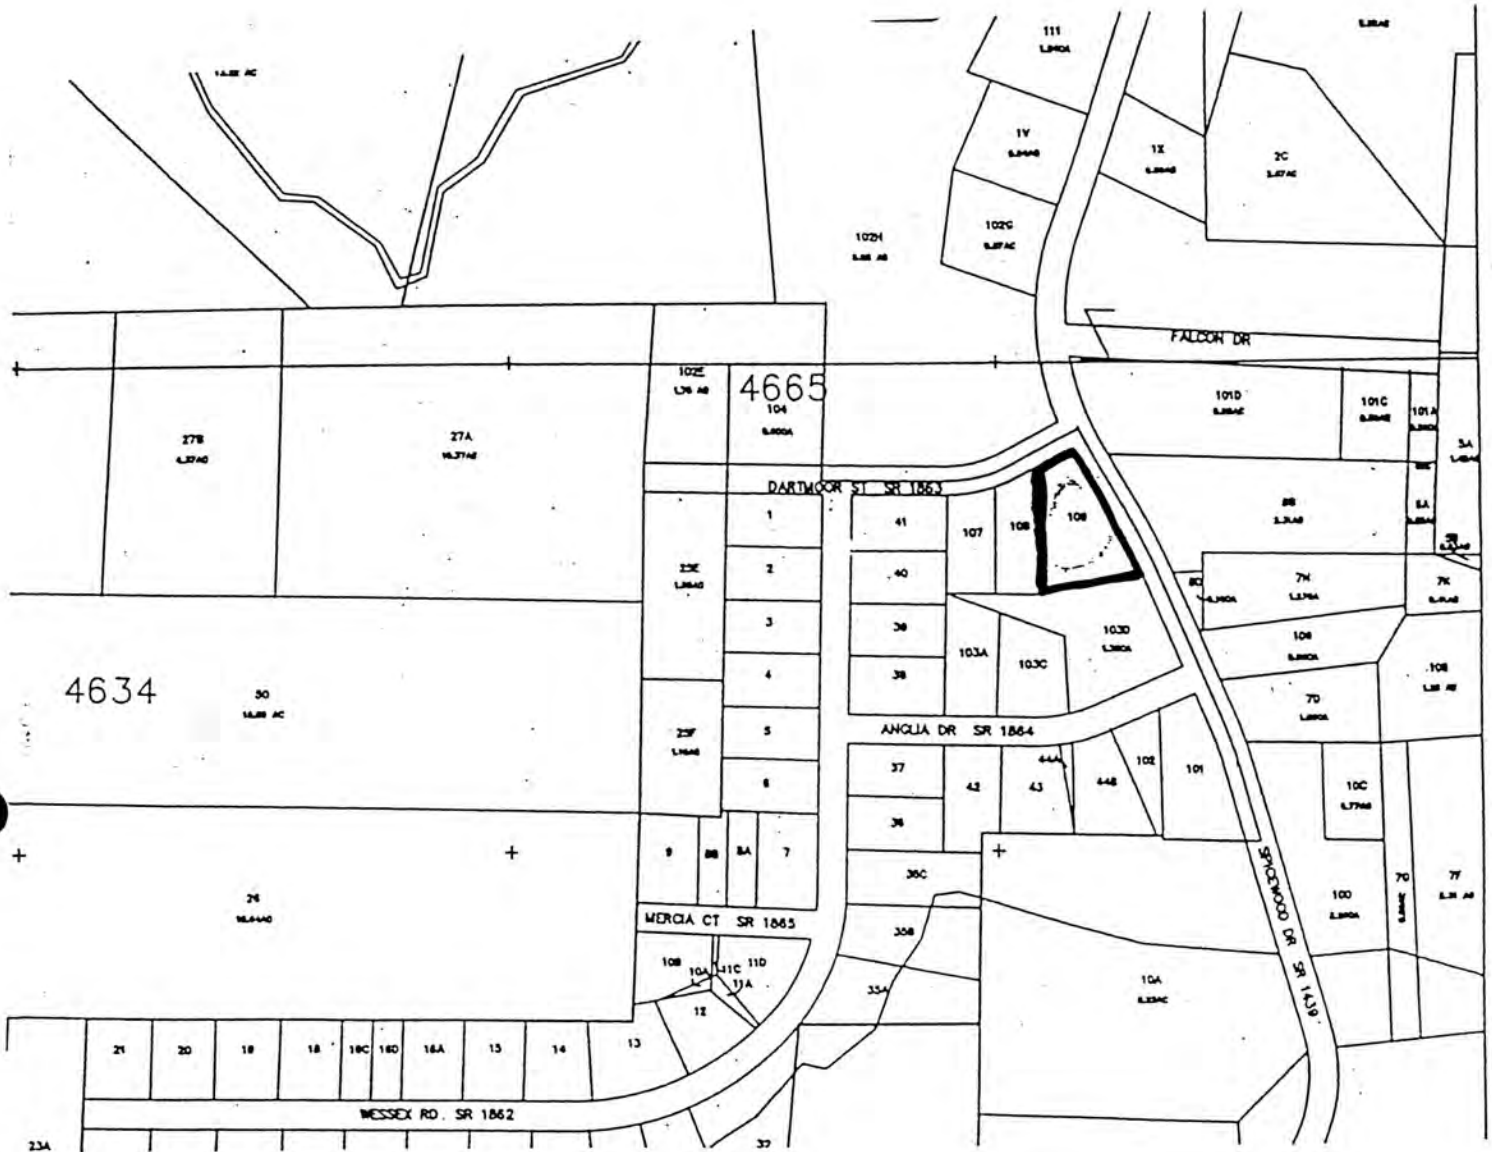
Jeremiah Bahnson Conrad House Tax Map Showing Eligible Boundaries

Boundary Description and Justification: Of Jeremiah Conrad's large farm, the house and a little over an acre retain integrity and are included in the eligible area. Surrounding acreage, which was once part of the farm, has been developed within the past fifty years.

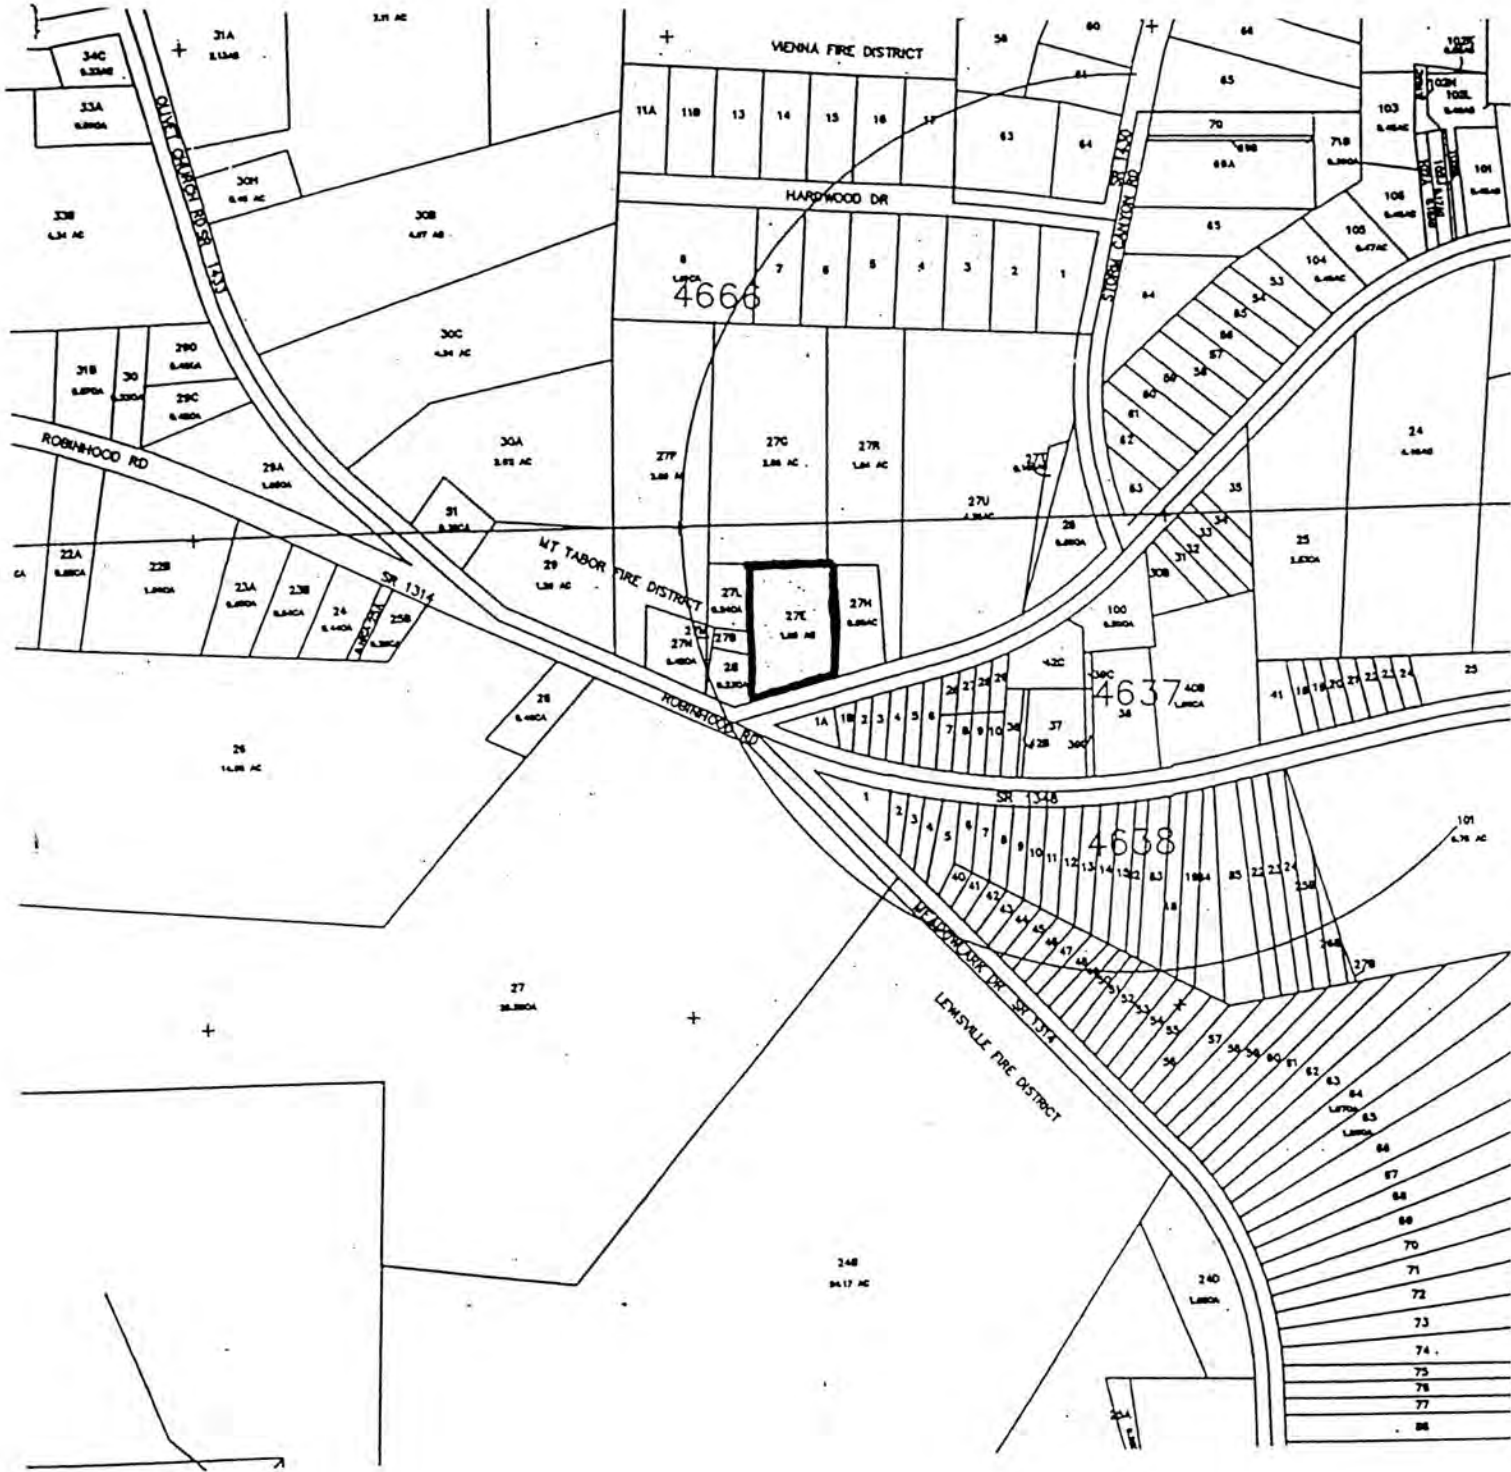
Doub-Yarborough House Tax Map Showing Eligible Boundaries

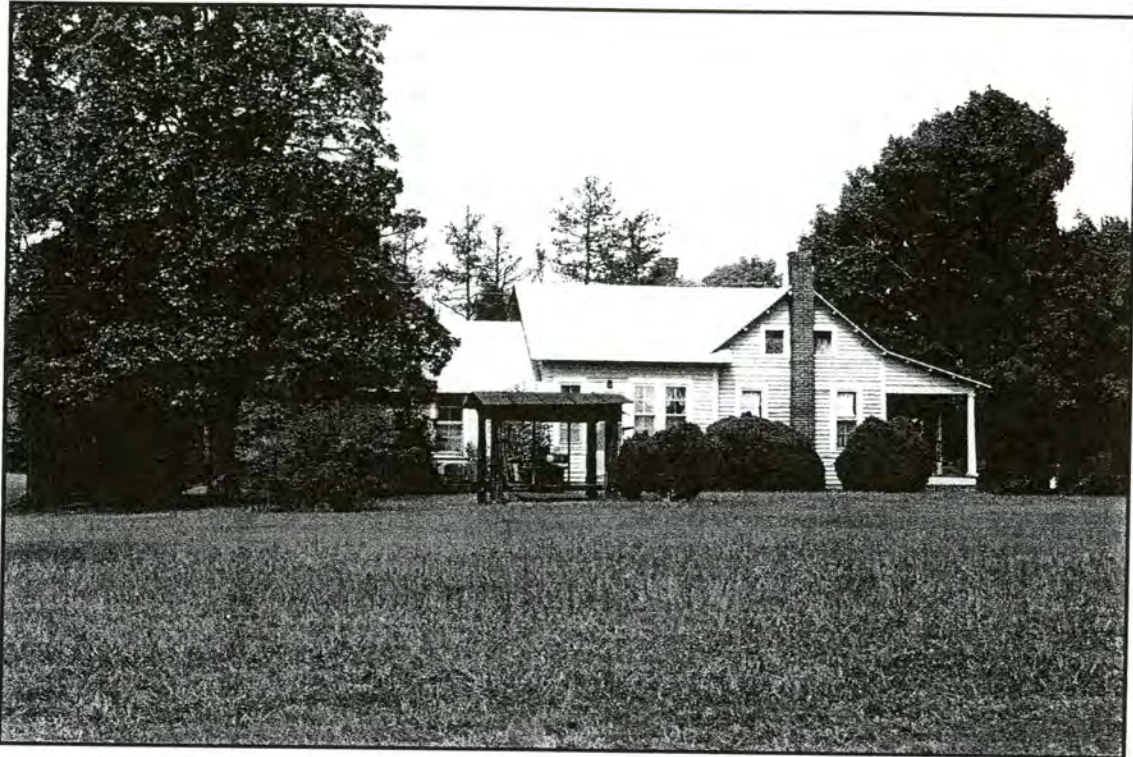
Description: The Ploughboy Jarvis Farm is a late nineteenth century complex in an open rural setting. The house is a one-story frame L-shaped building with its projecting front cross gable to the north and an engaged shed-roofed porch covering the remaining two bays. The porch is supported by slender classical columns and has a beaded-board ceiling. Both roofs are metal shingle. At the central entrance is an unadorned replacement door; windows are 4-over-4 sash in plain surrounds, with paired sash (probably a later alteration) on the front elevation and on the south side addition. A corbelled brick interior chimney rises from the ridge of the east-west gable; a smaller corbelled brick exterior (flue) chimney is at the southern end, and a rear interior chimney heats the rear ell. Foundations are brick; the porch foundation has openwork and ca. 1920 brick steps. One-story rear gable ell with standing-seam metal roof; smaller gable addition. House is weatherboarded; smallest rear ell is covered with asbestos siding.

“Ploughboy” Jarvis Farm, house

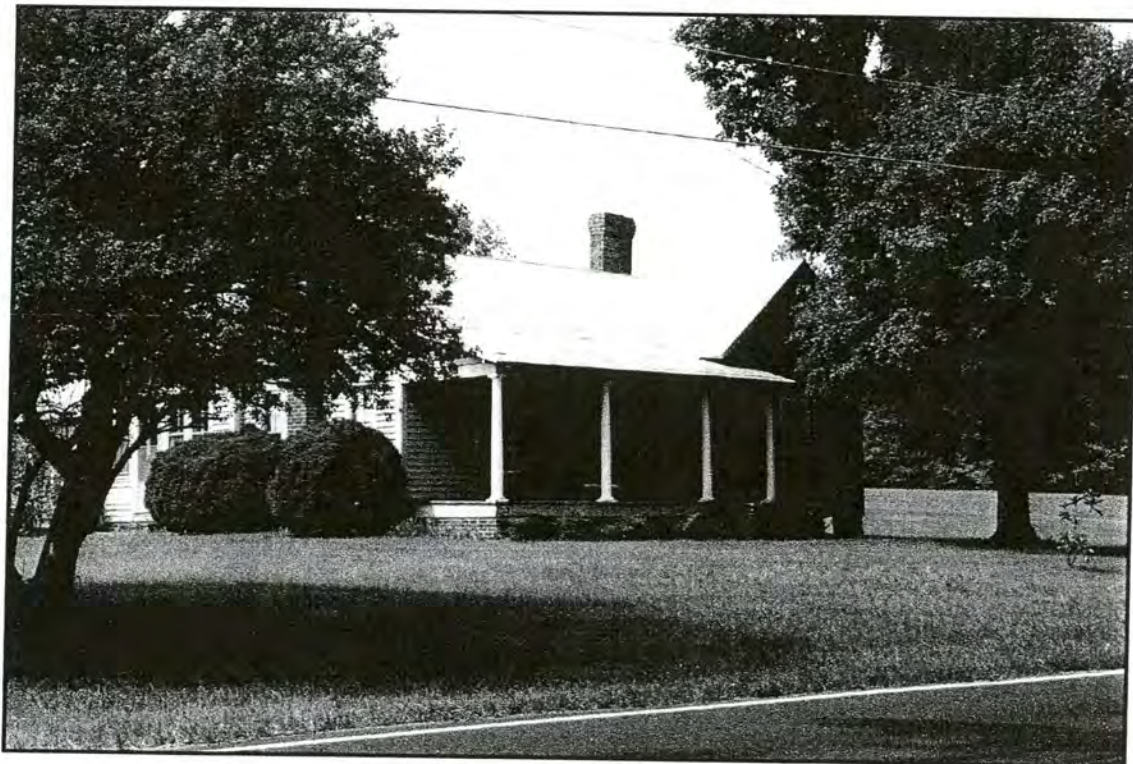
“Ploughboy” Jarvis Farm, house

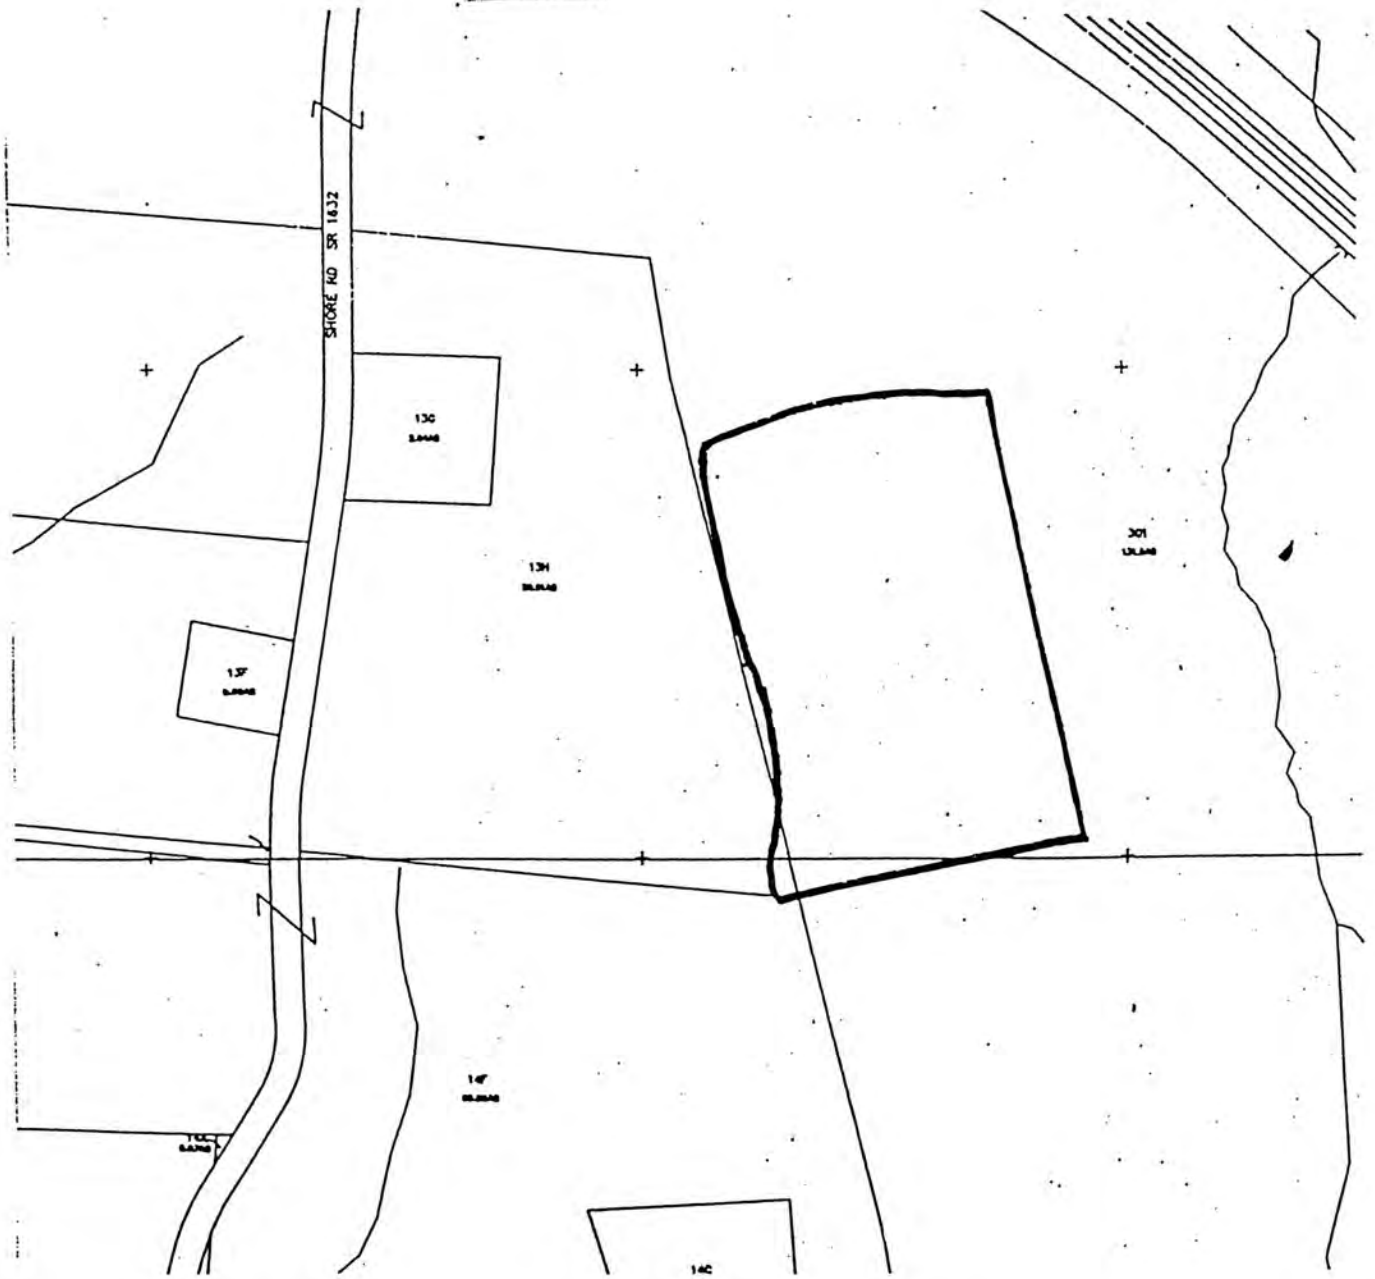
Columbus Kapp Farm Tax Map Showing Eligible Boundaries

the plateau on which the complex sits. This area contains about 13 acres of a 130-acre tract still with the house. Additional acreage has been excluded from the eligible area because the formerly agricultural lands have mostly grown up in forest and no longer retain their historic field patterns, nor the ratio of field to wooded area. The farmhouse complex, however, retains a sufficient number of buildings and a high level of integrity from its agricultural use during the late-nineteenth and early twentieth centuries.

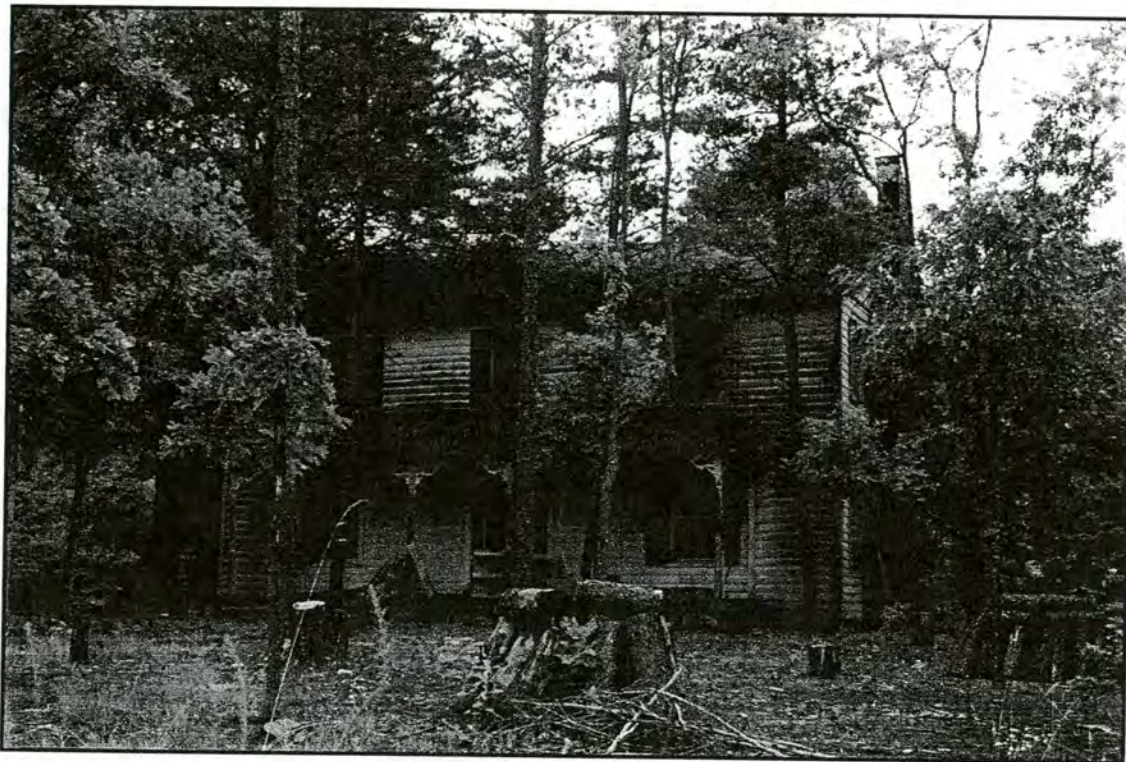
Description: The Columbus Kapp House is a late nineteenth century I-house. The house is of frame construction with brick noggin. It is three bays wide with a central entrance; windows are 2-over-2 sash with louvered shutters. At the front is an attached 3-bay porch supported by turned posts and sawn brackets. Carved rafter and purlin ends, unusual in the study area, are found at the eaves and gables of the house and porch. The porch ceiling is flush-board sheathed. The four-paneled front door is flanked by four-light sidelights over a molded panel, and topped by a two-light transom.

At the back is a one-story gable ell with engaged porch running its full length. The porch turns to meet an attached porch behind the two-story portion. These porches are also supported by turned posts and the same carved brackets as those on the front porch. Also found here are the decorative sawn ends found on the front porch and house. Two plain porch posts are in front of the 1906 one-room extension.

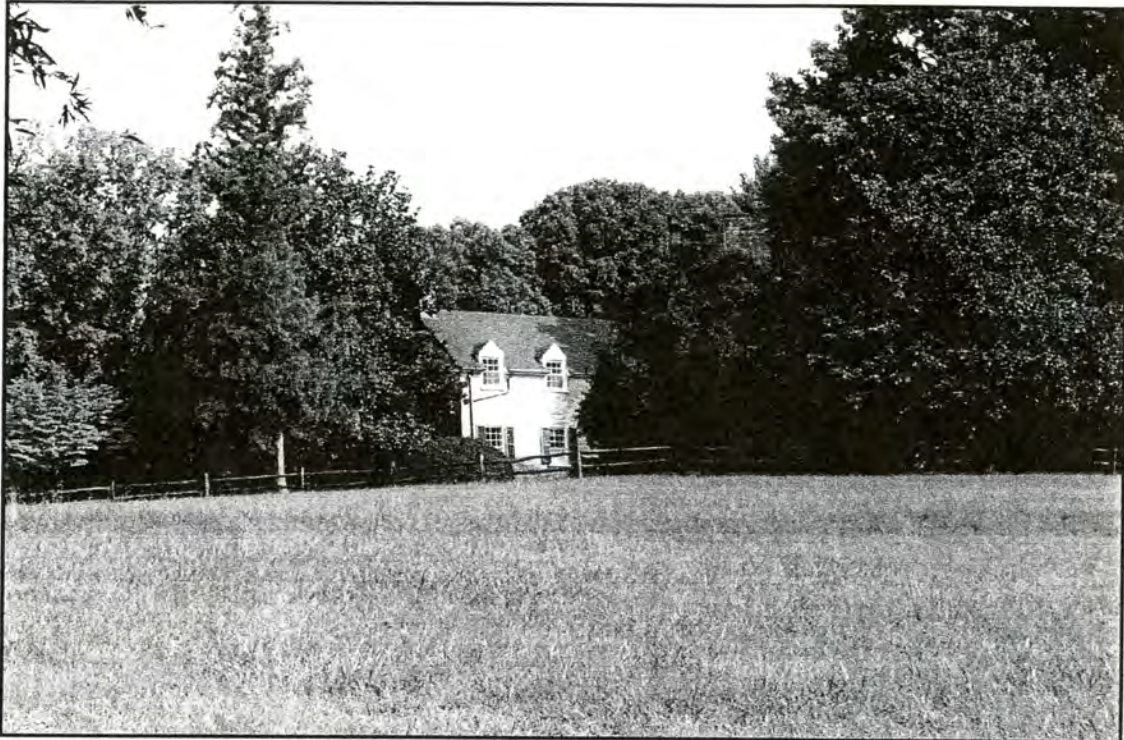
Brookberry Farm, main house, south elevation

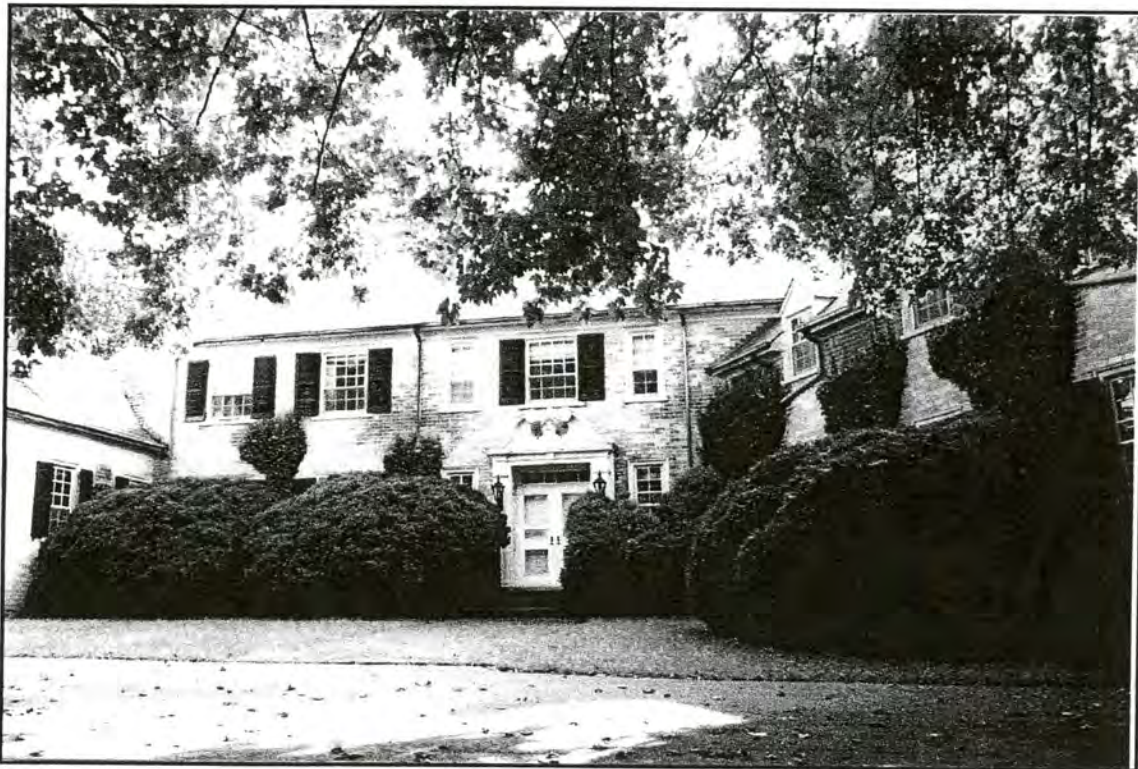
Brookberry Farm, main house, west elevation

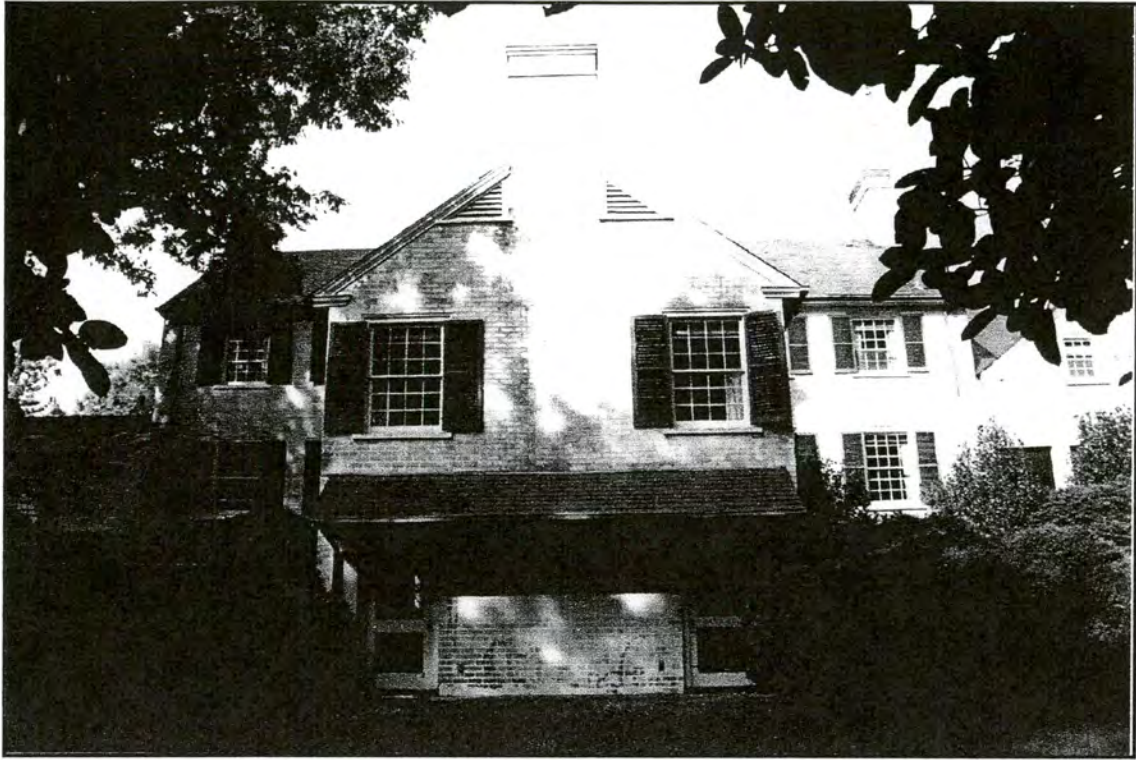
Brookberry Farm, main house, east elevation

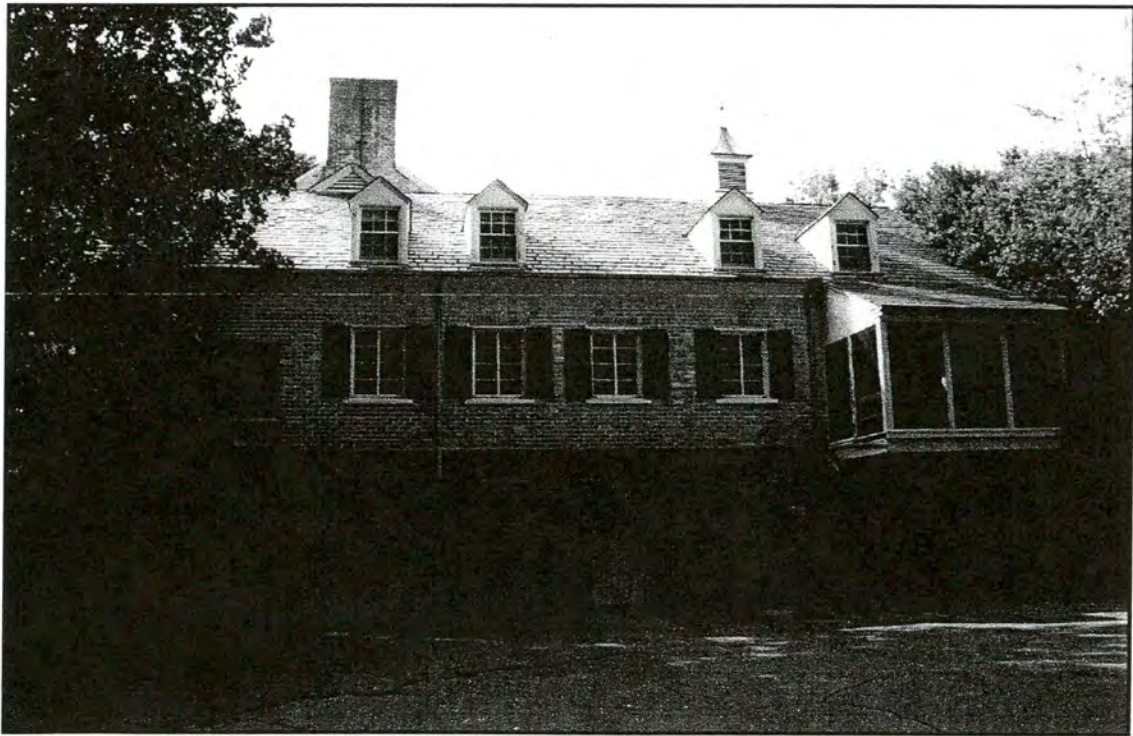
Brookberry Farm, main house, north elevation

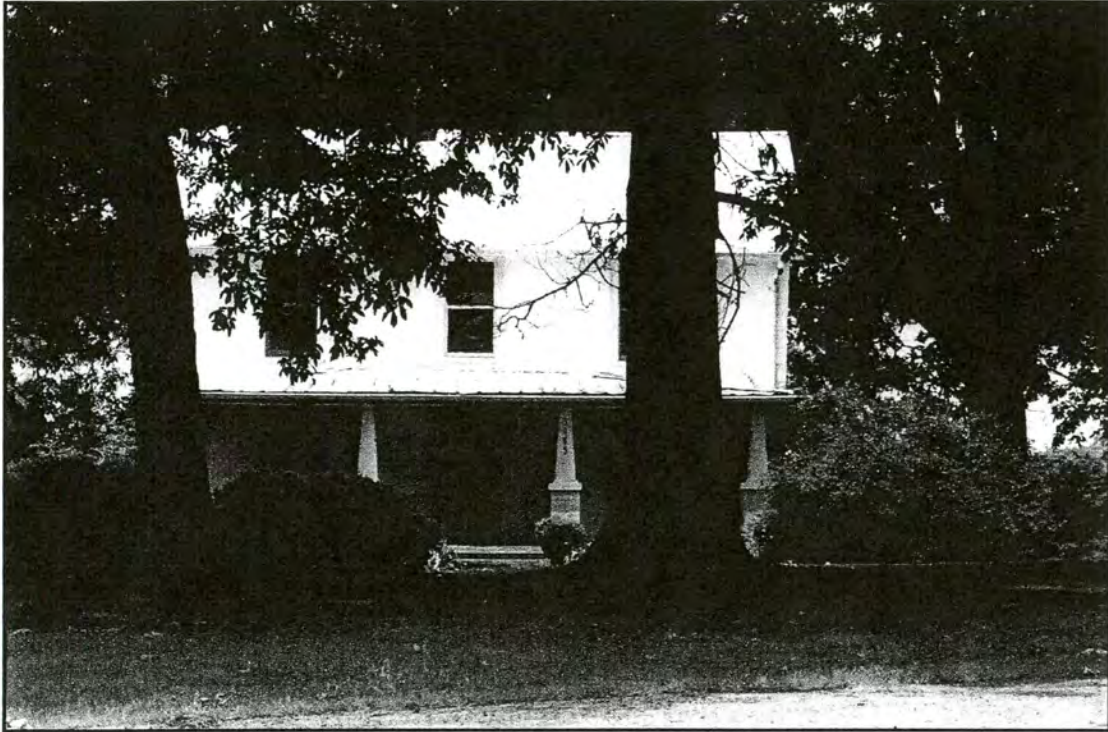
Brookberry Farm, Conrad House, south elevation

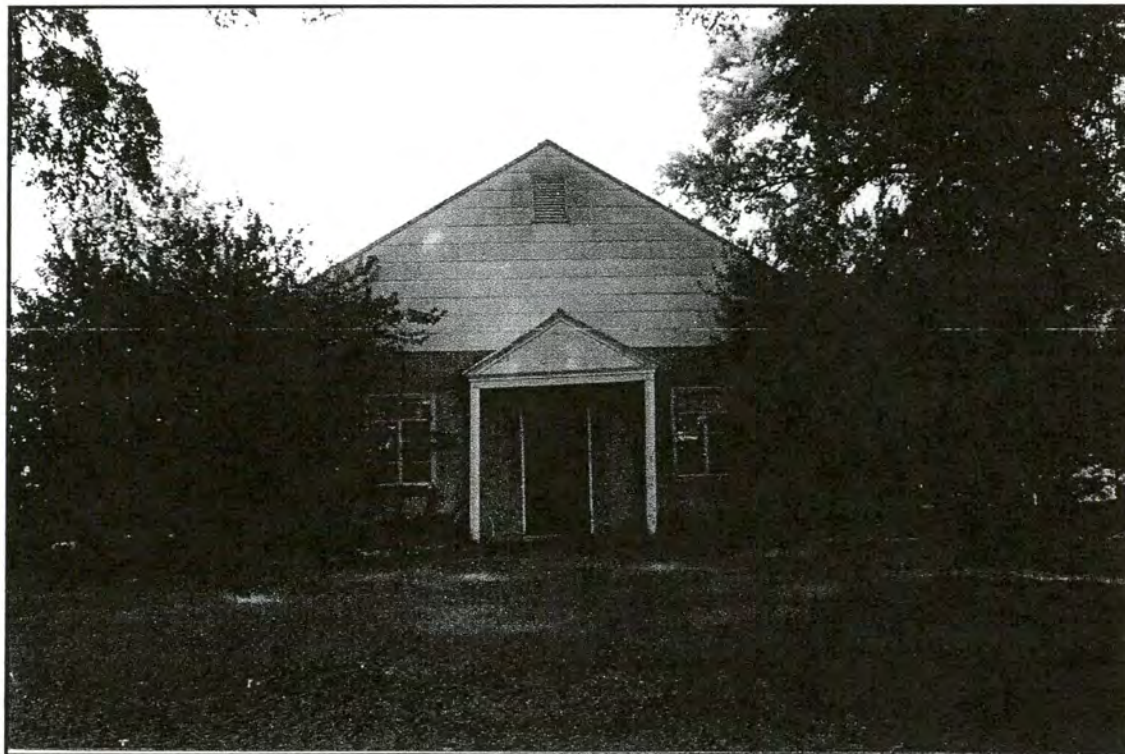
Brookberry Farm, dairy building, south elevation

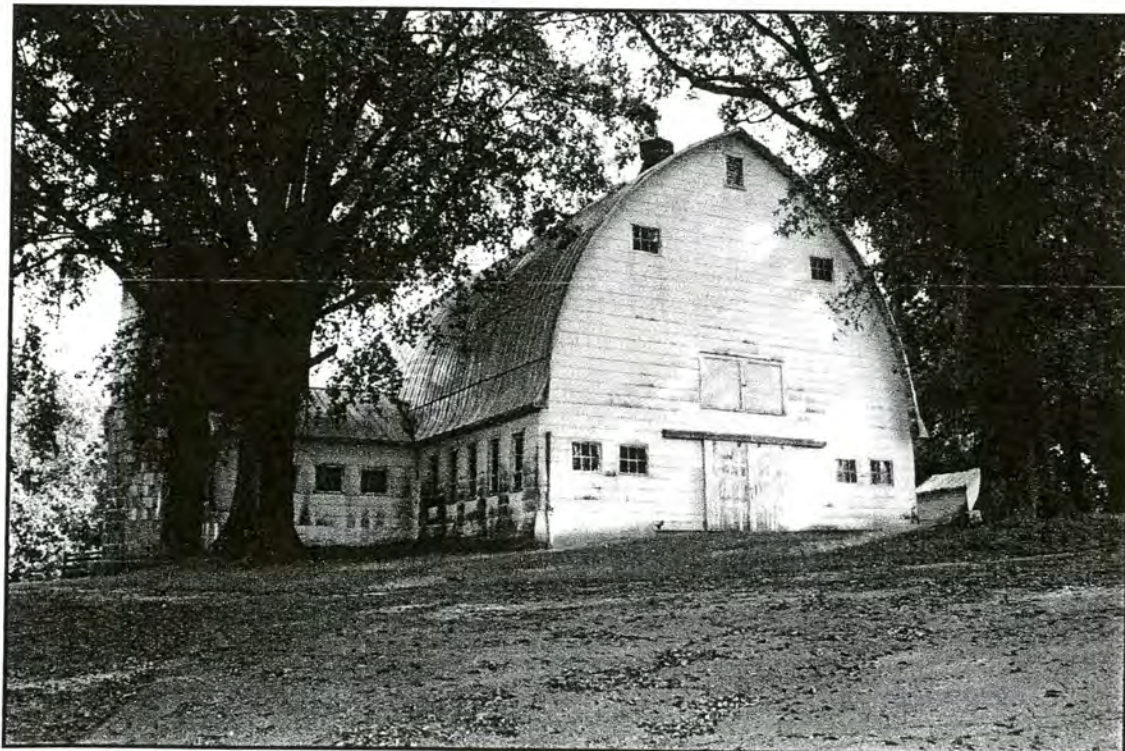
Brookberry Farm, Quonset hut dairy barn

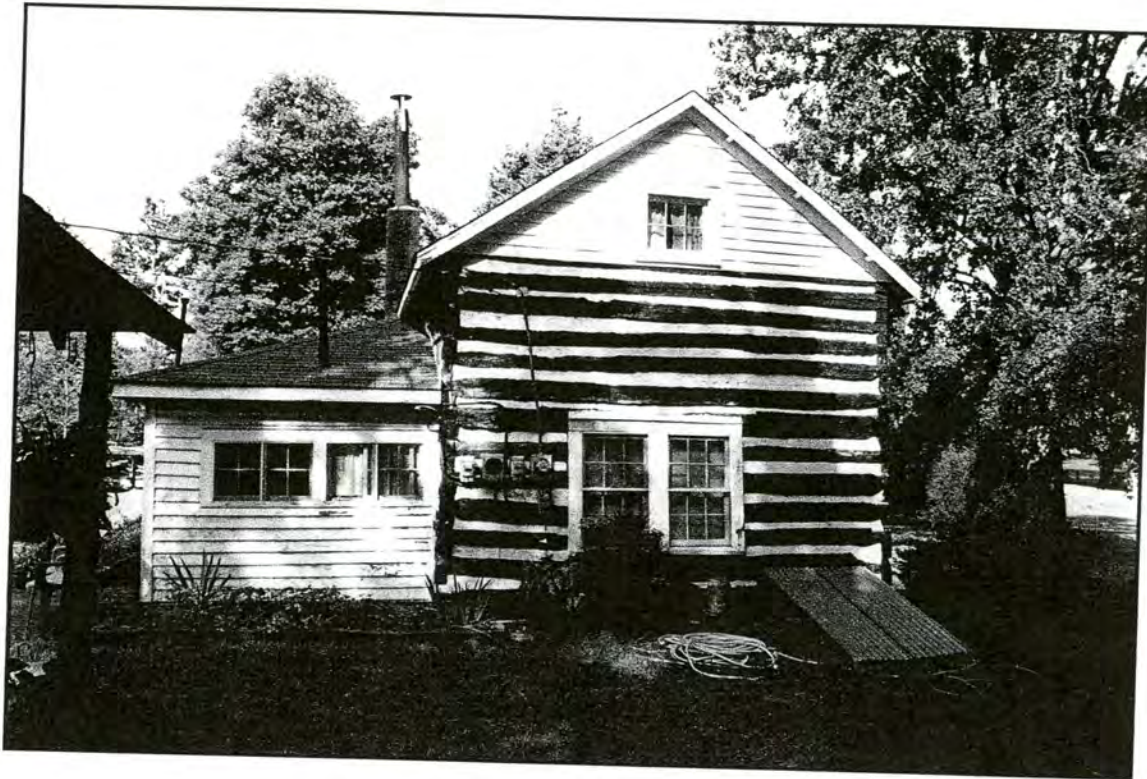
Alexander Hege House, east elevation
