SUBJECT: Historic Architectural Resources Survey Report/Winston-Salem Northern Beltway,
Western Section, US 158 to US 52, R-2247, Forsyth County, CH91-0603

Clayton House

April 2003

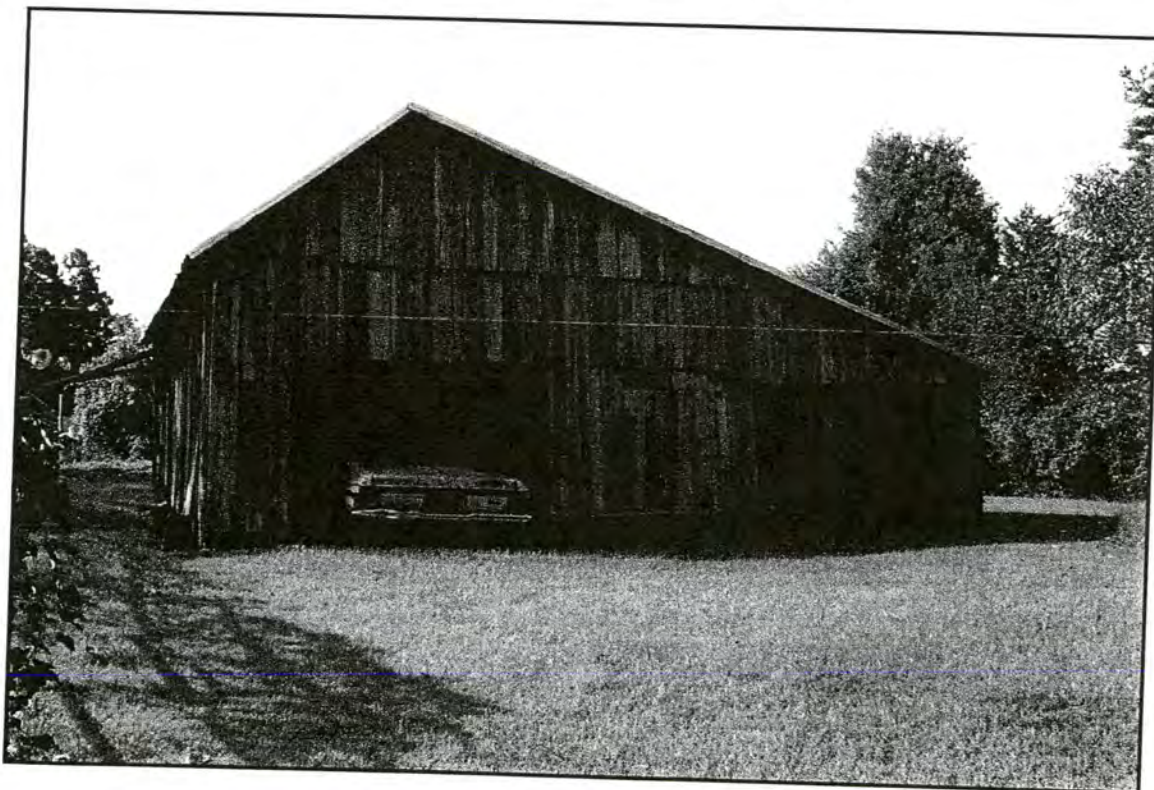
Alexander Hege House, barn

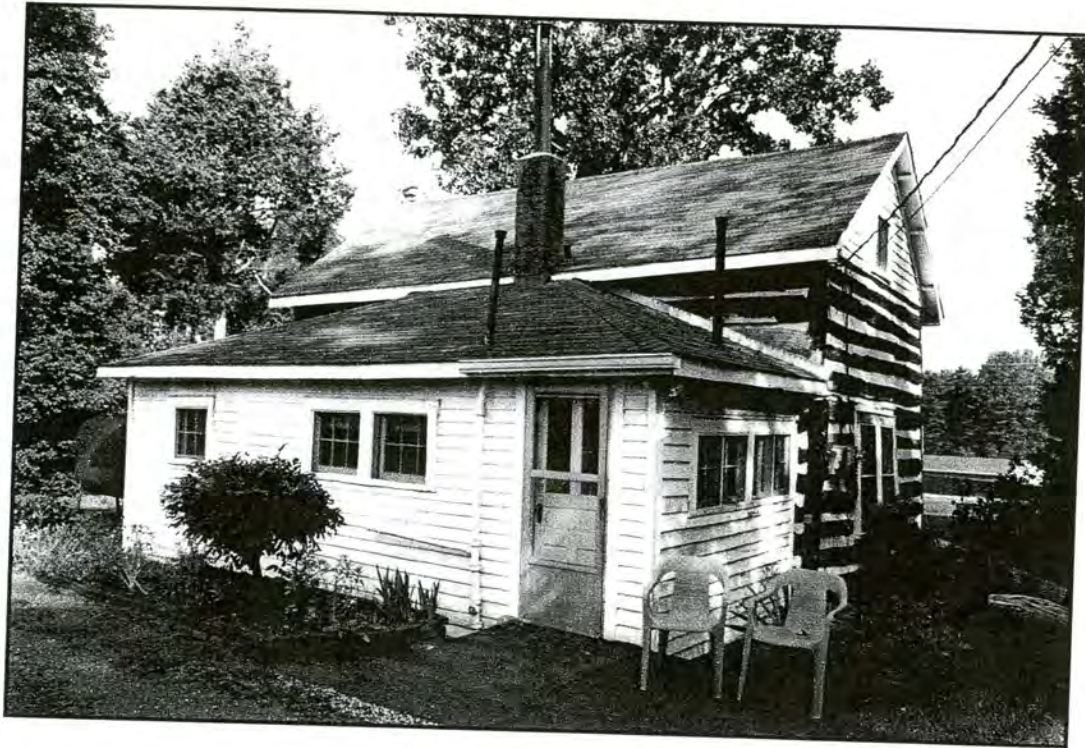
Alexander Hege House, southeast corner

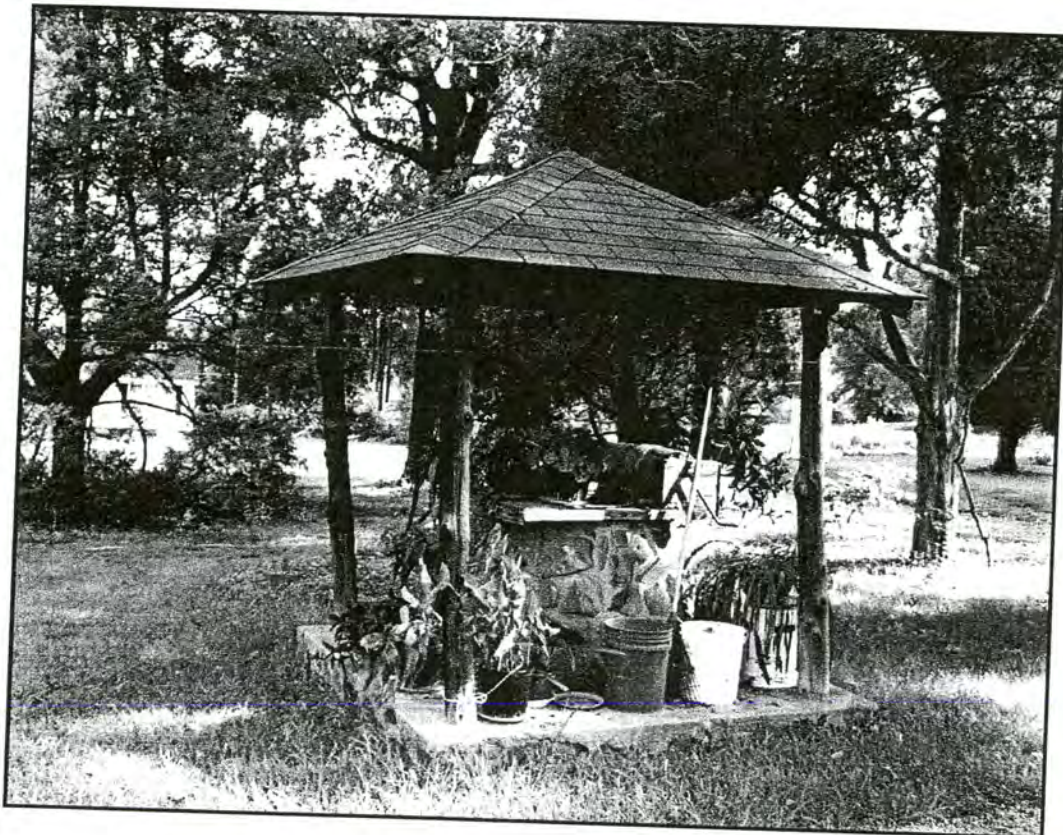
Alexander Hege House, well pavilion

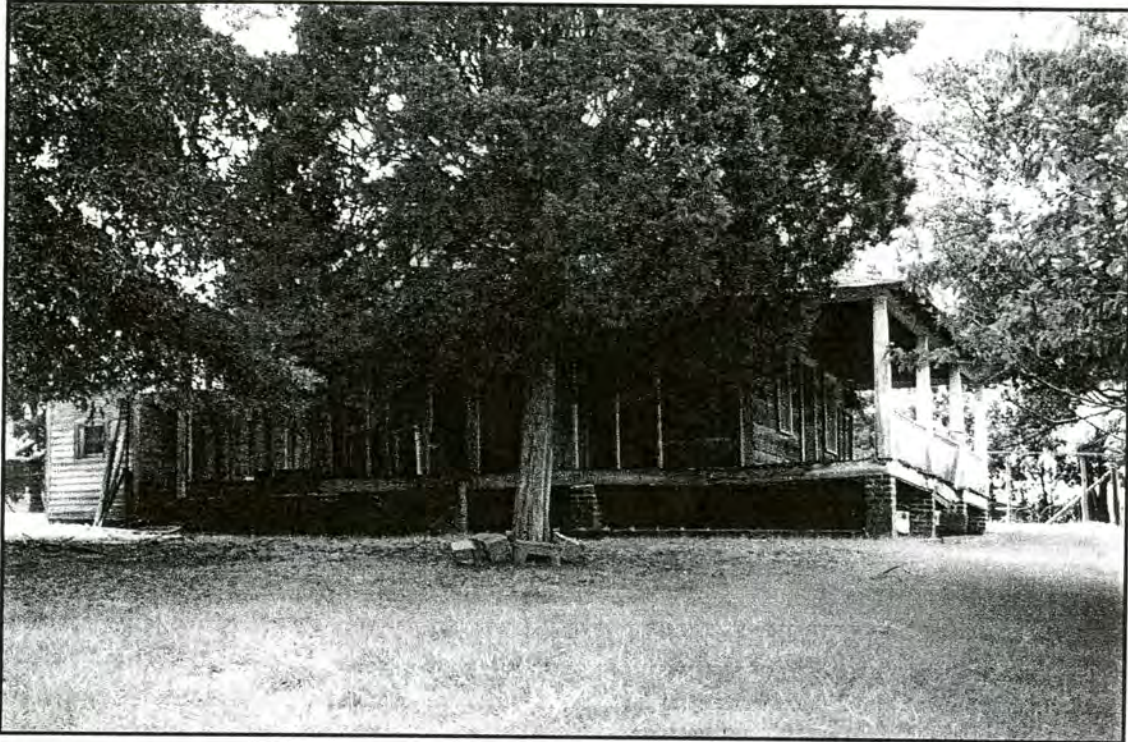
Todd House, northeast corner

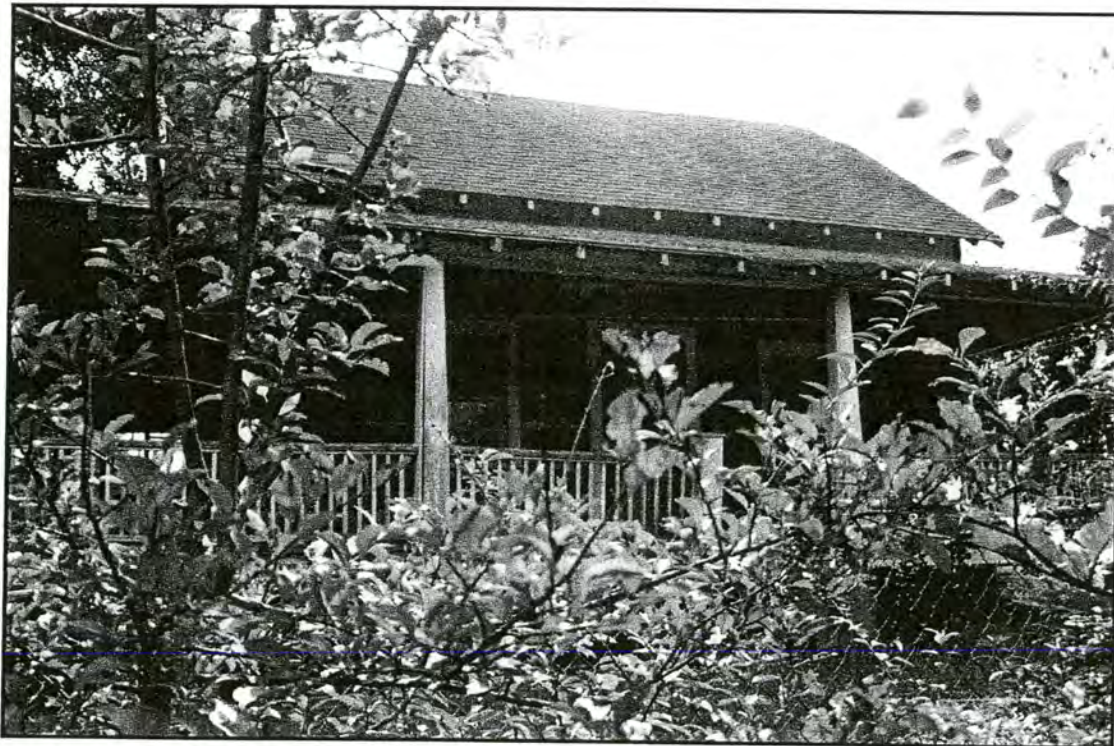
Todd House, north elevation

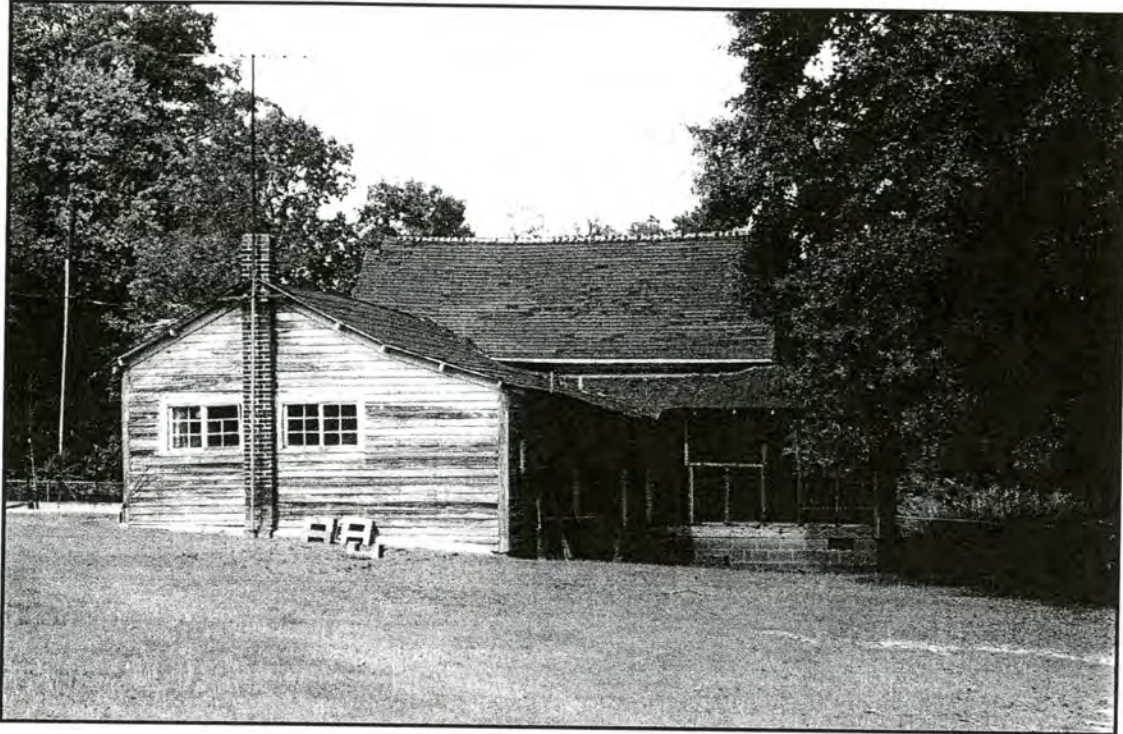
Todd House, south elevation

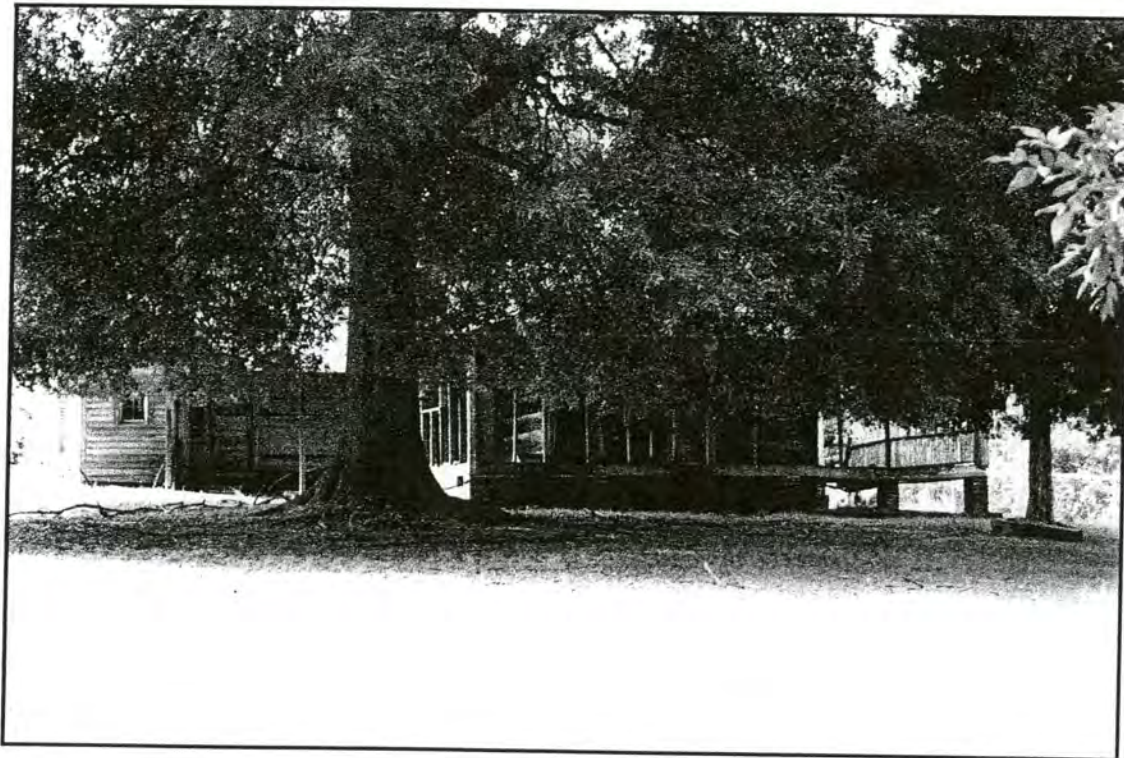
Todd House, east elevation

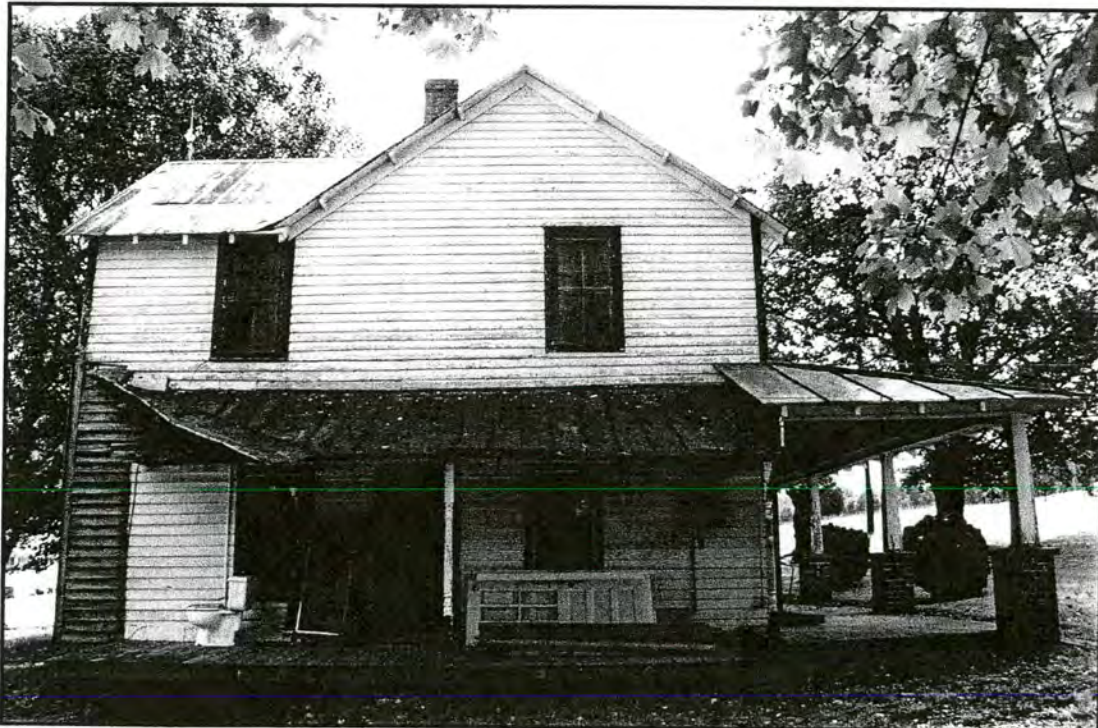
Evaluation: The property does not meet the eligibility criteria for listing in the National Register because it has undergone numerous character-altering changes. In addition, the rear elevation of the John Henry Kearney House has deteriorated significantly, and its condition adversely affects the dwelling's integrity.

John Henry Kearney House, northwest elevation

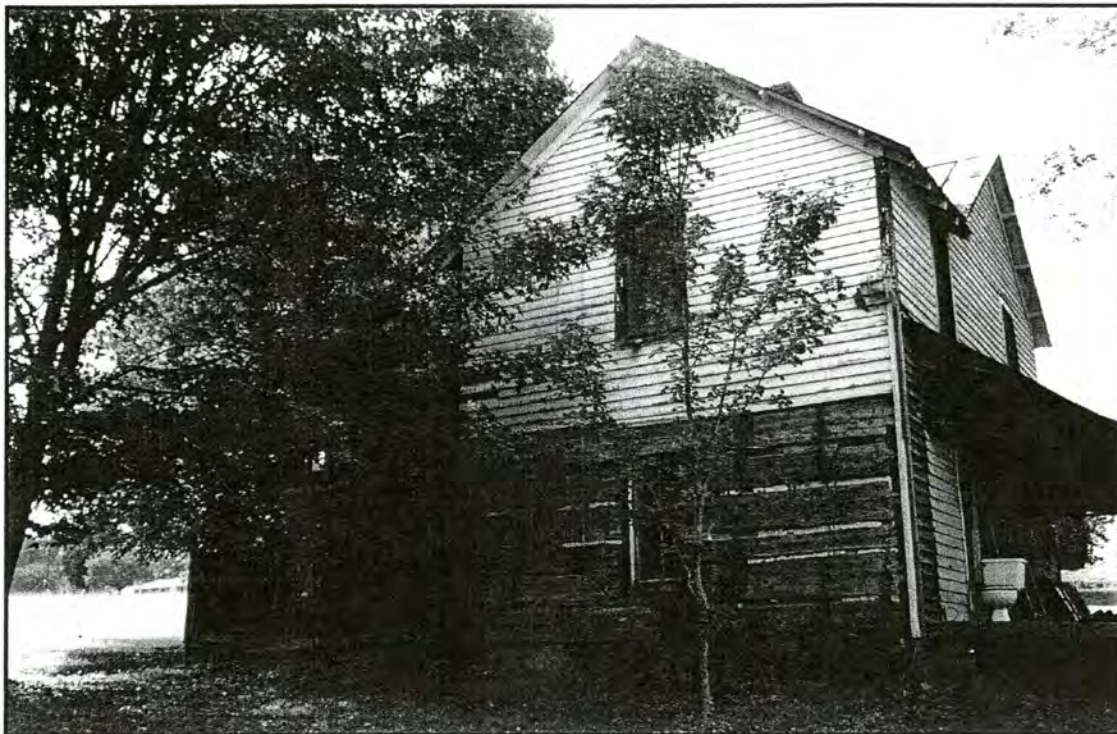
John Henry Kearney House, northeast elevation

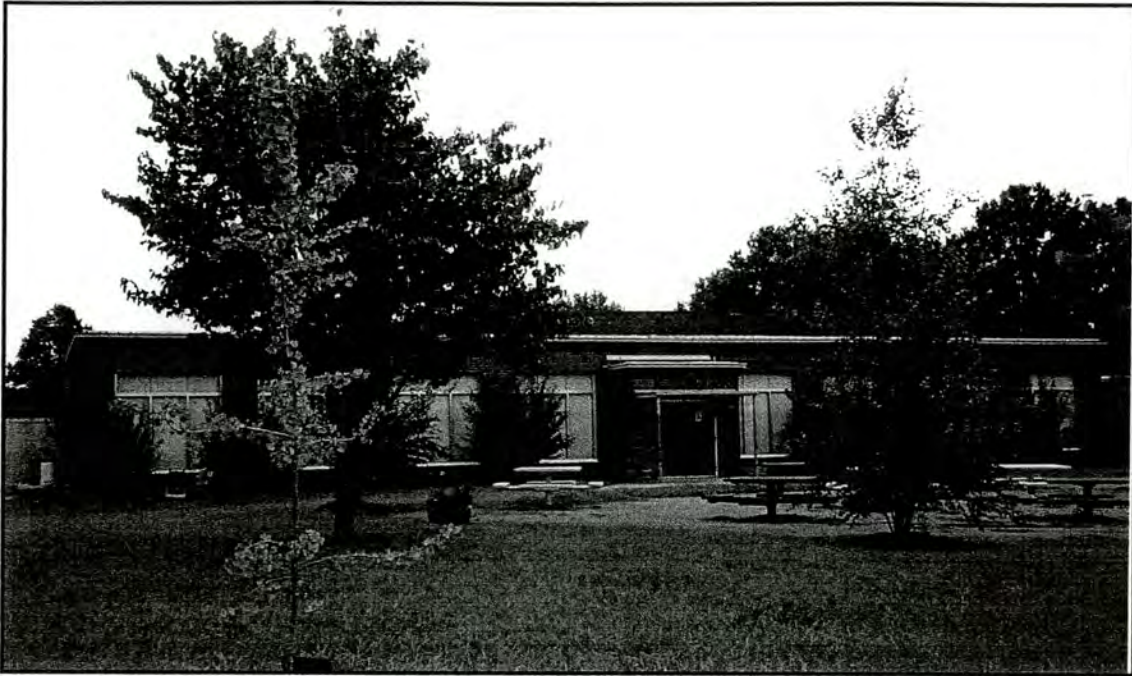
Southwest Elementary School, west elevation

Description: Southwest Elementary School is a one-story, brick school building with a cafeteria building and a gymnasium. The building features components typical of one-story Modernist schools such as banks of windows, exposed I-beams, and a flat roof with deep overhangs in some sections. Although generally intact architecturally, replacement windows have been installed and a new pitched roof has been installed over the original one in some parts of the sprawling building.

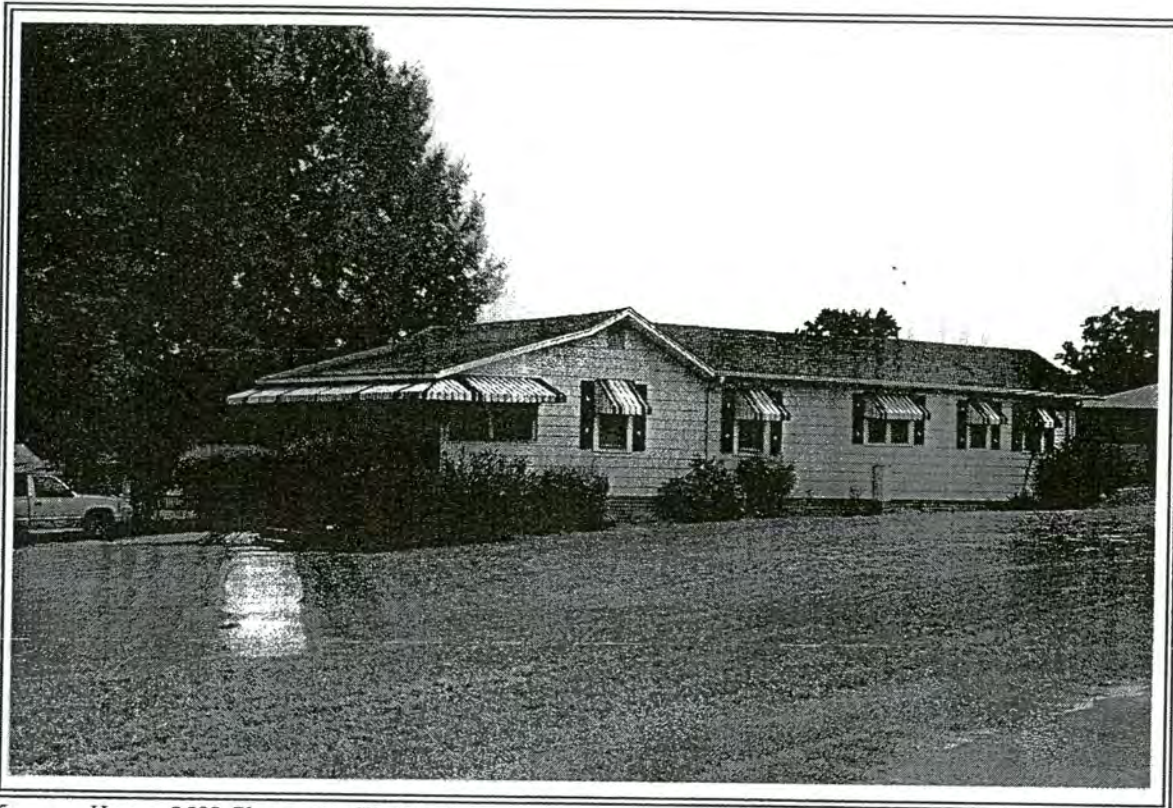
5. House, 25?? Clemmons Road

5. **House**, ca. 1950
25?? Clemmonsville Road
One-story, side-gable house with an enclosed front porch, aluminum siding, and a brick foundation. *Does not appear eligible (synthetic siding, alterations)*

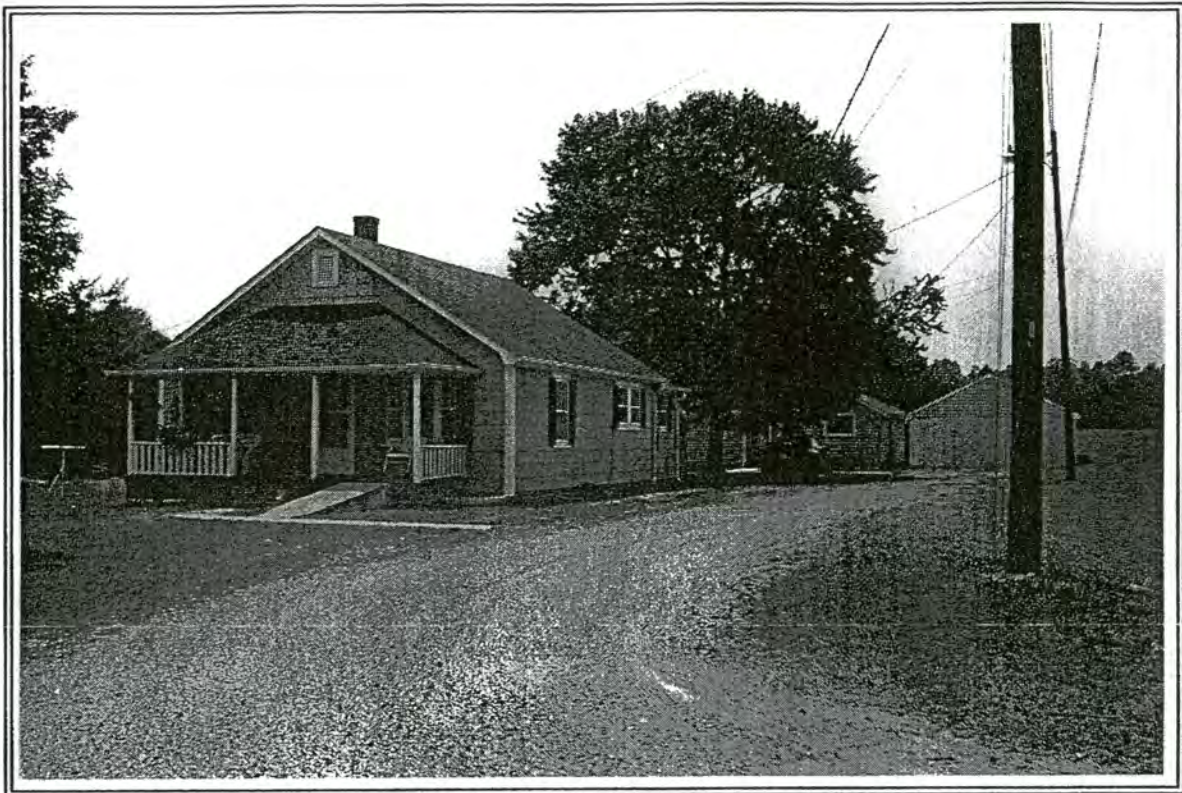
7. House, 2836 Woodard Road

7. **House**, ca. 1925
2836 Woodard Road
One-story, gable-front bungalow with asbestos siding and replacement windows. Retains original sidelights that flank one window on the façade. Hip roof porch with square posts. Brick foundation and an interior brick chimney. *Does not appear eligible (common type, alterations)*

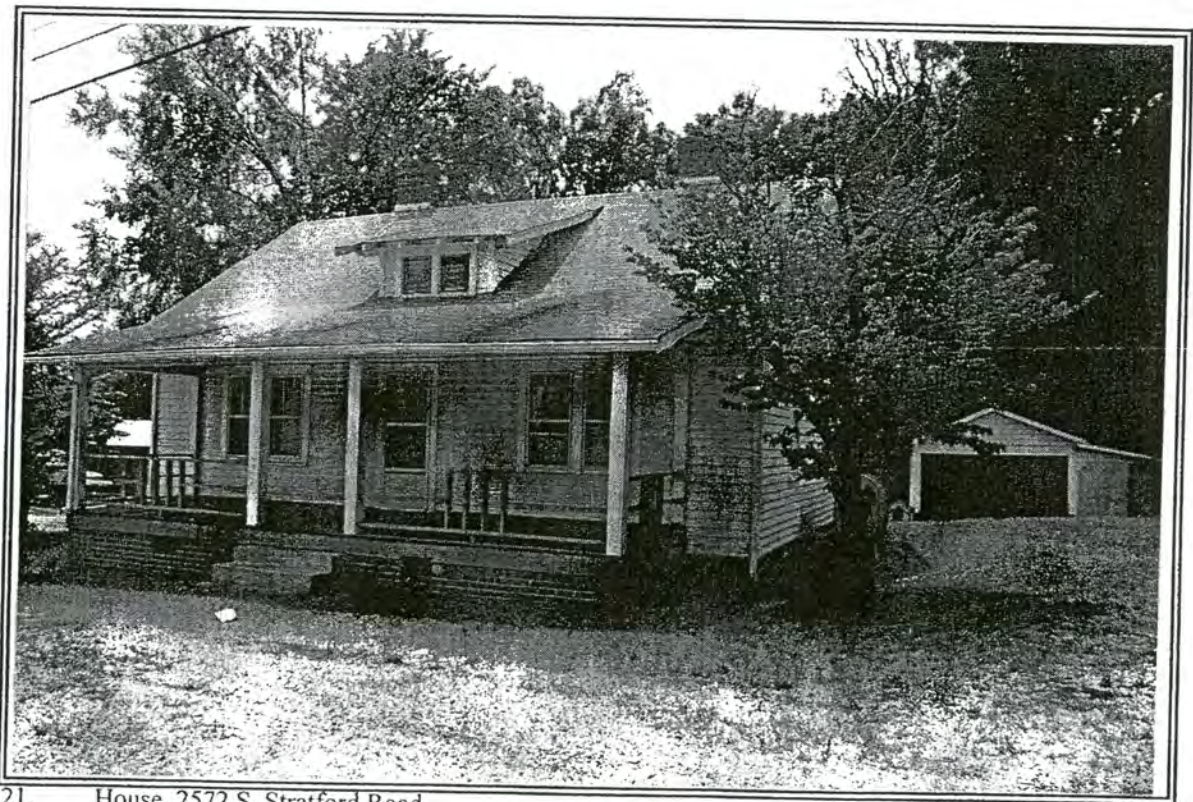
21. House, 2572 S. Stratford Road

21. **House**, ca. 1925
2572 S. Stratford Road (U.S. 158)
One-story, side-gable bungalow with weatherboard siding, three-over-one sash windows, shed porch with square posts, shed dormer, brick foundation, and brick chimneys. *Does not appear eligible (common type)*

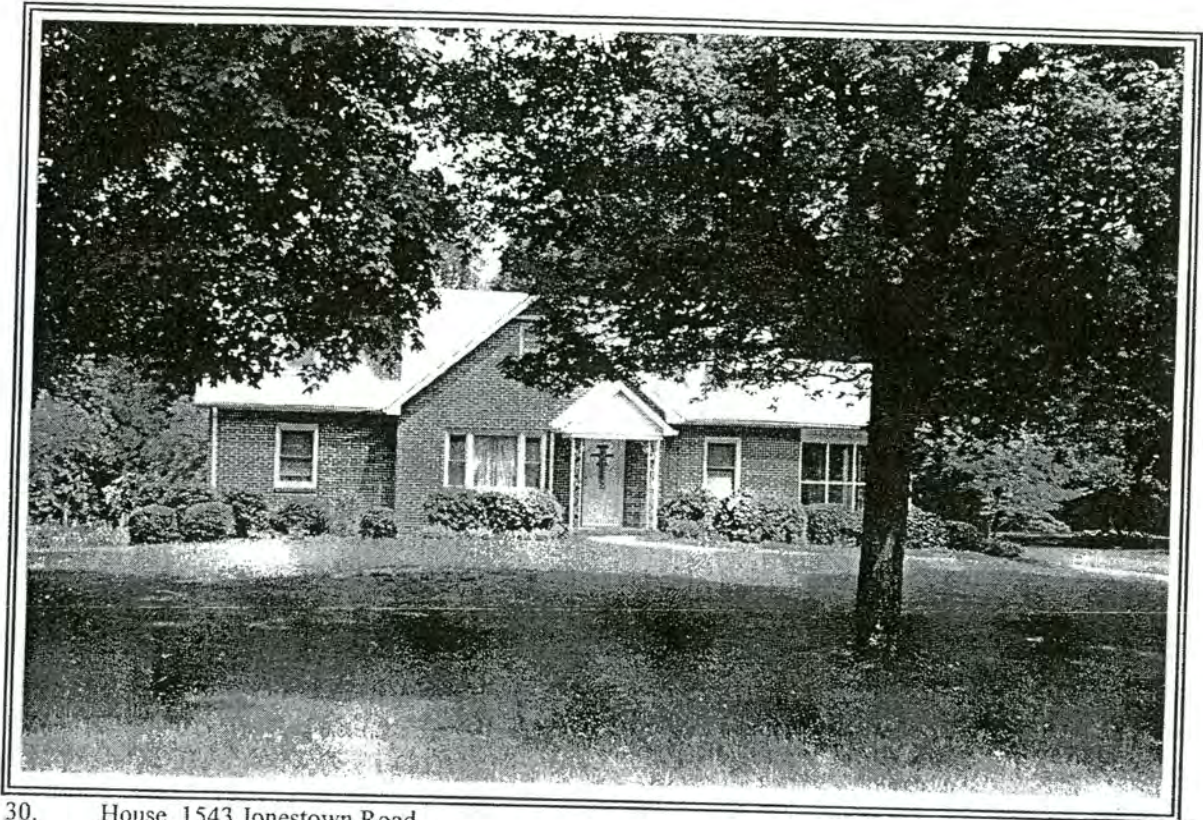
30. House, 1543 Jonestown Road

30. **House**, ca. 1950
1543 Jonestown Road
Side-gable Minimal Traditional house with screened side porch and replacement windows. Brick. *Does not appear eligible (no special significance)*

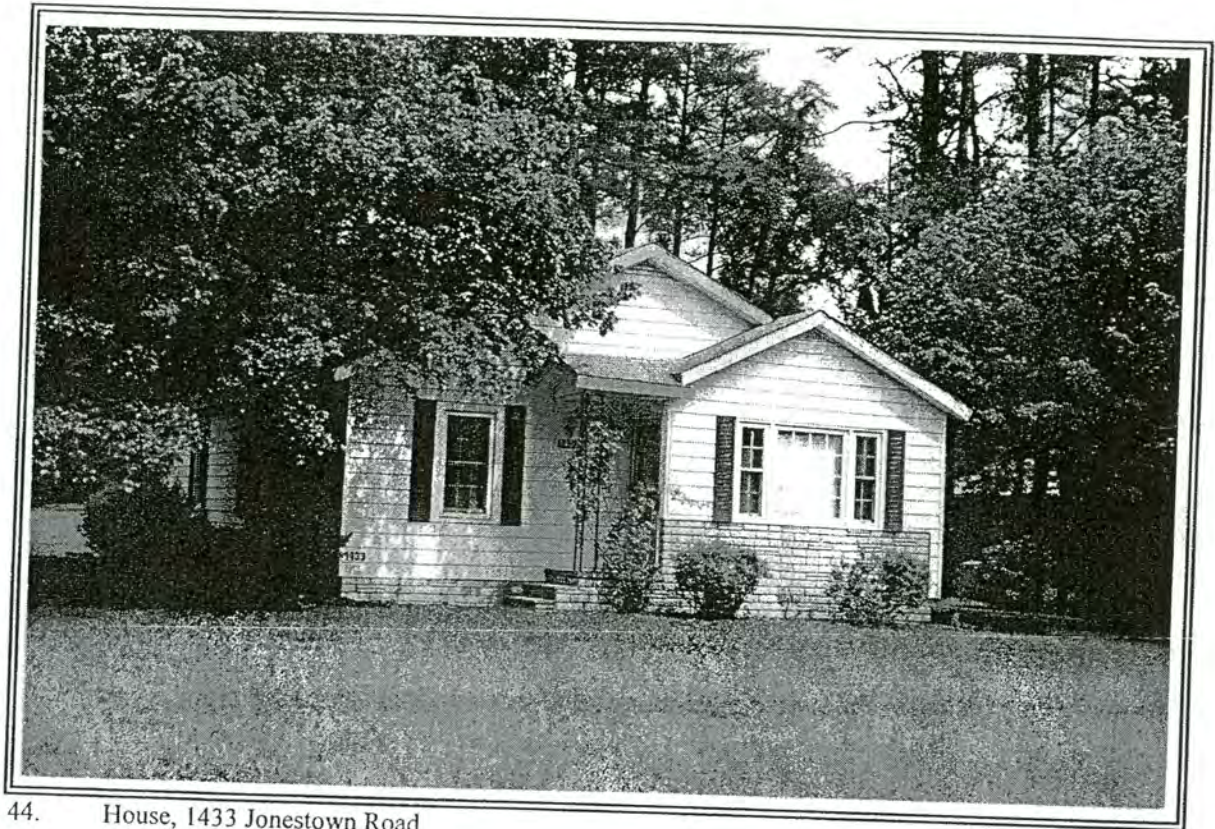
44. House, 1433 Jonestown Road

44. **House**, ca. 1950
1433 Jonestown Road
Gable-front house with new windows, vinyl, and formstone foundation and formstone skirt below picture window. *Does not appear eligible (synthetic siding, no special significance)*

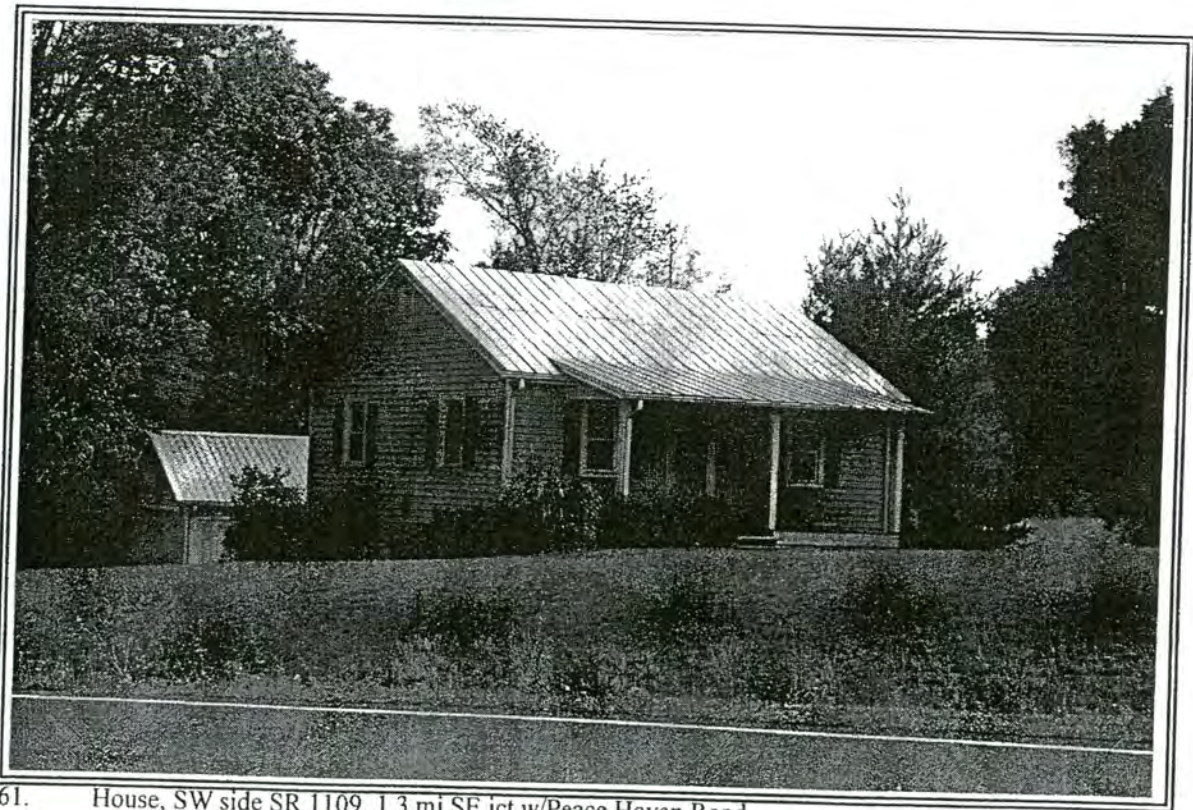
60. House, 922 Peace Haven Road

60. **House**, ca. 1925
922 Peace Haven Road
One-story, side-gable, Rustic Revival log house with saddle notching. Two large sunroom additions. *Does not appear eligible (alterations)*

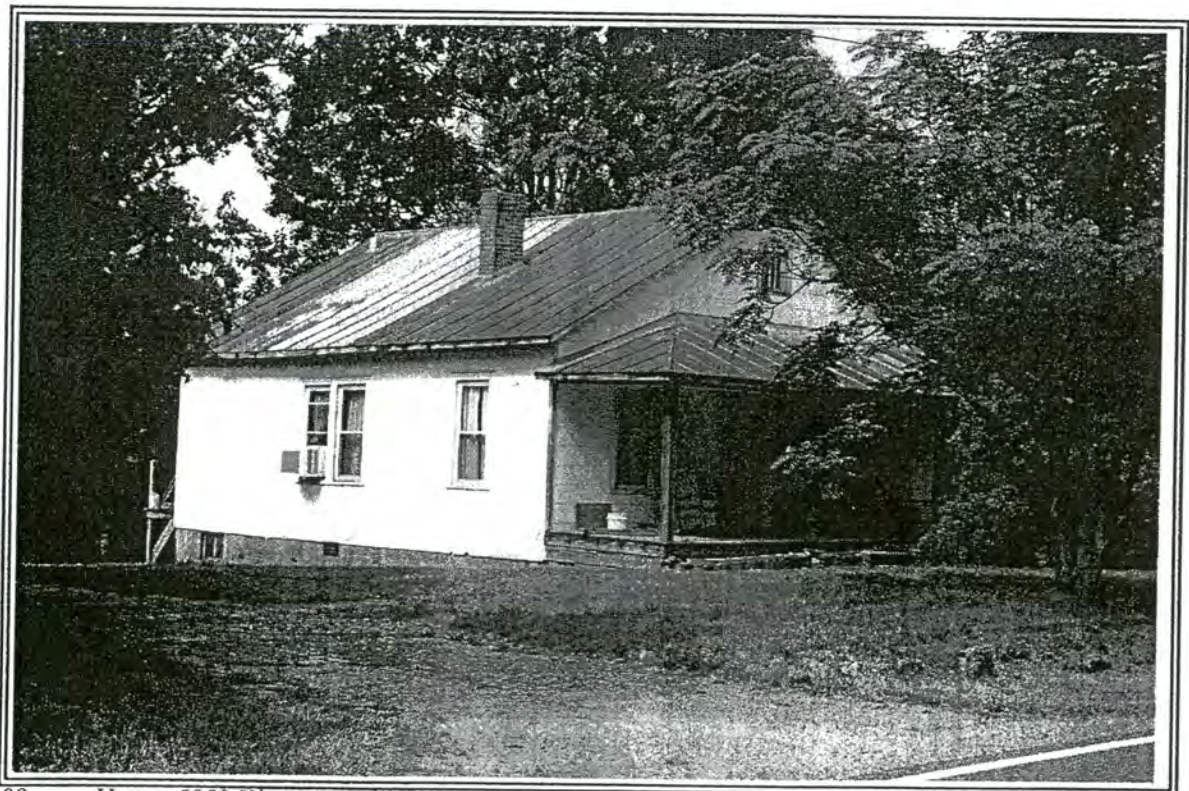
86. House, 5835 Kinney Road

86. **House**, ca. 1950
5835 Kinney Road
One-story side-gable house with vinyl siding and replacement windows. *Does not appear eligible (synthetic siding, no special significance)*

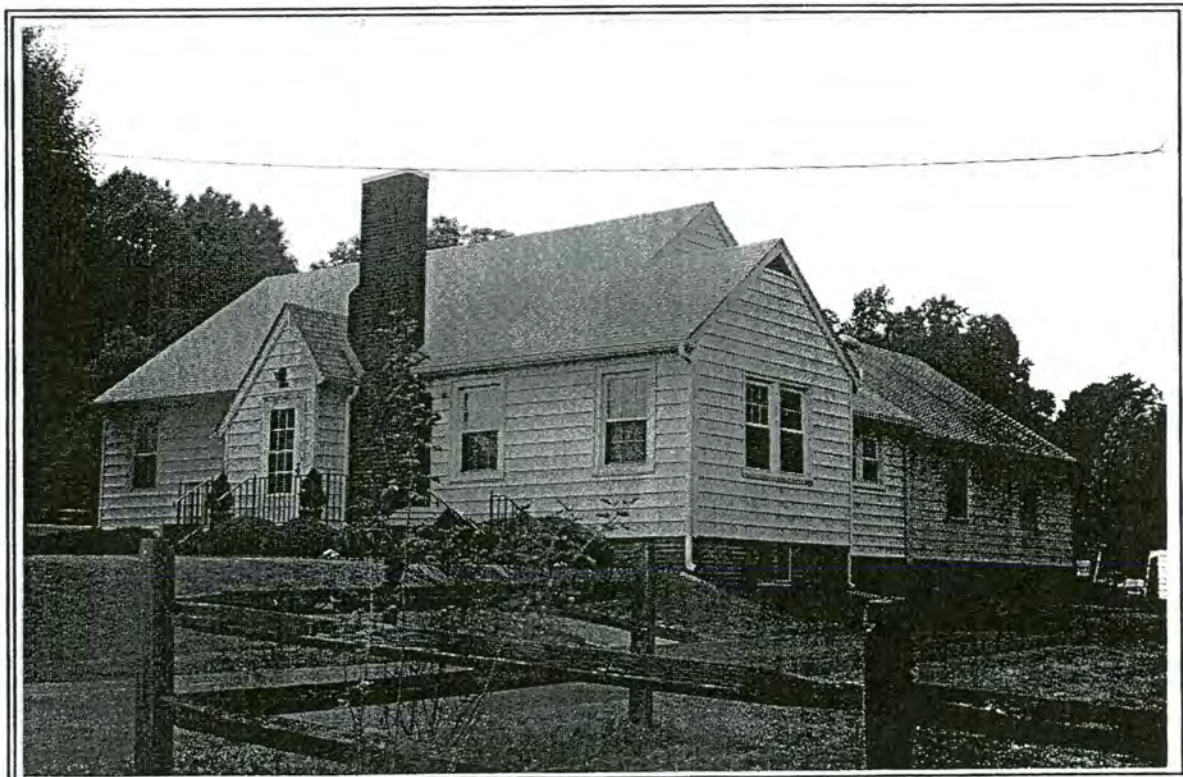
187. House, S side Robinhood Road, 0.2 mi W of Chickasha Road

187. **House**, ca. 1950
South side of Robinhood Road, .2 mile west of Chickasha Road
Brick, side-gable house with replacement windows. Screened breezeway connects house to garage. *Does not appear eligible (alterations)*

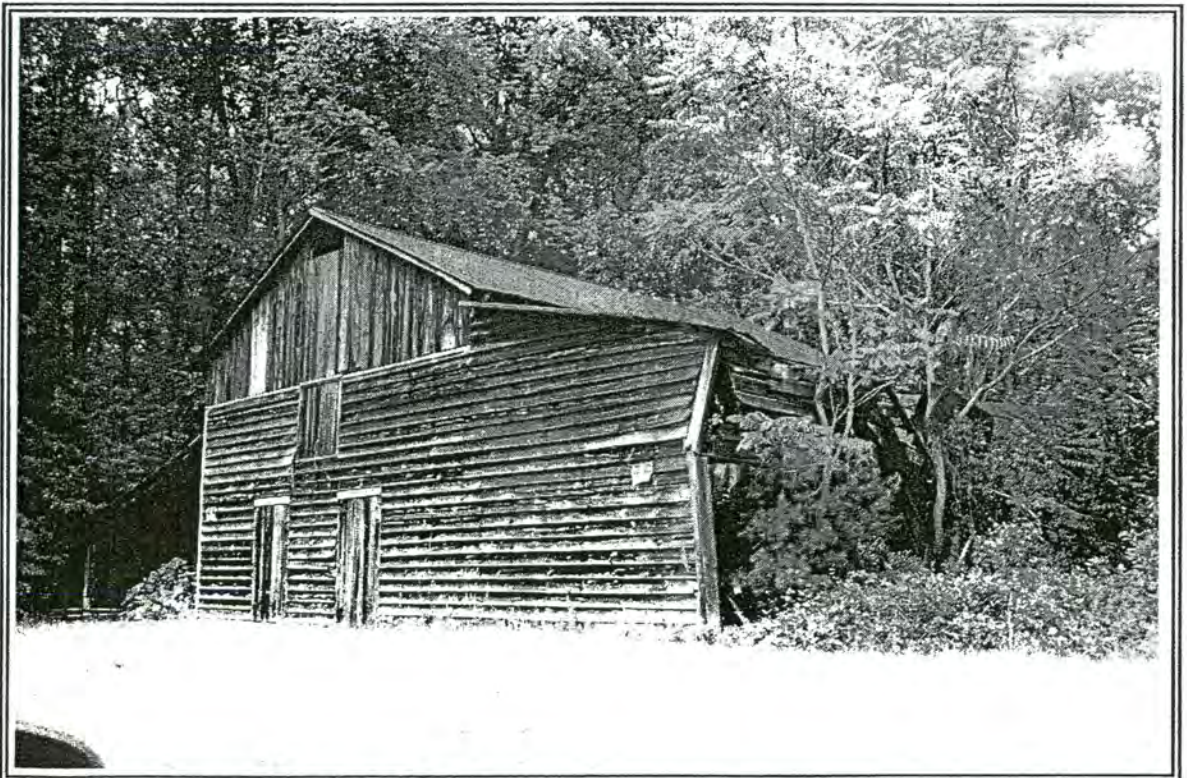
189. House, 1660 Chickasha Road

189. **House**, ca. 1925
1660 Chickasha Road
Side-gable bungalow with an engaged porch, gabled dormer, nine-over-one sash windows, and asbestos siding. Deteriorated barn across the road. *Does not appear eligible (common type)*

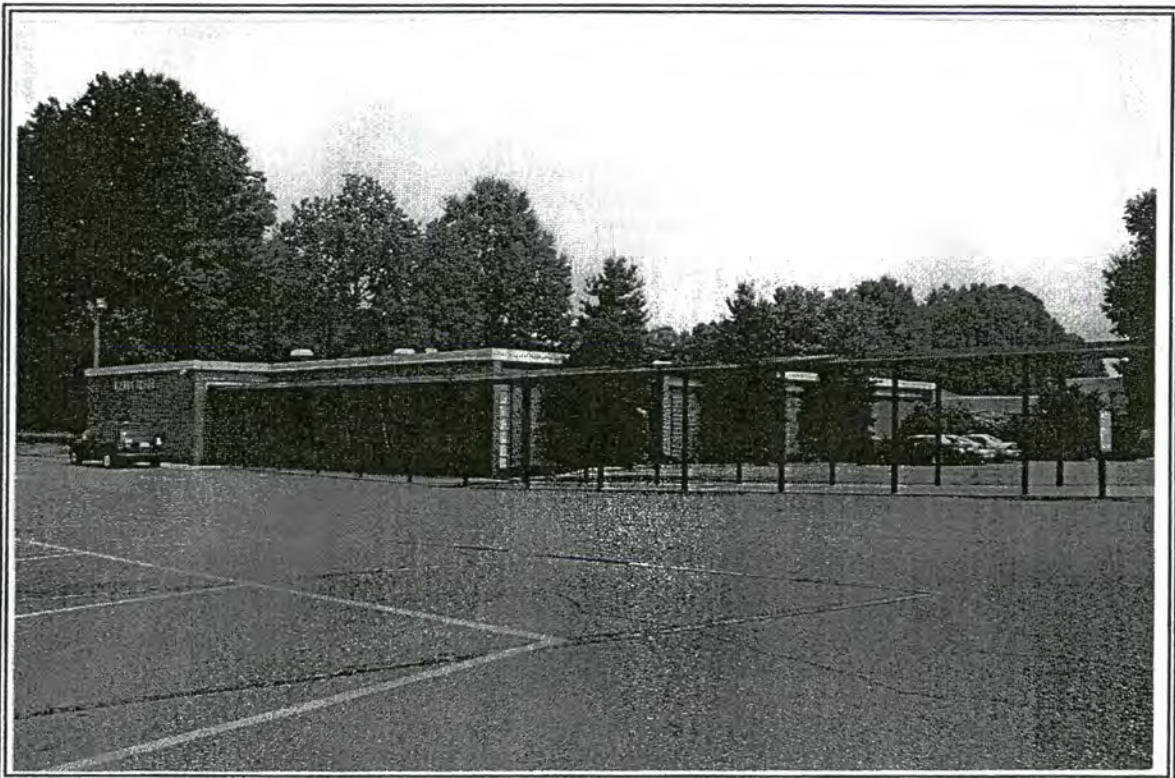
196. House, 1980 Chickasha Road

195. **House**, ca. 1925
1990 Chickasha Road
Side-gable house clad in formstone with replacement windows. *Does not appear eligible (alterations)*
196. **House**, ca. 1925
1980 Chickasha Road
Side-gable bungalow with aluminum siding, replacement windows. *Does not appear eligible (common type, synthetic siding)*

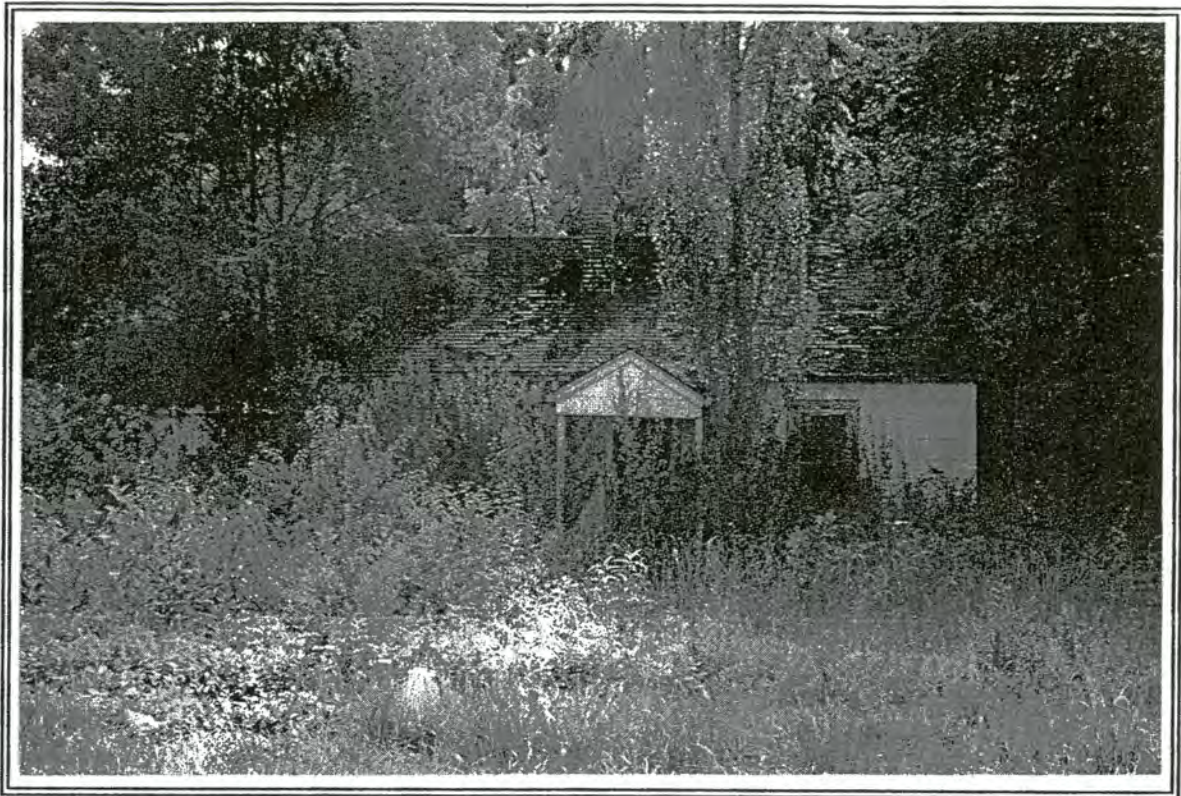
233. House, 3655 Transou Road

233. **House**, ca. 1900
3655 Transou Road
Two-story, L-plan house with new windows and vinyl siding. *Does not appear eligible (alterations)*
234. **House**, ca. 1940
36?? Transou Road
One-story, side-gable cottage with asbestos siding. Deteriorated condition. *Does not appear eligible (common type, synthetic siding)*

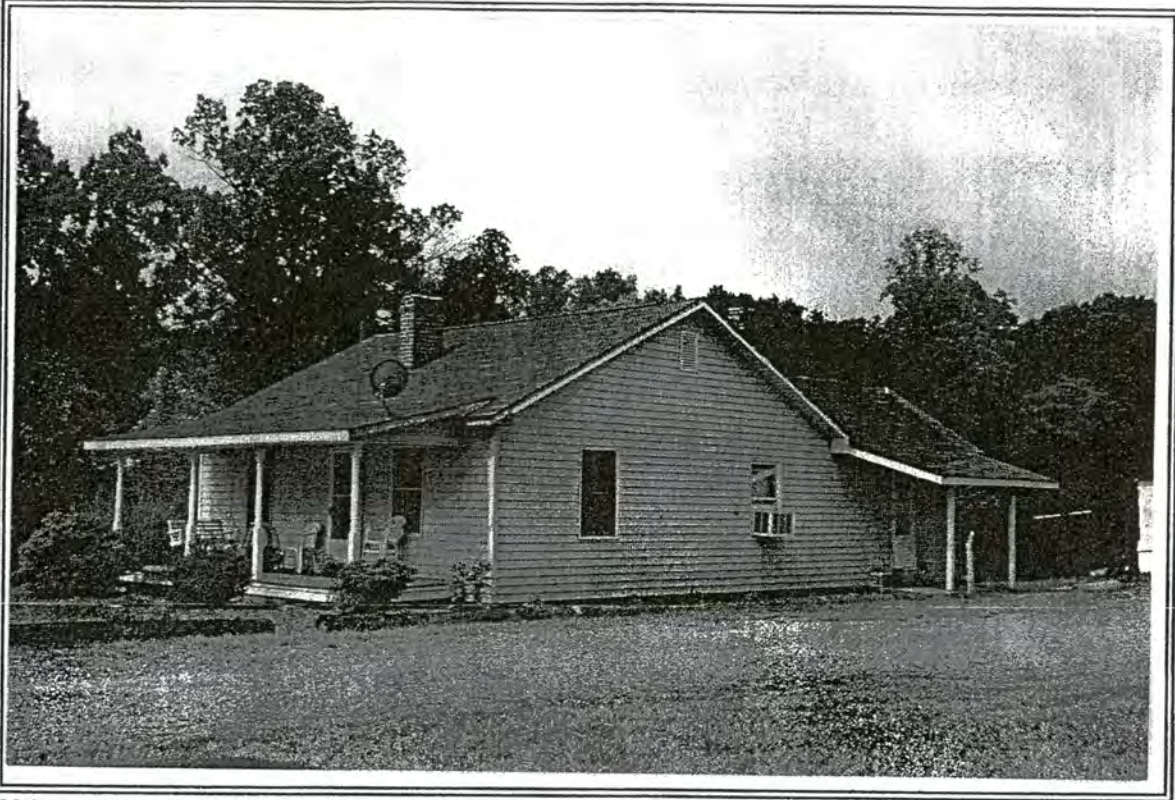
235. House, 36?? Transou Road

235. **House**, ca. 1940
36?? Transou Road
Similar to #234. Deteriorated, one-story, side-gable cottage with weatherboard siding. *Does not appear eligible (common type)*

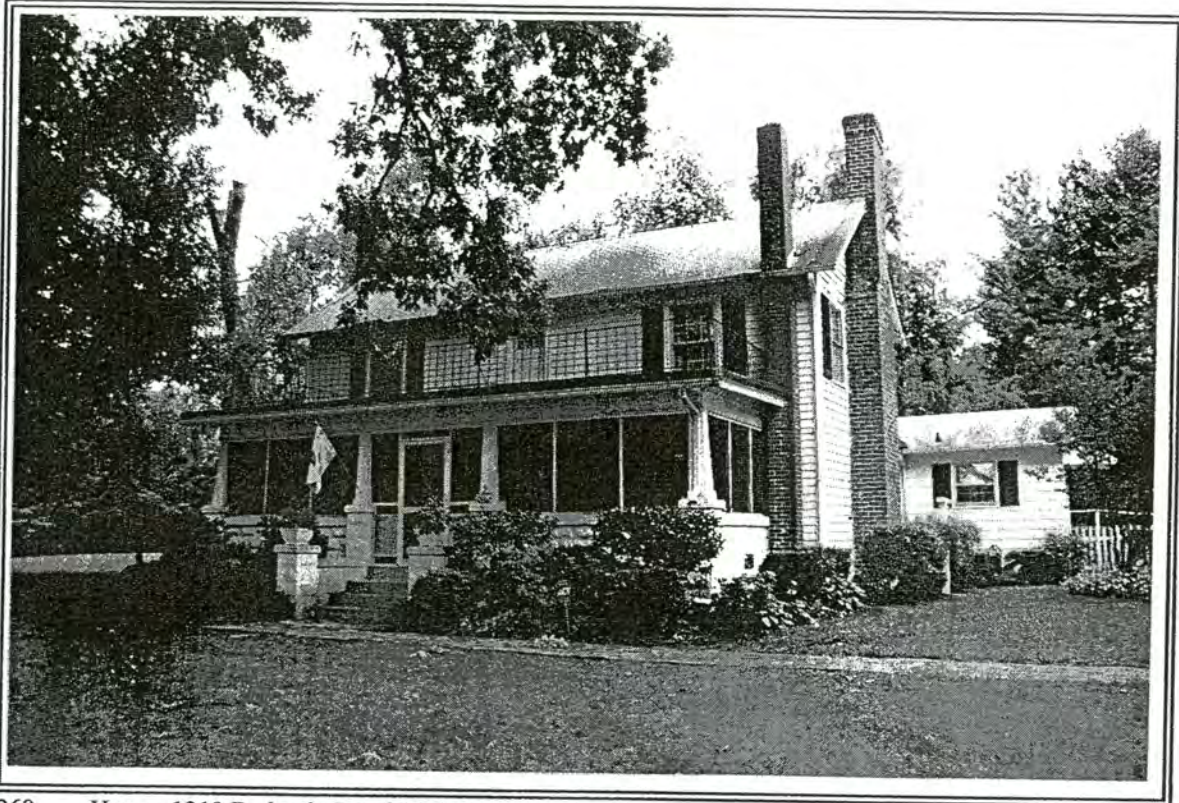
268. House (corn crib), 12?? Shore Road

268. **House**, ca. 1900
12?? Shore Road
Single pen log house with log corn crib across the road. Very deteriorated. Chimney has fallen down. *Does not appear eligible (alterations)* (FY 596)

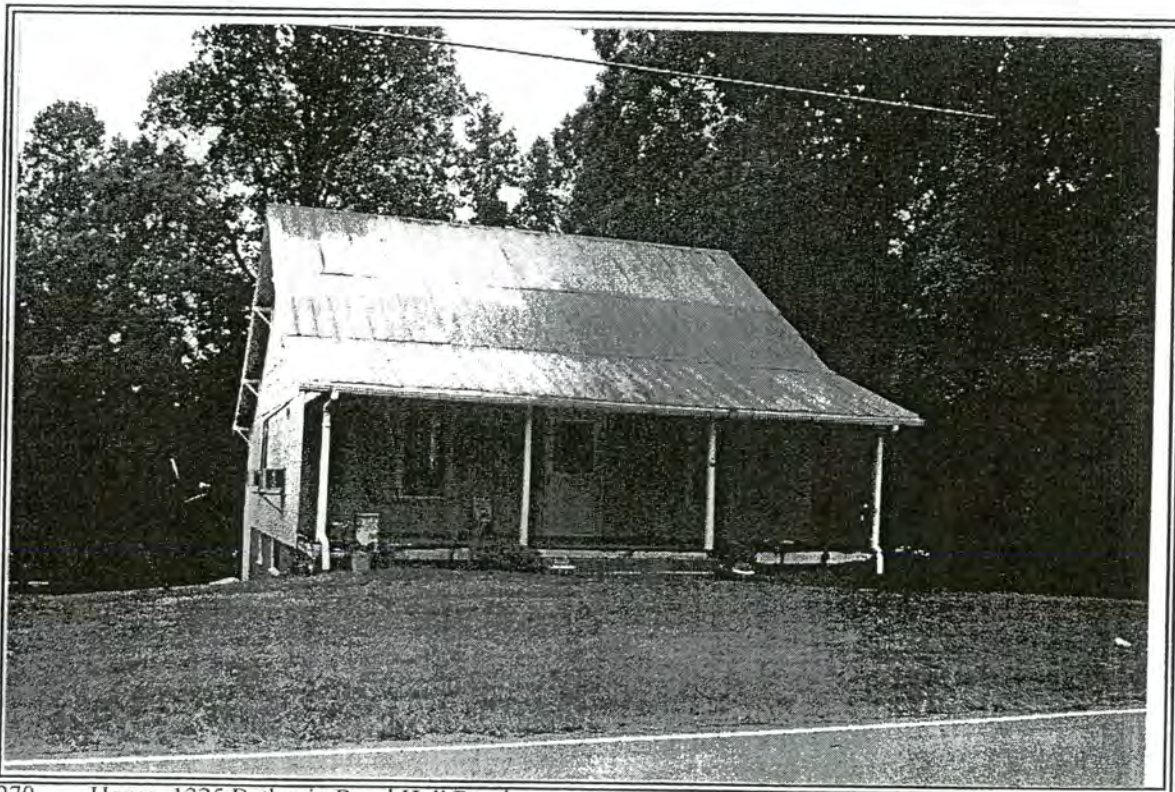
269. House, 1210 Bethania-Rural Hall Road

269. **House**, ca. 1880
1210 Bethania-Rural Hall Road
Two-story, side-gable house with brick gable end chimneys, six-over-six sash windows and sidelights and transom at front door. Bungalow porch with rusticated concrete block. Several outbuildings. *Does not appear eligible (alterations)*
