SUBJECT: Historic Architectural Resources Survey Report/Winston-Salem Northern Beltway,
Western Section, US 158 to US 52, R-2247, Forsyth County, CH91-0603

Clayton House

April 2003

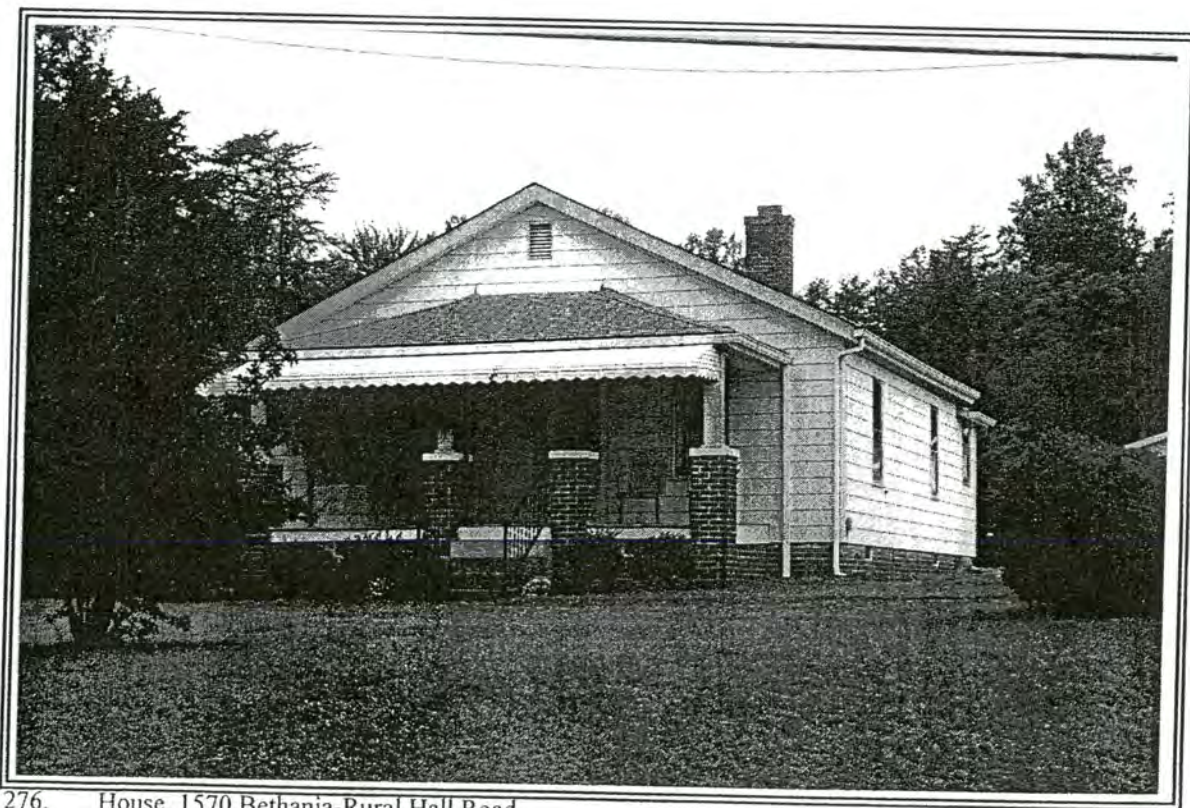
275. House, 1580 Bethania-Rural Hall Road

275. **House**, ca. 1925
1580 Bethania-Rural Hall Road
Gable front bungalow clad in formstone with large gabled addition and replacement posts on the front porch. *Does not appear eligible (alterations)*

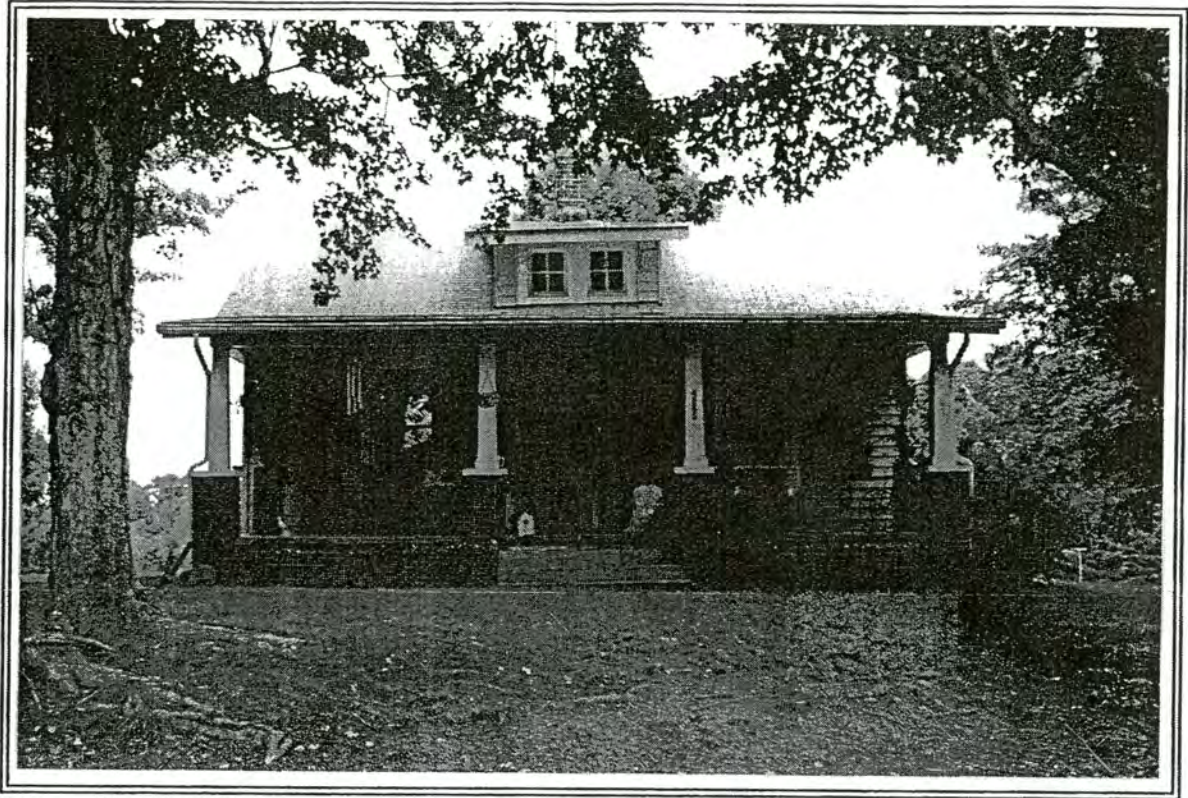
317. House, 4565 Balsom Road

317. **House**, ca. 1925
4565 Balsom Road
One-story, side-gable bungalow with weatherboard siding and replacement windows. *Does not appear eligible (common type)*

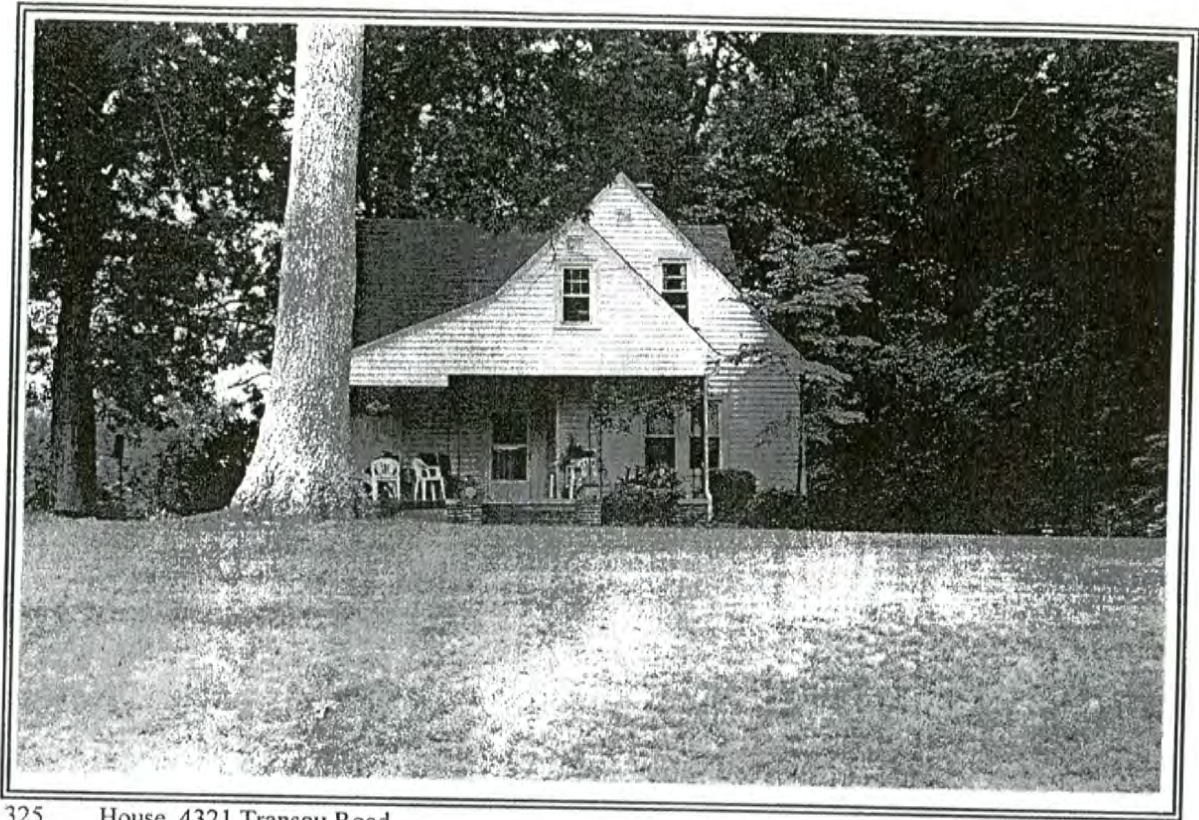
325. House, 4321 Transou Road

325. **House**, ca. 1945
4321 Transou Road
Altered Period Cottage with replacement windows and vinyl siding. *Does not appear eligible (alterations)*
326. **House**, ca. 1925
4320 Transou Road
One-story cottage with vinyl siding, replacement windows, and addition. *Does not appear eligible (synthetic siding)*
