NATIONAL REGISTER OF HISTORIC PLACES  
REGISTRATION FORM

historic name Cape Lookout Village Historic District

**Section 7 Page 1  
Cape Lookout Village Historic District  
Carteret County, North Carolina**

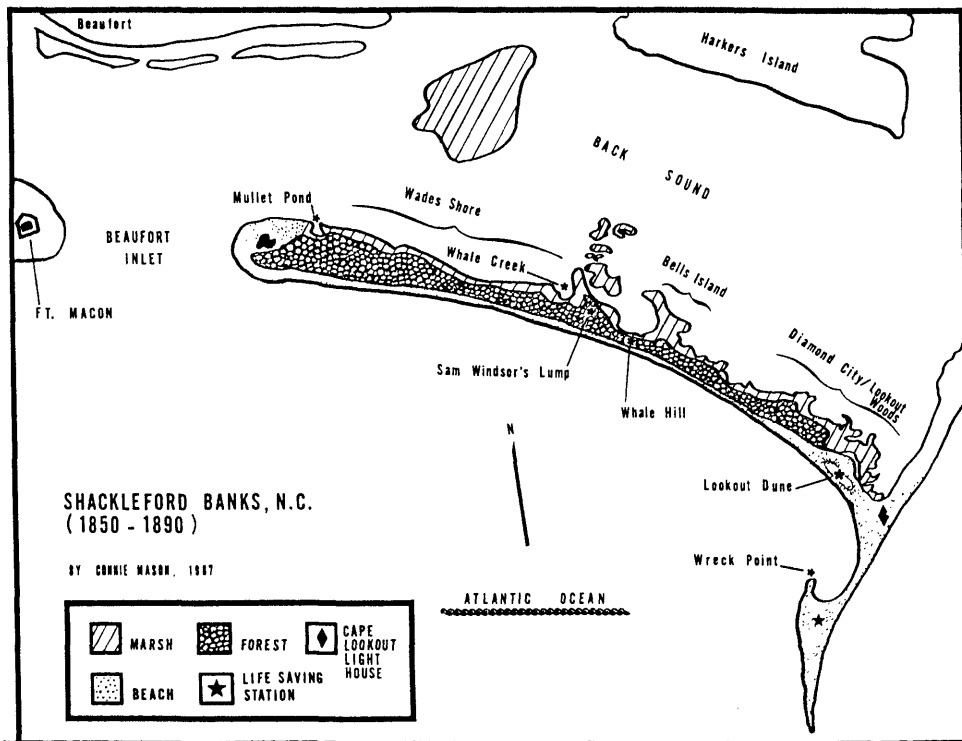
**Section Figure 1 Page 38  
Cape Lookout Village Historic District  
Carteret County, North Carolina**

The following map shows the former physical linkage between Shackleford Banks and Core Banks. The map was drawn by Connie Mason, National Park Service, and is taken from Marcus B. and Sallie W. Simpson, "The Pursuit of Leviathan: A History of Whaling on the North Carolina Coast," *North Carolina Historical Review* LXV, 1, January 1988, 33.

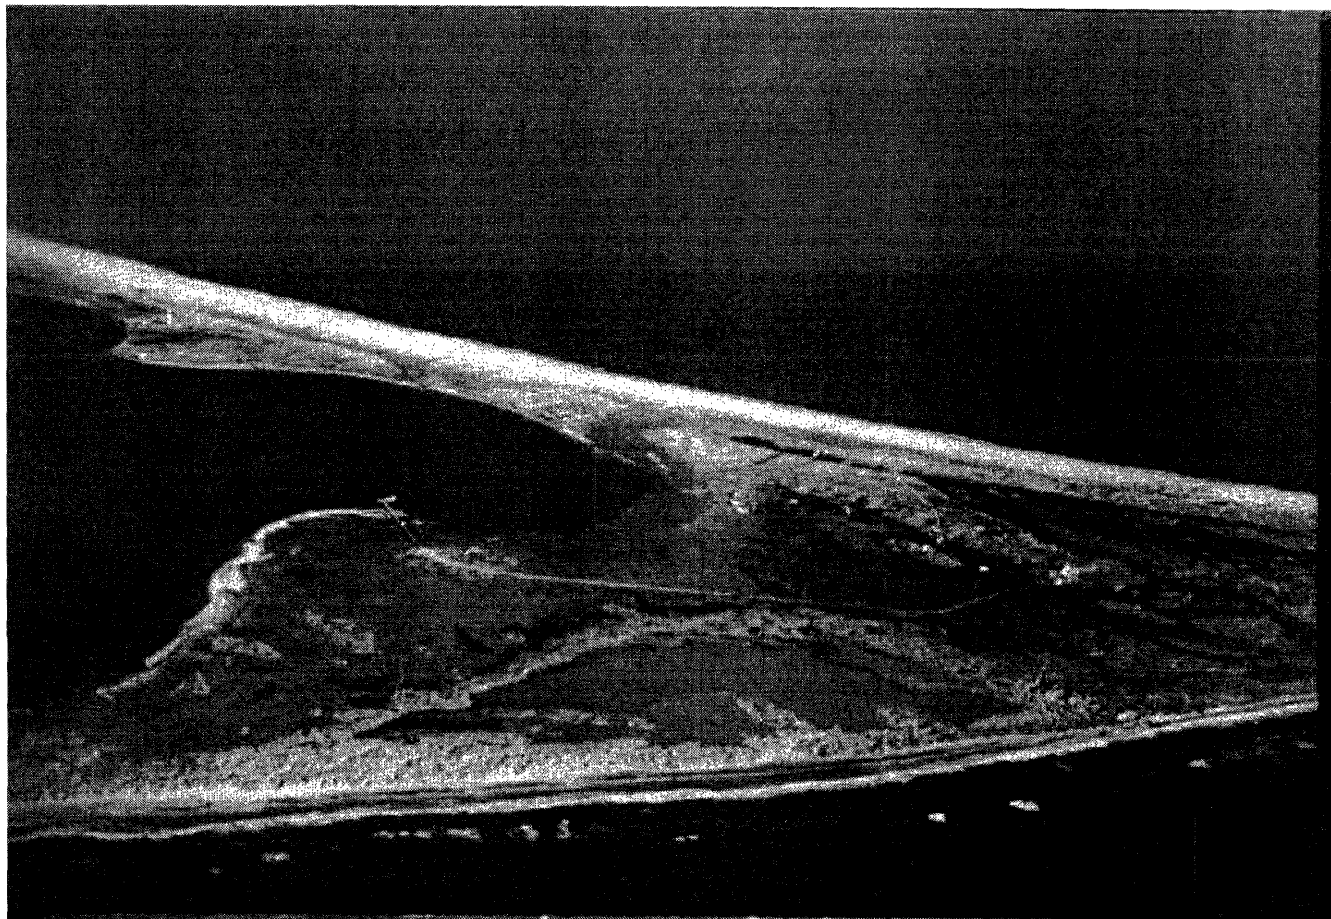
**Section Figure 3 Page 40  
Cape Lookout Village Historic District  
Carteret County, North Carolina**

Taken early in 1996 and looking to the east, the aerial photograph below shows all of the Cape Lookout Village Historic District and almost all of Cape Lookout.
