# NATIONAL REGISTER OF HISTORIC PLACES

**George E. Barnhardt House** Mocksville vicinity, Davie County, DE0029, Listed May 4, 2009 Nomination by Beth Keane Photographs by Beth Keane, May 2008

# NATIONAL REGISTER OF HISTORIC PLACES REGISTRATION FORM

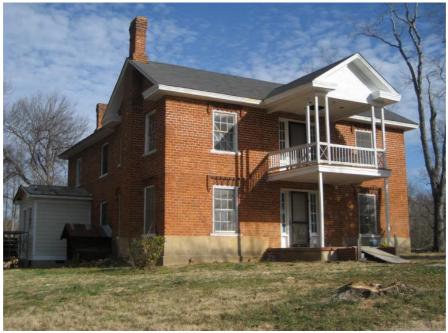
Façade view

A center-bay, two-tier, pedimented, front-gable porch supported by thin square posts with caps, grouped in threes, dominates the symmetrical three-bay facade. Several of the posts have recently been removed for repair and will be put back in place. The prominent porch gable is sheathed in horizontal flush boards, while the porch roof is covered with asphalt shingles. The porch ceiling at both levels consists of one- by six-inch tongue-and-groove boards. An original balustrade with slender, square balusters, along with crossed slats between the front posts that form an "X", survives on the second tier. The first-level wood porch floor was replaced in the 1950s with a cement floor. At approximately the same time, a large flat stone used as a front porch step was replaced with brick steps. Multi-light sidelights at both levels frame the central four-panel doors.

Tall single-shoulder chimneys with corbelled stacks that pierce the eaves stand centered on the east- and west-side elevations and the north elevation of the two-story rear ell. Windows flank the chimneys at both levels on each side elevation. Corbelled hood molding frames the top portion of the windows on the façade and the east elevation at both levels, but only on the first level of the west elevation. The only original window in the house is positioned on the north wall of the first level, east-side room, but early-twentieth-century replacement windows fill the remaining original symmetrically-placed window openings.

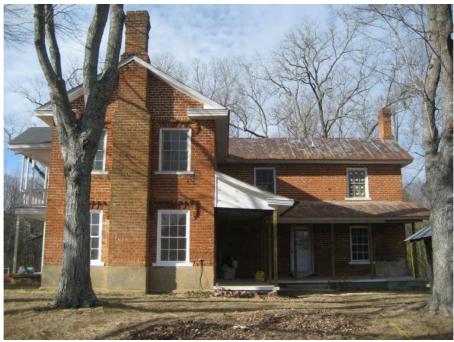
Side and rear view

A small, frame one-story, gabled addition with weatherboard siding has recently been added to the west side of the rear ell. The new addition contains a bathroom and laundry room separated by a short, narrow hall. A door, flanked on its south by a small window, is located on the west gable end of the addition. The door opens into the short hall and another door located on the opposite end of the hall opens into the kitchen. A window positioned south of the addition illuminates the dining room. A small frame structure with a gable roof, located south of the window protects steps that descend to a small dug-out basement.

A one-story, previously-enclosed, shed-roof porch, located on the east side of the rear ell and the north (rear) side of the main block of the house, has recently been opened to its original design. A 1950s-era bathroom located on the north end of the porch and a small electrical closet located at the east end of the main block were removed at the same time. The porch retains its original tongue-and-groove ceiling, although the original wood floor was placed in the 1950s with a cement floor. A 1950s-era door with six-lights-over-one-panel, accesses the dining room and a window located north of the door lights the kitchen. There is a single five-panel replacement door that opens into the central hall on the west end of the rear main block. A window is located to the east of this door. There are no windows on the north elevation of the rear ell.
