NATIONAL REGISTER OF HISTORIC PLACES

Holloway Street Historic District Boundary Increase

Durham, Durham County, DH2181, Listed April 30, 2009

Nomination by Heather Wagner

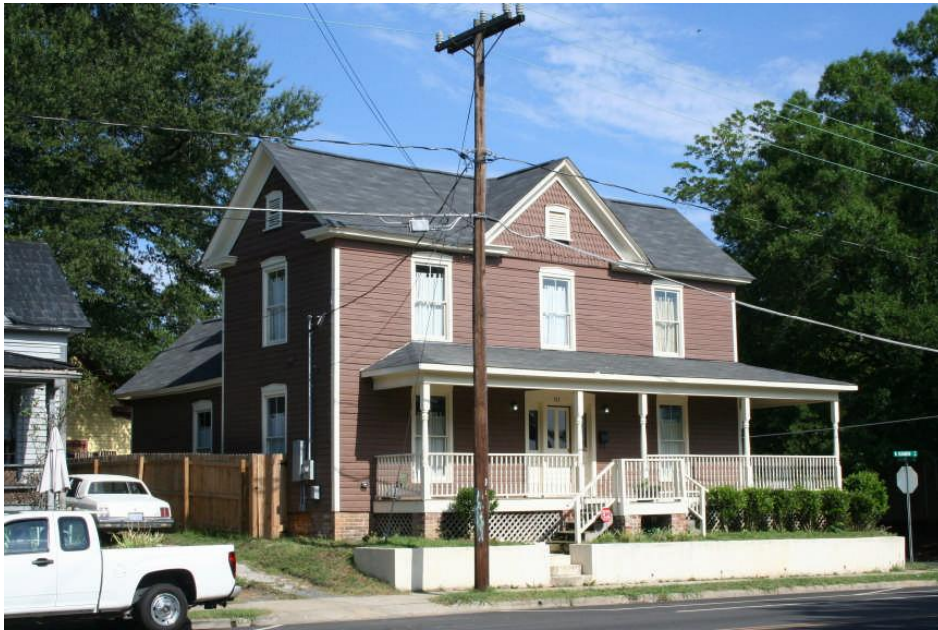
Lynn House, 311 North Elizabeth Street

C The Lynn House is a two-story, I-house with two-story gabled rear ell on the north end and a one-story gabled ell on the south end. A one-story, hip-roofed porch extends across the entire east and north sides of the house and wraps around the rear (west) side of the house, terminating at the one-story rear ell. The porch features turned posts and modern turned rails. The house rests on a brick pier and curtain foundation and is covered with plain wood weatherboards. It has boxed gable returns, a plain friezeboard, cornerboards, decorative sawtooth shingles in the front three gables, and gable vents with pointed-arched wood surrounds. Two-over-two wood windows have pointed-arched wood surrounds and the front door is a two-light over three-raised panel door with original matching sidelights over panels and a pointed-arched surround. A corbelled brick chimney extends from the asphalt-shingled roof. The house is prominently sited on a slight rise at the intersection of Elizabeth and Carlton Streets. It has a stuccoed retaining wall and stair. The earliest known residents are Arthur Lynn (messenger, Postal Telegraph Cable Company) and Walter W. Lynn (sawmill) in 1907. Cary J. Markham (superintendent, Virginia Life Insurance) and Ella E. Markham are listed from 1911 to 1915 and Robert L. Reams (conductor, Durham Traction Company) in 1919.

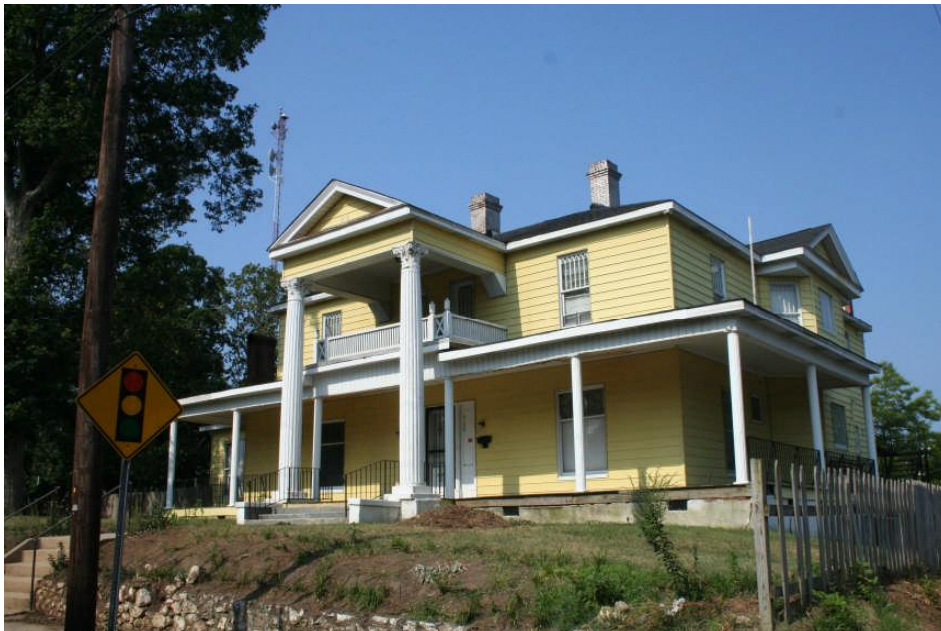
William Proctor House, 311 Oakwood Avenue

C The house at 311 Oakwood Avenue is an impressive two-story, Neoclassical-style house that anchors the neighborhood and provides a connection to the grand Queen Anne-style houses that line Holloway Street. The house is three bays wide and triple-pile with a stuccoed brick foundation, and aluminum siding, soffits, and fascia. The house retains many of its original features including an impressive wraparound porch with a two-story portico supported by large, fluted Corinthian columns. The main porch is supported by smaller vinyl versions of the fluted columns but without capitals and the left (south) side of the porch has been enclosed. The second-floor porch retains its historic rail with urn-like finials. The front door is a one-pane over one-panel door with beveled-glass over panel sidelights and has fluted pilasters on either side of the door and sidelights. The first floor has large matching one-over-one windows on the façade with leaded-glass in the upper sash. Multi-pane-over-one sashes are located throughout the main block with single fixed, multi-light sashes in the cut-away bays. Two matching multi-light over single-panel doors provide access to the second-floor porch. Two tall, corbelled brick chimneys pierce the hipped roof while the one-story addition to the left (south) side has a modern exterior brick chimney. Two-story, three-sided cut-away bays with full gable returns extend both the left (south) and right (north) ends of the house. A two-story rear ell features simple two-over-two and one-over-one windows and shelters a shed-roofed porch at the southeast corner. The house is impressively sited atop a small hill and a low, stone wall runs along Oakwood Avenue in front of the building. In 1909, William and Elizabeth Proctor were listed as the home's occupants. In 1915, a Miss Harriet Marshall, a boarder, also lived with the Proctors and by 1919, Mrs. Malissa Proctor, widow of J. R. Proctor, was its only listed resident. She remained in the house through the 1930s. The house is now divided into at least three separate units.
