Re: Demolish Building 3 at the Durham VA Medical Center, 508 Fulton Street, Durham,  
Durham County, ER 17-2509

**RE: Determination of Eligibility for Durham VA Medical Center, Durham, Durham County, North Carolina**

## Durham VA Medical Center Determination of Eligibility

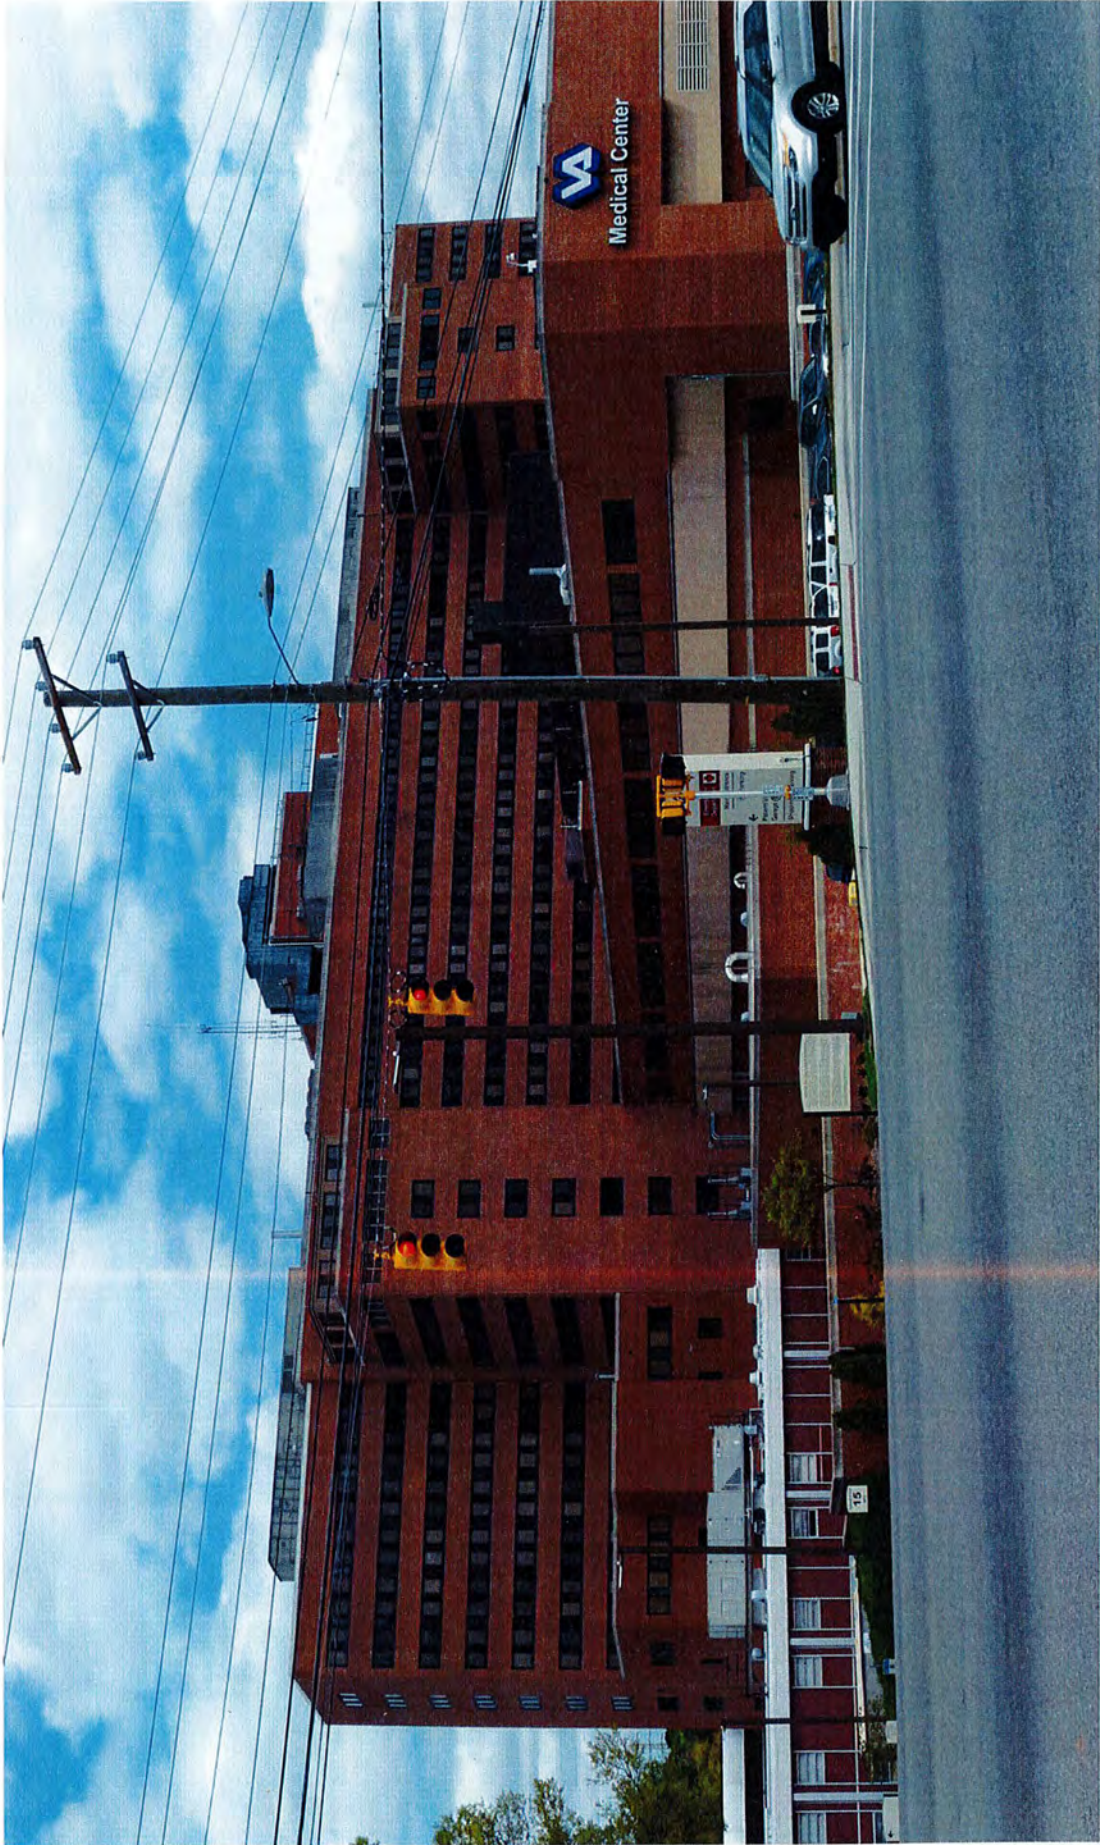
Photo 1  
Durham Veterans Affairs Medical Center  
Durham, North Carolina

Building #1 was constructed as the primary hospital of the Durham VA Hospital and retains that function today. The ten-story hospital has mechanical equipment on the flat roof and a basement (total 12 stories). It was constructed of red brick set in common bond. Horizontal bands of concrete framed the windows. The footprint of the original hospital was similar in appearance to most Third Generation VA hospitals: a central spine with projecting wings. The entrance was one-story in height and shaded by a metal awning.

1. Erwin Street introduce at Building #1, facing NE.
2. Main entrance of Building #1, facing SW.
3. Primary elevation of Building #3, facing N.
4. Primary elevation of Building #5, facing NE.
5. Primary elevation of Building #6, facing NE.
6. Buildings #7 and #9, facing NW.
7. Primary elevation of Building #8, facing NE.
8. Primary elevation of Building #14, facing E.
9. Entrance to Building #15 and elevated connecting corridor, facing N.
10. Primary elevation of Building #16, facing SE.
11. Entrance to Building #23, facing SW.
12. Entrance and elevator bays of Building #26, facing NW.
13. Building #33, facing E.

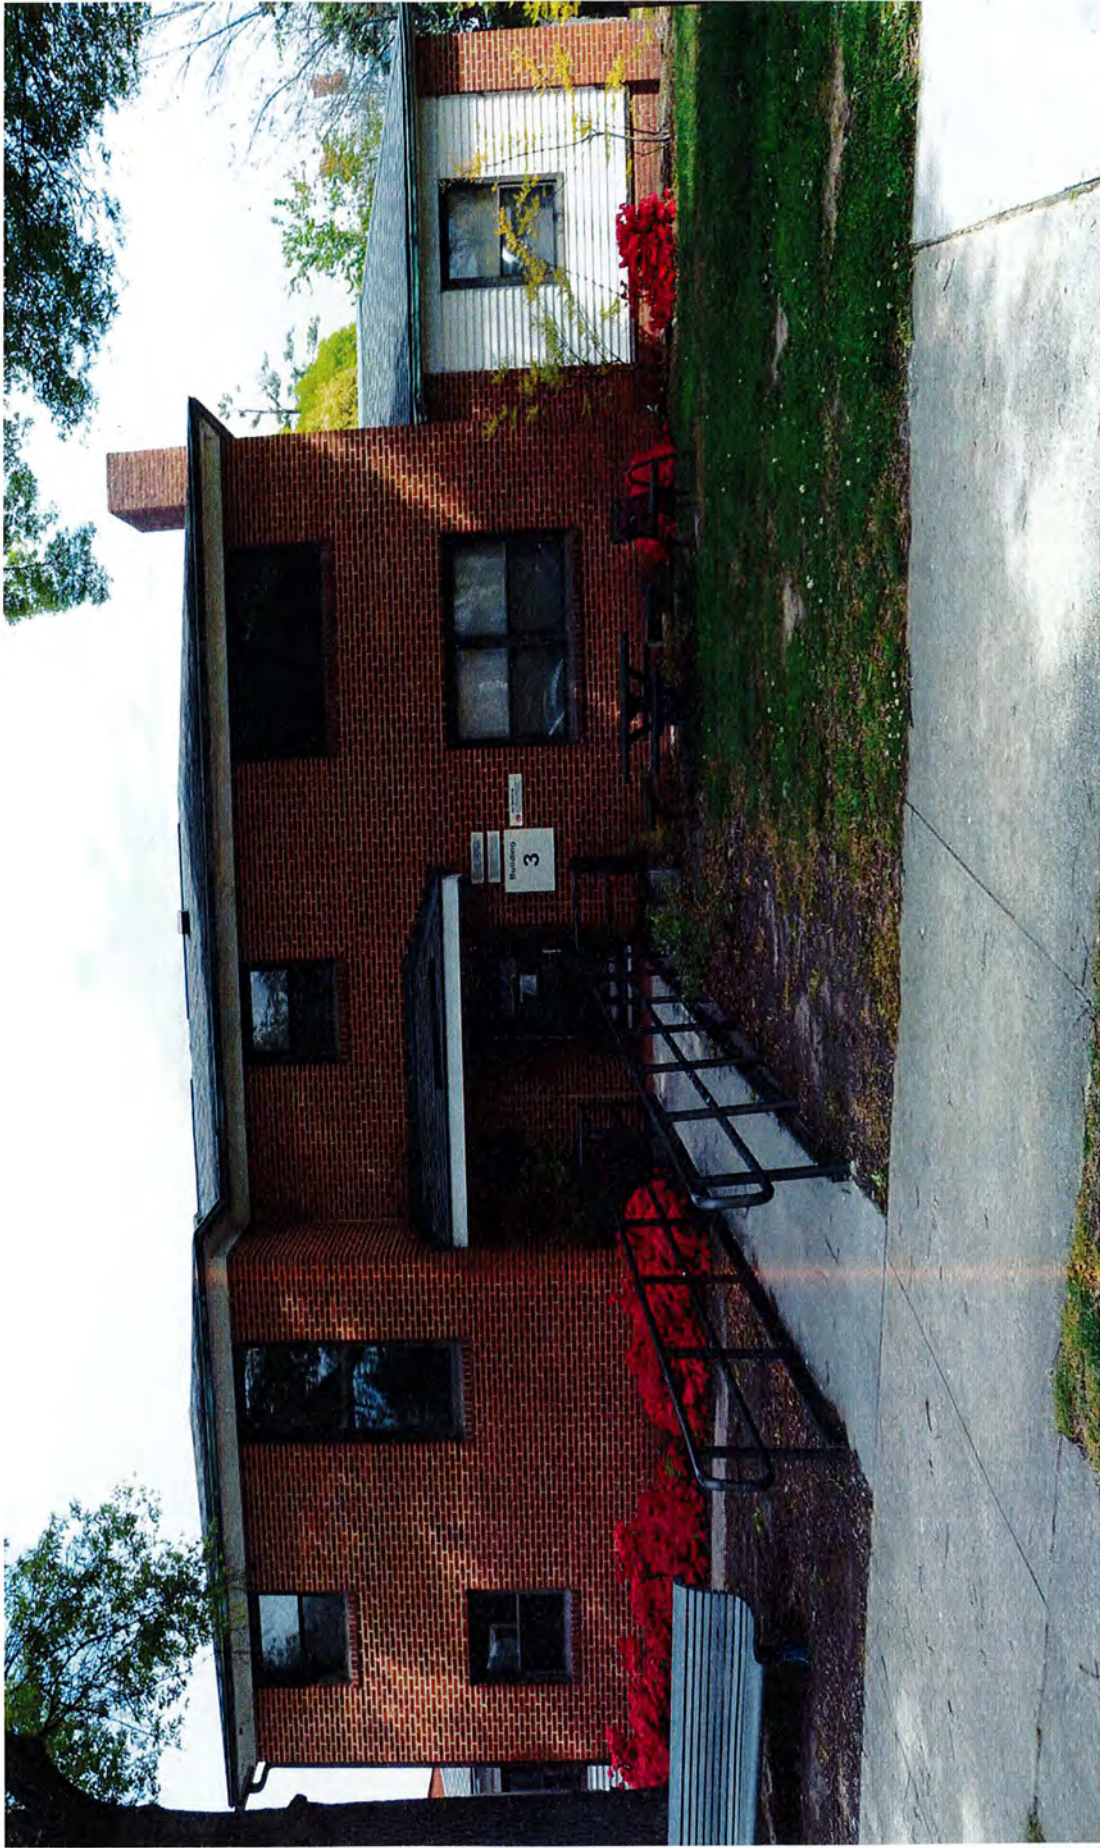
Photo 3  
Durham Veterans Affairs Medical Center  
Durham, North Carolina

Building #3 was constructed as a quarters building for the Durham Hospital when it opened in 1953. The residence is located near the southern border of the campus. The primary body of the building was constructed of red brick. It features a low hip roof and the building is two stories tall. The western portion of the building projects forward from the façade. The primary entrance is recessed and shaded by an asphalt-covered awning. A small circular window is located west of the primary entrance. A porch on the eastern elevation has been filled and now is clad in vinyl.

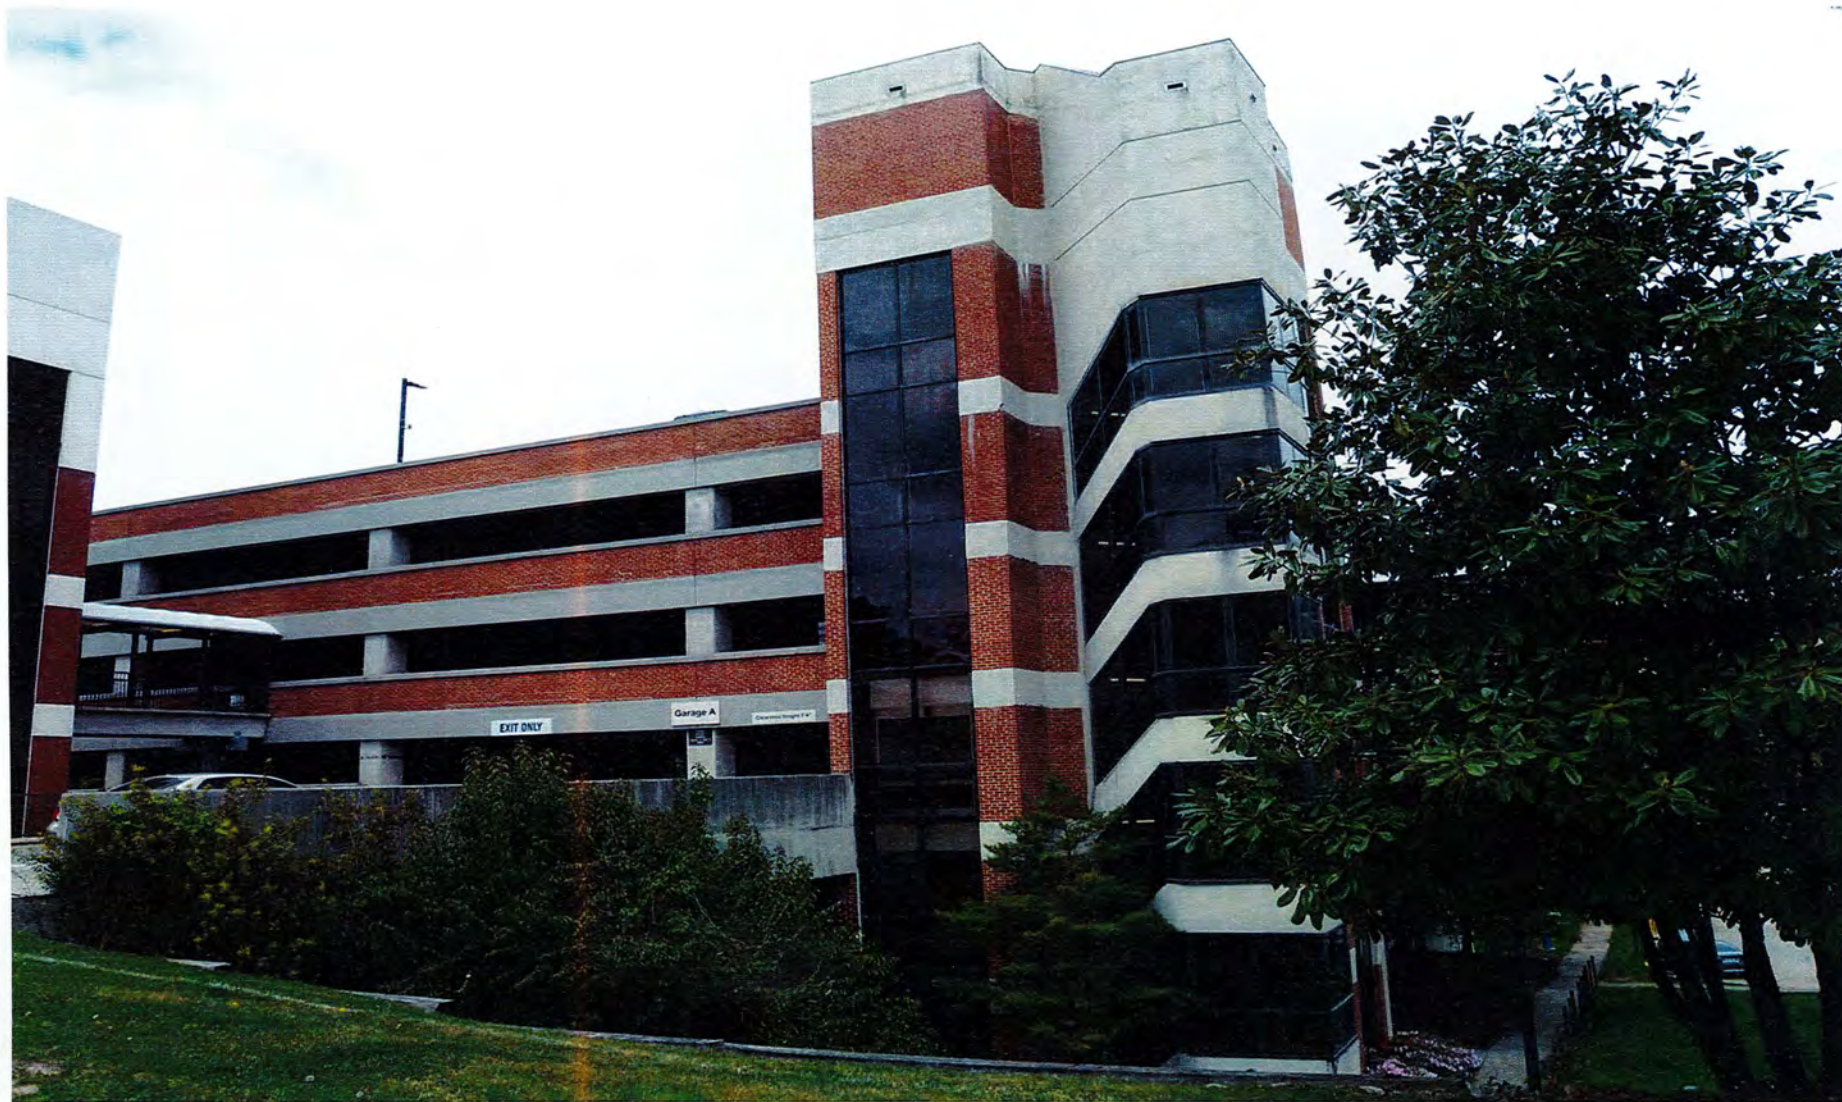
Photo 12  
Durham Veterans Affairs Medical Center  
Durham, North Carolina

Structure #26 is a multi-level parking garage near the northern border of the campus. It was constructed of concrete, red brick, and metal. The structure is accessible by a concrete ramp. The primary elevator bay is located on the exterior of the structure at the southeast corner. The windows of the elevator bay and stairwells are tinted panes of glass set in metal frames.

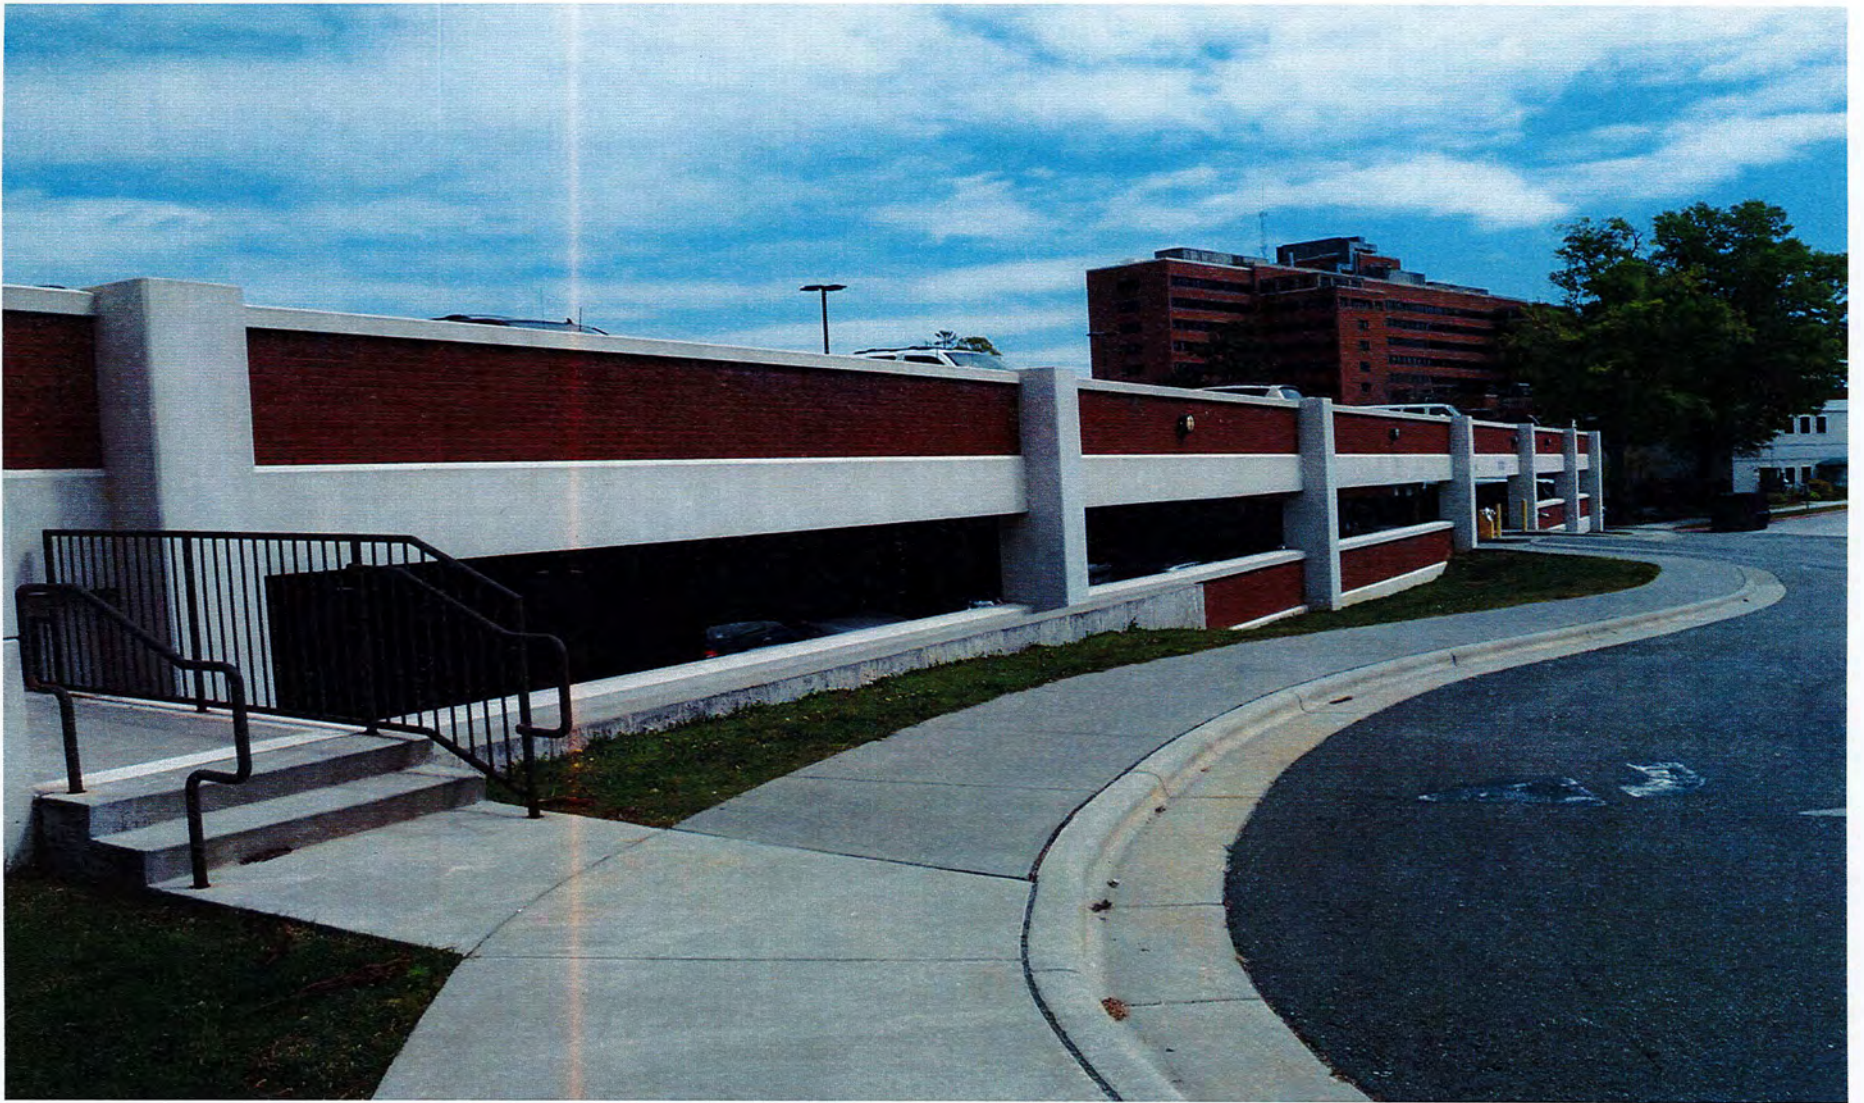
Photo 13  
Durham Veterans Affairs Medical Center  
Durham, North Carolina

Structure #33 is a low-slung parking garage located near the southern boundary of the campus. The structure is two levels in height and bears a rectangular footprint. The structure was constructed of brick, concrete, and metal. The exterior walls are panels of brick set in common bond framed by concrete. The upper level is uncovered.
