RE: Historic Building Survey of NC Army National Guard Armories, Multi County, ER09-0905

The survey project expanded in 2008-2009 to include 31 Cold War era buildings built in the late 1950s and 1960s, specifically 26 armories, two field maintenance shops, and three non-armory buildings that are part of the Claude T. Bowers Military Center in Raleigh. The first phase of the project included the survey and evaluation of three armories and four buildings of the Claude T. Bowers Military Center in Raleigh: the Joint Force Headquarters building, the United States Property and Fiscal Office building, the Combined Support Maintenance Shop, and Field Maintenance Shop (FMS) No. 20 (Figure 1). This phase was completed by Berger cultural resource staff; historical research and field surveys were undertaken in October 2008. Berger completed the second phase including the survey of 23 armories and FMS No. 9 in October 2009.

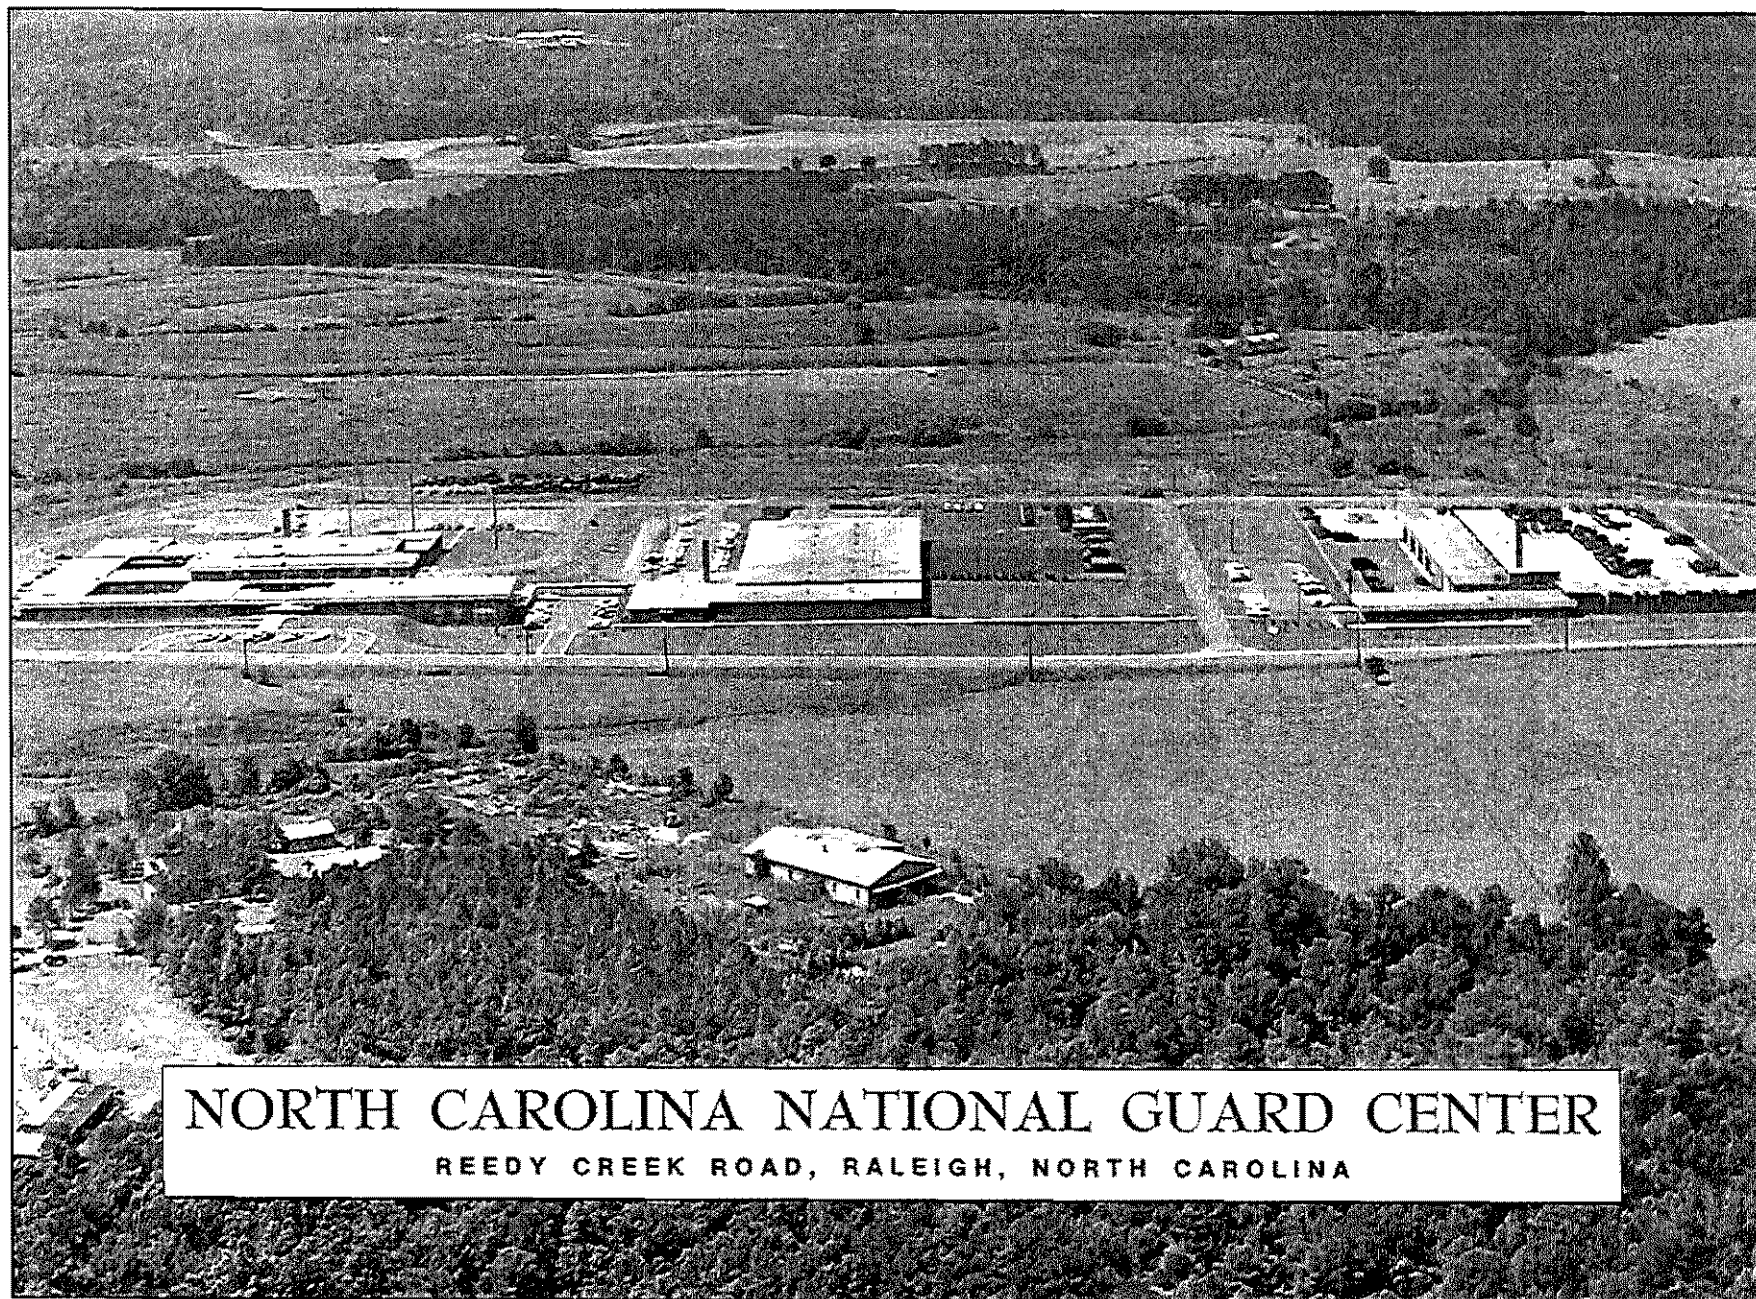
FIGURE 4: Claude T. Bowers Military Center

Plans emerged in 1961 for the military center in Raleigh. The United States Property and Fiscal Office building [USPFO] was listed in the 1961-1962 adjutant general's report as being approved for construction with a total cost of \$349,134.68 all from federal funds. In addition, \$797,964.09 had been appropriated for the acquisition of the property and the construction of the headquarters building and the Combined Support Maintenance Shop [CSMS]. The adjutant general's report stated that the "long awaited consolidation of all National Guard activities in the Raleigh area had been accomplished with the acquisition of the site on Reedy Creek Road." Both the construction of the headquarters building and the CSMS began in 1964. Raleigh architect Leif Valand designed the buildings of the new military center in a decidedly modern style (Figure 4).

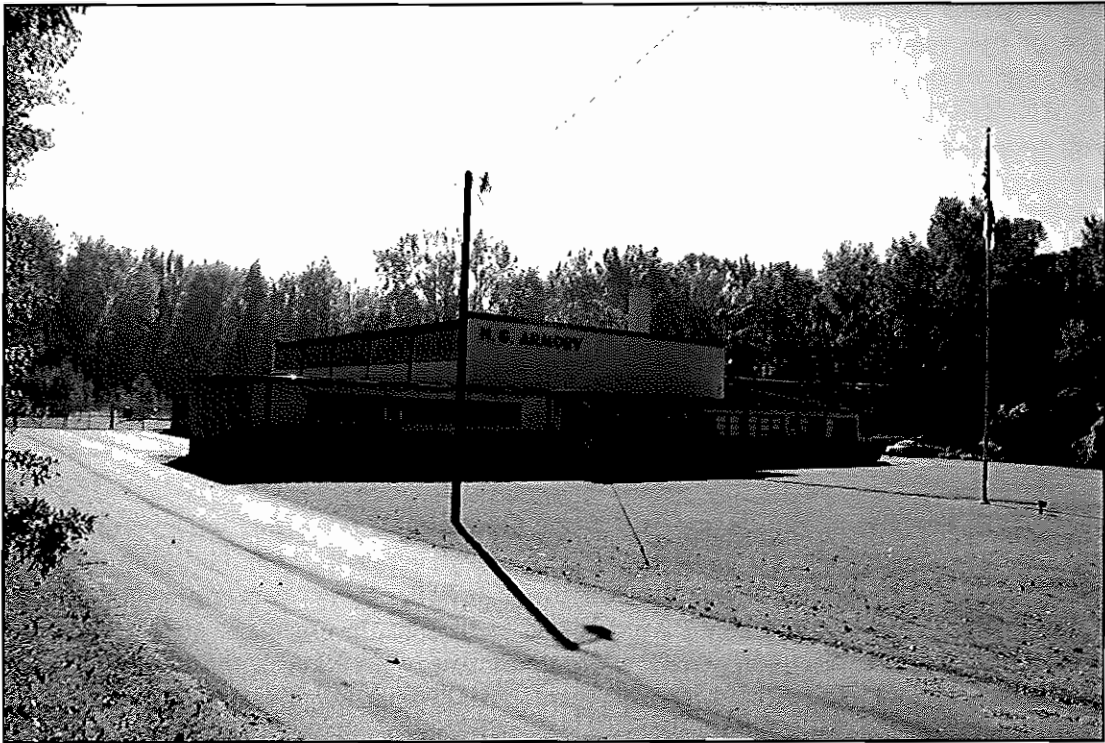
PLATE 1: Belmont National Guard Armory

Architectural Description: The Belmont National Guard Armory was built in 1960-1961 as a Alt-A standard plan armory (Plate 1). It sits on a solid poured-concrete foundation and is constructed of concrete block masked in a five-course Flemish-bond veneer of buff-colored brick. It has a flat roof with metal coping. The building consists of a central two-story drill hall that is surrounded on all of its elevations except the east (rear) by one-story wings. Clerestory ribbon windows line the north and south elevations of the drill hall. The clerestory windows consist of five sets of nine vertical one-light metal-sash awning windows. The unfenestrated second story of the main (west) elevation of the drill hall is adorned with metal lettering reading "N.G. ARMORY." The rear elevation of the drill hall is pierced by a full-height vehicular metal roll-up door flanked by two double-leaf metal doors.

Known Alterations: No major changes have been made to the Belmont Armory since its construction.

National Register Evaluation: The Belmont Armory is not eligible for listing in the National Register. Completed in 1961, the armory does not meet the minimum age requirement of 50 years of age or more. In addition, it does not possess the exceptional importance required for eligibility under Criteria Consideration G, regarding properties that have achieved significance within the past 50 years. This study has found no evidence that this armory is associated with important events (Criterion A) or people (Criterion B) in the history of Belmont, North Carolina, or the United States. The Belmont Armory is a late example of an Alt-A standard plan armory and is therefore not eligible under Criterion C as an important example of this architectural type. The site does not appear to have the potential to yield important information that would contribute to the understanding of prehistory or history and therefore does not meet Criterion D. It is therefore unlikely that the armory will be eligible for the National Register after it has reached the age requirement of 50 years.

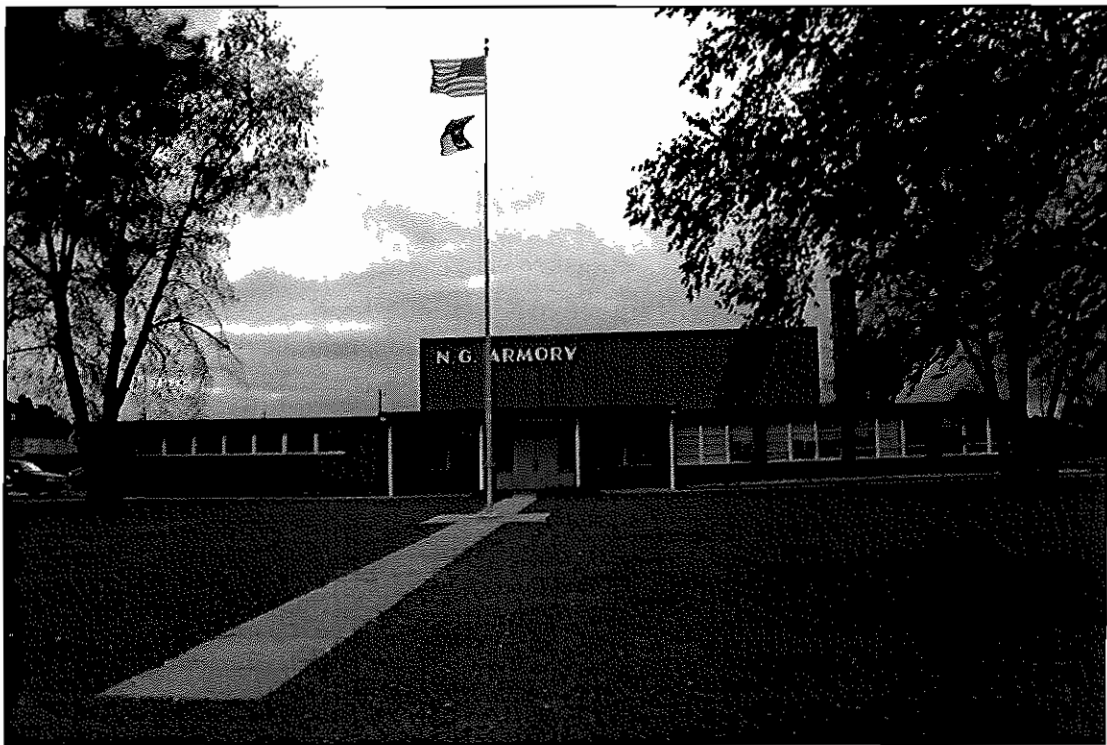
PLATE 2: Benson National Guard Armory

Architectural Description: The Benson Armory was built in 1961 as an Alt-A standard plan armory (Plate 2). The Benson Armory sits on a solid poured-concrete foundation and is constructed of concrete block masked in a five-course Flemish-bond brick veneer. It has a flat roof with metal coping. The building consists of a central two-story drill hall that is surrounded on all of its elevations except the south (rear) by one-story wings. Clerestory ribbon windows line the east and west elevations of the drill hall. The clerestory windows consist of five sets of nine vertical one-light metal-sash awning windows. The unfenestrated second story of the main (north) elevation of the drill hall is adorned with metal lettering reading "NG ARMORY." The rear elevation of the drill hall is pierced by a full-height vehicular metal roll-up door flanked by two double-leaf metal doors.

Known Alterations: No major changes have been made to the Benson Armory since its construction. A repair has been made to the brick on the south wall of the drill hall after a

vehicle damaged the building, but it is almost unnoticeable. The original gun range underwent lead abatement and other renovations, presumably in the 1990s, and is currently used for storage.

National Register Evaluation: The Benson Armory is not eligible for listing in the National Register. Constructed in 1961, the armory does not meet the National Register requirement of 50 years of age or more. In addition, the building does not possess significance in regard to historic events, architecture, or important persons to warrant National Register eligibility under Criteria Consideration G: Properties That Have Achieved Significance Within the Past Fifty Years. This study has found no evidence that this armory is associated with important events (Criterion A) or people (Criterion B) in the history of Benson, North Carolina, or the United States. The Benson Armory is a late example of an Alt-A standard plan armory and is therefore not eligible under Criterion C as an important example of this architectural type. The site does not appear to have the potential to yield important information that would contribute to the understanding of prehistory or history and therefore does not meet Criterion D. It is therefore unlikely that the Benson Armory will be eligible for the National Register after it has reached the age requirement of 50 years.

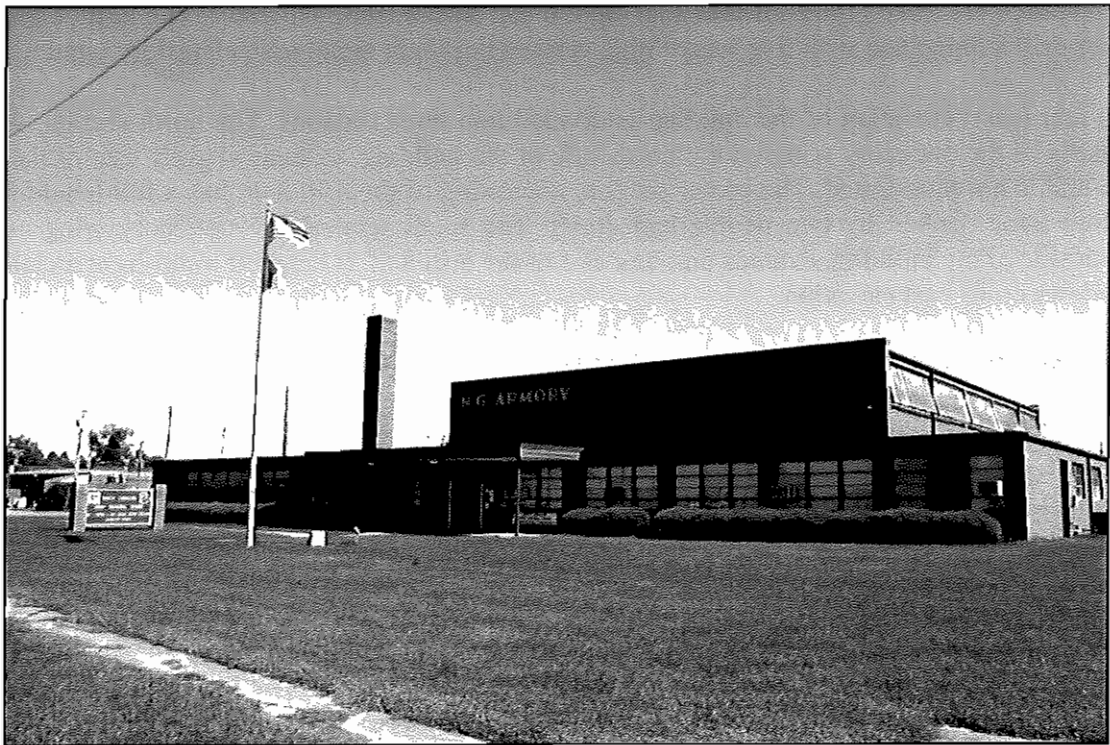
PLATE 4: Elizabeth City National Guard Armory

Architectural Description: The Elizabeth City National Guard Armory was built in 1961 as a B-Coffey & Olsen-plan armory (Plate 4). The armory sits on a solid poured-concrete foundation and is constructed of steel framing and concrete block masked in a five-course Flemish-bond brick veneer. It has a flat roof with metal coping. The building consists of a central high-bay drill hall that is surrounded on all of its elevations except the east (rear) by one-story wings.

The one-story main (west) elevation of the building is nine bays wide and extends north and south of the west elevation of the drill hall. The main entrance is offset and consists of a double-leaf metal door with one-light transom windows and sidelights. It is flanked by paired three-light metal-sash awning windows. A one-story three-bay porch with a flat roof shelters the main

National Register Evaluation: The Elizabeth City Amory is not eligible for listing in the National Register. This study has found no evidence that this armory is associated with important events (Criterion A) or people (Criterion B) in the history of Elizabeth City, North Carolina, or the United States. The Elizabeth City Armory is a late example of a B-Coffey & Olsen standard plan armory and is therefore not eligible under Criterion C as an important example of this architectural type. The site does not appear to have the potential to yield important information that would contribute to the understanding of prehistory or history and therefore does not meet Criterion D.

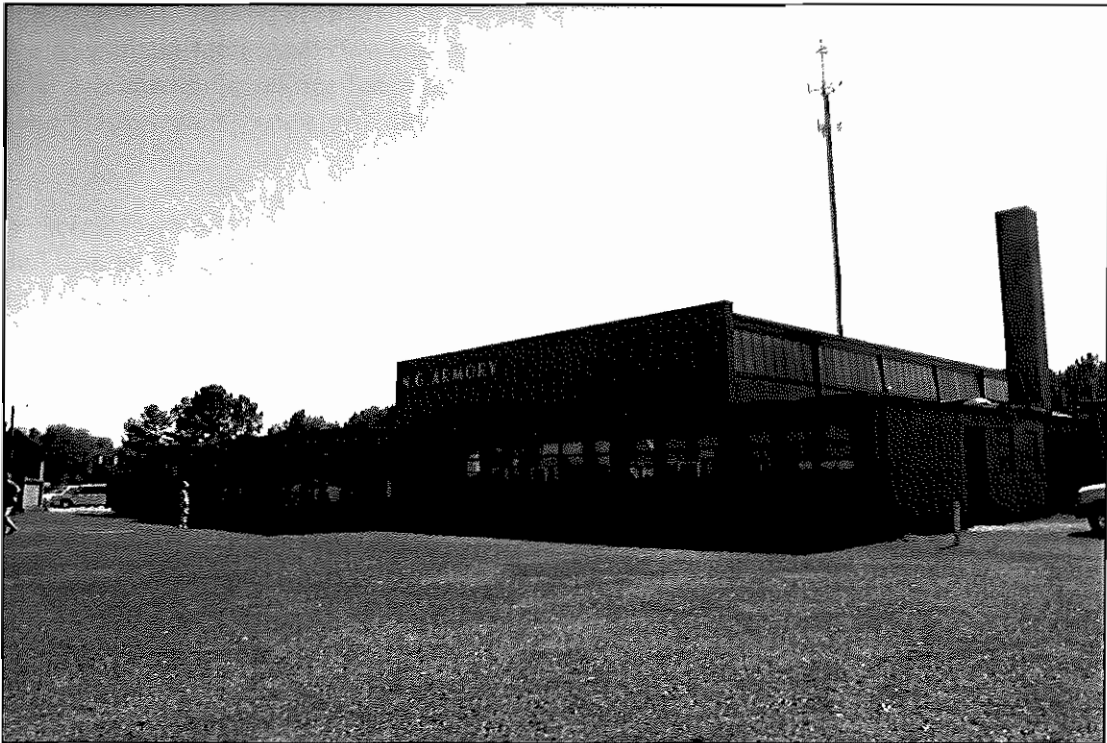
PLATE 5: Elizabethtown National Guard Armory

Architectural Description: The Elizabethtown Armory was built in 1963 as an Alt-A standard plan armory (Plate 5). The armory sits on a solid concrete foundation and is constructed of steel framing and concrete block masked in a five-course Flemish-bond brick veneer. The building consists of a central high-bay drill hall that is surrounded on all of its elevations except the south (rear) by one-story wings. The drill hall and wings are capped with flat roofs with metal coping.

National Register Evaluation: The Elizabethtown Armory is not eligible for listing in the National Register. Constructed in 1961, the armory does not meet the National Register requirement of 50 years of age or more. In addition, the building does not possess sufficient significance in regard to historic events, architecture, or important persons to warrant National Register eligibility under Criteria Consideration G: Properties That Have Achieved Significance Within the Past Fifty Years. This study has found no evidence that this armory is associated with important events (Criterion A) or people (Criterion B) in the history of Elizabethtown, North Carolina, or the United States. The Elizabethtown Armory is a late example of an Alt-A armory and is therefore not eligible under Criterion C as an important example of this architectural type. The site does not appear to have the potential to yield important information that would contribute to the understanding of prehistory or history and therefore does not meet Criterion D. It is therefore unlikely that the Elizabethtown Armory will be eligible for the National Register after it has reached the age requirement of 50 years.

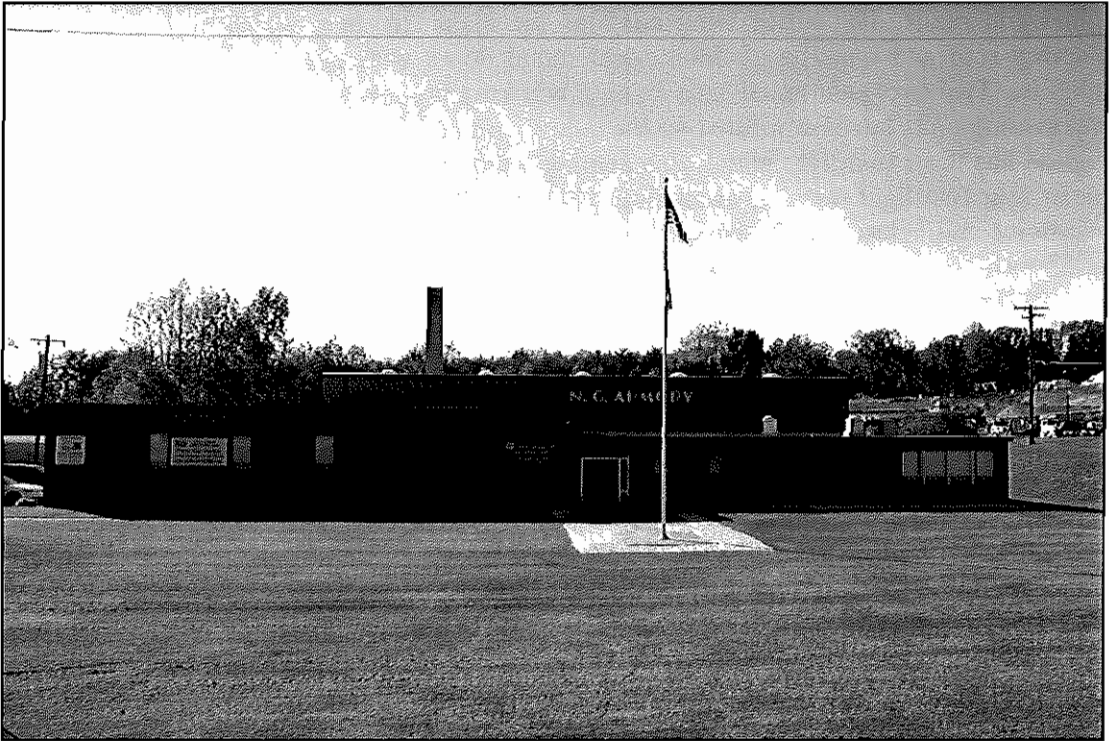
PLATE 6: Elkin National Guard Armory

Architectural Description: The Elkin National Guard Armory was built in 1965 as a Type A armory (Plate 6). It sits on a solid poured-concrete foundation and is constructed of concrete block masked in a stretcher bond brick veneer. It has a flat roof with metal coping. The building consists of a central two-story drill hall that is surrounded on all of its elevations except the south, by one-story wings. Rather than the typical clerestory windows, the drill hall features skylights in the roof—two between each main girder supporting the roof. The unfenestrated second story of the east elevation of the drill hall is adorned with metal lettering reading “N.G. ARMORY” on a background of brick laid in an unusual pattern of un-staggered courses of stretcher bond. The south elevation of the drill hall has a full-height metal roll-up door flanked by two double-leaf metal doors.

A one-story office and administrative wing is located along the northern half of the east elevation of the drill hall, facing North Bridge Street. The southern half of this elevation contains the original gun range. The office wing contains the main entrance, which is recessed beneath a projecting roof and consists of double-leaf metal doors with one-light transom windows and sidelights. Two two-light metal-sash awning windows are located north of the entrance, and the lower awning units have been filled with window-unit air conditioners. The south end of the east elevation has three two-light metal-sash awning windows. The north end of this elevation has a bank of four two-light metal-sash awning windows. All of the windows on this elevation have brick above and below laid in the same un-staggered stretcher-bond pattern used on the façade. The majority of windows throughout the building except for those on the west and south elevations have a similar brick treatment.

National Register Evaluation: The Elkin Armory is not eligible for listing in the National Register. Completed in 1965, the armory does not meet the minimum age requirement of 50 years of age or more. In addition, it does not possess the exceptional importance required for eligibility under Criteria Consideration G, regarding properties that have achieved significance within the past 50 years. This study has found no evidence that this armory is associated with important events (Criterion A) or people (Criterion B) in the history of Elkin, North Carolina, or the United States. The Elkin Armory is a late example of a standard Type A armory and is therefore not eligible under Criterion C as an important example of this architectural type. The site does not appear to have the potential to yield important information that would contribute to the understanding of prehistory or history and therefore does not meet Criterion D. It is therefore unlikely that the armory will be eligible for the National Register after it has reached the age requirement of 50 years.

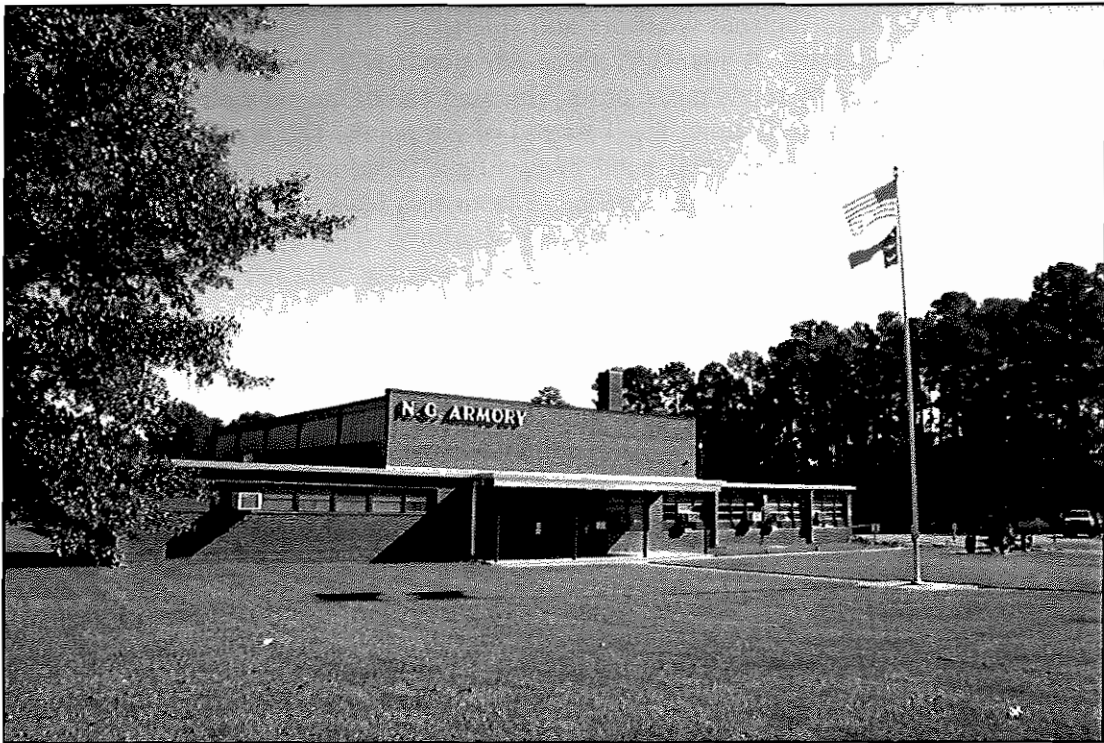
PLATE 7: Farmville National Guard Armory

Architectural Description: The Farmville Armory was built in 1961 as an Alt-A standard plan armory (Plate 7). The armory sits on a solid concrete foundation and is constructed of steel framing and concrete block masked in a five-course Flemish-bond brick veneer. It has a flat roof with metal coping. The building consists of a central high-bay drill hall that is surrounded on all of its elevations except the north (rear) by one-story wings.

The one-story east elevation of the building is six bays wide and extends north and south of the five-bay east elevation of the drill hall. The south section of the elevation is pierced by an inset single-leaf door, two paired three-light metal-sash awning windows, and an inset porch that shelters a single-leaf door and a three-light metal-sash awning window. The northern end of the east elevation extends one-bay east and is not fenestrated. A tall chimney stack rises above the roof near the northern end of the east elevation, indicating the location of the boiler. The east elevation of the drill hall is lined with five sets of nine vertical one-light metal-sash clerestory windows.

National Register Evaluation: The Farmville Armory is not eligible for listing in the National Register. Constructed in 1961, the armory does not meet the National Register requirement of 50 years of age or more. In addition, the building does not possess sufficient significance in regard to historic events, architecture, or important persons to warrant National Register eligibility under Criteria Consideration G: Properties That Have Achieved Significance Within the Past Fifty Years. This study has found no evidence that this armory is associated with important events (Criterion A) or people (Criterion B) in the history of Farmville, North Carolina, or the United States. The Farmville Armory is a late example of an Alt-A armory and is therefore not eligible under Criterion C as an important example of this architectural type. The site does not appear to have the potential to yield important information that would contribute to the understanding of prehistory or history and therefore does not meet Criterion D. It is therefore unlikely that the Farmville Armory will be eligible for the National Register after it has reached the age requirement of 50 years.

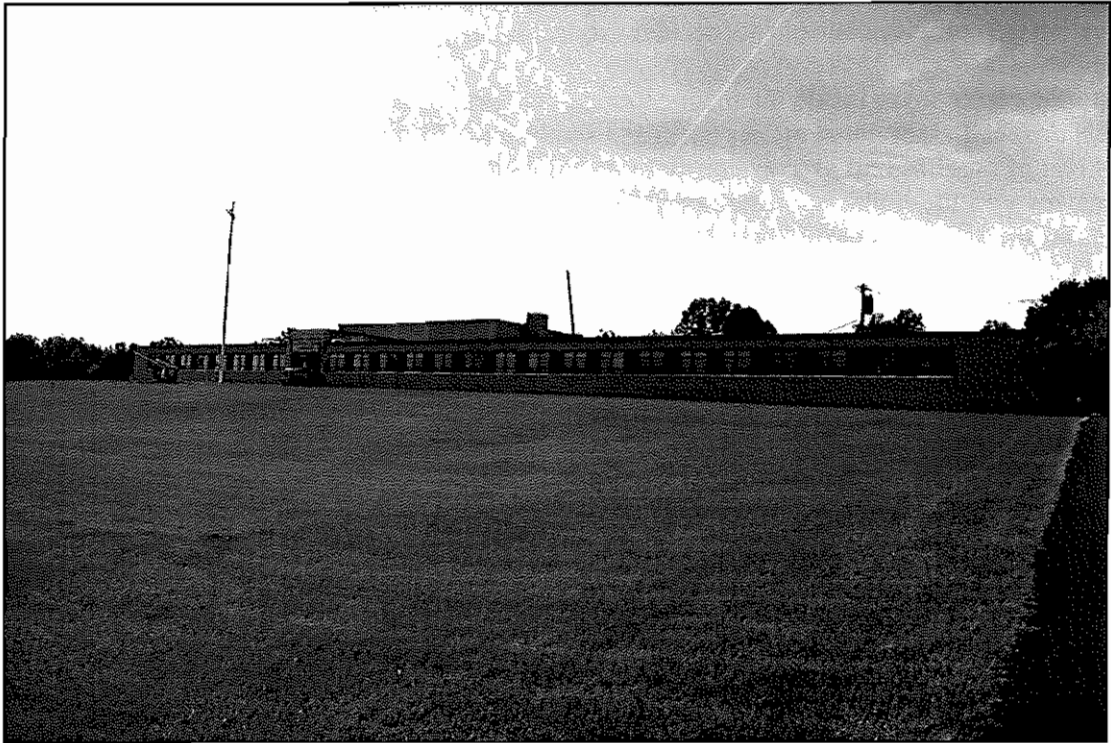
PLATE 9: Greensboro National Guard Armory

Architectural Description: The Greensboro National Guard Armory was constructed in 1961 as an “original design” rather than according to one of the standard armory design templates. The building follows the general pattern typical of armories of its time, containing a high-bay drill hall fronted by a smaller administrative section or head house and flanked by wings forming a U-shape around the drill hall (Plate 9). The concrete-block building has red brick facing laid in a five-course Flemish bond and flat roofs. The administrative section at the front (east elevation) of the building contains the recessed main entrance. Here full-glass double-leaf doors are set behind a small concrete slab patio. The entrance bay stands slightly taller than the wings on either side of it and has a simple concrete surround. Metal lettering above the entrance reads “North Carolina National Guard Armory.” The entire 26-bay façade features paired four-light metal awning windows. The concrete windowsill is continuous along both sections of the façade and newer brick in between each of the paired awning window units suggest that there might originally have been continuous banks of windows.

National Register Evaluation: The Greensboro Armory is not eligible for listing in the National Register. Completed in 1961, the armory does not meet the minimum age requirement of 50 years of age or more. In addition, it does not possess the exceptional importance required for eligibility under Criteria Consideration G, regarding properties that have achieved significance within the past 50 years. This study has found no evidence that this armory is associated with important events (Criterion A) or people (Criterion B) in the history of Greensboro, North Carolina, or the United States. The Greensboro Armory is an example of an original-design armory. It shares much in common with the standard armories of the period and is not eligible under Criterion C as an important example of its type. The site does not appear to have the potential to yield important information that would contribute to the understanding of prehistory or history and therefore does not meet Criterion D. It is therefore unlikely that the armory will be eligible for the National Register after it has reached the age requirement of 50 years.

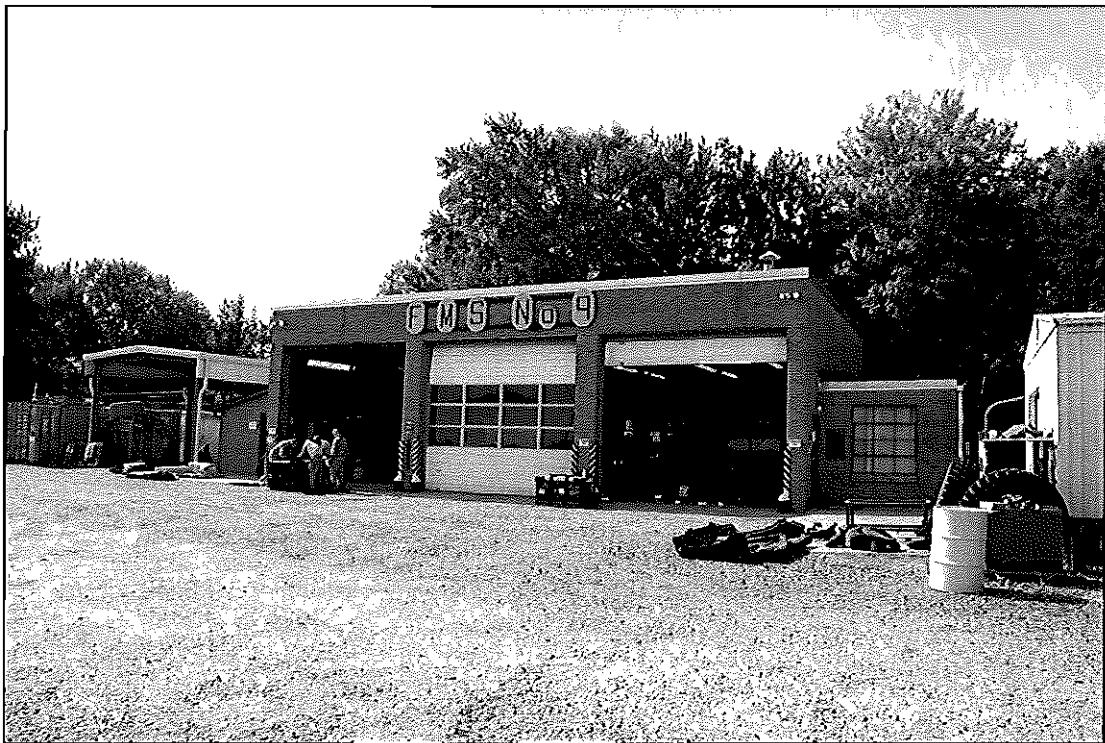
PLATE 10: FMS No. 9, Greensboro

Historical Background: F.M.S. No. 9 was financed with federal funds and was completed in December 1960, prior to construction of the armory. The 35x60-foot shop building included "three working bays, a battery room and office (*Greensboro Record* 1960b).

National Register Evaluation: FMS No. 9 is not eligible for listing in the National Register. This study has found no evidence that this building is associated with important events (Criterion A) or people (Criterion B) in the history of Greensboro, North Carolina, or the United States. FMS No. 9 is an example of a standard three-bay FMS. It shares much in common with the standard buildings of the period and is not eligible under Criterion C as an important example of its type. The site does not appear to have the potential to yield important information that would contribute to the understanding of prehistory or history and therefore does not meet Criterion D.

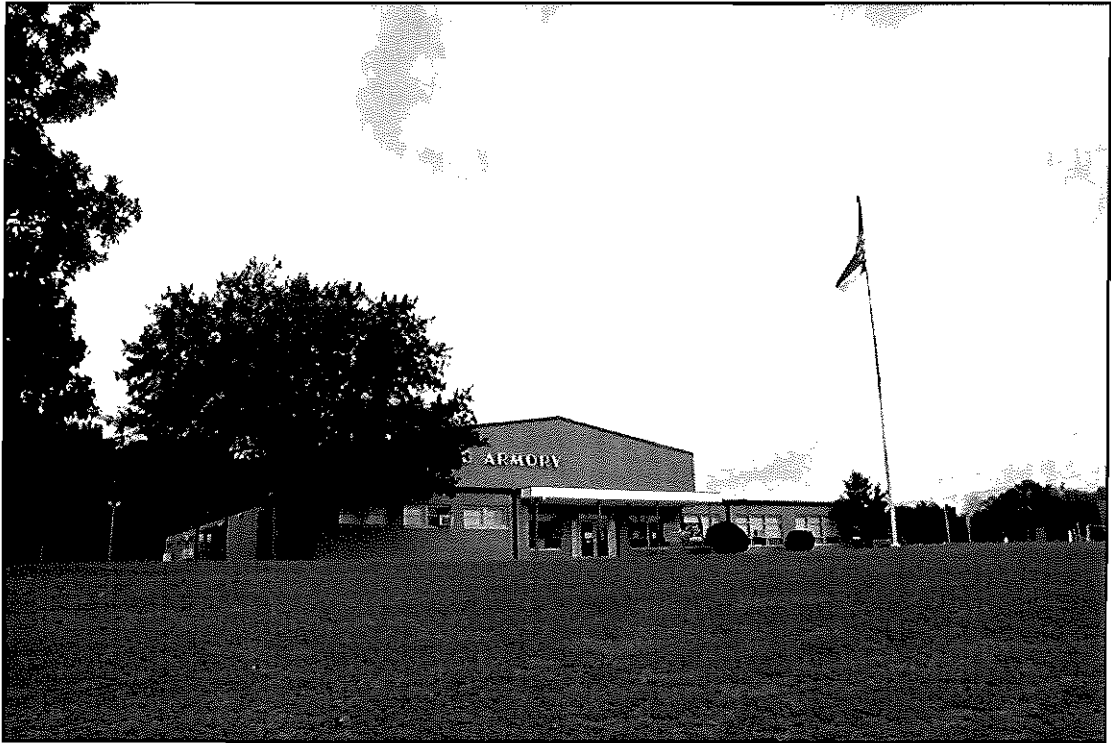
PLATE 11: Hamlet National Guard Armory

Architectural Description: The Hamlet Armory was built in 1963 as a Type B armory (Plate 11). The armory sits on a solid concrete foundation and is constructed of steel framing and concrete block masked in a five-course Flemish-bond brick veneer. The building consists of a central high-bay drill hall that is surrounded on all of its elevations except the northwest (rear) by one-story wings. The drill hall has a shallow-pitched front gable roof, and the wings are capped with flat roofs.

The rear (west) elevation of the building is divided into three sections. The south section is part of the one-story wing that lines the south side of the drill hall and is not fenestrated on its west elevation. The center section consists of the drill hall, which is pierced by a full-height metal roll-up door that is flanked by two double-leaf metal doors. The north section, the one-story wing

National Register Evaluation: The Hamlet Armory is not eligible for listing in the National Register. Constructed in 1961, the armory does not meet the National Register requirement of 50 years of age or more. In addition, the building does not possess sufficient significance in regard to historic events, architecture, or important persons to warrant National Register eligibility under Criteria Consideration G: Properties That Have Achieved Significance Within the Past Fifty Years. This study has found no evidence that this armory is associated with important events (Criterion A) or people (Criterion B) in the history of Hamlet, North Carolina, or the United States. The Hamlet Armory is a late example of a Type B armory and is therefore not eligible under Criterion C as an important example of this architectural type. The site does not

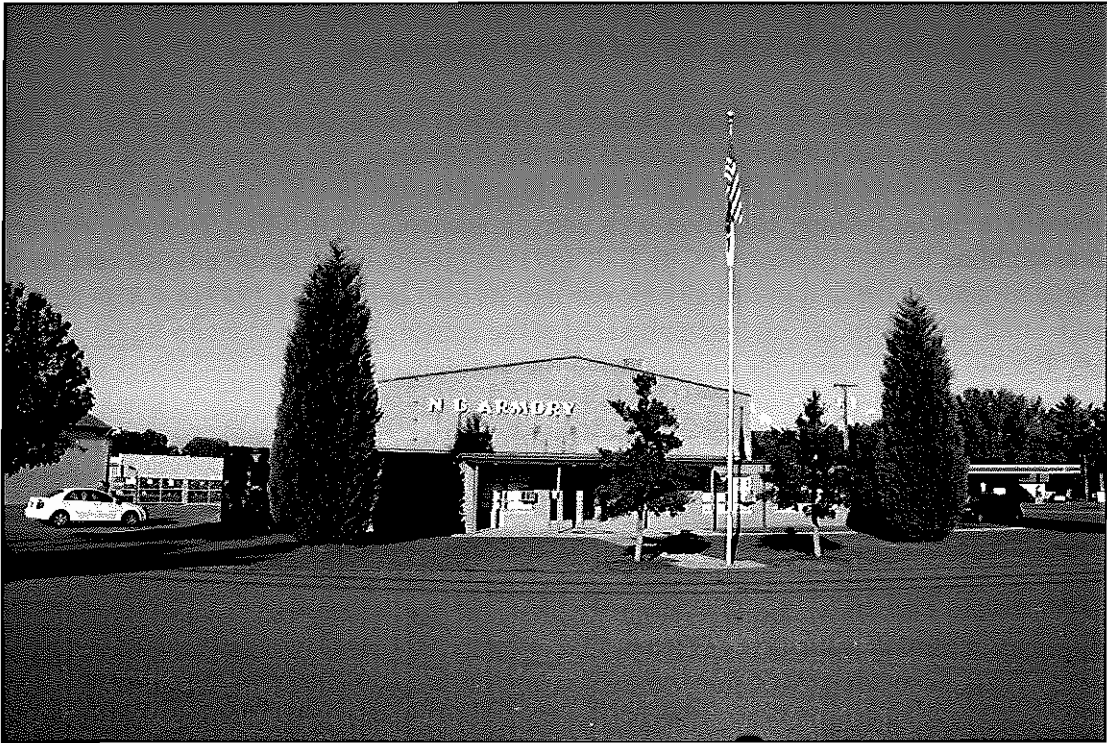
PLATE 12: Kings Mountain National Guard Armory

From the center foyer inside the main entrance double-leaf one-light metal doors lead to the drill hall. Individual offices north and south of the foyer are accessible by metal doors at the east end

National Register Evaluation: The Kings Mountain Armory is not eligible for listing in the National Register. Completed in 1962, the armory does not meet the minimum age requirement of 50 years of age or more. In addition, it does not possess the exceptional importance required for eligibility under Criteria Consideration G, regarding properties that have achieved significance within the past 50 years. This study has found no evidence that this armory is associated with important events (Criterion A) or people (Criterion B) in the history of Kings Mountain, North Carolina, or the United States. The Kings Mountain Armory is a late example of a standard Type B armory and is therefore not eligible under Criterion C as an important example of this architectural type. The site does not appear to have the potential to yield important information that would contribute to the understanding of prehistory or history and therefore does not meet Criterion D. It is therefore unlikely that the armory will be eligible for the National Register after it has reached the age requirement of 50 years.

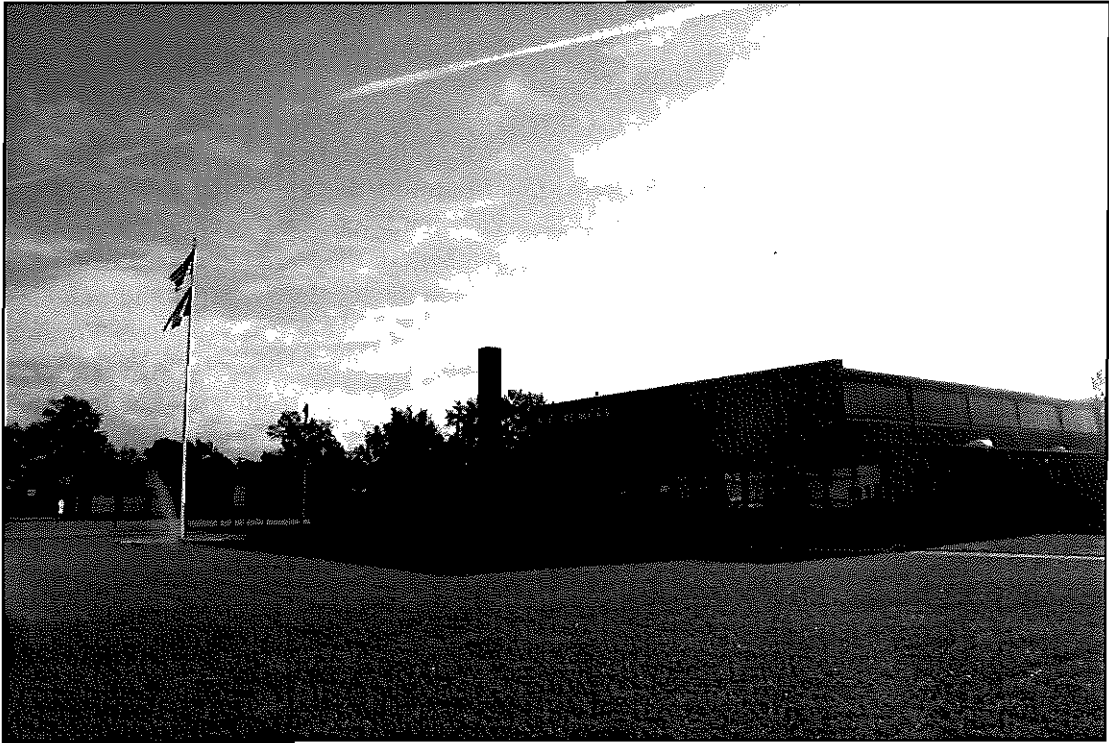
PLATE 13: Laurinburg National Guard Armory

Architectural Description: The Laurinburg Armory was built in 1961 as a B-Coffey & Olson type armory that was slightly modified to enlarge the kitchen (Plate 13). The armory sits on a solid concrete foundation and is constructed of steel framing and concrete block masked in a five-course Flemish-bond brick veneer. The building consists of a central high-bay drill hall that is surrounded on all of its elevations except the southeast (rear) by one-story wings. The drill hall and wings are capped with flat roofs with metal coping.

The rear (east) elevation of the building is divided into three sections. The north section, which consists of the one-story wing on the north side of the building, extends one-bay east from the drill hall and is not fenestrated. The center section, consisting of the drill hall, has a full-height metal roll-up door flanked by two double-leaf doors. The south section, the one-story wing on the south side of the building, extends one-bay east of the drill hall. It has a metal roll-up door and four multi-light metal-sash windows on its east elevation.

National Register Evaluation: The Laurinburg Armory is not eligible for listing in the National Register. Constructed in 1961, the armory does not meet the National Register requirement of 50 years of age or more. In addition, the building does not possess significance in regard to historic events, architecture, or important persons to warrant National Register eligibility under Criteria Consideration G: Properties That Have Achieved Significance Within the Past Fifty Years. This study has found no evidence that this armory is associated with important events (Criterion A) or people (Criterion B) in the history of Laurinburg, North Carolina, or the United States. The Laurinburg Armory is a late example of a B-Coffey & Olsen armory and is therefore not eligible under Criterion C as an important example of this architectural type. The site does not appear to have the potential to yield important information that would contribute to the understanding of prehistory or history and therefore does not meet Criterion D. It is therefore unlikely that the Laurinburg Armory will be eligible for the National Register after it has reached the age requirement of 50 years.

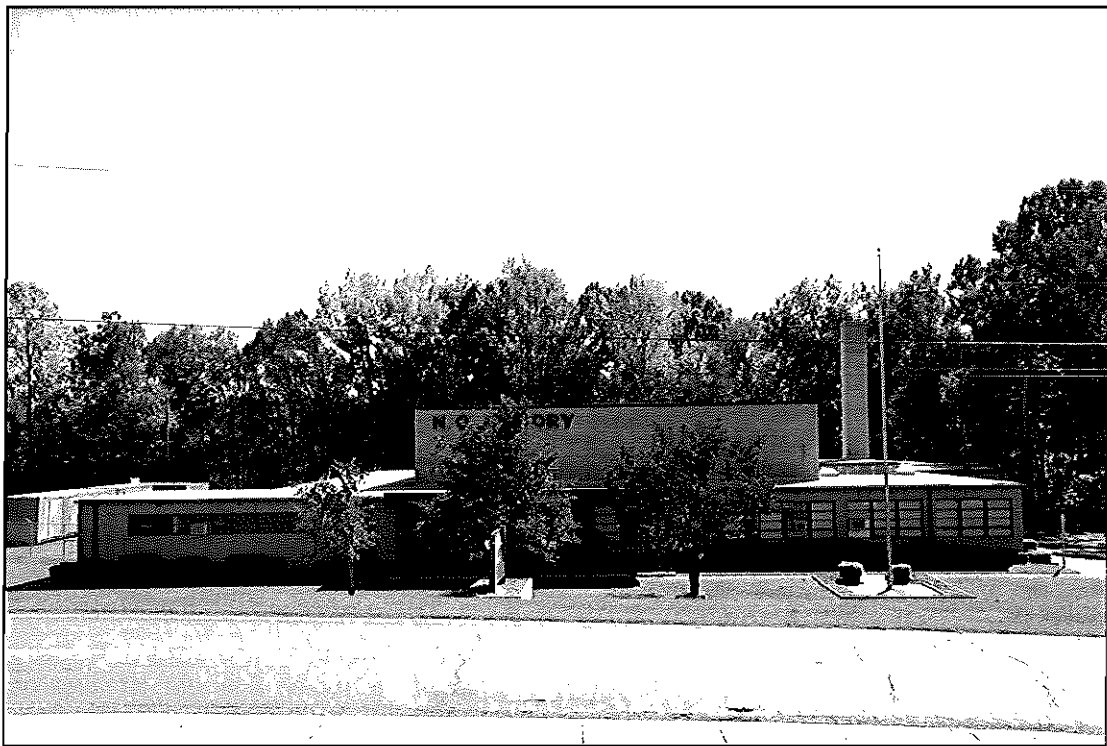
PLATE 14: Lincoln National Guard Armory

The double-height drill hall is located behind the administrative section. It stands approximately twice as high as the administrative section, with clerestory windows set high on the side walls. The unfenestrated second story of the main (west) elevation of the drill hall is adorned with metal lettering reading "N.G. ARMORY." The clerestory windows consist of five sets of nine vertical one-light metal-sash awning windows.

National Register Evaluation: The Lincolnton Armory is not eligible for listing in the National Register. Completed in 1961, the armory does not meet the minimum age requirement of 50 years of age or more. In addition, it does not possess the exceptional importance required for eligibility under Criteria Consideration G, regarding properties that have achieved significance within the past 50 years. This study has found no evidence that this armory is associated with important events (Criterion A) or people (Criterion B) in the history of Lincolnton, North Carolina, or the United States. The Lincolnton Armory is a late example of a standard Alt-A armory and is therefore not eligible under Criterion C as an important example of this architectural type. The site does not appear to have the potential to yield important information that would contribute to the understanding of prehistory or history and therefore does not meet Criterion D. It is therefore unlikely that the armory will be eligible for the National Register after it has reached the age requirement of 50 years.

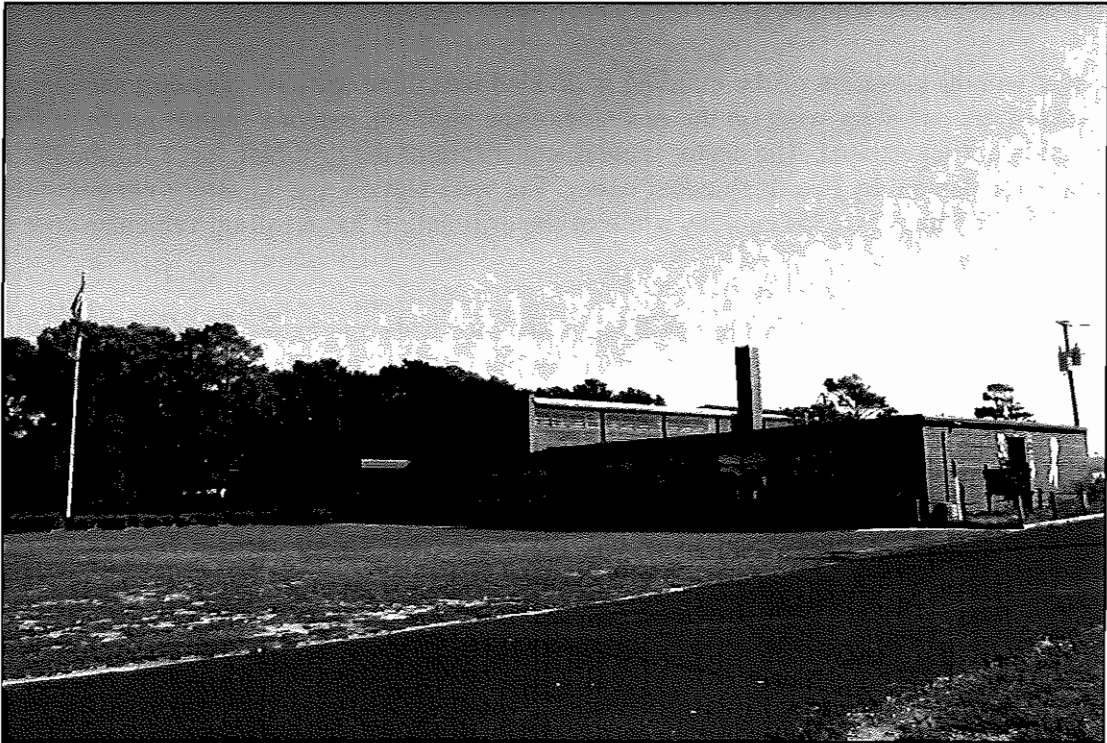
PLATE 15: Morehead City National Guard Armory

Architectural Description: The Morehead City Armory was built in 1963 as a standard Type B armory and has a subsequently constructed one-story addition on the west side of the primary (north) elevation (Plate 15). The armory sits on a solid poured-concrete foundation and is constructed of steel framing and concrete-block masked in a five-course Flemish-bond brick veneer. The addition has an identical brick veneer as the main block. The building consists of a central high-bay drill hall with a low-pitched front gable roof that is surrounded on all of its elevations except the north (rear) by one-story flat-roofed wings.

The one-story main (north) elevation of the building extends east and west of the south elevation of the drill hall. Originally the north elevation was nine bays wide; however, a one-story four-bay-wide addition is attached to the west side. The north elevation contains the main entrance to the building, which is offset and consists of a double-leaf metal door with one-light transom windows and sidelights. It is flanked by paired three-light metal-sash awning windows. A one-story three-bay porch with a flat roof shelters the main entrance and is supported by round metal

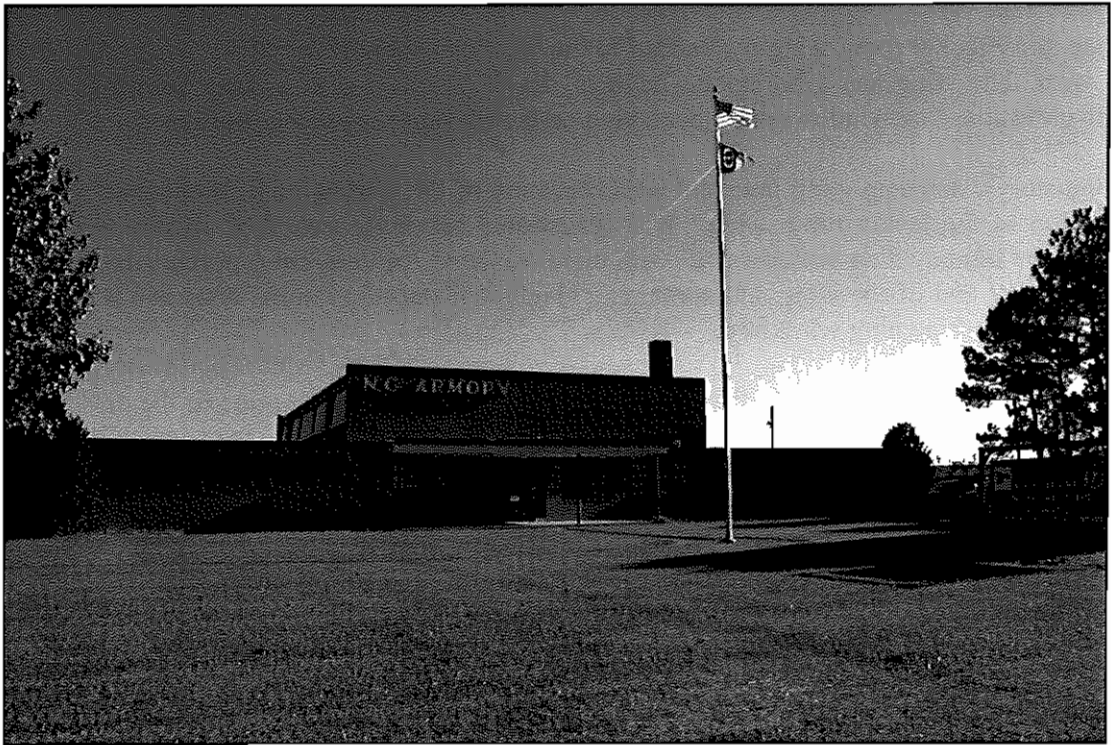
PLATE 16: Mount Olive National Guard Armory

Architectural Description: The Mount Olive Armory was built in 1961 as a standard Alt-A plan armory (Plate 16). The armory sits on a solid poured-concrete foundation and is constructed of concrete block masked in a five-course Flemish-bond brick veneer. It has a flat roof with metal coping. The building consists of a central two-story drill hall that is surrounded on all of its elevations except the north (rear) by one-story wings. Clerestory ribbon windows line the drill

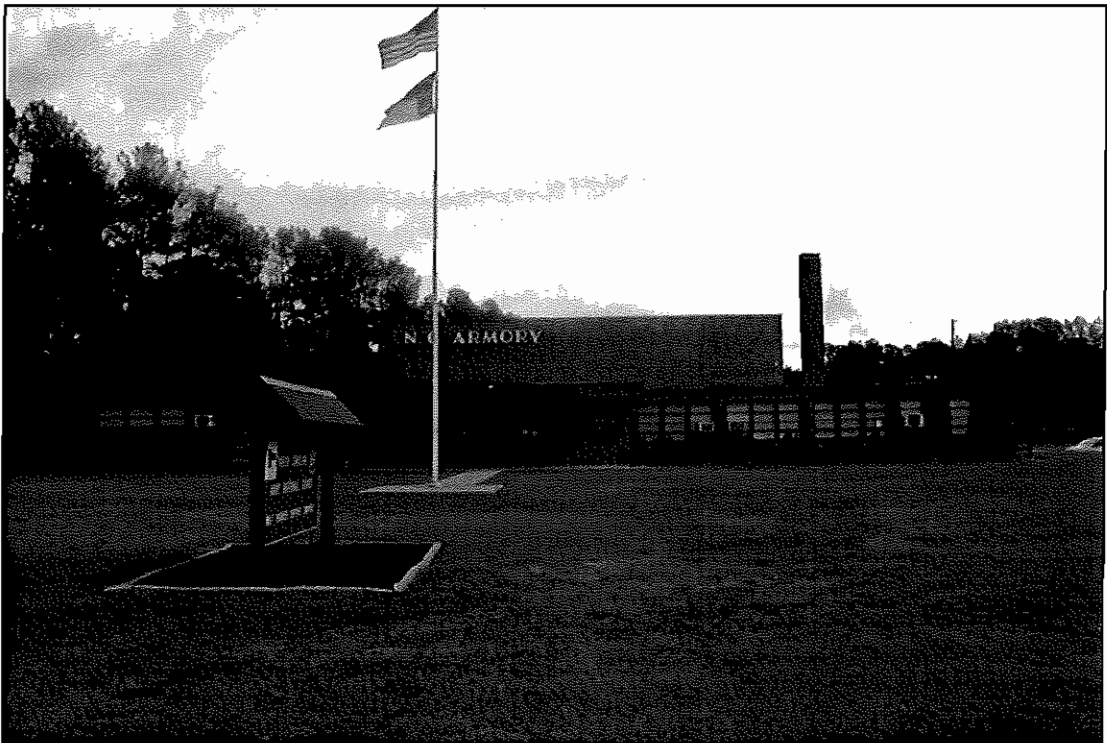
PLATE 17: Rockingham National Guard Armory

The one-story south elevation of the building is six bays wide and extends east and west of the five-bay south elevation of the drill hall. The west section of the elevation is pierced by an inset single-leaf door, two paired two-light metal-sash awning windows, and an inset porch that holds
