RE: Historic Building Survey of NC Army National Guard Armories, Multi County, ER09-0905

The survey project expanded in 2008-2009 to include 31 Cold War era buildings built in the late 1950s and 1960s, specifically 26 armories, two field maintenance shops, and three non-armory buildings that are part of the Claude T. Bowers Military Center in Raleigh. The first phase of the project included the survey and evaluation of three armories and four buildings of the Claude T. Bowers Military Center in Raleigh: the Joint Force Headquarters building, the United States Property and Fiscal Office building, the Combined Support Maintenance Shop, and Field Maintenance Shop (FMS) No. 20 (Figure 1). This phase was completed by Berger cultural resource staff; historical research and field surveys were undertaken in October 2008. Berger completed the second phase including the survey of 23 armories and FMS No. 9 in October 2009.

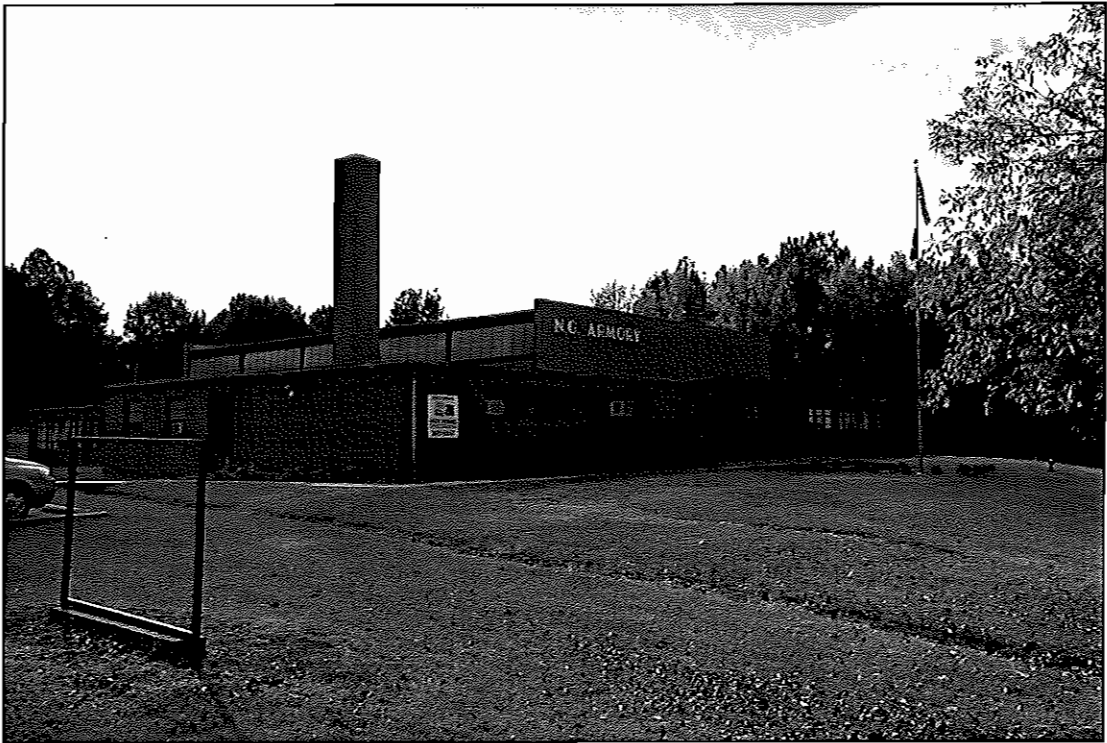
PLATE 18: Roxboro National Guard Armory

The interior consists of various rooms and corridors arranged around the large open space of the drill hall, which is a large multipurpose room with gymnasium-type flooring. The metal roof beams are exposed. A metal overhead door located on the center of the east (rear) elevation of the building allows vehicle access into the drill hall. A set of double-leaf metal doors located at each end of the elevation also provides outside access into the drill hall.

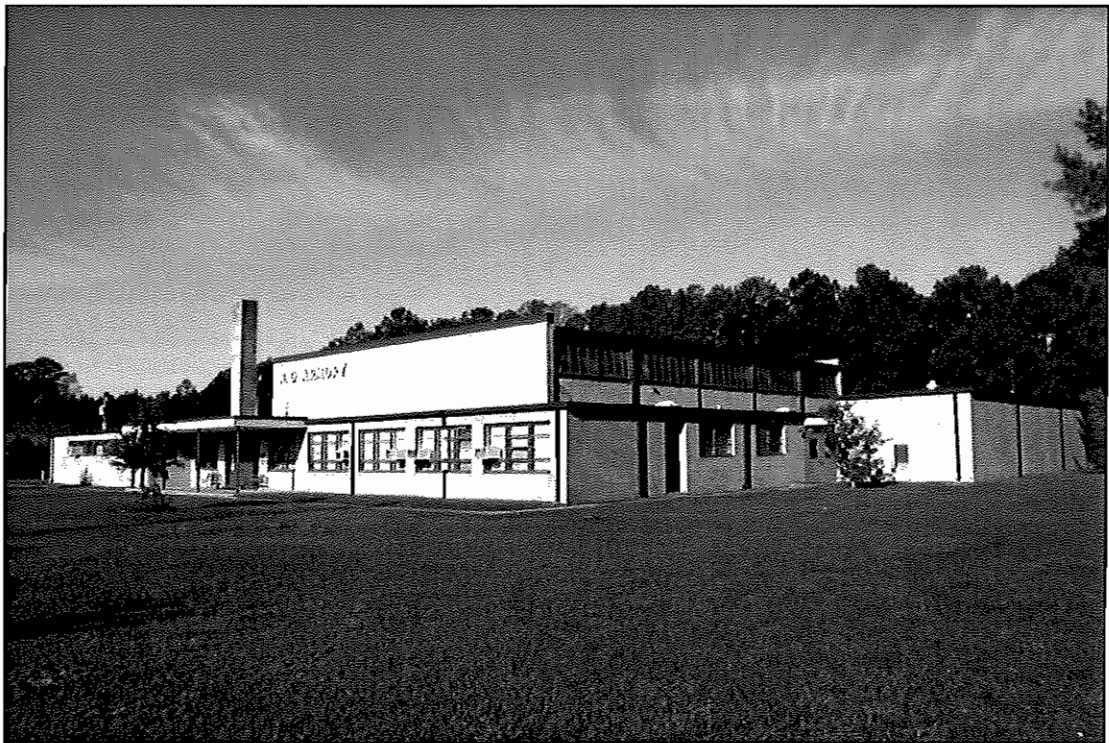
PLATE 19: Shallotte National Guard Armory

The one-story main (south) elevation of the building is 10 bays wide and extends east and west of the drill hall. The main entrance is offset on the south elevation and consists of a double-leaf metal door with one-light transom windows and sidelights. It is flanked by paired three-light metal-sash awning windows. A one-story three-bay porch with a flat roof shelters the main entrance and is supported by round metal posts. The one-story western section of the main elevation projects from the building and creates a wall along the west end of the porch. It is pierced by a horizontal band of two-light metal-sash replacement windows across its south elevation. The windows are placed high on the elevation, near the roofline. The one-story eastern section of the south elevation features triple four-light metal-sash awning windows. The upper portion of the main (south) elevation of the drill hall is adorned with metal lettering reading "NG ARMORY."

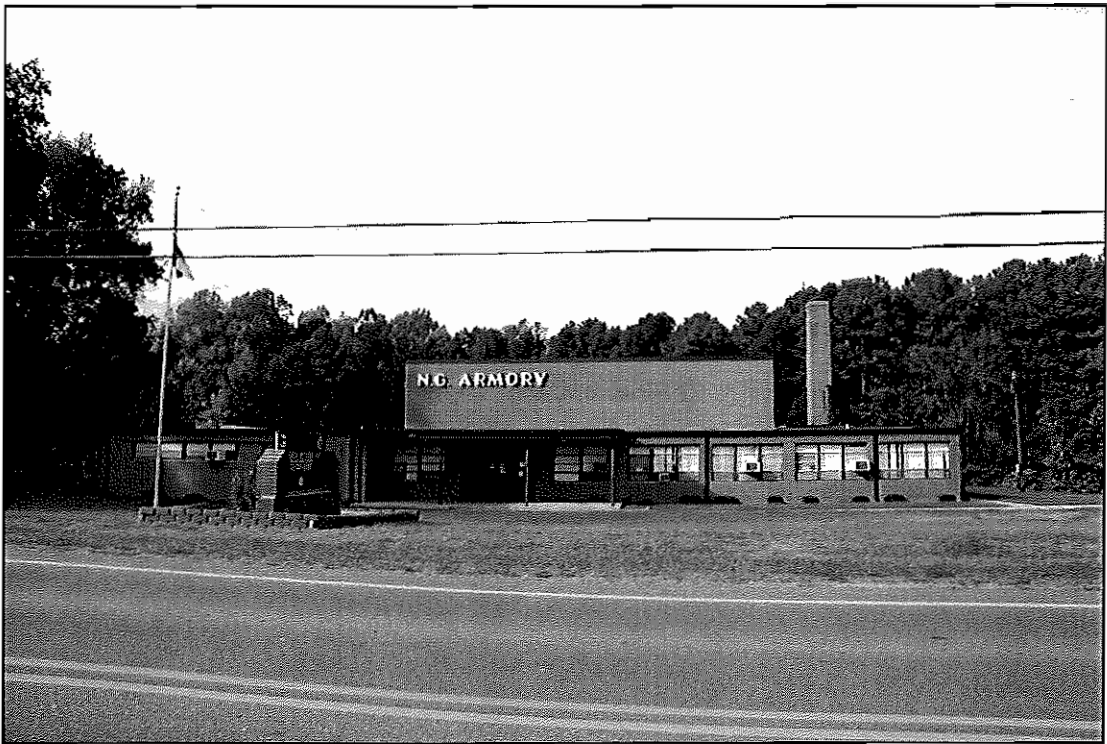
PLATE 20: Siler City National Guard Armory

A one-story office wing fronts the main (south) elevation of the drill hall east of the main entrance. This entrance consists of a double-leaf metal door with one-light transom windows and sidelights. The doors are flanked by paired four-light metal-sash awning windows. A flat-roofed three-bay porch supported by rounded metal posts shelters the main entrance. The remainder of the office wing's main elevation is pierced by triple four-light metal-sash awning windows.

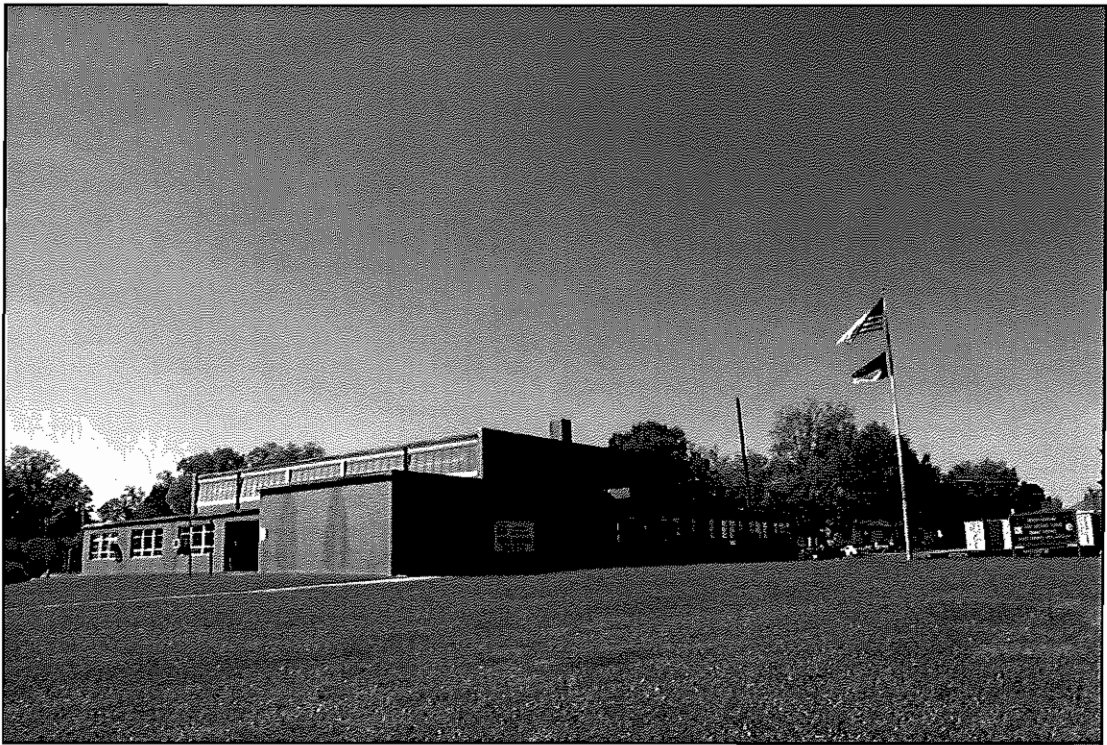
PLATE 21: Smithfield National Guard Armory

Architectural Description: The Smithfield Armory was built in 1961 as an Alt-A standard plan armory (Plate 21). The Smithfield Armory sits on a solid poured-concrete foundation and is constructed of concrete block masked in a five-course Flemish-bond brick veneer. It has a flat roof with metal coping. The building consists of a central two-story drill hall that is surrounded on all of its elevations except the south (rear) by one-story wings. Clerestory ribbon windows line the east and west elevations of the drill hall. The clerestory windows consist of five sets of nine vertical one-light metal-sash awning windows. The unfenestrated second story of the main (north) elevation of the drill hall is adorned with metal lettering reading "NG ARMORY." The rear elevation of the drill hall is pierced by a full-height vehicular metal roll-up door flanked by two double-leaf metal doors.

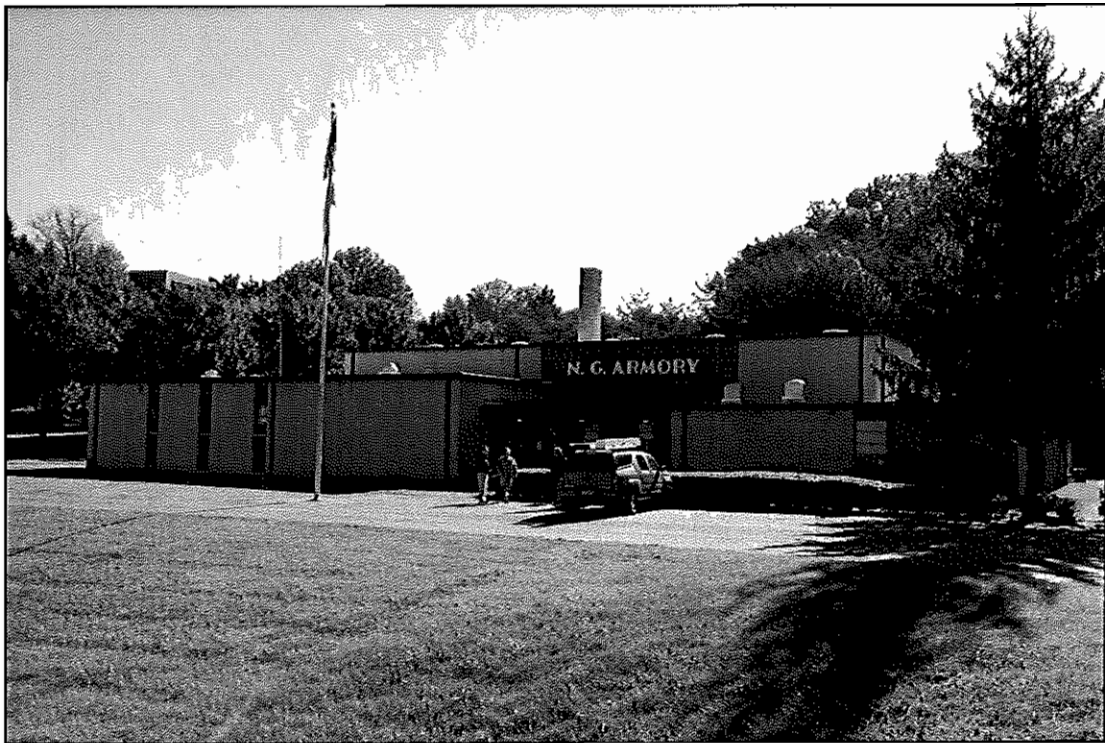
PLATE 22: Sylva National Guard Armory

Architectural Description: The Sylva National Guard Armory was built in 1964-1965 as a "Type A" armory (Plate 22). It sits on a solid poured-concrete foundation and is constructed of concrete block masked in a five-course Flemish-bond veneer of buff-colored brick. It has a flat roof with metal coping. The building consists of a central double-height drill hall that is surrounded on all of its elevations except the north by one-story wings. Rather than the typical clerestory windows, the drill hall features skylights in the roof—two to three between each main girder supporting the roof. The unfenestrated second story of the main (west) elevation of the

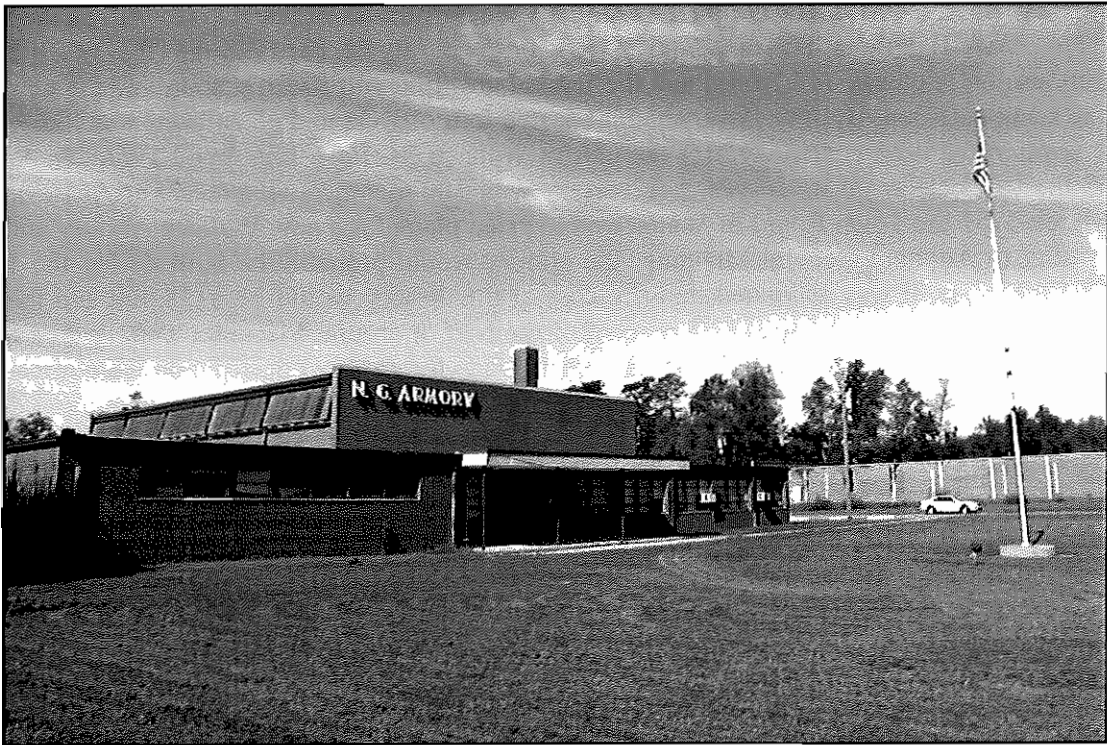
PLATE 23: Wallace National Guard Armory

The one-story north elevation of the building is six bays wide and extends east and west of the five-bay north elevation of the drill hall. The east section of the elevation is pierced by a single-leaf door and two paired two-light metal-sash awning windows and an inset porch that holds a single-leaf metal door and a two-light metal-sash awning window. The west section of the

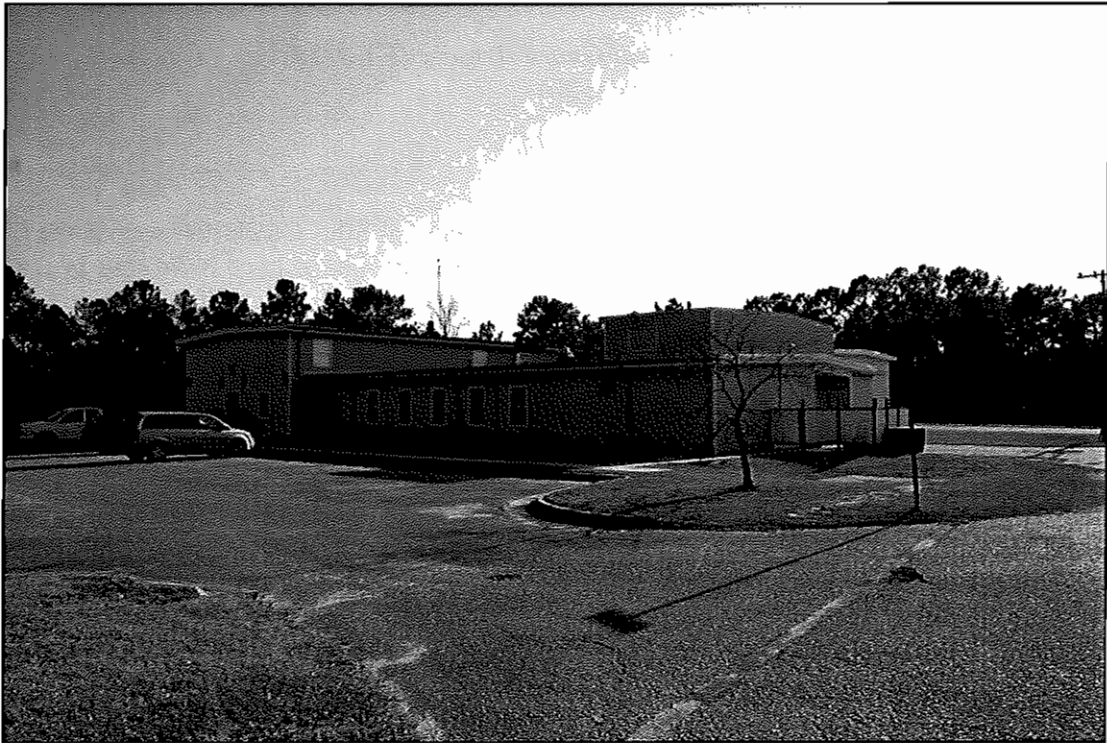
PLATE 25: Wilmington (Infantry Road) National Guard Armory

The Infantry Road Armory is organized around a rear two-story office wing that runs the full length of the building. Two projecting one-story wings extend to the west from the office wing, forming a roughly U-shaped building (Plate 25). The northern wing contains the kitchen and dining hall, and the southern wing (which used to be a fire station) contains a gym. The former fire station occupies the southwest corner of the building and is notable for its exposed concrete-block construction and wire-joint roof construction. It features a metal roll-up door on its west elevation, facing Infantry Road. The large brick chimney stack for the boiler room is located at the northeast corner of the building.

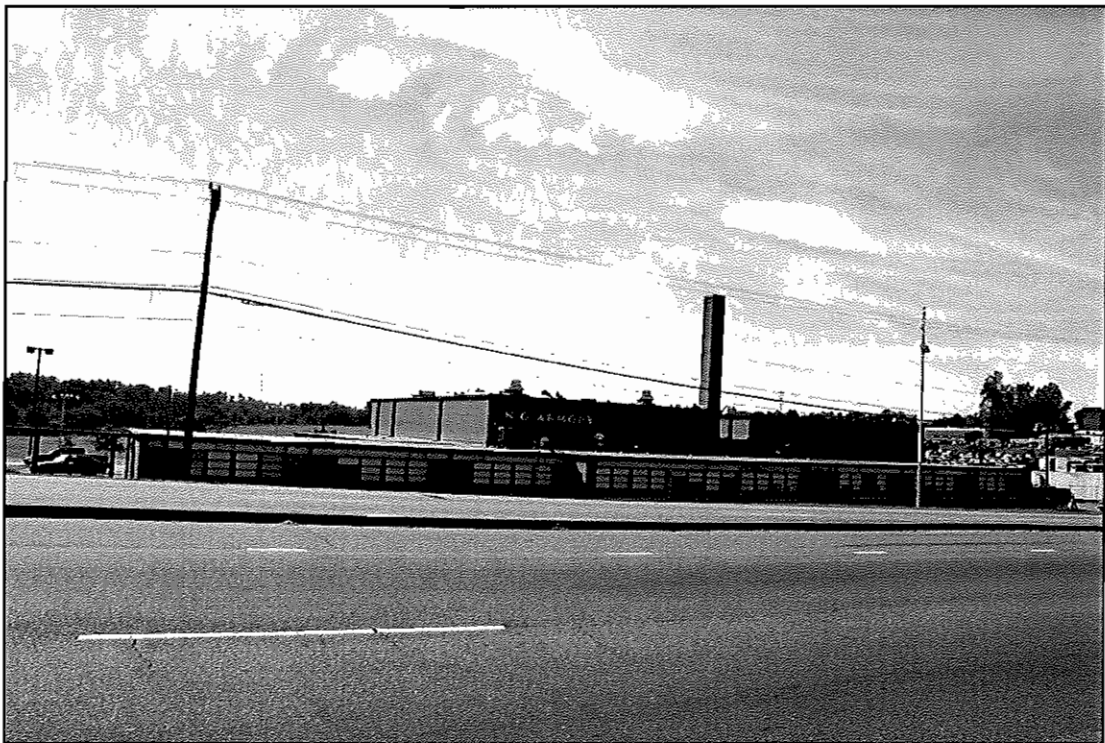
PLATE 26: Winston Salem National Guard Armory

Architectural Description: The Winston-Salem National Guard Armory was constructed in 1961 according to an original design rather than one of the standard armory design templates. The layout of the building has much in common with standard armories of its time, containing a high-bay drill hall fronted by a smaller administrative section or head house with side wings off of the drill hall (Plate 26). The concrete-block building has brick facing laid in a stretcher bond and flat roofs. The administrative section at the front (north elevation) of the building contains the main entrance. Here, recessed double-leaf metal-frame full-glass doors with transom windows are set behind a concrete slab. The 10-bay administrative section features four-light metal awning windows in banks of four.

The double-height drill hall is located behind the administrative section. It stands approximately twice as high as the administrative section, and is windowless except for skylights in the roof. The second story of the main (north) elevation of the drill hall is adorned with metal lettering reading "N.G. ARMORY."

A two-story office and classroom wing is located to the west of the drill hall and runs the full length of the west elevation, which contains four single-leaf metal doors at the ground level but no windows. This two-story section has paired four-light metal awning windows on the north and south elevations. A one-story section that contains the boiler room and also housed the original rifle range separates this two-story wing from the drill hall.

A one story wing extends east of the drill hall. This section contains supply rooms and the vaults. Windows in this wing consist of three eighteen-light metal units, all on the east elevation.

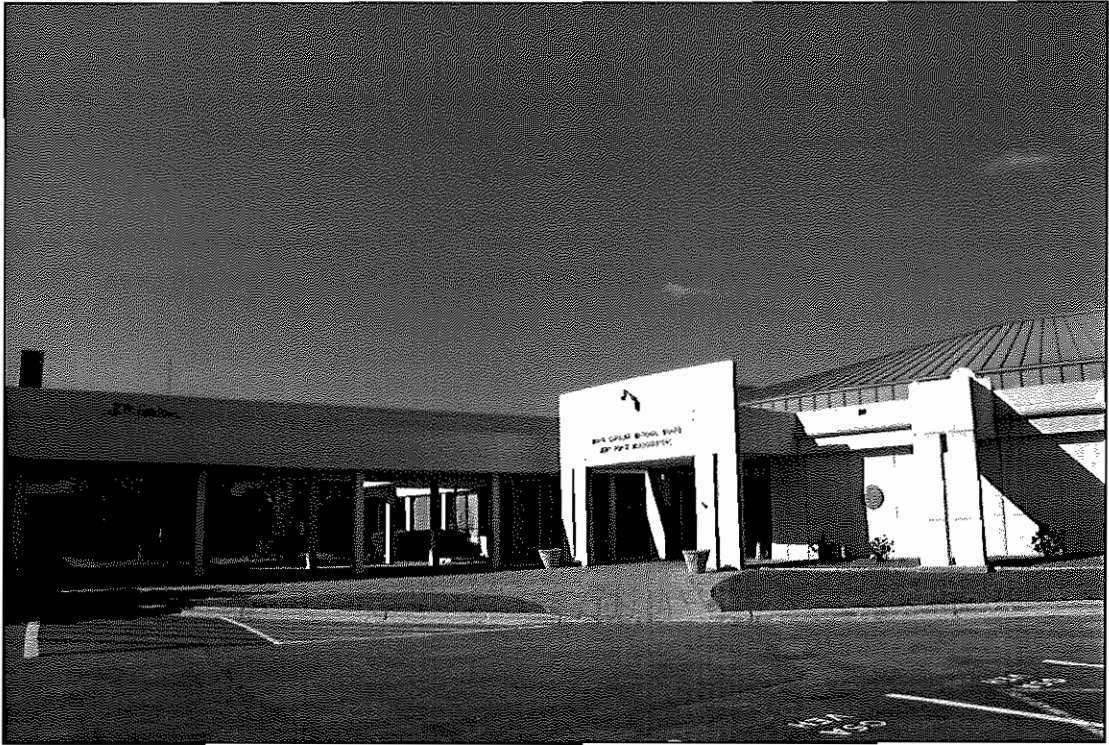
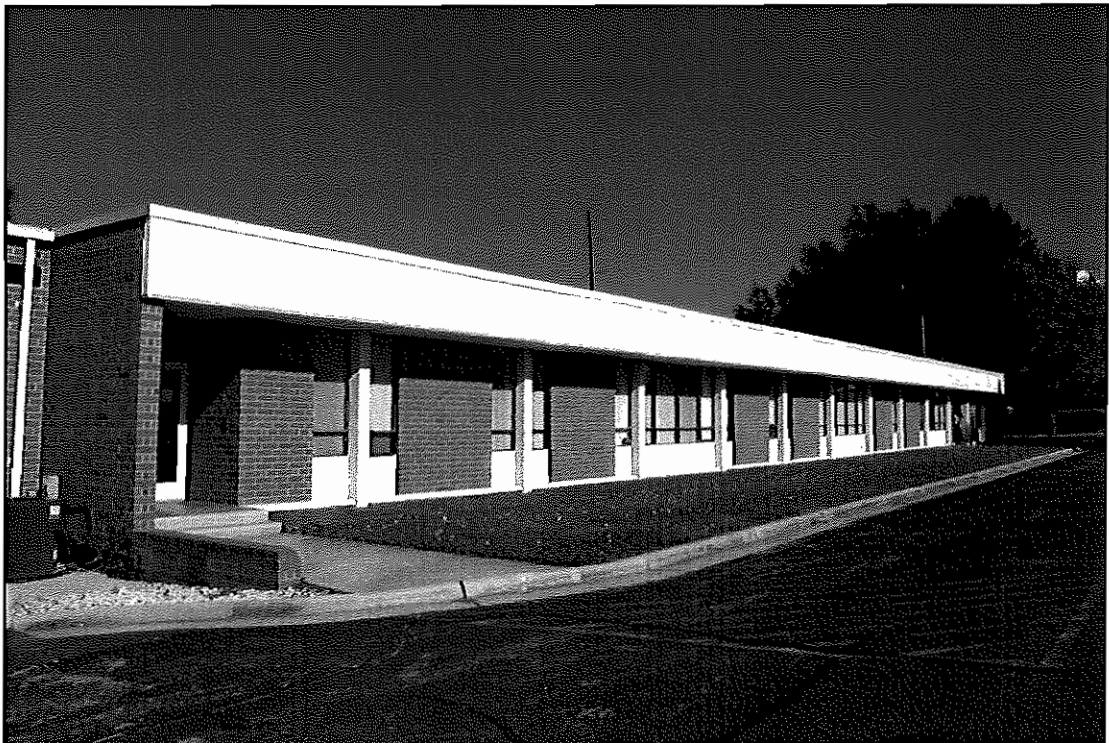
PLATE 28: Claude T. Bowers Military Center, JFHQ

Architectural Description: The Joint Force Headquarters (JFHQ) is a one-story building displaying a predominantly rectangular plan with three original projecting bays and one circa 1990 wing (Plates 28 and 29). The rectangular plan is pierced by two open courtyards along the east side of the building and a courtyard at the main entrance near the northwest corner of the building. A bay extends west on the building's west elevation near the northwest corner. Two separate bays extend south from the building's south elevation, one near the building's southeast corner and another on the building's southwest corner. A curved wing, built circa 1990, is attached to the north elevation of the building near its northwest corner and curves north and west.

The 1964 building sits on a solid poured-concrete foundation and its walls are constructed of concrete block. A flat roof spans the entire building. The building has one story with a two-story drill hall and office wing that is located near the center of the building along its west elevation. The courtyard on the northwest corner leads to the main entrance, which is located in the two-story office wing that fronts the drill hall. The projecting bay on the west elevation is exposed on the basement level because of the lot's slope, giving it a two-story appearance.

Common of federal buildings built in the post-World War II era, the Modernist design of the headquarters building emphasizes the building's horizontal nature and expresses the building's structural system on its exterior. The flat roof of the front (north) section of the building is accentuated by a heavy, flat cornice that projects from the building. The elevations have a rhythmic grid-like pattern created by symmetrically placed, squared concrete posts intersected by a horizontal concrete ledge that lines the foundation. The curtain walls, set between the posts and the ledge, are faced in five-course Flemish-bond brick and are pierced by vertical one-light

metal-sash windows with one-light metal-sash awning windows in the lower sash. Below the windows extending to the concrete ledge are concrete panels.

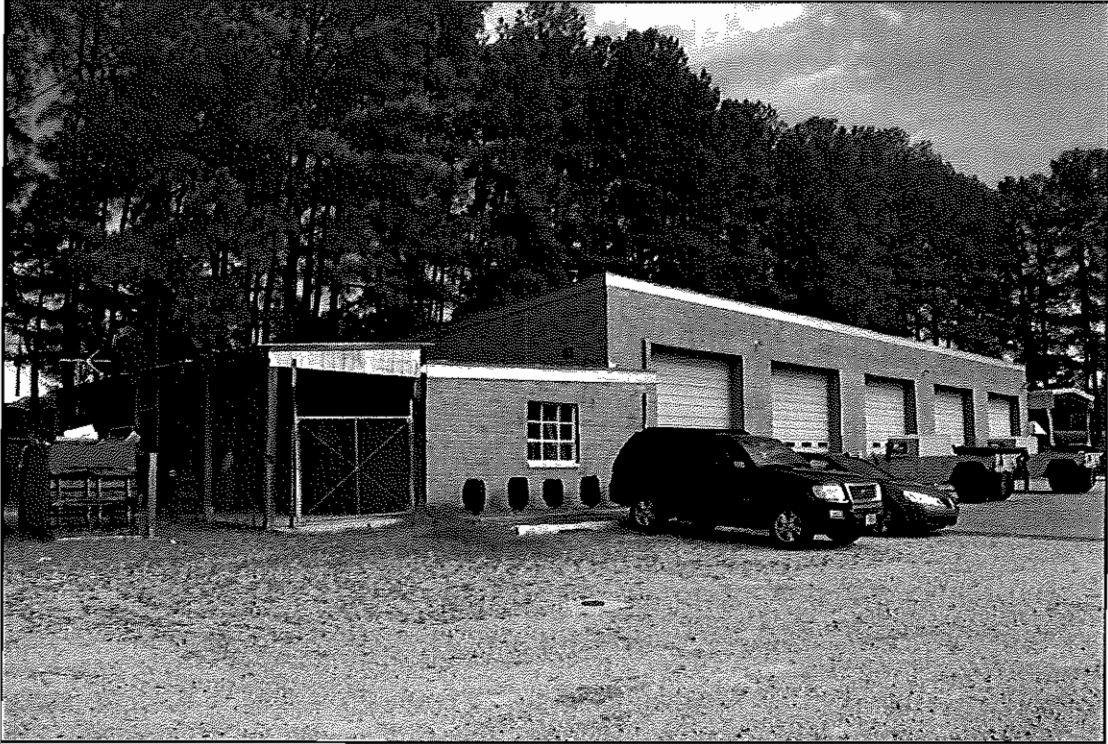
PLATE 30: Claude T. Bowers Military Center, FMS No. 20

Architectural Description: Built in 1972, the Field Maintenance Shop (FMS) No. 20 building has a rectangular form and is one and a half stories high (Plate 30). It sits on a solid poured-concrete foundation and its exterior walls are concrete block with a stretcher-bond brick veneer. A shed roof caps the building and is lined with metal coping. Five full-height vehicular bays pierce the south elevation of the building and hold metal roll-up vehicular doors. A single-leaf one-light metal door is located on the east elevation. Twelve-light metal-sash windows with concrete sills fenestrate the north elevation of FMS No. 20. A one-story shed bay lines the west elevation of the building. This concrete-block bay is clad in stretcher-bond brick and its south elevation has a nine-light metal-sash window with a concrete sill. A wood-frame open shed bay is attached to the west elevation of the brick-faced shed bay.

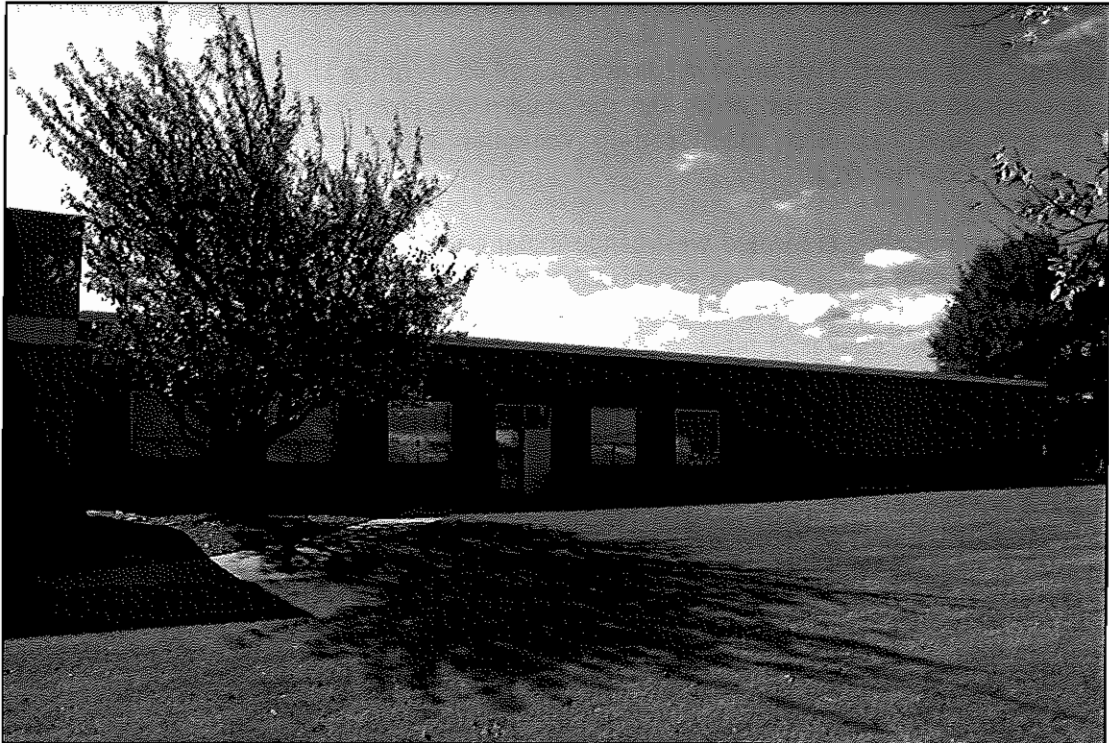
PLATE 31: Claude T. Bowers Military Center, USPFO

Architectural Description: The United States Property and Fiscal Office (USPFO) building was constructed in 1961 and was the first building constructed on the site (Plate 31). The original 1961 building consists of a one-story rectangular main block and a one-story wing that is attached to the east elevation. A one-story wing was added to the southern end of the west elevation of the main block circa 1965. An additional wing was constructed circa 1995 on the north and east elevations of the one-story wing.

The 1961 main block is constructed of concrete block with its exterior walls veneered in five-course Flemish-bond brick. The roof is flat with metal coping. The main (north) elevation holds the main entrance to the building, which is a single-leaf metal door that is offset toward its east end. The door has a one-light transom and three one-light sidelights on the door's east side. Two tripartite metal-sash windows are located to the west of the door and three tripartite one-light metal-sash windows are located to the east of the door. Metal lettering above the entrance and windows reads "USP AND FO FOR NORTH CAROLINA." The east elevation of the building is pierced with evenly spaced three-light metal-sash awning windows with concrete sills. The south elevation is fenestrated by a roll-up metal vehicular door and three-light metal-sash awning windows. A raised loading dock fronts the vehicular door on the south elevation and is sheltered by a flat-roofed awning supported by metal posts. The west elevation has a roll-up metal vehicular door, three-light metal-sash awning windows, and a double-leaf metal door.

All of the windows on the east, south, and west elevations of the main block have concrete sills and have been covered with metal grates.

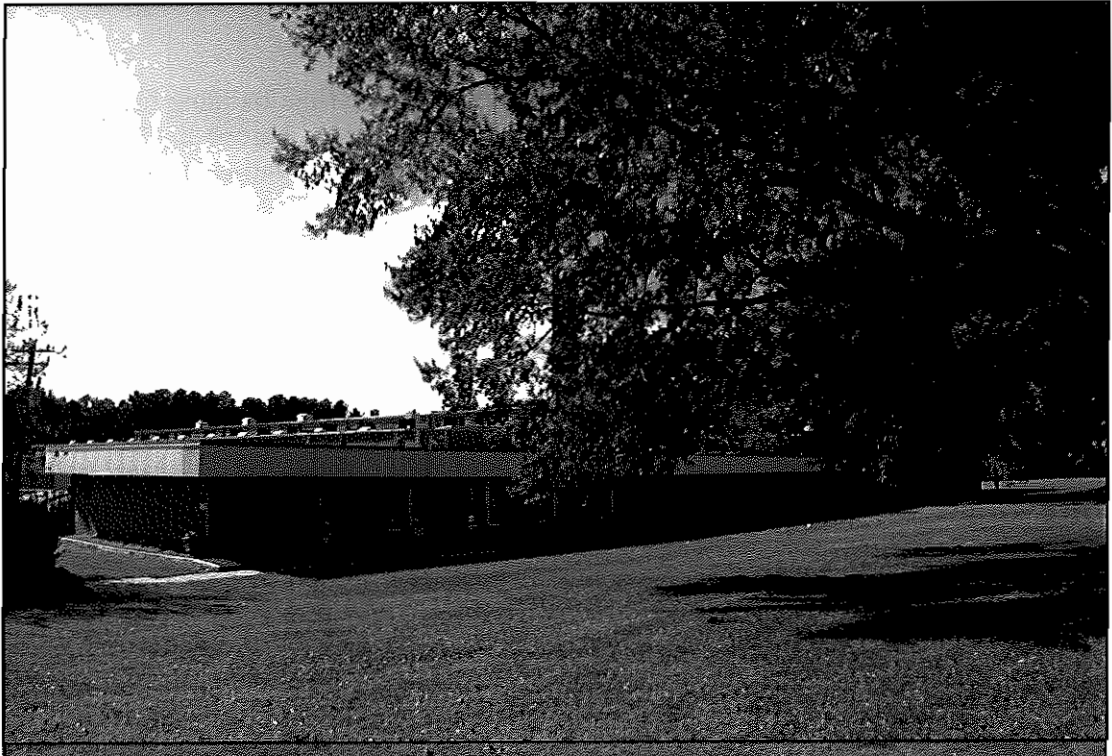
PLATE 32: Claude T. Bowers Military Center, CSMS

Architectural Description: The Combined Support Maintenance Shop (CSMS) building was constructed in 1964 simultaneously with the headquarters building (Plate 32). The building has a T-shaped plan with the horizontal part of the T on the north and the vertical extending south. The north section of the building is composed of a one-story office wing on the east half and a one-and-a-half-story workshop on the west half. The south section includes a two-story workshop on the west half and a one-and-a-half-story workshop on the east half. The building in its entirety sits on a solid poured-concrete foundation, is constructed of concrete block with a five-course Flemish-bond veneer, and has a flat roof.

The roof of the one-story office wing is lined with a heavy concrete cornice that projects from the building, giving the building façade a horizontal quality. The façade is fenestrated by symmetrically placed, paired metal-sash windows that are separated by squared concrete posts. Concrete spandrels are located below the windows. The recessed main entry is located at the western end of the office wing. The rhythm of the concrete posts continues across the façade at the entrance where it supports the roof overhang. The entrance consists of a double-leaf metal and glass door with a one-light transom flanked by full-height one-light metal-sash windows. The westernmost bay of the wing is not fenestrated and reads with metal lettering "NCNG SUPPORT MAINTENANCE SHOP."
