North Carolina Department of Cultural Resources
State Historic Preservation Office

SUBJECT: Historic Structures Survey Report for the Widening of NC 150 from NC 16 Bypass to I-77, R-2307, Multi County, ER 12-2211

NCR-0190

APRIL 2014

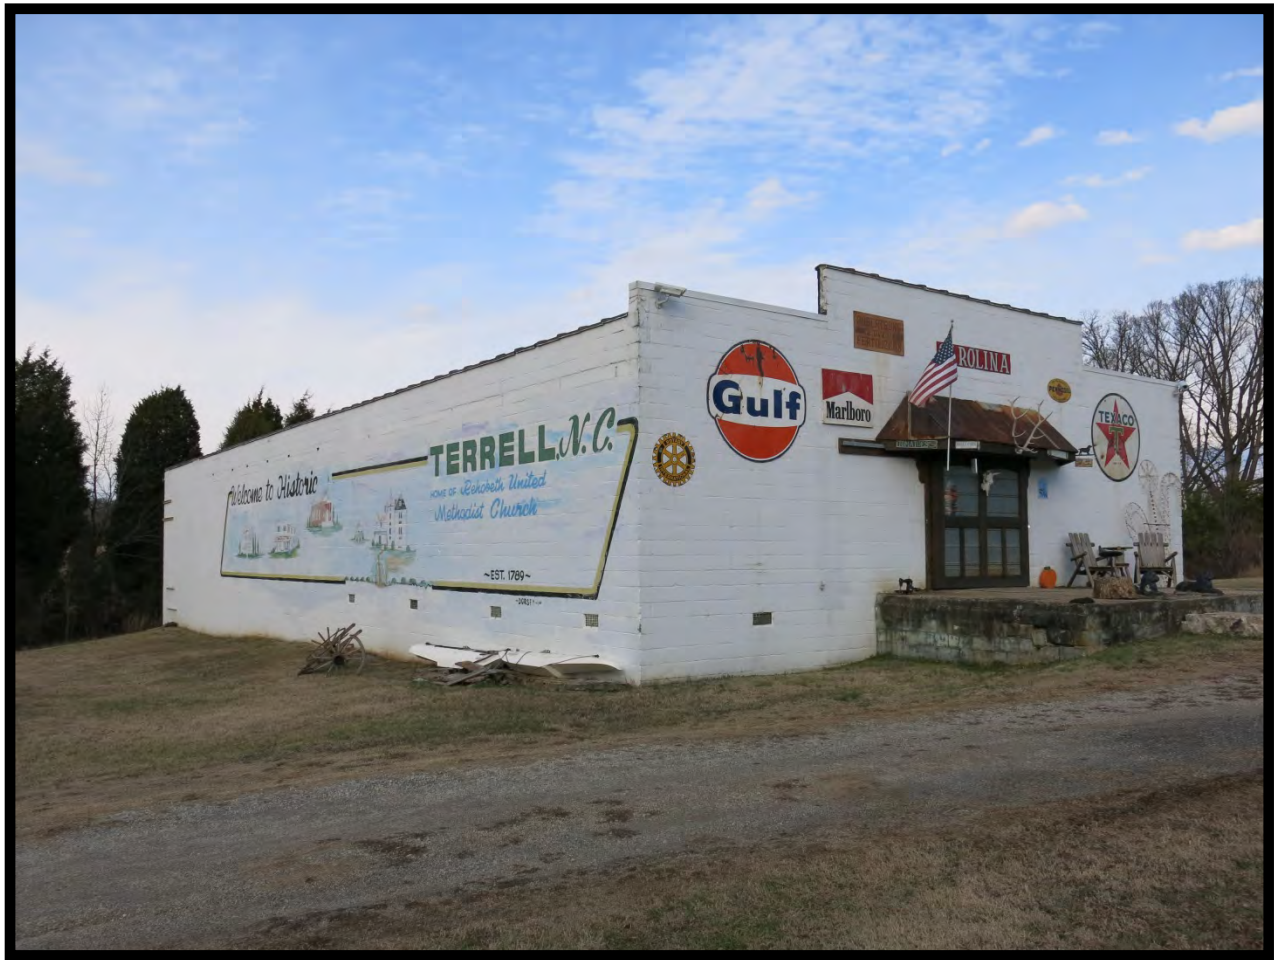
Figure 12: Cinderblock Warehouse (# 62) (ca. 1940), Looking Northeast.

The Cinderblock Warehouse (# 62) was considered fill in the 1986 NRHP nomination and is not recommended individually eligible. Because of the loss of the previously mentioned grist mill and cotton gin, and its associated storage building, which were located on the same tax parcel it is proposed to remove this from the historic district.

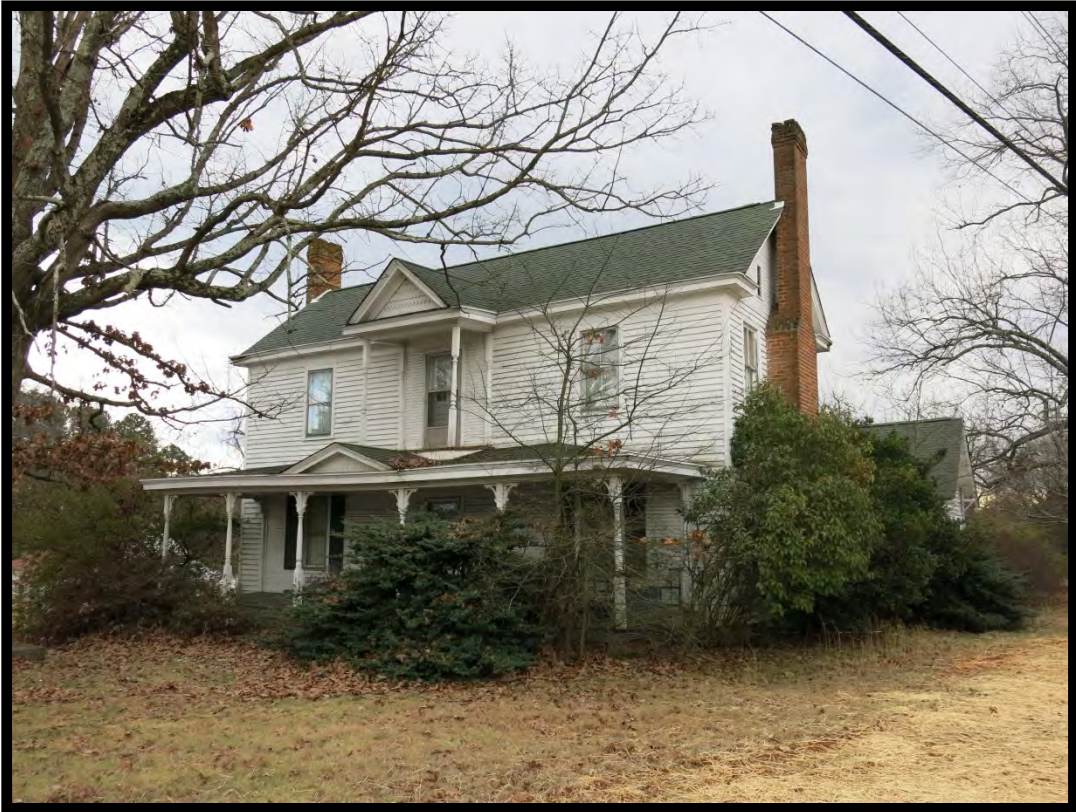
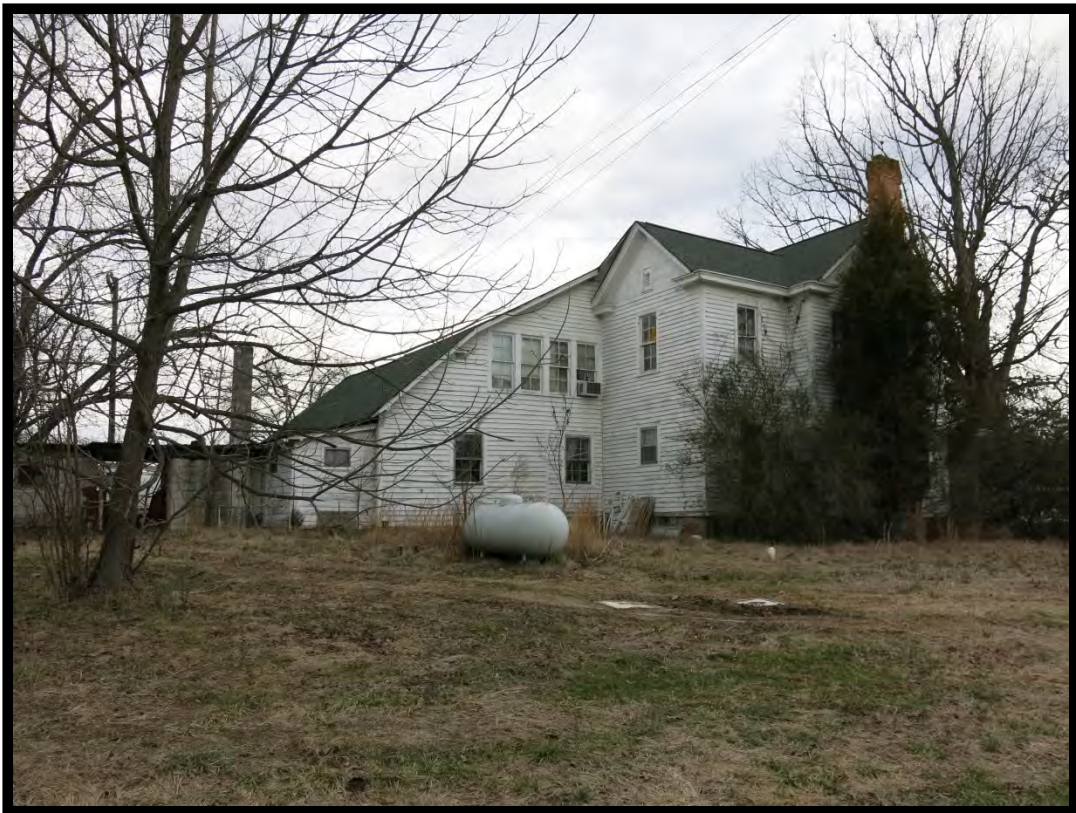
Figure 13: Sherrill-Gabriel House (# 63) (ca. 1880 & 1906), Looking Southwest.

The original one-story, three-room frame dwelling was built in the early 1880s by Cebring Sherrill (1856-1927). In 1906, his son-in-law R. E. Gabriel (1866-1940) rotated the original dwelling to face west and added a two-story, side-gabled dwelling, which faces east and is currently the main block of the dwelling. The three-bay wide main block has single shouldered, gable-end chimneys and is clad in weatherboard siding with German (or drop) siding on the gable ends and the walls of the front porch and balcony. A one-story, hip-roofed porch supported by turned posts shelters the east (front) elevation and has a central pediment. Located above the pediment is a small, one-bay, pedimented balcony (Figures 13 and 14). The 1906 dwelling has a central stair-hall with beaded-board wainscot and five-panel doors with plain surrounds.

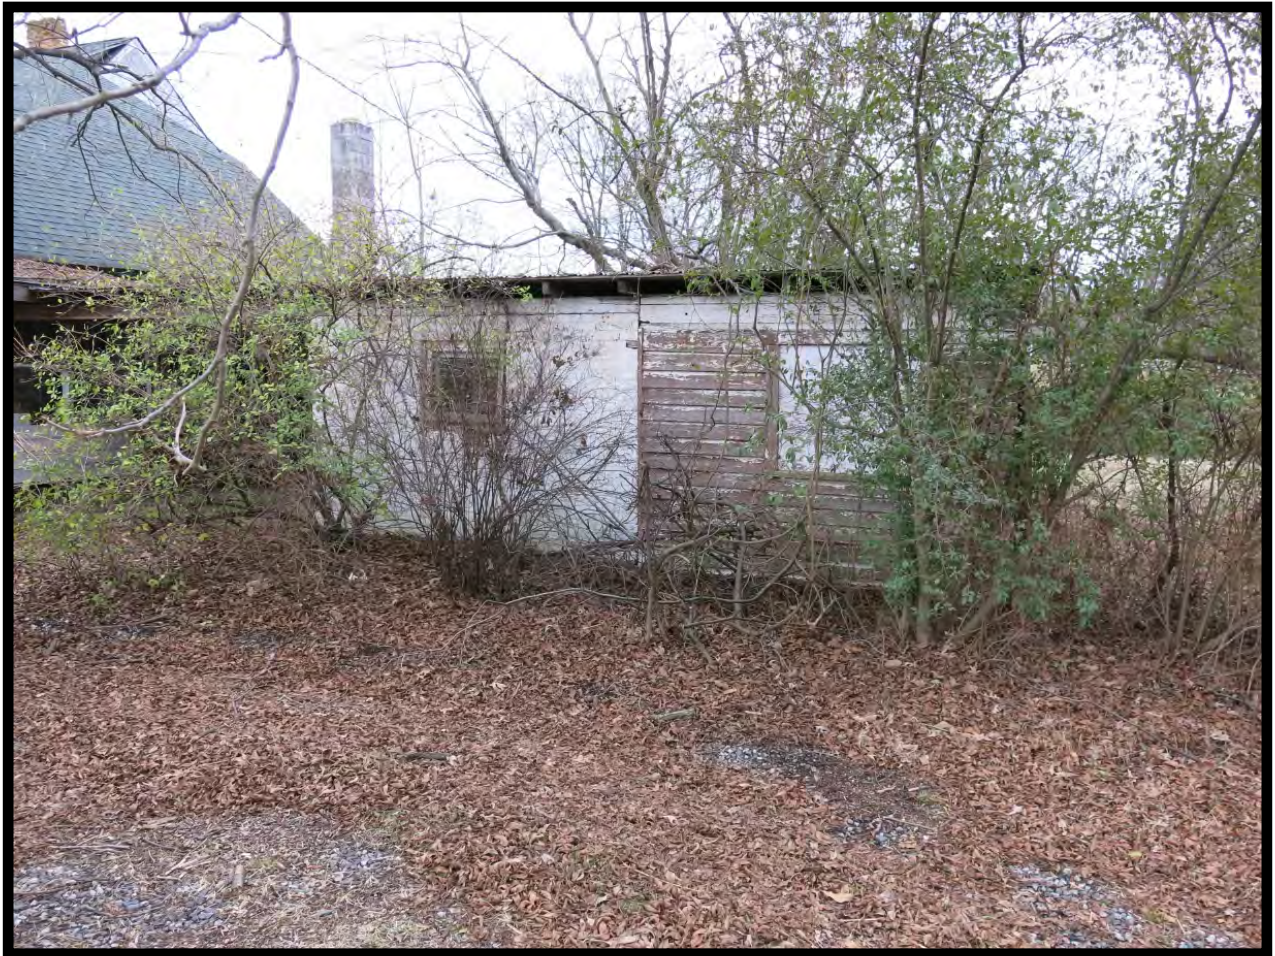
Located behind the house are a pair of connected sheds (one brick and one frame) joined to the original section of the house via a breezeway, as well as a frame garage, a circular metal grain bin, a chicken coop, and R. E. Gabriel's carpenter shop (# 90) (Figures 15 through 18).

Figure 15: Sherrill-Gabriel House (# 63), Semi-attached Sheds, Looking Southeast.

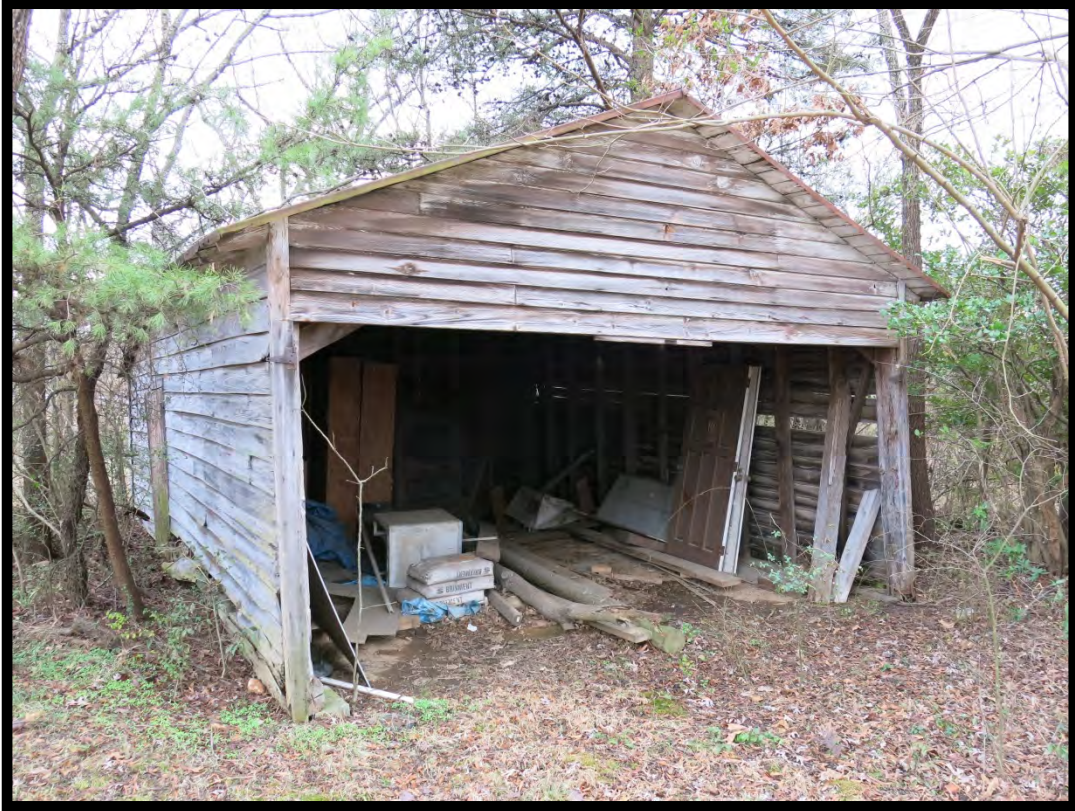
Figure 16: Sherrill-Gabriel House (# 63), Garage, Looking South.

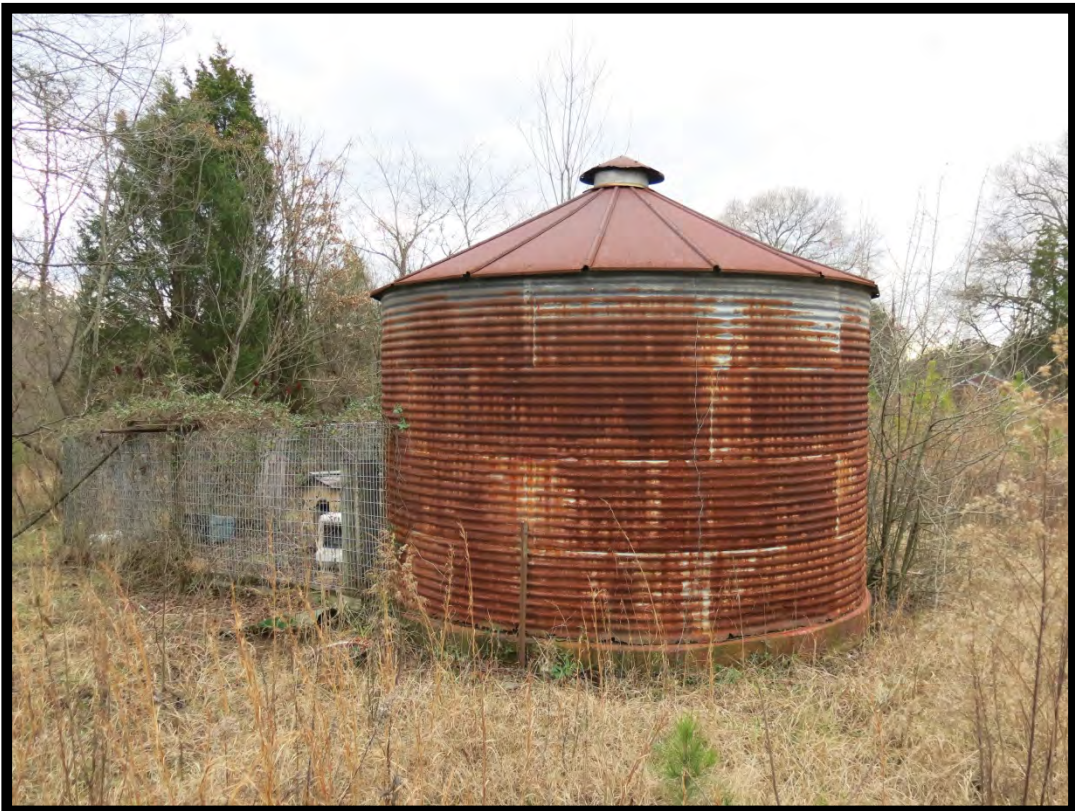
Figure 17: Sherrill-Gabriel House (# 63), Grain Bin, Looking Southwest.

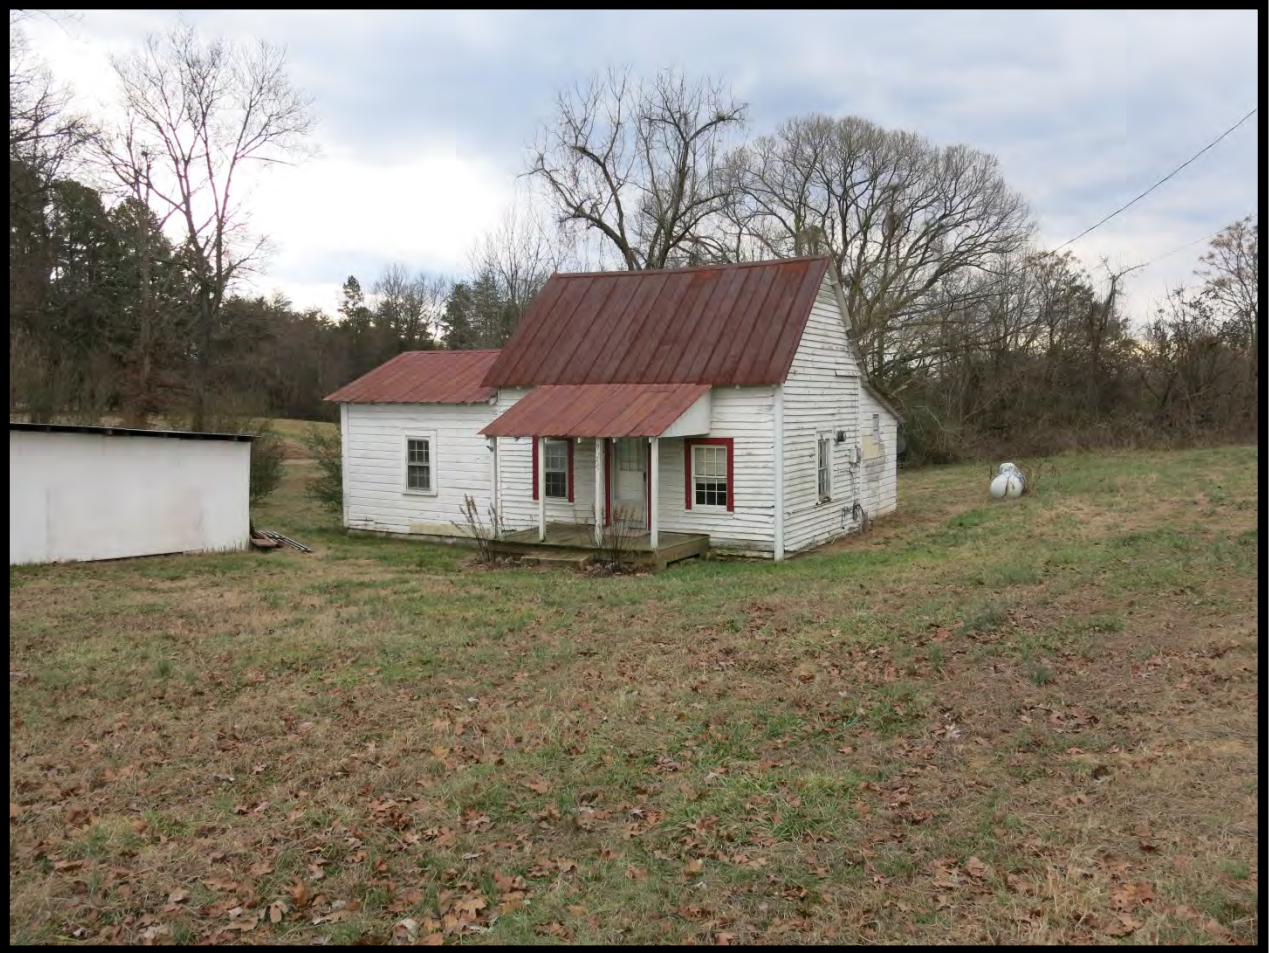
Figure 18: Sherrill-Gabriel House (# 63), R. E. Gabriel's carpenter shop (# 90), Looking Southwest.

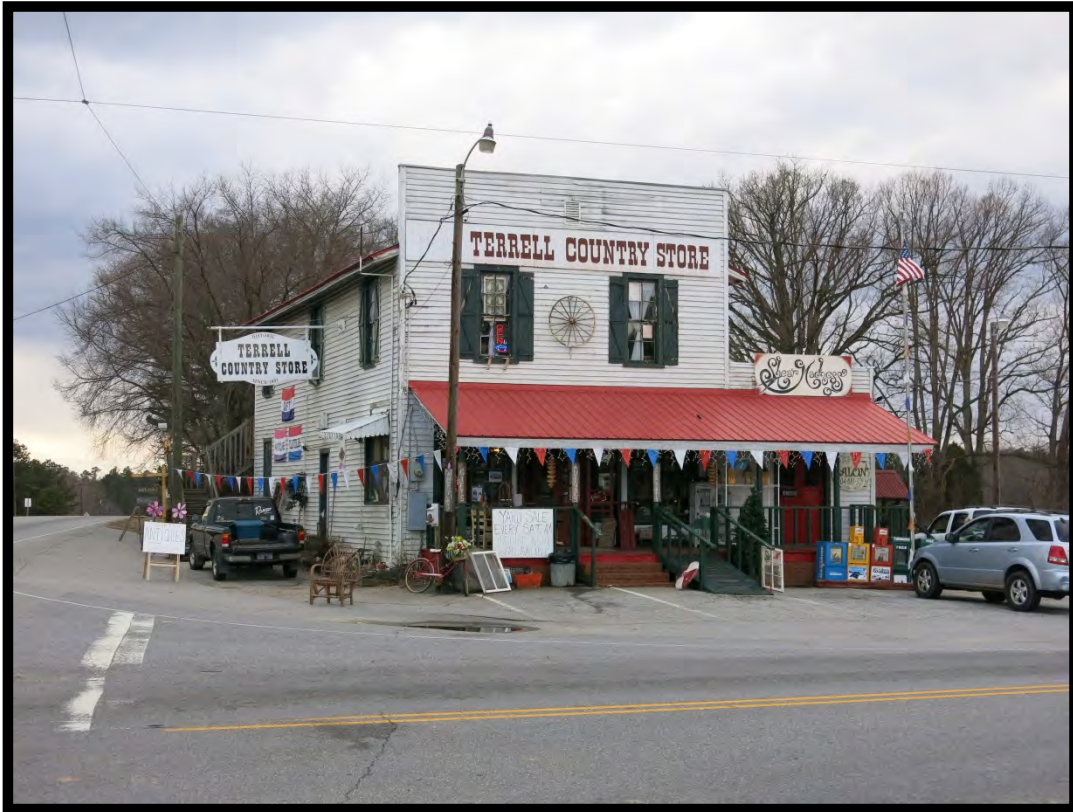
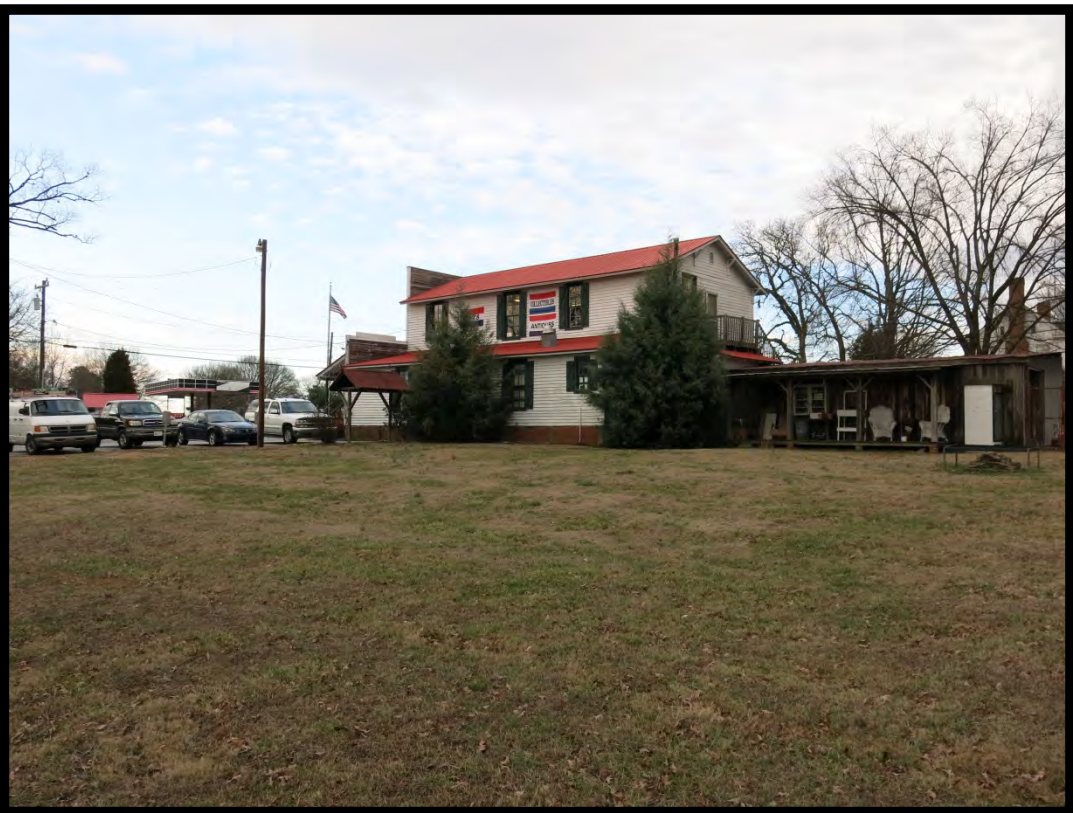
This two-story, two-bay, front-gabled building has a parapet on the east (front) elevation of the building. The building is two bays wide and three bays deep and purportedly was originally twice as long. A one-story shed-roofed wing runs along the north (side) elevation of the building and houses the post office. A shed-roofed porch shelters the front elevation of both the store and the post office. Recessed double doors, flanked by large four-light windows, give access to the store (Figures 19 and 20).

Figure 19: Connor Store and Post Office (# 64) (ca. 1891), Looking West.

Figure 20: Connor Store and Post Office (# 64) (ca. 1891), Looking East.

The Connor Store and Post Office (# 64) was considered a pivotal resource in the 1986 NRHP nomination and there have been no significant additions or alterations to the property since its listing. It should still be considered contributing to the Terrell Historic District.

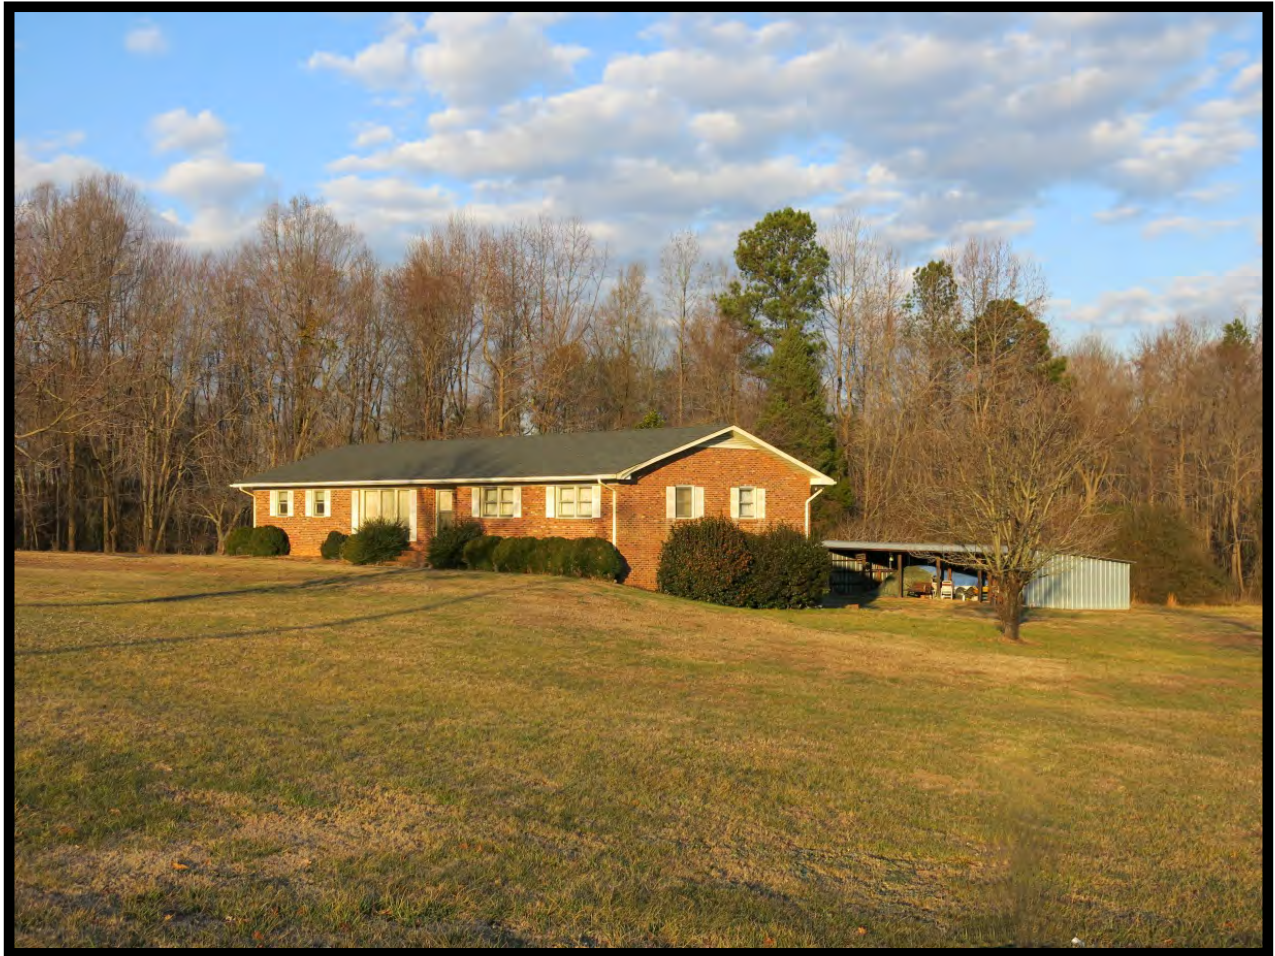
Figure 21: Kermit Lee Howard House (# 70) (ca. 1970), Looking Northwest.

This one-story, side-gabled, Ranch-style brick dwelling was built around 1970 according to the Catawba County tax record. A large six-light picture window flanks the recessed entry door on the southeast (front) elevation of the dwelling, and an integral one-car garage is located on the southwest gable end (Figure 21).

The Kermit Lee Howard House (# 70) was considered fill in the 1986 NRHP nomination and is not recommended individually eligible. The property was included in the original nomination because the land was once part of Jason Sherrill's farm (#s 71/72); however, the dwelling is non-historic, its presence diminishes the overall historic character of the district, and it is proposed to remove this from the historic district.

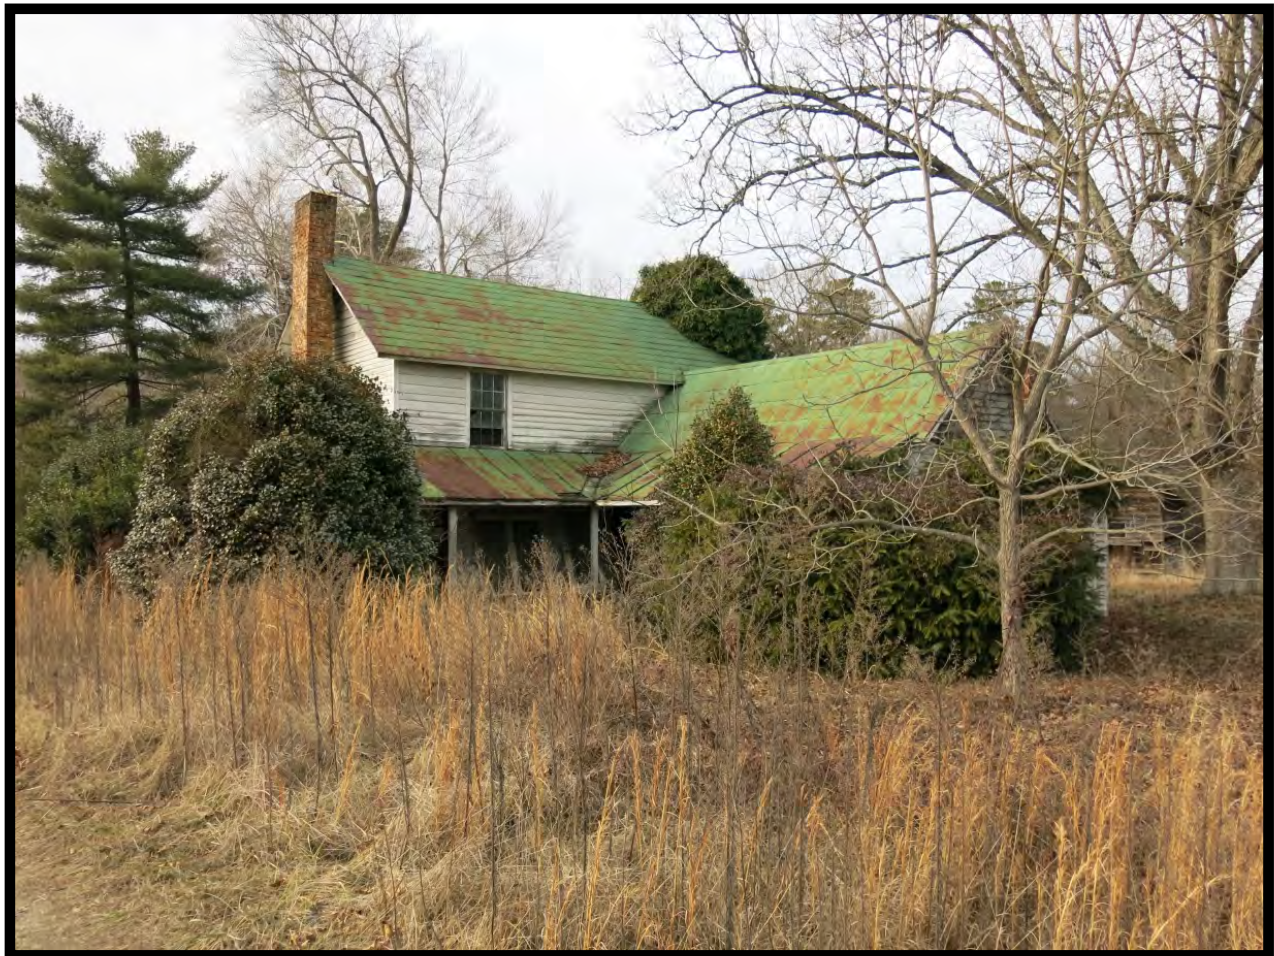
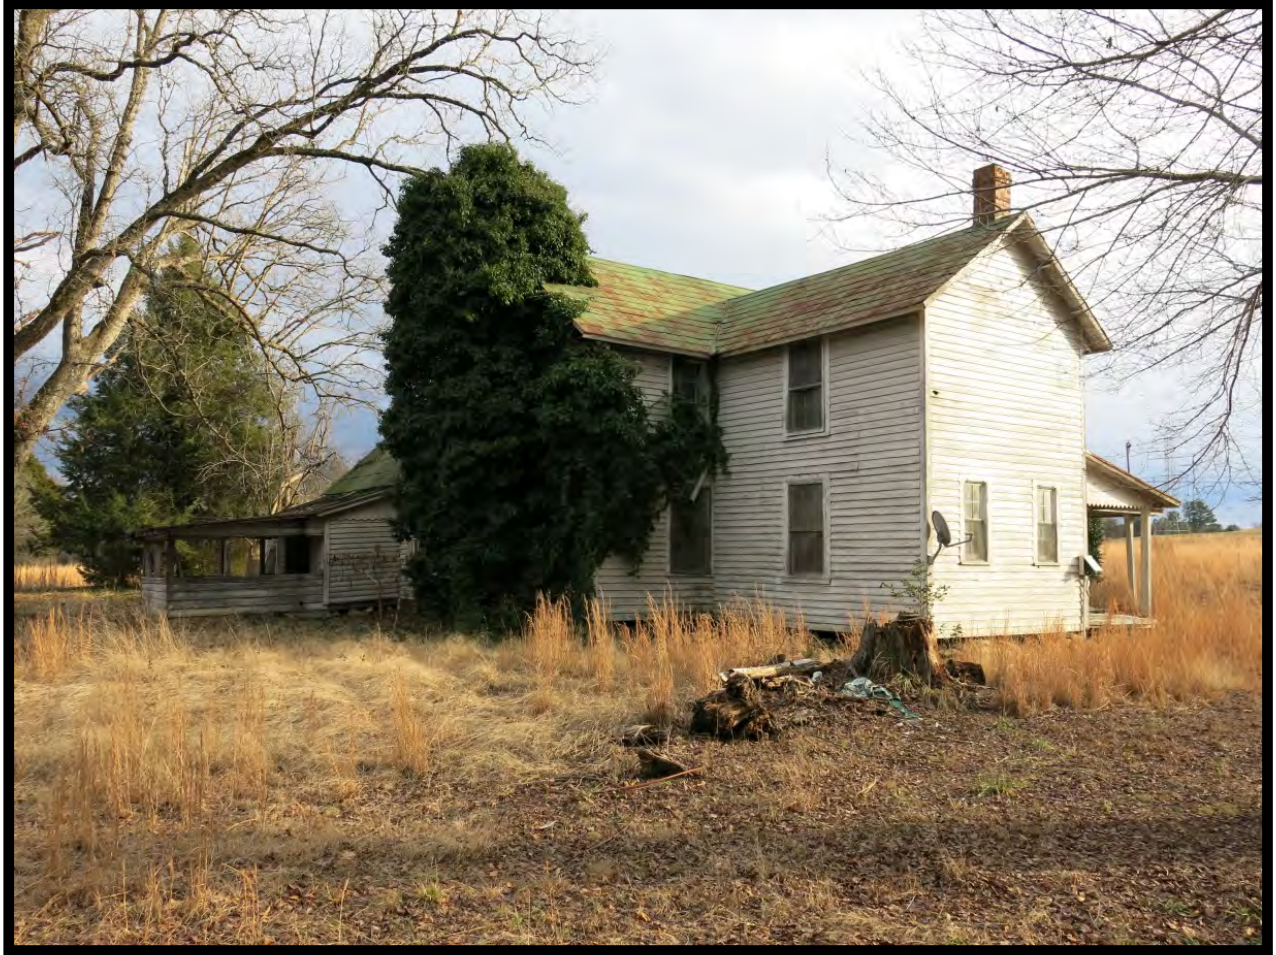
Figure 22: Jason Sherrill House (# 71/72) (ca. 1890 & 1930), Looking North.

The original section of this dwelling is a two-story, side-gabled frame structure with a two-story ell extending off the northwest elevation of the building, which was added in 1930, giving it a T-shaped footprint.⁴ Earlier a one-story gable-roofed kitchen and dining ell was constructed against the southeast elevation of the main block. A one-story, shed-roofed porch, supported by chamfered posts, runs along the southwest elevation of the two-story ell and wraps around the southwest gable end of the main block extending along its southeast elevation. The porch continues along the southwest elevation of the one-story kitchen and dining ell. The building sits on a stone foundation, is clad in weatherboard siding, and has stone and brick single-shouldered chimneys on the southwest and northeast gable ends of the main block and an interior brick flue on the northwest gable end of the two-story ell (Figures 22 and 23).

⁴ According to the HPOWEB GIS Service the resource consist of the Jason Sherrill House (No. 71/CT0389) and the Early Sherrill House (No. 72/CT0644), however according to the NRHP Nomination this is the same resource and the latter is the 1930s addition.

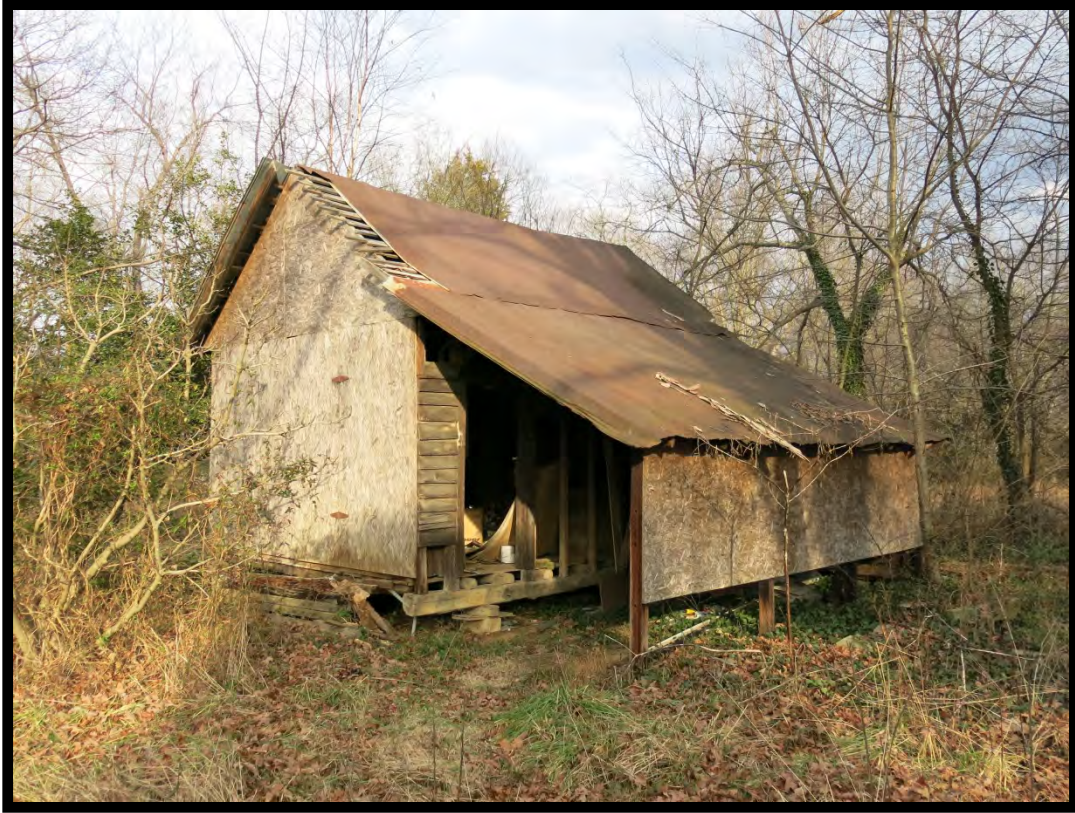
Located around the house are several outbuildings, including a smokehouse clad in board-and-batten siding, a former kitchen, two frame sheds, a chicken coop, a wood shed, and a front-gabled, one-car, frame garage (Figures 24 through 28).

Figure 24: Jason Sherrill House (# 71/72), Former Kitchen, Looking Northeast.

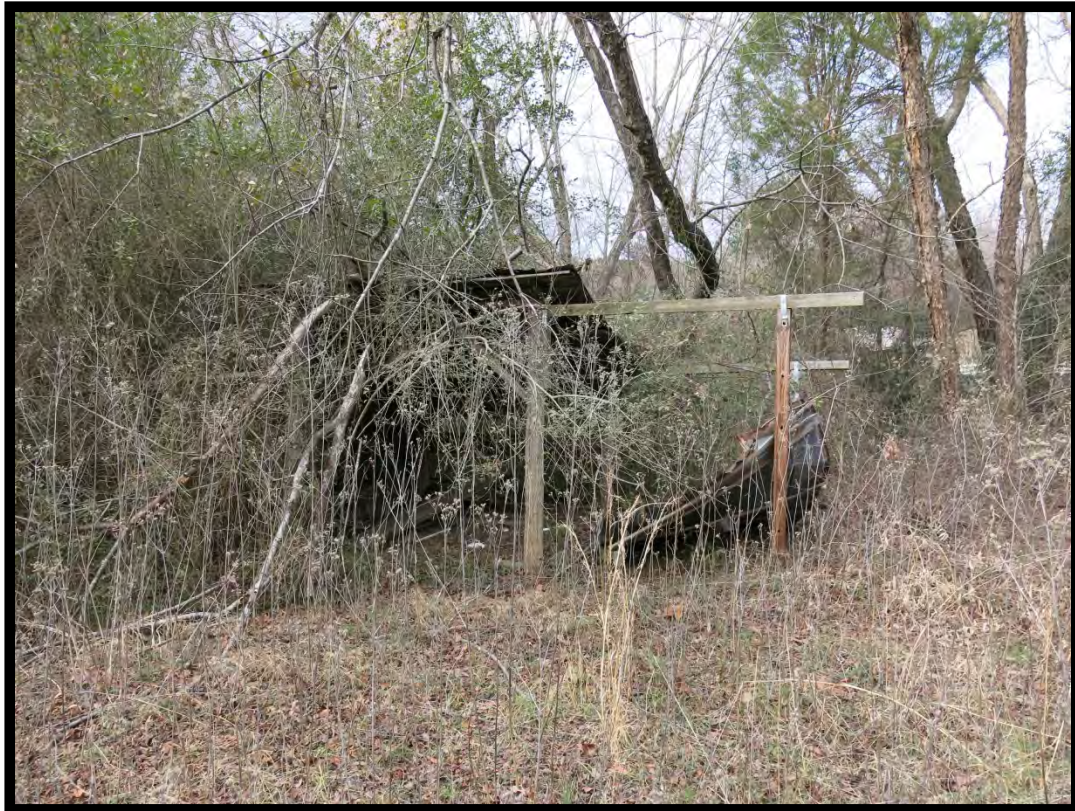
The smokehouse and one of the sheds are no longer extant.

Figure 25: Jason Sherrill House (# 71/72), Shed, Looking North.

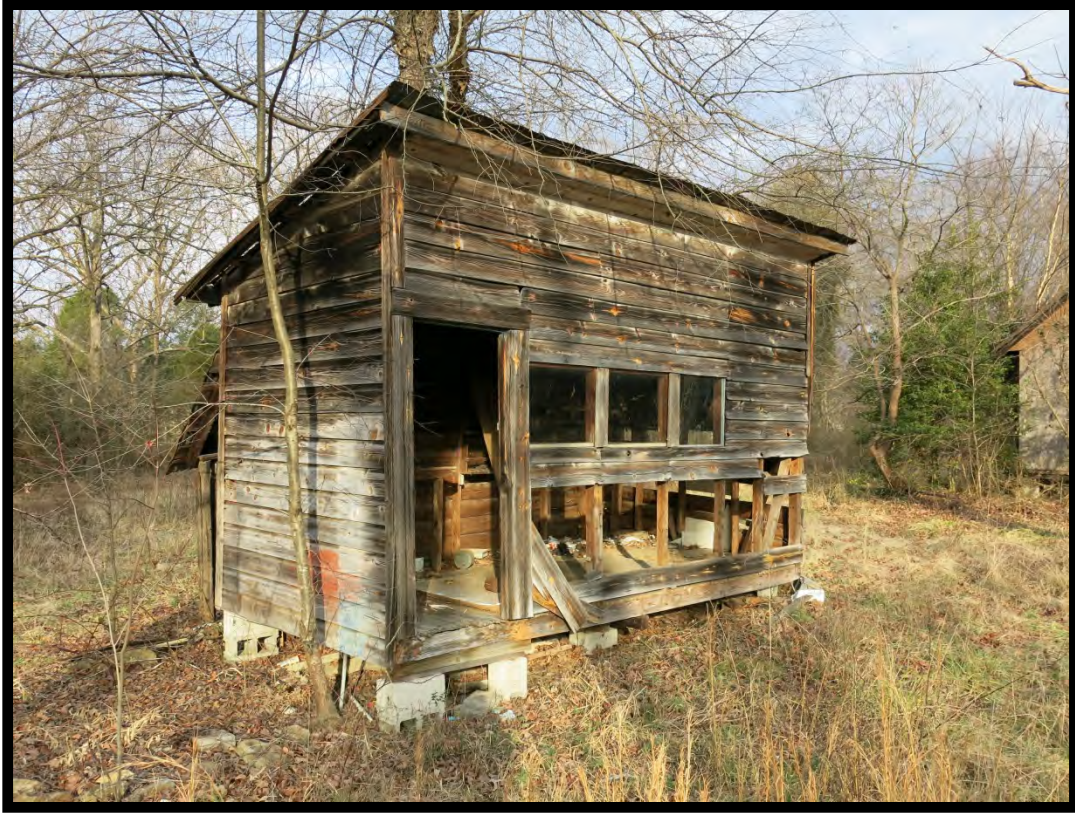
Figure 26: Jason Sherrill House (# 71/72), Chicken Coop, Looking Northeast.

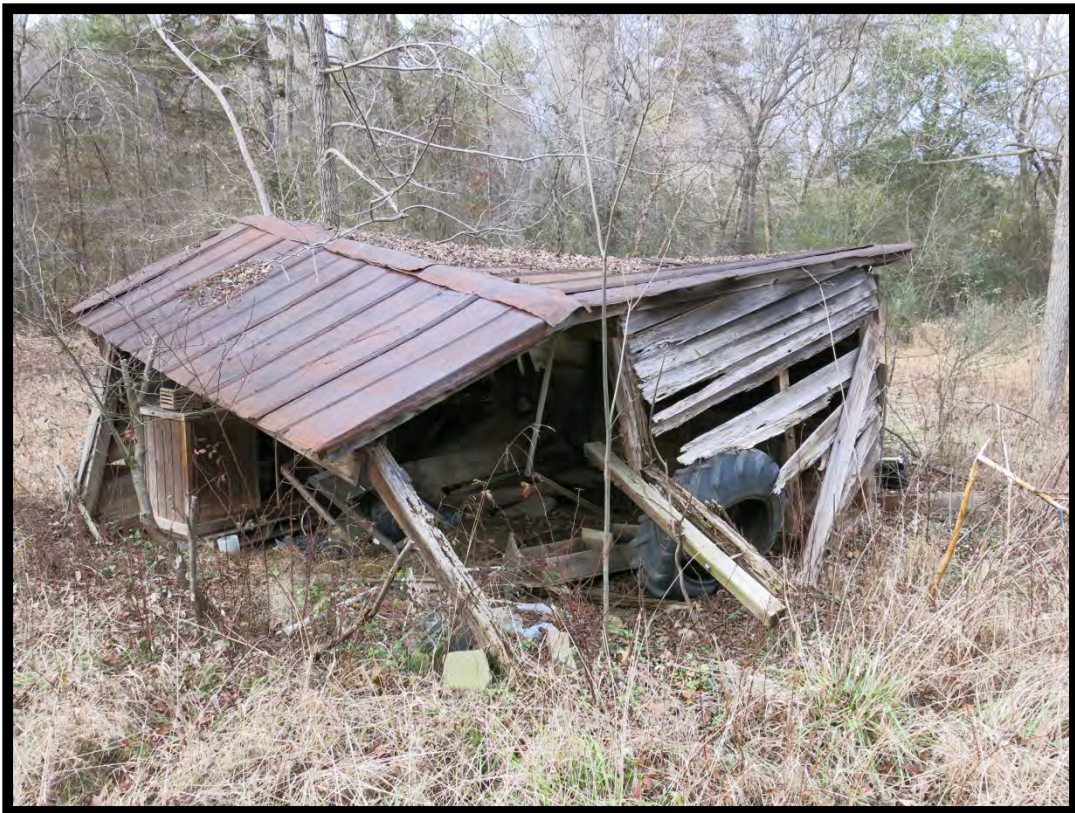
Figure 27: Jason Sherrill House (# 71/72), Wood Shed, Looking Northwest.

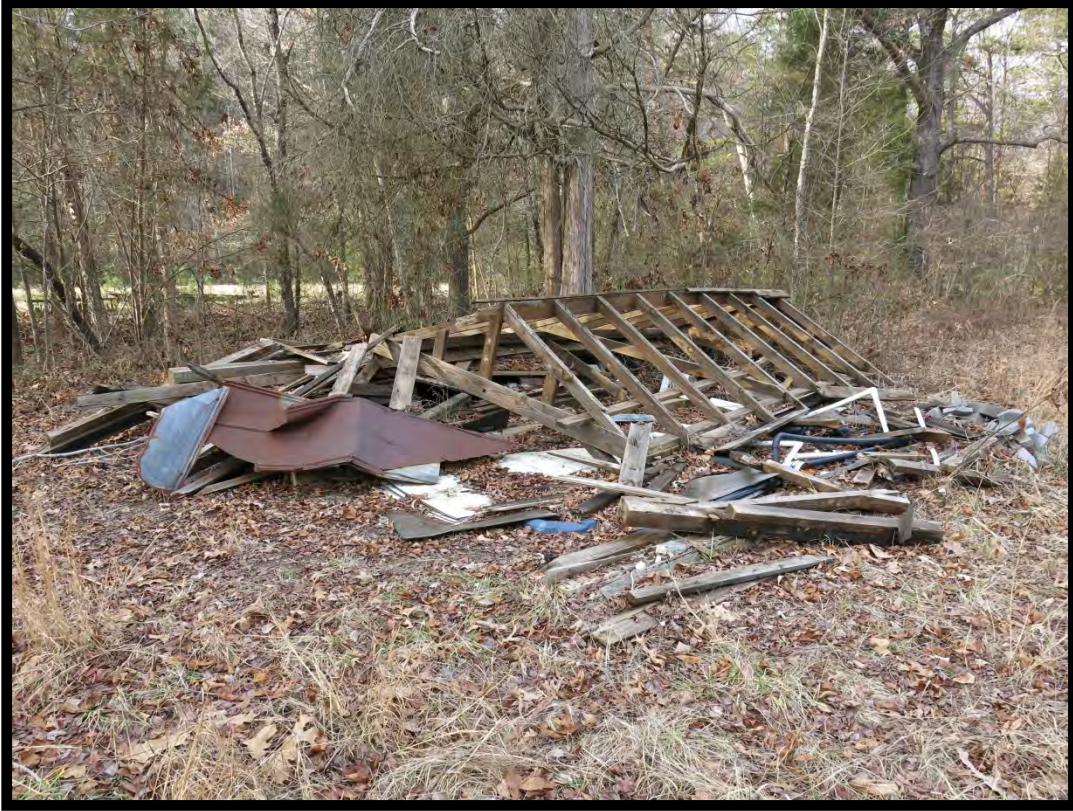
Figure 28: Jason Sherrill House (# 71/72), Remnants of Garage, Looking North.

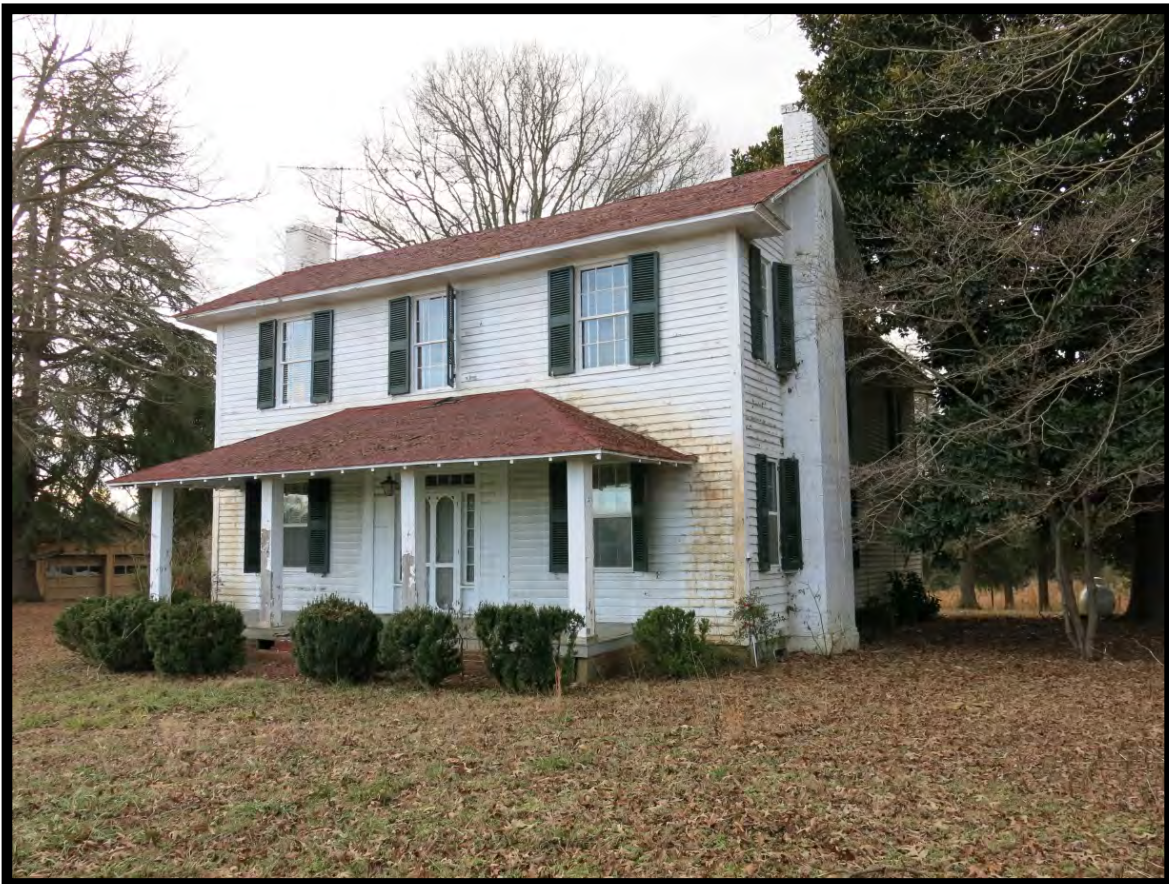
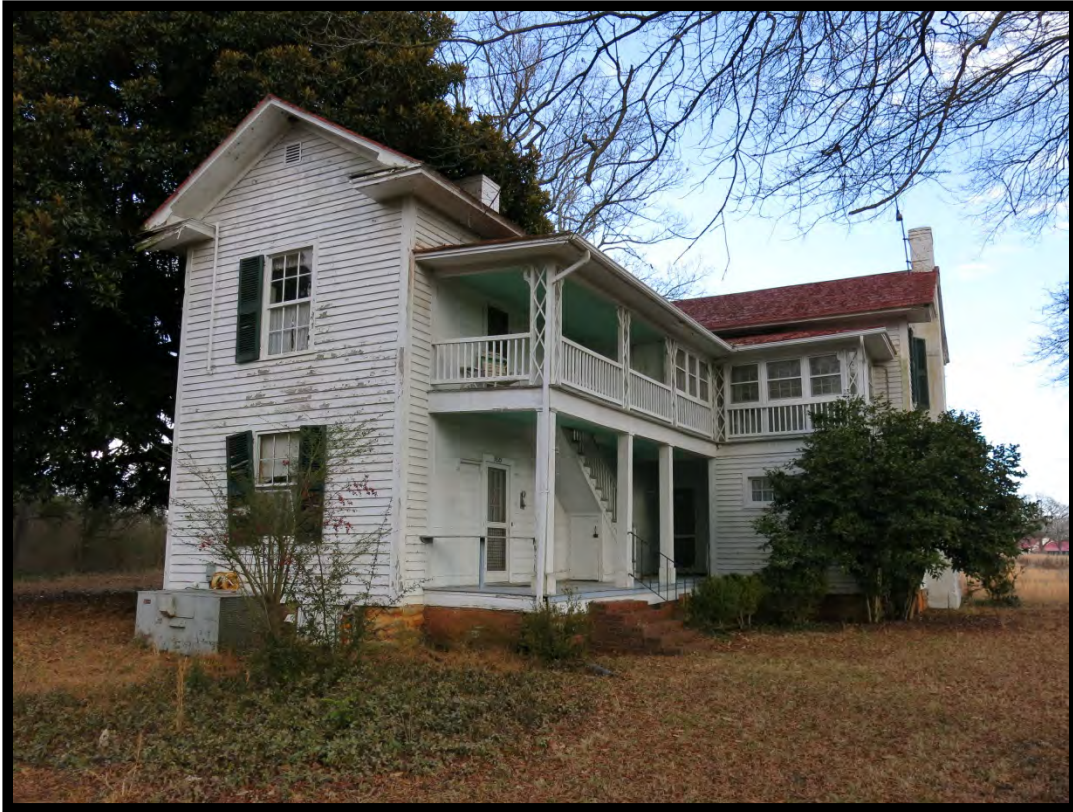
Dr. Littleton T. Coleman may have built this house around 1854, which would make it the oldest house in the district. In 1877, Franklin Caldwell purchased the property. The Caldwell family owned the property until 1914, when it was sold to R. E. Gabriel. The estate of his son, R. H. Gabriel, still owns the property. This two-story, three-bay, side-gabled frame dwelling has modest Greek Revival elements and a two-story ell extending off the west (rear) elevation giving the building an L-shaped footprint. A one-story, hip-roofed porch, supported by heavy square columns, shelters the three bays on the front elevation including the double entry doors, which are surrounded by a simple transom and sidelights. A two-story porch, with an external staircase, runs along the south elevation of the wing and continues along the west (rear) elevation of the main block. The main block has a center-passage plan with plaster ceilings and flush-board walls. The doors and windows have molded surrounds with corner blocks typical of the Greek Revival style (Figures 29 and 30).

Figure 29: Coleman-Caldwell-Gabriel Farm (# 88) (ca. 1854) Looking Southwest.

Figure 30: Coleman-Caldwell-Gabriel Farm (# 88) (ca. 1854), Looking Northeast.
