North Carolina Department of Cultural Resources
State Historic Preservation Office

SUBJECT: Historic Structures Survey Report for the Widening of NC 150 from NC 16 Bypass to I-77, R-2307, Multi County, ER 12-2211

NCR-0190

APRIL 2014

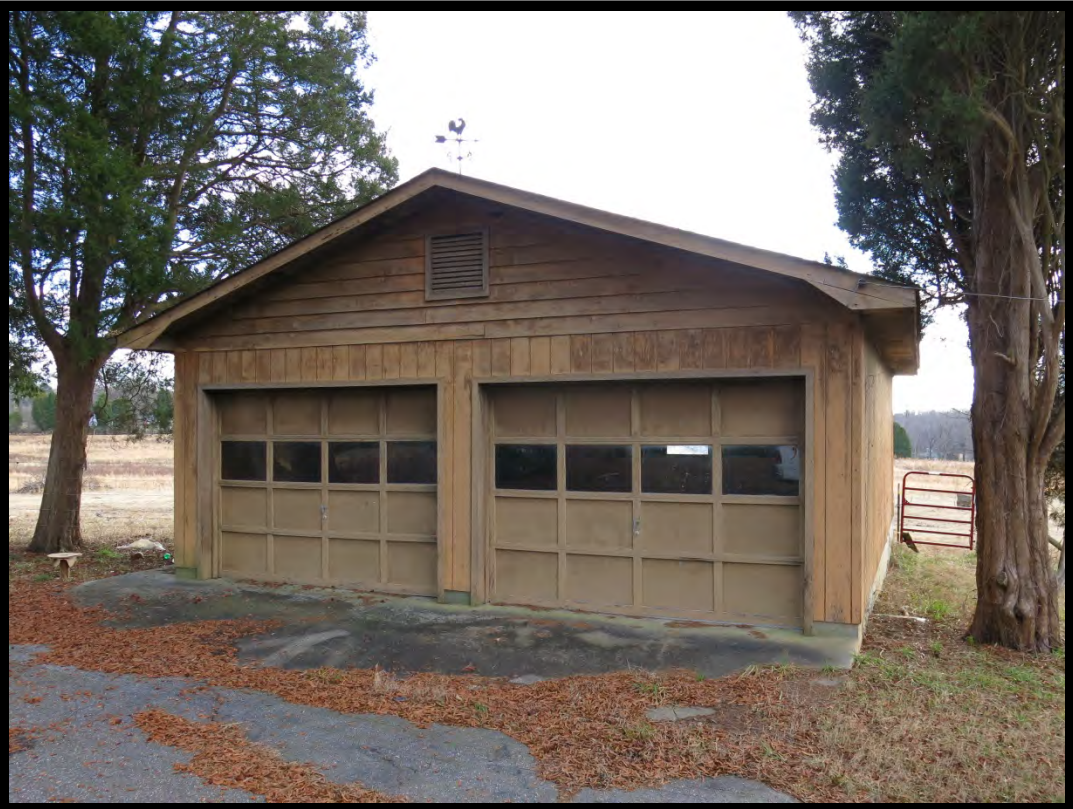
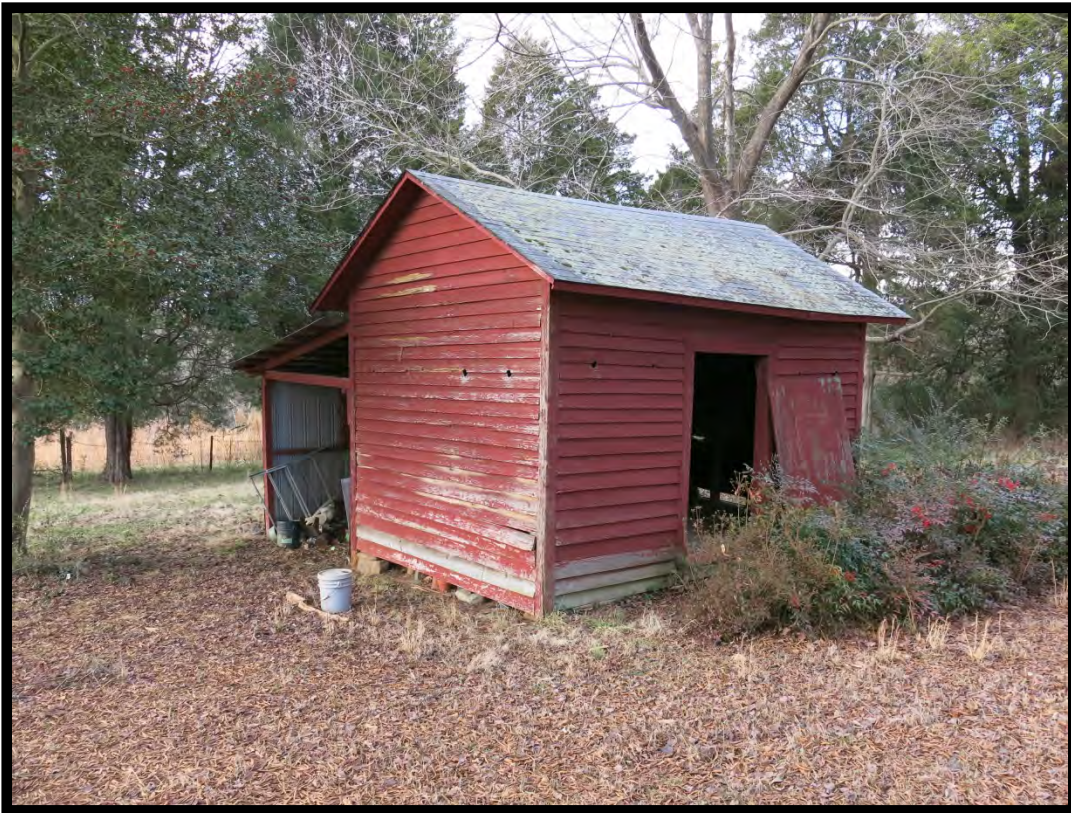
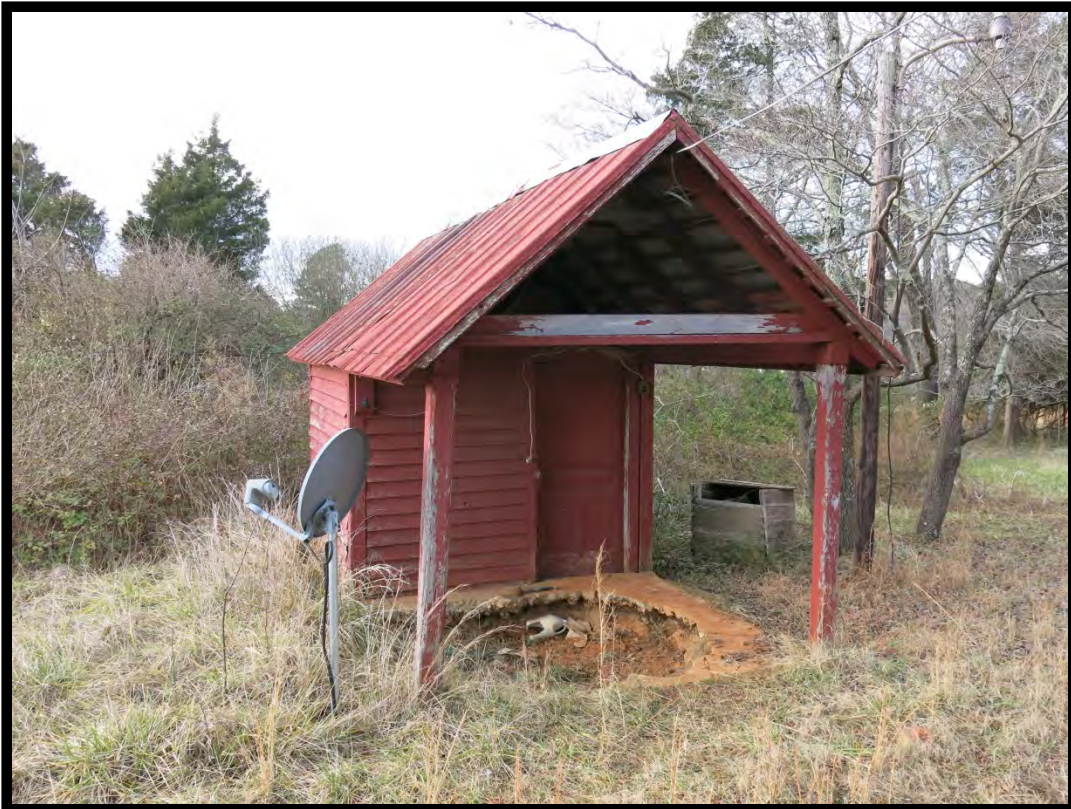
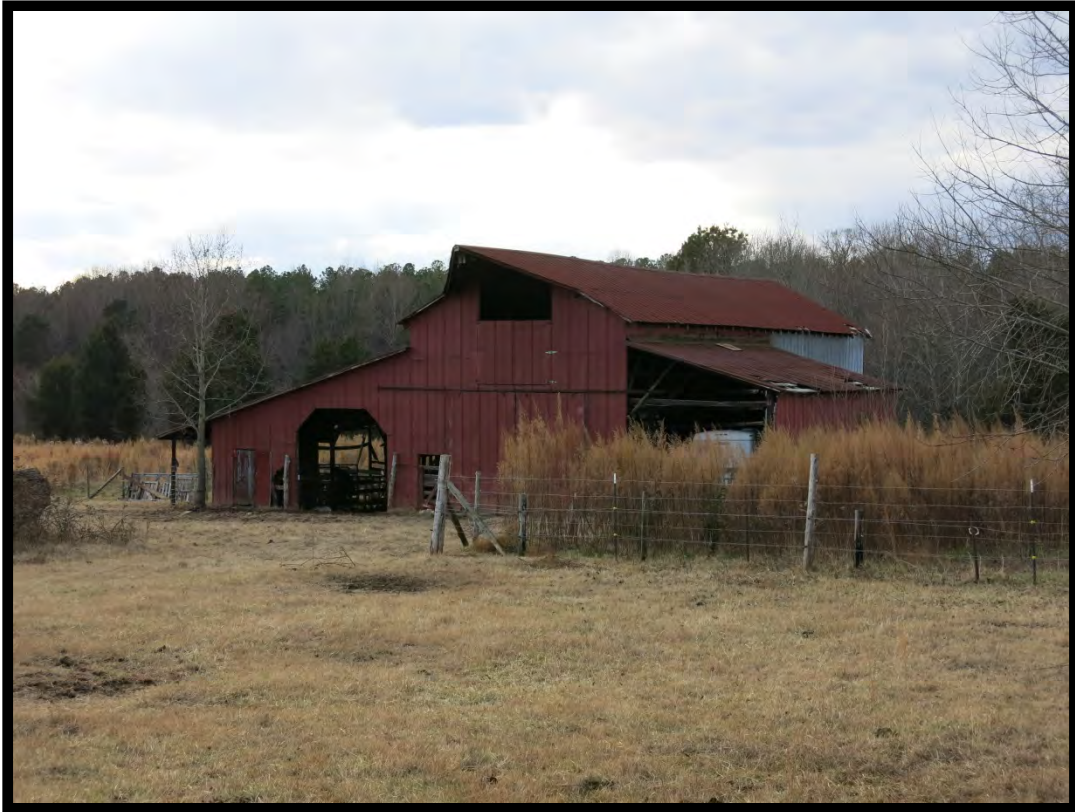
Located to the south and west of the house are a modern front-gabled, two-car garage, a side-gabled frame smokehouse, a front-gabled well house, and a large front-gabled, two-story barn, with shed sections along the north and south (side) elevations (Figures 31 through 34).

Figure 31: Coleman-Caldwell-Gabriel Farm (# 88), Garage, Looking Southeast.

Figure 32: Coleman-Caldwell-Gabriel Farm (# 88), Smokehouse, Looking Northwest.

Figure 33: Coleman-Caldwell-Gabriel Farm (# 88), Well House, Looking Northwest.

Figure 34: Coleman-Caldwell-Gabriel Farm (# 88), Barn, Looking Southwest.

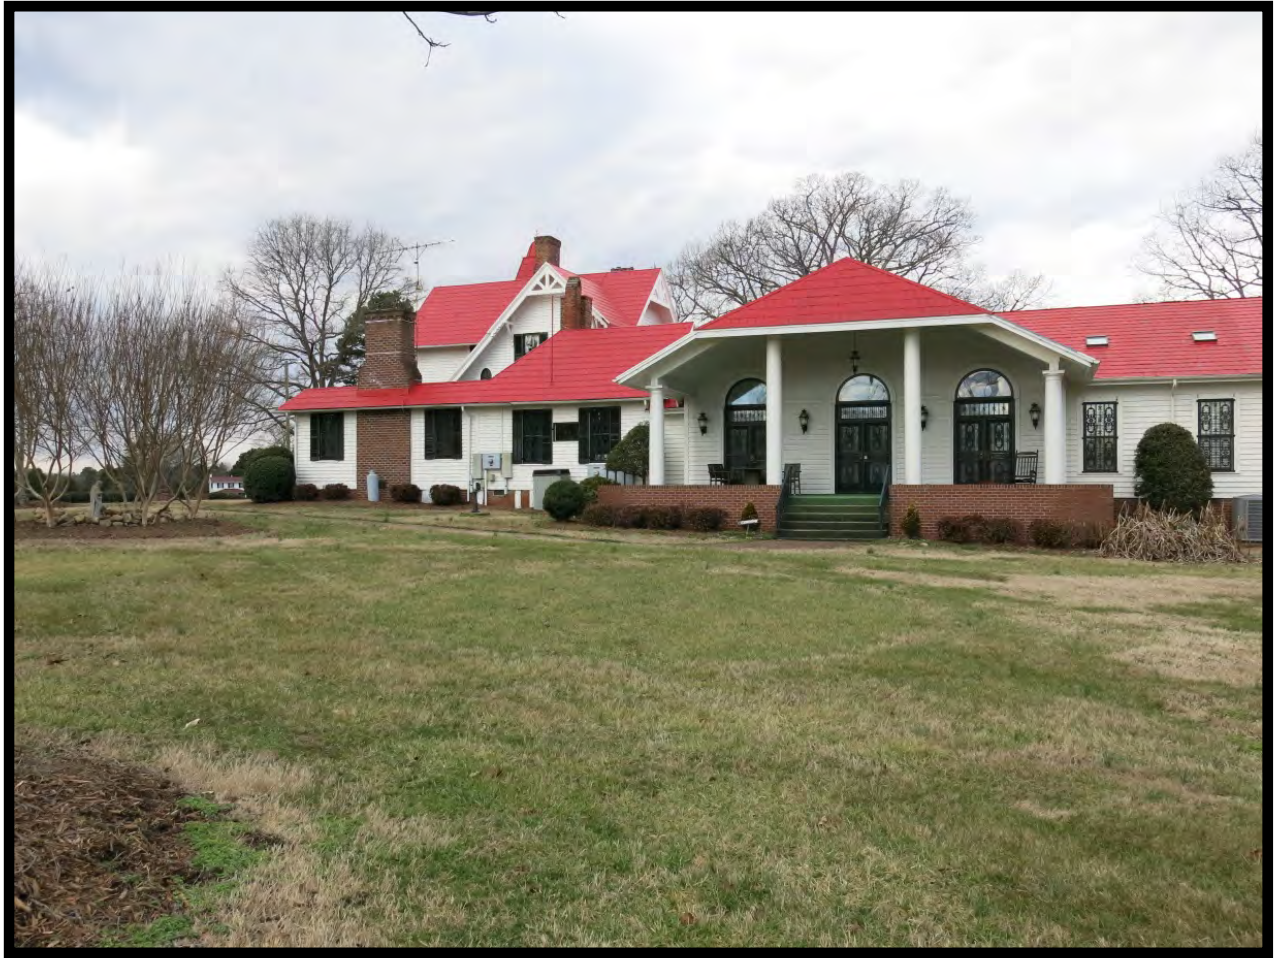
Figure 36: T. F. Connor House (# 89) (ca. 1886, 1911, & ca. 1993), Looking West.

The well house and carriage house are no longer extant. After 1993 the dwelling was substantially expanded off the northeast (rear) elevation, and a one story wing was added onto the south corner at the front of the building. The Connor House can now be rented for weddings, receptions, corporate events and social gatherings.

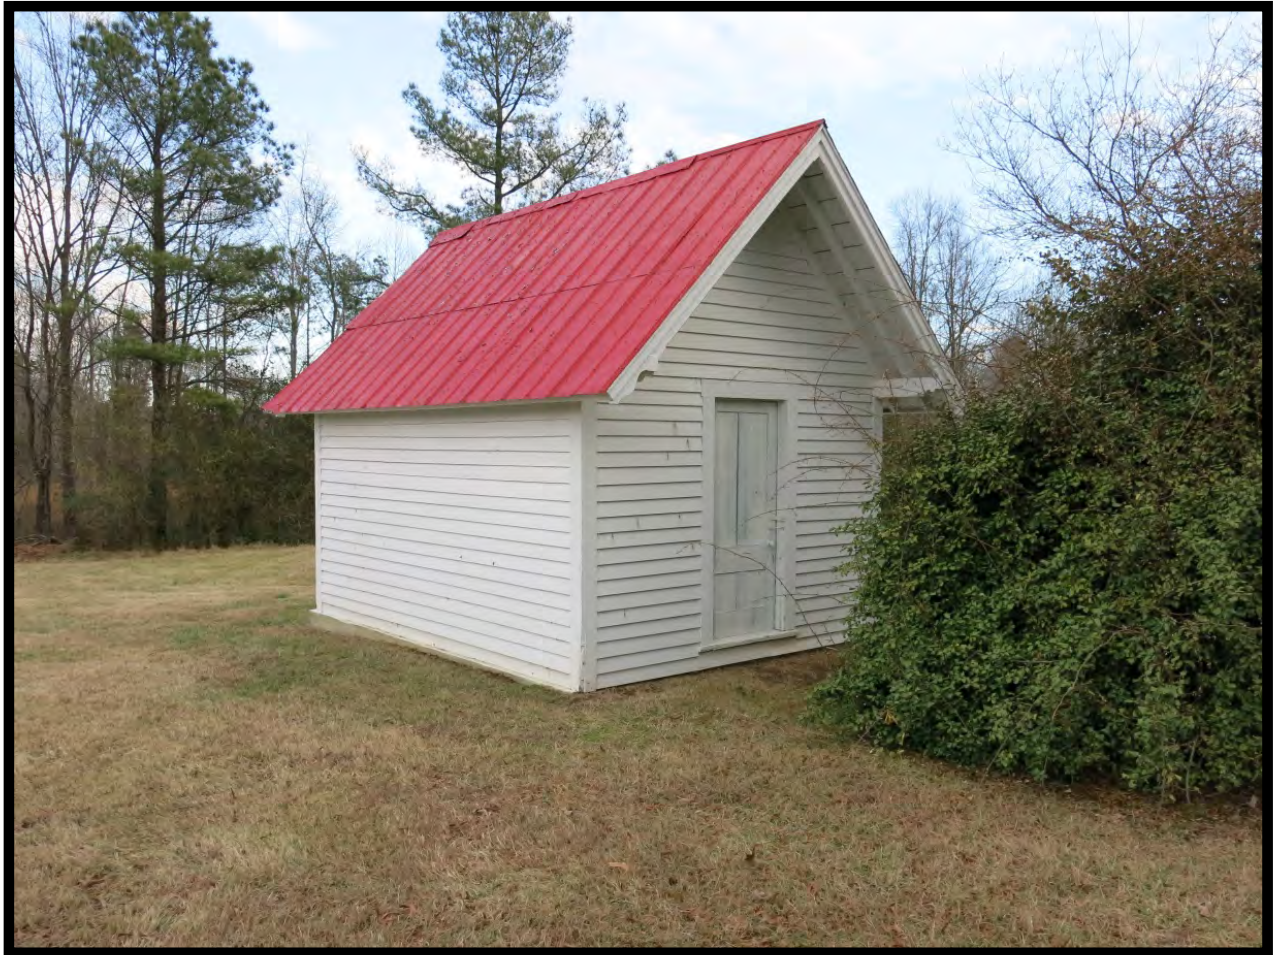
A well house is attached to the east porch of the house, and located at the rear of the house lot is a smokehouse with wide overhanging eaves. Located to the east of the smokehouse stands a deteriorated carriage house (Figure 37).

Figure 37: T. F. Connor House (# 89), Smokehouse, Looking Southeast.

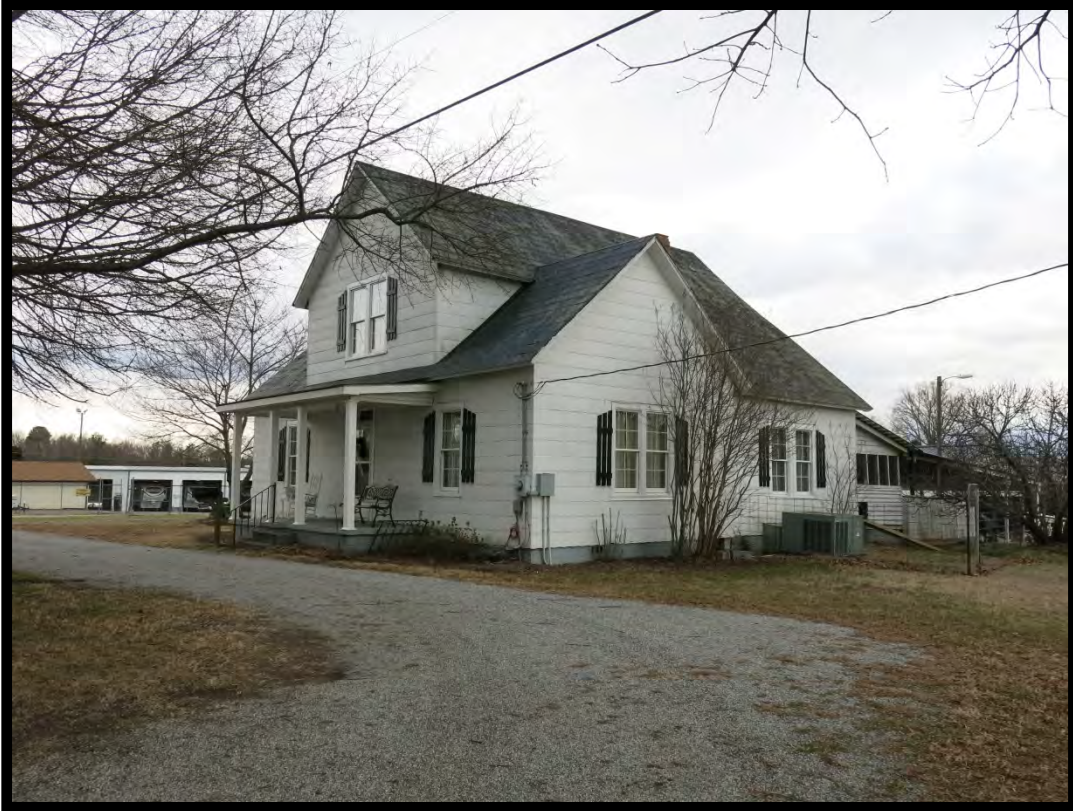
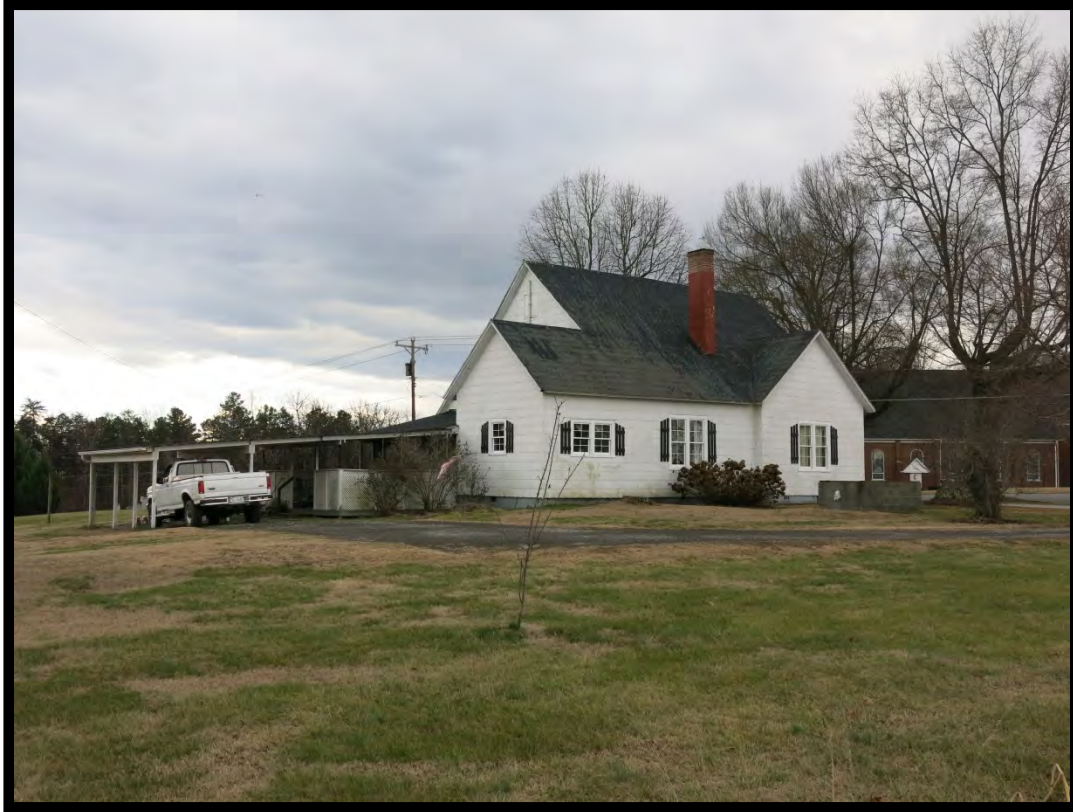
Figure 39: Walter Gabriel House (# 92) (ca. 1902), Looking North.

Figure 40: Walter Gabriel House (# 92) (ca. 1902), Looking South.

- The Walter Gabriel House and the James Gillin House have not lost sufficient integrity to be re-evaluated as non-contributing. The houses essentially look the way they did when the district was listed. The loss of outbuildings does not have a direct impact on the contributing status of the house.

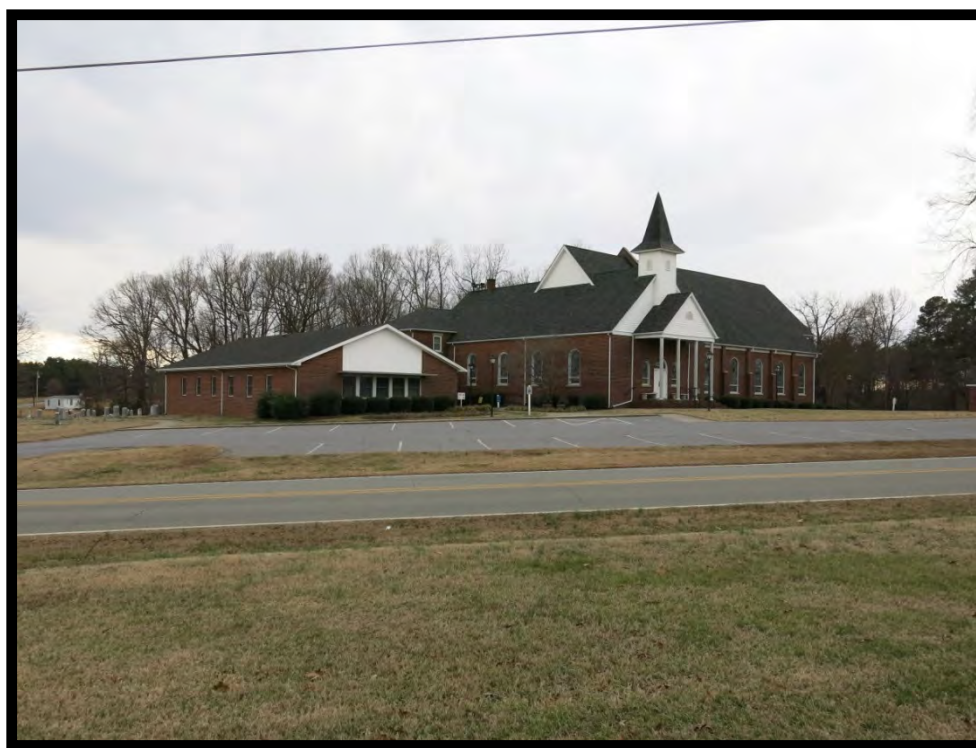
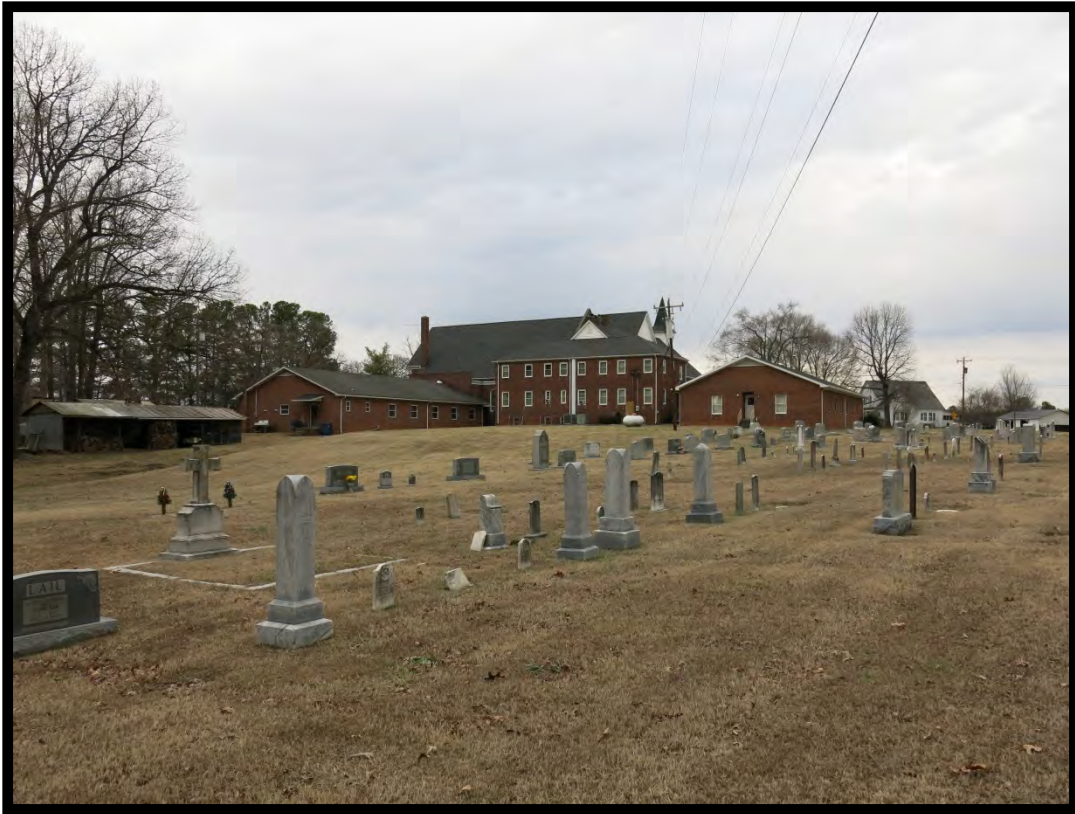
The Rehobeth Methodist Church was organized prior to 1791, and the oldest section of the present church was built in 1889. The church was extensively remodeled and clad in brick veneer around 1955 (Figure 42 and 43).

Figure 42: Rehobeth Methodist Church (#s 93 & 94) (1889, ca. 1955, ca. 1986), Looking Southwest.

Figure 43: Rehobeth Methodist Church (#s 93 & 94) (1889, ca. 1955), Looking Northwest.

The Rehobeth Methodist Church, Cemetery, and Parsonage (Nos. 93 and 94) was considered fill in the 1986 NRHP nomination and is not recommended individually eligible. The cemetery does not meet Criteria Consideration D. Despite the fact that a number of the stones date back to the nineteenth century, the majority date to the twentieth century and they are typical for the period and lack distinctive designs. Furthermore, the cemetery lacks significant association with persons or events of transcendent importance and is therefore not recommended as eligible for listing in the National Register under Criteria Consideration D. As such, it is proposed to remove the Rehobeth Methodist Church and Cemetery from the historic district.

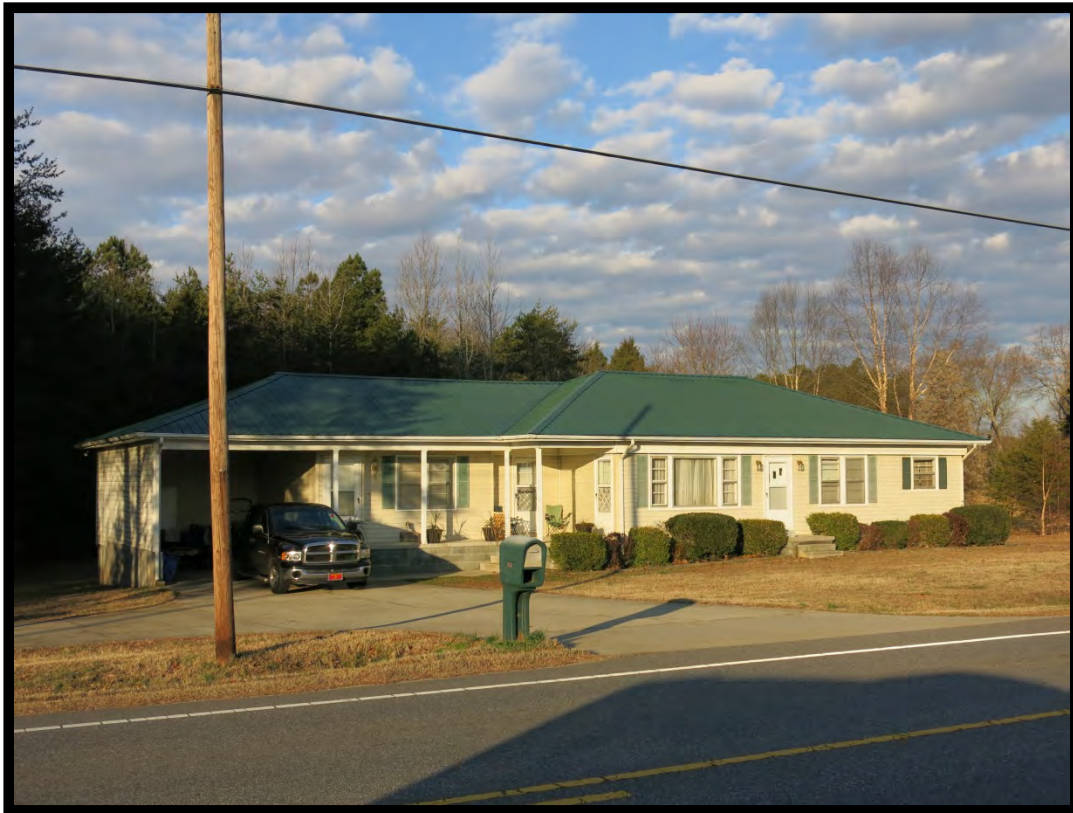
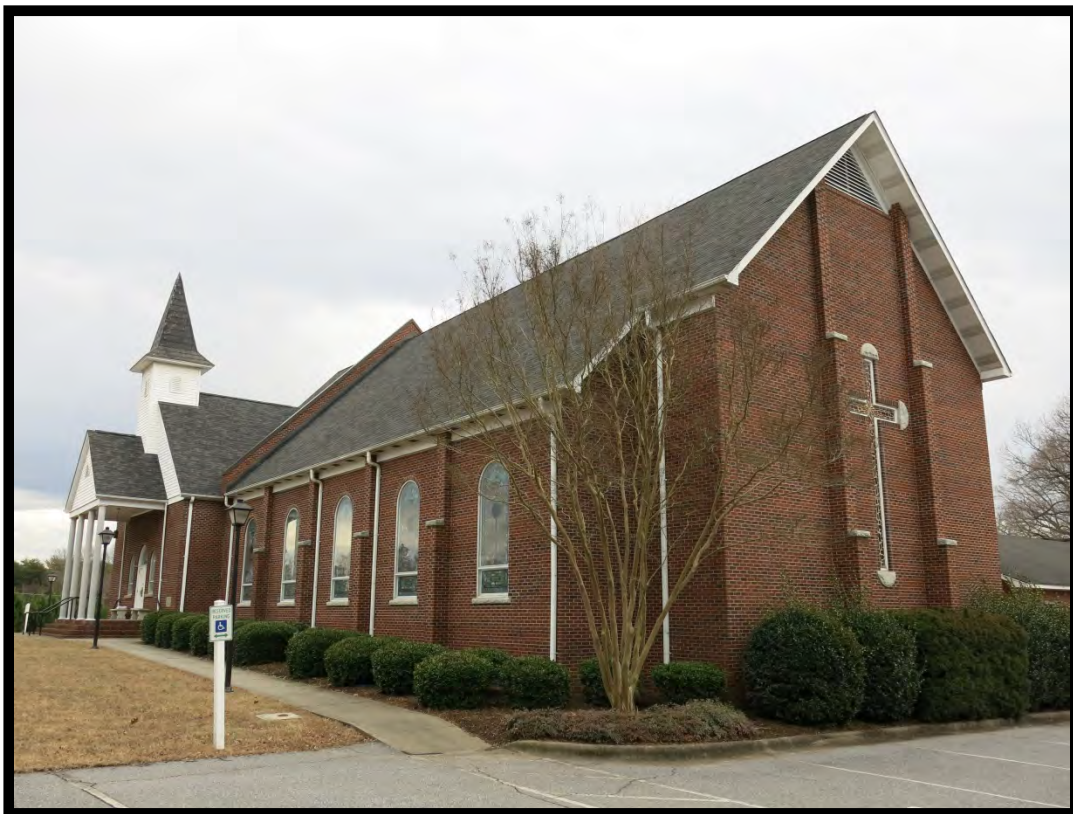
The parsonage was moved approximately one mile up the road to Mott's Grove United Methodist Church in 2006 according to a local resident.⁵ At some point after 1986, a new sanctuary was added to the west elevation of the original sanctuary – the west windows of the original sanctuary were placed in the north elevation of the new sanctuary. A modern shed and carport were also built on the property (Figures 49 and 50).

Figure 49: Rehobeth Methodist Church (#s 93 & 94), Former Parsonage, Looking Northwest. Note moved to new location.

Figure 50: Rehobeth Methodist Church (#s 93 & 94), New Sanctuary (ca. 1986), Looking Southeast.

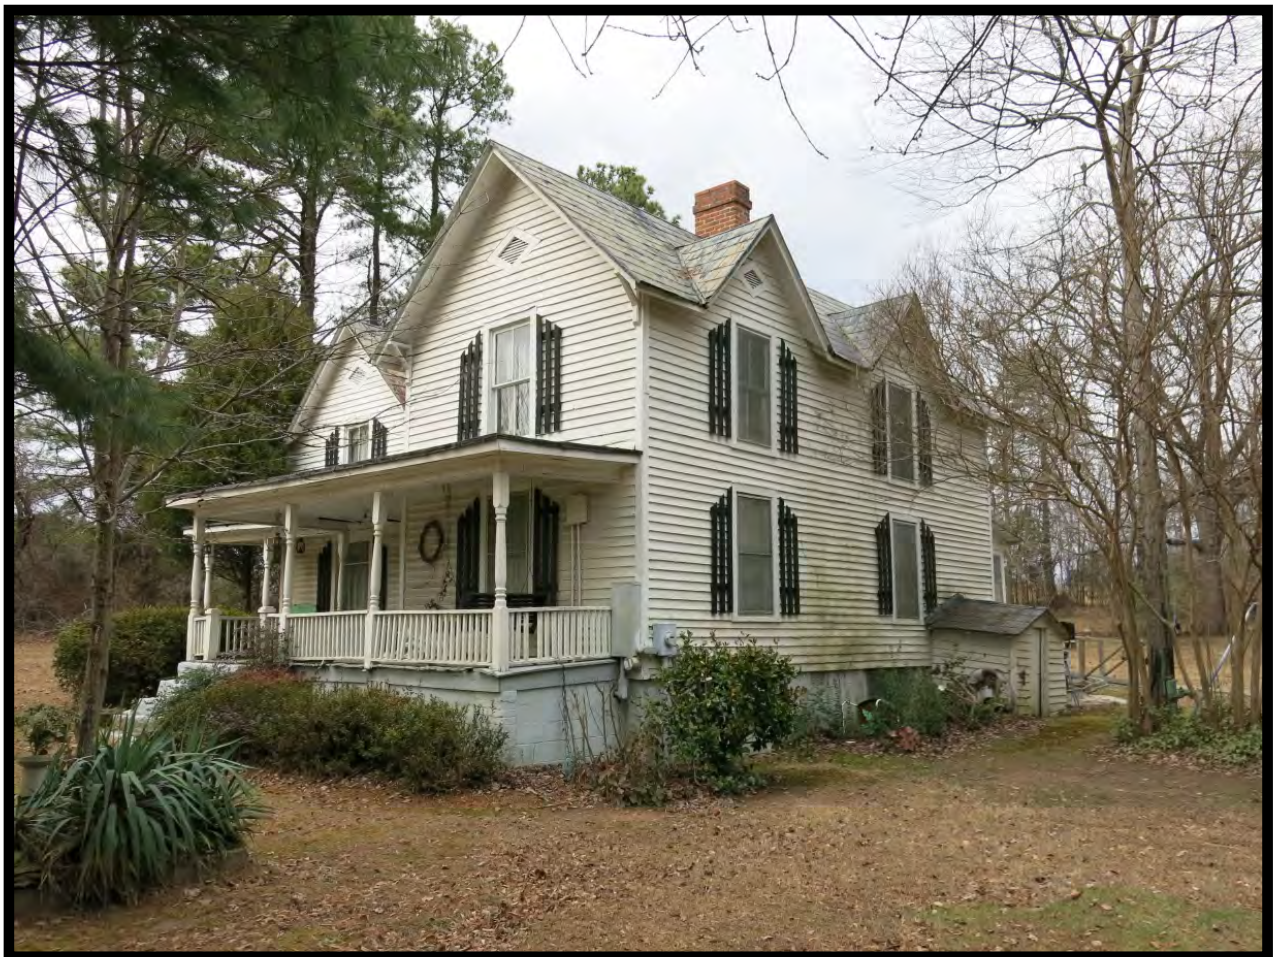
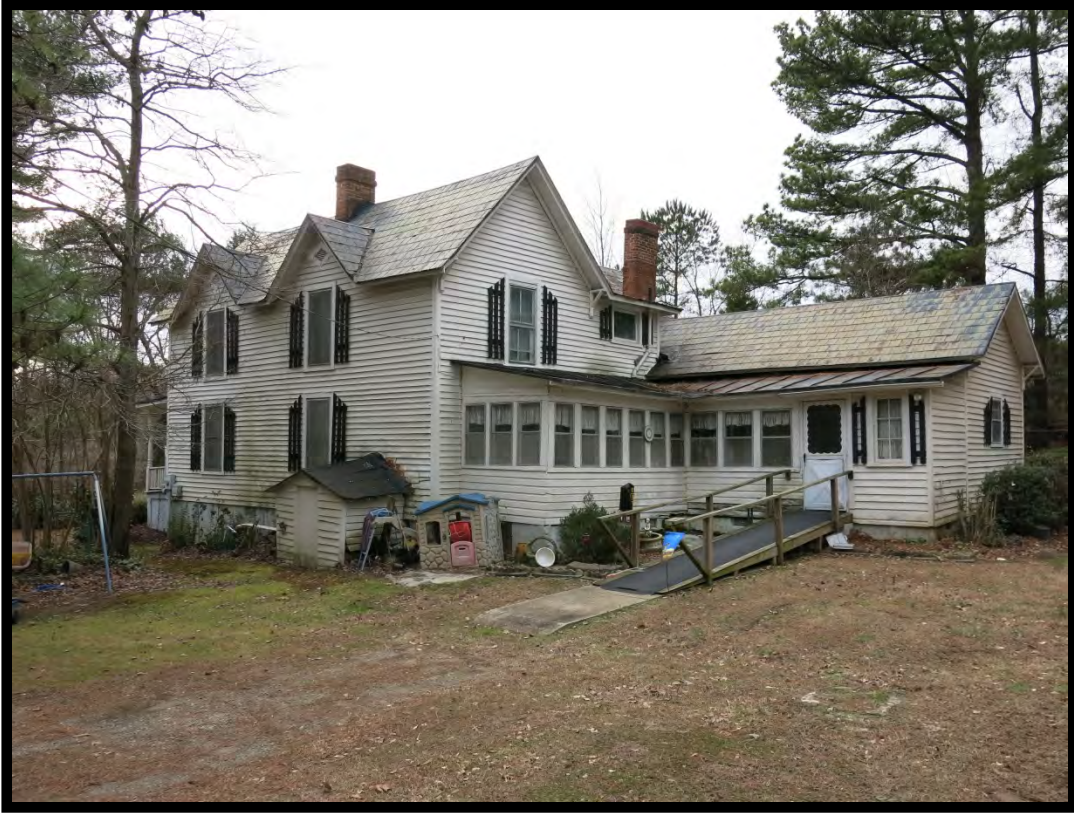
James Gillin is believed to have been the first miller at R. E. Gabriel's grist mill in the early twentieth century. The two-story, frame-dwelling has an irregular footprint with a cross gable and has a front-gabled projecting bay on the southwest (front) elevation of the dwelling. A hip-roofed porch, supported by turned posts, extends along the front elevation and wraps around the projecting bay. The building is clad in plain weatherboard siding and has two-over-two wooden sash windows (Figures 51 and 52).

Figure 51: James Gillin House (# 98) (ca. 1908), Looking Northwest.

Figure 52: James Gillin House (# 98) (ca. 1908), Looking Southwest.

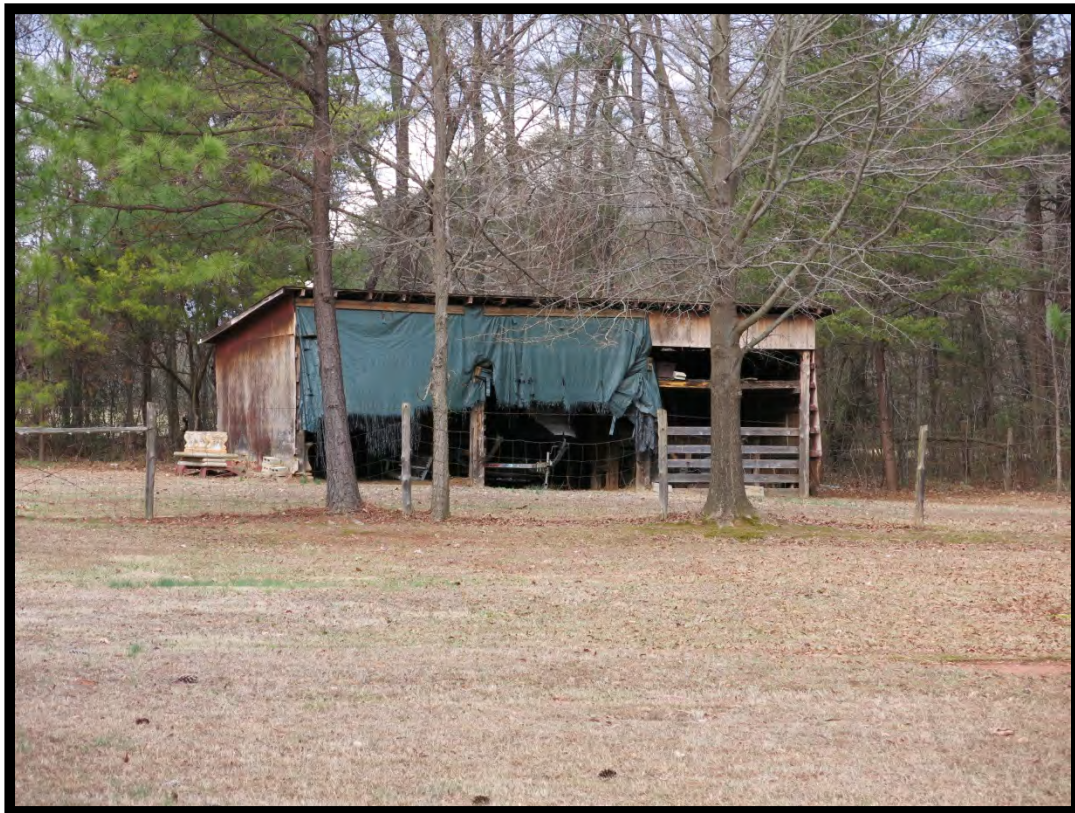
Figure 55: James Gillin House (# 98), Machine Shed, Looking North.

One of the trailers is gone, and an additional machine shed is located to the northeast of the former granary (Figure 55).

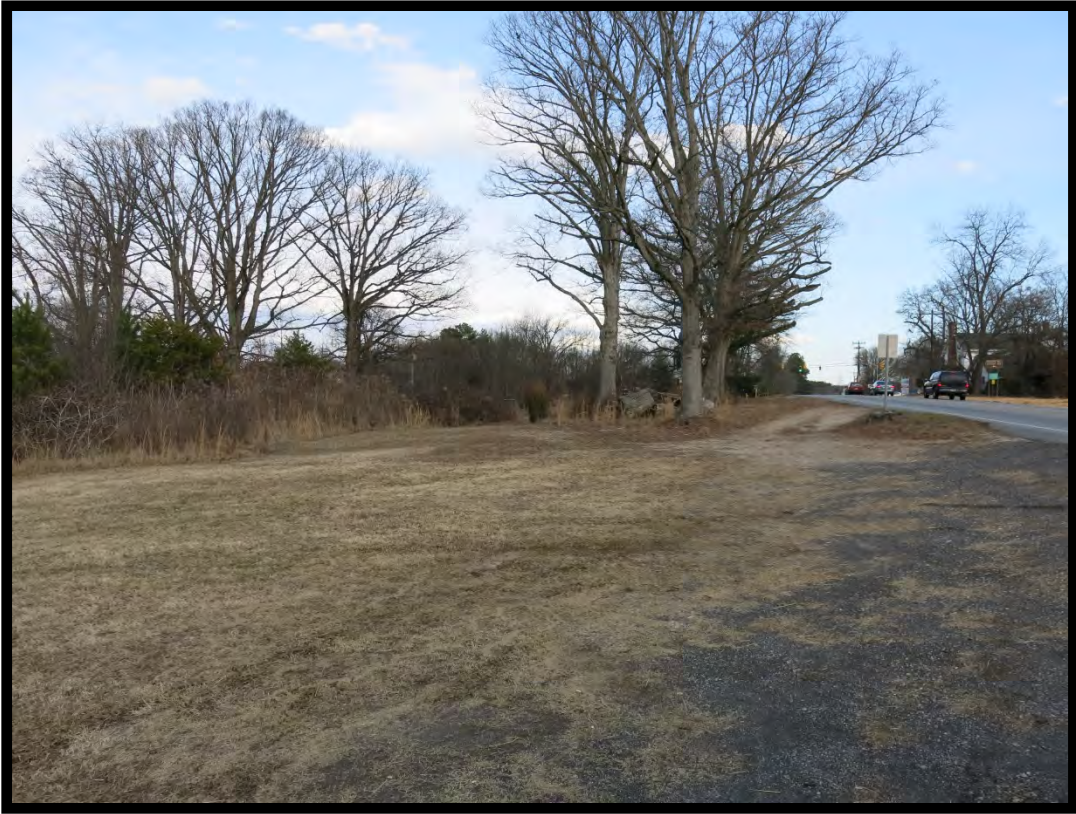
Figure 56: Site of the Gristmill, Gabriel Cotton Gin, and the Cotton Storage Building Looking Northeast.

⁶ Aerial photographs of Terrell on Google Earth suggest they were demolished at some point after 2004.

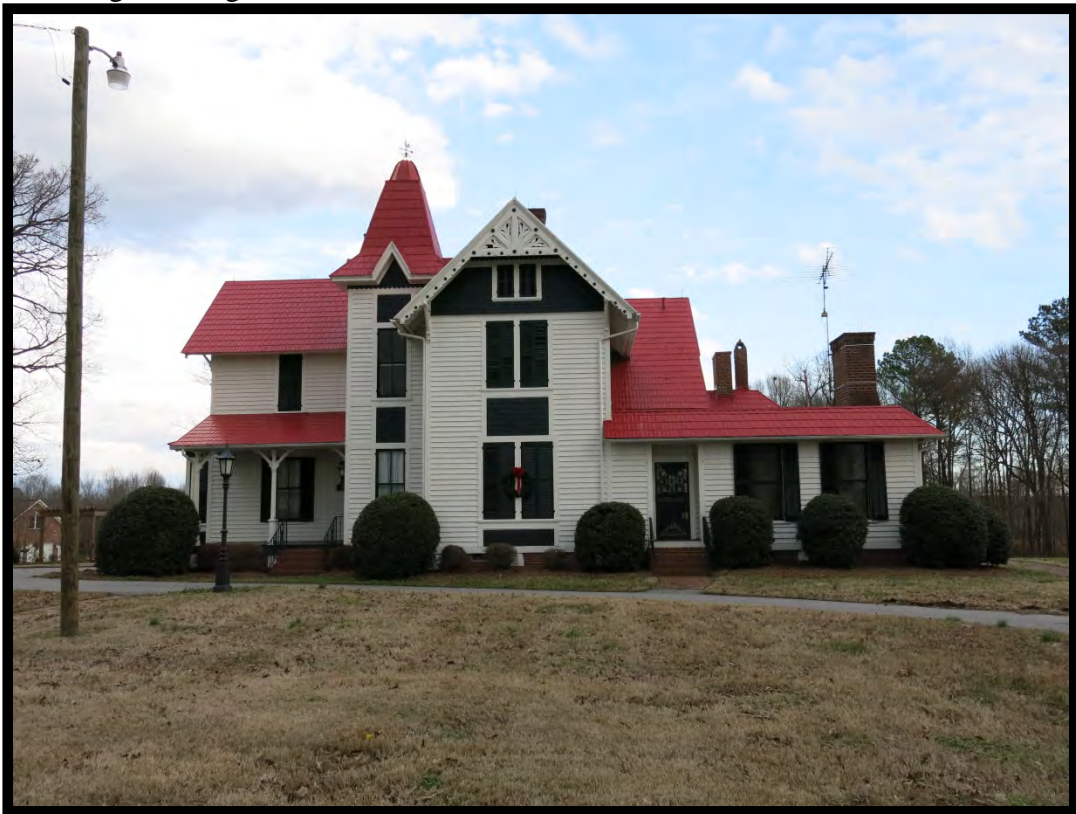
Figure 57: T. F. Connor House (# 89) with One-story Addition to the Right.

The T. F. Connor House (# 89) was considered a pivotal resource in the 1986 NRHP nomination; however, it has been so drastically altered that it is recommended as no longer contributing and not individually eligible. The alterations included the appending of a major addition off the rear elevation and the addition of a one-story wing at the front, which have altered the proportions, setting, and feeling of the property and diminished its ability to convey its historic character.

- The large rear addition and the small side addition on the Connor House have significantly lessened the integrity of the house, and it is appropriate to re-evaluate it as a non-contributing resource.
- The loss of the grist mill, cotton gin and cotton storage building on NC 150 is acknowledged, however, we do not recommend carving that individual piece of property out of the district. The property has not been re-developed, and the farm streetscape along NC 150 still conveys the rural historic character of the district.

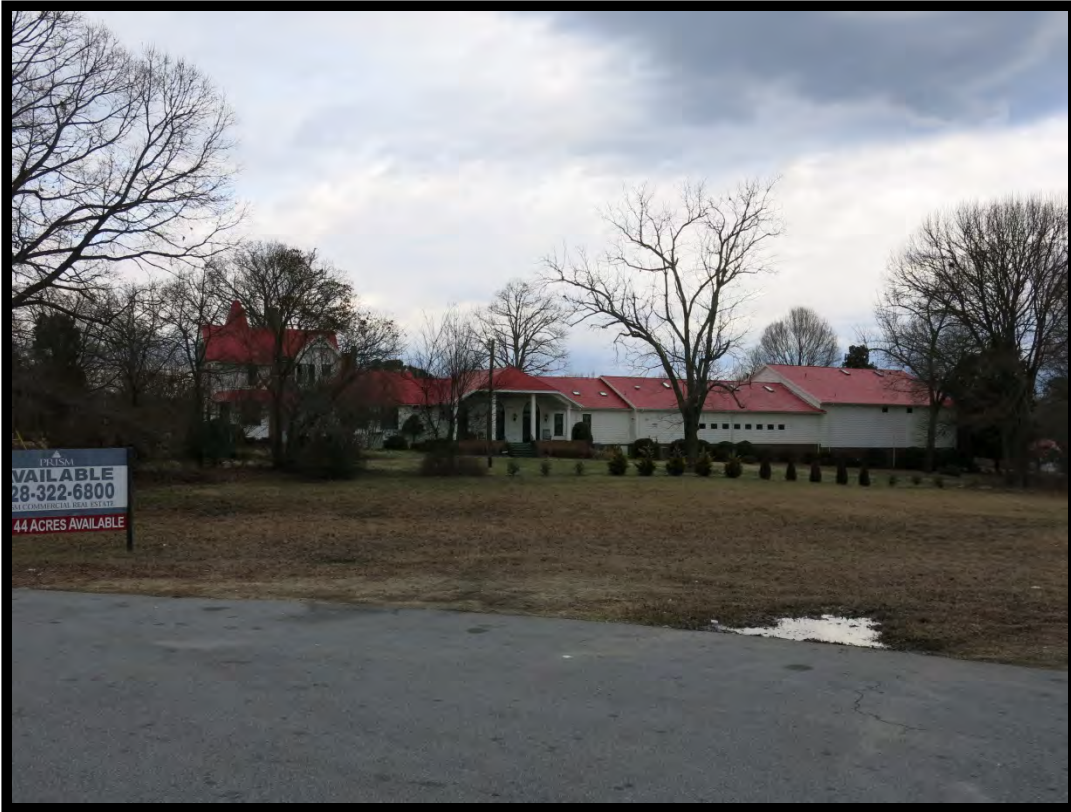
Figure 58: Addition to the T. F. Connor House (# 89), Looking North.

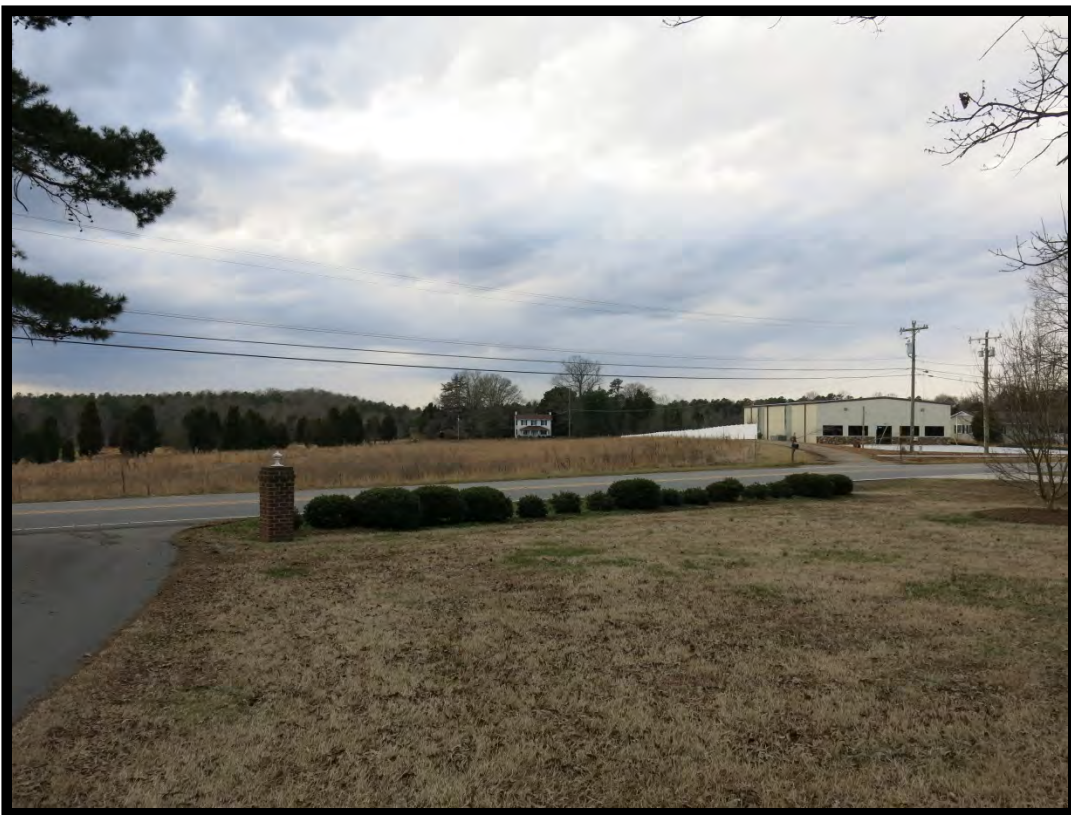
Figure 59: View Towards the Coleman-Caldwell-Gabriel Farm (# 88) with Recent Development to the North Just Outside the Historic District Looking West.

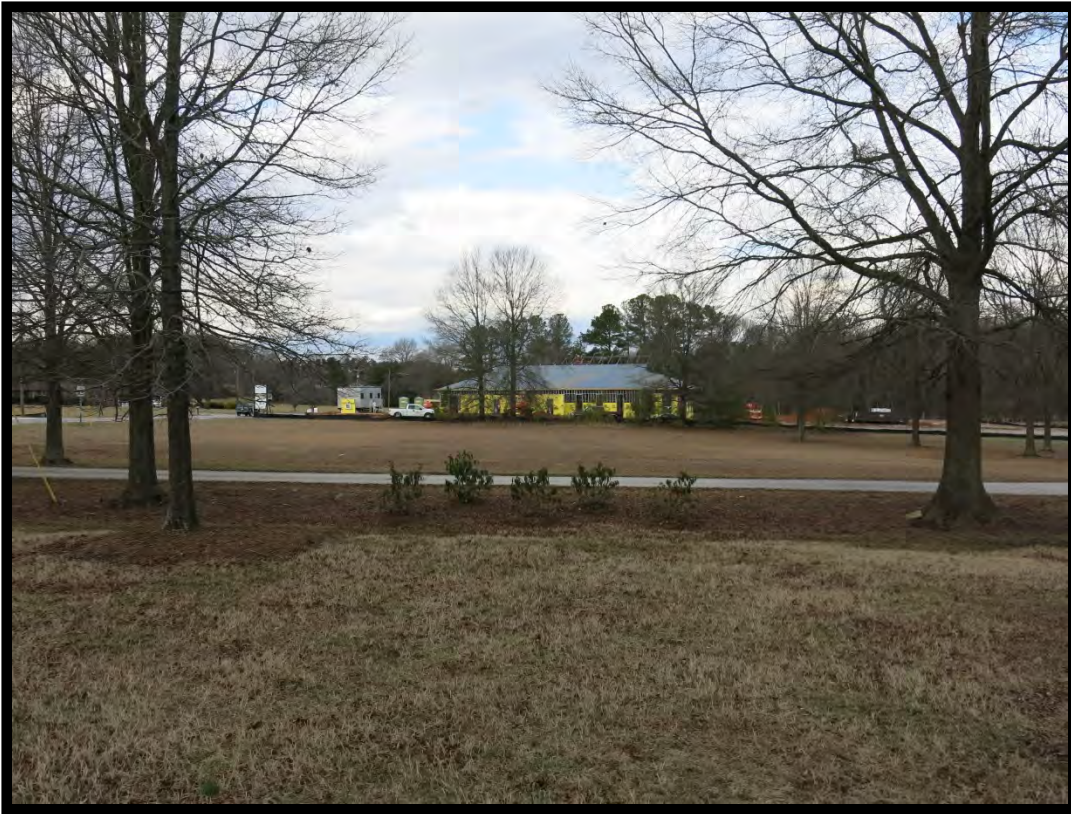
The Terrell Historic District is located in southeastern Catawba County at the intersection of NC 150 and Sherrills Ford Road (SR 1848). The setting is predominantly rural and agricultural with some twentieth-century commercial development along NC 150, although since the initial survey (August 2013) one commercial building has been constructed east of the Coleman-Caldwell-Gabriel Farm (# 88) and one is under construction north of the T. F. Connor House (# 89) (Figures 10 and 11).

Figure 60: New Branch Library North of the T. F. Connor House (# 89) within the Current Historic District, Looking North.

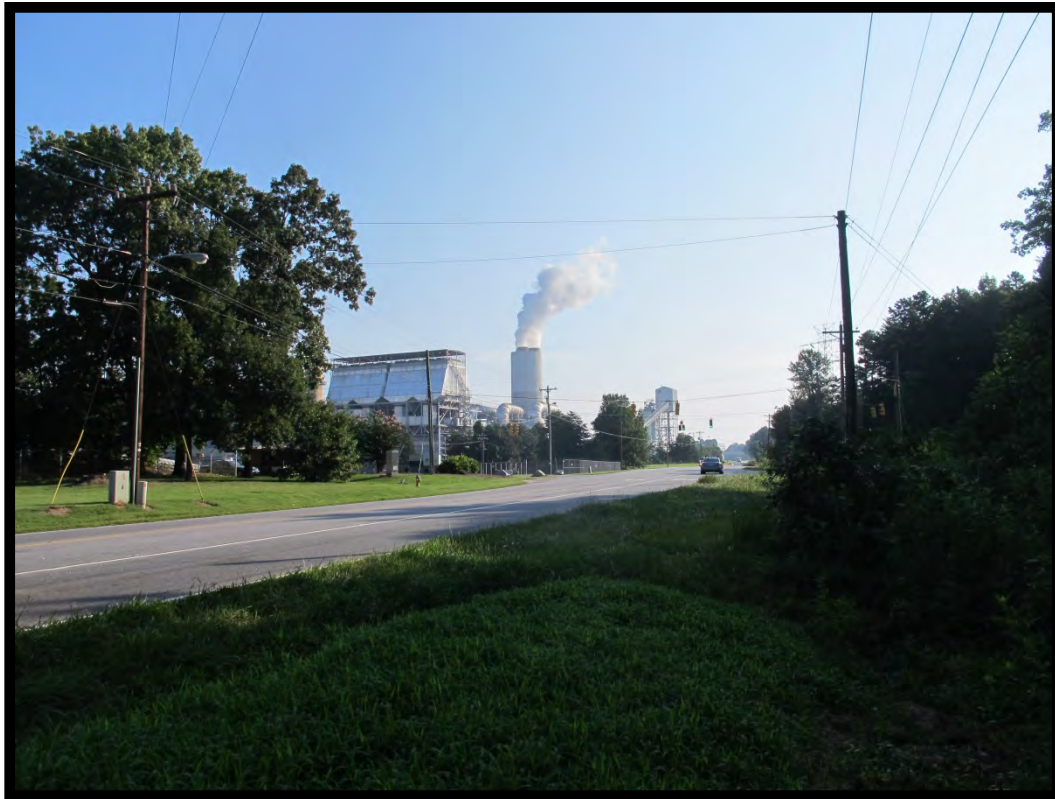
Figure 64: Marshall Steam Station (# 99), Looking Northeast.

The Marshall Steam Station is located on the north side of NC 150, across from Kiser Island Road (SR 1841), between Marshall Road and Greenwood Road (SR 1840). The complex is comprised of numerous structures, the closest of which sits approximately 90 feet back from the road (Figures 64 and 65).

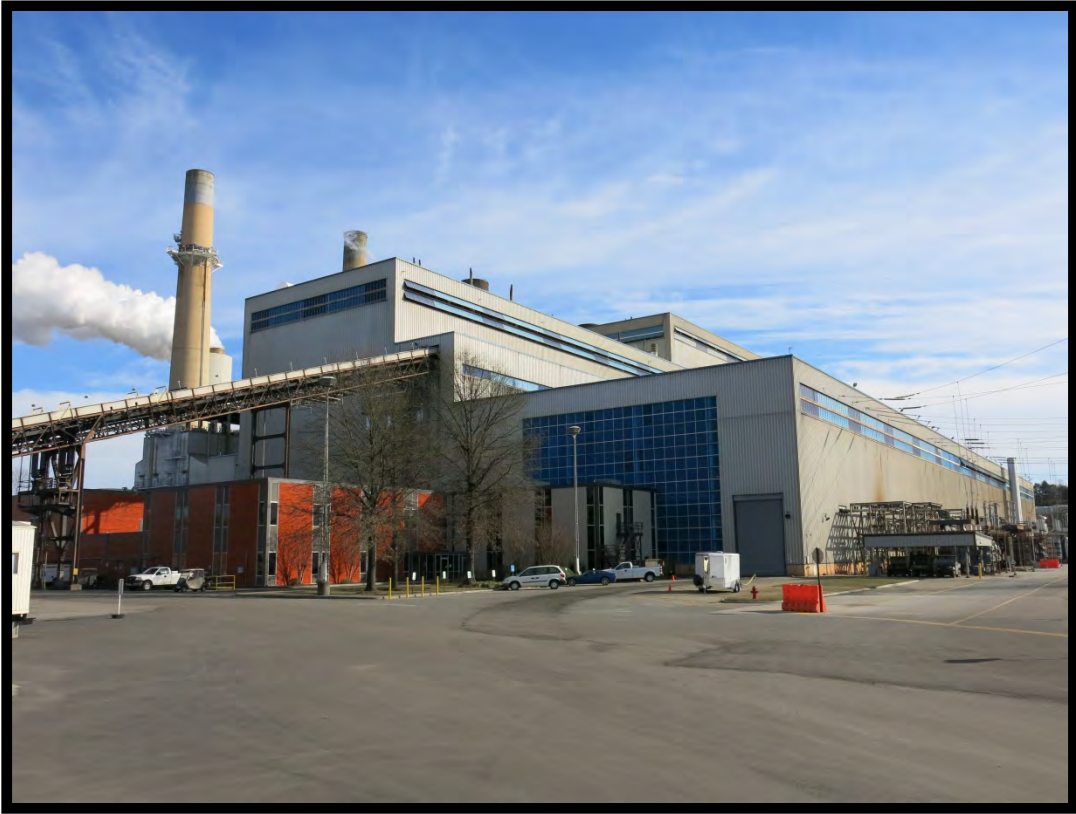
Figure 66: Marshall Steam Station (# 99), Main Building (No. 2), Looking Southeast.

The Marshall Steam Station consists of four power-producing units contained in one rectangular, flat-roofed, multi-story, utilitarian-styled building, constructed between 1965 and 1970 (No. 2 – Figure 66). The main building is a steel-frame building with metal siding and ribbons of two-light awning windows along the upper edges of the structure. Located to the northeast of the main building are the four original chimneystacks, which vented the four coal-burning units. Attached to the northwest elevation of the main building is a two-story flat roofed office building clad in orange glazed bricks (No. 1 – Figure 67). Bays with double casement windows and dark-grey panels alternate with the brick sections, and accentuate the northwest corner of the building. A system of conveyor belts transports coal from the coal pile located to the northwest of the main building to one of the four coal bunkers and mills inside the main building, which pulverize the coal to the fineness of talcum powder before it is burned in the boilers (Figure 68). To comply with stricter emission standards the station has been updated between 2006 and 2008.

The main building contains four coal-burning units (Units 1-4). Each unit consists of a coalbunker, which receives the coal that is transported from outside the building, and a coal mill, which pulverizes the coal before it is burned in the boiler. The bunkers and mills for each unit are located at the center of the main building. Located to the east in the tallest section of the building are the boilers, which generate the steam to drive turbines. The turbines and generators are located to the west of the coalbunkers and mills in the lowest section of the building. The turbines for Units 1 (built 1965) and 2 (built 1966) each generate 400 megawatts and Units 3 (built 1969) and 4 (built 1970) generate 700 megawatts each.
