North Carolina Department of Cultural Resources
State Historic Preservation Office

SUBJECT: Historic Structures Survey Report for the Widening of NC 150 from NC 16 Bypass to I-77, R-2307, Multi County, ER 12-2211

NCR-0190

APRIL 2014

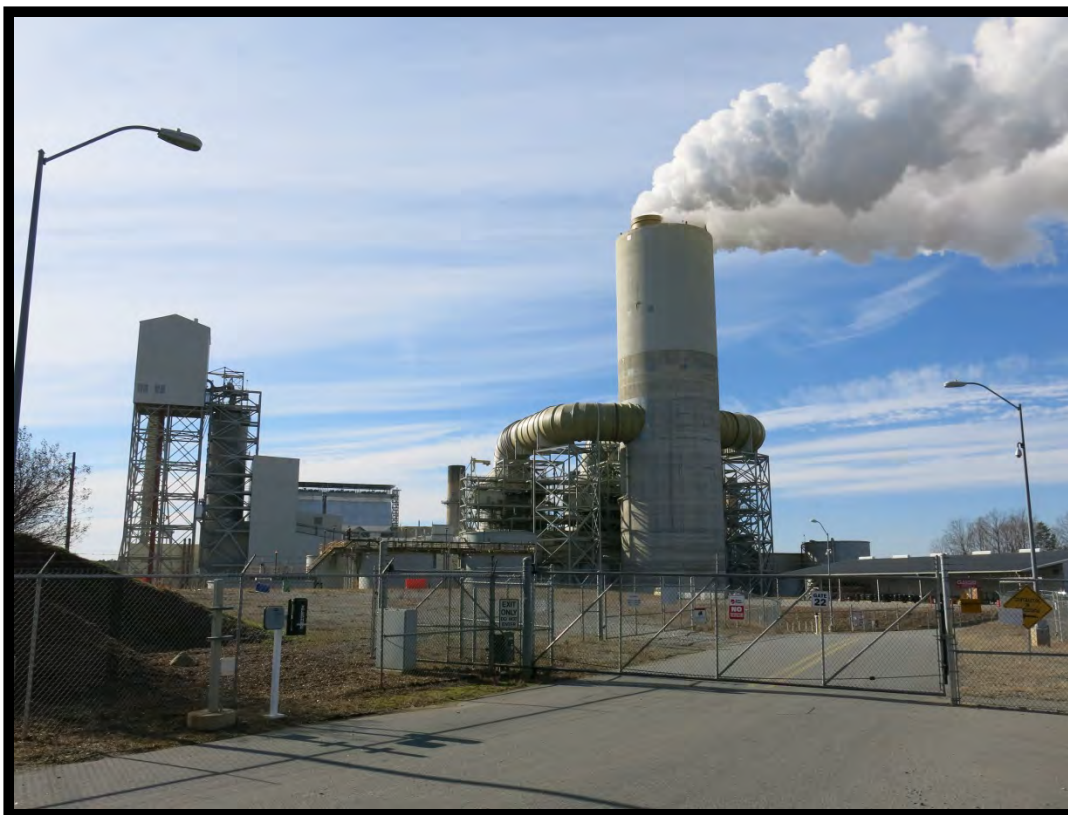
Figure 69: Marshall Steam Station (# 99), Scrubber Elements (No. 3), Looking West.

Flue gas desulfurization equipment, commonly known as scrubbers, was installed between 2006 and 2007 to the west of the original station (No. 3 – Figure 69). It diverts the exhaust from the boilers, which originally went up the chimneystacks, leading it to a much larger freestanding chimneystack and lowers the station's sulfur dioxide emissions. A byproduct of the scrubbing process is gypsum, which can be used for drywall and which is transported around the site via a system of conveyors to a collection area west of the coal pile. In 2008 an electrostatic precipitator was built against the southeast elevation of the main building to provide an additional emissions control for two of the units (Figure 70).

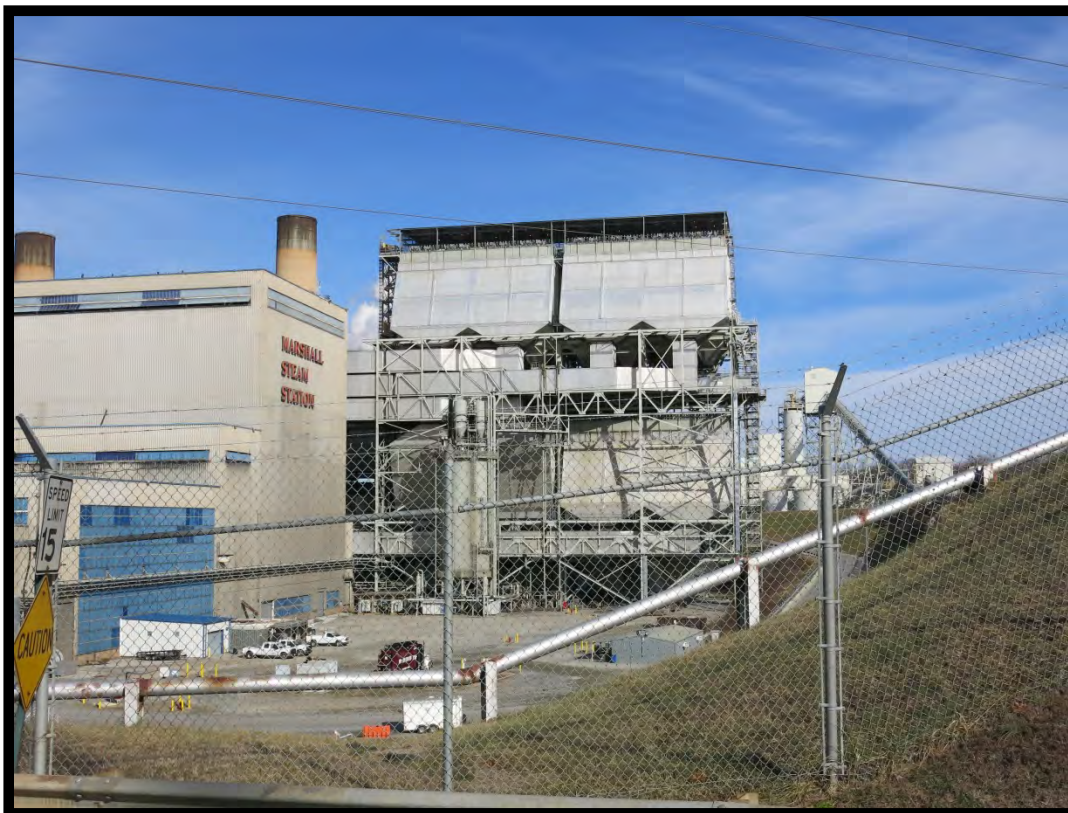
Figure 70: Marshall Steam Station (# 99), Precipitator for Units 3 & 4 (No. 4), Looking Northeast.

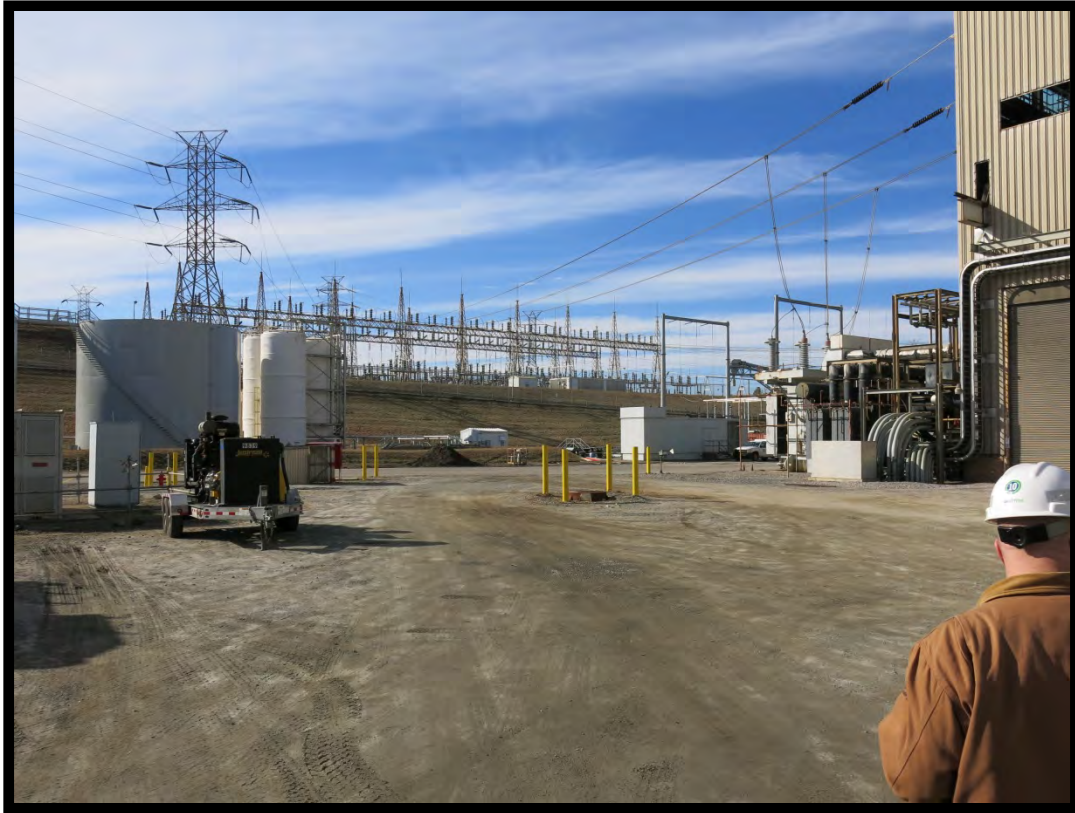
Figure 71: Marshall Steam Station (# 99), Fuel & Urea Tanks (left) and Switchyard (center), Looking West.

Located around the site are several other structures associated with the operation of the steam station and the distribution of the power to the main grid. Located to the northeast of the station are a warehouse and a tractor shed, and to the west are fuel and urea tanks (No. 7) and the switchyard; the latter relays the power from the station to the main grid (Figure 71, the former two were not photographed).

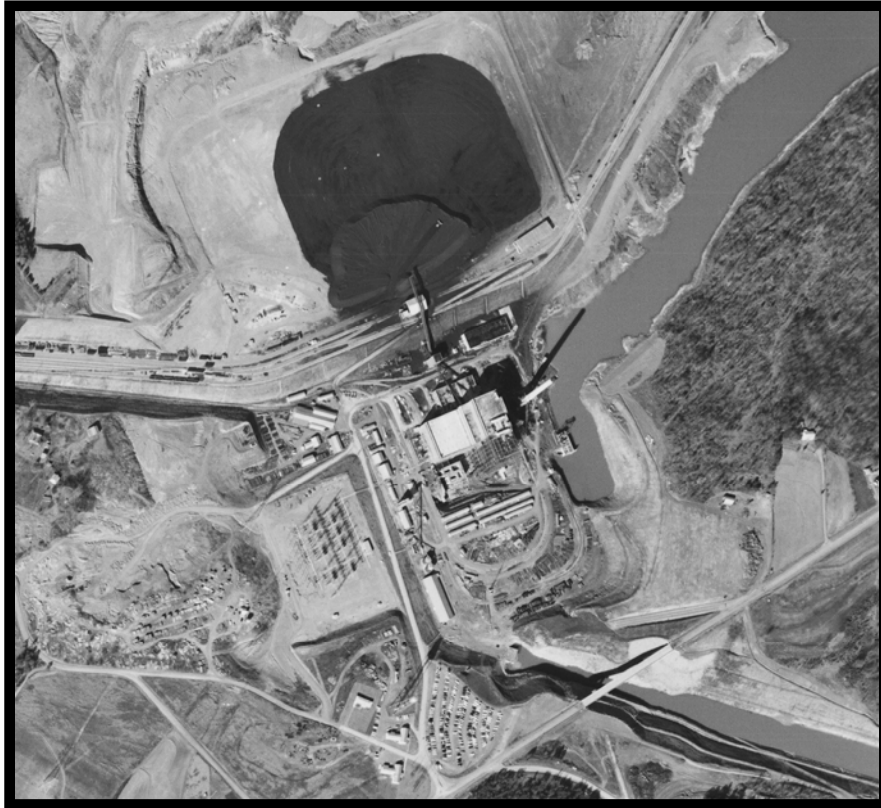
Figure 72: Marshall Steam Station (# 99), Detail of 1965 Aerial Showing Unit 1 (USGS EarthExplorer 2014a).

The Marshall Steam Station went into operation in 1965. It is a four-unit, coal-fired generating facility named after former Duke Power president E. C. Marshall. The first unit was constructed in 1965, the second in 1966, the third in 1969, and the fourth in 1970 (Figures 72 and 73). Duke Energy engineers provided the research and design plans for the steam station, whereas the boilers were built by Combustion Engineering and the turbines by General Electric.⁷ The Marshall Steam Station is among the most efficient power plants in the nation and generates enough electricity (2,090 megawatts) to power approximately two million homes. A unique type of burner arrangement in the boilers keeps the nitrogen oxide emissions well below regulatory limits, and between 2006 and 2007 flue gas desulfurization equipment was installed – commonly known as scrubbers – which lowered the station’s sulfur dioxide emissions by approximately 95 percent.⁸ In 2008, an electrostatic precipitator was built, which provides an additional emissions control for Units 3 and 4.⁹

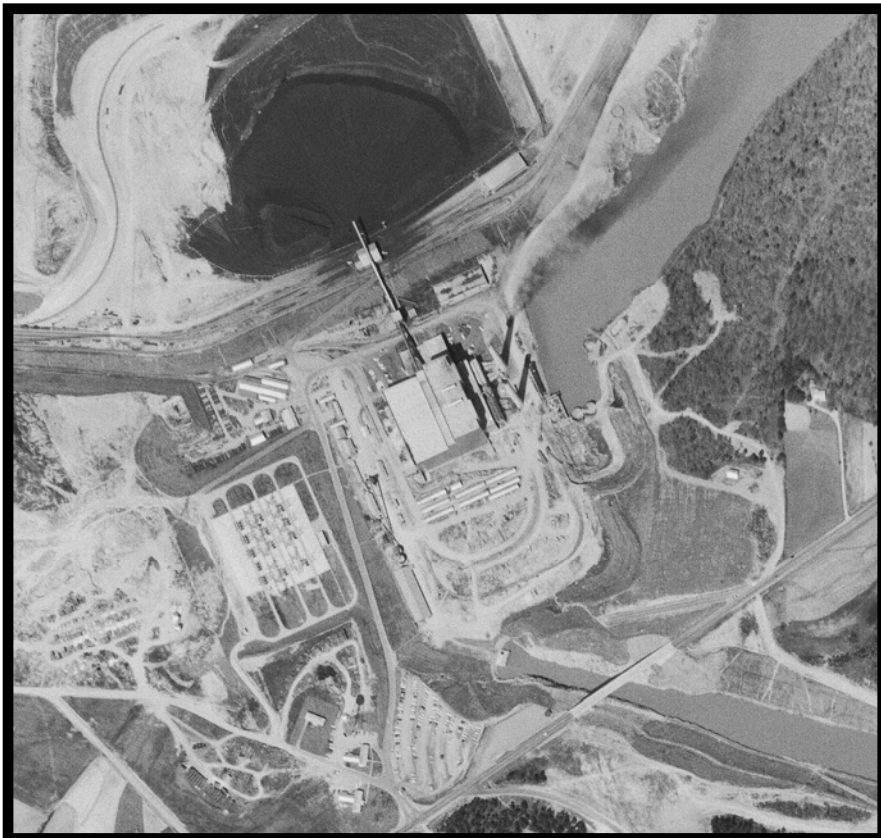
Figure 73: Marshall Steam Station (# 99), Detail of 1966 Aerial Showing Unit 1 & 2 (USGS EarthExplorer 2014b).

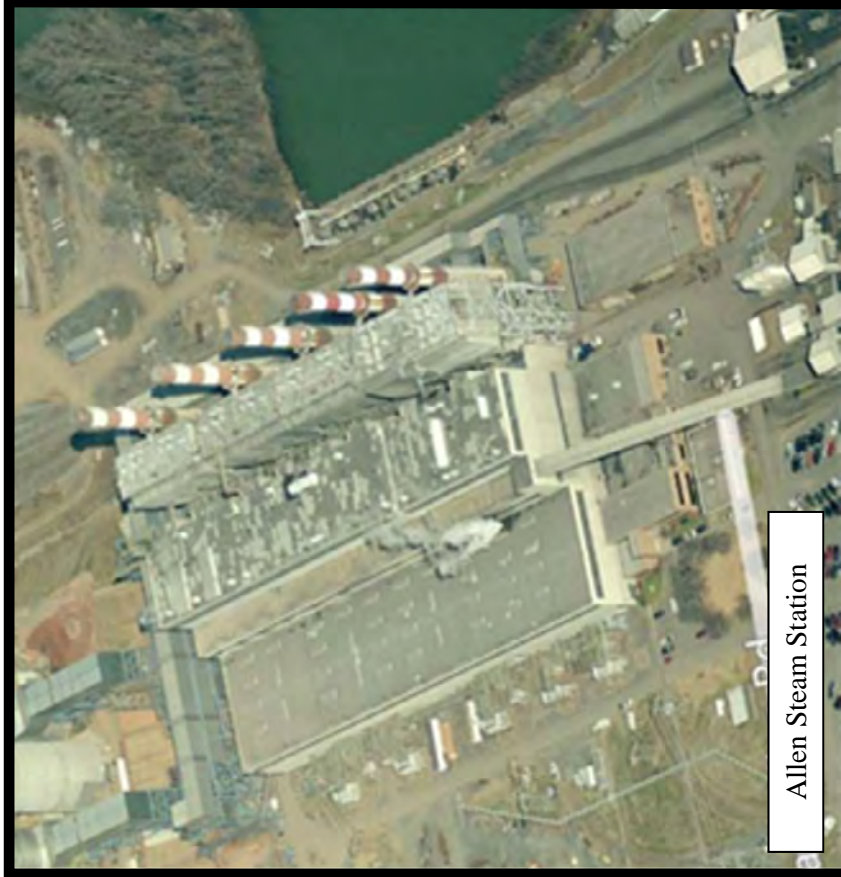
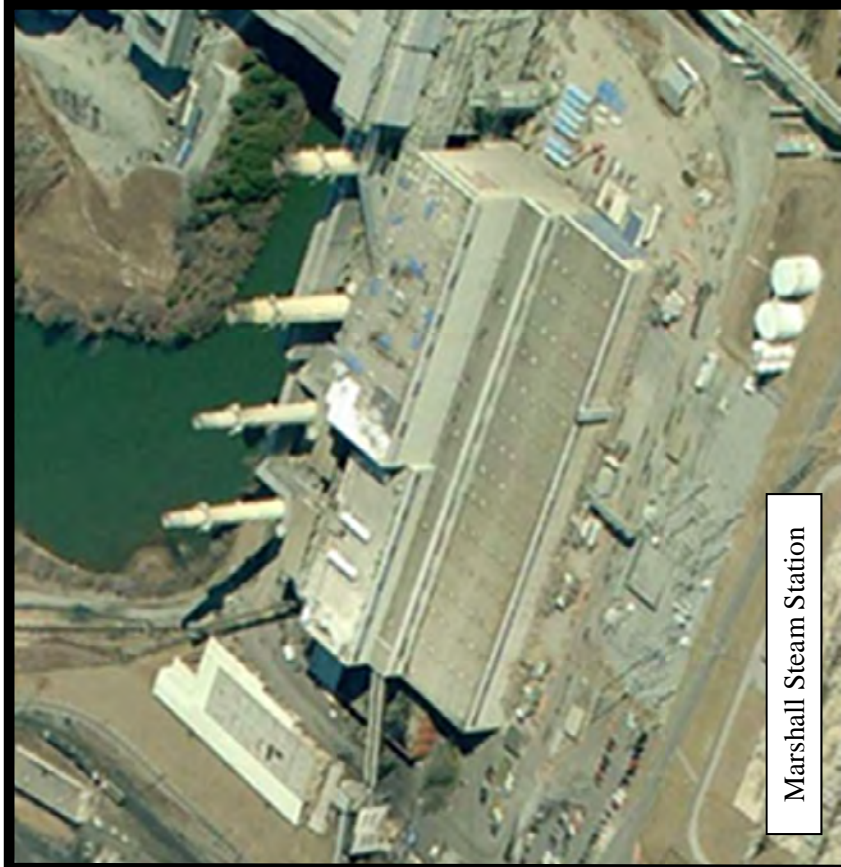
Figure 74: Birdseye Views of the Allen and Marshall Steam Plants (Bing Maps).

Despite its high level of integrity and the fact that the station embodies the distinctive characteristics of a twentieth-century coal-fired power plant in its design and method of construction, there are other examples of this type of architecture still in existence. These include the nearby Allen Steam Station located approximately 45 miles south in Gaston County, which predates the Marshall Steam Station by eight years, and which follows a similar design and relies on similar technology. Both the Allen and Marshall Steam Stations are examples of post-World War II utilitarian structures, designed by Duke Energy engineers (Figure 74). Both have undergone improvements to reduce emissions, but their main components remain the same. The Allen Steam Station has five coal-fired units, which for practical purposes are identical to those at the Marshall Steam Station, consisting of a hopper and pulverizer, a boiler, and a turbine. The Marshall Steam Station does not represent a breakthrough in methods of construction or technology for the production and distribution of electricity and is therefore not recommended eligible under Criterion C.

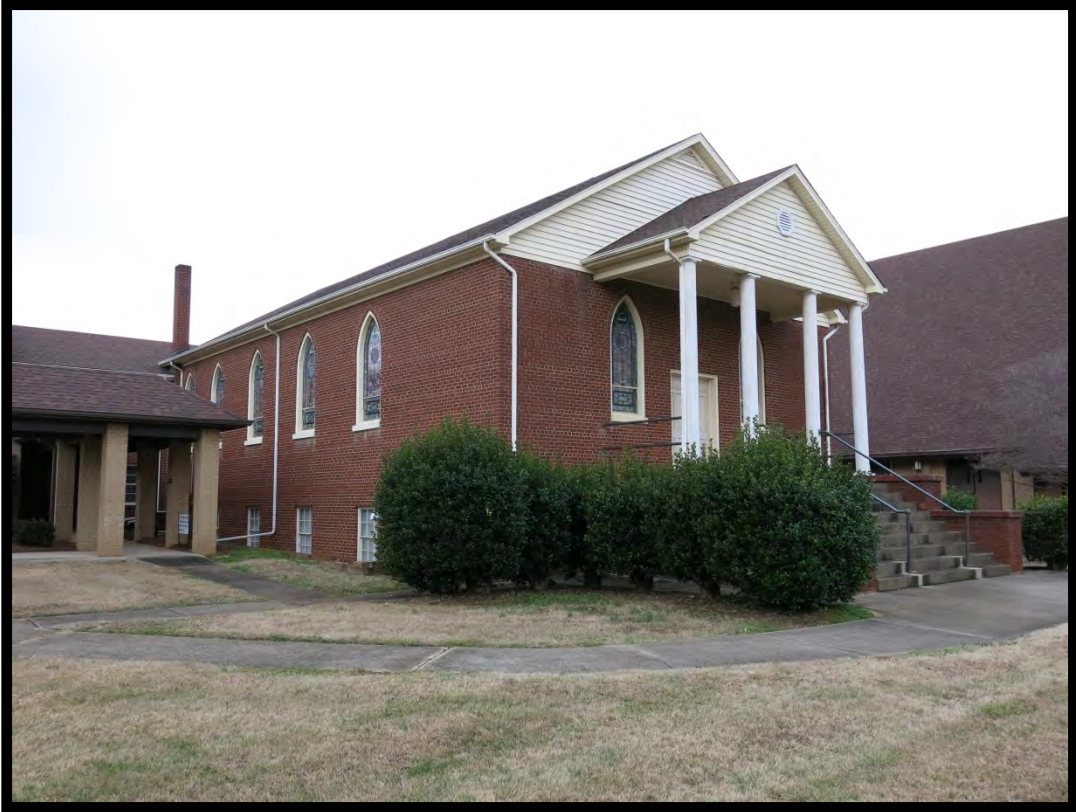
Figure 77: Berea Baptist Church (# 111), Original Sanctuary (ca. 1951), Looking Southwest.

door and two pointed-arched windows on the northeast (front) gable end (Figure 77). A two-story, gable-roofed Sunday School/office building runs perpendicular to the sanctuary across the southwest (rear) gable end (Figure 78). In 1979 a new sanctuary was built northwest of the original sanctuary (Figure 79). It connected, via a one-story vestibule and office wing across southwest (rear) gable end of the new sanctuary, to the northwest gable end of the former Sunday School (Figure 80). The new education building/fellowship hall was constructed in 1996 off the southeast gable end of the original Sunday School completing the current complex (Figure 81).

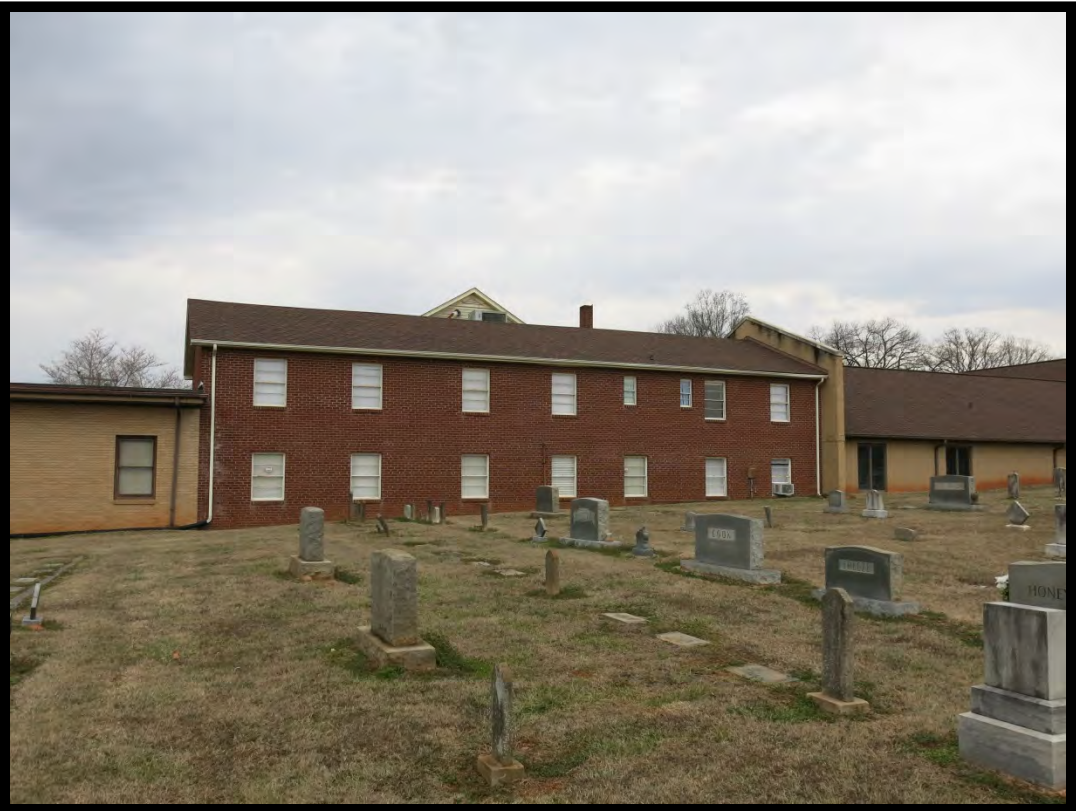
Figure 78: Berea Baptist Church (# 111), Sunday School/office wing, Looking Northeast.

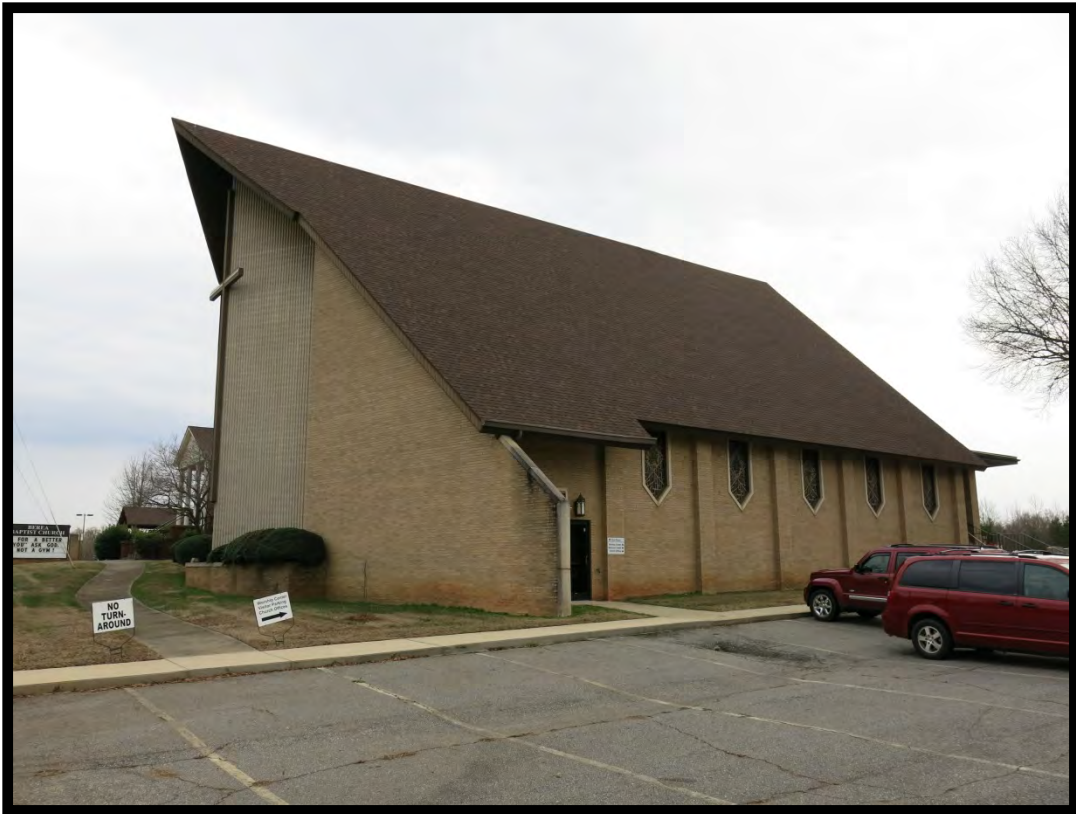
Figure 79: Berea Baptist Church (# 111), New Sanctuary (1979), Looking Southeast.

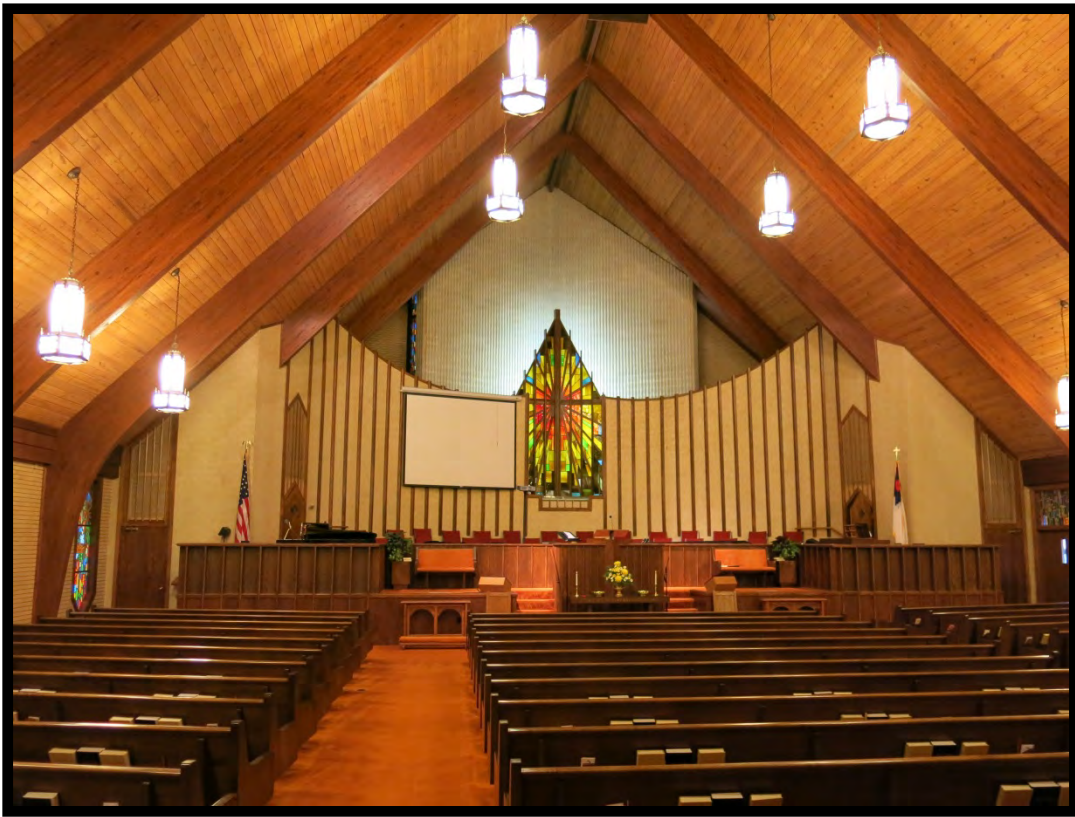
Figure 83: Berea Baptist Church (# 111), Interior of the New Sanctuary (1979) Looking Northeast Towards the Altar and Baptistry.

After the new sanctuary was built, the original sanctuary was converted into additional Sunday School classrooms (Figure 82). The layout of the new sanctuary consists of a large rectangular open plan with the altar and a large baptistry at the northeast end, and a separate vestibule at the southwest end. The roof structure is exposed on the interior and consists of crucks supporting the roof (Figures 83 and 84).

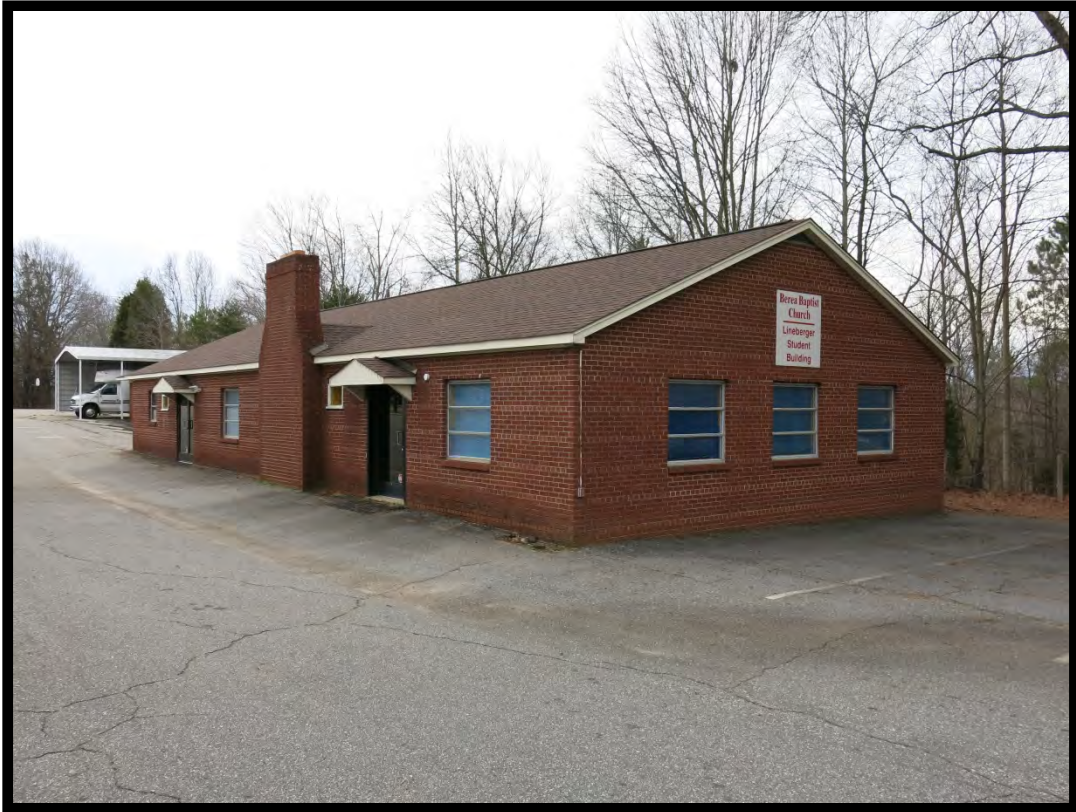
Figure 85: Berea Baptist Church (# 111),Original Fellowship Hall (ca. 1961), Looking Southwest.

Located to the west of the new sanctuary is the original fellowship hall built in 1961 (Figure 85). It is a one-story, side-gabled building with steel three-light awning windows and five-over-one common bond brick walls. Located to the northeast of the original fellowship hall is a small brick well house, and to the southwest are a front-gabled brick garage/workshop and a modern gable-roofed carport (Figures 86 and 87). Located to the southeast of the new fellowship hall is a small modern pyramid-roofed picnic shelter (Figure 88)

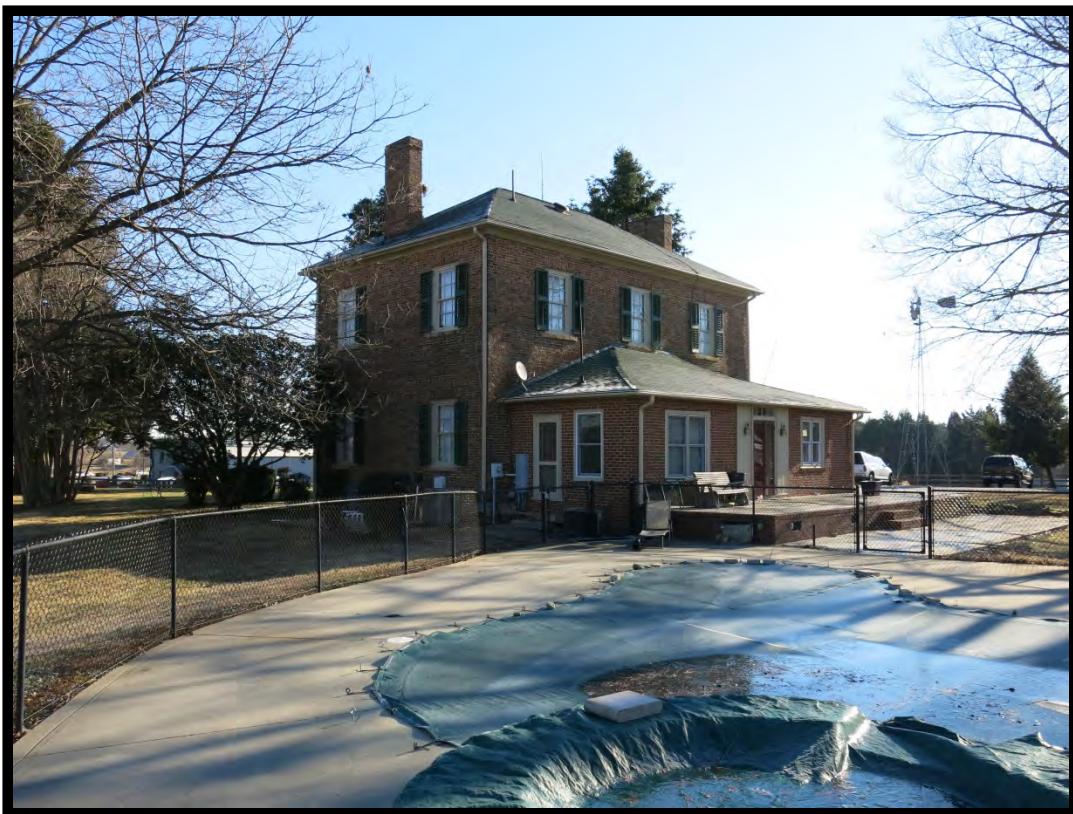
Figure 94: Johnson-Neel House (#123), Looking Northeast. Note the section with the enclosed porch is the original front elevation of the dwelling.

The Johnson-Neel House is a two-story, three-bay, hip-roofed brick house. The walls are laid in Flemish bond, and it has six-over-six wooden sash windows with flat arches. The building originally faced southwest, but at some point the northeast (rear) elevation became the front elevation when River Highway (NC 150) became the main thoroughfare. At that point the original one-story front porch was removed, leaving behind traces of its placement and scale (Figures 93 and 94). Early photographs show a hip-roofed porch, supported by short classical columns on brick pedestals, with a pedimented section at the center of the northeast (front)

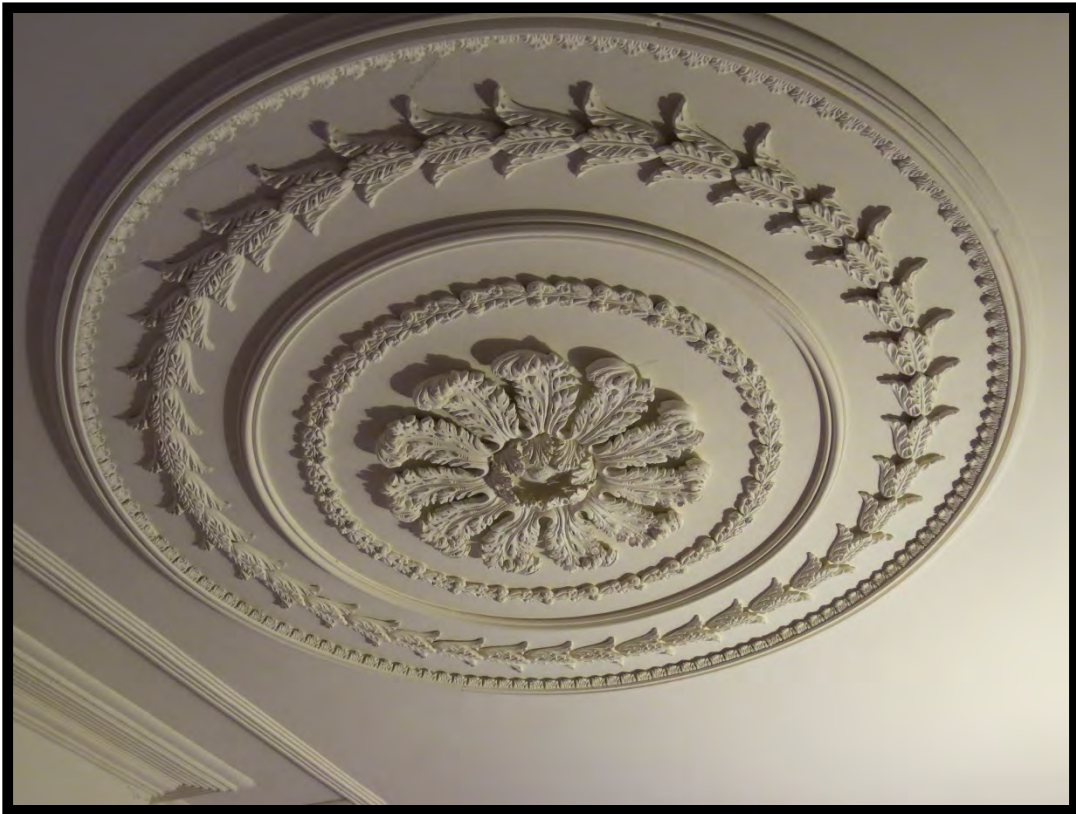
Figure 95: Johnson-Neel House (#123), Interior: Detail of Five-part Circular Medallion in Northwest Room.

The Johnson-Neel House has a central hall, with a single chamber to the northwest of the passage and two equally sized rooms to the southeast. The original double entrance doors in the southwest (current rear) elevation give access to the hall and have a transom with tracery. A cantilevered Federal style stair leads to the second floor. The design of the stair is similar to a design in Owen Biddle's *Young Carpenter's Assistant* (1805) and is typical of the work of local builder Jacob Stirewalt. Stirewalt's hand is also seen in the unusual molded baseboards, which can also be found at nearby Mount Mourne, the Maxwell Chambers House, and Mill Hill, each attributed to Stirewalt, and the latter being his home. The northwest chamber is the most refined and has a ceiling with a five-part circular medallion and a wide molded plaster cornice, and a large Federal style mantel (Figures 95 through 99).

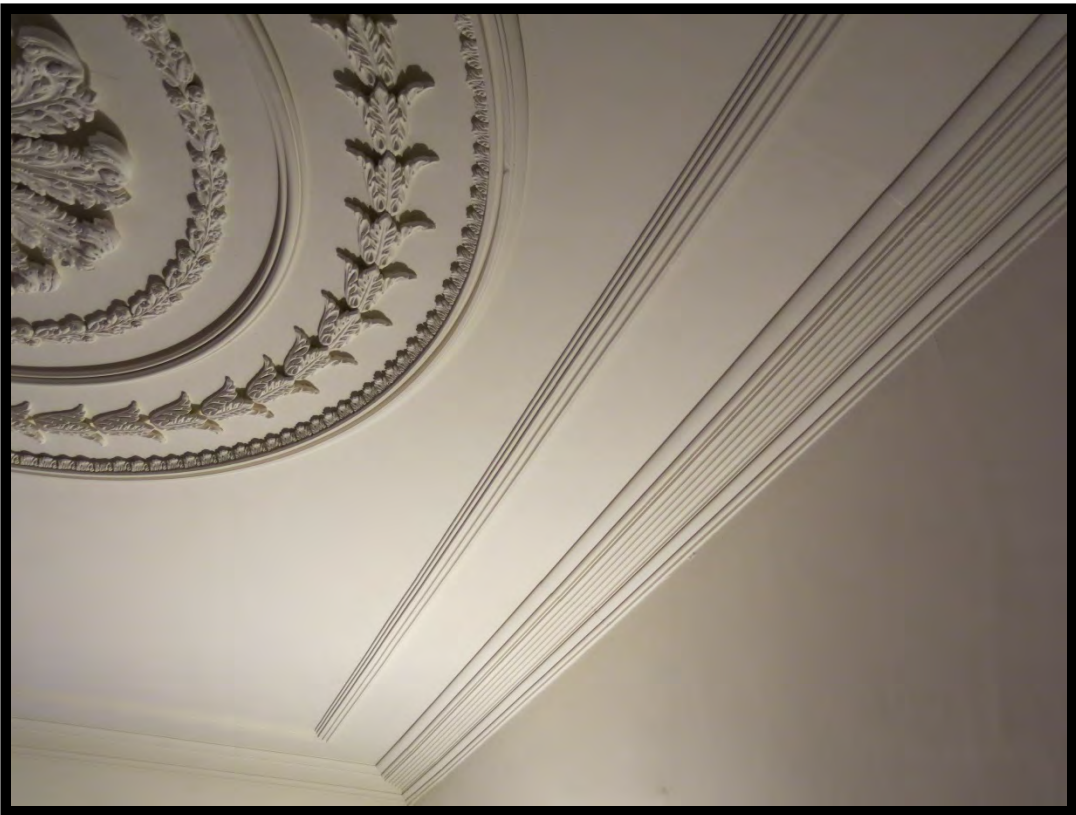
Figure 96: Johnson-Neel House (#123), Interior: Detail of Medallion and Molded Plaster Cornice in Northwest Room.

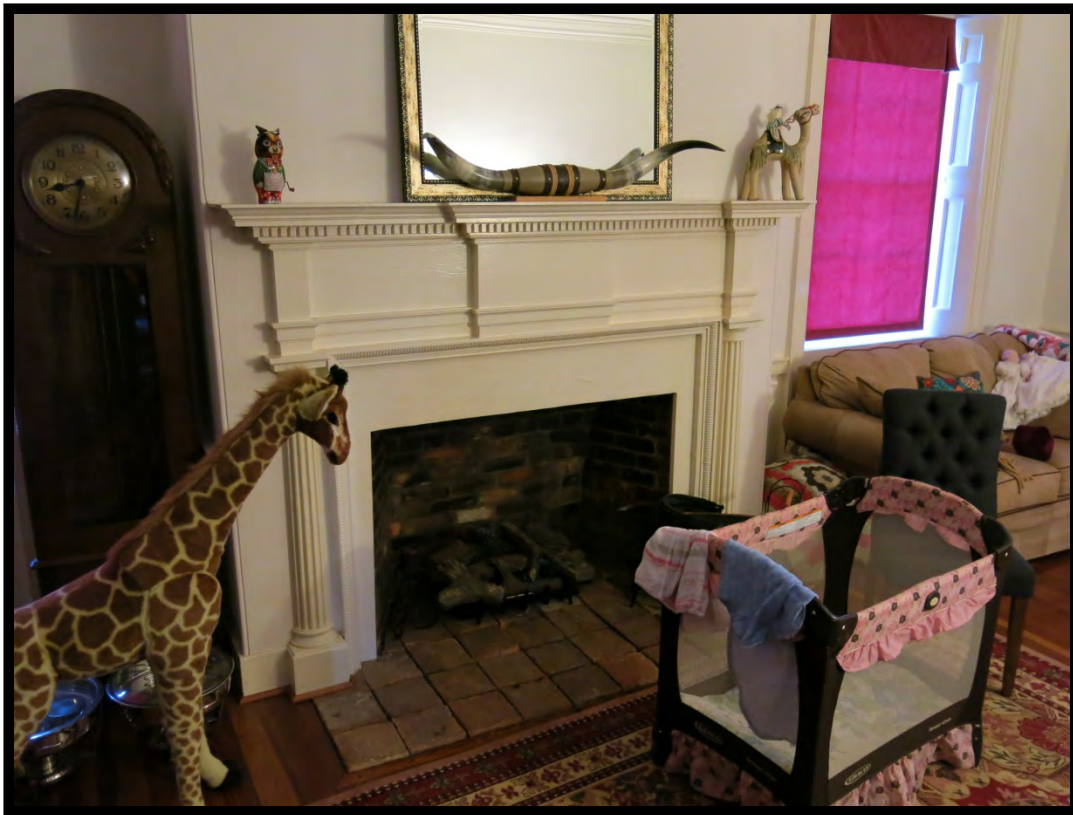
Figure 97: Johnson-Neel House (#123), Interior: Detail of Federal-style Mantel in Northwest Room.

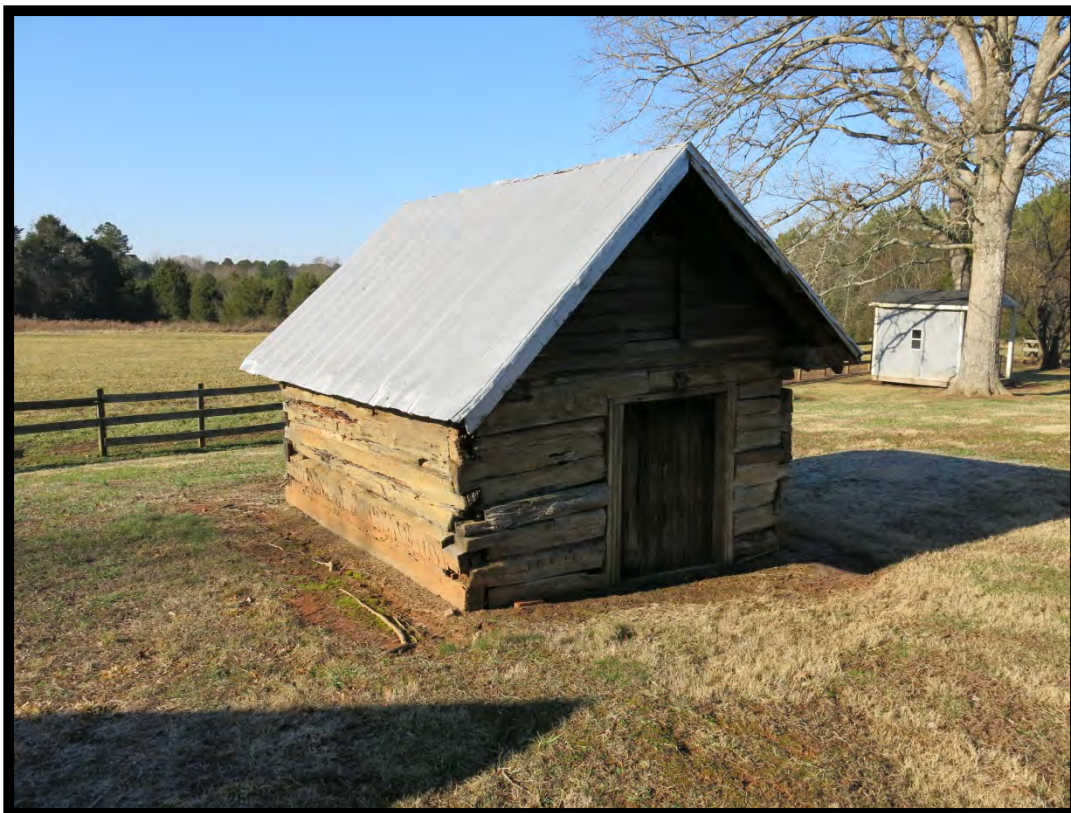
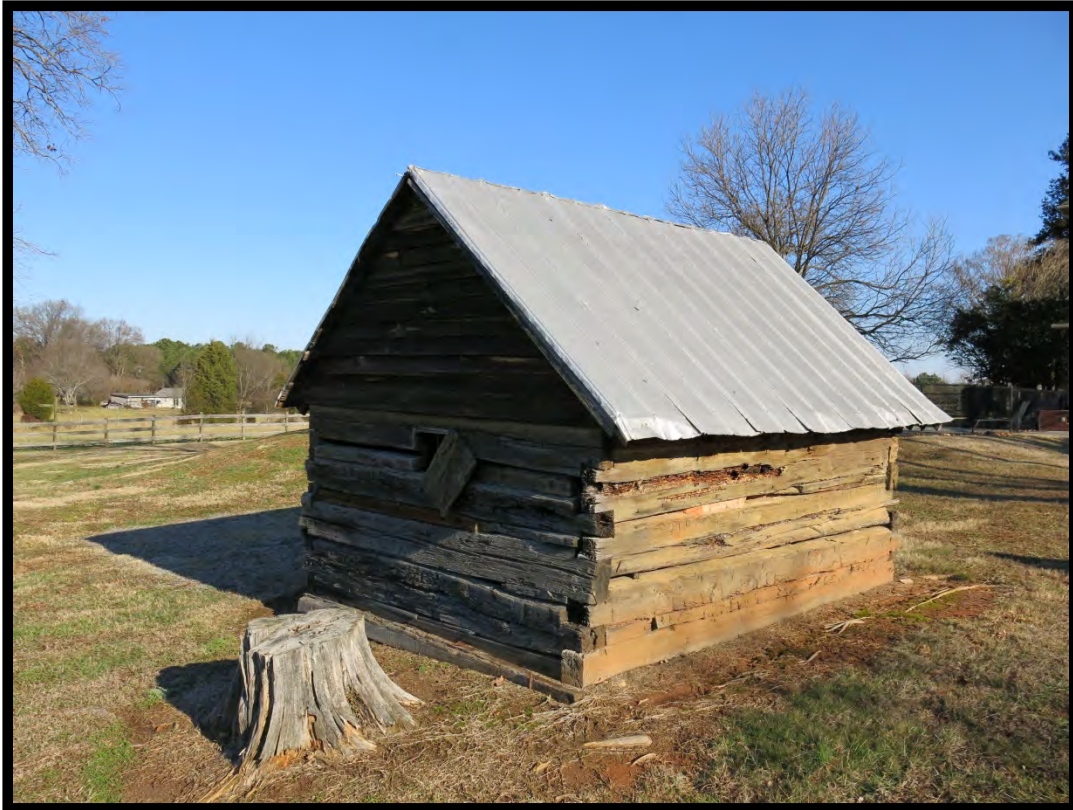
Figure 100: Johnson-Neel House (#123), Log Outbuilding (No. 4), Looking West.

Figure 101: Johnson-Neel House (#123), Log Outbuilding (No. 4), Looking North.

Located behind the house is an outbuilding constructed of sawn logs, with dovetail notches at the corners (Figure 100 and 101).

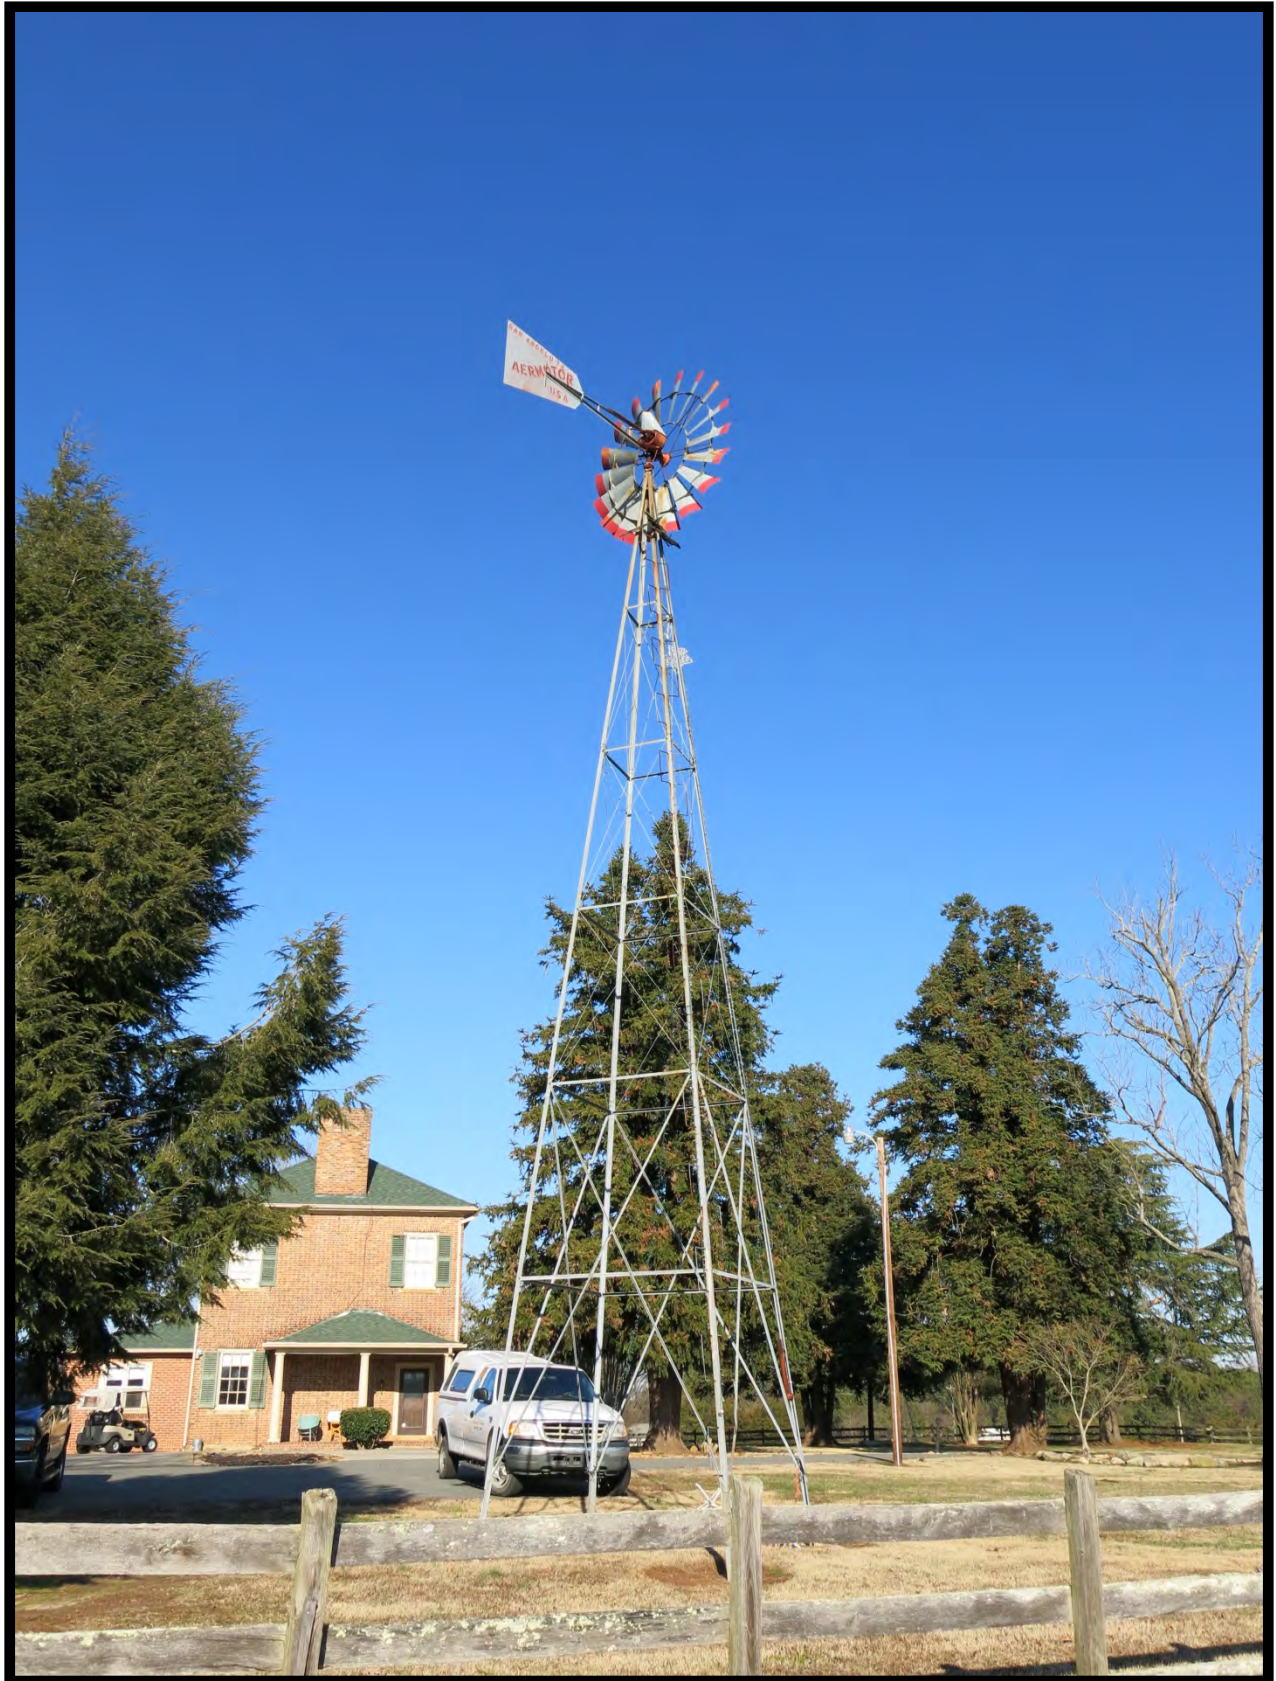
Figure 112: Johnson-Neel House (#123), Aermotor Windmill, Looking Northwest.

appears to be extant. Located southeast of the dwelling is a mid-twentieth-century, two-story, front-gabled, frame barn/garage with a partially open shed section off the southwest (side) elevation, and an enclosed shed section against the southeast (rear) gable end, which is currently used as an office (Figures 108 and 109). Located southwest of the barn is a small, nineteenth-century, front-gable, sawn-log outbuilding on a loose rubble foundation (Figures 110 and 111). Located northeast of the barn is an early-twentieth-century Aermotor windmill (Figure 112).

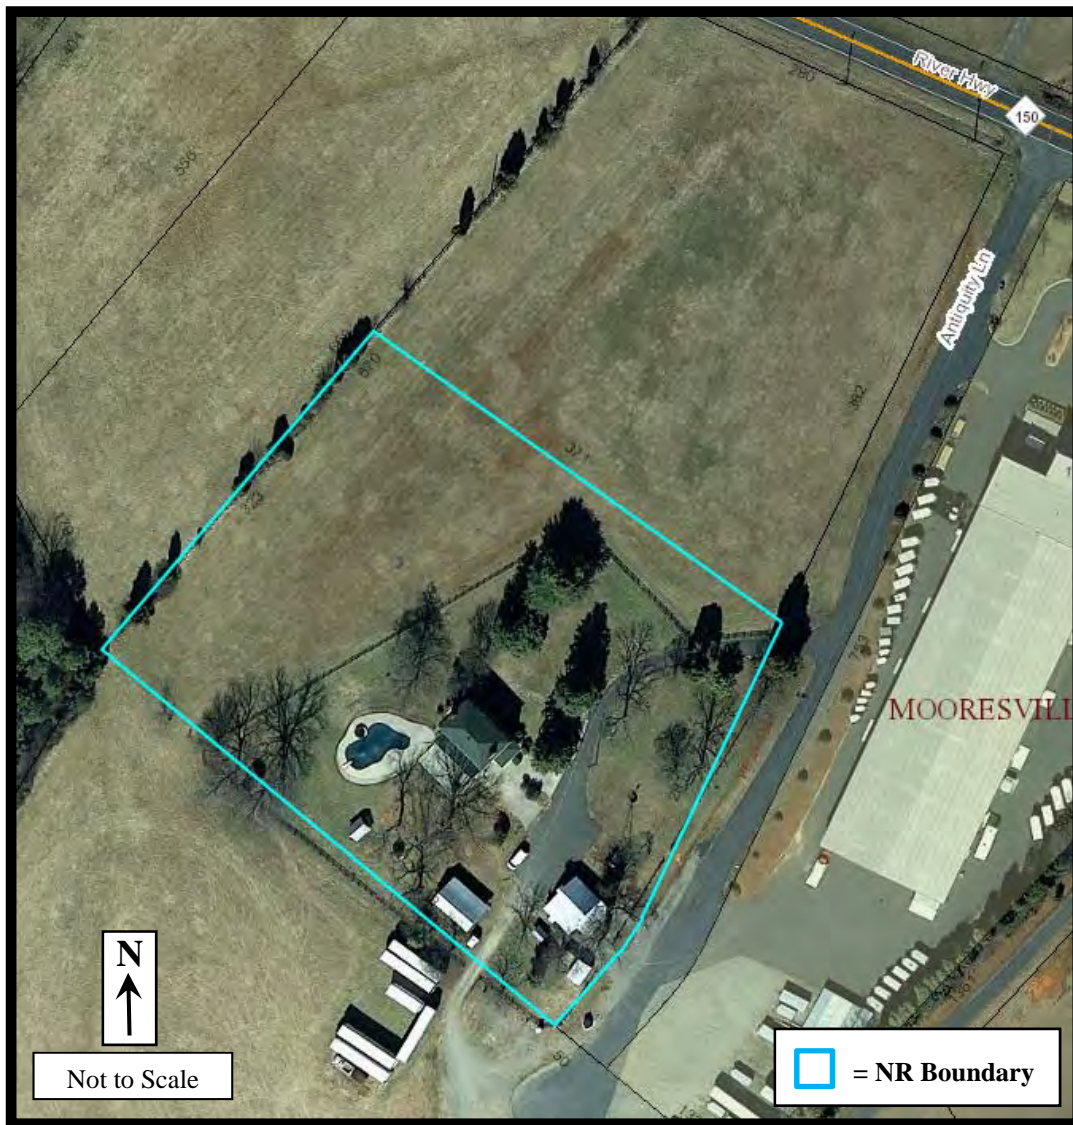
Figure 113: Aerial Map of the Johnson-Neel House, Showing the NRHP Boundary (ArcGIS Image Service 2013a).

The 1975 nomination focuses on a 9.9-acre parcel, which was not clearly defined. The current owners purchased the property in 1998, at which point it consisted of approximately 45.06 acres.²⁴ They have since subdivided the property, and a new proposed National Register boundary for the Johnson-Neel House has been drawn according to the guidelines of National Register Bulletin 21, *Defining Boundaries for National Register Properties*. The boundary is drawn to include the dwelling and the outbuildings as well as part of the surrounding landscaping that constitute the historic setting of the property and coincides with the current tax parcel. The proposed boundary contains approximately 3.2 acres. The legal property boundary is identified as parcel 4637972322.000 (Iredell County PIN) and does not follow, or abut, the ROW along NC 150 (Figure 113).
